CONDITION ASSESSMENT OF (FRP)
FIBER REINFORCED POLYMER
STRENGTHENING OF BRIDGE
COMPONENTS

MASTER OF SCIENCE IN CIVIL ENGINEERING

THE UNIVERSITY OF TEXAS AT ARLINGTON

December 2014

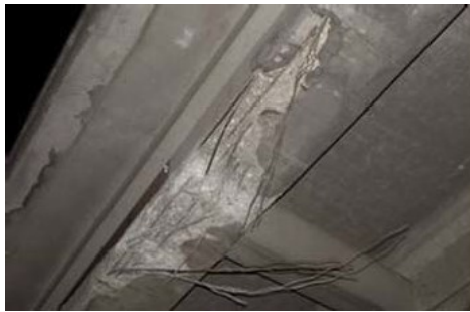
Figure 2-1 Damaged concrete girder (Image Courtesy: TXDOT)

Figure 2-1 shows a damaged concrete girder due to over height vehicle collision.

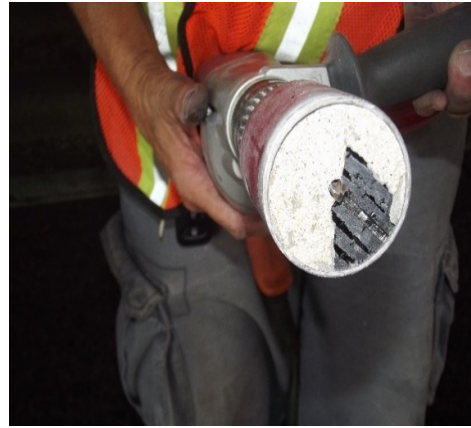
Figure 5-3 Core failure in sample 4 after drilling

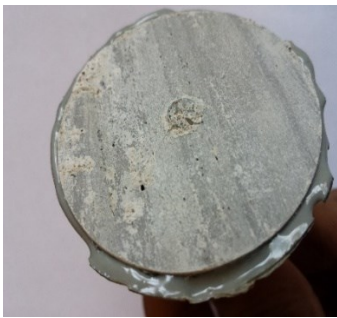
(a) Failure Mode F in sample 1

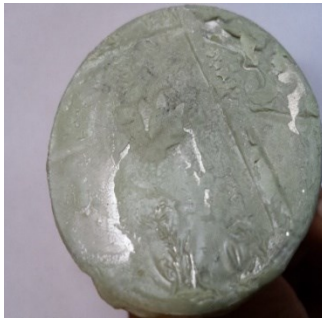
(b) Failure Mode A in sample 2

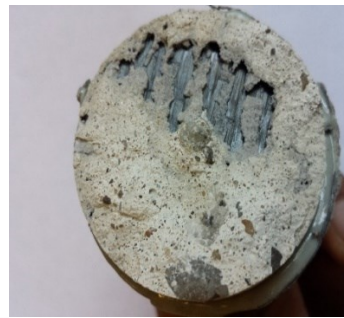
(c) Failure Modes G and C in sample 3

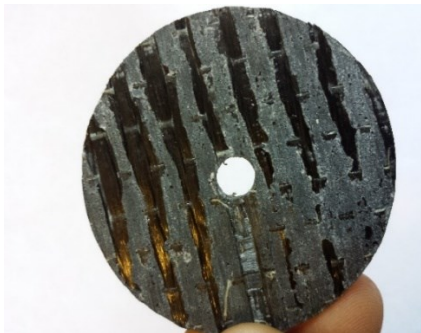
(d) Core failure in sample 4

* Test dolly came off glue at 281 psi. When area was cleaned for repair, it was found that the glue/FRP piece was loose and the entire 2 in. circle came off in one piece at concrete level.

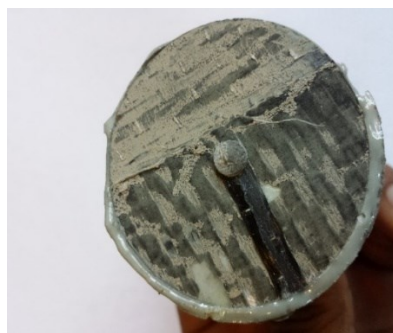
(e) Mixed failure mode in sample 5

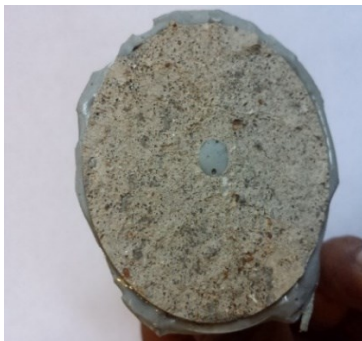
(a) Failure Mode G in sample 1

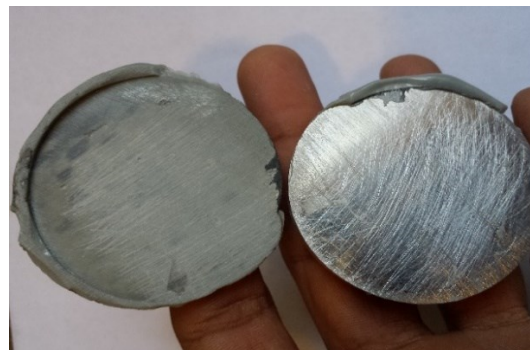
(b) Failure Mode A in sample 2

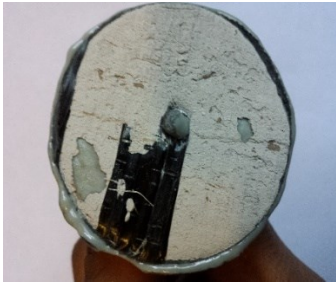
(a) Mixed failure Mode B in sample 1

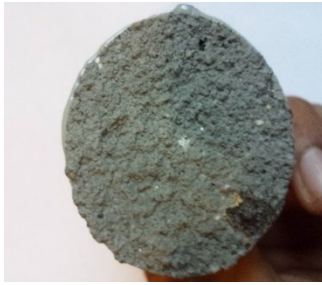
(b) Failure Mode G in sample 2

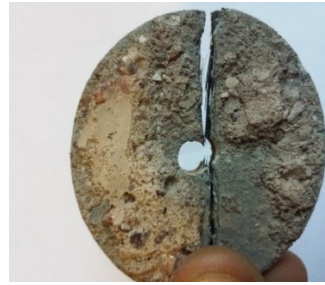
(c) Failure of core in sample 3

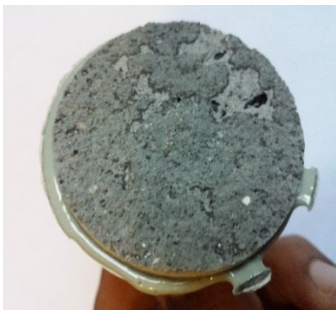
(d) Failure Mode G in sample 4

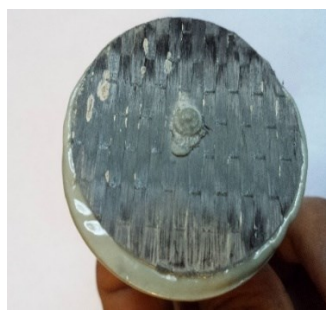
(e) Failure Mode C in sample 5

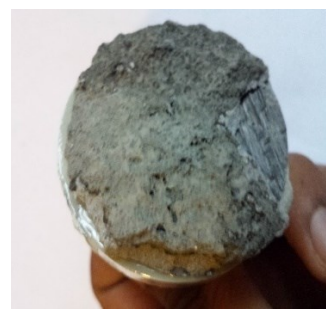
(f) Failure Mode F in sample 6

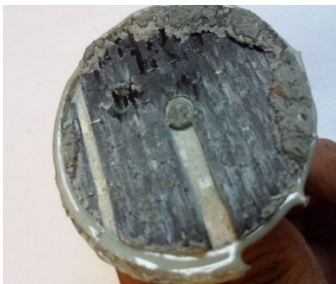
(g) Failure Modes F in sample 7

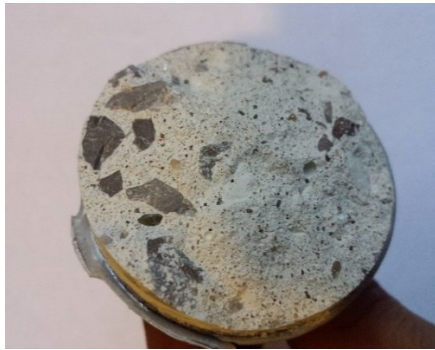
(a) Failure Mode G in sample 1

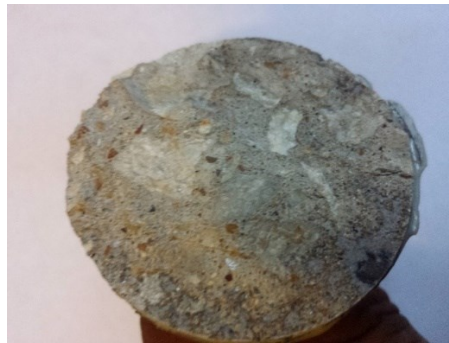
(b) Failure Mode G in sample 2

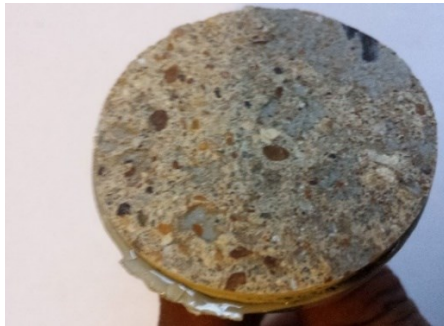
(a) Failure Mode G in sample 1

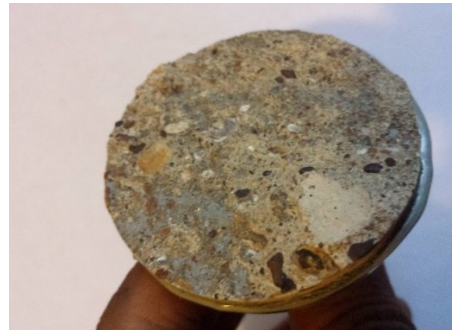
(b) Failure Mode G in sample 2

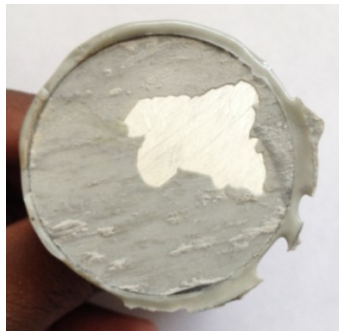
(a) Failure Mode A in sample 1

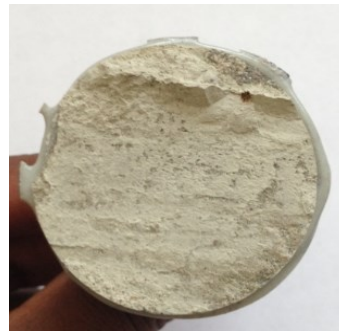
(b) Failure Modes F in sample 2

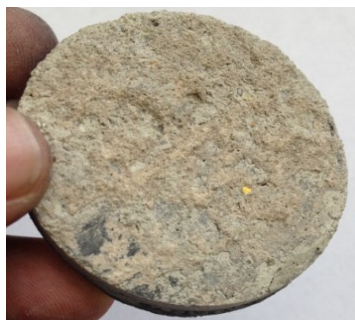
(c) Failure of core in sample 3

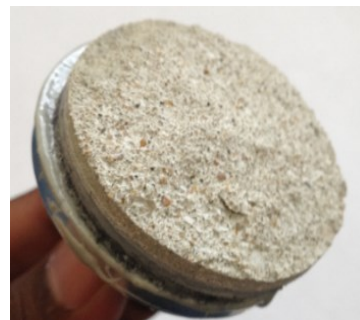
(d) Failure Mode G in sample 4

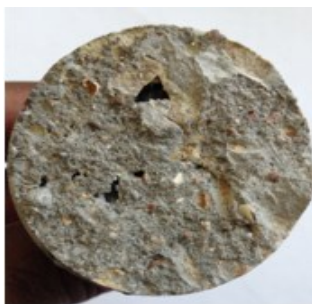
(a) Failure Mode G in sample 1

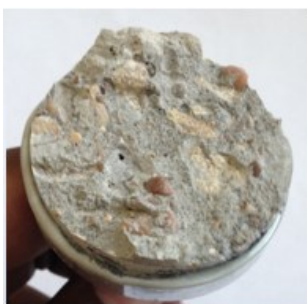
(b) Failure Mode G in sample 2

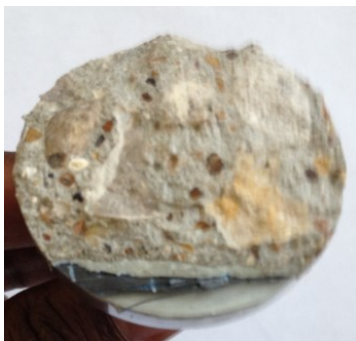
(a) Failure Mode G in sample 1

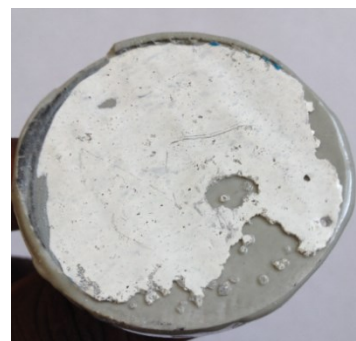
(b) Failure Mode G in sample 2
