ALGORITHM DEVELOPMENT FOR SEWER PIPE SYSTEM CONDITION
ASSESSMENT USING MULTI-SENSOR (MSI) TECHNOLOGY

ALGORITHM DEVELOPMENT FOR SEWER PIPE SYSTEM CONDITION ASSESSMENT USING MULTI-SENSOR (MSI) TECHNOLOGY

This study investigates the performance of all the current large-diameter pipeline system of The City of Arlington (COA) sewer lines of 48 miles (24-inch inner diameter and above for rigid and flexible pipes). Proper inspection and rehabilitation plan for the city sewer pipeline system are better choice for the municipality and tax payers in terms of cost than dealing with pipe damage and collapsing problems when they happen.

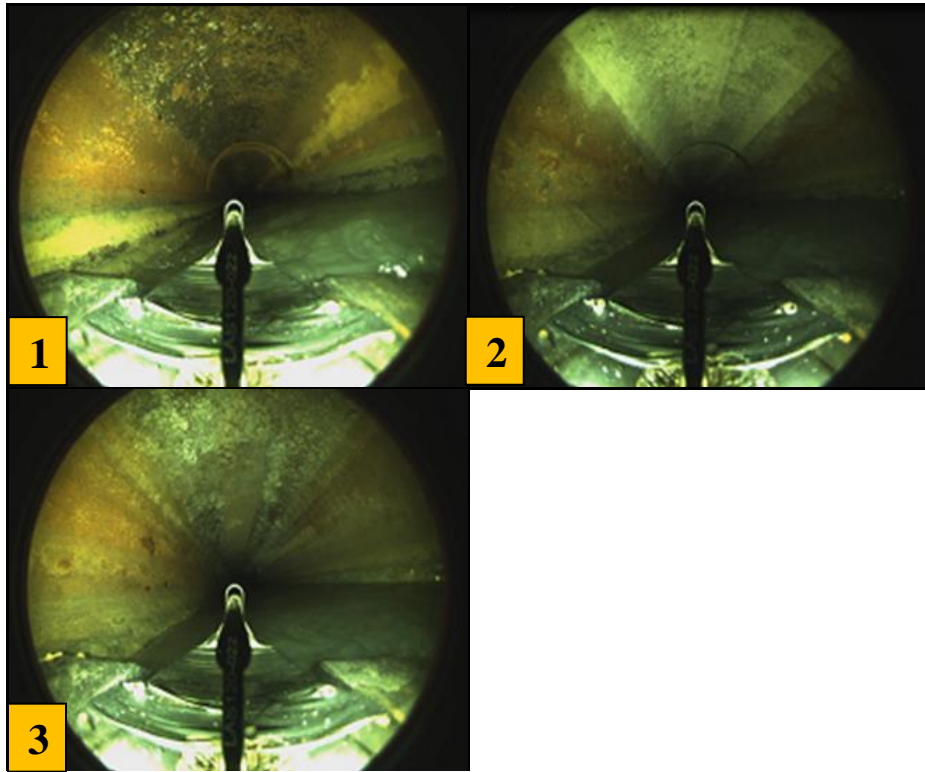
Figure A4-6 images from 1 through 3

SN	Distance (feet)	Video Ref.	Code Group/ Descriptor/ Modifier	Continuous Defect	Value			Joint	Circumferential Location		Img Reference	Remarks
					Dimension		%		At/From	To		
					1st	2nd						
1	0		AMH									
2	6		MWL			15%						
3	7.05			S01						1 TO 3		CORROSION
4	182.55			F01								CORROSION
5	182.55		MSA

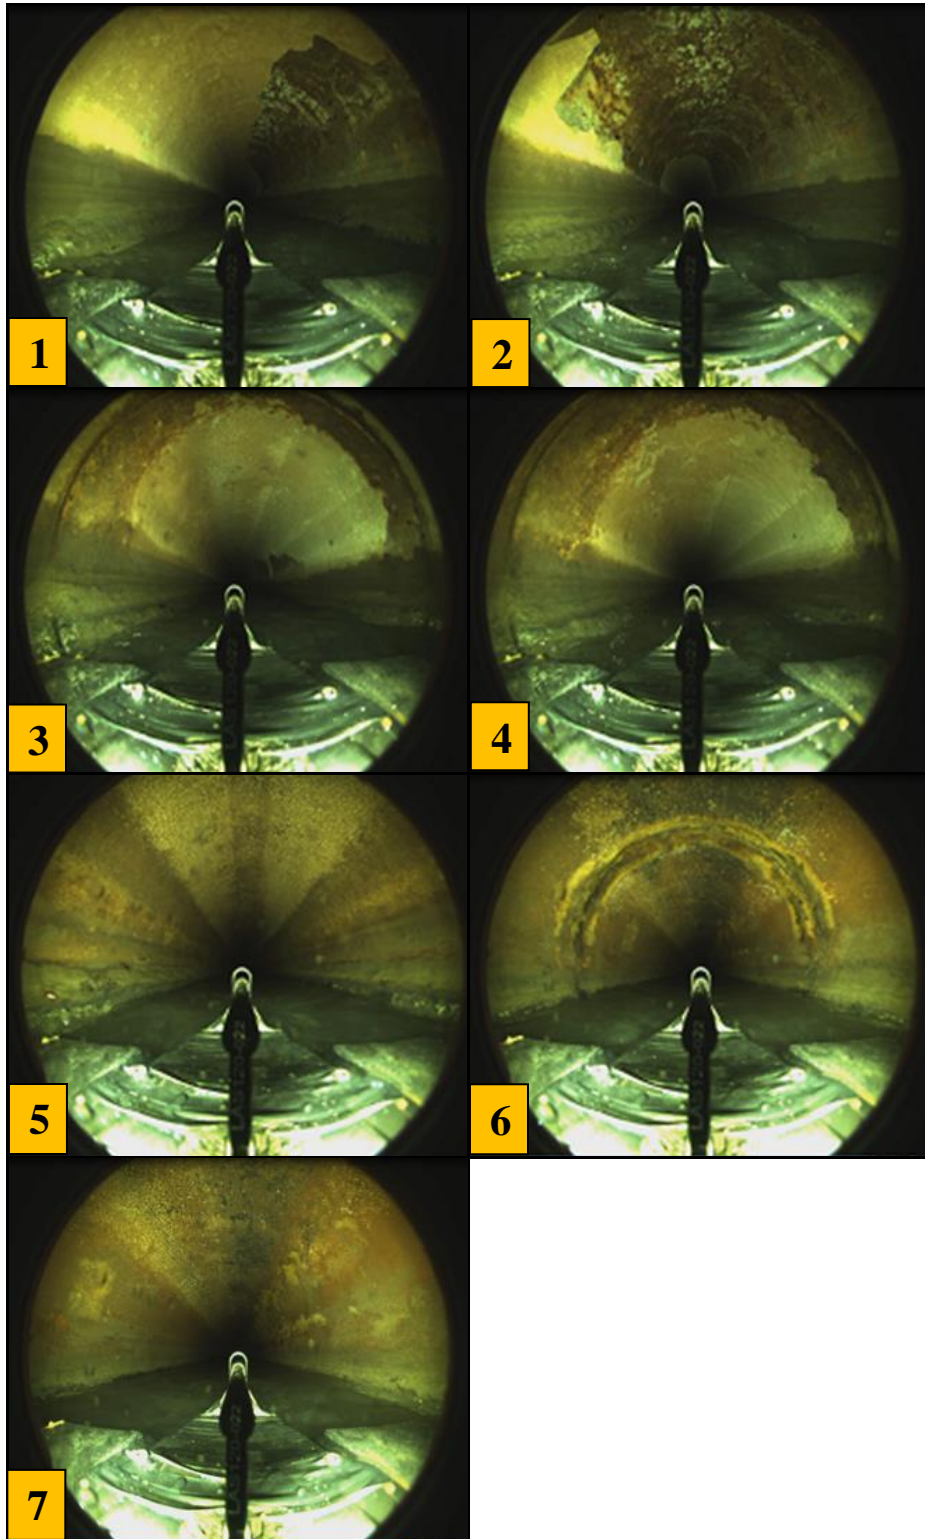
Figure A5-6 images from 1 through 7

SN	Distance (feet)	Video Ref.	Code		Continuous Defect	Value			Joint	Circumferential Location		Img Reference	Remarks
			Group/Descriptor/Modifier			Dimension		%		At/From	To		
						1st	2nd						
1	0		AMH										
2	6.1		MWL				5%						
3	32.5			S01							1		CORROSION
4	42.5			F01									CORROSION
5	51.25			S02							2		CORROSION
6	60.1			F02									CORROSION
7	66.5							J			3		CORROSION
8	86.6							J			4		CORROSION
9	279.5		DAE	S03			5%				5		
10	313.45			F03									
11	373.8							J			6		CORROSION
12	375.6			S04							7		CORROSION
13	470.3			F04									CORROSION
14	470.3		MSA

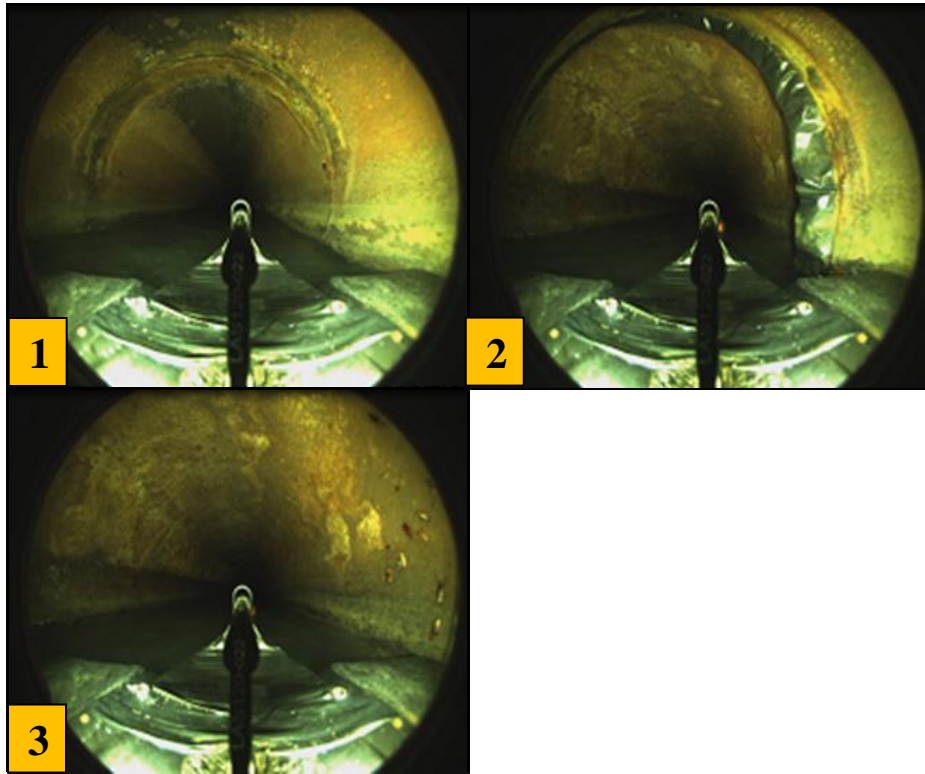
Figure A6-6 images from 1 through 3

SN	Distance (feet)	Video Ref.	Code Group/ Descriptor/ Modifier	Continuous Defect	Value			Joint	Circumferential Location		Img Reference	Remarks
					Dimension		%		At/From	To		
					1st	2nd						
1	0		AMH									
2	4.45		MWL				5%					
3	104.45							J			1	CORROSION
4	146.5		MGO								2	THE PIPE DIRECTION HAS CHANGED
5	146.5		ISGT				5%	J			2	
6	147.3			S01							3	CORROSION
7	155.3			F01								CORROSION
8	155.3		MSA

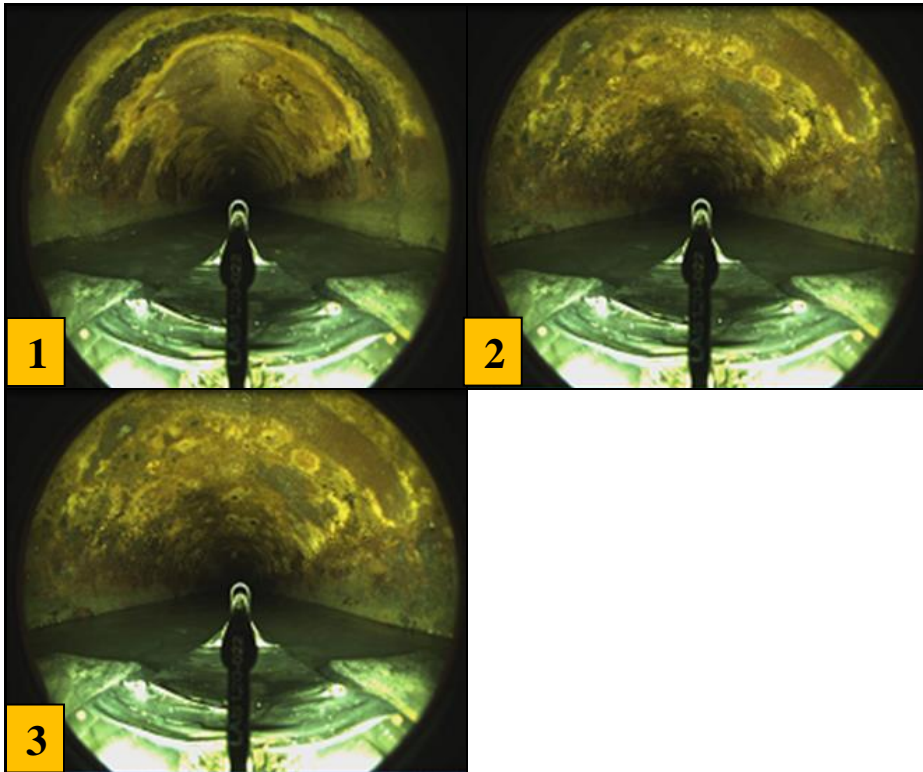
Figure A7-4 images from 1 through 3

SN	Distance (feet)	Video Ref.	Code	Continuous Defect	Value			Joint	Circumferential Location		Img Reference	Remarks
			Group/Descriptor/Modifier		Dimension		%		At/From	To		
					1st	2nd						
1	0		AMH									
2	0.4		MWL			10%						
5	97.35			S01						1	CORROSION	
6	105.7			F01							CORROSION	
7	220.85						J			2	CORROSION	
8	310.6			S02						3	CORROSION	
9	320.2			F03							CORROSION	
10	320.2		MSA

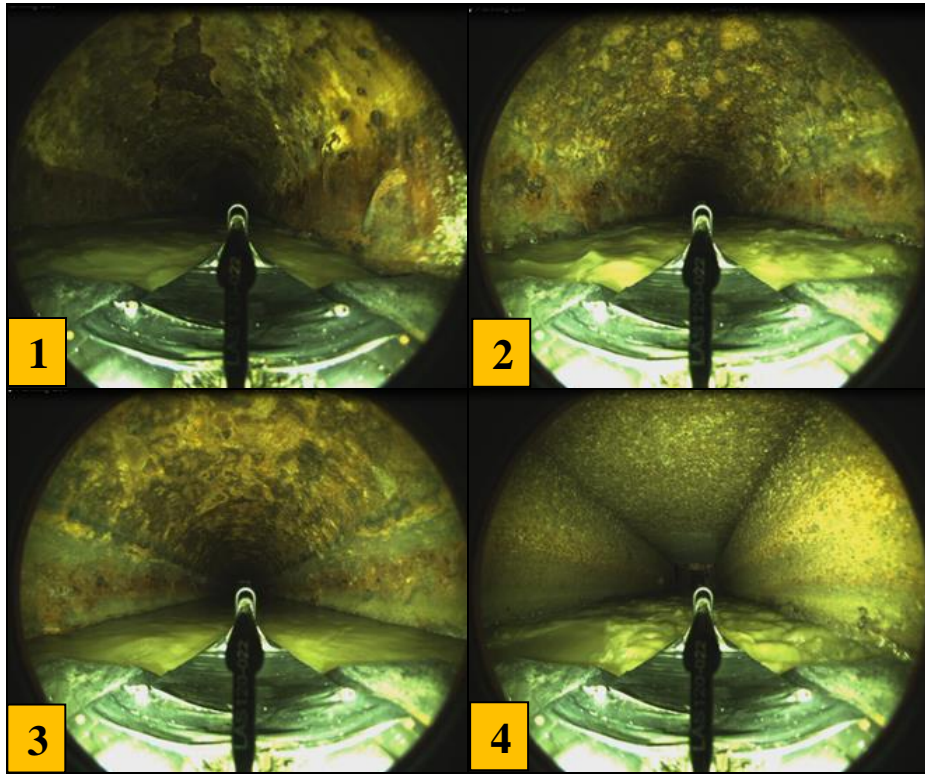
Figure A8-6 images from 1 through 4

SN	Distance (feet)	Video Ref.	Code Group/ Descriptor/ Modifier	Continuous Defect	Value			Joint	Circumferential Location		Img Reference	Remarks
					Dimension		%		At/From	To		
					1st	2nd						
1	0		AMH									
2	0		MWL				20%					
3	5.1			S01						1 TO 3		CORROSION
4	44.4			F01								CORROSION
5	45		MMC							4		MATERIAL HAS CHANGED TILL THE END
6	56.25		MSA

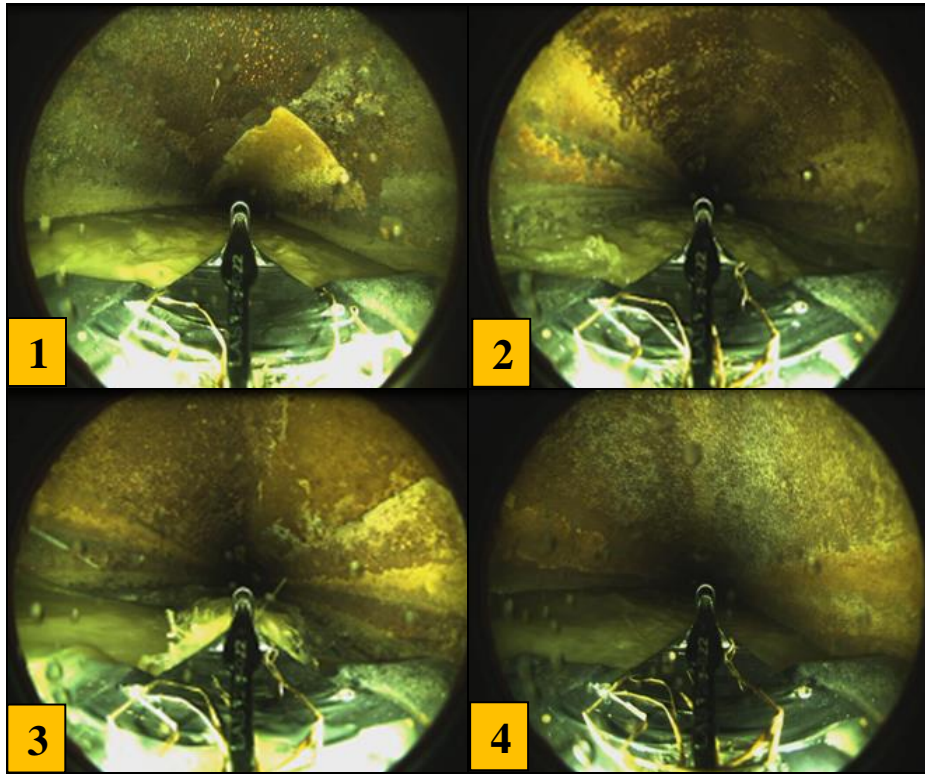
Figure A10-4 images from 1 through 4

SN	Distance (feet)	Video Ref.	Code Group/ Descriptor/ Modifier	Continuous Defect	Value			Joint	Circumferential Location		Img Reference	Remarks
					Dimension		%		At/From	To		
					1st	2nd						
1	0		AMH									
2	6.3		MWL			10%						
3	6.6			S01						1 TO 5	CORROSION	
4	729.75			F01							CORROSION	
5	729.75		MSA

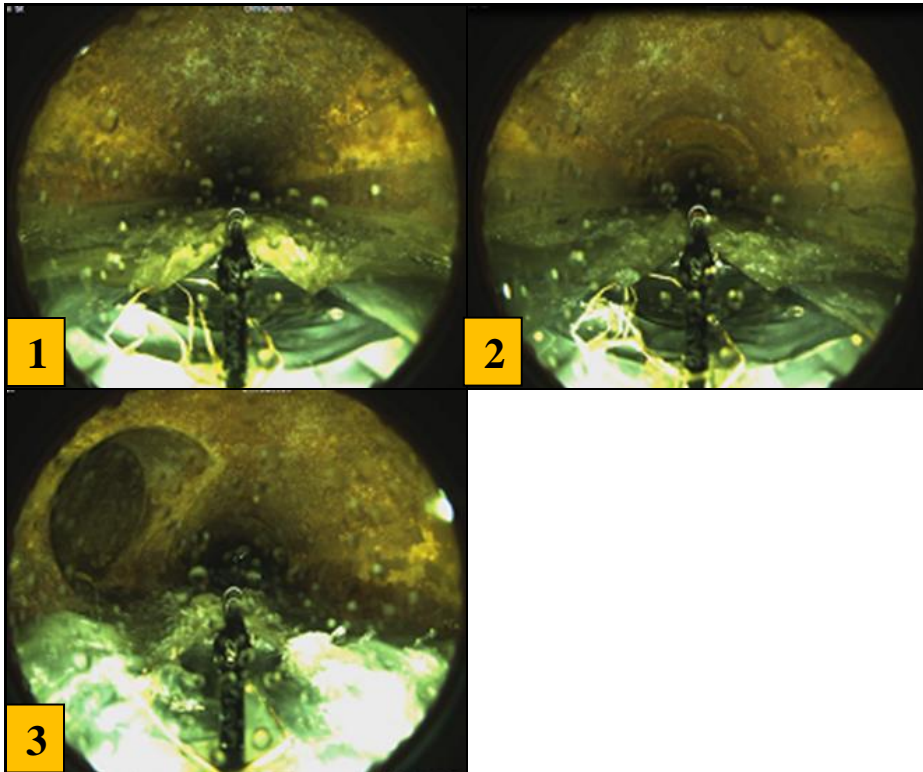
Figure A12-1 images from 1 through 3

SN	Distance (feet)	Video Ref.	Code	Continuous Defect	Value			Joint	Circumferential Location		Img Reference	Remarks
			Group/ Descriptor/ Modifier		Dimension		%		At/From	To		
					1st	2nd						
1	0		AMH									
2	0.9		MWL				10%					
3	733.8			S01						1	CORROSION	
4	746.6			F01							CORROSION	
5	796.95									2	CORROSION	
6	983.7		TBA					9	12	3		
7	993.6		MSA

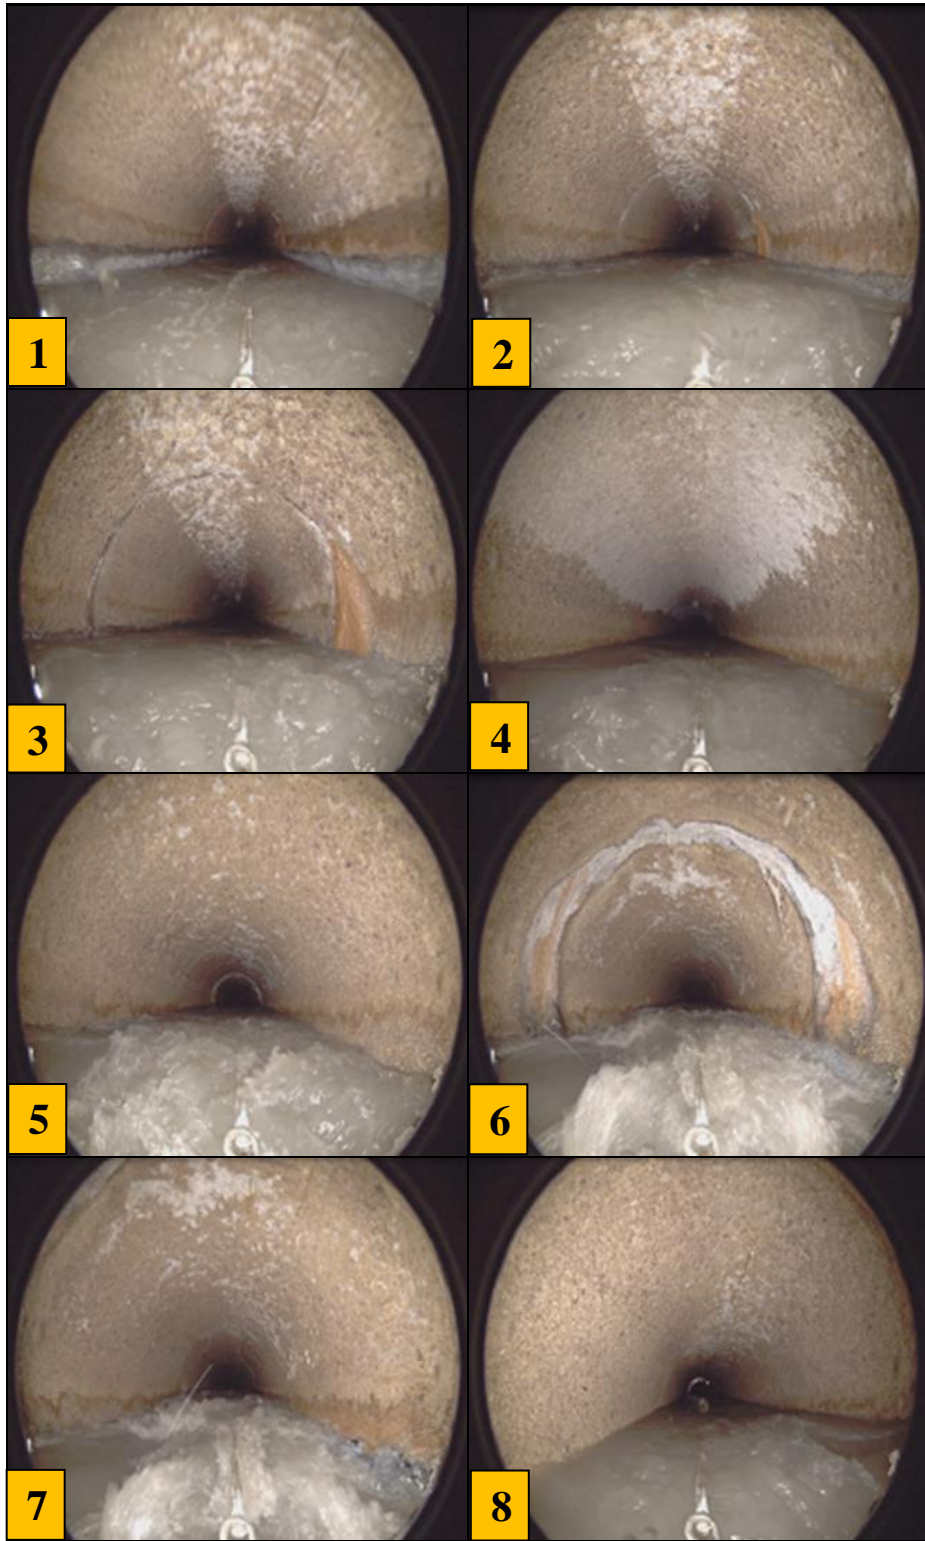
Figure A12-7 images from 1 through 9

SN	Distance (feet)	Video Ref.	Code	Continuous Defect	Value			Joint	Circumferential Location		Img Reference	Remarks
			Group/Descriptor/Modifier		Dimension		%		At/From	To		
					1st	2nd						
1	0		AMH									
2	6.1		MWL				10%					
3	6.1		SRV								1	
4	7.75		SAV	S01							2,4,5	
5	9.8							J			3	MUD INTRUDING
6	160.45							J			6	MUD INTRUDING
7	161.9		SRV								7	
8	186.7		SRV	S02							8	
9	193.8		SRV	F02								
9	202.65		SAV	F01							9	
10	205.3		MSA

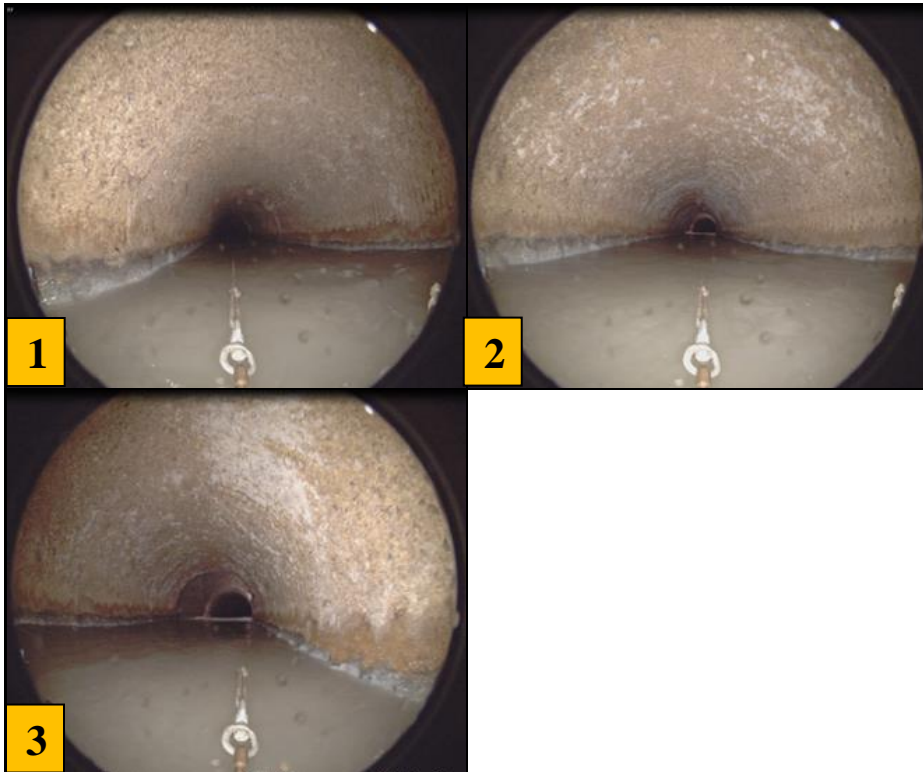
Figure A14-5 images from 1 through 3

SN	Distance (feet)	Video Ref.	Code	Continuous Defect	Value			Joint	Circumferential Location		Img Reference	Remarks
			Group/ Descriptor/ Modifier		Dimension		%		At/From	To		
					1st	2nd						
1	0		AMH									
2	1.45		MWH				10%					
3	1.45		SAV	S01								
3	36.5		SRV	S02						1 TO 3		
4	55.1		SRV	F02								
4	83.05		SRV							2		
5	102.6		SAV	F01								
6	102.6		MSA

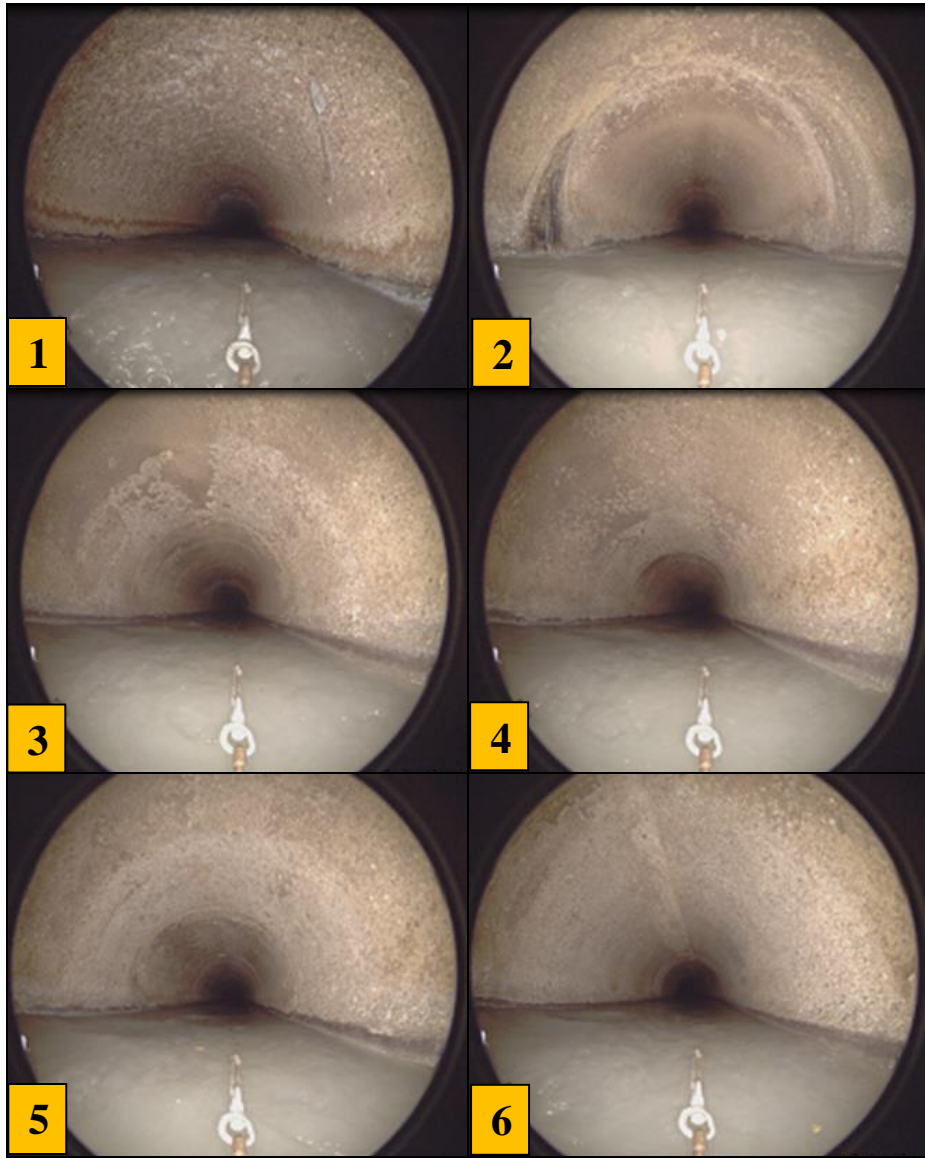
Figure A15-5 images from 1 through 6

SN	Distance (feet)	Video Ref.	Code Group/ Descriptor/ Modifier	Continuous Defect	Value			Joint	Circumferential Location		Img Reference	Remarks
					Dimension		%		At/From	To		
					1st	2nd						
1	0		AMH									
2	0.05		MWL			15%						
3	5.35		SAV	S01							1 TO 6	
4	1237		IDJ								2	
5	2688.7		SAV	F01								
6	2688.7		MSA

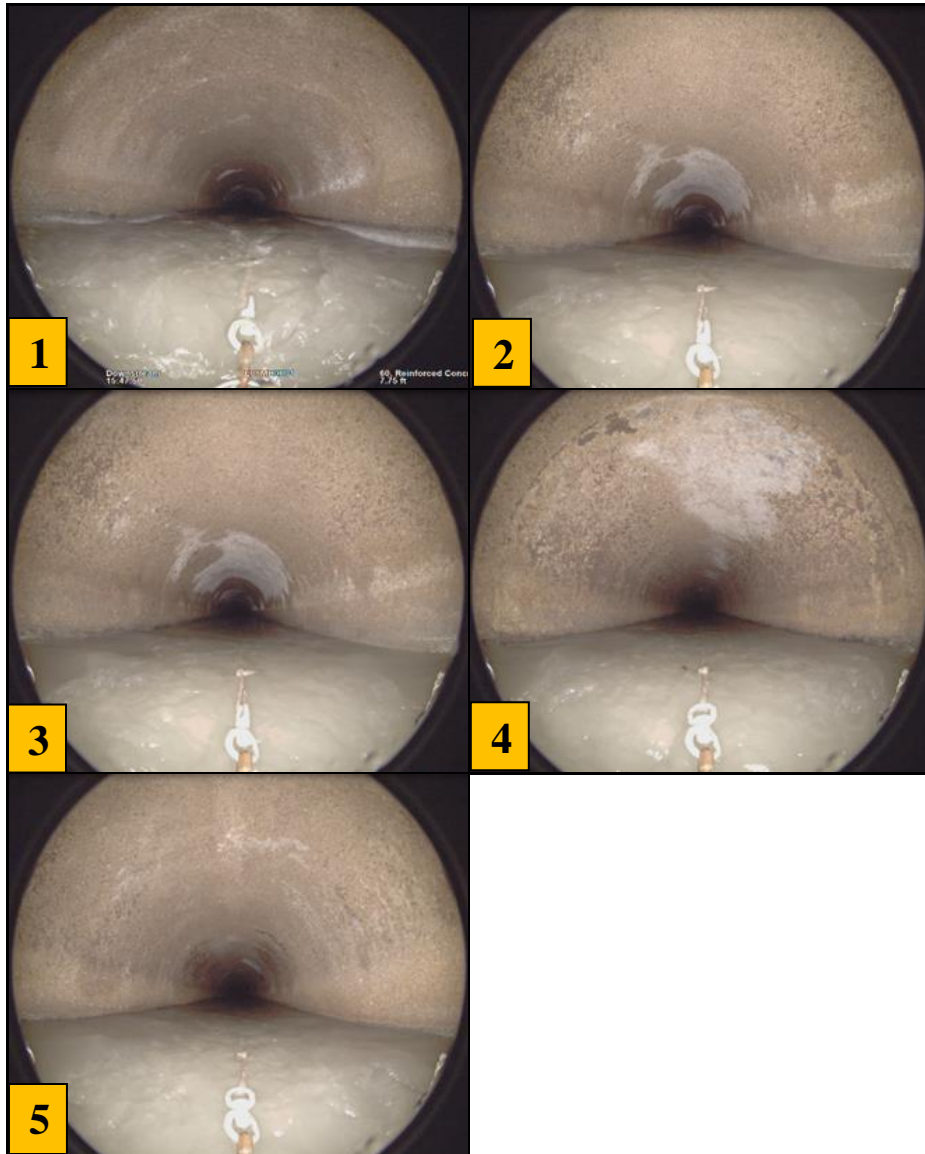
Figure A16-5 images from 1 through 5

SN	Distance (feet)	Video Ref.	Code Group/ Descriptor/ Modifier	Continuous Defect	Value		Joint	Circumferential Location		Img Reference	Remarks	
					Dimension			%	At/From			To
					1st	2nd						
1	0		AMH									
2	7.5		MWL			15%						
3	7.5		SAV	S01						1 TO 5		
4	626		SAV	F01								
5	626		MSA

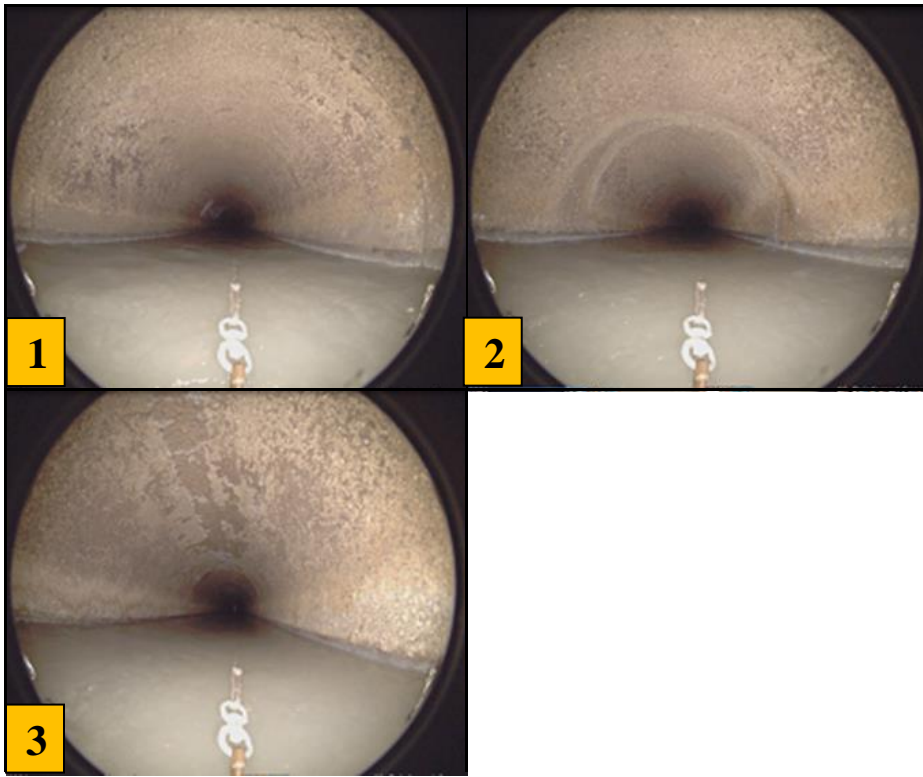
Figure A17-7 images from 1 through 3

SN	Distance (feet)	Video Ref.	Code	Continuous Defect	Value			Joint	Circumferential Location		Img Reference	Remarks
			Group/Descriptor/Modifier		Dimension		%		At/From	To		
					1st	2nd						
1	0		AMH									
2	6		MWL			15%						
3	6		SAV	S01						1,3		
4	277.6		IDJ							2		
5	1220.45		SAV	F01								
6	1220.45		MSA

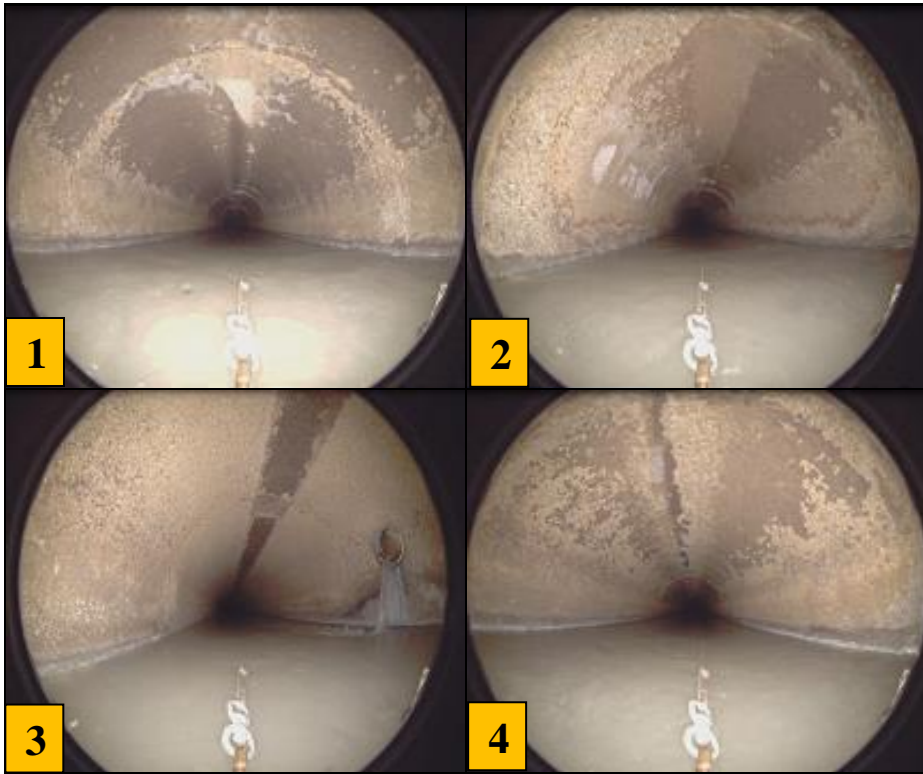
Figure A18-7 images from 1 through 4

SN	Distance (feet)	Video Ref.	Code	Continuous Defect	Value			Joint	Circumferential Location		Img Reference	Remarks
			Group/ Descriptor/ Modifier		Dimension		%		At/From	To		
					1st	2nd						
1	0		AMH									
2	0.85		MWL				10%					
3	0.85		SAV	S01						1 TO 4		
4	1306.35		TBA					12	3	3		
5	2035.55		SAV	F01								
6	2035.55		MSA

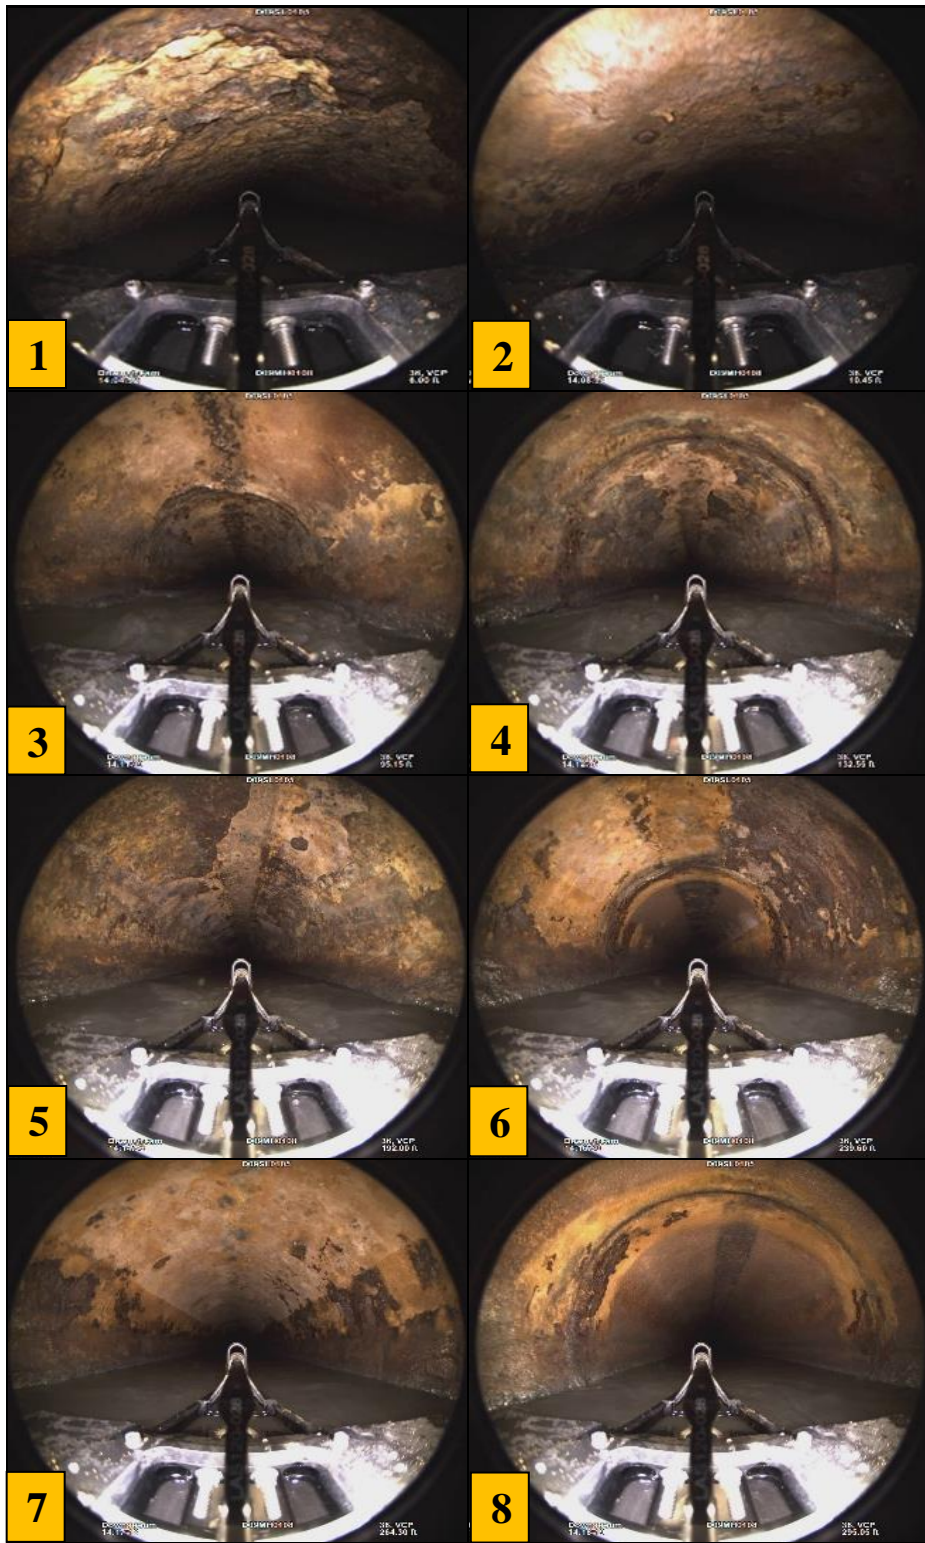
Figure A19-6 images from 1 through 8

27	545.4		DAE	F10						20		
28	545.4		DAG	F09						20		
29	562.6		DAE	S11		10%				16		
30	562.6		DAG	S12		10%				16		
31	581.05		DAE	F11						21		
32	581.05		DAG	F12						21		
33	590.85		MSA

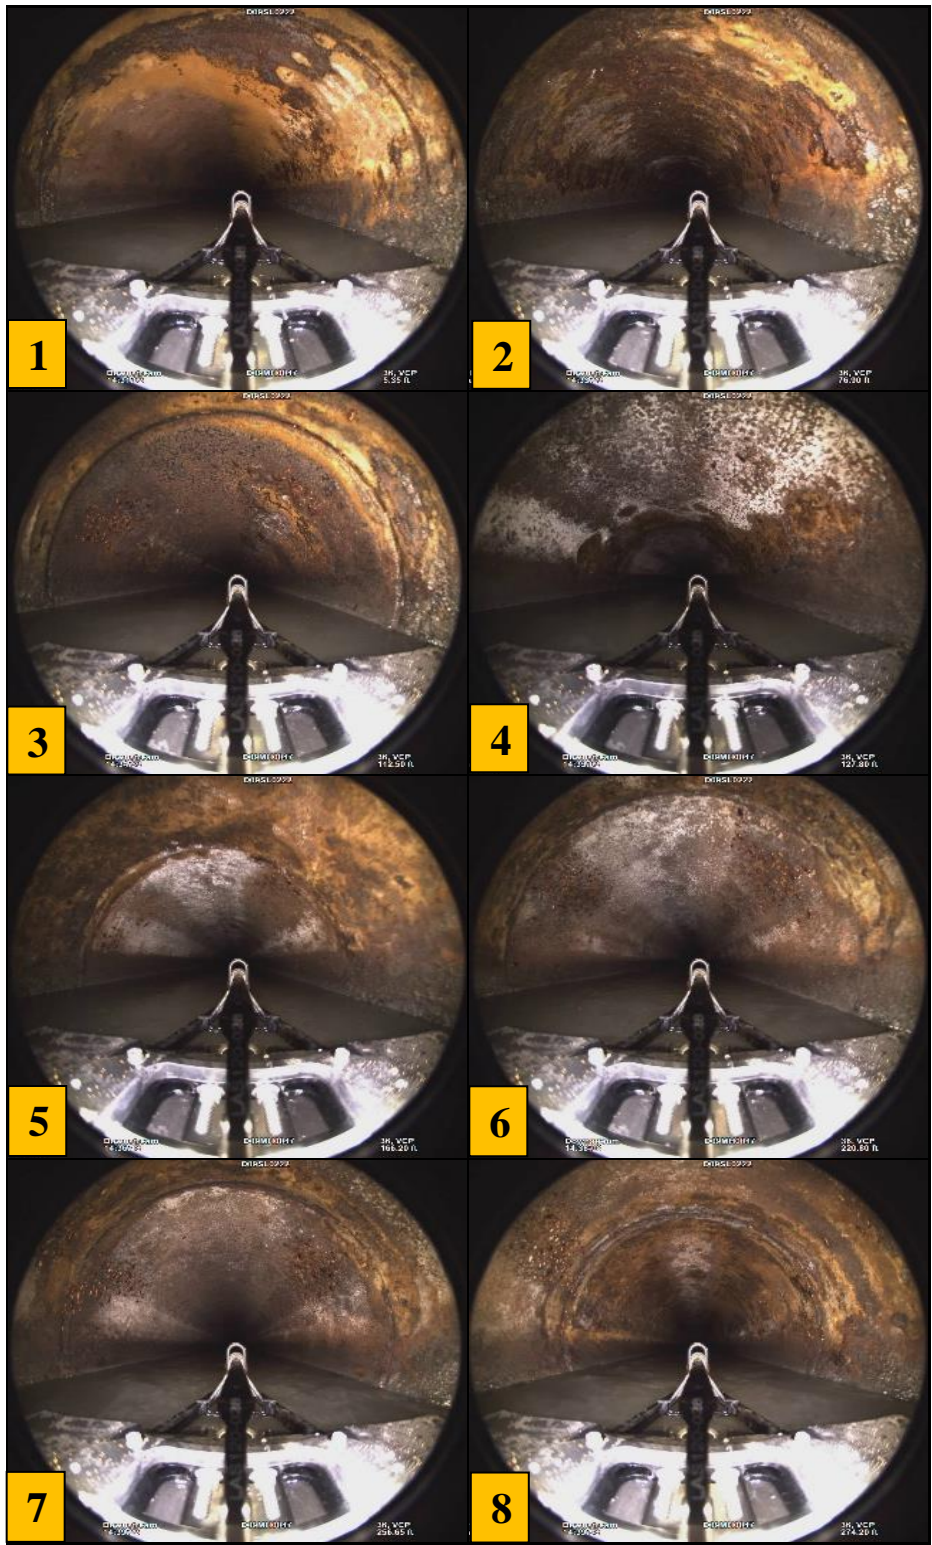
Figure A20-6 images from 1 through 8

SN	Distance (feet)	Video Ref.	Code Group/ Descriptor/ Modifier	Continuous Defect	Value		Joint	Circumferential Location		Img Reference	Remarks	
					Dimension			%	At/From			To
					1st	2nd						
1	0		AMH									
2	0		MWL			30%						
3	5.35		DAG	S01		10%				1		
4	43		DAG	F01						17		
5	76.9		DAG	S02		10%				2		
6	95.2		DAG	F02						18		
7	112.5		DAG	S03		10%				3		
8	127.8		DAE	S04		15%				4		
9	132		DAG	F03						19		
10	166.2		DAG			10%				5		
11	220.8		DAG			10%				6		
12	239.75		DAE	F04						20		
13	256.65		DAG			5%				7		
14	274.2		DAG	S05		10%				8		
15	292.95		DAG	F05						21		
16	309.6		DAG			5%	J			9		
17	379.9		DAG			5%	J			10		
18	412.45		DAG	S06		5%				11		
19	415.1		DAG	F06						22		
20	450.65		DAG	S07		10%				12,13		
21	642.05		DAG	F07						23		
22	663.7		DAG			5%				14		
23	681.85		DAG	S09		10%				15,24		
24	700		DAG	F09						25		
25	721.3		DAG	S10		5%				16		
26	735.4		DAG	F10						26		
27	747.2		MSA

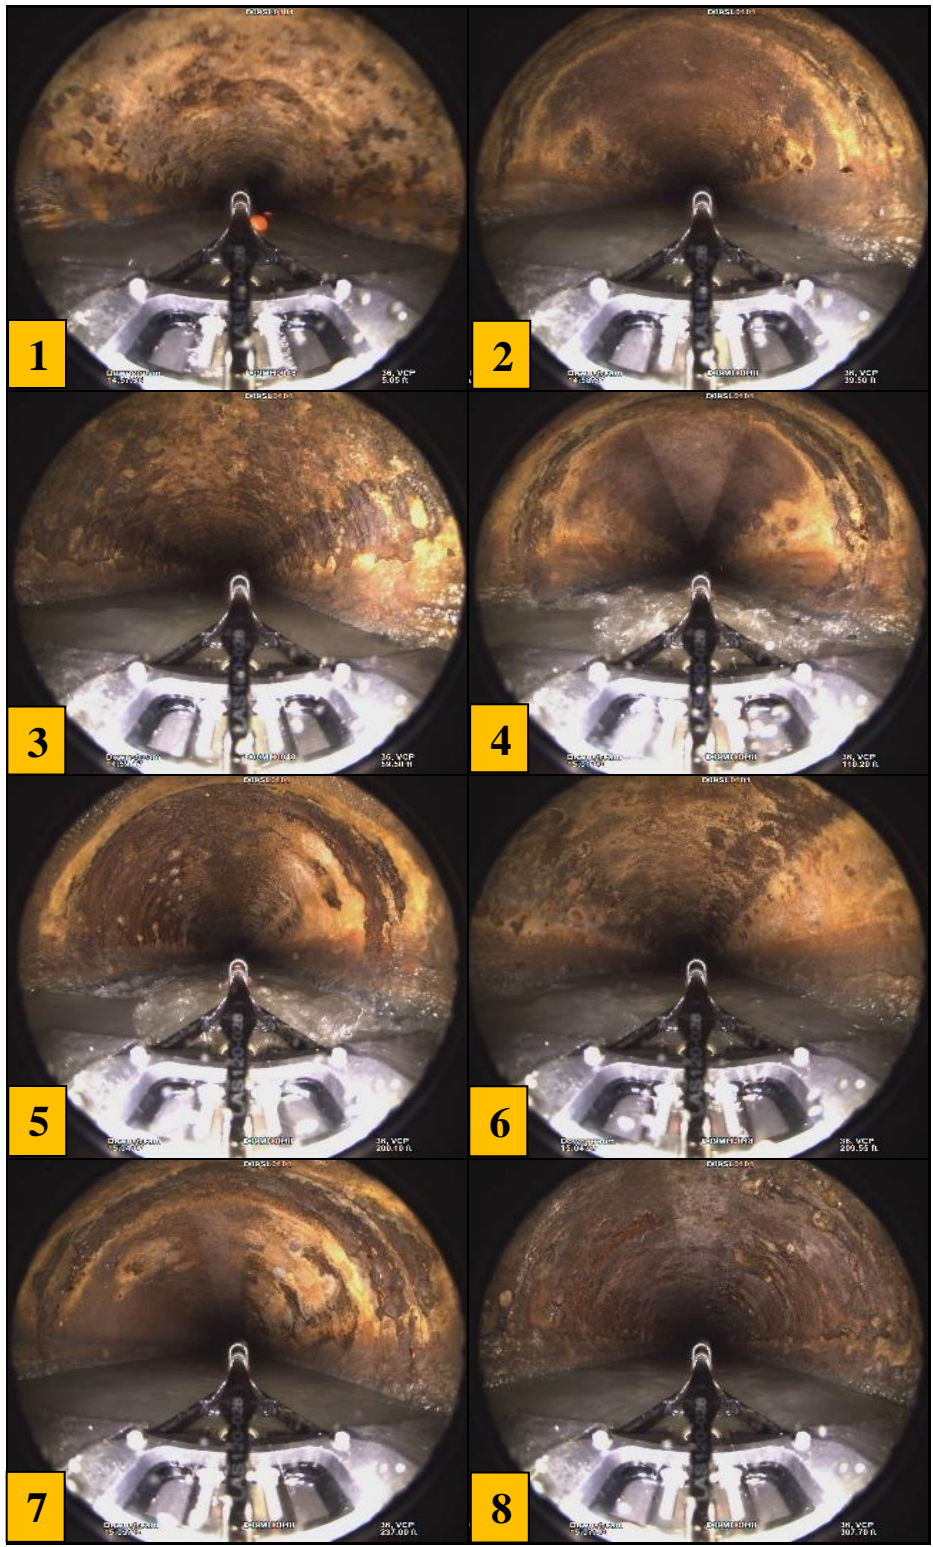
Figure A21-6 images from 1 through 8

SN	Distance (feet)	Video Ref.	Code Group/ Descriptor/ Modifier	Continuous Defect	Value		Joint	Circumferential Location		Img Reference	Remarks	
					Dimension			%	At/From			To
					1st	2nd						
1	0		AMH									
2	0		MWL			20%						
3	5.05		DAG	S01		10%				1		
4	22.05		DAG	F01						9		
5	39.5		DAG, DAE	S02		5 TO 20%				2,3		
6	93.15		DAG, DAE	F02						10		
7	110.2		DAG	S03		5%				4		
8	183.9		DAG	F03						11		
9	200.1		DAG	S04		10%				5,6		
10	219.7		DAG	F04						12		
11	237		DAG	S05		10%				7		
12	273.25		DAG	F05						13		
13	307.7		DAG	S06		20%				8		
14	326.1		DAG	F06						14		
15	353.45		MSA

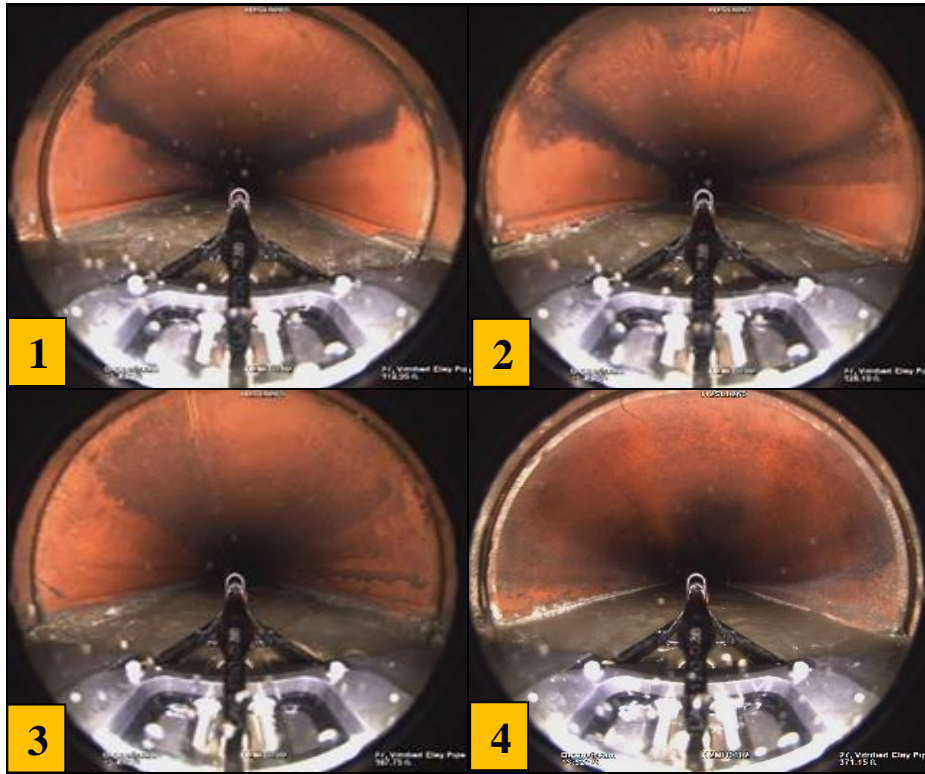
Figure A20-6 images from 1 through 4

SN	Distance (feet)	Video Ref.	Code Group/ Descriptor/ Modifier	Continuous Defect	Value			Joint	Circumferential Location		Img Reference	Remarks
					Dimension		%		At/From	To		
					1st	2nd						
1	0		AMH									
2	0		MWL				5%					
3	112.95		FL	S01				J			1,8	LASER DOESN'T SHOW FRACTURE MOVEMENT
4	118		FL	F01							2	
5	128.1		FL	S02							3	
6	133.05		FL	F02							4	
7	187.75		FL	S03				J			5,9	LASER DOESN'T SHOW FRACTURE MOVEMENT
8	192.6		FL	F03							6	
9	371.15		FL					J			7,10	LASER DOESN'T SHOW FRACTURE MOVEMENT
10	464.05		MSA

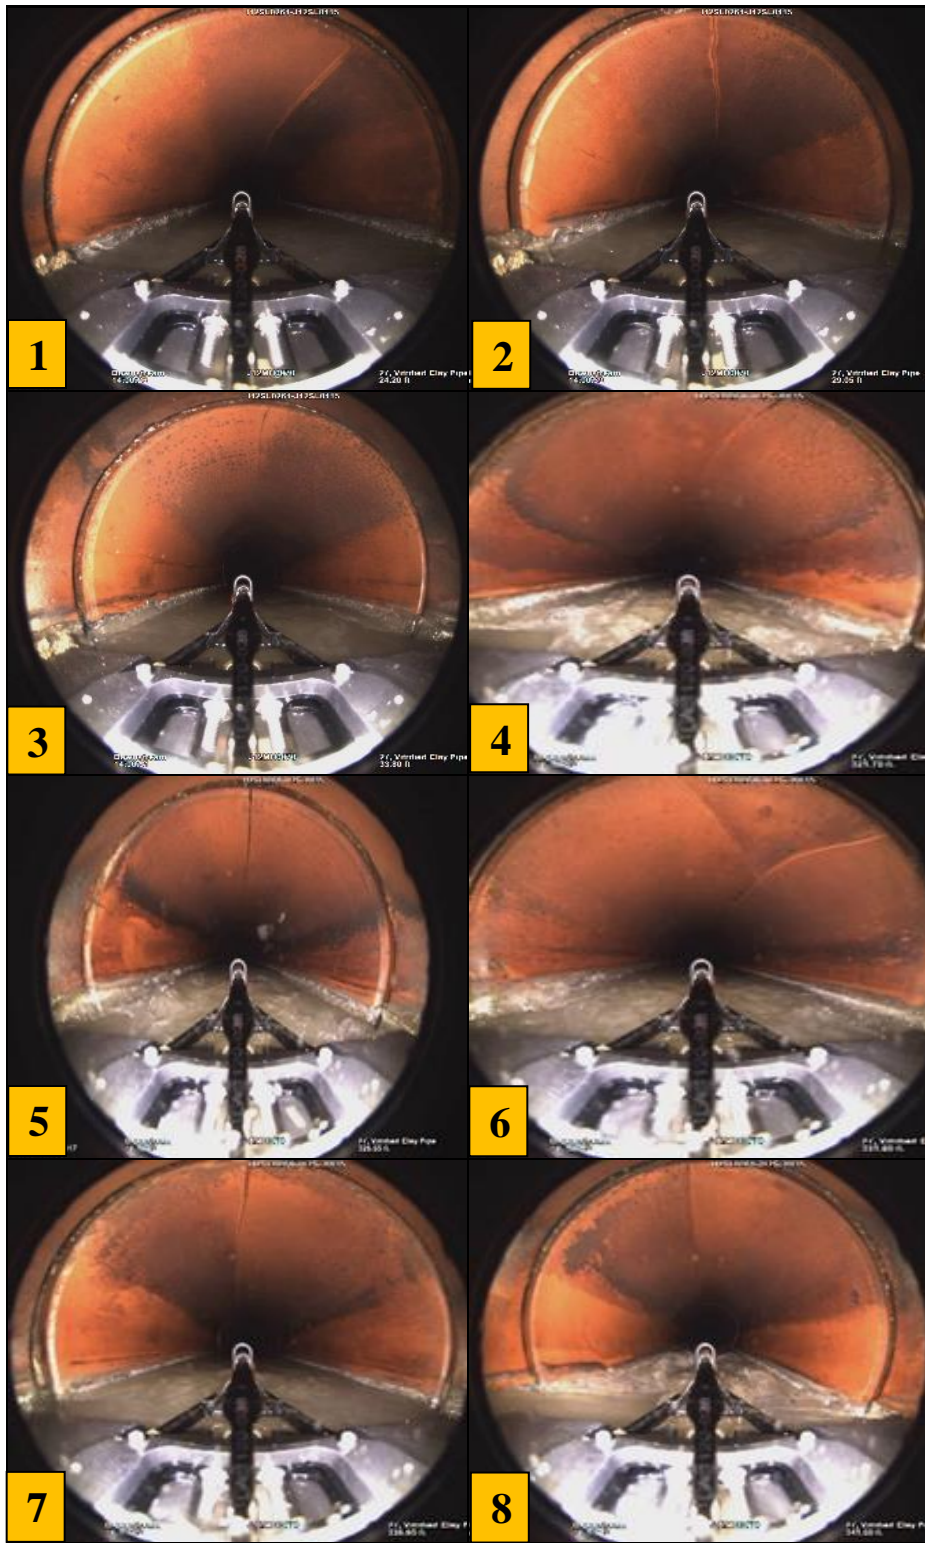
Figure A24-6 images from 1 through 8

33	386.55		FL	F15				J		15	
34	386.55		FL	S16				J		15,32	LASER DOESN'T SHOW FRACTURE MOVEMENT
35	391.45		FL	F16						16	
36	475.5		DAE				5%	J		17	
37	478.7		MSA

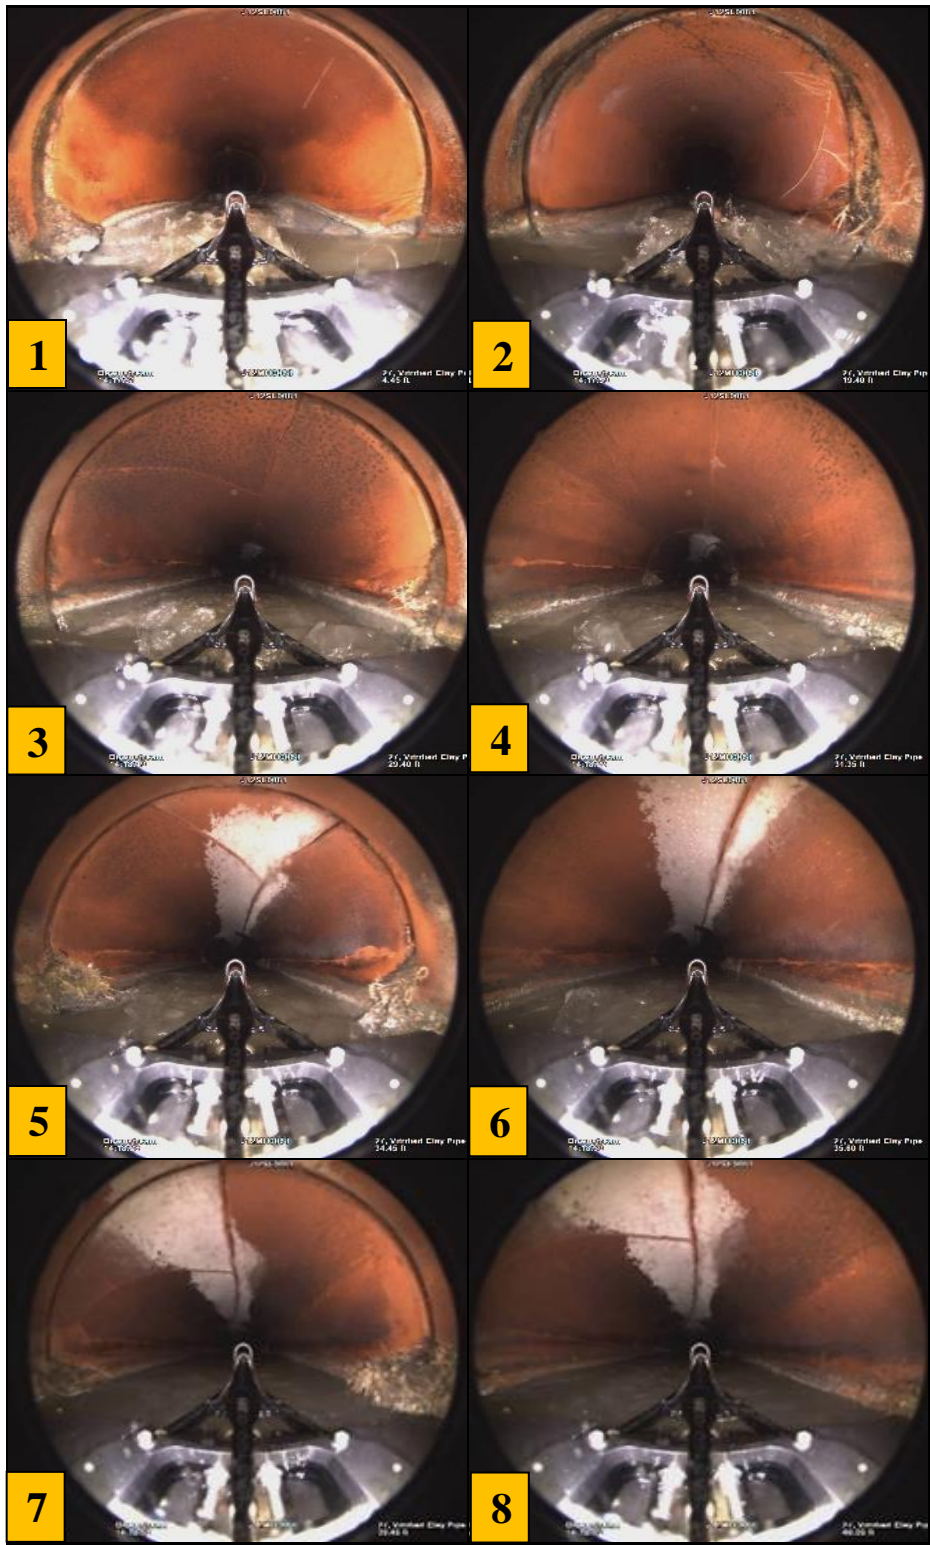
Figure A25-6 images from 1 through 8

40	103.5		FL	F11						19	
41	103.5		FM				J			19,49	LASER SHOWS VERY VERY LITTLE HORIZONTAL FRACTURE MOVEMENT
42	104.95		FL	S12			J			19,64	LASER SHOWS VERTICAL MOMENT AND LASER RING DEFORMED
43	108.4		FL	F12						20	
44	108.4		FM				J			20,50	LASER SHOWS VERTICAL FRACTURE MOVEMENT AND LASER RING DEFORMED
45	109.4		FL	S13			J			20,51	LASER SHOWS VERTICAL FRACTURE MOVEMENT AND LASER RING DEFORMED
46	113.35		FL	F13			J			21
