ALGORITHM DEVELOPMENT FOR SEWER PIPE SYSTEM CONDITION
ASSESSMENT USING MULTI-SENSOR (MSI) TECHNOLOGY

ALGORITHM DEVELOPMENT FOR SEWER PIPE SYSTEM CONDITION ASSESSMENT USING MULTI-SENSOR (MSI) TECHNOLOGY

This study investigates the performance of all the current large-diameter pipeline system of The City of Arlington (COA) sewer lines of 48 miles (24-inch inner diameter and above for rigid and flexible pipes). Proper inspection and rehabilitation plan for the city sewer pipeline system are better choice for the municipality and tax payers in terms of cost than dealing with pipe damage and collapsing problems when they happen.

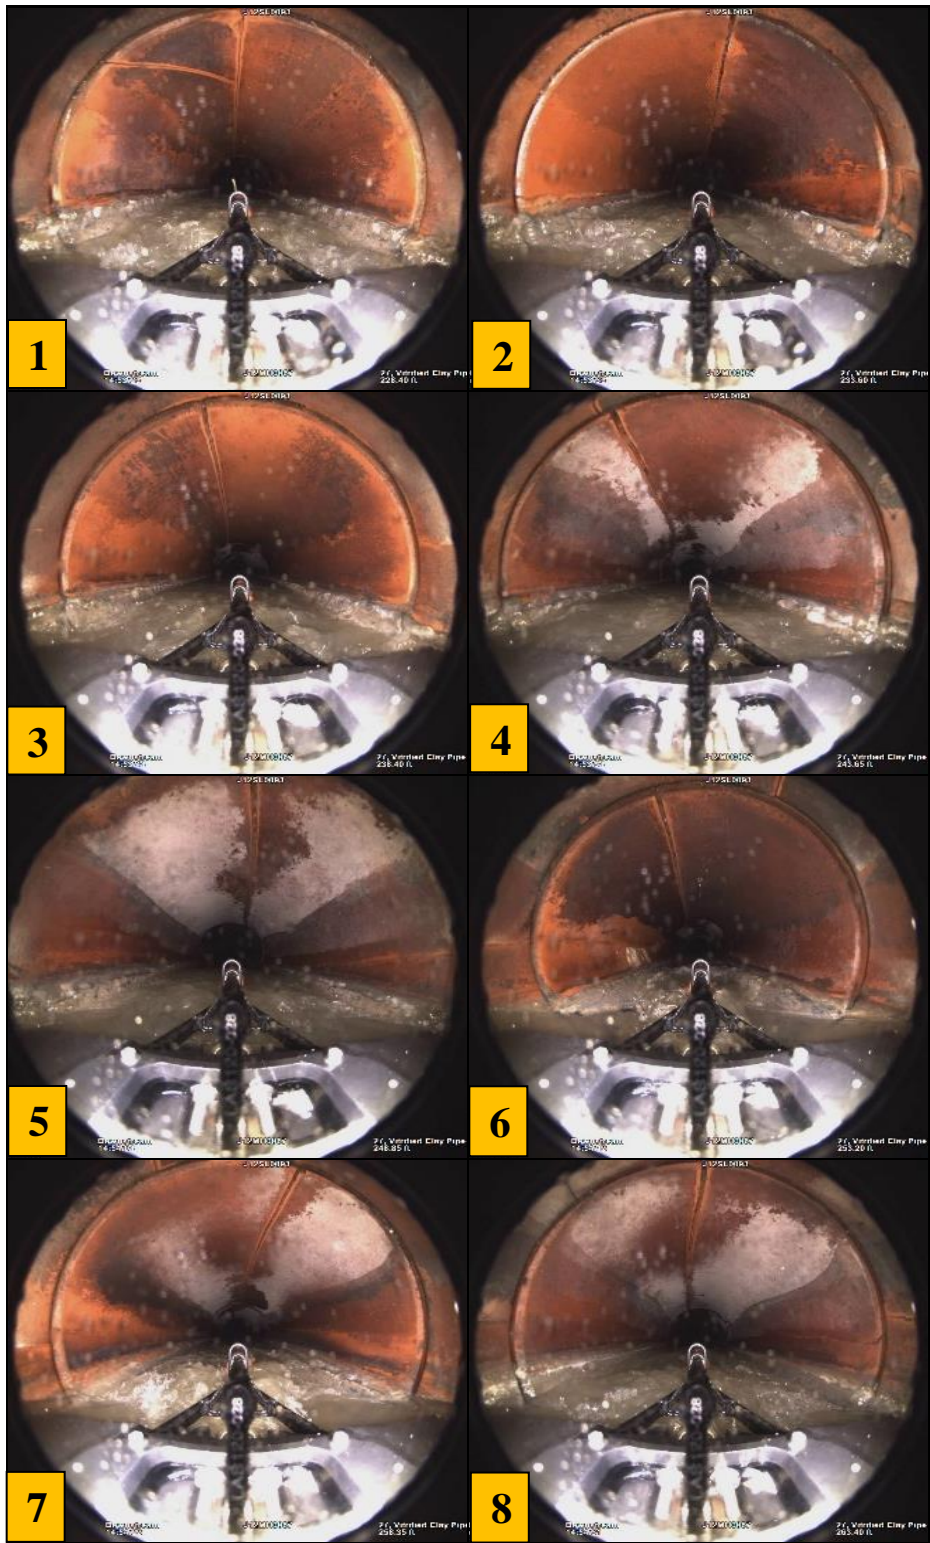
Figure A26-6 images from 1 through 8

82	438.6		FL	S35				J			36,84	LASER SHOWS VERY VERY LITTLE HORIZONTAL FRACTURE MOVEMENT
83	443.65		FL	F35				J			37	
84	443.65		FL	S36				J			37,85	LASER SHOWS VERY VERY LITTLE HORIZONTAL FRACTURE MOVEMENT
85	448.65		FL	F36				J			38	
86	448.65		FL	S37				J			38,86	LASER DOESN'T SHOW FRACTURE OPENING
87	453.4		FL	F37				J			39	
88	453.4		FL	S38				J			39,87	LASER DOESN'T SHOW FRACTURE OPENING
89	458.65		FL	F38				J			40	
90	458.65		FL	S39				J			40,88	LASER DOESN'T SHOW FRACTURE OPENING
91	463.5		FL	F39				J			41	
92	463.5		FL	S40				J			41,89	LASER SHOWS VERY VERY LITTLE HORIZONTAL FRACTURE MOVEMENT
93	468.5		FL	F40				J			42	
94	468.5		FL	S41				J			42,90	LASER DOESN'T SHOW FRACTURE OPENING
99	473.6		FL	F41				J			43	
96	473.6		FL	S42				J			43,91	LASER DOESN'T SHOW FRACTURE OPENING
97	478.75		FL	F42							44	
98	490.45		MSA

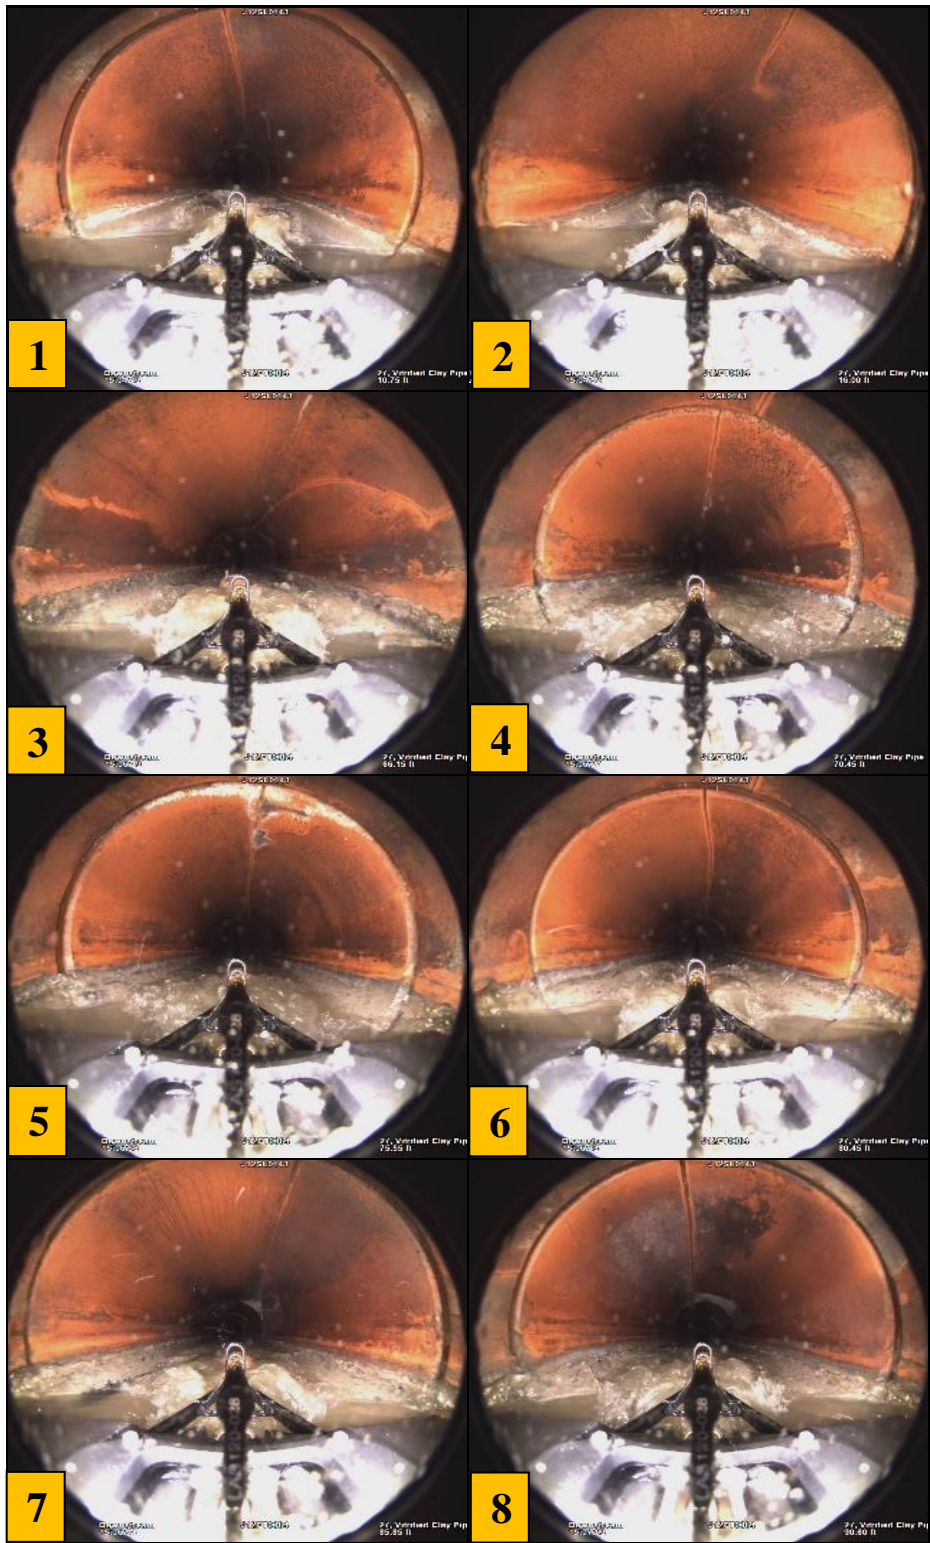
Figure A28-4 images from 1 through 8

18	95.5		FL	F08			J			9	
19	95.5		FL	S09			J			9,22	LASER SHOWS VERY VERY LITTLE HORIZONTAL FRACTURE MOVEMENT AND LASER RING DEFORMED
20	100.5		FL	F09			J			10	
21	100.5		FL	S10			J			10,23	LASER DOESN'T SHOW FRACTURE MOVEMENT
22	105.45		FL	F10			J			11	
23	105.45		FL	S11			J			11,24	LASER SHOWS VERY LITTLE HORIZONTAL FRACTURE MOVEMENT AND LASER RING DEFORMED
24	110.5		FL	F11			J			12	
25	110.5		FL	S12			J			12,25	LASER SHOWS VERY LITTLE HORIZONTAL FRACTURE MOVEMENT AND LASER RING DEFORMED
26	120.35		FL	F12			J			13	
27	120.35		FL	S13			J			13,26	LASER DOESN'T SHOW FRACTURE MOVEMENT
28	125.45		FL	F13						29	
29	162.25		MSA

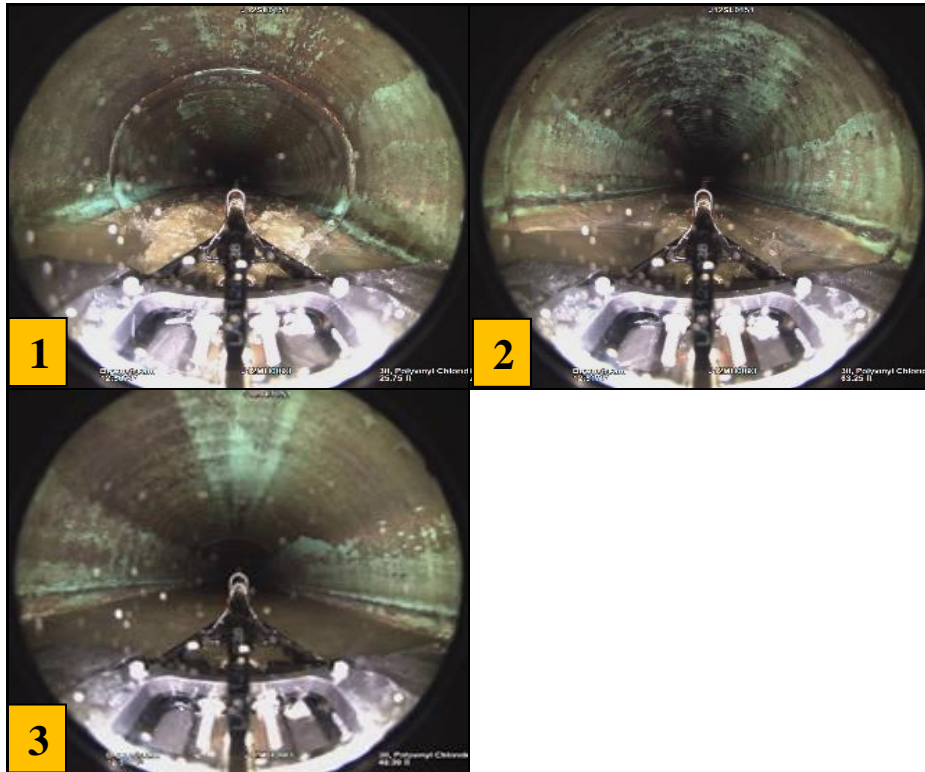
Figure A30-4 images from 1 through 3

SN	Distance (feet)	Video Ref.	Code Group/ Descriptor/ Modifier	Continuous Defect	Value			Joint	Circumferential Location		Img Reference	Remarks
					Dimension		%		At/From	To		
					1st	2nd						
1	0		AMH									
2	6		MWL				5%					
3	25.75		MWL				15%			1,2		
4	63.25		MWL				5%			3		
5	106.55		MSA

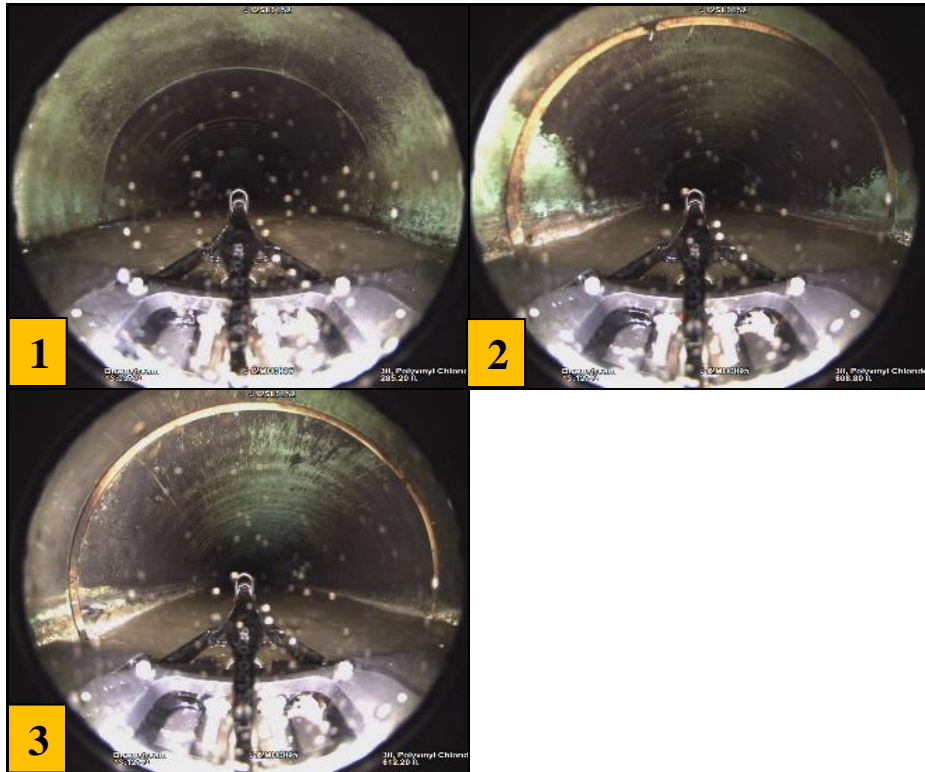
Figure A31-4 images from 1 through 3

SN	Distance (feet)	Video Ref.	Code Group/ Descriptor/ Modifier	Continuous Defect	Value			Joint	Circumferential Location		Img Reference	Remarks
					Dimension		%		At/From	To		
					1st	2nd						
1	0		AMH									
2	0		MWL				10%					
3	285.2		MWL				15%			3		VIDEO JUMPED
4	608.8		JO							1		
5	612.2		JO							2		
6	737.8		MSA

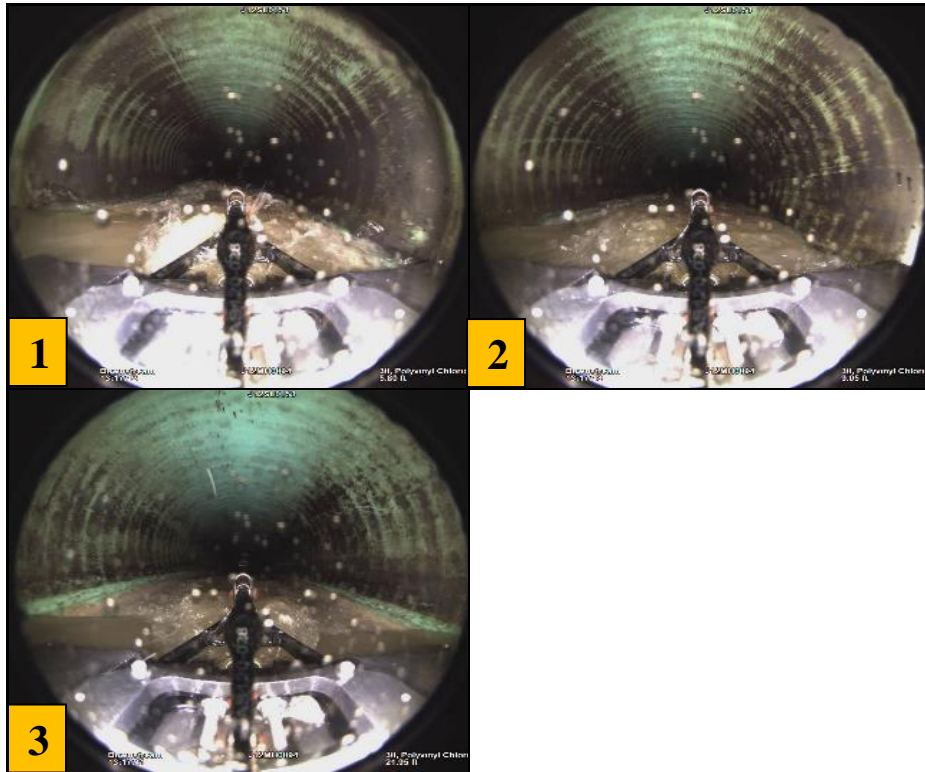
Figure A32-4 images from 1 through 3

SN	Distance (feet)	Video Ref.	Code Group/ Descriptor/ Modifier	Continuous Defect	Value			Joint	Circumferential Location		Img Reference	Remarks
					Dimension		%		At/From	To		
					1st	2nd						
1	0		AMH									
2	0		MWL				5%					
3	9.05		MWL				10%				1,2	
4	21.95		MWL				5%				3	
5	60.75		MSA

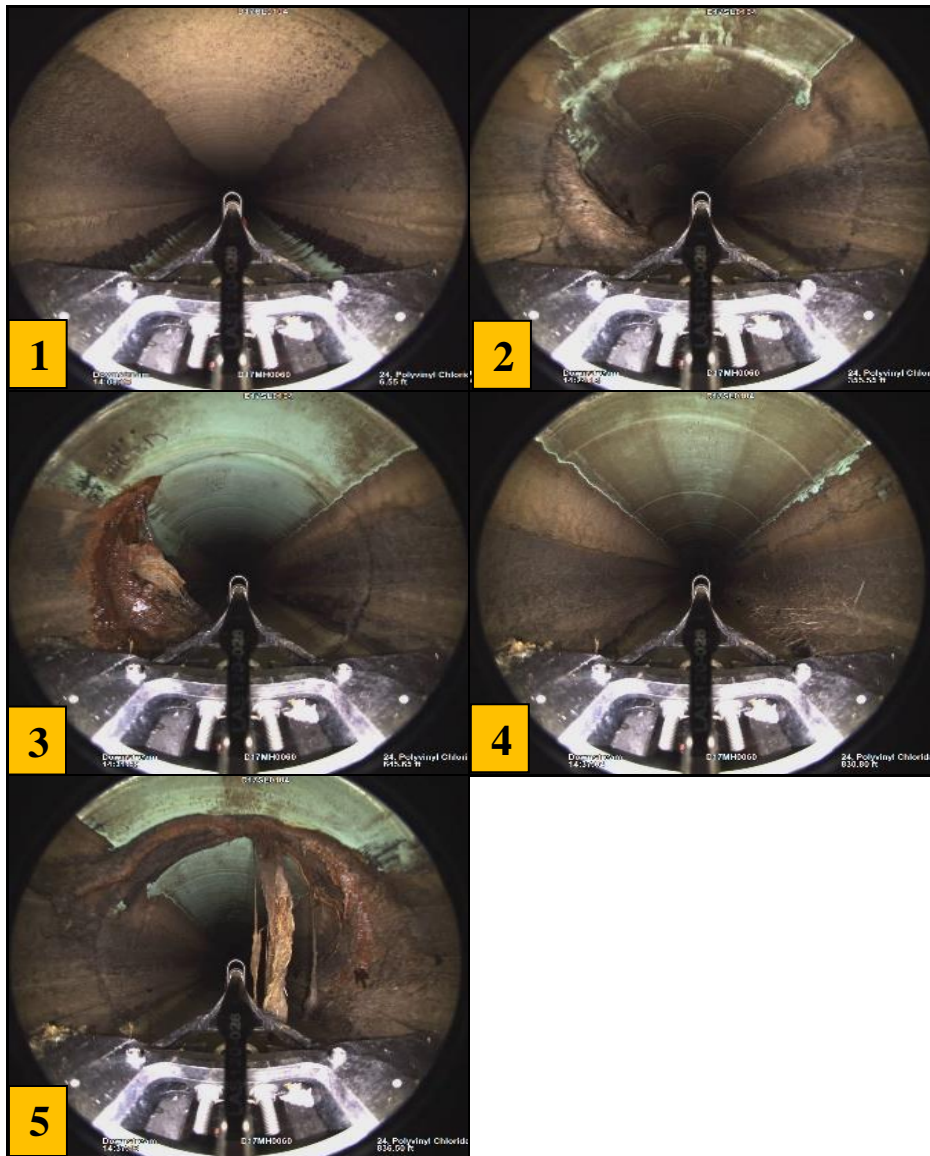
Figure A33-4 images from 1 through 5

SN	Distance (feet)	Video Ref.	Code Group/ Descriptor/ Modifier	Continuous Defect	Value			Joint	Circumferential Location		Img Reference	Remarks
					Dimension		%		At/From	To		
					1st	2nd						
1	0		AMH									
2	0		MWL			5%						
3	6		DAE	S01		5%				1		
4	355.55		RLJ				J			2		
5	645.65		RLJ				J			3		
6	830.9		RMB	S02						5		
7	836.5		RLJ							4		
8	836.5		DAG			10%	J			4		
9	845.25		RMB	F02								
10	1141.45		DAE	F01								
11	1141.45		MSA
