LONG TERM PERFORMANCE MONITORING OF SHALLOW SLOPE STABILIZATION
UTILIZING RECYCLED PLASTIC PINS

MASTER OF SCIENCE IN CIVIL ENGINEERING

THE UNIVERSITY OF TEXAS AT ARLINGTON

May 2019

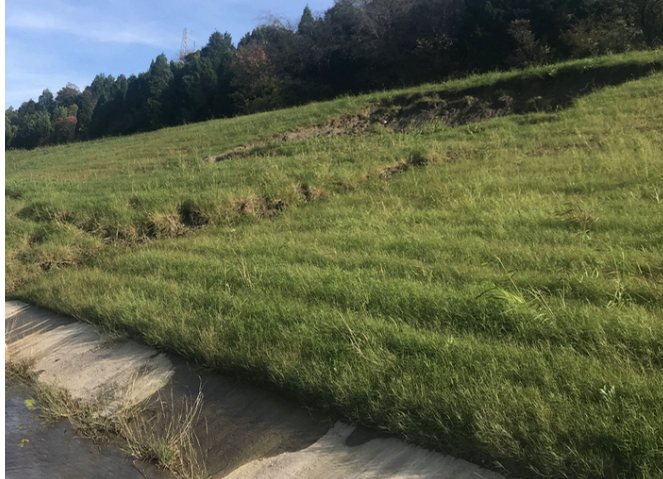
Figure 2- 2 Slope Failure off I-20 east bound near Clark Rd.

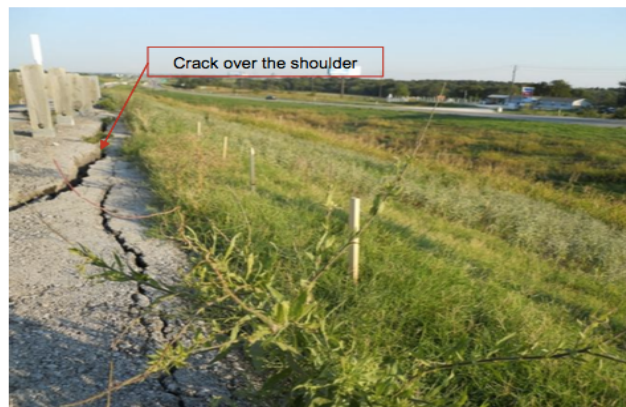
Figure 3- 2 Shoulder cracks observed at crest of US 287 slope (Khan, 2013)

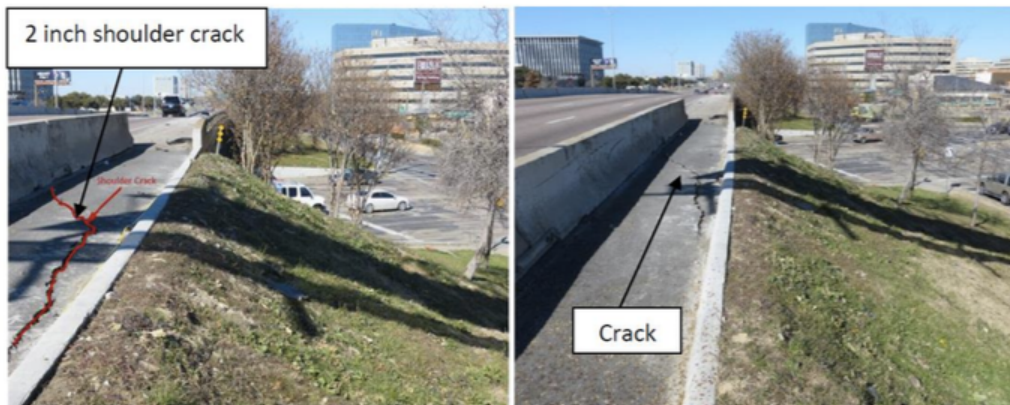
Figure 3- 11 Failure photos on shoulder of I-35 (Tamrakar, 2015)

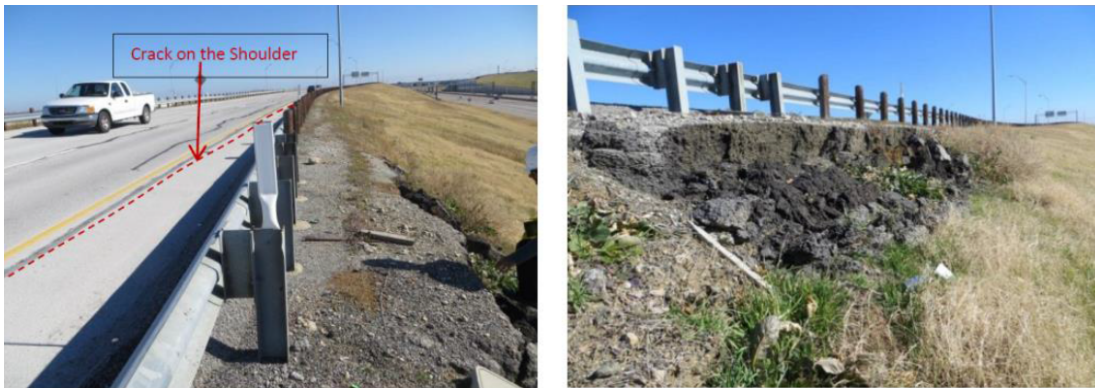
Figure 3- 19 Slope failure photos at SH-183 (Tamrakar, 2015)

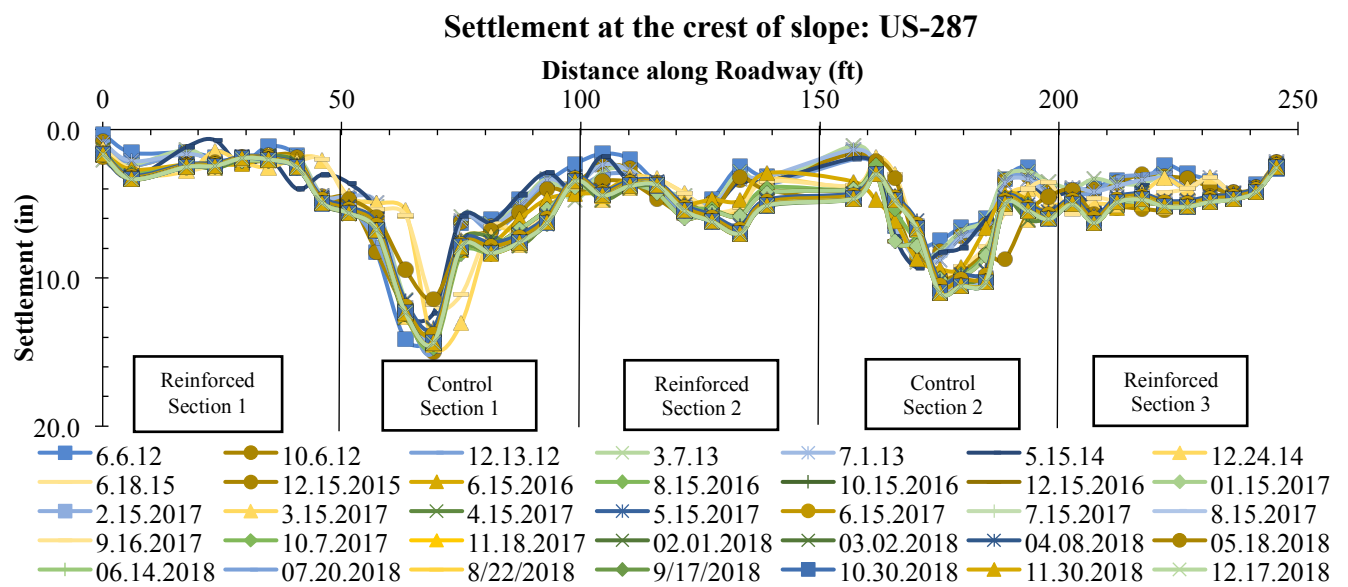
terms of vertical deformation, or settlement. Presented in previous sections, during the investigation of the US-287 site, cracks were observed along the shoulder of the highway slope section. To better analyze the performance of the RPP to resist surficial movement of the slope, the cracks were left unsealed, therefore allowing for repeated wetting and drying cycles with the potential of an increase in rainfall infiltration into the slope. The results of the monthly topographic survey measurements are presented in Figure 4-2

Figure 4- 2 Settlement at the crest of US-287

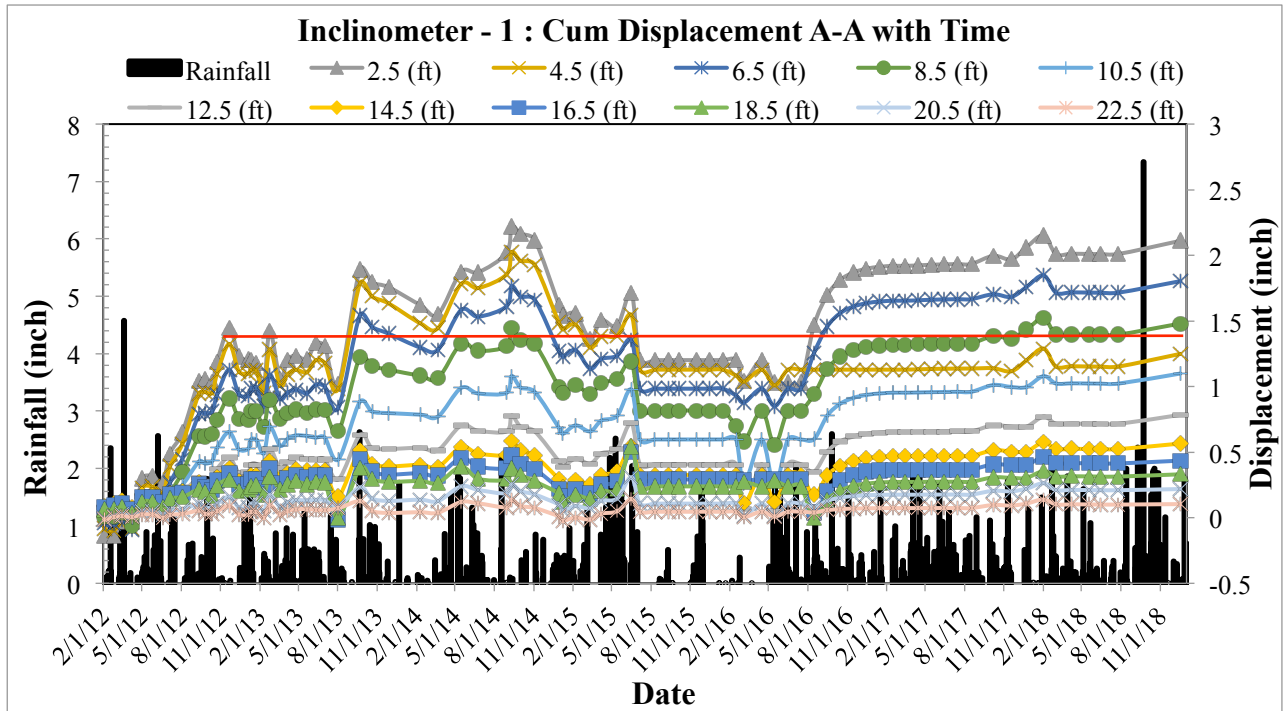
Figure 4- 6 Displacement in Inclinometer I-1 at US-287

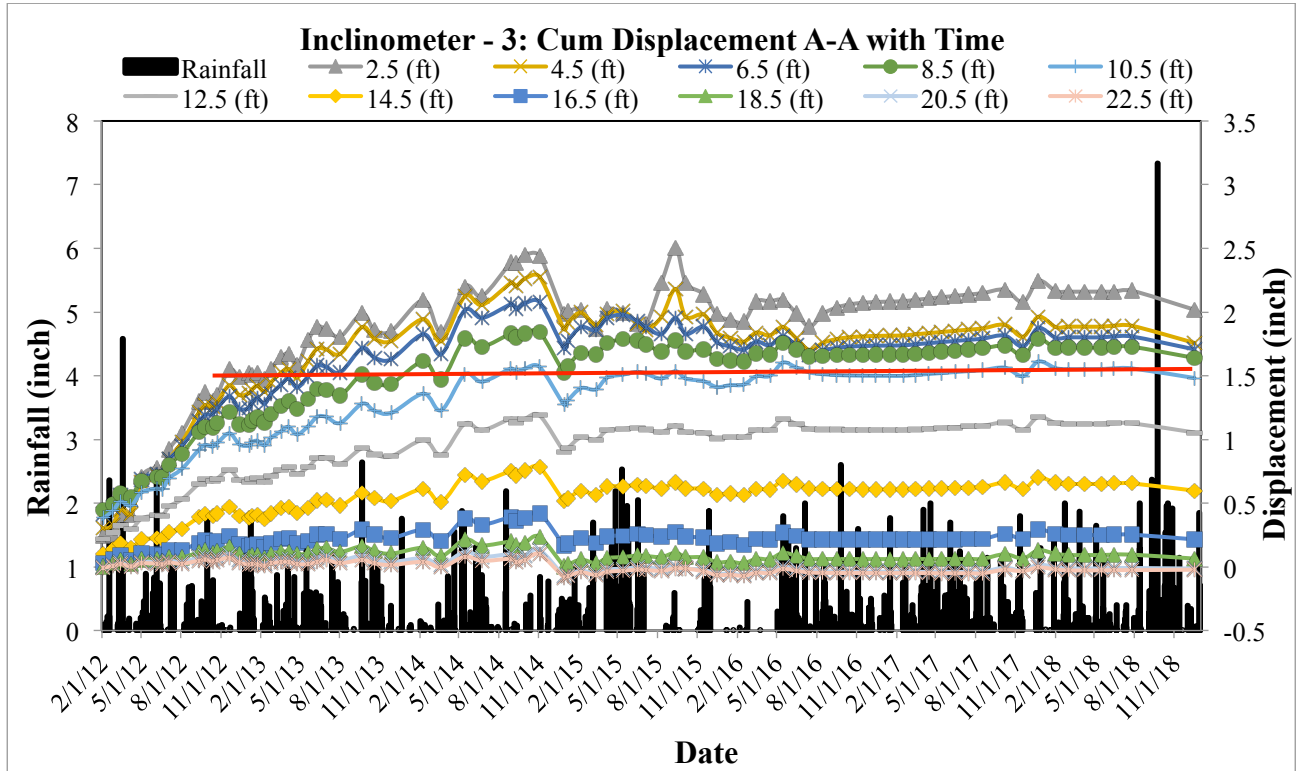
Figure 4- 7 Displacement in Inclinometer I-3 at US-287

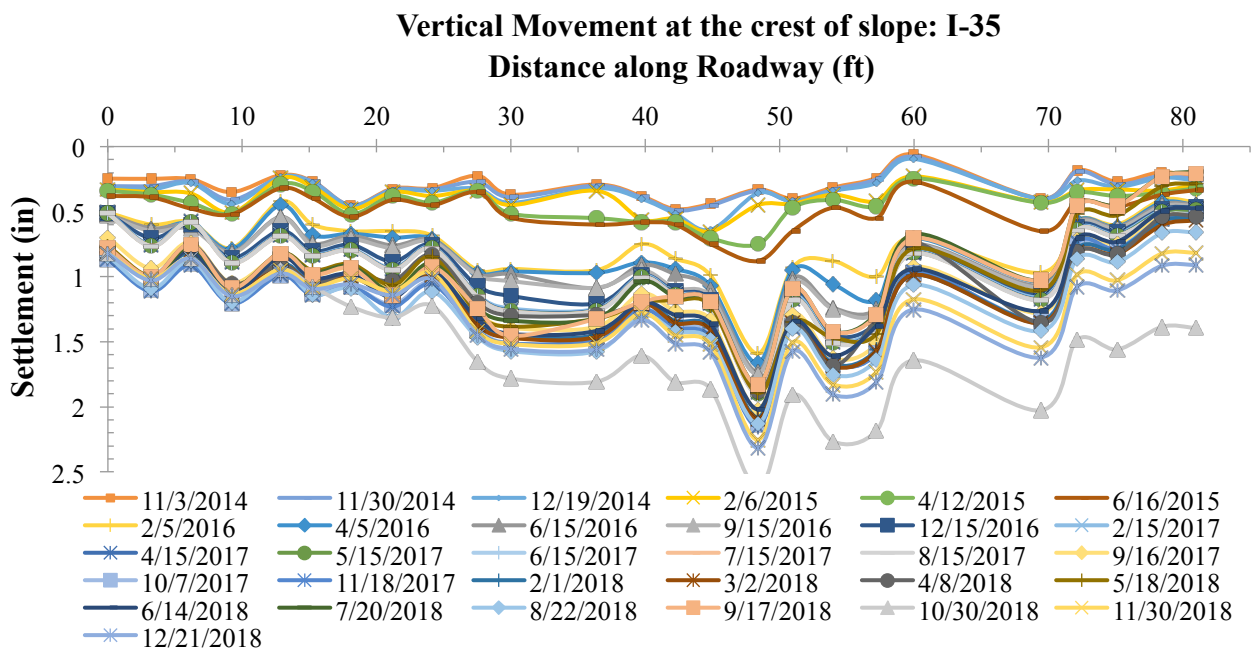
Figure 4- 9 Settlement at the crest of I-35 Slope

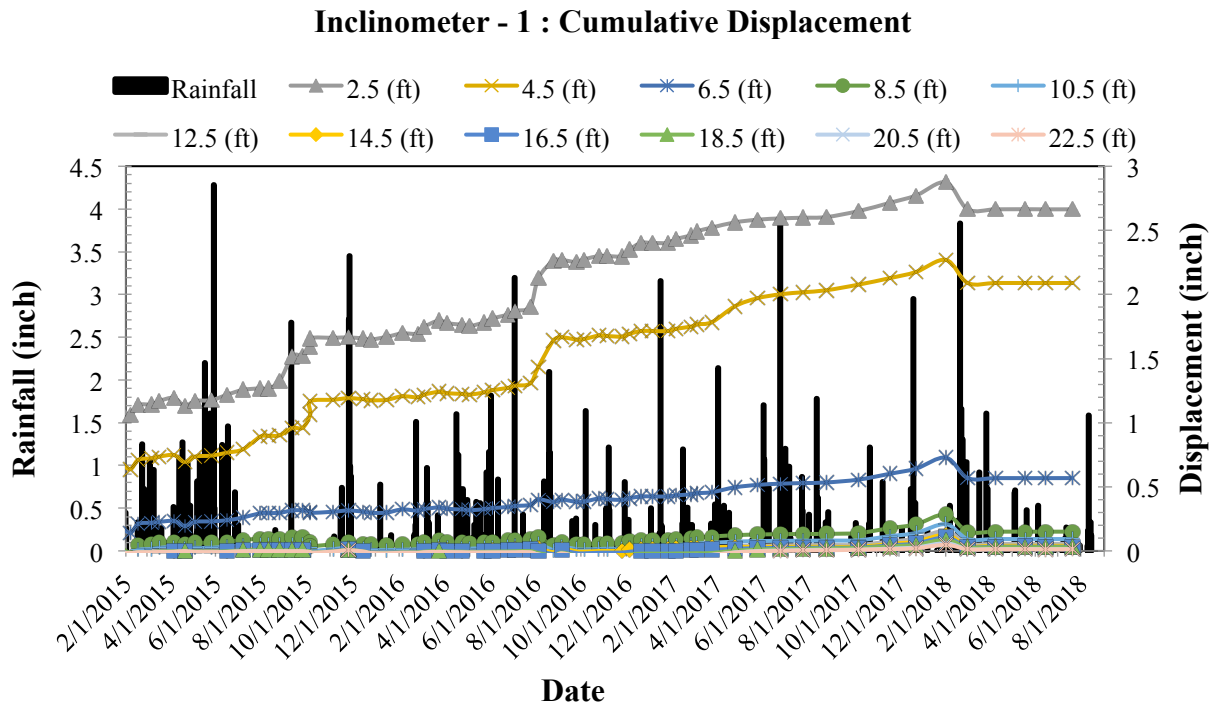
Figure 4- 14 Displacement in Inclinometer I-1 at I-35

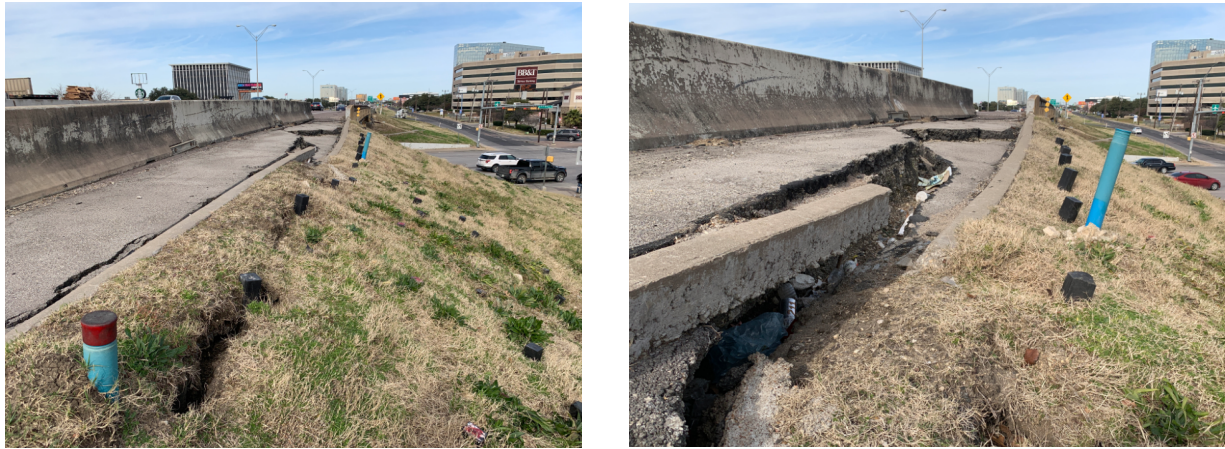
Figure 4- 15 Condition of I-35 slope near Inclinometer 1

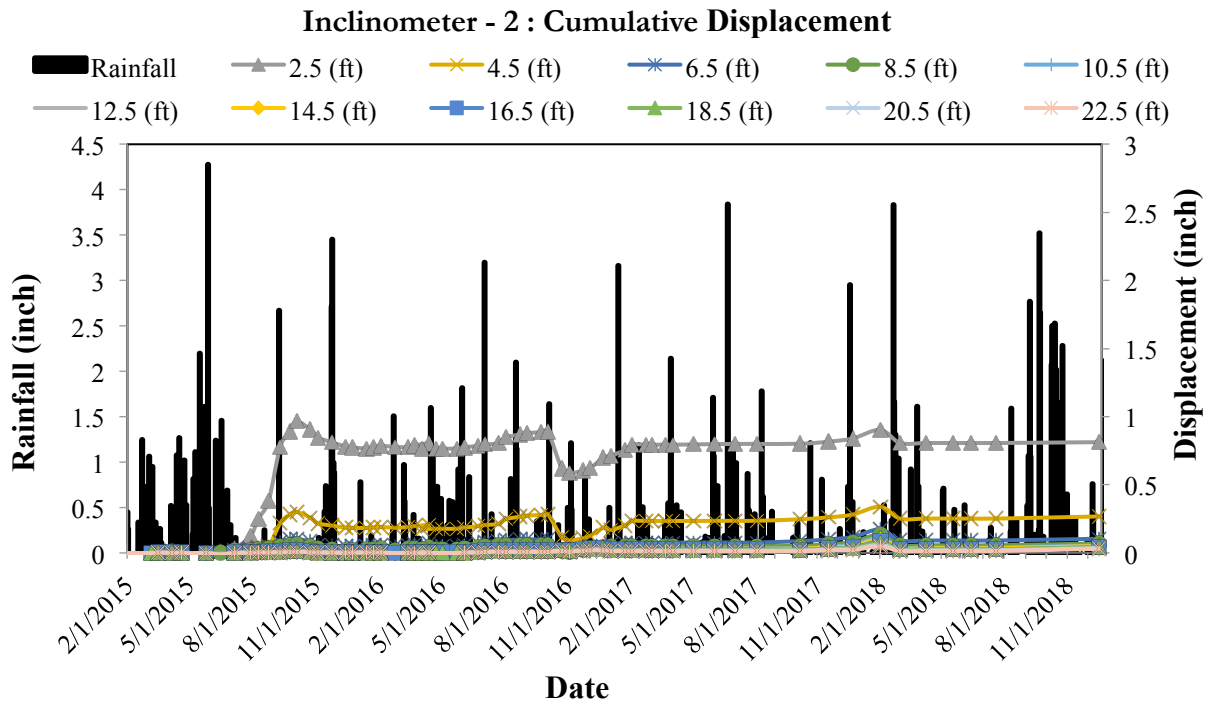
Figure 4- 16 Displacement in Inclinometer I-2 at I-35

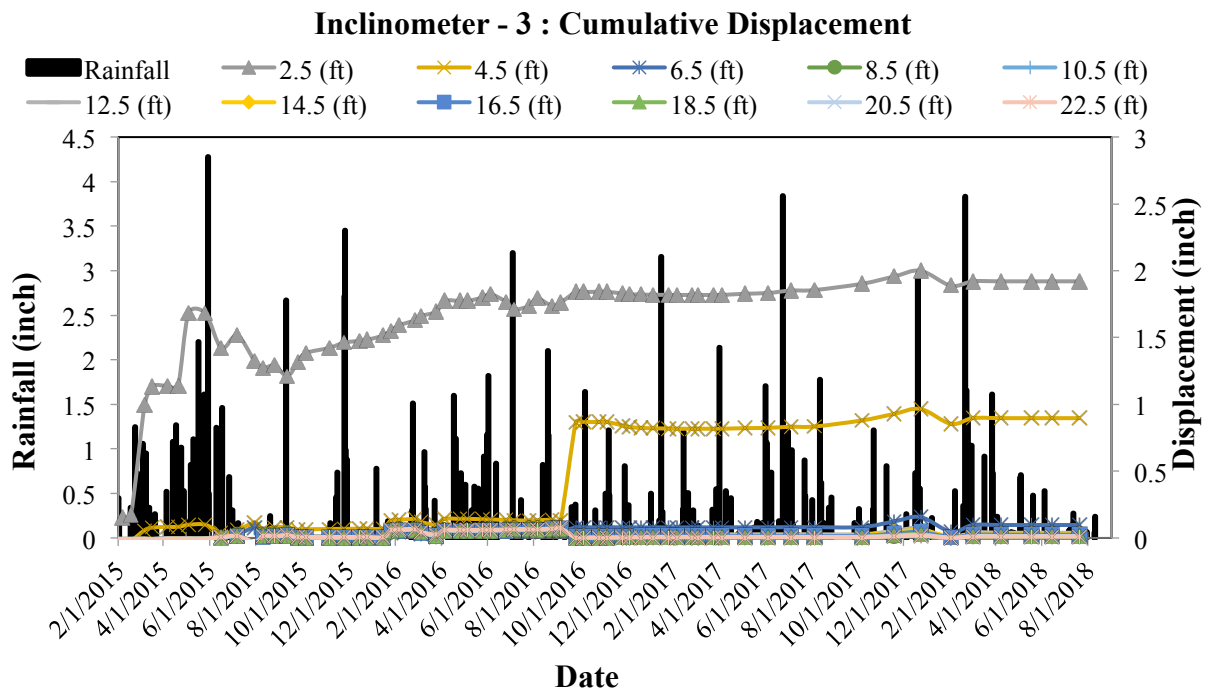
Figure 4- 17 Displacement in Inclinometer I-3 at I-35

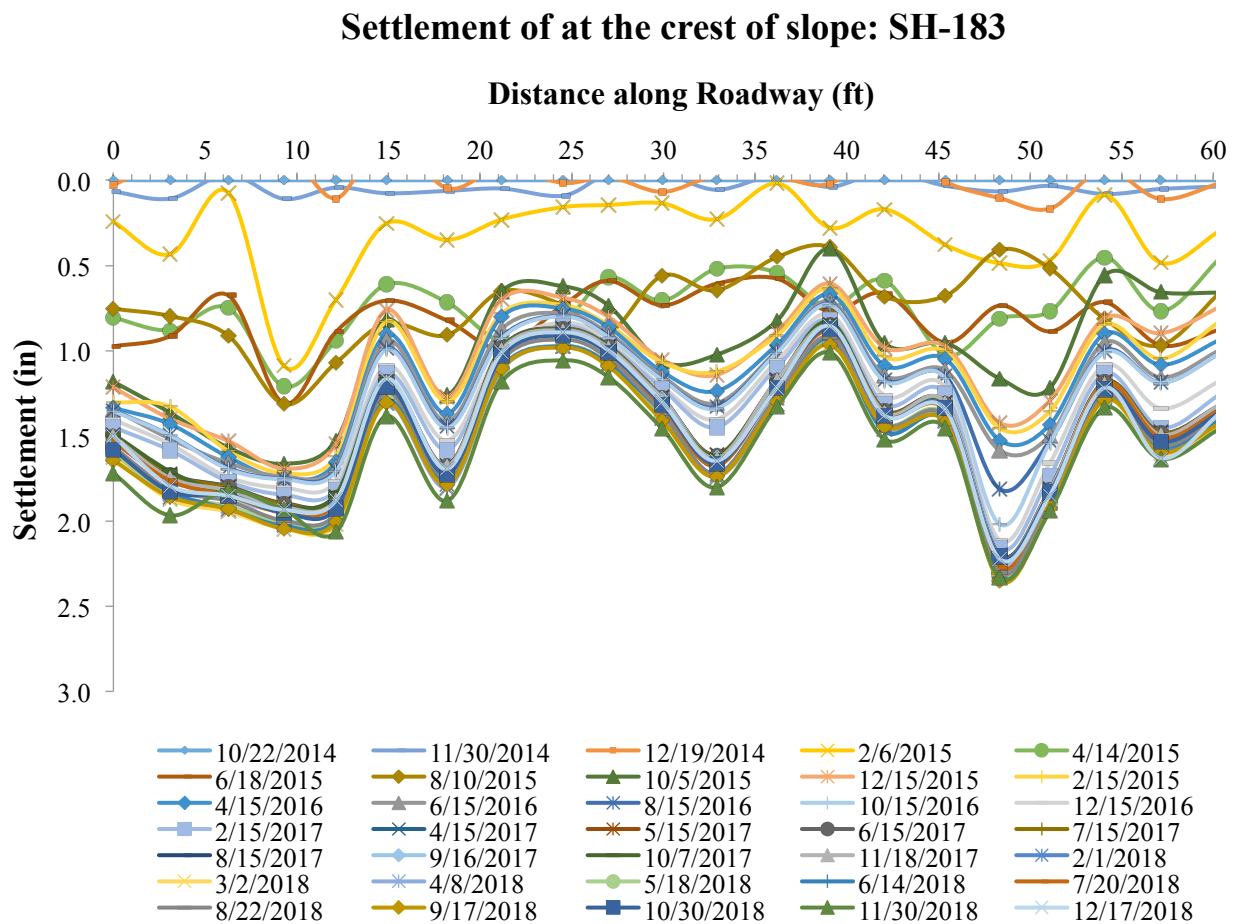
Figure 4- 18 Settlement at the crest of SH-183 slope
