IN-SERVICE PERFORMANCE EVALUATION OF FIRE AND IMPACT
DAMAGED BRIDGES WITH CFRP LAMINATE STRENGTHENING

SANTOSH TIMILSINA

DOCTOR OF PHILOSOPHY

THE UNIVERSITY OF TEXAS AT ARLINGTON

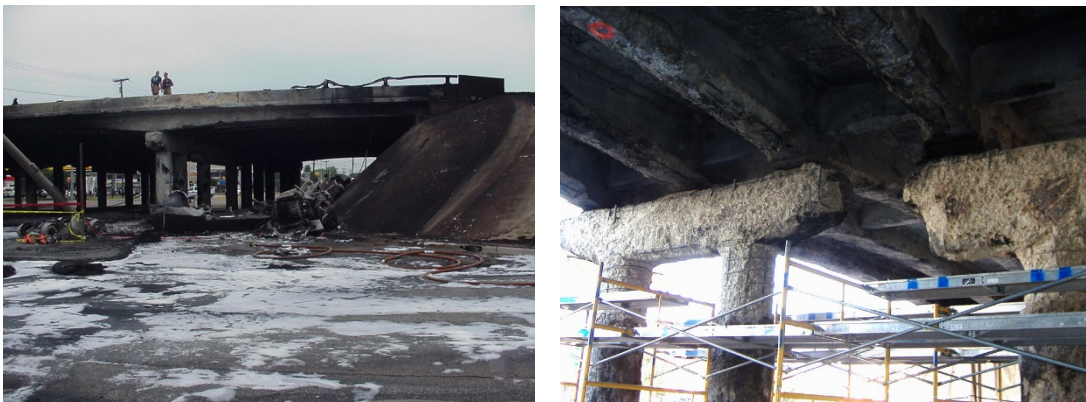
Figure 3-4 Fire damage of MacArthur Bridge (Okafor, Fisher 2005)

bridge at about 6:30 a.m. before landing upside down and catching fire on MacArthur Boulevard. It took firefighters 30 minutes to extinguish the blaze. Officials initially closed all lanes in both directions of both roads before reopening State Highway 183 westbound lanes at 11:15 a.m. It took 11 hours to clean up the wreckage. There was extensive heat, and the concrete on the bridge columns and beams spalled and “popped” as a result (Figure 3-4). Gazing at the charred structure, Texas Department of Transportation (TxDOT) engineers said they had never seen anything like the combination of bridge damage and potential traffic headaches confronting them on State Highway 183 due to this accident (Sika, 2006). The east bound traffic was shut down for more than 12 hours and only one lane was open until the bridge could be repaired.

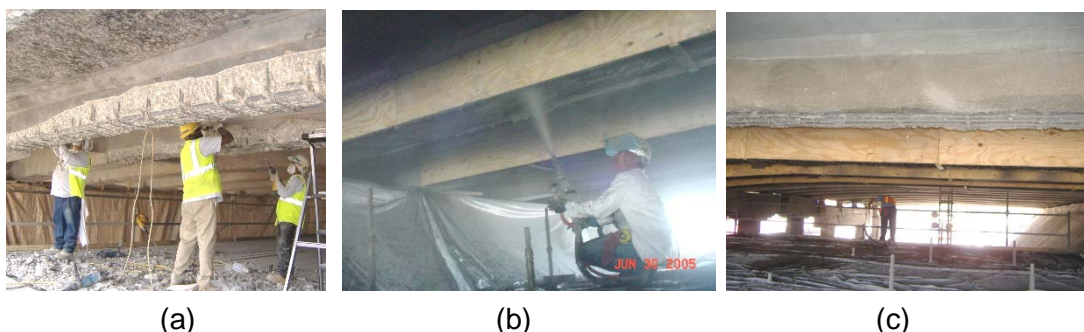
Figure 3-5 (a) Removing loose concrete (b) Applying repair mortar (c) Setting forms

Based on this inspection, it was determined that, although the damage was extensive, the bridge could be repaired.

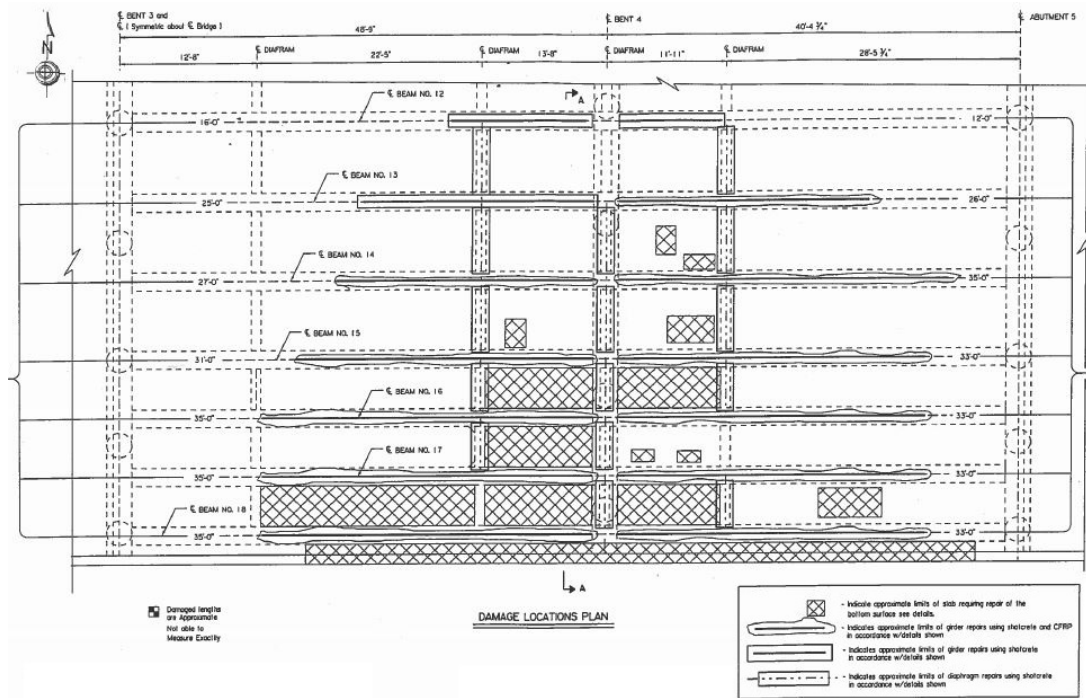
Figure 3-6 MacArthur Bridge beam and deck damage detail

were provided every 600 mm (24 in.) spacing. An elastomeric, breathable coating over the CFRP for UV stability and aesthetics was also provided. The damaged area of the deck was repaired with a wet-spray-fiber-reinforced mortar with compressive strength 21 MPa (3,000 psi). The damage location plan can be seen in Figure 3-6.

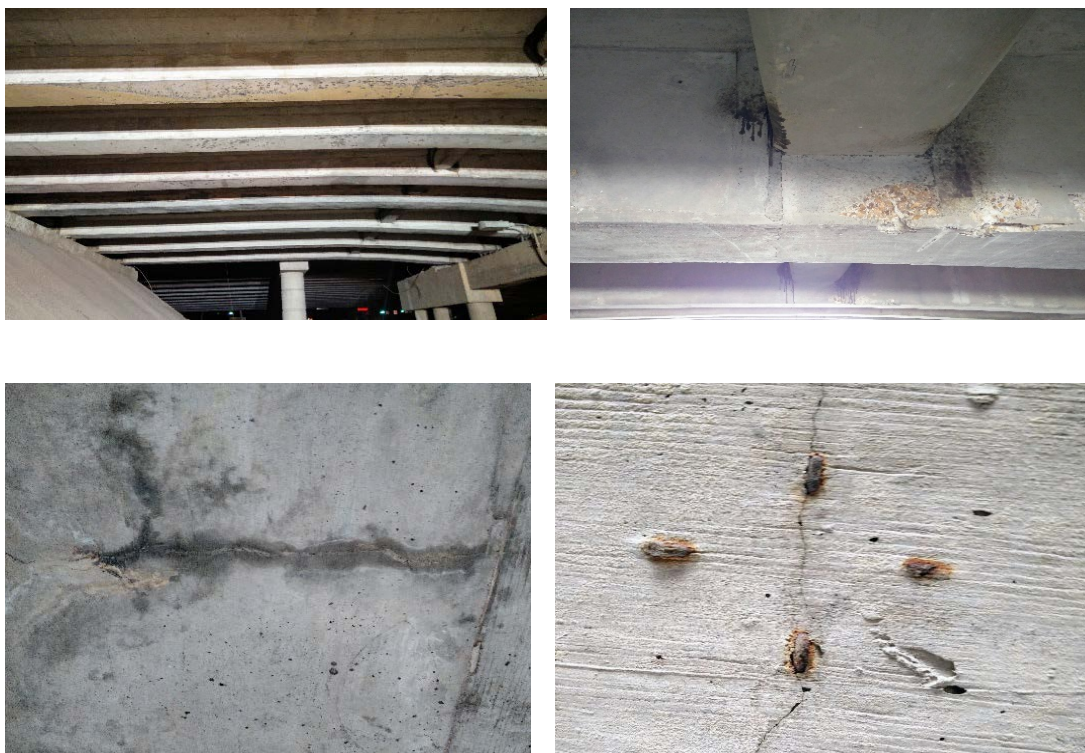
Figure 3-8 Current condition of the bridge

been corroded which was also the location of the cracks along the girders [Figure 3-8(d)]. Other cracks along the section of the bridge were also noted in the diaphragm and girder interface [Figure 3-8(b)]. Black residue along the crack was observed which was correlated to the result of progression of corrosion in the rebar [Figure 3-8(c)]. Minor spalling and section loss was also seen in different parts the bridge [Figure 3-8(b)]. The effect of temperature exposure was clearly visible in Span 3 and Span 4 of the bridge. The bearing seats of the bridge were epoxy injected as part of the repair process. The mechanical bearing seats were old and it can be safely assumed that they had lost their bearing restraint. The CFRP did not show any visible signs of debonding or delamination. The FRP seemed well bonded to the substrate concrete and the U-wraps were still intact.

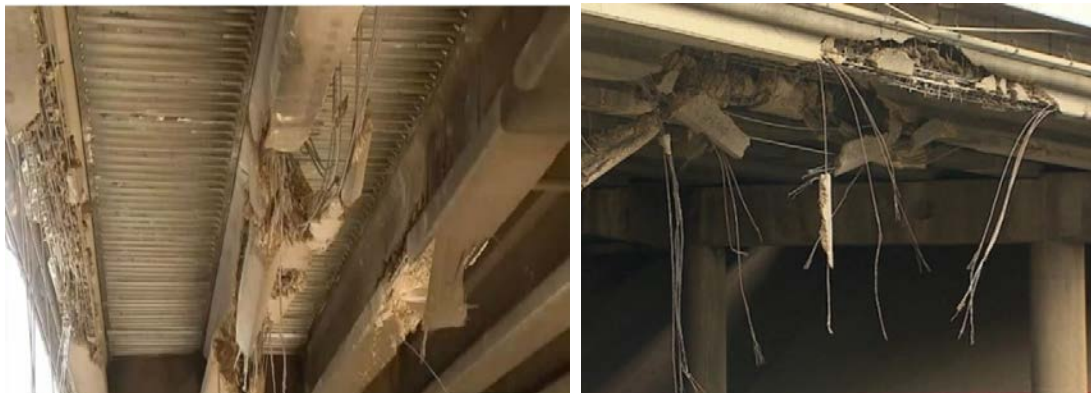
Figure 3-13 Damage of Loop 12 Bridge by over-height vehicle

The bridge suffered another significant damage in December 2014 when an over-height garbage hauling truck struck the underside of the bridge and caused significant damage. The garbage hauling truck traveling on North-bound Loop 12 suffered a hydraulic mechanism failure which caused the vehicle to hit three girders and cause significant damage in Beams B1, B2 and B3 of the Eastbound Bridge. TxDOT engineers performed a thorough visual inspection of the damage and the level of severe damage was evident (Figure 3-13).

It was decided that the two girders, B1 and B2 had to be completely replaced. Beam B1 was replaced with a Texas Type Tx34 prestressed I-girder and the damaged Beam B2 was replaced with a Texas Type Tx40 prestressed I-girder as shown in Figure 3-10. Beam B3, although suffering from significant section loss and severed strands, was adjudged to be repairable and a repair plan was formulated. Beam B3, which was initially repaired in 2006, had a few strands which were exposed as the result of the collision. Several strands were damaged and needed splicing which was done by using a pre-approved 'Grab-it Cable splice' (Figure 3-14). The splicing and tightening was done such that a tension of at least 107 KN (20,000 lb.) in each 12.5 mm (0.5 in.) strand was guaranteed. The cracks greater than 0.1 mm (0.004 in.) were all injected with high strength epoxy to seal the cracks.

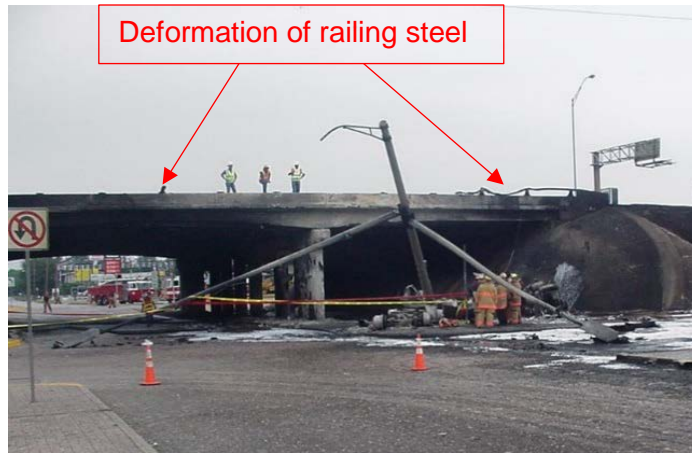
Figure 5-19 Deformation of Steel

has been reported in literature that steel starts to lose its elastic behavior around 700°C and starts to show plastic deformation with no significant increase in strain. Outinen and Makelainen 2004) performed tensile tests on steel exposed to elevated temperature and observed significant plastic deformation at 700°C (Figure 5-17). This was verified by the deformation seen on the railing steel as seen in Figure 5-19.

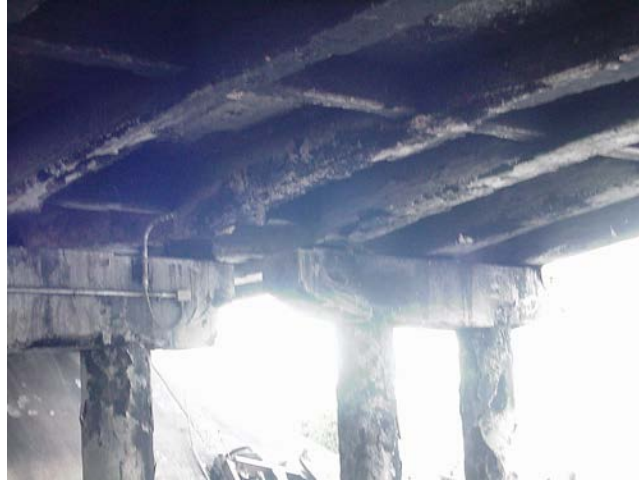
Figure 5-20 Damage on the girders, bent cap and columns

There was significant spalling and loss of concrete section on the location of the fire. Severe thermal shock and sudden change in temperature gradient caused the concrete to pop and spall. The Eastbound side of the bridge was severely damaged as seen from Figure 5-20. Seven girders in Span 3 and Span 4 of the bridge suffered significant fire damage and had section loss ranging from 1 in up to 3 in. depth as a result. The FDS fire model was able to replicate the range of severe damage as seen from the temperature slice output shown in Figure 5-21. This can also be used as a verification for the fire model. Soot deposition was also seen throughout the bridge. Soot deposition could be seen on both the EB and the WB bridge and extended as far as Span 1. However, the most heavy soot deposition was seen in the girders and bent cap on Span 3 and Span 4. The level of spalling seen on the concrete substrate also shows that the concrete was exposed to high temperatures.
