DETERMINING THE EFFECTIVENESS OF CHLORINE-BASED
BIOFILM CONTROL ON THE FRICTION FACTORS
OF LARGE DIAMETER PIPELINES
IN RAW WATER

SHELLY STAMLER HATTAN

MASTER OF SCIENCE

THE UNIVERSITY OF TEXAS AT ARLINGTON

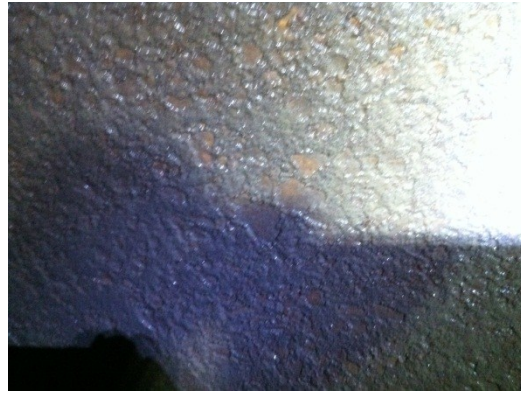
Figure 2.2: Observed Wintertime Biofilm on (a) Cedar Creek and (b) Richland Chambers Pipe Interiors.

A loss in the pipeline pumped flow rate is observed on a yearly basis. Based on field observations of the interior of the pipe, it is assumed the loss of capacity is due to the cyclical loss and regrowth of biofilm. Figure 2.2 are photographs of the wintertime biofilm found in both the Cedar Creek and Richland Chamber's pipelines.

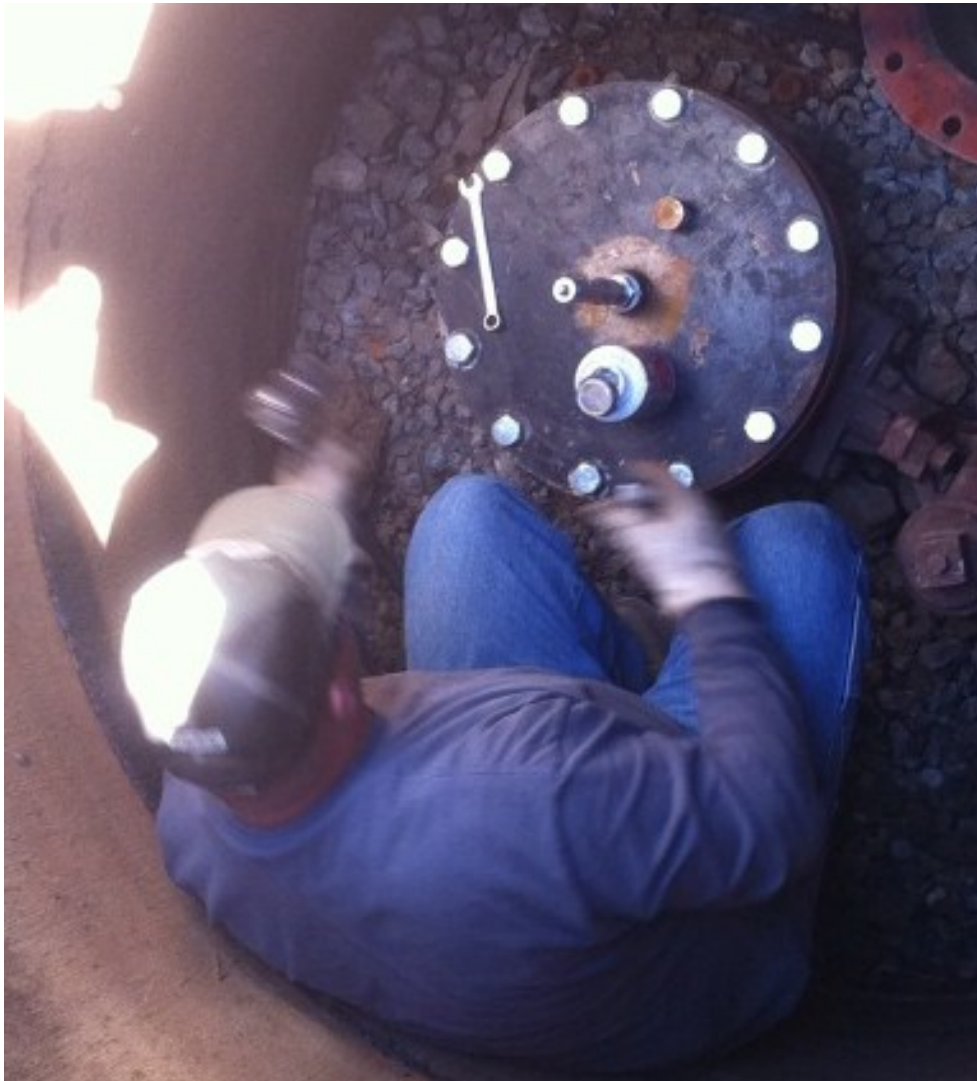
Figure 2.4: Transducer Connected to Pipeline – Cedar Creek Sta. 3873+60

Twenty-two (22) Omega Engineering OM-CR-PRTEMP-1-300G pressure transducers were installed along both the Richland-Chambers and Cedar Creek pipelines.

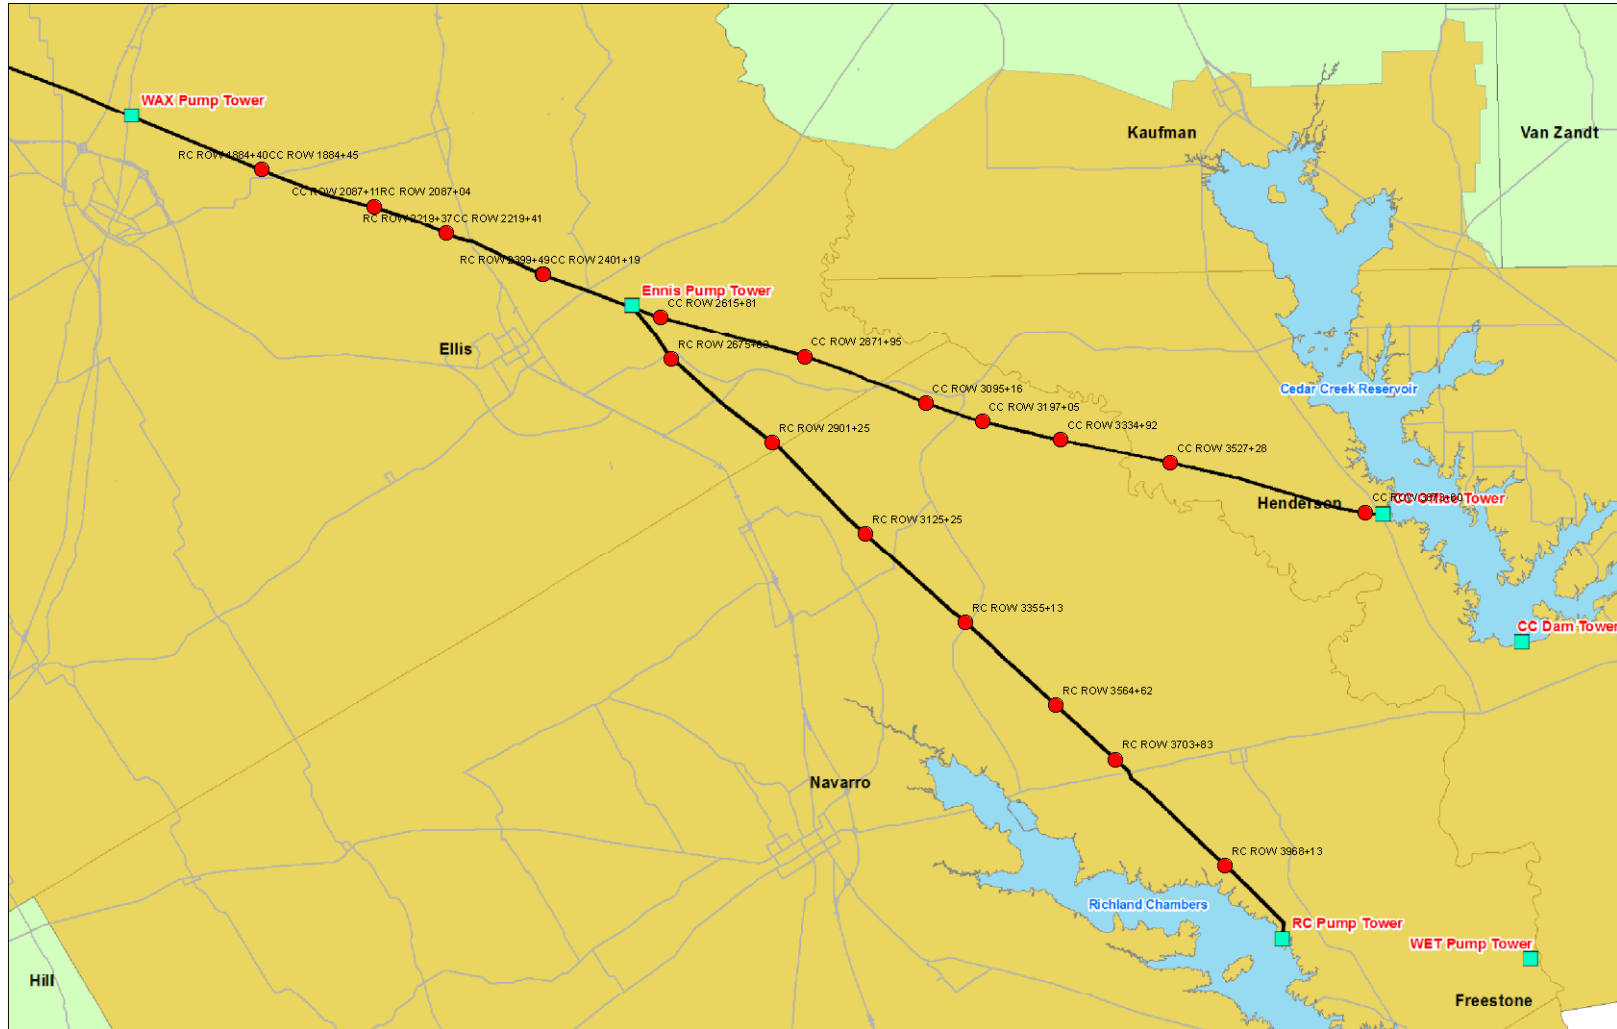
Figure 2.5: Pressure Transducer Locations

The locations for each pressure transducer, shown in Figure 2.5, are selected based on somewhat even spacing along the pipeline and ease of access to the collection site. Table 2.2 lists the discrete sections based on the station and location of each pressure transducer.

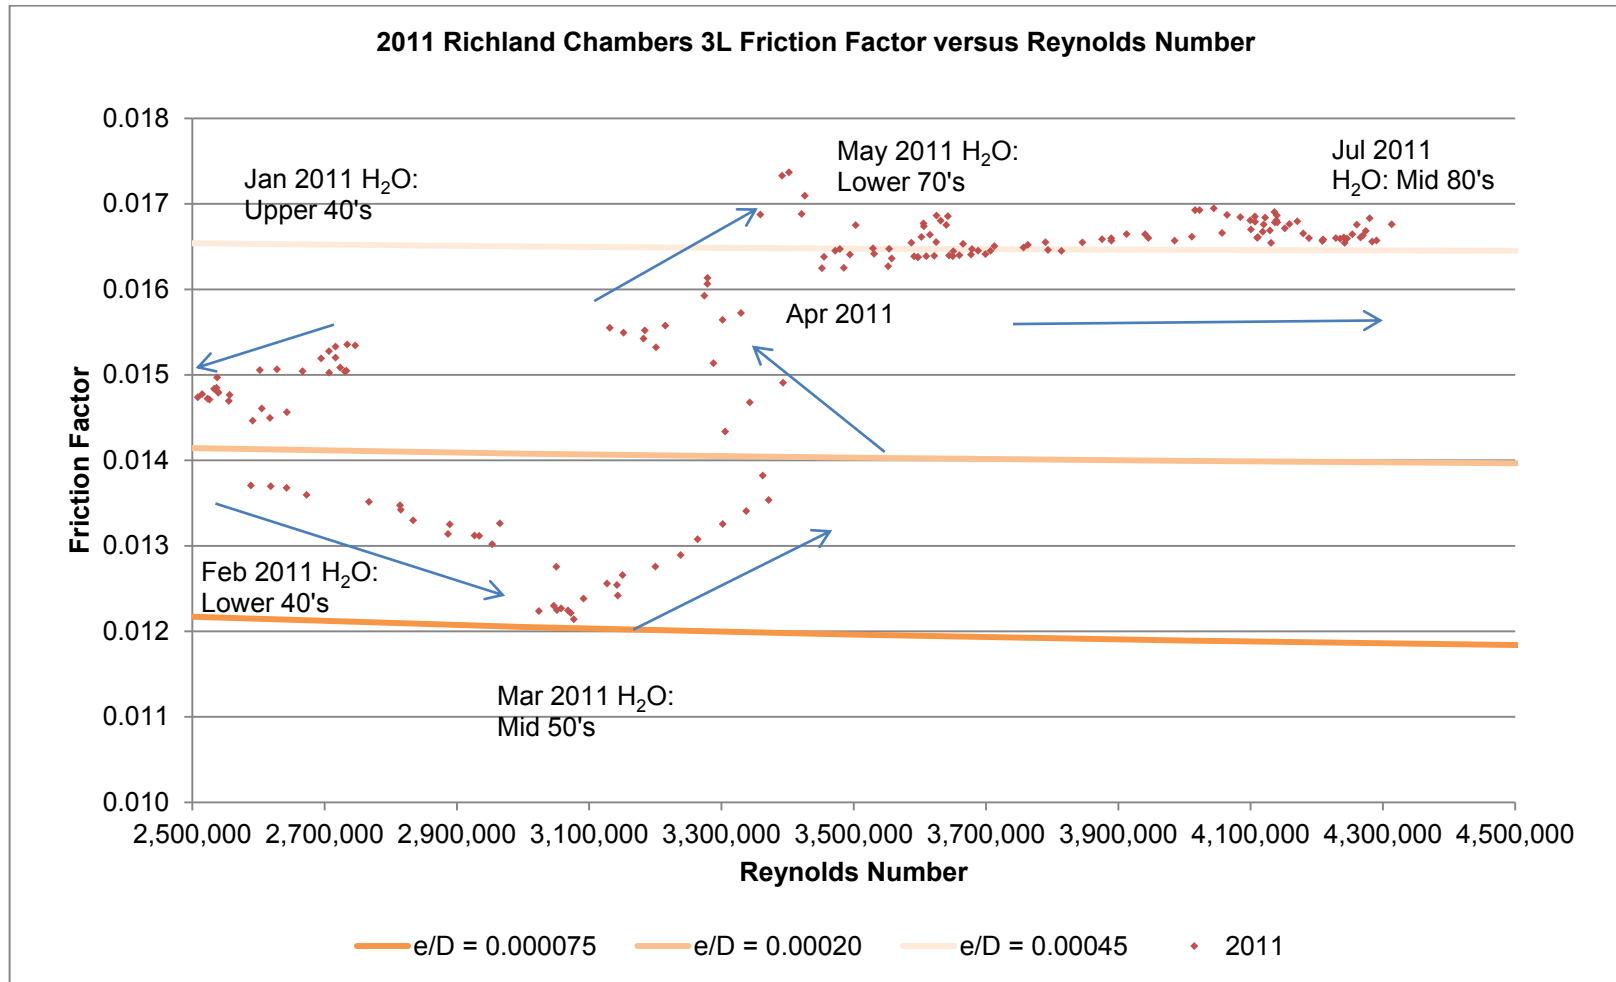
Figure 3.4: Friction Factor versus Reynolds Number for 2011 3L Richland Chambers Pump

The physical profile of the pipe directly impacts head loss. The hydraulic roughness of the pipe remains constant in the fully turbulent range in a classical Colebrook-White relationship as shown in a typical Moody Diagram. When plotting the friction factor versus the Reynolds number of the study data, it is found that use of the Moody Diagram to determine friction factor based on an assumed pipe condition breaks down. Figure 3.4 and Figure 3.5 demonstrates the variability of the friction factor and Reynolds number when pumping with three pumps at low capacity for the Richland Chambers pipeline. Variability in friction factor is attributed to the growth and regression of biofilm thickness while variability in the Reynolds number is directly linked with the viscosity of the water which is adjusted based on water temperature. The general shape starting in winter has low friction factors and low Reynolds numbers. The values then increase in both cases until the July or August months as demonstrated in Figure 3.4. After the summer months, the opposite occurs and the friction factors and Reynolds numbers return to being low as illustrated in Figure 3.5. Both figures confirm that biofouled pipe friction factor can

no longer be determined using a Moody Diagram and an assumed hydraulic roughness based on pipe condition.

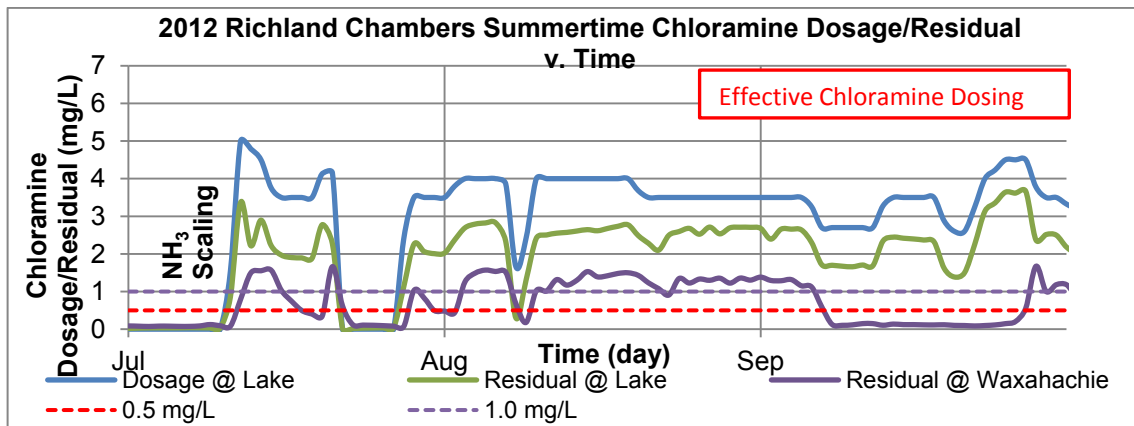
Figure 3.11: Richland Chambers Summertime Chloramine Dosing for 2012

No chloramines were used in the Richland Chambers lines during 2010 and 2011 due to chemical system upgrades. The Richland Chambers chloramine residual at Waxahachie is effective in 2012 with a majority of the values over 1.0 mg/L as seen in Figure 3.11. During the month of July, the aqueous ammonia line scaled closed and only free chlorine was dosed for a period of time. This was remedied in the middle of July and chloramine effectiveness increased as evidenced with seeing a residual at Waxahachie.

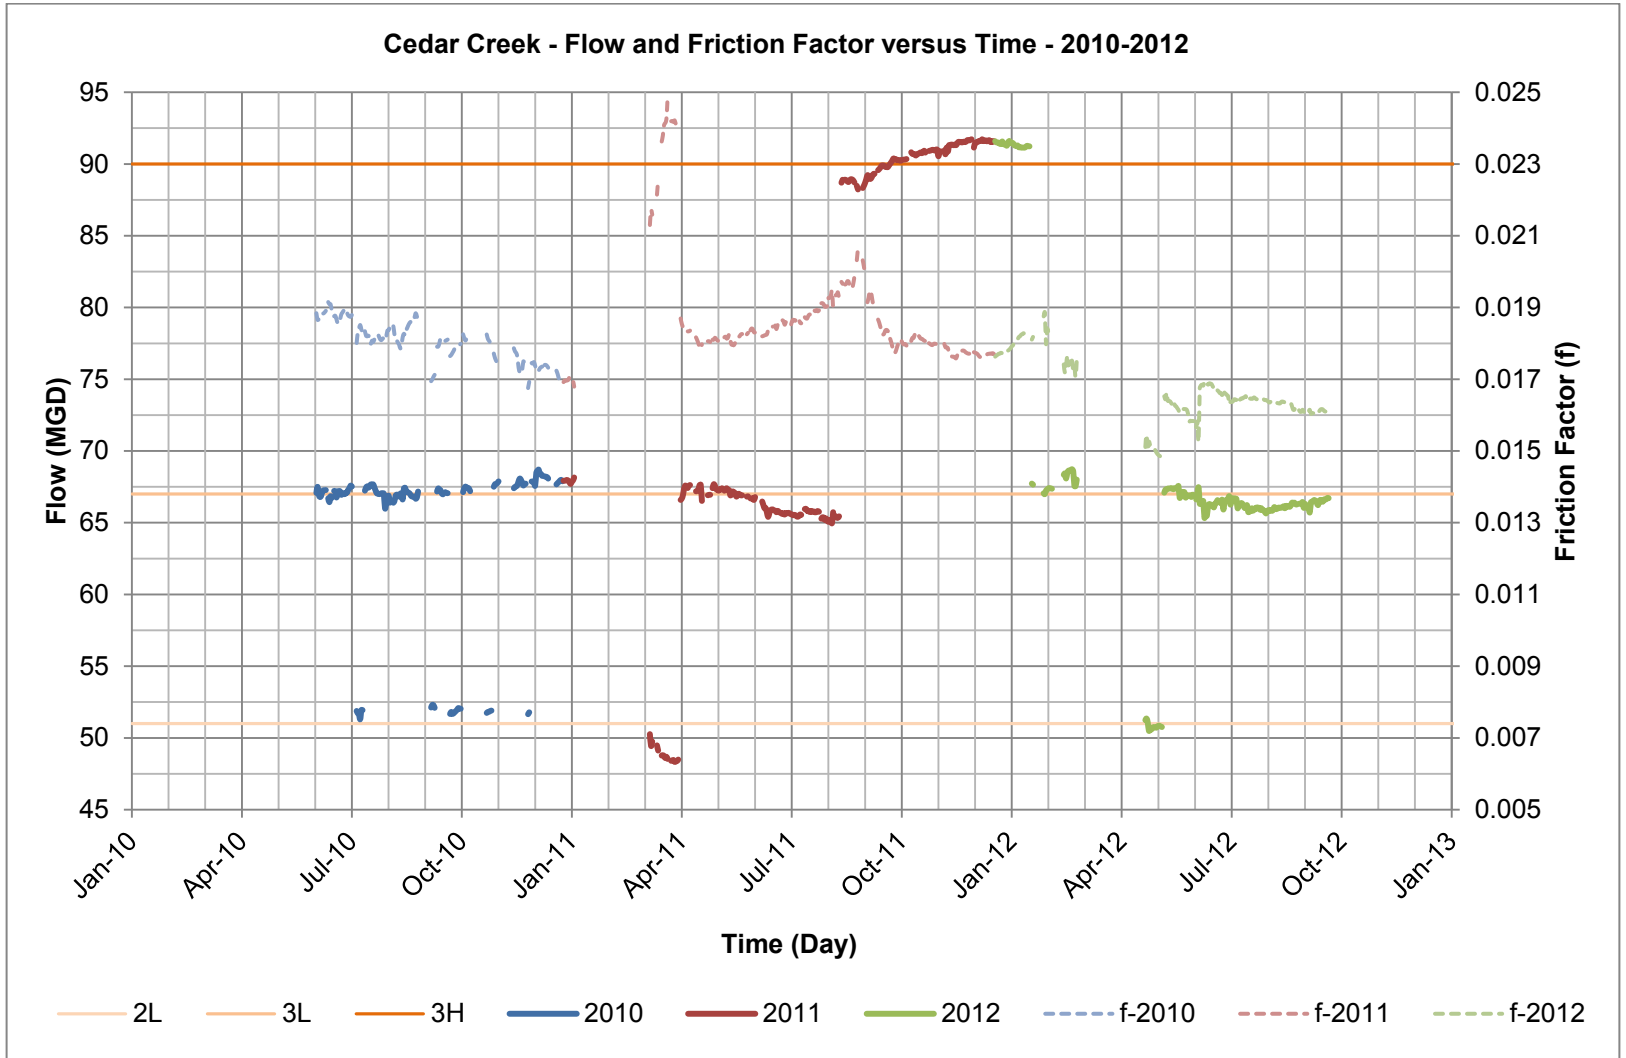
Figure 3.14: Flow Rates and Calculated Friction for the Cedar Creek Lake Pump Station

Whenever there is a pump combination change, the friction factor changes also. The friction factor increases from 0.015 to 0.016, for example, when the pump combination increases from 2L to 3L in the April-May 2012 timeframe. The same thing occurs in January/February 2012 when going from the 3H pump combination where the friction factor is 0.018 to the 3L friction factor value of 0.017. The Cedar Creek pipeline finds the lower the velocity, the lower the friction factor. Both timeframes discussed above occurred prior to chloramine treatment. Richland Chambers (Figure 3.15), demonstrates the same type of relationship in 2010. In 2010, the 1L pump configuration has a calculated friction factor value of 0.012 in April. The pump configuration changes to 2L and the friction factor goes up slightly to 0.013. The greatest difference occurs from the 2L to 3L pump change with the friction factor going from 0.014 to 0.019 in June. All these scenarios occurred when chloramines were not being applied. Further investigation in pump configuration and friction factor is needed when the chloramines are being properly applied to determine if there is a similar relationship.

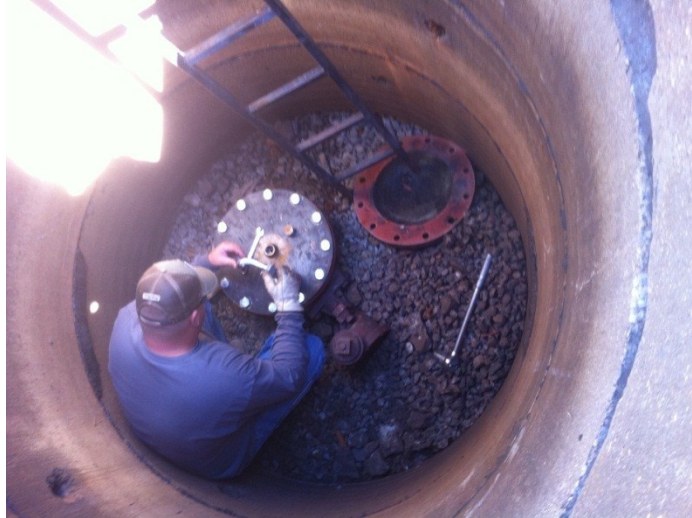
Figure 2: Blind Flange with Half Coupling

Figure 2 is a photo of the drilled blind flange and welded 1-inch half coupling prior to installing the pressure transducer.

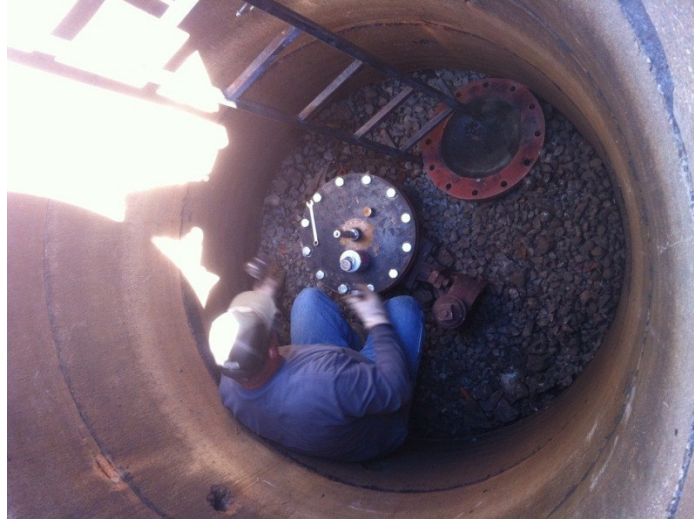
Figure 3: Transducer Connected to Pipeline - Sta. 3873+60

A 1" x 1/4" reducer was installed to allow the transducer, which has a 1/4" NPT, to be attached directly to the top of the blind flange. Figure 3 is a photo of the transducer connected to the pipeline. Pipe dope is added to the threads of the transducer to ensure a water tight fit.

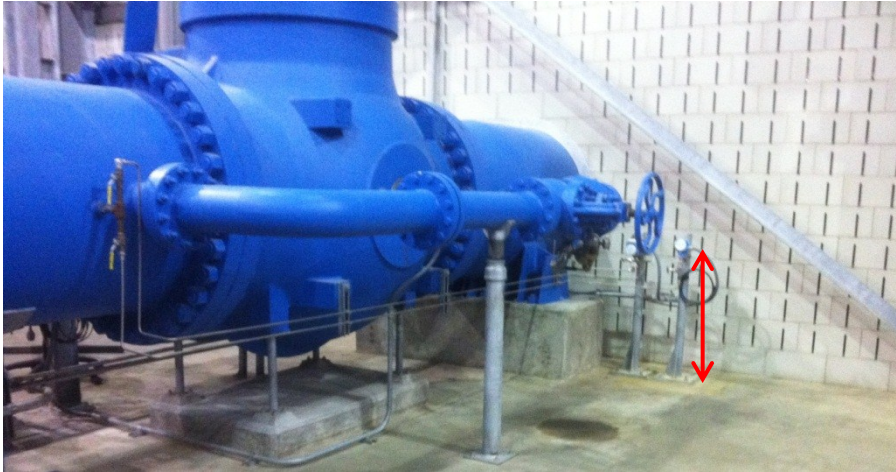
RC2 Pump Discharge Pressure Elevation:

RC2 FF elevation + Discharge Pressure Gage CL elevation = 454.0 + 3.167 =
457.021 msl

As-Built FF elevation: 454.00 msl

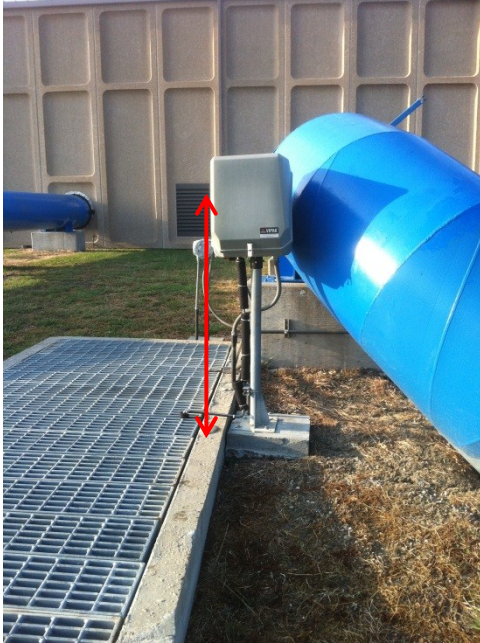
RC2 Station Pressure:

Concrete Vault Elevation +C/L gage to lip of concrete vault = $453.496 + 4.0 \text{ ft} =$

457.496 msl

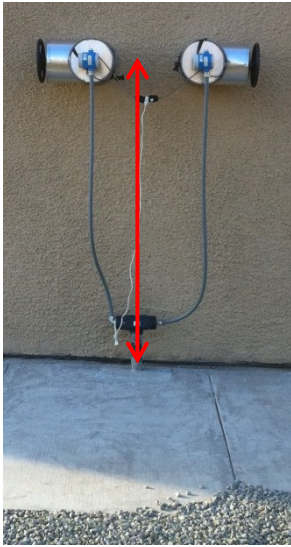
RC2 Tank Level:

The tank is measured at the following location:

Sidewalk Elevation + Sidewalk to C/L level indicator = $448.53 + 5.9 \text{ ft} = 454.43$
ft msl (5 ft mark for SCADA)

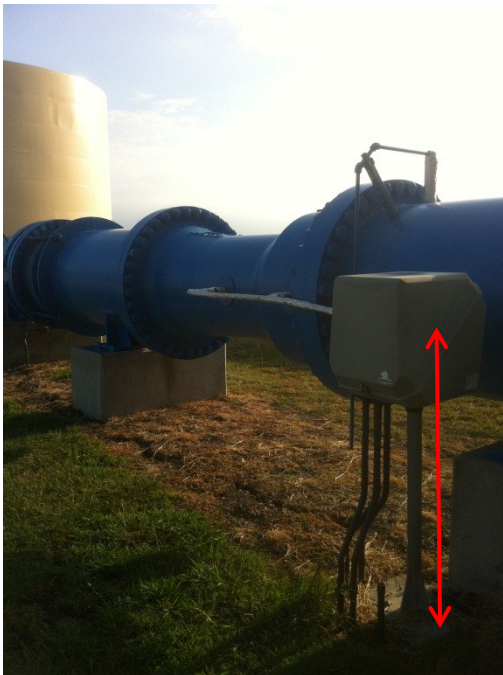
RC2 Flow

Each pump for the RC2 site has a Venturi meter located on each pump.

Concrete Pad Elevation + C/L gage = 453.670+ 4.4 ft = 458.07

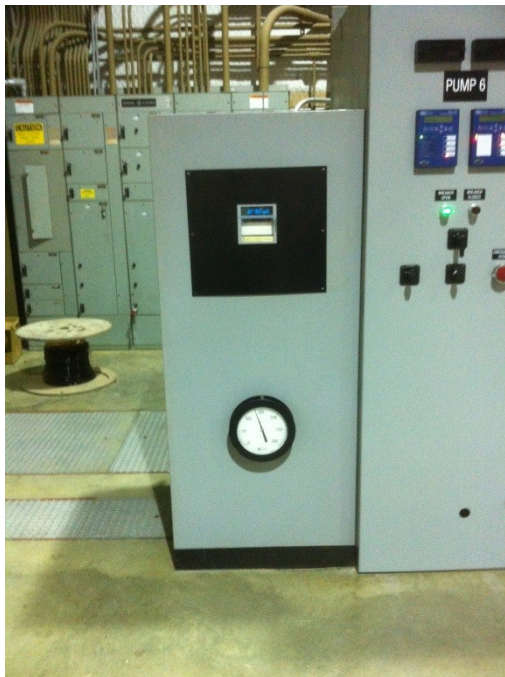
CC2 Tanks:

CC2 FF Elevation + C/L gage Elevation = 454.7 ft + 1.6 ft = 456.3 msl

As-built FF Elevation = 453.00

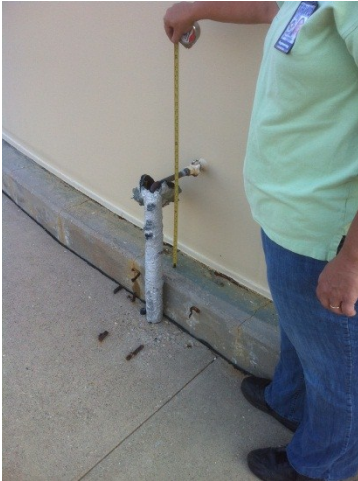
West Tank:

Concrete Curb Elevation + Curb to C/L Level Tap = 453.014 + 1.52 = 454.534

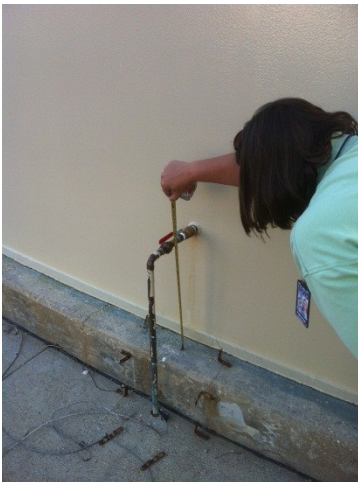
East Tank:

Concrete Curb Elevation + Curb to C/L Level Tap = 453.068 + 1.52 = 454.588
msl

Note: Tank As-Built Elevation: 452.00 msl, Surveyed Elevation: 453.01/453.07.

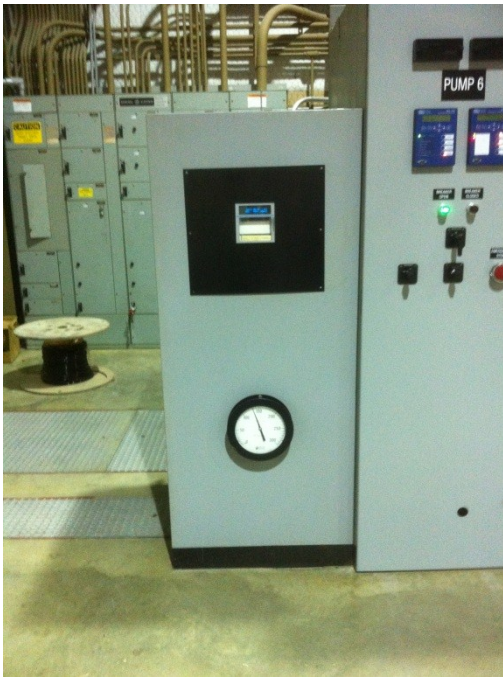
CC2 Station Discharge Pressure:

CC2 FF Elevation + C/L gage Elevation = 455.202 ft + 1.791 ft = 456.993 msl

As-built FF Elevation = 453.00

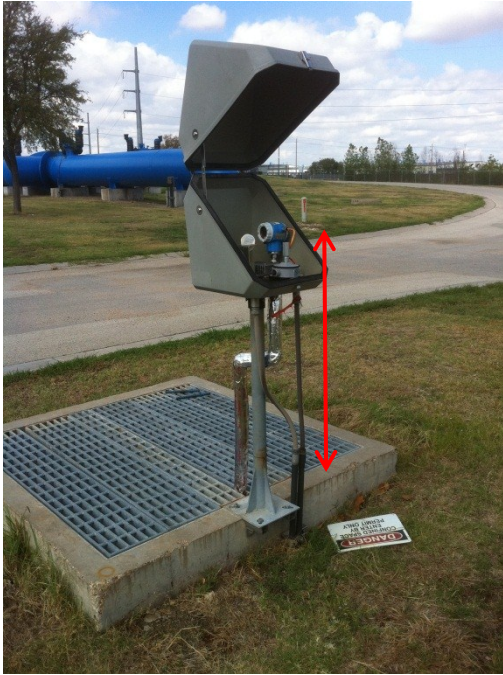
RC3H Station Discharge Pressure:

Concrete lip of vault elevation + C/L gage distance = 617.033+ 4.1 ft = 621.133

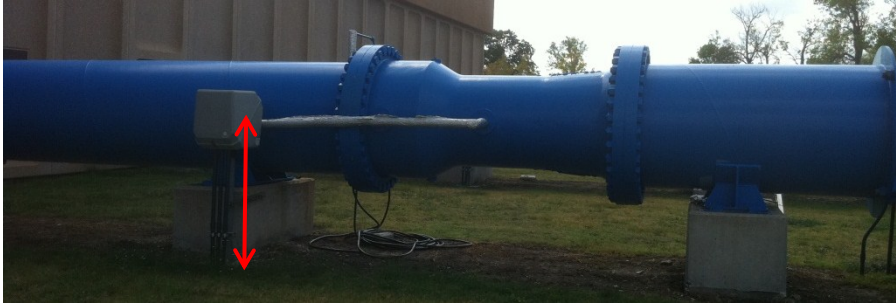
RC3H Flow

Concrete pedestal elevation + Distance to C/L gage = 617.820+ 4.45 ft =
622.27 ft msl

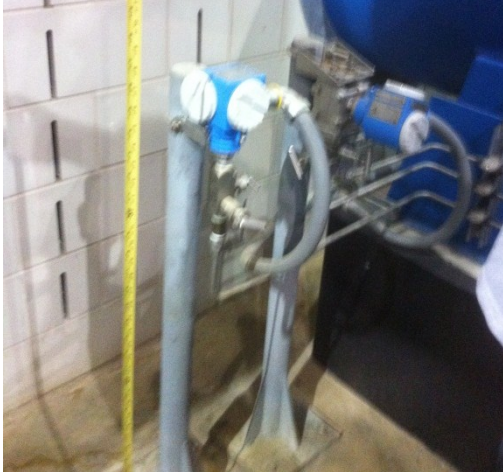
RC3H Pump Discharge Pressure:

RC3H Finished Floor Elevation + Distance to C/L gage = 617.648+ 3.75 ft =

621.398 ft msl

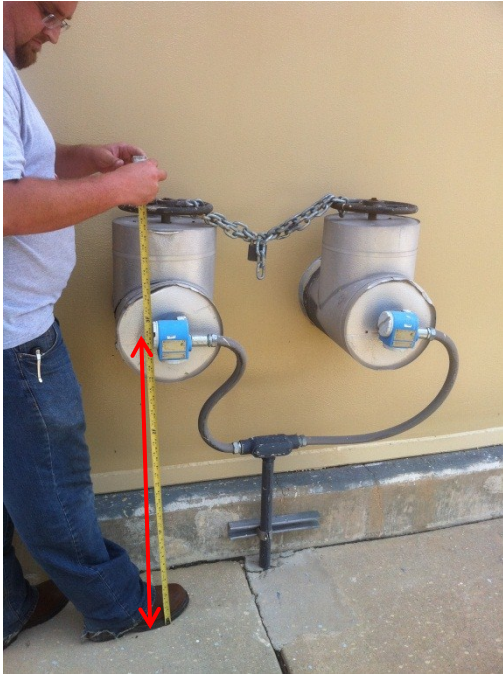
RC3H Tank Elevation:

Sidewalk elevation + Distance to C/L gage = 618.139 + 3.83 ft = 621.969 ft msl

There are two level instruments which alternate based on SCADA operator's choosing. The level will only start measuring when the water level reaches the level instrumentation level. If below the instruments, they will read 3'.

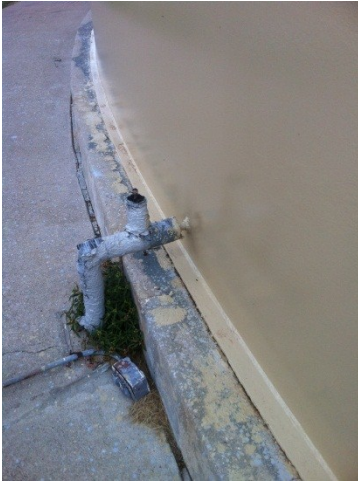
West Tank:

Concrete Curb Elevation + Curb to C/L Level Tap = 616.571+ 1.15 = 617.721 ft

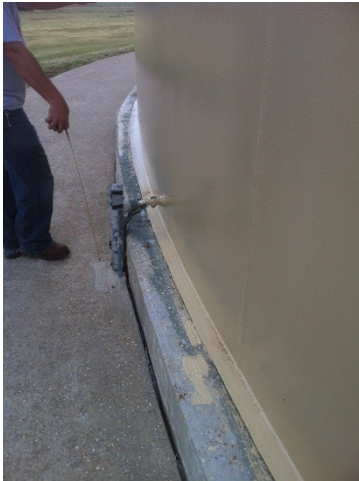
East Tank:

Concrete Curb Elevation + Curb to C/L Level Tap = 616.101+ 1.25 = 617.351 ft

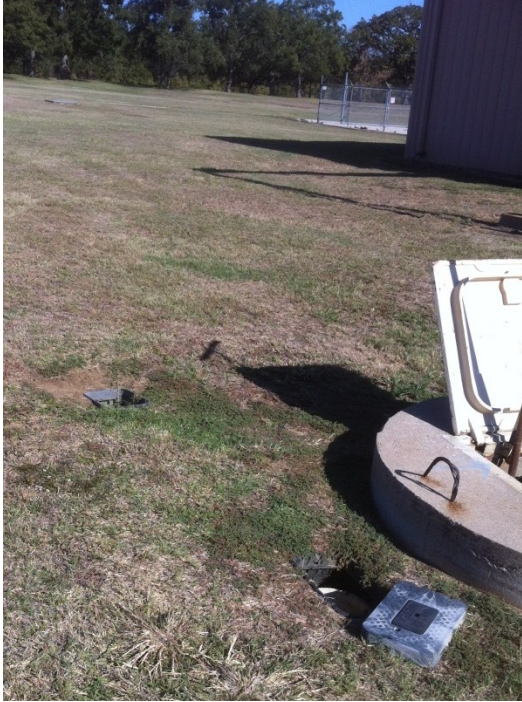
RC Venturi Meter Plans Showing Tap Locations

Yard Piping showing venturi tap locations

Measurements were taken to verify the location of the pressure taps on the venturi.

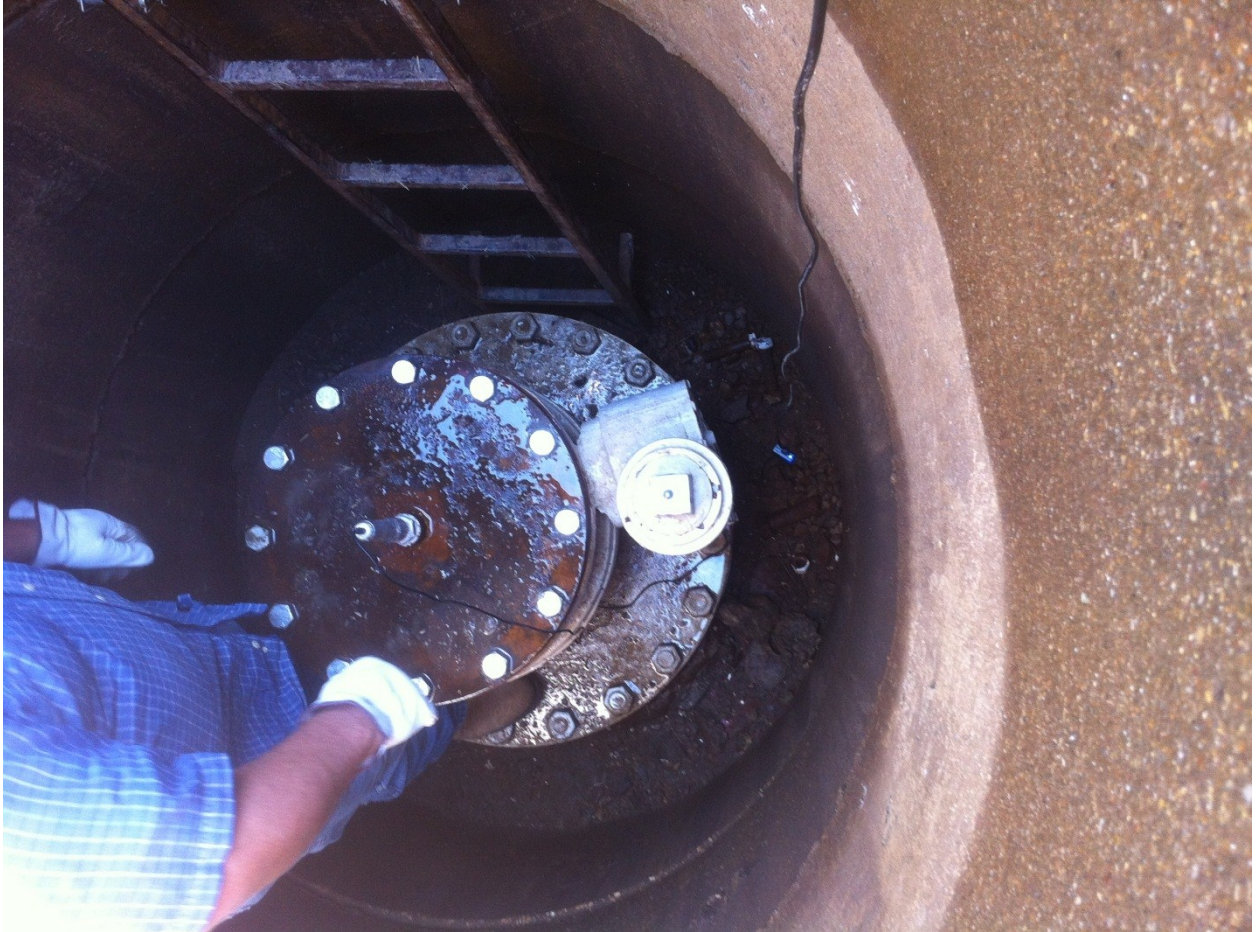
RC 3726+16 Blow-off (Highway 31)

While collecting data, it was observed that not all blow offs were configured as originally thought. Station 3726+16 on the Richland Chambers line (Highway 31) had a 24-inch man-way with a reduction to a 12-inch blow-off and a 12-inch blow off valve. The distance from the top blind flange to the top of man-way flange is 32-inches.

Revised Top of Pipe Elevation: $346.147 - 2.667 = 343.480$ msl

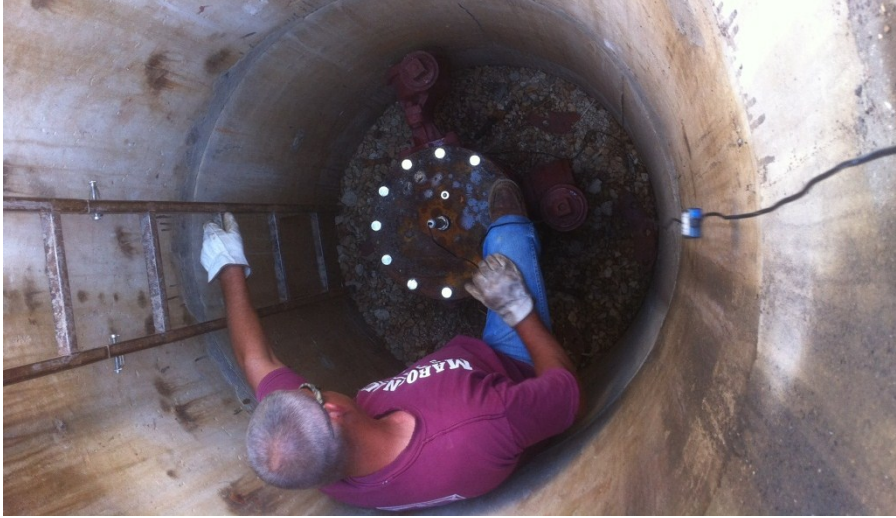
RC Sta. 2087+04 Blow off (Ebenezer Road)

Another location which differed is also on Richland Chambers at Station 2087+04 (Ebenezer Road). There were two 12-inch butterfly valves instead of one. The practice along the pipeline is to add a butterfly valve on top of a leaking isolation valve in the time where the valve cannot be removed due to the pipeline being live.

Revised Top of Pipe Elevation: $463.095 - (9+(2*8)+1.25)/12 = 460.908$ msl

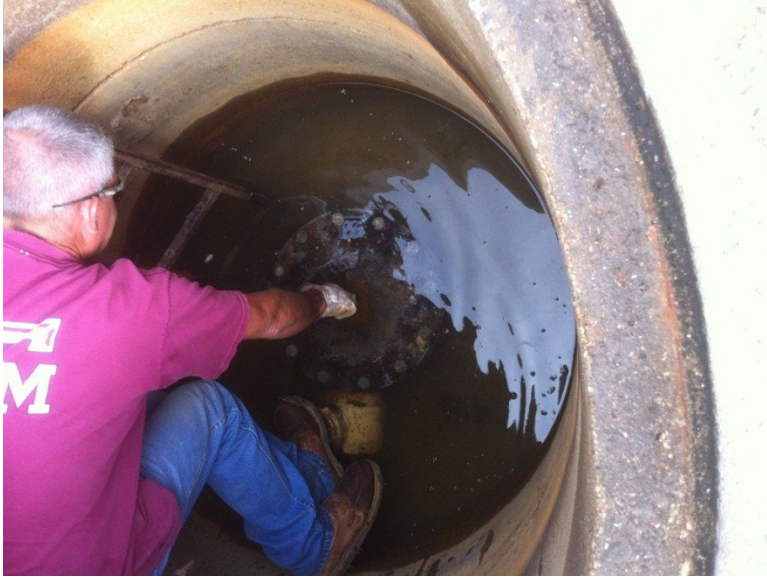
Station 2675+83 on the Richland Chambers line (Highway 85)

All of the vaults were fairly dry, with the exception of water found at Station 2675+83 on the Richland Chambers line (Highway 85). The pressure transducer did not get submerged at this time and data was successfully downloaded.

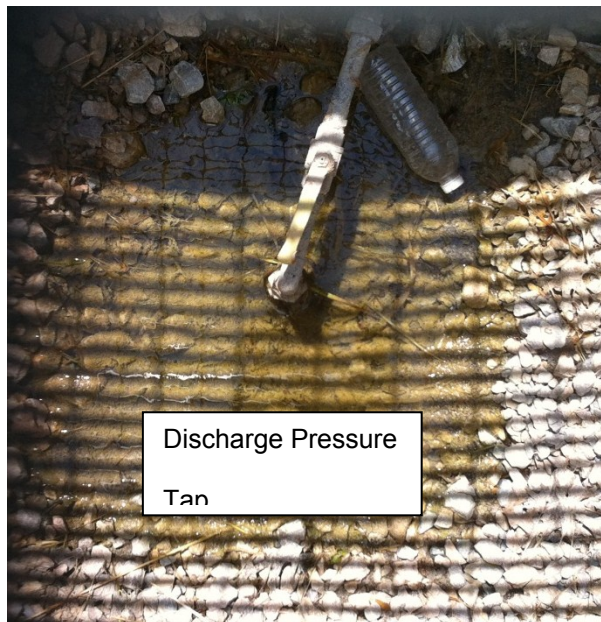
CC2 Discharge Pressure Tap

The tap is located at the top of the pipe at a man way located in an open vault.
