LABORATORY AND FIELD INVESTIGATIONS TO ADDRESS EROSION,
VOLUME CHANGE AND DESICCATION CRACKING OF
COMPOST AMENDED EXPANSIVE SUBSOILS

Presented to the Faculty of the Graduate School of
The University of Texas at Arlington in Partial Fulfillment
of the Requirements for the Degree of

THE UNIVERSITY OF TEXAS AT ARLINGTON

December 2005

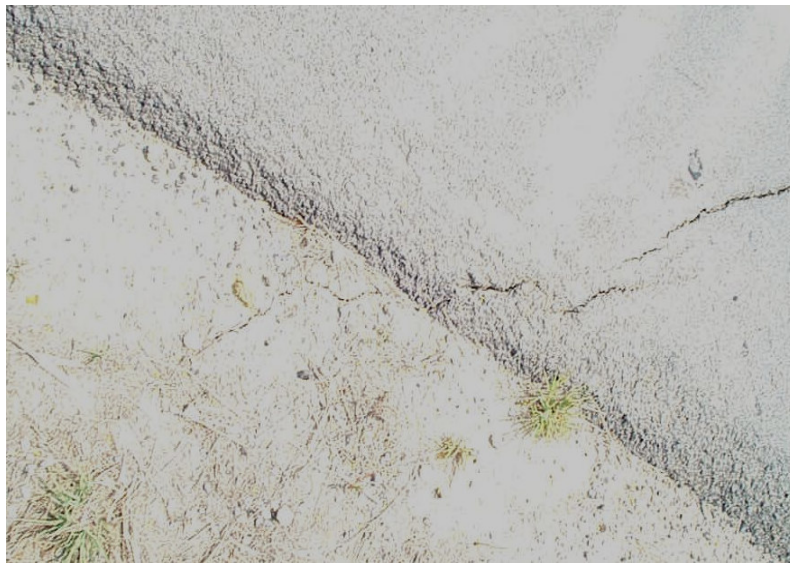
Figure 1.1 Shoulder cracking of SH 108 (Transverse Cracks)

Effective remediation methods must be immediately applied to prevent desiccation cracking of subsoils. Several chemical and mechanical treatment methods have been used to stabilize expansive shoulder subgrades. However, these methods have their own limitations and restrictions. Some are expensive, some less effective and some are not suitable in sulfate rich soils. Compost materials, given their moisture affinity (hydrophilic), low permeability and fibrous characteristics, are expected to reduce swell and more importantly shrinkage behaviors of underlying natural subsoils by encapsulating and reinforcing them. As a result, pavement shoulder cracking could be mitigated.

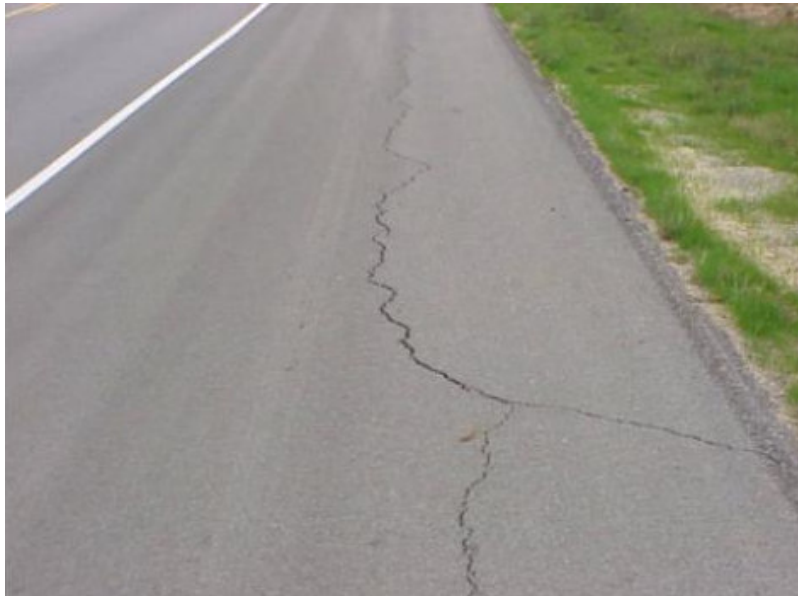
Figure 1.2 Longitudinal and transverse cracks

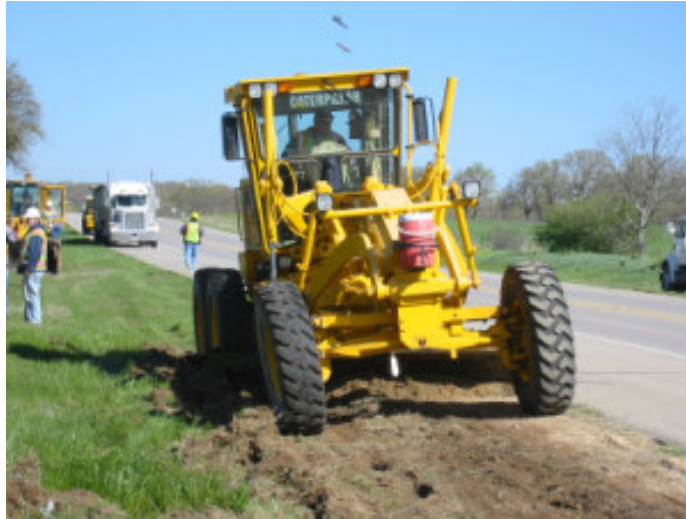
Figure 4.2 Maintainer to blade the subgrade shoulder

The field construction was started by first by removing the top layer (thickness is t_1 in.) of the soil, which was composed of vegetation and other organic matter. The ‘maintainer’ was then used to blade the remaining shoulder subgrade section to the required grade and cross-section in accordance with the specifications obtained from the spreadsheet-based program. Figure 4.2 shows a photograph of this step in the field.

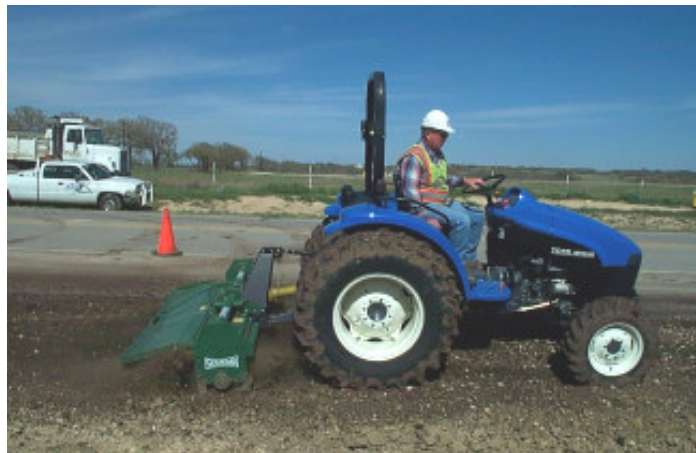
Figure 4.3 Rotary tiller for tilling operations

The shoulder was then scarified to full length (which is 50 ft. long test section and 25 ft. long of transition), width (variable) and tilling thickness (t_2 in.) using a rotary tiller. Any lumps in the subgrades were broken up such that no large sized particles (2 in. or above) were present in the tilled soil (Figure 4.3).

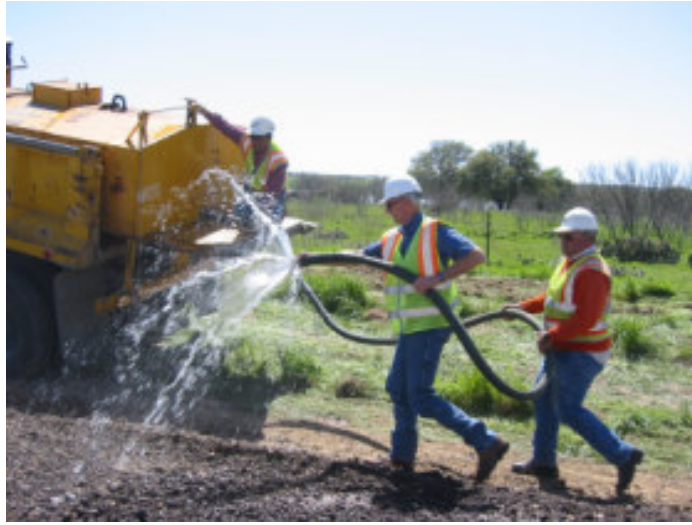
Figure 4.5 Application of water over the CMT loose mixture

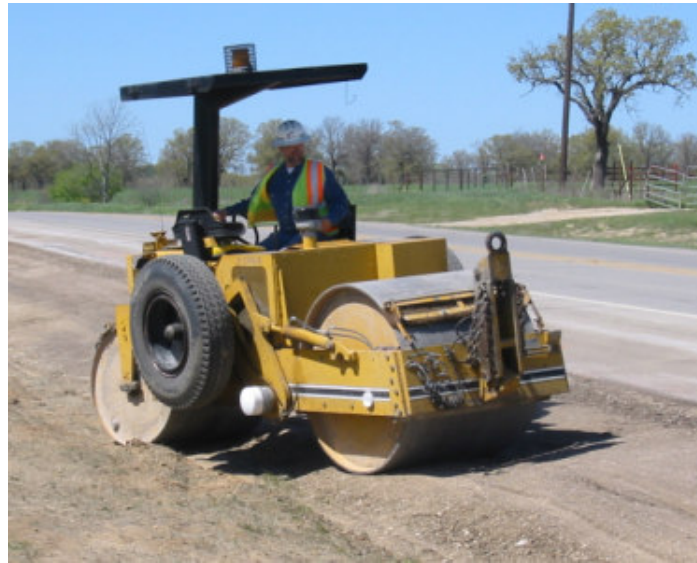
Figure 4.6 Smooth drum roller used for soil compaction

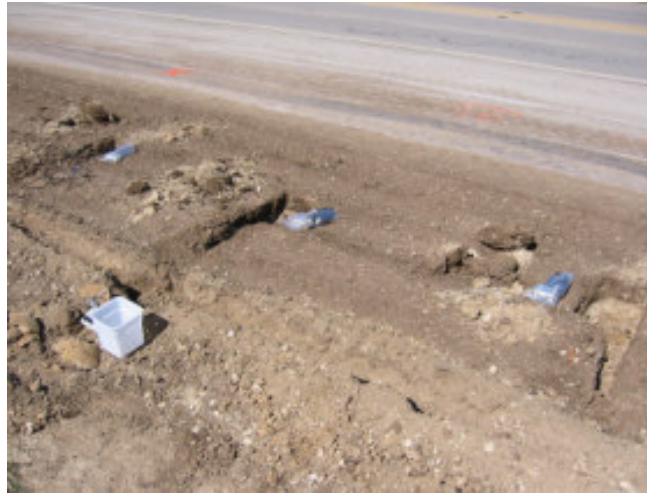
Figure 4.7 Placement of sensors in a test section

compacted in short lifts (4 in.). Extreme care was taken to ensure the compaction was similar to the adjoining subsoils. The sensors placement is shown in Figure 4.8.

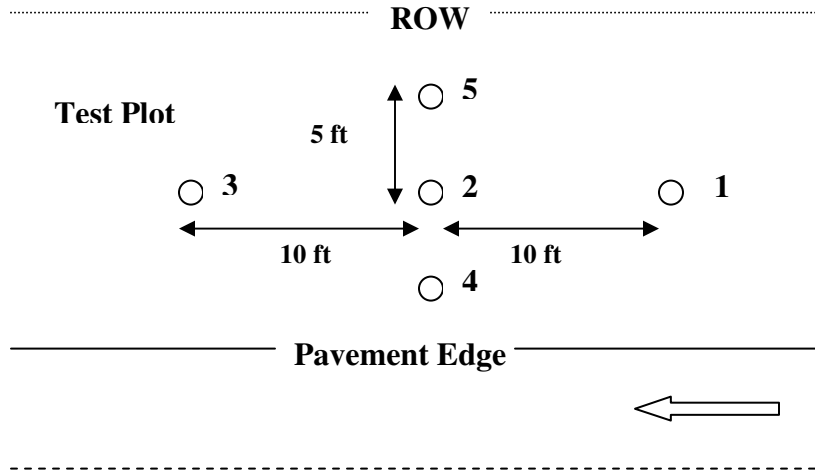
Figure 4.12 Typical section showing spike orientation

The vertical displacements were calculated by subtracting the elevation of each spike from an initial elevation, which was established at the beginning of the monitoring process immediately after the test plot construction in April, 2003. For example, the elevation of spike 3 on June 1, 2003 would be equal to $-9.79 - (-9.75)$ or -0.04 ft. This implies that the surface of the test plot has been eroded by an amount of 0.04 feet.

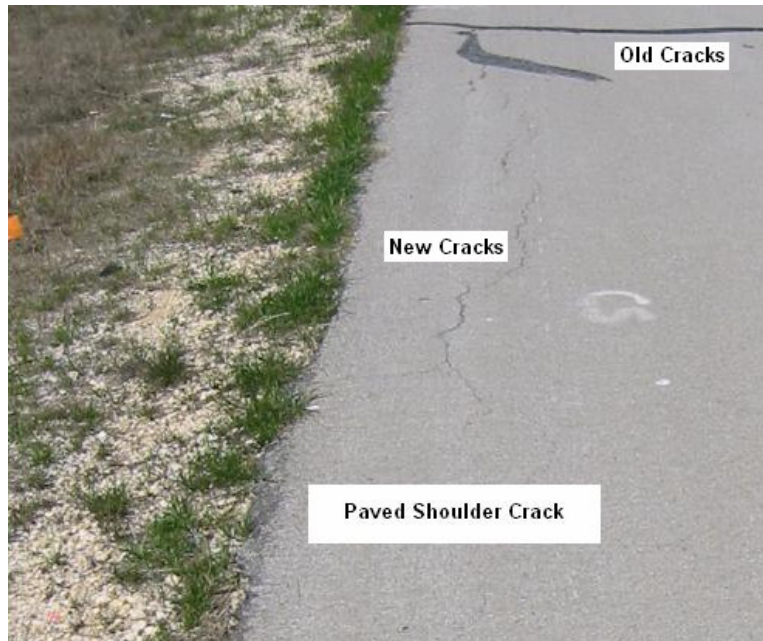
Figure 4.14 Paved shoulder cracks on the Control Plot at Stephenville site

In order to distinguish between the new and old cracks on the adjoining pavement, digital pictures of the paved shoulder were periodically taken. Old cracks had been crack sealed with a bitumen product and these can be seen in a digital photograph shown in Figure 4.14. As the paved shoulder began to deteriorate, cracks would continue to appear and propagate as well as widen. These cracks were recorded. By comparing the photographs at the same location, the severity of cracking could be estimated.

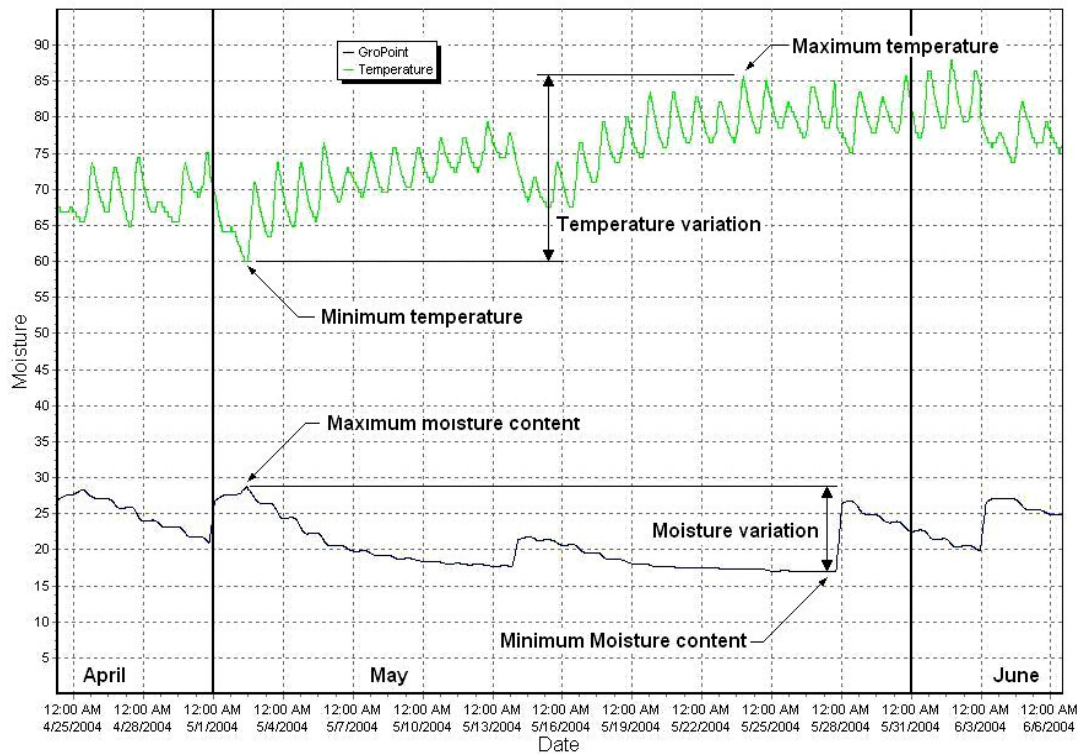
Figure 5.1 Typical temperature and volumetric moisture data

and minimum volumetric moisture contents in each month. Average values of these moisture variations are determined and used as the ‘mean moisture variation’ in this research. Moisture variation analysis was done by comparing the ‘mean moisture variation’ of every plot to the ‘mean moisture variation’ of the Control Plot. It should be mentioned that the analysis was also conducted on biweekly data. However, no significant difference was found.

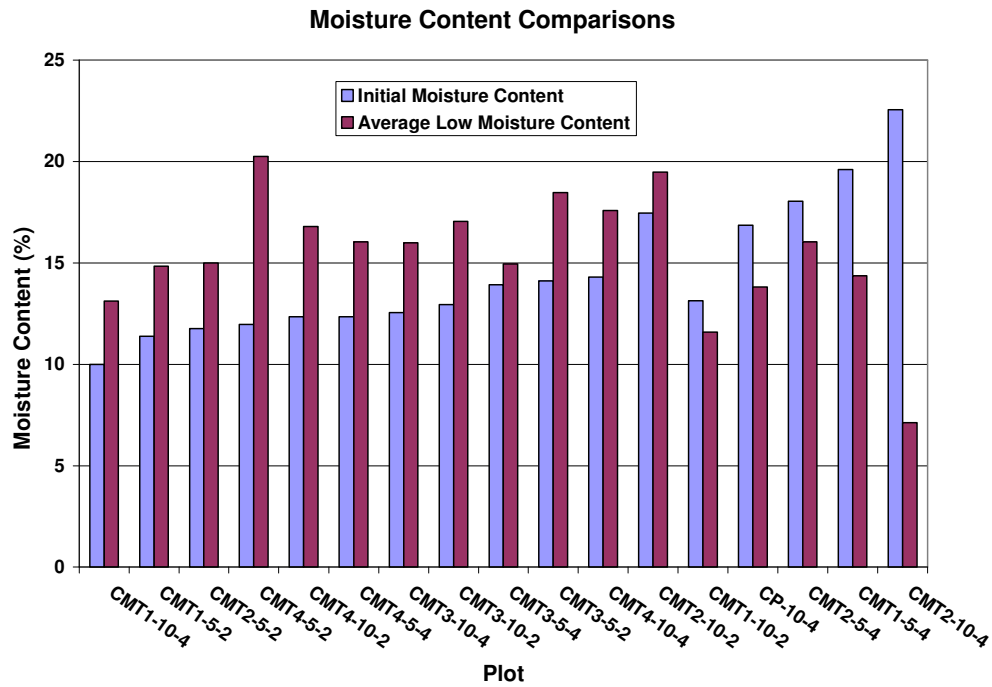
Figure 5.3 Moisture content comparisons

moisture content. In table 5.3, plots with minimum moisture readings less than initial moisture readings are highlighted in gray. As mentioned earlier, most compost plots, except plots 3, 8, 15 and 16, did not experience any moisture losses beyond their initial compaction moisture contents. The Control Plot (17) with no compost covers experienced loss in moisture content below the initial compaction moisture contents. The plots that experienced the most moisture losses were some of the Dairy Manure Compost plots indicating that this material possibly did not provide effective encapsulation of the surface. In the case of the Biosolids Compost plots, the reduction of the CMT treatment width appeared to result in higher moisture variations.

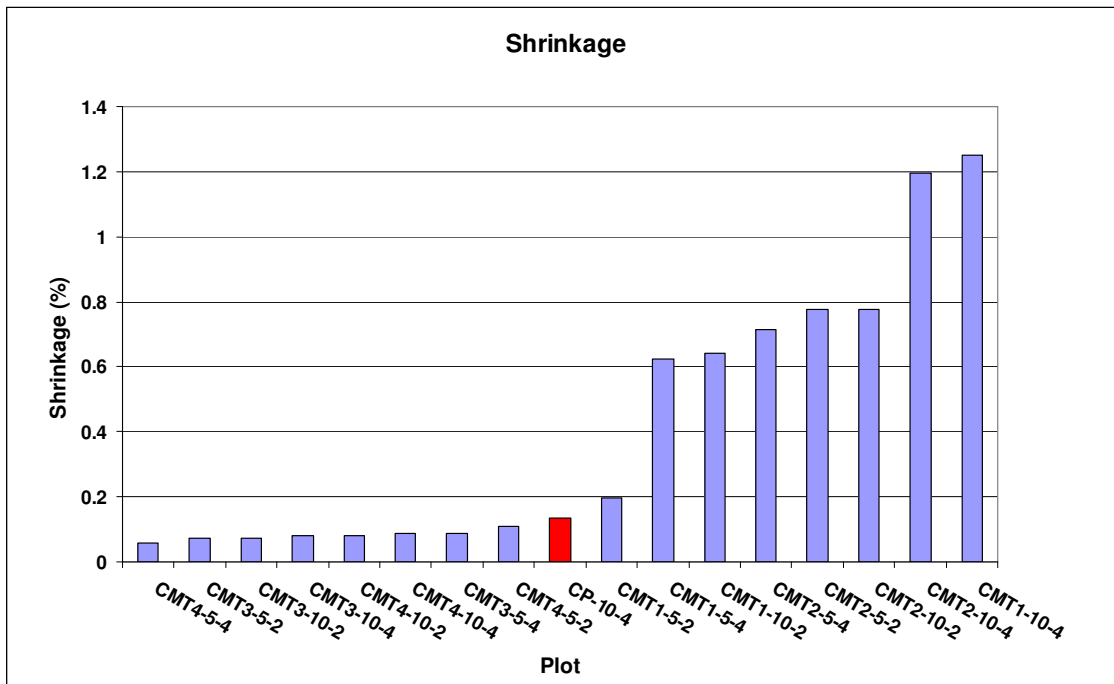
Figure 5.14 Shrinkage cracking in the test plots

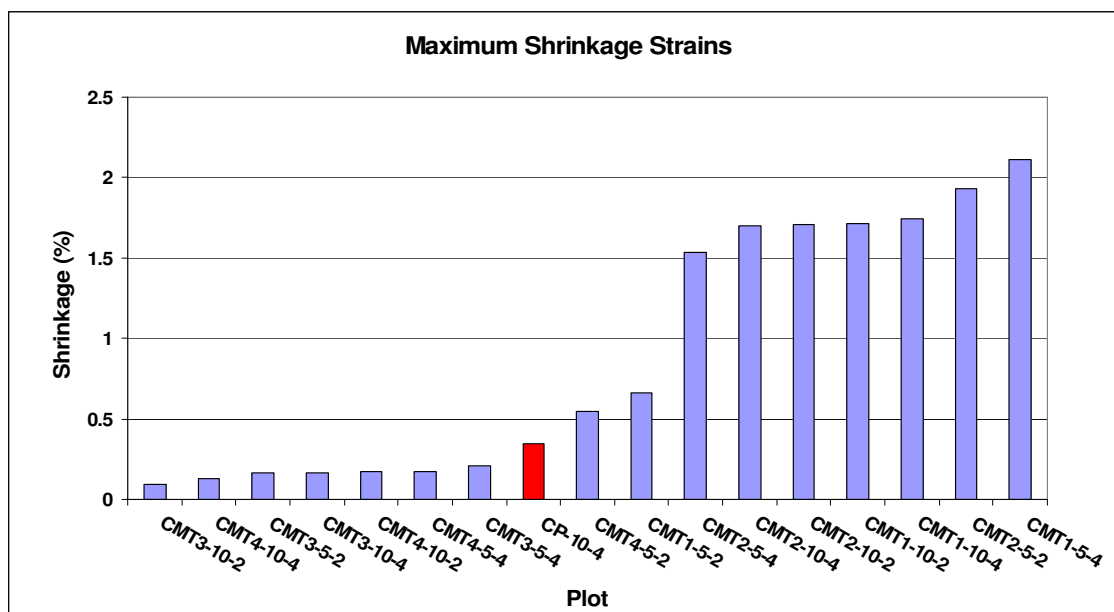
Figure 5.15 Maximum shrinkage strains

Plot	Compost	Shrinkage
CMT3-10-2	BSC	0.17
CMT4-10-4	BSC	0.17
CMT3-5-2	BSC	0.18
CMT4-5-4	BSC	0.20
CMT3-10-4	BSC	0.23
CMT4-10-2	BSC	0.23
CMT3-5-4	BSC	0.31
CP-10-4	-	0.34
CMT1-5-2	DMC	0.64
CMT4-5-2	BSC	1.04
CMT1-5-4	DMC	1.47
CMT2-10-2	DMC	1.71
CMT1-10-2	DMC	1.81
CMT2-5-4	DMC	1.93
CMT2-5-2	DMC	1.93
CMT2-10-4	DMC	2.03
CMT1-10-4	DMC	2.53

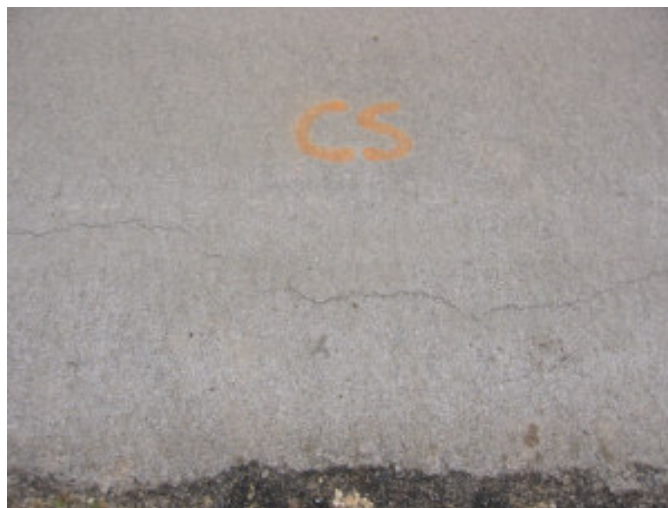
Figure 5.16 Paved shoulder on Apr 2003

Pavement shoulder cracking can be attributed to moisture intrusion into the adjacent shoulder subgrade layers due to either desiccation cracking or shrinkage cracking movements. Less cracking on paved shoulders could be used to identify the CMT's effectiveness as an acceptable cover material. Figures 5.16 and 5.17 show a few digital images of pavement shoulder cracks adjacent to the Control Plot taken at different time periods during monitoring. In the first picture, a few longitudinal cracks can be seen. The next image, which was taken a year later, shows the widening and joining of the cracks. Due to the high amount of shrinkage cracking in the Control Plot, paved shoulders exhibited unacceptable cracking. This allowed water intrusion into the underlying subsoils, which further weakened the subgrade. As a result, the paved surface experienced further cracking and widening of existing cracks as shown in Figure 5.17.

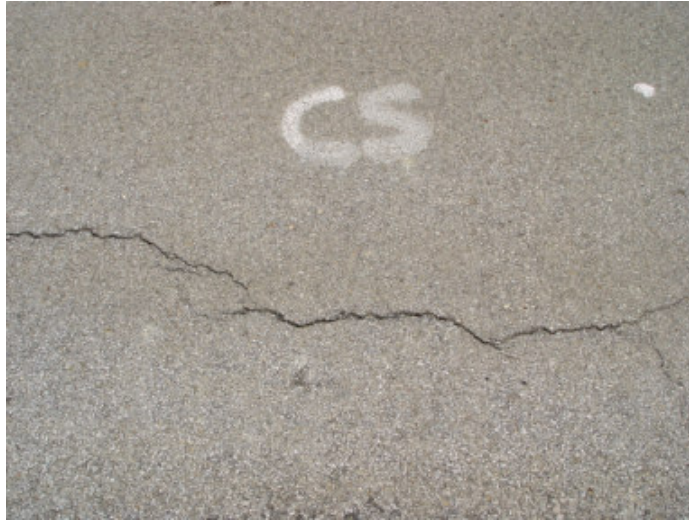
Figure 5.17 Paved shoulder on Apr 2004

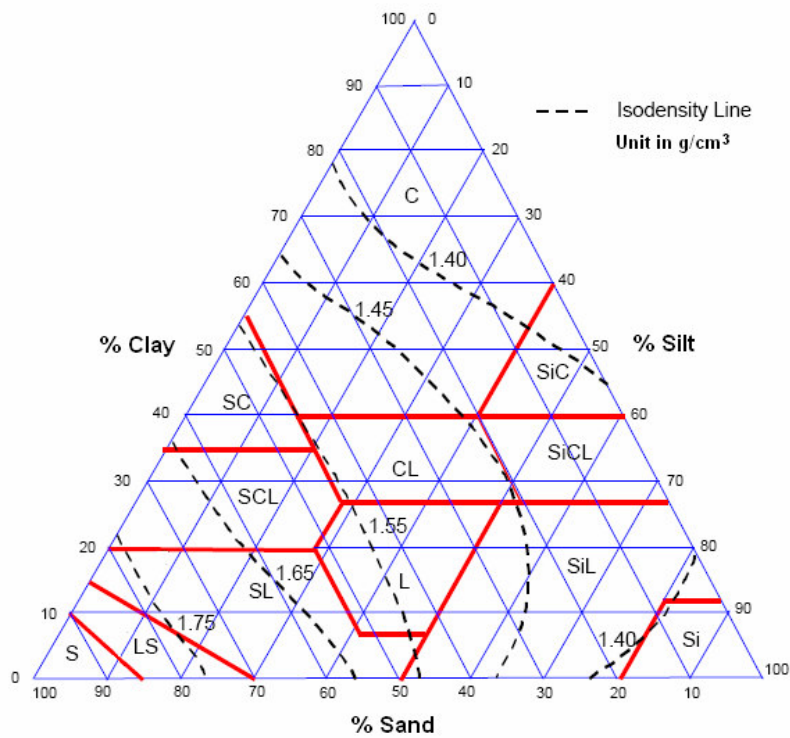
Figure 5.24 Growth-limiting bulk density textural triangle (Modified from Goldsmith et al. 2001)

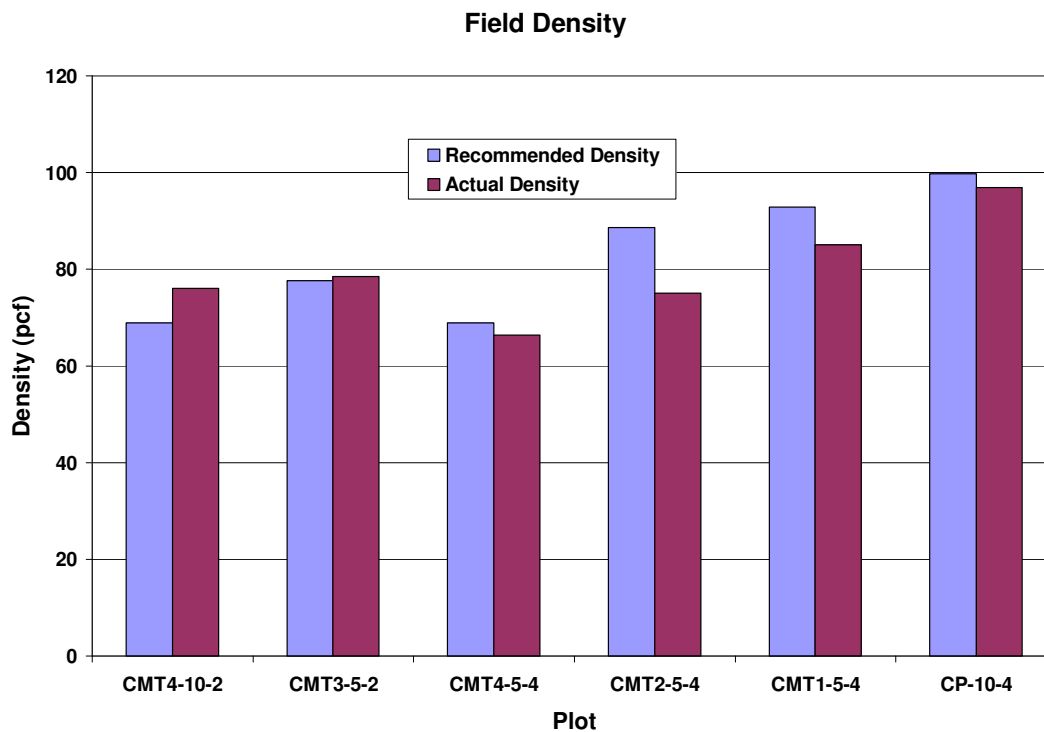
Figure 5.25 Actual and recommended field dry densities

Tyler (2003) reported that in general, a compaction between 80-85 percent of the standard proctor maximum dry unit weight or density optimizes the performance of slope stability with vegetation development and growth. In the present case, this criterion did affect the vegetation growth in certain plots whose relative compactions were above 90%. Vegetation was noted on the compost test plots whose compaction densities were less than 80 pcf (relative compactions less than 85%) and not noted extensively on test plots whose compaction densities were more than 90 pcf (relative compactions more than 85%). However, with continuous seeding, one expects the vegetation growth even on the Dairy Manure Compost test plots.

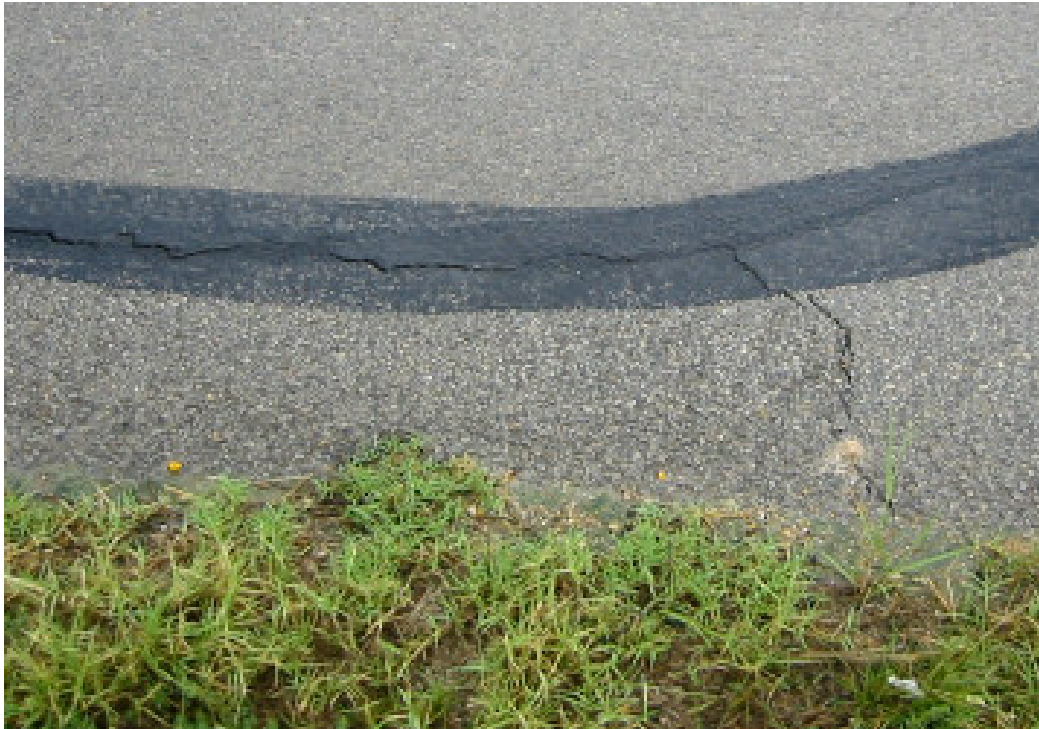
Figure 6.6 Shrinkage of the asphalt concrete

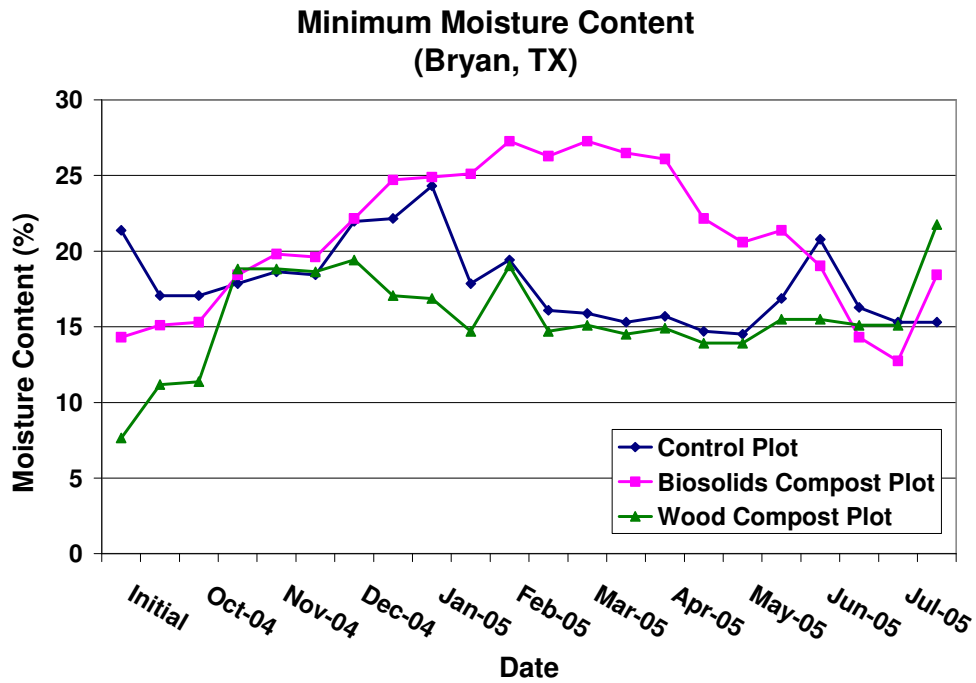
Figure 6.8 Records of minimum moisture content at Bryan site

The minimum moisture contents determined for every two weeks were plotted in Figures 6.7 to 6.9. The minimum moisture contents of both compost plots at Lubbock site did not go below the initial compaction moisture contents whereas at Bryan site, the control and biosolids plots experienced losses of 7% and 2% moisture content below their initial compaction moisture contents. The Corpus Christi site was constructed during a rainy day, and hence all plots were unable to maintain compaction moisture content levels, which were higher than initial compaction moisture content level. Although all plots at Corpus Christi experienced losses in moisture contents below the initial compaction moisture content, both compost sections were able to retain more moisture during early February till early April. This indicates that compost materials used in this research were able to retain and sustain moisture and hence provided effective encapsulation of the surface.

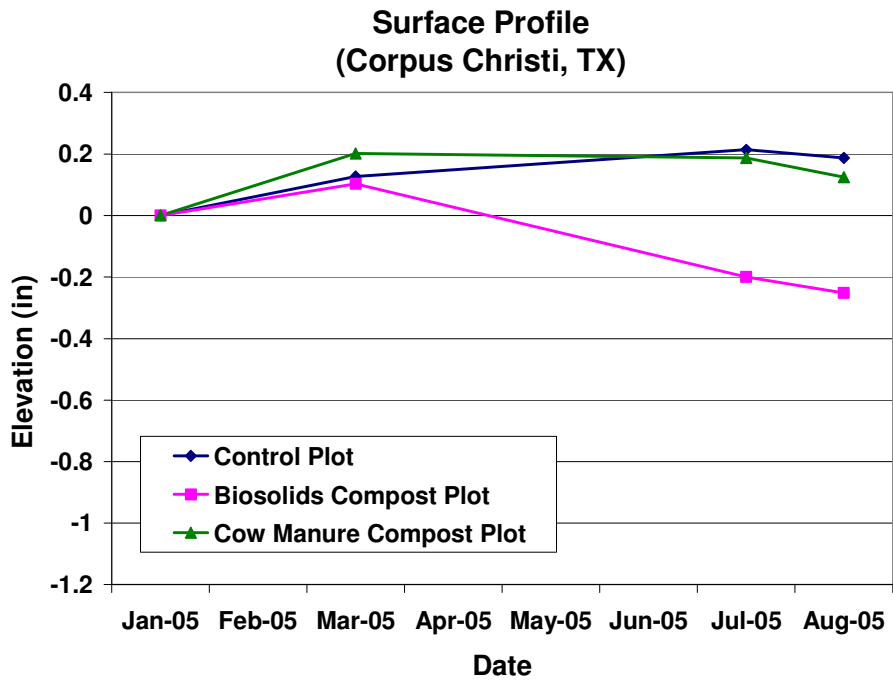
Figure 6.12 Surface profile at Corpus Christi site

increased the erosion rate. Figure 6.12 indicate a swelling pattern for the control soil and Cow Manure Compost section, which are matched with the laboratory results. Both plots experienced heaving during the wet season period. Biosolids Compost plot, on the other hand, experienced erosion of 0.23 in. This erosion is considerably lesser. Nevertheless, it indicates moderate surface erosion in this plot, perhaps due to the low organic contents of this material when compared to the Biosolids compost used in Stephenville site.
