PERFORMANCE OF LARGE DIAMETER  
POLYVINYL CHLORIDE (PVC) PIPES  
IN WATER APPLICATIONS

MASTER OF SCIENCE IN CIVIL ENGINEERING

THE UNIVERSITY OF TEXAS AT ARLINGTON

December 2012

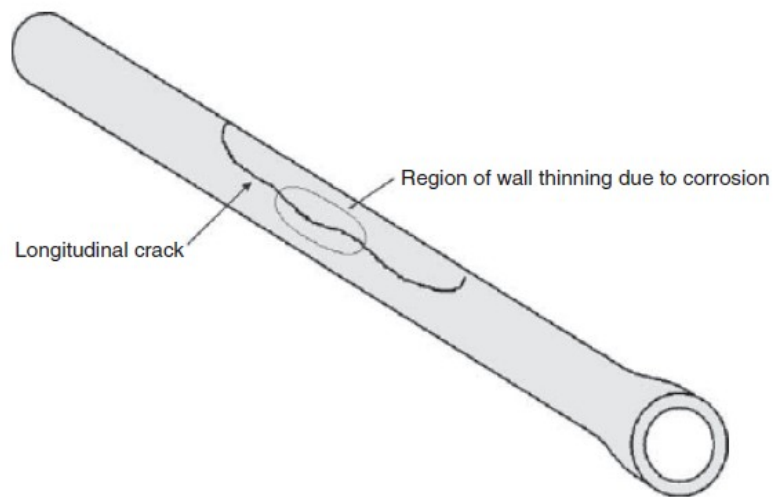
Figure 1.3 Longitudinal Failures in Cast Iron Pipes Caused by Corrosion (Najafi, 2010)

According to Makar (2000), cast iron pipes were extremely popular in North America from the 1870s to the 1970s but are no longer in use. There are two types of cast iron pipes: the gray cast iron pipe and the ductile iron pipe. The gray cast iron pipe is made partly by graphite flakes while the ductile iron pipe is made of iron and carbon. The gray cast iron and ductile iron pipes are both lined with nonmetallic material on the inside of the pipe, which makes the pipe material resistant to internal corrosion. Cast iron pipes have experienced the greatest amount of failures per mile. The gray cast iron pipe experiences external corrosion causing

deformity of the pipe structure on the outside. For this reason, ductile iron pipes have replaced the gray cast iron pipes in previous decades. The ductile iron pipe comes with an additional advantage: because it is ductile, this material can handle stress (Makar, 2000). The gray cast iron and the ductile iron pipe are both used for sanitary engineering and especially for water transportation (Liu, 2003). Figure 1.3 shows the natural ability of cast iron pipes to undergo heavy corrosion-related degradation externally.

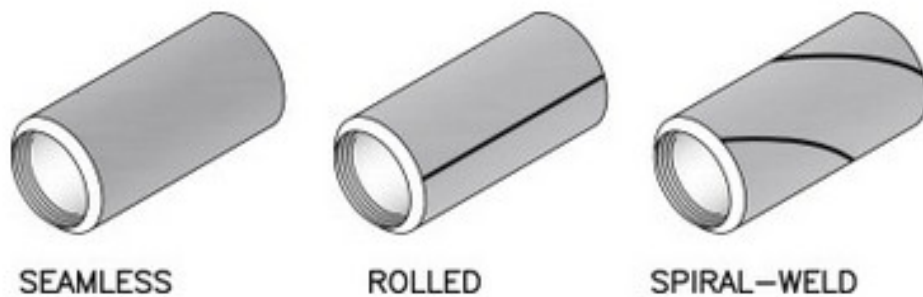
Figure 1.4 Different Types of Steel Pipes: Seamless, Rolled and Spiral Weld (Parisher & Rhea, 2012)

Carbon steel pipes are most commonly used in the industry today. Steel pipes are manufactured in different ways to give them their respective characteristics. Steel pipes can be manufactured using seamless welds, butt-welds or spiral welds (see Figure 1.4). Seamless pipe is formed when a molten steel rod is combined with a clamp. Butt welded steel pipe is formed when hot steel is rolled into a hollow cylinder-like shape--giving the pipe a joint or a steel. Finally, a spiral welded steel pipe is formed when strips of steel metal are twisted and welded where the edges join each other. Steel pipes are known for their strength and ability to transport water at high pressures. The carbon steel material's drawback is the ability to corrode easily via

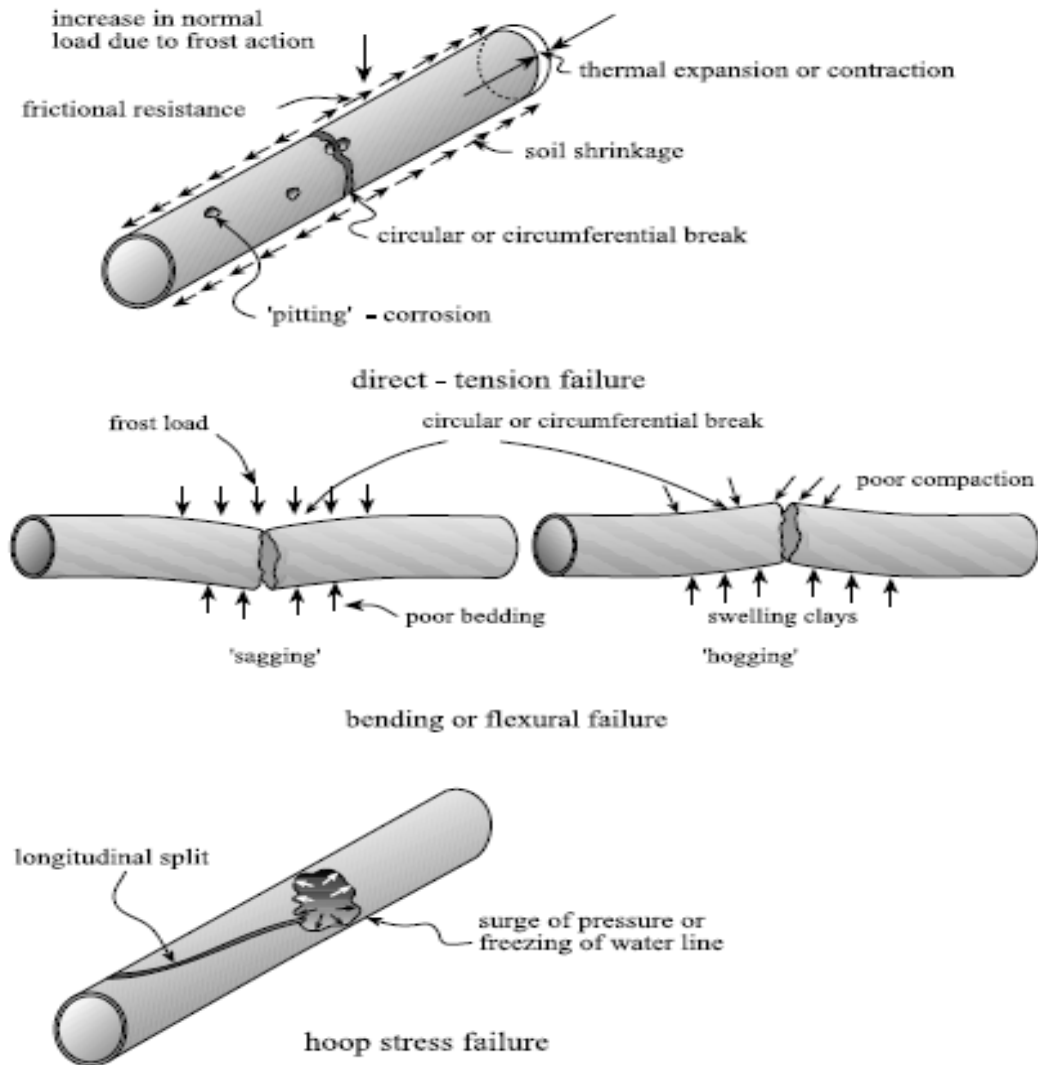
Figure 1.5: Different Failure Modes for Buried Pipes (Kleiner & Rajani, 2001)

Kleiner & Rajani (2001) published models of different types of pipe wall breaks caused by three different reasons: circumferential breaks, longitudinal breaks and split bell. Figure 1.5 above depicts these different breaks. Longitudinal stresses in the material cause circumferential breaks due to low water temperature in the pipes acting on the pipe, soil movements around the pipes and inappropriate bedding of the pipe. Transverse stress causes longitudinal breaks due to hoop stress caused by the intense pressure in the pipe, ring stress due to the soil above the pipe as well as any traffic pressure the pipe experiences. Hoop stress is mostly caused by frozen soil that permeates the ground during extreme winter conditions.

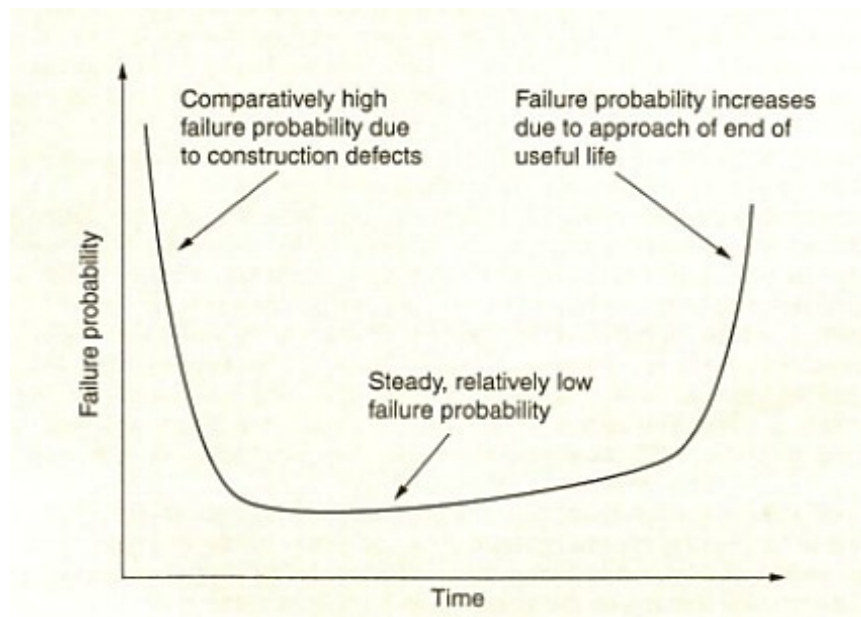
Figure 1.6: Bathtub Curve of Pipe Performance with Age (Najafi & Gokhale, 2005)

Finally the pipe's age is an important indicator of its failure. As shown in Figure 1.6, when the pipe is first installed it has a high probability of experiencing failure due to construction defects. During its midlife, the probability of pipe failure decreases. However, as the pipe approaches the end of its lifetime, the probability of failure increases again (Najafi & Gokhale, 2005).

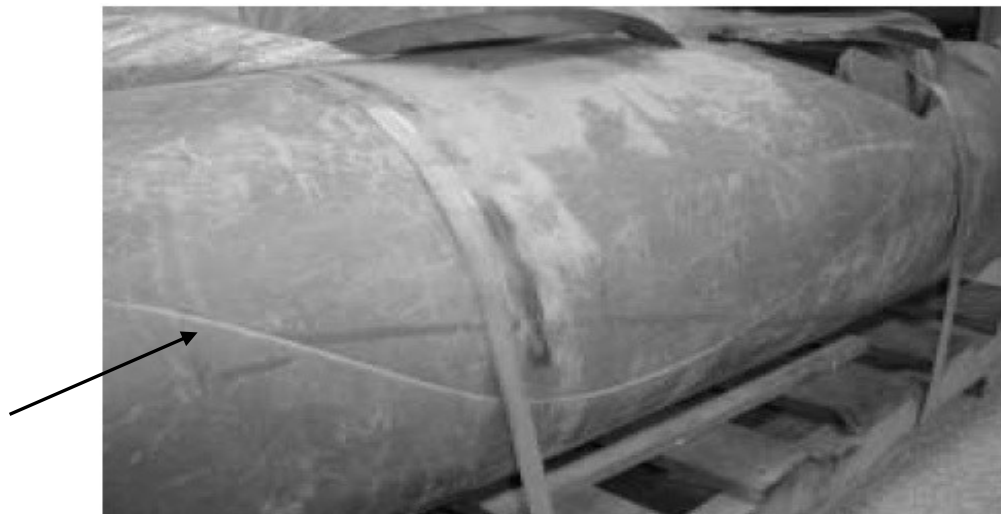
Figure 2.4: Noticeable Crack in PVC Pipe (Burn, et al., 2005)

As PVC pipes are known to be brittle, they experience cracks along their walls if left with high pressure internally. Their brittleness is caused by improper handling during processing or processing in higher temperatures. They can also be easily damaged if struck by tools during installation or rough handling by employees on site (Carroll, 1985).

PVC can also be damaged if it is improperly processed. The material is made from a gelation process by which it is melted and allowed to reform several times to strengthen individual crystallites into a strong polymer. Hence, hindering this process can alter its brittleness and make it more prone to cracks. Figure 2.4 shows a crack in a PVC pipe caused by stress due to high temperature processing (Burn et. al, 2005).

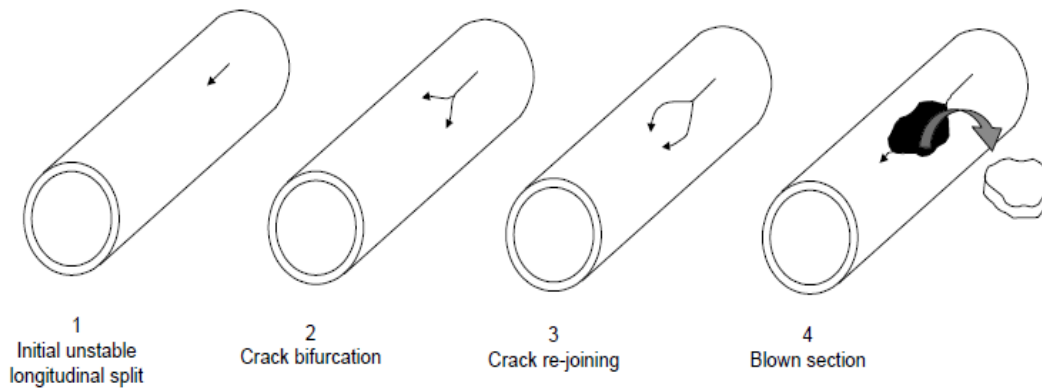
Figure 2.5 Events Leading to a Blown Section (Burn, et al., 2005)

PVC pipes undergo blown selection, which begins initially with a longitudinal split as shown below in Figure 2.5.

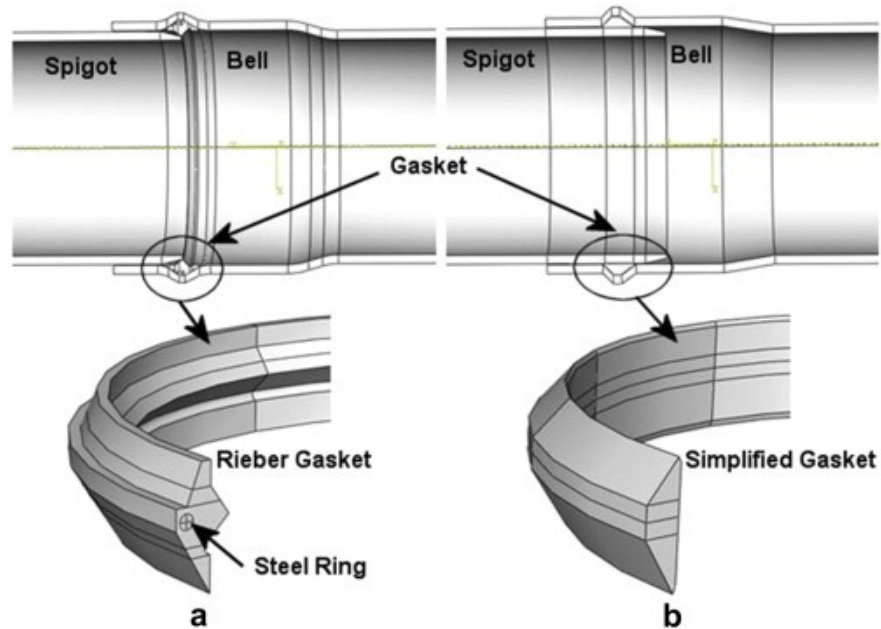
Figure 2.7: Left (a) Shows Newer Type of Gasket, While Right (b) Shows the Type of Gasket Used in Earlier Days (Balkaya et al., 2012)

The bell and spigot joints are more commonly used in diameters greater than 24". In the earlier days, the gaskets were mostly made out of homogenous rubber or an elasticized sealing ring. Nowadays, they are made of a locked in gasket (Rieber joint). The reason for this transformation is that the steel ring ensures pipe gasket stability and formidability formability. The joint is compressed between the spigot (which is at the distal end of a smaller pipe that fits into a bigger component of another pipe to make a pipe joint) and the bell to form a tight seal. Insertion into the spigot disables leakages along the pipe which is explained through Figure 2.7 (Balkaya et.al, 2012).

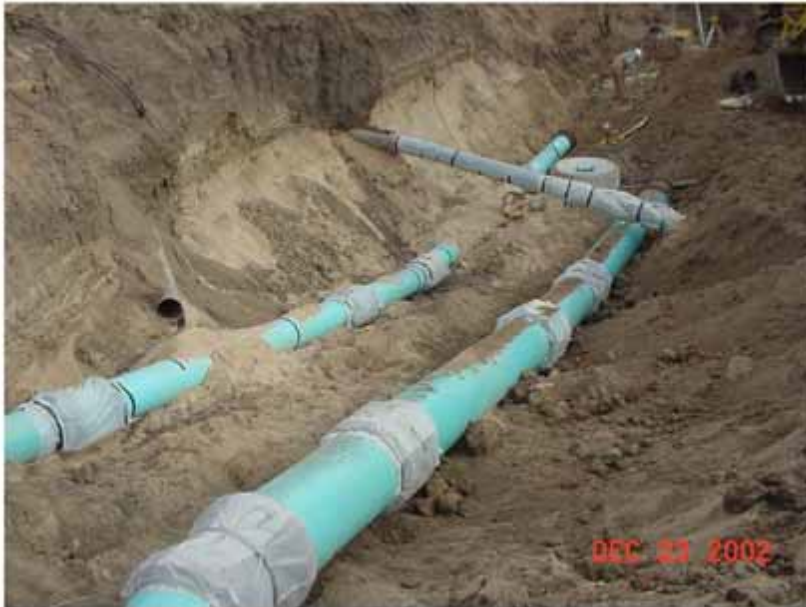
Figure 2.8: Improper Bedding Conditions Leading to Uneven External Pressure on PVC Pipes (Lackey, 2010)

Kent A. Lackey did a case study in 2010 involving 16" and 24" PVC pipes in a service station at an undisclosed location. The causes of the failures were attributed to many reasons. Firstly, the pipe bedding was uneven leading to an improper installation process which ultimately put unbalanced pressure on the pipe exterior. The continuous pressure led to pipe fatigue which caused the pipe to ultimately fail. Figure 2.8 shows the improper bedding conditions which led to the PVC pipe malfunction (Lackey, 2010).

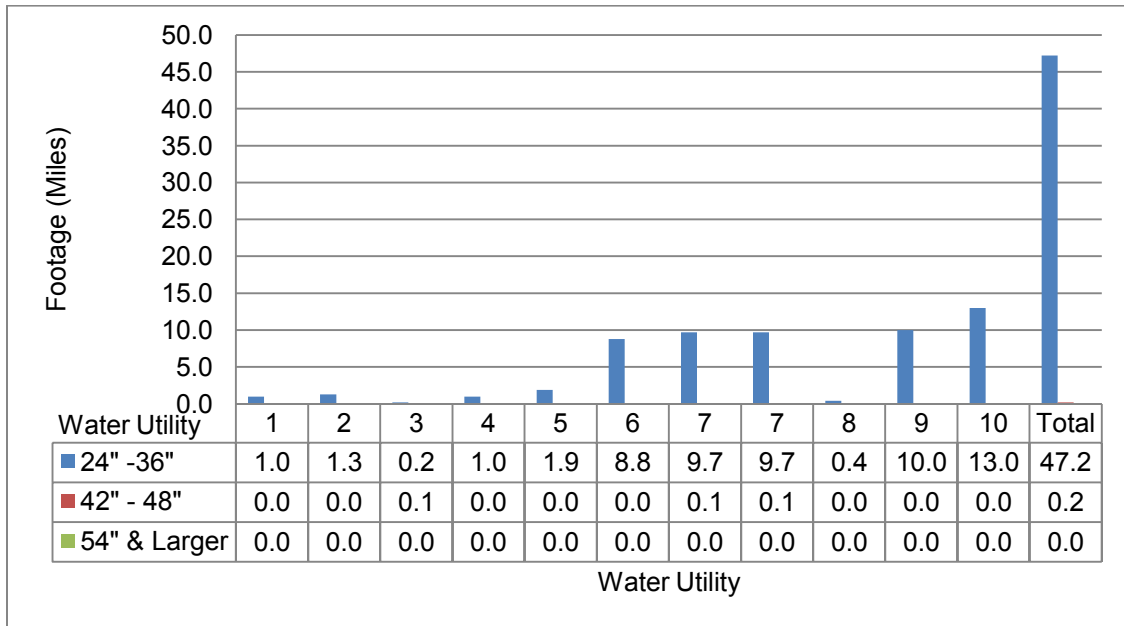
Figure 4.4 Footage of Water System for PVC Pipes with 24" and Larger Pipe Diameter (Based on 10 Respondents)

Figure 4.4 breaks down the footage of the pipelines per diameter length. Utility 1 and utility 4 have 1 mile of PVC pipelines ranging in the 24" to 36" diameter only. Utility 2 has 1.3 miles of 24" to 36" diameter only. Utility 3 has 0.2 miles of 24" to 36" diameter and 0.1 miles of 42" to 48" diameter. Utility 5 has 1.9 miles of 24" to 36" diameter only. Utility 6 has 8.8 miles of 24" to 36" diameter only. Utility 7 has 9.7 miles of 24" to 36" diameter and 0.1 miles of 42" to 48" diameter. Utility 8, 9 and 10 have 0.4 miles, 10 miles and 13 miles respectively all in the 24" to 26" diameter category. The total length of PVC pipes of diameter 24" to 36" is 47.2 miles and of diameter 42" to 48" is 0.2 miles with 0 miles in the 54" and larger diameter range as per the 10 utilities.

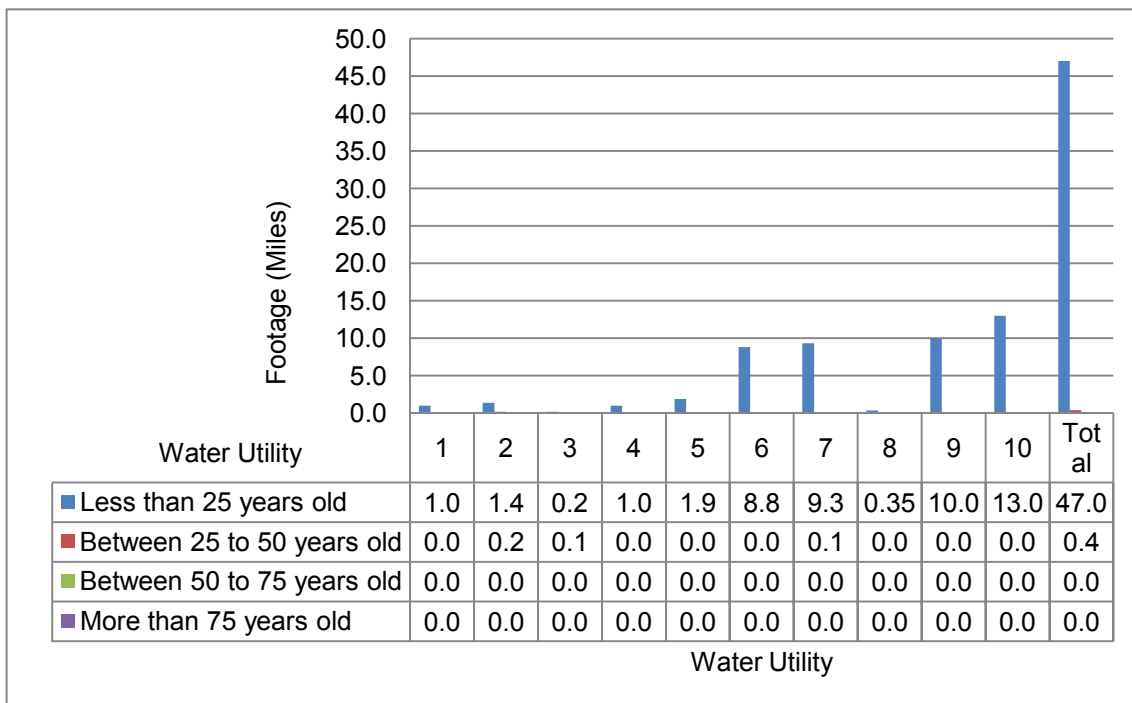
Figure 4.7 Relationship between Inventory and Age of PVC Pipes for 24" and Larger Pipe Diameter (Based on 10 Respondents)

Figure 4.7 breaks down the PVC pipe material footage based on its age. Utility 1 has 1 mile of PVC material that is less than 25 years old. Utility 2 has 2 miles of PVC material that is less than 25 years old and 0.2 miles of PVC material between 25 to 50 years old. Utility 3 has 0.2 miles of PVC pipe that is less than 25 years old and 0.1 miles of PVC pipe that is between 25 and 50 years old. Utility 5 has 1.9 miles of PVC pipe that is less than 25 years old. Utility 6 has 8.8 miles of PVC pipe that is less than 25 years old. Utility 7 has 9.3 miles of PVC pipe that is less than 25 years old and 0.1 miles of PVC pipe that is between 25 to 50 years old. Utility 8, 9 and 10 have 0.35 miles, 10 miles and 13 miles of PVC pipes respectively and all are less than 25 years old. A total of 47.0 miles of PVC pipe is less than 25 years old and 0.4 miles of PVC pipe is between 25 to 50 years old in all the utilities combined.

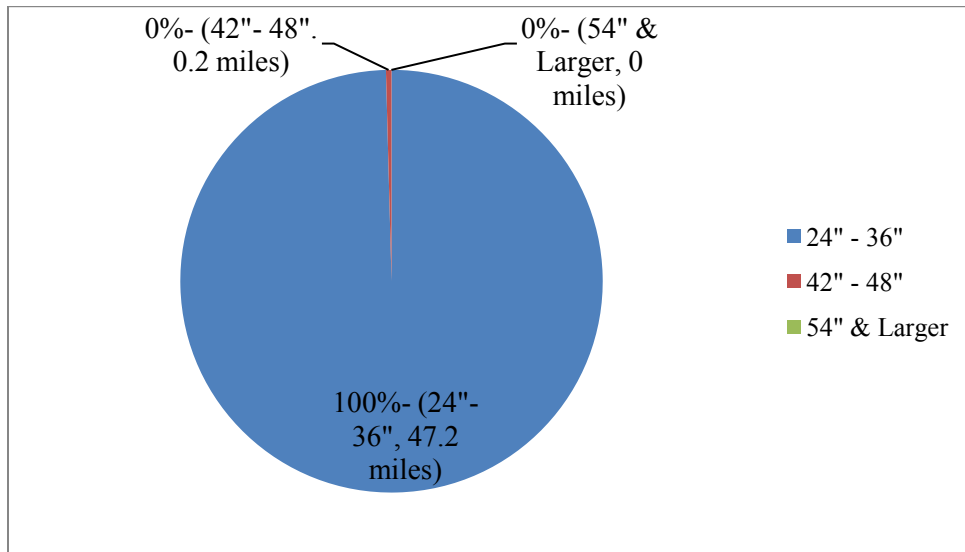
Figure 4.8 Percentage of PVC Pipe by Different Diameter Range for 24" and Larger Diameter Pipe (Based on 10 Respondents)

Figure 4.8 explains that 100 percent of PVC material is in the 24" to 36" diameter range, while a negligible percentage (0.2 miles out of 47.4 miles) is in the 42" to 48" diameter range. No pipes were reported as being in the 54" and larger diameter range.

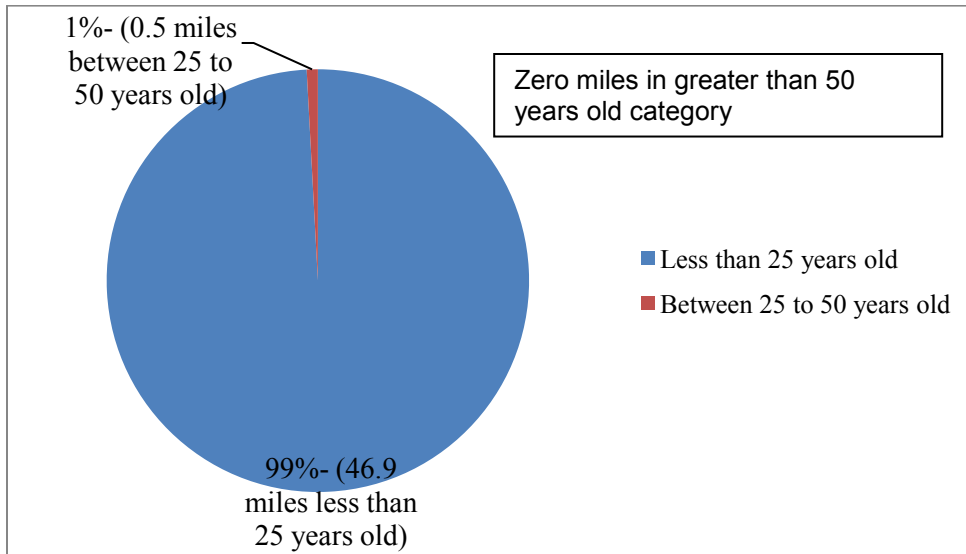
Figure 4.9 Percentage of PVC Pipe by Different Age Ranges for 24" and Larger Pipe Diameter (Based on 10 Respondents)

Figure 4.9 explains that 99 percent of PVC material in the utilities surveyed is less than 25 years old category, 1 percent of the PVC pipe material is in the 25 to 50 years old category and 0 percent in the greater than 50 years of age category.

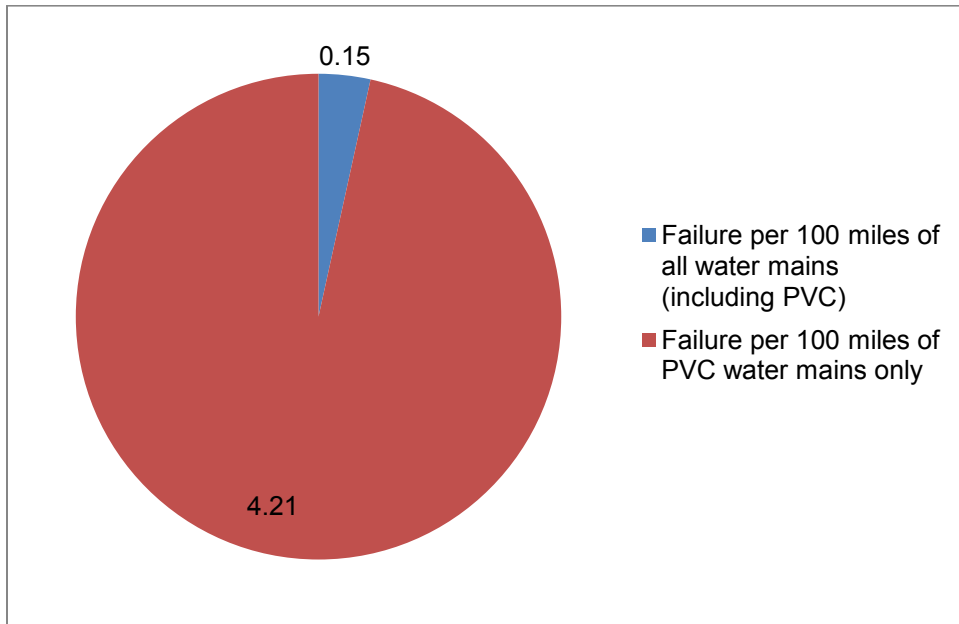
Figure 4.10 Failure Rates per Hundred Miles of All Pipes Compared to PVC Pipes of 24" and Larger Pipe Diameter (Based on 10 Respondents)

Figure 4.10 compares the failure rate per 100 miles of all water mains and that of PVC water mains only.
