MISSION ROSARIO

ARCHEOLOGICAL INVESTIGATIONS 1974

TEXAS PARKS AND WILDLIFE DEPT.
PARKS DIVISION
HISTORIC SITES AND RESTORATION BRANCH
ARCHEOLOGICAL REPORT NUMBER 14, PART II

MISSION ROSARIO
ARCHEOLOGICAL INVESTIGATIONS - 1974

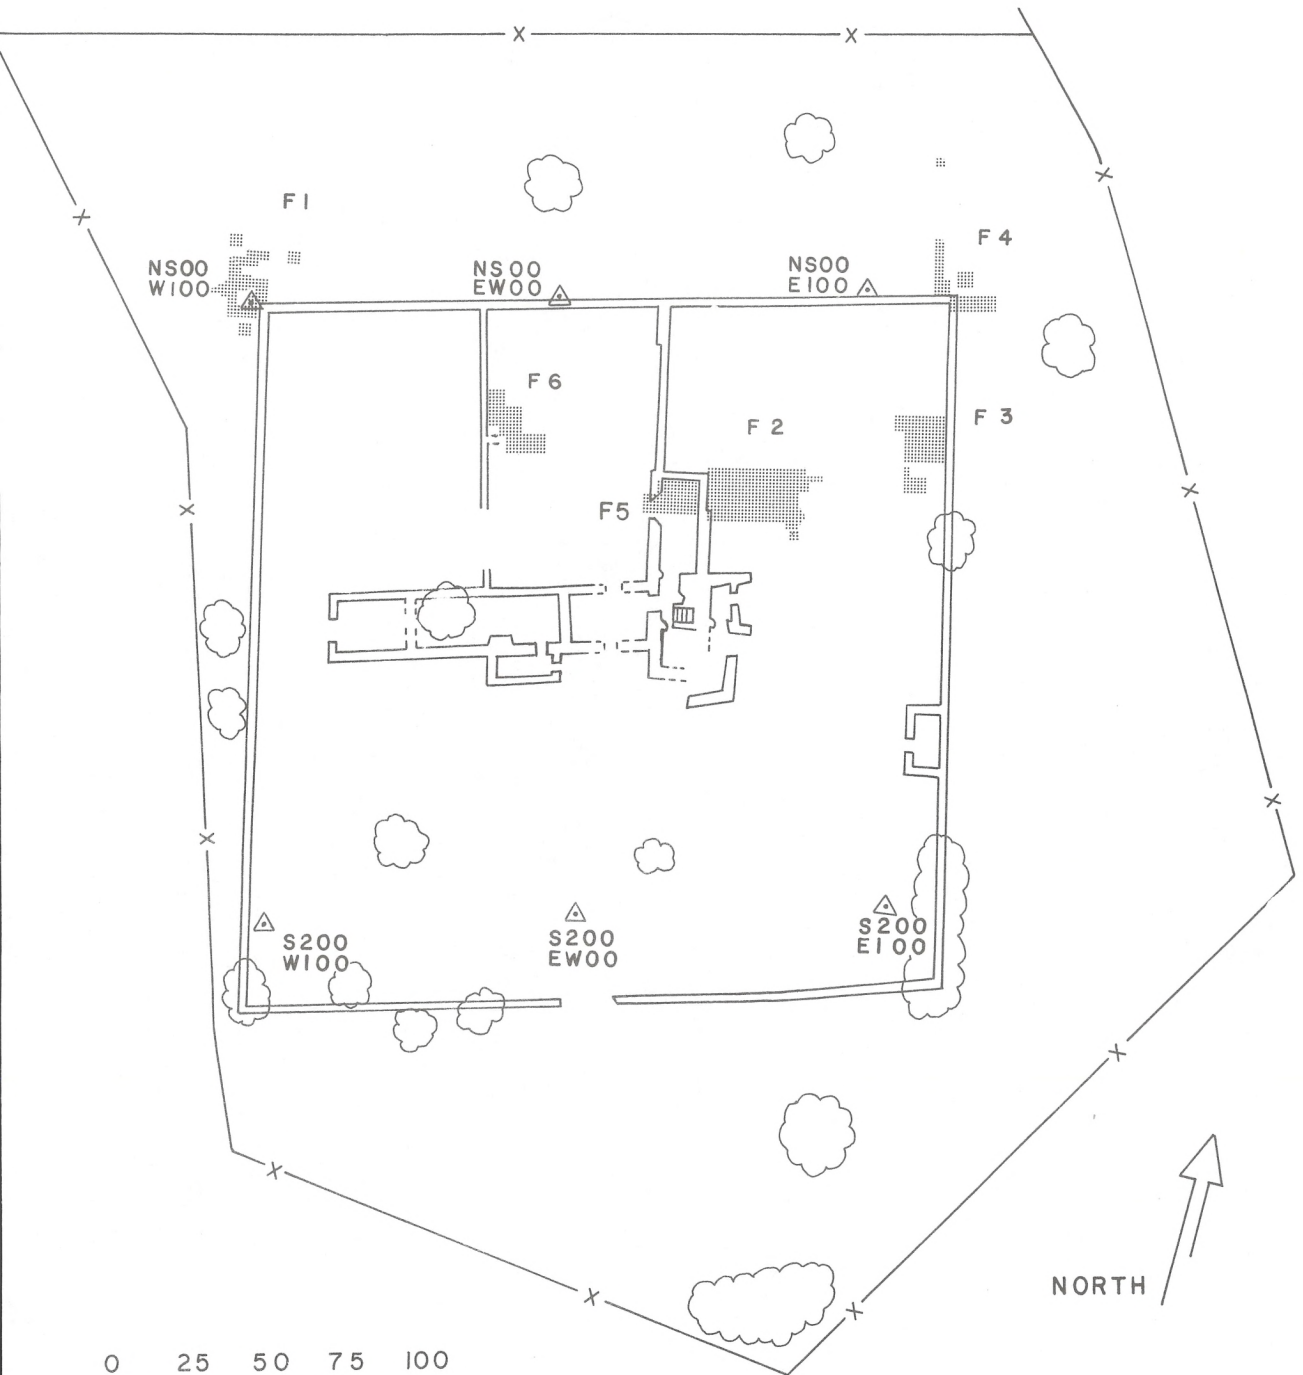
Fig.1

MISSION ROSARIO (41GD2)
SPRING 1974 EXCAVATION AREAS

Feature 2 (Fig. 1). This feature was named Structure 2 in the previous report (Gilmore 1974), and from the Spring 1973 tests in the area, it was surmised to be a single room measuring about 15 feet by 40 feet. Extensive excavation was not made during the Spring 1973 field season since that was a pilot season; and, furthermore, polychrome painted plaster had been found in abundance, and no provision had been made for its preservation nor for the stabilization of walls.

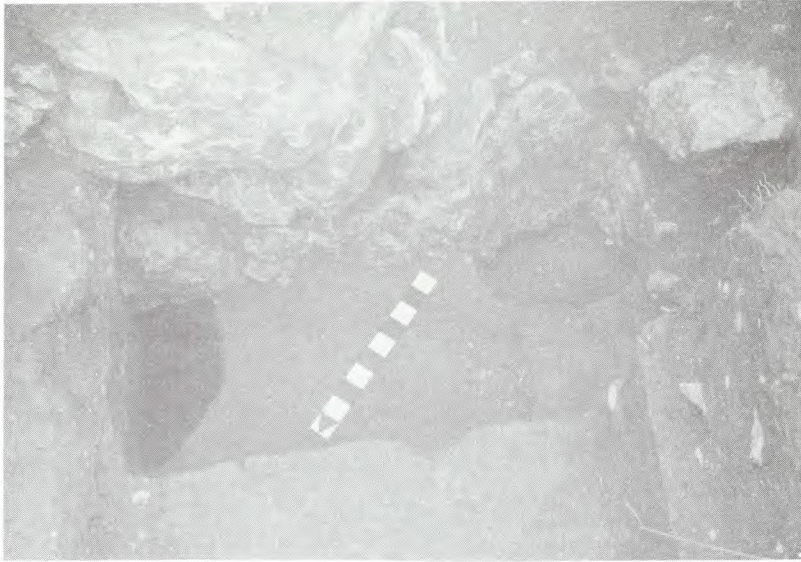
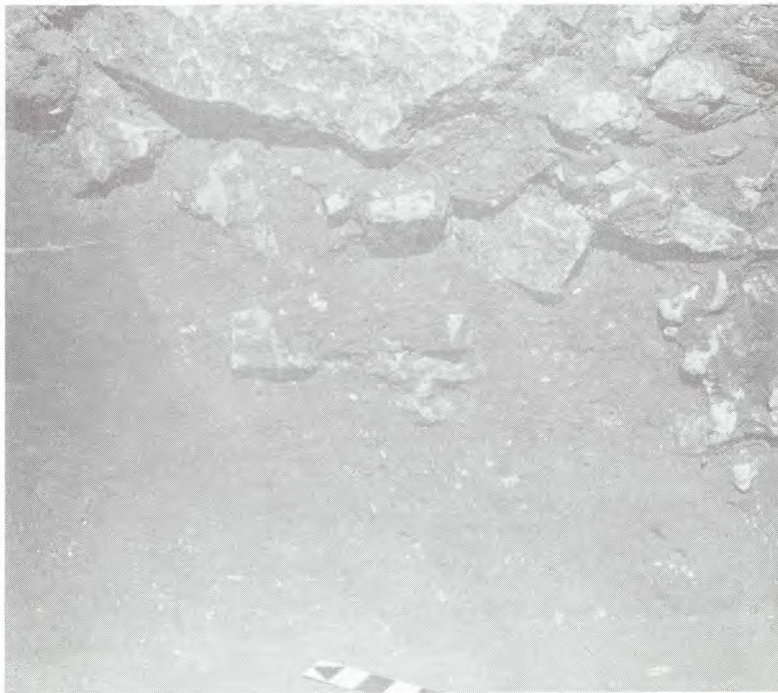
Fig. 4

Fig. 4. FEATURE 1 (scale in inches)

- A. Postholes under wall at northwest corner
- B. Filled posthole or rubble filled trench
under wall, South 5 West 99, looking
east

Three postholes were found under the stone wall near the northwest corner, suggesting that the stone wall was placed where the wooden wall had been (Fig. 4). This placement was also indicated in the 1973 excavations along the northern wall at grid point North 0 East 85.

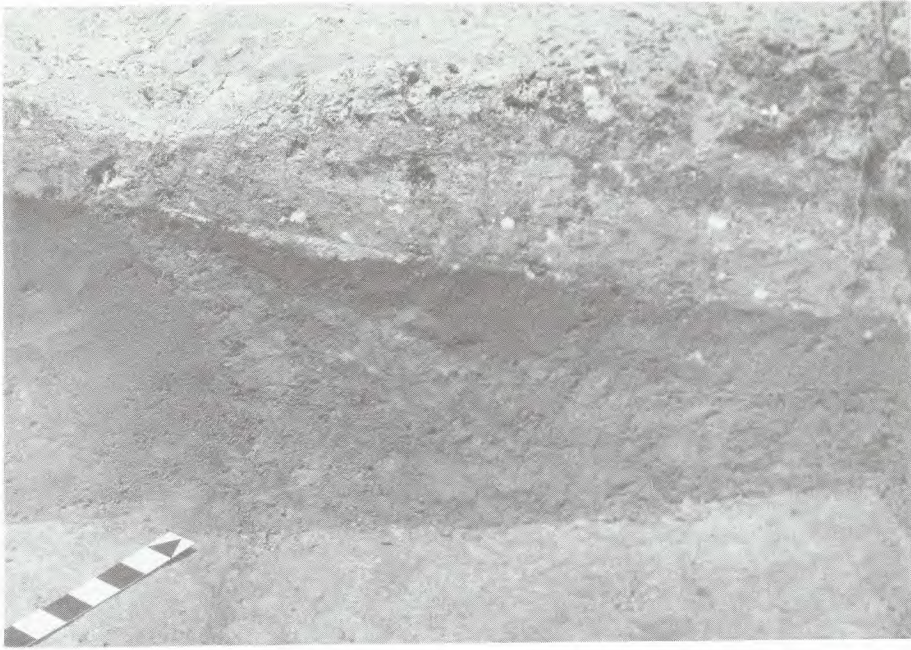
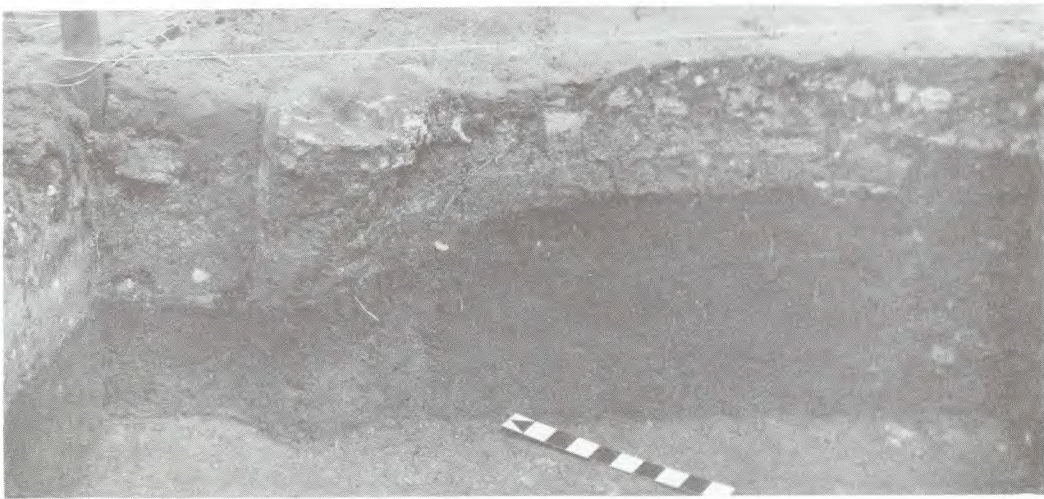
Fig. 5

Fig. 5. FEATURE 2 (scale in inches)

- A. Feature 2E, looking north, showing grave pit refill on right, and floors above
- B. Feature 2E, grave pit on left under floors; Feature 2U grave pit on right cutting two floors

During the process of clearing the floor, disturbed areas in the floor were noted, and one of these was sectioned (Feature 2E; Fig. 5B). This feature was eventually found to be a grave pit over which the tan caliche floor had sunk with compaction of the grave fill. The floor had not been cut through to dig the grave. The grave pit was dug through a dark brown sandy stratum which grades into sticky red clay. Consequently, the back fill of the pit consisted of a red and black mottled matrix. Directly overlying the pit was a lense of the dark brown sandy

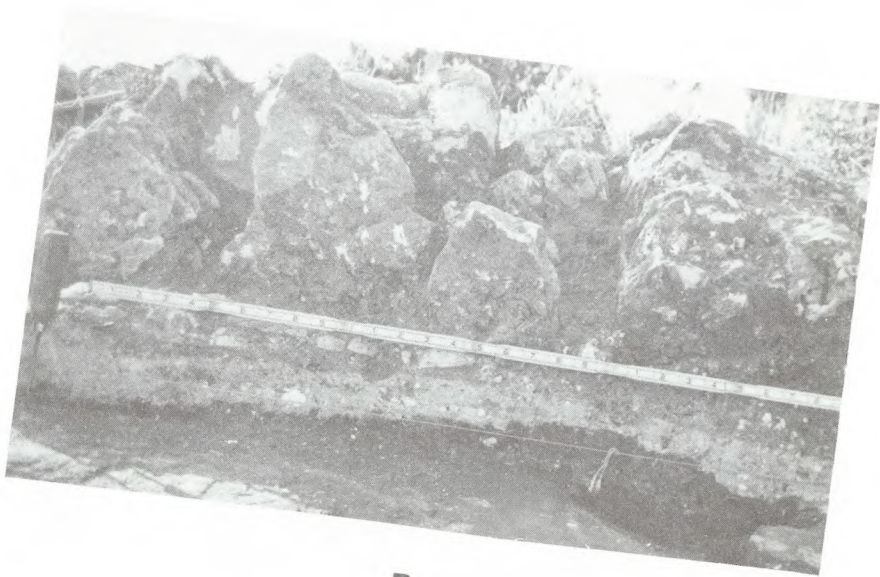
Fig. 6

Fig. 6. FEATURE 2A (scale in inches)

- A. Fragment of fallen wall with painted plaster
resting on the floor
- B. Close-up of 6A showing stratigraphy

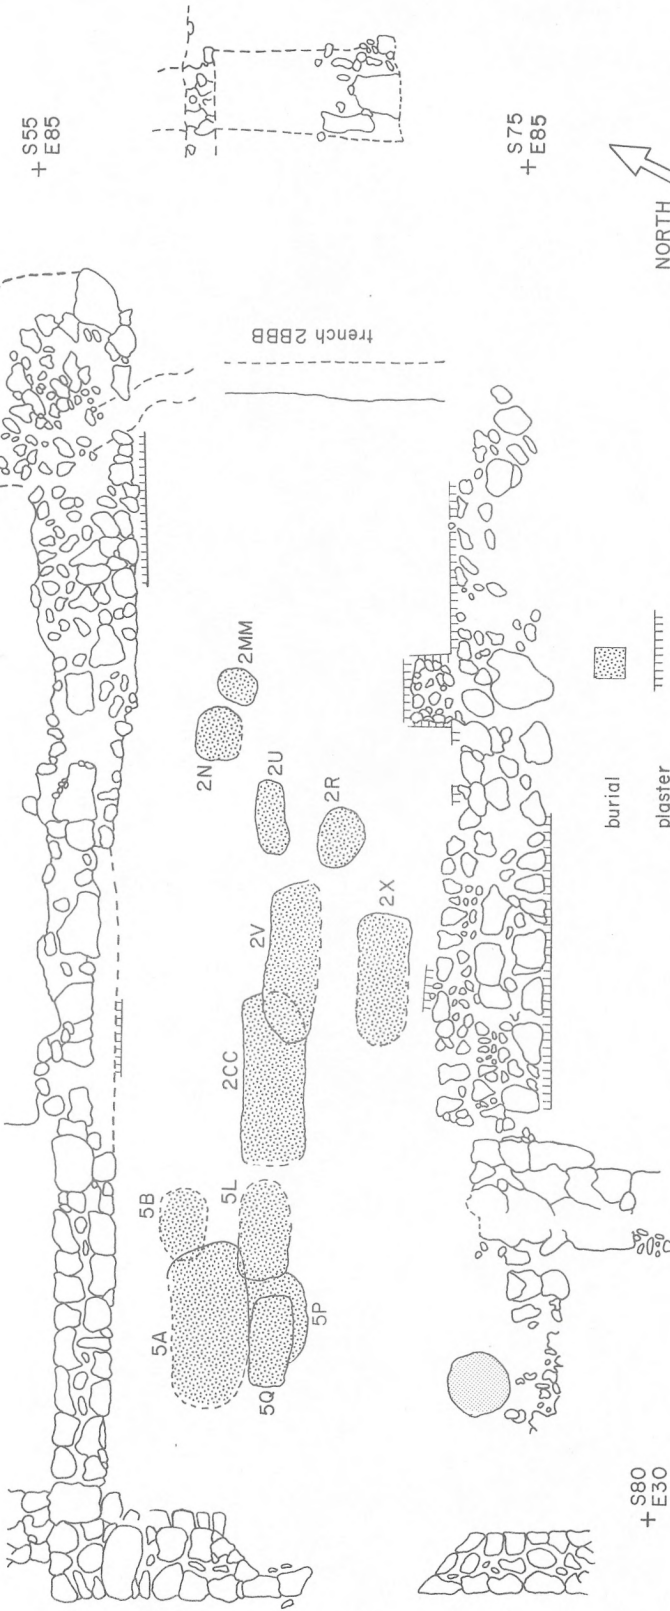
MISSION ROSARIO 4IGD2
 THE ORIGINAL CHURCH
 BUILDING PHASE 3

Phase 3 (Fig. 9) is indicated by the laying of a gray white caliche floor which was associated with rock walls. During this phase, burials were interred in grave pits which were dug through both the gray white floor and the light tan caliche floor. Polychrome painted murals (Fig. 13) recovered on fragments of rock walls which fell into the room, decorated the walls. Phase 3A, repair of the church is indicated by overpainting of the murals and the possible addition of a buttressing column (Feature 2D).

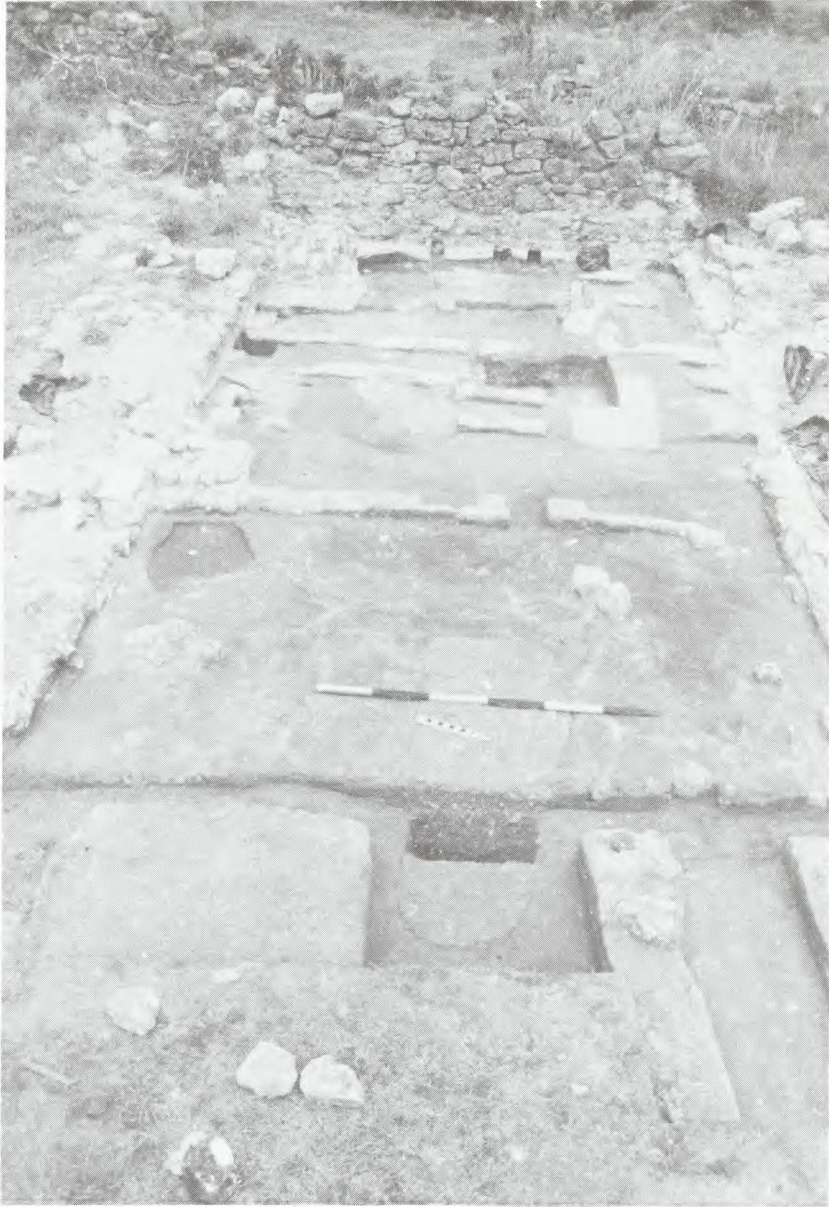
Fig. II

Overview showing balks left over pits;
north-south cross wall in background,
grave pit 2F in foreground under scale

In order to uncover burials which preceded the laying of the gray white floor, the floors were removed; but across each apparent grave pit or posthole, a balk was left for reference (Fig. 11). During this process, three burial pits (2DD, 2EE, 2HH; Fig. 12) were found to partly underlie the north-south cross wall, and two (2G, 2PP) were under the north wall. Two of these, 2DD, 2EE, were excavated (see Appendix for analysis). A total of twenty-six

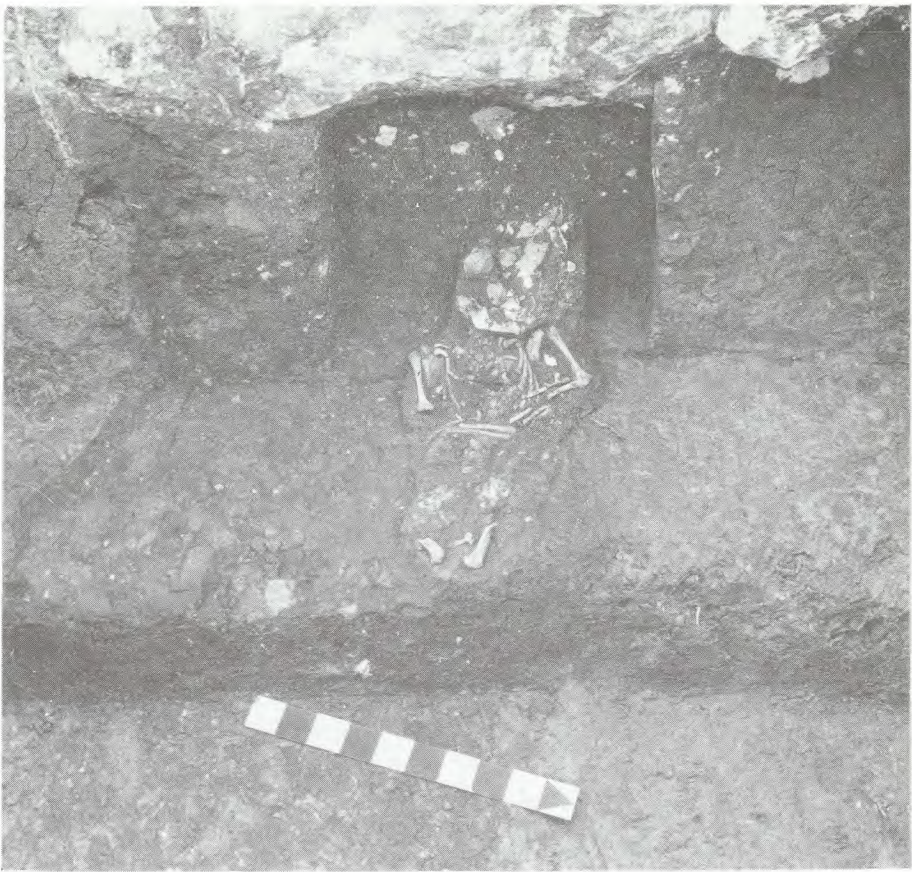
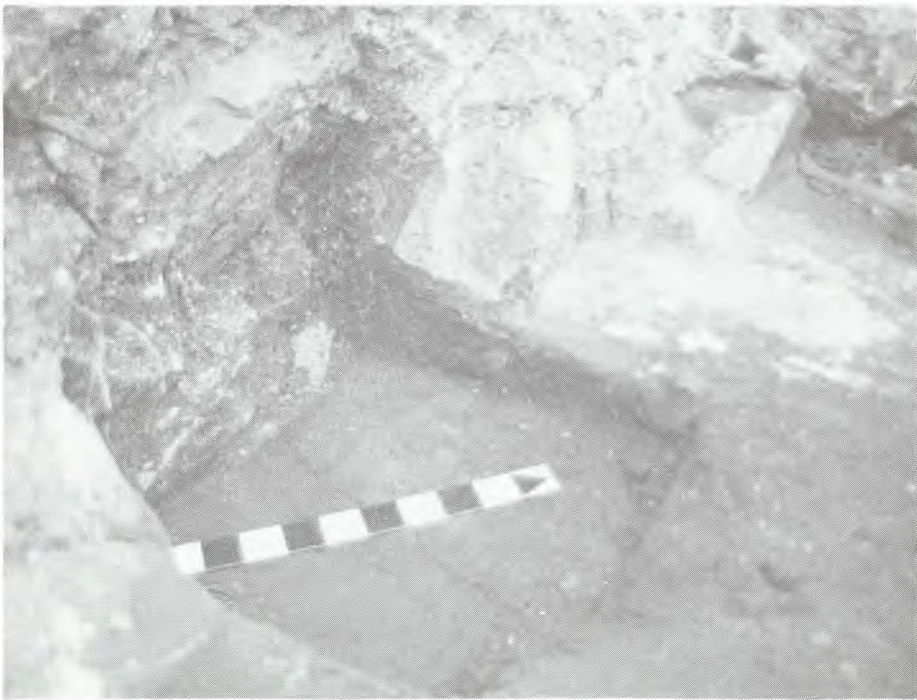
Fig.12

Fig. 12. FEATURE 2D

- A. Infant burial 2DD under north-south cross wall
- B. Grave pit 2FF at north-south cross wall

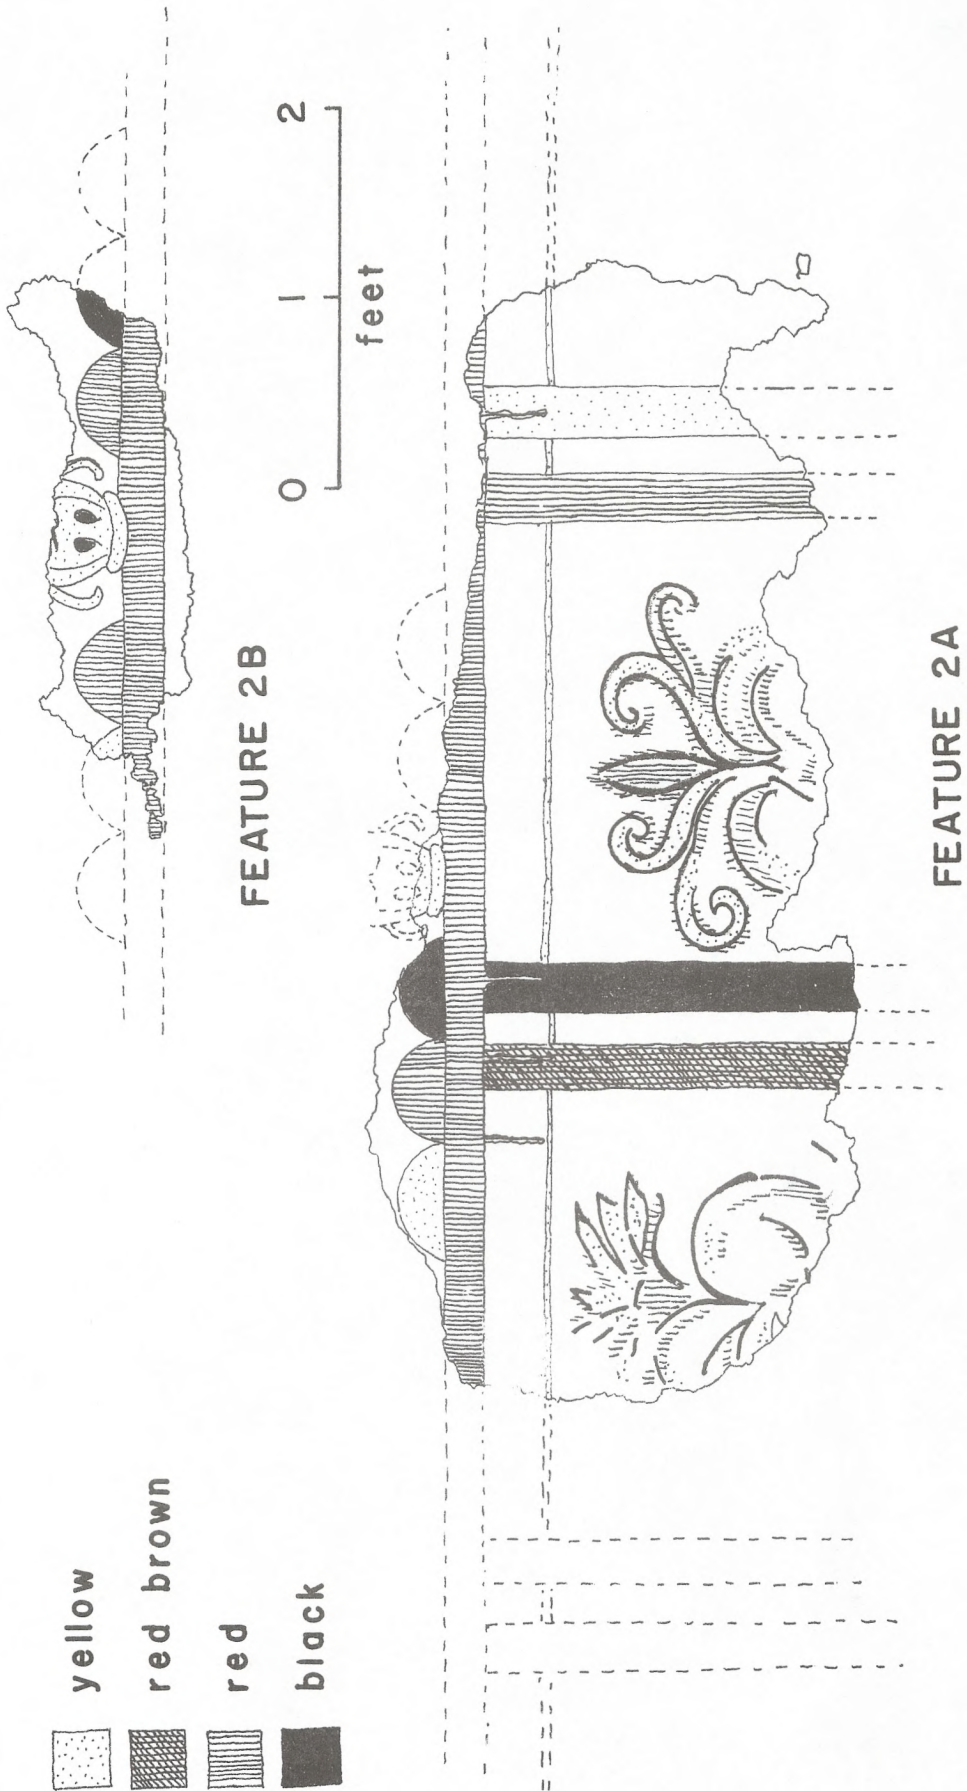
Fig. 13

MISSION ROSARIO (4IGD2)
WALL MURALS AFTER REMOVAL OF OVERPAINTING

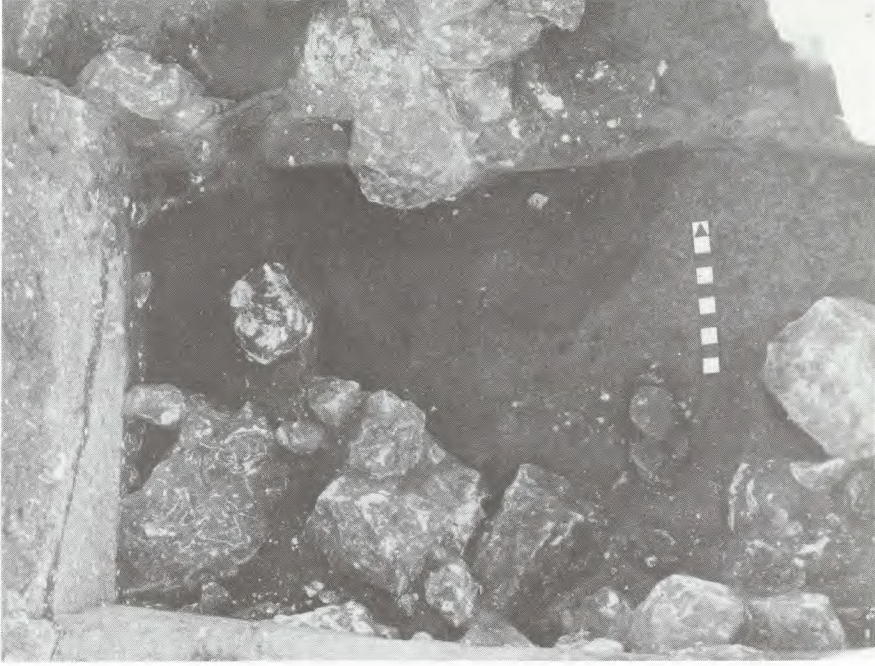
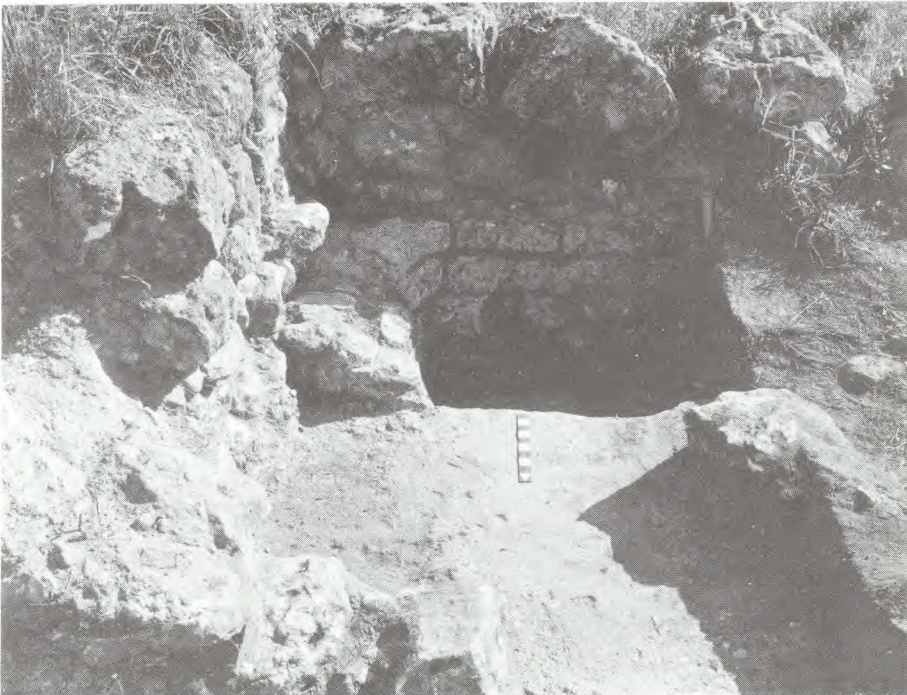
Fig. 15

Fig. 15. FEATURE 7, FEATURE 13 (scale in inches)

- A. Feature 7, looking northward at plaster fall, "pothole" fill, and posthole; caliche with soil layer on left
- B. Feature 13, caliche brick under south wall

The southern part of this unit is puzzling. Here a segment of what appeared to be floor material -- light gray caliche with small particles of red and tan clay and pieces of plaster -- sloped or dipped toward the north (Fig. 15A). The profile (Fig. 15C), however, showed two layers separated by 0.2 foot of dark brown clayey sand mottled with red clay. As previously noted, the in situ floor is as much as 1.5 feet higher (Fig. 14A) in the southern part of this area, and the caliche floor-like material may be the remains of a step or steps leading upward into the south room after disturbance by man and weathering. This may also be remains of fallen roofing material as roofs in many such buildings were reinforced by a layer of mud or caliche. The area where the two floors should have met is a highly disturbed area, but it is possible further excavation of the room could clarify the relationship. That two rooms existed, however, is undoubted.

Excavation of square South 111 West 57 found evidence of previous excavations. A not too clear photo made in 1940-41 indicates it probably was excavated at that time. The profile (Fig. 15B, 16B) shows rocks were placed on the dark brown sand; caliche brick in two courses were placed atop this base. The rock base did not seem to be tied into the wall on the east, and although it was not clear because of previous excavation, the caliche bricks did not seem to extend north along the north-south wall more than 1.5 feet. The caliche bricks are 0.3 to 0.4 foot in thickness and 1.1 feet in length.

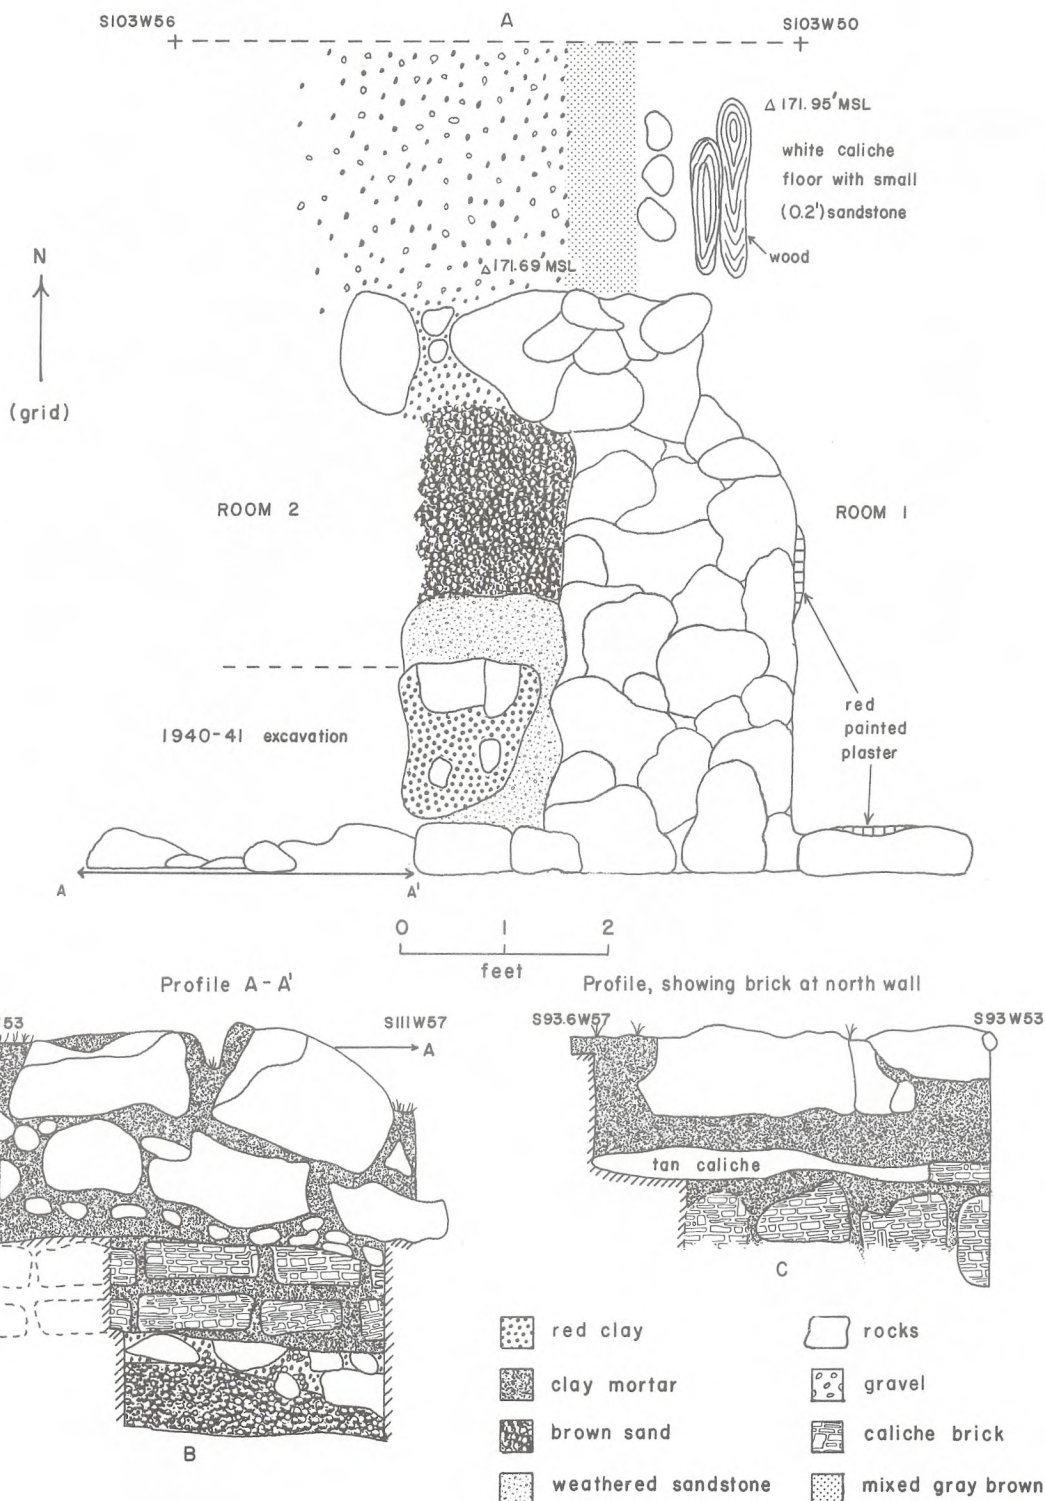
Fig. 16

FEATURE 13 THE FINAL CHURCH, SOUTH SECTION AT ENTRANCE

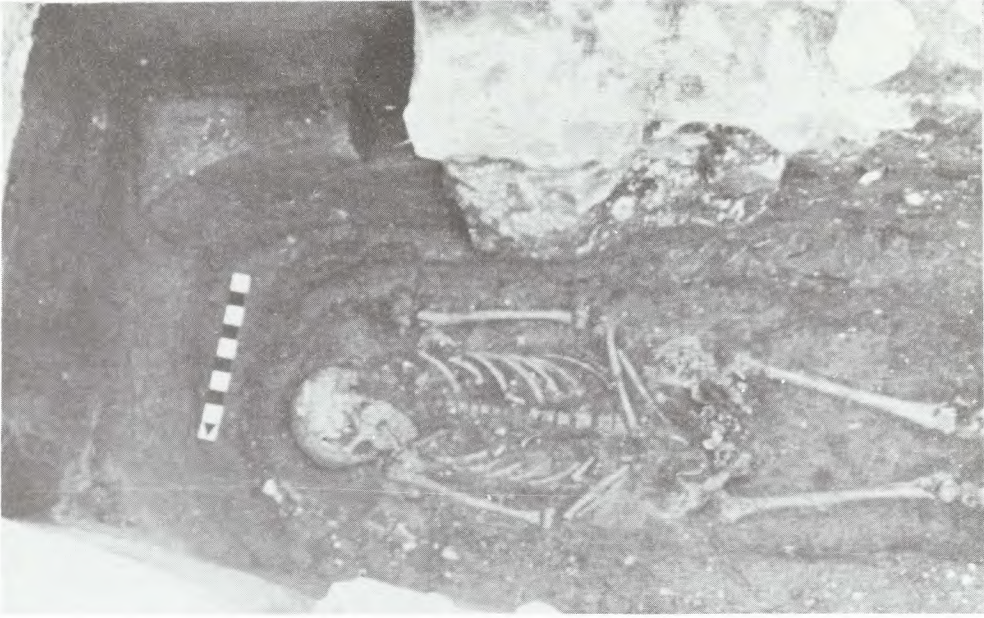
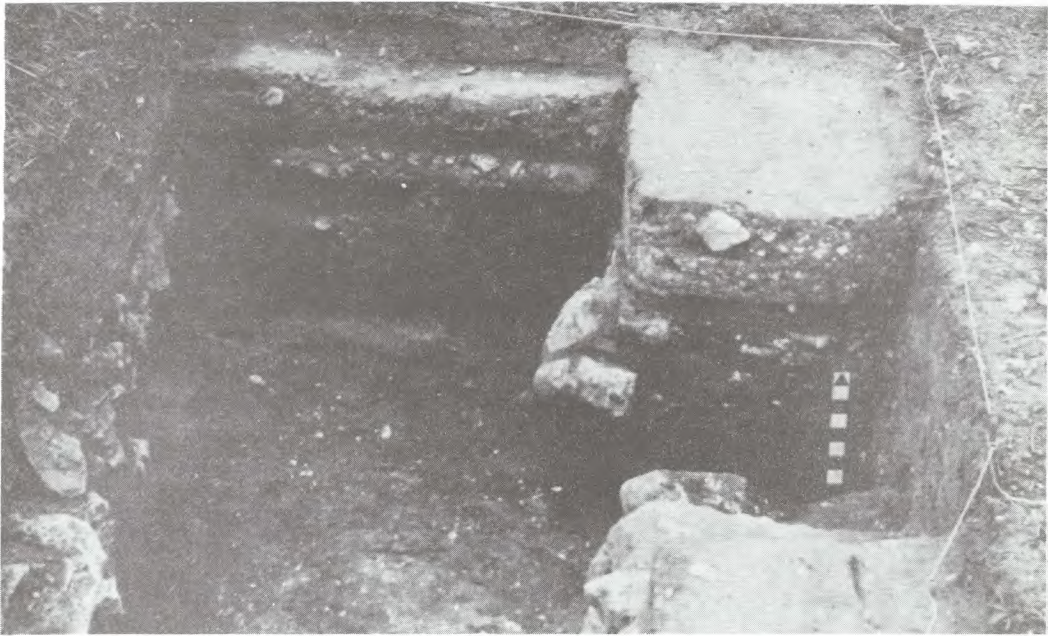
Fig. 18

Fig. 18. FEATURE 14 (scale in inches)

A. Burial

B. Stratigraphy in western section at South 10
West 22, location of attempted peel at
arrow; burial under center foreground

The area between the profiles mentioned above was disturbed and was eventually found to be a burial pit containing a skeleton with the head to the east (Fig. 18A).

A stratigraphic peel was attempted at South 102 along West 15 so that the sequence might be studied in the laboratory and could be used for future display. The peel, which strips off one to several inches from the surface, was not entirely successful because rain and high humidity prevented solidification of the white glue used to penetrate the strata.

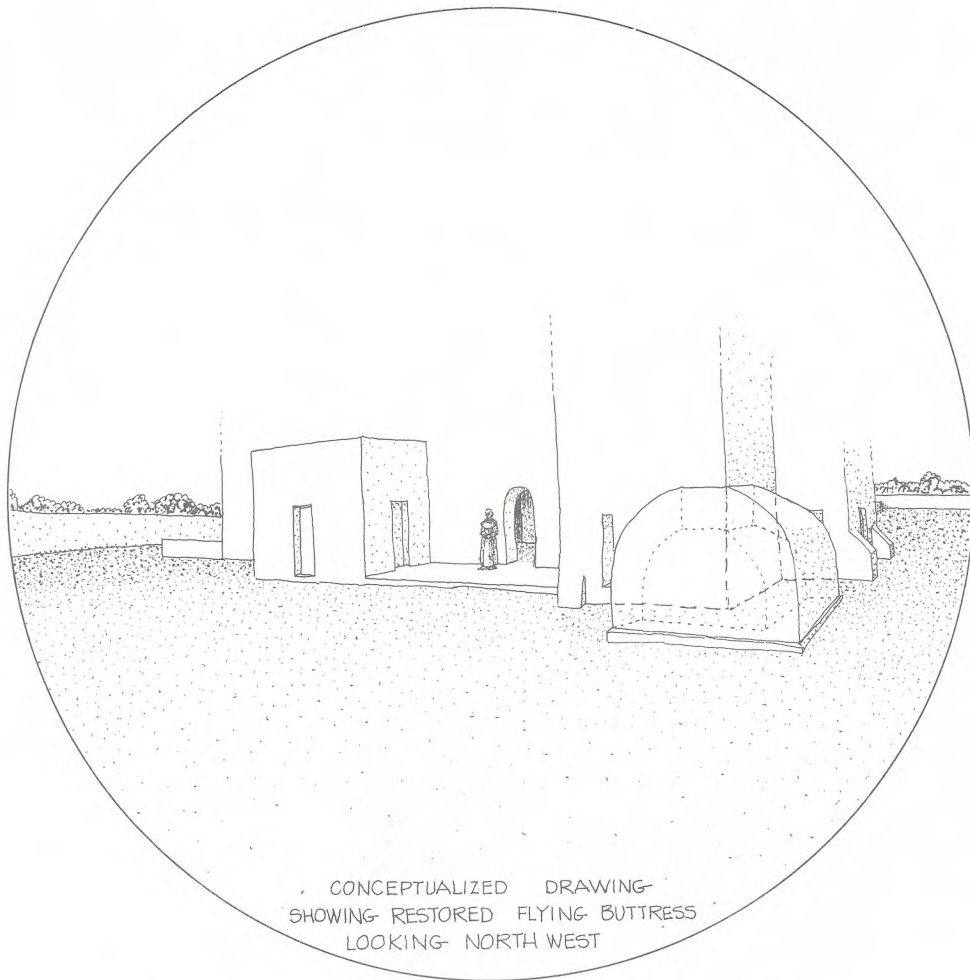
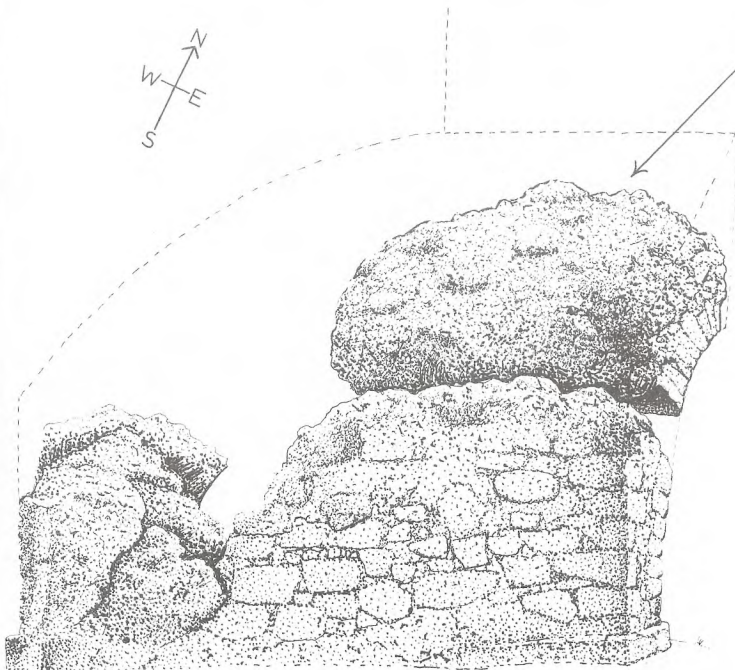
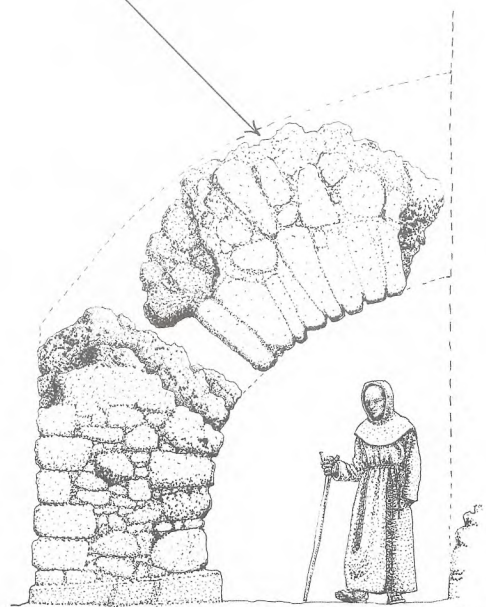
Fig. 20

MISSION ROSARIO (41GD2)
CONCEPTUAL RESTORATION OF FLYING BUTTRESS

FALLEN SECTION DRAWN
IN ORIGINAL POSITION

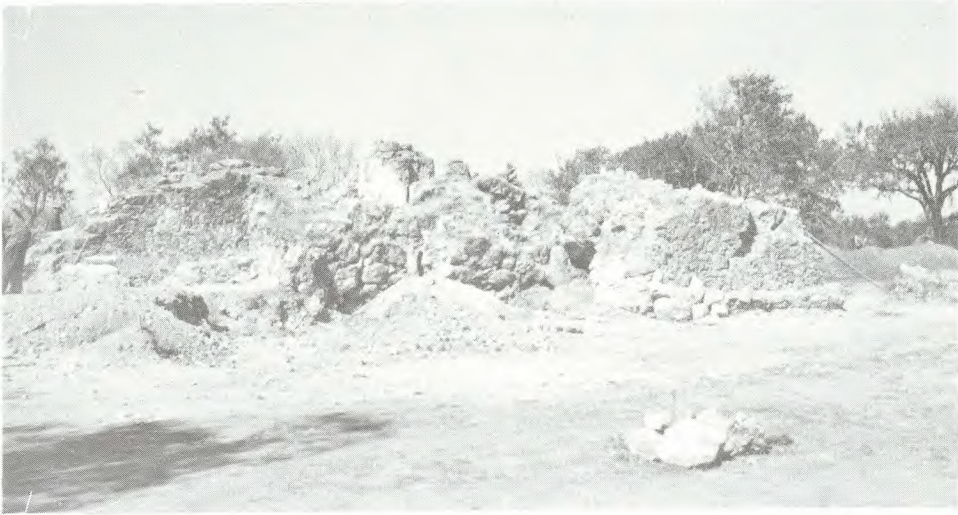
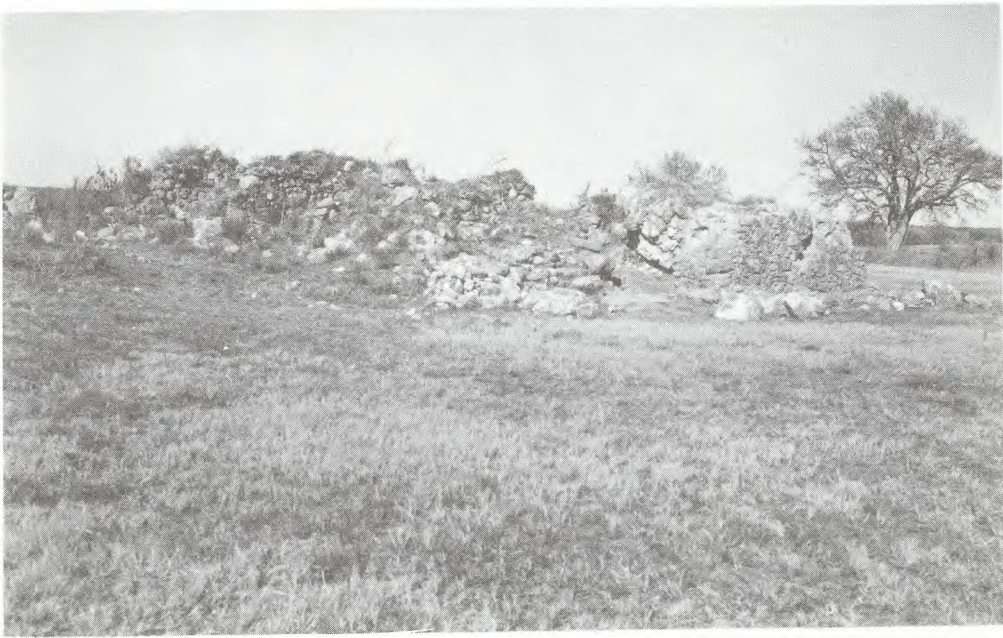
Fig. 21

Fig. 21. BUTTRESS AREA (facing Northward)

- A. 1940-41 photograph showing two stories and buttress
- B. Photograph taken near same spot as Fig. 21A, Fall 1974

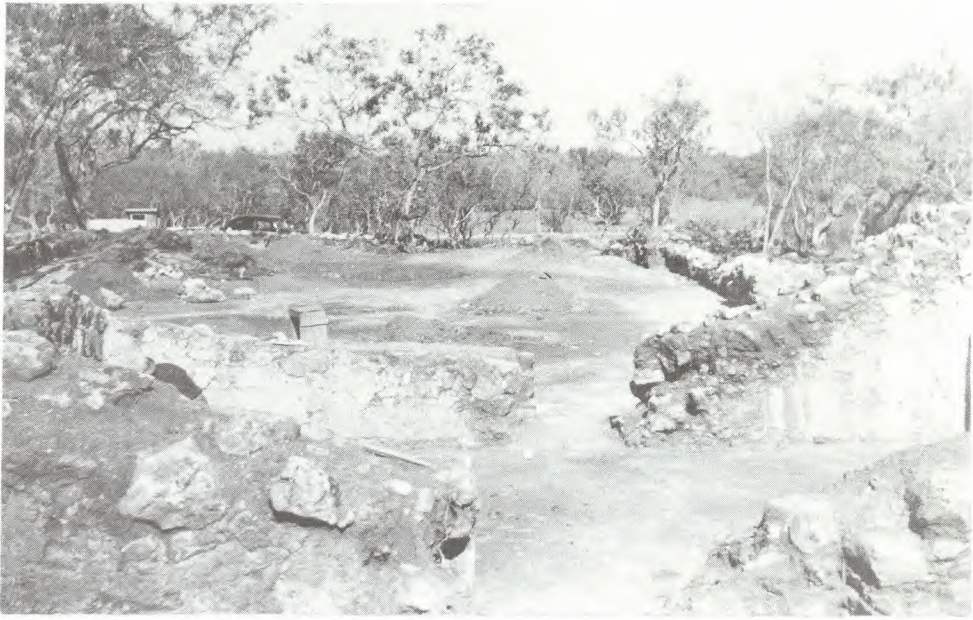
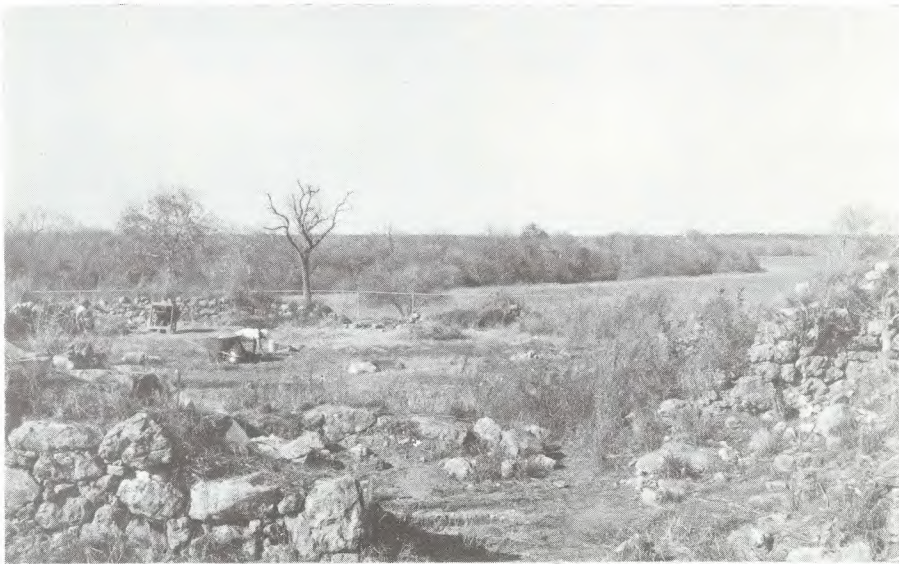
Fig.23

Fig. 23. FEATURE 6 (facing Northward)

- A. Feature 6, 1940-41 photograph of inner courtyard with Room 3 in foreground
- B. Photograph taken near same spot as Fig. 23A, Fall 1974

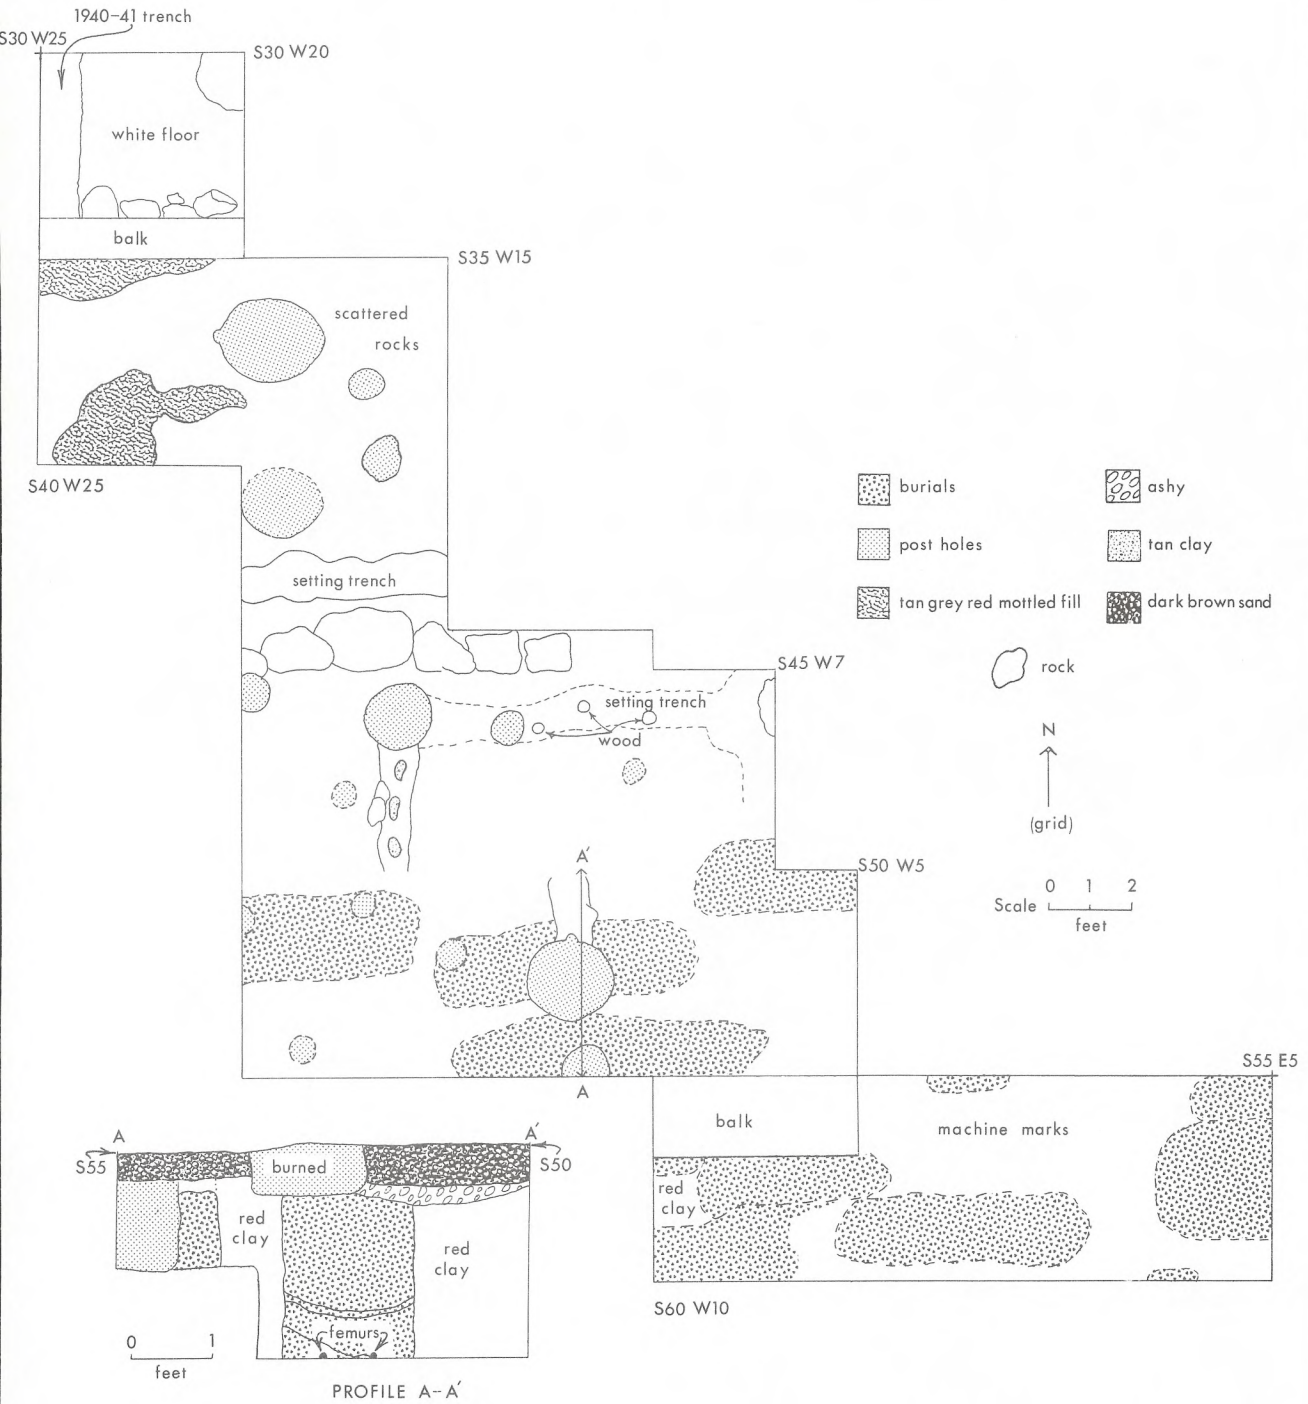
Fig. 25

FEATURE 6 AREA B

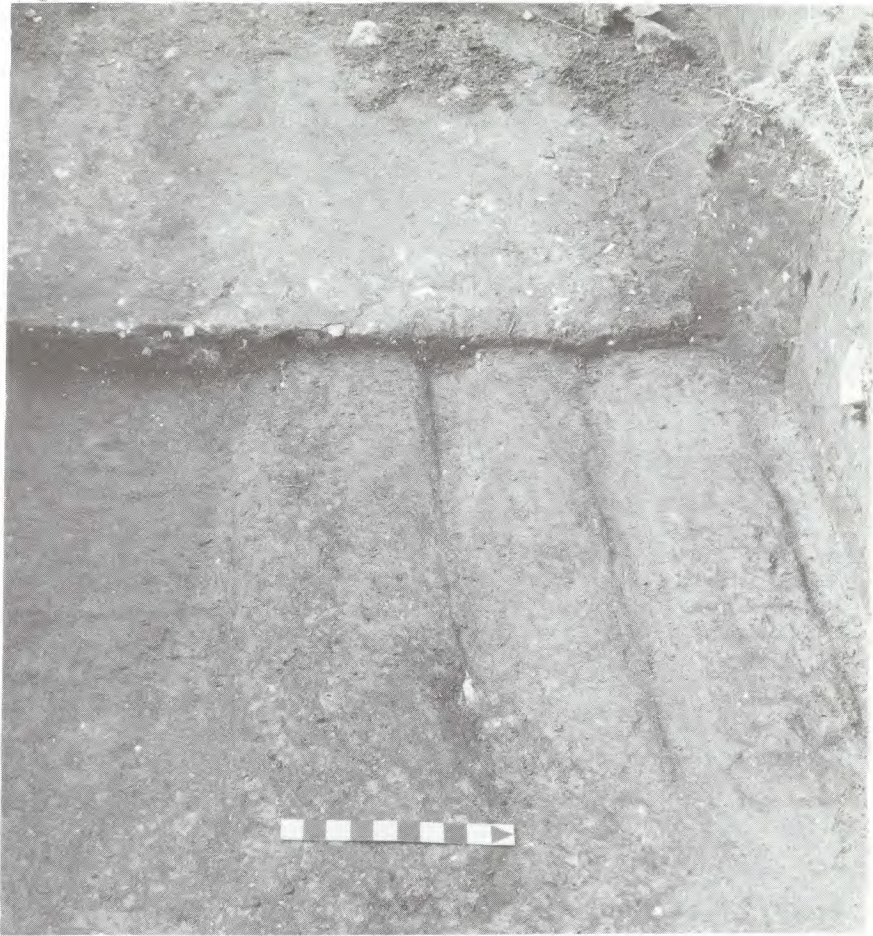
Fig. 26

Fig. 26. FEATURE 6, AREA B

Showing machine marks
