MISSION ROSARIO

ARCHEOLOGICAL INVESTIGATIONS 1974

TEXAS PARKS AND WILDLIFE DEPT.
PARKS DIVISION
HISTORIC SITES AND RESTORATION BRANCH
ARCHEOLOGICAL REPORT NUMBER 14, PART II

MISSION ROSARIO
ARCHEOLOGICAL INVESTIGATIONS - 1974

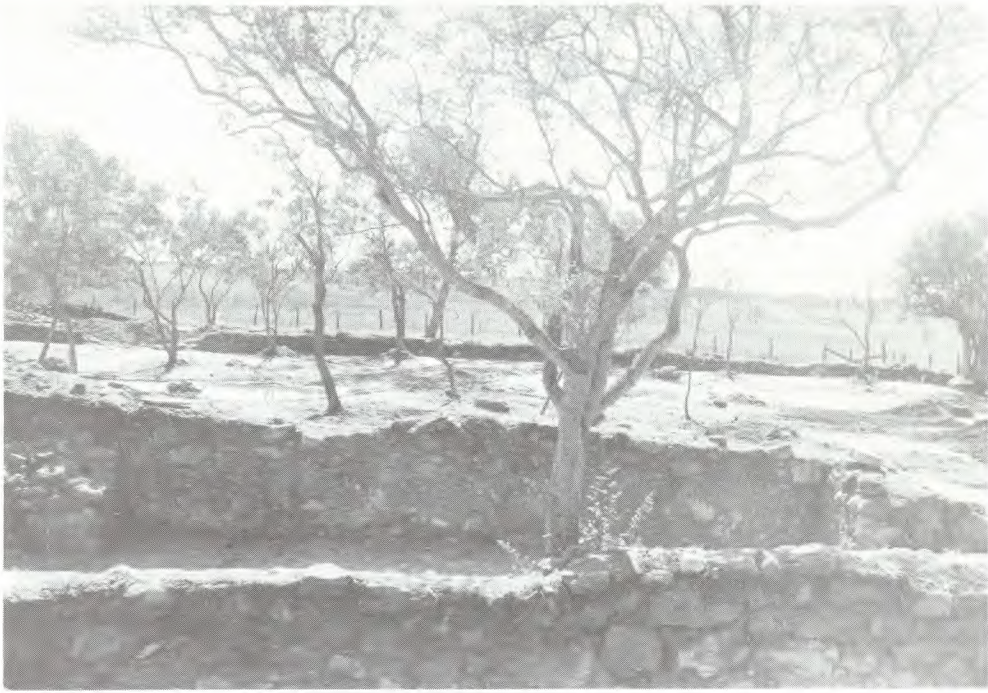
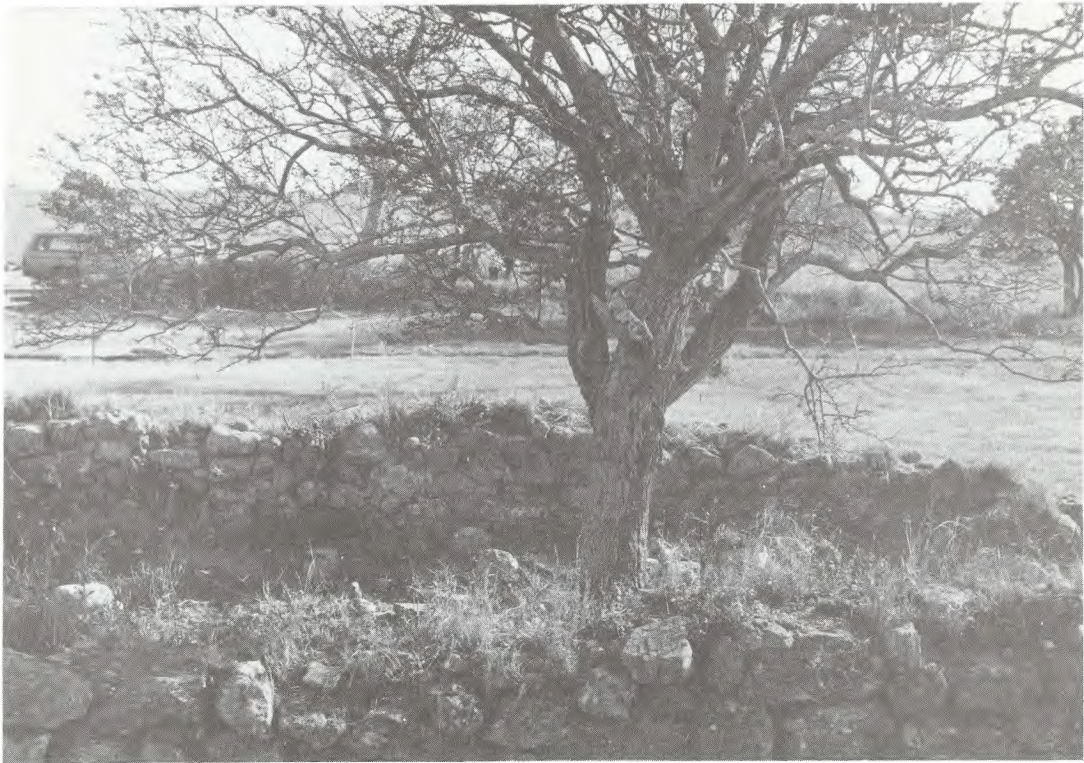
Fig. 27

- Fig. 27. SUNKEN AREA, VICINITY TRENCH SOUTH 190
- A. 1940-41 photograph showing sunken area
near gate left center
 - B. Photograph taken near same spot as Fig.
27A, Fall 1974

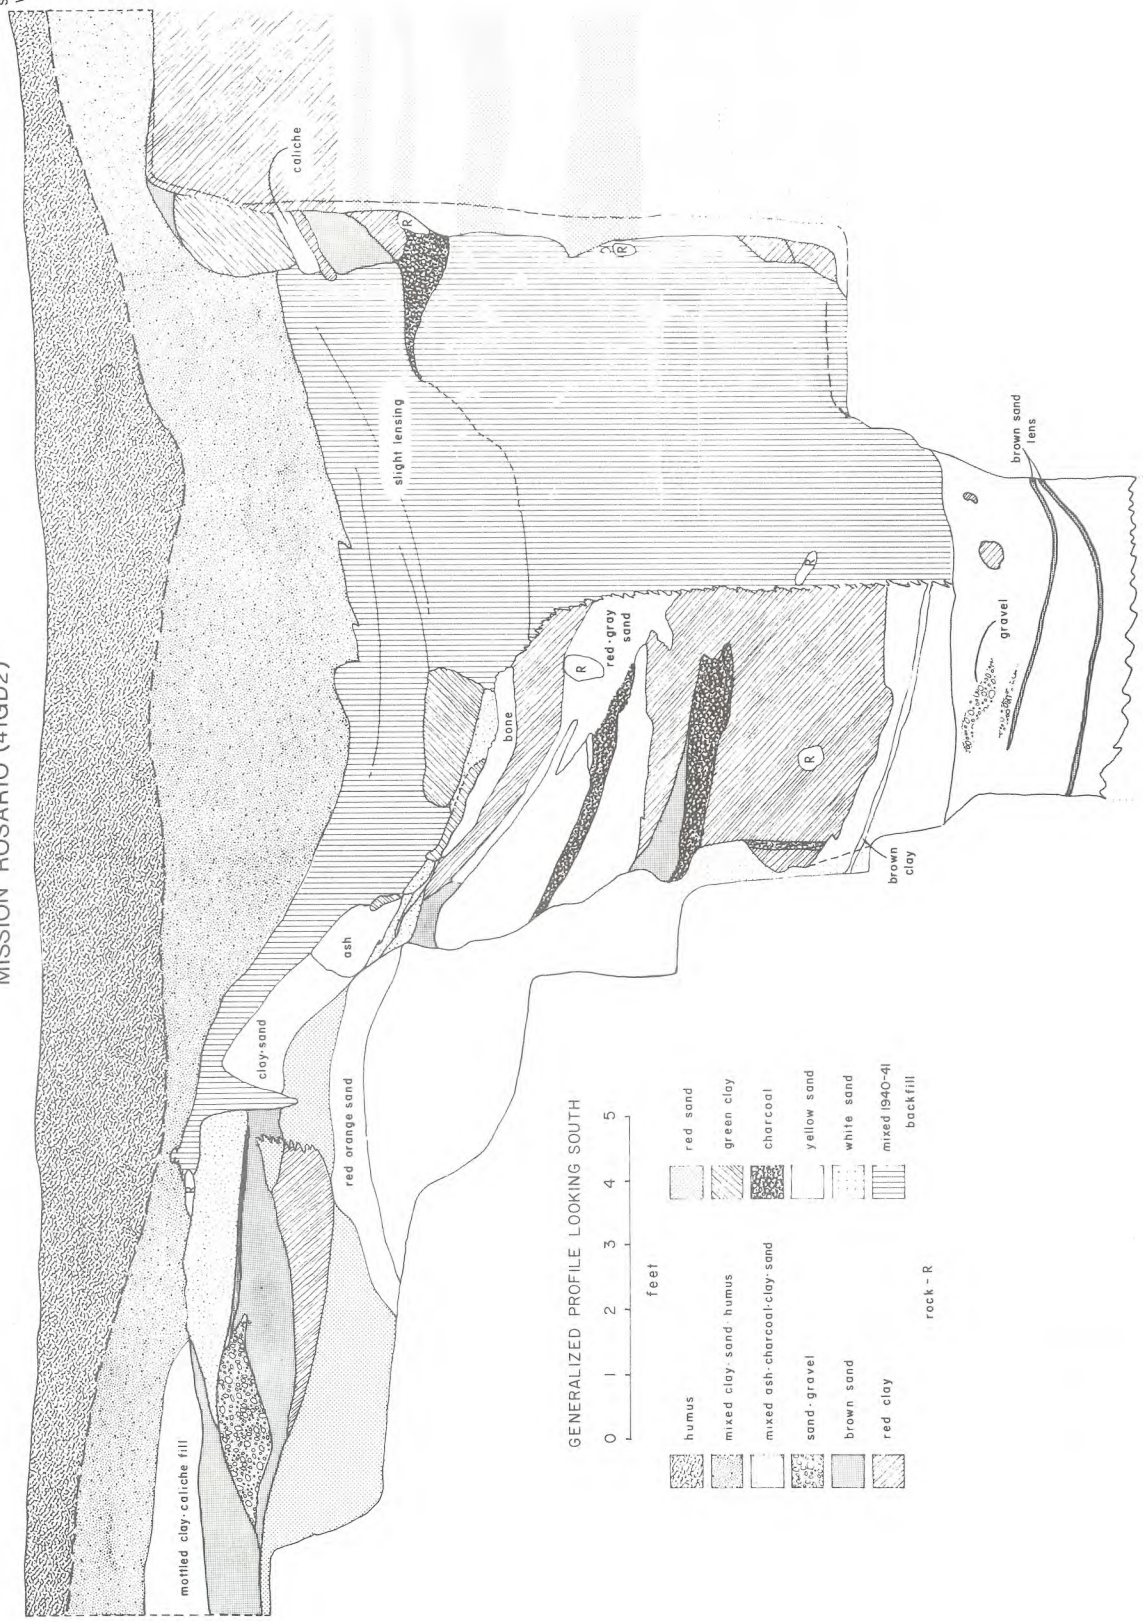
Fig 28

TRENCH 190, THE WELL (?)
MISSION ROSARIO (41GD2)

GENERALIZED PROFILE LOOKING SOUTH

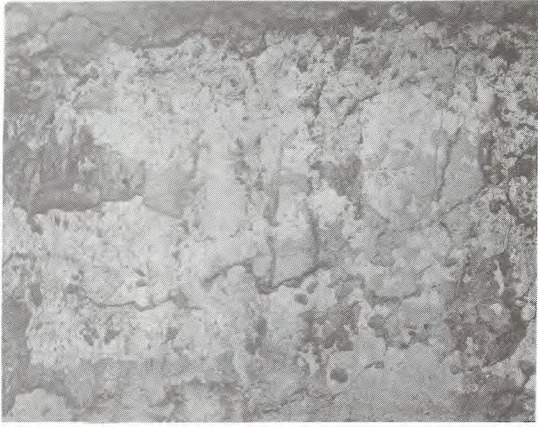
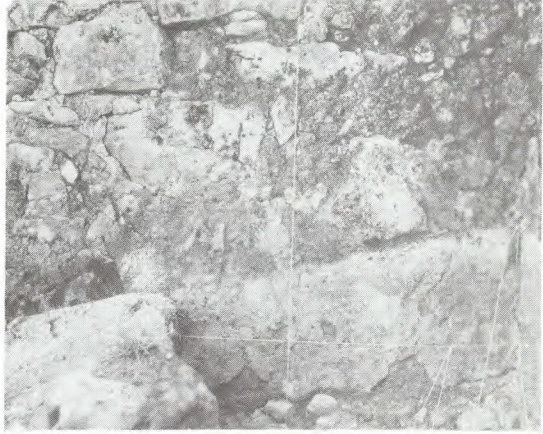
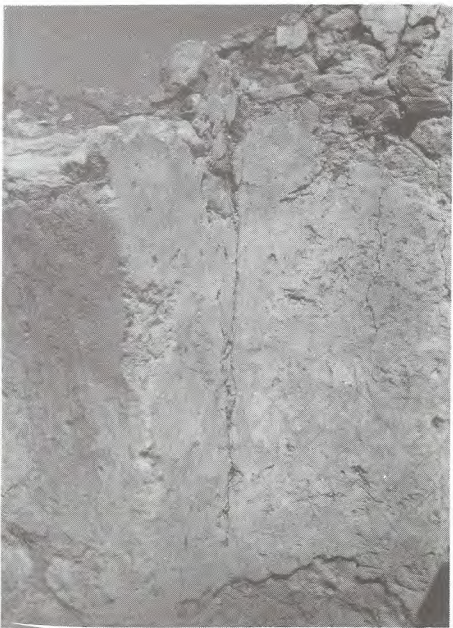
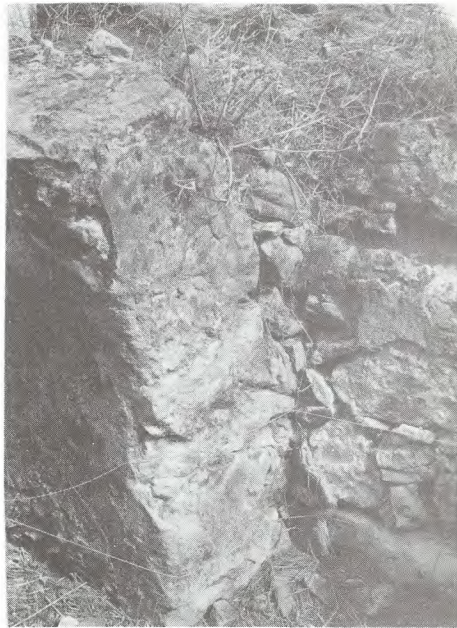
Fig. 3I

Fig. 31. WALL PLASTER WITH SCORING

- A. 1940-41 photograph of southwest corner Room 3; faint diamond scoring on plaster at left
- B. Same area as Fig. 31A, photograph taken Fall 1974
- C. 1940-41 photograph of archway showing diamond scoring on plaster
- D. Same area as Fig. 31C, photograph taken Fall 1974

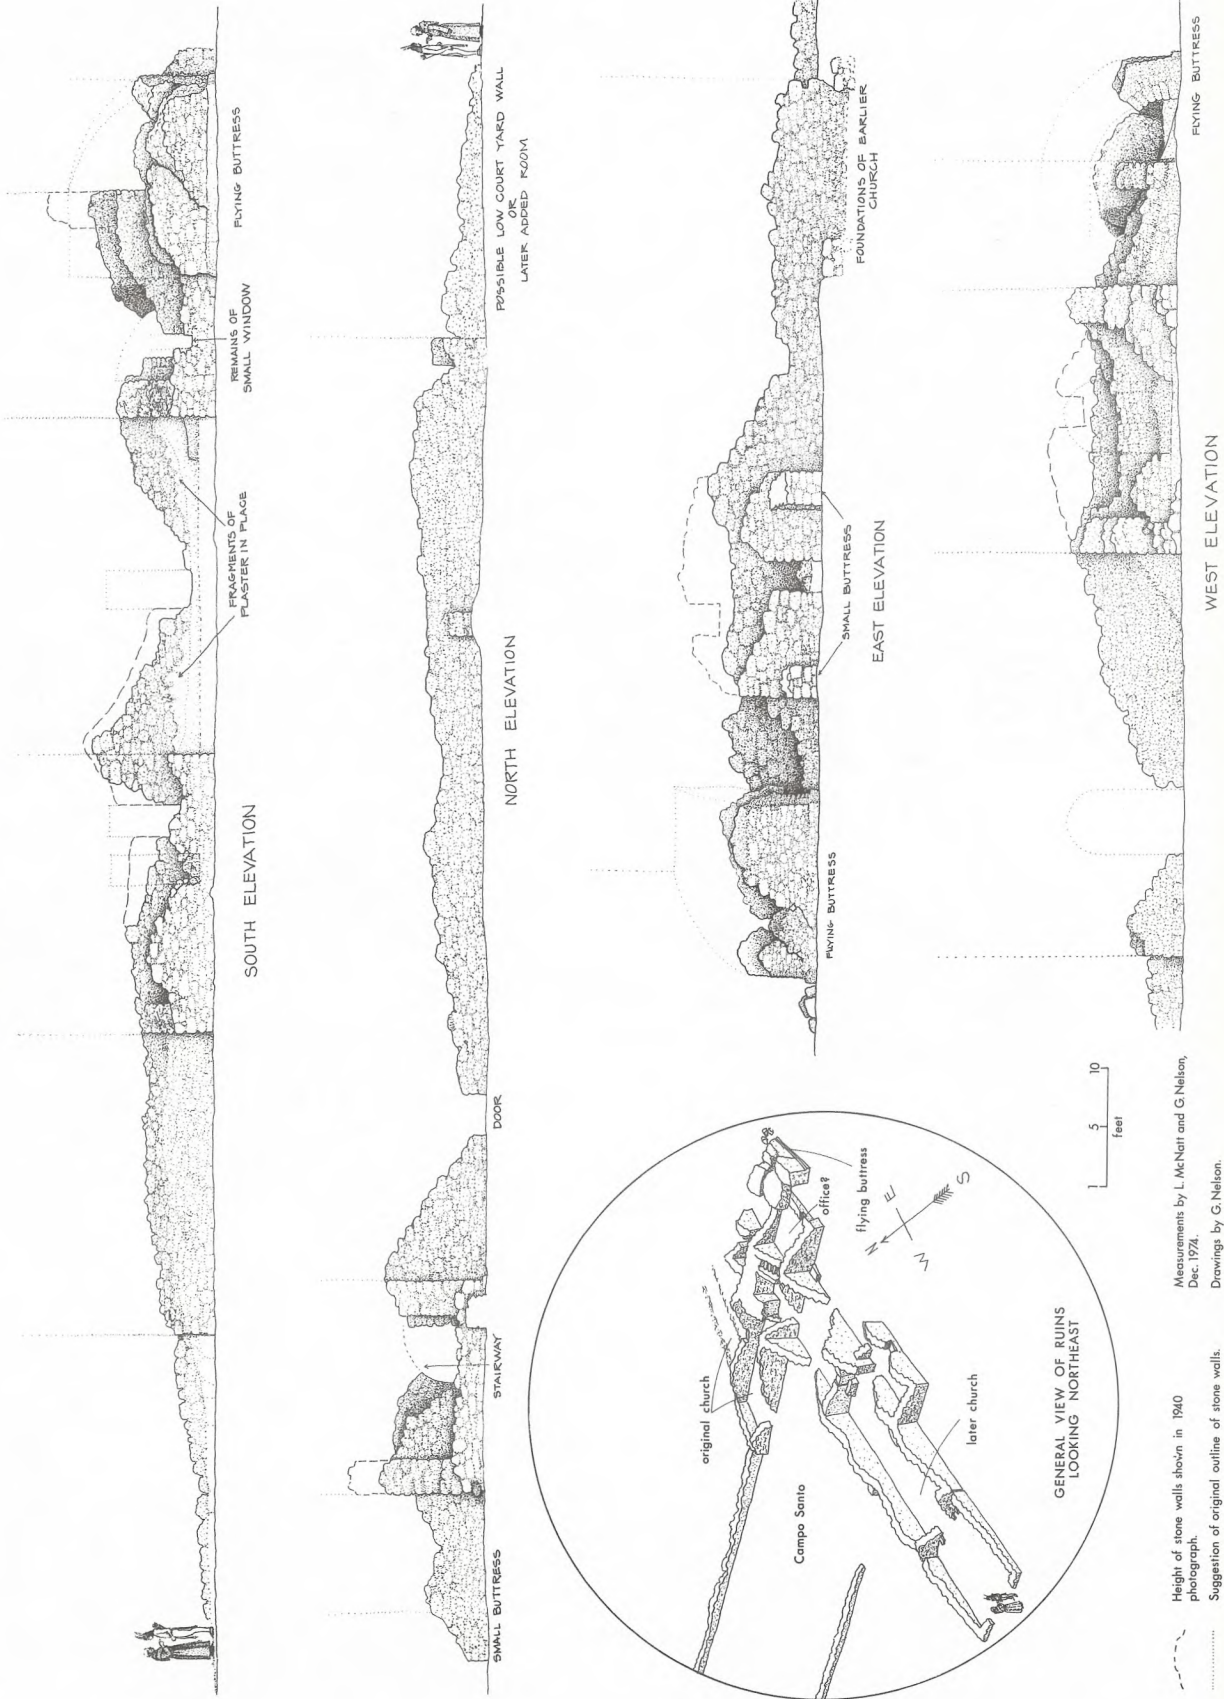
MISSION ROSARIO (41GD2)
ELEVATIONS OF ROCK WALLS, 1974

Measurements by L. McNair and G. Nelson,
Dec. 1974.
Drawings by G. Nelson.

Height of stone walls shown in 1940
photograph.
Suggestion of original outline of stone walls.
