PERFORMANCE COMPARISON OF HIGH DENSITY POLYETHYLENE PIPE  
(HDPE) IN MUNICIPAL WATER APPLICATIONS

MASTER OF SCIENCE IN CIVIL ENGINEERING

THE UNIVERSITY OF TEXAS AT ARLINGTON

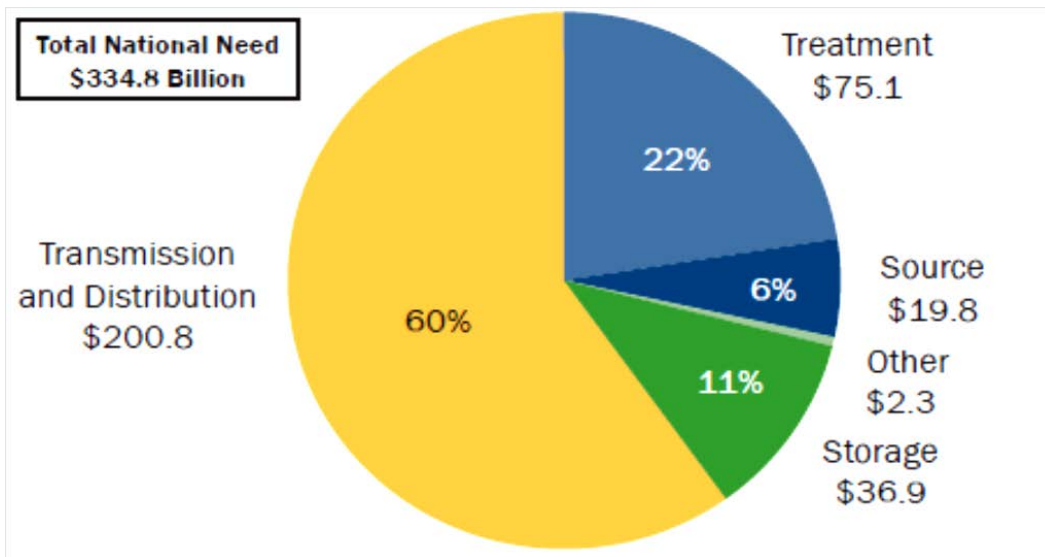
Figure 1.1 Estimated Cost for Drinking Water Projects for the Next 20 Years (EPA, 2007)

Figure 1.1 shows the estimated national water need cost breakdown forecasted by AWWA for the next 30 years. About 60% of the cost has to be invested on repair and replacement of the existing U.S. water transmission and distribution systems.

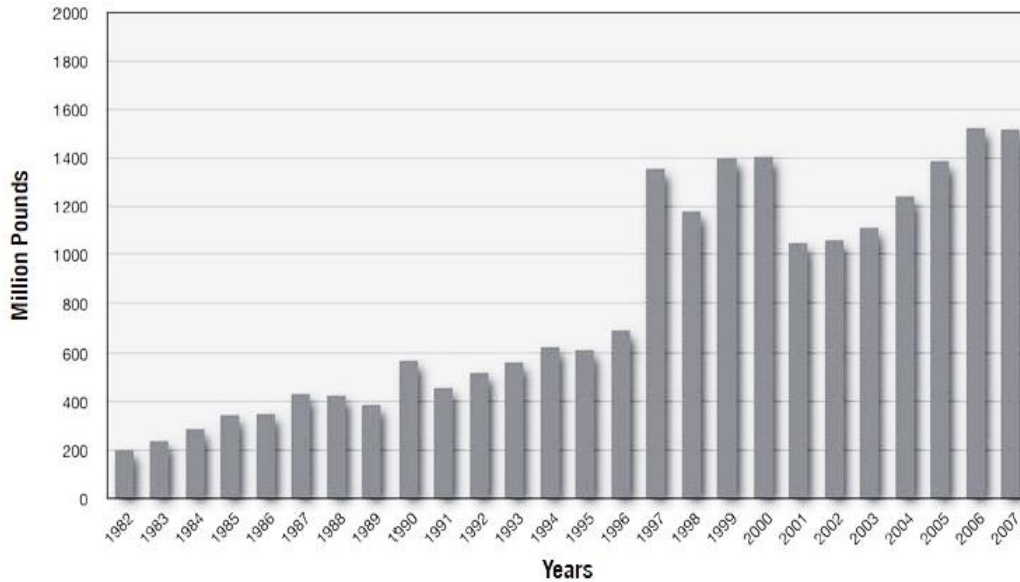
Figure 2.2 HDPE Pipe Manufacturing in North America (PPI, 2008)

The growth of HDPE pipe in North America is shown in Figure 2.2. Since 1982 the demand for HDPE pipe has grown from 200 million pounds production to over 1,500 million pounds in 26 years.

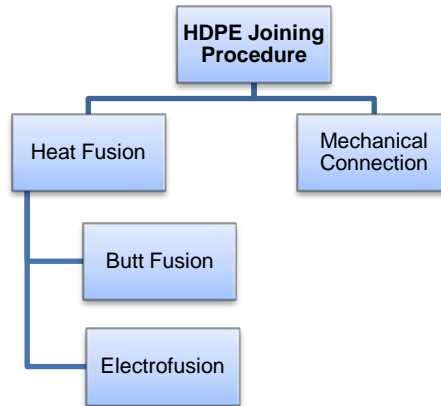
Figure 2.3 Types of HDPE Pipe Joining Procedure (PPI, 2008)

As Figure 2.3 shows, joining procedures of HDPE pipes can be mainly classified into Heat Fusion and Mechanical Connection. The heat fusion can be further categorized into Butt Fusion and Electrofusion.

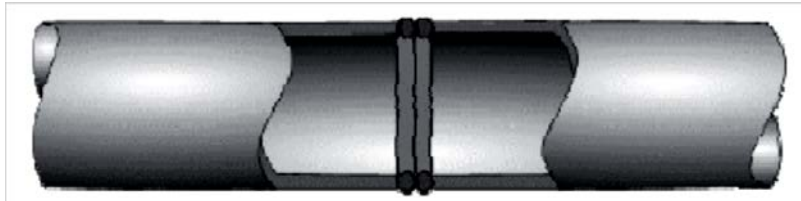
Figure 2.4 Standard Butt Fusion (PPI, 2008)

According to Zhao et al (2002) and Beamer and Kendall (2009), butt fusion is the most effective method for connecting HDPE pipes on job sites. The process of joining is explained as follows, the pipes to be joined are mounted on the clamps of the butt fusion equipment and this is checked for initial alignment. The pipes ends are then trimmed to remove any uneven surfaces, surface voids or any manufacturing defects. The hot plate is sandwiched between the pipe ends and pressure is increased to give a good thermal contact. The pipe ends melts to form weld beads on the inner and outer surfaces. This process is called bead up stage. Then pipes are slowly pulled away and hot plate is removed. The pipe ends are now pushed together and pressure is applied gradually. The process is called initial bead-up stage. When further more pressure is added to the pipe

the inner and outer surfaces of the pipes tend to curve outwards. The stage is called beadroll over stage. A leak proof joint is achieved when the weld is cooled (Davis et al., 2007). A typical standard butt fusion is shown in Figure 2.4 and Figure 2.5.

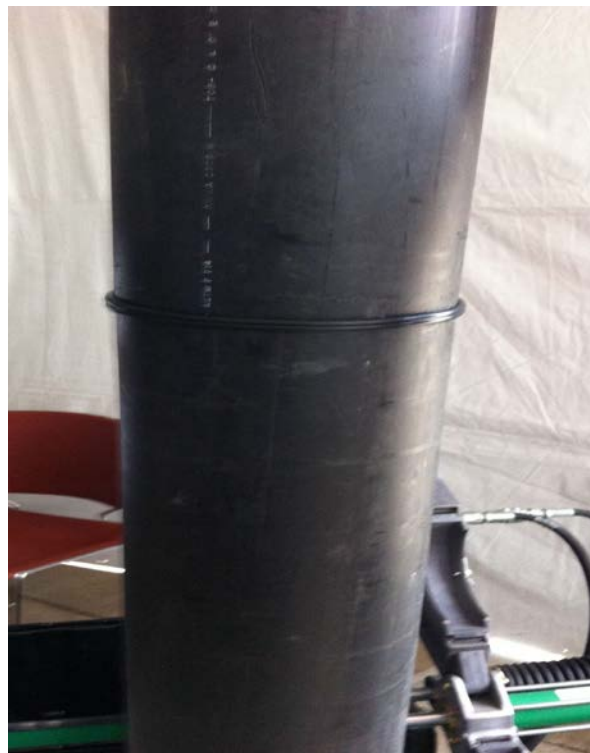
Figure 2.5 Butt Fusion

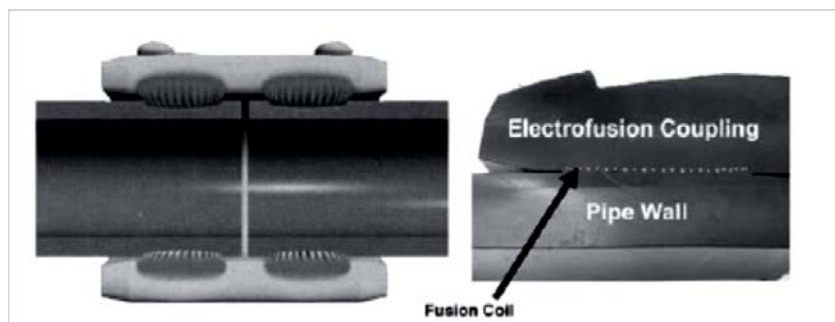
Figure 2.6 Standard Electrofusion (PPI, 2008)

The electrofusion joining process can be achieved with the help of coupler. A coupler consists of resistance wires, stopper to prevent the meeting of pipe ends and this is connected to an electronic device. The pipe ends to be joined is slides into the coupling which has stopper. Controlled electric current is passed through the wires which heats the pipe surface. When sufficient heat is passed the pipe surface melts. Upon cooling the electrofusion joint is achieved (Davis et al., 2007). Typical electrofusion is as shown in Figure 2.6.

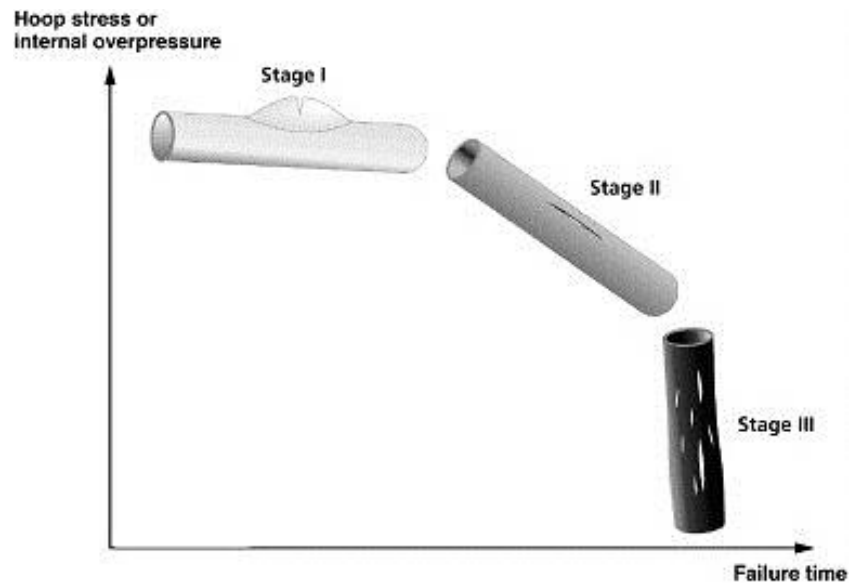
Figure 2.7 Failure Stages in HDPE Pipe (Duvall and Edwards, 2010)

Stage III failure is referred to as brittle-chemical failure or brittle-oxidative failure. The indication of this failure is noticeable when the material degrades due to oxidation and also the action of stress induced due to the crack propagation corresponding to Stage II.

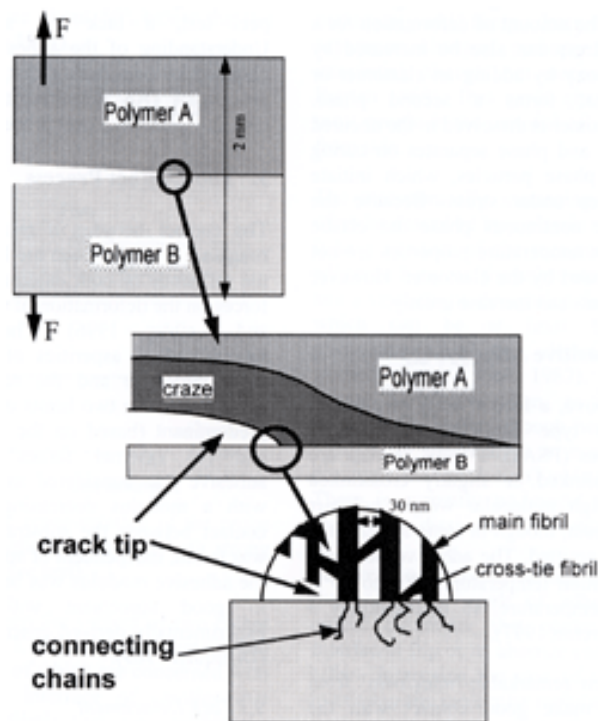
Figure 2.8 Schematic Representation of Crazing at the Crack Tip (Brown, 2000)

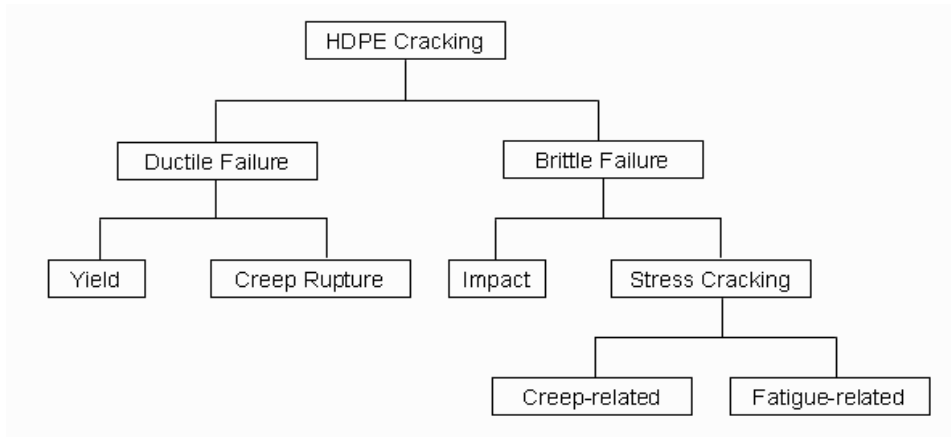
Figure 2.9 Failure Modes in HDPE Cracking (Zhang, 2005)

The premature failure of HDPE pipe due to cracking was most common type of failure seen in the 1<sup>st</sup> generation of HDPE pipes. The cracking of HDPE pipe can be categorized into three types, 1) third party damage, 2) joint failure and 3) material failure. Improper construction practices leads to third party damage, which occurs when the connection of pipes is not according to the standard specifications and practice manual. Poor design and quality of material used in manufacturing such as impurities and defects will promote material failure (Zhang, 2005; Lustiger and Corneliussen, 1987).

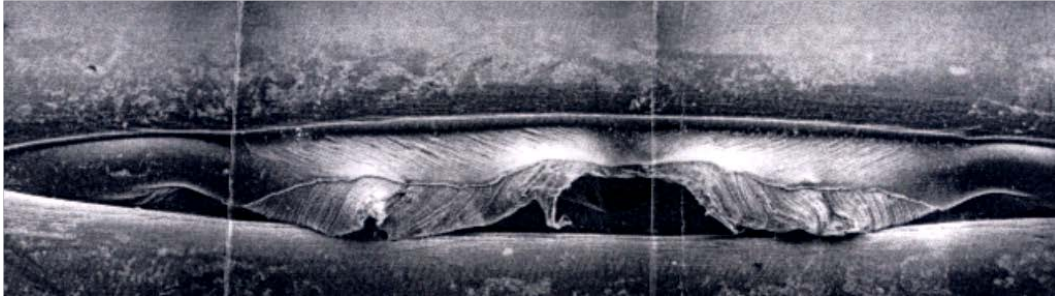
Figure 2.10 Macroscopic Ductile Failure of HDPE (Zhang, 2005)

The ductile cracking undergoes substantial yielding before undergoing failure. The growth of cracking in ductile failure occurs very slowly and is accompanied by a large amount of plastic deformation. Ductile fracture surface will have a larger necking. The microscopic phenomenon of ductile failure is shown in Figure 2.11 where initially all the polymeric fibers stretched creating a micro void. As the stress is continuously induced the deformation continues and the micro voids enlarge to form a crack. This crack is propagated in the direction of the tensile load and finally the necking of the material takes place and bonding between the polymeric fibers is decreased resulting in ductile failure (Lustiger and Corneliussen, 1987; Zhang, 2005; Davis et al., 2007).

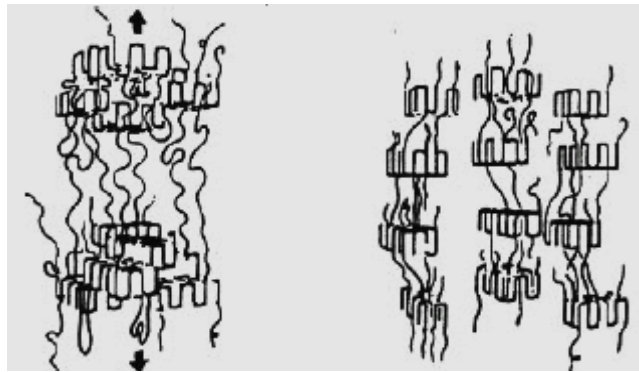
Figure 2.11 Microscopic Failure of Ductile Failure (Zhang, 2005)

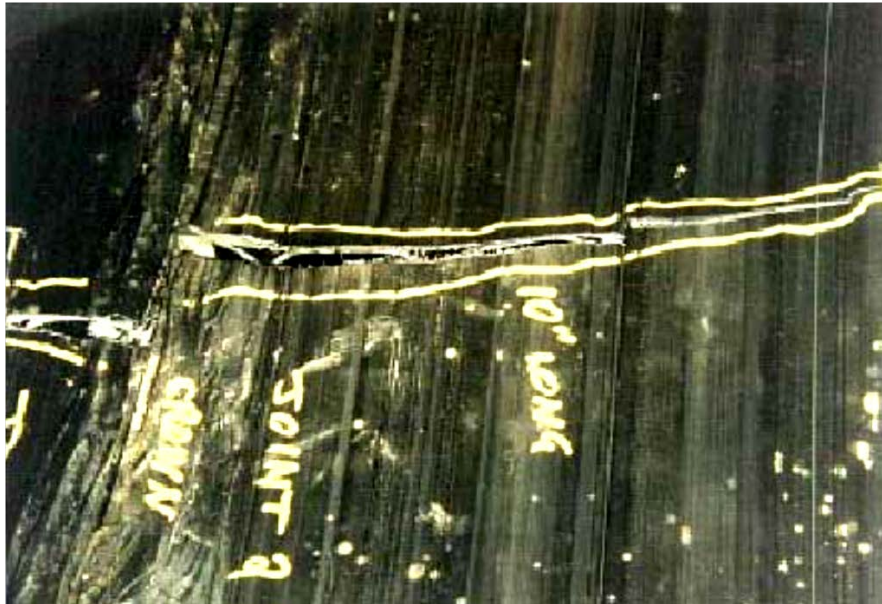
Figure 2.12 Macroscopic Brittle Failure of HDPE (Zhang, 2005)

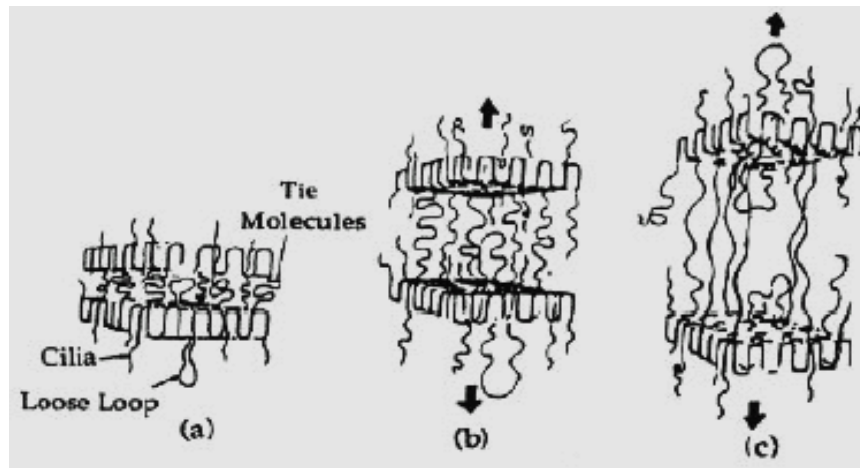
Figure 2.13 Microscopic Failure of Brittle Failure (Lustiger, 1985)

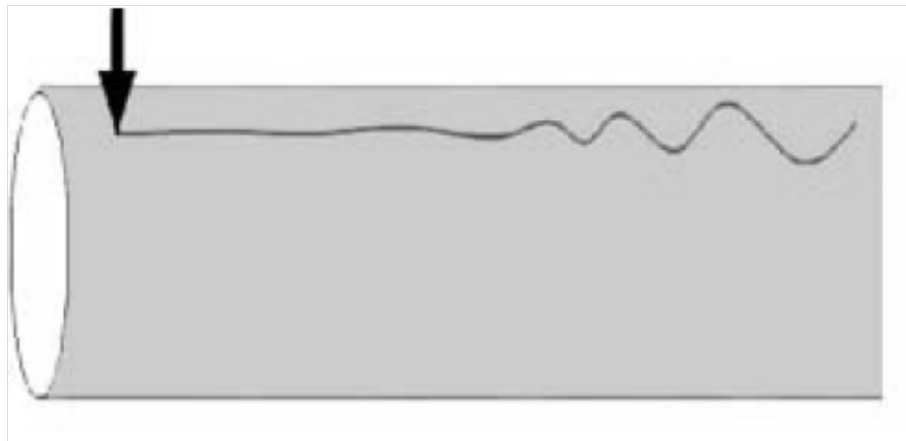
Figure 2.14 Rapid Crack Propagation (Adapted from Performance Pipe, 2012)

material, internal pressure, temperature, joining techniques, and third party damage (Palermo, 2010). According to Frank et al. (2011), properties of HDPE such as ductility and semi-crystallinity resist the RCP in HDPE pipe when compared to other plastic material pipe such as PVC which are brittle in nature. According to Frank et al. (2011), very few failures were recorded under RCP in HDPE pipe for water application from various utilities in Europe and the U.S. In the typical RCP is as shown in Figure 2.14, the direction of the crack will be always normal to the surface of the pipe. Fast running crack rate can vary from 300 ft/s – 900 ft/s for an indeterminate length (Ivankovic and Venizelos, 1998).

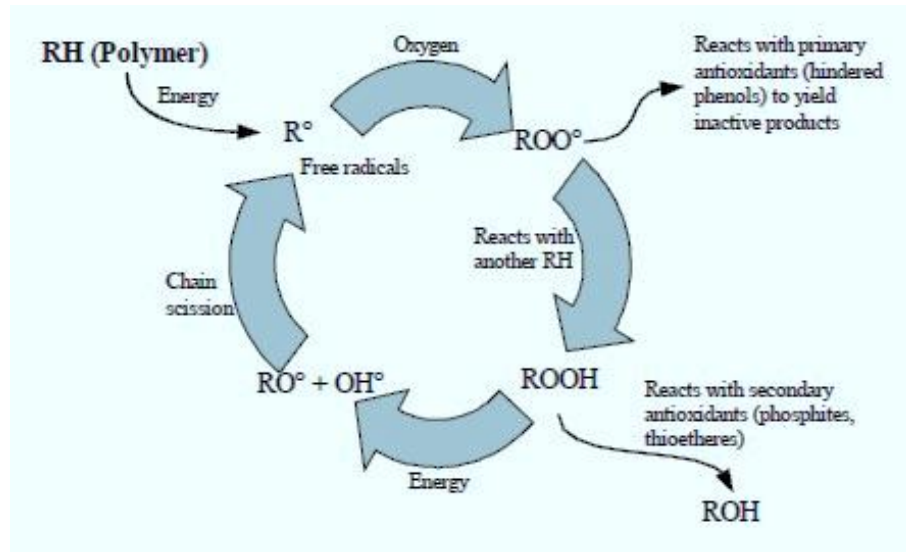
Figure 2.15 The Process of Polyethylene Degradation and Stabilization (Lundback, 2005)

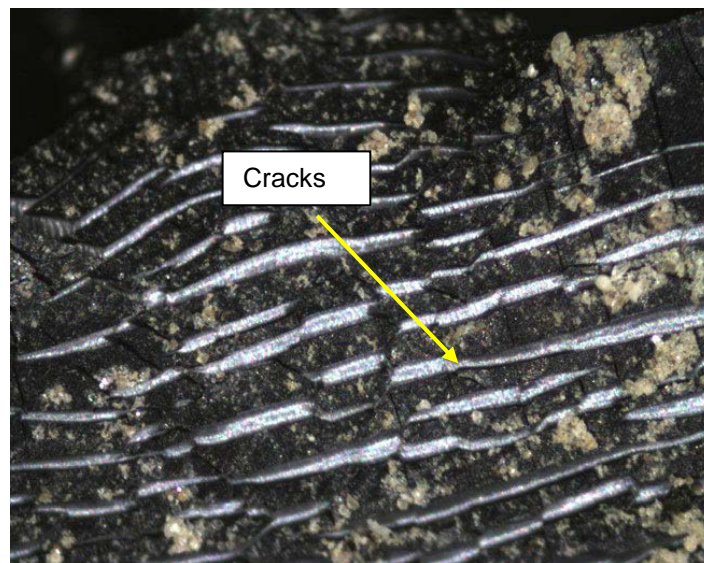
Figure 2.16 Cracks Due to Oxidation of HDPE (Chung et al., 2007)

Figure 2.16 shows the wall surface cracking of HDPE due to the oxidation process, and Figure 2.17 shows a sample of HDPE degradation due to continuous reaction with the chlorinated water.

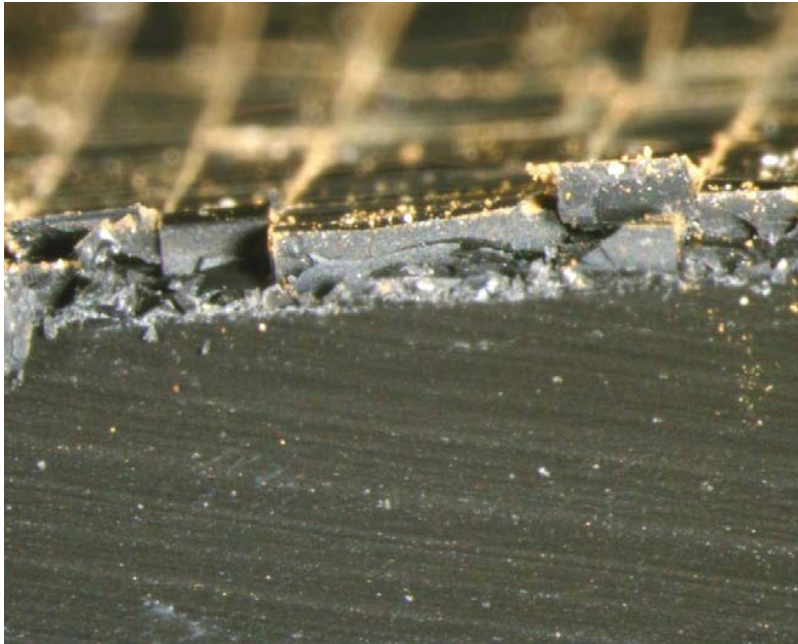
Figure 2.17 HDPE Pipe Wall Degradation Due to Oxidation (Duvall and Edwards, 2010)

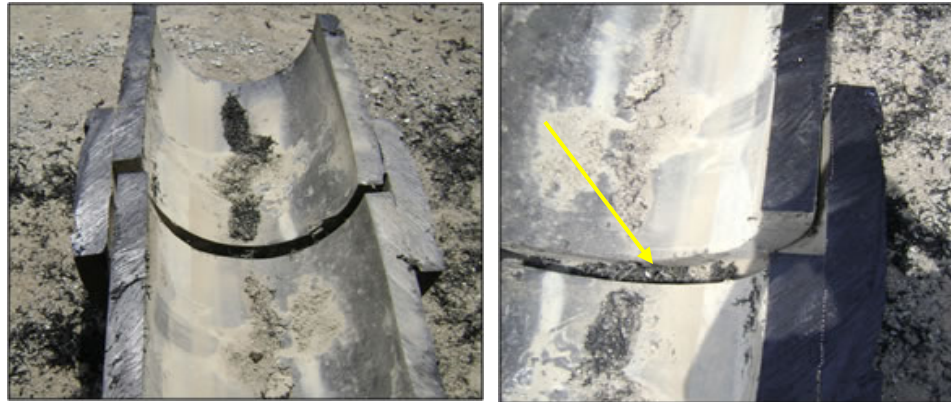
(a)

The arrow in the Figure 2.18 is the electrofusion coupling failure of HDPE water pipe resulted due to bad workmanship. Separation is another type of failure that can be observed in electrofusion joints. The failure occurs when there is moisture trapped between the pipes and coupling. When the coupling is heated to high temperature for the joining purpose, the moisture vaporizes and attempts to escape, creating air bubble in the coupling during the joining process. Over a period of time the pipe is separated from coupling and fails (Davis et al., 2007).

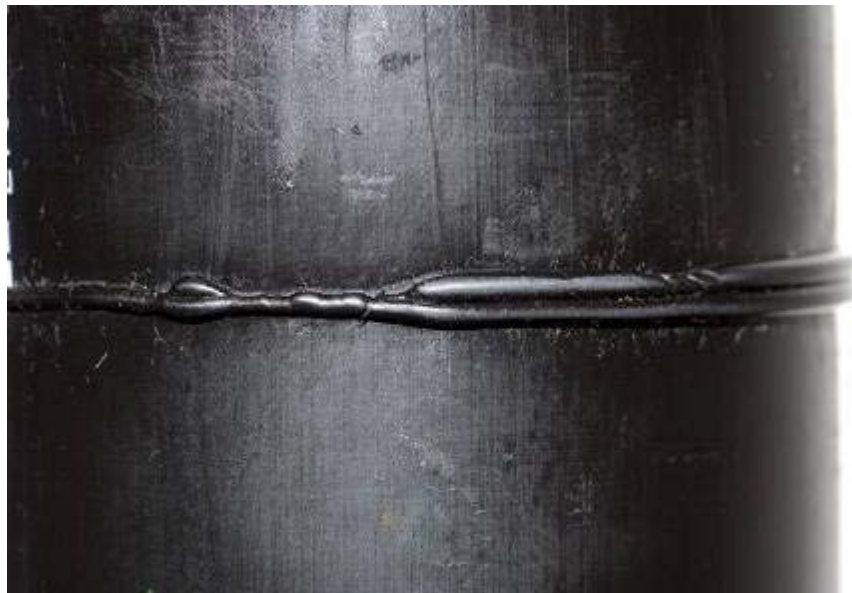
Figure 2.19 Butt Fusion Failure Due to Contamination of Material (PPI, 2008)

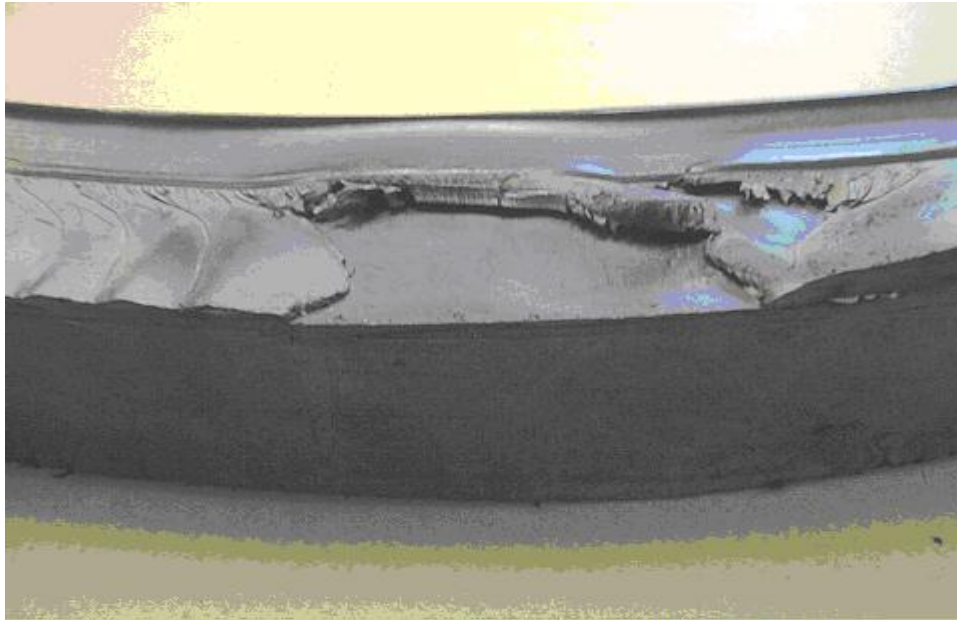
Figure 2.20 Butt Fusion Failure Due to Improper Trimming of HDPE Pipe Surface

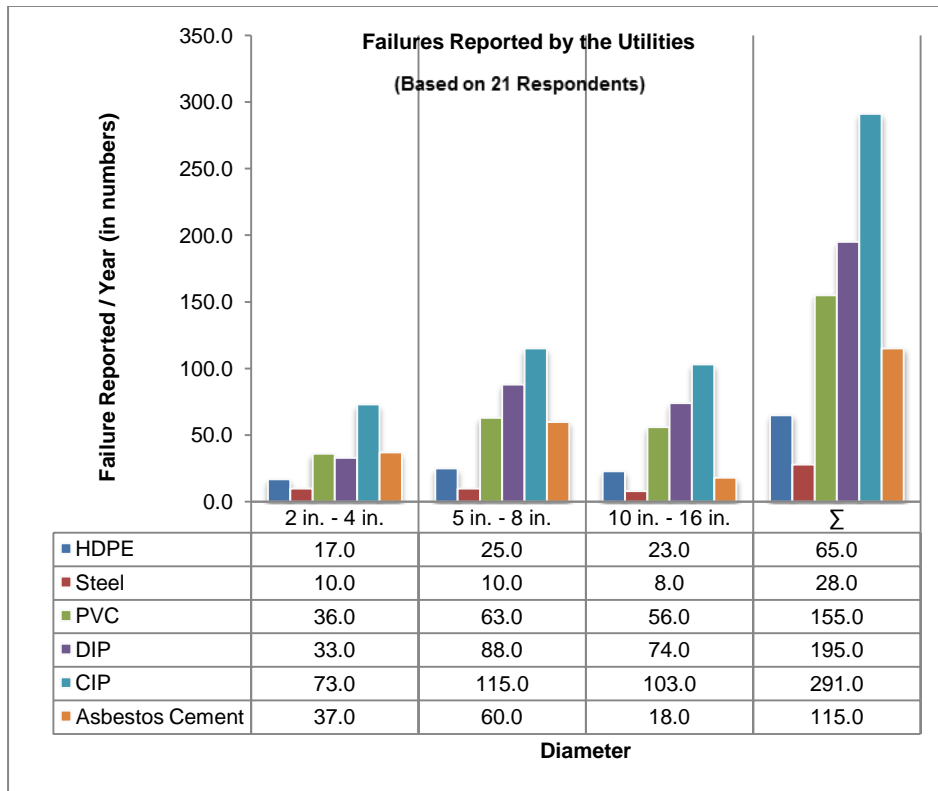
Figure 4.10 Failures of Different Pipe Material

From the Figure 4.10, steel has the least cumulative failures per year with 28 and Cast Iron pipe has highest cumulative failures per year with 291 irrespective of diameter. Cumulative failure of HDPE pipes per year for the surveyed utilities is 65.

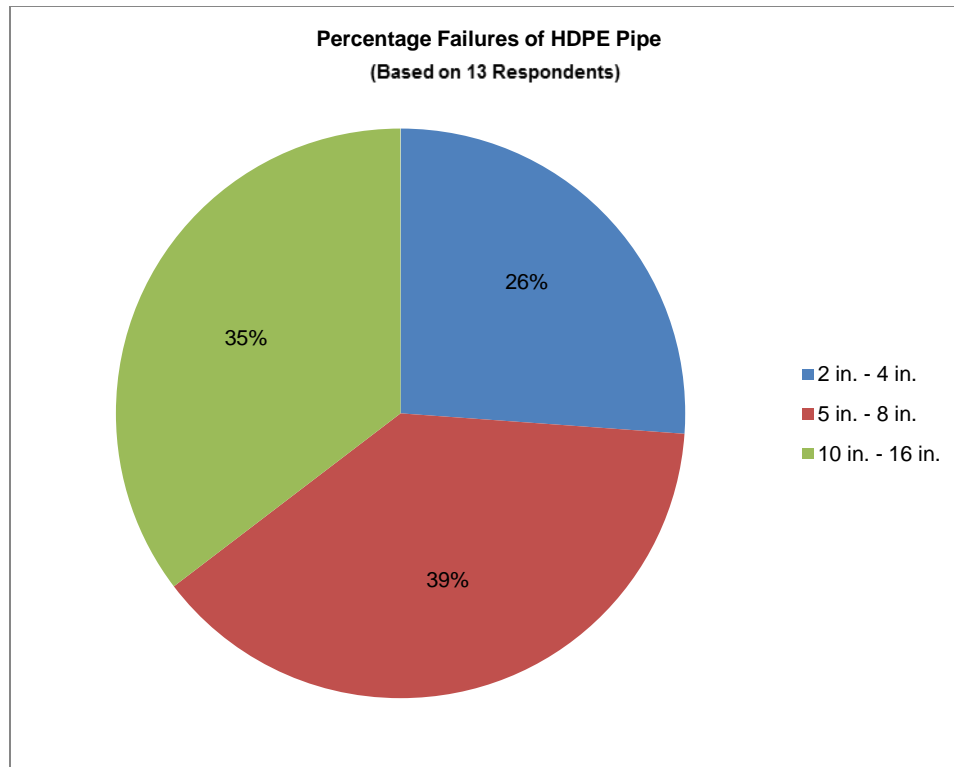
Figure 4.11 Percentage Failures of HDPE Pipe

The percentage failure for different HDPE pipe diameter sizes is illustrated in Figure 4.11. The failure rate for pipe size diameters 2 in.–4 in. is 26% with 39% of HDPE pipe failure occurring in pipes with diameters of 10 in.–16 in. Finally, 35% of pipe failures shown in the Figure 4.11 occurred for HDPE pipes with a diameter of 10 in.–16 in for the survey respondents.

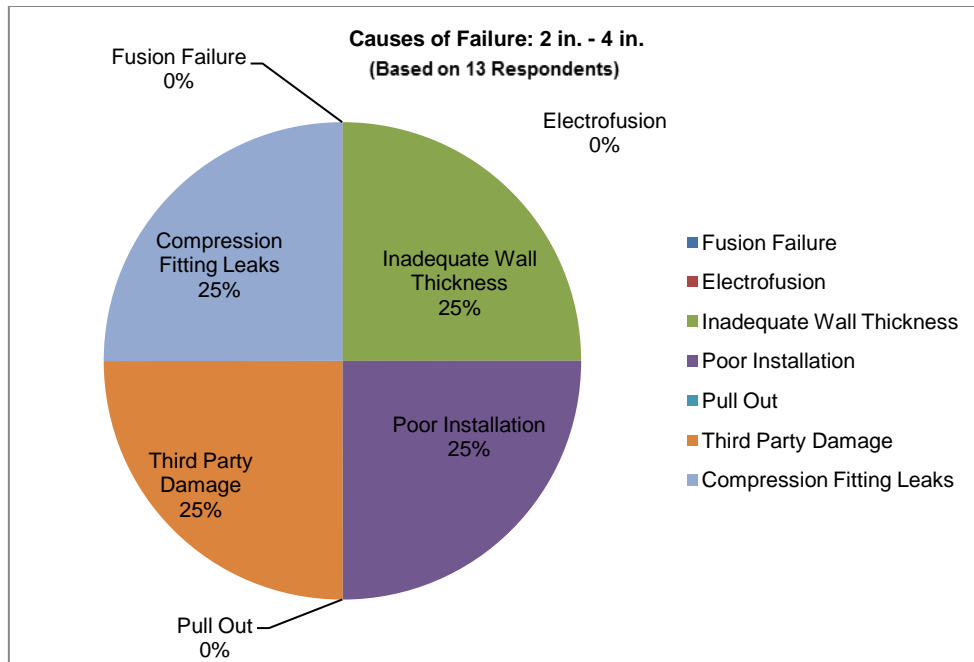
Figure 4.12 Causes of Failures for Diameter Range 2 in.–4 in.

Figure 4.12 is the pie chart with the cause of failure percentages for diameters ranging from 2 in.–4 in. Poor installation, third party damage, compression fitting leaks and inadequate wall thickness all share equally in the failure causation summary with 25% each. The rest of the possible causes for failure had not occurred in the surveyed utilities. For pipes with 4 in. diameters and below, the segments are joined using fittings such as tees and couplings; hence, electrofusion and butt fusion are not reported.

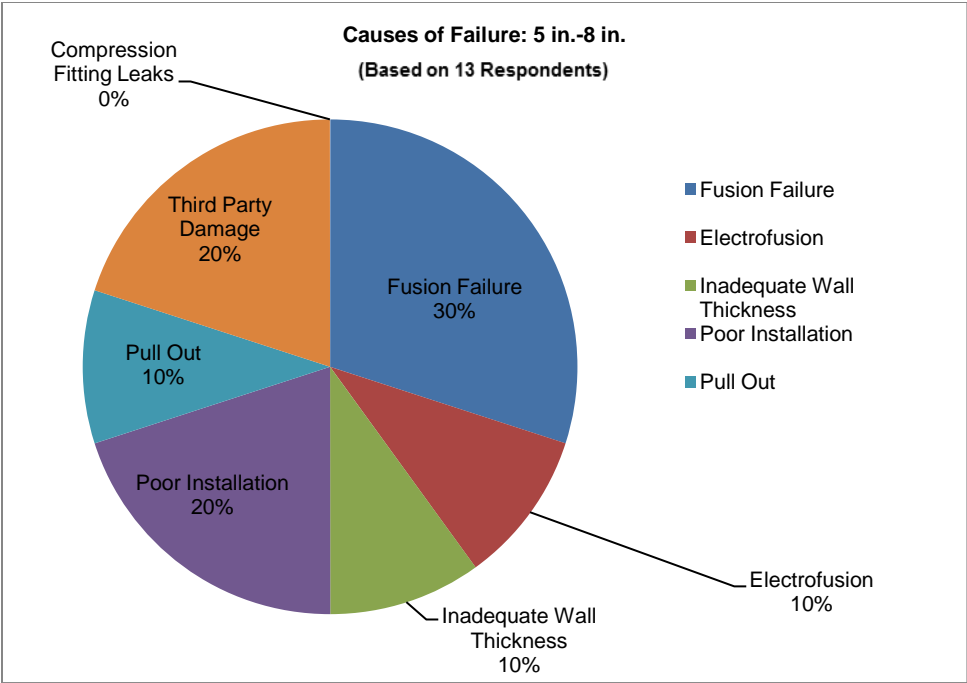
Figure 4.13 Causes of Failures for Diameter Range 5 in.–8 in.

Figure 4.13 is the graphical representation of failure causes occurring in utilities for diameters ranging 5 in.–8 in. Fusion failure accounted for 30% of the failure. Poor installation and third party damage shared 20% each. Electrofusion, inadequate wall thickness and pull out failure all share 10%. There were no compression fitting leaks reported for this diameter range.

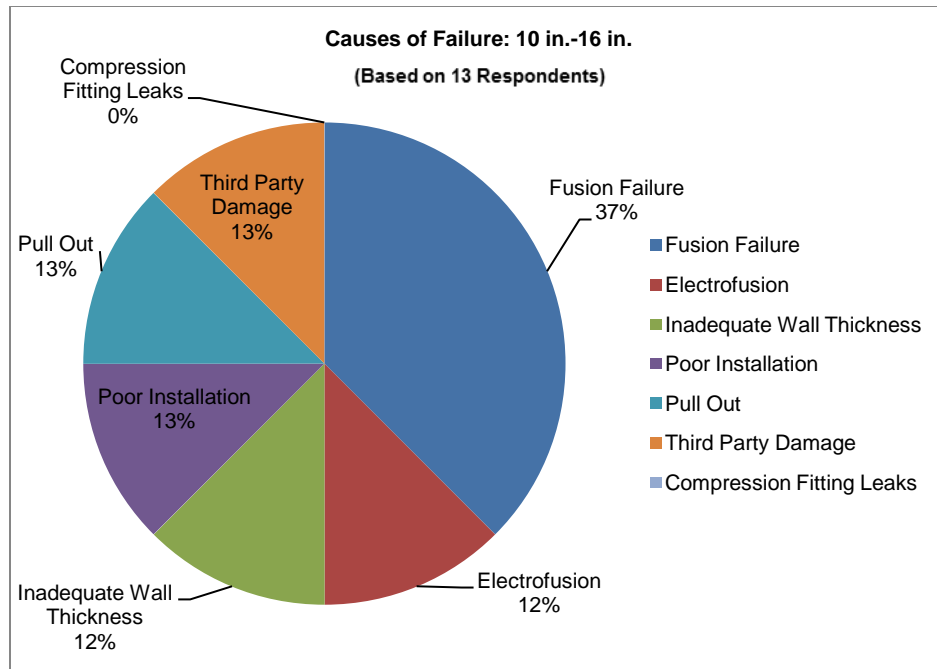
Figure 4.14 Causes of Failure for Diameter Range 10 in.–16 in.

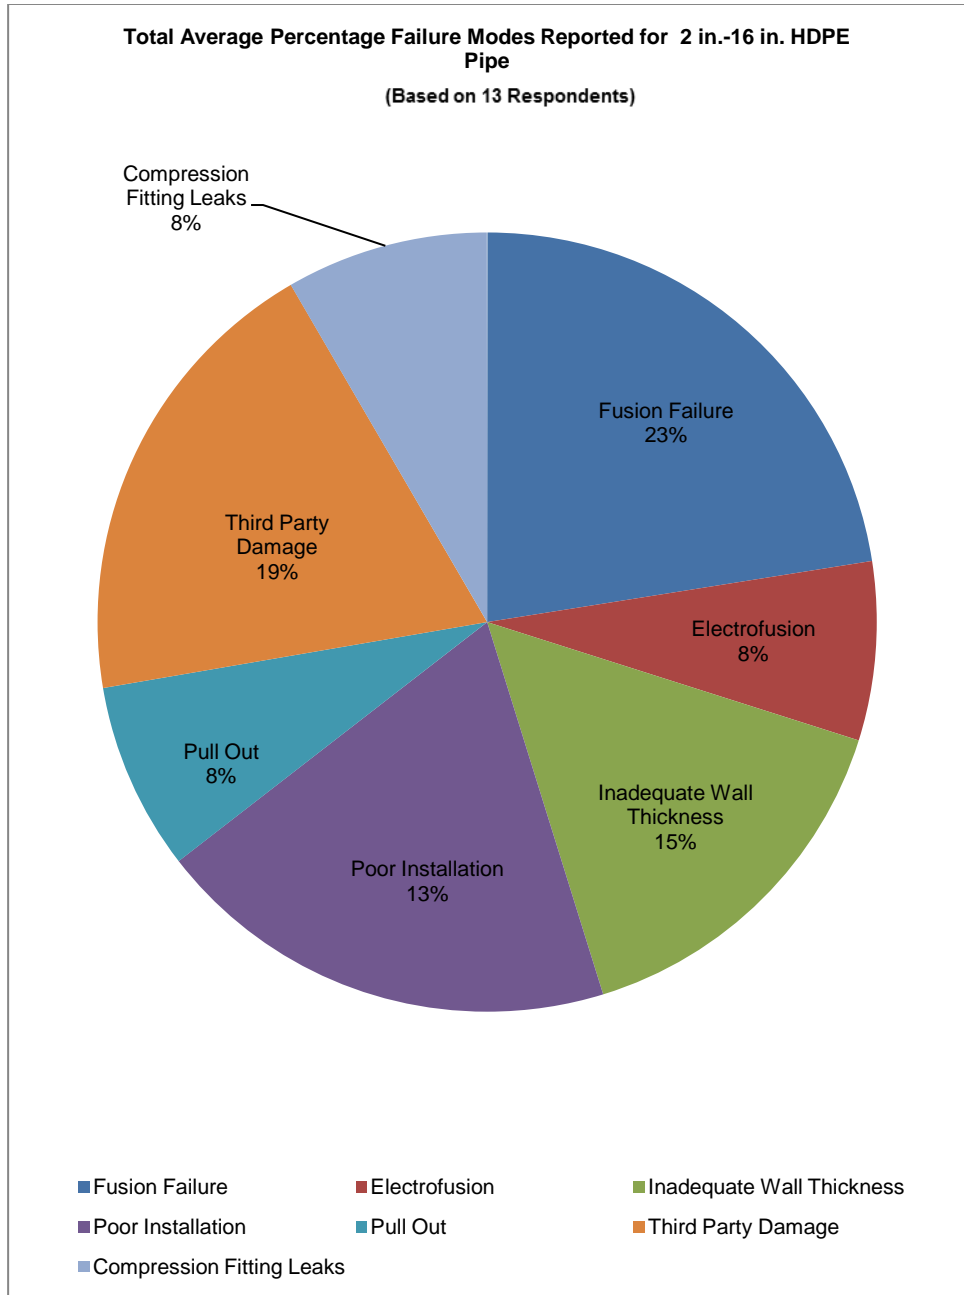
Figure 4.24 Average Percentage Failure Causes Reported

Similarly pull-out and fusion failures were not reported for pipe size 2 in.–4 in. because fusion joints cannot be achieved for 2 in.–4 in. due to the insufficient thickness of pipe wall. The average failure caused due to pull-out is 11.5% for the diameter range 2 in.–16 in. is 8% .The average fusion failure for pipe diameter range 2 in.-16 in. is 23 % and electrofusion is 8%. The graphical presentation of average failure causes reported for 2 in.–16 in. is shown in Figure 4.24.

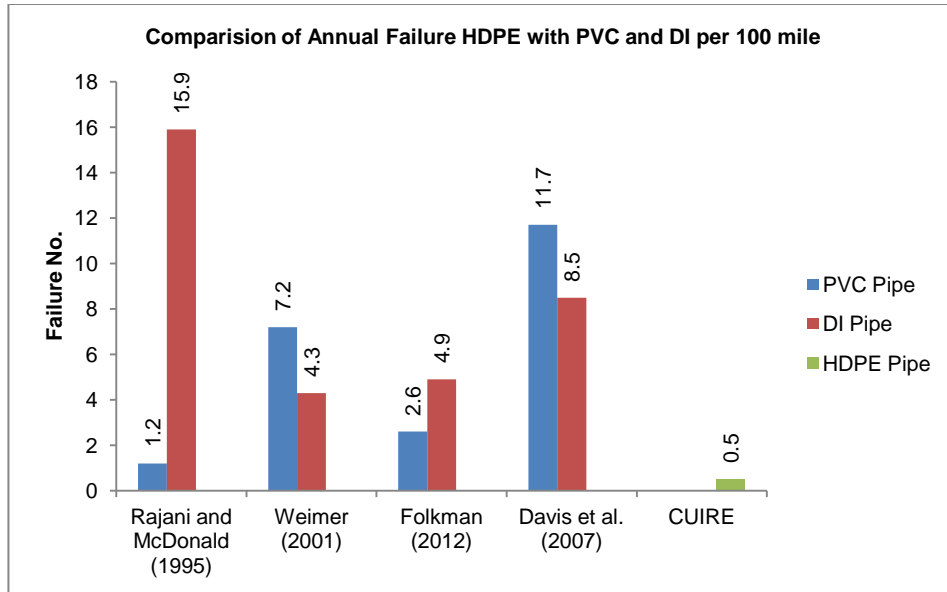
Figure 4.26 Comparisons of Annual Failure of HDPE, PVC and DI per 100 Mile

The primary objective of current research was to make comparisons of HDPE performance results with PVC and DI pipe. This was achieved by comparing the research results from previous studies on failure of PVC and DI pipes. Figure 4.26 is the graphical representation of annual failure comparisons per 100 miles from different studies.
