PERFORMANCE OF FULL-SCALE ULTRA-HIGH PERFORMANCE FIBER-
REINFORCED CONCRETE COLUMN SUBJECTED TO EXTREME EARTHQUAKE-
TYPE LOADING AND EFFECT OF SURFACE PREPARATION ON THE COHESION
AND FRICTION FACTORS OF THE AASHTO INTERFACE SHEAR EQUATION

MASTER OF SCIENCE IN CIVIL ENGINEERING

THE UNIVERSITY OF TEXAS AT ARLINGTON

May 2015

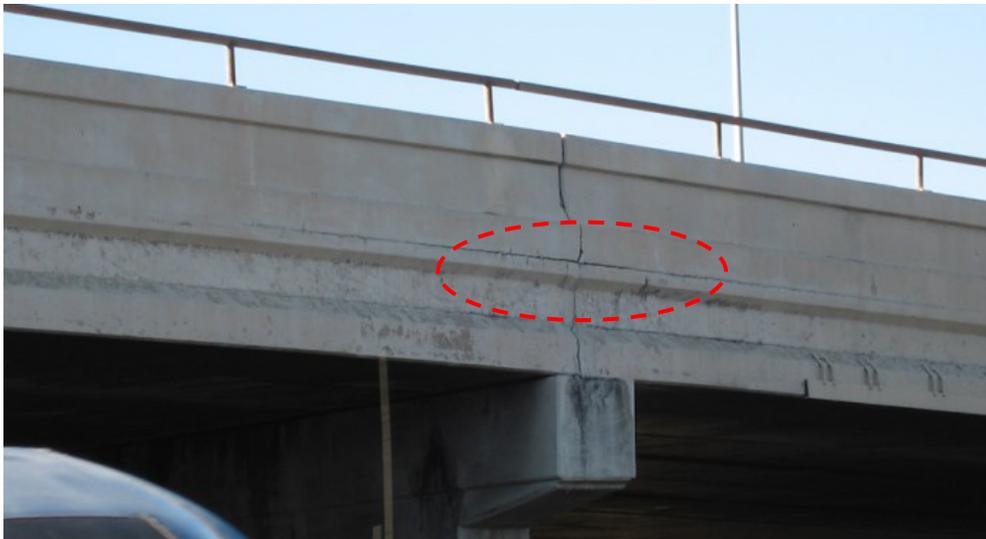
Horizontal cracks between the precast beams and the CIP decks have been noticed in several older TxDOT bridges. Figure 1 below shows horizontal cracks on an older bridge located at the Riverside Drive Underpass at I-35 in Austin, Texas. These cracks could result from shrinkage or excessive shear forces. Shrinkage of the deck can induce significant stresses along the interface between the precast beam and the CIP deck leading to cracking or slip if shear resistance at the interface is insufficient. More details regarding the cracks are discussed in Section 7.5.2.

Figure 1. Interface cracks on Riverside Dr. Underpass at I-35

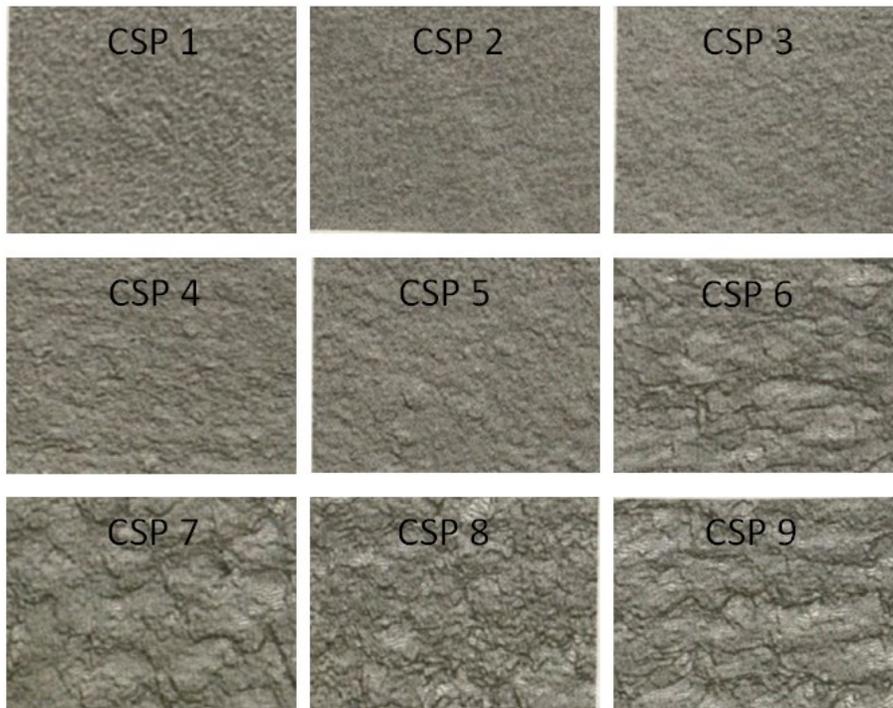
Figure 3. ICRI concrete surface profiles (CSPs)

Also, TxDOT is moving towards using the ICRI (International Concrete Repair Institute) guidelines for concrete surface preparation as a measure of surface roughness. The ICRI guidelines offer nine distinct surface configurations graded from smooth to very rough. These configurations are identified as concrete surface profiles (CSPs) ranging from CSP 1 which is nearly flat to CSP 9 which is very rough (Figure 3). The Precast Panel-Fabrication Standard recommends that the top of the panel should be finished to a roughness between a CSP 6 and a CSP 9. Therefore, by investigating these different surface configurations, we can recommend the roughness that will lead to an improvement to the horizontal shear resistance of composite TxDOT beams.

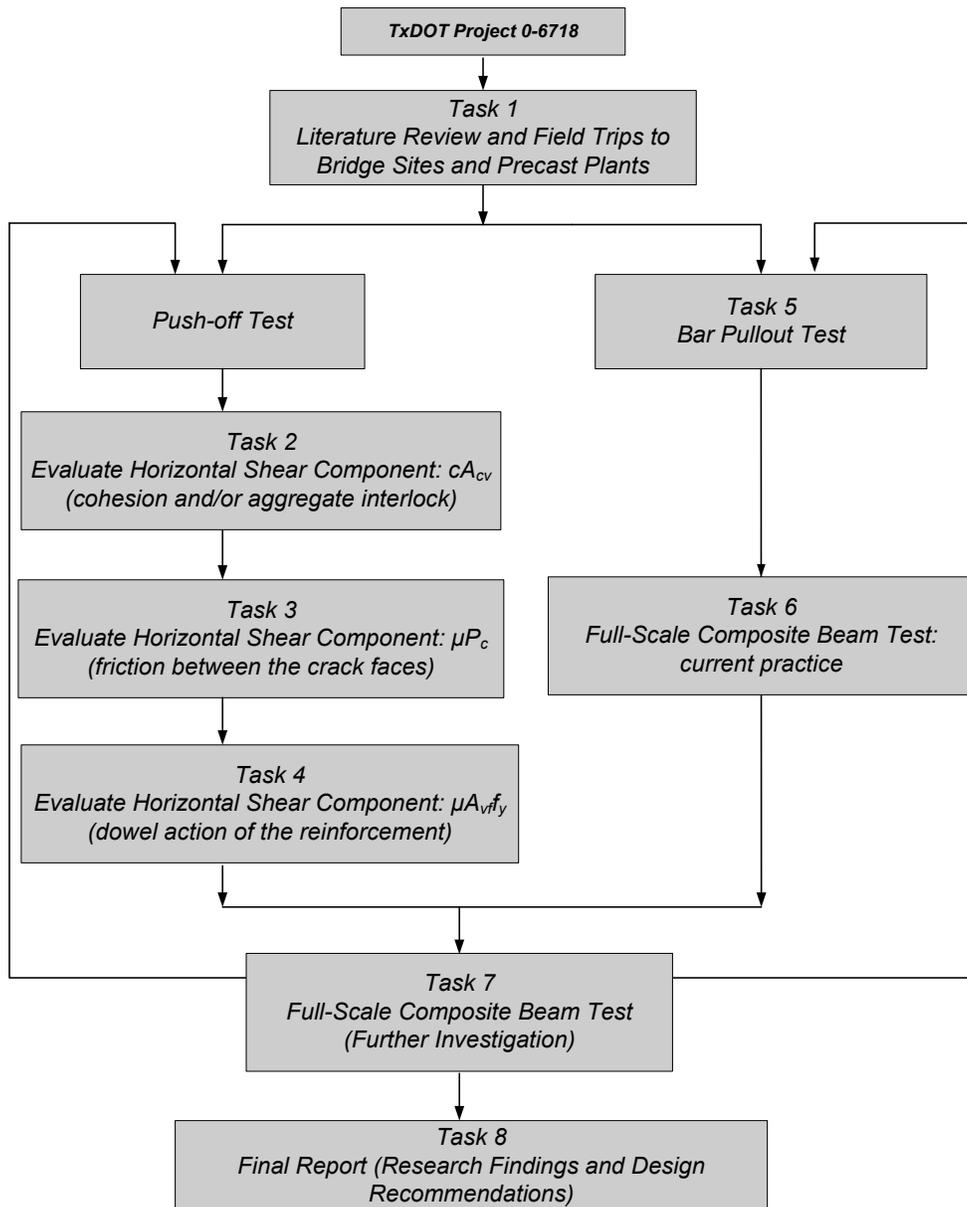
Figure 4. TxDOT project No. 0-6718 experimental investigation

A complete experimental investigation was carried out as part of TxDOT project No. 0-6718 comprising of 7 Tasks as shown in the flowchart on Figure 4 to investigate if adequate horizontal shear capacity is provided by the 5 in. concrete deck on slab and box beams, despite lack of reinforcement development. The first three tasks correspond to small-scale push-off tests to investigate the three major components of horizontal shear resistance: (1) cohesion and/or aggregate interlock, (2) friction between the crack faces, and (3) dowel action of the reinforcement. A simple bar pullout test was also used to evaluate the influence of the bend curvature on the bond and slip characteristics of the horizontal shear reinforcement. Alternative details for surface roughness and bar geometries were also investigated. The second phase of this research consists of testing several full-scale composite box and slab beams with current TxDOT detailing and alternative details to investigate the overall composite behaviors that may be overlooked in the small-scale component tests.

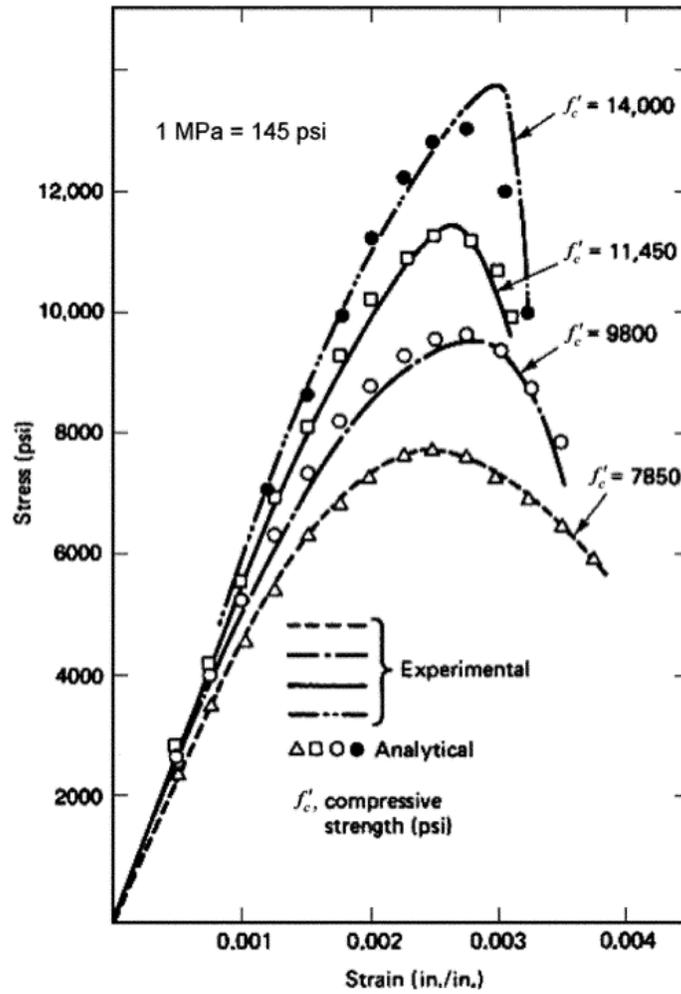
Figure 8. Stress-strain curves for concrete in compression (ACI-363R-11, 2011)

HSC as per ACI 363R-10 (2010) is defined as concrete that has a specified compressive strength of 8,000 psi. or greater. Figure 8 shows the stress-strain curves for concrete with various high compressive strengths. It can be observed from Figure 8 that as the compressive strength increases so does the slope of the initial linear portion of the stress-strain curve; demonstrating that there is a direct relation between the modulus of elasticity and the compressive strength of HSC. It is important to note that while there are many advantages to HSC its increase in strength also comes with an increase in brittleness as denoted by the post-peak behavior of the stress-strain curves shown in Figure 8. As mentioned previously, the higher modulus of elasticity can be attributed to

the higher volume and increased elastic modulus of the aggregate used within the mix as well as the lower w/c ratio.

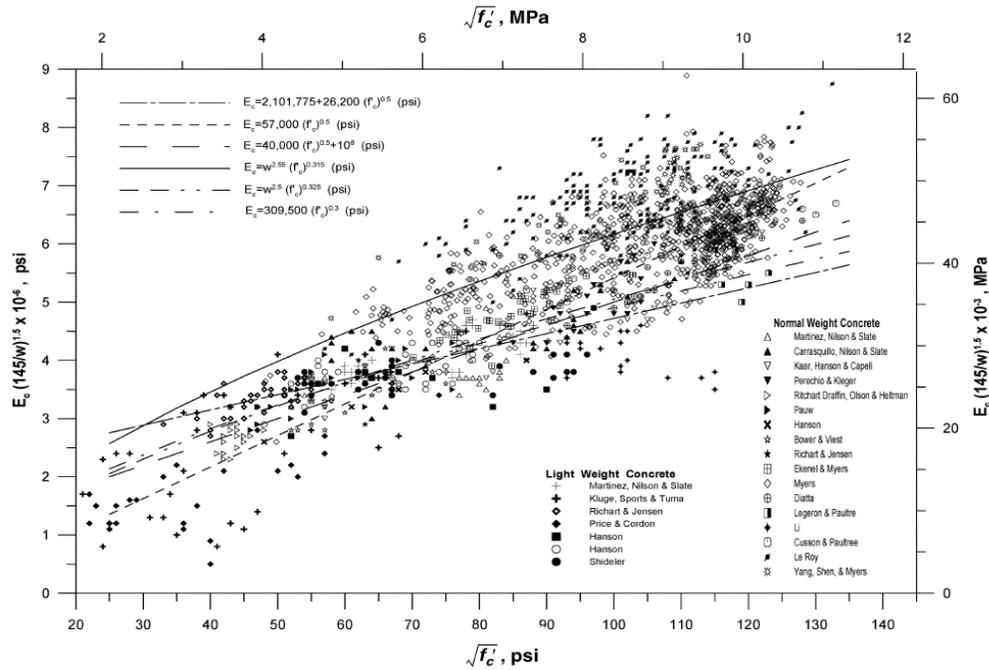
Figure 9. Elastic modulus and square root of concrete strength relationship (ACI 363R-10, 2010)

The expressions above do not predict the modulus of elasticity with very high accuracy as shown by the wide variety of test data collected by ACI in Figure 9. The E_c value is highly dependent on many other factors such as aggregate type, mix design proportioning, and curing conditions.

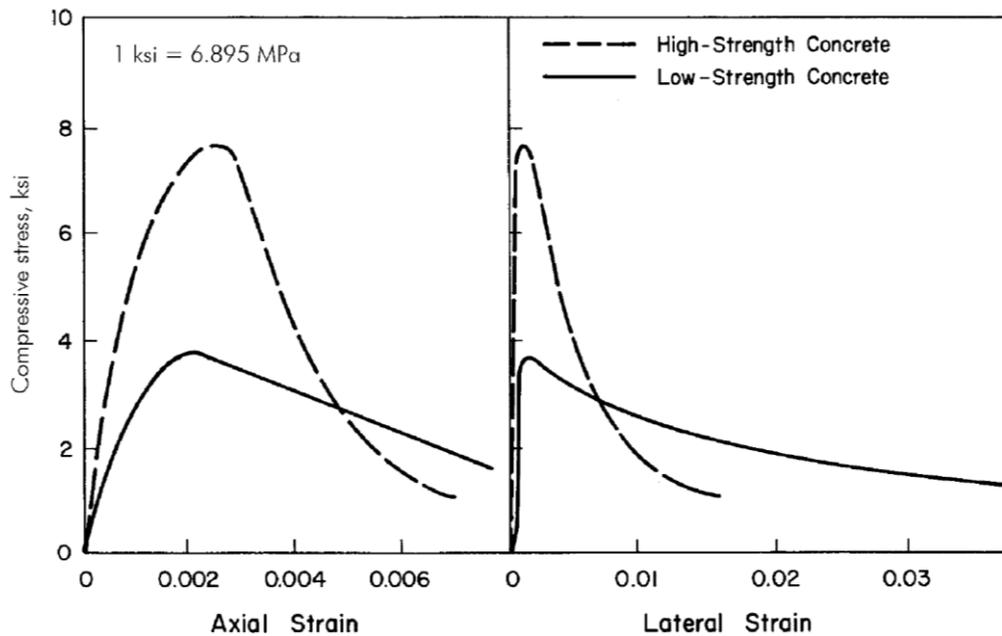
Figure 10. Axial and lateral stress-strain curve (ACI 363R-10, 2010)

strain will be higher for the same bending condition compared to NSC, and more ductile behavior can be achieved. Figure 10 shows a stress-strain curve comparison between HSC and low-strength concrete. Figure 8 shows that the post-peak behavior of the low-strength concrete has a less steep slope compared to that of the higher strength concrete, representing a relatively higher ductility than that observed in HSC.

From the stress-strain information shown in Figure 10, let's compare two RC columns subjected to concentric loading, one made from NSC and the other made from HSC, both designed with the same reinforcement ratio. As the applied load increases, the concrete will crush and eventually fail the column. The comparison between the two cases can be observed in Figure 11 and Figure 12.

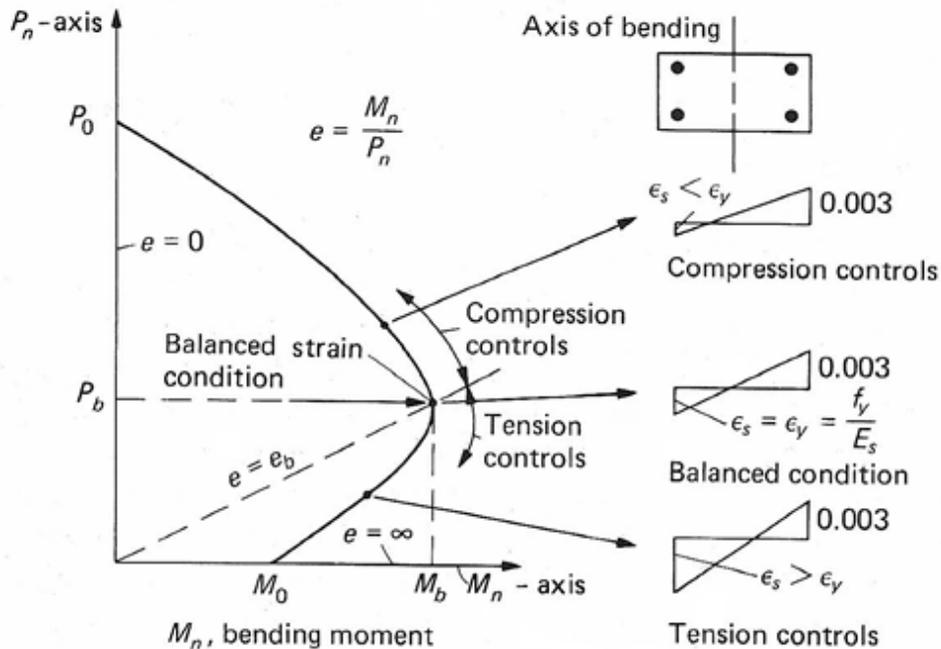
Figure 13. Column interaction diagram (ASDIP, 2015)

For a typical column design, assuming the column is non-slender and the $P-\Delta$ effects may be ignored, the capacity of a column subjected to eccentric loading can then be represented by the interaction diagram shown in Figure 13. For a simple comparison, the balanced failure condition will be considered, where concrete crushes and steel yields at the same time.

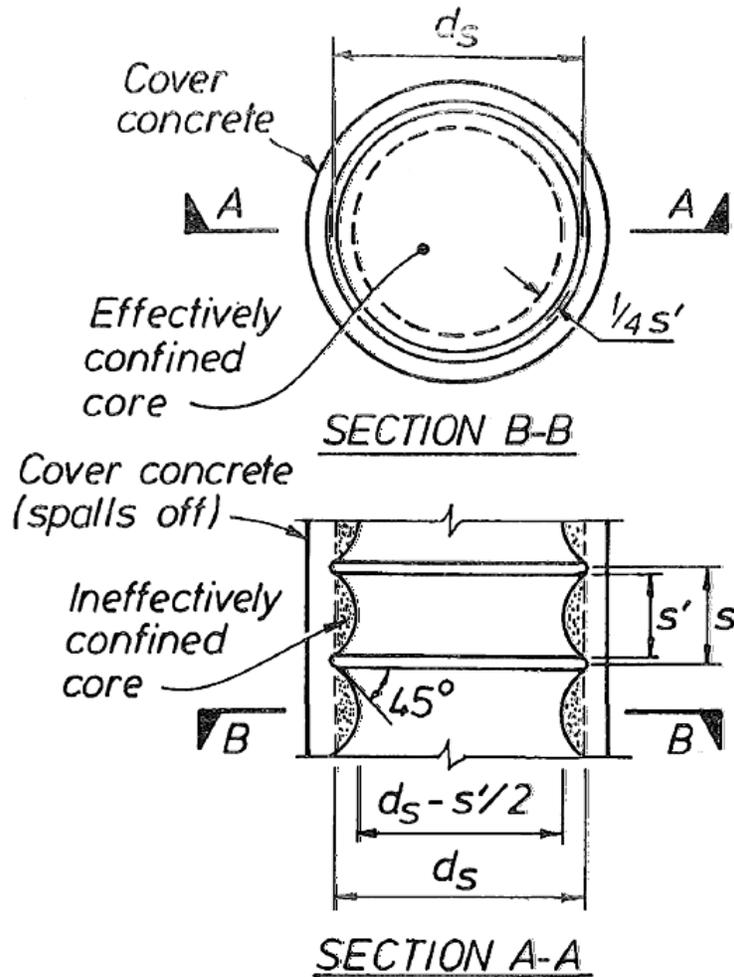
Figure 18. Effective area of circular or spiral confined concrete (Mander et al., 1988)

Figure 17 explains how the strength of a concrete column can still be regained even after the initiation of cover spalling due to the confinement effect. Confinement stress is considered as uniform stress in the case of circular hoops or spiral transverse reinforcement (Figure 18). While the contribution of the longitudinal reinforcement is typically ignored in circular steel arrangements, it is accounted for in the strength model for confined concrete of rectangular sections, where its contribution can be more significant (Mander et al., 1988).

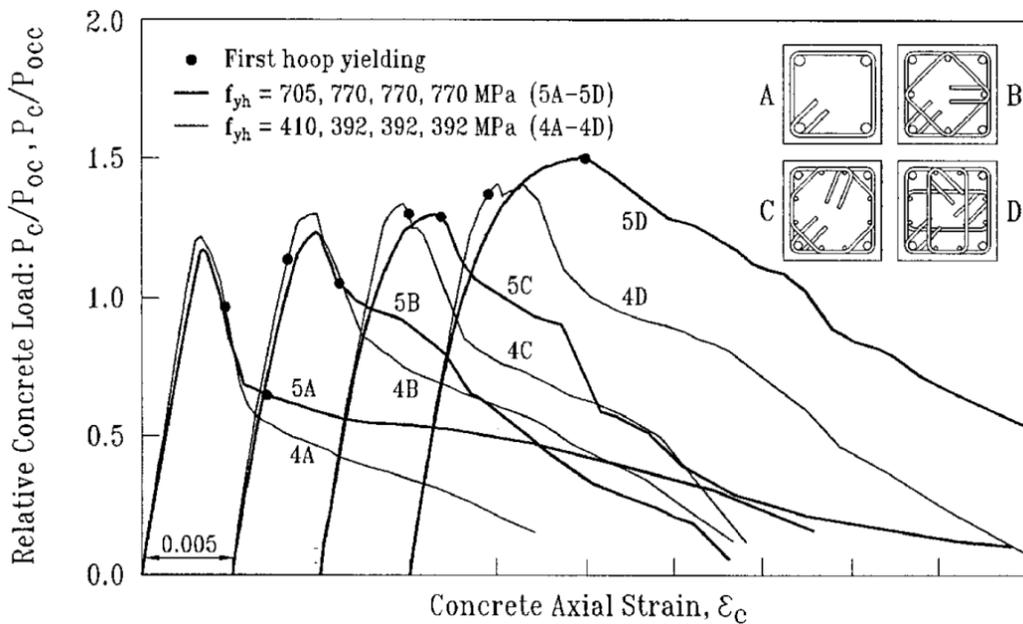
Figure 23. Effect of transverse reinforcement yield strength and configuration on column performance (Cusson and Paultre, 1994)

yield strength. In addition, If a hoop configuration is chosen that provides adequate confinement to the concrete core, the contribution of the higher transverse reinforcement yield strength becomes more evident as there is a notable increase in the strength and ductility of the concrete column in comparison to the column with a lower transverse reinforcement yield strength.

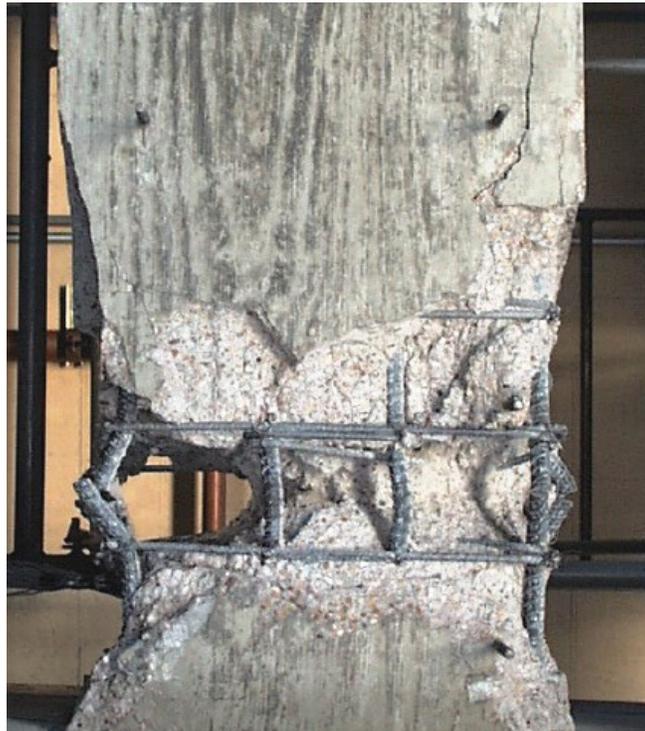
Figure 26. Specimen S24-4UT after failure (Bae, 2005)

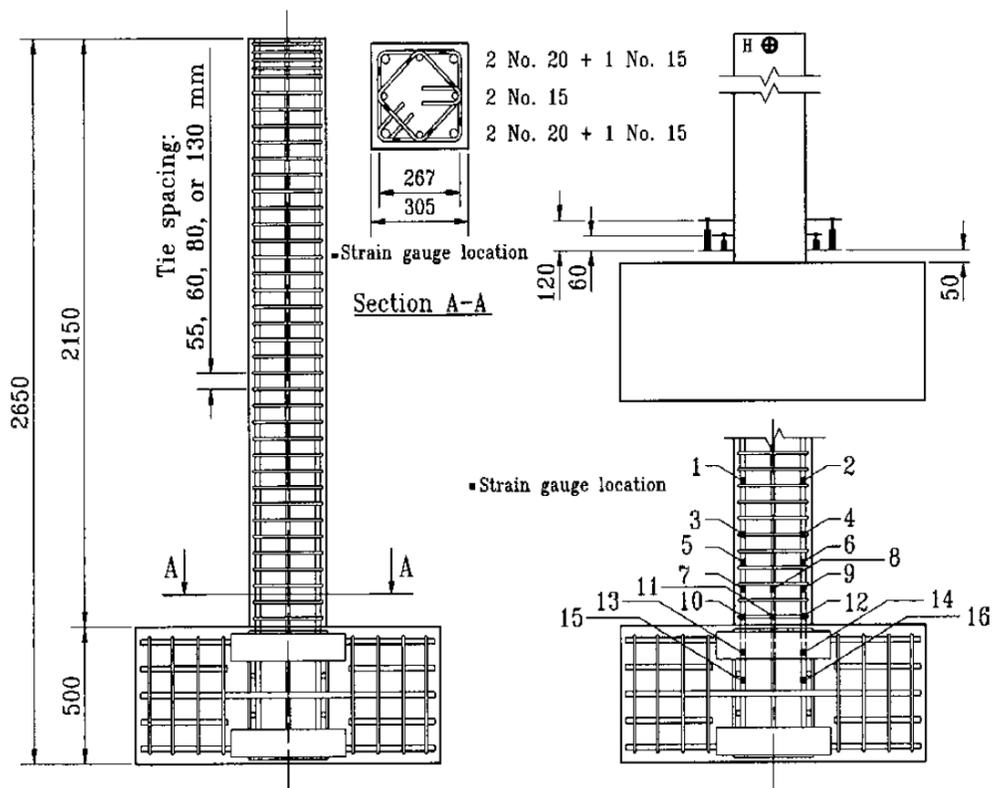
Figure 27. Specimen configuration (Legeron and Paultre, 2000)

Legeron and Paultre (2000) studied the behavior of HSC columns under cyclic flexure and constant axial load. The researchers tested six large scale specimens with a target concrete strength of 100 MPa (14.5 ksi) in order to investigate the influence of the volumetric ratio of the confining reinforcement and the axial load level. The specimen dimensions and testing setup can be seen in Figure 27. To study the effect of the confining reinforcement, the tie configuration was kept constant and the spacing of ties was varied from 60 mm (2.36 in.) to 130 mm (5.12 in.). The researchers observed the main failure mechanism to be the buckling and rupture of the longitudinal reinforcement with significant concrete damage visible as shown in Figure 28. From the figure, the relationship between axial load level and plastic hinge length can also be seen. As the axial load level increases, so does the length of the plastic hinge region. It was also noticed that the region just above the base stub remained undamaged due to a confinement effect provided by the base stub. The researchers concluded that for axial load levels less than or equal to 15% of the gross axial load capacity, approximately 50% of the confinement reinforcement is necessary, similarly observed by Bae and Bayrak (2008) for NSC columns. Legeron and Paultre (2000) stated that HSC can be used in seismic zones provided that it is adequately confined, and that high-yield strength steel may be a solution for columns subjected to a high-axial load-level where excessive high reinforcement ratios may be necessary, typically difficult to use in practice.

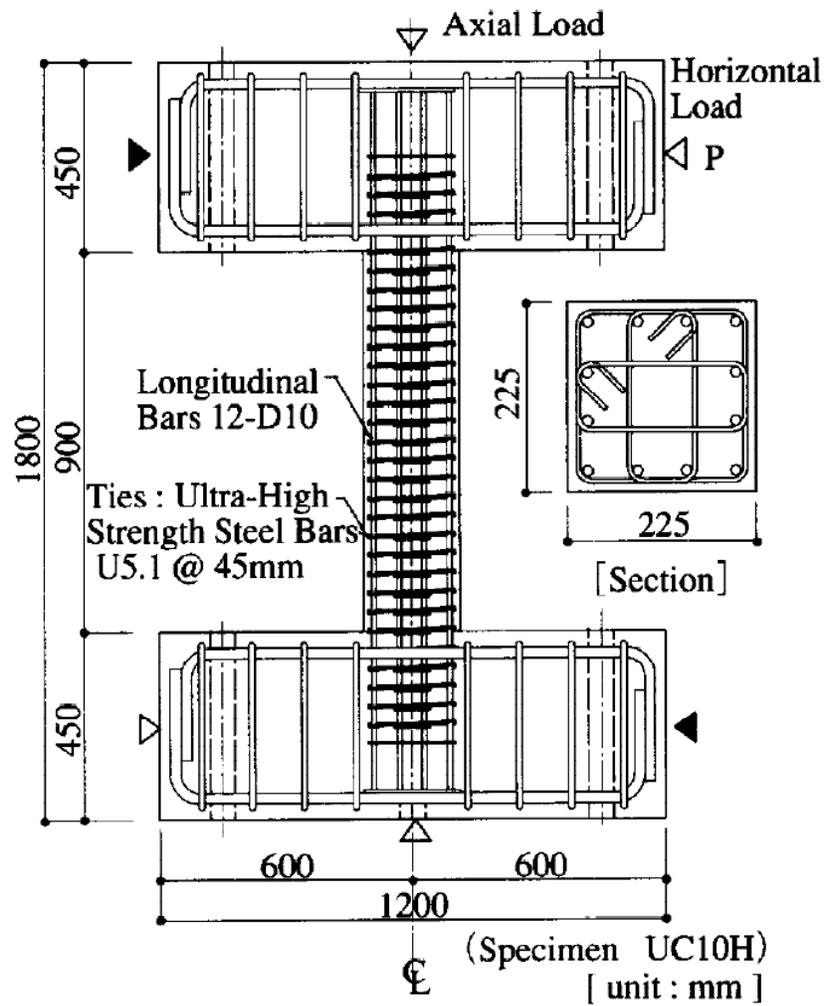
Figure 29. Column specimen configuration (Sugano, 1996)

Sugano (1996) tested five ultra-high strength concrete column specimens laterally reinforced with ultra-high-strength steel bars under reversed cyclic loading and constant axial compression to investigate the influence of axial stress level and capacity of lateral reinforcement. The column specimens were constructed with a specified compressive strength of 120 MPa (17.4 ksi) and lateral reinforcement with yield strength of 1,380 MPa (200 ksi). The column specimen configuration can be seen in Figure 29. Sugano (1996) noticed that the effect of the capacity of the transverse reinforcement was more notable for specimens with high axial load ratios compared to low axial load ratios. For this reason, as shown in Figure 30 the two column specimens subjected to high axial load with lower lateral reinforcement capacity failed in a brittle compressive manner (UC10H and UC15H) while the specimen with high axial load and high lateral reinforcement capacity (UC20H) failed in flexure along with the lower axial load specimens (UC15L and UC20L). Sugano (1996) concluded that in order for the brittle ultra-high strength concrete to have sufficient ductility, relatively more capacity of lateral reinforcement is required compared to that of lower strength concrete. This confinement can be found in the form of high or ultra-high strength lateral reinforcement.

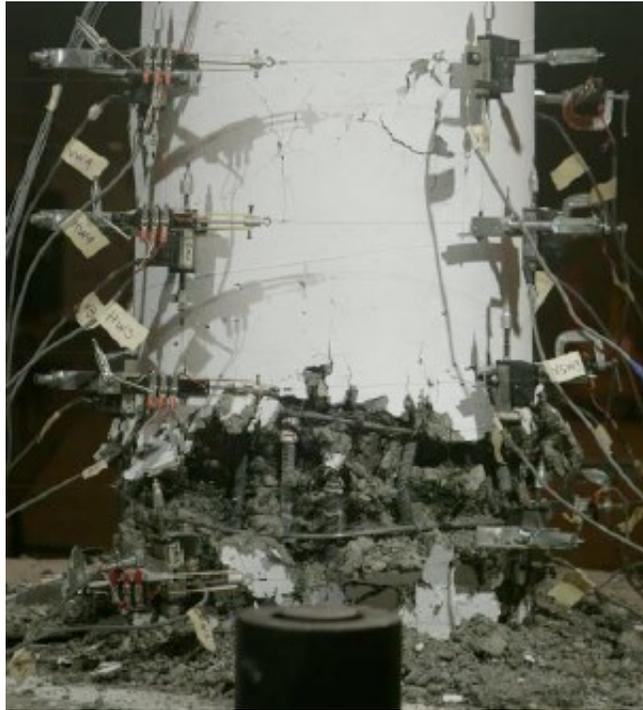
Additional methods to improve the confinement and seismic performance of concrete columns through the use of more modern design techniques have been investigated. For example, Aviram et al. (2010) tested two quarter scale circular bridge column specimens with high performance fiber-reinforced concrete (HPFRC) under bidirectional cyclic loading. The column specimens were detailed with additional dowel reinforcement and debonding techniques so as to force the inelastic deformations to occur slightly above the column base. In specimen S1 long dowels were used and the upper portions of the dowels were debonded with the use of plastic tubes. Specimen S2 used shorter dowels terminating in the plastic hinge region, and the main longitudinal bars were debonded. Both columns were compared to a reference column of the same geometry cast with regular reinforced concrete. The enhanced techniques showed an improved maximum ductility of 10.7% and 5.4% drift ratios for the S1 and S2 columns respectively compared to the reference column which had a maximum ductility of 3.9% drift ratio. However, while such techniques may improve the seismic performance and ductility of the concrete columns they could complicate the design and construction; in addition they fail in the prevention of concrete deterioration, crushing, and bar buckling and result in the same failure mechanism as that of regular RC as shown in Figure 31.

Figure 31. Specimen S1 after 10.7% drift ratio (Aviram et al., 2010).

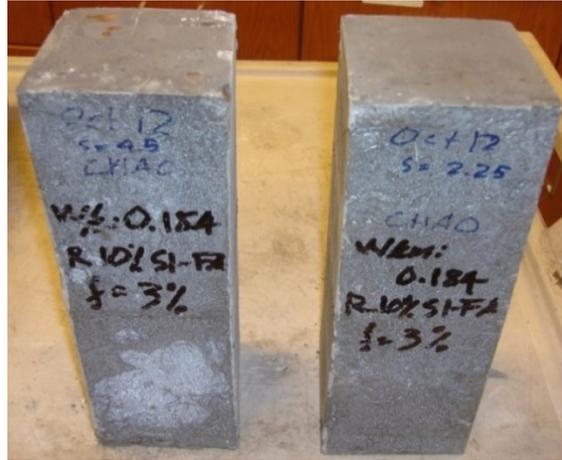
After formwork removal, the specimens were grinded on all sides and smoothed to ensure proper contact during testing; they were then marked and placed in the curing room (Figure 39).

Figure 39. Specimens B2 and B4 after formwork removal and grinding

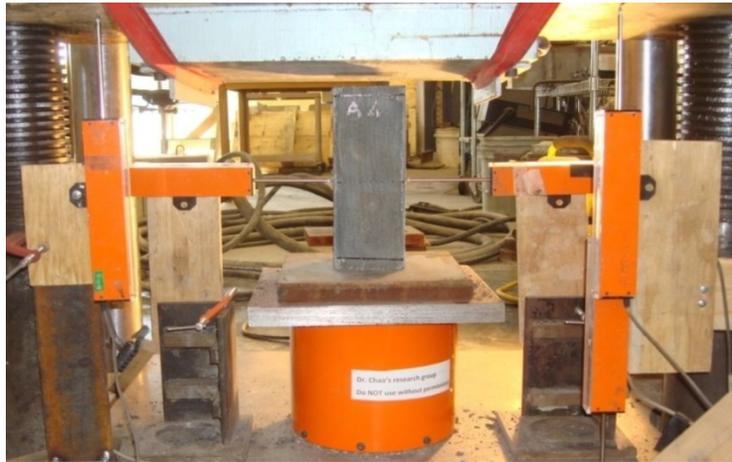
To observe the deformation of the specimens in both the longitudinal and lateral directions, five linear varying differential transformers (LVDTs) were utilized as the diagram indicates shown in Figure 40. The LVDT 04 and 05 are placed in the same location and measure in opposite directions relative to external reference points to observe the movements of the testing machine during the experiments. A picture of the actual test setup used is shown in Figure 41.

Figure 41. Test setup with LVDTs and load cell

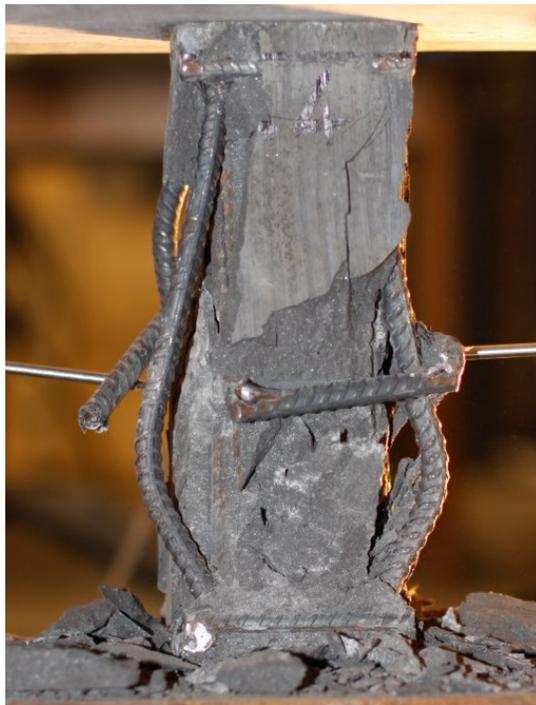
the column showed a strength increase of 24% from specimen A2 to specimen A4. The failure mode of the UHPC columns was also controlled by the failure of the transverse reinforcement and occurred the same way as that of NSC however a few differences were observed. Because of the reduced number of defects and higher strength of UHPC, the reduction of the crushing and failure of the columns occurred slightly slower than that of the NSC columns however the failure was more explosive due to the higher stress levels. The most important difference observed was that more of the core concrete remained intact after crushing compared to that of the NSC which attributes to the increased strength of the UHPC columns. Most of the crushing occurred at the concrete cover and outer regions near the reinforcement. Specimens A4 and A2 can be seen in Figure 44 and Figure 45 respectively.

Figure 44. Crushing of specimen A4

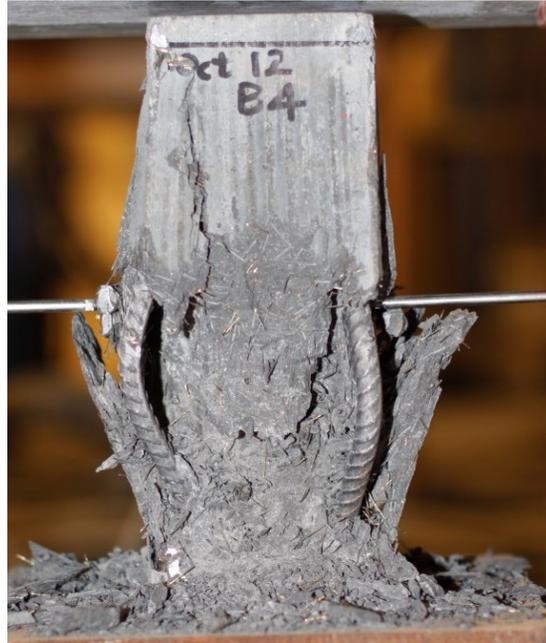
Specimens B2 and B4 were made with UHP-FRC with a fiber volume fraction of 3%. In this case doubling the transverse reinforcement ratio only increased the strength of the UHP-FRC column by 18.5% because the confinement is no longer dependent on solely the transverse reinforcement but a combination of both the transverse reinforcement ratio and the fiber volume fraction. The failure mode for the UHP-FRC columns was very different compared to that of NSC and UHPC columns without fibers. As the column was loaded a number of micro cracks began to develop with only a few visible on the exterior surface but many occurring within the interior of the column as it begins to expand laterally. Without fibers the column would exhibit brittle behavior and continue to spall and crush as observed with the previous specimens. However, with the addition of fibers the cracks were restrained from opening and the tensile stresses were then transferred through the concrete by the fibers causing a bulging effect. The fibers were engaged in confining the core concrete as the compressive stresses continued to increase. A sudden explosive bulging then occurred, however, only a small amount of

spalling is observed. This explosive bulging represents the fibers pulling out and rupturing as they can no longer withstand the tensile stresses and prevent the cracks from opening. Once the fibers have begun to fail more spalling of the concrete cover is seen around the reinforcing bars. Since the fibers can no longer transfer the stresses through the concrete the longitudinal bars are forced to sustain some of the compressive stresses which lead to buckling of the longitudinal reinforcement and eventually rupturing the transverse reinforcement. This failure mode sequence is a much more ductile process compared to that of the previous specimens without fibers. However, it is important to note how the failure regions were still similar to those of the other specimens for each respective transverse reinforcement ratio. Specimen B4 experienced spalling along the height of the column parallel to the direction of loading with the rupture of the hoop at mid height. Specimen B2 had a more localized failure region in which two hoops failed due to the buckling of the longitudinal reinforcement. It can also be observed that the buckling of the longitudinal reinforcement has more curvature compared to that of the previous specimens due to the higher compressive stresses. Specimens B4 and B2 can be seen in Figure 47 and Figure 48 respectively. Also visible in the figures is the interface between the inner core concrete and the exterior spalling cover concrete in which the fibers pull out or break.

Figure 47. Crushing of specimen B4

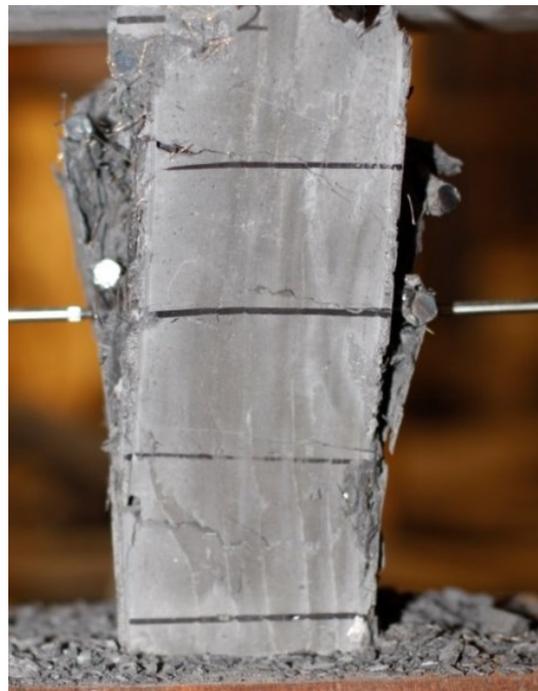
Figure 48. Crushing of specimen B2

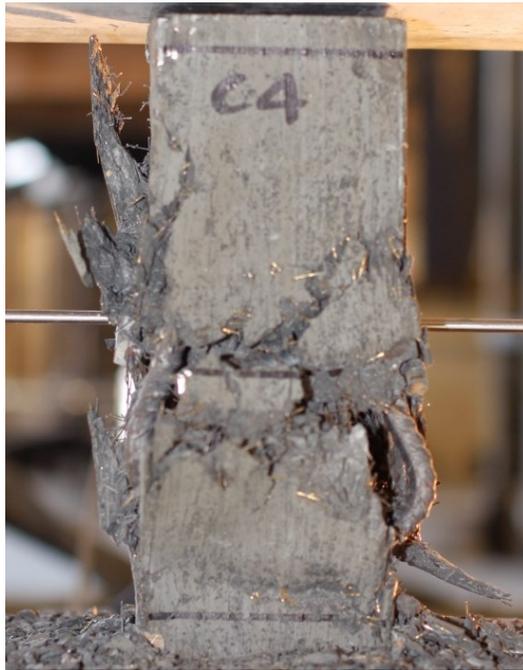
As shown in Table 4 and Figure 46 very interesting behavior was observed with specimens C2 and C4. The results showed that in the case of UHP-FRC with a volumetric fiber fraction of 5%, doubling the transverse reinforcement ratio had no effect on the ultimate strength of the column. This means that the confinement effect and ultimate strength was predominantly controlled by the volumetric fiber fraction and not the transverse reinforcement ratio. The failure mode was also different than that of specimens B2 and B4 with a volumetric fiber fraction of 3%. The failure of C4 began with micro cracking followed by a very explosive burst as the concrete cracked but was held together by the high percentage of fibers which resulted in significant bulging. Once the fibers could no longer restrain the bulging spalling began and spread along the height of the column as previously seen with specimens with a transverse reinforcement ratio of 1.26. The buckling of the longitudinal reinforcement followed as well as the rupture of the hoop. However, the interior core remained almost completely intact with only slight spalling visible. Even though specimens C4 and C2 had the same strength, the behavior of C2 was much more impressive. The failure mode also began with micro cracking and a sudden explosive burst that lead to bulging. As the load increased, the bulging continued and the fibers were able to restrain the cracking and lateral expansion with the help of the transverse reinforcement. Two hoops where then exposed appearing to be ruptured however the specimen remained completely intact due to the high volume of fibers providing confinement to the core concrete. The core concrete was not clearly visible since there was no significant spalling of the cover concrete. Specimens C4 and C2 can be seen in Figure 49 and Figure 50 respectively.

Figure 49. Crushing of specimen C4

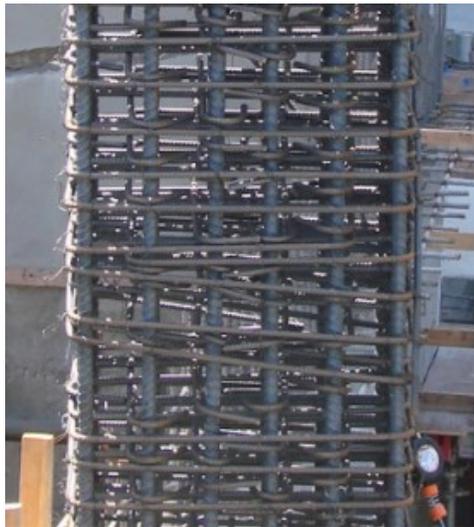
increased from normal strength to ultra-high strength, significant amounts of transverse reinforcement are needed to confine the concrete in order to prevent premature brittle failure even though this is practically impossible due to the already congested reinforcing cage for normal strength concrete (Figure 51). However, the necessary amount of transverse reinforcement is considerably less when UHP-FRC is used due to the much enhanced confinement caused by the addition of microfibers as demonstrated by the previous small scale column study. This allows the transverse reinforcement amount used in UHP-FRC to be the same as that used in the plastic hinge region of a normal strength RC column, significantly less than the typical reinforcement amount required for concretes with such high strengths. The transverse reinforcement consists of groups of three overlapping ties bent from No. 5 bars (ASTM A615 Grade 60) spaced at 5 in. for the first 42 in. near the plastic hinge region, and 6 in. for the remainder of the height of the specimen above the plastic hinge region (Figure 52).

Figure 51. Typical confinement reinforcement used in normal strength columns for RC moment frames (photo courtesy of Dr. Shih-Ho Chao)

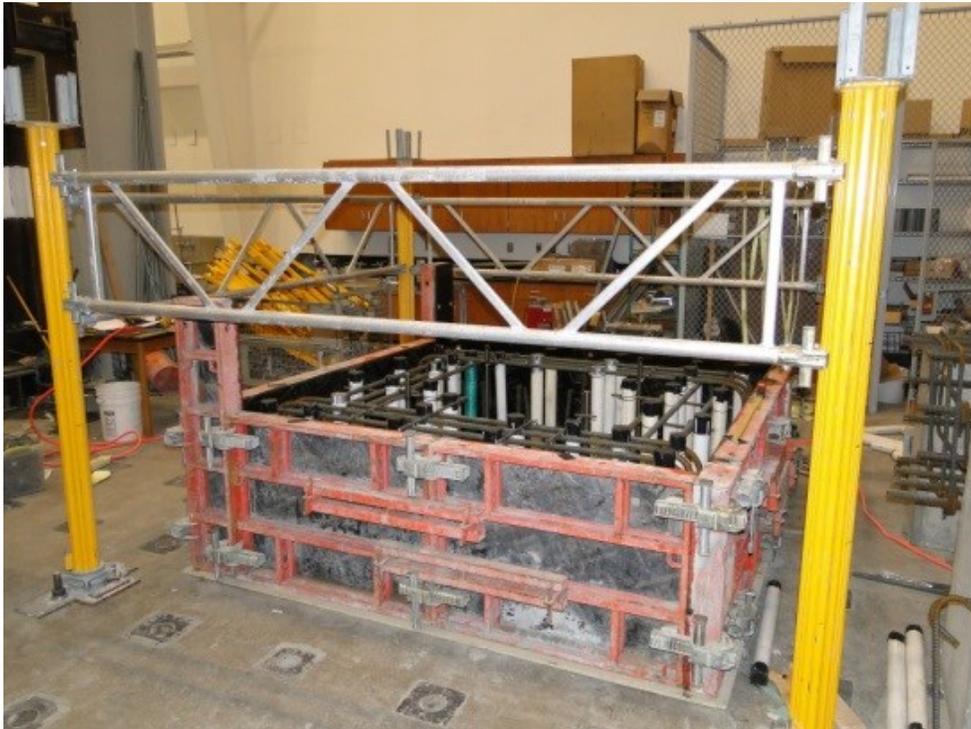
All of the column specimens were constructed at the UTA Civil Engineering Laboratory Building (CELB). Each specimen was built in three major parts and cast vertically to simulate real world construction as accurately as possible. Prior to the start of construction all steel strain gauges were placed on the reinforcing bars. The reinforcing cage for the footing block and column cage were constructed separately but simultaneously. Once the footing block cage was completed, it was placed inside the formwork and the truss support frame was erected as shown in Figure 53. After the column cage was completed and instrumented with concrete strain gauges as shown (Figure 54), it was placed inside the footing cage (Figure 55), centered, and secured with high-strength straps to the truss frame to prevent it from moving during casting (Figure 56).

Figure 53. Footing block reinforcement and formwork

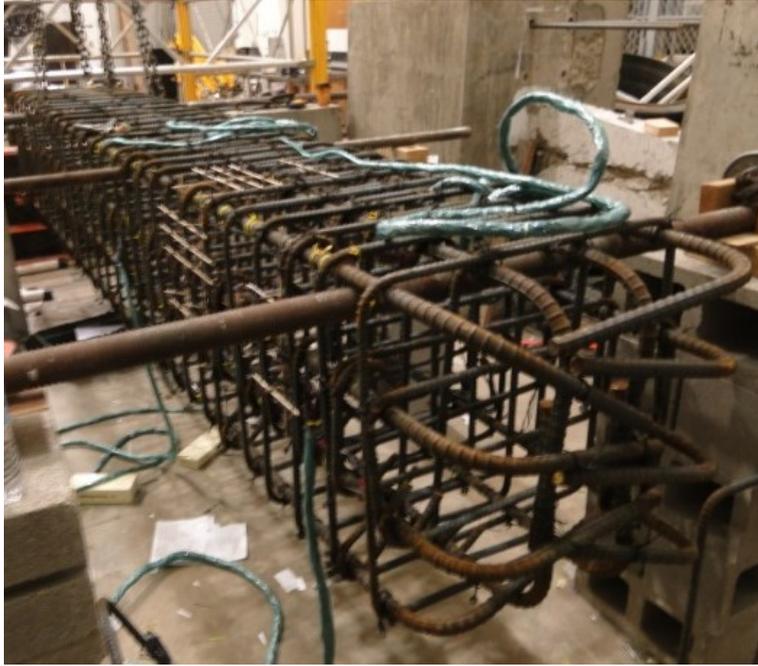
Figure 54. Completed column reinforcement cage

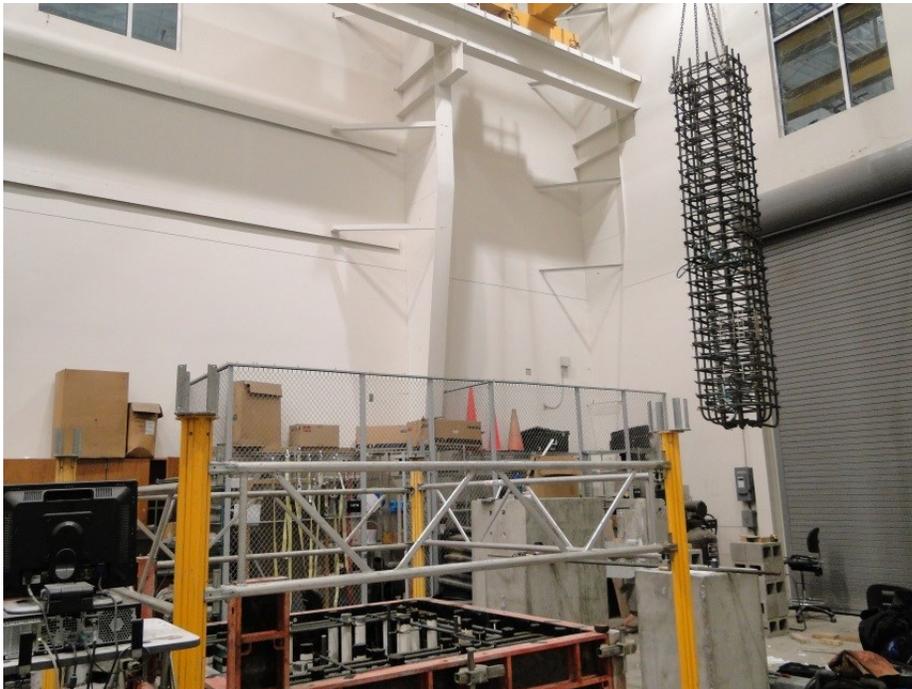
Figure 55. Placing of the column cage into the footing block

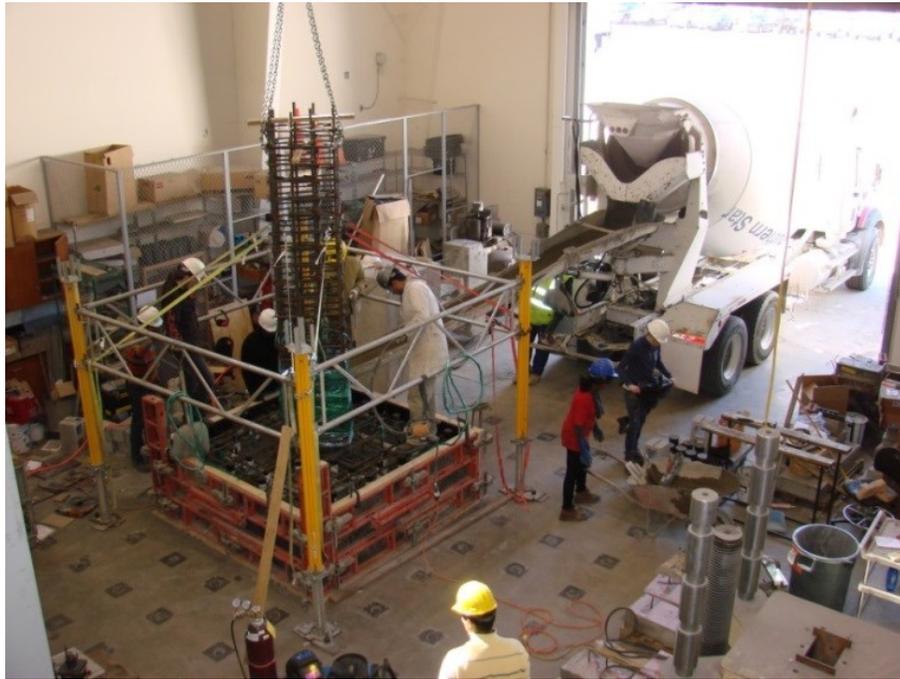
The bottom block was cast using 5 ksi concrete provided by a ready mix truck as shown in Figure 57. Twelve concrete cylinders were made to be tested under uniaxial compression and track the concrete strength progression. After the bottom block concrete had gained sufficient strength, the formwork for the column and the platform were placed (Figure 58). The loading block reinforcing cage was constructed (Figure 59) and placed on the platform together with the loading block formwork. The remainder of specimen SP5 was cast using 5 ksi concrete provided by a ready mix truck. The concrete

Figure 57. Footing block casting

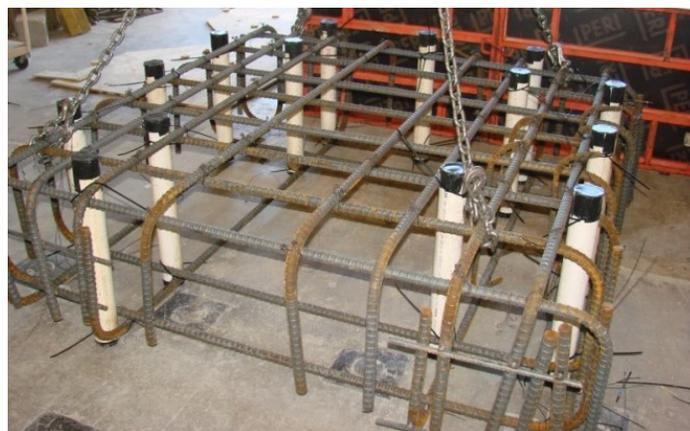
Figure 58. Loading block cage and formwork

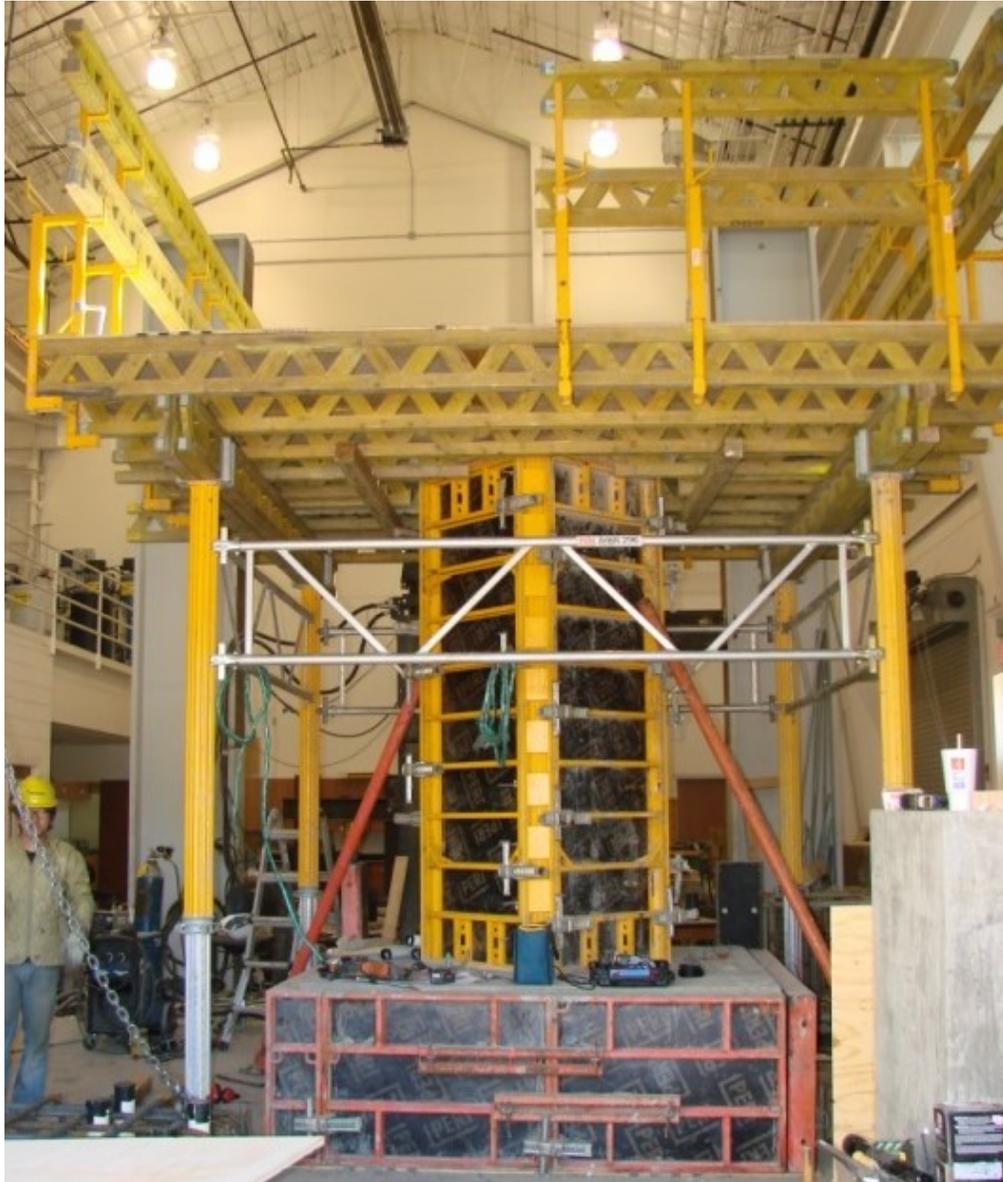
Figure 59. Column formwork and loading block platform

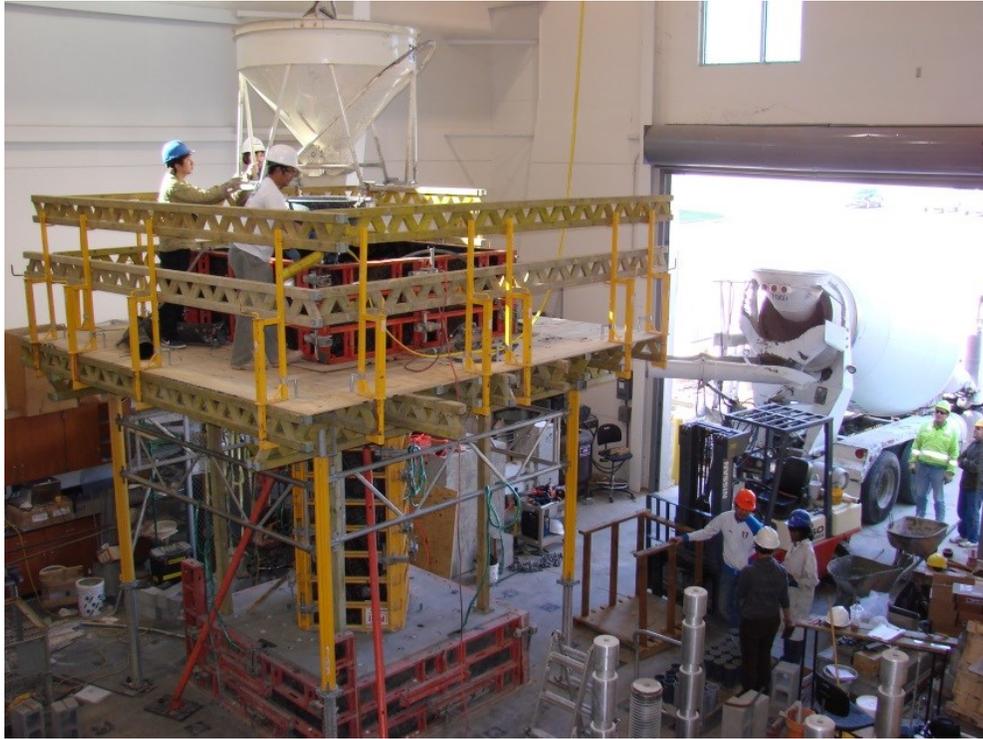
was poured into a large bucket which was then lifted with a crane to pour the concrete into the column section as shown in Figure 60.

Figure 60. Final column and loading block casting
