PERFORMANCE OF FULL-SCALE ULTRA-HIGH PERFORMANCE FIBER-
REINFORCED CONCRETE COLUMN SUBJECTED TO EXTREME EARTHQUAKE-
TYPE LOADING AND EFFECT OF SURFACE PREPARATION ON THE COHESION
AND FRICTION FACTORS OF THE AASHTO INTERFACE SHEAR EQUATION

MASTER OF SCIENCE IN CIVIL ENGINEERING

THE UNIVERSITY OF TEXAS AT ARLINGTON

May 2015

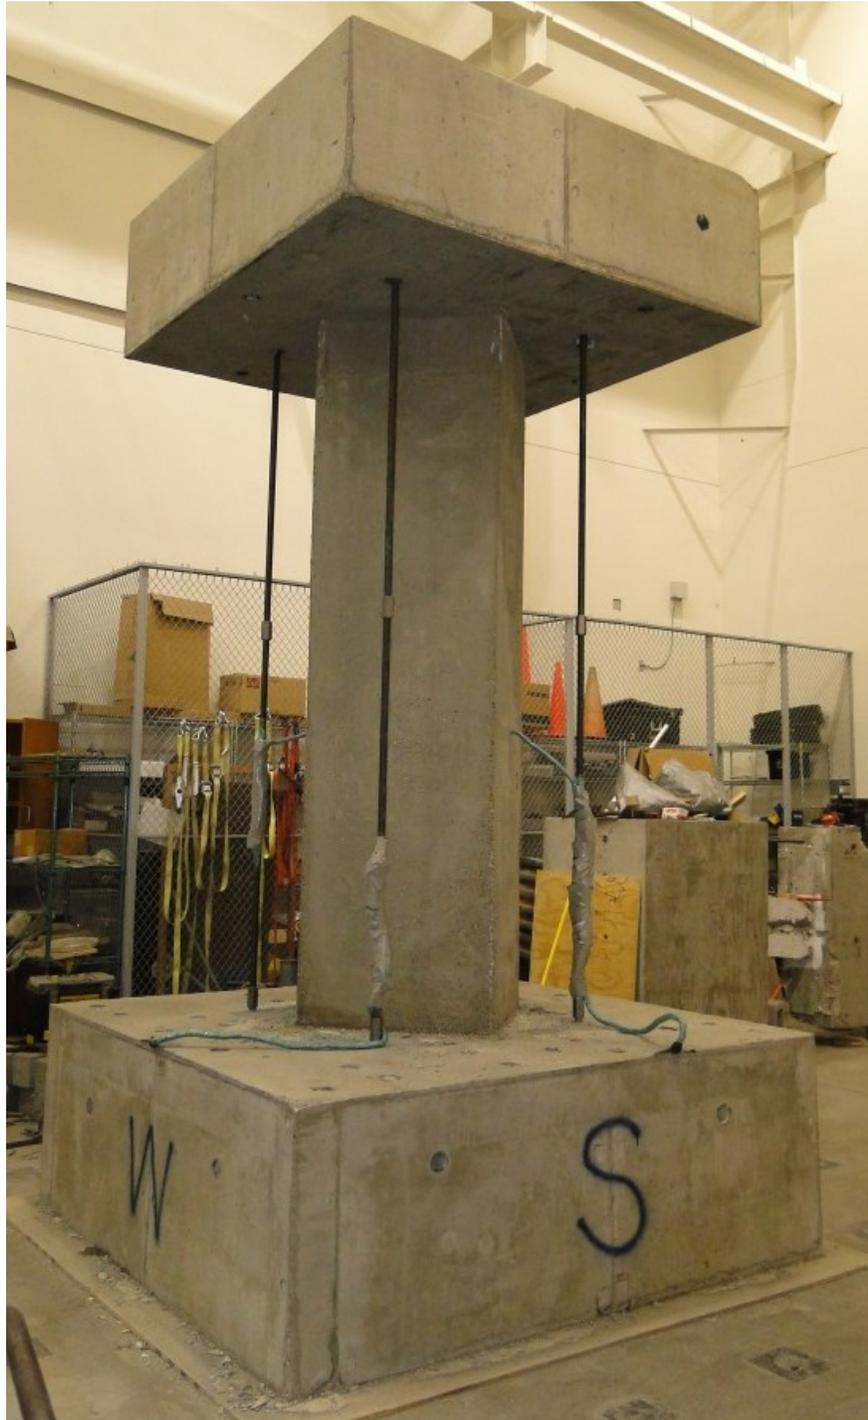
After two days of curing the formwork was removed and the column specimen prepared for shipping. Four post-tensioning rods were used to protect the specimen from cracking during lifting and transportation. The finished SP5 column specimen can be seen in Figure 61. The column was removed from the CELB by the use of heavy duty forklifts (Figure 62) and placed on a flatbed truck to be transported to the University of Minnesota (Figure 63).

Figure 61. SP5 column specimen

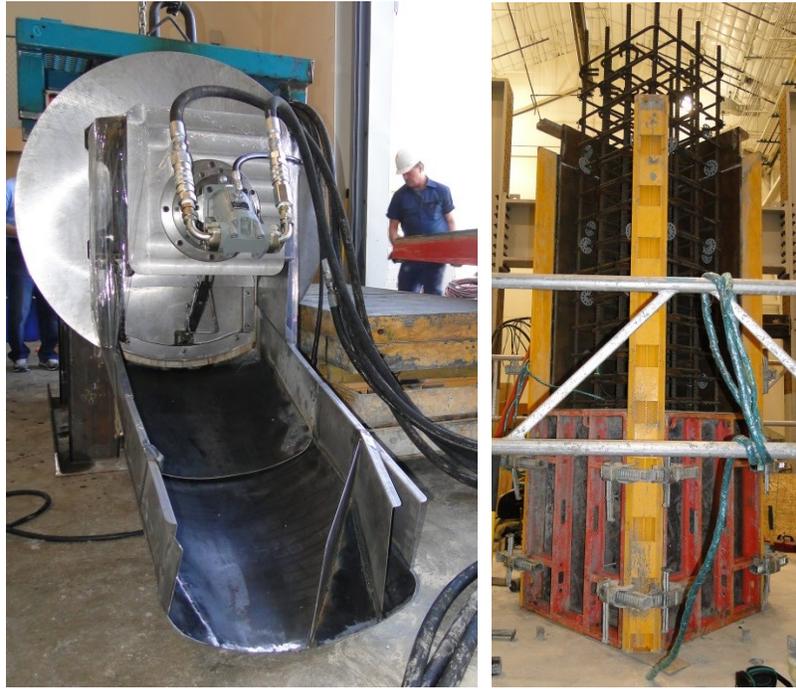
While the capabilities of UHP-FRC may suggest it to be a valuable alternative in earthquake resistant structures it has still yet to be tested in large scale structural applications. To further explore its capabilities, the first 40 in. of the column section of specimen SP8 was cast with UHP-FRC. Since no tests had been conducted with UHP-FRC on full scale structural elements, it presented an interesting construction challenge. In order to correctly mix the UHP-FRC in large quantities a special concrete mixer had to be designed. The mixer was designed and fabricated with the help of a local manufacturing company and can be seen in Figure 64. The column formwork was set up prior to casting to a height of 40 in. above the footing surface (Figure 64). All of the dry materials for the casting were premeasured and placed inside of a large bucket (Figure 65). The dry material is then added to the mixture slowly followed by water and super plasticizer. The microfibers are added last as shown in (Figure 66). In order to pour the 40 in. section the mixer must be elevated to a height well above the section to allow the UHP-FRC concrete to flow downwards into the column formwork. The mixer was raised with the crane and placed on an elevated platform as shown in Figure 66. An extension is placed to guide the UHP-FRC mix towards the column section. The UHP-FRC concrete is then poured into the formwork until it is completely filled (Figure 68). The UHP-FRC mix proved to be essentially self-consolidating and required no vibration.

Figure 64. Mixer and formwork for 40 in. UHP-FRC section

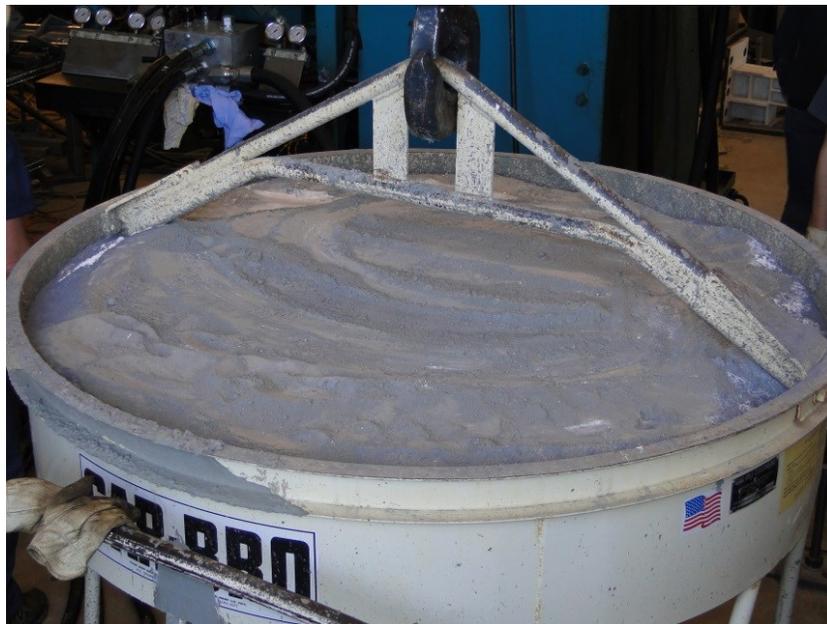
Figure 65. Premeasured dry materials

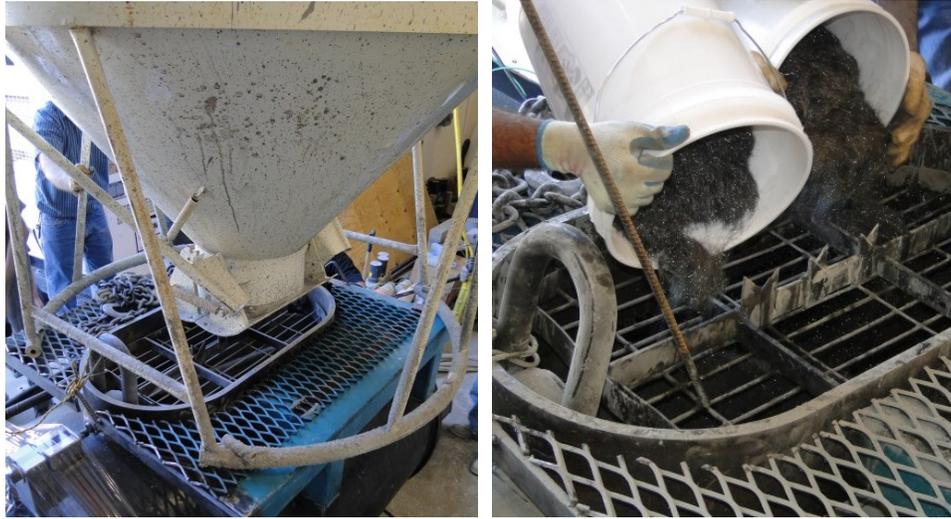
Figure 66. Pouring dry material and addition of micro-fibers

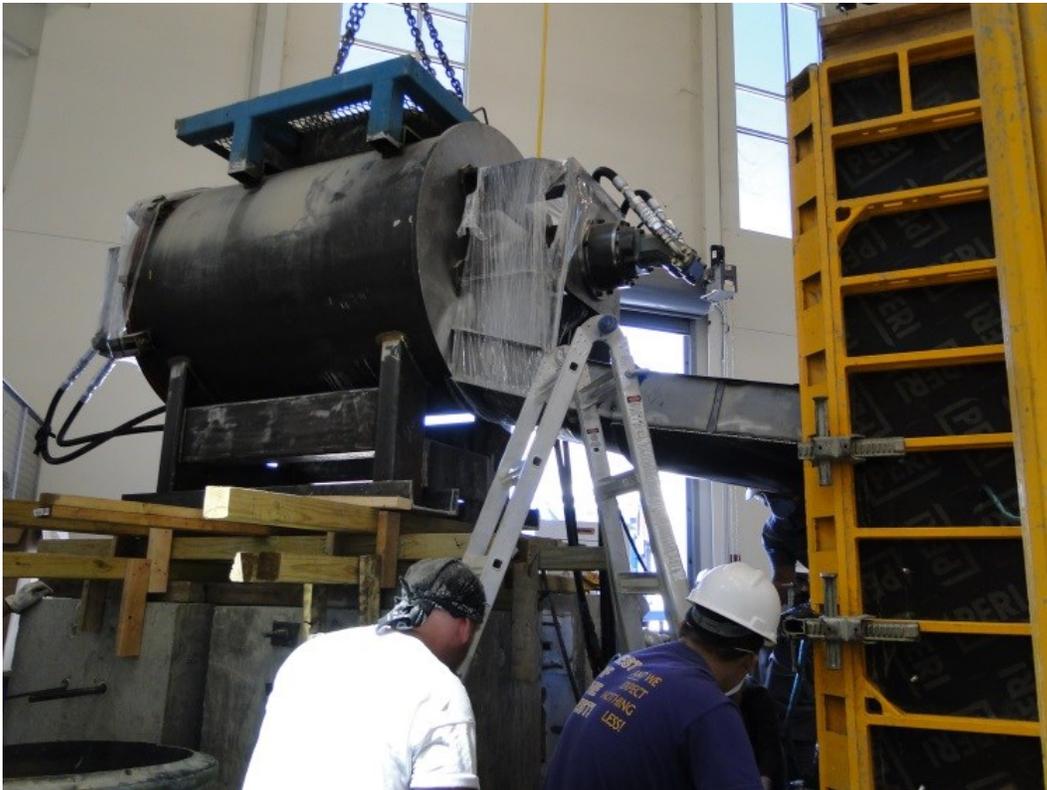
Figure 67. Elevated mixer ready for pouring

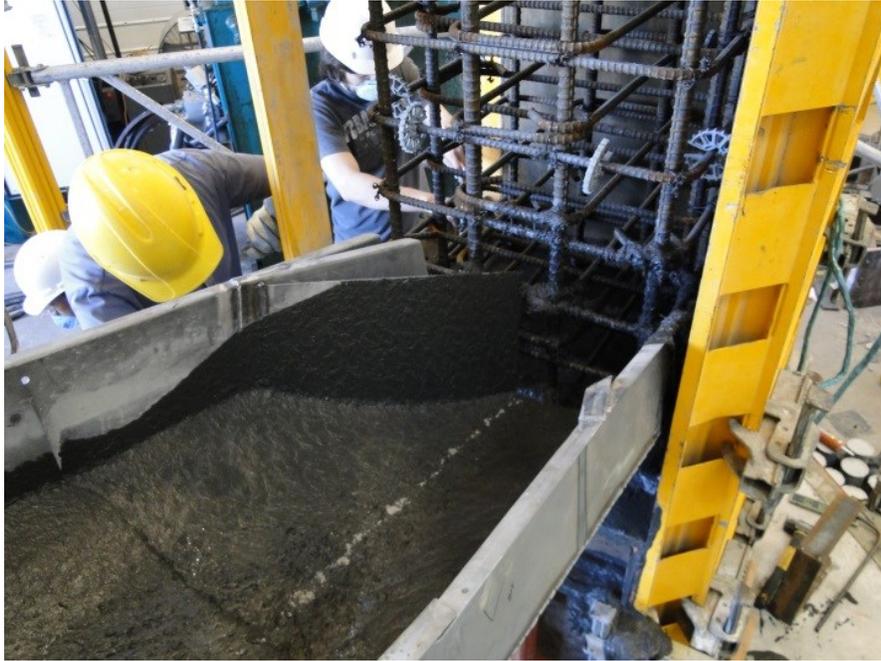
Figure 68. Pouring of UHP-FRC 40 in. section

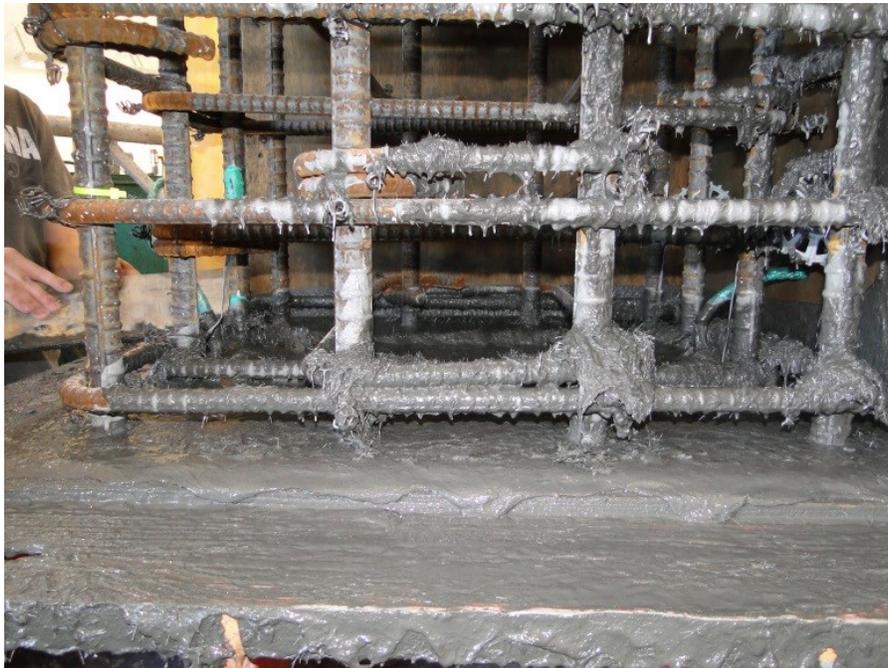
Figure 69. UHP-FRC section after casting

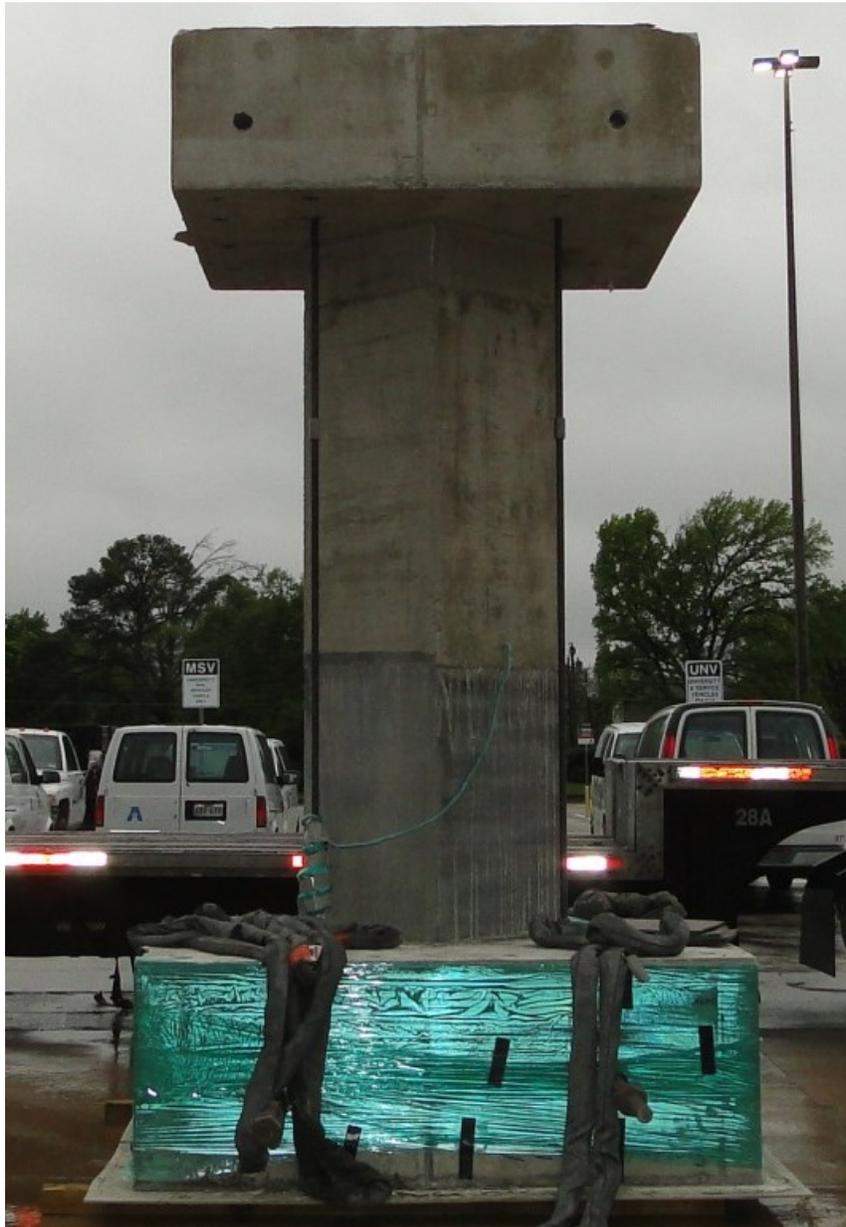
After the casting of the UHP-FRC section the remainder of the column SP8 was cast identically to that of column SP5. The completed specimen SP8 can be seen in Figure 70.

Figure 70. Space frame column specimen SP8

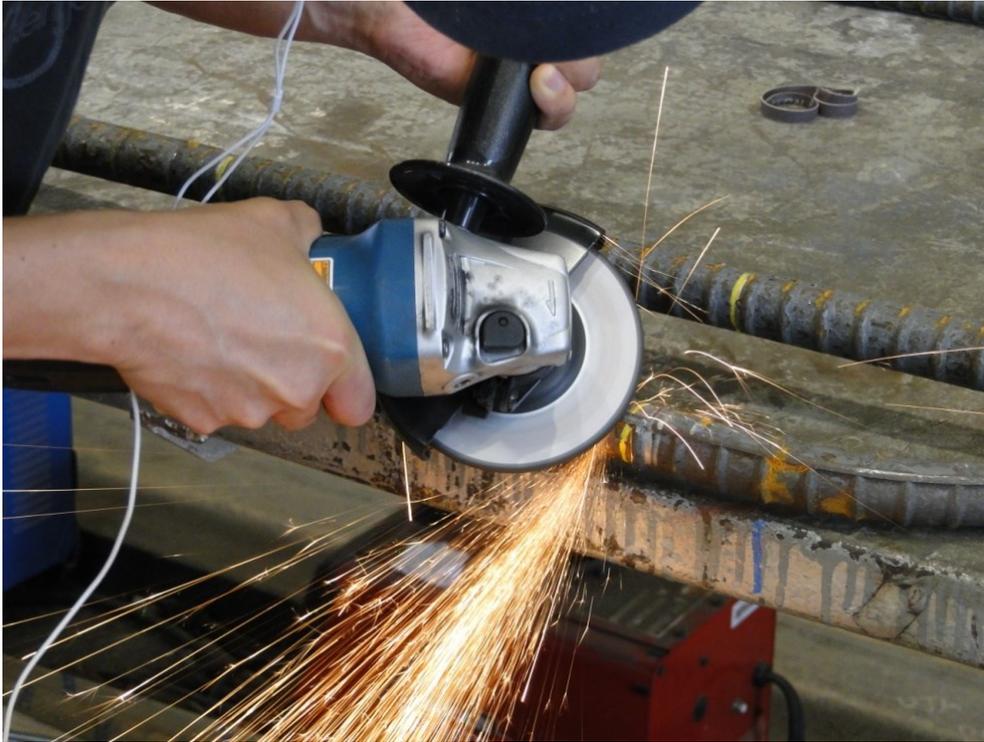
The determination of the strain development within both the longitudinal and transverse reinforcement used in the specimens of this study is essential to analyzing the behavior of reinforced concrete columns. This information can be gathered by installing strain gauges directly to the surface of the steel reinforcement prior to constructing the reinforcing cage and pouring the concrete. In order to obtain accurate data from these sensors, a special procedure was used that creates a smooth, flat surface to which the strain gauge is attached, and ensures protection of the device from damage due to the conditions of casting and pouring. This procedure involves different forms of grinding to obtain a smooth and more efficient contact surface prior to the installation of the strain gauge (Figure 72). Once the strain gauge is applied following the manufacturers recommendations (Figure 73), various forms of sealants and waterproofing layers are applied to protect the strain gauges during construction and casting (Figure 74). Finally, the strain gauge is covered with moisture sealing rubber tape and liquid tape to further protect the stain gauge. A zip tie is also placed on the wire near the gauge to prevent and accidental wire pull-outs during construction (Figure 75). A more extensive explanation of

Figure 72. Grinding of the reinforcing bars

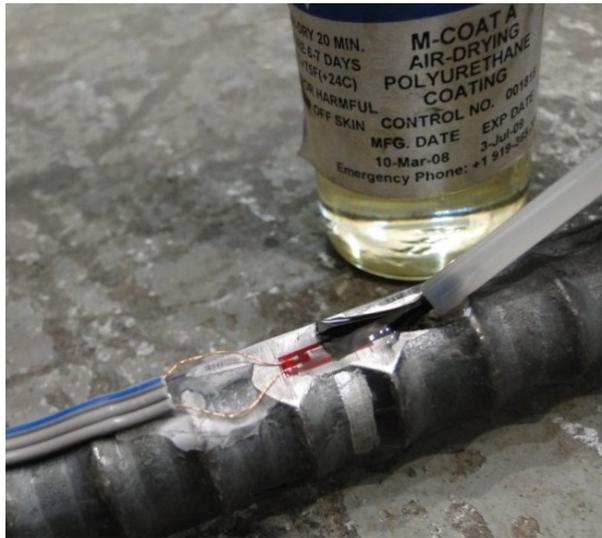
Figure 74. Application of coat A

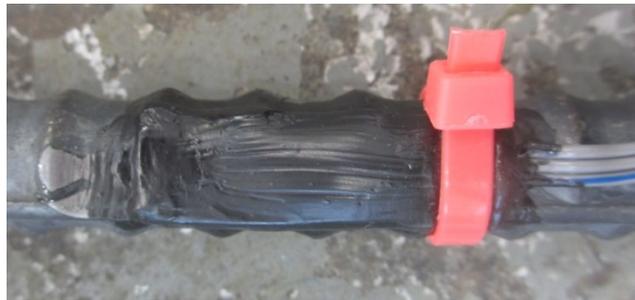
Figure 75. Completed strain gauge installation

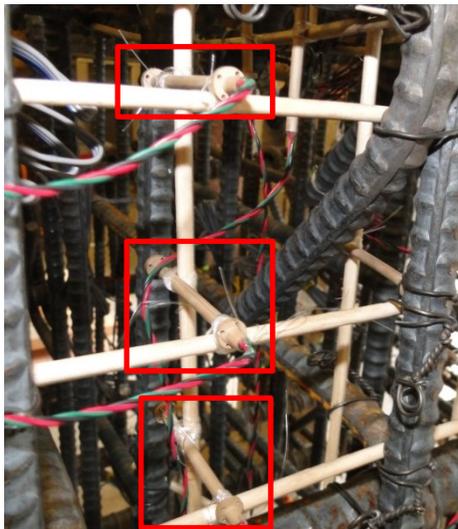
To measure strains in the concrete during testing each specimen was instrumented with concrete strain gauges. The concrete strain gauges are embedded within the concrete. A length of steel wire is tensioned within the concrete strain gauge. As the concrete deforms, the steel wire is pulled or loosened and strains are measured between the two flanges of the concrete gauge. An example of the concrete strain gauge can be seen in Figure 79.

Figure 79. Concrete strain gauges

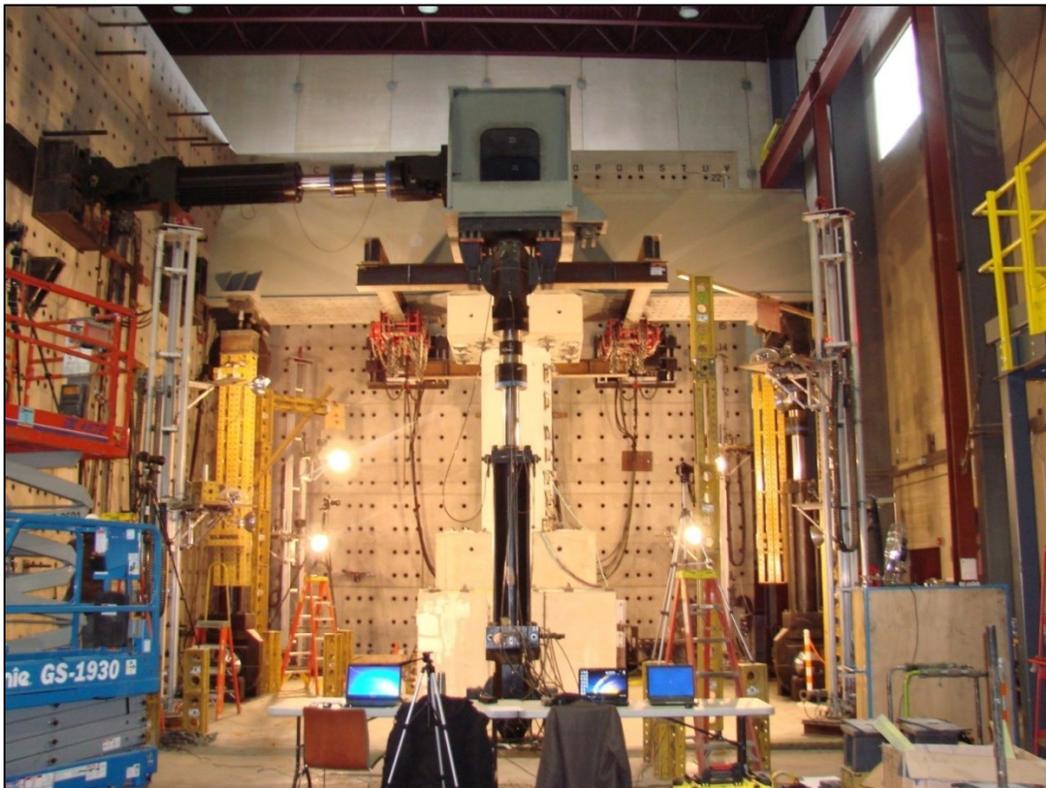
Figure 88. MAST testing facilities

The Multi-Axial Subassemblage Testing (MAST) Laboratory located at the University of Minnesota is one of the largest laboratories of its kind in the world (Figure 88). The laboratory is used to test a variety of structural elements up to 29 ft. tall under various extreme loading conditions. The sophisticated six degrees-of-freedom (DOF) control system allows for multi-directional loading schemes while being able to maintain a constant axial load that may more accurately simulate the loading effects of an earthquake. Additionally, the combination of actuators (4 vertical and 4 horizontal) are capable of exerting a total vertical force of 1,320 kips and a horizontal force of 880 kips (French et al., 2004).

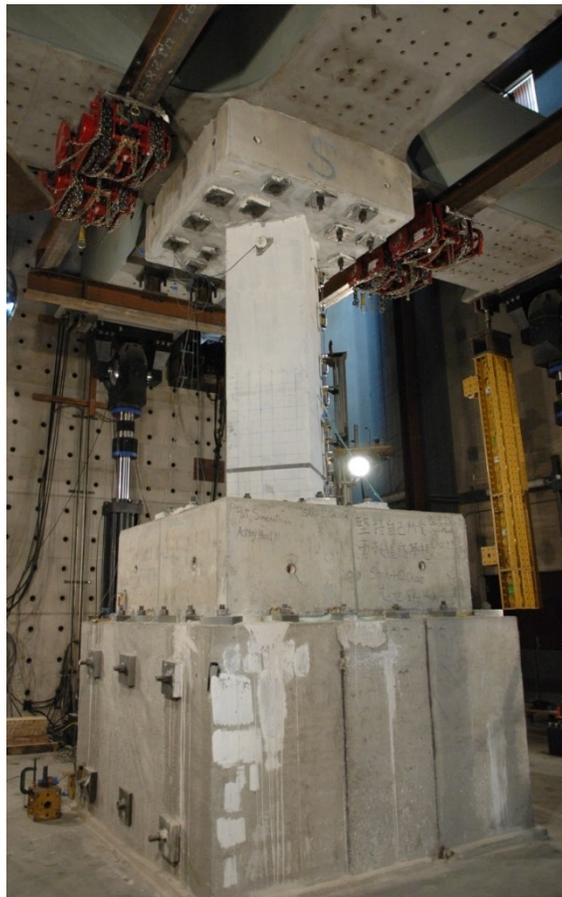
Figure 89. Overall test setup

The footing block of the column specimen was post-tensioned to a base block which was fixed to the strong floor of the laboratory. The loading block of the column specimen was post-tensioned to the crosshead which will apply the loading during testing (Figure 89). Each specimen was instrumented with LVDTs along the height of the column on both the NW and SE sides (Figure 90 and Figure 91) as well as string potentiometers to measure displacements during testing (Figure 92). Furthermore, cameras were positioned in the North-west, South-east, and South-west faces of the column in addition to the remote control telepresence system of the MAST facilities (Figure 88).

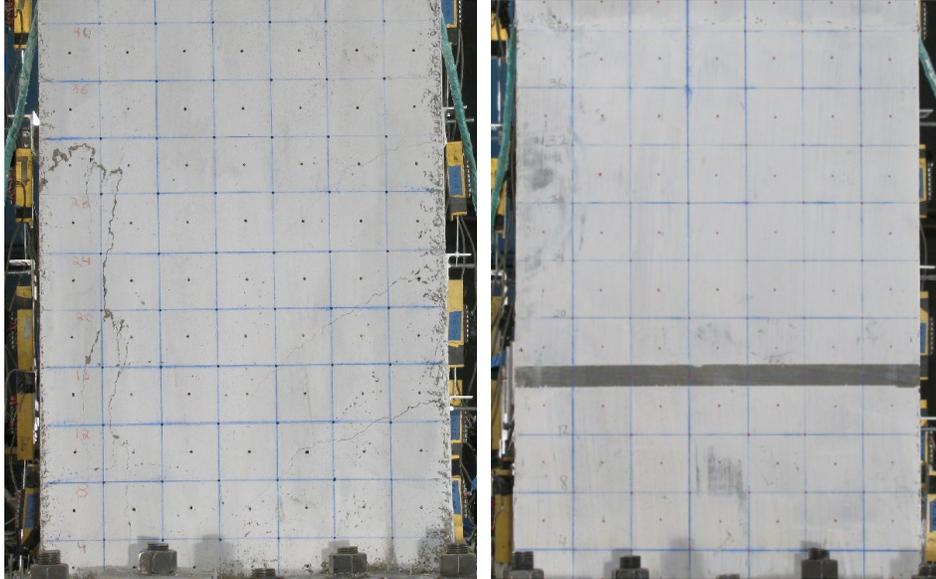
Figure 96. Column specimen SP5 and SP8 at 0.75% drift

The first longitudinal bar yielding was observed at 0.75% for both column specimens at the column base. At 1.0% drift a longitudinal crack was observed along with concrete crushing at the south-west corner of column SP5 and no visible damage observed in SP8 as shown in Figure 96.

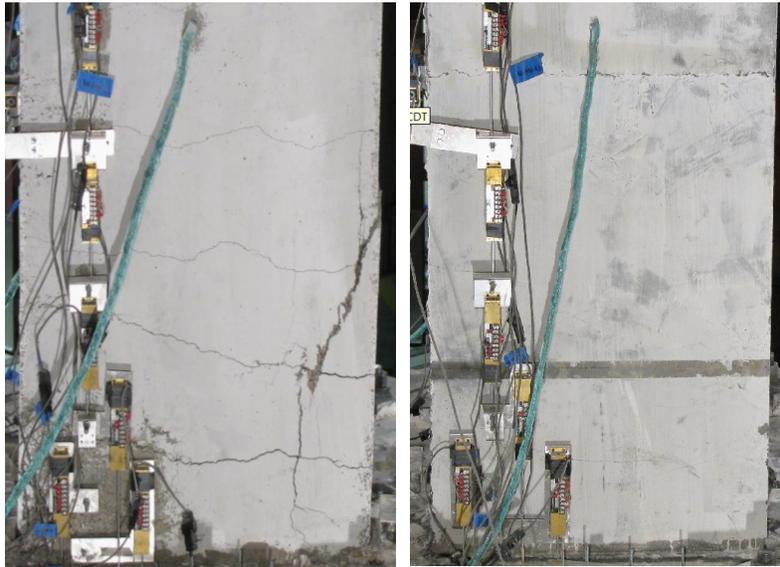
Figure 97. Column specimen SP5 and SP8 at 1.4% drift

A strength decrease was observed for column SP5 at 1.4% drift. The concrete crushing observed at the south-west corner increased and also the flexural crack width (Figure 97). No cracking was observed in the UHP-FRC section of column SP8 at this drift level and the column's lateral strength continued to increase.

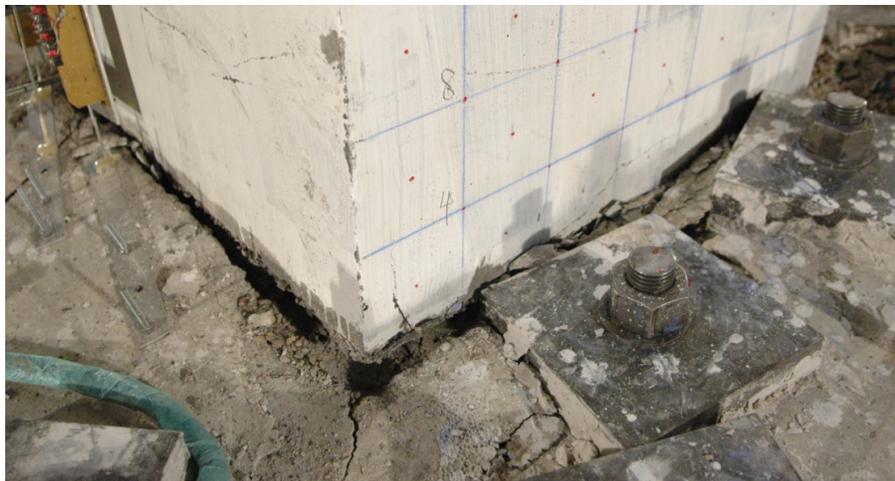
Figure 100. Damage and separation at the column-footing interface

loading. Longitudinal bar buckling and rupture was also observed in the direction of loading, consistent with the significant strength degradation seen during testing. At this point in the test, there is still no perceivable damage to the UHP-FRC section of column SP8. However, there was noticeable concrete damage to the RC footing block as well as a separation between the column section and the footing section (Figure 100).

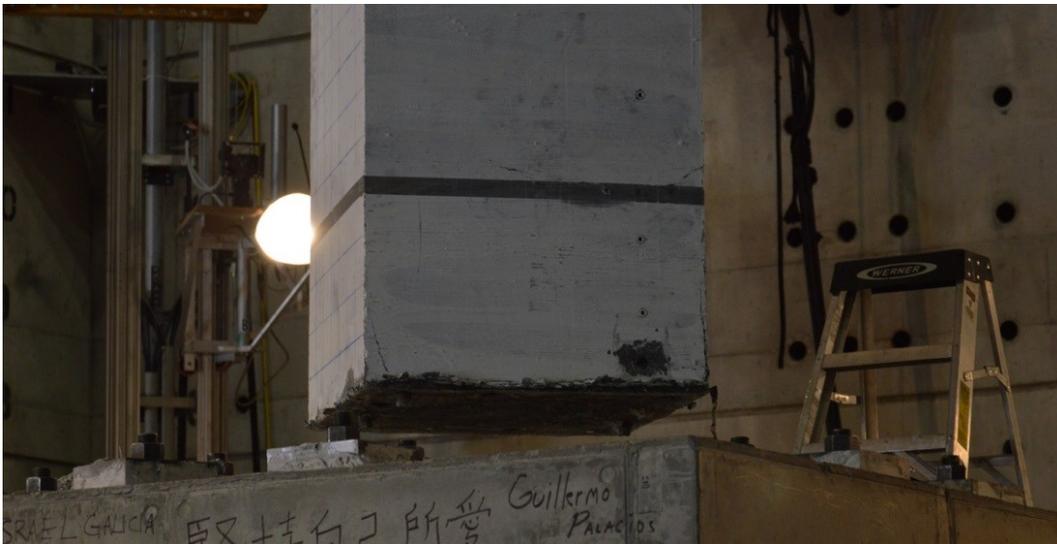
Figure 101. SP8 column specimen after testing

Specimen SP8 failed in a very different manner than that of SP5, mainly due to the low-cycle fatigue and rupture of the longitudinal reinforcement at the column-footing interface. The column specimen SP8 dropped to less than 20% of its lateral peak strength at a drift of 8.6%. The UHP-FRC section remained intact with no visible damage, thus SP8 failed solely due to the behavior of the longitudinal reinforcement which ruptured at the interface (Figure 101).

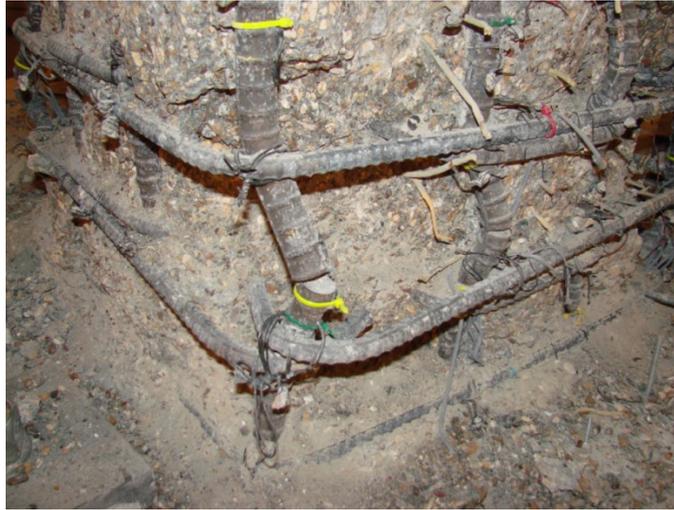
Figure 107. Column SP5 after testing

Essentially, the damage progression and strength degradation of the column is initiated by the concrete behavior and its strength limitations. Column SP5 after the end of testing is shown in Figure 107, it can be seen that there is a significant reduction in core concrete in the region between 7 in. to about 15 in. above the footing surface, consistent with the recorded strains previously discussed. Longitudinal bar buckling and rupture is also visible as well as a hoop that has opened.

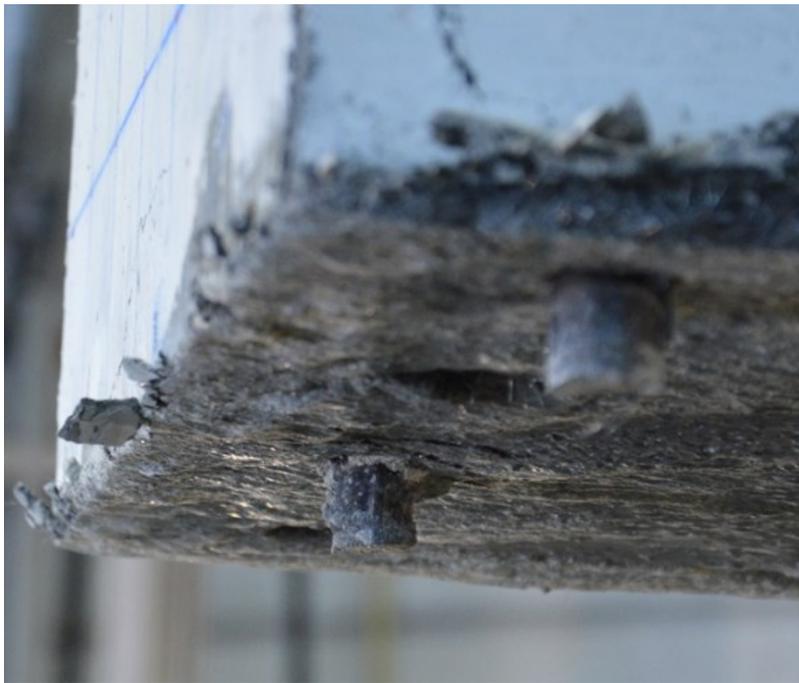
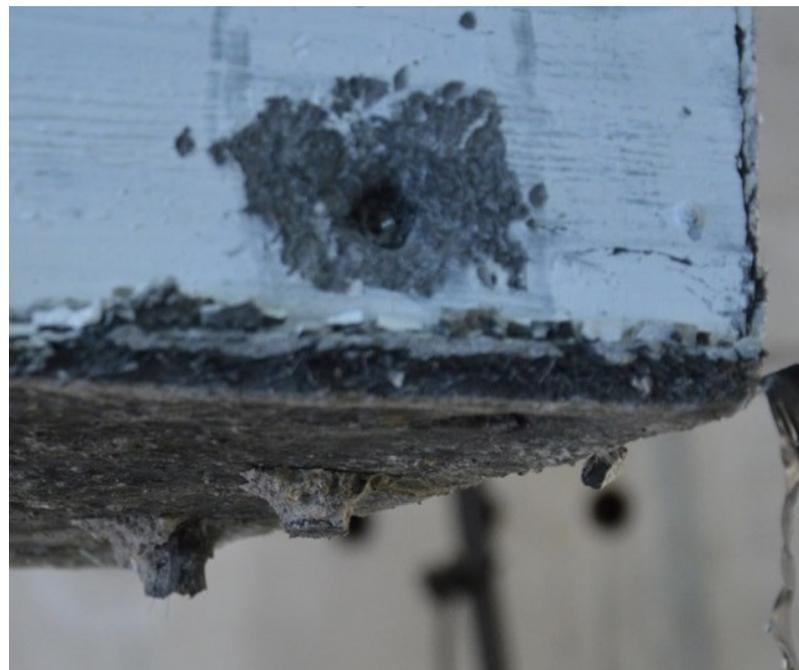
Figure 110. Longitudinal bar pull-out from footing after testing

Higher strains were also observed in the longitudinal reinforcement within the footing compared to the longitudinal reinforcement of specimen SP5; this is attributed to the high bonding strength of UHP-FRC and is responsible for the increased deformation of column SP8. Chao (2005) stated that the unique characteristics of HPRCCs can significantly enhance the bonding characteristics of reinforcing bars and pre-stressing strands embedded in concrete matrices because of multiple cracking due to fiber bridging as shown in Figure 109. After testing it was also visible how some of the longitudinal bars remained in the column section and pulled out of the footing section (Figure 110).

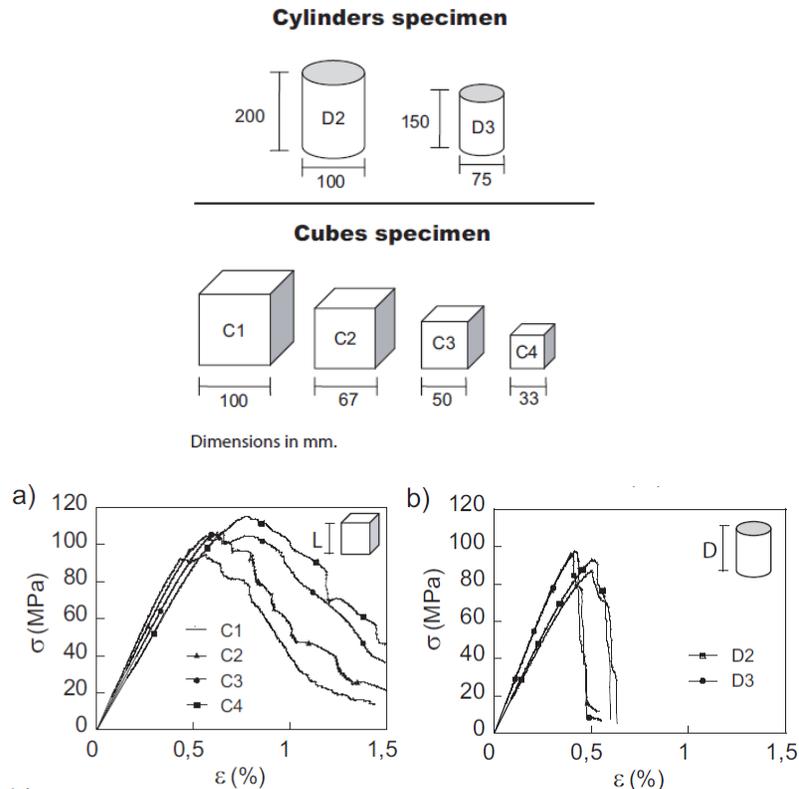
Figure 113. Specimen geometry and compressive stress-strain curves (del Viso et al., 2008)

geometry of the high strength concrete cylinder and cube specimens tested by del Viso et al. (2008) and the corresponding compressive stress-strain curves are shown in Figure 113. As differences in UHP-FRC mix designs and casting sizes may vary significantly, this will also introduce additional variables not considered in previous research.

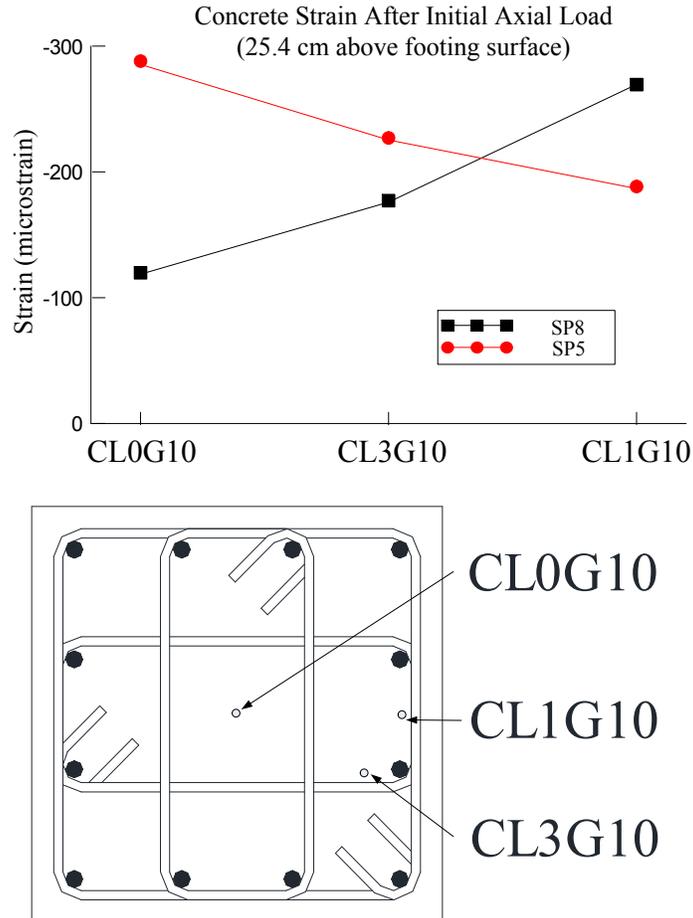
Figure 116. Concrete strain distribution after initial axial load;

A unique strain distribution was also observed for the UHP-FRC column under the initial axial loading. The concrete strain gauges embedded within the column cross-section in the longitudinal position at 10 in. above the footing surface showed opposing compressive strain distributions for the RC column and the UHP-FRC column. In the RC column a higher compressive strain was observed in the core of the column while in the UHP-FRC column lower strains were observed in the core with slightly higher strains observed along the perimeter of the cross-section which includes the longitudinal reinforcement and the surrounding concrete (Figure 116).

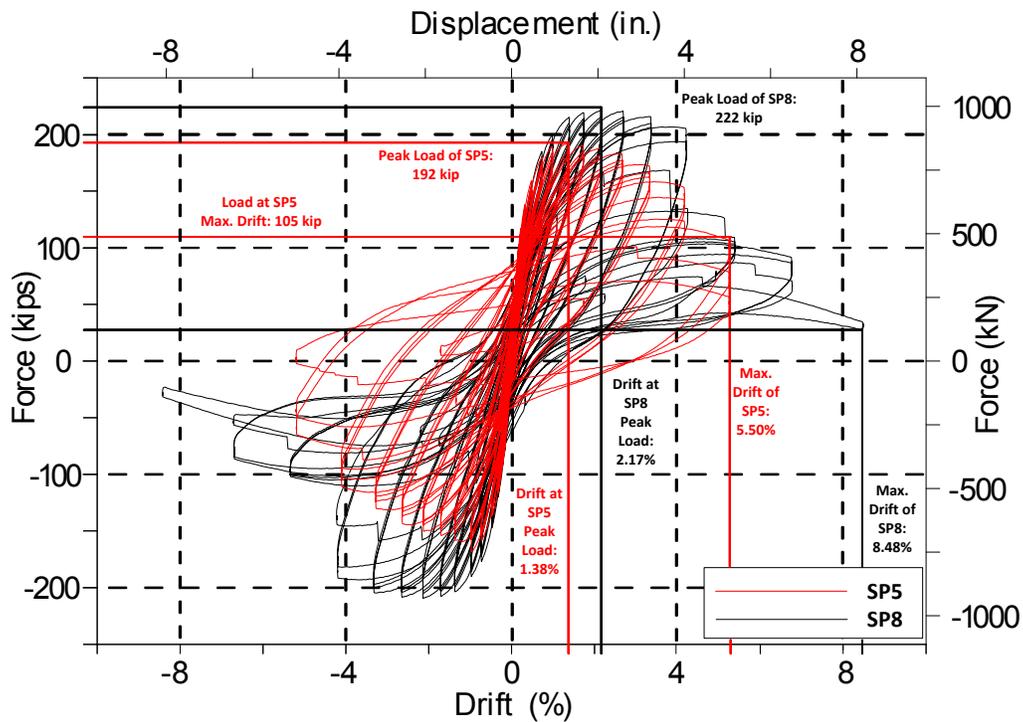
Figure 118.SP5 and SP8 force vs. drift comparison

The force versus drift response and backbone comparison shown in Figure 118 and Figure 119 indicate that the UHP-FRC column could maintain strength up to nearly 4% drift ratio while the conventional reinforced concrete column deteriorated very fast after 1% drift ratio. While the axial load ratio ($P_u/A_g f'_c$) for the conventional concrete was 0.3, it dropped to 0.06 with the addition of UHP-FRC to the column due to the high compressive strength of the UHP-FRC. This smaller axial load ratio minimized the detrimental influence of the axial load effect at the post-elastic stage.

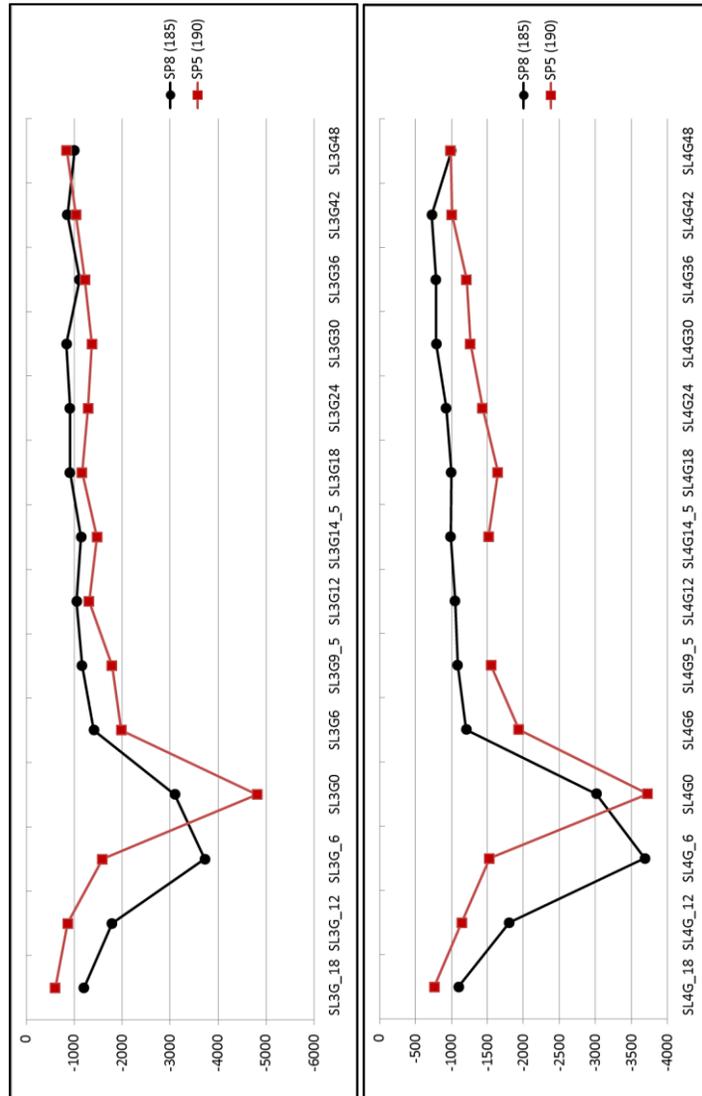
Figure 122. Comparison of bars SL3 and SL4 in compression

Figure 122 shows a comparison of the two longitudinal bars in compression (SL3 and SL4). It can be observed that for column SP5 the corner bar (SL3) has higher peak compressive strains than the inner bar (SL4), while SP8 the strain distribution in the two bars appear to be nearly identical. SP5 shows higher compressive strains in the longitudinal bars compared to SP8 suggesting that most of the compressive forces in specimen SP8 are being shared by both the reinforcing bars and the UHP-FRC, while in the case of SP5 the increased concrete degradation during the cyclic loading reversals has lowered the concrete contribution and distributed a larger amount of compressive stresses to the longitudinal reinforcement. SP5 has peak compressive stresses at the interface. Within the footing the compressive strains decrease rapidly, while along the height of the column the compressive strains decrease steadily. However, SP8 has a peak compressive strain 6 in. within the RC footing with significant strains also being observed at the interface. In the region within the footing higher strains were observed for column SP8 compared to column SP5, and at 45 in. above the footing surface, outside the UHP-FRC region, both specimens recorded nearly identical strains.

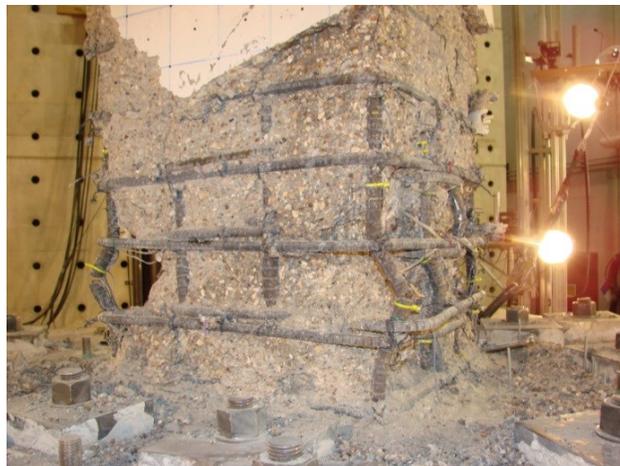
Figure 135. SP5 at the end of testing

The strain gauge observations were consistent with the damage observed at the end of the testing of column SP5 with the highest reduction in core concrete was seen to be between 7 in. and 12 in. Bar buckling was also observed in this region. From this direct comparison it is clear to see the differences in the strain distribution of the two specimens due to the properties of UHP-FRC. No hoops yielded up to the peak load of column SP8 suggesting that transverse reinforcement may be reduced with the use of UHP-FRC potentially reducing costs and facilitating construction. The highest hoop strain was observed 3 in. below the footing surface.

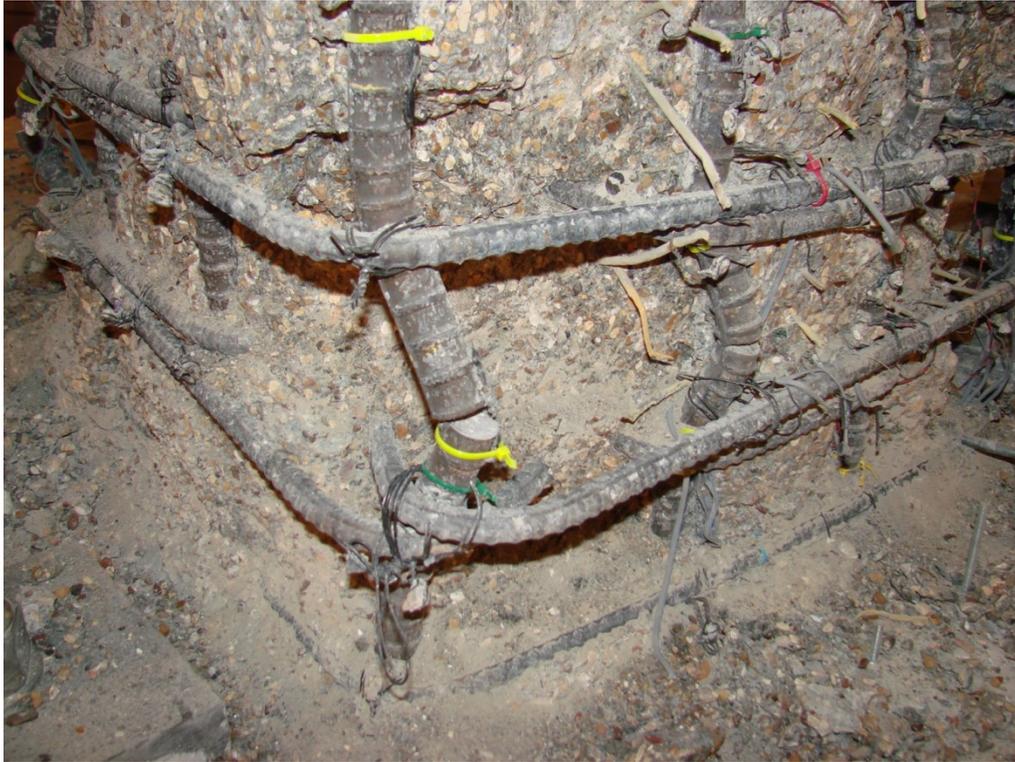
Figure 136. SP5 bar buckling and rupture

The first notable comparison is made in the core region of the columns, strain gauge location STR6 (Figure 123). Figure 124 shows the strain of the inner hoop at location STR6. From Figure 124 it can be observed that within the inner core of the column, SP8 recorded very minor strains (below 150 microstrain) while STR6 in SP5 showed significant strain close to yielding more specifically at 7 in. above the footing surface. This is also consistent with the bar buckling observed near this height after testing (Figure 136).

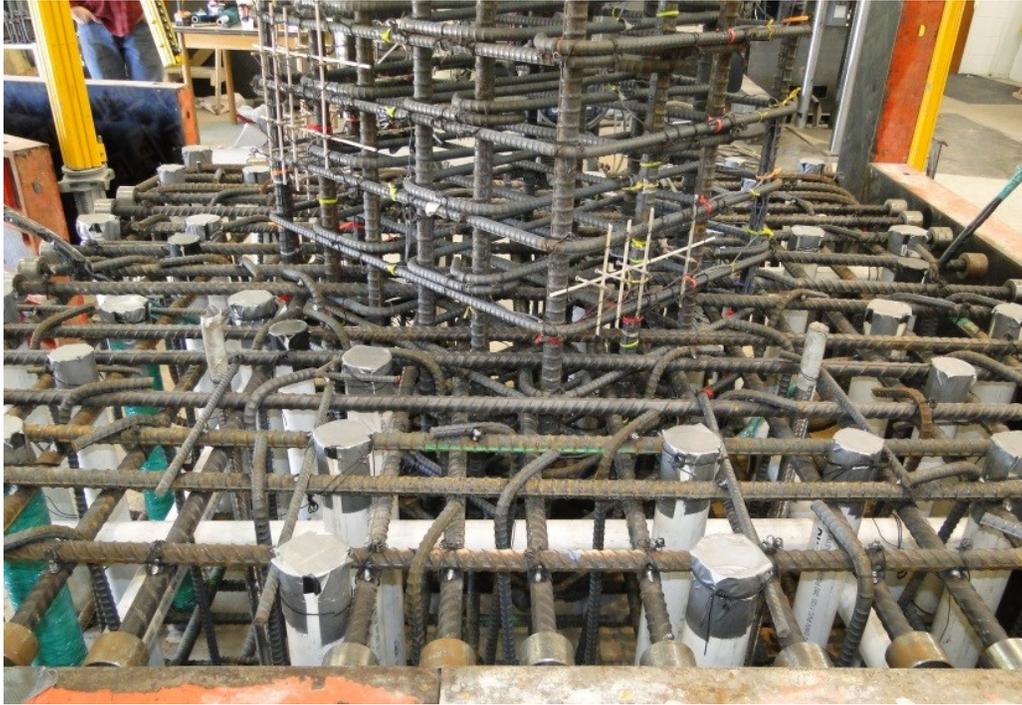
Figure 139. SP3 column and footing cage prior to casting

All specimens were constructed at the University of Texas at Arlington and cast in the upright position as to simulate real world construction (Figure 139). The footing block was cast first with self-consolidation concrete with a specified 28-day compressive strength of 5,000 psi. After the concrete had hardened the column formwork was erected and the column and loading block sections were subsequently cast. After casting, the specimens were then shipped to the University of Minnesota for testing.

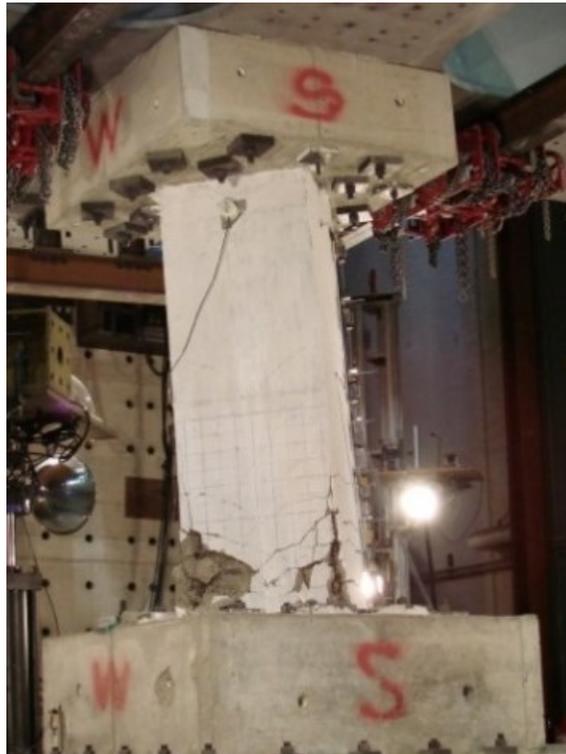
Figure 143. SP3 column subjected to a symmetric cyclic loading protocol

Most damage was concentrated to the plastic hinge region of the column above the footing (Figure 143). No footing failure was observed in any of the eight columns with

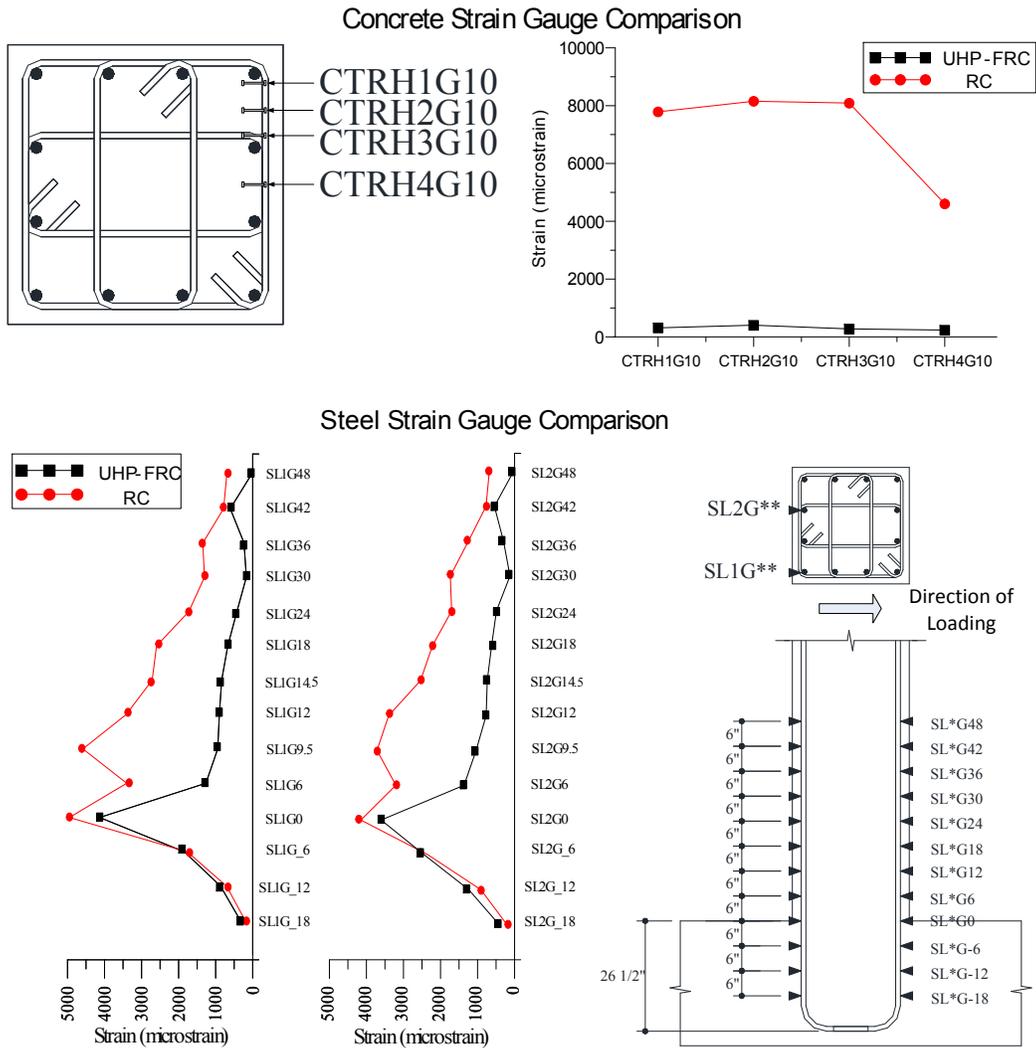
Figure 144. Concrete gauge and strain gauge comparison between RC and UHP-FRC specimens

Overall the deformation of both columns during testing can be attributed to two very different mechanisms. Longitudinal bar yielding was recorded in the RC column from 6 in. below the footing to 36 in. above the footing with observable bar buckling and rupture within that range. However, the longitudinal bar yielding of the UHP-FRC column was concentrated from the column footing interface and penetrated 12 in. into the footing. Higher strains were also observed in the longitudinal reinforcement within the footing of column SP8 compared to the longitudinal reinforcement of specimen SP5; this is attributed to the high bonding strength of UHP-FRC and is responsible for the increased deformation of column SP8.
