PERFORMANCE OF FULL-SCALE ULTRA-HIGH PERFORMANCE FIBER-
REINFORCED CONCRETE COLUMN SUBJECTED TO EXTREME EARTHQUAKE-
TYPE LOADING AND EFFECT OF SURFACE PREPARATION ON THE COHESION
AND FRICTION FACTORS OF THE AASHTO INTERFACE SHEAR EQUATION

MASTER OF SCIENCE IN CIVIL ENGINEERING

THE UNIVERSITY OF TEXAS AT ARLINGTON

May 2015

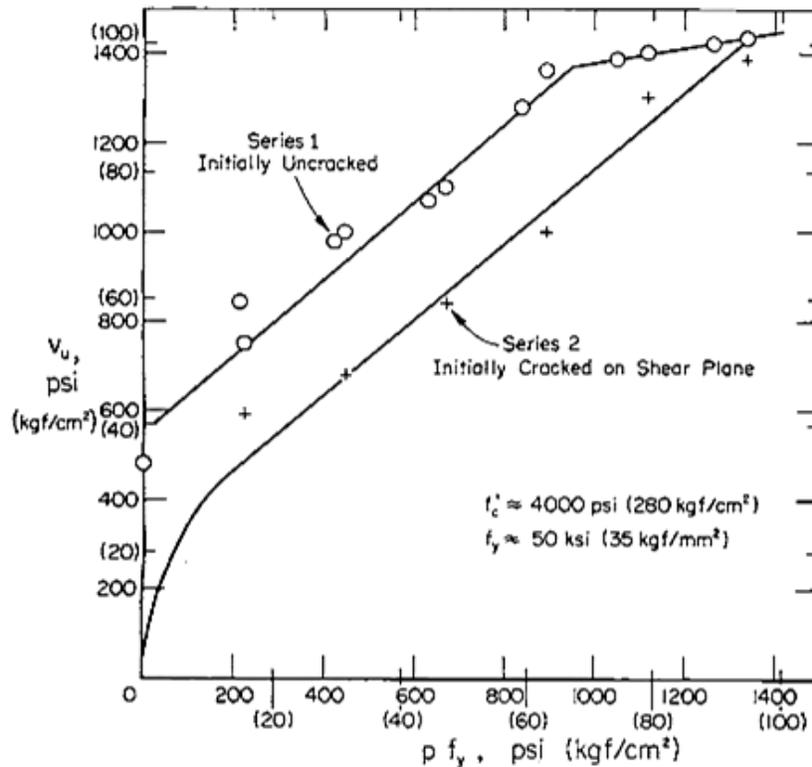
Figure 155. Push-off test results (Hofbeck et al., 1969)

researchers concluded that a pre-existing crack along the shear plane reduced the ultimate shear transfer and increased the horizontal slip. A 250 psi reduction in the shear strength was expected for a 4,000 psi normal weight concrete with clamping stresses between 200 psi and 1,000 psi. The reduction was higher for lower values of clamping stress. For clamping stresses above 1,000 psi, there is a very slow rate of increase in the interface shear strength of initially un-cracked specimens with an increase in clamping stress, while the strength of the initially cracked specimens continued to increase at the same rate as for lower clamping stresses. Consequently, the horizontal shear strength for cracked and un-cracked interface was approximately equal for a clamping stress of 1,340 psi as shown in Figure 155.

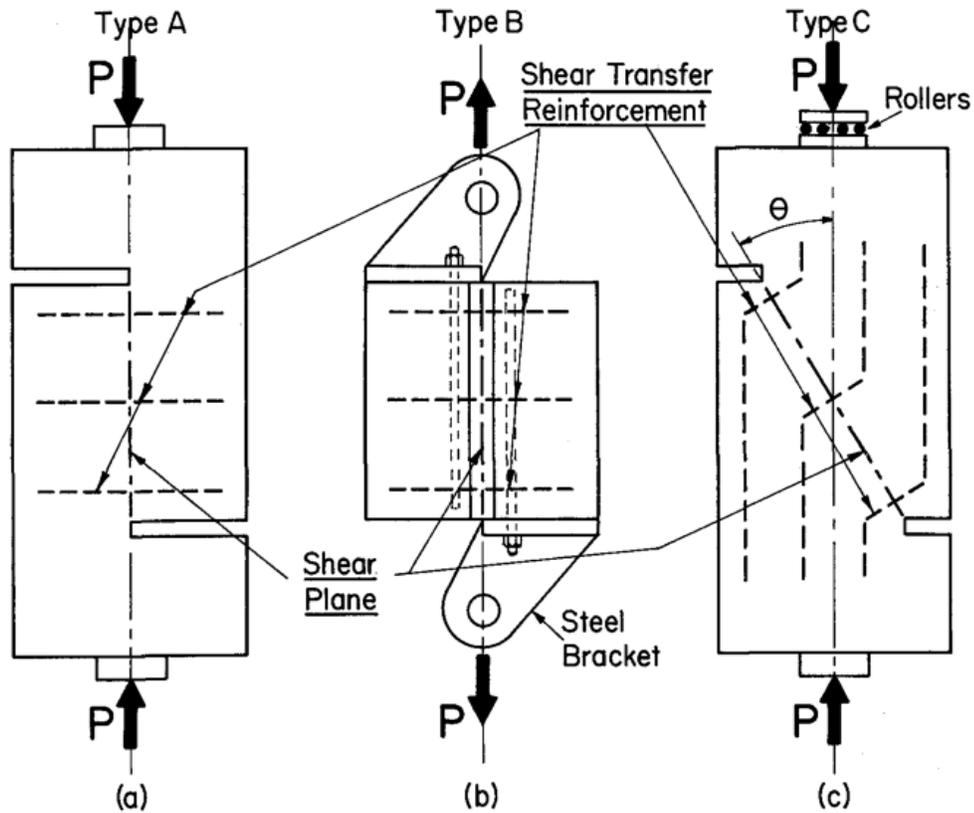
Figure 156. (a) Push-off; (b) Pull-off; and (c) Modified push-off specimens (Mattock, 1969)

parallel or transverse to the shear plane) affect the interface shear strength of reinforced concrete. Pull-off and modified push-off specimens were used to study the influence of direct stresses acting parallel and transverse to the shear plane respectively.

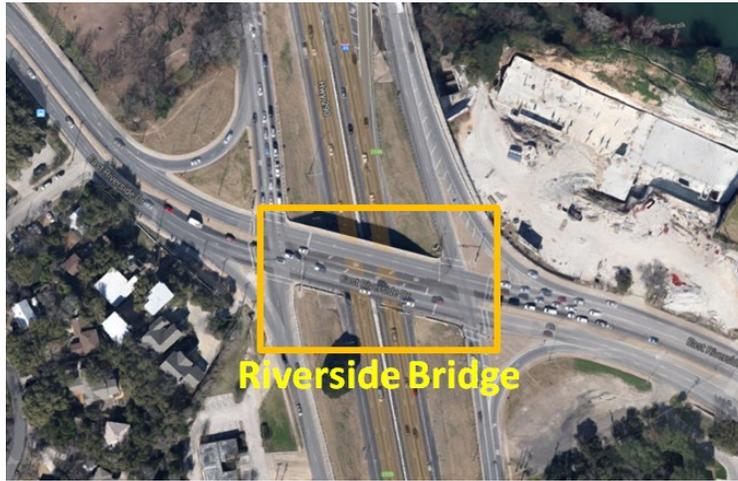
Figure 162. Riverside bridge location and design drawings

A visit was made to the Riverside Bridge (Intersection of I-35 and Riverside Rd.) to observe possible horizontal shear cracks. The location of the bridge and design drawings can be seen in Figure 162. Observation of the bridge revealed extensive horizontal cracks at the end spans and the middle span of the bridge. Crack widths as wide as 10 mm were measured. It is important to note however that this is an older bridge which uses an asphaltic concrete overlay of 2 in. as opposed to a 5 in. CIP concrete slab. There was therefore no horizontal shear reinforcement at the interface. The only composite section on the beam was observed to be between the precast beam and the sidewalk. The interface at this section was also observed to be very smooth (Figure 163).

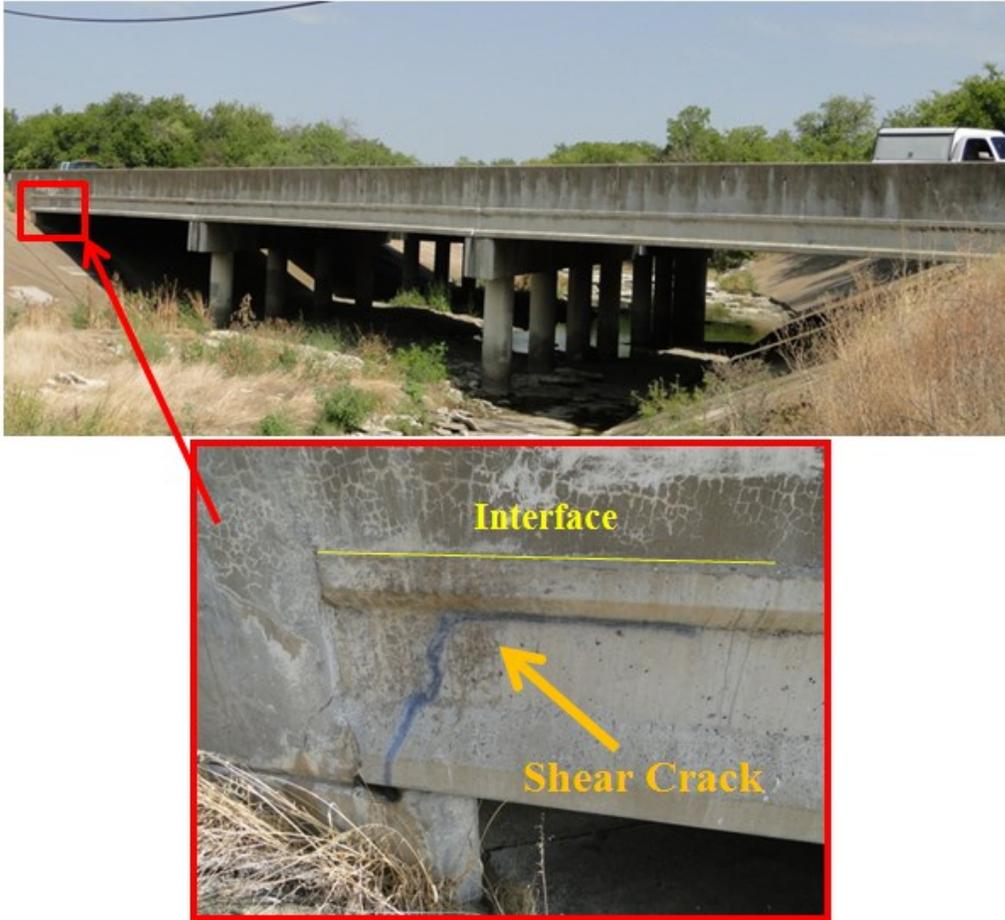
Figure 165. Shear cracks observed at the South-West end of the Long Ave. Bridge

It was witnessed on arrival that this bridge did not have any interface shear damage; however other forms of damage were observed. A number of shear cracks and crushing was observed at the ends of the girders. Figure 165 shows an example of some of the observed shear cracks. Horizontal shear cracks were present on the girders but did not extend into the deck interface.

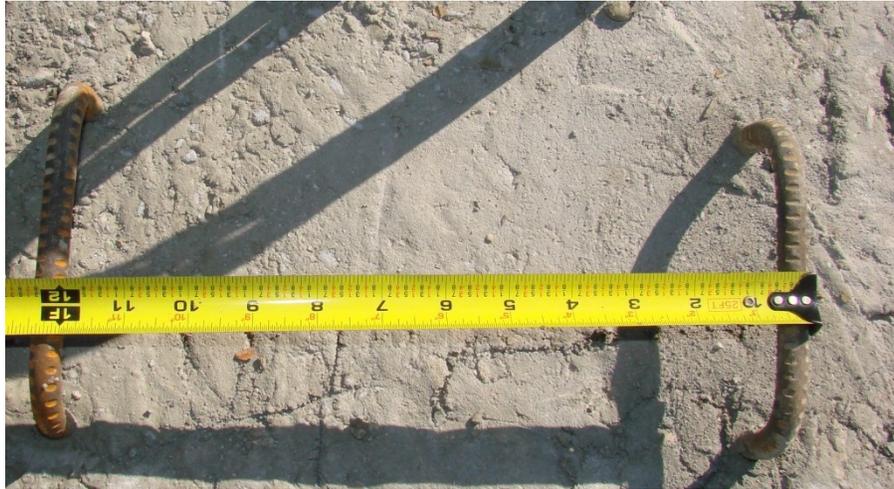
Figure 167. Spacing of horizontal shear reinforcement

shear reinforcement (Grade 60, No. 4 bar) is spaced at 12 in. and has an embedment length of 2 in. as per TxDOT specifications (Figure 167 and Figure 168).

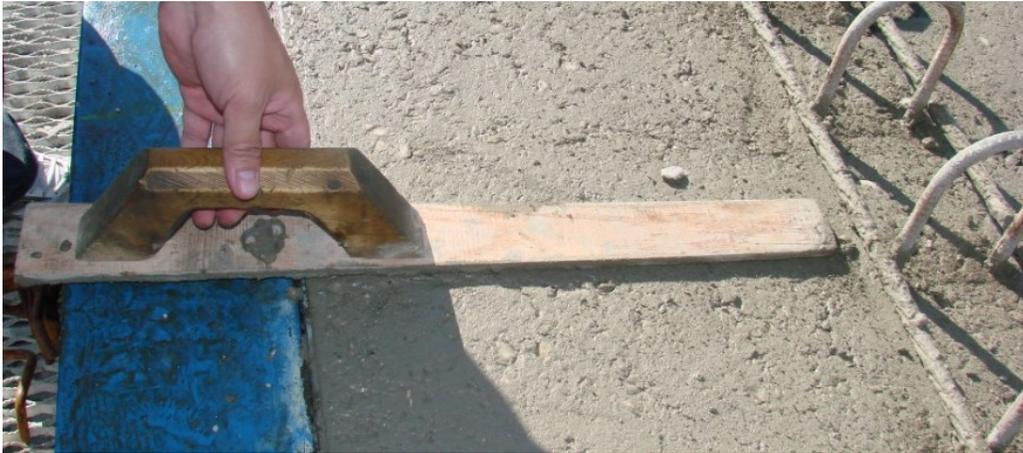
Figure 169. Application of wood float finish

The slab beams are typically finished by using a wood float as shown in Figure 169. On comparing the surface finish with the CSP surface profiles, it was observed that

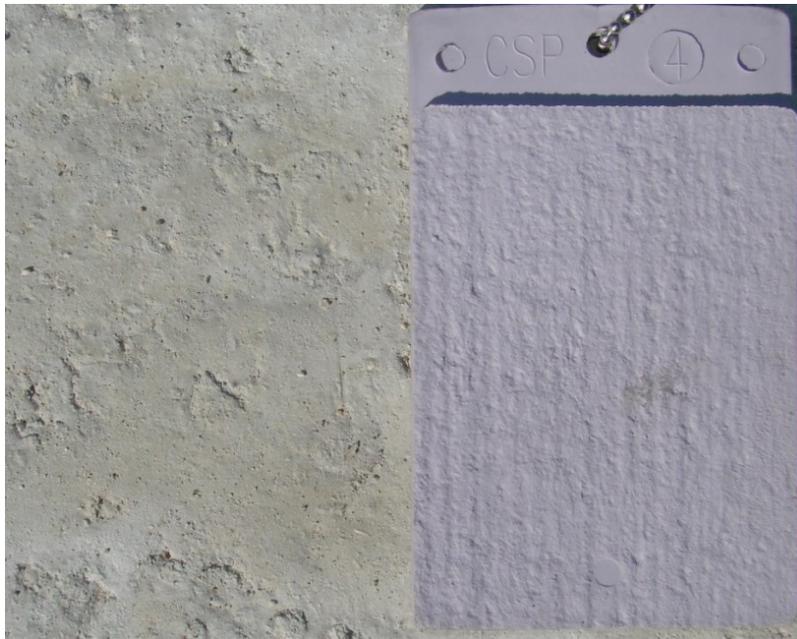
Figure 170. SCC concrete surface compared to CSP 4

the surface roughness for the conventional concrete slab beam was between a CSP 6 and a CSP7 (Figure 171) while an SCC slab had a surface roughness of CSP 4 (Figure 170).

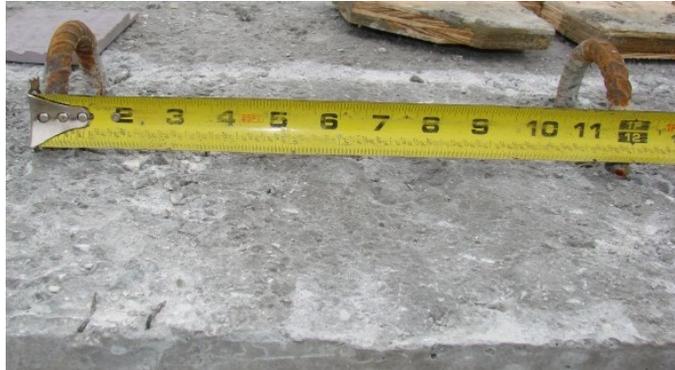
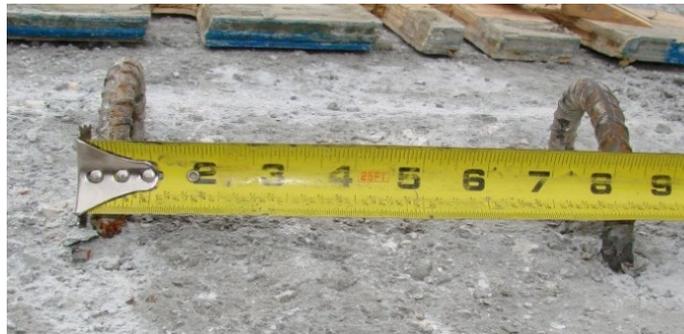
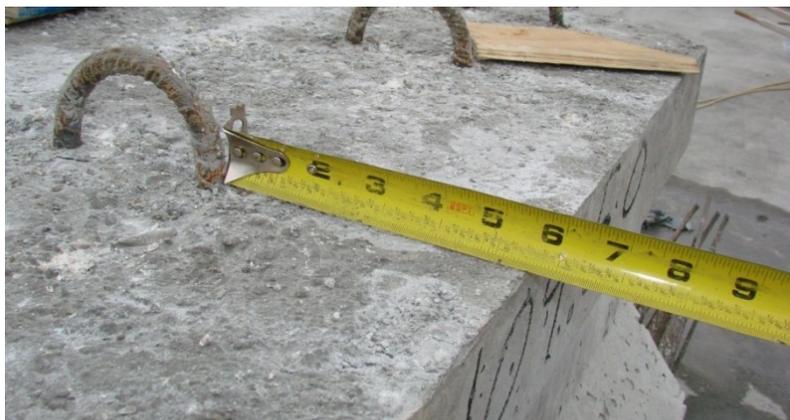
Figure 173. Horizontal shear reinforcement details

The horizontal shear reinforcement of the box beam is spaced at approximately 12 in. spacing and 8 in. at the ends. The horizontal shear reinforcement is 2 in. high with a width of 3.5 in. The horizontal reinforcements are placed at a distance of 6 in. from the edge of the box beam (Figure 173).

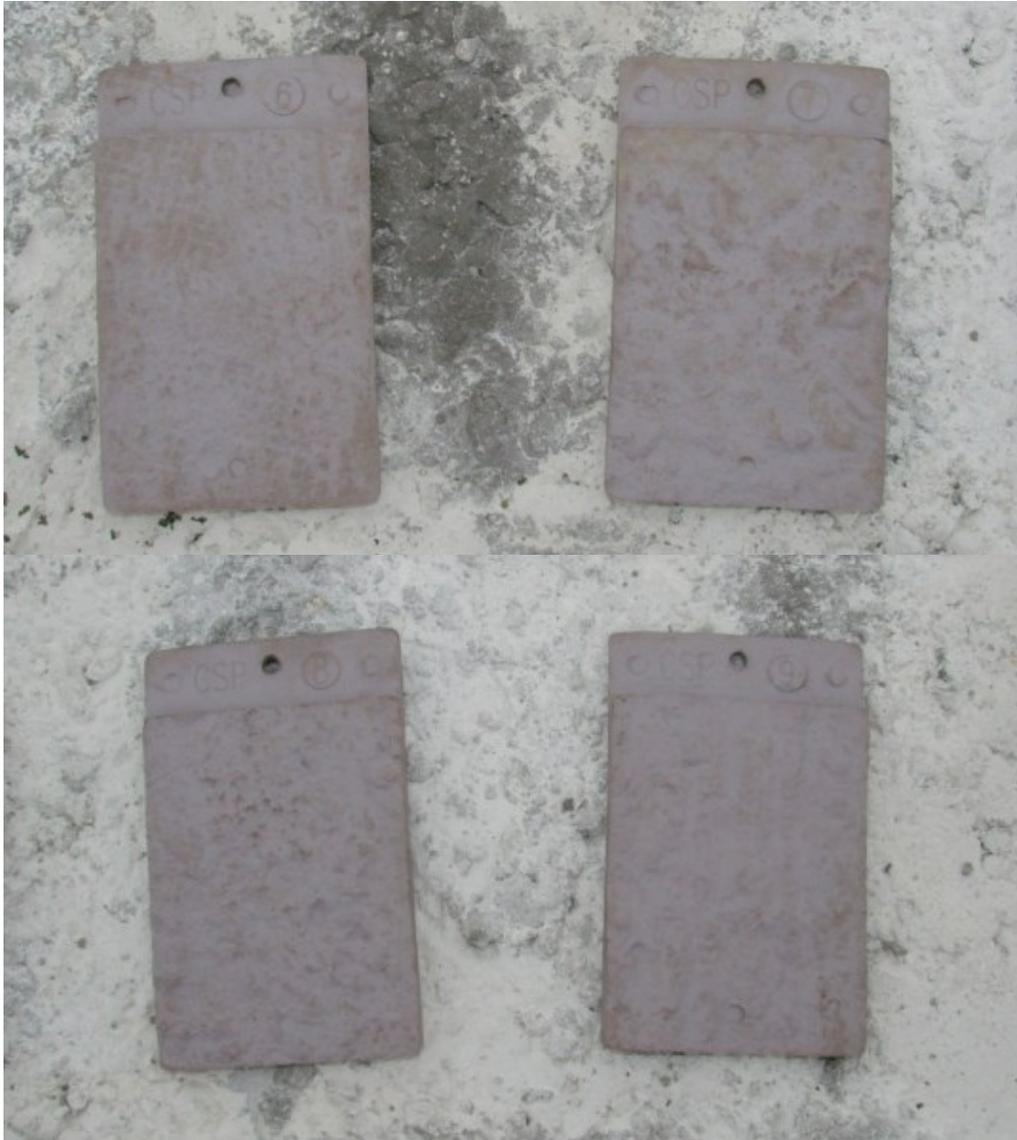
Figure 174. Box beam surface roughness compared to CSPs

A wood float finish is provided for the surfaces of all TxDOT box and slab beams fabricated at the plant. The wood float finish created a surface roughness between CSP 7 and CSP 9 as shown in Figure 174.

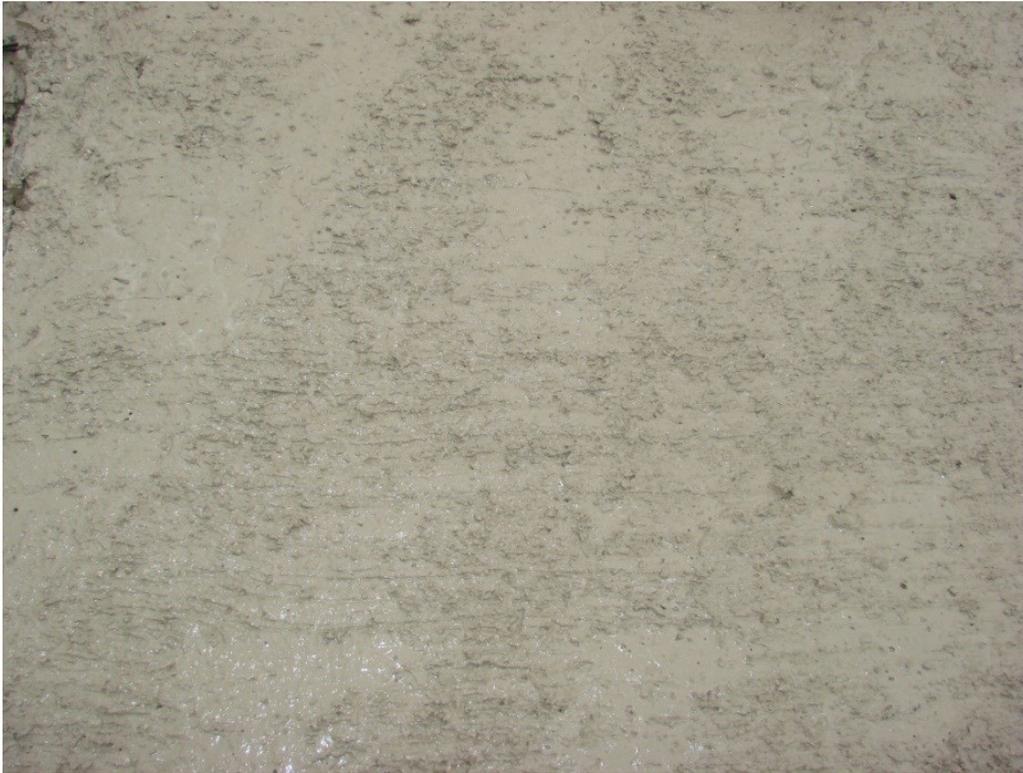
Figure 175. Surface finish on precast panel

Bexar provides a broom finish on precast panels (Figure 175), suggesting that other methods of surface preparation may be applied to box and slab beams if necessary.

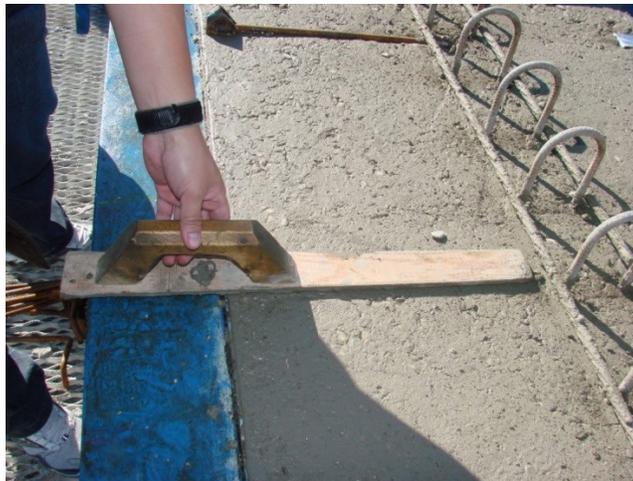
Figure 191. Applying a wood float finish (Texas Prestressed, Elm Mott, Texas; I-girder)

After contacting a number of precast plants it was found that TxDOT box and slab beams are typically given a wood float finish. This is done by sliding a wooden float across the top of the wet concrete as shown in Figure 191, resulting in a coarse finish as shown in Figure 192. A similar type of finish was observed on site while visiting the precast plants as shown in Figure 193 and Figure 194. This is why it is of great importance to investigate the effects of a wood float surface finish on the shear transfer across an interface.

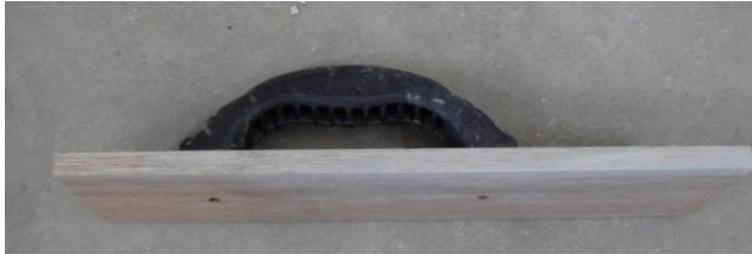
Figure 195. Wood float

After an unsuccessful initial method in which a stamping approach was used to generate different surface profiles, a modified method of surface preparation was then developed by using a number of concrete tools such as concrete rakes and brooms that will expose aggregate along the interface. The tools used are shown in Figure 195 through Figure 199. The method provides a systematic way to obtain each of the CSP

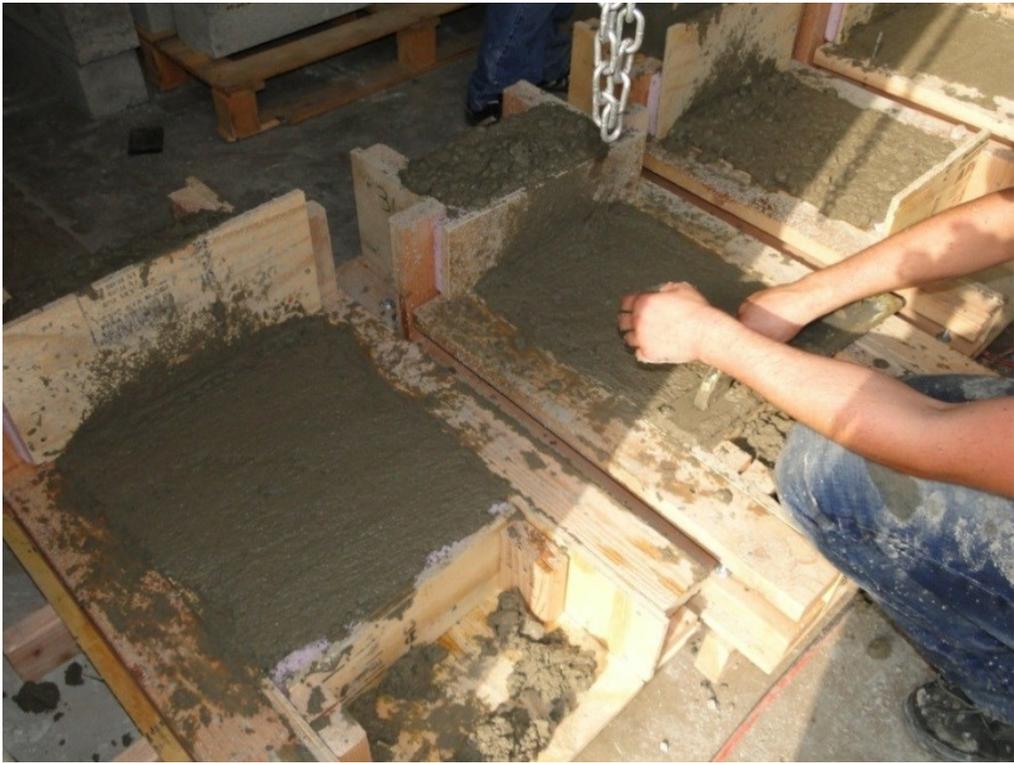
Figure 208. Wood float finish on all specimens

Concrete was delivered to the UTA CELB for the casting of the precast part of the push-off specimen with concrete class “H”. After the concrete was cast on the precast part of the specimen, the surfaces were first finished by a wooden float after which the processes mentioned in Table 15 for making the surface profiles were employed. Figure 202 through Figure 206 show the different surfaces made. As can be seen, the surfaces closely matched those of the CSP molds. The specimens were covered by a plastic sheet after the surface preparation was completed to avoid moisture loss during curing.

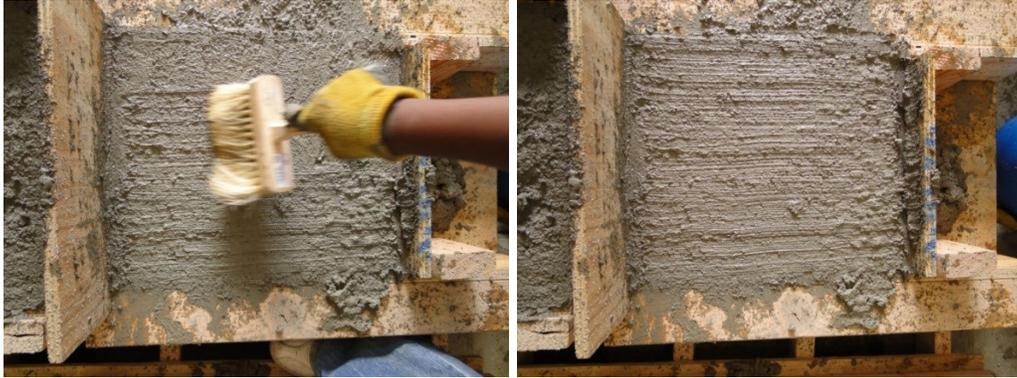
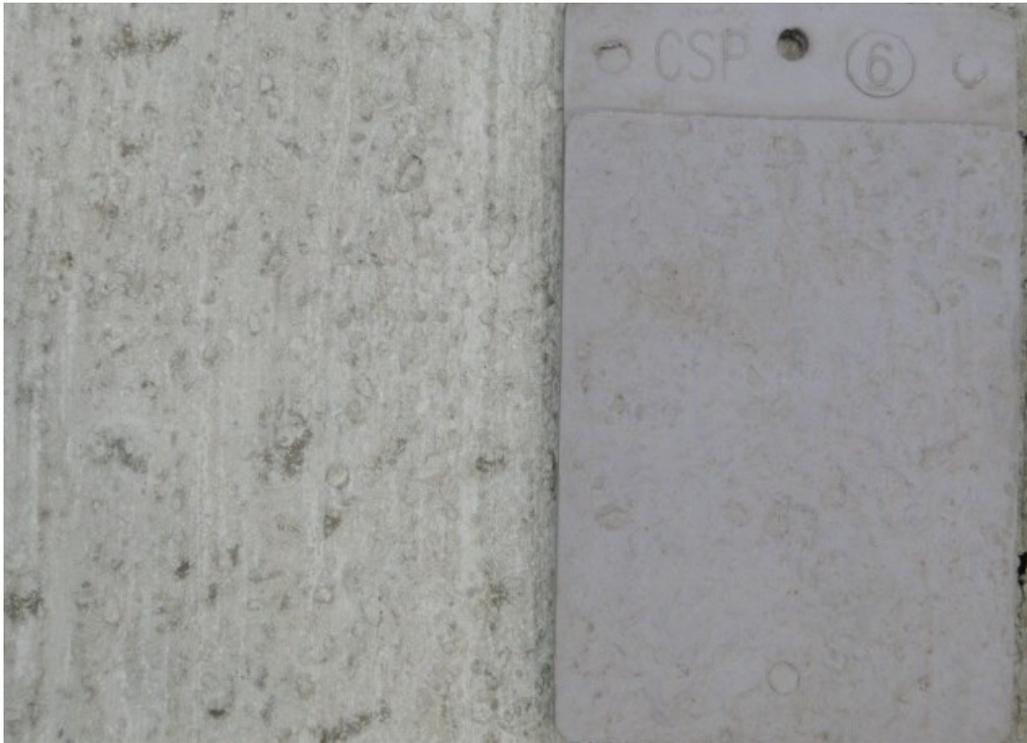
Figure 210. CSP 6

(a) Brush once in same direction

(b) Finished surface.

Surface Finish	Tools	Technique
CSP 5	Rubber Float	Slide two times in the same direction.
CSP 6	Concrete Broom	One brush in the same direction.
CSP 7	Sponge Float	Slide three times in the same direction.
CSP 8	Concrete Broom	One brush back and forth.
CSP 9	Concrete Rake, Concrete Broom, Sponge Float	Slide once with rake, once with broom, once with sponge, in that order all in the same direction.

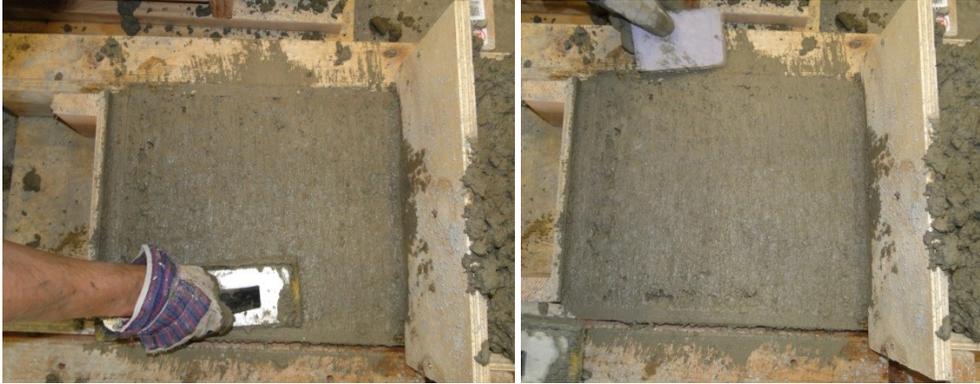
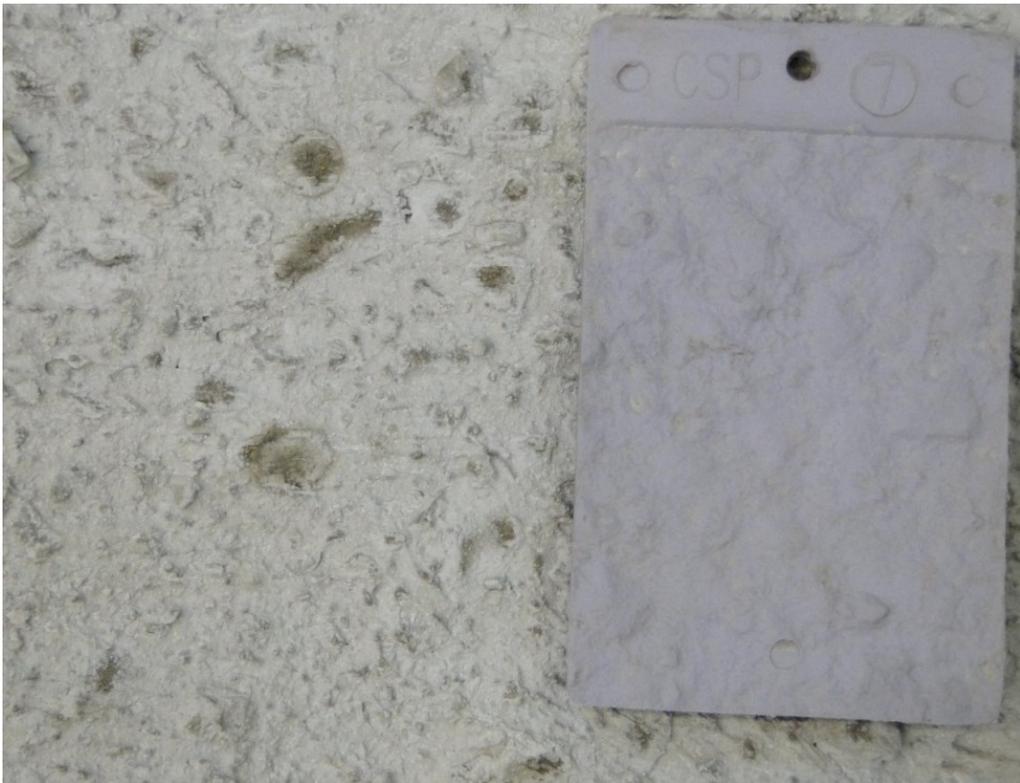
Figure 211. CSP 7

(a) Slide three times in the same direction.

(b) Finished concrete surface.

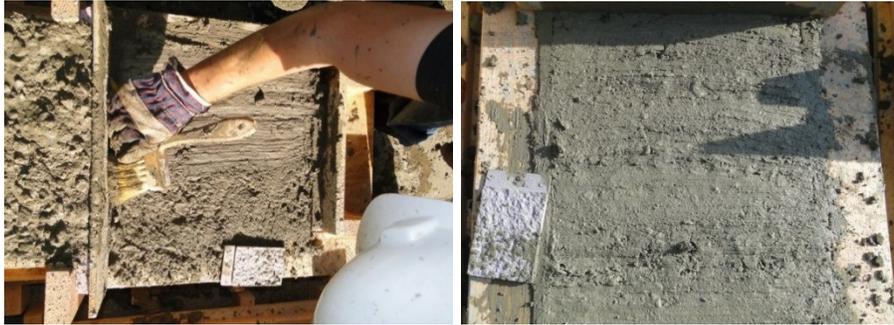
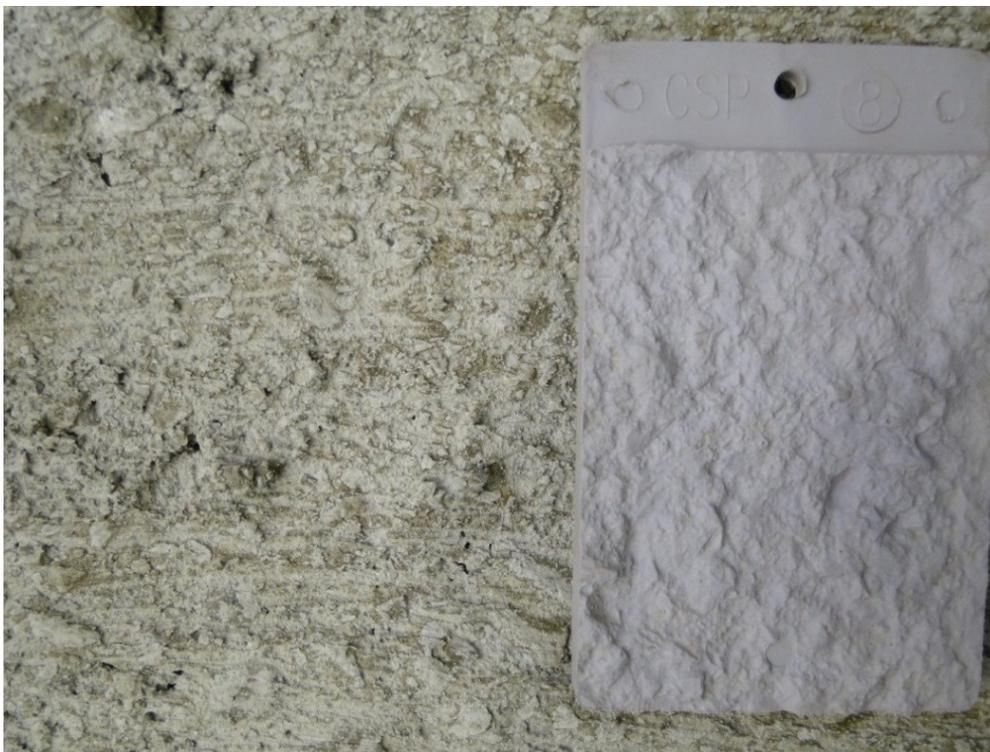
Figure 212. CSP 8

(a) Brush once back and forth.

(b) Finished surface

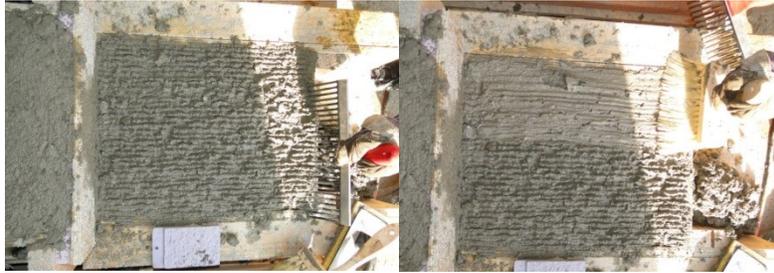
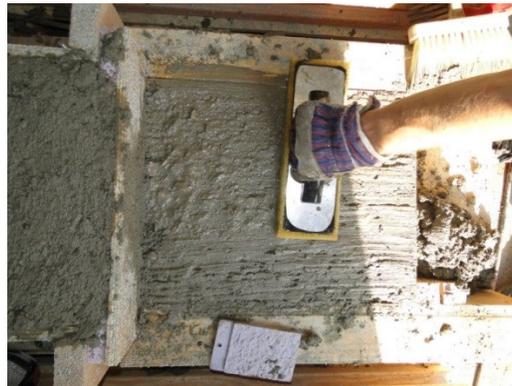
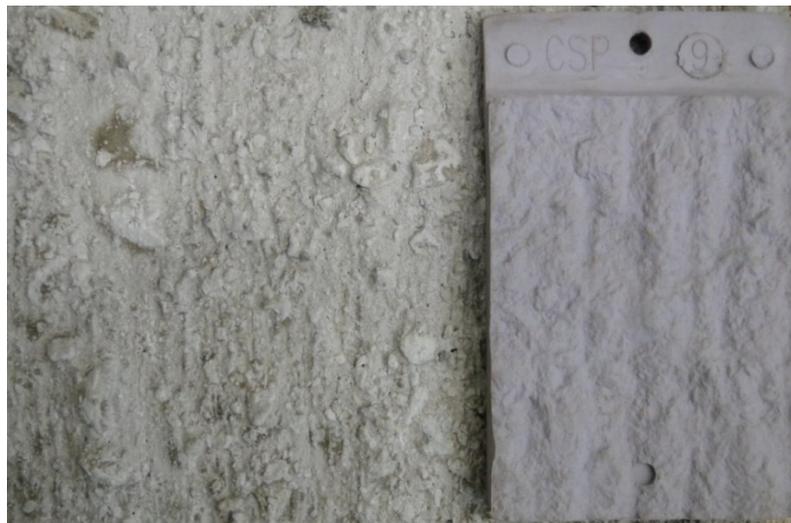
Figure 213. CSP 9

(a) Slide once with rake. and brush once with broom.

(b) Slide once with sponge float.

(c) Finished surface

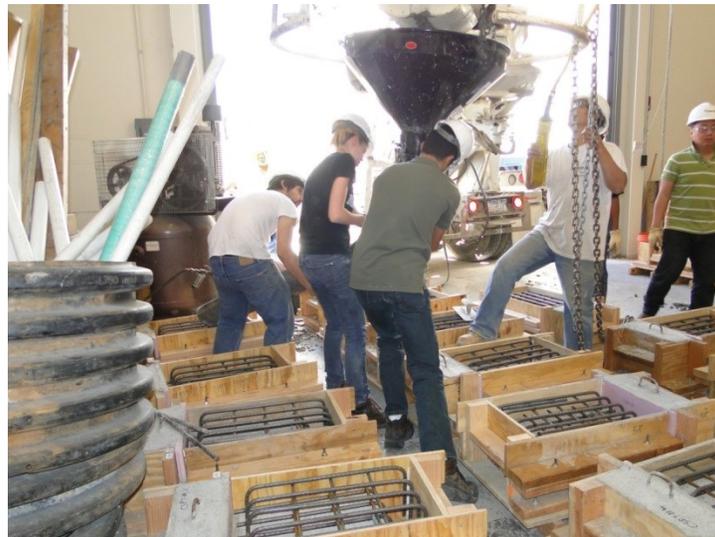
Figure 215. CIP caging and formwork

The surfaces of the precast section were air blown to remove dust and dirt particles prior to the next concrete casting. The reinforcement cage was then placed and the concrete (Class “S”) for the CIP portion of the specimen was cast as shown below.

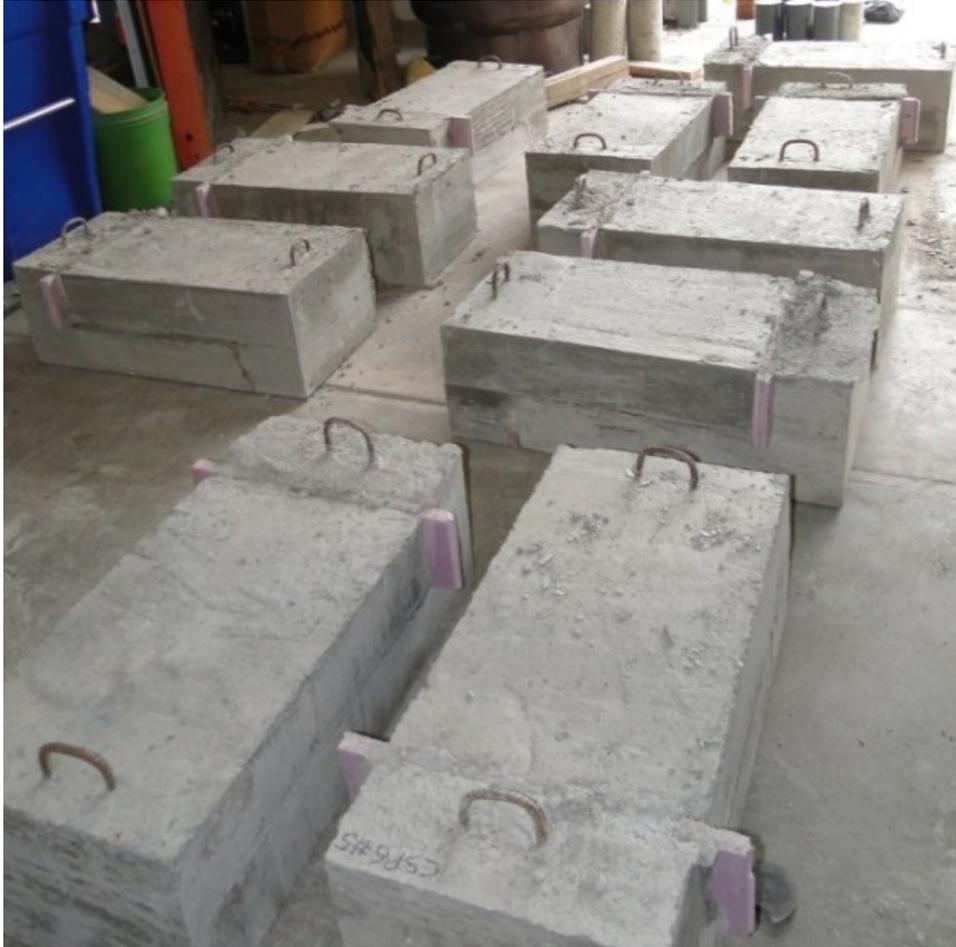
Figure 218. Demolded specimens

The specimens were then covered with a plastic sheet and cured for 28 days after which they were demolded and prepared for testing. The concrete strength after 28 days was 4.5 ksi for the precast part and 5.0 ksi for the CIP part.

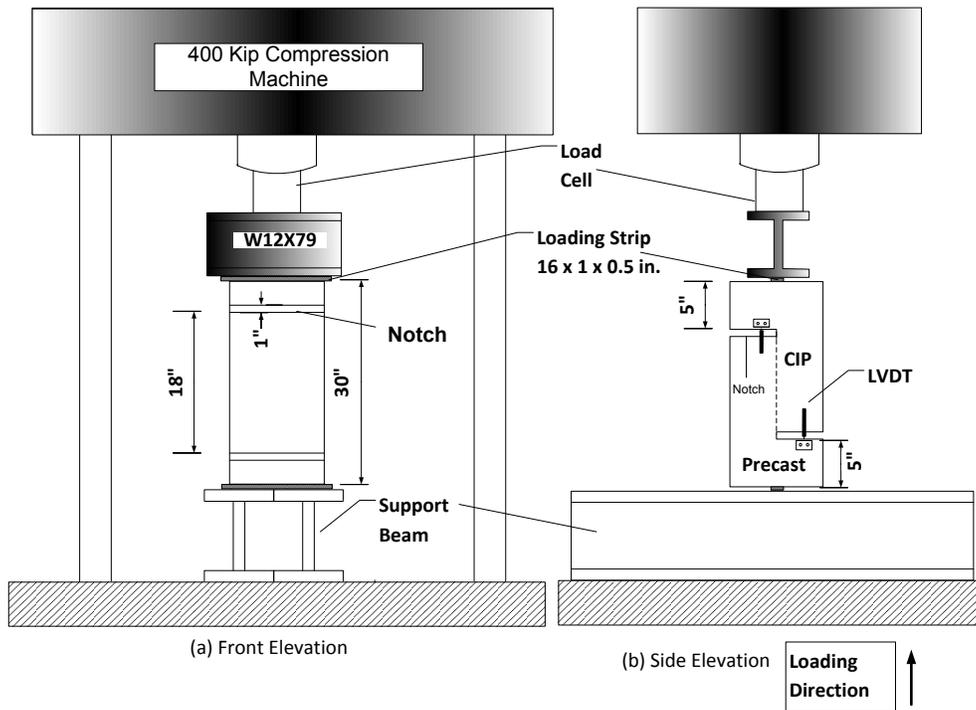
Figure 220. Schematic view of Task 2 test setup

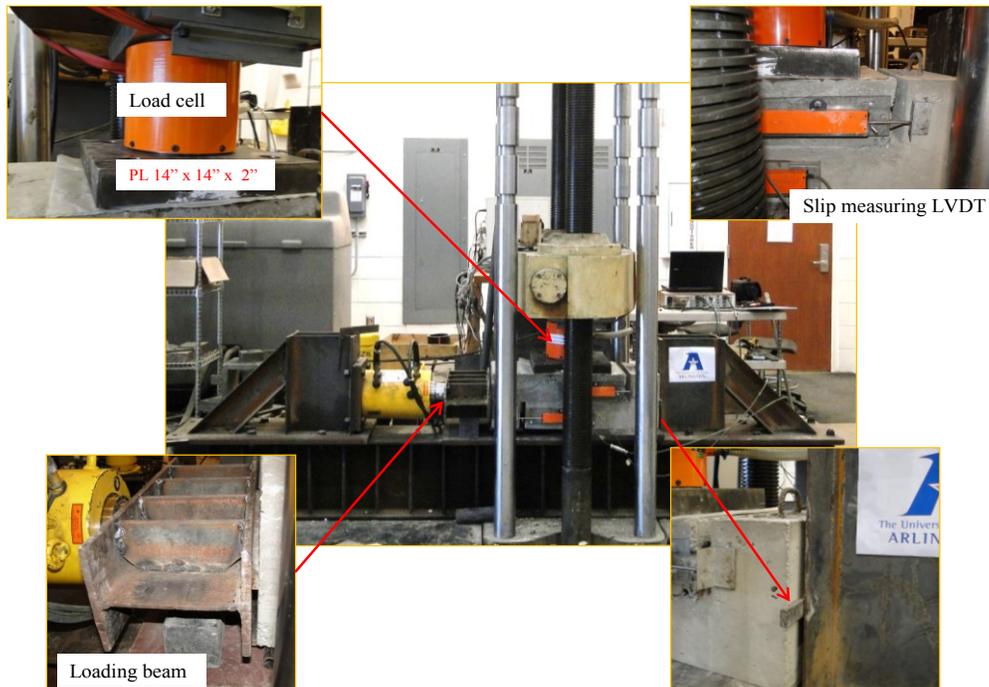
Figure 222. Details of Task 3 test setup

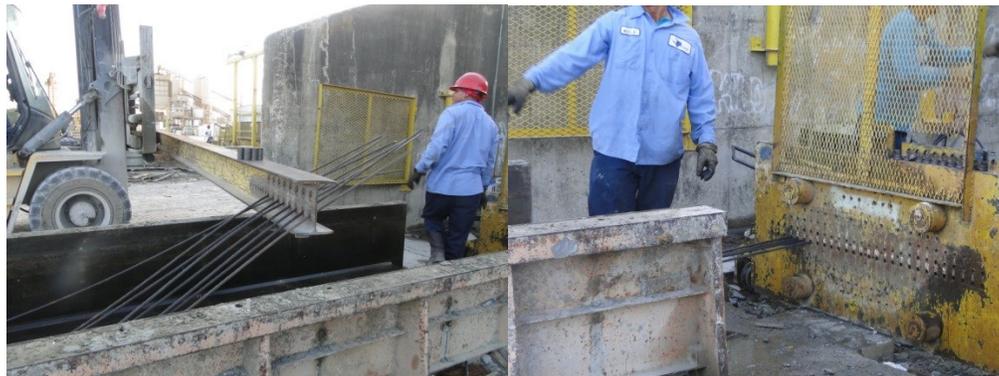
Figure 232. Prestressing of strands

The beams were fabricated at Flexicore of Texas located in Pearland, TX. First, the prestressing bed was cleaned and sprayed with water due to the high temperatures on the day of casting. The prestressing strands were then drawn and stressed at a jacking force of 31 kips per strand. The longitudinal reinforcement was then placed in the bed as well as the end mat reinforcement. The Bars C were then positioned at a spacing of 6 in. whereas Bars U were placed at a spacing of 9 in. Strain gauges were installed on the longitudinal reinforcement and on Bars C so as to monitor the strains on the bars. The reinforcement layout is as shown in Figure 231. The horizontal shear reinforcement at both ends of the beam and the center were strain gauged on both sides of the bar. Cylinders were also made to test the compressive strength of the mix after 28 days.

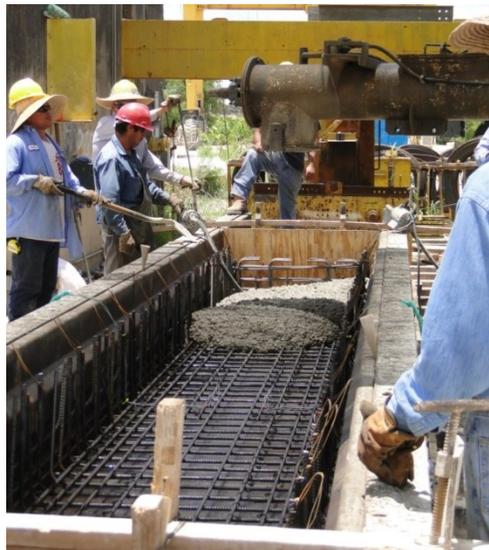
Figure 240. Concrete pouring

The concrete mix used was chosen according to TxDOT specifications. Box and slab beams are typically cast with concrete class “H”, while the CIP slab is cast with concrete class “S”. The two box beams were cast in two sections. After the bottom reinforcement was placed, the concrete was poured to a height of 5 in. after which Styrofoam was placed to create the hollow section of the box beam (Figure 240 to Figure 242).

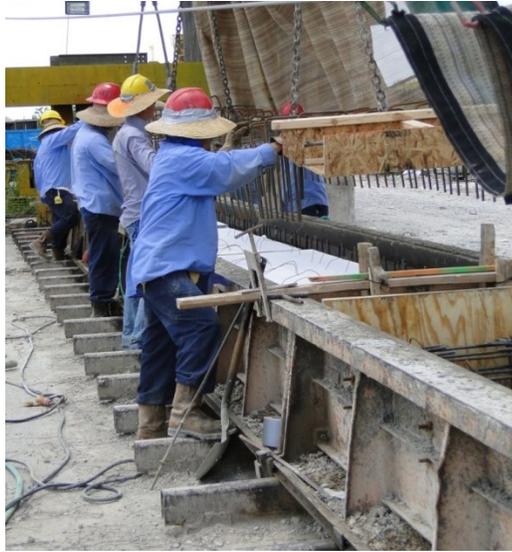
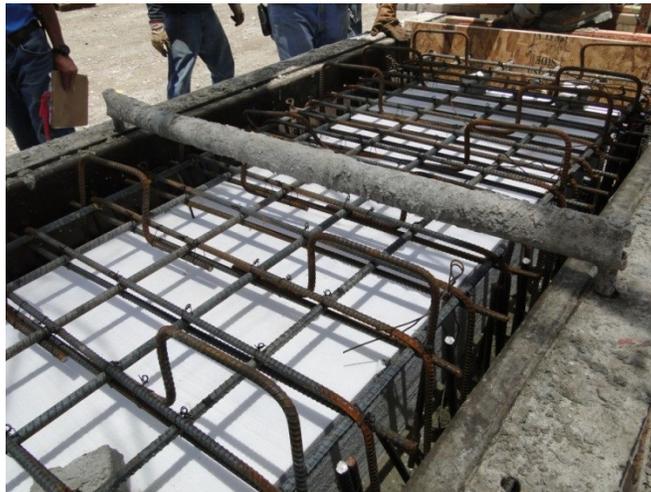
Figure 243. Top reinforcement for box beam with horizontal shear reinforcement

The reinforcement cage for the top portion of the box beam was then placed using a crane and concrete poured to the top of the box beams. As the concrete was poured the horizontal shear reinforcement was adjusted to its correct location and the surface was initially finished using a wood float.

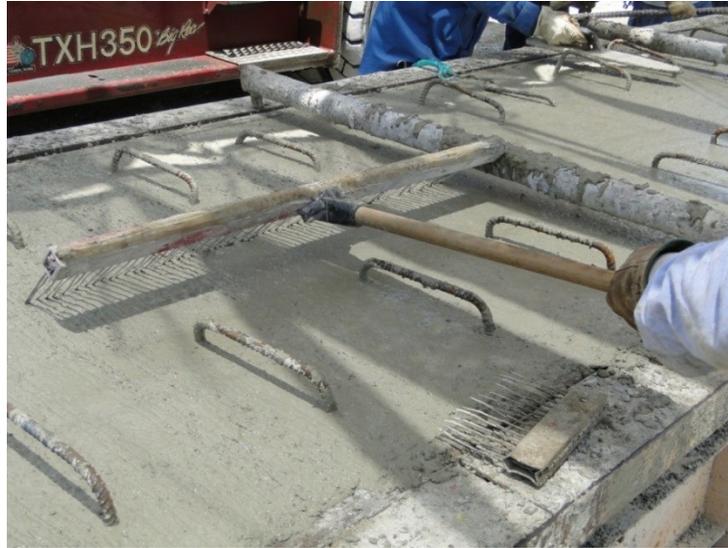
Figure 246. Rake finish

Flexicore of Texas provides a rake finish to all their box and slab beams therefore a rake finish was provided on all of the Task 6 beam specimens to simulate what is typically done in practice. The rake was passed through the wet concrete surface transverse to the beam length as demonstrated in Figure 246.

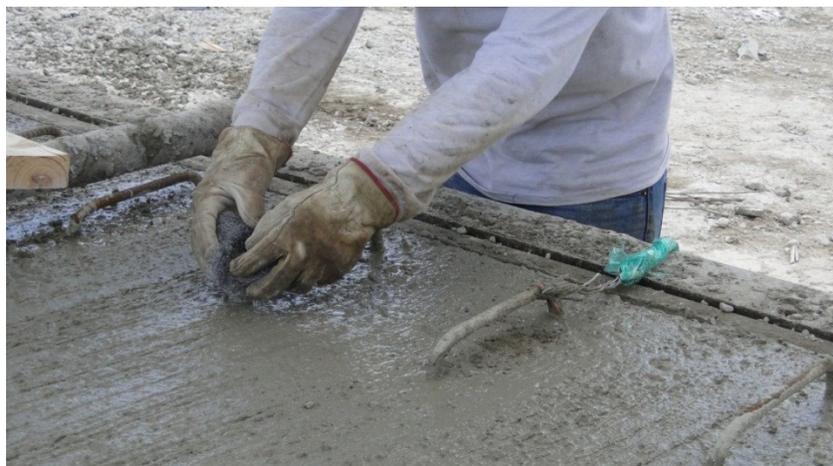
Figure 247. Cleaning of horizontal shear reinforcement

After placing, the horizontal shear reinforcements were then lightly scrubbed by a steel wool to remove concrete from their surfaces.

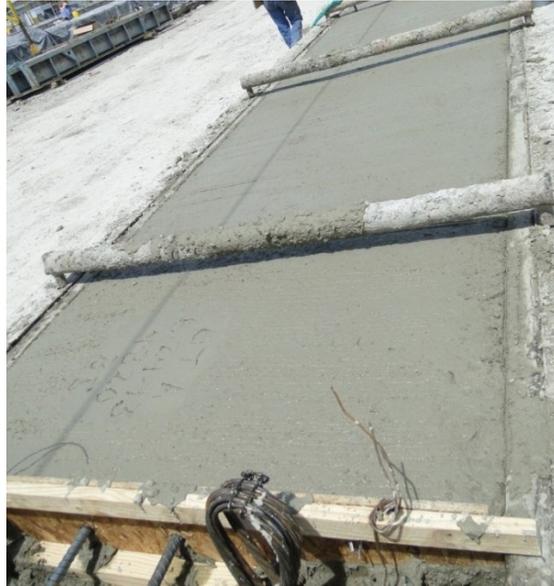
Figure 248. Finished box beam

The specimens were then covered to avoid moisture loss during curing. The prestressing strands were cut the next day and the beam specimens demolded for storage. The concrete strength after 28 days was 11 ksi for the precast box beams.

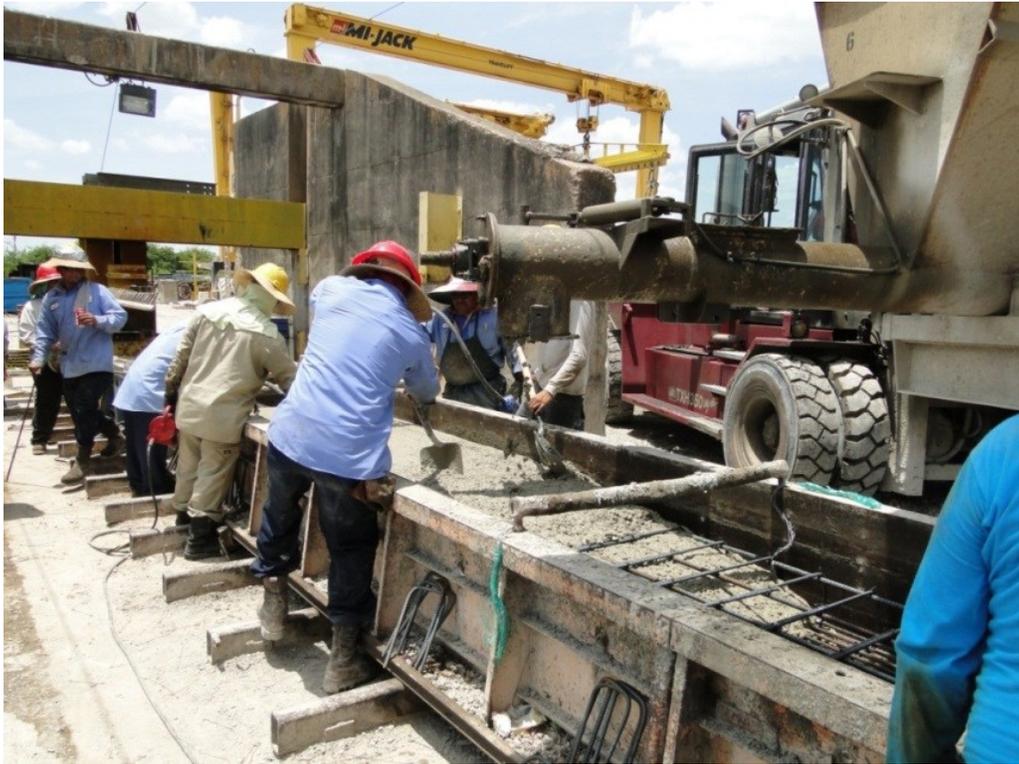
Figure 258. Slab beam casting

The concrete was cast using Class “H” concrete mix according to TxDOT specifications. The slab beams were cast in one single pour. A rake finish was applied on the wet concrete surface in the transverse direction before the beams were covered for curing.

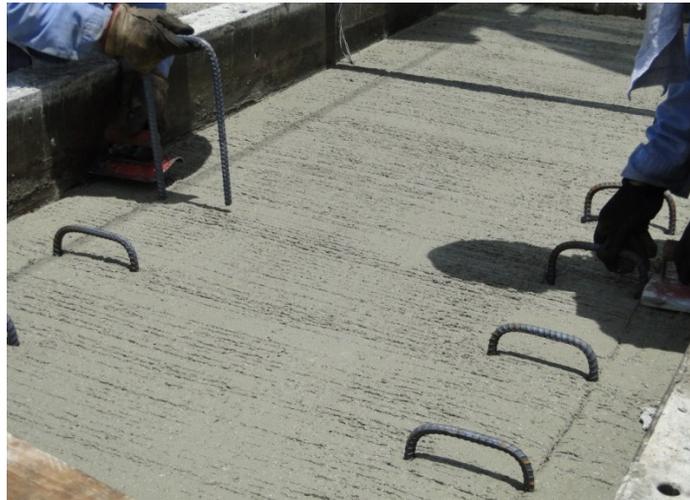
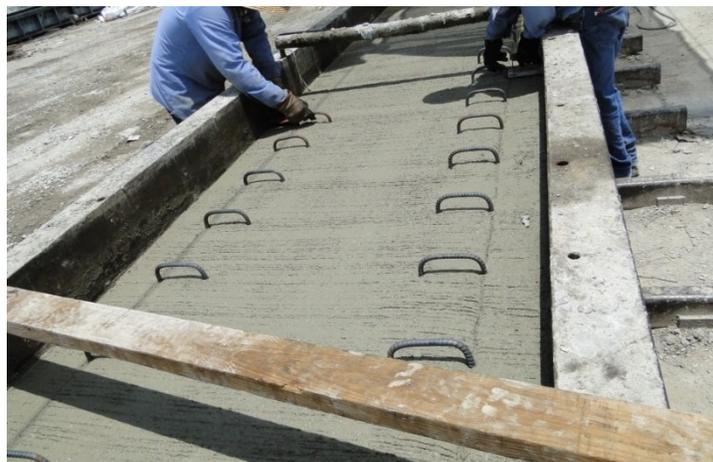
Figure 260. Placing of horizontal shear reinforcement

A longitudinal line was then made on the wet concrete at 6 in. from the edge to mark the position where the horizontal shear reinforcement would be placed. The horizontal shear reinforcement bars were then pushed into the wet concrete until a height of 2 in. remained above the concrete surface (Figure 260). The concrete strength after 28 days was 10 ksi for the precast slab beams.

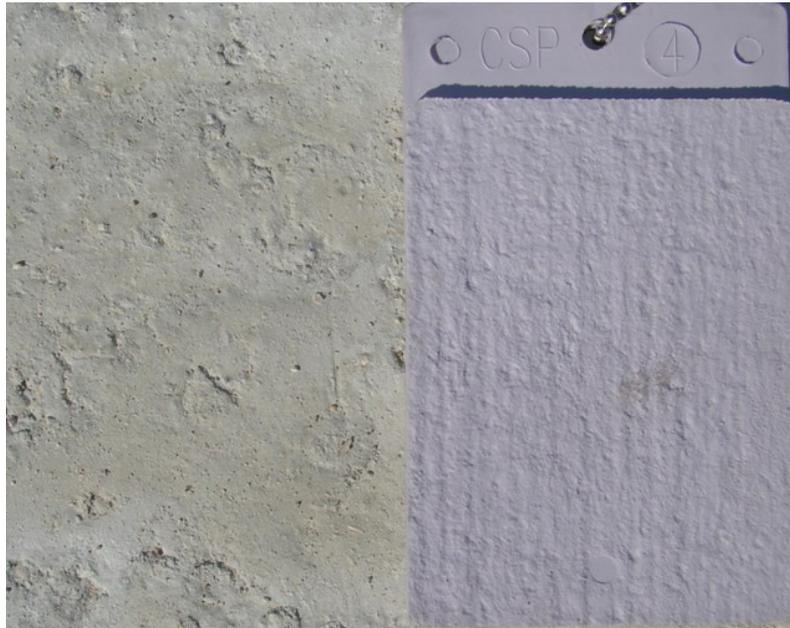
TxDOT is also pushing towards the use of self-consolidating concrete (SCC) on precast beams although it has not yet been widely accepted by fabricators. However, on our visit to Texas Prestressed Concrete plant, we observed that they do use SCC on their slab beams. It was observed that a wood float finish on SCC slab beams resulted in a much smoother interface (Figure 283) comparable to a CSP 4. There is currently no known research that investigates the horizontal shear resistance of beams constructed with SCC. Therefore, testing SCC beams would provide valuable information to determine the effect of a much smoother interface on the horizontal shear resistance. It should also be noted that although AASHTO recommends a cohesion factor of 0.28 ksi for a surface roughened to an amplitude of 0.25 in., it does not address the fact that a smoother interface may result from the use of SCC. Consequently, there is no cohesion and friction factor suggested in the case where SCC is used.

Figure 283. Surface finish on SCC slab beams comparable to CSP 4
