PERFORMANCE OF FULL-SCALE ULTRA-HIGH PERFORMANCE FIBER-
REINFORCED CONCRETE COLUMN SUBJECTED TO EXTREME EARTHQUAKE-
TYPE LOADING AND EFFECT OF SURFACE PREPARATION ON THE COHESION
AND FRICTION FACTORS OF THE AASHTO INTERFACE SHEAR EQUATION

MASTER OF SCIENCE IN CIVIL ENGINEERING

THE UNIVERSITY OF TEXAS AT ARLINGTON

May 2015

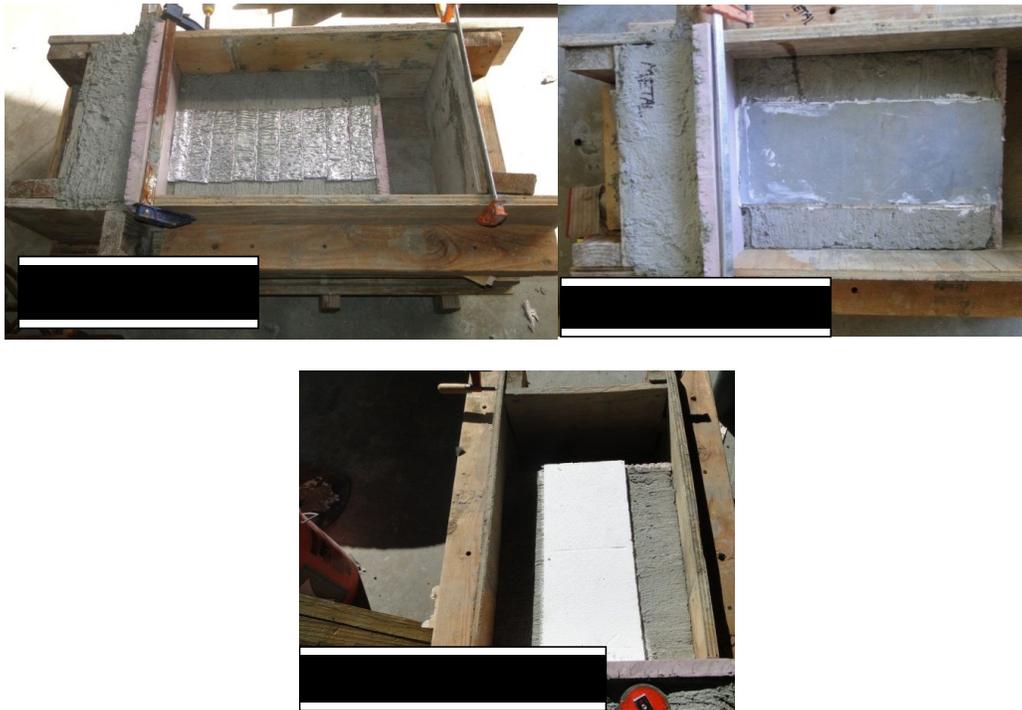
To ensure that the full-scale beams fail by horizontal shear, it is necessary to reduce the interface shear resistance by reducing the interface area. Three methods were attempted for reducing the interface area; using aluminum strips, using Styrofoam, or using a polyethylene foam tape at the interface to prevent contact between the precast beam and the CIP slab. The most suitable method will be the one providing the least resistance to sliding. Push-off specimens were therefore cast with the each different method to determine the best to use for the full-scale precast beams.

Figure 285. Push-off specimen with (a) foam tape, (b) aluminum strip and (c) Styrofoam to reduce interface area

The foam tape was found to provide less resistance to sliding compared to the steel plate and the Styrofoam. Foam tape was therefore chosen to reduce interface area on the full-scale specimens (Figure 286).

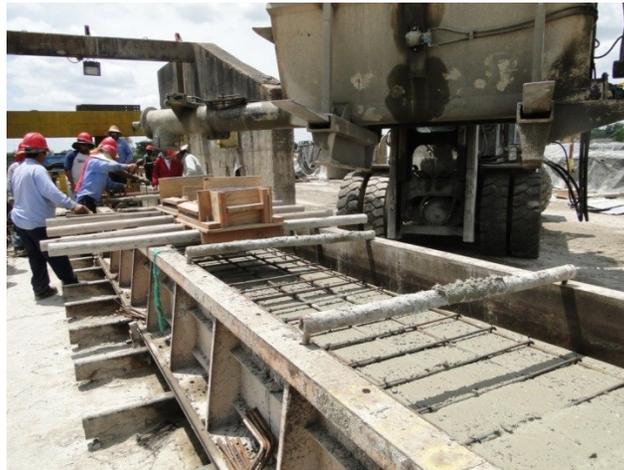
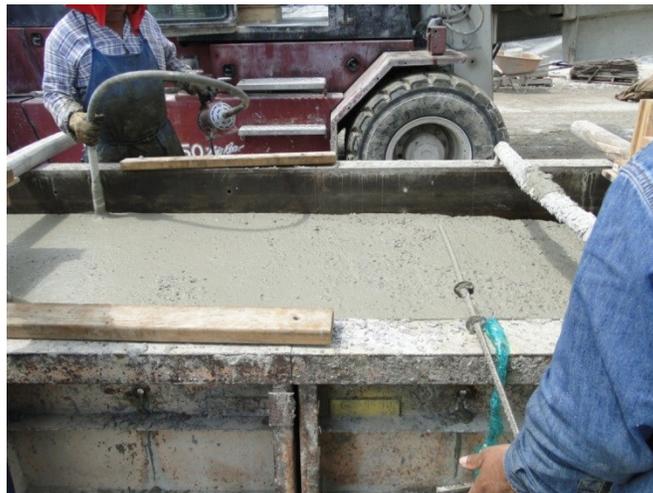
Figure 292. SCC slab beam casting

The concrete mix used was chosen according to TxDOT specifications as mentioned earlier. Slab beam were cast in a single pour and a wood float finish provided at the surface. One of the slab beams was cast with SCC typically used in precast panels.

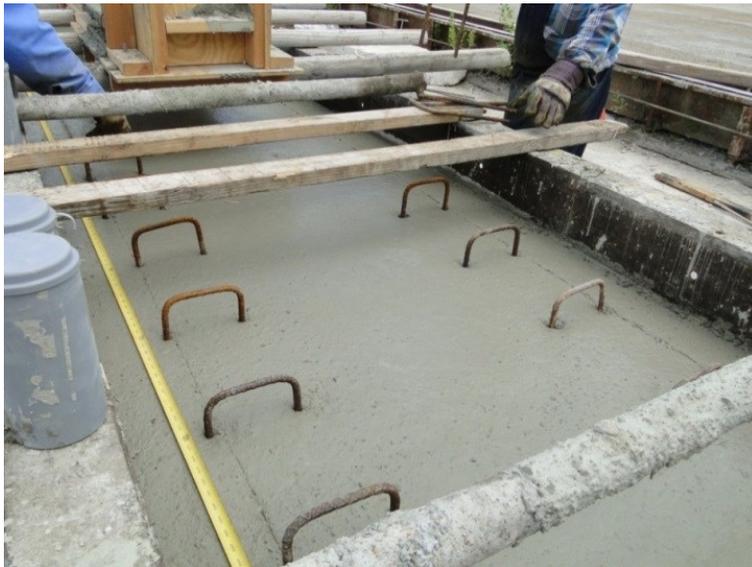
Figure 294. Placing of horizontal shear reinforcement

A longitudinal line was then made on the wet concrete at 6 in. from the edge to mark the position of the horizontal shear reinforcement. The horizontal reinforcements were then pushed into the wet concrete to a height of 2 in. from the concrete surface (Figure 294).

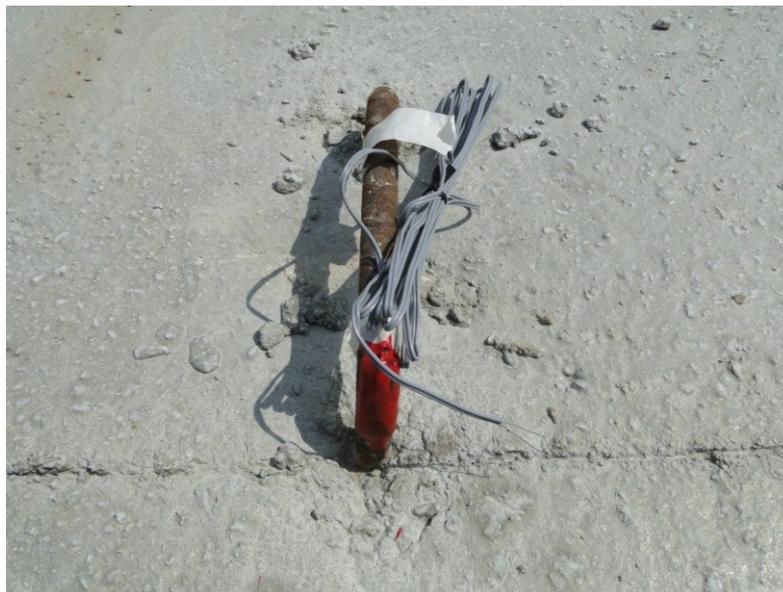
Figure 300. Strain gauges installation on horizontal shear reinforcements

Strain gauges were installed on the horizontal shear reinforcement prior casting of the CIP slab. The foam tape was then placed on the surface of the beam to reduce the interface area to 12 in. It was placed in two layers to guarantee that no tear will occur during casting of the CIP slab.

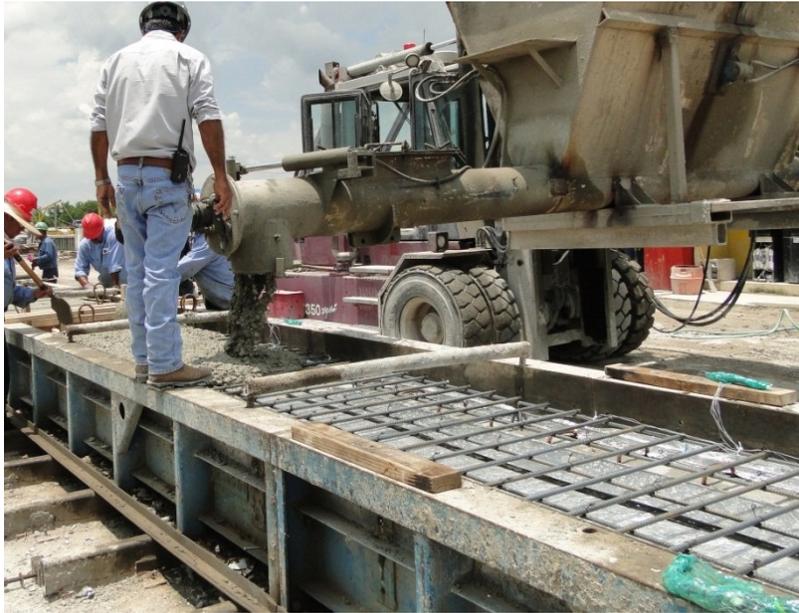
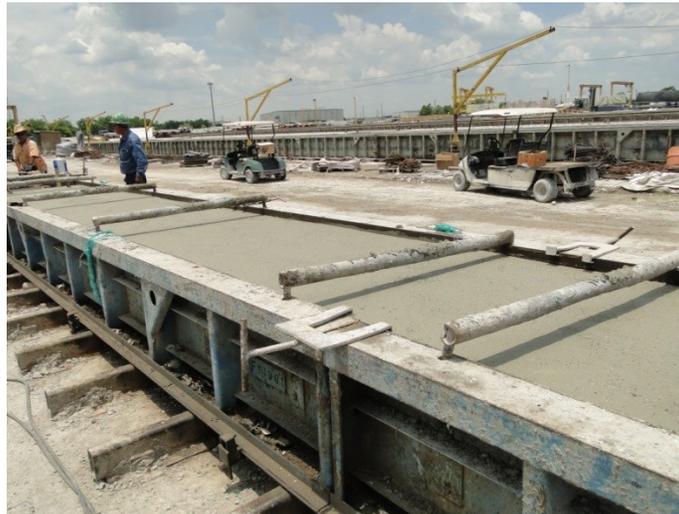
Figure 302. Casting of the CIP slab

The reinforcement for the CIP was consistent with that used on actual bridges. Surfaces of the precast beam were cleaned to remove dust and dirt particles before casting. The reinforcement cage (Figure 302 and Figure 303) was then placed and the concrete (Class "S") was cast as shown below.

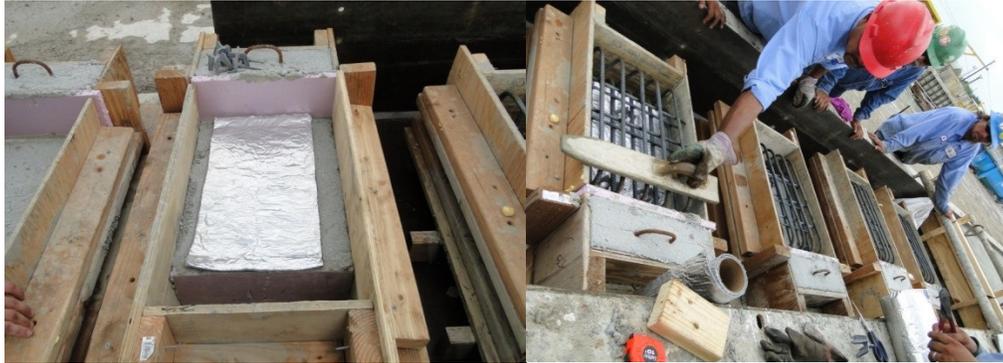
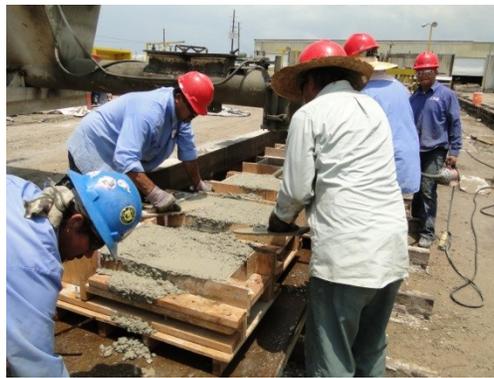
Figure 303. Casting of the push-off specimens

Push-off specimens were also cast to determine the friction between the tape and the concrete. Six specimens were cast in which two had no tape at the interface while the rest had foam tape at the interface to reduce the interface area.

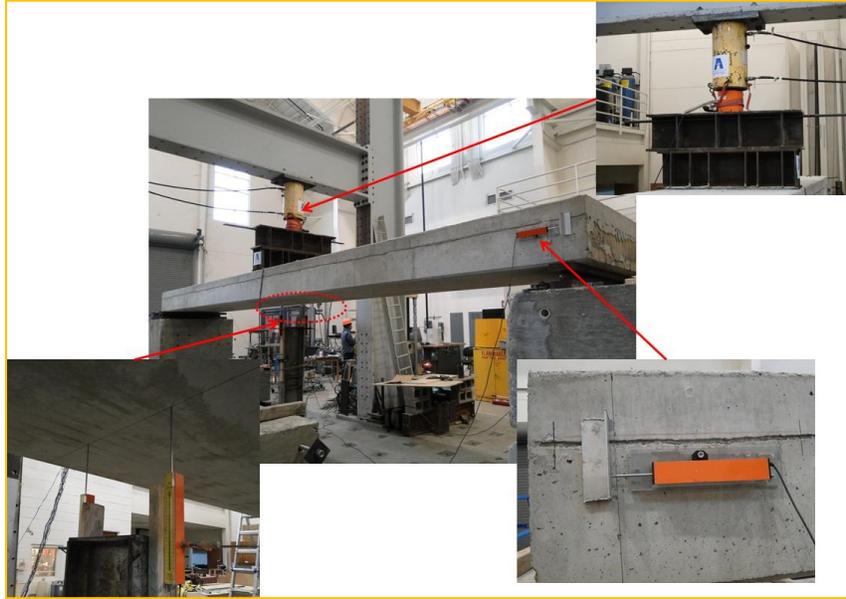
Figure 306. Test setup: LVDT's and loading beams

Four LVDT's were placed to measure the slip at each end of the beam. Two LVDT's were placed at the center to measure the displacement of the beam. The load was then applied at the center of the beam at different intervals.

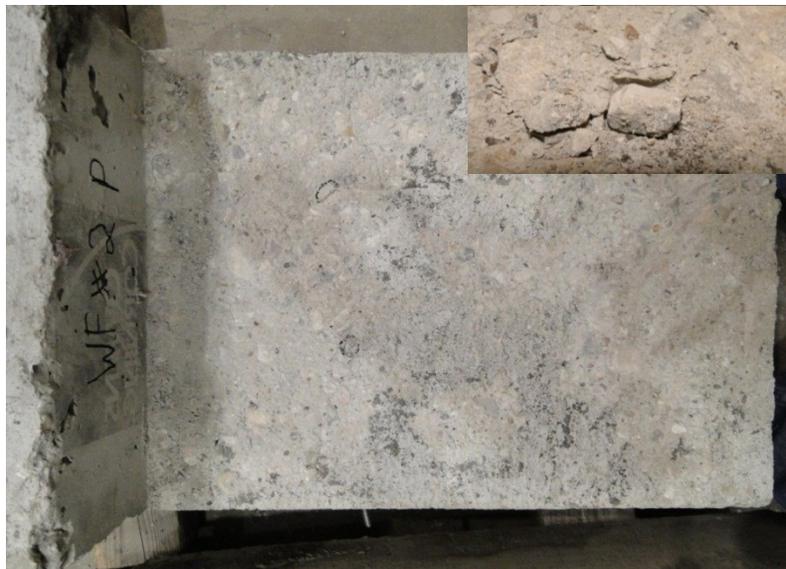
Figure 309. Precast failure plane showing dislodged aggregate

All three wood float finish specimens failed at the interface as seen in Figure 308. There was however some disparity in the shear stress recorded for the three wood float specimens. It was also noticed that some aggregates were dislodged (Figure 309) from the concrete when the precast part was observed after failure. The specimens with the dislodged aggregates showed a higher shear stress compared to the specimens with no visible aggregate dislodgement indicating that a stronger bond was created when there was adequate contact between the exposed aggregate of the precast segment and the concrete matrix of the CIP segment. The average shear stress was however 60% lower than that suggested by AASHTO (2014) (Figure 313).

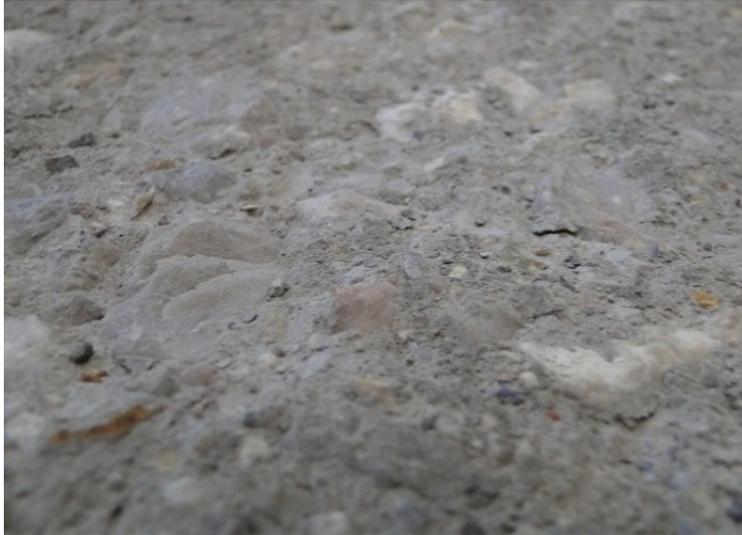
Figure 310. CSP 6 Specimen precast surface profile

An increase in shear stress was observed in the CSP 6 specimens where an average cohesion factor of 0.20 ksi was recorded. The surface of the precast segment of

the CSP 6 specimen exhibited more aggregate exposure however very minor aggregate dislodgement was observed (Figure 310). The overall roughness was still relatively minor compared to that of the other CSPs.

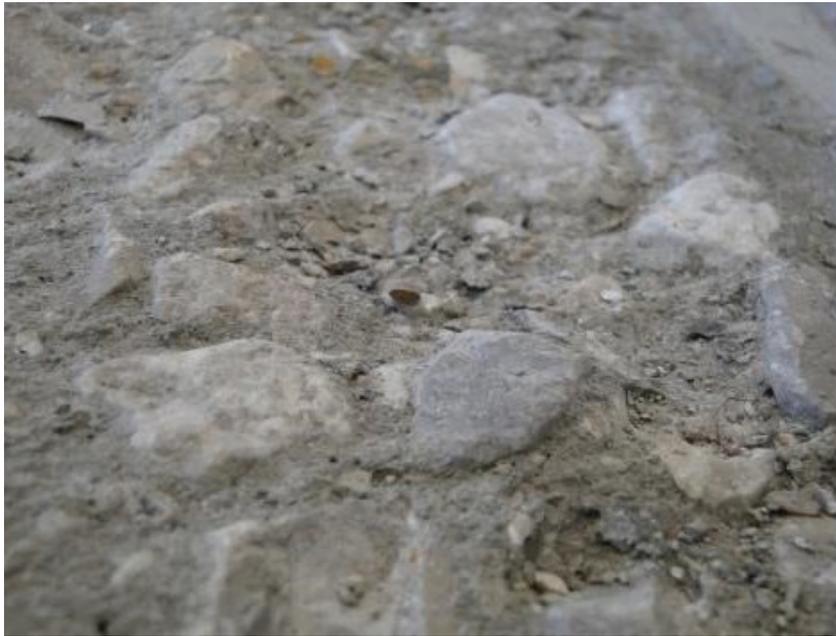
Figure 312. CSP 9 specimen surface profile

a rough surface with many protrusions and visible aggregate surfaces (Figure 312); however the cohesion values still remained well below the 0.28 ksi suggested by AASHTO (2014) (Figure 313). Overall, the cohesion factors for the different CSP profiles were all very similar averaging a shear stress of 0.21 ksi, suggesting that the cohesion factor cannot be further increased by increasing the level of surface roughness but the strength of the concrete matrix and its ability to bond the exposed aggregates.

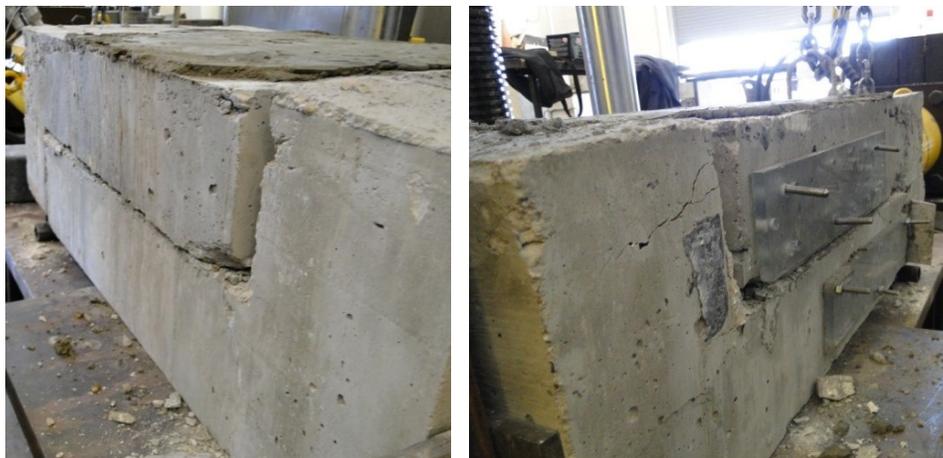
Figure 314. Typical failure mode

Table 23 were obtained by using the average cohesion factors (c) for each respective surface type from Task 2 together with the failure load from Task 3 and the applied 20 kip normal force (P_c), to calculate the friction factor (μ) as per the AASHTO (2014) nominal interface shear equation. As previously mentioned, it is important to observe the behavior of the wood float finish as it is the most common surface preparation method used in precast plants across the nation. The wood float specimens failed at an average load of 53 kips resulting in a friction factor of 0.85, lower than $\mu = 1.0$ specified in AASHTO Section 5.8.4.3 for a surface roughened to an amplitude of 0.25 in. The same issue experienced with the wood float specimens of Task 2 was observed once again where disparity was seen between the test results where two of the specimens had lower shear strength than the other. It was noticed that some aggregates were dislodged from the concrete in the precast after failure. Dark areas on the surface seem to indicate that there was lack of contact between the precast and CIP part of the specimen (Figure 315). Hence the whole interface area was not utilized leading to lower interface shear strength. The two specimens having a low shear stress were observed to have failure surfaces that were quite smooth after failure indicating there was not much aggregate interaction.

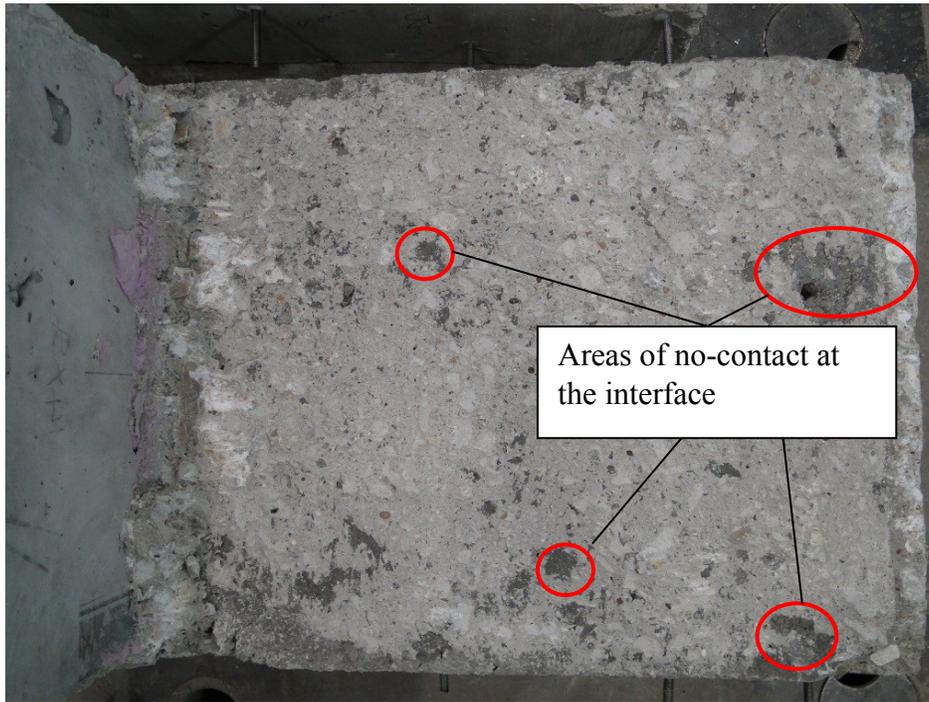
Figure 315. Interface after failure showing area of no-contact

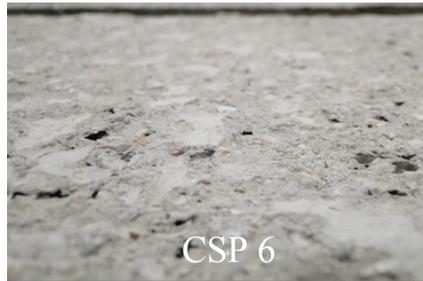
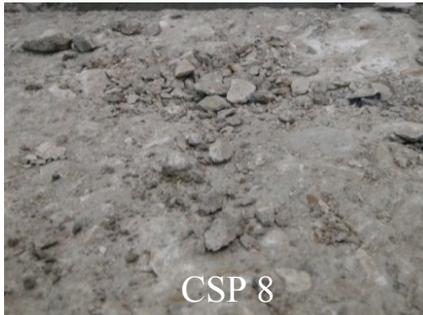
Figure 316. Task 3: horizontal push-off tested specimens (a) CSP 6 (b) CSP 8

The results for the CSP 6 specimens had much higher consistency in shear strengths for all three specimens. All the three specimens failed at the interface with an average peak load of 71.4 kips resulting in a friction factor of 1.0 equivalent to that suggested by AASHTO (2014). After failure the precast segment of the CSP 6 specimen was observed to have a relatively smooth surface with few protrusions from dislodged aggregates (Figure 316(a)). CSP 7 specimens showed significantly more interaction at the interface with aggregate fracture and pullout. Fracture of concrete from the CIP part was also observed in some specimens. The CSP 7 specimens failed at the interface at an average peak load of 85.6 kips which resulted in a friction factor of 1.4. Two of the CSP 8 specimens failed at exactly the interface while the third failed out of the interface suggesting that the bond on the interface was very strong. As the surface roughness increased so did the friction factor. The average peak load for the CSP 8 specimens was

88.9 kips which translates into a friction factor of 1.8. Considerable aggregate pullout and fracture was observed on the surface of the precast specimens of CSP 8 (Figure 316). A progressive increase in the friction factor was observed from CSP 6 to CSP 8 with CSP 8 and CSP 9 registering the same friction factor. Furthermore, the friction factor was seen to increase only to a certain extent in surface amplitude, also suggesting that the friction factor is limited by the strength of the concrete matrix. CSP 8 and CSP 9 recorded the highest friction factor of 1.8 which is 80% higher than the highest recommended by AASHTO for “normal-weight concrete placed monolithically” (Figure 317).

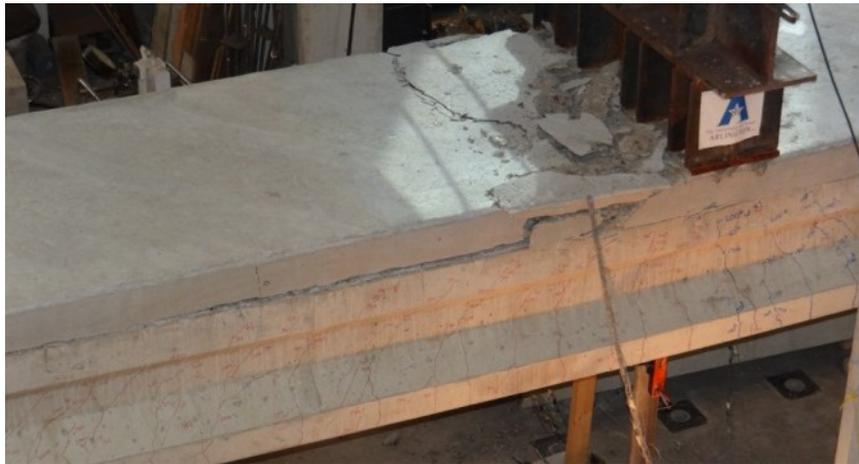
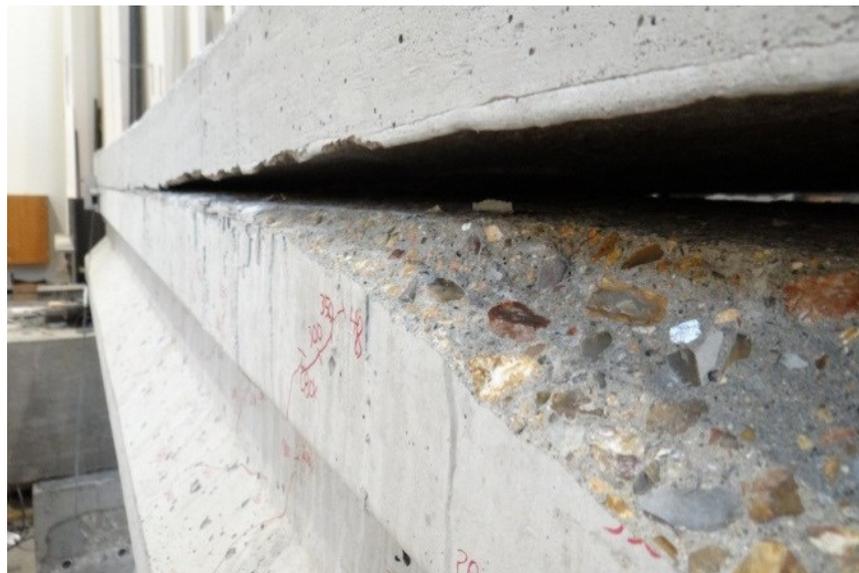
Figure 318. Flexural/ horizontal shear failure near midspan

The first flexural crack in the box beam specimen was observed at 110 kips. At a load of 170 kips, flexural cracks had progressed reaching the interface of the CIP slab and the precast beam. Cracks of 1.0 mm in width were recorded with some spalling being observed. At 189 kips, the cracks progressed into the CIP slab with crack widths as wide as 1.5 mm. It should be noted that the flexural cracks did not propagate along the interface but instead passed through the interface into the CIP slab. The beam failed in flexure due to concrete crushing in the compression zone within the CIP slab (Figure 318). No cracking was observed within the interface of the prestressed beam and the CIP slab.

being observed. At a load of 350 kips, the cracks had progressed up to the interface of the CIP and precast sections. Initial crushing of the concrete under the loading point was observed at 400 kips. With increase in load, the concrete crushed and the cracking propagated into the interface leading to a sudden horizontal shear failure. However, the horizontal shear crack did not propagate the entire length of the beam. Therefore no slip was recorded by the LVDTs at the ends.

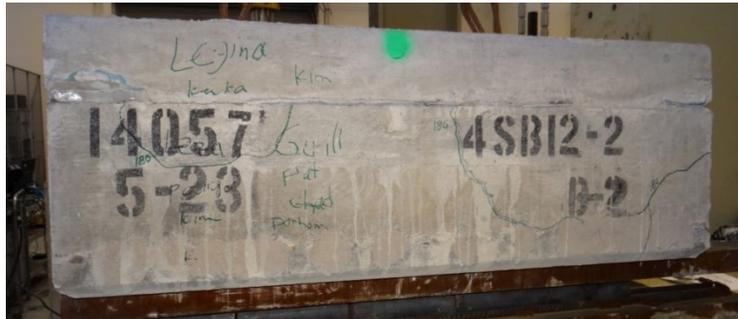
Figure 320. Crack at the interface widens at 180 kips

The load was first applied at 5 to 10 kips interval until the first flexural crack was observed at 55 kips, near the mid-span of the beam. With continued increase in applied load, the crack was observed to progress towards the top of the beam. Also more cracks began to form along the length of the beam and also at the bottom of the beam. The crack width also increased gradually. The crack continued to progress towards the interface with every increment in load up to a load of 120 kips. The crack did not continue propagating towards the interface with further increase in the load. However, an increase in the strain in the horizontal shear reinforcements was observed at 150 kips, and yielding of the horizontal shear reinforcements at the quarter span in the West-end of the beam was also observed. At a load of 160 kips, the strain on the horizontal shear reinforcement increased and yielding was observed on the horizontal shear reinforcement located at the beam ends. At 170 kips and a midspan displacement of 3.6 in., slip was recorded at the East-end of the beam with an increase in the crack width at that end of the beam. With the development of shear cracks at the beam ends, the strain on the horizontal shear reinforcement continued to increase. The width of the flexural cracks increased to 1 mm. At a displacement of 5.24 in. and a load of 180 kips (Figure 320), the slip at the East-end increased to 0.15 in. with an increase in the crack width at the interface. Fracture of the concrete was also observed on the East-end of the beam. The beam failed in flexure at a load of 181 kips and a displacement of 6.65 in. (Figure 321). Crushing of concrete occurred near the loading point and the flexural cracks significantly widened to more than 6 mm. A separation between the CIP slab and the precast beam was also observed with a slip of 0.15 in. being recorded (Figure 322). From

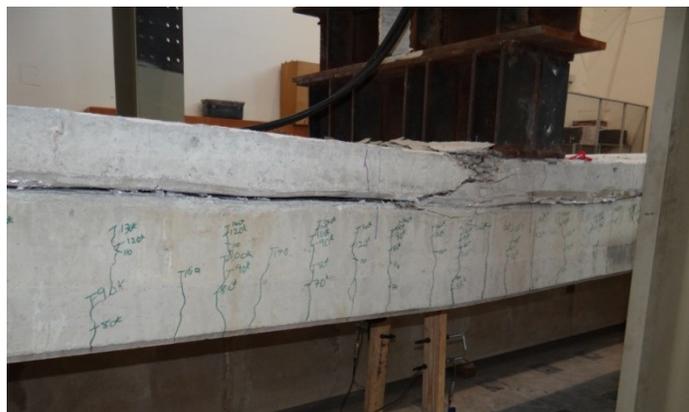
Figure 321. Beam at failure

strain gauge information of the horizontal shear reinforcement, it was clear that almost all the horizontal shear reinforcement had yielded at this point.

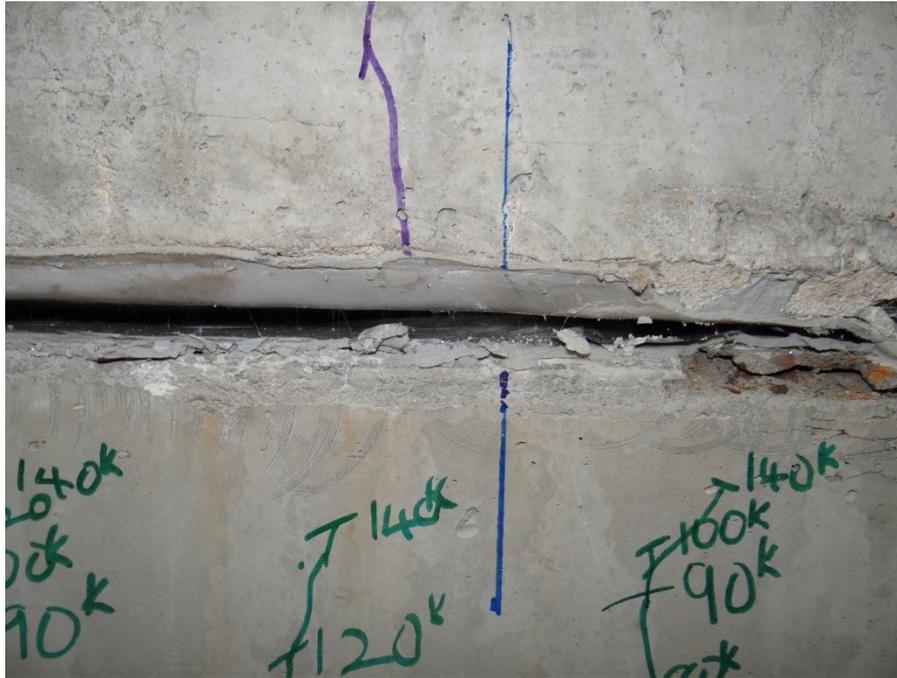
Figure 322. Separation of the interface at failure

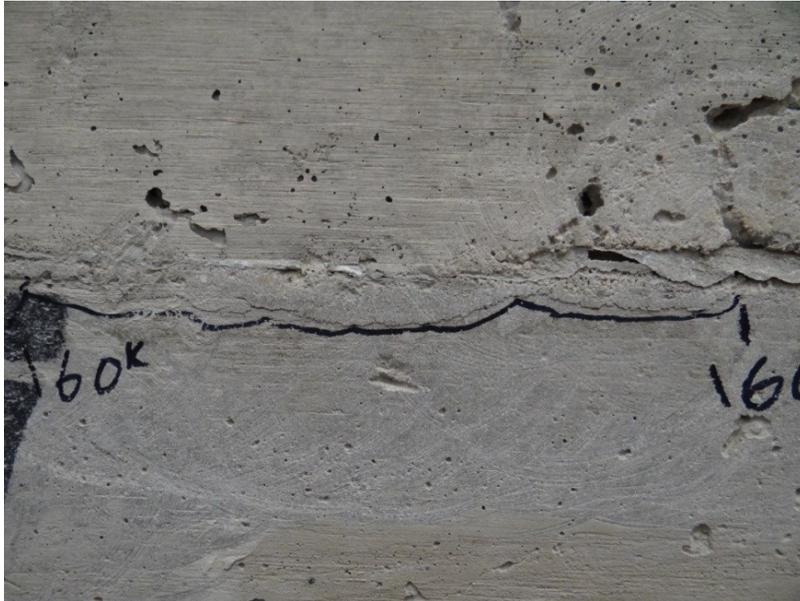
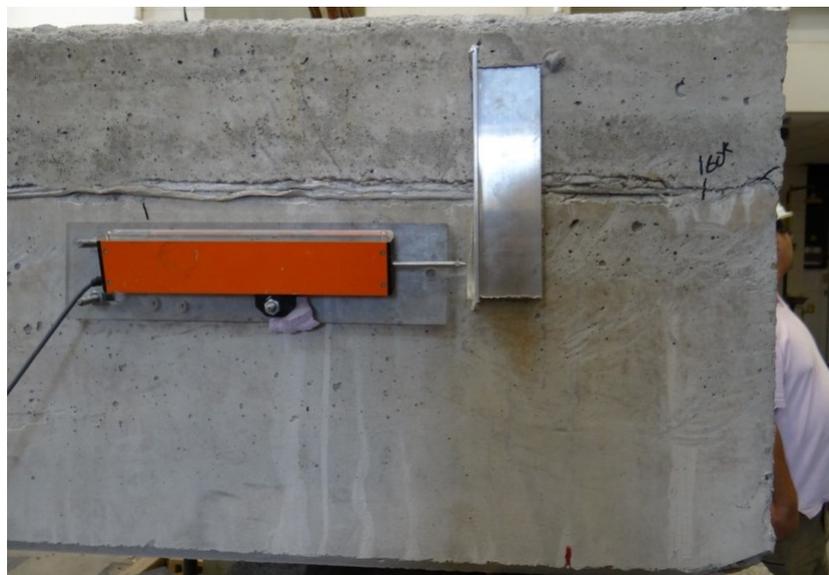
Figure 323. Visible interface cracks at beam ends

Slip gradually increased as the load was increased and at a load of 160 kips, a slip of 0.015 in. was recorded. Horizontal shear reinforcement near the support yielded at

this point including the longitudinal reinforcement. Cracks at the interface became noticeably larger at both ends of the beam (Figure 323).

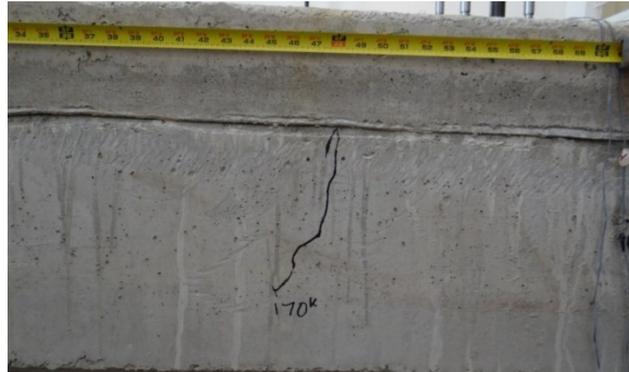
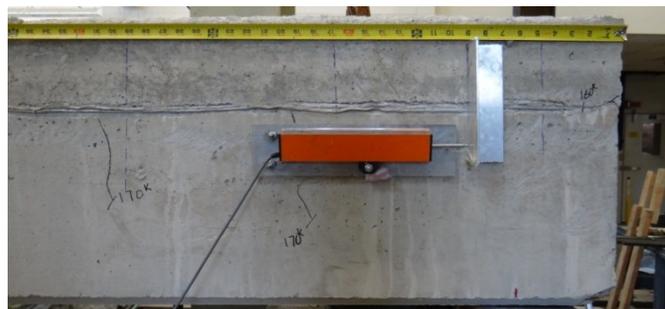
Figure 324. Vertical cracks close to beam ends

Cracks propagating from the interface towards the bottom of the beam started to appear at a load of 170 kips (Figure 324). The crack positions were approximately at the location of horizontal shear reinforcement.

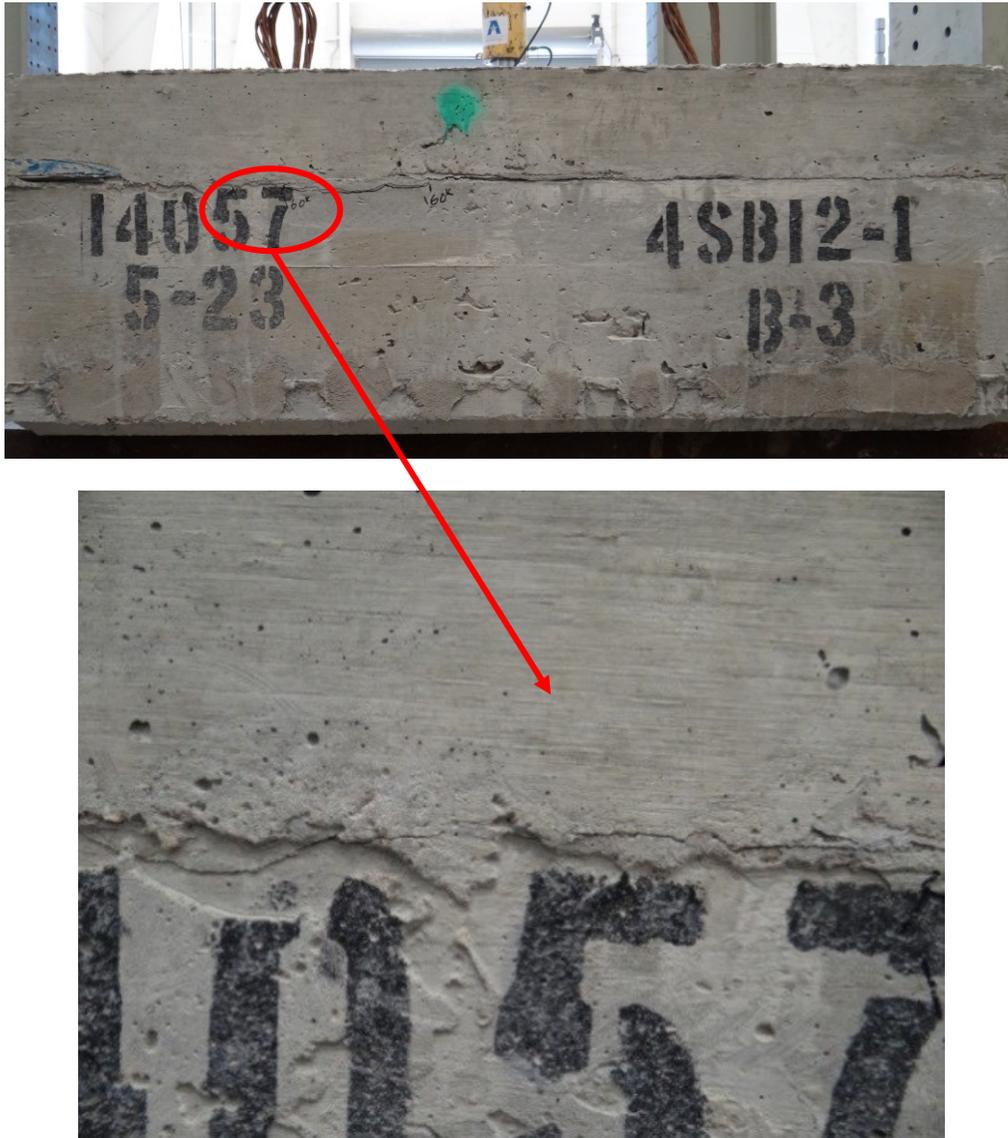
Figure 325. Interface cracks at beam ends

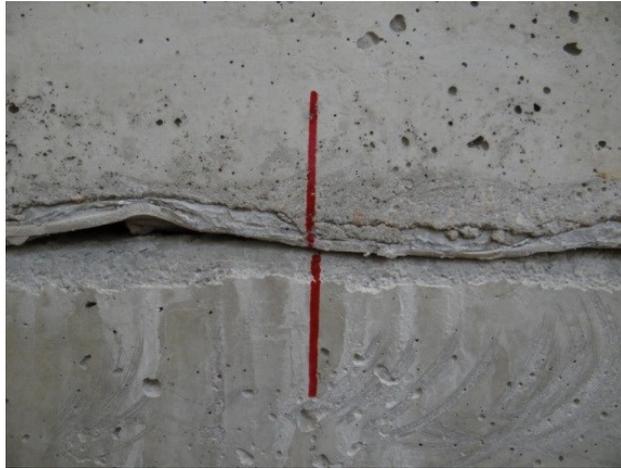
Figure 326. Interface slip at 180 kips

Cracks at the beam ends and the interface were also observed to widen with increase in load (Figure 325), as well as an increase in slip at a load of 180 kips as demonstrated by the red line in Figure 326.

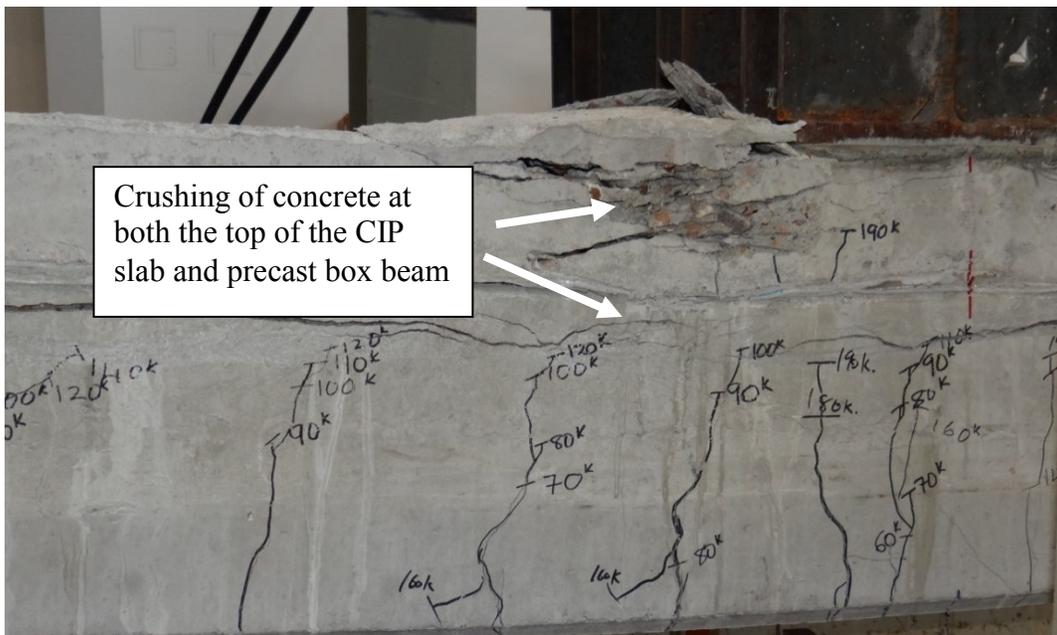
Figure 328. Crushing of concrete at failure

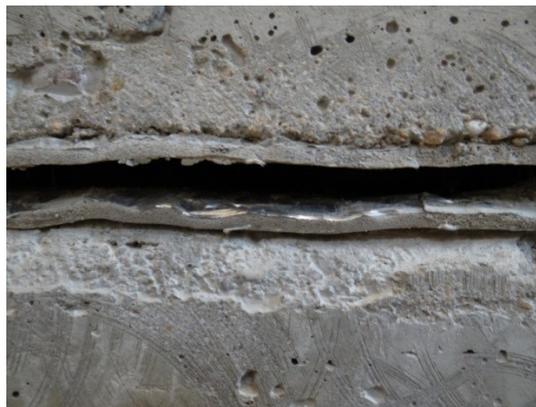
Figure 329. Separation between CIP slab and precast beam

The beam failed by flexure at a load of 191.7 kips with crushing of the concrete under the loading point. A slip of 0.12 in. was recorded. Crushing of concrete was however observed on both the CIP slab and the precast beam (Figure 328). The wide crack opening at the interface (Figure 329) and the concrete crushing at both the slab and the beam indicated that the composite action is partly lost.

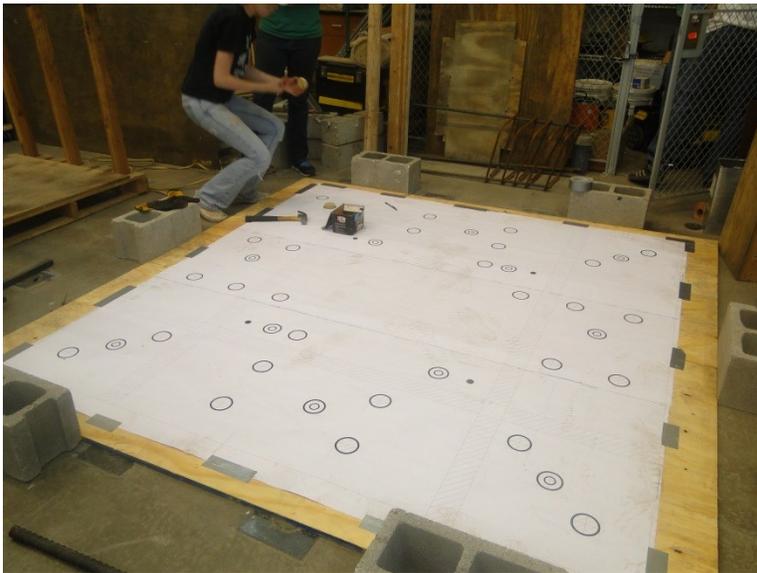
Figure 5. Printed out drawing placed on plywood with duct tape.

Print the construction drawings shown in Figure 3 to scale and carefully place the drawings on the sheets of plywood. This may be done using small nails at the corners or duct tape along the edges to make sure that the sheet lies completely flat as shown in Figure 4 and Figure 5.

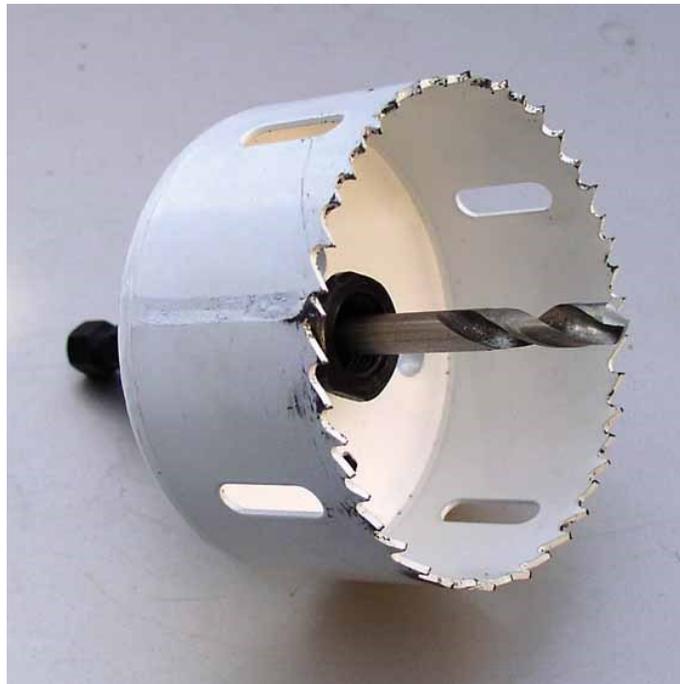
Figure 6. Hole drill bit used for making discs

important that the pvc pipes do not move and remain perfectly vertical so to prevent any instillation problems during the testing of the column. The discs are made of ply wood (of any thickness greater than 1/8") using hole drill bits of 2" and 2.5" similar to the one shown in Figure 6. Each hole drill bit corresponds to each size of pipe used in the bottom block. The hole drill bit is attached to the drill shown in Figure 7 and a piece of wood is placed underneath so as to not damage the drill during cutting. The wooden discs are then cut by turning on the drill and slowly lowering the knobl while holding the plywood in place as shown in Figure 7. Repeat this until all the discs have been cut. Figure 8 shows all of the cut discs.

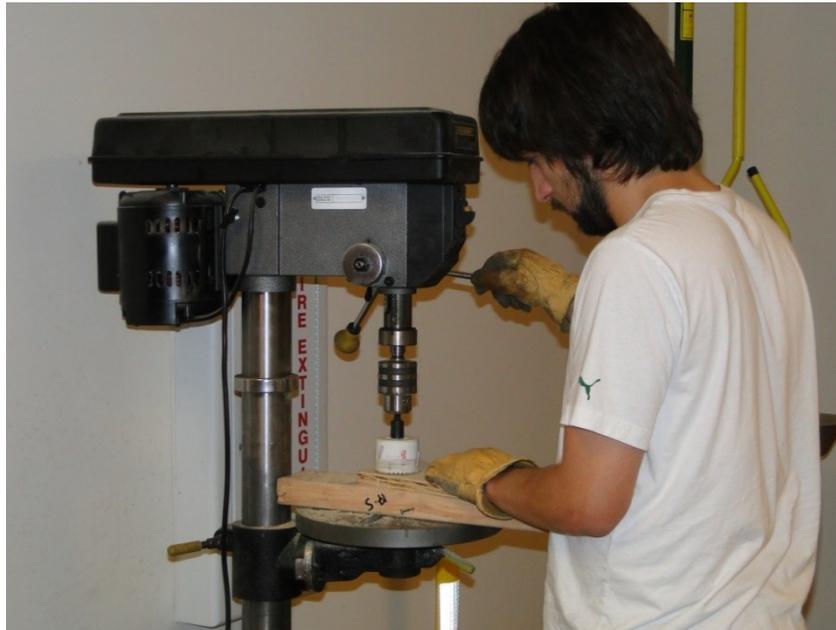
Figure 7. Cutting the wooden discs

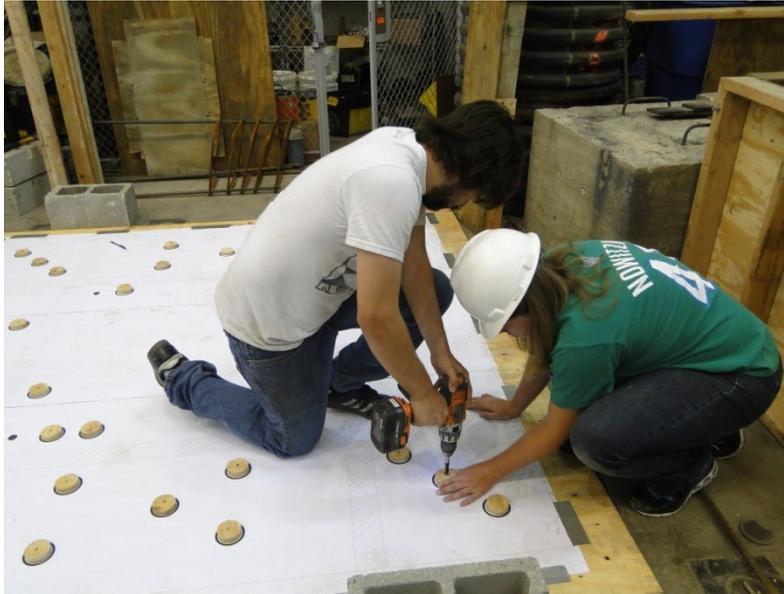
Figure 10. Drilling the wooden discs to the plywood

After all of the wooden discs have been made they should be placed in the center of the circles shown on the drawings (Figure 9). All of the wooden discs are then drilled to the plywood using small 1 inch screws as shown in Figure 10 and Figure 11. This should be done very carefully as the location of the discs will be used as a reference during the rest of the construction.

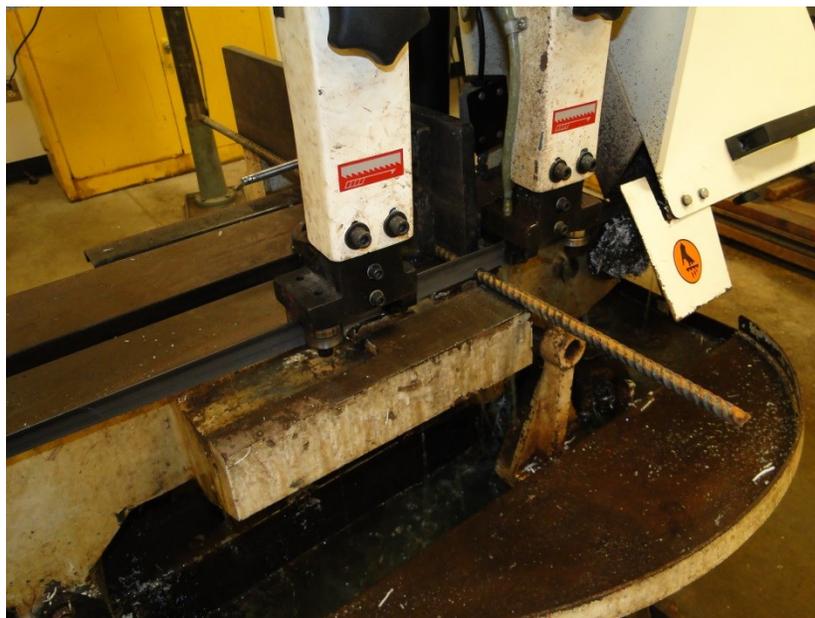
Figure 13. Cutting reinforcing bars for bottom block grid

cutting the pvc pipes as the length of the pvc pipes will also be used as a guide during the construction of the bottom block cage. The pipes will be cut using a ban saw as shown in Figure 13. Two sets of 30" pipes will be cut. One of 2" diameter pipes that will be used for grouting during the instillation of the column on the test setup and another set of 2.5" pipes that will be used for post tensioning during transportation and to anchor the column to the test setup. Also 4 84" pipes of 2.5" diameter will be cut and placed in the column cage horizontally for the lifting and transportation purposes. Next, the pipes must be taped at one end to prevent concrete from seeping through the inside of the pipe. Also tape must be provided around the bottom edge that will sit on top of the disc for a better contact grip that will keep the pipe in place. The long horizontal pipes must be taped completely on both ends to prevent the concrete from entering. All of the 30" pvc pipes may now be placed on top of the discs as shown in Figure 16, while the 84" horizontal pipes are set aside to be used later on (Figure 15). During this step it is also necessary to cut the 4 1-1/8" post tensioning rods that will be inserted in the bottom block for the use of post tensioning during transportation. The rods should also be cut very carefully at the steel setting a very slow speed. The 4 rods should be cut at a length of 33" in which 3" will stick out above the footing enough for the coupler to be inserted. Also, the reinforcing bars (No. 3 and No. 4) are cut to provide a grid in which to secure the pvc pipes and place the top layer of reinforcement as shown in Figure 22 and Figure 23.

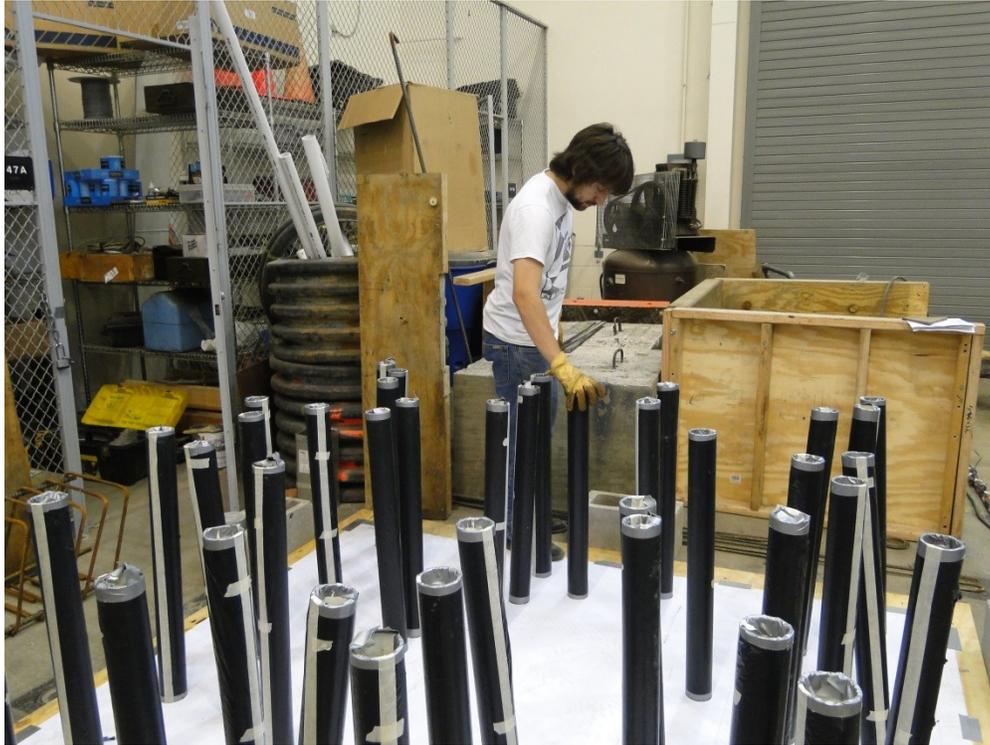
Figure 16. Placing of the pvc pipes on the wooden discs.

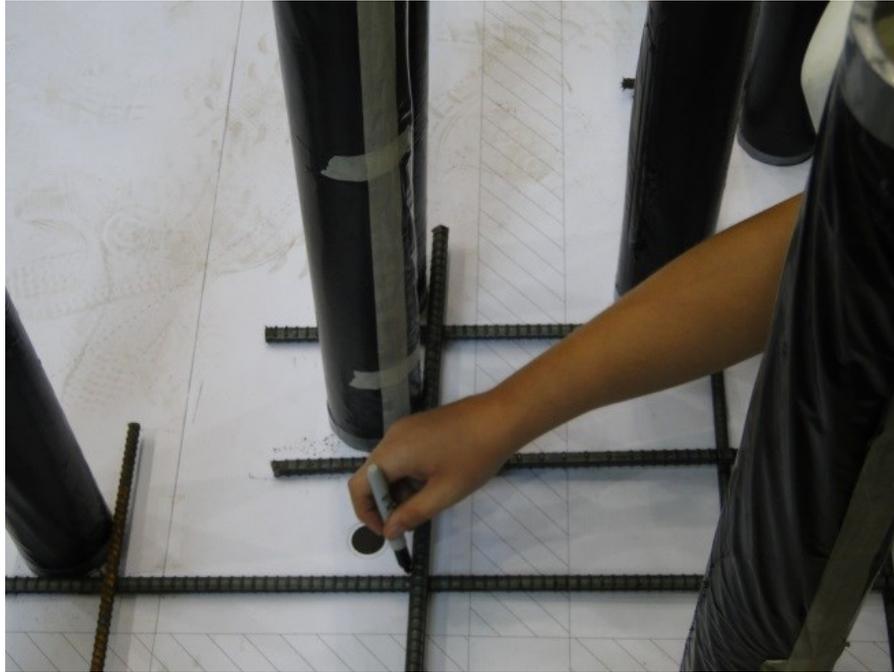
Figure 17. The four outside bars of the grid

Now that the pvc pipes have been placed and the reinforcing bars have been cut, the next step is to construct the grid for the bottom block. First the 4 outside bars are laid out. Next lay out the rest of the reinforcement into a grid form in which there will be at least one corner where to tie the pvc pipe once it is raised as shown in Figure 17 and Figure 18. After the grid has been laid out, mark the locations of the reinforcing bars on the paper as well as the intersection in which where to weld as shown in Figure 19 and Figure 20. Figure 21 shows all of the reinforcing bars laid out, marked and ready to be welded. Next carefully weld the reinforcement grid as shown in Figure 22. Once the flat grid has been welded, add reinforcing bars vertically to raise it to the correct height. This may be done with 2 cinder blocks. Reinforcing bars may then be added in the bottom to stabilize the grid as shown in Figure 23.

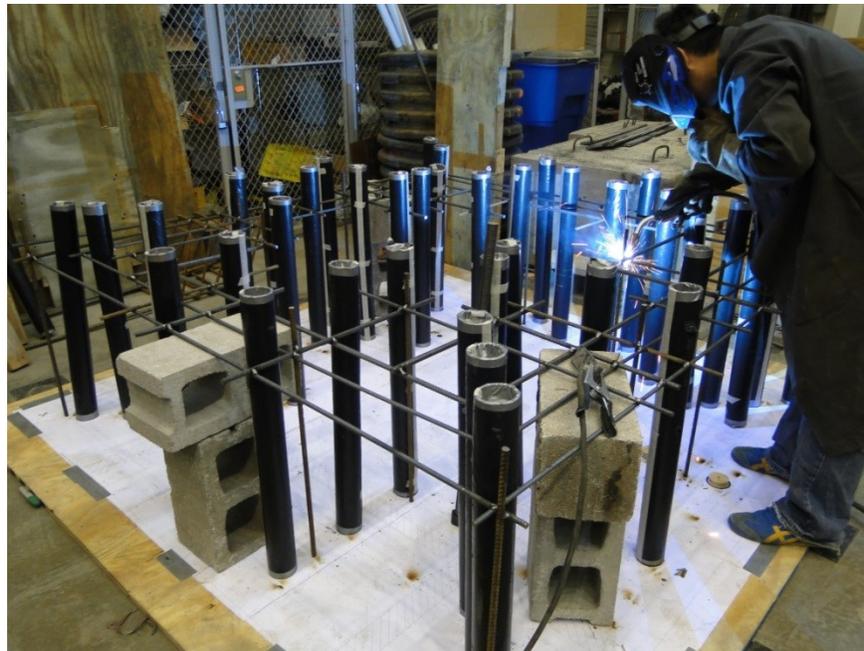
Figure 22. Raising and welding the reinforcement grid.

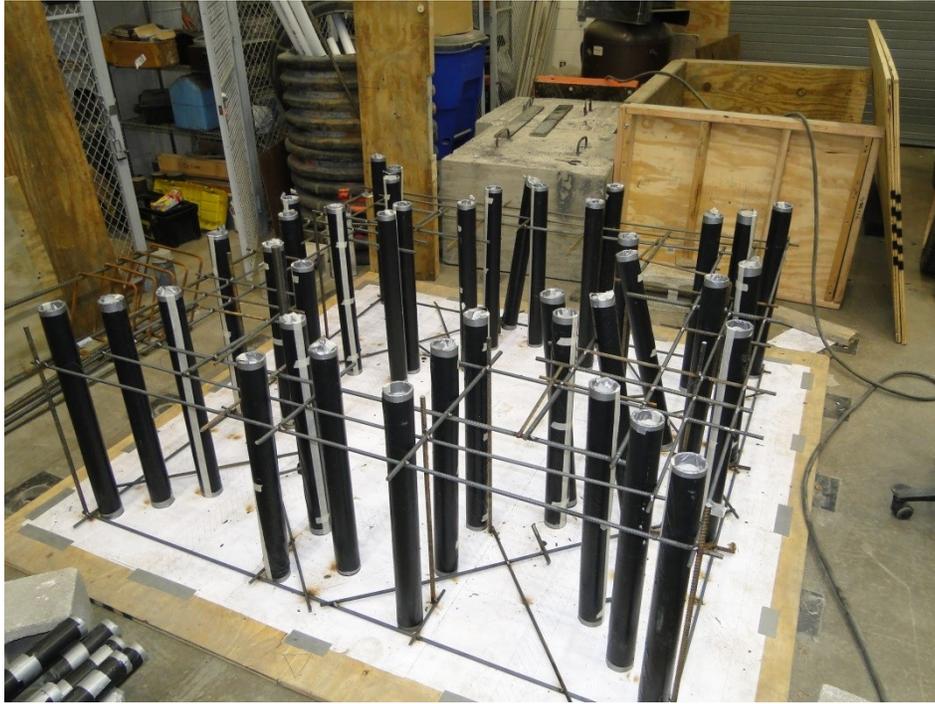
Figure 23. Final bottom block reinforcing bar grid.
