PERFORMANCE OF FULL-SCALE ULTRA-HIGH PERFORMANCE FIBER-
REINFORCED CONCRETE COLUMN SUBJECTED TO EXTREME EARTHQUAKE-
TYPE LOADING AND EFFECT OF SURFACE PREPARATION ON THE COHESION
AND FRICTION FACTORS OF THE AASHTO INTERFACE SHEAR EQUATION

MASTER OF SCIENCE IN CIVIL ENGINEERING

THE UNIVERSITY OF TEXAS AT ARLINGTON

May 2015

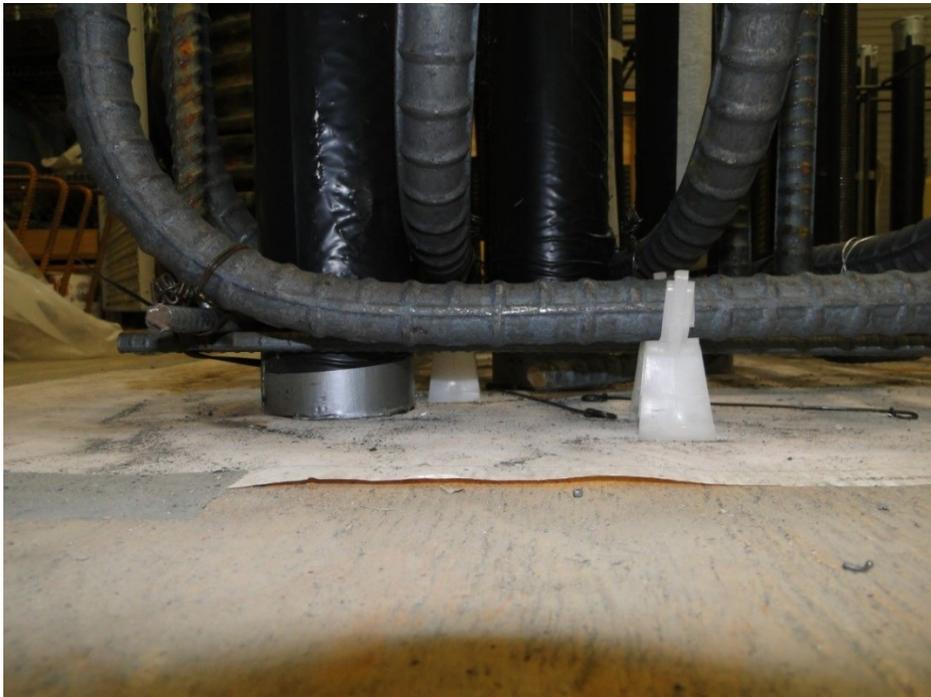
Figure 28. Chairs underneath bottom block for 1 ½ inch cover

Finally we are ready to begin constructing the bottom block cage. The cage will be constructed based on the drawings shown in Figure 24. A 1.5" cover is required at the bottom of the block from the phase of the reinforcing bar to the outside phase of the bottom block. This will be accomplished by the use of rebar chairs as shown in Figure 28 and concrete blocks near the center to support the column cage as shown in Figure 29. First lay the bottom layer of reinforcing bars on the chairs and tie a number three bar at the ends to keep the bars standing straight as displayed in Figure 25. Next lay one U-bar on top of the bottom layer of reinforcement perpendicularly. Continue to place the second layer of reinforcement and tie them in a crisscross pattern to the bottom layer of U-bars, this may be done by hand or using a tie gun as shown in Figure 26 and Figure 27. Next tie the post tensioning rods to both the top and bottom reinforcement ensuring

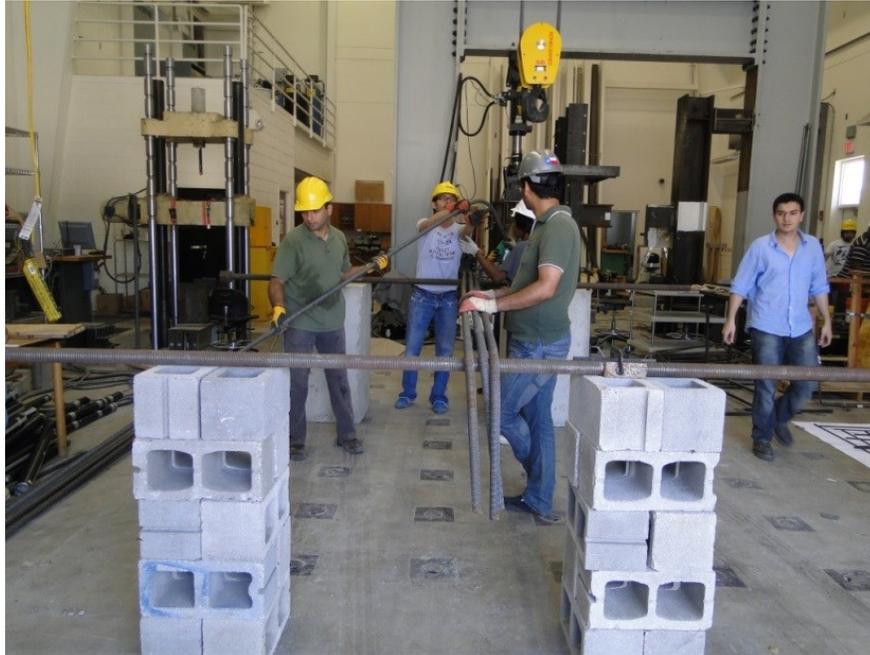
during construction. Now place the top layer of longitudinal reinforcement as shown in Figure 36.

Figure 36. Placement of top layer of longitudinal bars

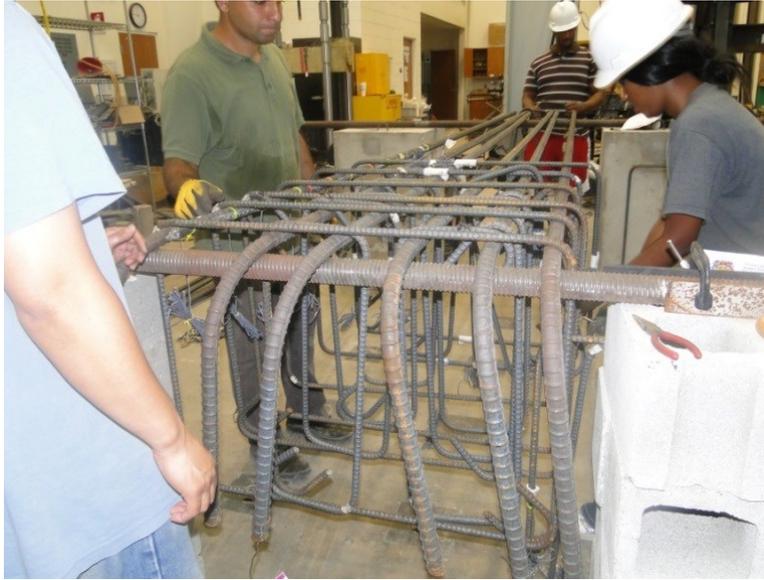
Note that special care should be taken with the bars that already have strain gauges on them to ensure that they are not damaged during the construction process. Once the top layer of longitudinal reinforcement has been placed the hoops may now be inserted in the correct order according to the construction drawings. This is done by lifting the longitudinal bars at the top end and sliding the hoops in the correct order as demonstrated in Figure 37 and Figure 38.

Figure 37. Placing of transverse reinforcement

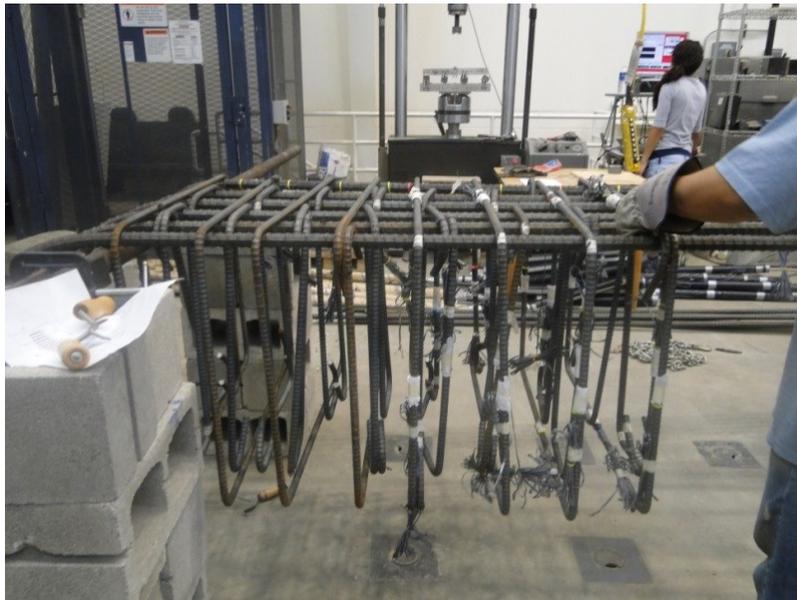
Once again this is done with caution to ensure that the strain gauges on both the longitudinal reinforcement and the transverse reinforcement is not damaged during the construction.

Figure 38. Transverse reinforcement with strain gauges

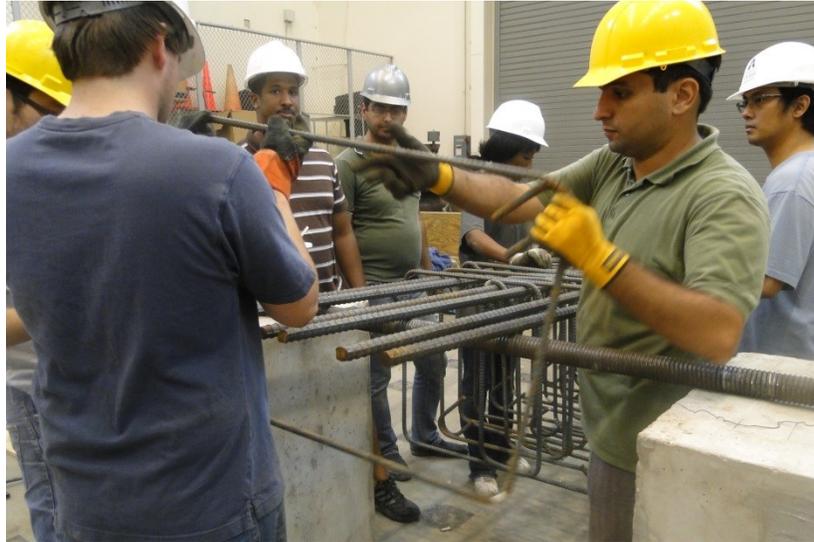
Note that after the 15th hoop the configuration changes from to inner hoops to only one throughout the rest of the column.

Figure 39. Placement of upper hoop configuration

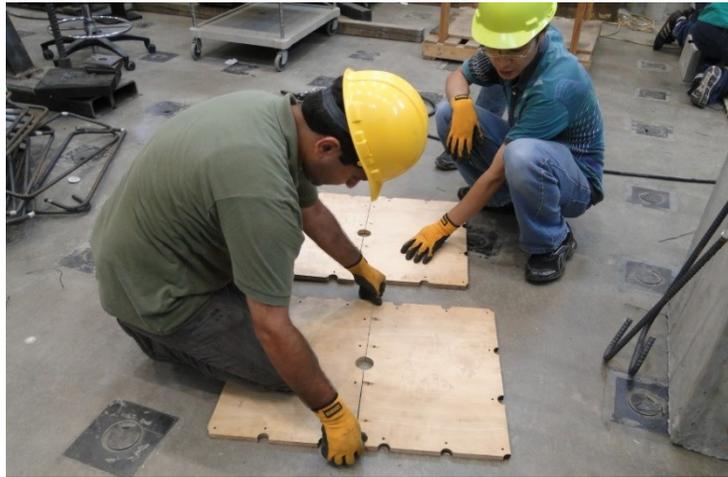
Two wooden templates were made from AutoCAD drawing printouts according to the exact locations of the longitudinal reinforcement. The purpose of these templates to aid in obtaining the correct spacing throughout the column length.

Figure 42. Column templates

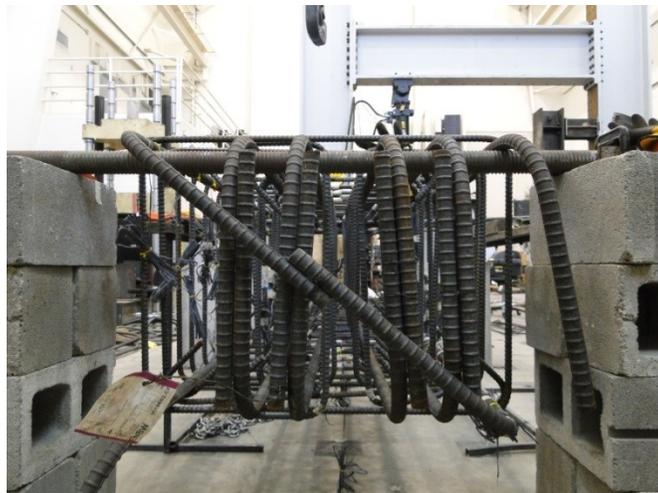
The templates will be placed at both ends so as to maintain the correct spacing. Place one half of a template at the end of the column cage by putting the longitudinal reinforcement through the spaces provided. Simultaneously, arrange the legs of the longitudinal reinforcement and tie them in place at the base of the column cage. The top and bottom layers of longitudinal reinforcement may be tied to one another to the four center bars while the corner bars are tied together.

Figure 43. Tied longitudinal bars at the base of the column

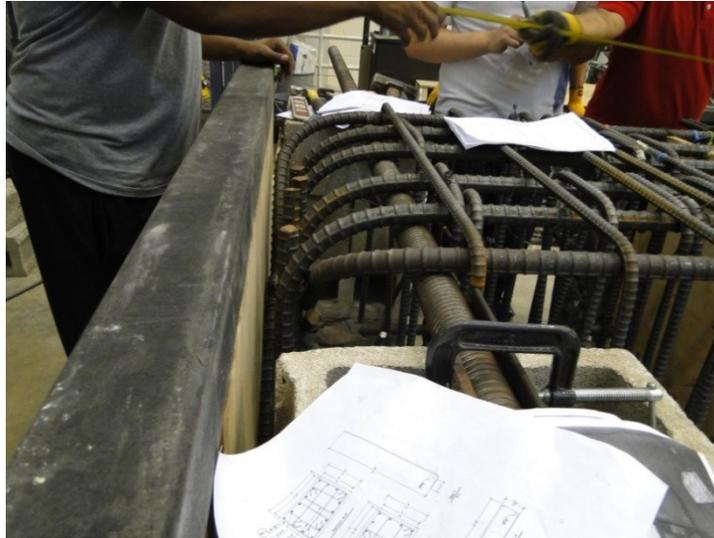
Next, place a flat piece of plywood at the end of the column cage to measure the locations of the hoops relative to the base of the column cage. Make sure that the bottom of the legs of the longitudinal reinforcement is flush with the plywood. Mark the correct location of the hoops according to the drawings.

Figure 46. Marking of hoop location relative to the base.

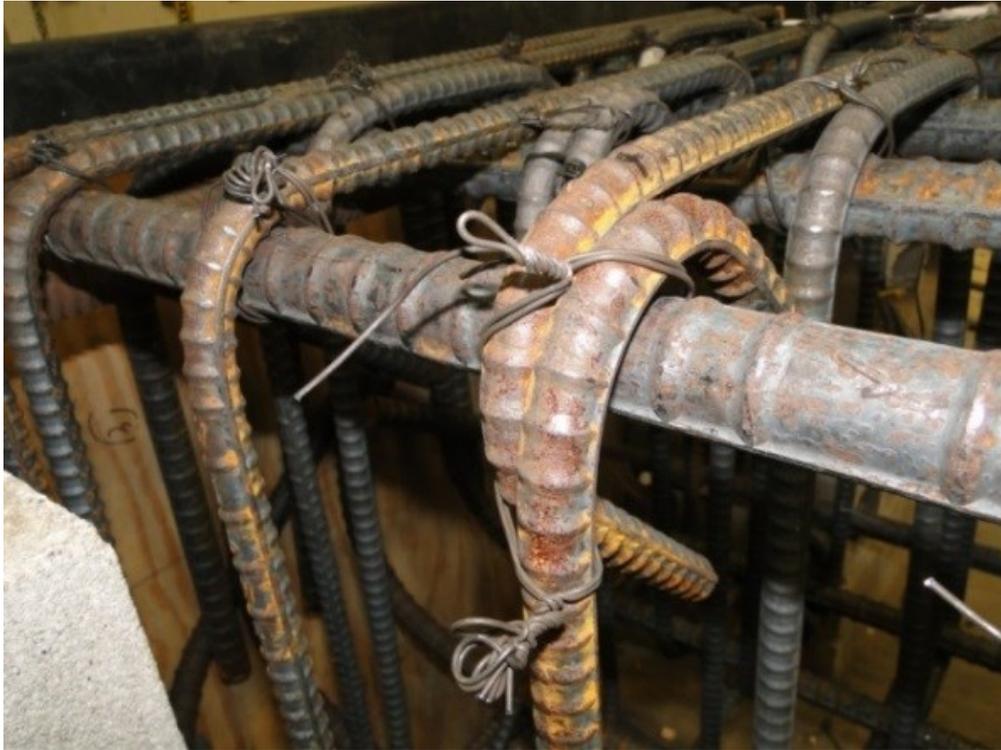
The reinforcement will be tied at each location where reinforcement intersects with tie wire as shown in Figure 48.

Figure 48. Tying of transverse reinforcement

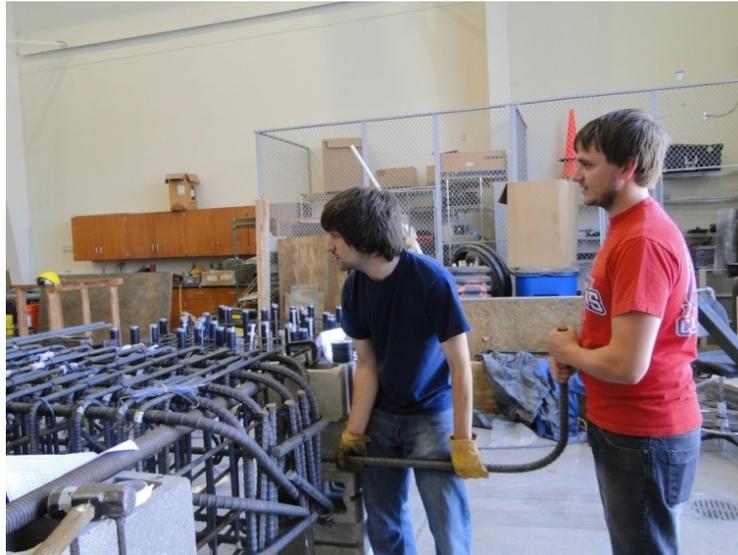
After all of the ties have been tied to the top and bottom layers of longitudinal reinforcement begin to place the longitudinal reinforcement located on the sides of the column cage. First the templates must be removed and placed on the side of the cage. Next begin to place the remaining longitudinal bars while carefully placing the remaining transverse hoops in their correct location and correct configuration. Continue to place all of the longitudinal reinforcement until all of the bars have been placed in the column cage.

Figure 49. Inserting the side longitudinal reinforcement

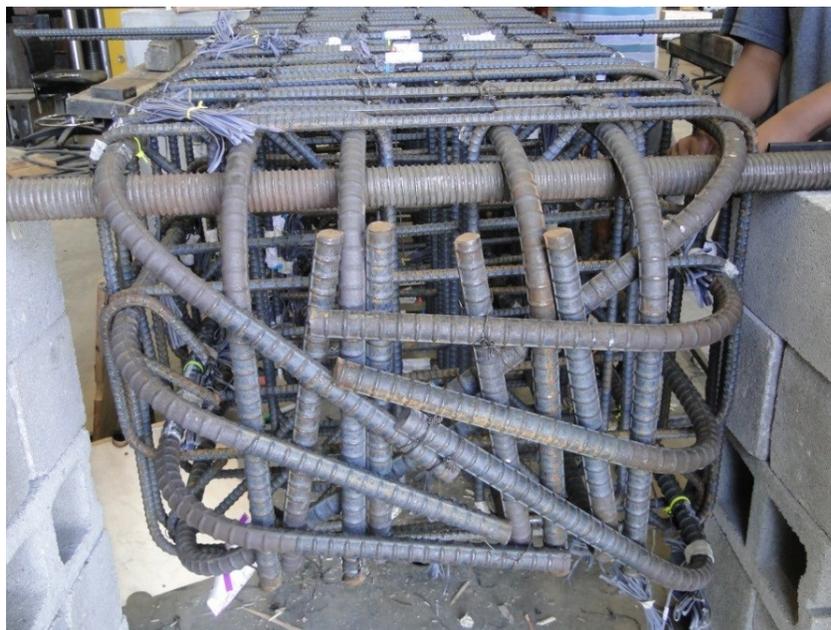
Tie the legs of all of the longitudinal reinforcement at the bottom of the cage towards the center of the column. This will be done in three layers as shown below. Tie all bar intersections until the column cage is complete.

Figure 50. Tied longitudinal reinforcement at the base of the column cage

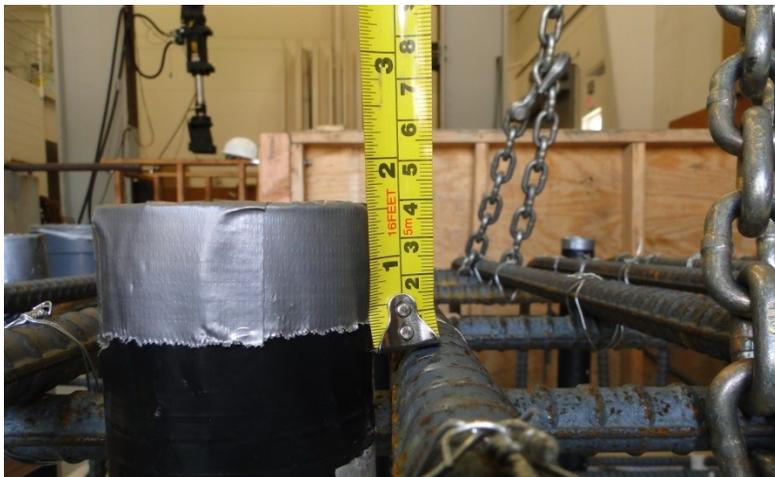
Double check that the concrete cover is 1.5 inches before tying the top and bottom layers of the reinforcement cage together.

Figure 59. Checking concrete cover

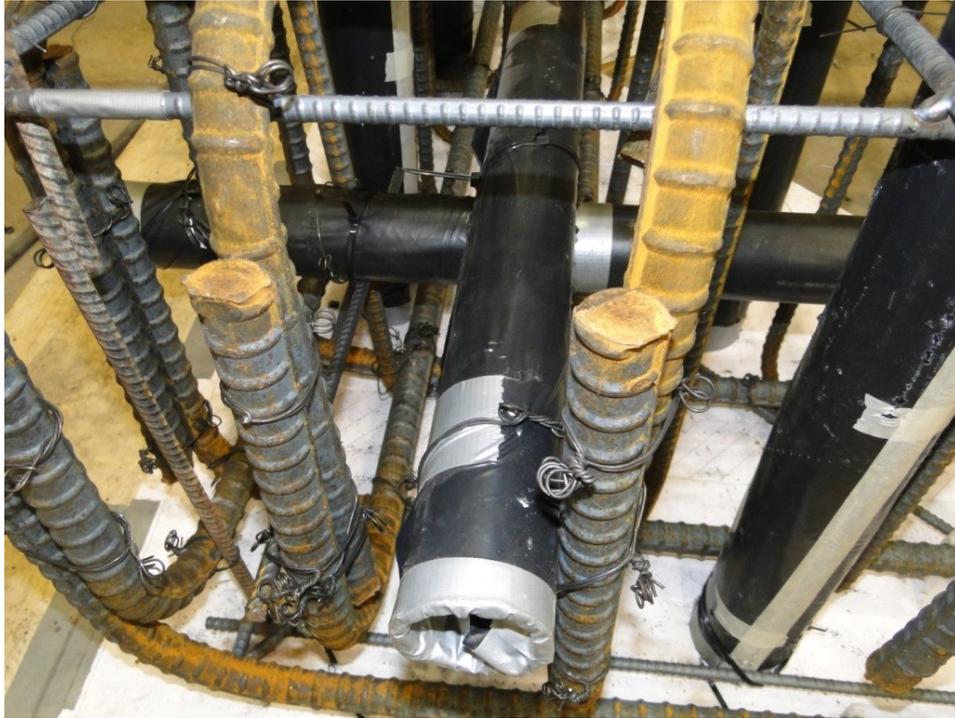
The shear reinforcement hooks on to the top and bottom layers of the reinforcement cage and are tied at both the top and bottom just as in the footing block. Make sure that the horizontal pvc pipes are securely tied to the reinforcing cage because they may move during casting.

Figure 61. Tying horizontal pvc pipe

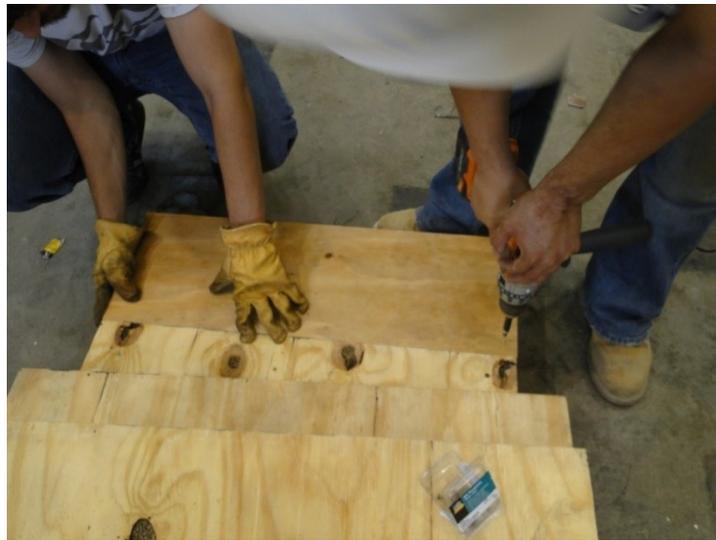
Plywood will be attached to the formwork to adjust it to the correct dimensions. Cut $\frac{3}{4}$ inch plywood to the dimensions of the two larger panels of the perimeter column (P Column). Drill the sheet of plywood to the formwork using 1 inch screws. Leave a 2 inch space near the top of the formwork to later place an extension. Cut the extension piece according to the drawings and place it flush against the plywood on top of the formwork panel. Drill the extension piece to the formwork panel until it is completely secure.

Figure 64. Drilling extension piece to modified column formwork

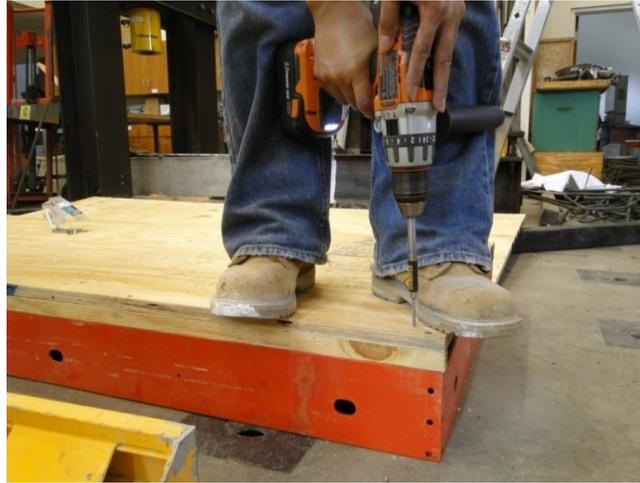
Place three wooden strips of $\frac{15}{16}$ inch equally spaced on the surface of the formwork. These pieces will be used to create the correct column dimensions. Place 2 more strips along the edge of the formwork to create a sealed form and prevent any concrete from seeping into the formwork. Put three more strips extending out through the formwork to be used as supports for the extension piece. Drill the plywood through the strips onto the formwork until it is securely in place.

Figure 65. Drilling plywood to the edge strips

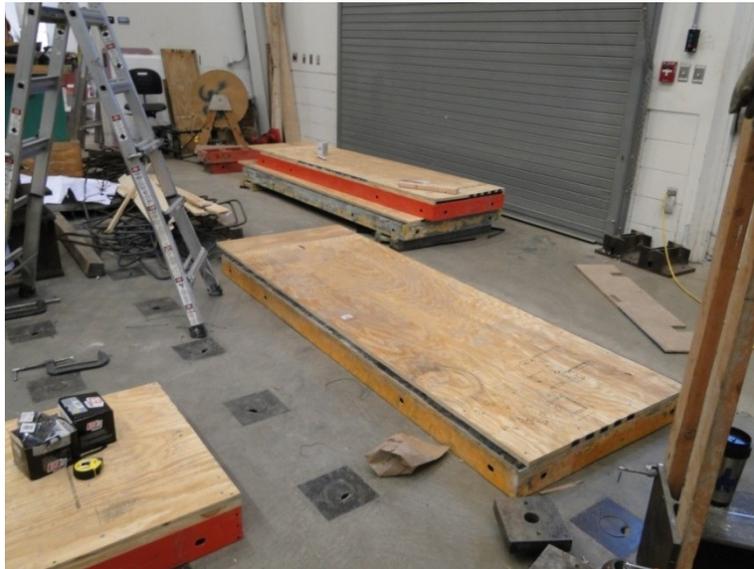
Figure 66. Completed column formwork modification

Since the formwork will be used many times, the plywood needs to be securely attached to the formwork. Place a screw at about every 10 inches. Continue modifying the rest of the formwork panels. Note that for the larger panels a $1 \frac{11}{16}$ " gap is left at the edge so that the panels located in the perpendicular direction fit inside this gap producing the correct column dimensions. Complete the rest of the panels.

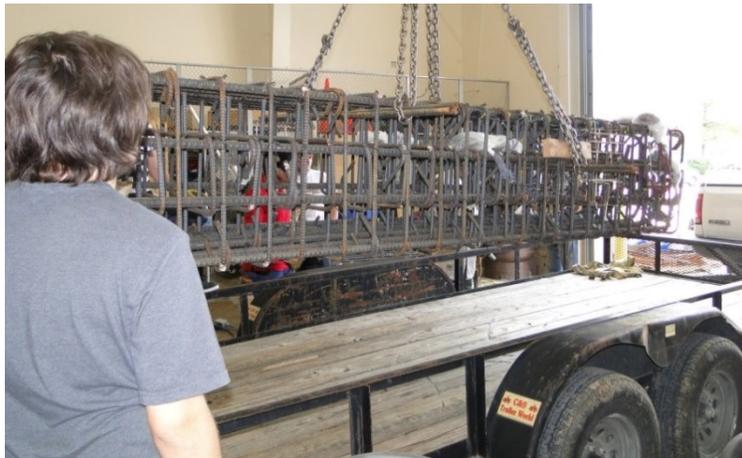
Figure 67. Shipping of column cage

The rest of the column construction will take place at Hanson Pipe & Precast. Now that the reinforcement cages and formworks have been prepared they must be shipped to the construction site at Hanson. The column is first lifted by using 2 chains and collections of reinforcement bars. The cage is lifted at two points near the center assuring the column cage is balanced and lifted horizontally.

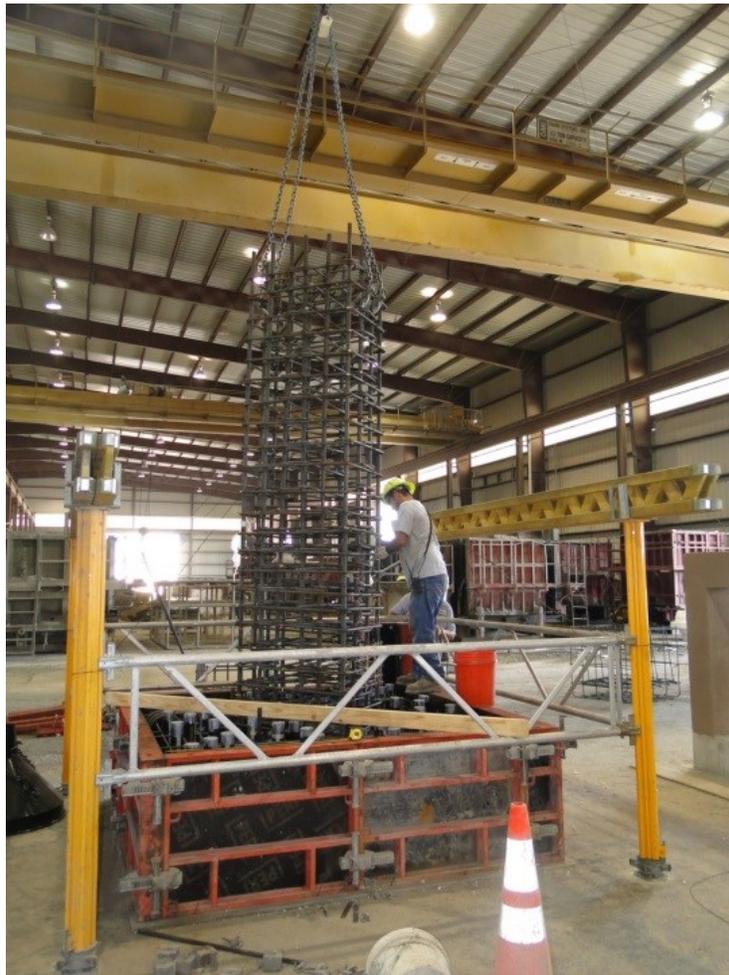
Figure 69. Placement of the column cage

The bottom block cage arrived and was placed on supports away from the formwork. Once the bottom block cage has been placed, assemble the other two sides of the bottom block formwork. Return the frame to its correct location. Note that the frame has been secured to the floor. Using the crane place the column cage in the center of the footing cage.

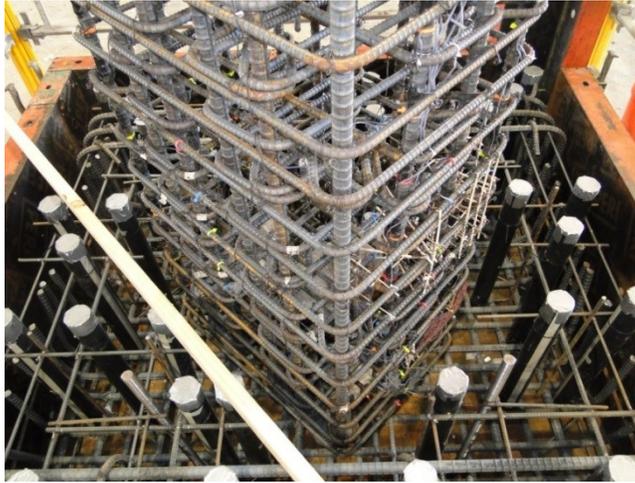
Figure 70. Placing the column cage at 45°

Two locations are measured and a 2x4 is used as a reference to orientate the column cage in the proper direction of 45 degrees.

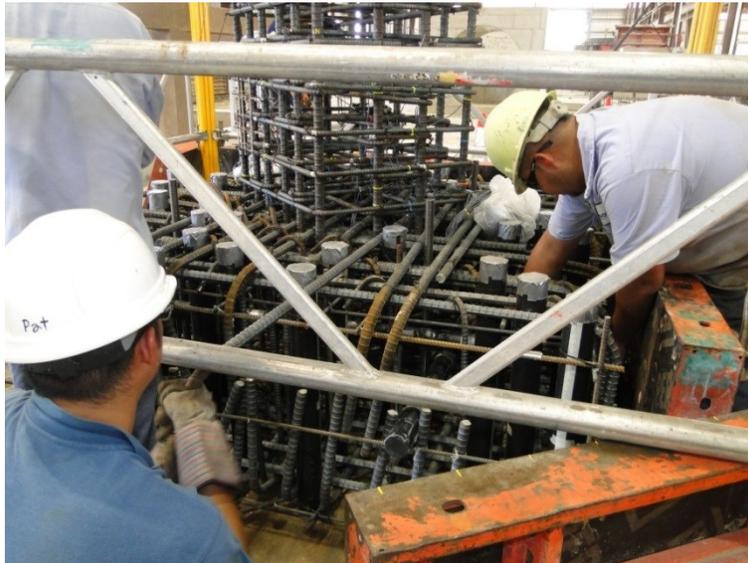
Figure 71. Placement of bottom block reinforcement through column cage

Now that the column has been placed in its correct location, remove two sides of the bottom block formwork once again to place the top layers of reinforcing bars for the bottom block that will pass through the column cage. Pass the reinforcing bars through the column cage very carefully as to not damage the concrete gauges. Make sure to securely tie the reinforcing bars.

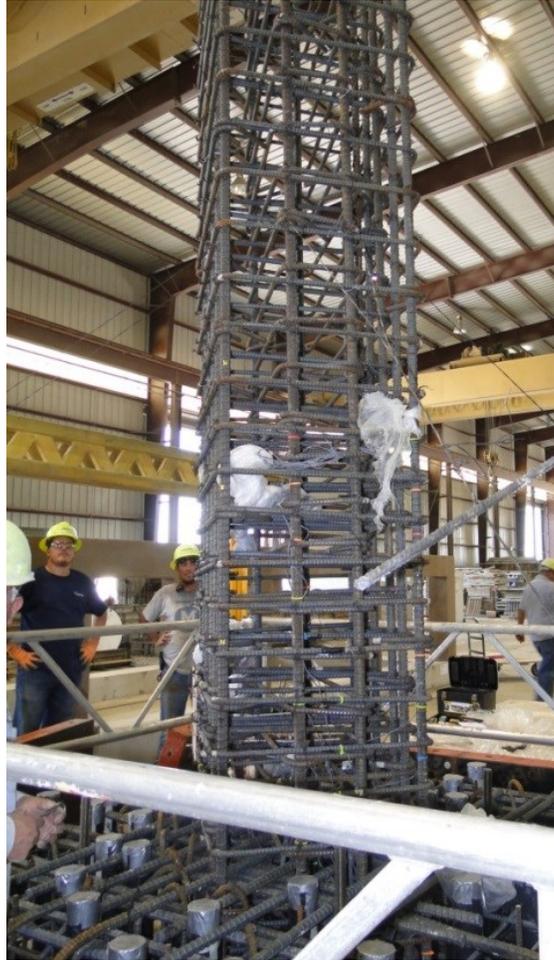
Figure 72. Leveled column cage

Level the column cage so that it is completely vertical. This is done by tying wire from the column cage to the 4 corner posts of the frame. Adjust the wires until the column cage is vertical.

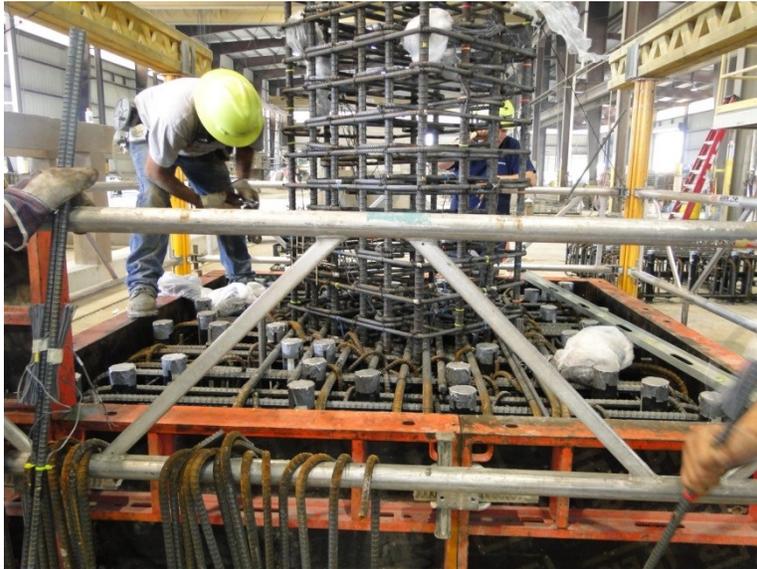
Figure 73. Placement of shear reinforcement

Next, add the shear reinforcement. The shear reinforcement is placed in higher concentration around the perimeter of the column cage section. The shear reinforcement is hooked to the top of the bottom block cage and securely tied so that it does not rise during casting. Note the plastic bags in which the strain gauge wires are located have been removed prior to the placement of the shear reinforcement.

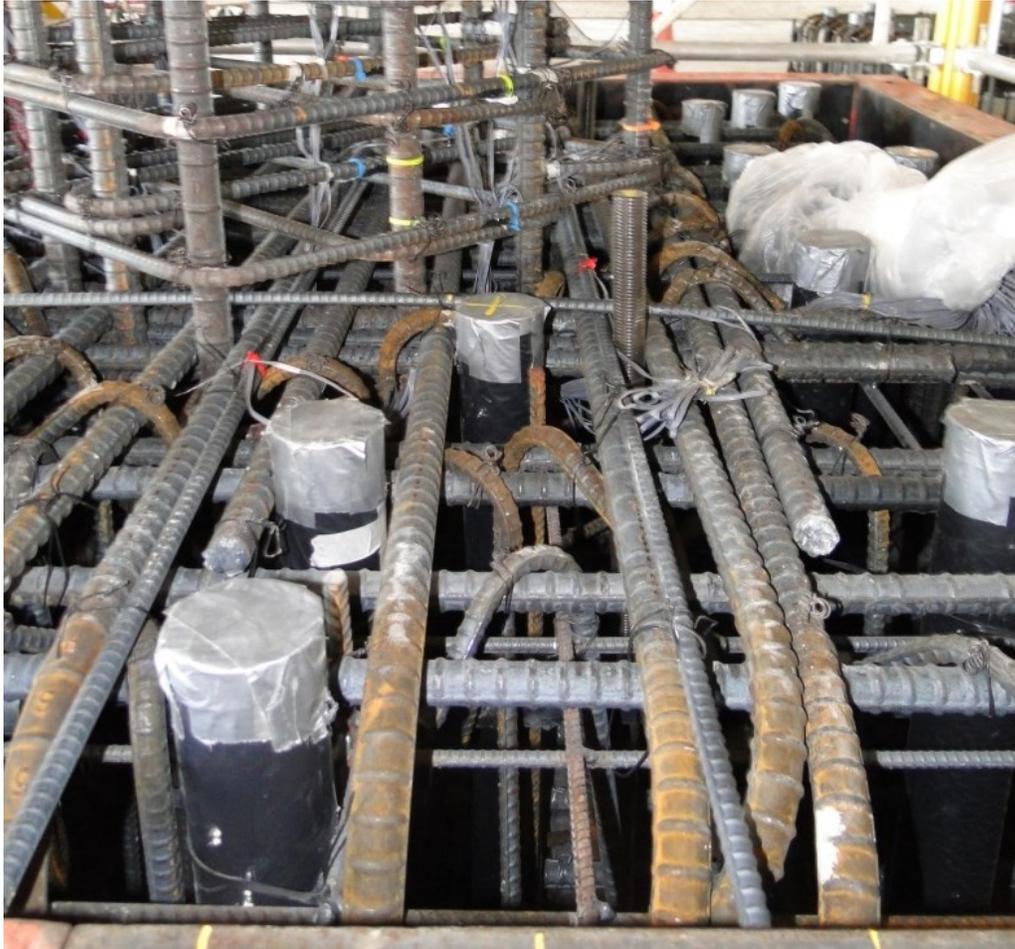
Figure 74. Placement of Footing Strain Gauges

Add two No. 3 bars instrumented with strain gauges to the top surface of reinforcement through the column as shown in the drawings below.

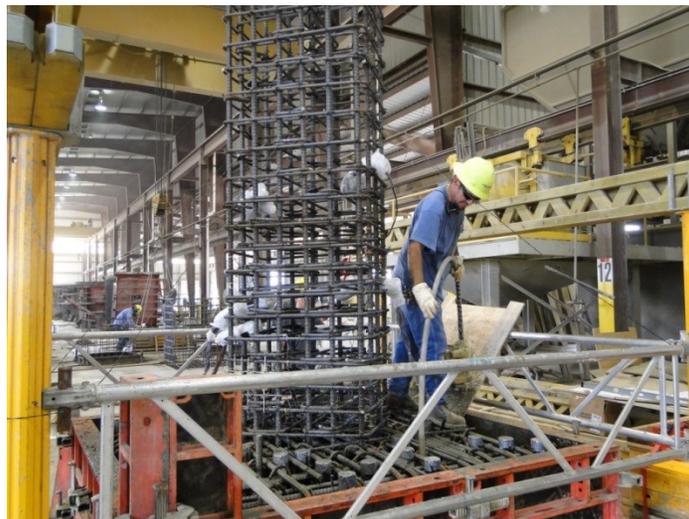
Figure 80. Vibrating the bottom of the footing block

Once the bottom block has been filled about halfway it is vibrated. The vibration is done to eliminate any unwanted voids in the concrete and ensure a better uniform flow. The vibrating is done very carefully away from the center of the column cage so as to not damage any of the strain gauges.

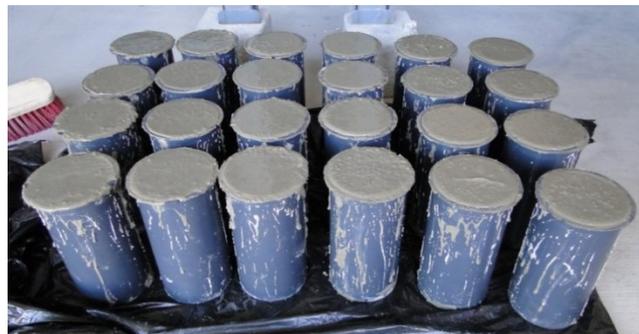
Figure 84. 24 Concrete Cylinders

A wheel barrel of concrete is then taken to the material testing lab where the slump and temperature of the concrete is taken. 24 cylinders are also made to evaluate the concrete strength at different time intervals.

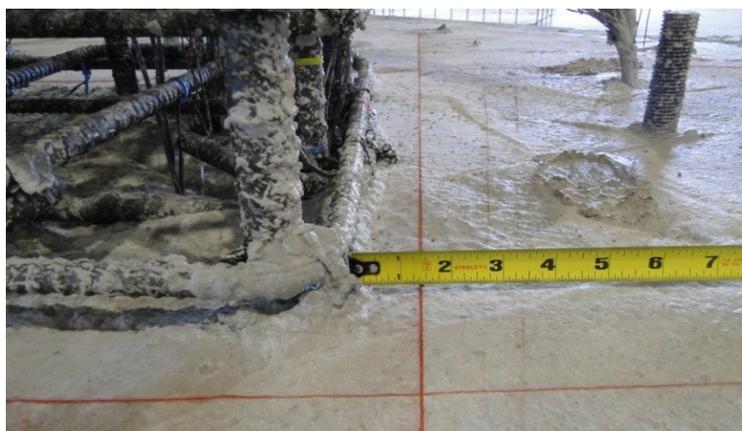
Figure 88. Checking column concrete cover

There should be a 1.5 inch concrete cover.

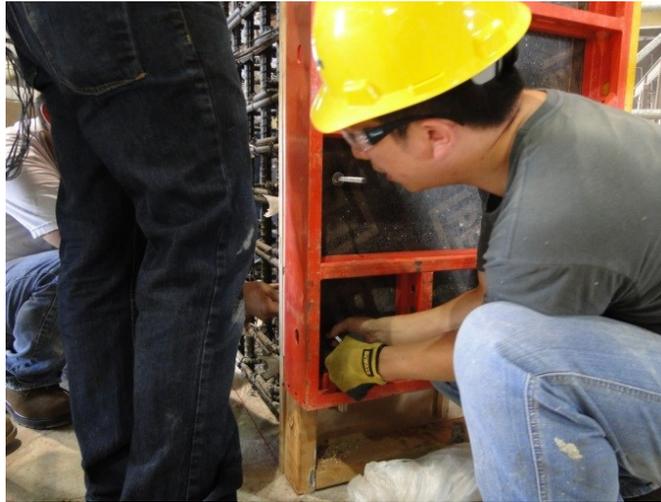
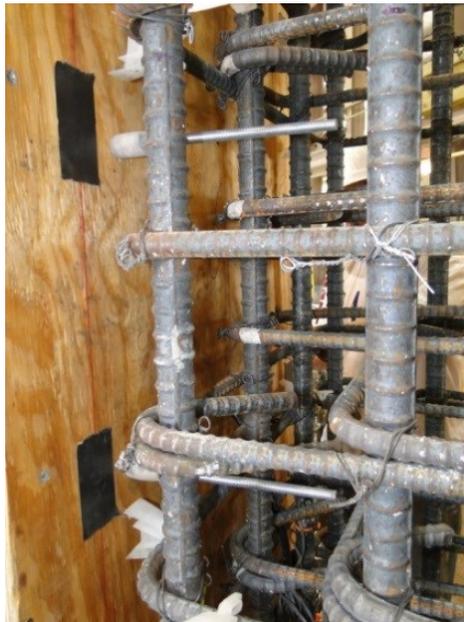
Figure 91. Inserting LVDT rods through the column formwork

Use the clamps to attach the two formwork panels so that they do not fall. Begin placing the LVDT rods on the side with the pre-drilled holes.

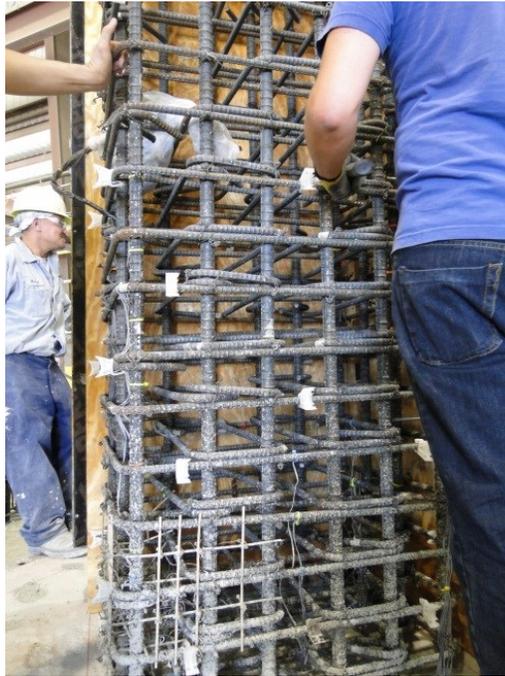
Figure 92. Placing concrete chairs

Place 1.5 inch plastic chairs all along the perimeter of the column cage to ensure adequate concrete cover.

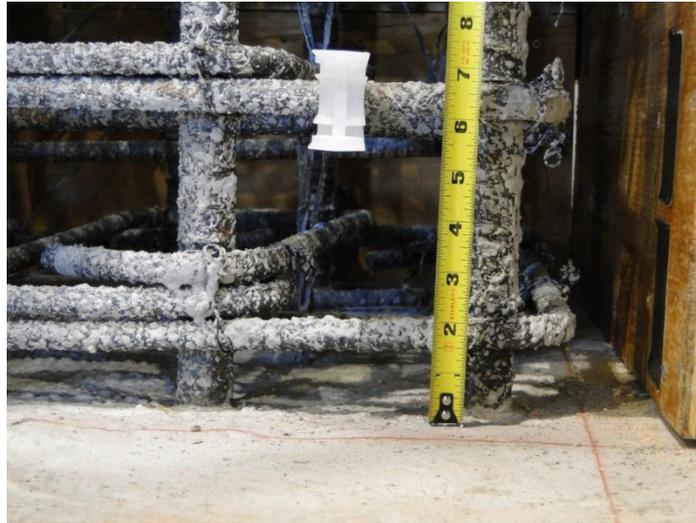
Figure 94. Checking of hoop spacing

Note that the first transverse reinforcement hoop should be at 2 inches from the surface of the footing.

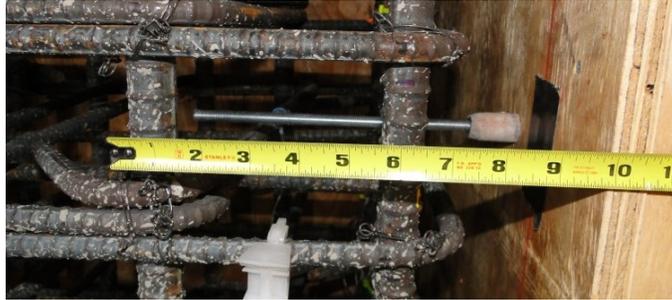
Figure 96. 10" embedment of LVDT rods

The LVDT rods should be embedded about 10 inches from the outer surface of the column. This is to ensure that the rods are not lost during the crushing and spalling that may occur during the testing of the column.

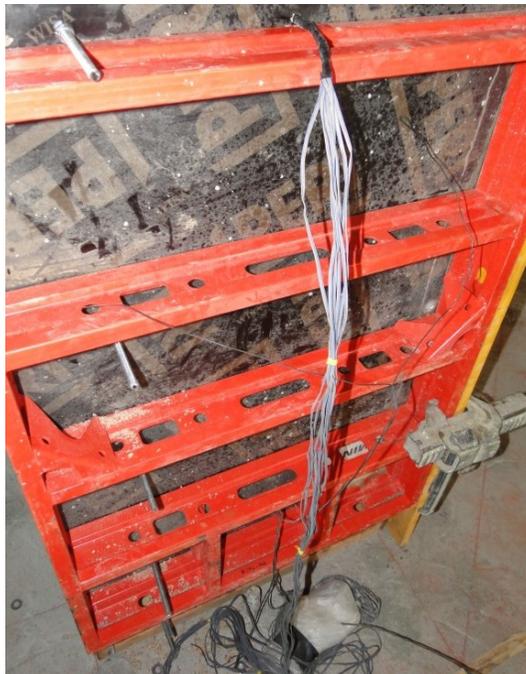
Figure 97. Passing strain gauge wires through the column panel

Carefully collect the wires and place them through the hole that has been drilled in the column section at about mid height. Wrap the wires tightly in duct tape so that they may easily pass through the hole without being damaged.

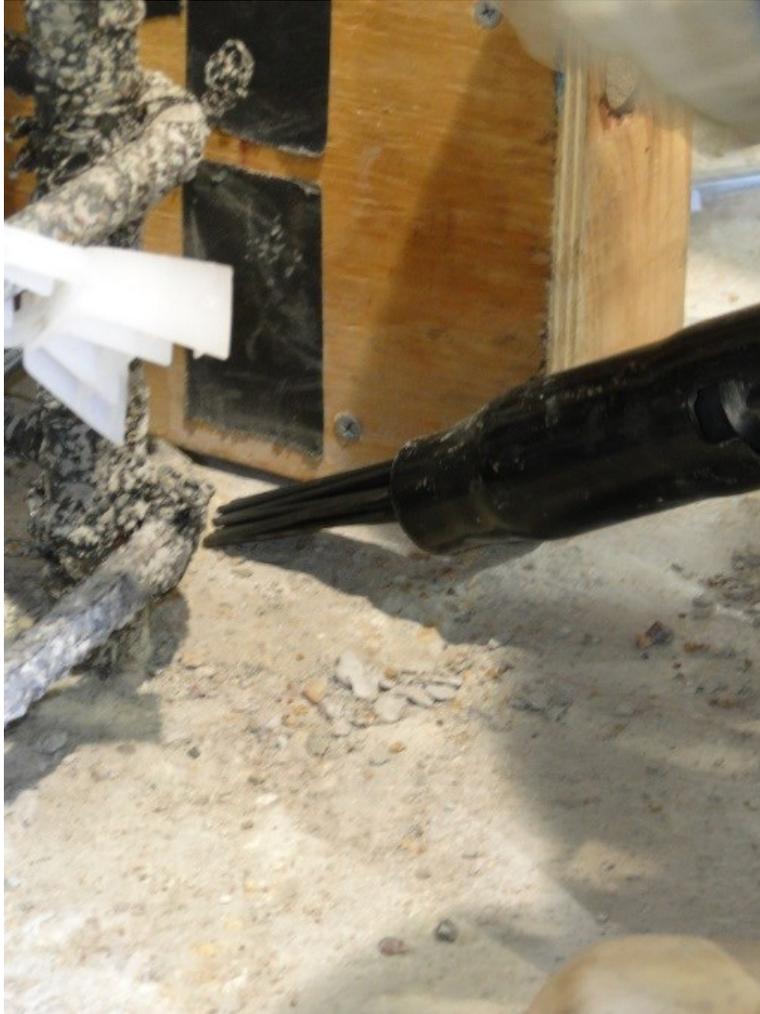
Figure 98. Chipping off top concrete layer

Finish placing all LVDT rods and ensure that they are all secure and tied tightly to prevent them from moving during casting. After placing all of the LVDT rods, chip the upper laitance layer of concrete.

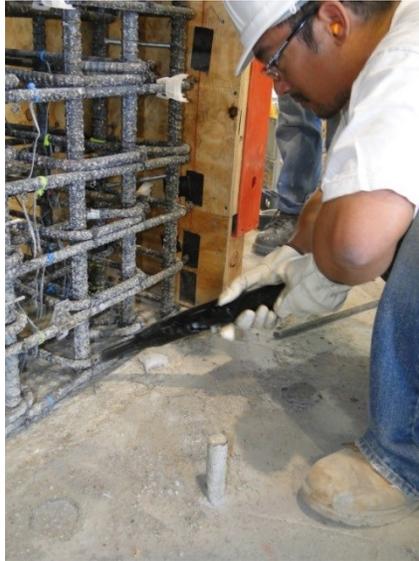
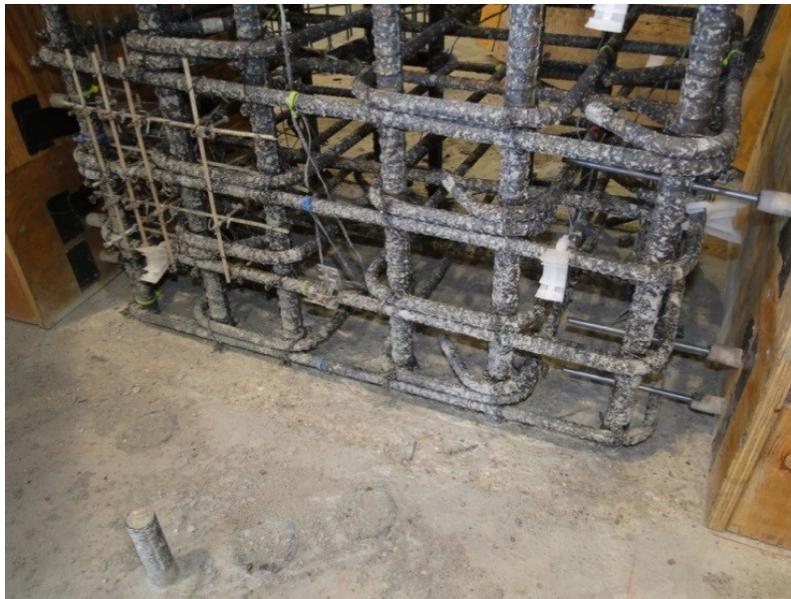
Figure 99. Removal of Laitance Layer

This is done by using a chisel all around the perimeter and interior of where the column will be located. The upper laitance layer is removed to ensure good bonding between the new and hardened concrete. Remove up to 3 inches of concrete from the perimeter of the column cage.

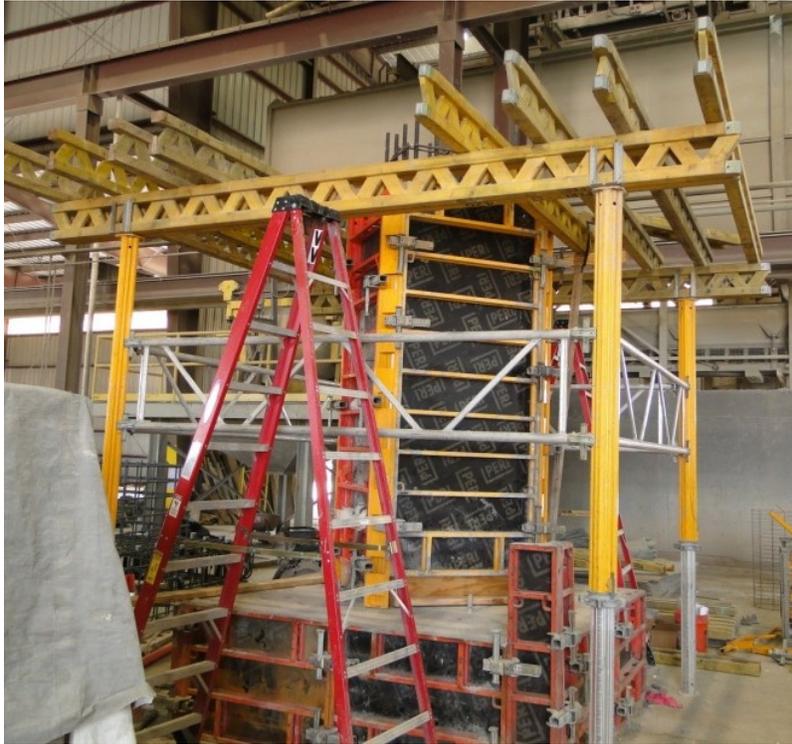
Figure 100. Placement of supporting beams

Once the column formwork has been placed raise the frame until the 2 supporting beams are well above the highest clamps on the formwork so that the rest of the support beams do not interfere with them. Continue to place the support beams equally spaced on both sides of the column cage.

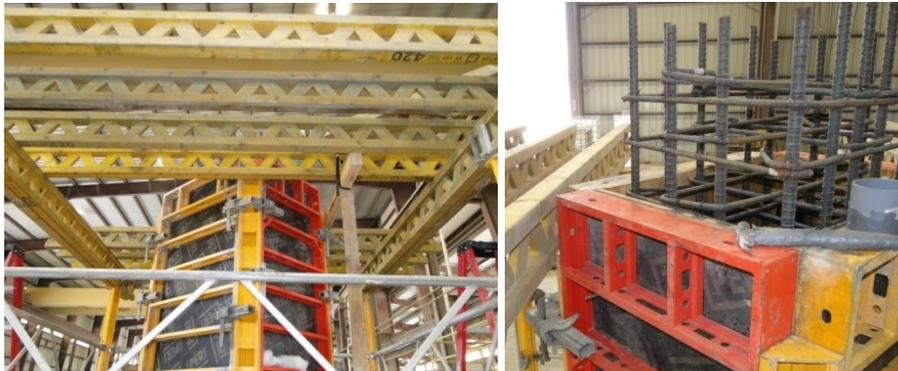
Figure 101. Column formwork construction

Tie 2x4's together to two beams on either side of the column. This is done as an additional support to place the smaller size beams.

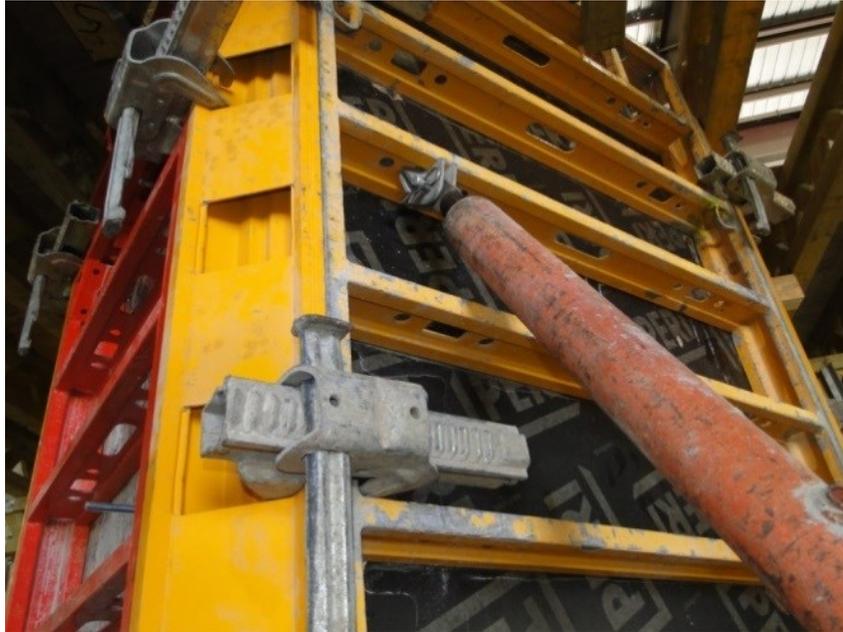
Figure 104. Attaching lateral supports

Raise the frame on all sides until the deck is on the correct location with respect to the column formwork taking into consideration the thickness of the plywood sheets. Once the deck has been constructed attach the red lateral supports to the column formwork.

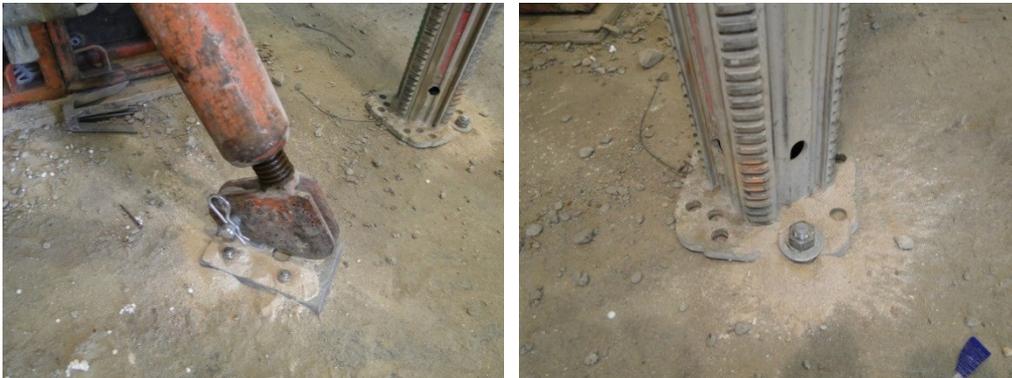
Drill the bottom of the lateral supports to the floor to secure stability.

Figure 105. Drilling supports to the floor

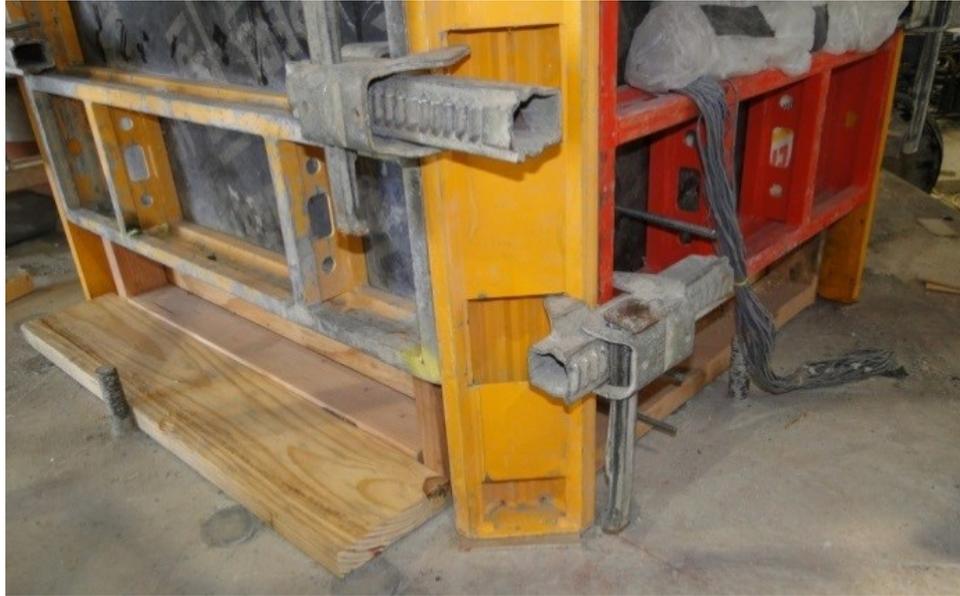
Note that all four of the columns of the frame have also been securely bolted to the floor. Place wooden pieces between the formwork and the embedded post tensioning rod so that the column formwork remains in place and does not move during casting.

Figure 106. Inserting wooden pieces to secure formwork

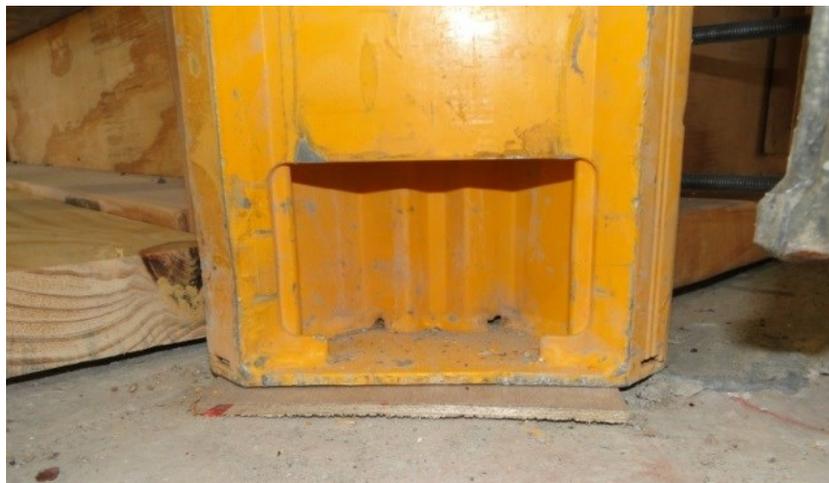
Place small pieces of wood underneath the formwork to prevent any leaking during casting.

Figure 107. Inserting small wooden pieces to prevent leaking

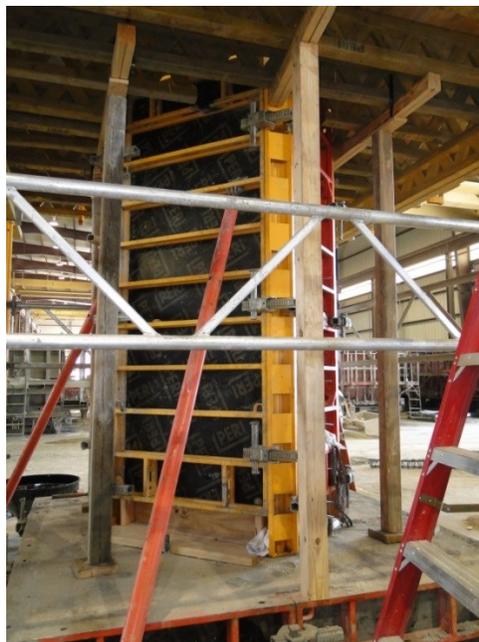
Place 6 4x4's underneath the perimeter of the column formwork for precaution and to support the weight of the top block when pouring.

Figure 109. Additional wooden supports

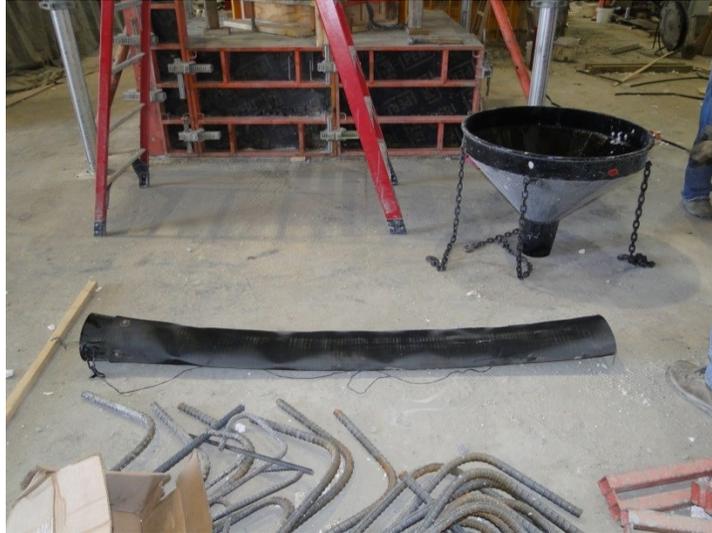
Prepare everything needed for casting the column section including the funnel and “elephant trunk”.

Figure 110. Funnel and “elephant trunk”
