PERFORMANCE OF FULL-SCALE ULTRA-HIGH PERFORMANCE FIBER-
REINFORCED CONCRETE COLUMN SUBJECTED TO EXTREME EARTHQUAKE-
TYPE LOADING AND EFFECT OF SURFACE PREPARATION ON THE COHESION
AND FRICTION FACTORS OF THE AASHTO INTERFACE SHEAR EQUATION

MASTER OF SCIENCE IN CIVIL ENGINEERING

THE UNIVERSITY OF TEXAS AT ARLINGTON

May 2015

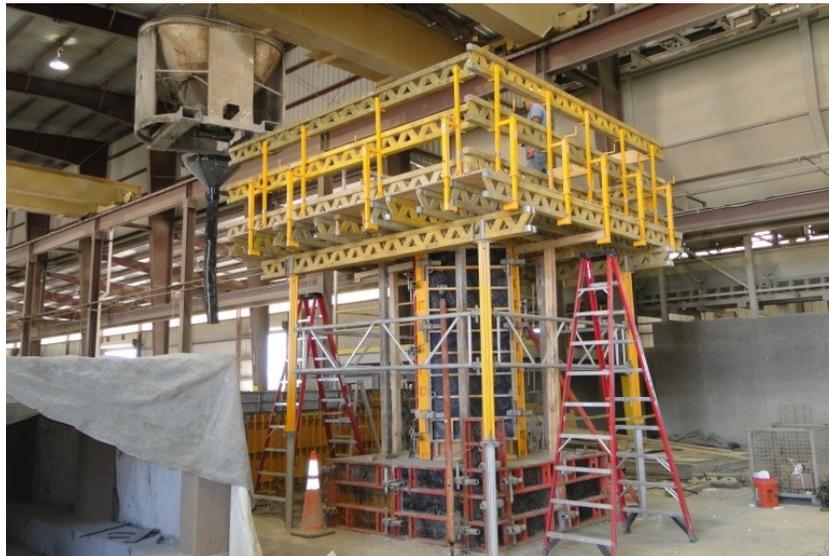
Next, add the “elephant trunk” extension. This will allow better control of the concrete pouring within the column section. Lift the bucket well above the column formwork. Guide the bucket of concrete towards the column formwork.

Figure 113. Lifting bucket over column

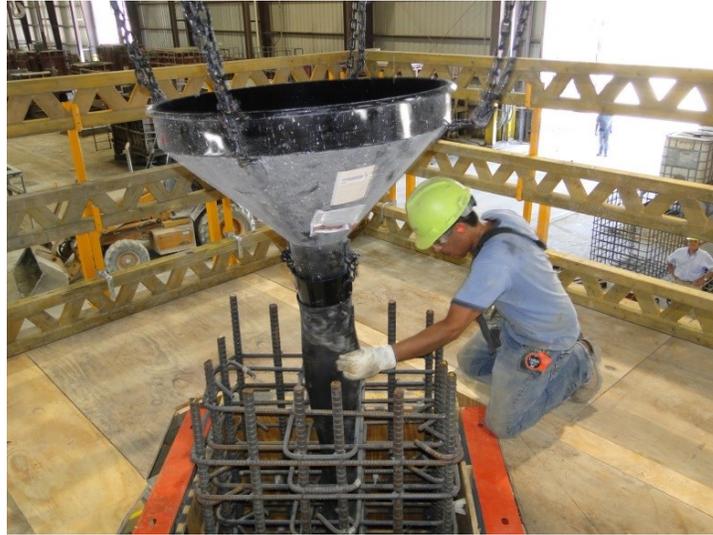
Lift the bucket straight over the column opening. Place the “elephant trunk” in the center of the column cage.

Figure 114. Placement of funnel

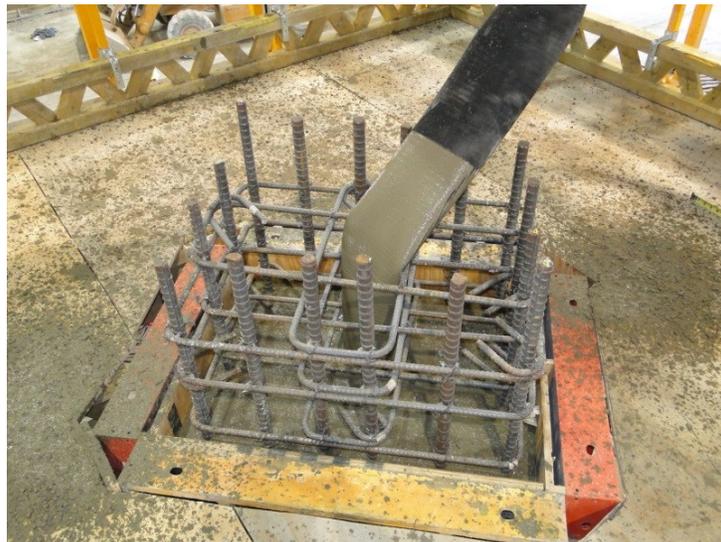
Pour the concrete carefully into the column formwork so as to not damage the concrete gauges and stop when the concrete is 1 foot below the top of the formwork.

Figure 115. Column Casting

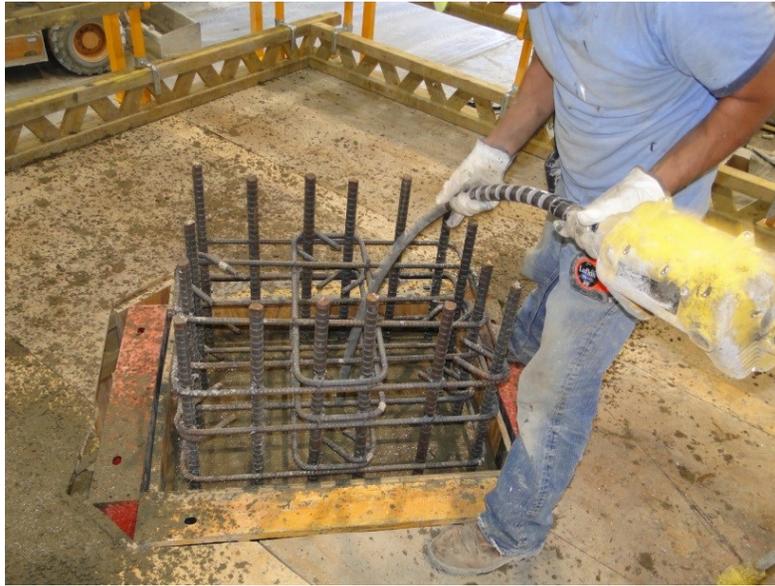
Vibrate the column section taking special care not to damage the concrete gauges.

Figure 116. Vibrating column section

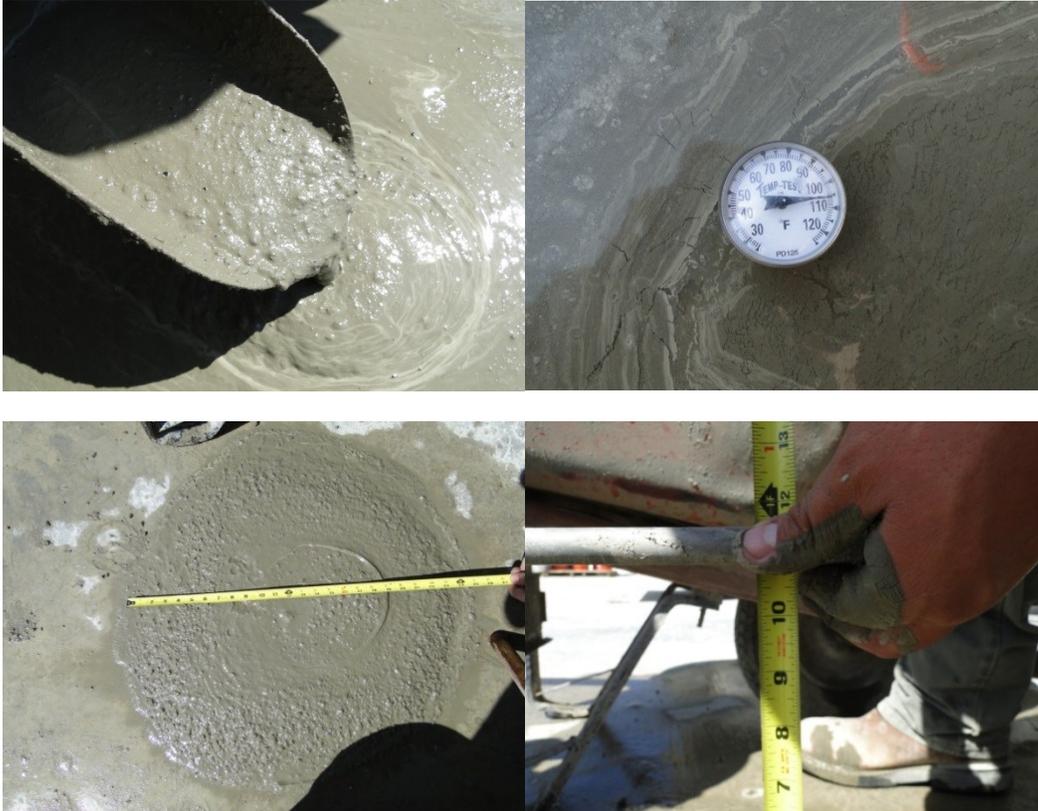
Take a wheelbarrow of concrete to the material testing lab and do a slump test and measure the temperature of the concrete.

Figure 118. Material Testing

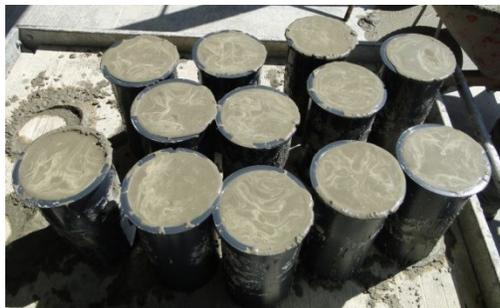
Prepare 24 cylinders that will later be tested to obtain the concrete strength at different time intervals and the testing day.

Figure 119. Concrete Cylinders

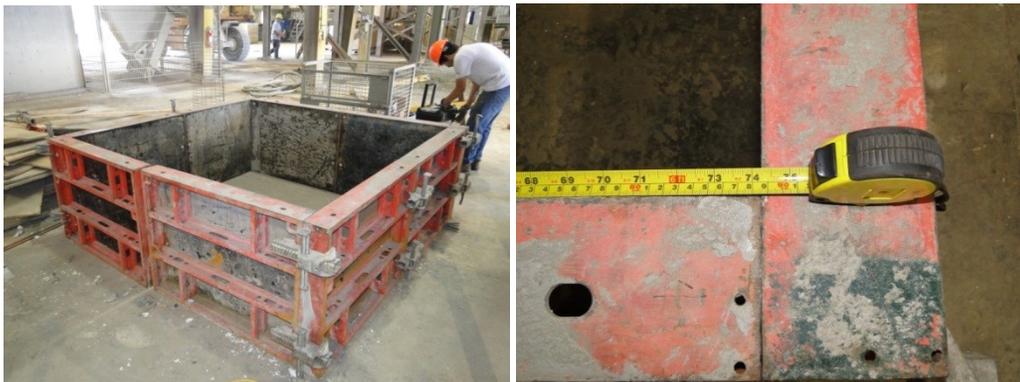
Assemble the formwork according to the dimensions of the top block as shown below.

Figure 121. Construction of top block formwork

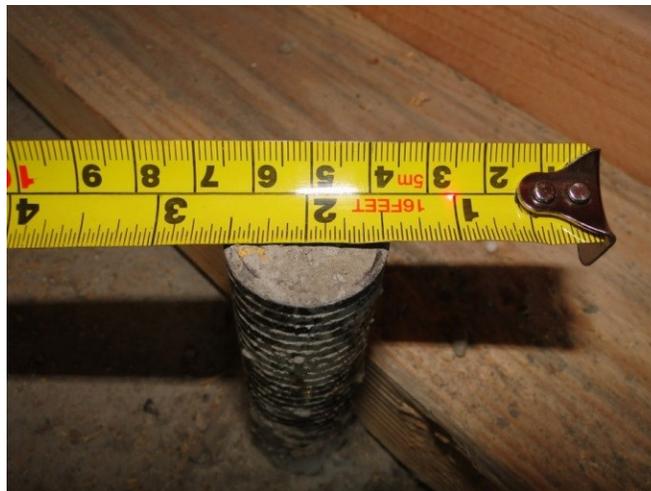
Drill small holes on the location where the post tensioning rods will pass through the top block. Place a laser straight down and see where it is located with respect to the post tensioning rod embedded on the bottom block. Do this until all four rods are aligned.

Figure 123. Aligning the top block with the bottom block

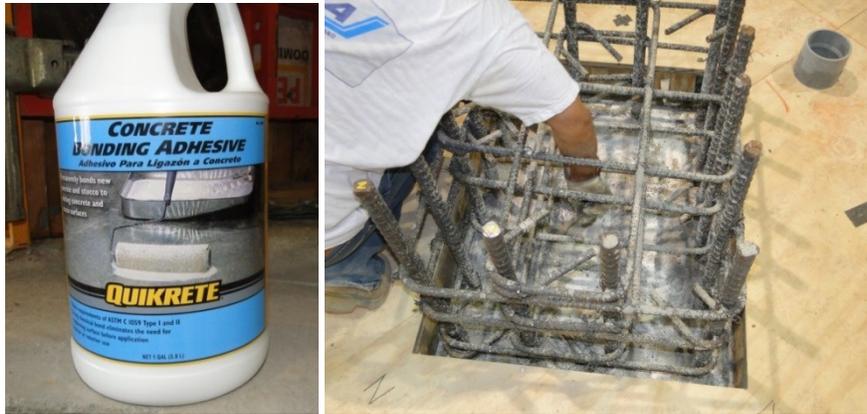
Prepare the surface of the top of the column once again removing the laitance layer with the chisel. This time adding a concrete adhesive to obtain a better bond between the two concretes. Dilute the concrete adhesive and pour it on the top surface of the column.

Figure 124. Addition of bonding adhesive

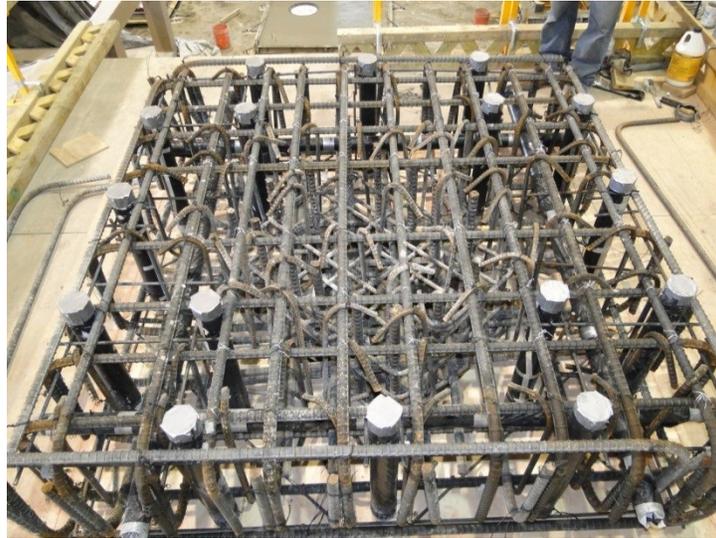
Using the drawings place the remaining bottom layer of reinforcement (L-bars) through the column cage.

Figure 126. Placing bottom layer of top block reinforcement through column cage

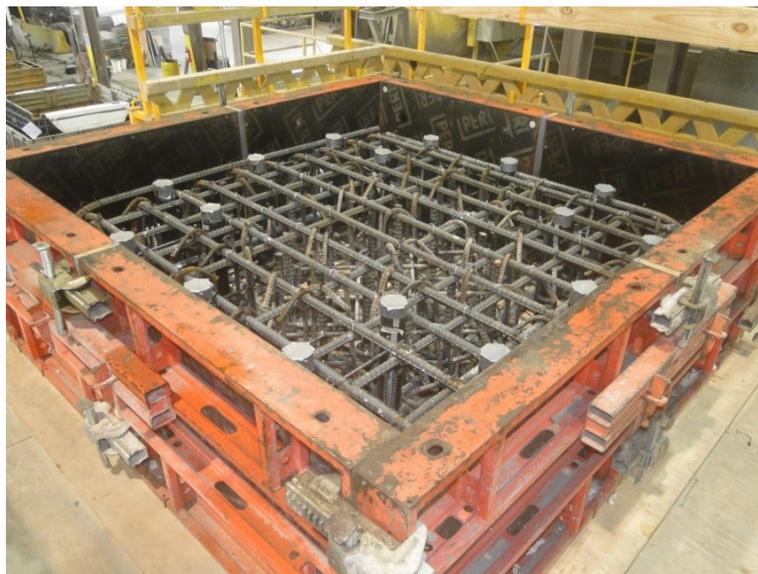
Place the shear reinforcement mostly concentrated around the column cage.

Next, using the crane place the formwork around the top block cage.

Figure 127. Top block cage and formwork ready for casting

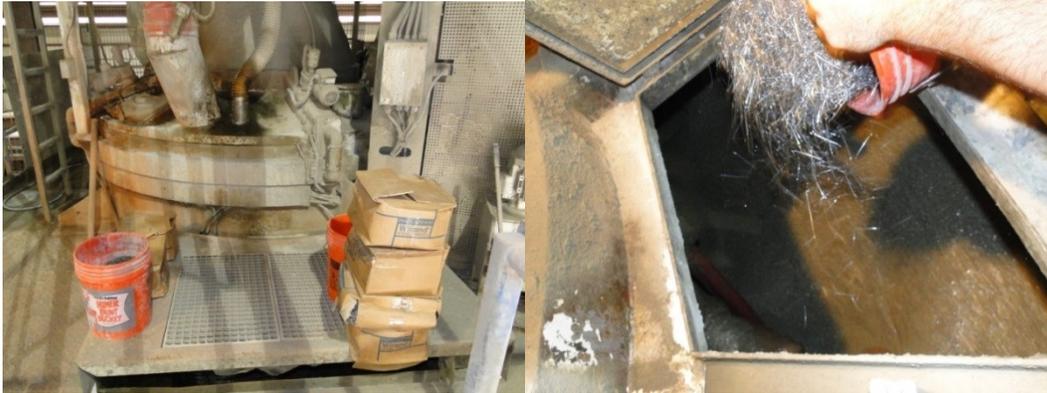
The top block will be cast with .75 percent fibers to prevent any cracking during transportation since the concrete will still be in its early age strength. Pour the fibers into the concrete mixer.

Figure 128. Addition of steel fibers to mixer.

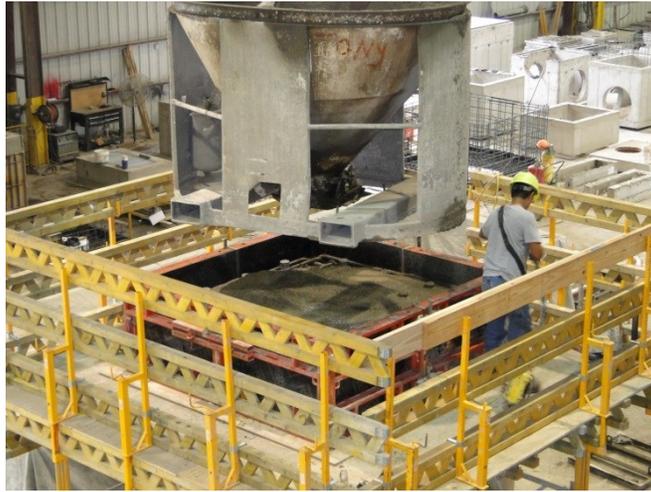
Pour the concrete on the top block until it has reached the top surface of the PVC pipes or 23 inches.

Figure 130. Top block casting.

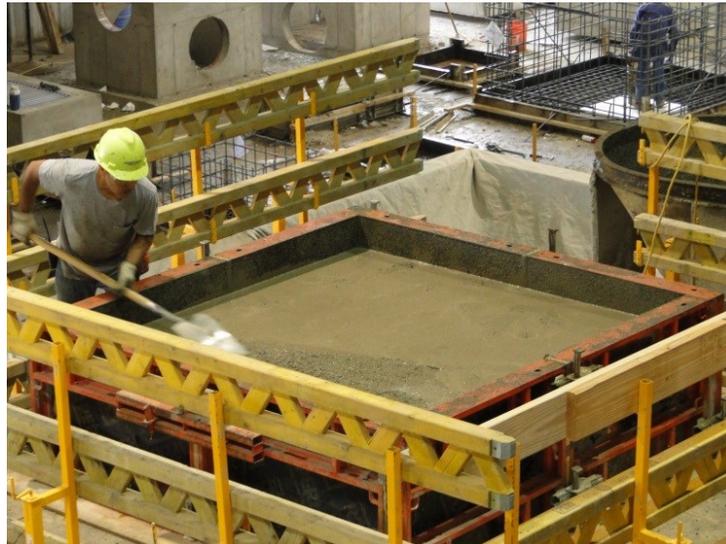
Spread the concrete around until it is evenly settled. Vibrate the concrete and finish the surface.

Figure 131. Finishing top block surface

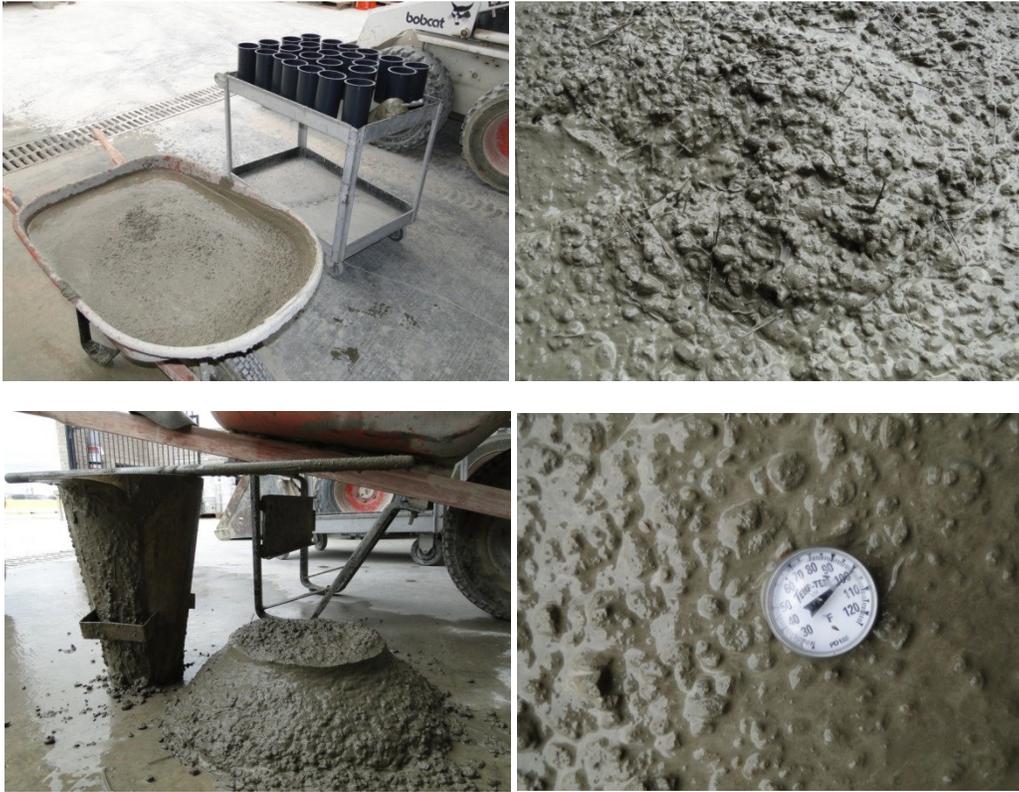
Take a wheelbarrow of concrete to the material testing lab to perform the necessary tests. Notice the high concentration of fibers in the mix. Perform a slump test and take the temperature of the concrete.

Figure 132. Material testing

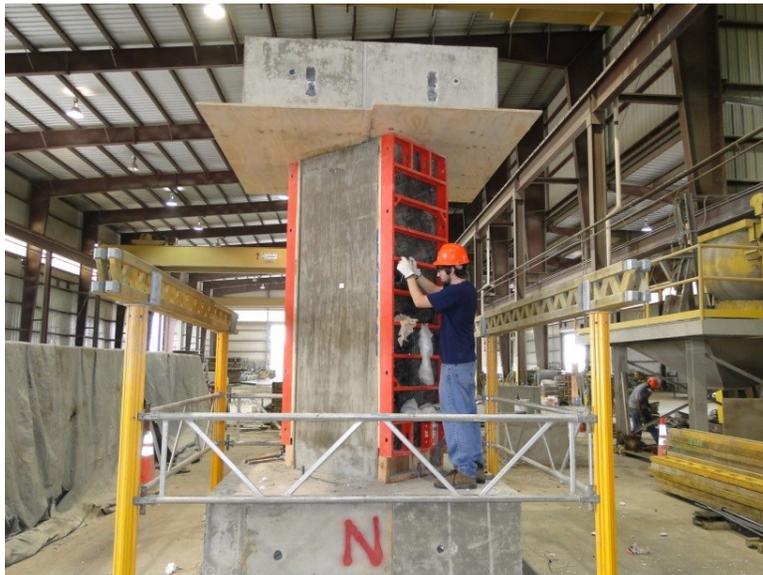
Remove all of the decking and lower the frame down. Also remove the two panels of formwork where there are no LVDT rods. Next, remove all of the LVDT rods from both of the column formwork panels.

Figure 135. Removing LVDT rods

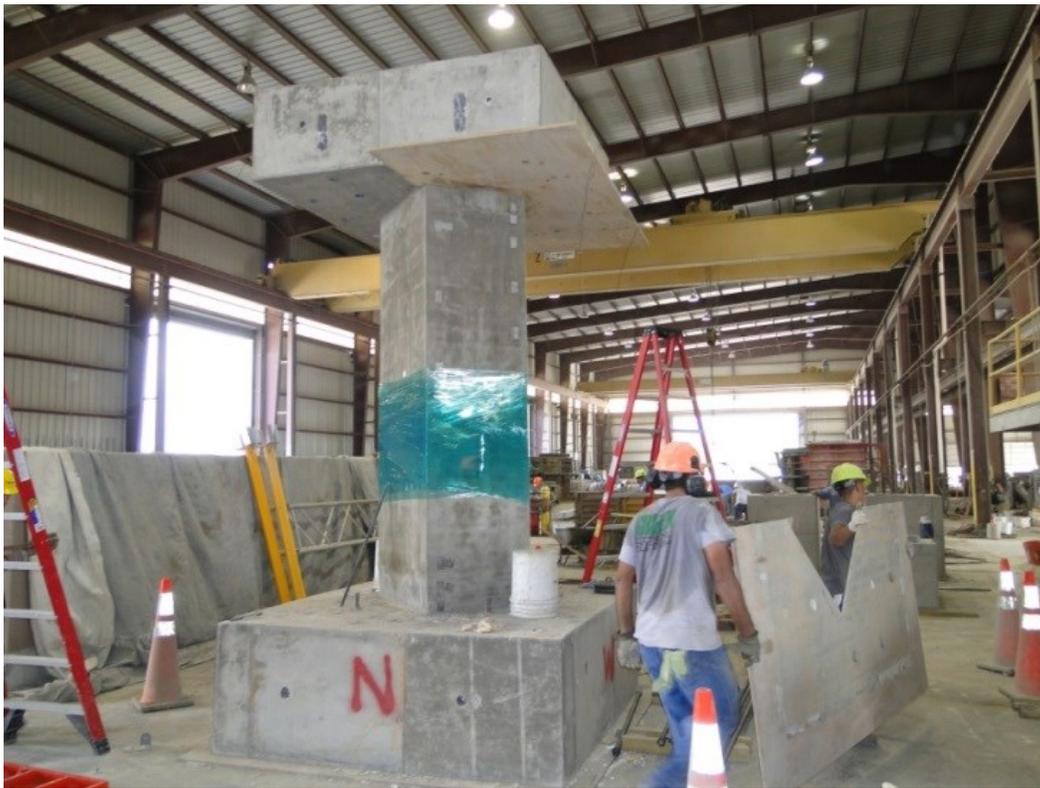
After all of the LVDT rods have been removed, very slowly and carefully begin to remove the two remaining panels. Special care should be taken to not damage the wires that are now cast within the concrete column and also pass through the hole in the column formwork and can be very easily ripped out. After removing all of the formwork, wrap the wires coming out of the column to the column using plastic wrap. This is to protect the wires during shipping and transportation.

Figure 136. Wrapping wires to column section

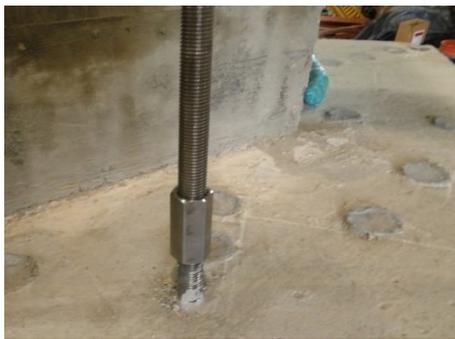
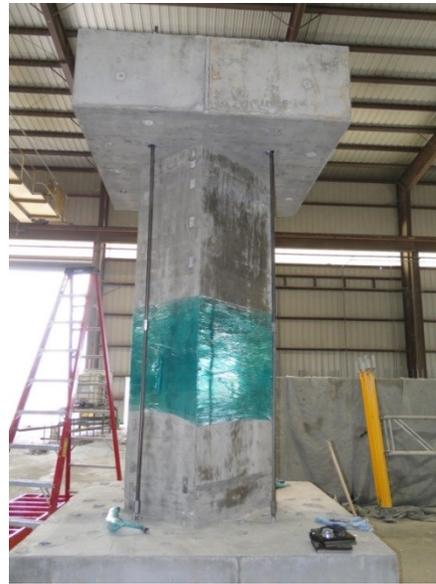
Use the couplers to attach two rods together and then passing through the top block attach the two rods using another coupler to the portion of post tensioning rod embedded within the footing block.

Figure 138. Inserting post tensioning rods

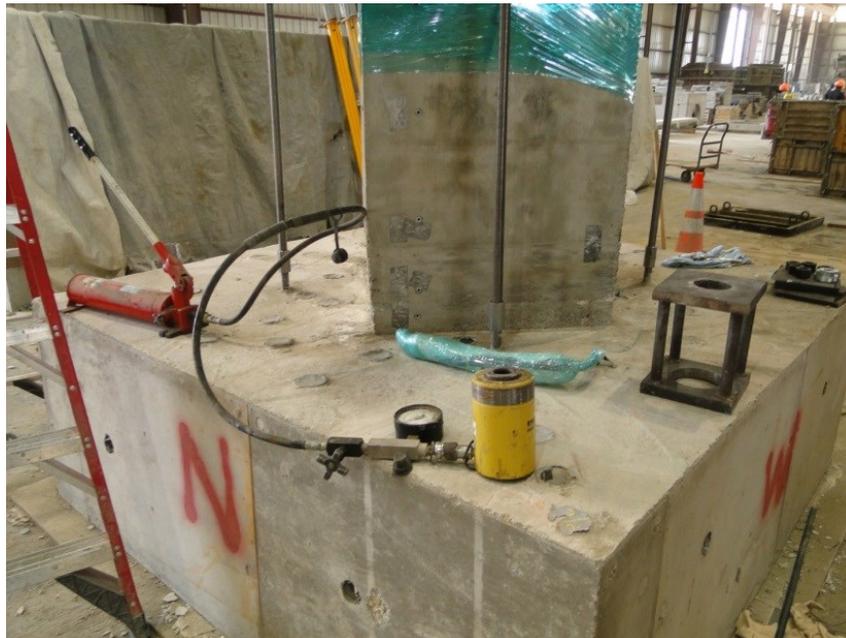
Figure 140. Post tensioning equipment

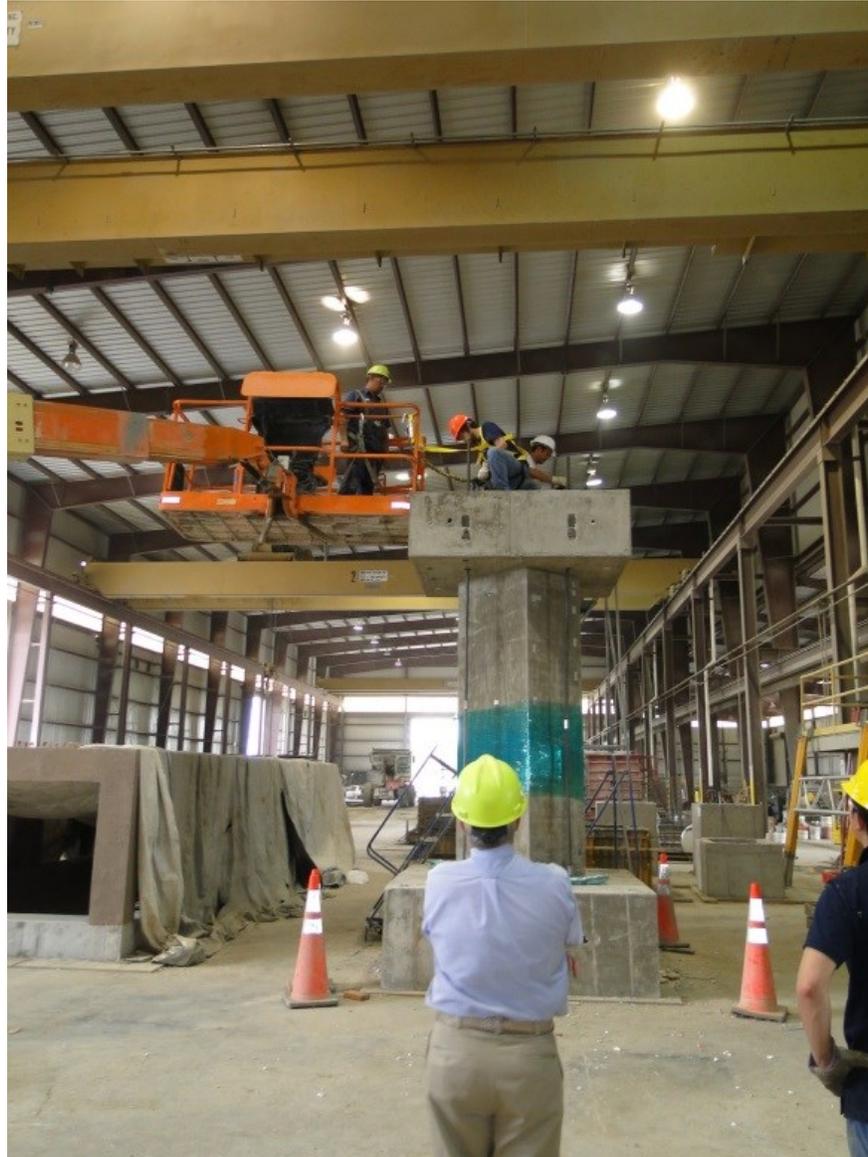
The post tensioning must be done from the top of the column.

Figure 141. Post tensioning of column

To post tension the rod, place the rod inside the jack. Pump to 3000 psi on each rod which has been calibrated to be a total force of approximately 20 kip. FEM analysis concluded that the best way to post tension the column without damage would be to post tension the rods from the top of the column cross alternating at 1000psi intervals.

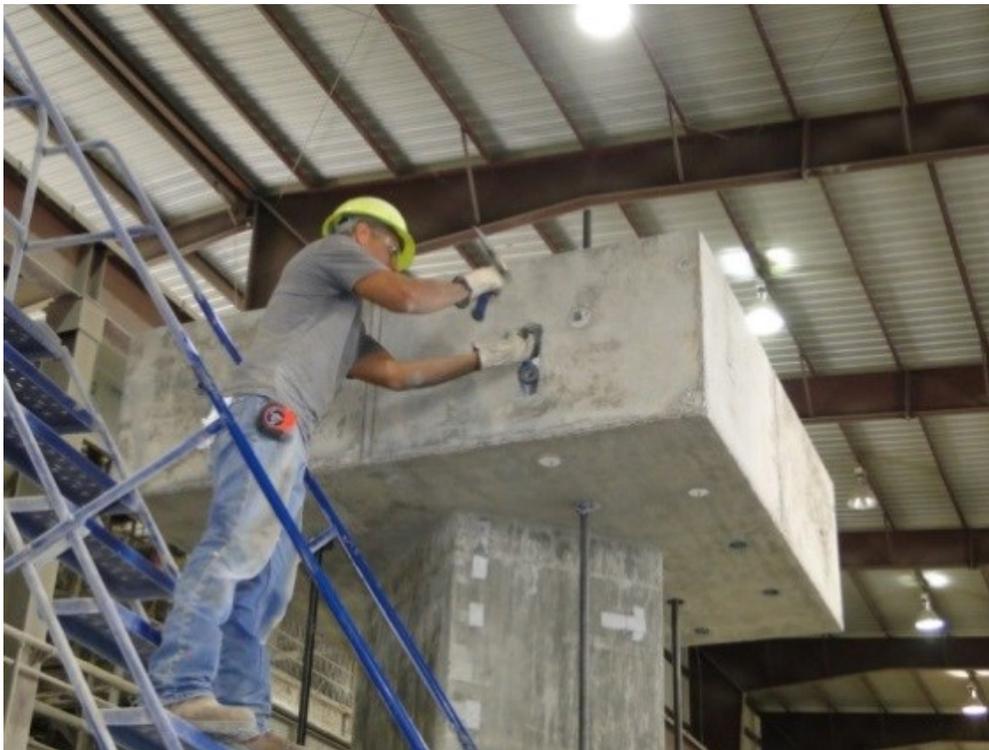
Once the column has been post tensioned chokers need to be placed inside the hooks to use the crane chains for lifting purposes.

Figure 143. Placing chokers for lifting

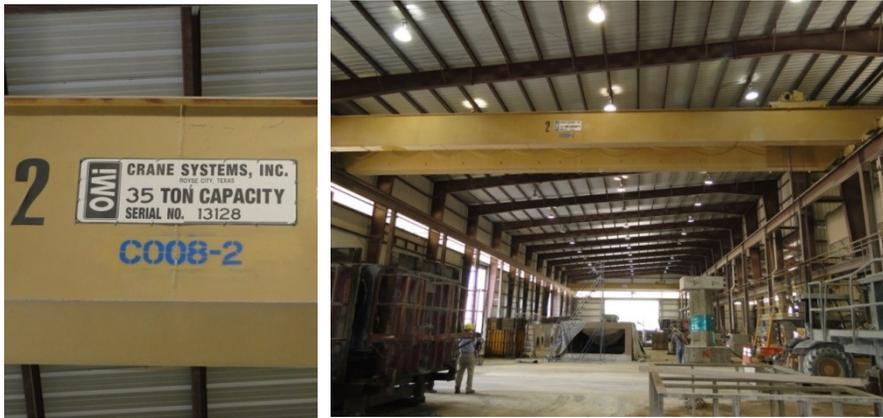
The column will be lifted using a 35 ton capacity crane located within the facilities at Hanson Pipe & Precast.

Figure 144. 35 ton capacity crane

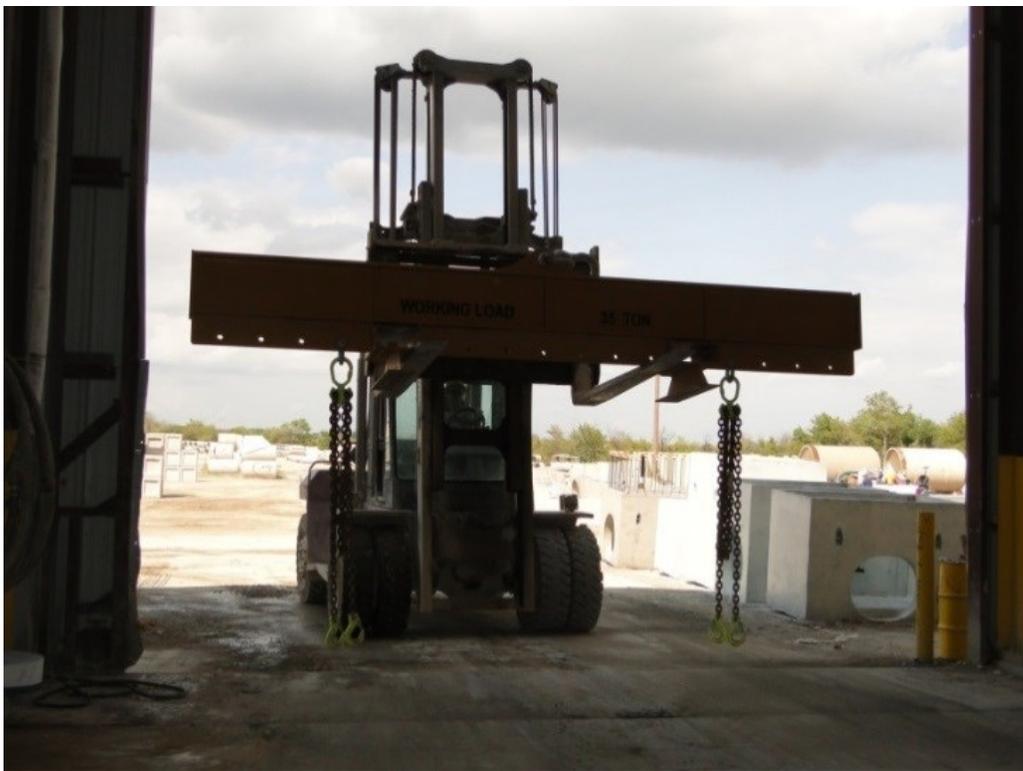
A spreader beam will be used to better distribute the load.

Figure 145. Spreader beam

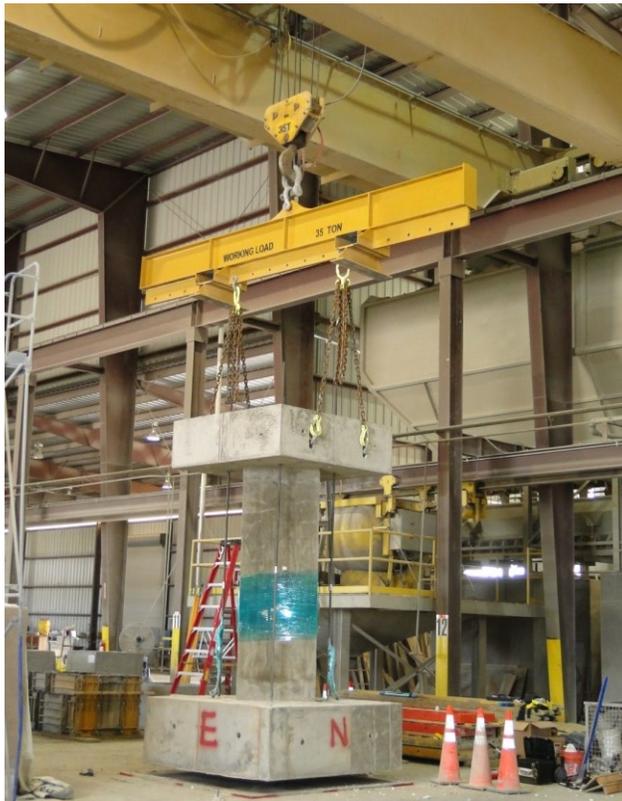
Slowly and carefully lift the column above the ground.

Figure 146. Lifting of column

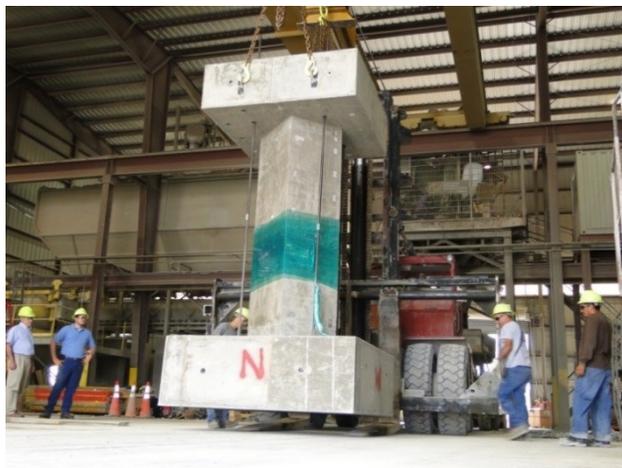
Set the column on the forks of the forklift.

Figure 147. Setting column on forklift

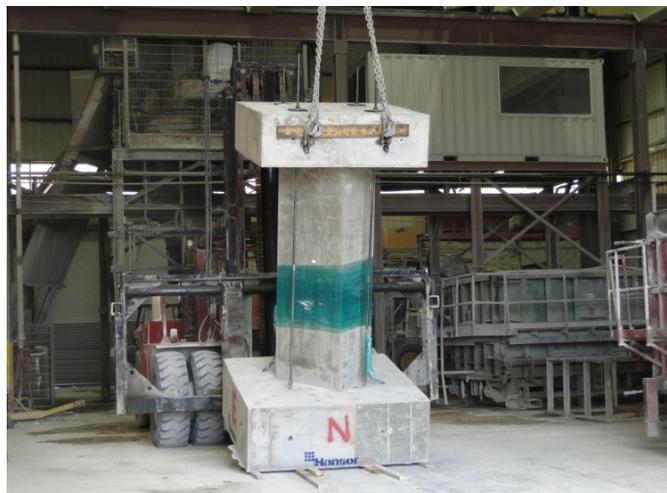
Attach the chains to the loops with two on each side on the phase opposite to the forklift. Place a piece of wood in between the chains and the concrete column. This is done so that the chains do not damage the concrete during lifting. Slowly begin to lift the column on one side using the crane. Place more wooden supports below the column to prevent it from crushing as it the column is laid down.

Figure 149. Starting to lower column

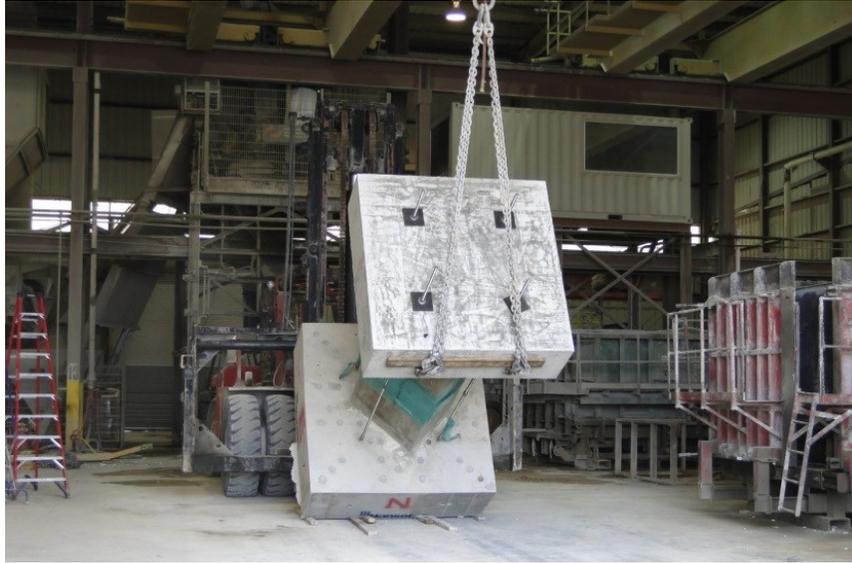
Continue to move the crane down while simultaneously moving it towards the door. Some crushing may still occur near the bottom of the footing.

Figure 150. Lowering column to the floor

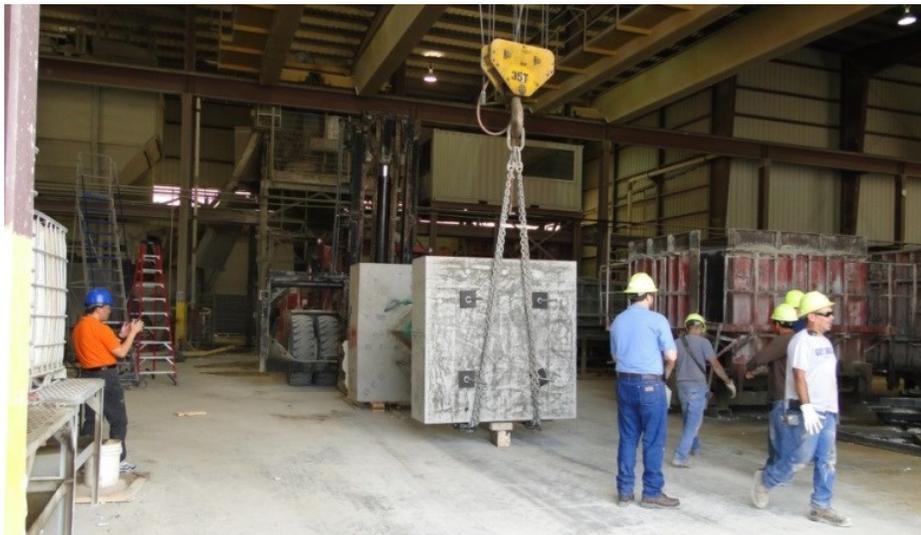
Once the column is completely horizontal place supports at the bottom of the top block to keep it leveled.

Figure 151. Column laying horizontally

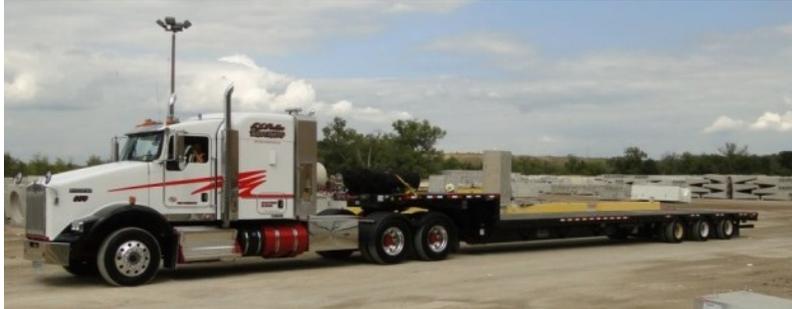
Bring the flat bed that will be used to transport the column around towards the gate.

Figure 152. Flatbed truck used for transportation

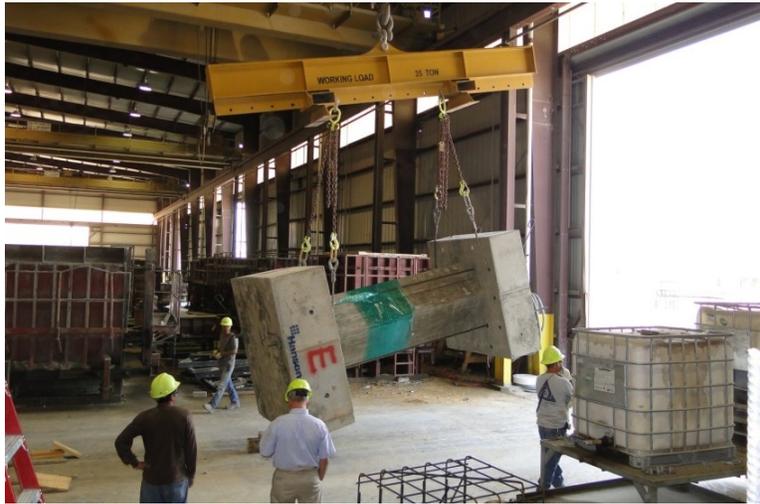
Slowly lift the column horizontally and guide the column as close as possible to the gate.

Figure 154. Lifting column horizontally

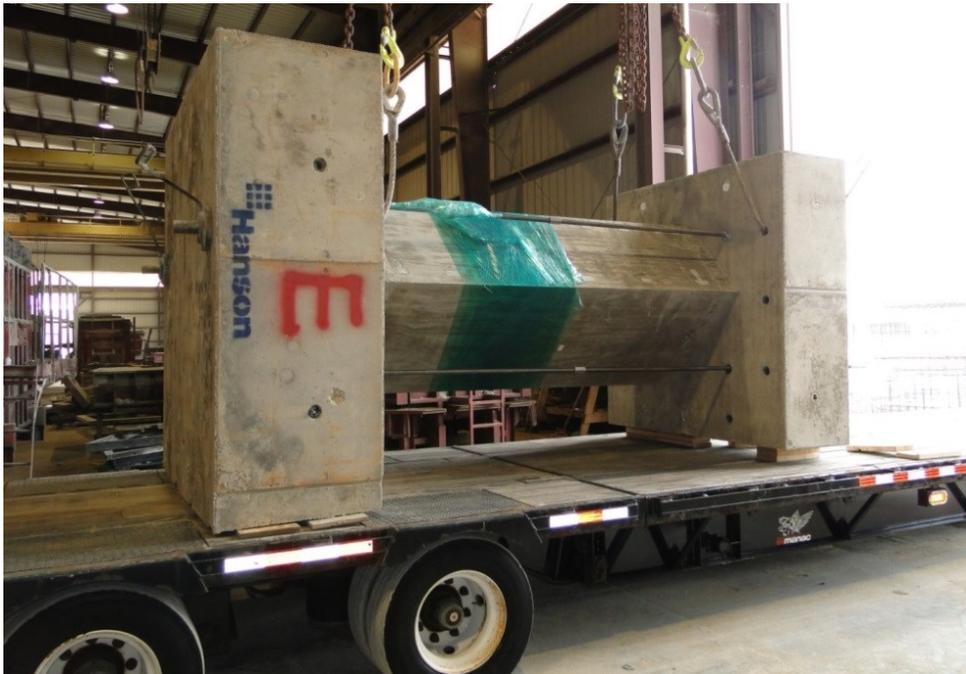
Reverse the flatbed truck into the building to the ideal location to centralize the weight of the column. Secure the column to the flatbed and begin transportation.

Figure 155. Setting column on flatbed truck

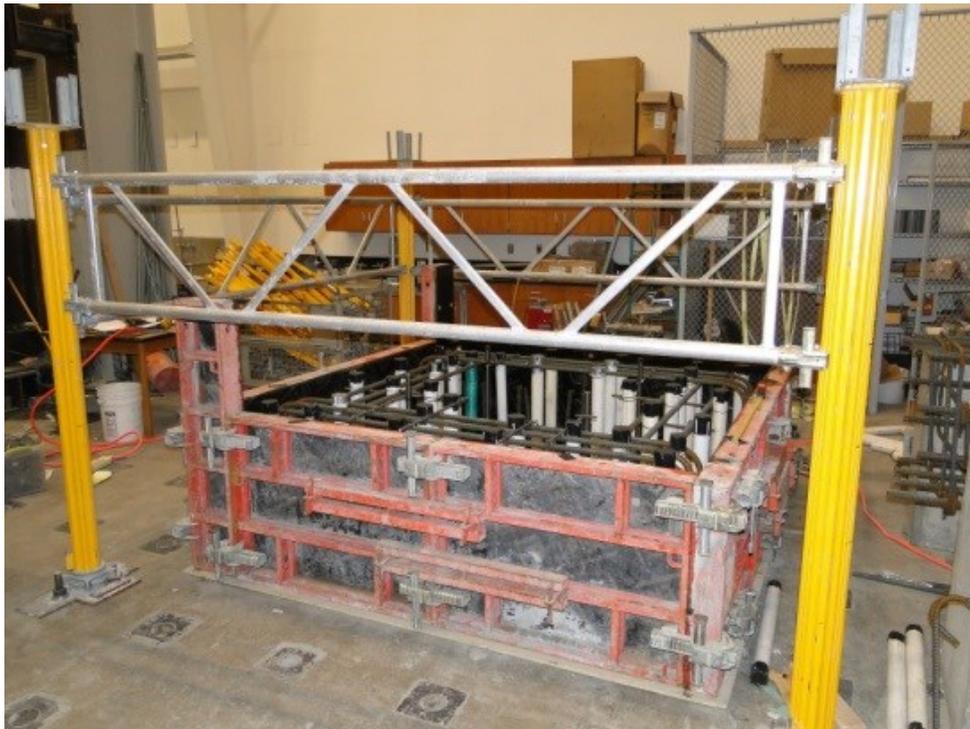
Figure 158. Footing Block Reinforcement and Formwork

All of the space frame column specimens were constructed at the UTA CELB. Each specimen was built in three major parts and cast vertically to simulate real world construction as accurately as possible. Before the construction began all steel strain gauges were placed on the reinforcing bars. The reinforcing cage for the footing block and column cage were constructed separately but simultaneously. Once the footing block cage was completed it was placed inside the formwork and the truss frame was erected as shown in Figure 158. After the column cage was completed and instrumented with concrete strain gauges as shown (Figure 159), it was placed inside the footing cage (Figure 160), centered and secured with straps to the truss frame to prevent it from moving during casting (Figure 161).

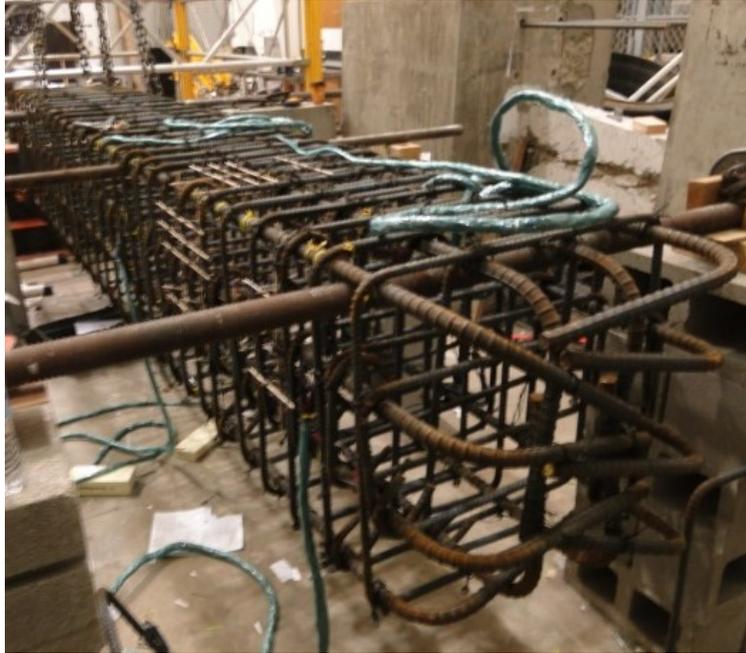
Figure 159. Completed Column Reinforcement Cage

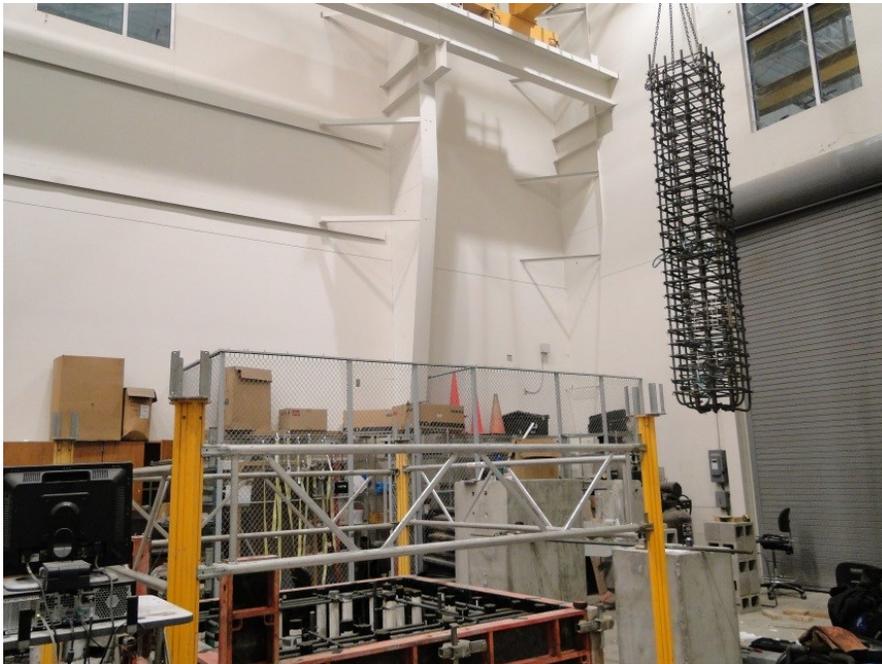
Figure 160. Placing of the Column Cage into the Footing Block

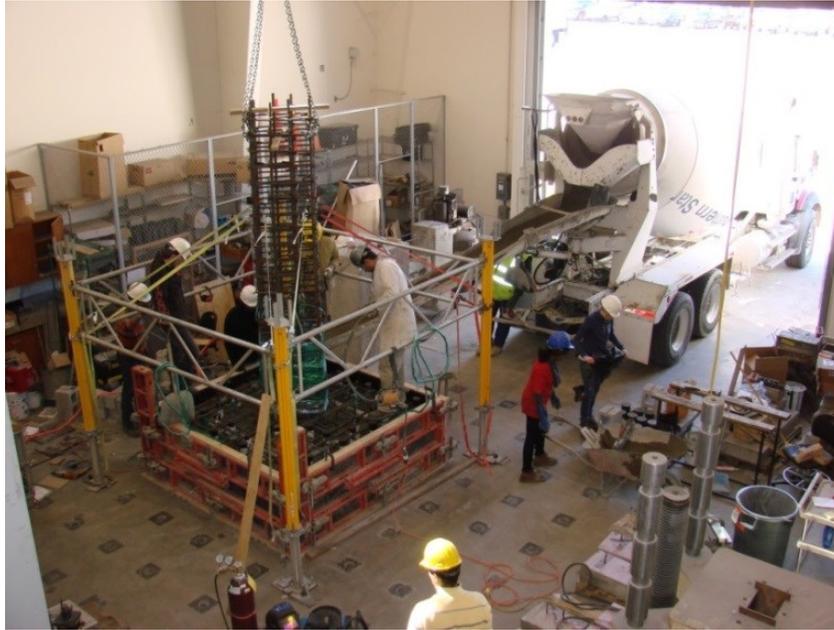
The bottom block was cast using 5 ksi concrete provided by a ready mix truck as shown in Figure 7. Twelve concrete cylinders were made to later be tested under uniaxial compression in order to determine the concrete strength progression.

Figure 162. Bottom Block Casting.

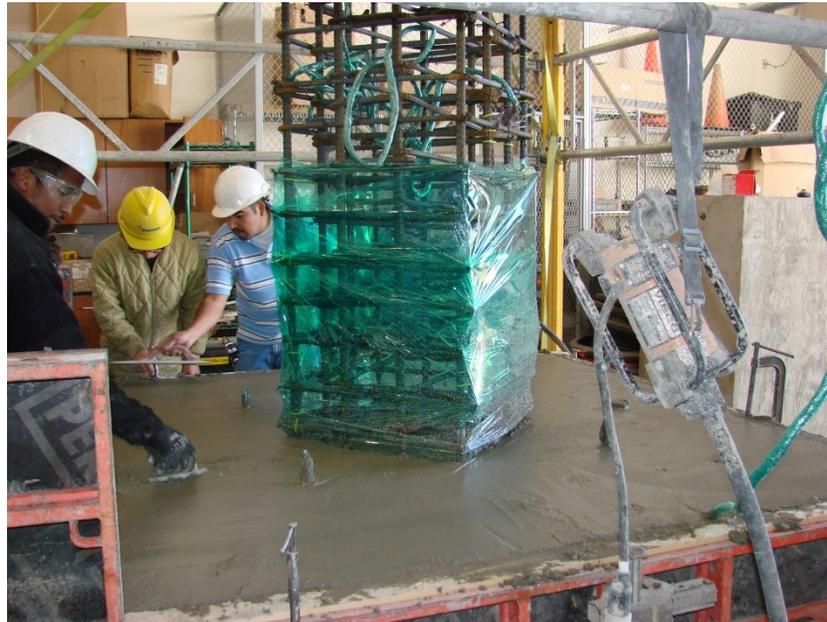
Figure 163. Finishing of bottom block surface

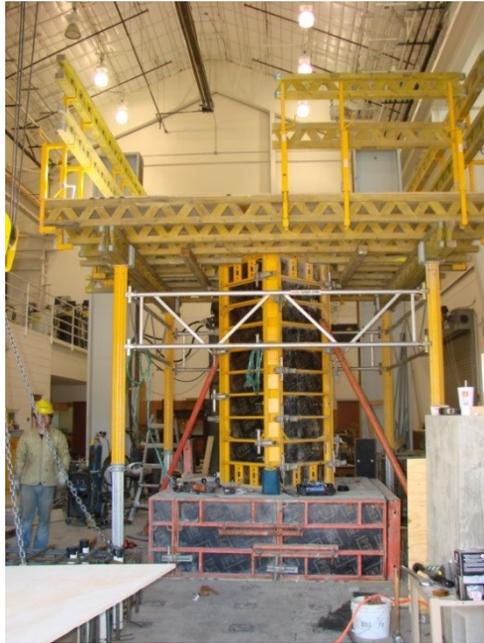
After the bottom block concrete had gained sufficient strength, the formwork for the column and platform was placed (Figure 164).

Figure 164. Column Formwork and Loading Block Platform

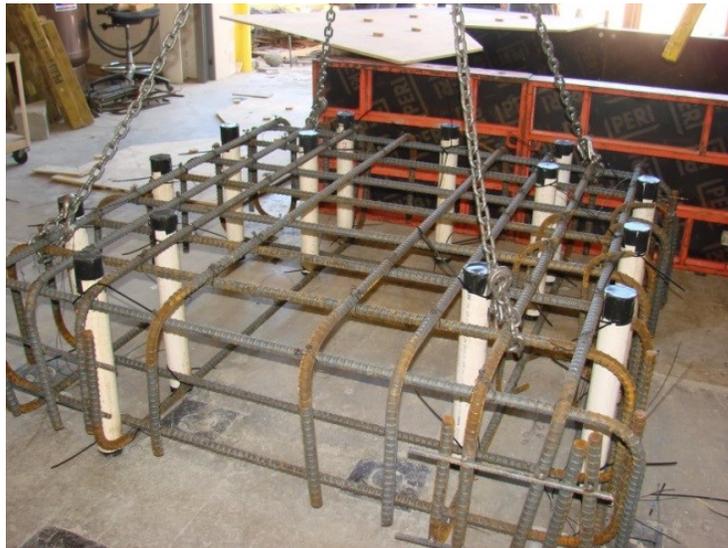
The top block reinforcing cage was constructed (Figure 165) and placed on the platform with the top block formwork.

Figure 165. Loading Block Cage and Formwork

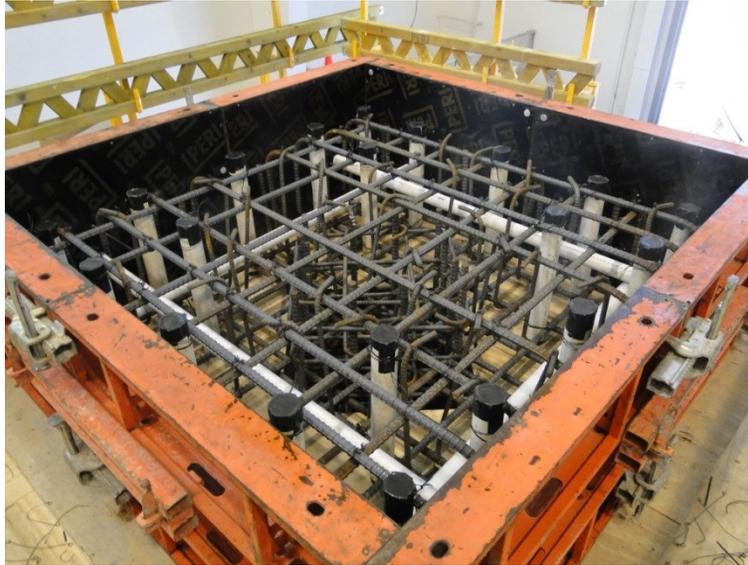
Figure 166. Top block cage and formwork

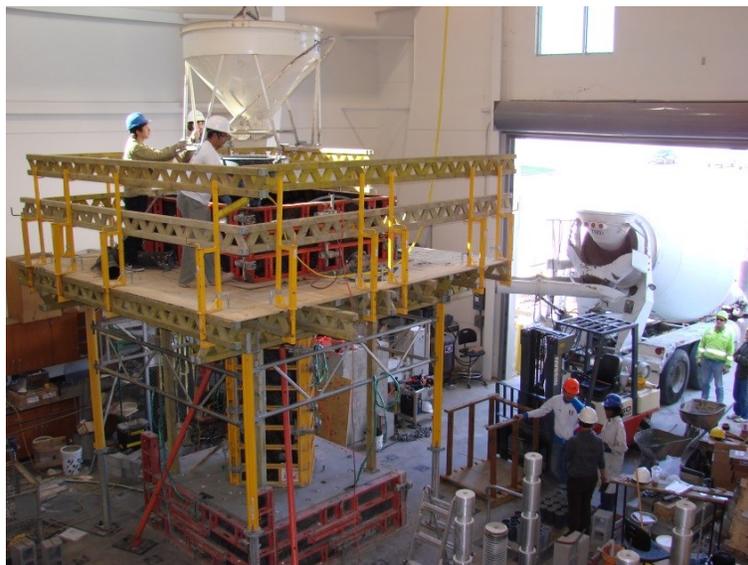
The column section and the loading block were cast vertically to simulate real world construction. The specimen was cast using 5 ksi concrete provided by a ready mix truck. The concrete was poured into a large bucket which was then lifted with a crane to pour the concrete into the column section as shown in Figure 167.

Figure 167. Final Column and Loading Block Casting

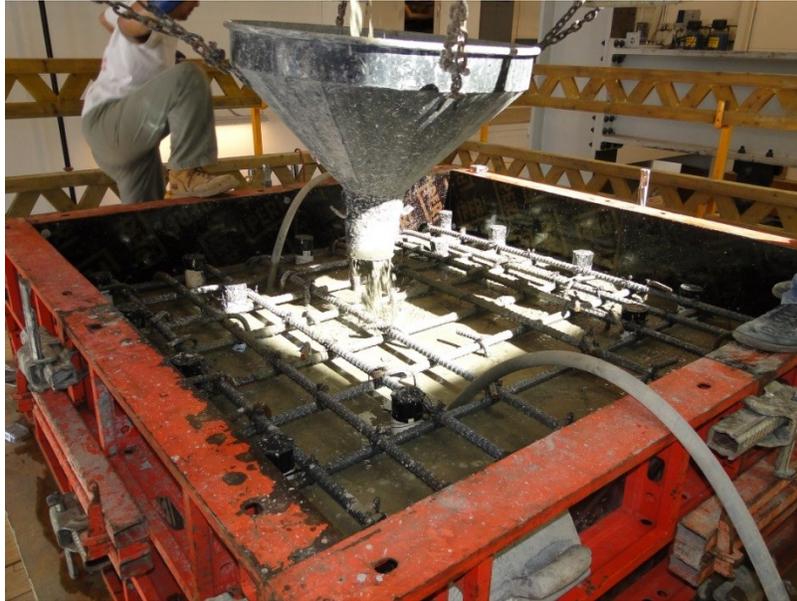
Figure 168. Casting of loading block

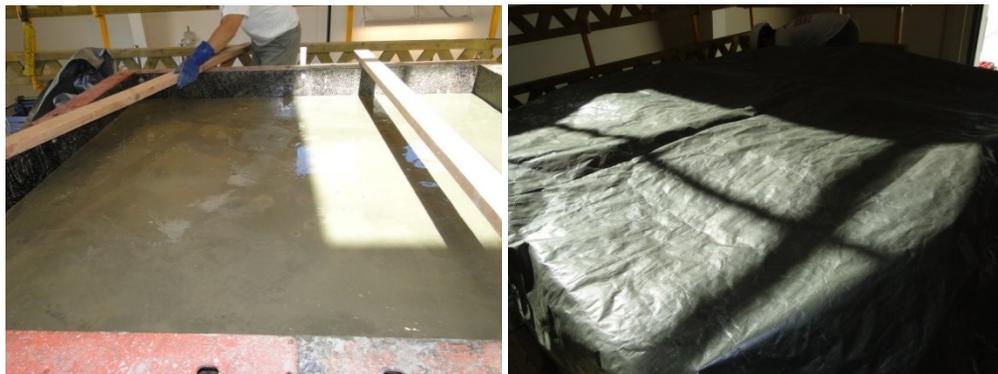
Figure 169. Finishing of top block surface and covering for curing
