PERFORMANCE OF FULL-SCALE ULTRA-HIGH PERFORMANCE FIBER-
REINFORCED CONCRETE COLUMN SUBJECTED TO EXTREME EARTHQUAKE-
TYPE LOADING AND EFFECT OF SURFACE PREPARATION ON THE COHESION
AND FRICTION FACTORS OF THE AASHTO INTERFACE SHEAR EQUATION

MASTER OF SCIENCE IN CIVIL ENGINEERING

THE UNIVERSITY OF TEXAS AT ARLINGTON

May 2015

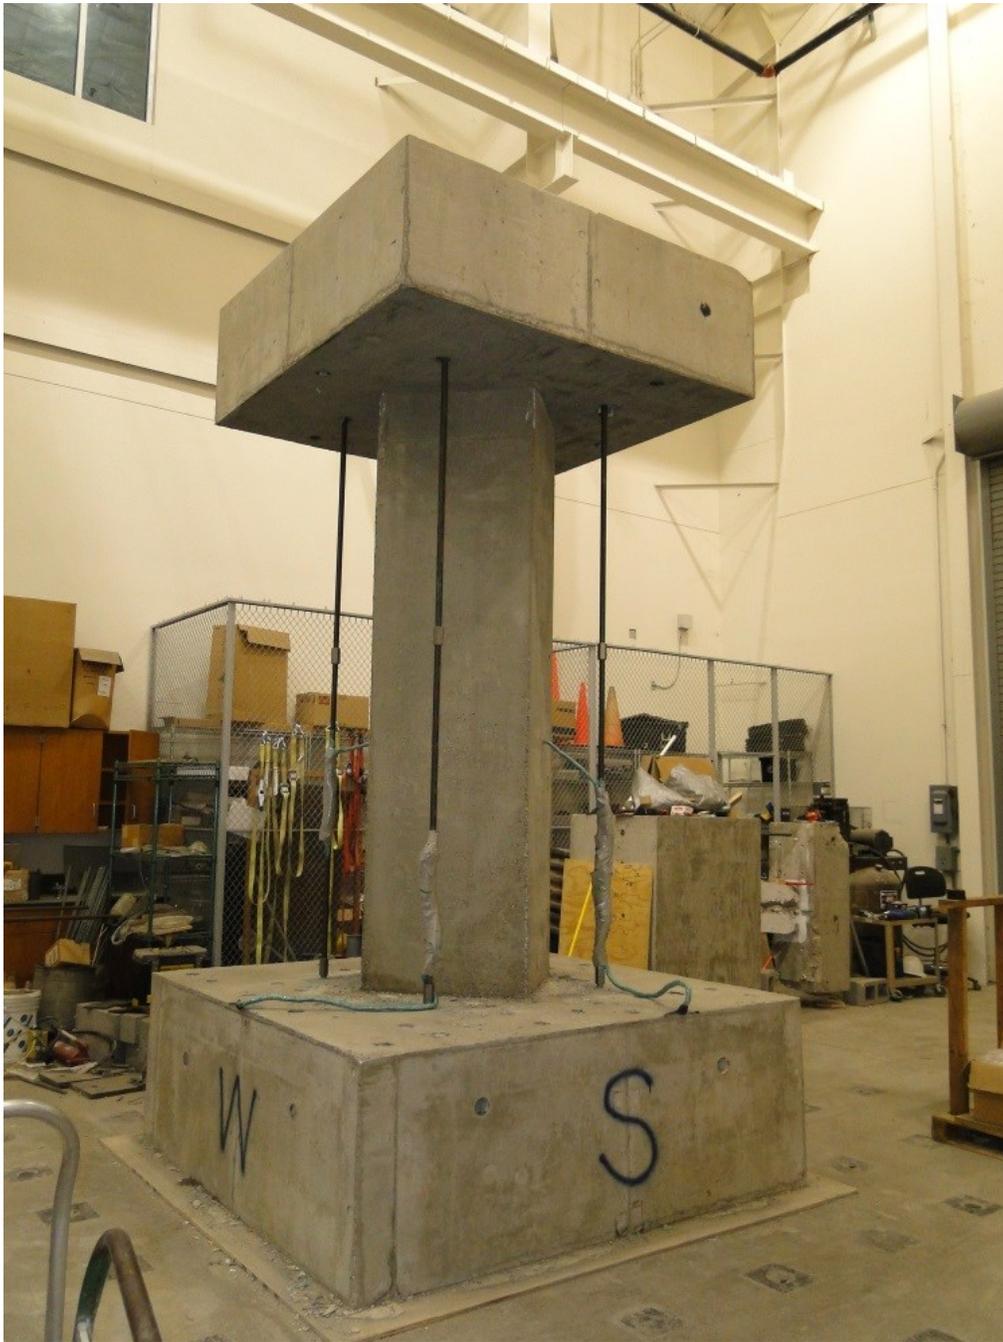
Figure 170. SP5 Space Frame Column Specimen.

After 2 days of curing the formwork is removed and the column is prepared for shipping. Four post tensioning rods were used to protect the specimen from cracking during lifting and transportation. The finished SP5 column specimen can be seen in Figure 170. The column was removed from the CELB by the use of heavy duty forklifts (Figure 171 and Figure 172) and placed on a flatbed truck to be transported to the University of Minnesota (Figure 173).

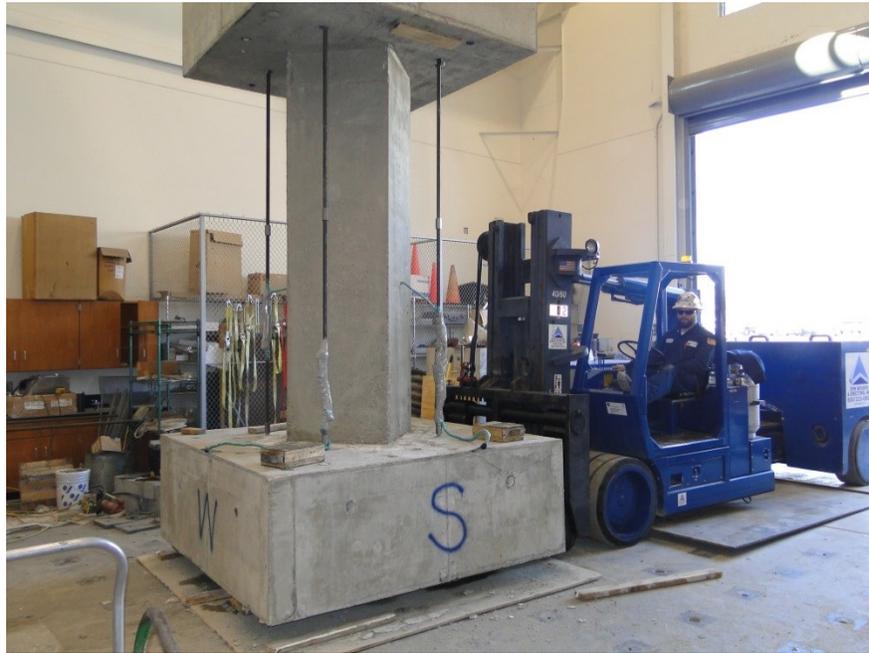
Figure 171. Lifting of column with forklift

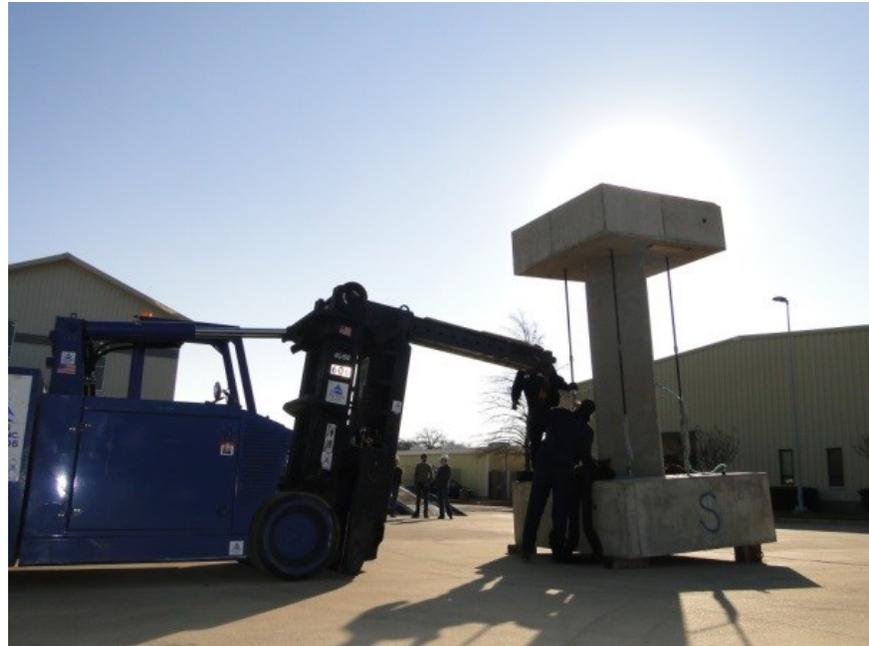
Figure 172. Removing Specimen from CELB.

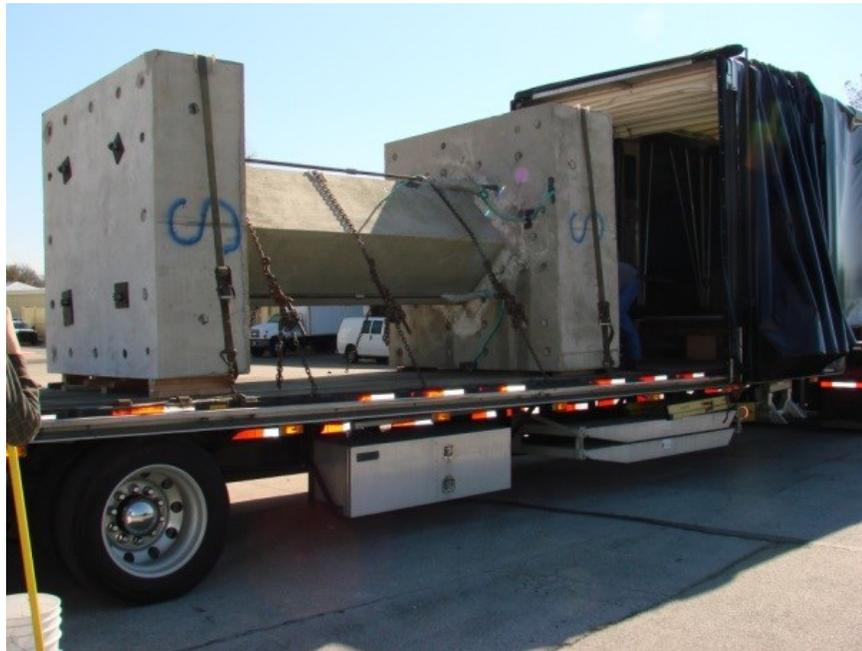
Figure 173. Shipping of Column Specimen to Minnesota

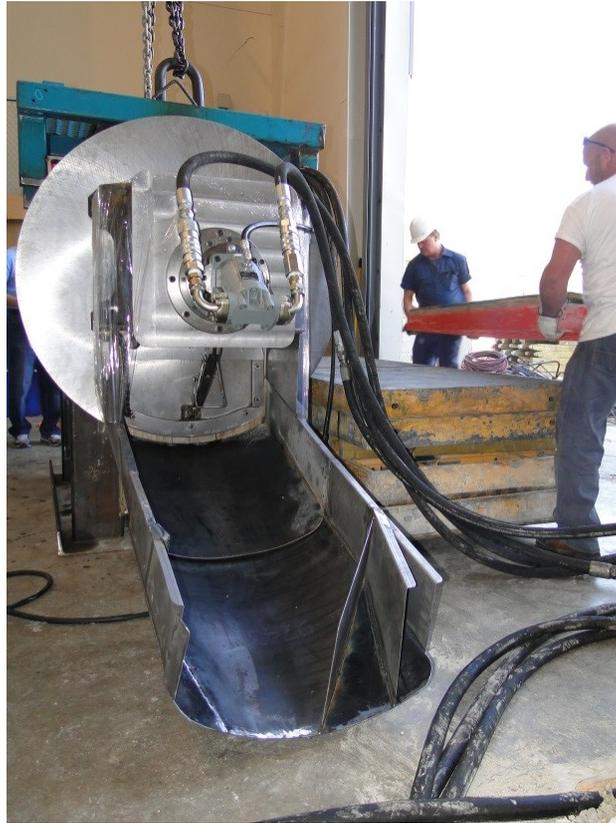
The first 40" of specimen SP8 was cast with UHP-FRC. Since no tests had been conducted with UHP-FRC on full scale structural elements, it presented an interesting construction challenge. In order to correctly mix the UHP-FRC in large quantities a special concrete mixer had to be designed. The mixer was designed and fabricated with the help of Bailey Tool & Manufacturing Company and can be seen in Figure 174.

Figure 174. Special UHP-FRC Mixer

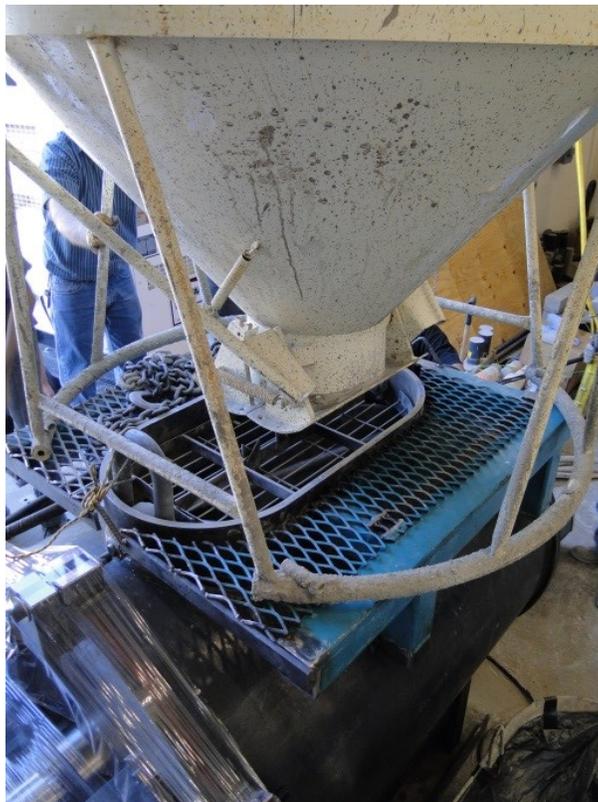
Figure 177. Pouring Dry Material

Formwork was set up prior to casting to a height of 40" as shown in Figure 175. All of the dry materials for the casting were premeasured and placed inside of a large bucket (Figure 176). The dry material is then added to the mixture slowly followed by water and super plasticizer (Figure 177). The microfibers are added last as shown in Figure 178. In order to pour the 40" section the mixer must be elevated to a height well above the section to allow the UHP-FRC concrete to flow downwards into the column formwork. The mixer was raised with the crane and placed on an elevated platform as shown in Figure 179. An extension is placed to guide the UHP-FRC mix towards the column section. The UHP-FRC concrete is then poured into the formwork until it is

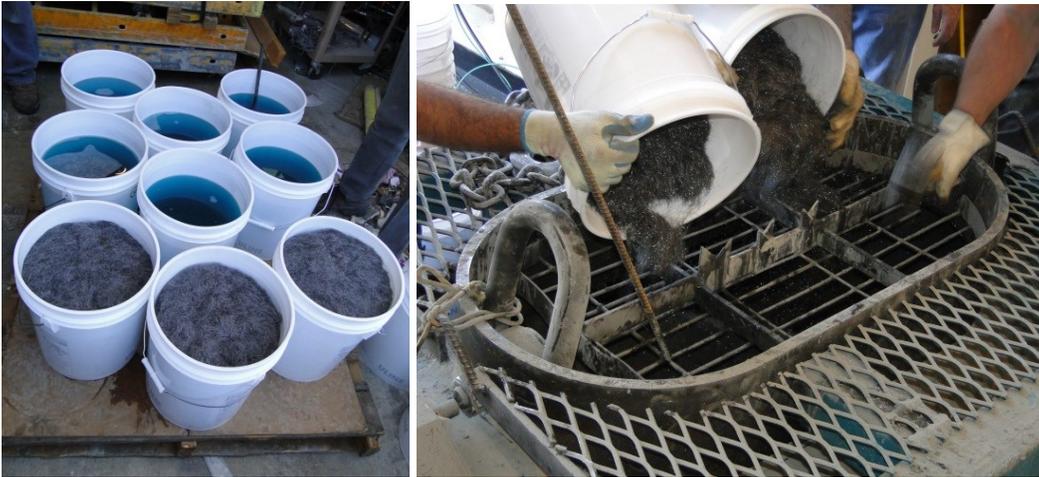
Figure 178. Addition of Micro-Fibers to Mixer

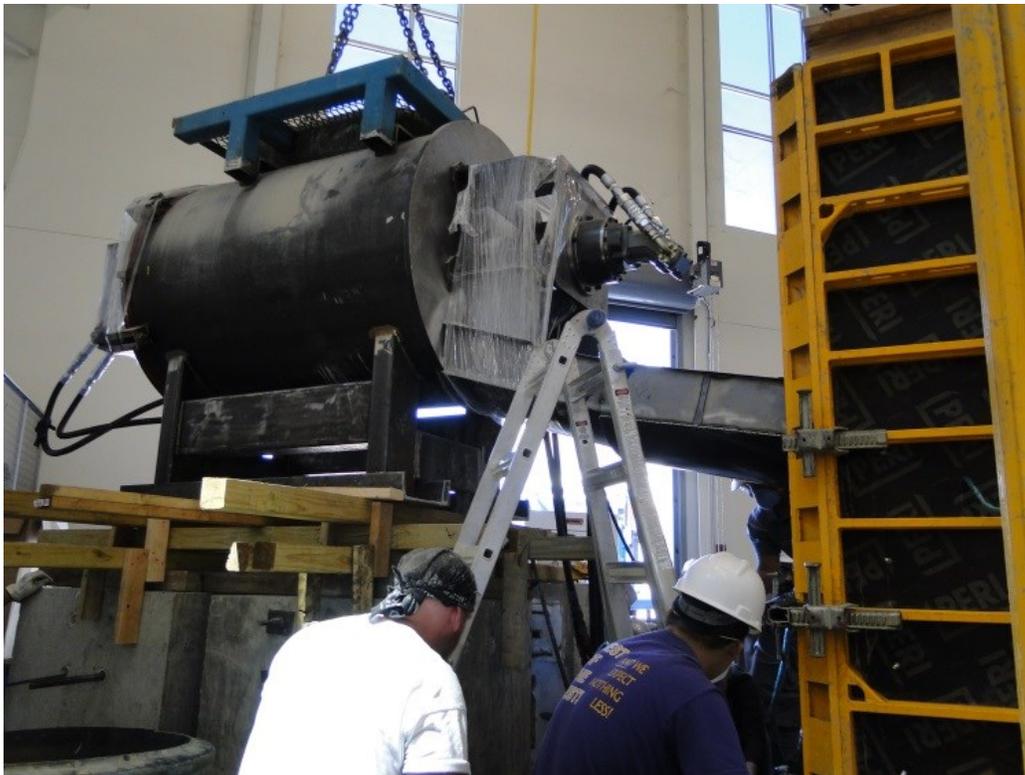
Figure 179. Elevated Mixer ready for pouring

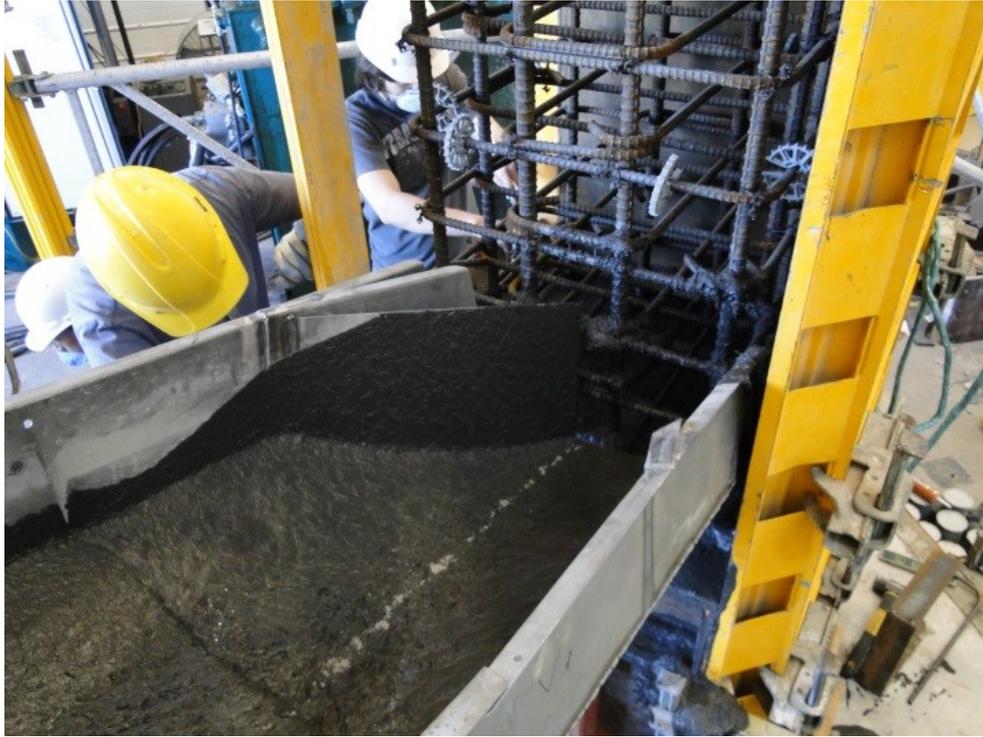
Figure 180. Pouring of UHP-FRC 40" Section

completely filled (Figure 180). The UHP-FRC mix is self-consolidating and requires no vibration.

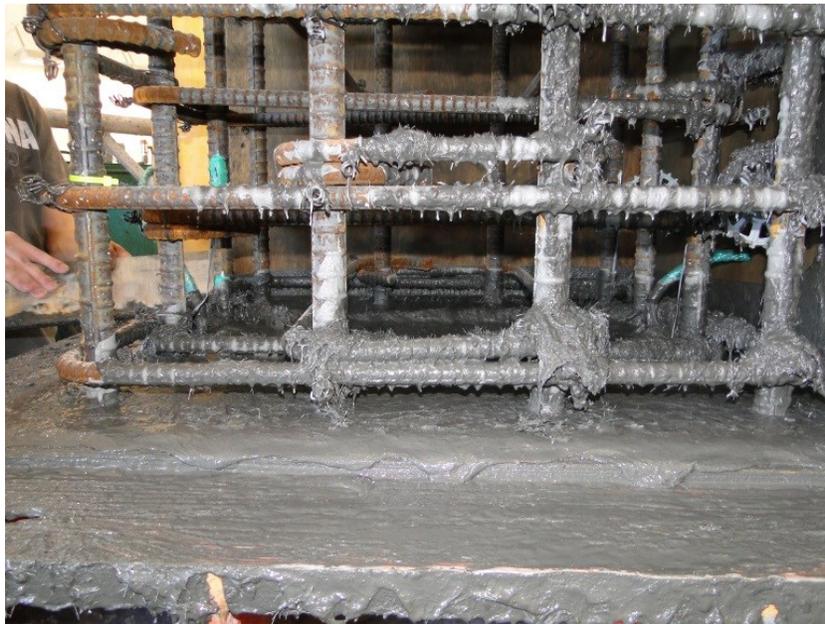
Figure 181. UHP-FRC Section after Casting

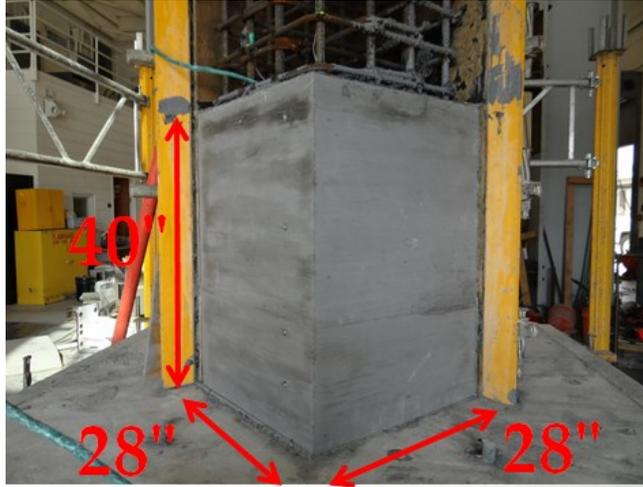
Figure 182. 40" UHP-FRC Section After demolding

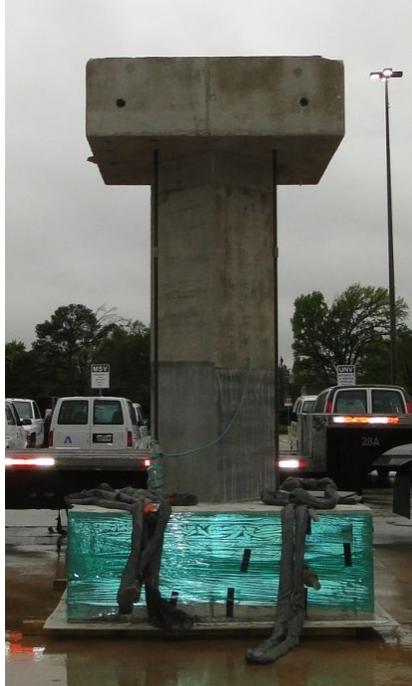
After the casting of the UHP-FRC section the remainder of the column SP8 is cast identically to that of column SP5. The completed specimen SP8 can be seen in Figure 183.

Figure 183. Space Frame Column Specimen SP8

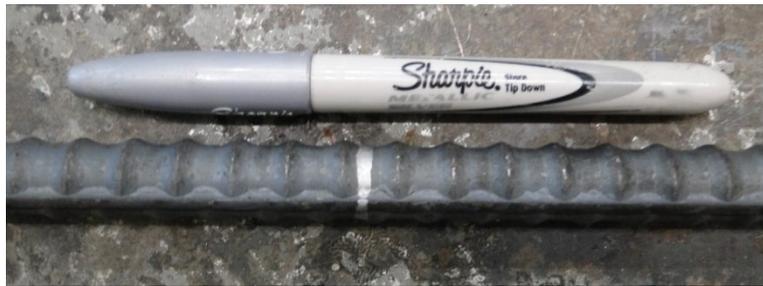
The locations shown in the above construction drawing should be marked accurately onto the L rebars (all from the same shipment batch) with a visible marker around the entire circumference of the rebars as shown in Figure.

Figure 1. Strain gauge location marking

This is done so that after attaching the strain gauges, and constructing the entire column and footing cages as one structure, the final locations of the strain gauges can be documented. Note that the locations are measured from the lowest point on the leg of the L rebar when the long leg rebar is perfectly level upward. That is, although the rebars are designed to be perfect 90° angles, they do not always come as such, and the locations of the strain gauges are measured from the point where the column and footing meet (the “footing” surface).

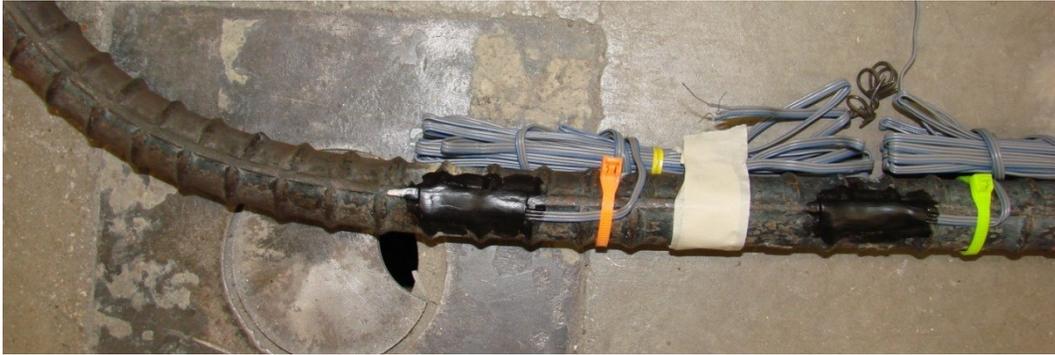
Figure and Figure depict on which side the strain gauges are to be attached. Ultimately, the strain gauges are to be attached to the strong axis of the rebars (on the ridge as shown in Figure) that does not eventually touch any of the hoops or ties when put together as one cage (note that some of the L rebars will be rotated at approximately 45°). The strain gauges are mounted on the strong axis because buckling typically occurs along the weak axis of the rebar, which would lead to considerably different strains on the compression and tension faces. As a consequence, it was decided that the strain gauges should be mounted onto the strong axis face so that the measured strains would be the

Figure 2. Location of strain gauge on longitudinal rebars

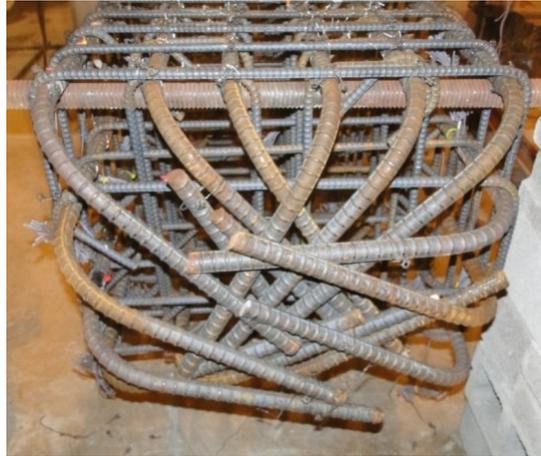
Figure 4. Photo of the bottom of the completed column caging

In order to do this, two L rebar can be placed with their short legs pointing in one direction, and the other two L rebar pointing in the opposite direction. Then, strain gauges would be placed on the strong axes (longitudinal ridge) on the tops of the L rebar.

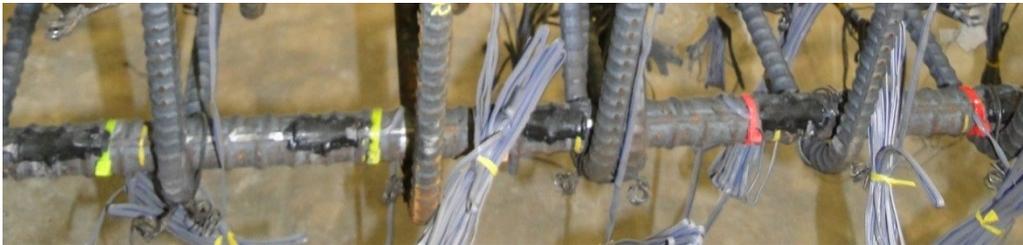
Figure 5. Orientation of strain gauges on longitudinal Bar 1 (on top ridge)

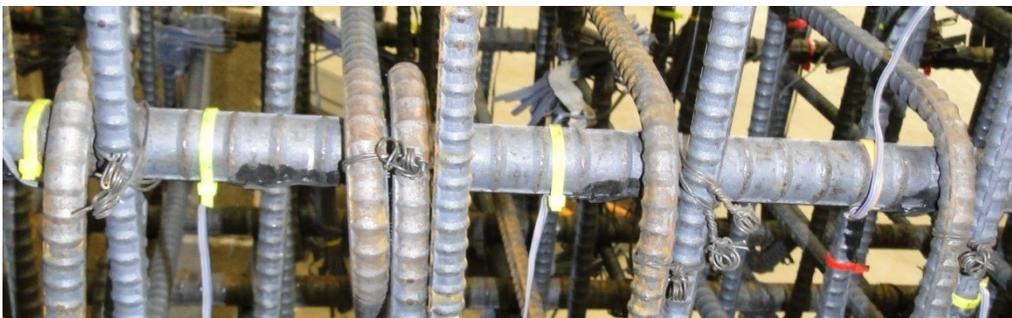
Figure 6. Orientation of strain gauges on longitudinal Bar 2 (on bottom ridge)

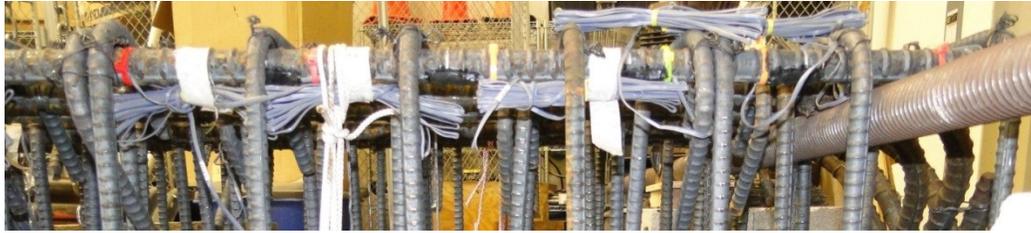
Figure 7. Orientation of strain gauges on longitudinal Bar 3 (on bottom ridge)

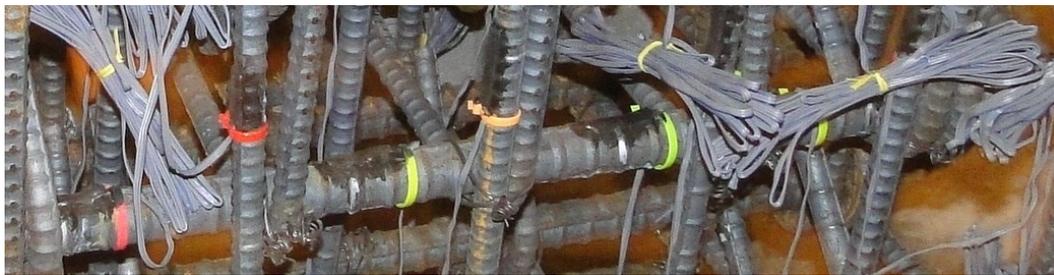
Figure 8. Orientation of strain gauges on longitudinal Bar 4 (on top ridge)

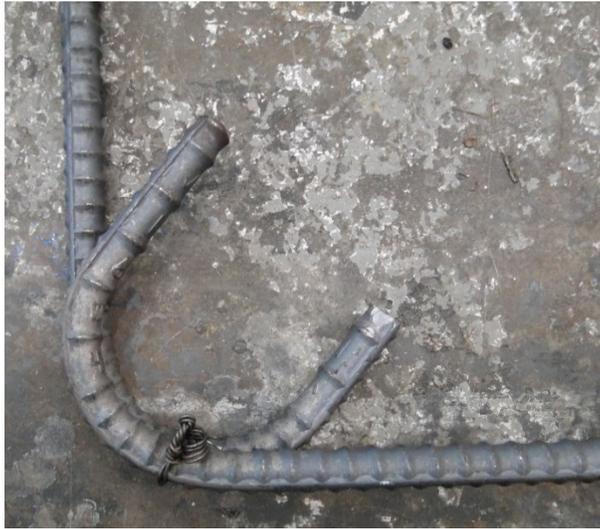
Figure 15. Hoop with hooks tied in place before measuring strain gauge locations

Before measuring the locations of the strain gauges, tie the hooks of the rebars into place tightly with steel wire so that the corresponding sides are perpendicular (as shown in Figure).

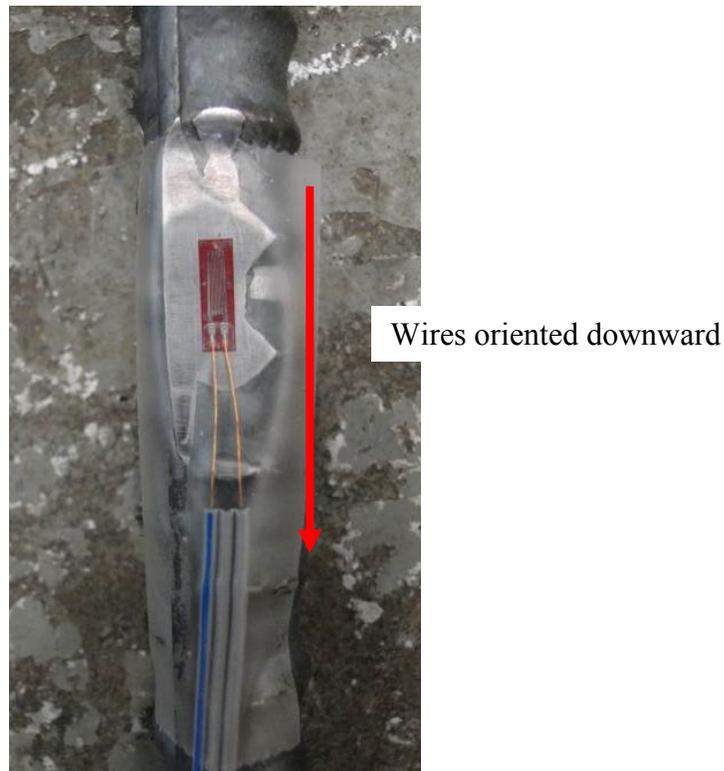
Figure 18. Strain gauge orientation

Before moving on to the actual application of the strain gauges, there is one final detail to clarify: the strain gauge orientation. Strain gauge orientation refers to the direction in which the wires of the devices should face (see Figure).

This detail is determined based on where the wires are planned to be pulled out of the formwork when casting the specimen. The goal is to have to gauges orientated so that the wire does not get folded back toward the actual electrical resistant gauge, risking it being damaged or even ripped off of the steel rebar. The below diagrams explain how to orient the gauges when placing on the longitudinal L rebars, hoops, and ties.

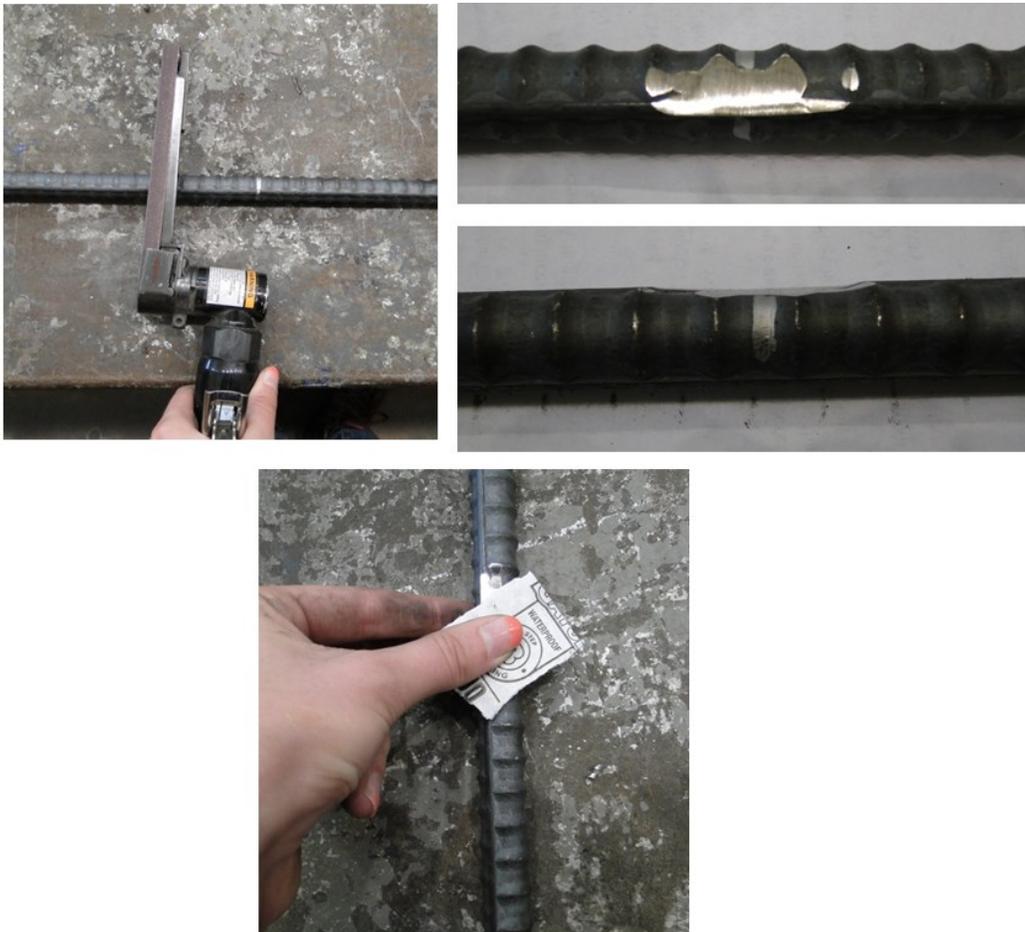
Figure 21. Grinding and sanding of deformed rebars

Once marked properly, the grooved surfaces of the steel are ground and then sanded with 400 grit sandpaper until a flat, smooth surface is created for the strain gauge to be attached. Be careful to grind no more of the deformed bar than necessary for the strain gauge surface so as to not disrupt the bond between the concrete and rebar. Also, be cautious to create a level surface, rather than a scooped surface, to place the strain gauge. See Figure for this step.

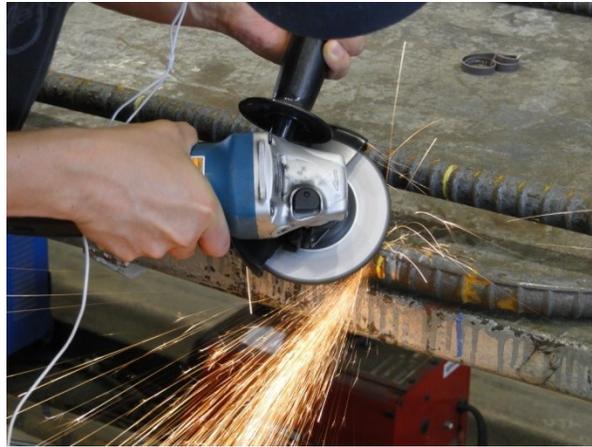
Figure 22. Grinding of deformed rebars with handheld grinder

Note: Here, a small sanding belt is used; however, to speed up the process, one can use a handheld grinder to grind down the ribs on the longitudinal (#9) rebars as shown in Figure , but it must be smoothed and leveled with the sanding belt after to ensure a flat surface is obtained.

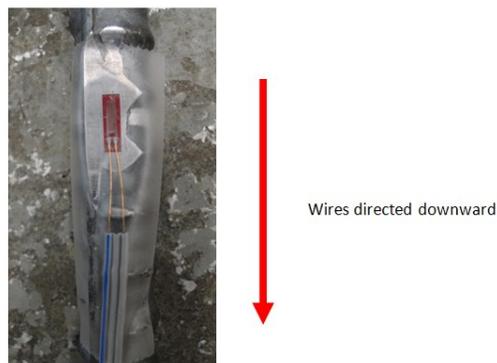
Figure 25. Lining up the gauge crosshairs to the proper location on the rebar

Then, to line up the center crosshairs on the strain gauge itself to the accurate location on the rebar, apply a strip of scotch tape longitudinally to the top side of the strain gauge (the side that has wires soldered to the gauge), and place directly onto the rebar lining up the crosshairs on the device to the previously marked location (S-01 and S-02 on pages 1 and 7). See Figure for this step.

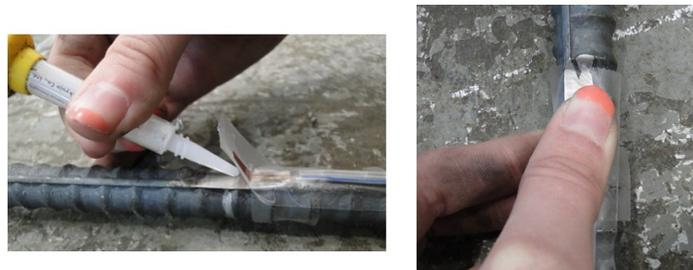
Figure 37. Glue application

Now, lift the top end of the longitudinal tape, pulling the gauge off of the rebar and allowing space to place a strip of glue (Cyanoacrylate adhesive) under the location of the strain gauge. Replace the tape and gauge over the strip of glue, and firmly press the gauge down for about two minutes while it dries. See Figure for this step.

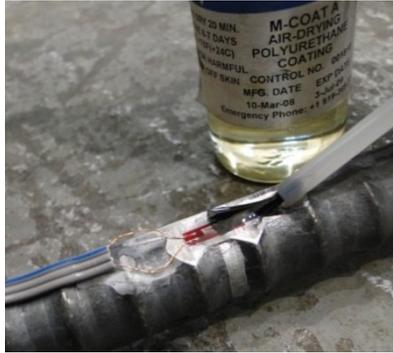
Figure 39. Coat A application

Now, apply a layer of polyurethane coating (“Coat A”) from the bottom of the gauge to the top of the gauge, i.e. not on the exposed wires, and allow to dry for about 15 minutes. See Figure for this step.

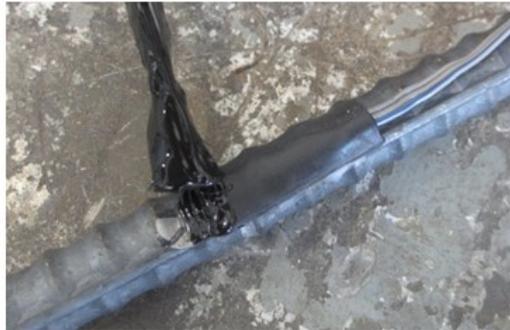
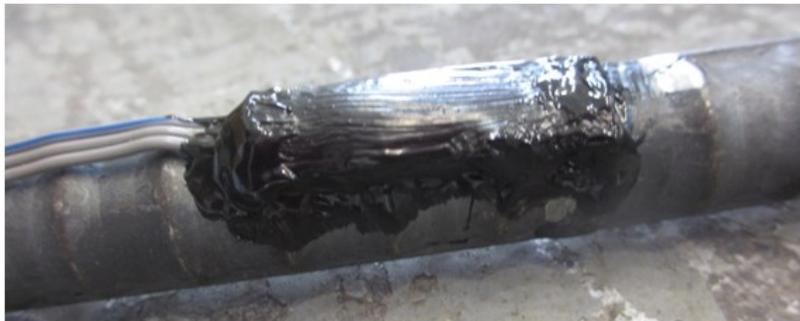
Figure 42. Liquid electrical tape application

Seal the edges of the electrical tape using liquid electrical tape. Be sure the liquid tape creates a barrier that does not allow the moisture sealing tape to lift off of the rebar surface, breaking the seal of the liquid tape. The liquid tape only takes about 5 to 10 minutes to dry. See Figure for this step.

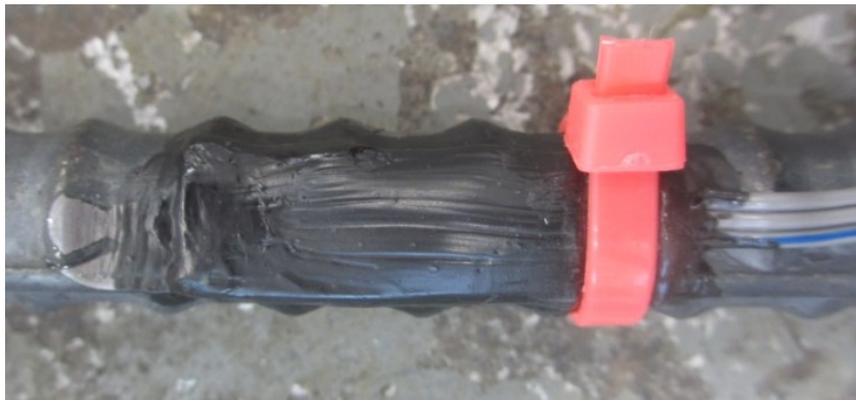
Figure 43 Zip-tie

Once the liquid electrical tape is dry, zip-tie on top of the bottom edge of the moisture sealing electrical tape. Be careful not to zip-tie over the exposed wire portion of the device below, for this would cause a weak point in the wire that will likely break under any additional stress. The goal is to zip-tie on top of the coated wires. The purpose of the zip-tie is to help protect the strain gauge from being pulled during the construction process. See Figure for this step.

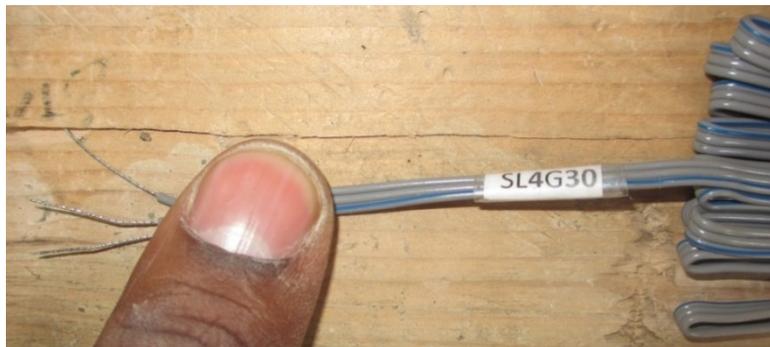
Figure 44. Strain gauge label

At this point, one can label the gauge according to the drawings above (S-01 and S-02). This is done by printing out labels (about 10 point font size), trimming them down to size, sticking them face up to the adhesive side of the tape, and wrapping it tightly around the coated wires at the end of the gauge wire. See Figure for this step.

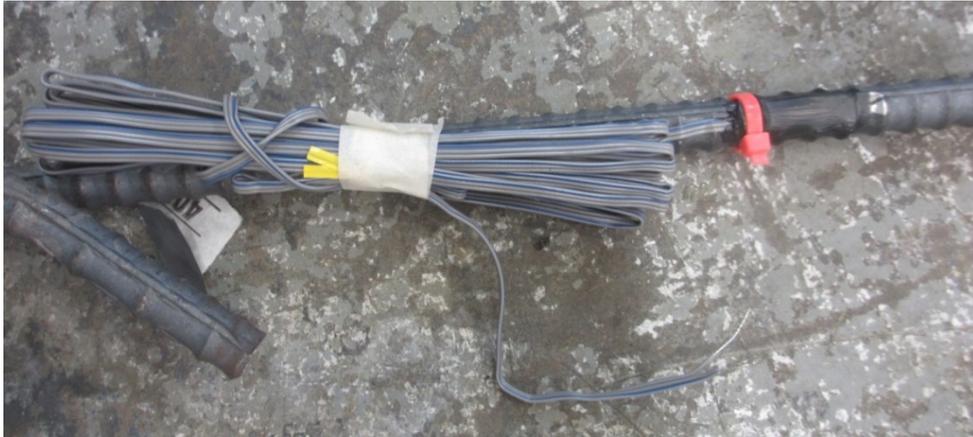
Figure 45. Secure wire bundle

Then, secure the bundle of wire to the rebar with masking tape for safekeeping as shown in Figure .

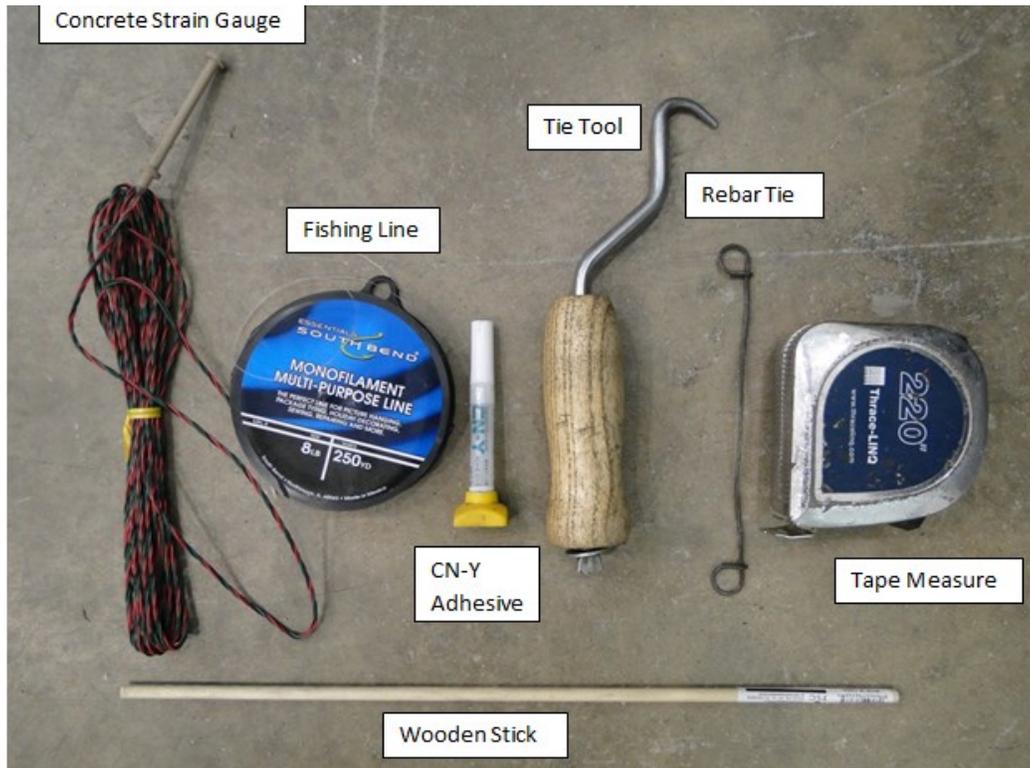
Figure 49. Concrete Strain Gauge Instillation Materials.

The materials necessary for the instillation of the concrete strain gauges are shown below in Figure 49.

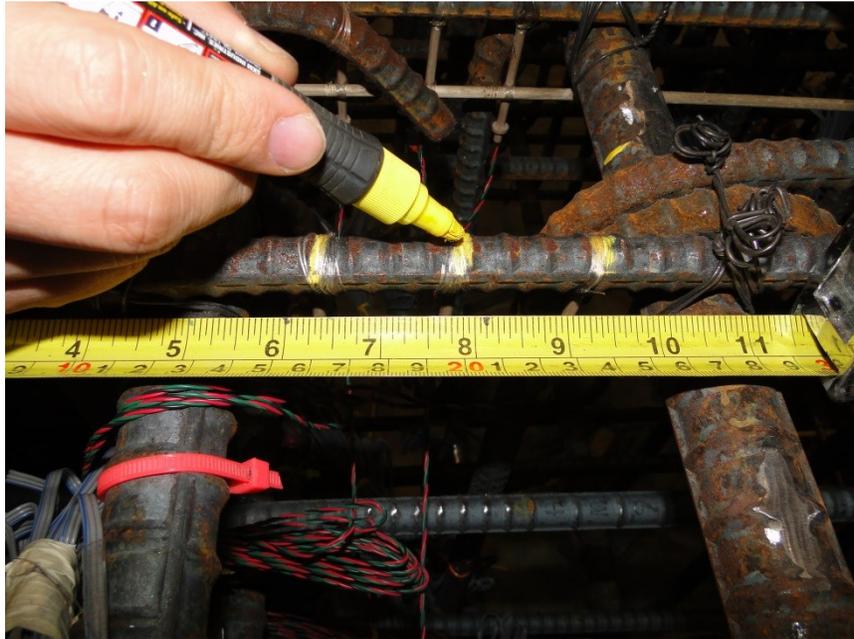
Figure 50. Marking of locations

First, use the drawings to mark the location of the wooden sticks and concrete gauges on the reinforcement bars using a marker.

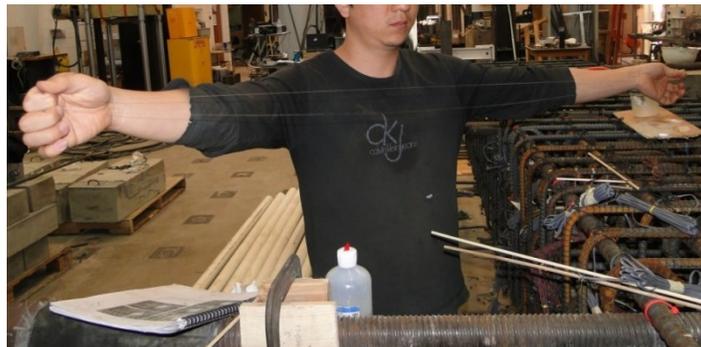
Figure 55. Measuring of string

3.1.1 Cut fishing line to a length about 2 meters long

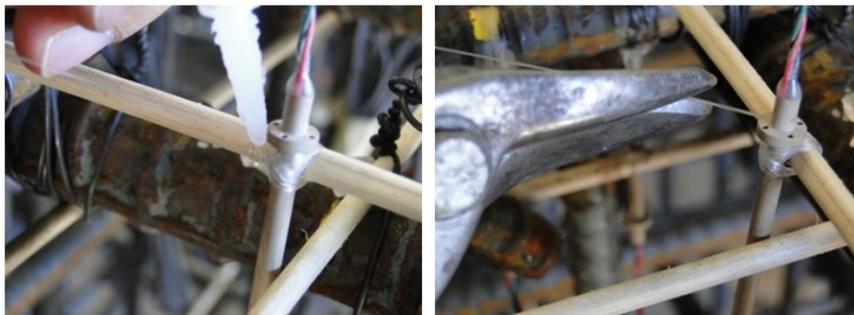
Figure 60. Apply super glue to fishing line and trim off the excess part

With the end of the fishing line pulled tightly, apply CN-Y adhesive to the fishing line tied to the wooden dowel. Then cut the excess part.

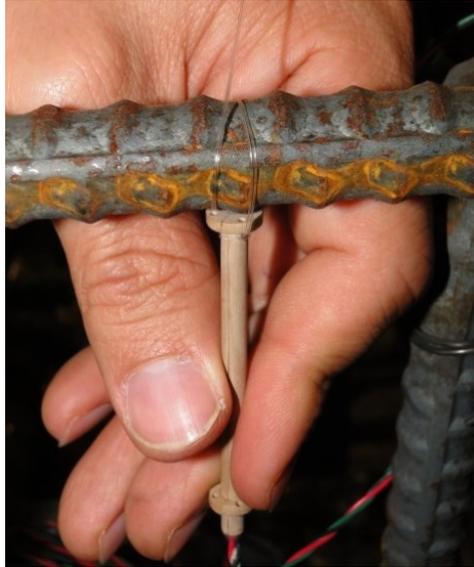
Figure 61. Placing of concrete gauge

To measure the strain in concrete that is in contact with steel rebar, the concrete strain gauge is tied directly to the steel rebar.

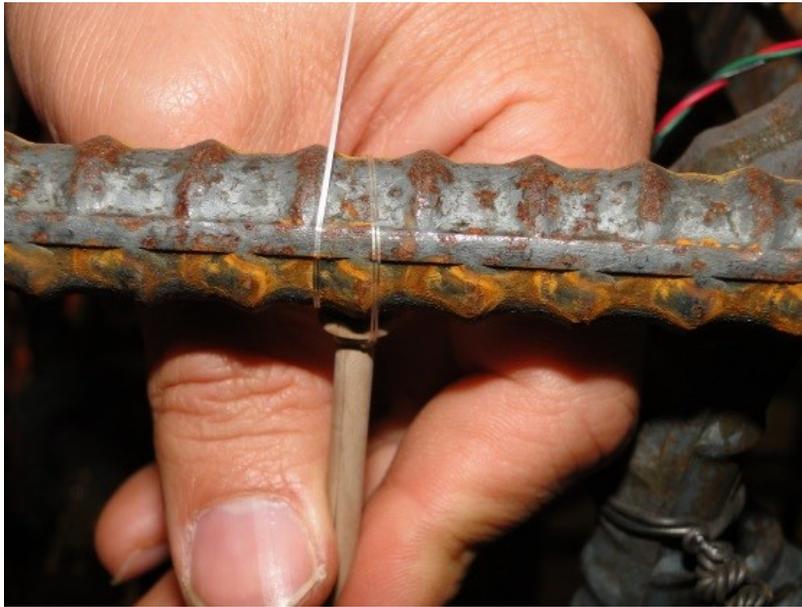
Figure 63. Tying concrete gauge to rebar

4.6 Place the concrete strain gauge in contact with steel rebar.

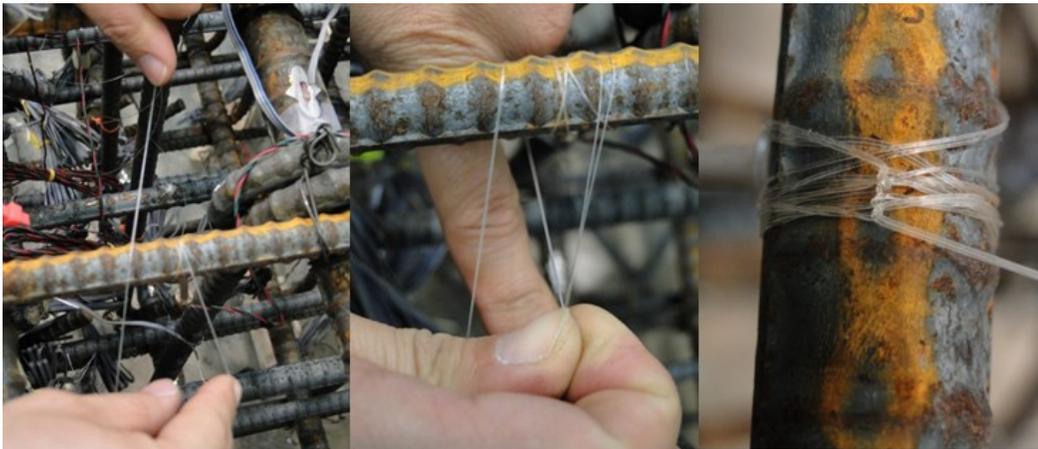
Figure 64. Securing gauge to bar

4.7 To secure the concrete strain gauge in place, using fishing line make a loop, then put the overhand-knot-end around the steel bar and through the loop. Repeat this process for a few times until the concrete strain gauge stays securely in place. As shown in figure 64.

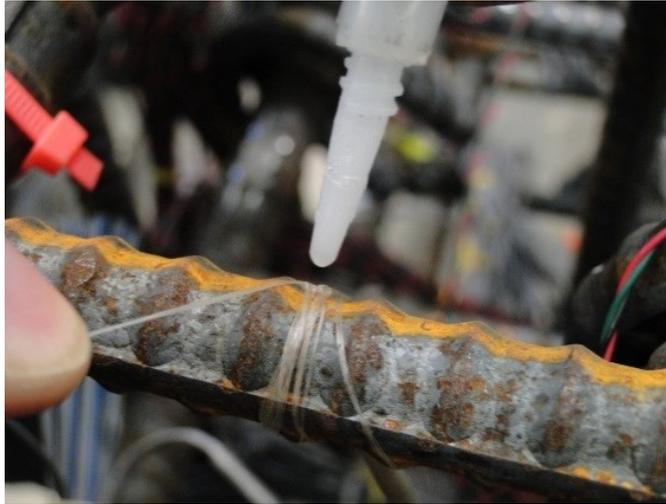
Figure 65. Applying glue

4.8 Apply CN-Y adhesive and trim off the excess part of the fishing line.

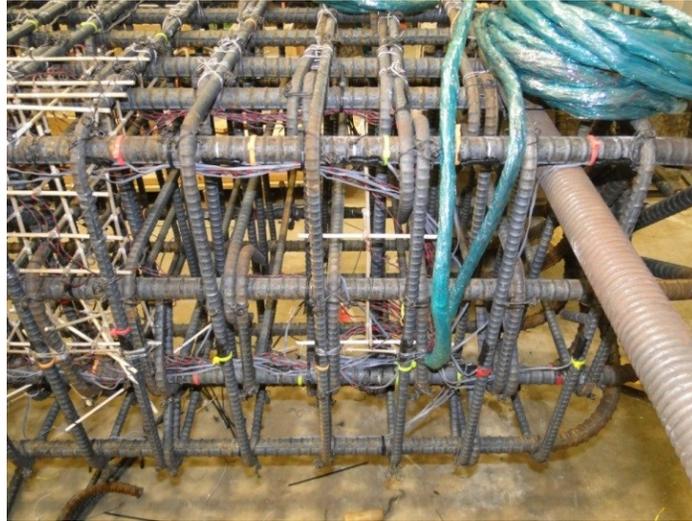
Figure 67. Wrapping of wires

Once all of the gauges have been installed the next step is to carefully wrap the wires using a plastic wrap. First all of the wires are carefully taken towards the 4 key locations of the column where the wrapping will occur.

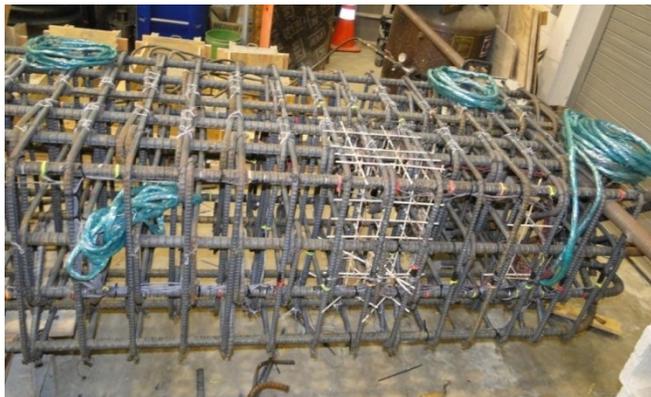
Figure 69. Completed gauge instillation

Two bunches of wires will come out at the bottom of the column cage below the footing and two bunches of wires will come out of the column section on opposite sides around mid-height as shown below.

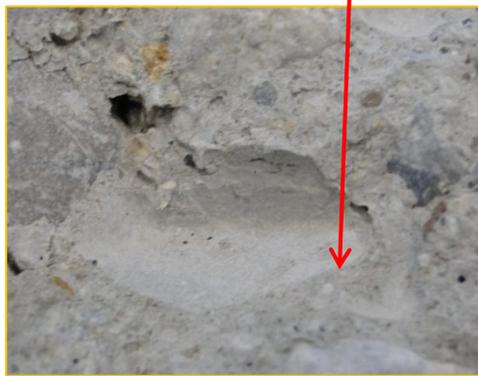
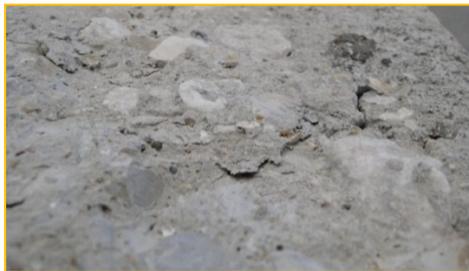
The three wood float specimens failed at loads of 38.5 kips, 23.6 kips and 45.9 kips. The failure occurred at the interface and no flexural cracks were observed. It was noticed that some aggregates were dislodged from the concrete when the precast part was observed after failure. The places where this occurred on the precast part are represented by black markings.

Figure 2. Wood float specimen # 1 precast (a) failure plane showing aggregate pullout and (b) surface profile.

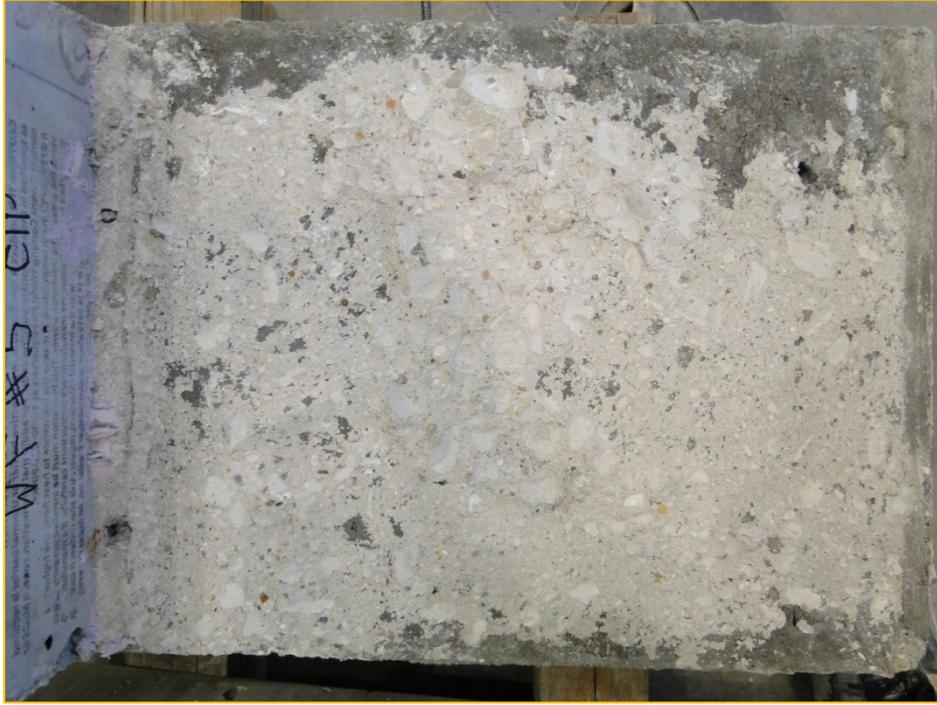
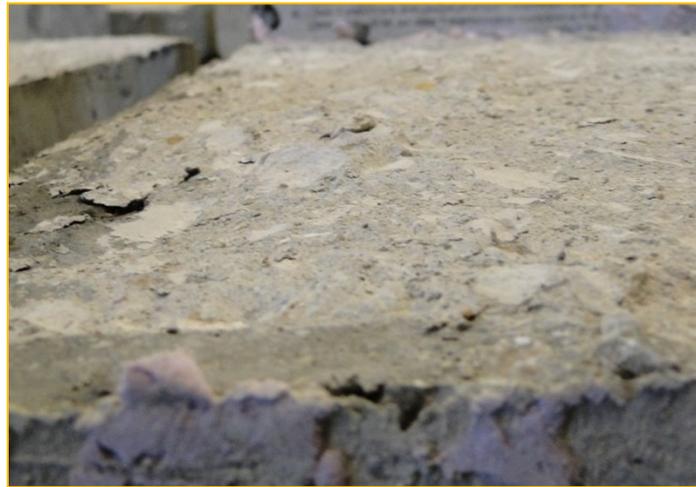
Figure 3. Wood Float Specimen #1 Cast in-place (a) failure plane and (b) surface profile.

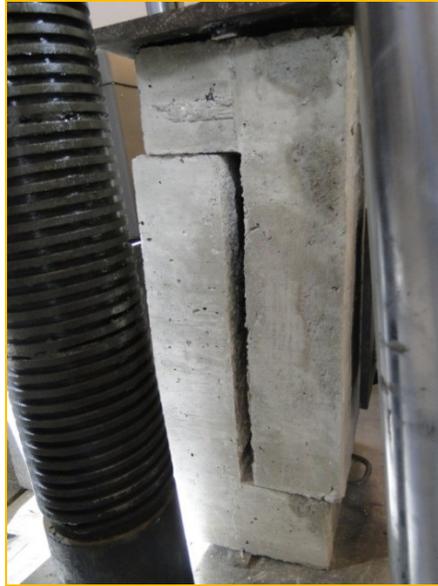
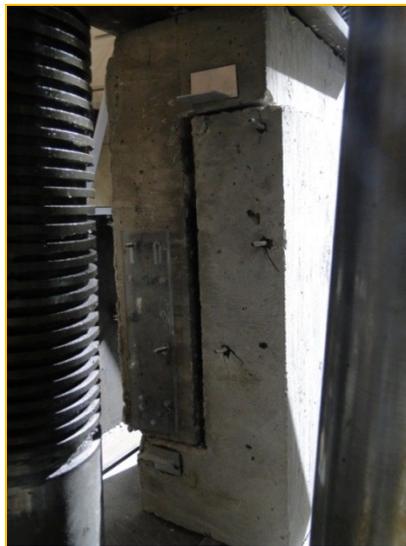
Figure 4. Wood Float Specimen #2 at failure (a) front view (b) back view.
