PERFORMANCE OF FULL-SCALE ULTRA-HIGH PERFORMANCE FIBER-
REINFORCED CONCRETE COLUMN SUBJECTED TO EXTREME EARTHQUAKE-
TYPE LOADING AND EFFECT OF SURFACE PREPARATION ON THE COHESION
AND FRICTION FACTORS OF THE AASHTO INTERFACE SHEAR EQUATION

MASTER OF SCIENCE IN CIVIL ENGINEERING

THE UNIVERSITY OF TEXAS AT ARLINGTON

May 2015

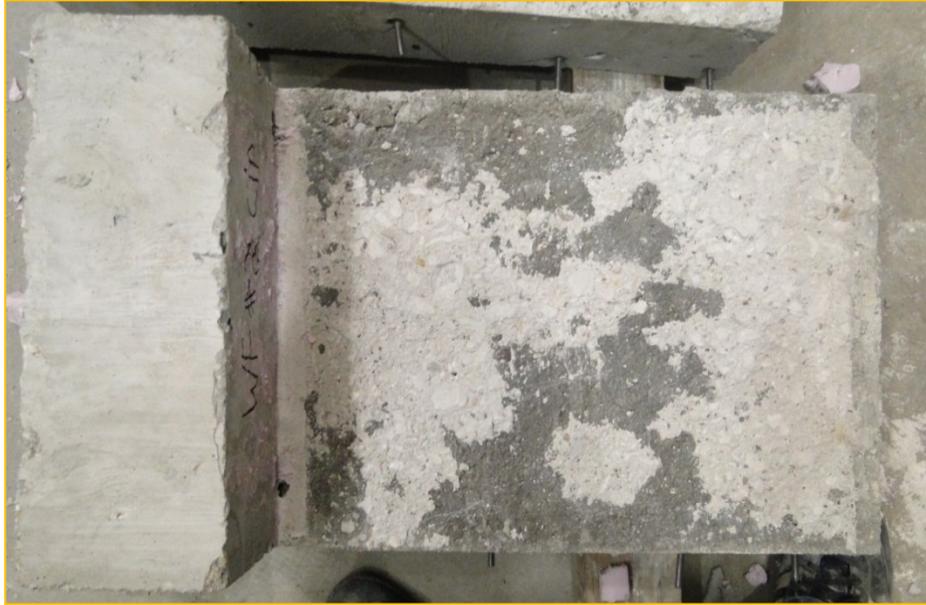
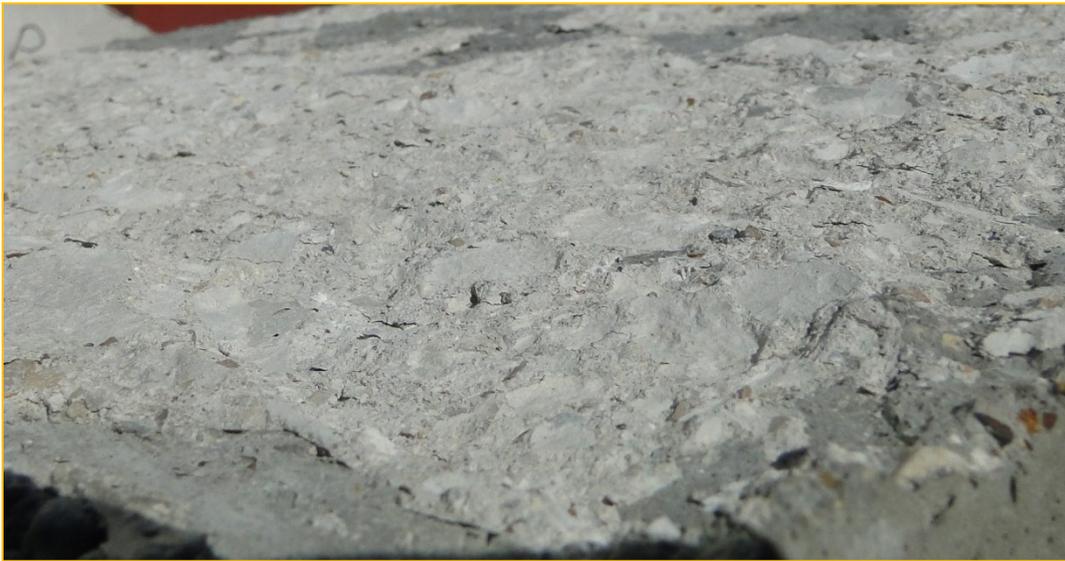
Figure 5. Wood Float Specimen #2 CIP (a) failure plane and (b) surface profile.

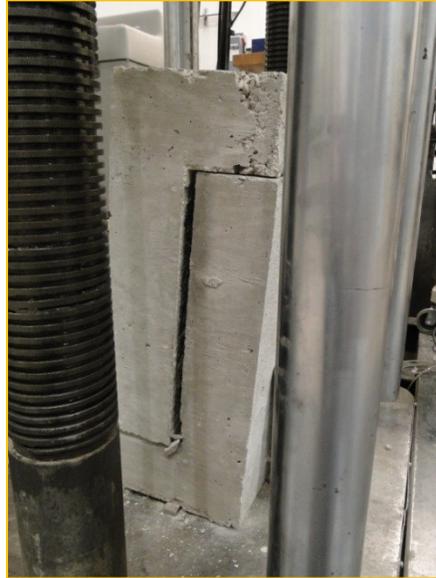
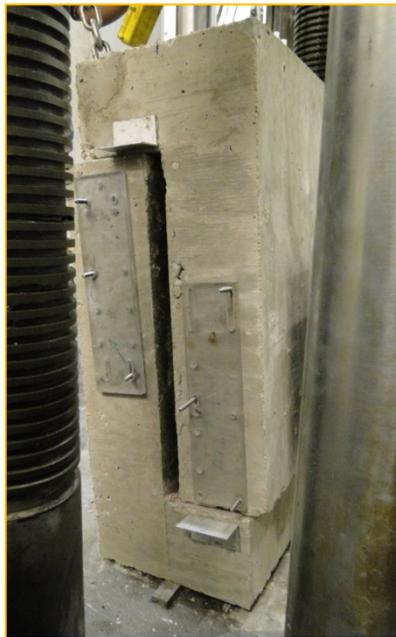
Figure 7. Wood Float Specimen #3 at failure (a) front view (b) back view.

The three wood float specimens failed at loads of 38.5 kips, 23.6 kips and 45.9 kips. The failure occurred at the interface and no flexural cracks were observed. It was noticed that some aggregates were dislodged from the concrete when the precast part was observed after failure. The places where this occurred on the precast part are represented by black markings.

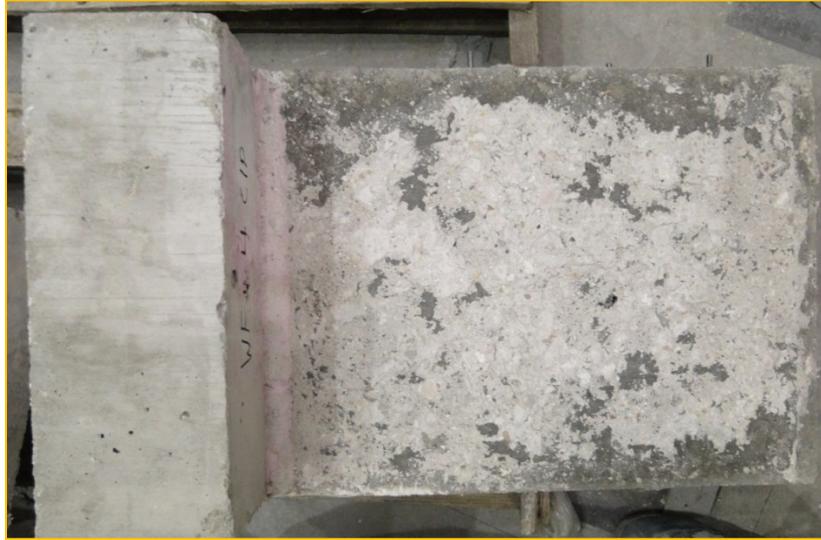
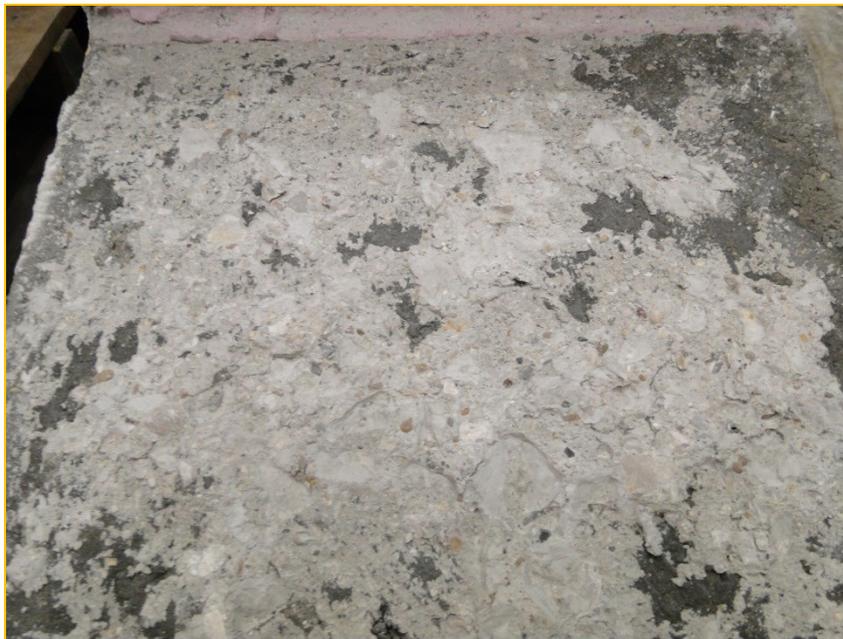
Figure 8. Wood Float Specimen #3 CIP (a) failure plane and (b) surface profile.

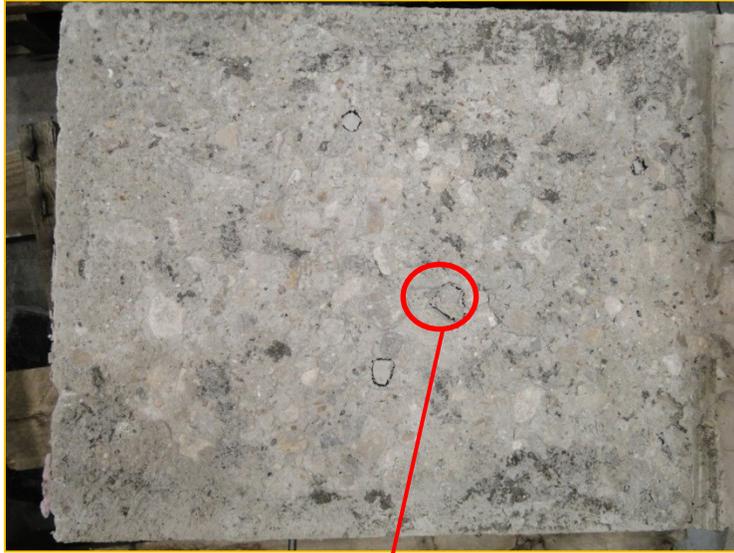
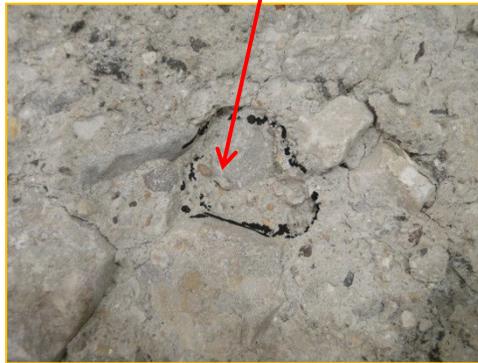
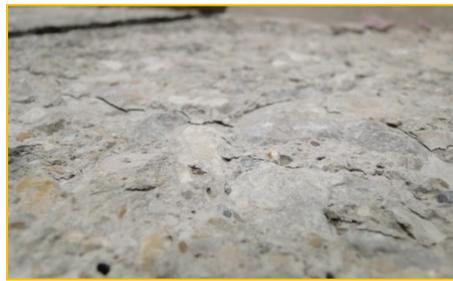
Figure 9. Wood Float Specimen #3 precast (a) failure plane showing dislodged aggregates and (b) surface profile.

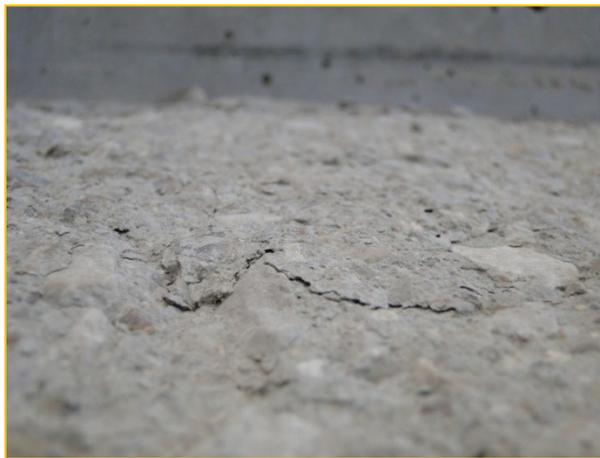
Figure 12. CSP 6 Specimen #1 precast (a) failure plane and (b) surface profile.

Figures 110 through 118 show the testing of both of the CSP 6 specimens. All three specimens failed at the interface with peak loads of 49.6 kips, 53.6 kips and 42.0 kips.

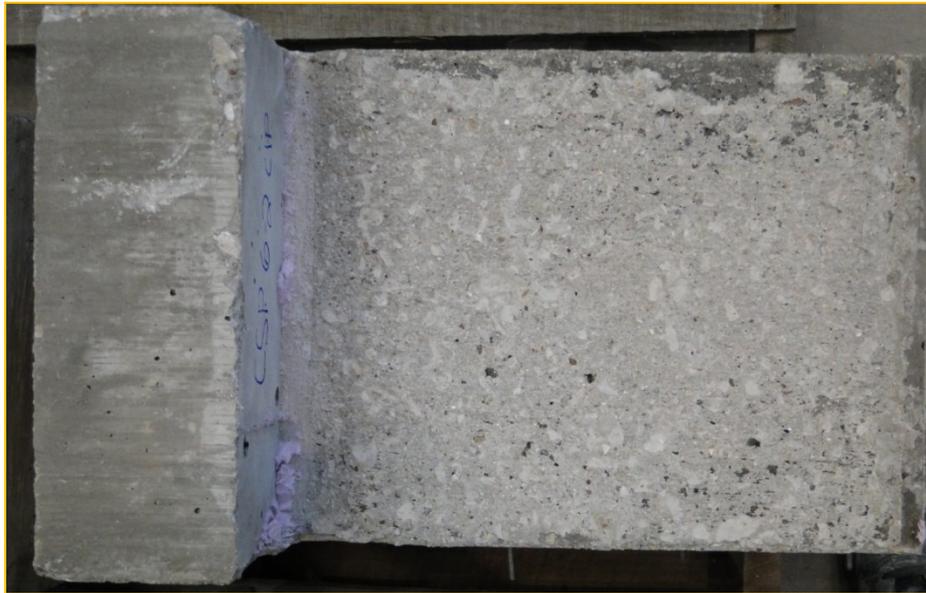
Figure 13. CSP 6 Specimen #2 failure

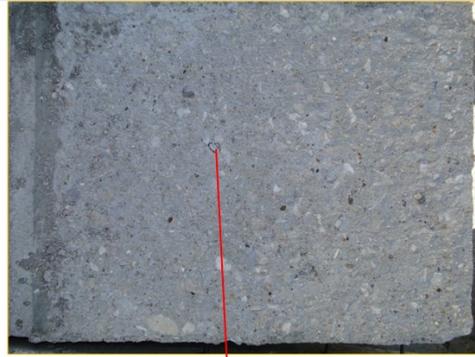
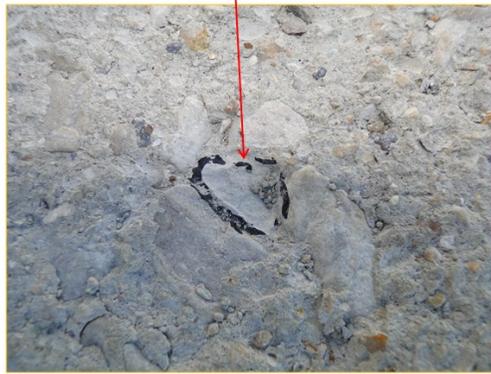
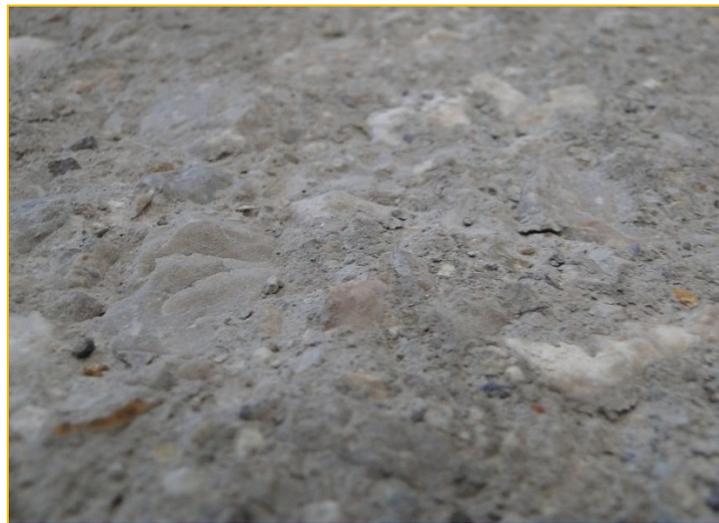
Figure 15. CSP 6 Specimen #2 precast (a) failure plane and (b) surface profile.

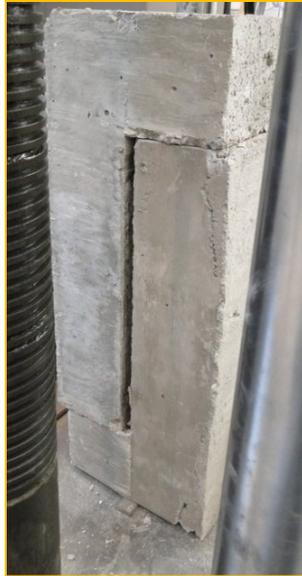
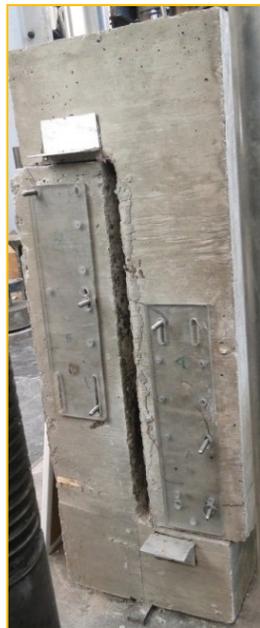
CSP 6_3

Figure 16. CSP 6 Specimen #3 failure.

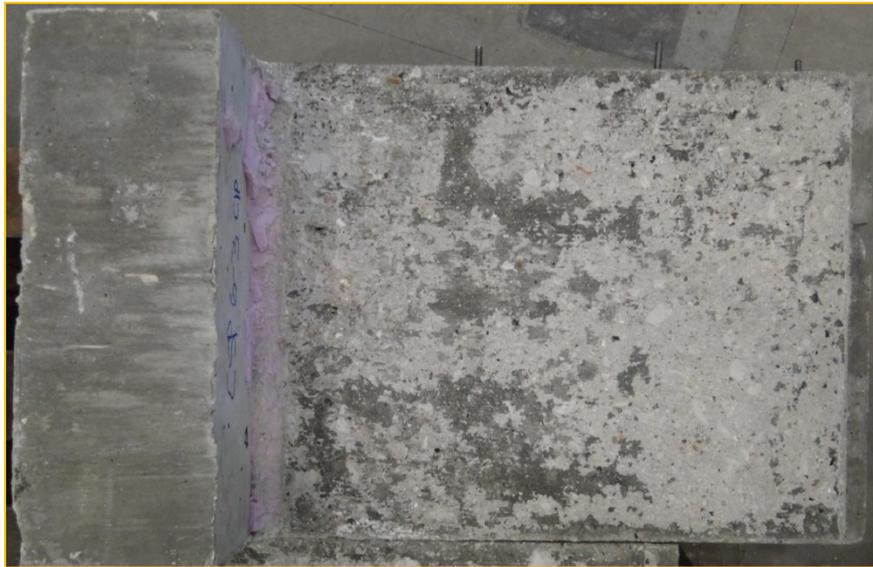
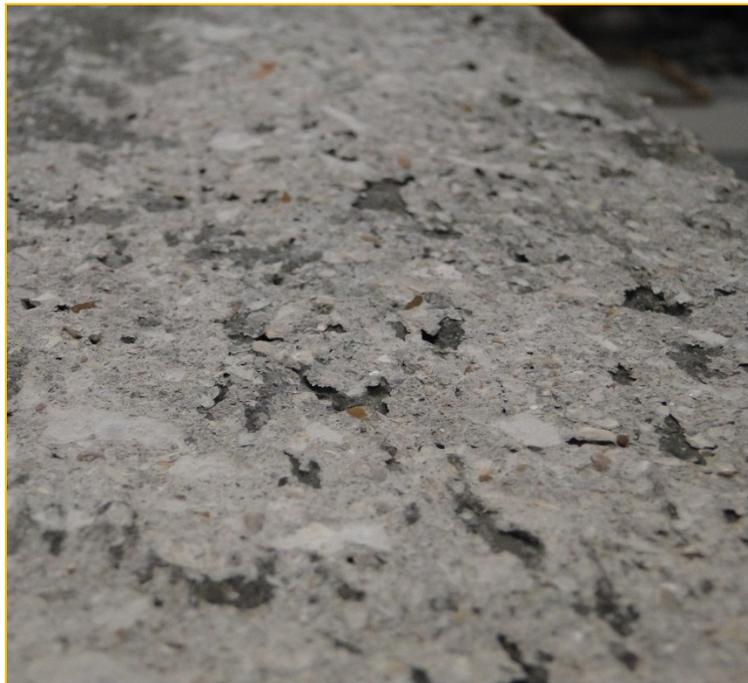
Figure 17. CSP 6 Specimen #3 CIP (a) failure plane and (b) surface profile.

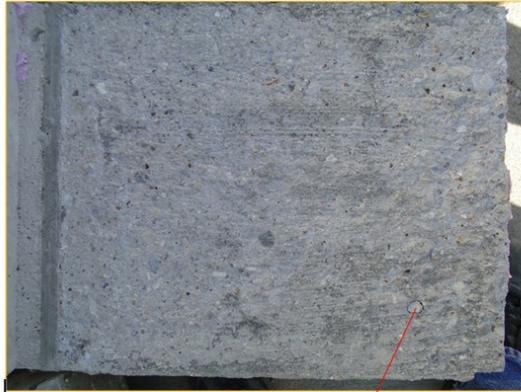
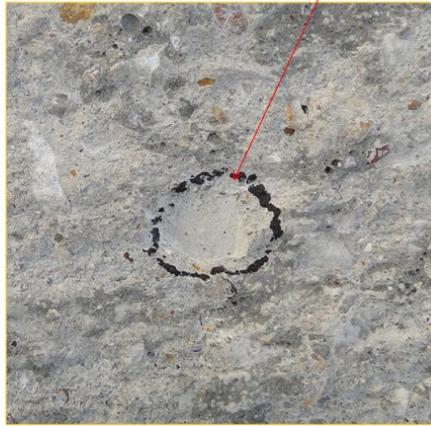
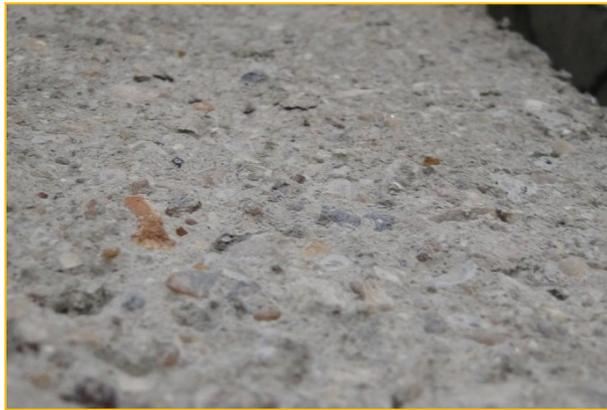
Figure 18. CSP 6 Specimen #3 precast (a) failure plane and (b) surface profile.

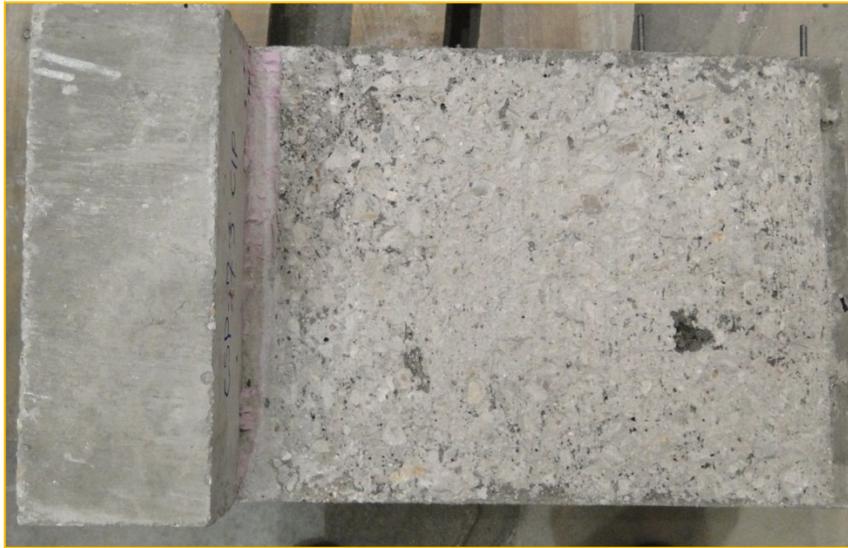
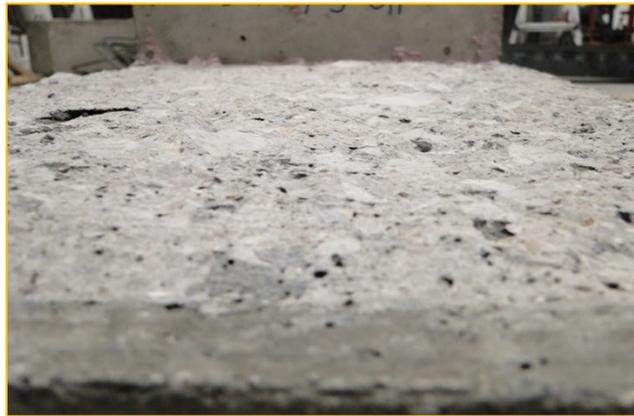
Figure 20. CSP 7 Specimen #1 CIP failure plane

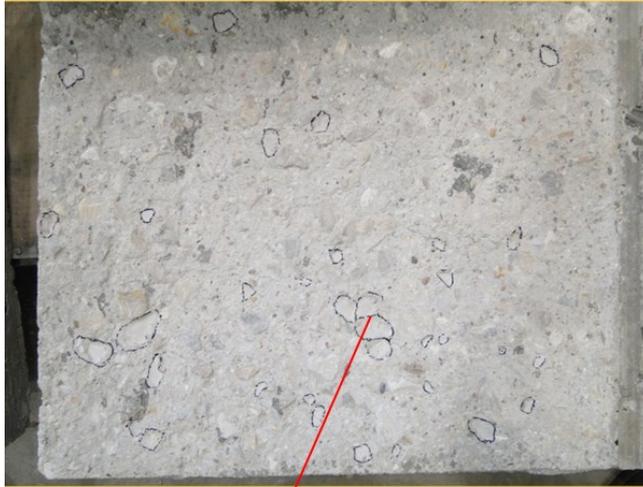
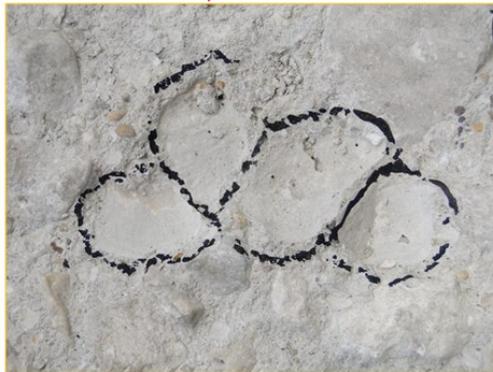
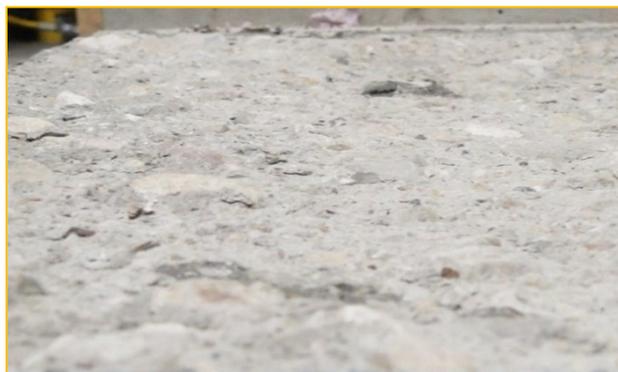
Figure 21. CSP 7 Specimen #1 precast (a) failure plane and (b) surface profile.

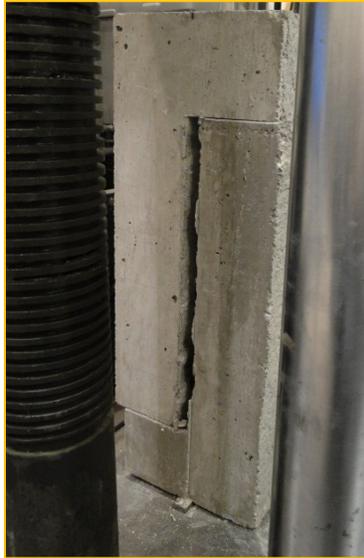
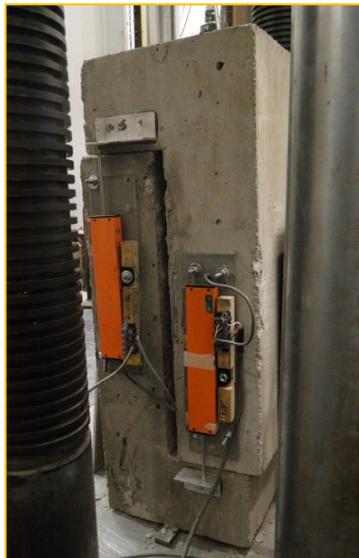
CSP7_2

Figure 22. CSP 7 Specimen #2 failure

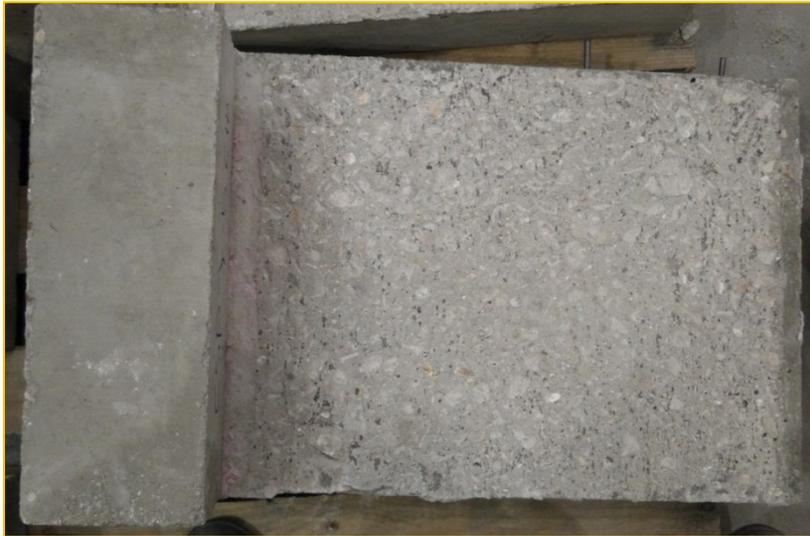
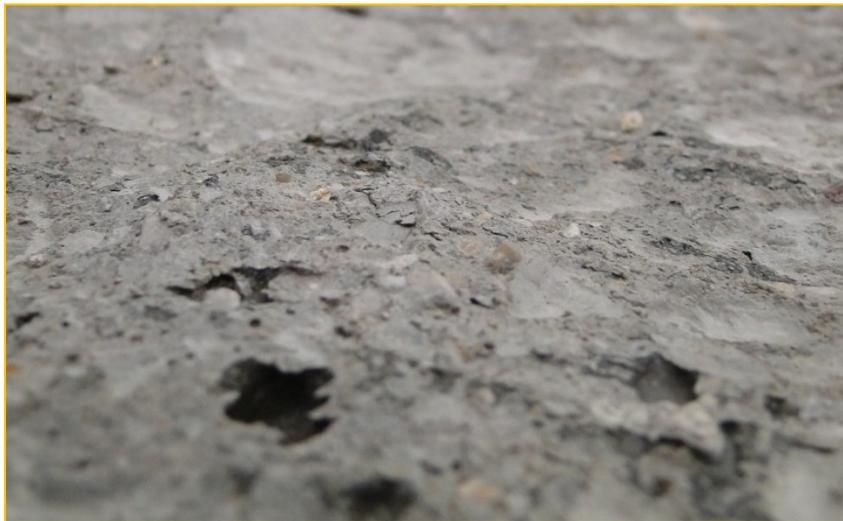
Figure 23. CSP 7 Specimen #2 CIP (a) failure plane and (b) surface profile.

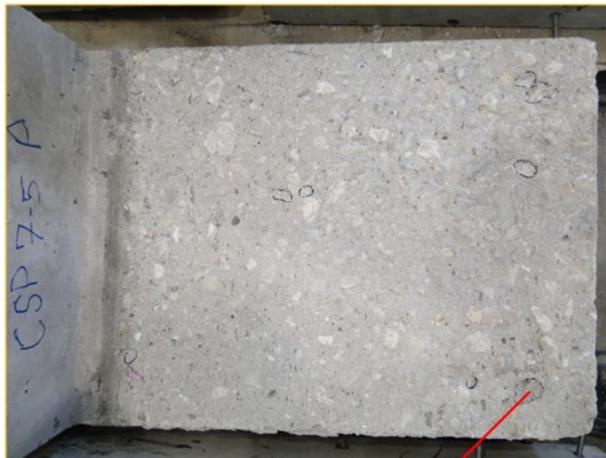
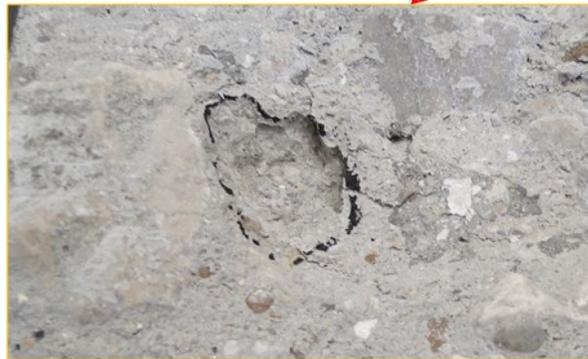
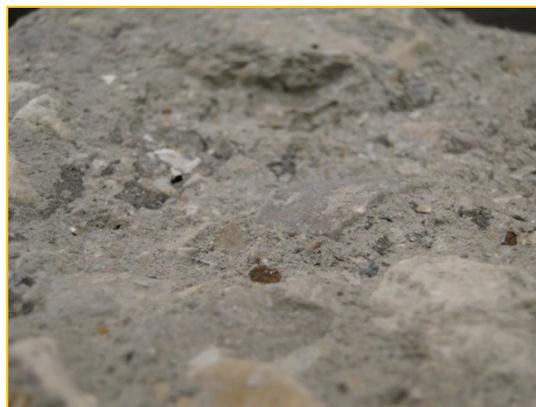
Figure 24. CSP 7 Specimen #2 precast (a) failure plane and (b) surface profile.

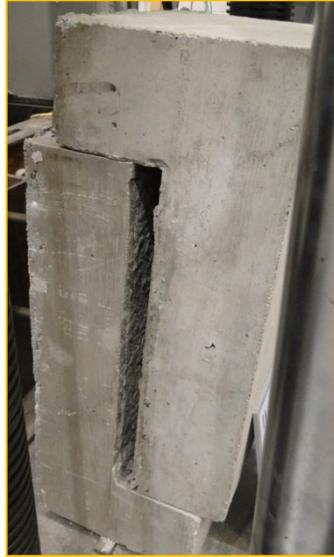
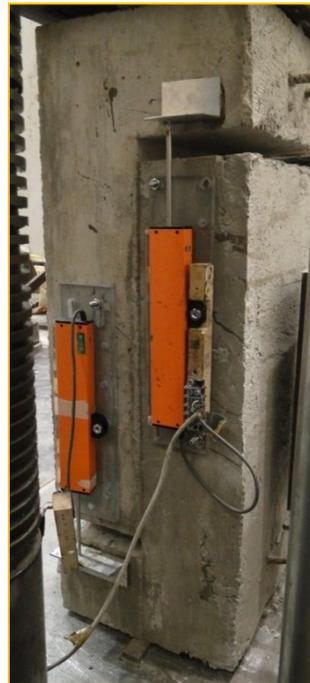
CSP7_3

Figure 25. CSP 7 Specimen #3 failure

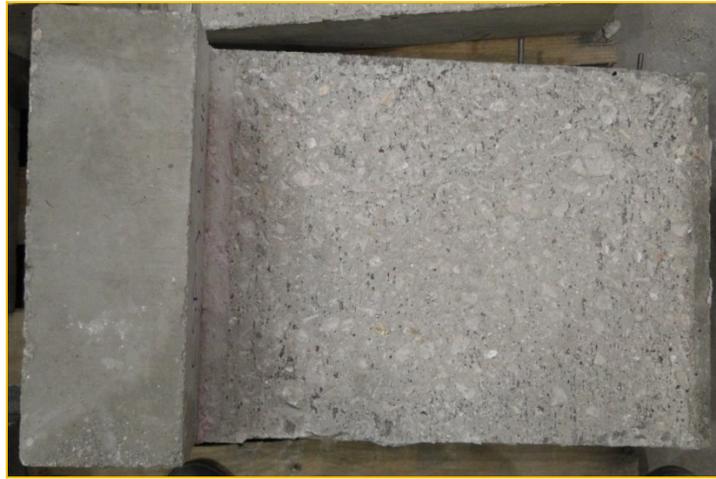
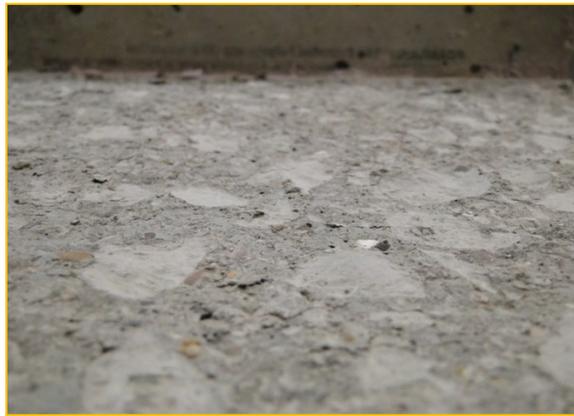
Figure 26. CSP 7 Specimen #3 CIP (a) failure plane and (b) surface profile.

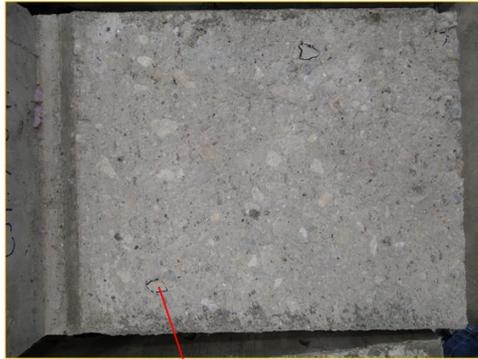
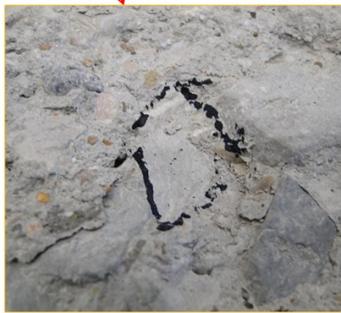
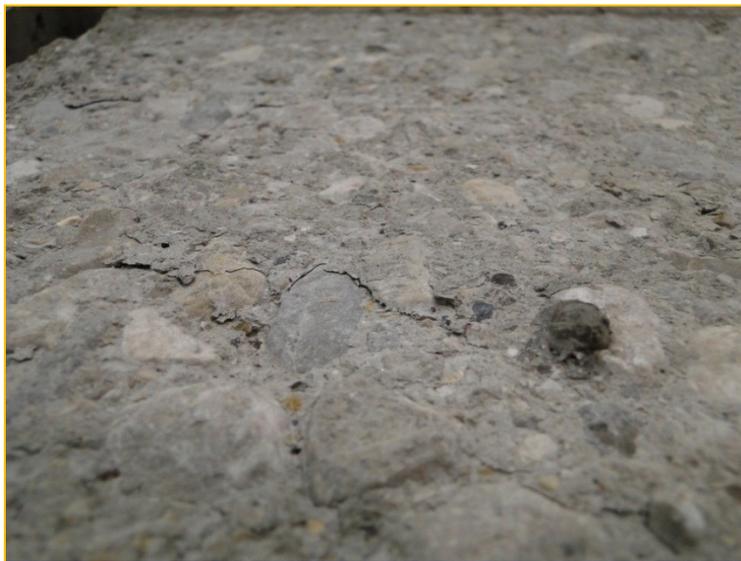
Figure 27. CSP 7 Specimen #3 precast (a) failure plane and surface profile.

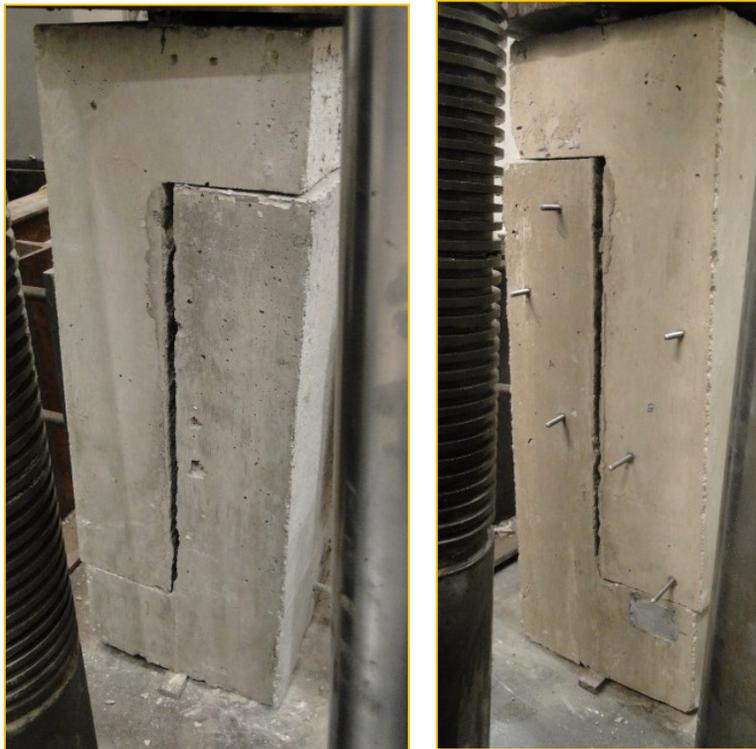
CSP8_1

Figures 128 through 138 below show the testing of the CSP 8 specimens. All three specimens failed mostly along the interface at peak loads of 61.1, 57.2 and 41.9 kips. The failure of the second and third specimen was by a small portion, into the CIP part near the notch. There was observed a lot of aggregate dislodgement and fracture as is shown in the diagrams.

Figure 28. CSP 8 Specimen #1 failure (a) front view (b) back view.

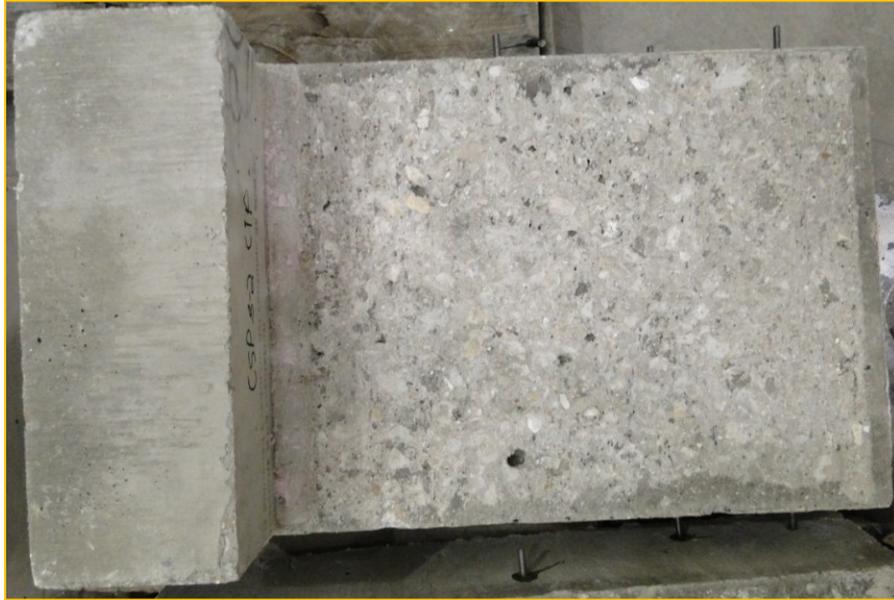
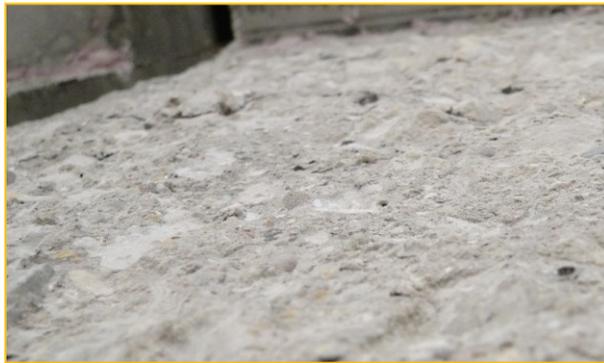
Figure 29. CSP 8 Specimen #1 CIP (a) failure plane and (b) surface profile.

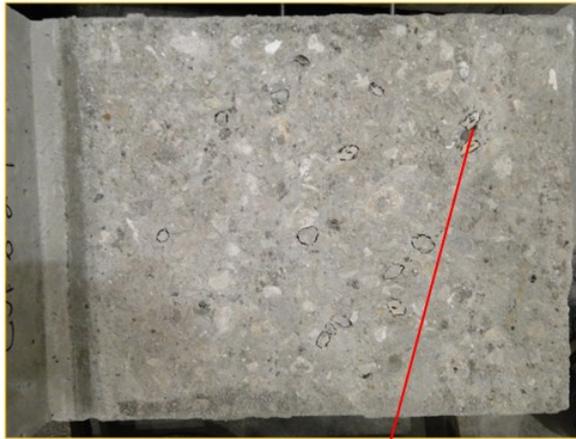
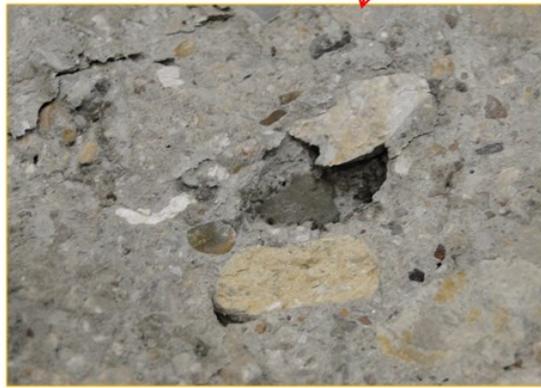
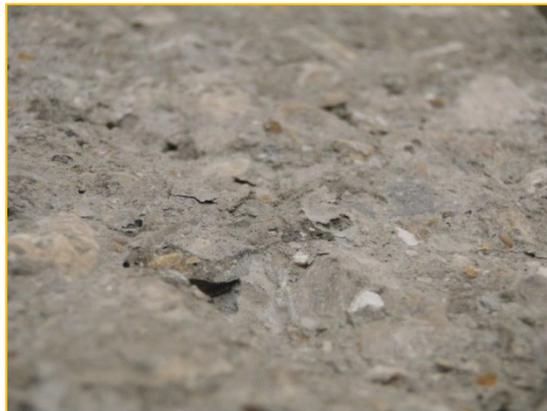
Figure 30. CSP 8 Specimen #1 precast (a) failure plane and (b) surface profile.

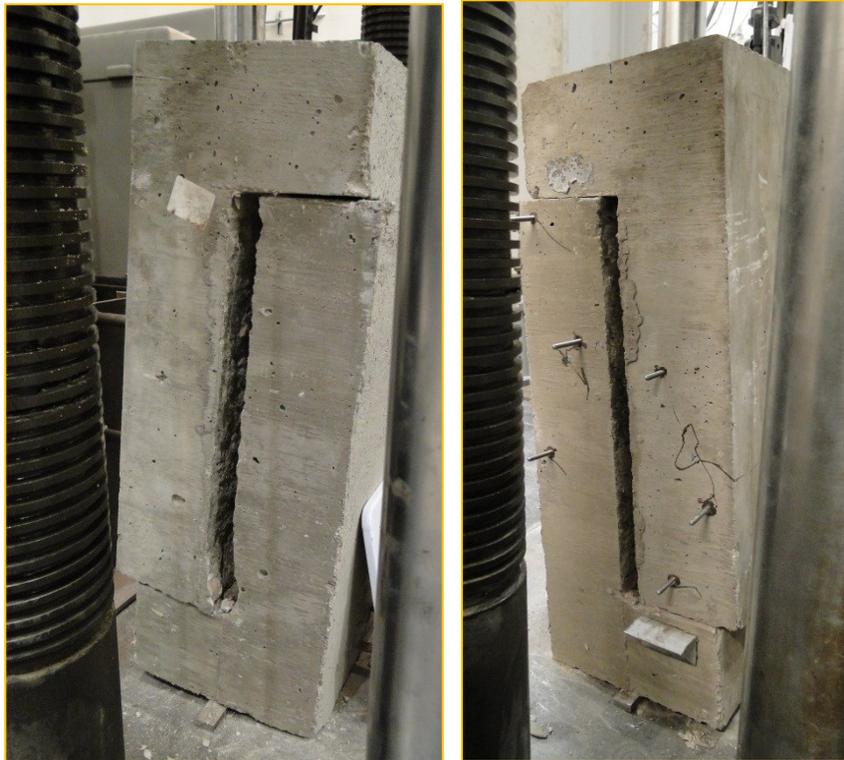
CSP8_2

Figure 31. CSP 8 Specimen #2 failure (a) front view (b) back view.

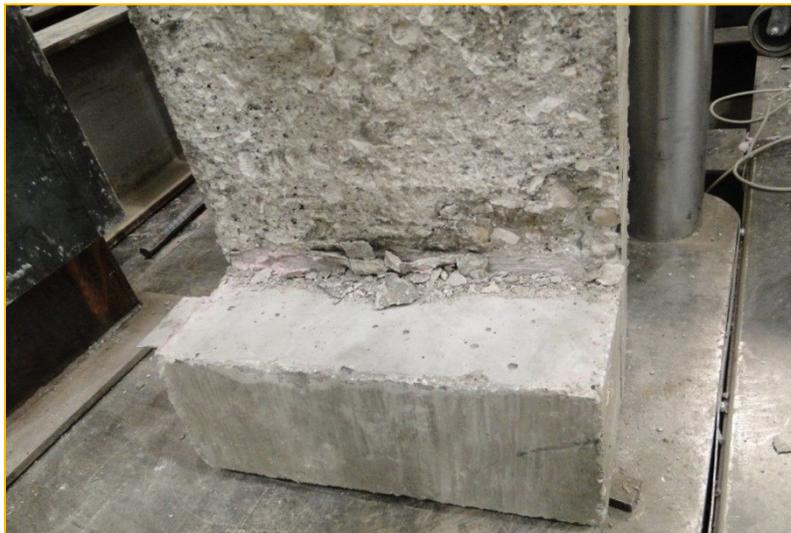
Figure 32: Failure into the CIP at the notch.

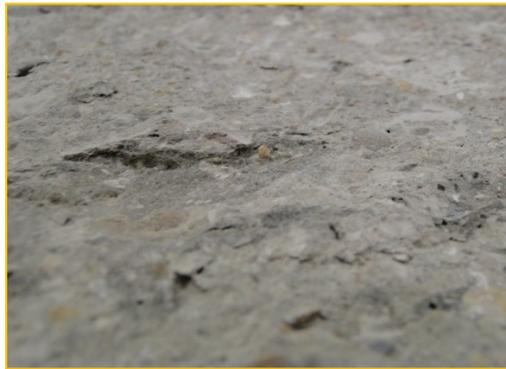
Figure 33. CSP 8 Specimen #2 CIP (a) failure plane and (b) surface profile.

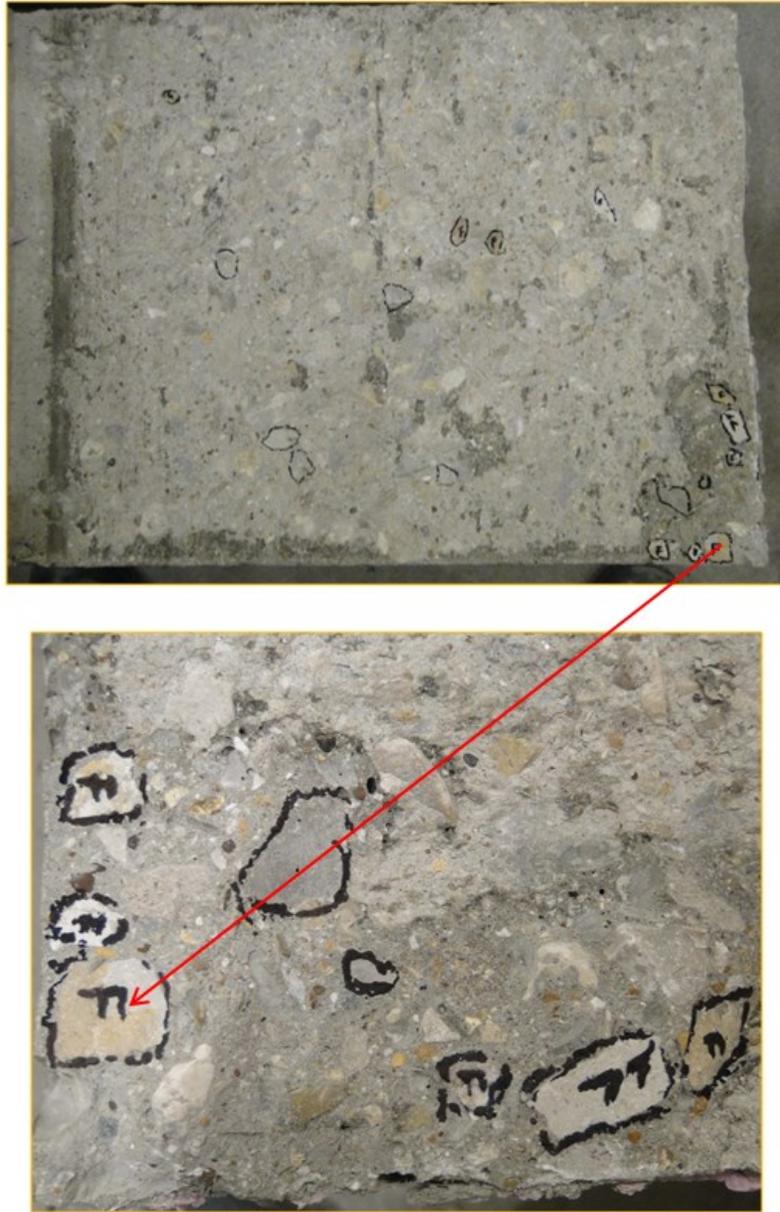
Figure 34. CSP 8 Specimen #2 precast failure plane showing dislodged and fractured aggregates.

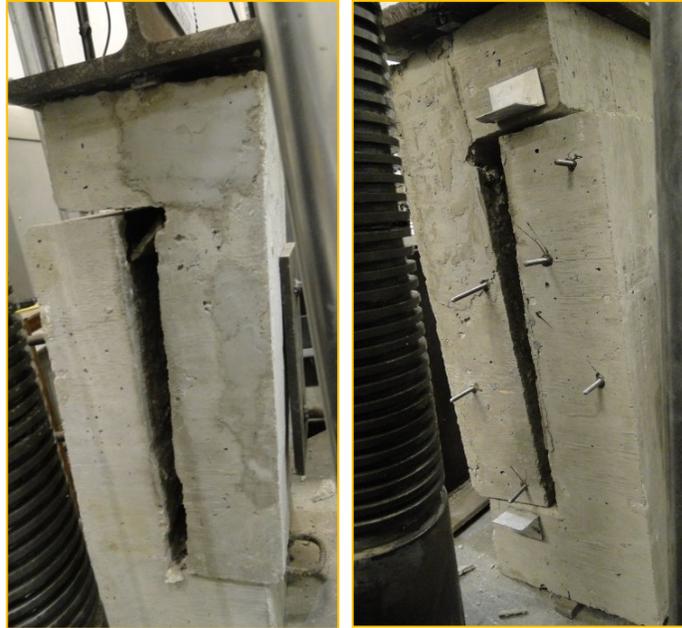
CSP8_3

Figure 35. CSP 8 Specimen #3 failure (a) front view (b) back view.

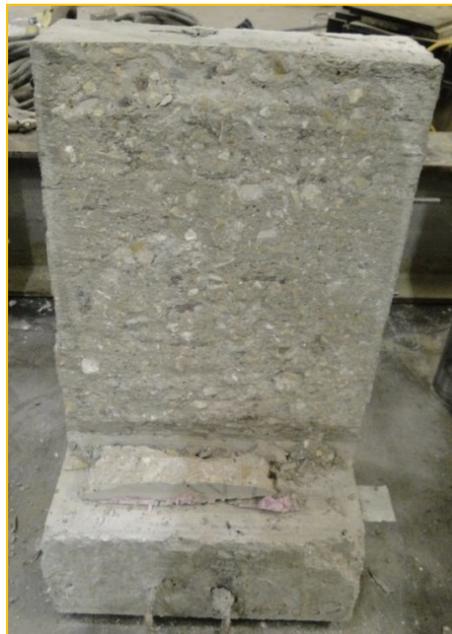
Figure 36: Failure into the CIP at the top notch.

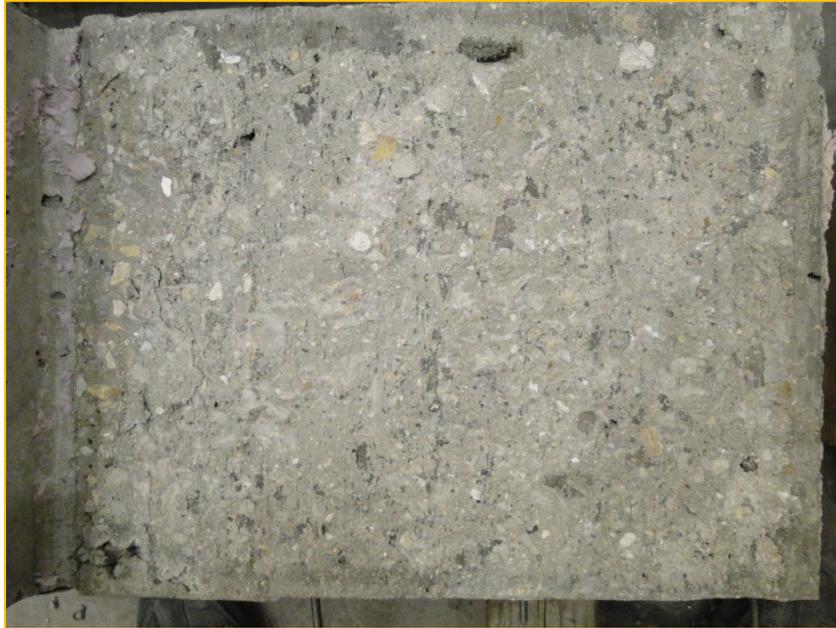
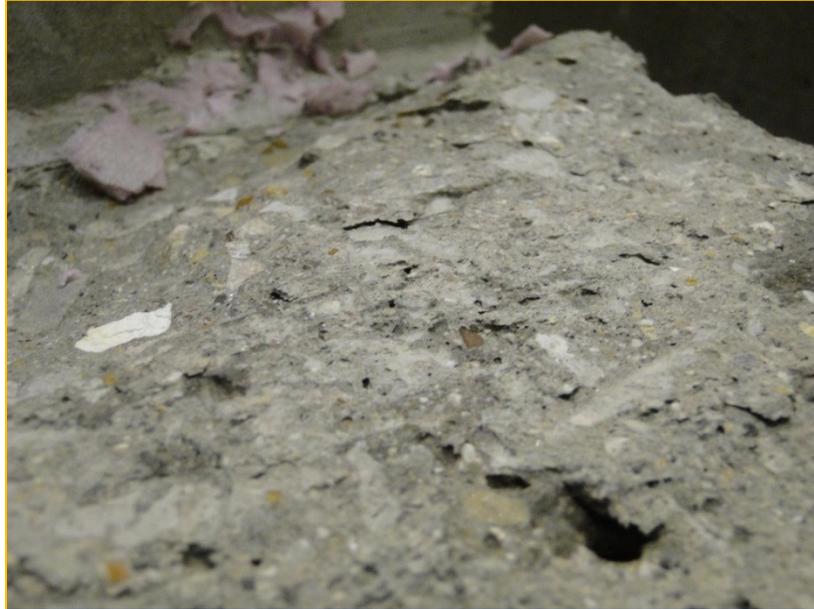
Figure 37. CSP 8 Specimen #3 CIP (a) failure plane and (b) surface profile.

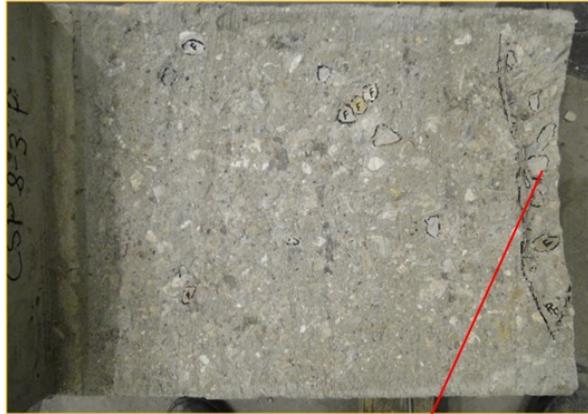
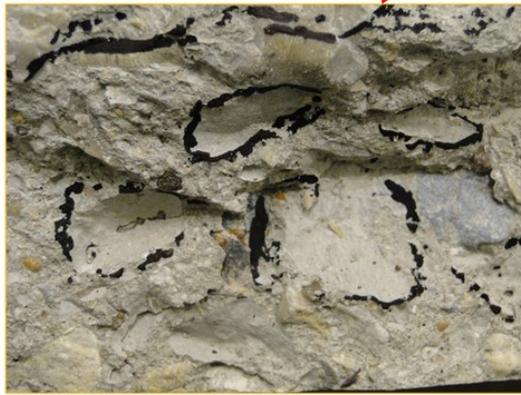
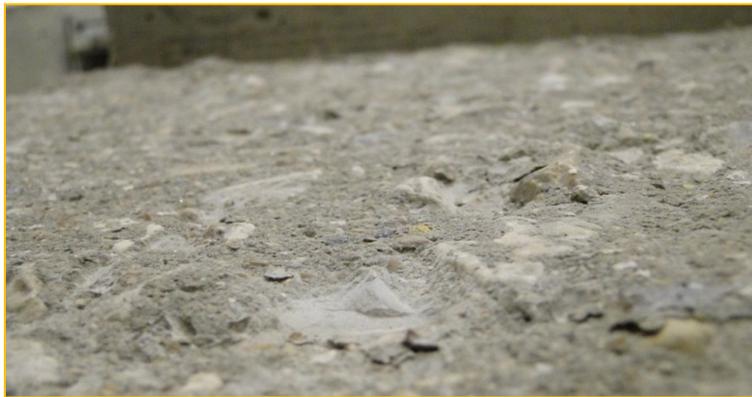
Figure 38. CSP 8 Specimen #3 precast (a) failure plane and (b) surface profile.

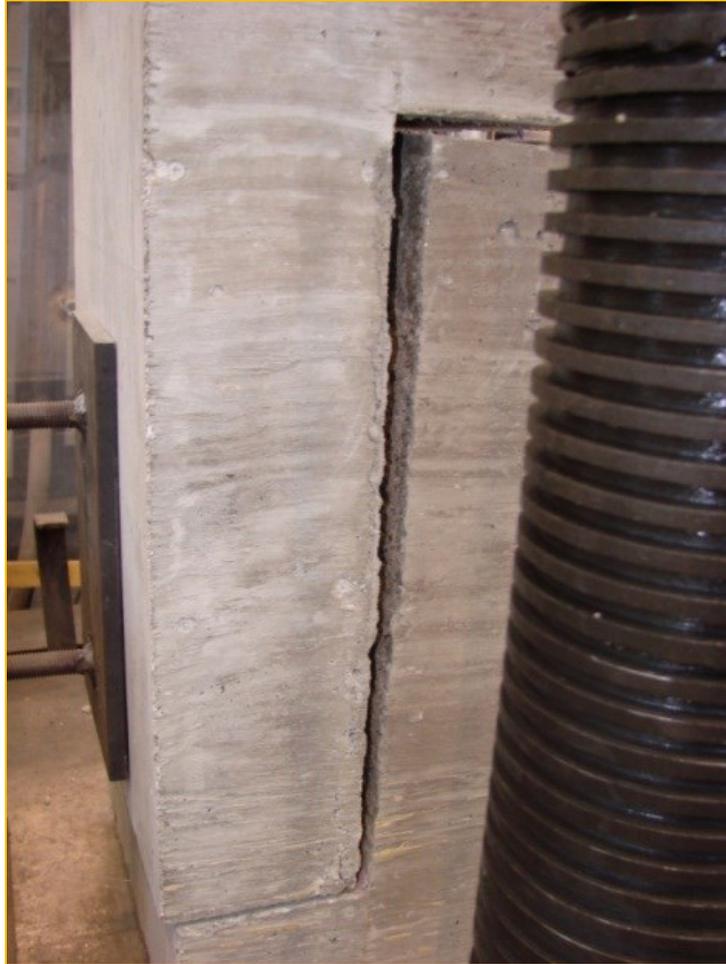
Figures 39 through 47 below show the testing of the CSP 9 specimens. All three specimens failed along the interface with peak loads of 47.72, 54.66 and 57.46kips.

Figure 39. CSP 9 Specimen #1 failure

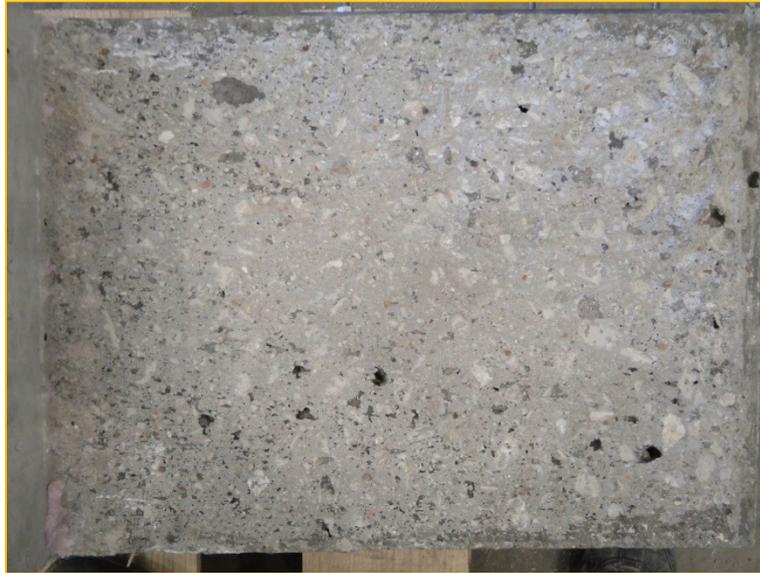
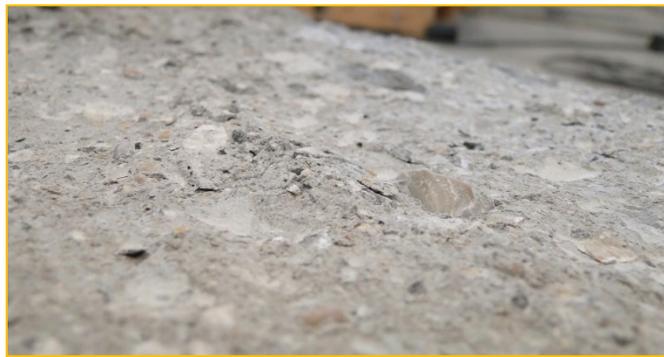
Figure 40. CSP 9 Specimen #1 CIP (a) failure plane and (b) surface profile.

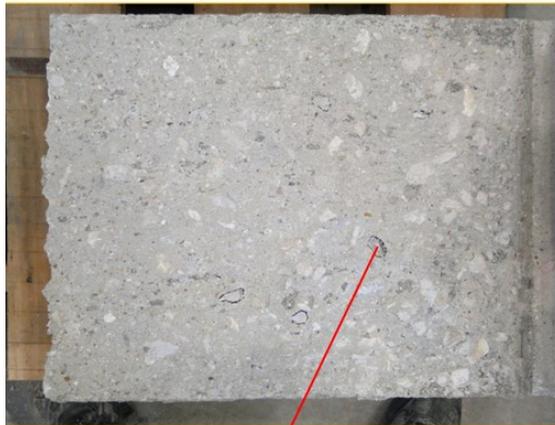
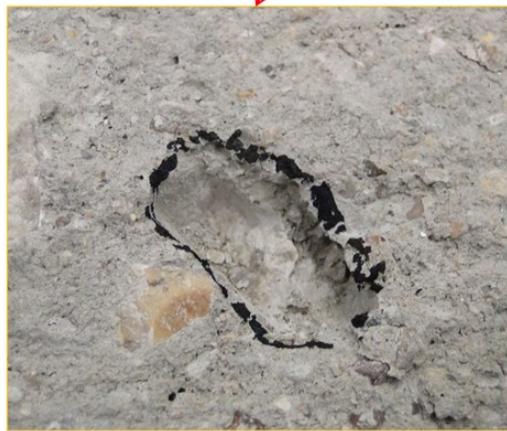
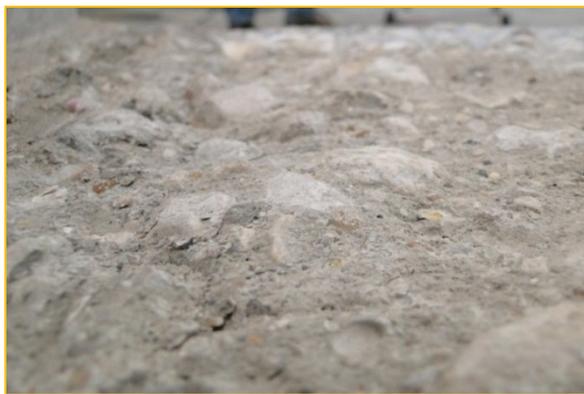
Figure 41. CSP 9 Specimen #1 precast (a) failure plane and (b) surface profile.

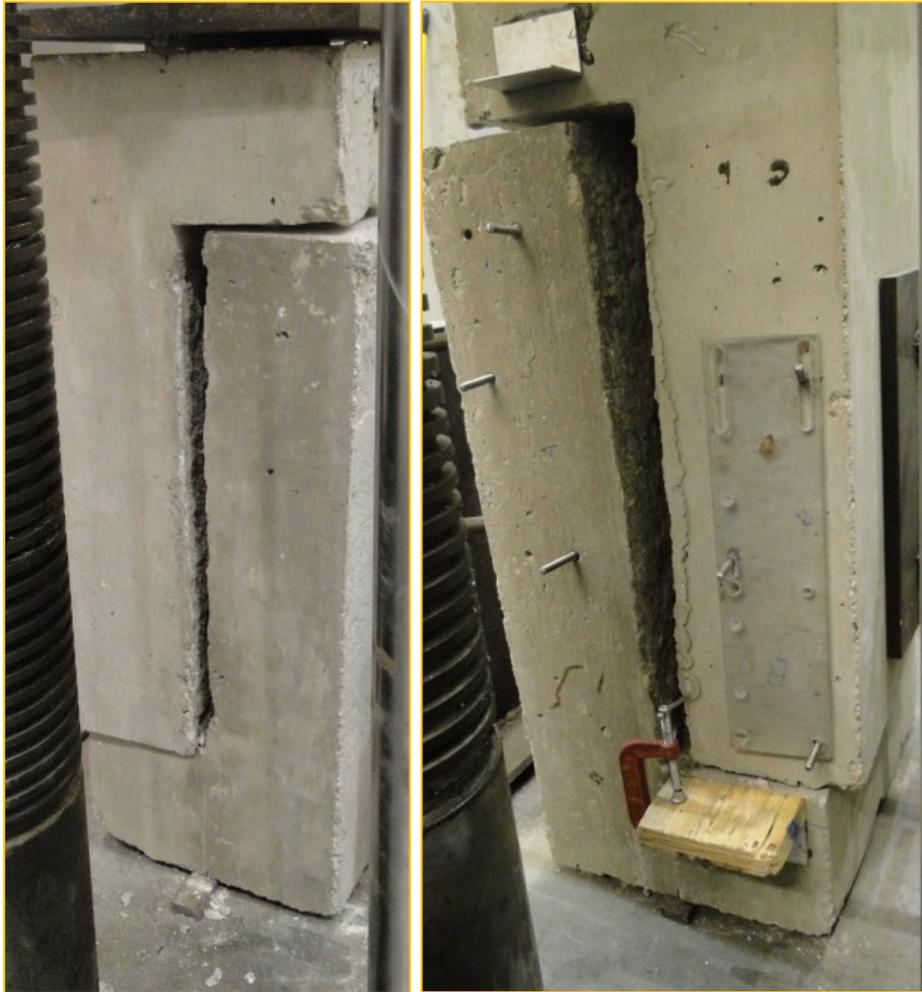
Figure 42. CSP 9 Specimen #2 failure (a) front view (b) back view.

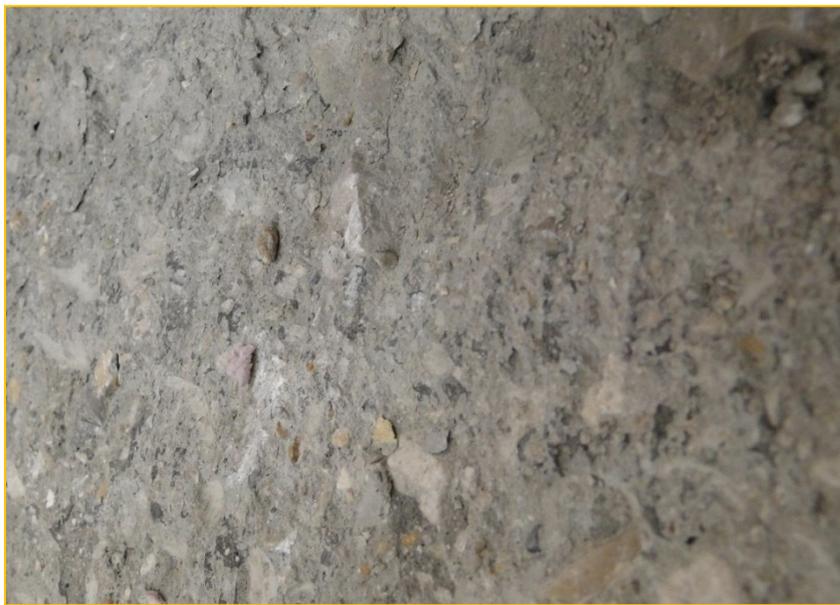
Figure 43. CSP 9 Specimen #2 CIP (a) failure plane and (b) surface profile.
