PERFORMANCE OF FULL-SCALE ULTRA-HIGH PERFORMANCE FIBER-
REINFORCED CONCRETE COLUMN SUBJECTED TO EXTREME EARTHQUAKE-
TYPE LOADING AND EFFECT OF SURFACE PREPARATION ON THE COHESION
AND FRICTION FACTORS OF THE AASHTO INTERFACE SHEAR EQUATION

MASTER OF SCIENCE IN CIVIL ENGINEERING

THE UNIVERSITY OF TEXAS AT ARLINGTON

May 2015

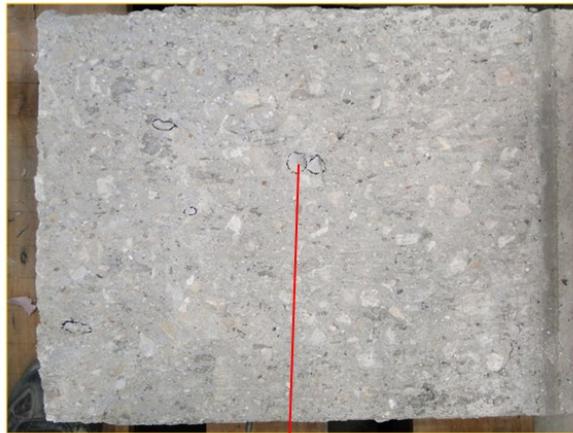
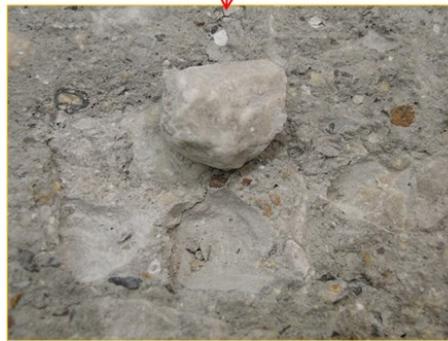
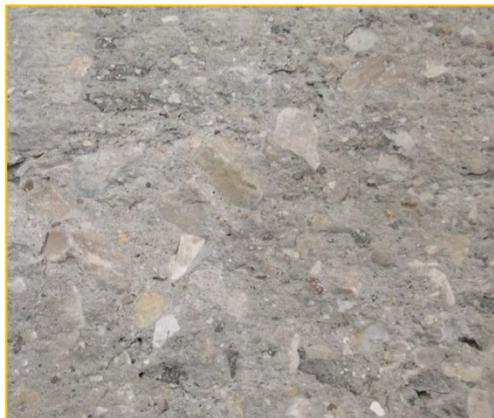
Figure 44. CSP 9 Specimen #2 precast (a) failure plane with dislodged aggregate and (b) surface profile.

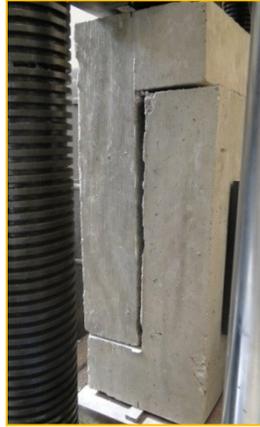
Figure 45. CSP 9 Specimen #3 failure front view

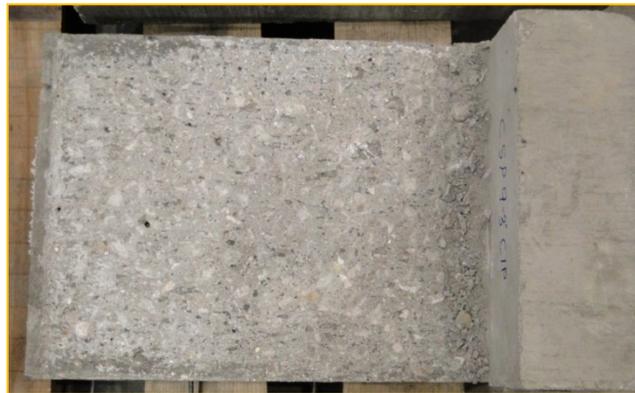
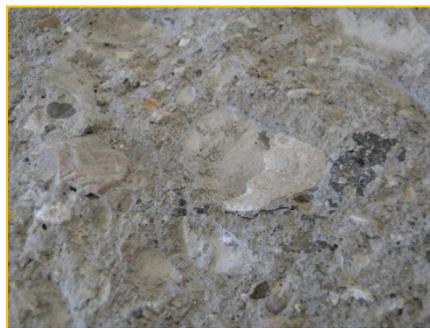
Figure 46. CSP 9 Specimen #3 CIP (a) failure plane and (b) fractured aggregate.

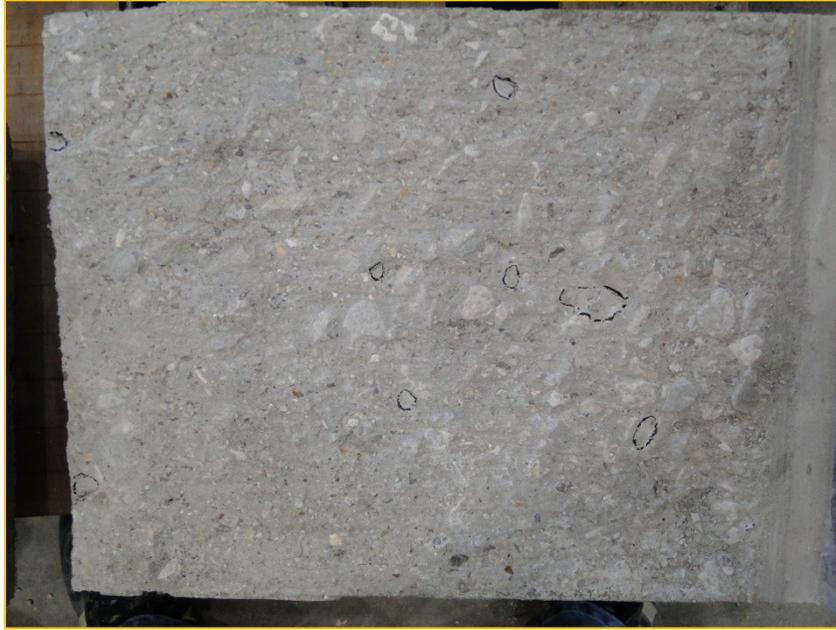
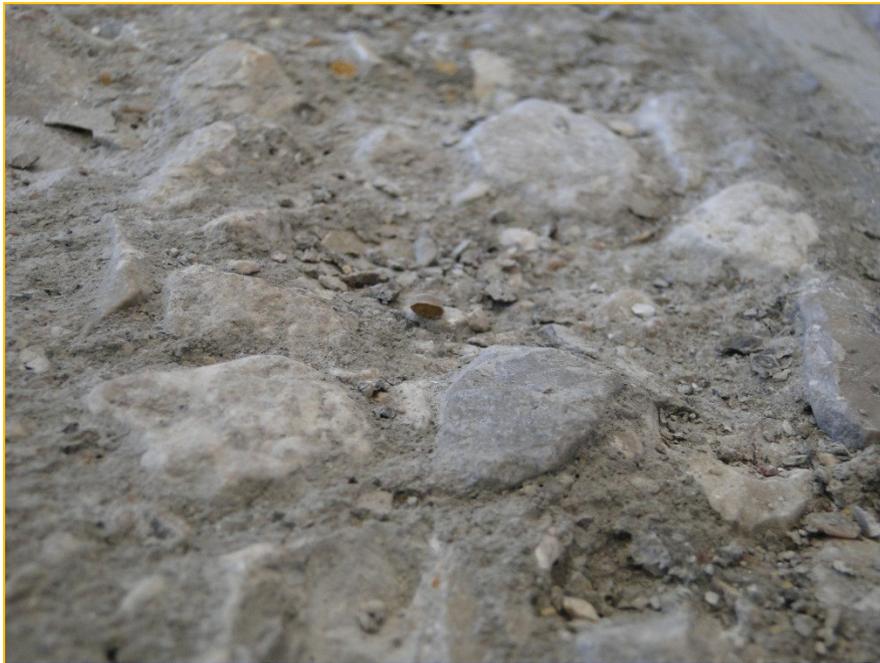
Figure 47. CSP 9 Specimen #3 precast (a) failure plane and (b) surface profile.

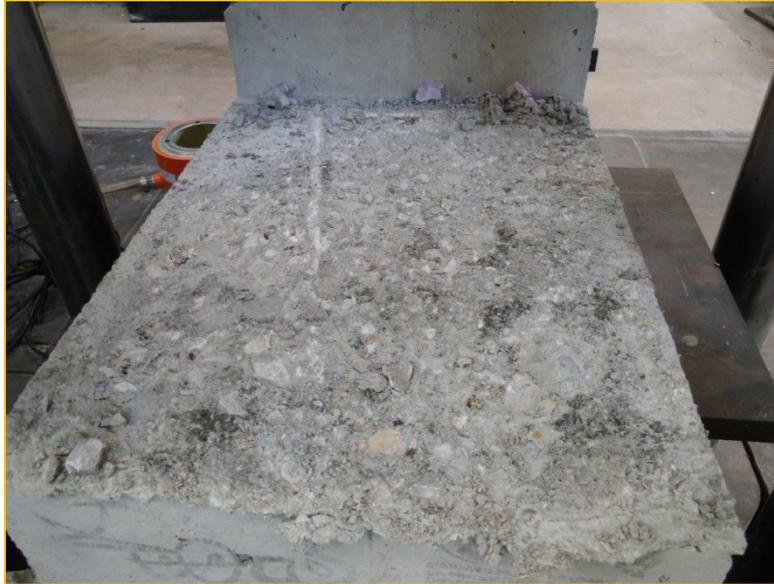
Figure 4. Wood float specimen # 1 precast failure plane showing aggregate pullout.

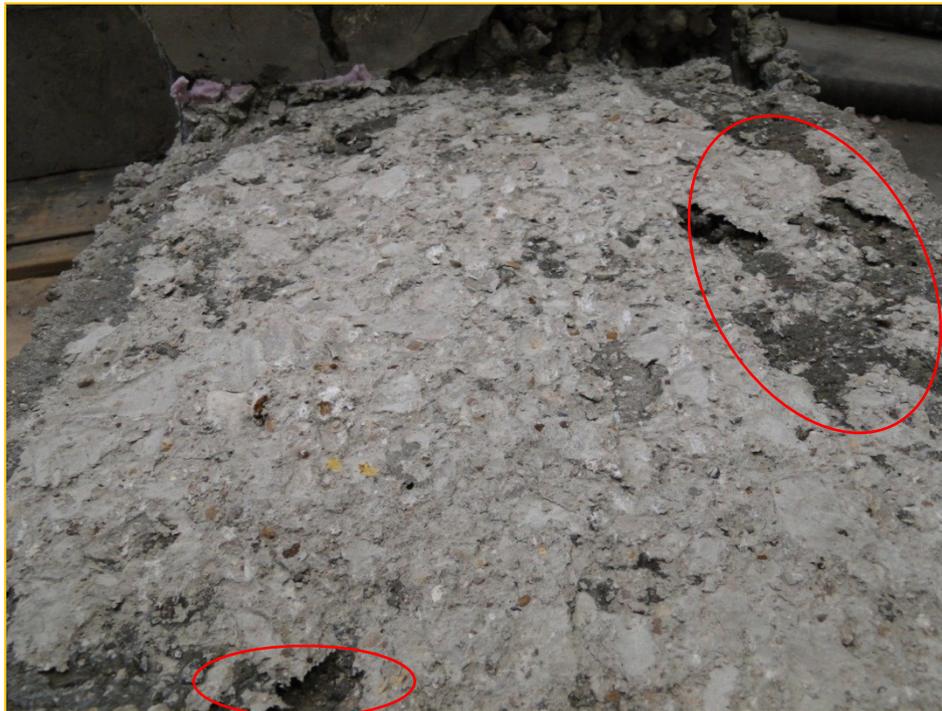
Figure 5. Wood Float Specimen #1 Cast in-place failure plane.

Dark areas on the surface (circled) show areas where it is believed there was lack of contact between the precast and cast in-place part of the specimen. Hence the whole interface area was not utilized hence lower interface shear strength.

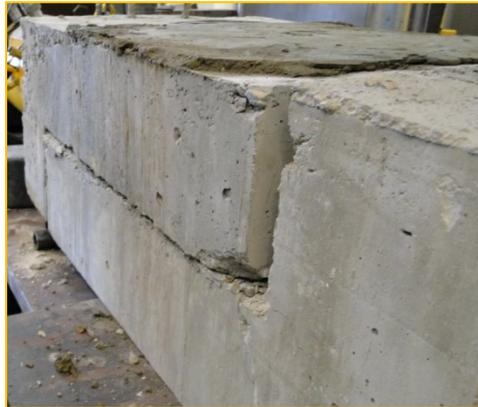
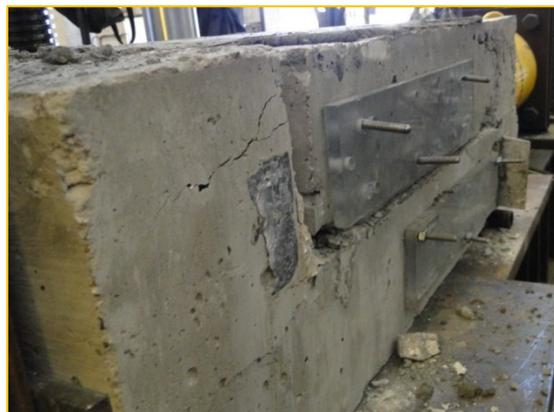
Showed the highest strength among the wood float specimens of 84.4 kips. This is evident also from inspection of specimen after failure which shows more aggregate pullout and also fracturing of the concrete near the notch indicating higher bond strength.

Figure 6. Wood Float Specimen #2 at failure (a) front view (b) back view.

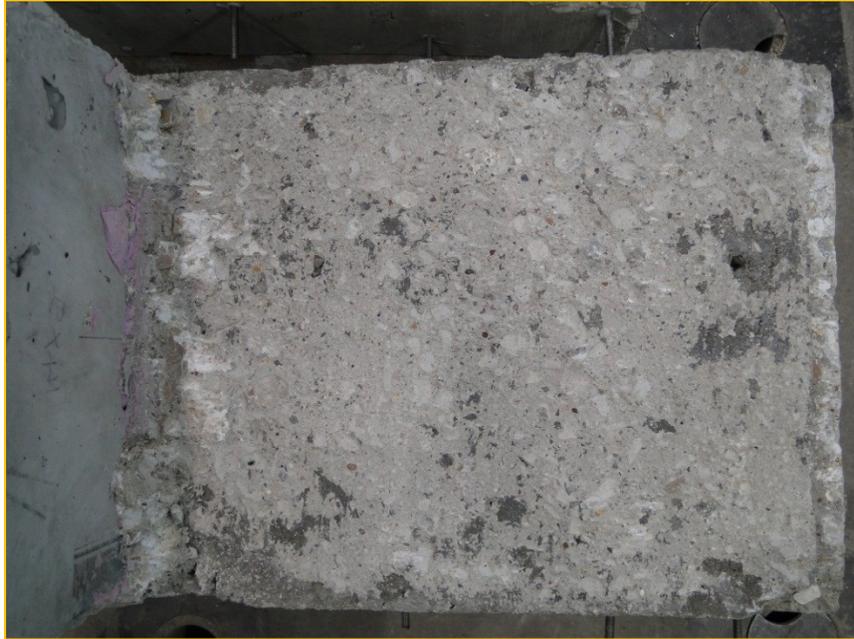
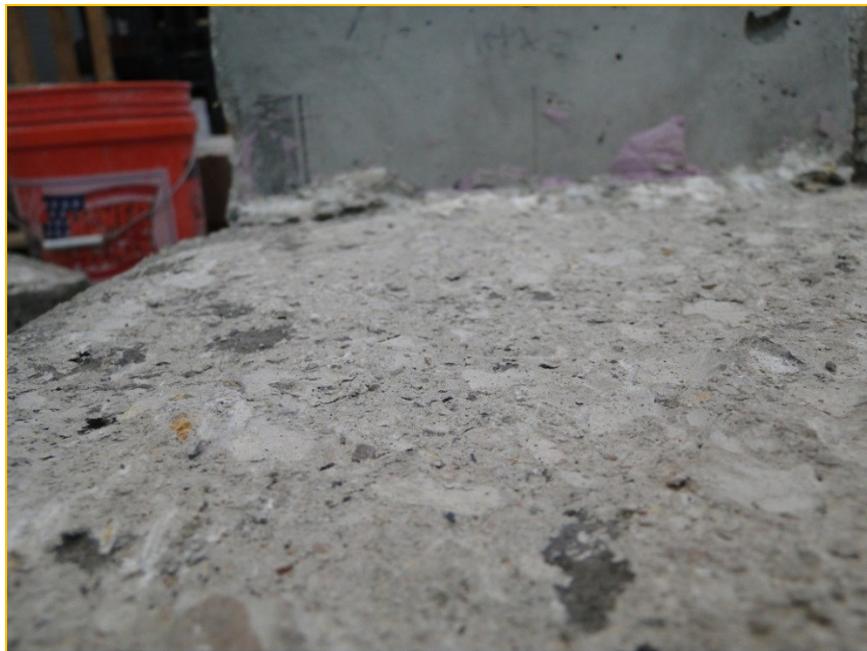
Figure 7. Wood Float Specimen #2 CIP failure plane.

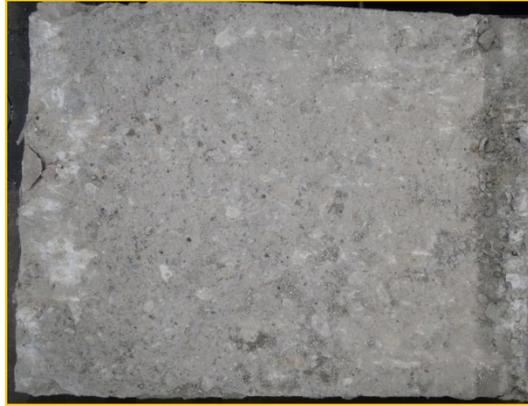
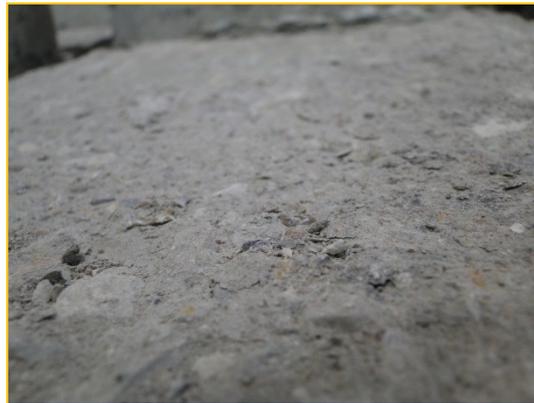
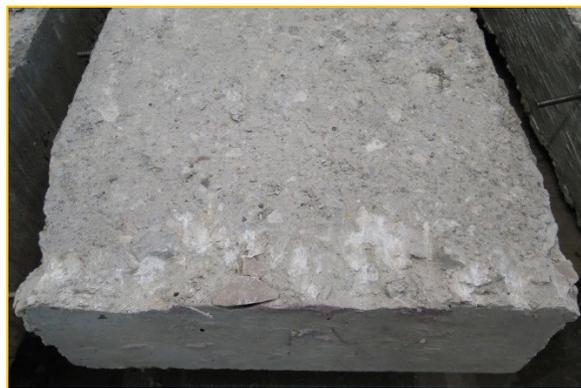
(c) Fracturing of concrete near notch.

Figure 8. Wood Float Specimen #2 precast failure plane showing dislodged aggregate.

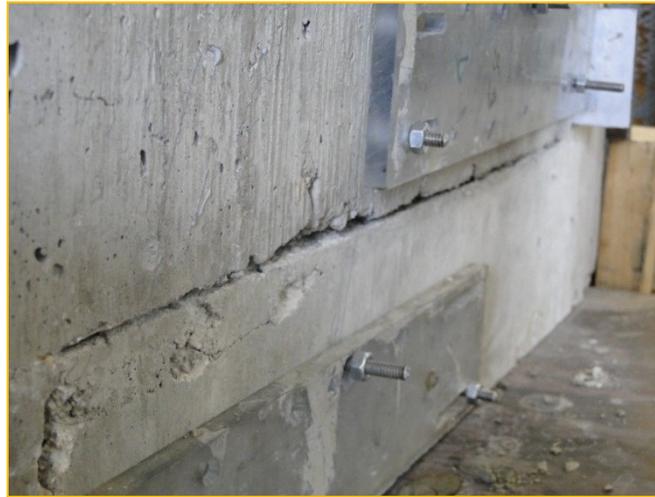
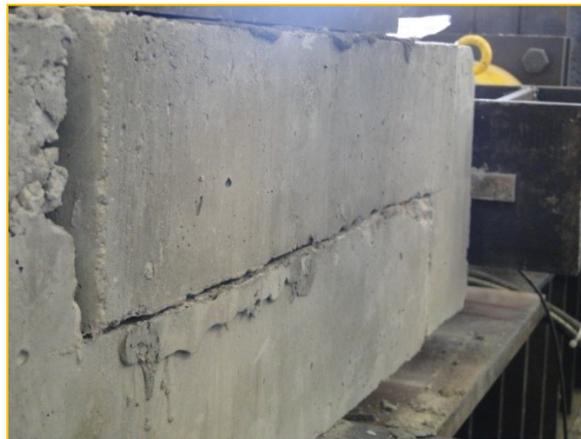
Shown the lowest strength of 36.4 kips which is caused by lack of complete contact between the cast in-place and precast part as is evident in the pictures. The failure surfaces were also observed to be quite smooth after failure indicate there was not much aggregate interaction.

Figure 9. Wood Float Specimen #3 at failure (a) front view (b) back view.

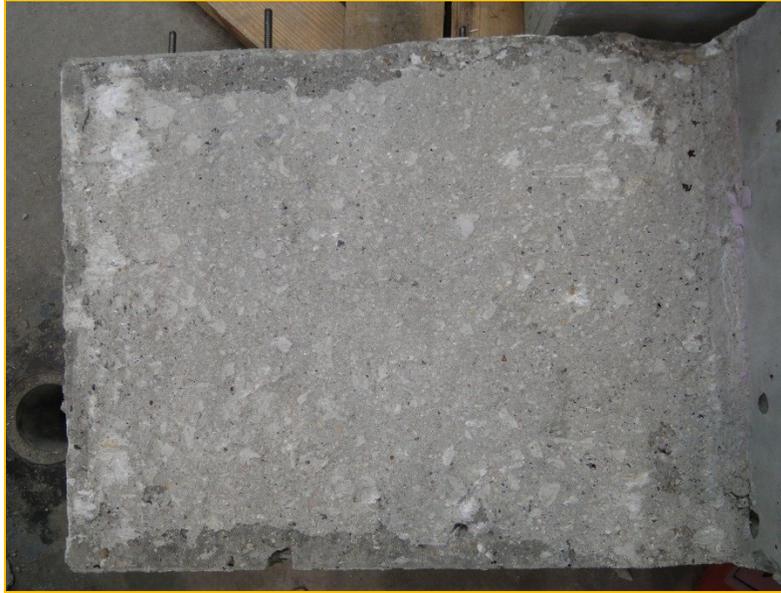
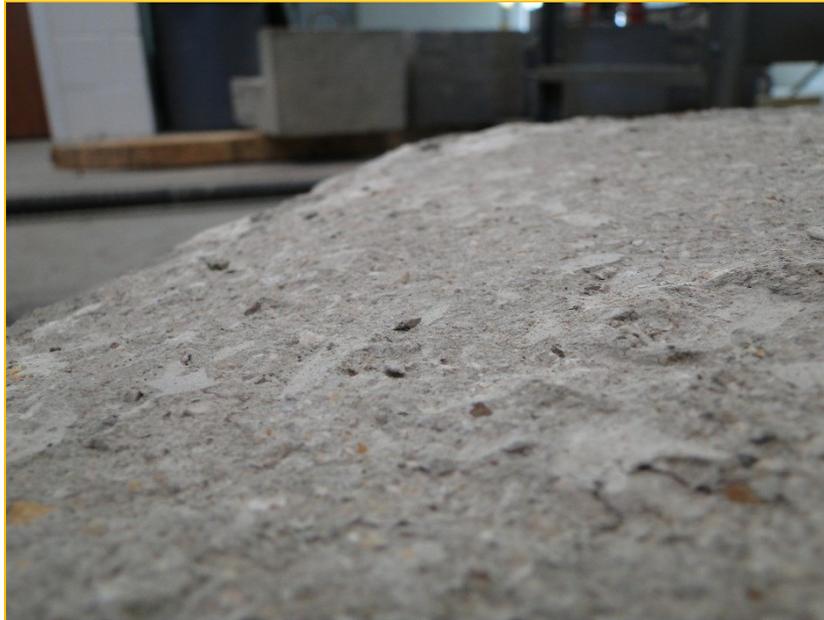
(a) Fairly smooth surface at failure.

(b) Surface profile.

Figure 10. Wood Float Specimen #3 CIP failure plane.

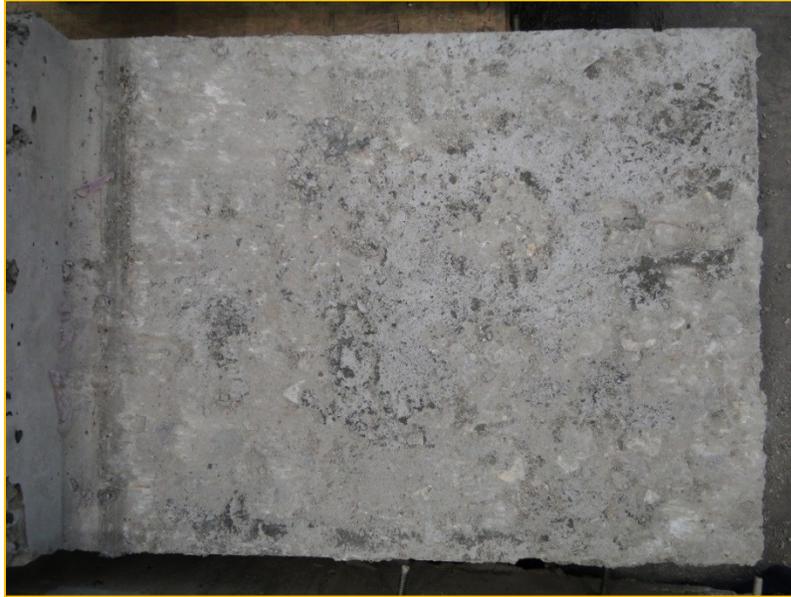
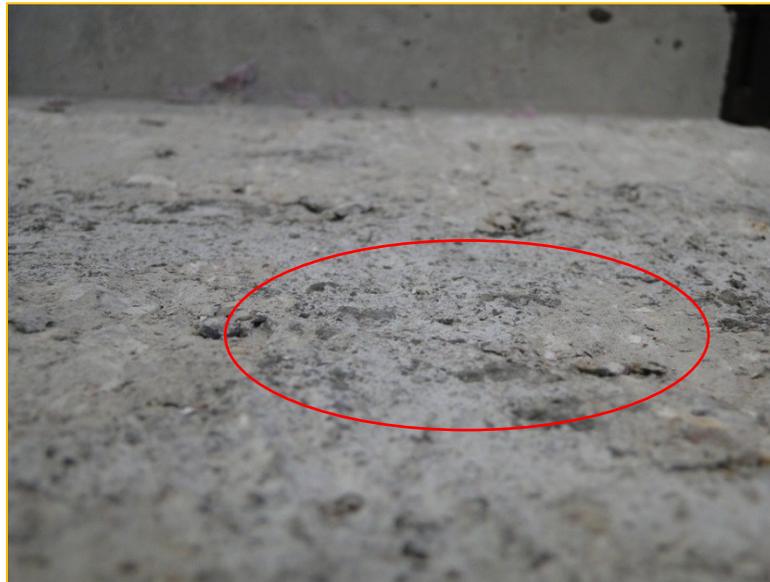
Figure 11. Wood Float Specimen #3 precast failure plane showing areas of no contact. Circled areas indicate areas where it is believed to have no contact between the cast in-place and precast part.

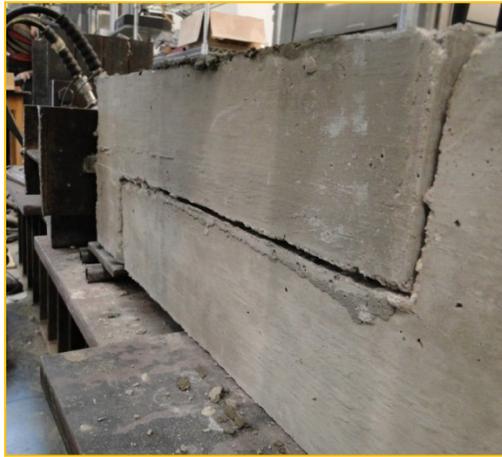
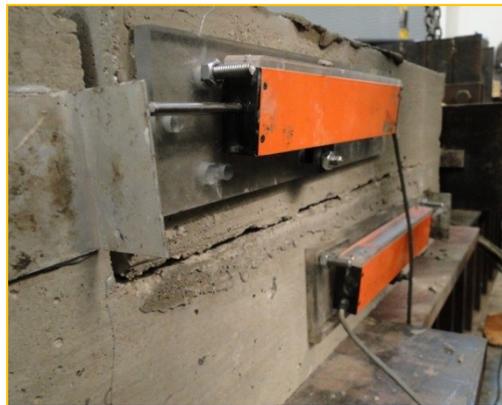
The Figures below show the testing of the CSP 6 specimens. All the three specimens failed at the interface with an average peak load of 71.43 kips. The failure load for the first two specimens was equal whereas for the third it was fairly close. Specimens #1 and #2 showed a very rough interface after failure which consisted of aggregate pullout and fracture whereas for the third, the surface was fairly smooth which can explain the slight drop in the peak load.

Figure 12. CSP 6 Specimen #1 failure (a) front view (b) back view.

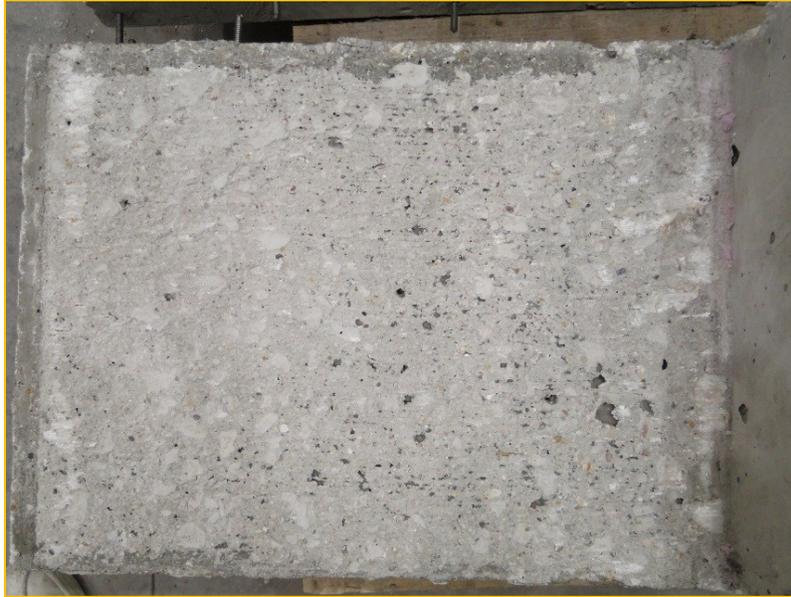
Figure 13. CSP 6 Specimen #1 CIP failure plane.

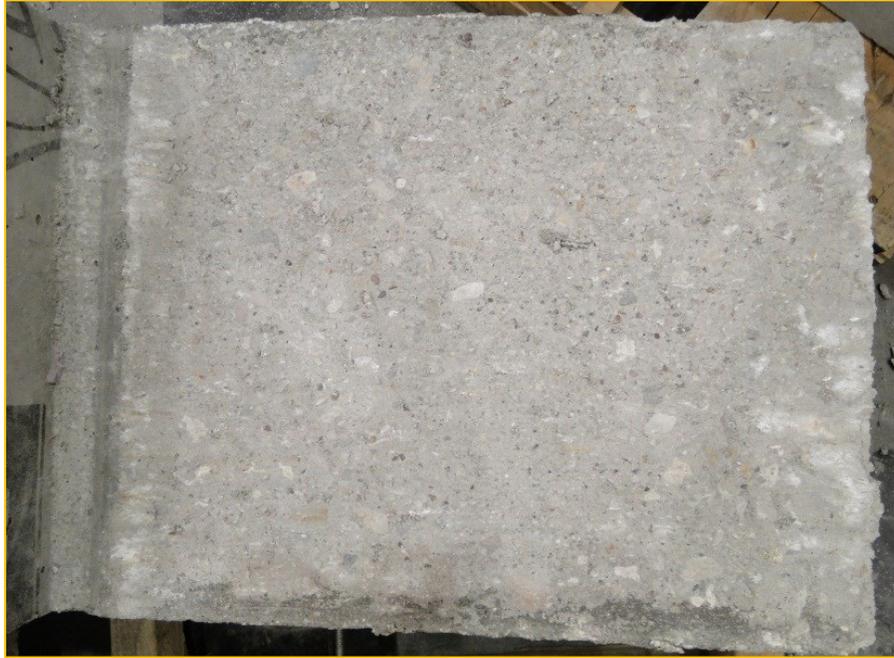
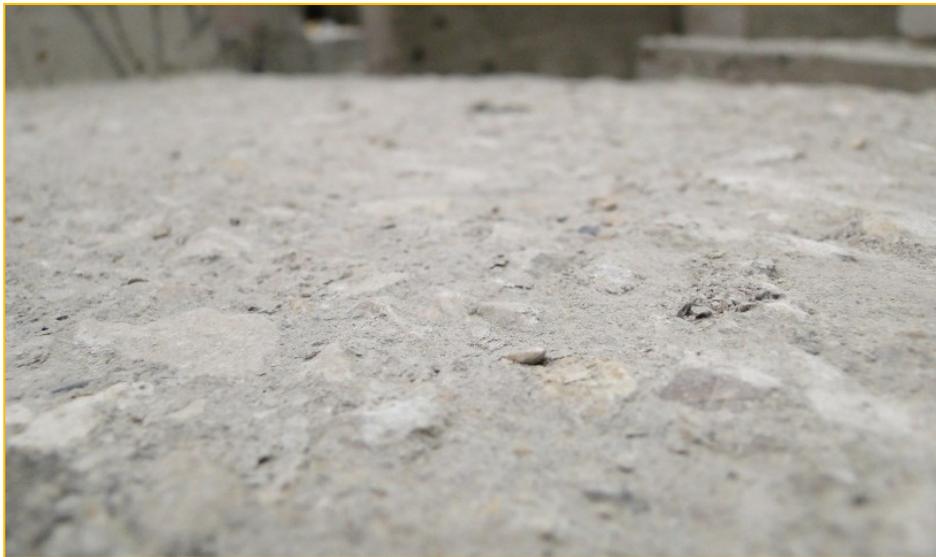
(b) Rough surface profile

Figure 14. CSP 6 Specimen #1 precast failure plane.

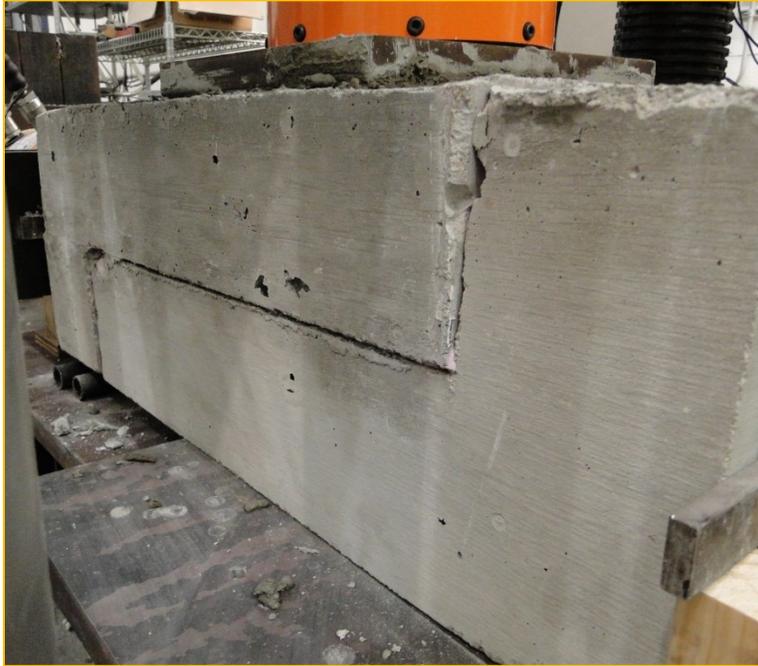
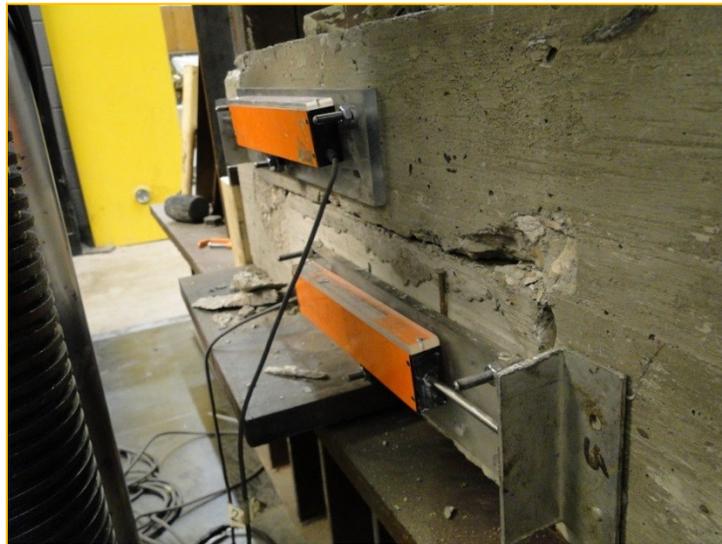
CSP 6_2

Figure 15. CSP 6 Specimen #2 failure (a) front view (b) back view.

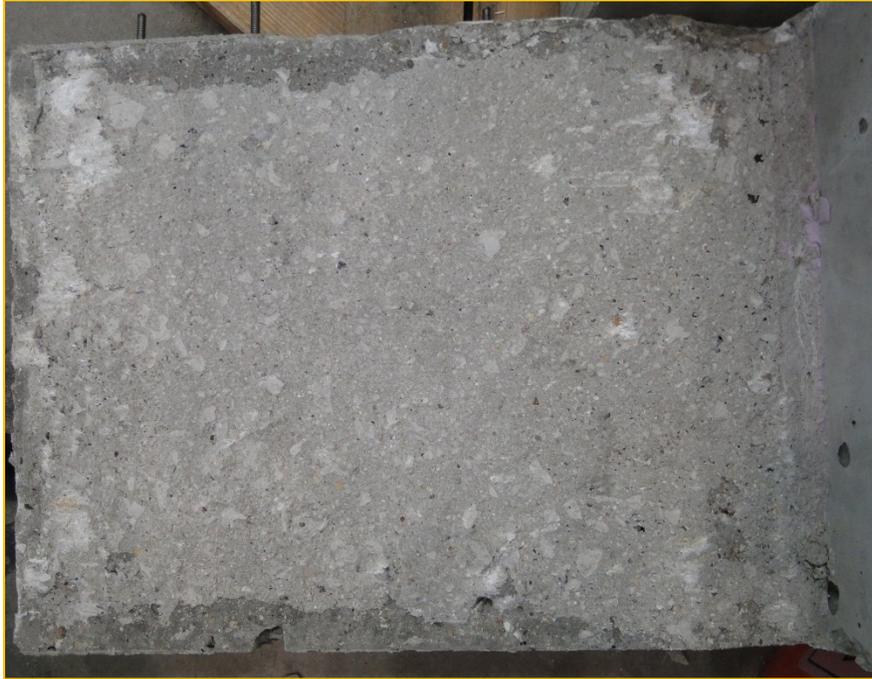
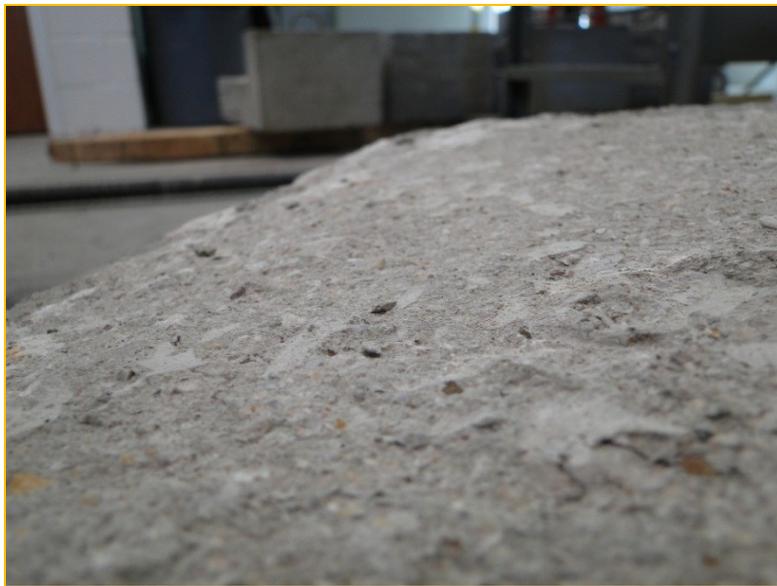
Figure 16. CSP 6 Specimen #2 CIP failure plane.

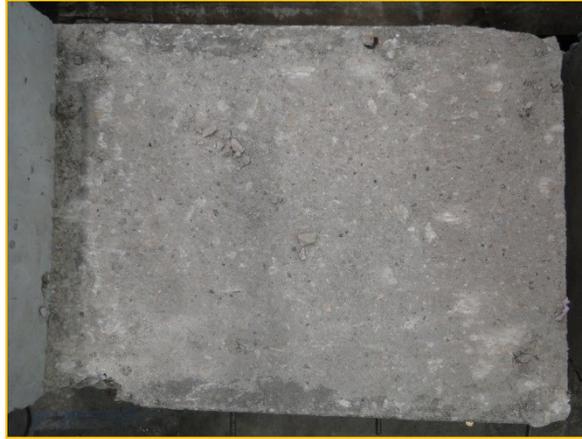
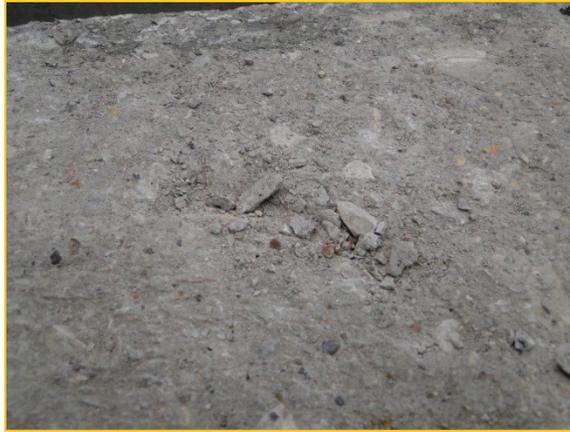
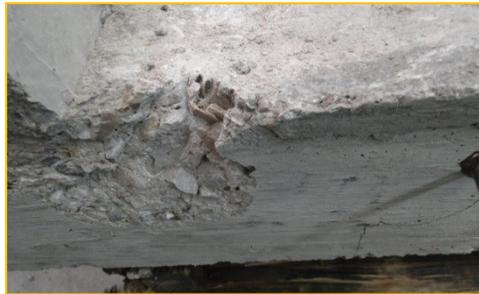
(b) Aggregate fracture

(c) Fracture near notch.

Figure 17. CSP 6 Specimen #2 precast failure plane.

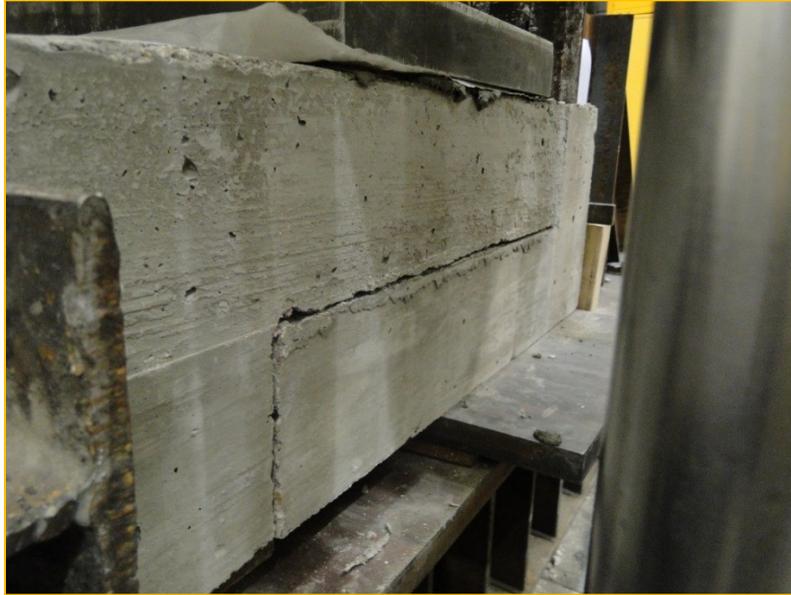
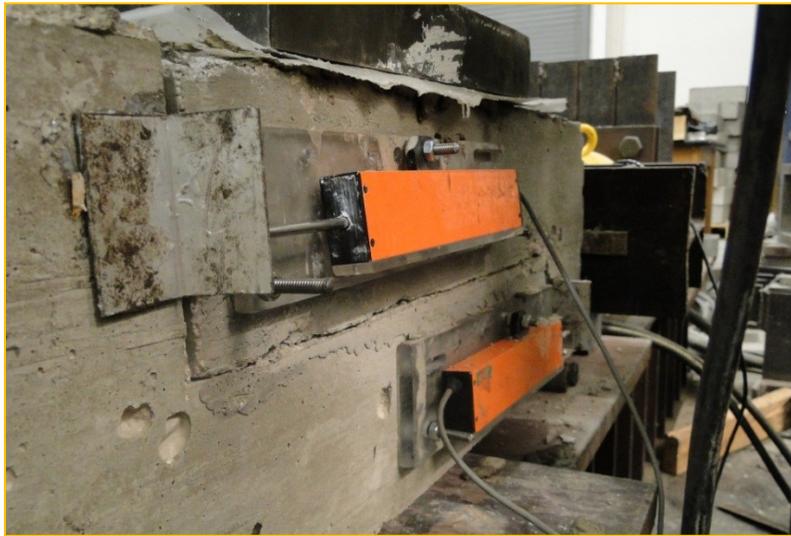
CSP 6_3

Figure 18. CSP 6 Specimen #3 failure (a) front view (b) back view.

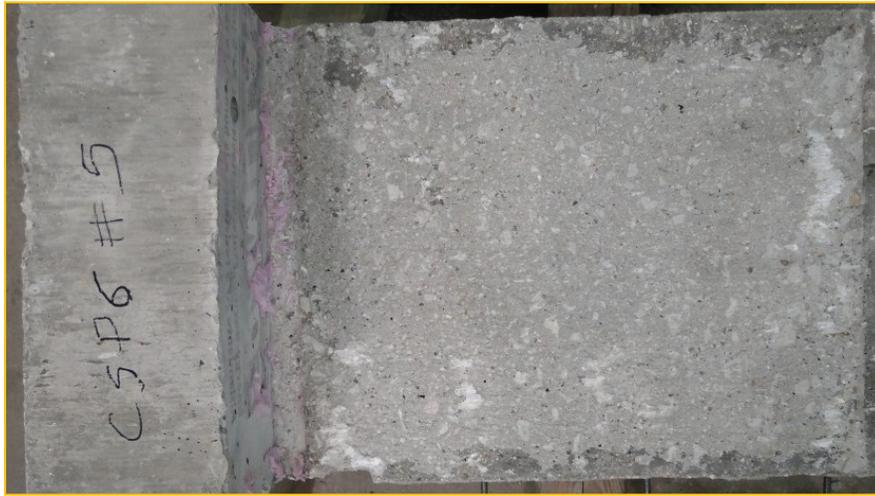
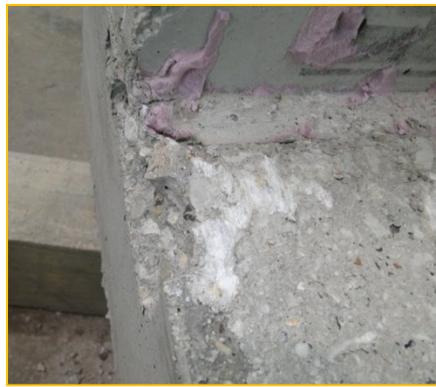
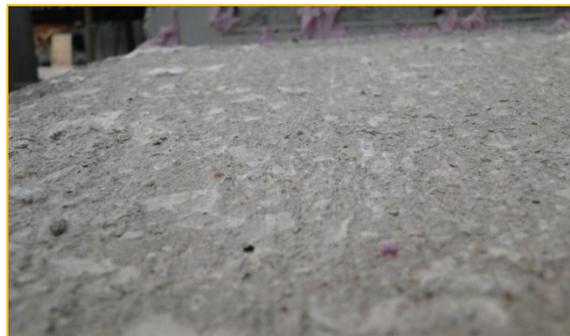
(b) Concrete fracture near interface

(c) Fairly smooth surface

Figure 19. CSP 6 Specimen #3 CIP failure plane.

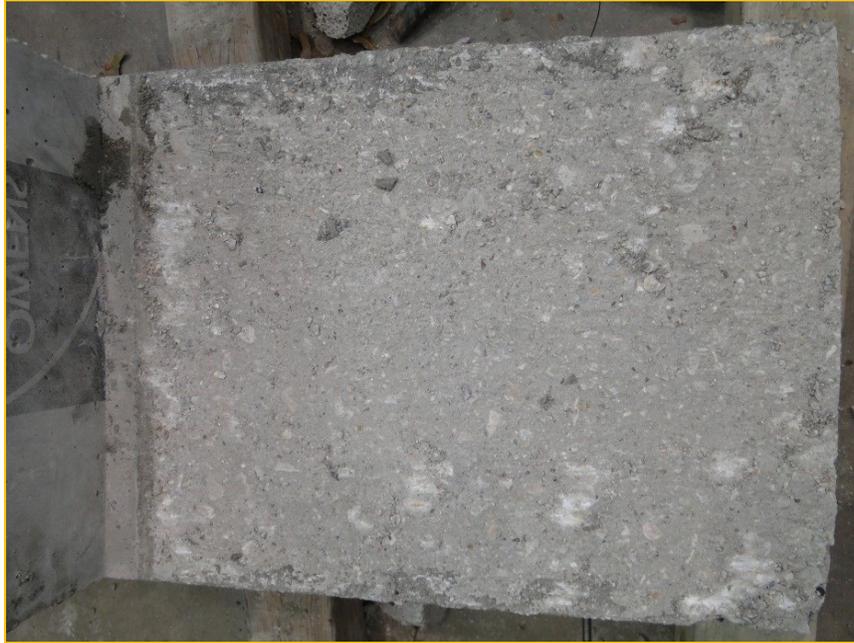
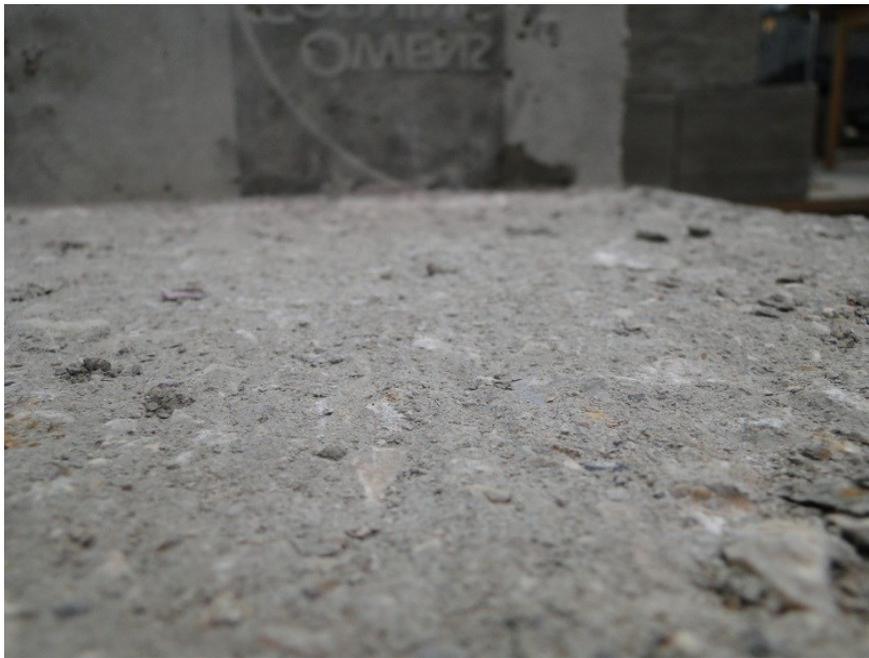
Figure 20. CSP 6 Specimen #3 precast failure plane.

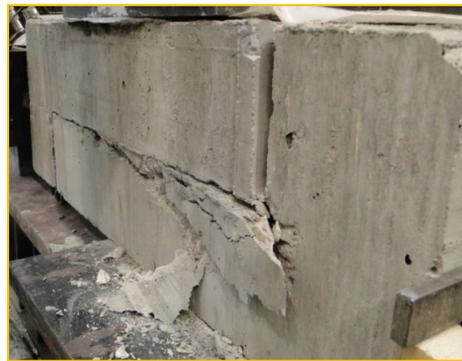
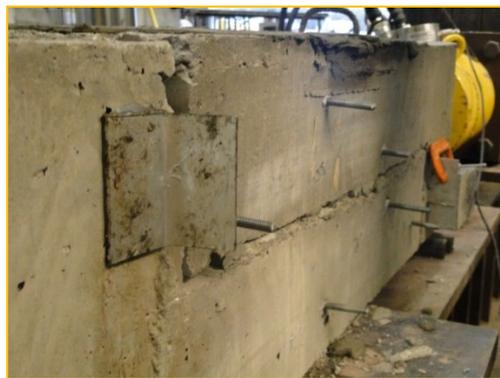
The Figures below show the testing of the CSP 7 specimens. No flexural cracking was observed during testing and both specimens failed along the interface at an average peak load of 85.6 kips. There was also some fracture of concrete near the interface. CSP 7 specimens showed significantly more interaction at the interface with aggregate fracture pullout and also specimen #1 showed failure that dislodge some part of the concrete from the precast part. Specimen #3 showed the highest strength and it can be observed from the interface after failure that there is more obvious aggregate fracture, pullout and concrete dislodged from the precast part.

Figure 21. CSP 7 Specimen #1 failure (a) front view (b) back view.

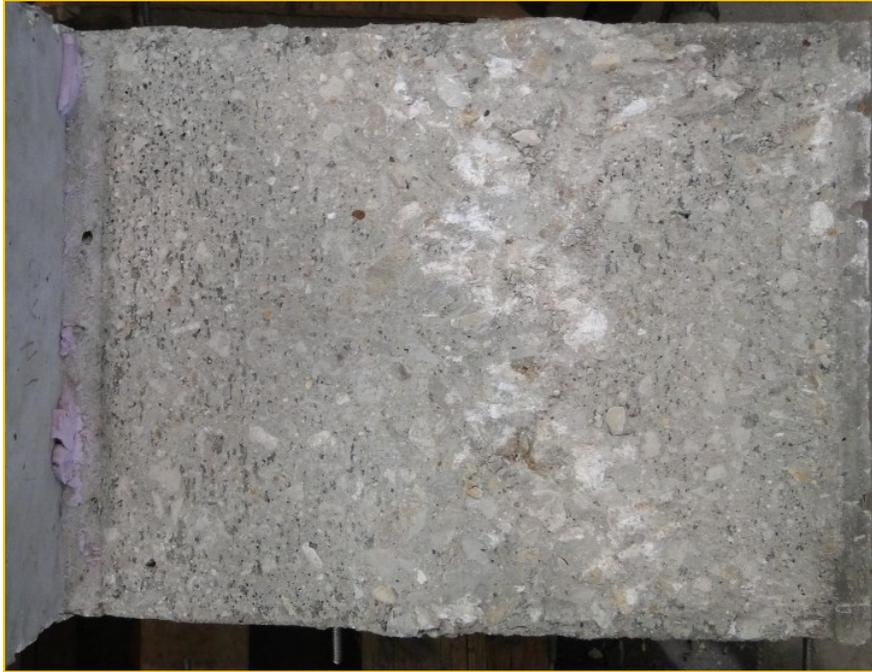
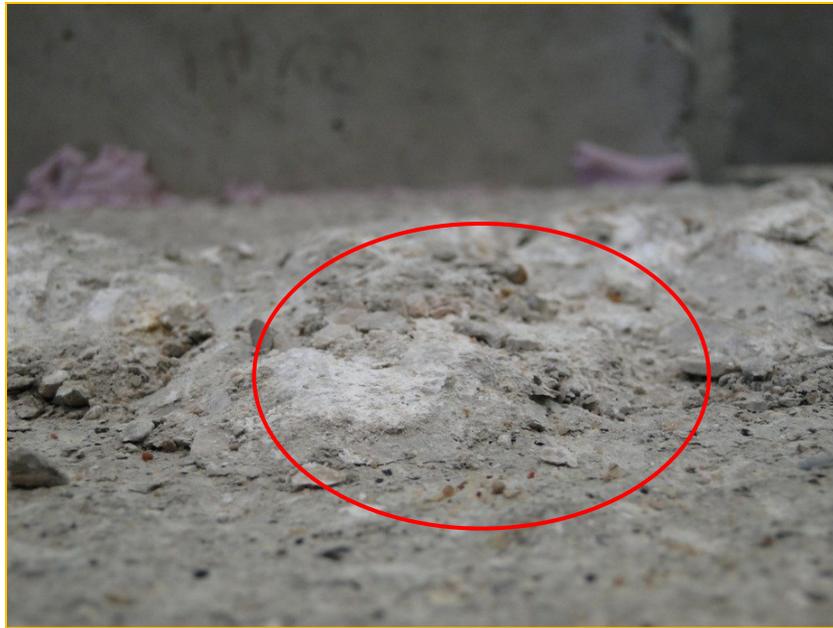
(b) dislodged from the precast part.

Figure 22. CSP 7 Specimen #1 CIP failure plane.

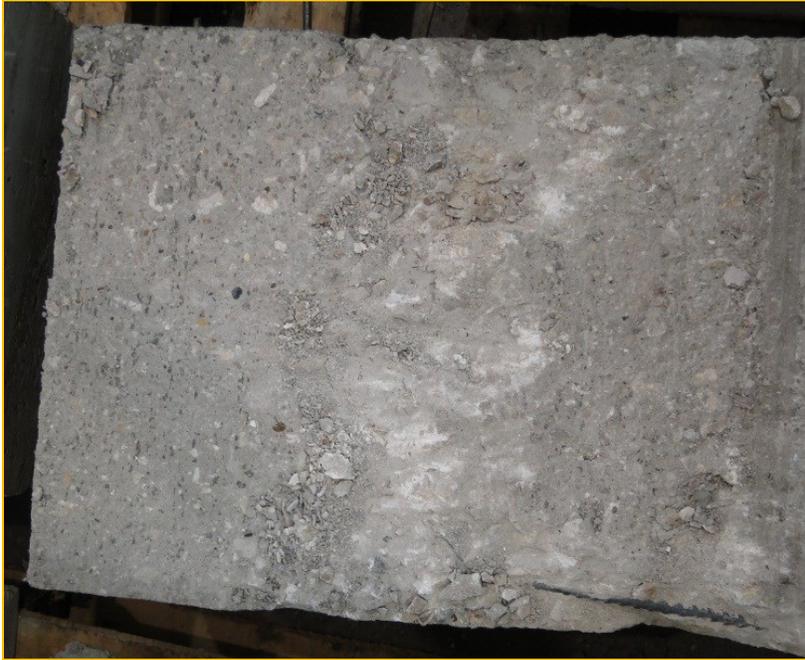
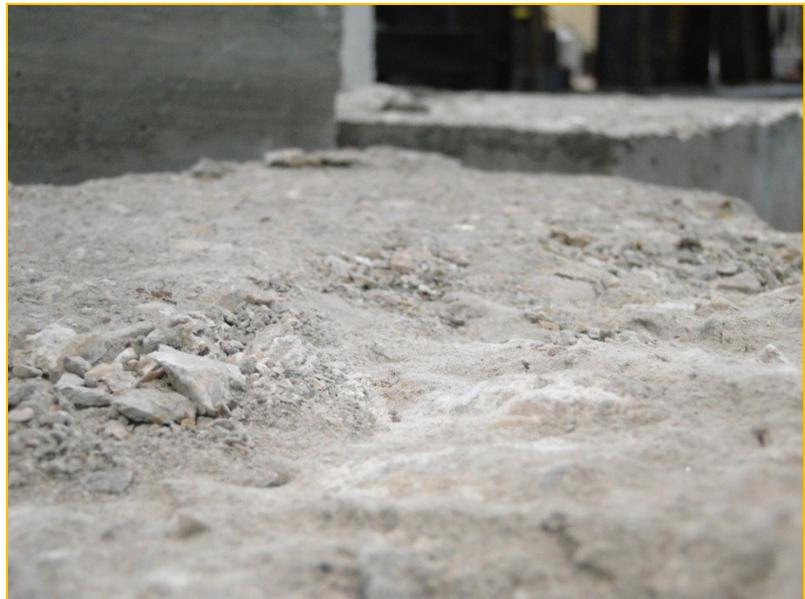
Figure 23. CSP 7 Specimen #1 precast failure plane.

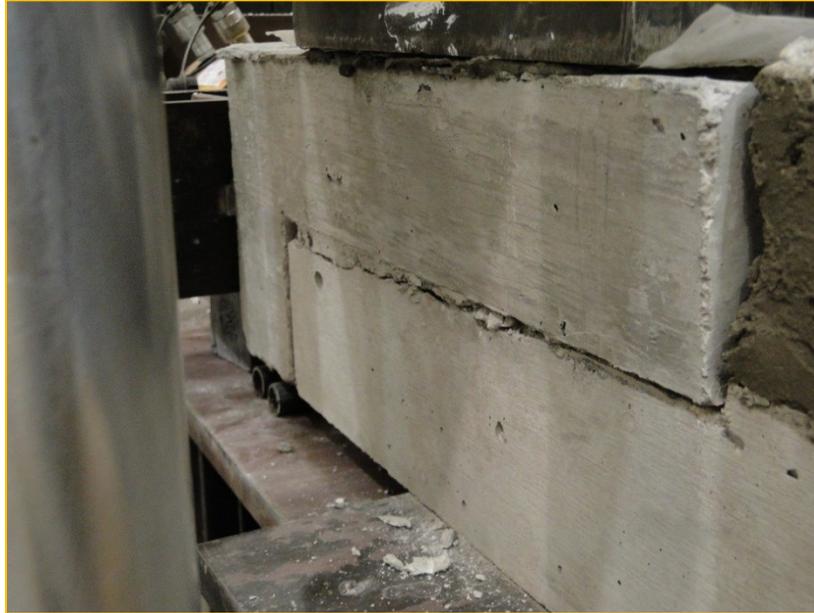
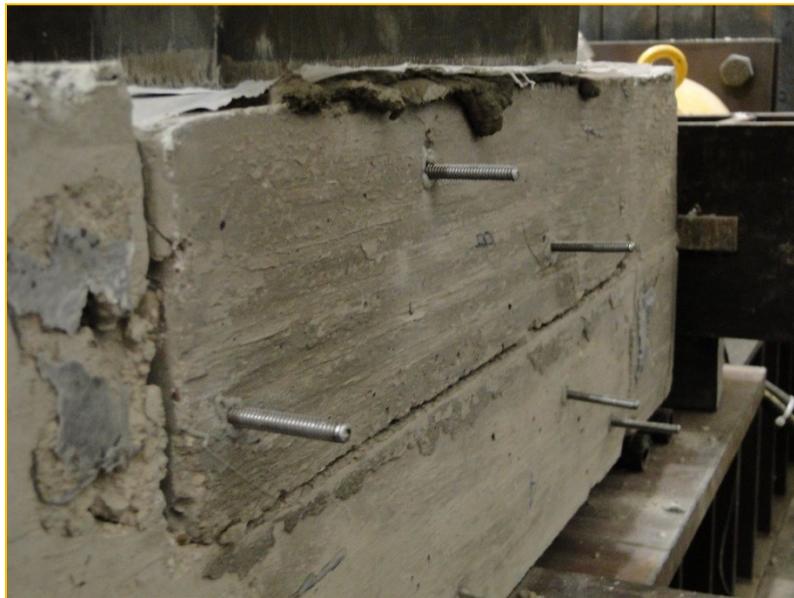
CSP7_2

Figure 24. CSP 7 Specimen #2 failure (a) front view (b) back view.

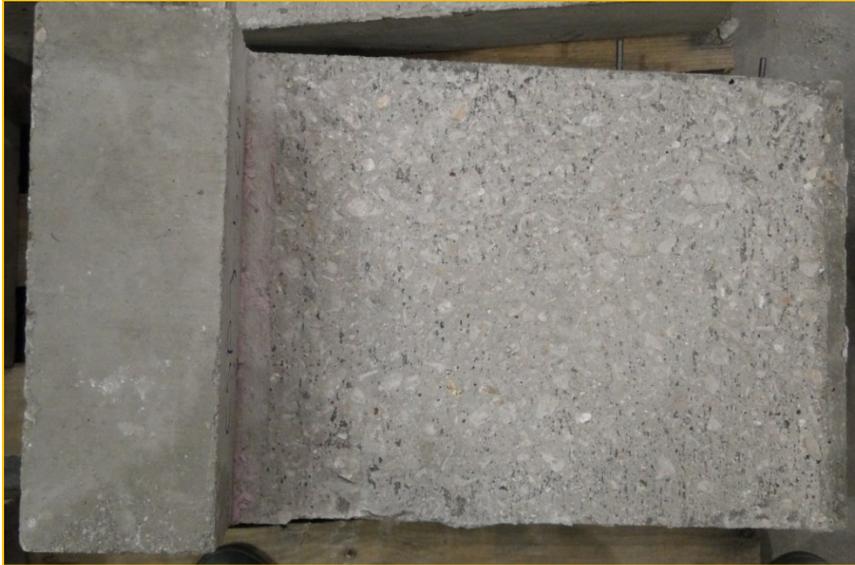
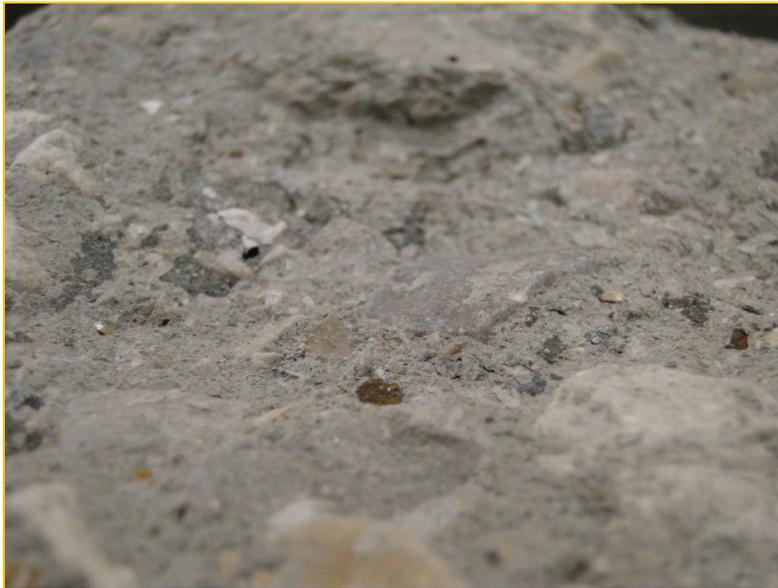
Figure 25. CSP 7 Specimen #2 CIP failure plane.

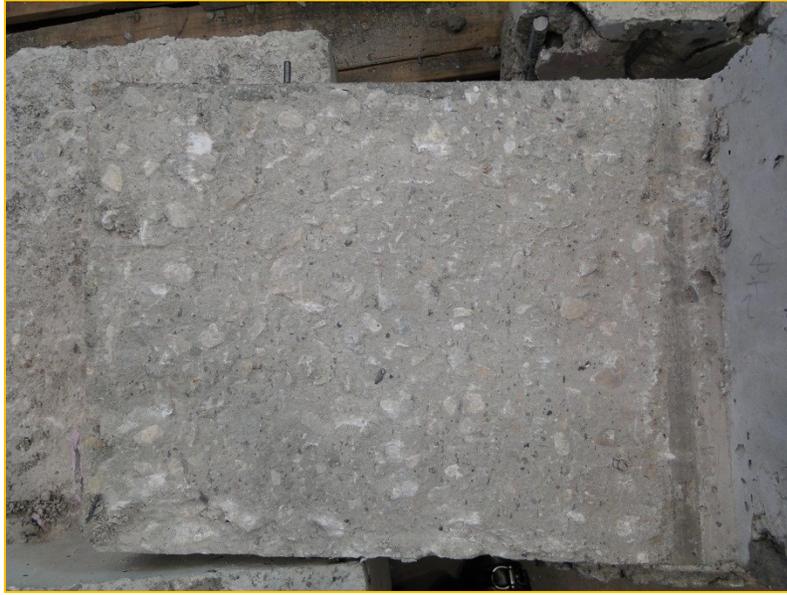
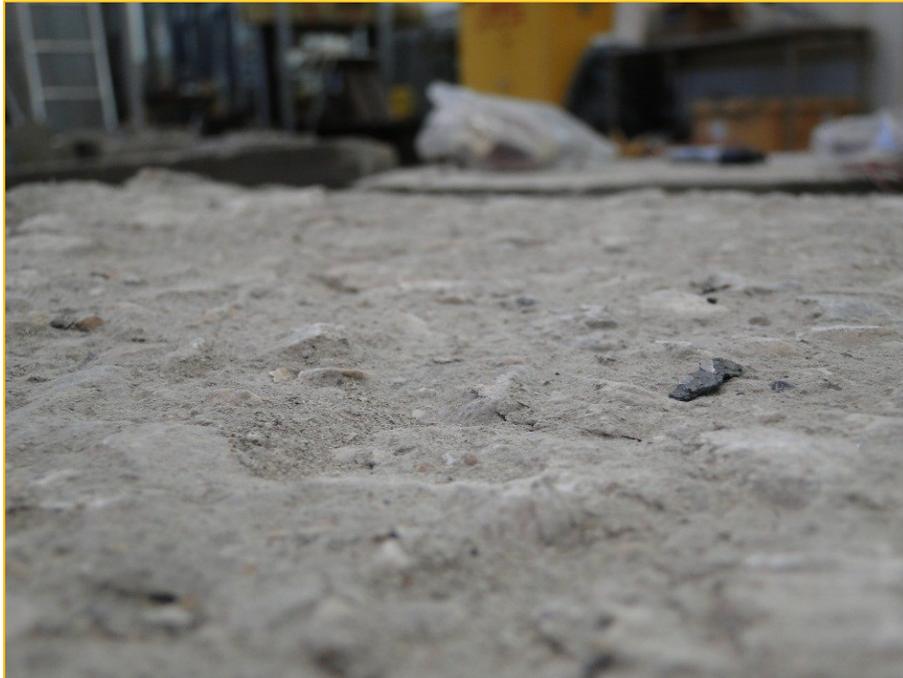
Figure 26. CSP 7 Specimen #2 precast failure plane.

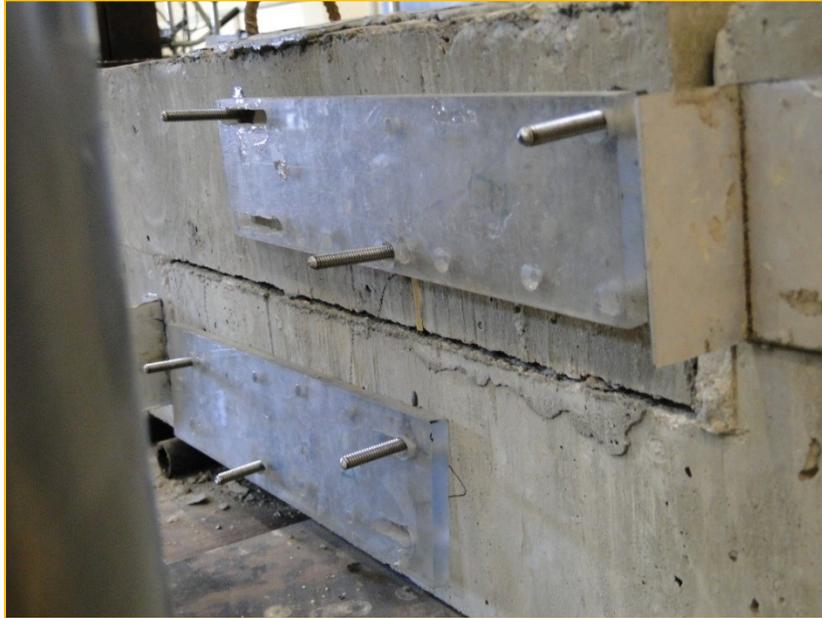
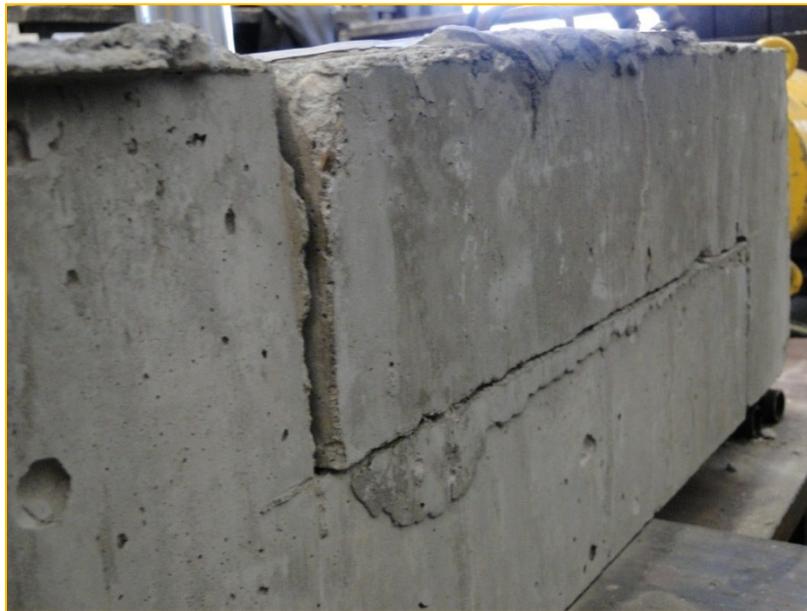
CSP7_3

Figure 27. CSP 7 Specimen #3 failure (a) front view (b) back view.
