PERFORMANCE OF FULL-SCALE ULTRA-HIGH PERFORMANCE FIBER-
REINFORCED CONCRETE COLUMN SUBJECTED TO EXTREME EARTHQUAKE-
TYPE LOADING AND EFFECT OF SURFACE PREPARATION ON THE COHESION
AND FRICTION FACTORS OF THE AASHTO INTERFACE SHEAR EQUATION

MASTER OF SCIENCE IN CIVIL ENGINEERING

THE UNIVERSITY OF TEXAS AT ARLINGTON

May 2015

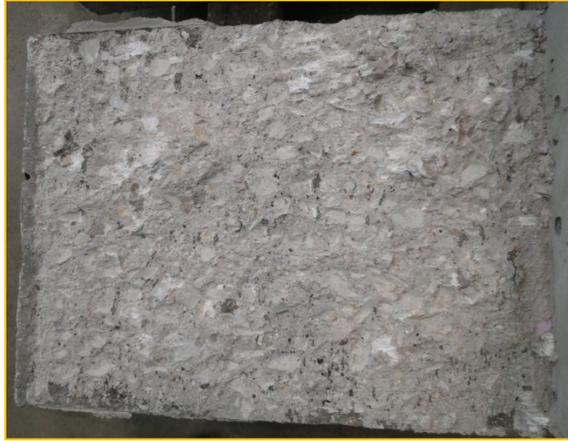
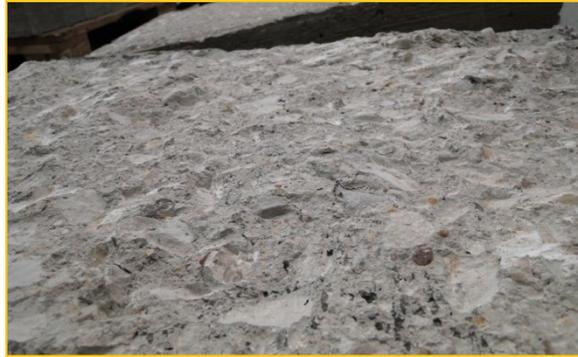
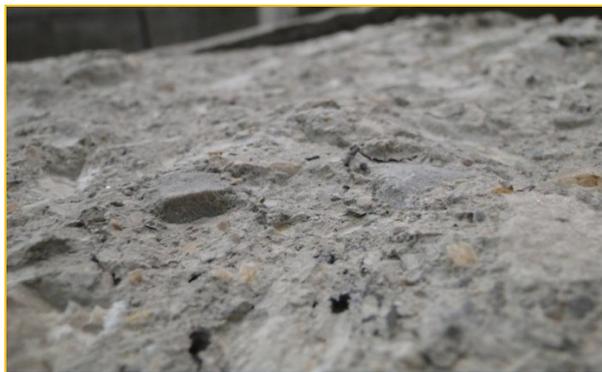
(b) Extremely rough surface showing both fracture and pullout

Figure 28. CSP 7 Specimen #3 CIP failure plane.

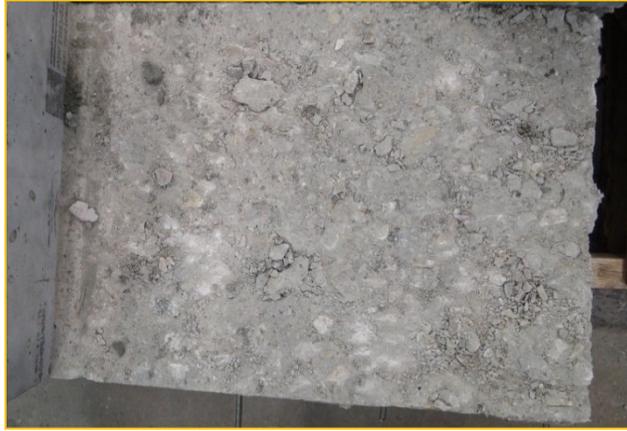
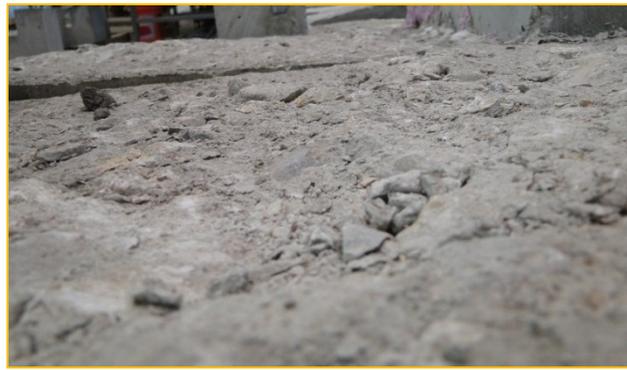
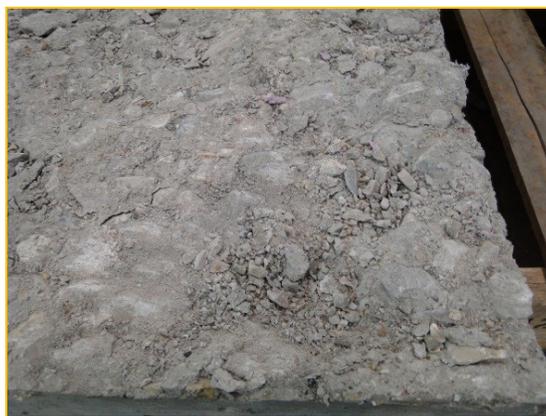
(a) Dislodged concrete and aggregates.

Figure 29. CSP 7 Specimen #3 precast failure plane.

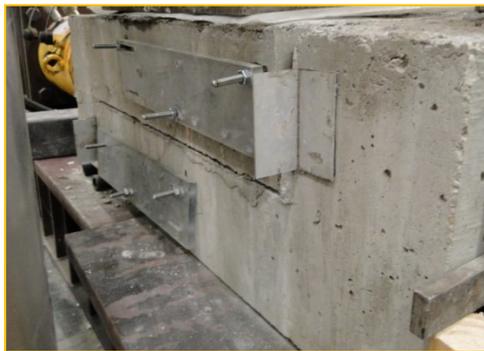
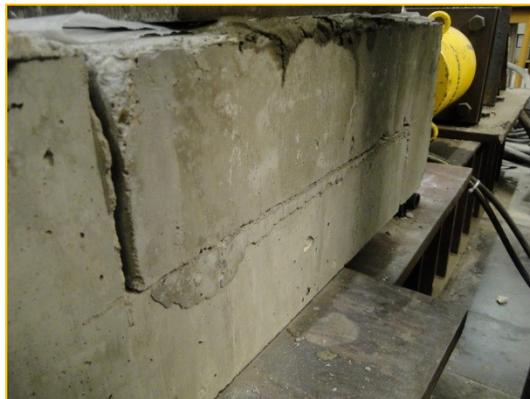
CSP8_1

The Figures below show the testing of the CSP 8 specimens. Two of the specimens failed at exactly the interface while Specimen #3 failed out of the interface suggesting that the bond on the interface was very strong. The average peak load was 88.85 kips. Specimen #2 showed the highest peak load which is evident from the surface after failure whereby there is a piece of concrete dislodged from the precast part and also considerable aggregate pullout and fracture.

Figure 30. CSP 8 Specimen #1 failure (a) front view (b) back view.

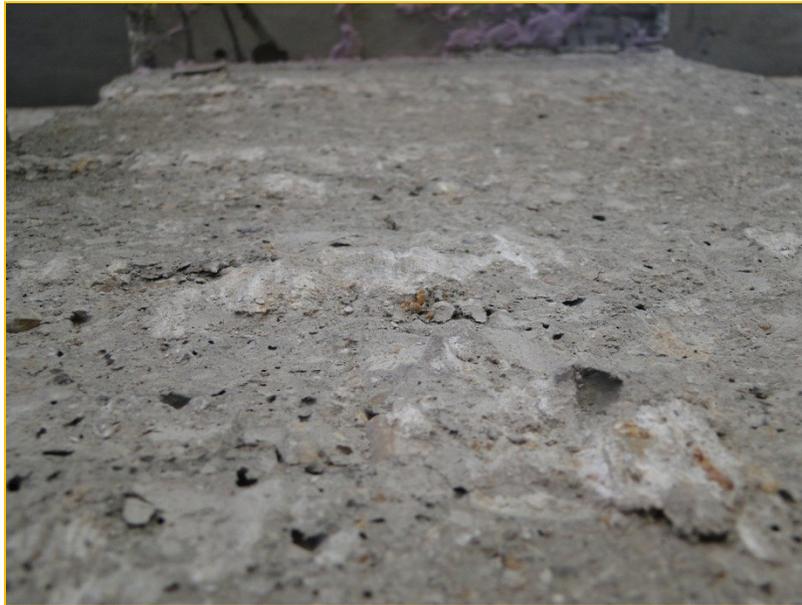
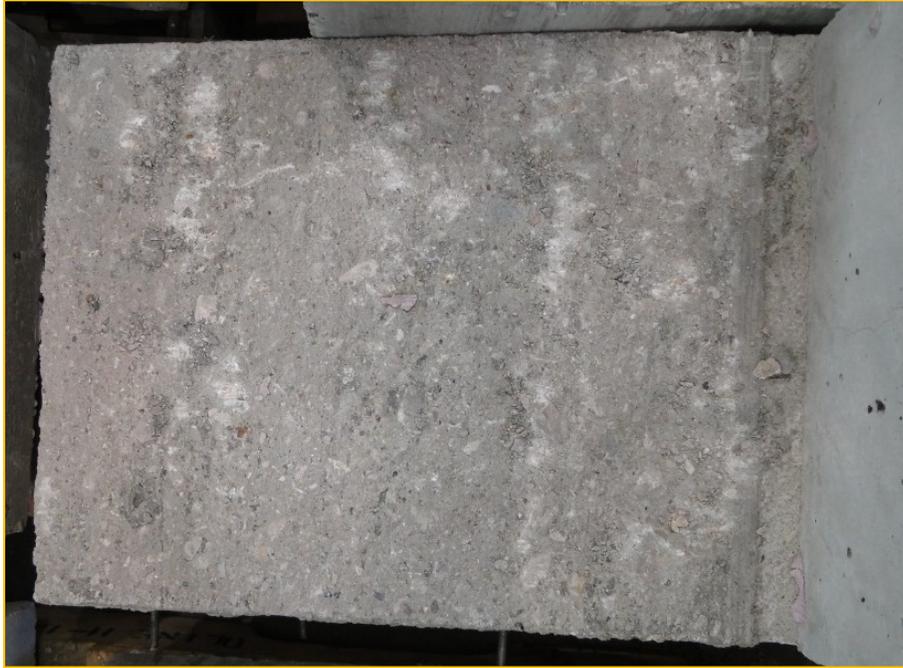
Figure 31. CSP 8 Specimen #1 CIP failure plane.

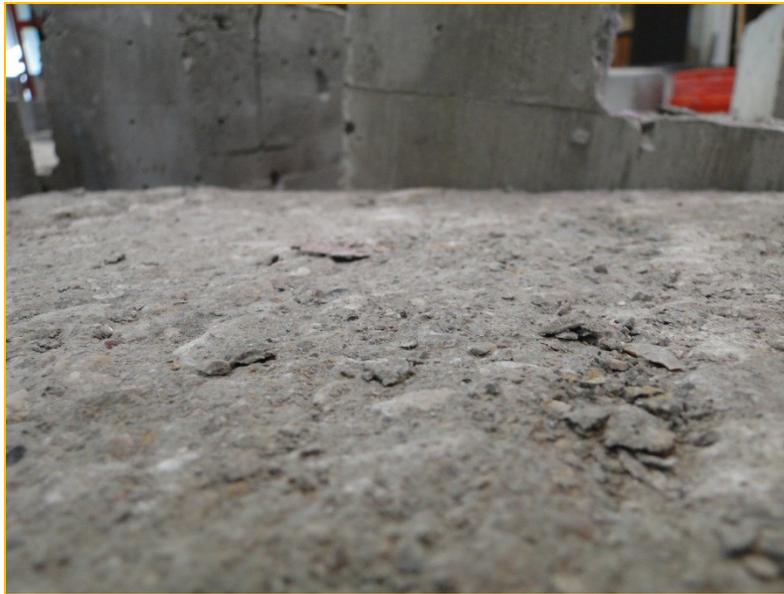
Figure 32. CSP 8 Specimen #1 precast failure plane.

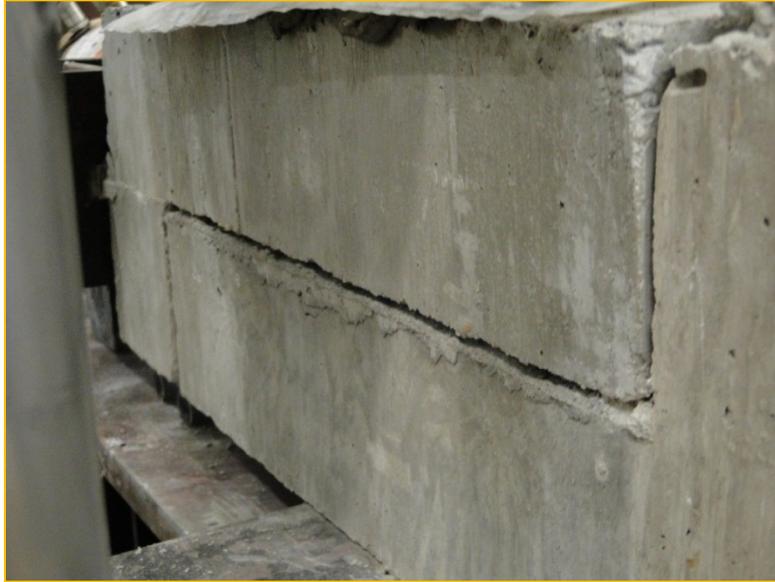
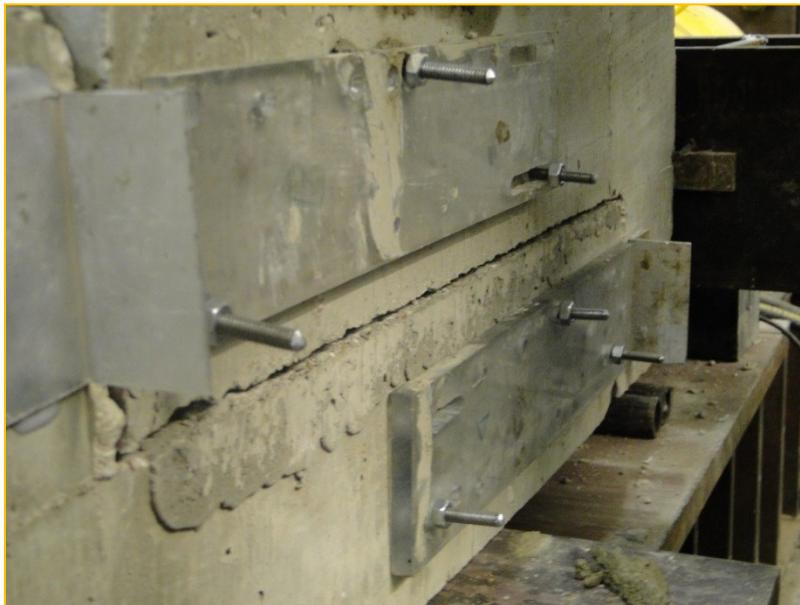
Figure 33. CSP 8 Specimen #2 failure (a) front view (b) back view.

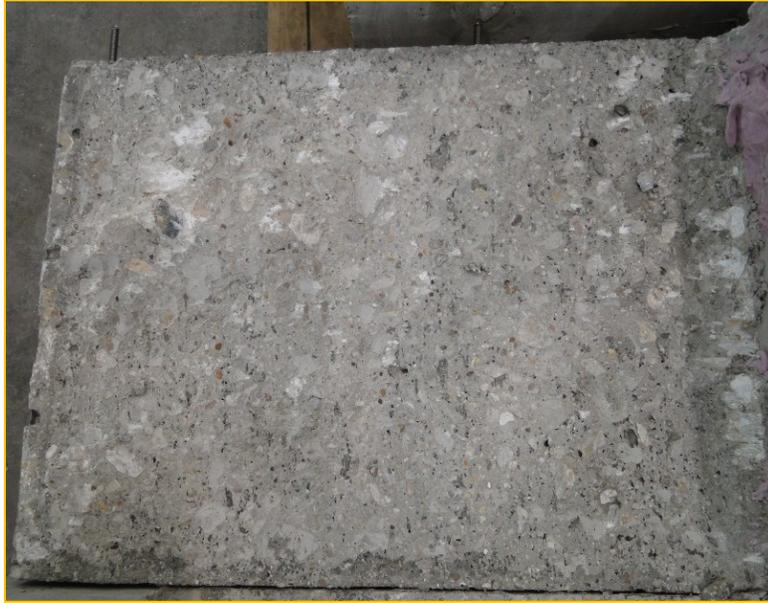
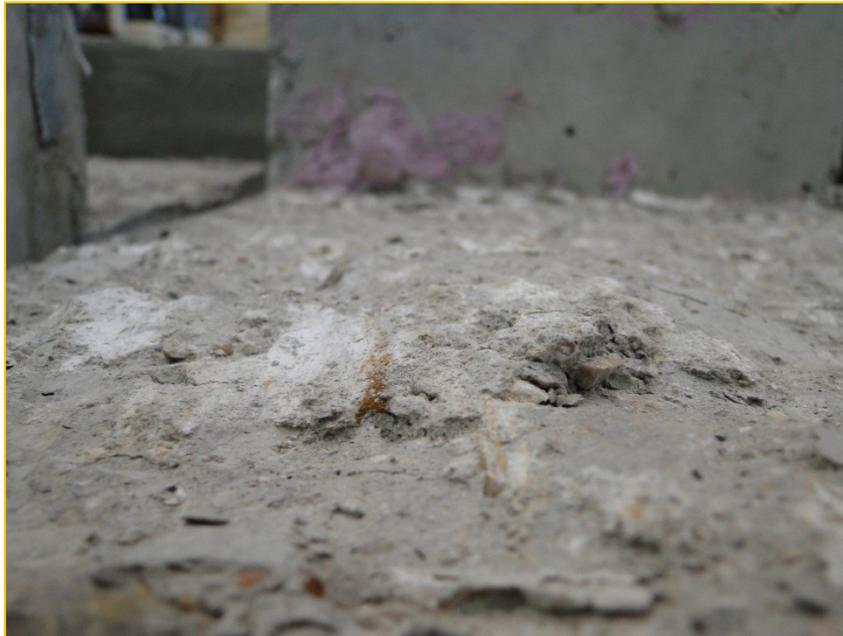
(b) Dislodged concrete.

Figure 34. CSP 8 Specimen #2 CIP failure plane.

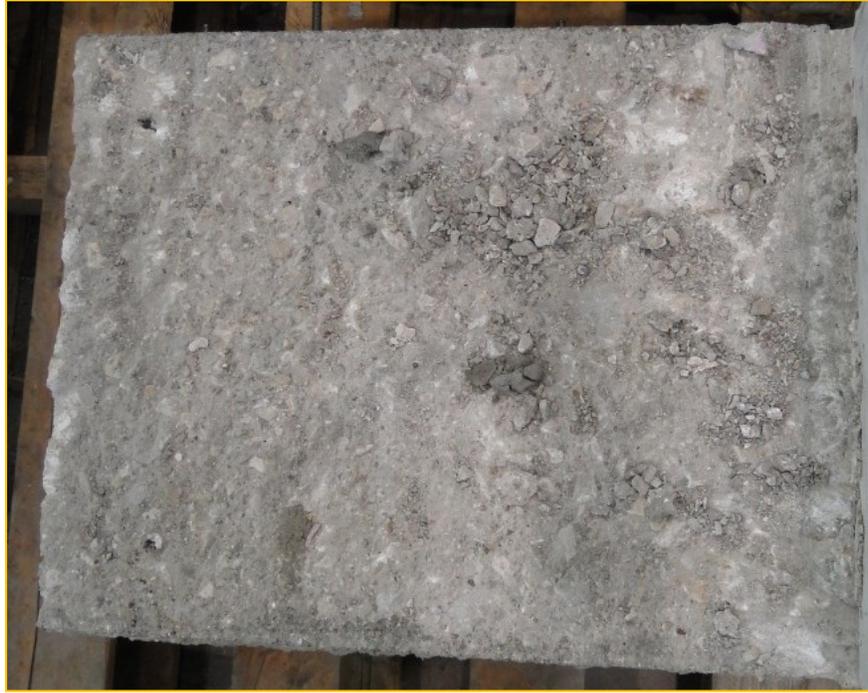
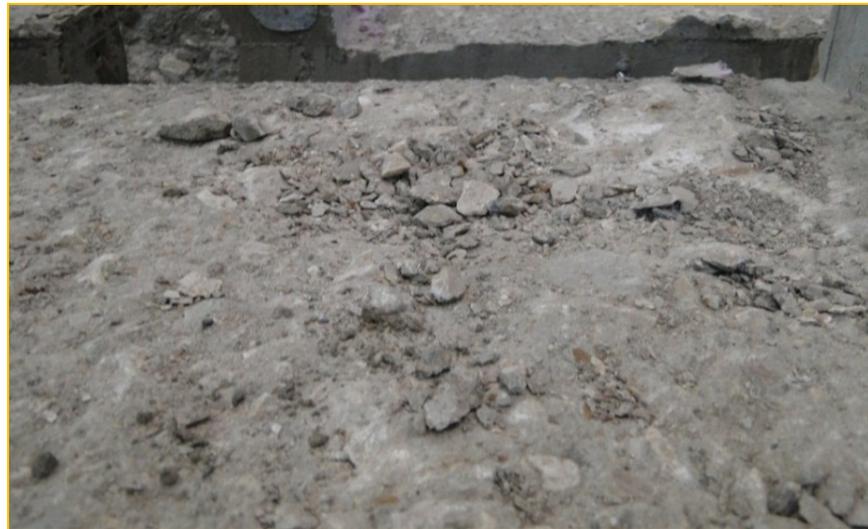
Figure 35. CSP 8 Specimen #2 precast failure plane showing dislodged and fractured aggregates.

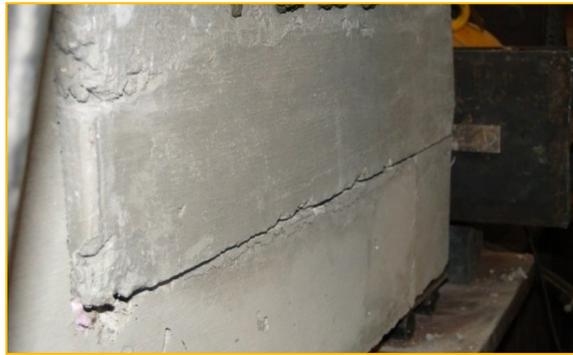
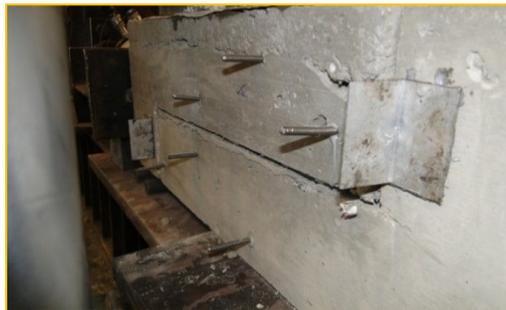
The Figures below show the testing of the CSP 9 specimens. Two specimens failed along the interface while the third failed at the legs. The average peak load was 80.22 kips. Specimen #1 showed a much smaller peak load compared to #2 and #3. It is believed that this specimen was one of the latest to be cast thus the concrete was less workable and hence poor bonding. Since the results were much lower than expected, they were not used in the calculation on the friction coefficient. Specimen 3 did not fail at the interface but started progressing into the precast part as can be seen in Figure 64 this is believed to indicate that the bond at the interface was so strong that failure followed the path of least resistance.

Figure 37. CSP 9 Specimen #1

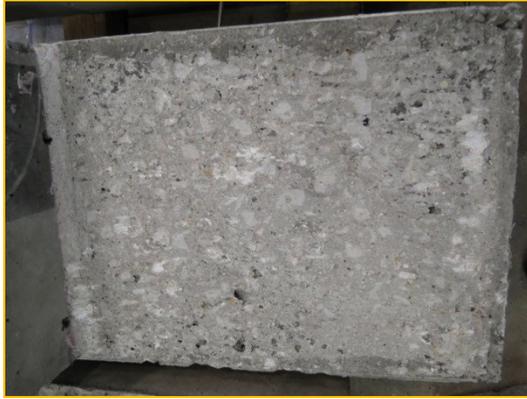
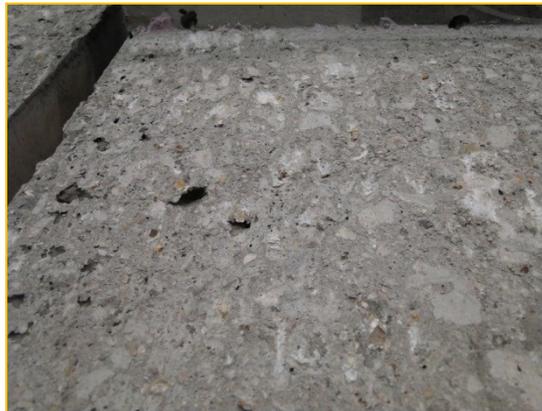
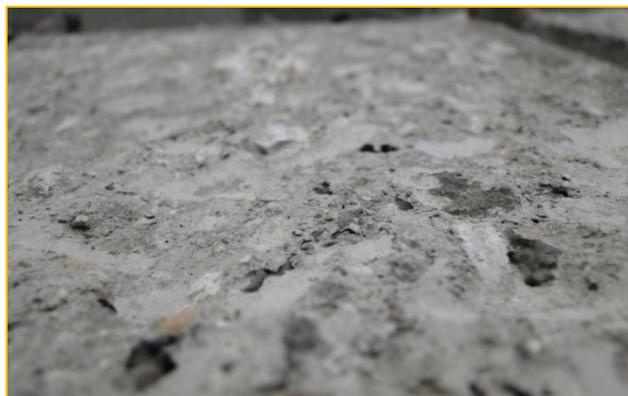
Figure 38. CSP 9 Specimen #1 CIP failure plane.

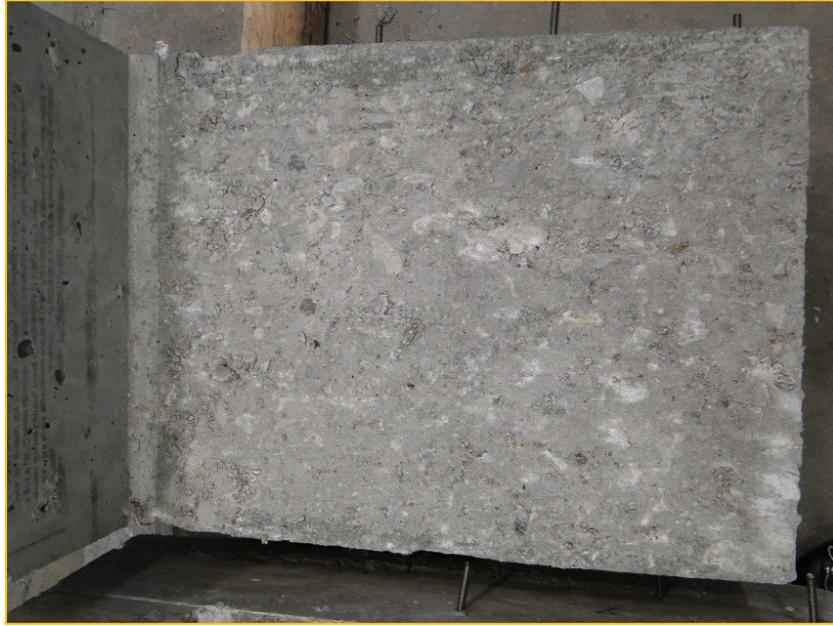
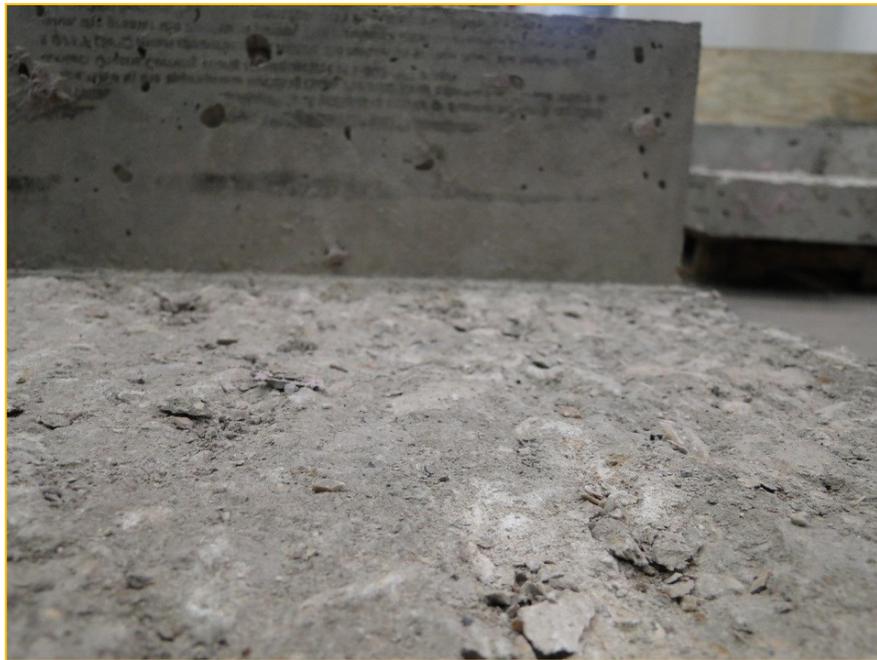
Figure 39. CSP 9 Specimen #1 precast (a) failure plane and (b) surface profile.

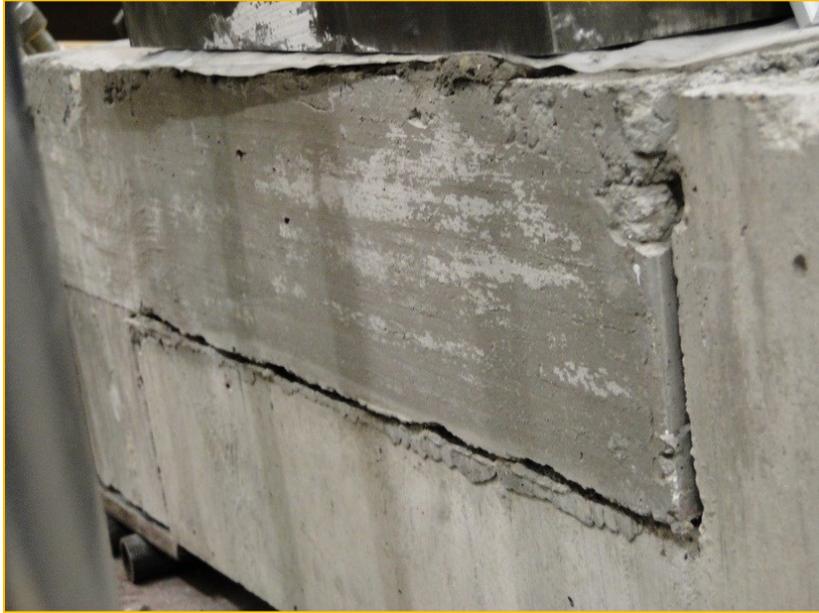
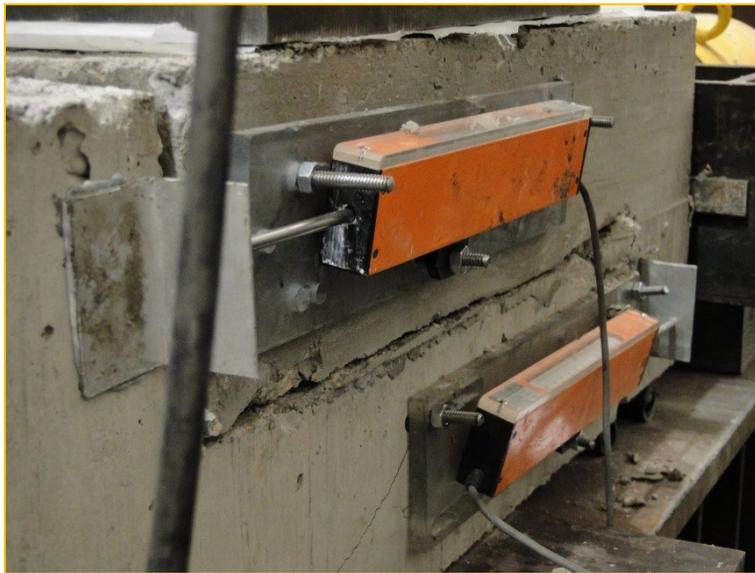
Figure 40. CSP 9 Specimen #2 failure (a) front view (b) back view.

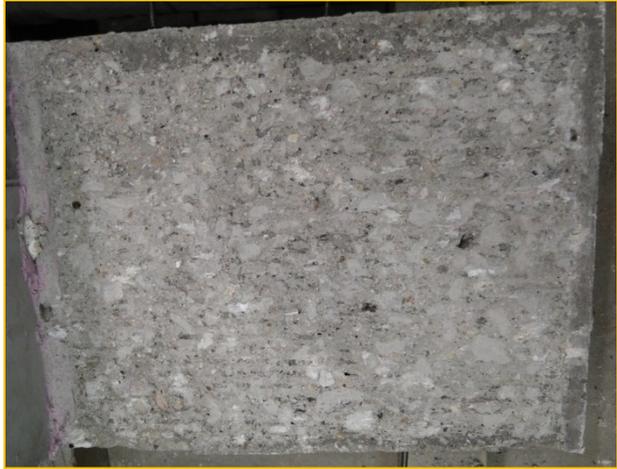
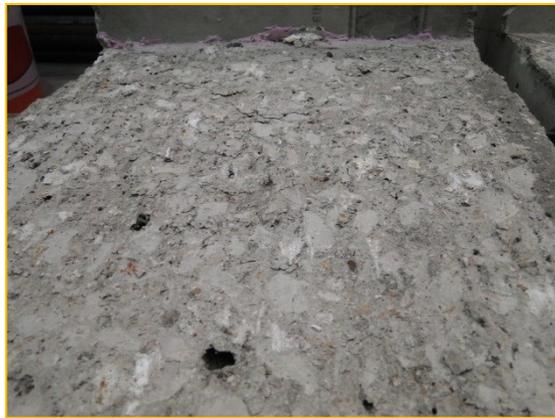
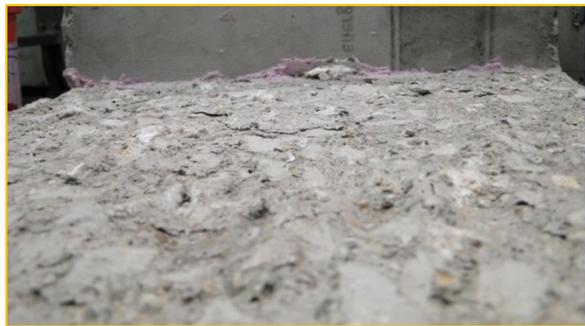
Figure 41. CSP 9 Specimen #2 CIP failure plane.

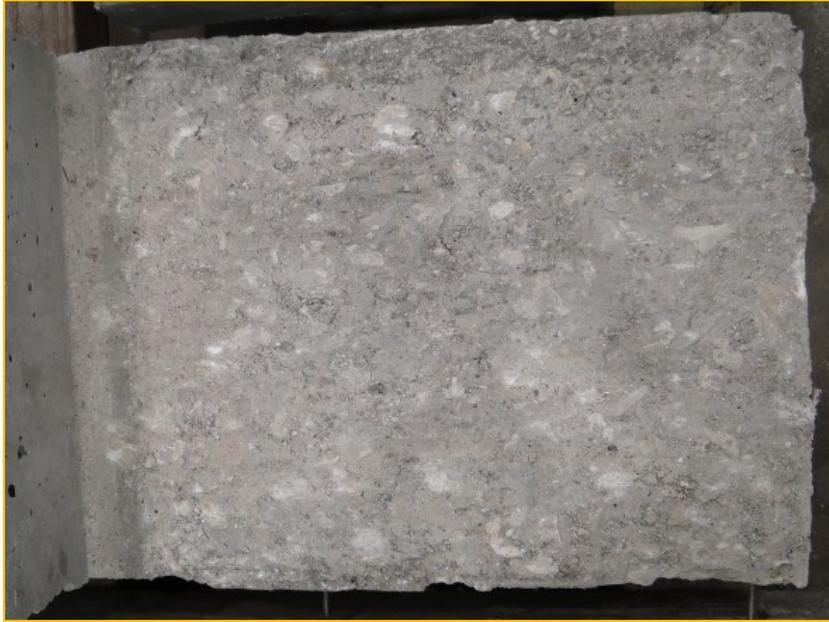
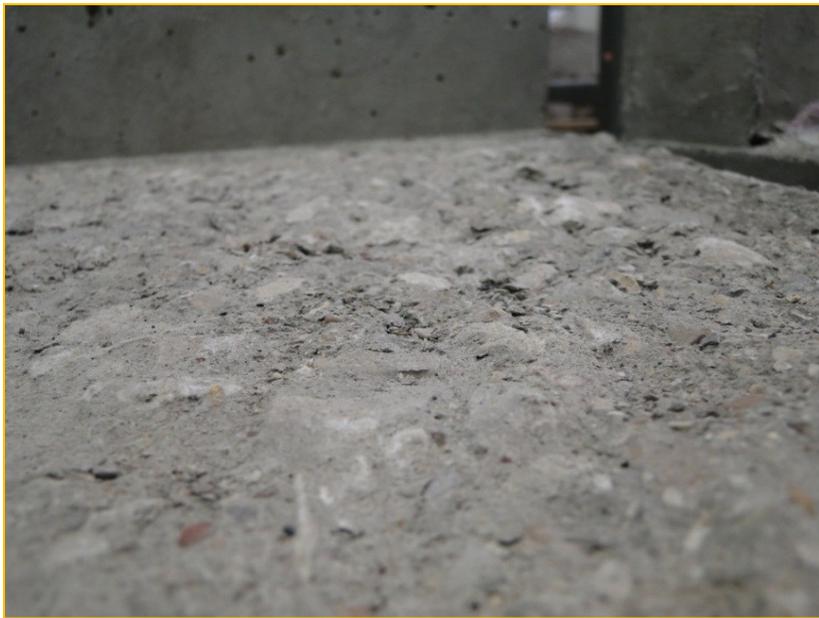
Figure 42. CSP 9 Specimen #2 precast failure plane.

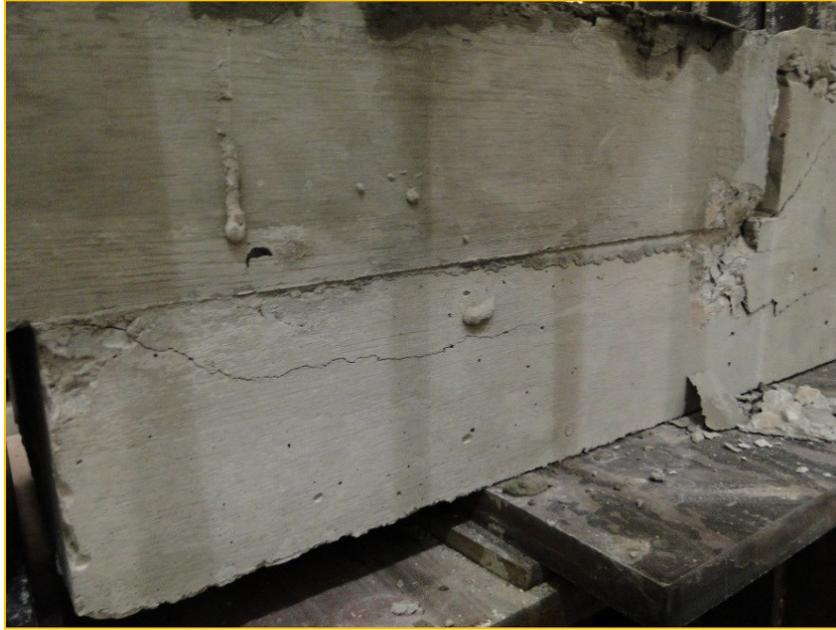
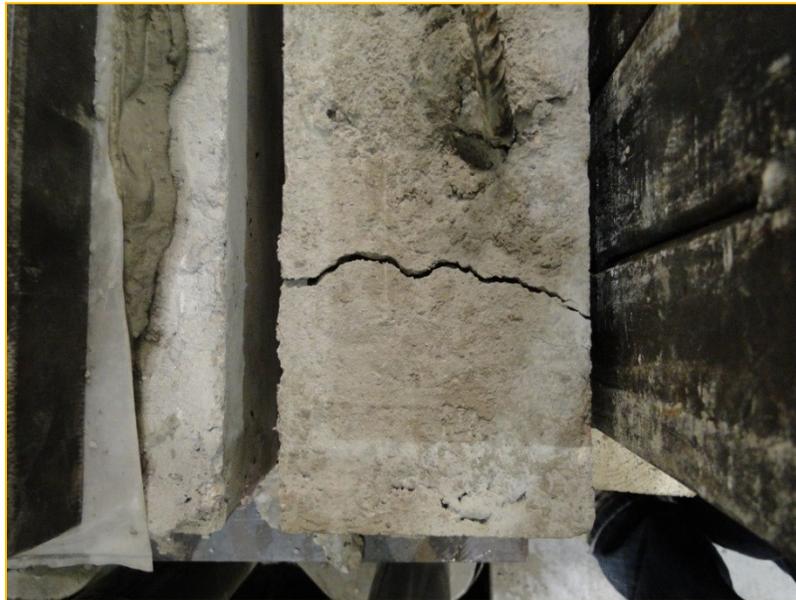
(a) Failure progressing into precast part.

Figure 43. CSP 9 Specimen #3 failure
