TESTING, ANALYSIS AND CLASSIFICATION OF NO-DIG MANHOLE
REHABILITATION MATERIALS

MASTER OF SCIENCE IN CIVIL ENGINEERING

THE UNIVERSITY OF TEXAS AT ARLINGTON

MAY 2015

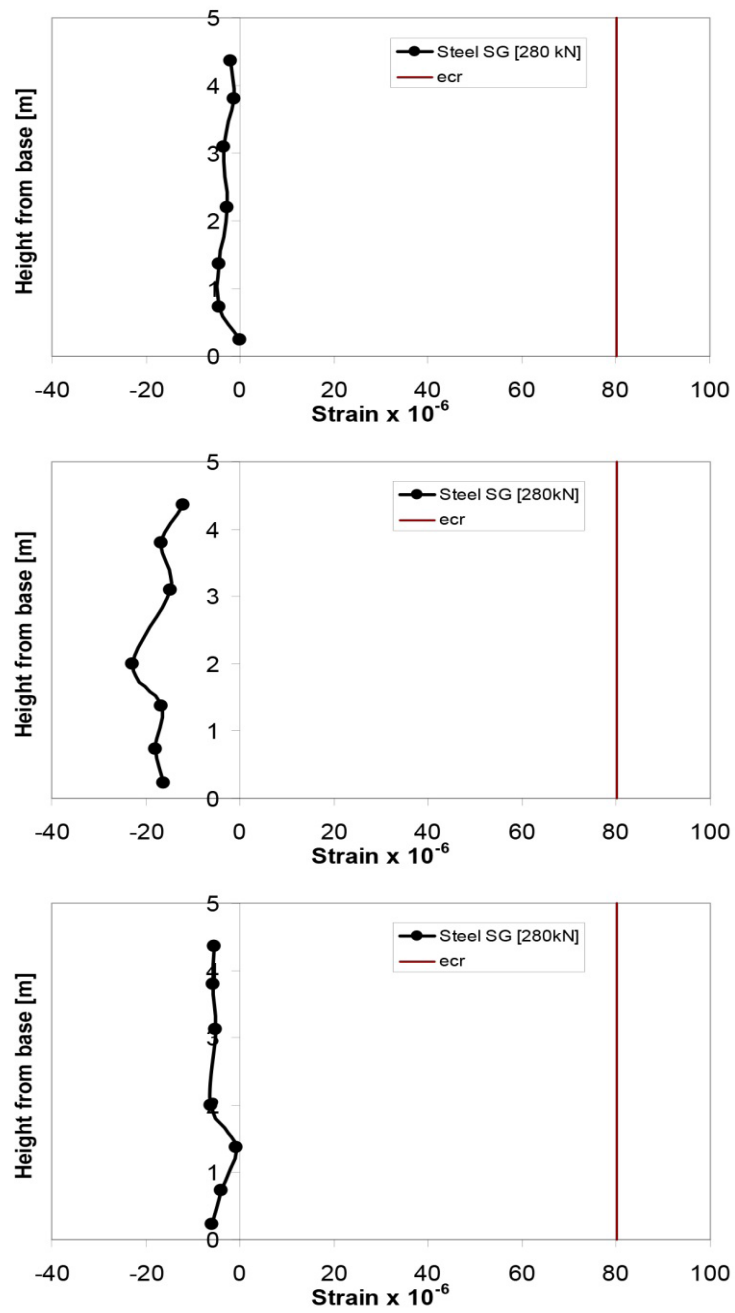
The following figure shows the axial vertical strain profile in the manhole structure under the following loading conditions:

- a) Four concentrated loads of 15.7 kip each applied around the manhole cover by slow loading
- b) A 63 kip distributed load applied on the manhole by slow loading
- c) A 63 kip distributed load applied on the manhole by fast loading

Figure 2.1. Axial vertical strain profile in a reinforced manhole wall

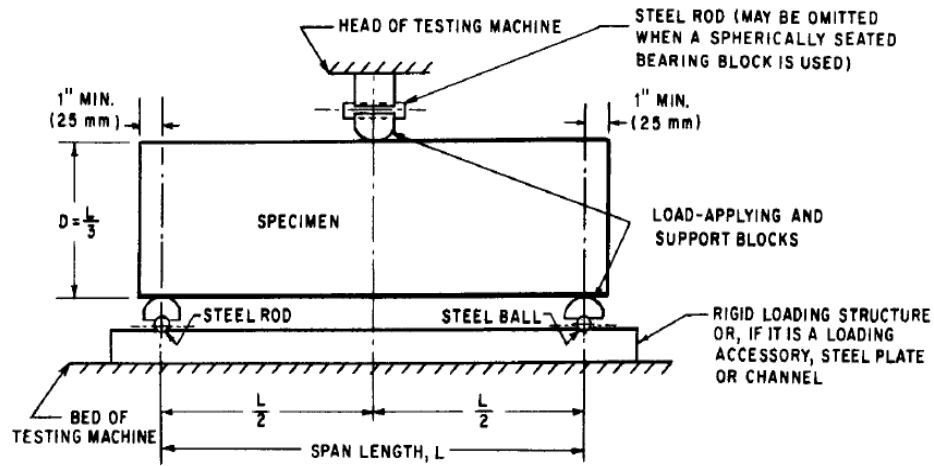
Two of the widely used standards for testing concrete beams for flexural strength are: ASTM C78 and ASTM C293. In ASTM C78 a simple concrete beam was tested by three-point loading. In ASTM C293 a simple concrete beam was tested by center-point loading (Figure 3.1). ASTM C293 is followed for the preliminary experiments. The results of this test method may be used to determine compliance with specifications or as a basis for proportioning, mixing and placement operations. This test method produces values of flexural strength significantly higher than Test Method C78. The flexural strength found is expressed as the "Modulus of Rupture" (MR) in MPa or psi. A 60 KIP Baldwin flexure testing machine (see Figure 3.2) is used for the flexural strength tests.

Figure 3.1. Flexural strength test setup per ASTM C293

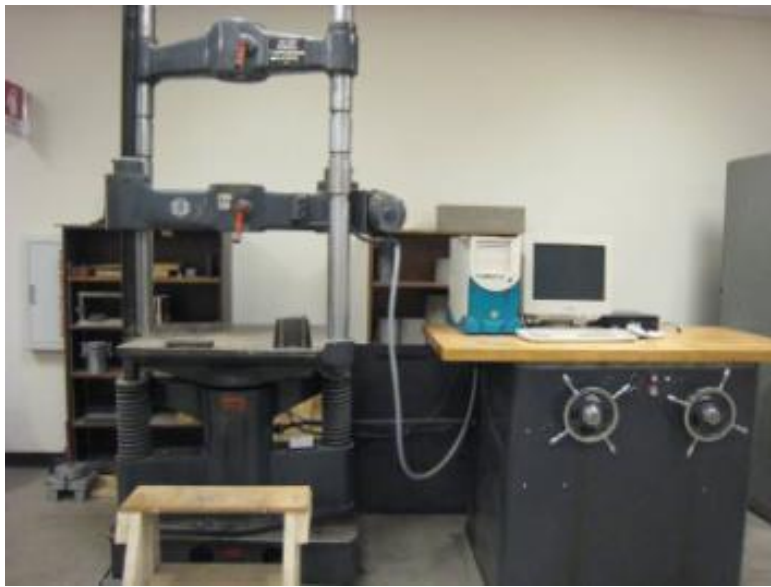
Figure 3.2. Baldwin 60 KIP flexural strength testing machine

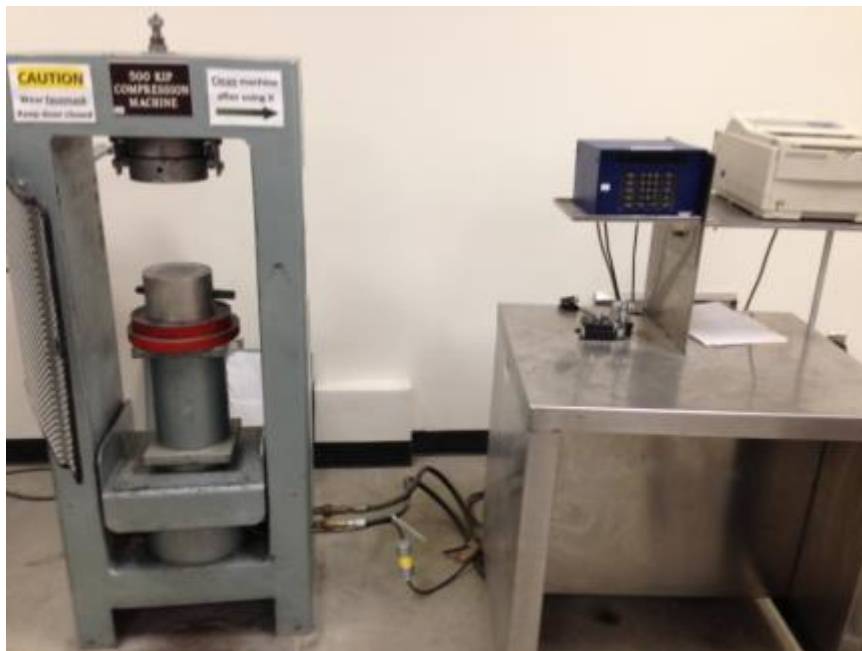
preliminary step was used as a basis to move forward with a more elaborate experimental design to better understand at what degree No-Dig Rehabilitation materials can enhance the compressive strength of an actual manhole in the field (see the Main Tests section below). This is an important property in determining the structural class of the lining material as the majority of the stresses/strains observed on a typical circular cross-section manhole are compressive. Compressive strength tests are applied by using an Admet (500 kip) testing machine available at CUIRE(Figure 3.3)

Figure 3.3. The testing instrument (ADMET 500 KIP) for compressive strength tests

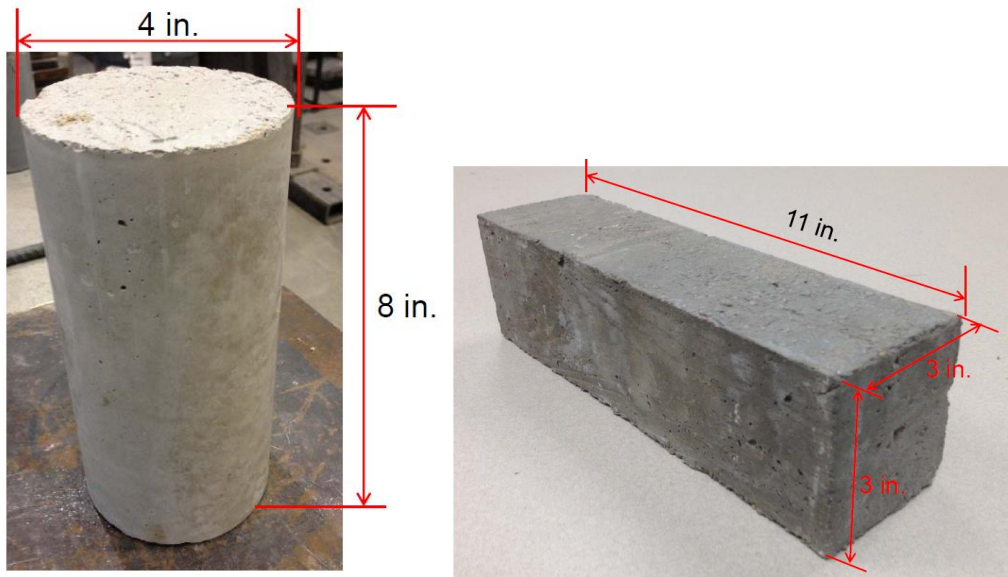
Forty two concrete cylinders (4 × 8 in.) and 41 concrete beams (3 × 3 × 11 in.) samples were prepared for the preliminary tests. The design strength of concrete was approximately 5,000 psi. The unlined (control) specimens prepared for the preliminary experiments are shown in Figure 3.4.

Figure 3.4. Typical concrete cylinder and beams used for the preliminary experiments

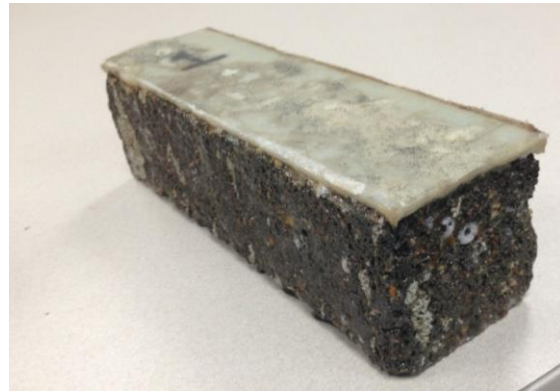
Figure 3.6. Concrete cylinder (a) and beam (b) samples lined with cured-in-place liner

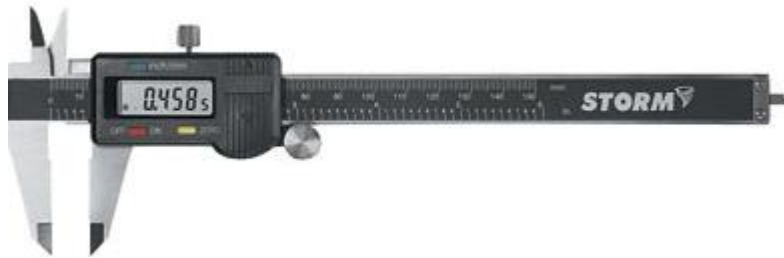
For the beam samples, each surface of the specimen was measured in three different locations, and then the average was taken for calculations.

Figure 3.7. Digital caliper used for measuring specimen dimensions

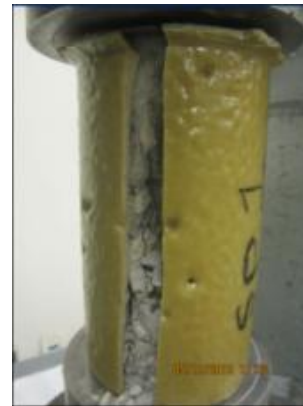
Figure 3.9. Beam (a) and cylindrical (b) specimens at failure while loaded for flexural and compressive strength, respectively

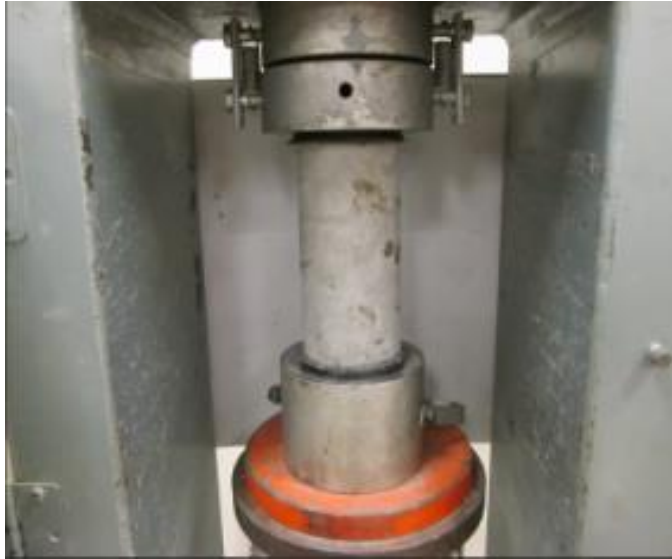
Figure 3.10. Unlined (control) cylinder prior to compression testing

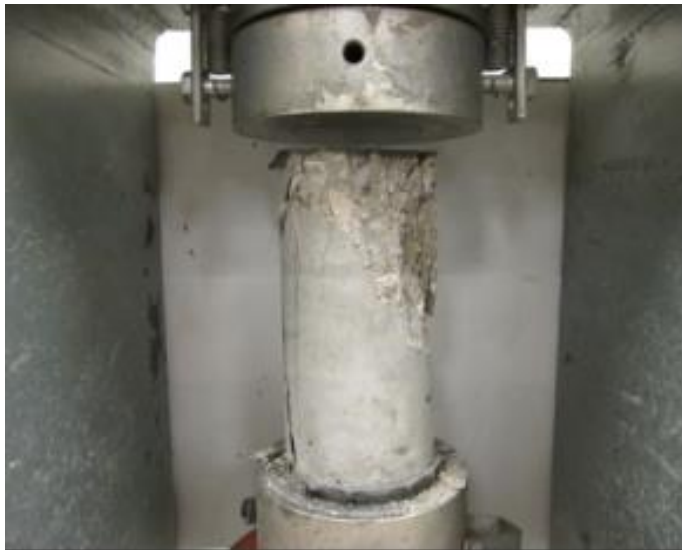
Figure 3.11. Unlined (control) cylinder after testing

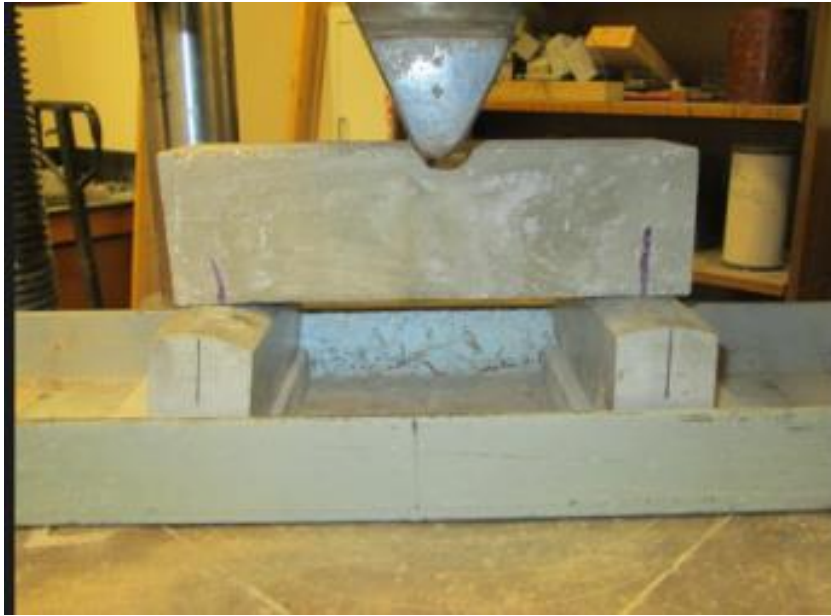
Figure 3.12. Unlined (control) beam prior to flexural testing

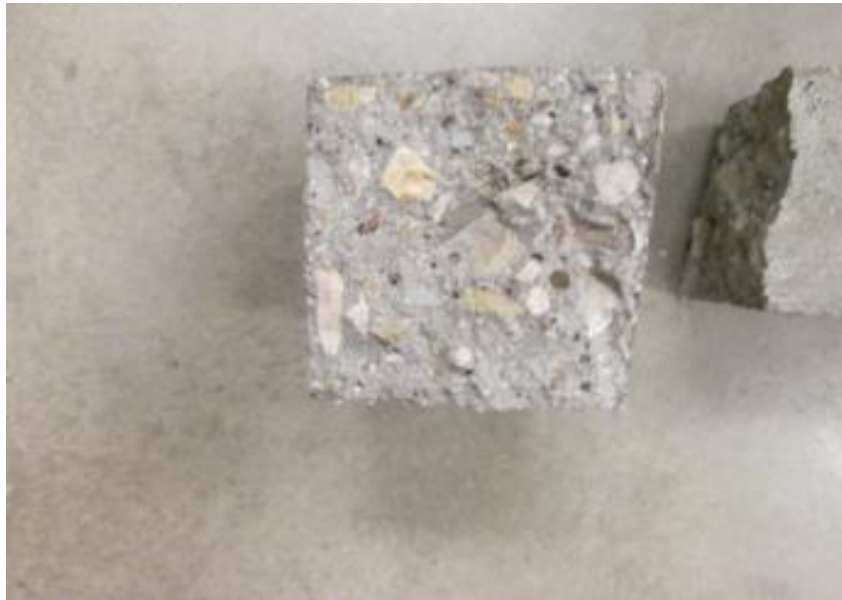
Figure 3.13. Unlined (control) beam after testing

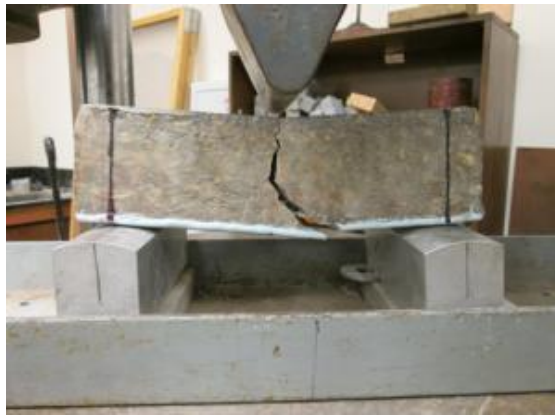
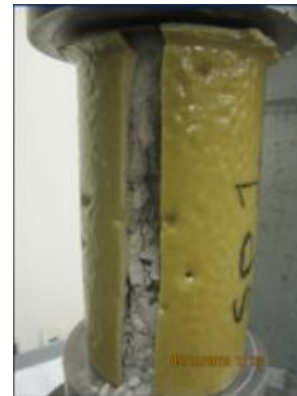
The following samples were tested in the preliminary tests. One epoxy lining materials (EPX1) one cured-in-place applied lining material (CIP), one polyurethane spray applied lining material (PU), one cementitious (CMT), and one multilayer polymer composite (MULT) for flexural strength and compressive strength. Five identical beam and cylinder specimens were lined by the manufacturer using their standard procedure (including surface preparation) and tested at CUIRE by three-point bending and compressive loading until failure.

Figure 3.14. Beam (a) and cylindrical (b) specimens at failure while loaded for flexural and compressive strength, respectively

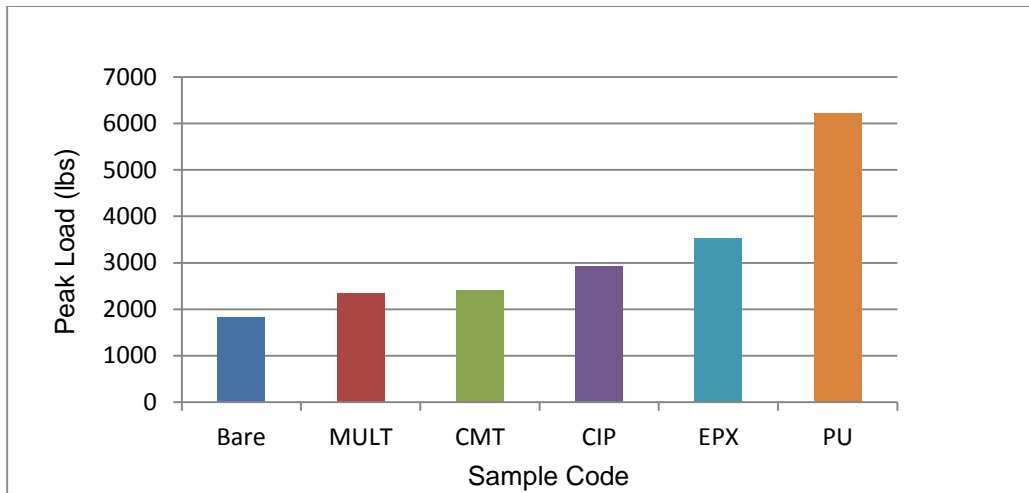
A summary of the preliminary flexural tests results is given in Figure 3.15. Additionally, basic statistical analyses for the flexural strength test results are indicated in Tables 3.5 through 3.11.

Figure 3.15. Ultimate flexural strength of unlined (bare) and lined specimens

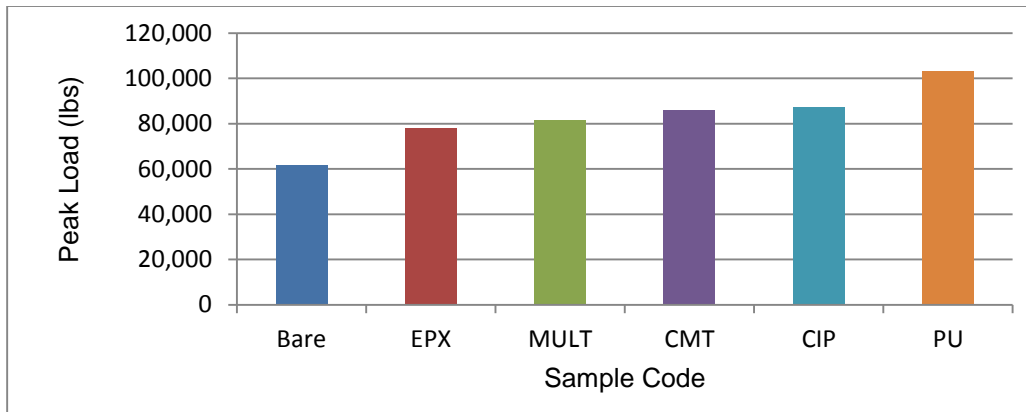
Figure 3.16. Ultimate compression strength of unlined (bare) and lined specimens

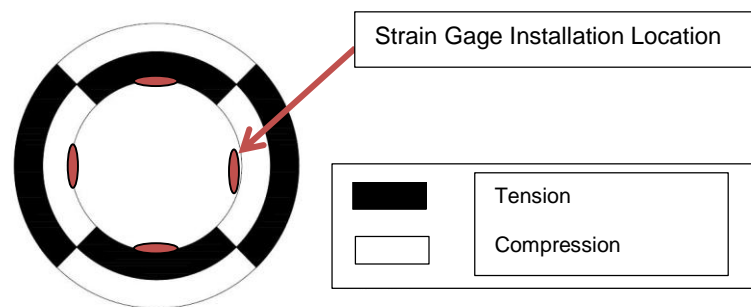
Figure 3.17. Stress/strain distribution along the pipe section loaded per ASTM C497 (D-Load) test and strain gages installation location

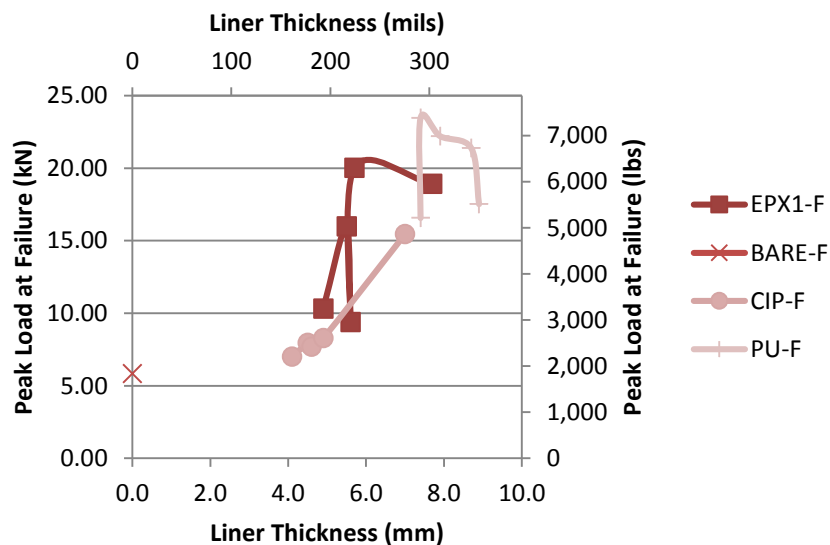
Vertical fracturing with a clear gap (up to 5 mm or 200 mils) was observed on the fifth CIP specimen at failure; whereas, the other four specimens failed with minor circumferential and vertical cracks in hairline patterns.

Figure 4.1. Peak load at failure (ultimate flexural strength) versus liner thickness based on the preliminary tests

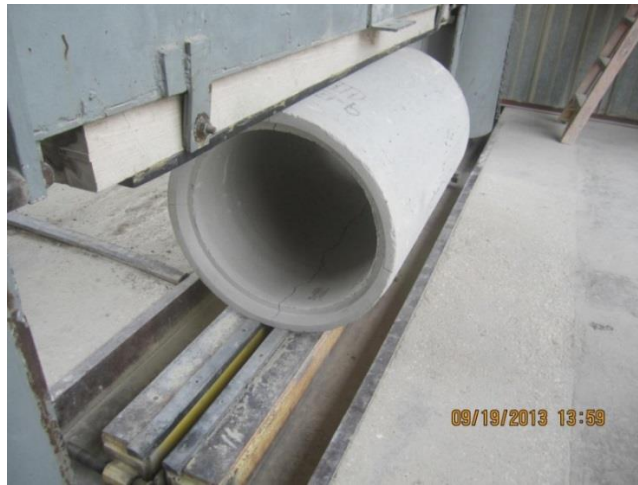
Figure 4.3. Three-edge-bearing test setup per ASTM C497

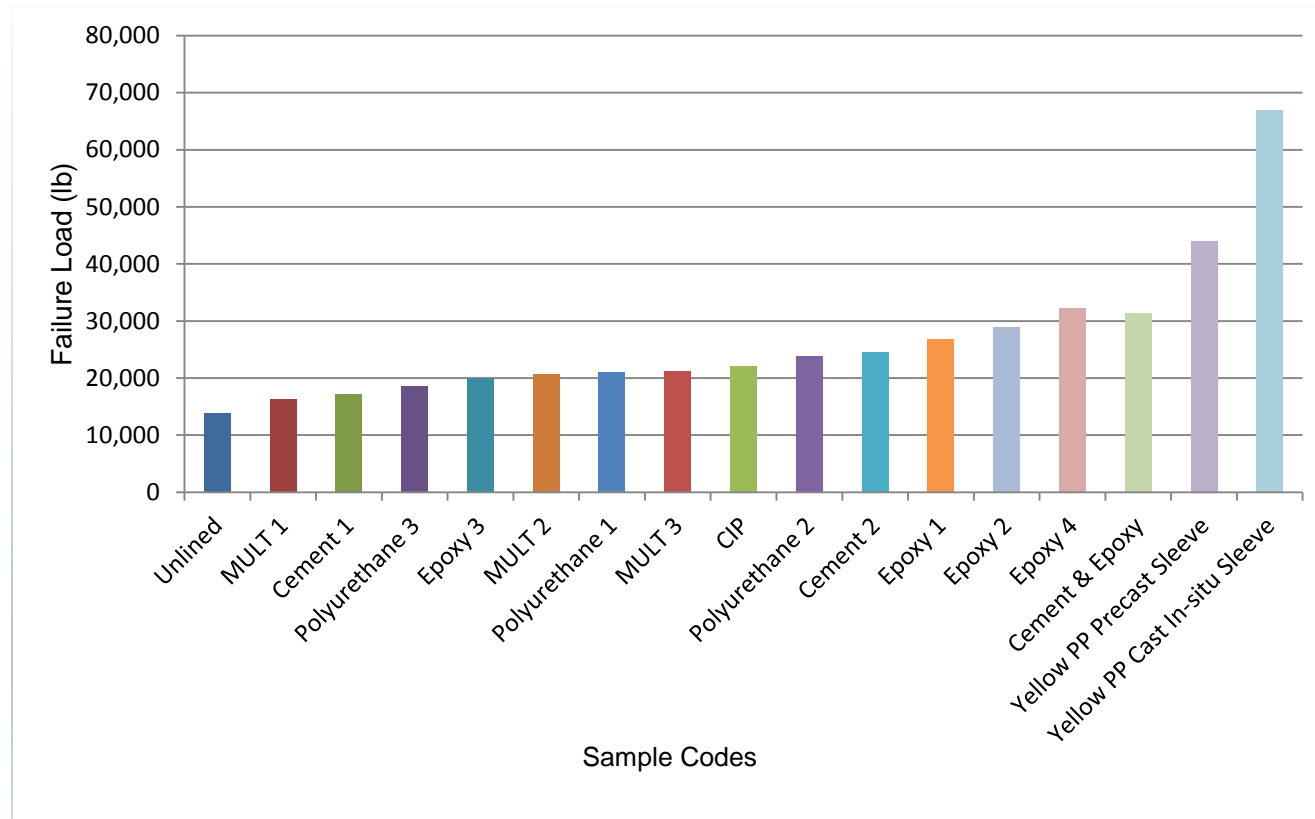
The results for main tests show significant increase in flexural and compression strength of concrete pipes. Figure 4.4 illustrates how the average peak load is increased as a result of applying lining materials on the inner surface of concrete pipes. Similar to the preliminary testing, thickness of the liner and the type of liner were among the key factors that affected the structural capabilities of concrete pipes. The other factors are quality of installation, substrate preparation, weather conditions (temperature, humidity, wind, etc.), and curing time.

The results of 250-mil thickness specimens for Epoxy, Polyurethane and Multi-Structural liners show that material property has a major impact on ultimate strength of manholes with epoxy having more impact than other two materials. Although thickness is a key factor in increasing the strength, it does not necessary mean that higher thickness of the liner will result in significant increase in the failure load. Test results of the samples with 125, 250 and 500 mils of polyurethane liner illustrated that liner thickness did not increase strength as expected when the liner thickness was increased from 250 to 500 mils.

Figure 4.4. Main test results

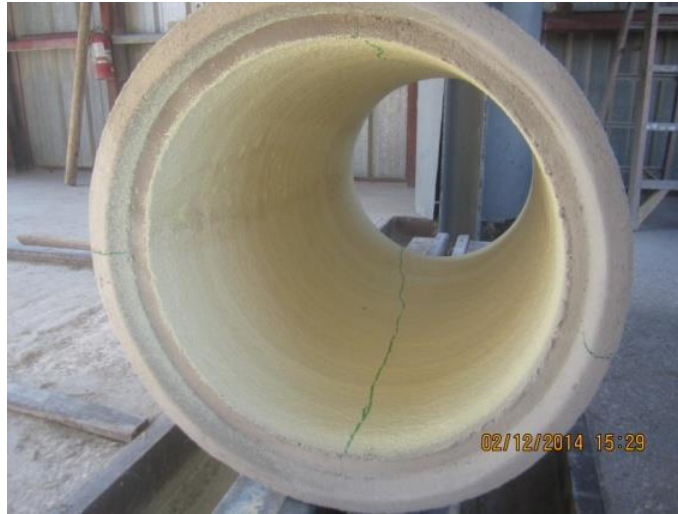
Figure 4.5. Example of simultaneous cracking in the concrete substrate and liner

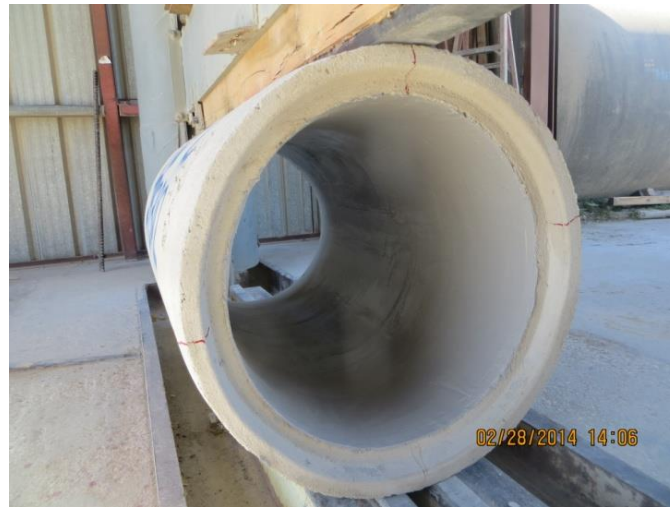
Figure 4.6. Example of failure by cracking in the concrete substrate only

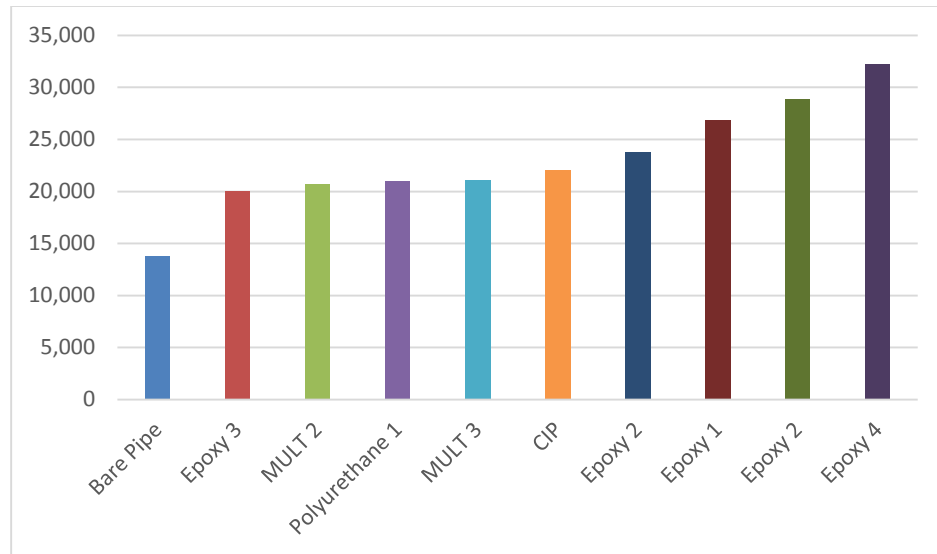
Figure 4.7. Main test results for specimens with a liner thickness smaller than 250 mils
with the bare pipe

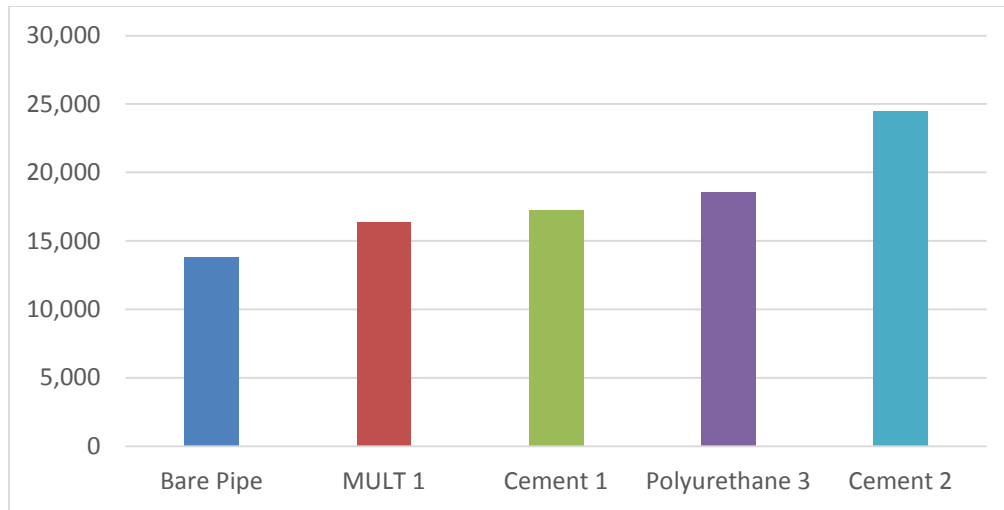
Figure 4.8. Main test results for specimens with liner thickness between 250 mils and 1000 mils with bare pipe

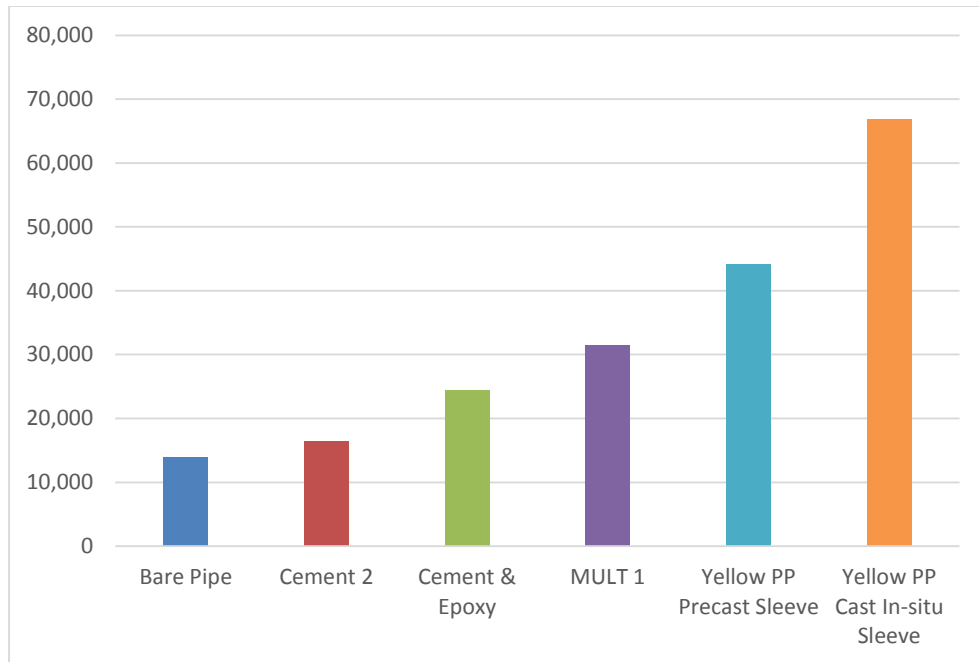
Figure 4.9. Main test results for specimens with liner thickness over 1000 mils with bare pipe

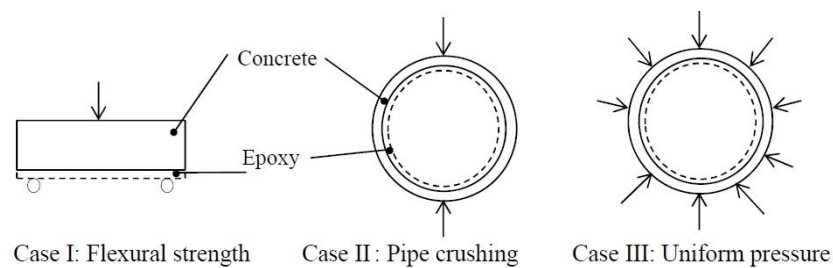
A multipurpose finite element software (ABAQUS) was used to study the structural capability of the epoxy liners. Simulations were performed on three cases: flexural beam test, pipe crushing test, and manhole structure under uniform soil and hydrostatic pressure (Figure 4.10). The experimental test results were used to calibrate the accuracy of the FEM.

Figure 4.10. Schematic diagram of three simulated cases

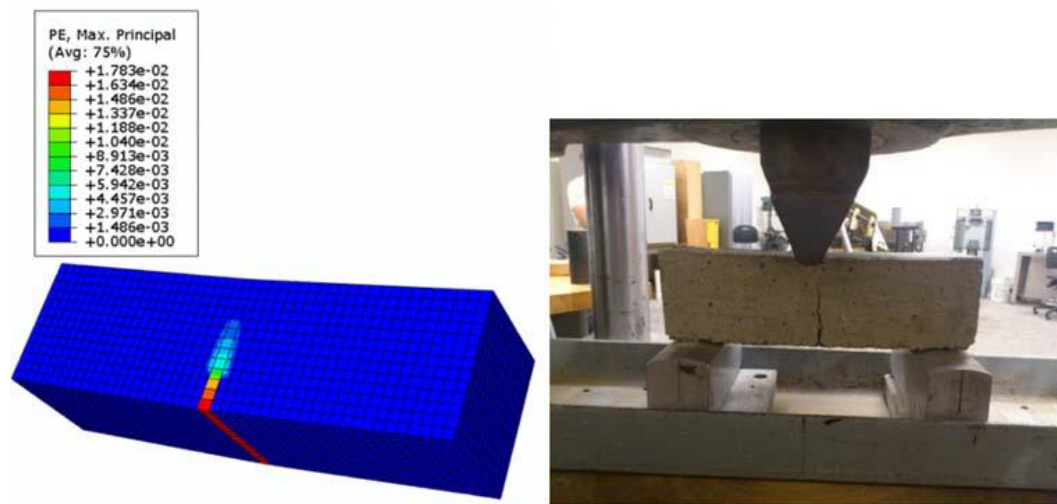
Figure 4.11. shows that the failure load obtained from simulation was 2,165 lb with a deflection of 0.0019 in. which is in good agreement with the average peak load from laboratory tests on bare concrete (1,834 lb). The failure load and deflection for lined specimen were 2,922 lb and 0.0051 in. respectively (Figure 4.12).

Figure 4.11. Crack propagation in the bare concrete beam

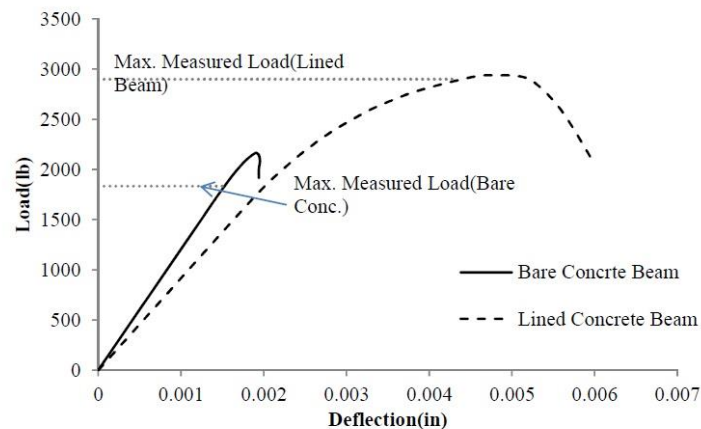
Figure 4.12. Load deflection curve from ABAQUS simulation for bare concrete

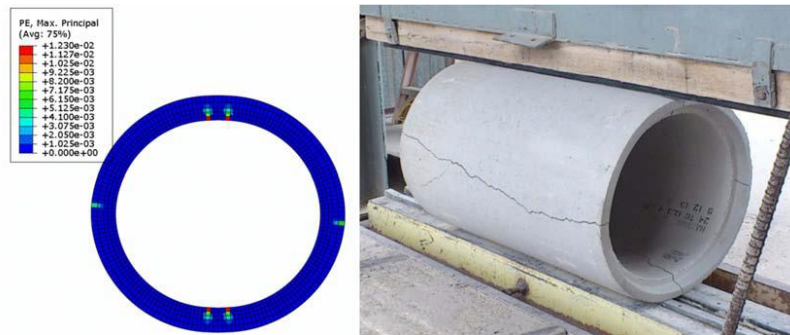
Figure 4.13. Crack propagation in bare concrete pipe

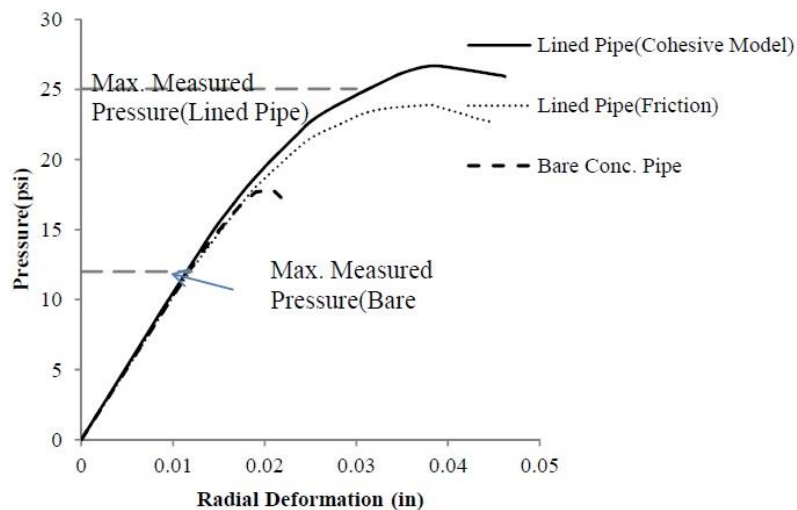
Figure 4.14. Pressure deformation curve of bare and lined concrete pipes

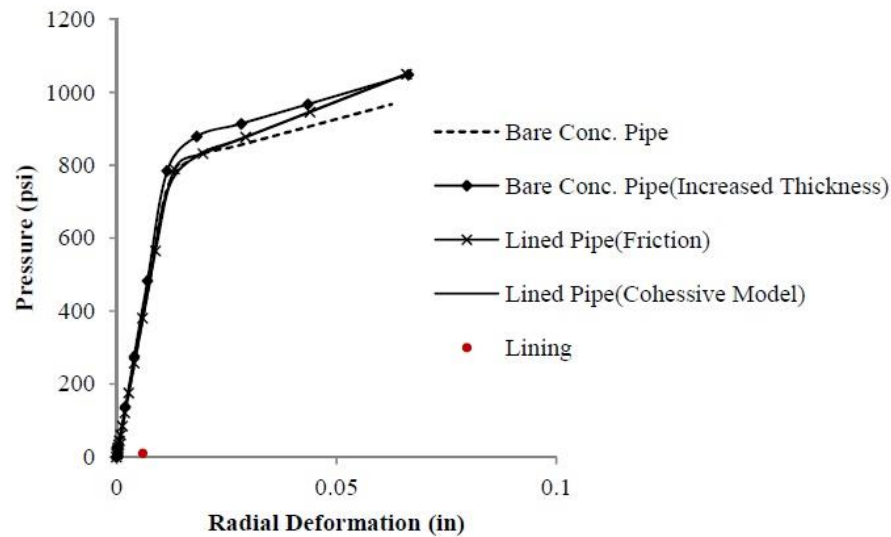
Figure 4.15 presents pressure-deformation curve obtained from the lined and unlined pipe simulations under uniform peripheral pressure. The pressure shown in the plot is the concrete radial stress at the outside boundary. The simulations were performed for four models: bare concrete pipe, lined concrete pipe with friction contact, lined pipe with cohesive contact, and bare concrete pipe with increased thickness equal to the total thickness of lined concrete pipe. The curves show that bare concrete with larger thickness can carry the largest pressure as expected. However, the pipe with lining does not show increase of the pressure.

Figure 4.4.15. Pressure deformation curve for bare and lined concrete pipes under uniform pressure
(Riahi, 2014)

Figure 4.15 illustrates that using epoxy liner with a cohesive interaction behavior increases the pressure capacity of the pipe.

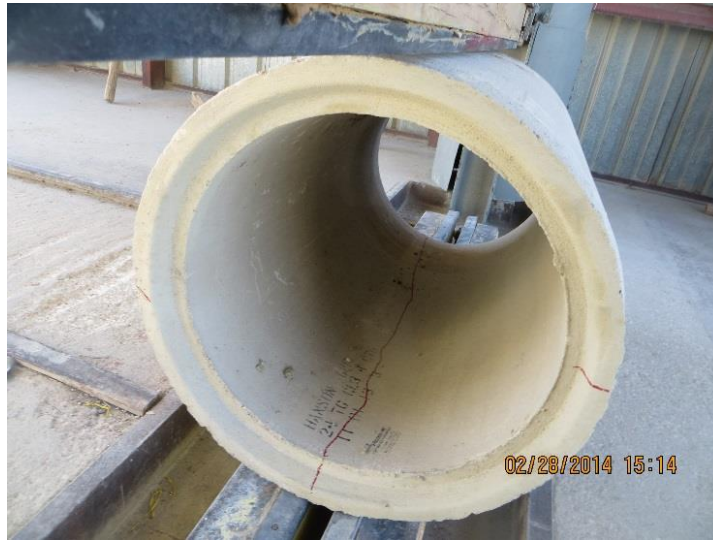
Bare Concrete Pipe at Failure

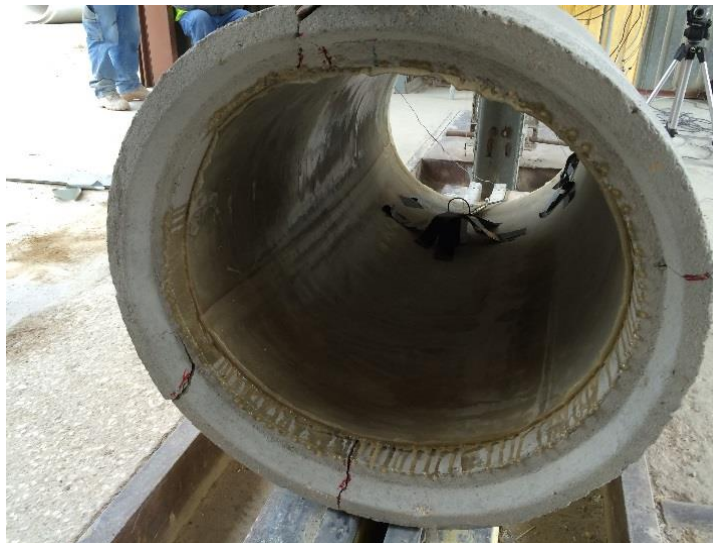
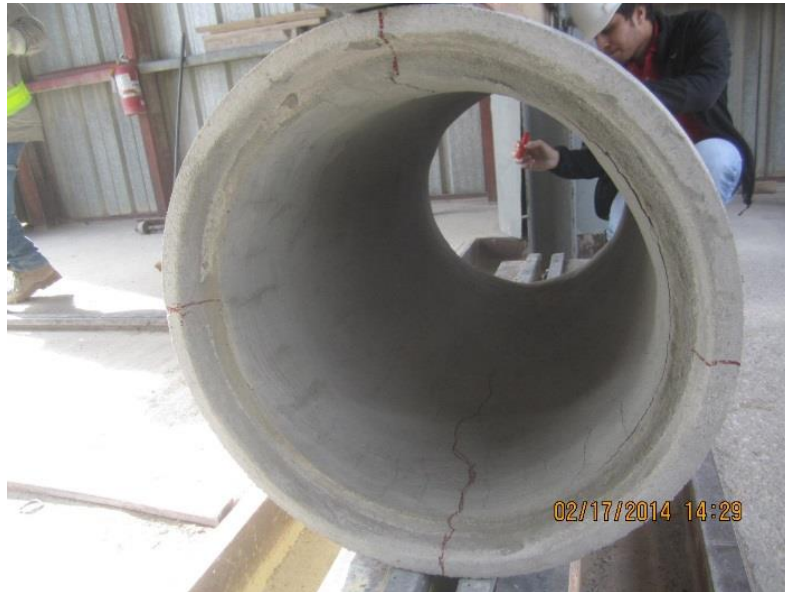
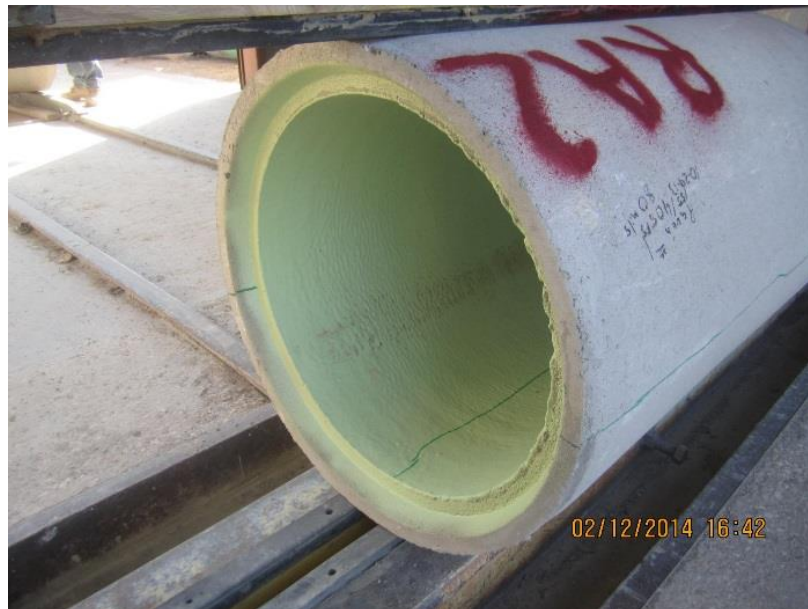
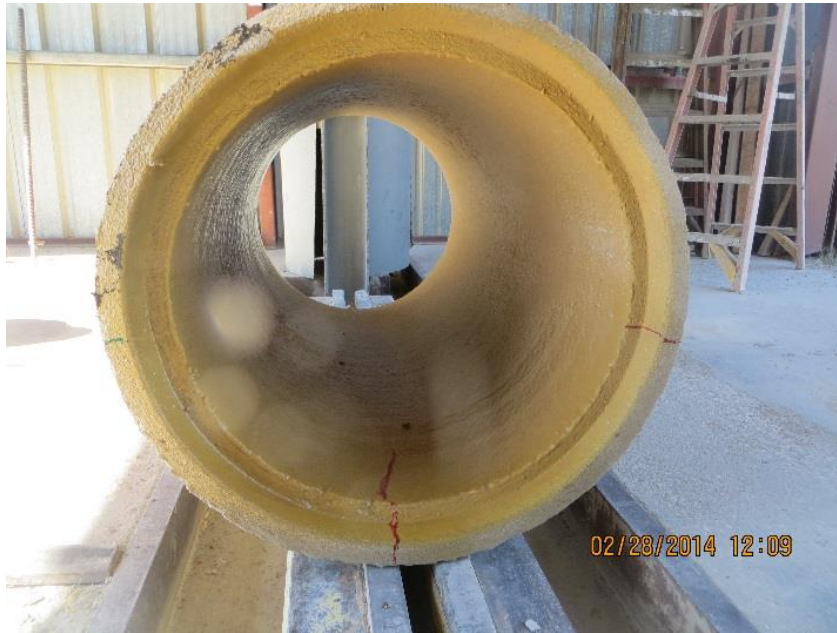
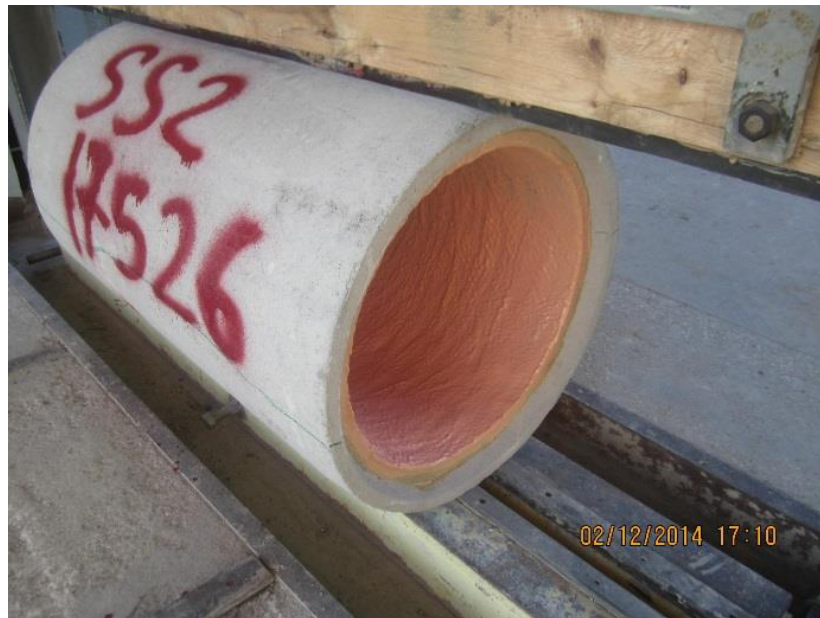
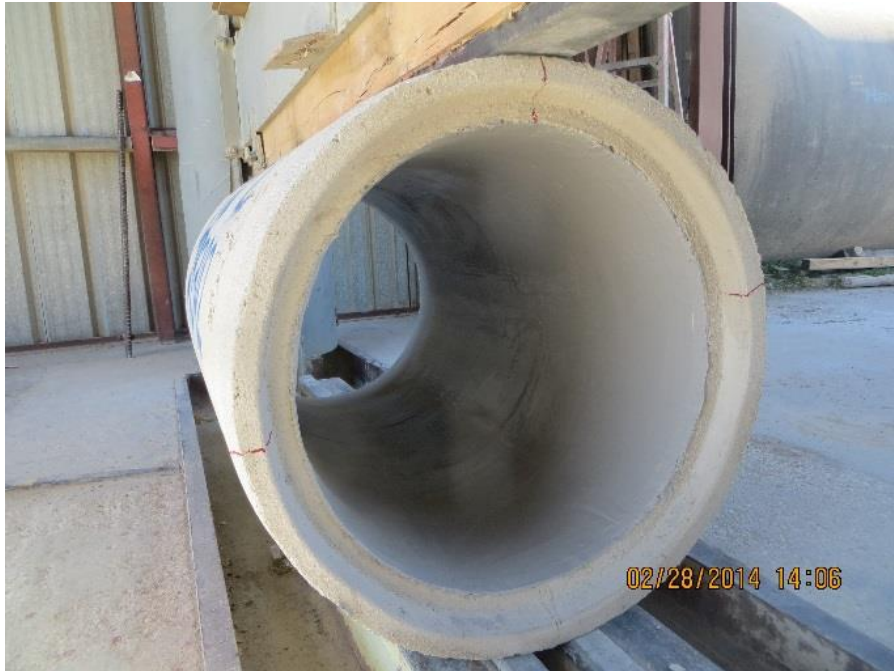
Lined Concrete Pipe at Failure
