STRENGTH OF HORIZONTAL SHEAR REINFORCEMENT WITH LIMITED
DEVELOPMENT

Presented to the Faculty of the Graduate School of
The University of Texas at Arlington in Partial Fulfillment
of the Requirements
for the Degree of

THE UNIVERSITY OF TEXAS AT ARLINGTON

MAY 2015

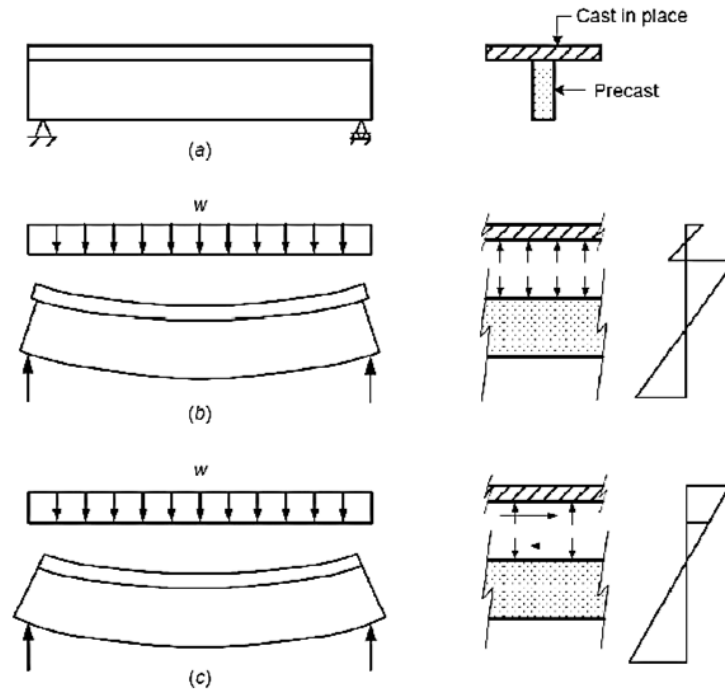
Figure 1-1 (a) Typical precast beam and CIP slab (b) Non-composite action. (c)

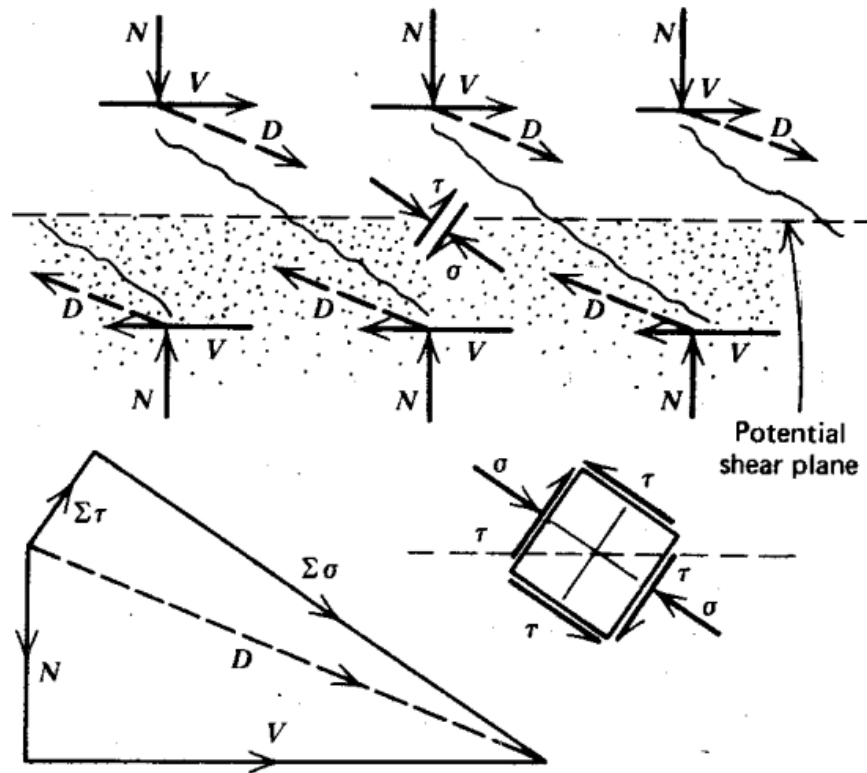
Diagonal principal stresses will be generated when shear is transferred along an un-cracked shear plane. This leads to short cracks less than or equal to 45° forming across the shear plane (Figure 2-2). Shear will be transferred by a truss mechanism if horizontal shear reinforcement is present.

Reinforcement and external compression provides the clamping force N . Failure occurs when the transverse steel yields permitting the concrete struts to rotate and the cracks to propagate at a flat angle that is almost parallel with the shear plane.

Figure 2-2 Interface shear mechanism along an un-cracked plane (Park and Paulay, 1975)

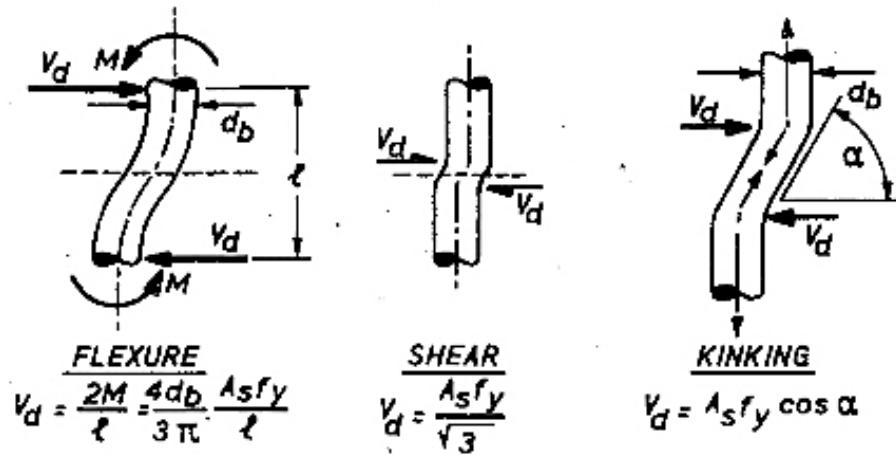
- The flexure of the reinforcing bar
- The shear strength across the bar
- Kinking of the bar

Figure 2-3 Dowel action along an interface (Park and Paulay, 1975)

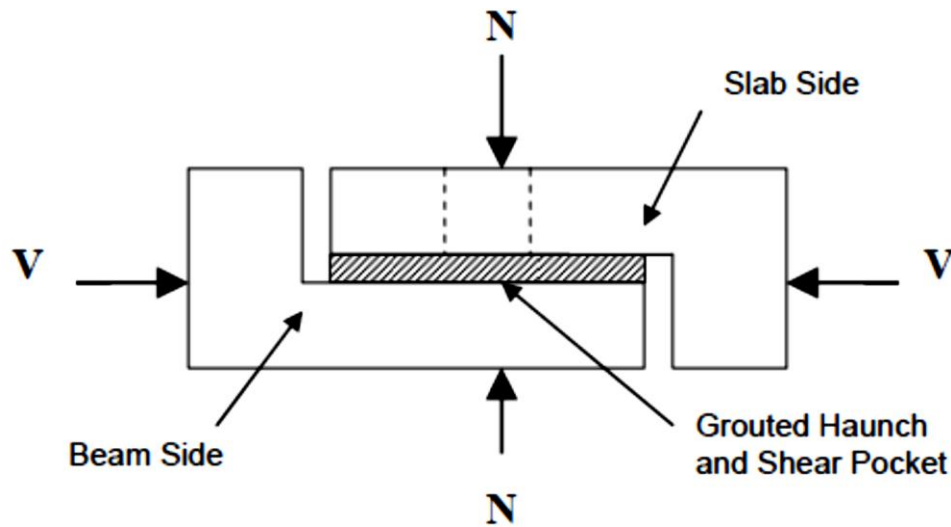
deck panel slab. The shear pocket and haunch were filled with the mortar. The specimen was then loaded directly along the center line of the haunch to failure (Figure 2-7). A small normal force (2.5 kips) was also provided to simulate the clamping stress resulting from the tributary weight of a deck panel per girder spacing as well as other dead loads.

Figure 2-7 Typical push-off specimen (Scholz, 2004)

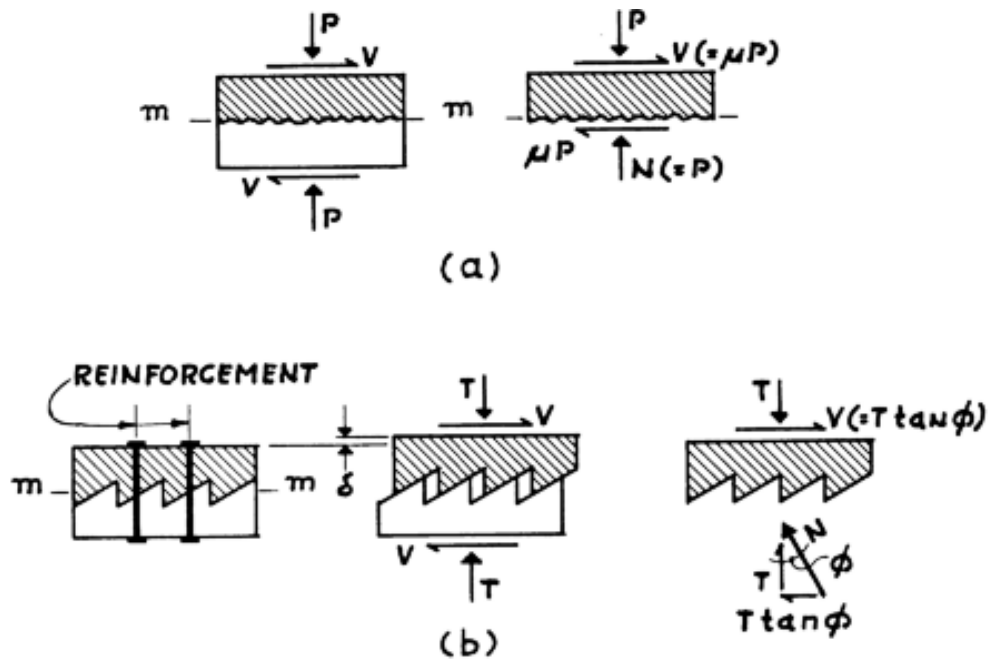
Birkeland and Birkeland (1966) postulated that a crack that forms in a monolithic concrete block along the failure plane will lead to slippage along the shear plane when an external shear load V is applied. The slippage is resisted by the friction μP resulting from the clamping force P . They also showed that the tension T due to reinforcement across the interface produced the equivalent of the external clamping force P (Figure 2-11).

Figure 2-11 Shear friction hypothesis (Birkeland and Birkeland, 1966)

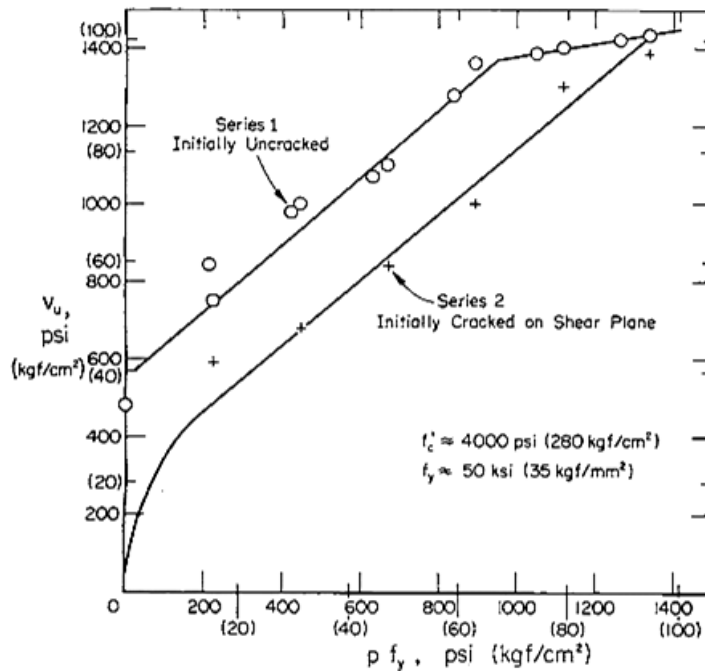
reinforcement yield strength were investigated by testing thirty-eight push-off specimens. The researchers concluded that a pre-existing crack along the shear plane reduced the ultimate shear transfer and increased the horizontal slip. A 250 psi reduction in the shear strength was expected for a 4000 psi normal weight concrete with clamping stresses between 200 psi and 1000 psi. The reduction was higher for lower values of clamping stress. For clamping stresses above 1000 psi, there is a very slow rate of increase in the interface shear strength of initially un-cracked specimens with an increase in clamping stress, while the strength of the initially cracked specimens continued to increase at the same rate as for lower clamping stresses. Consequently, the horizontal shear strength for cracked and un-cracked interface was approximately equal for a clamping stress of 1,340 psi as shown in Figure 2-12.

Figure 2-12 Push-off test results (Hofbeck et al., 1969)

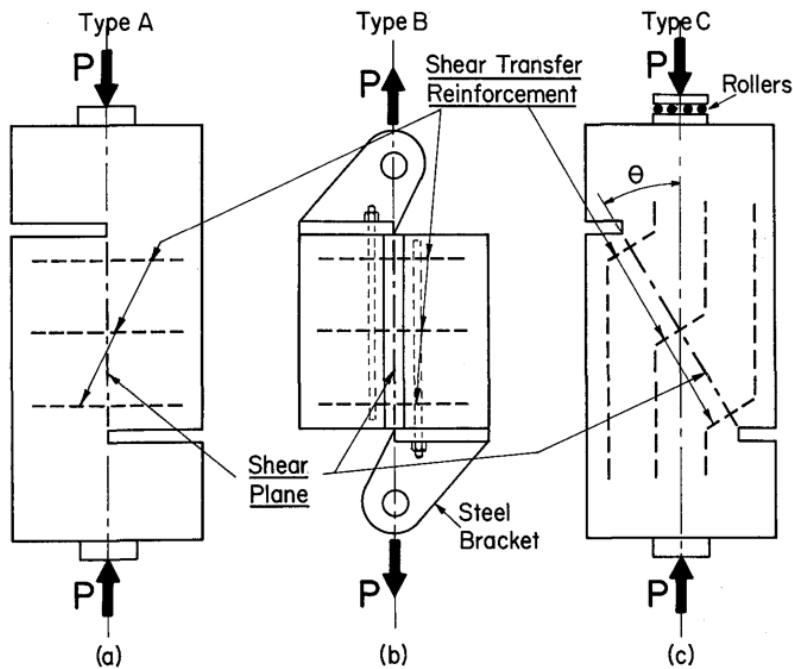
Figure 2-13 (a) push-off; (b) pull-off; and (c) modified push-off specimens
(Mattock, 1969)

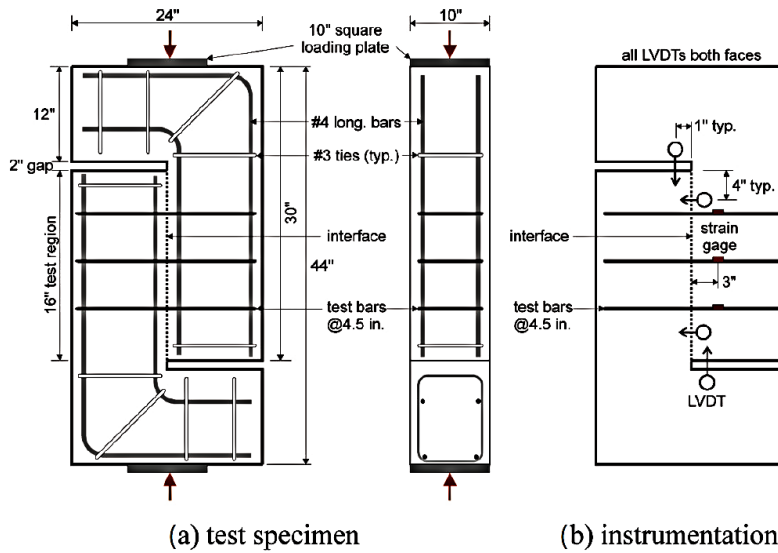
Figure 2-14 Typical push-off specimen (Kent et al., 2012)

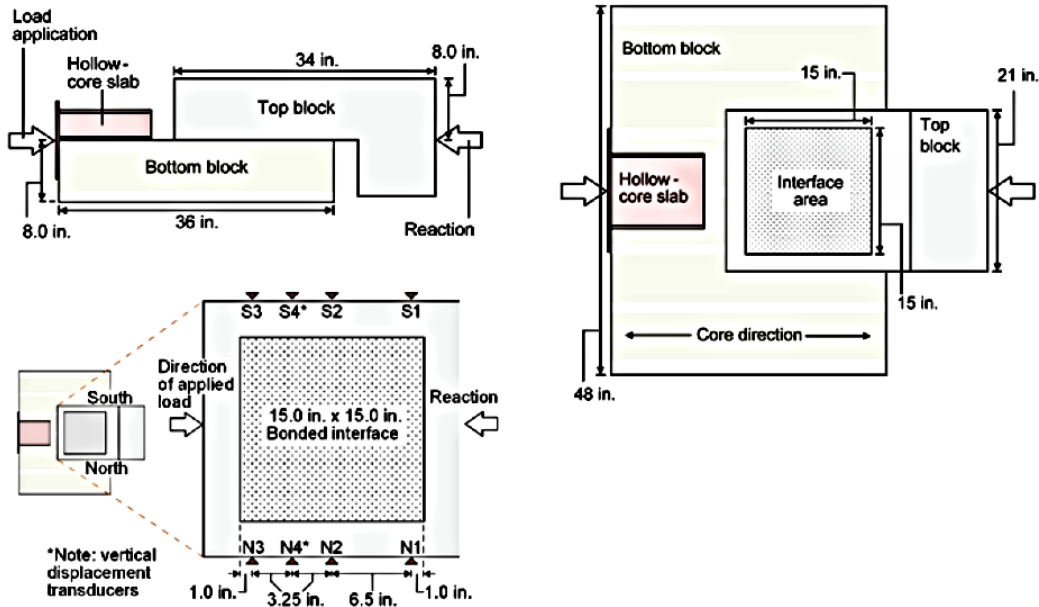
Figure 2-15 Typical push-off specimen and instrumentation (Mones and Brena, 2013)

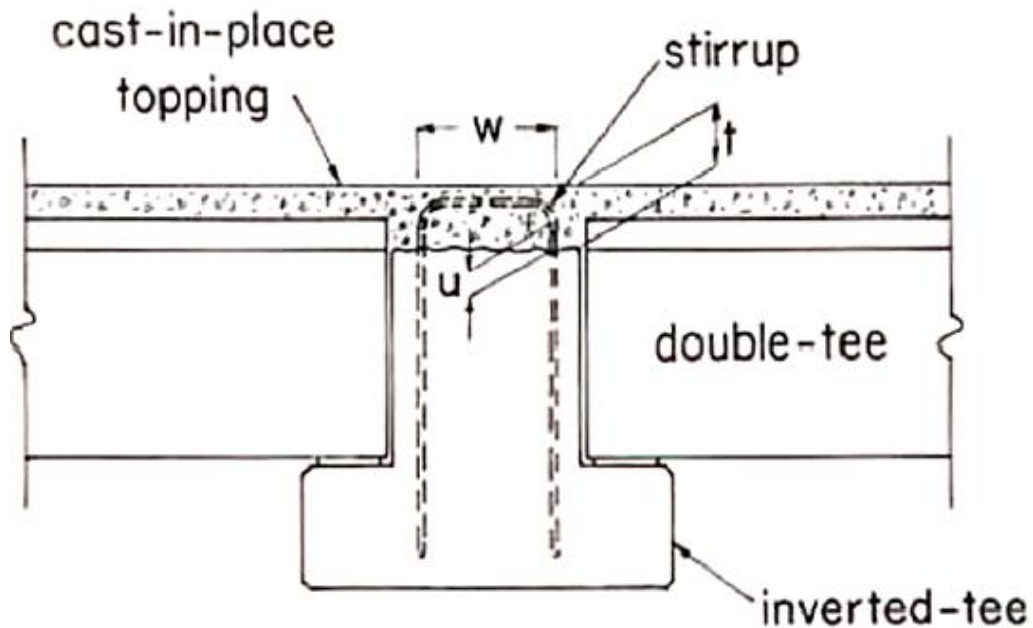
Figure 2-18 Typical test specimen (Mattock, 1987)

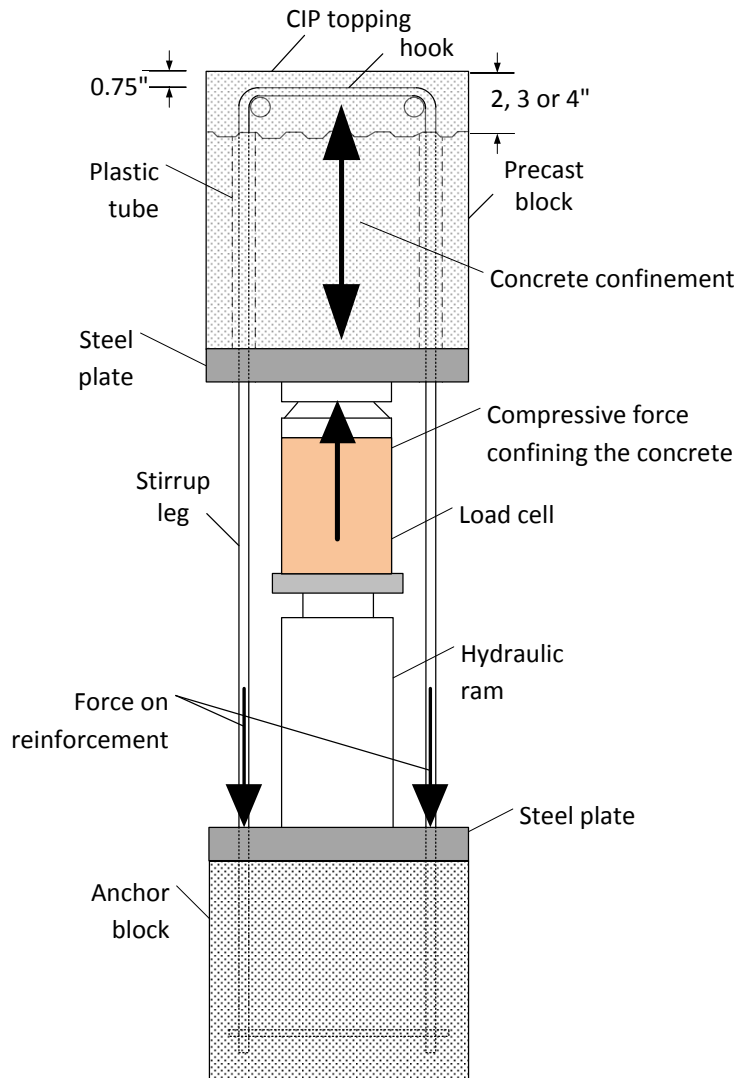
It is shown that No. 3, No. 4, and No. 5 bar stirrups can be anchored in 3-in., 3.5-in., and 4-in. thick, normal weight concrete toppings, respectively. For design purposes, he suggested that either standard 90° hooks or closed loop anchorages of overall width w (see Figure 2-18), at least 9-in. This is 2.6 and 1.5 times the widths of the interface reinforcement used in the TxDOT box (before 2012) and slab beams, respectively. The embedded length of the No. 4 reinforcement in a 3.5-in. thick topping in his study was 2.75-in., which is close to the one used in current TxDOT practice (2-in.). However, Mattock's set-up is not representative of what occurs in real bridges. It provides concrete confinement due to the compressive force applied by the hydraulic ram which delays the concrete from cracking (Figure 2-19).

Figure 2-19 Test set-up used by Mattock (1987)

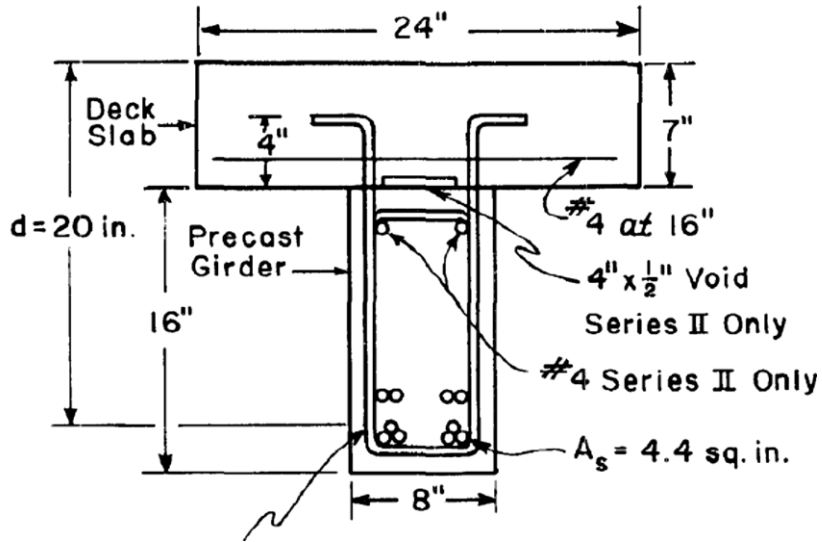
Figure 2-20 Cross section of beams (Hanson, 1960)

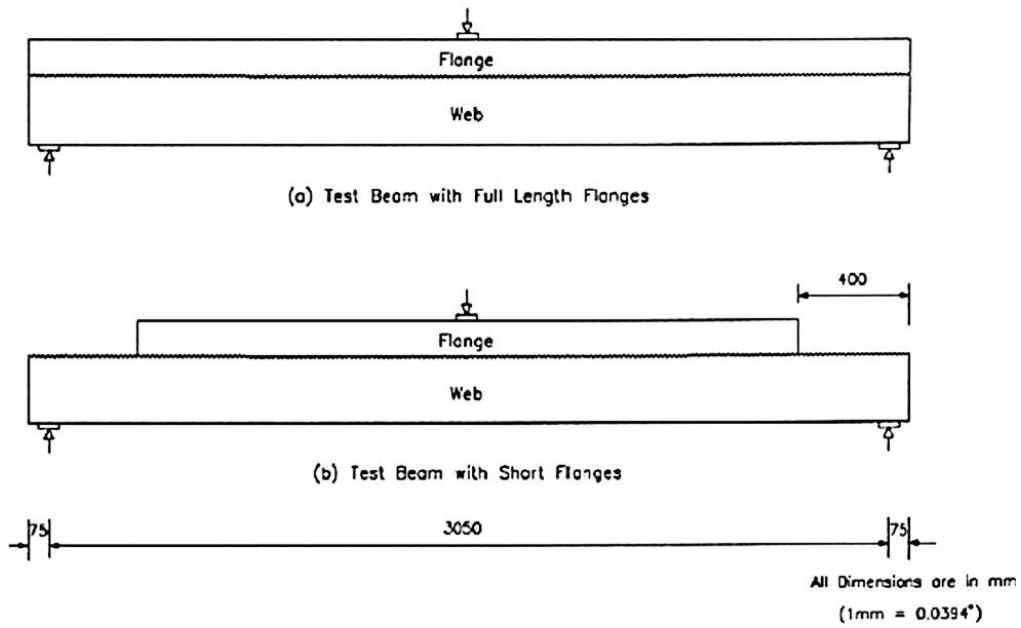
Figure 2-22 Typical test beams (Loov and Patnaik, 1994)

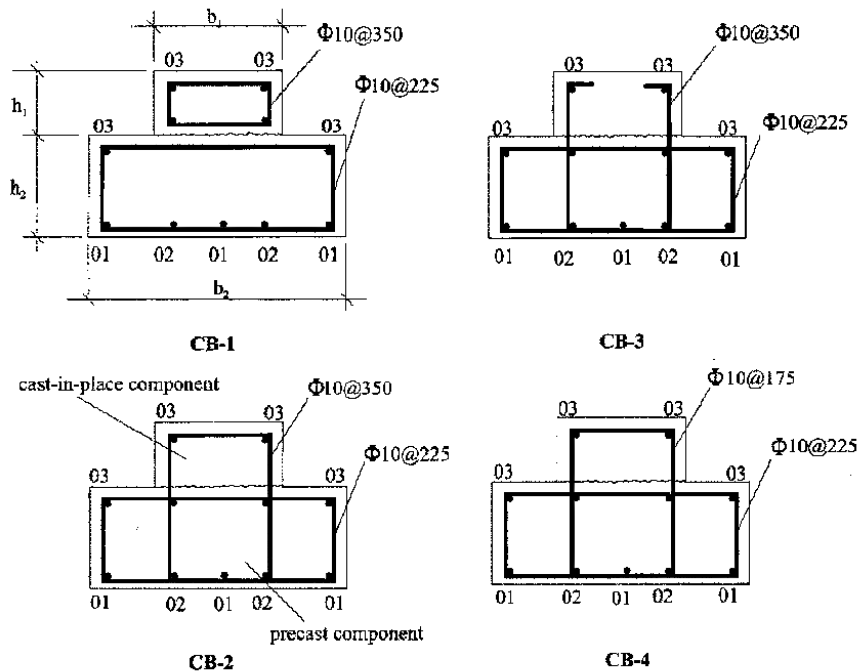
Tan et al. (1999) conducted tests on four composite beams loaded in indirect two-point load to ascertain their horizontal shear strength. Two shapes of ties were used; open and closed ties (Figure 2-25).

Figure 2-25 Test specimens (Tan et al., 1999)

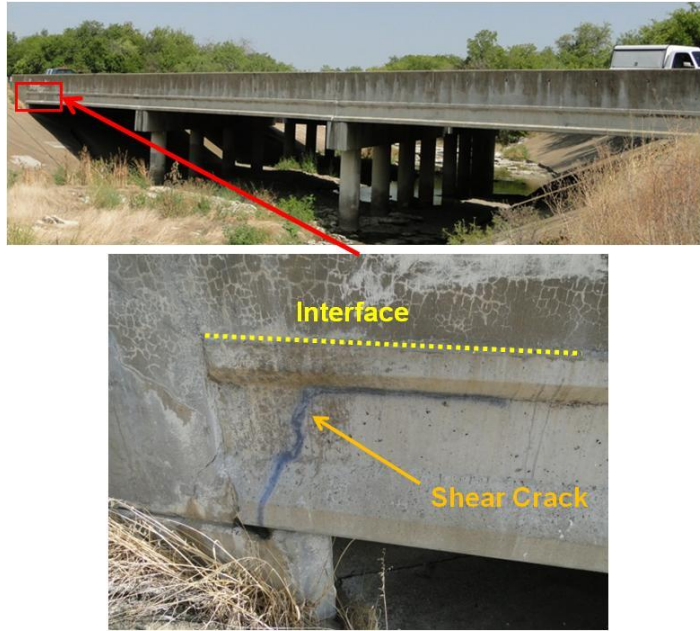
It was observed on arrival that this bridge did not have any interface shear damage; however other forms of damage were seen. A number of shear cracks and crushing was observed at the ends of the girders. Figure 3-4 shows an example of some of the observed shear cracks. Horizontal shear cracks were present on the girders but did not extend into the deck interface.

Figure 3-4 Shear cracks observed at the South-West end of the Long Ave. Bridge

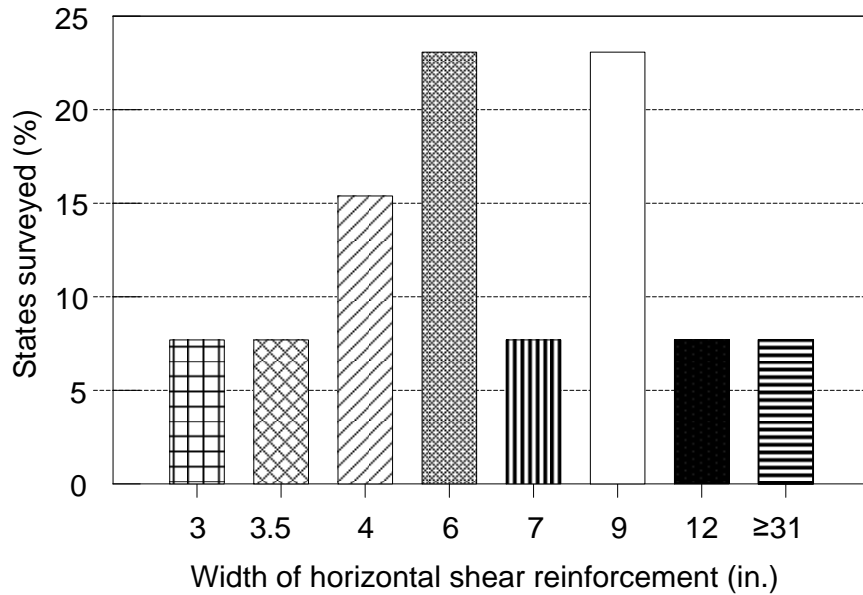
In this survey, the width of the horizontal shear reinforcement was investigated for both the slab and box beam. Although some states had this information specified in their standard drawings, some states did not because they use an asphaltic concrete overlay as the wearing surface. Although Illinois DOT provides a 5-in. concrete wearing surface on deck beams, it is non-composite and just serves as a plate to help reduce reflective shear key cracking and improve rideability hence no interface shear reinforcement is provided. Connecticut DOT previously used a water proof membrane on top of the precast beams with a minimal of 3.5-in. bituminous overlay. However, 20 years later, they began to experience some pre-mature failures due to the failure of the waterproof membrane. They have more recently started using cast-in-place slab but have no standard details available yet. Idaho DOT does not provide details and drawings for the box beams. On further inquiry I was informed that the girder stirrups are designed to project into the concrete decks although no details are provided. The width of the horizontal shear reinforcement was seen to span the full width of the beam for Maryland and Michigan DOT. Widths of 6-in. and 9-in. were found to be the most common as shown in Figure 3-22.

Figure 3-22 Width of horizontal shear reinforcement

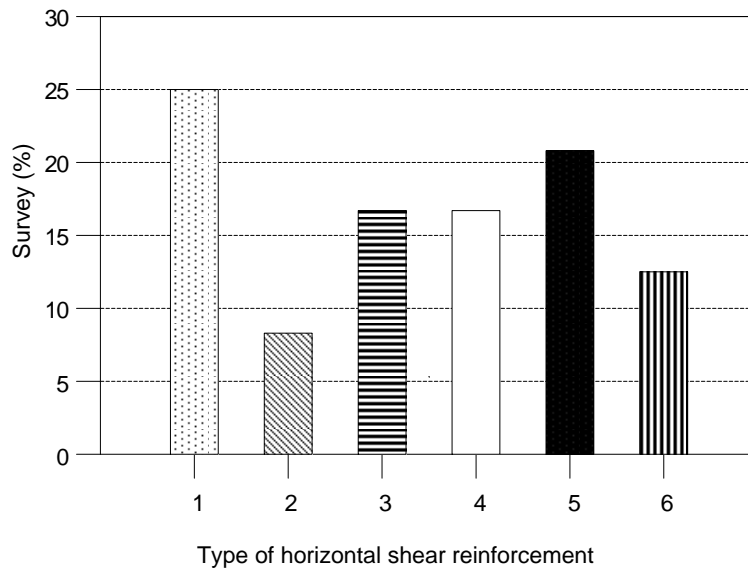
It was observed that there are essentially six types of horizontal shear reinforcement (Figure 3-25 and Table 3-1) being used in different states. Type 6 beams correspond to a case in which the horizontal shear reinforcement is placed perpendicular to the cross sections observed in Maine, Massachusetts and Rhode Island DOT.

Figure 3-24 Type of horizontal shear reinforcement

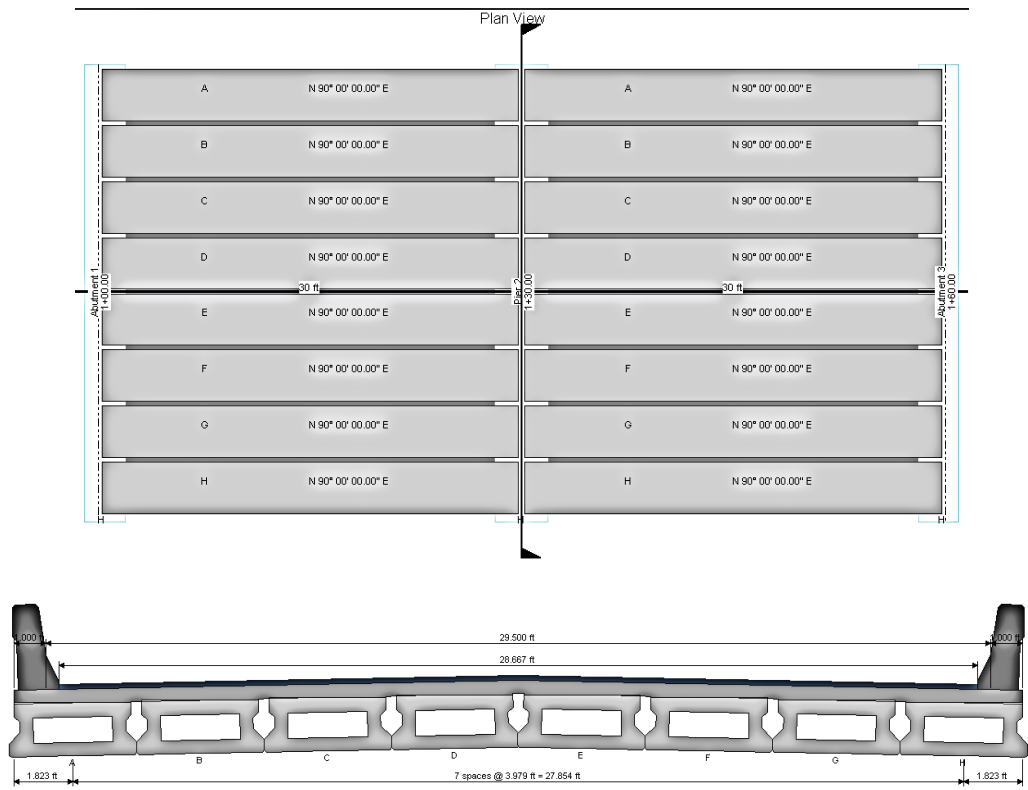
PGSuper Bridge Engineering Software was used to design the box and the slab beams for Task 6. A 30 ft. long composite beam was selected for both the slab and box beams due to the lifting capacity of the crane in UT Arlington CELB. The beam selected was one that did not exceed the crane capacity of 15 tons.

Figure 4-9 PGSuper model

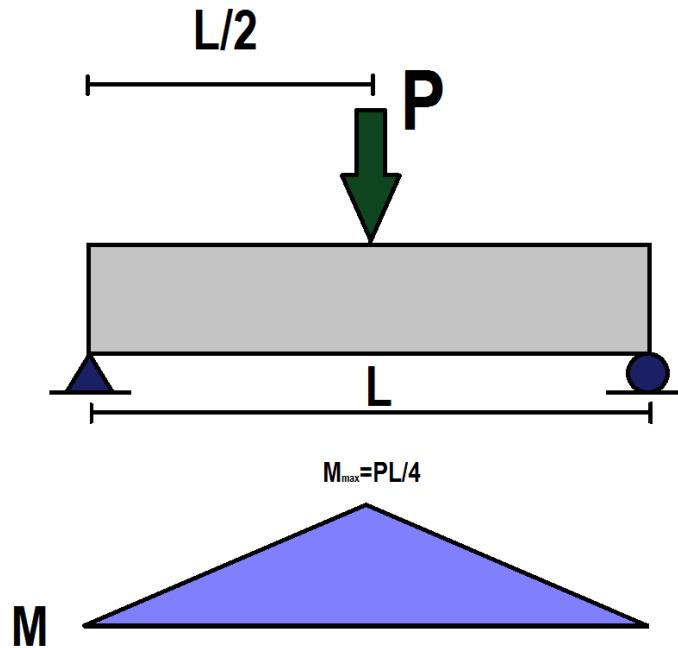
Figure 4-12 the expected failure load was calculated to be 81 kips and 160 kips for typical TxDOT slab beams and box beam respectively.

Figure 4-12 Moment Diagram of Simply Supported Beam with Point Load at Mid-span

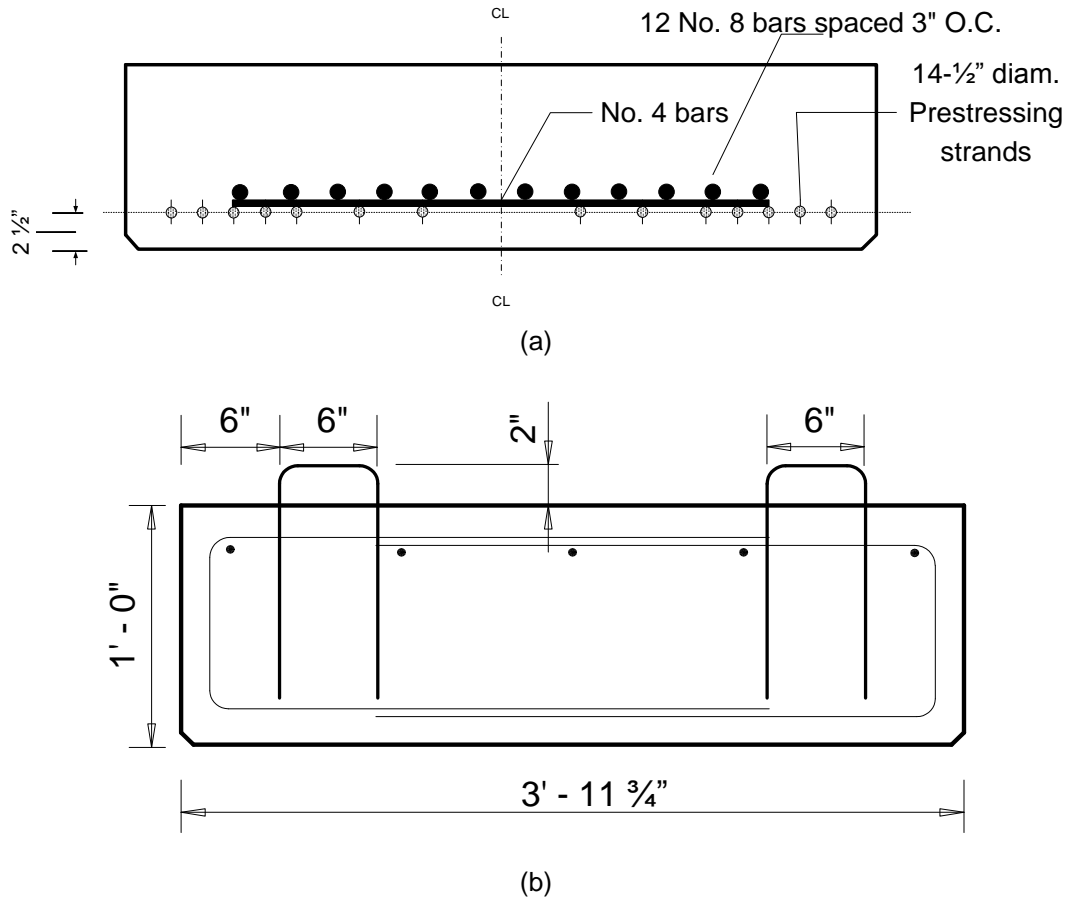
Figure 4-16 4SB12 section with (a) tension reinforcements and (b) horizontal shear reinforcements

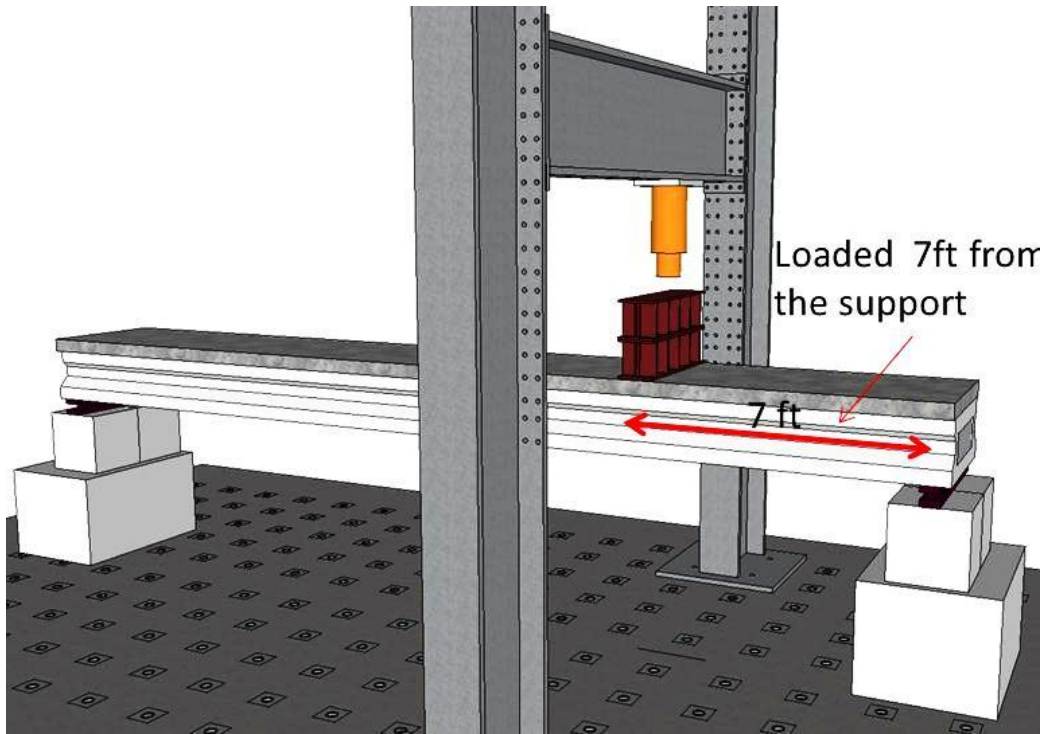
Figure 4-19 Box beam test set-up

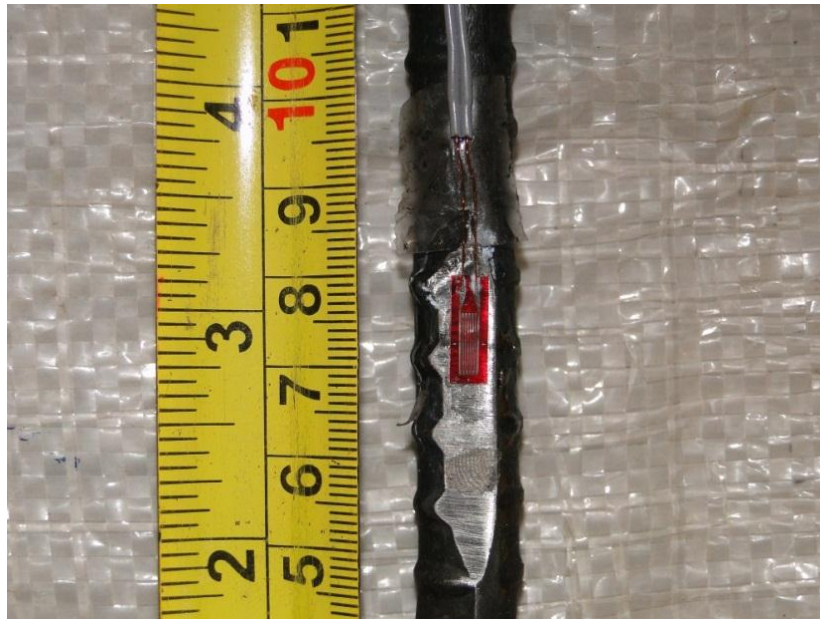
Strain gauges were mounted on the bars within 1-in. from the embedded length above the concrete to measure the strains in the bar.

Figure 4-31 Mounted strain gauge

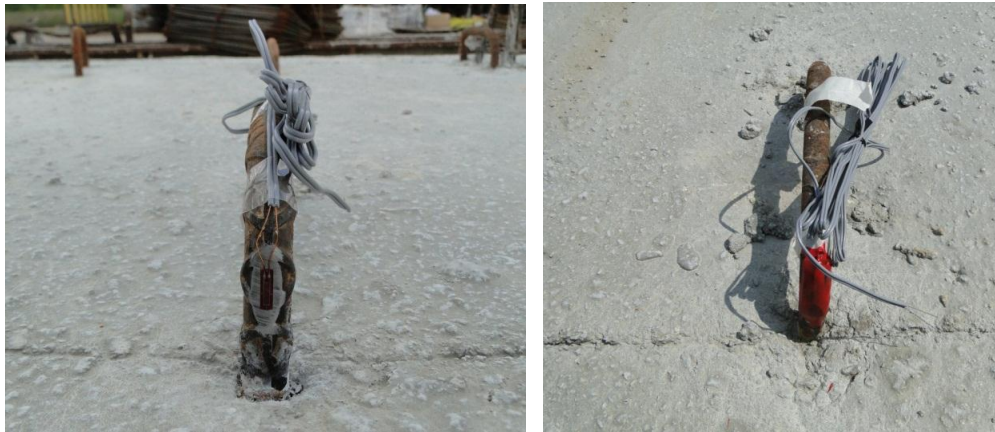
Strain gauges were installed on the horizontal shear reinforcement prior casting of the CIP slab (Figure 4-90).

Figure 4-90 Strain gauges installation on horizontal shear reinforcements

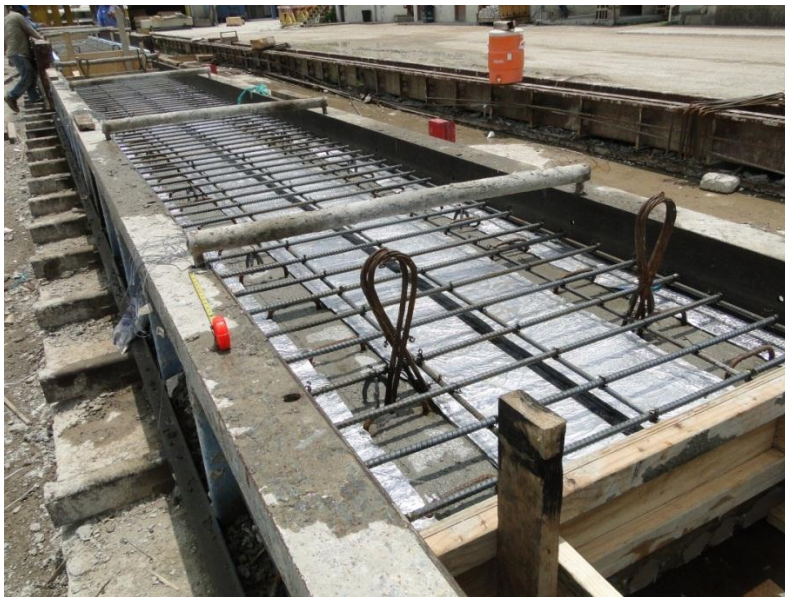
The foam tape was then placed on the surface of the beams to reduce the interface area. The interface area of the slab beam was reduced from 47.75-in. to 12-in. (Figure 4-93), and the interface area for the box beam was reduced from 43.75-in. to 14-in. (Figure 4-94). The foam tape was placed in two layers to guarantee that no tear will occur during casting of the CIP slab.

Figure 4-93 Foam tape on the slab beams

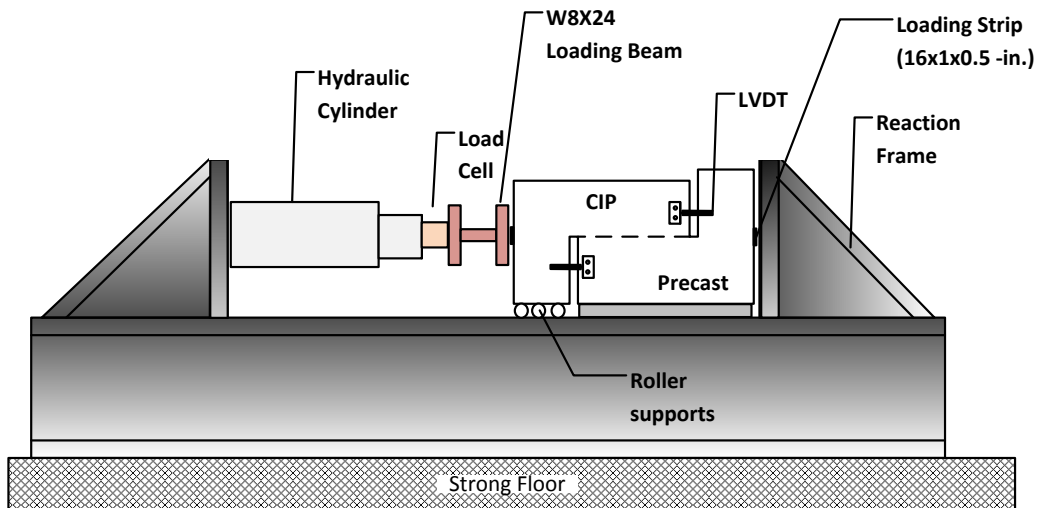
The test set-up for the horizontal push-off test is shown in Figure 4-99. It consisted of a hydraulic cylinder that applies the horizontal force on the interface, a load cell to record the load being applied, and a W8x24 loading beam. A 14x1x0.5-in. steel strip was used to transfer the compression load to the specimen. The specimen was instrumented with two LVDTs placed on both the CIP and precast parts to measure the slip at the notch during testing. For specimens that had a 4-in. shear reinforcement embedded length, a vertical LVDT was placed to measure the crack opening at the interface.

Figure 4-98 Schematic view of test set-up

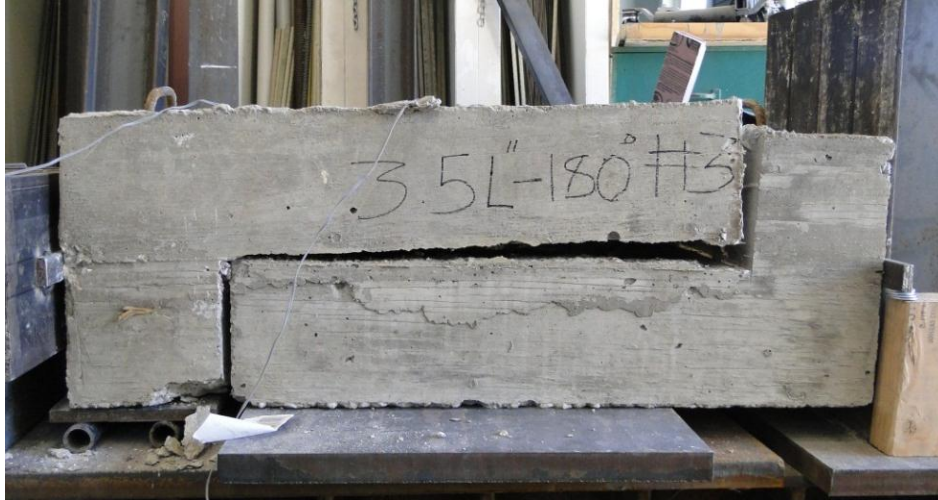
Figure 5-1 shows the typical failure mode observed for Task 4 specimens with a 2-in. embedment length. Individual specimen failure can be found in Appendix E. Results from specimens having horizontal shear reinforcement with a width of 3.5-in. placed in both the longitudinal and transverse location (used by Maine DOT, Rhode Island DOT and Massachusetts DOT), showed no significant change in the failure load. The bars did not yield and the main mechanism of failure was by bar pullout (Figure 5-2). These results are consistent with the results from bar pullout tests, which indicated that the short embedded length (2-in.) could not provide sufficient bond to allow bars to yield before pullout. A bar stress less than 24 ksi was recorded for these specimens.

Figure 5-1 Typical failure mode of push-off specimen failure with a 2-in. embedment; bar pulled out from the CIP slab

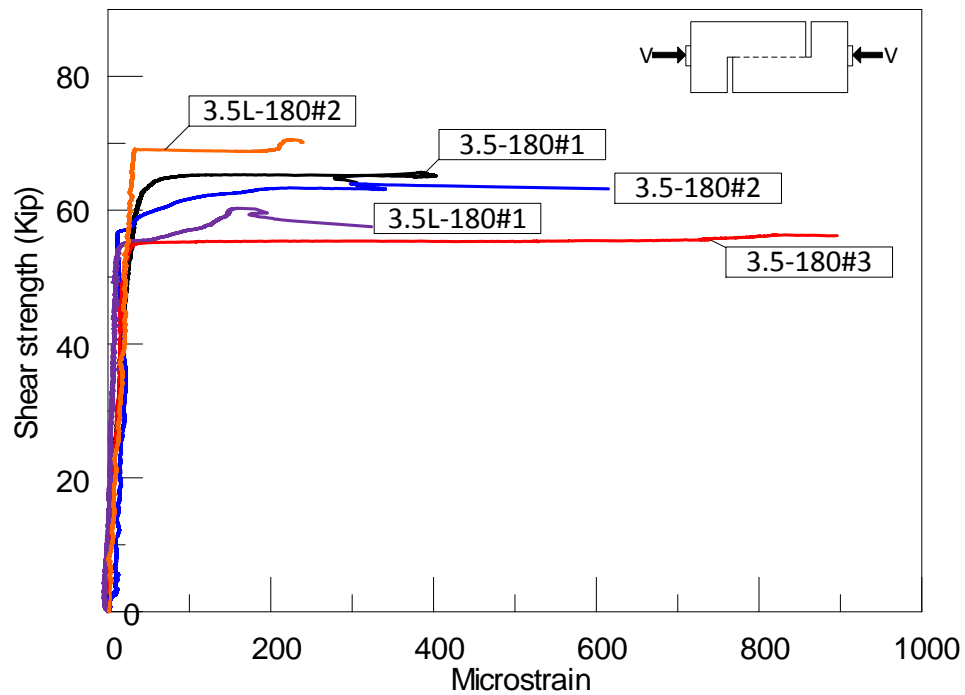
Figure 5-3 Shear strength vs strain plot of 3.5-in. push-off specimens

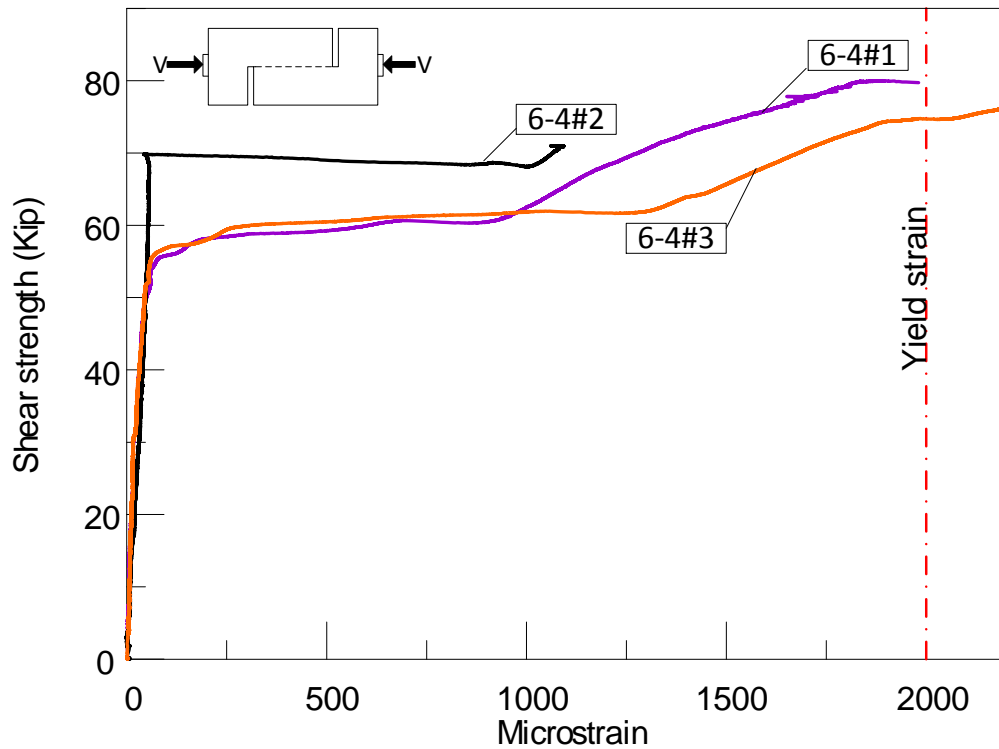
Figure 5-4 Shear strength vs strain plot of 6-in. width horizontal shear reinforcement with 4-in. embedded length push-off specimens

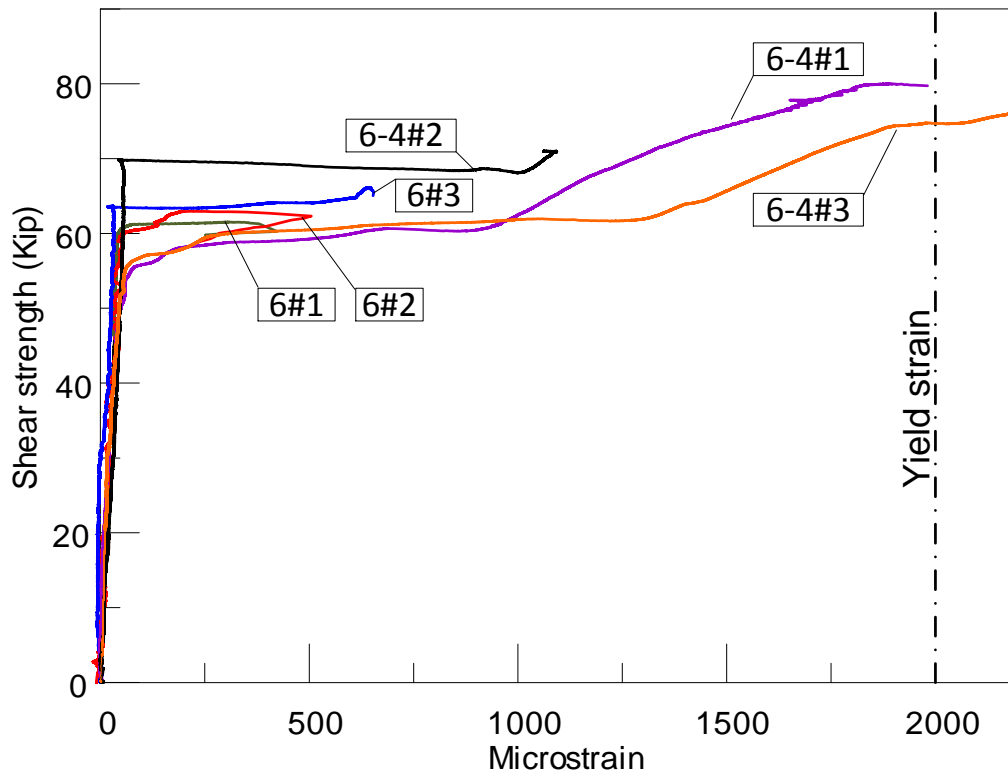
Figure 5-5 Shear strength vs strain plot of 6-in. width horizontal shear reinforcement with 2-in. and 4-in. embedded length push-off specimens

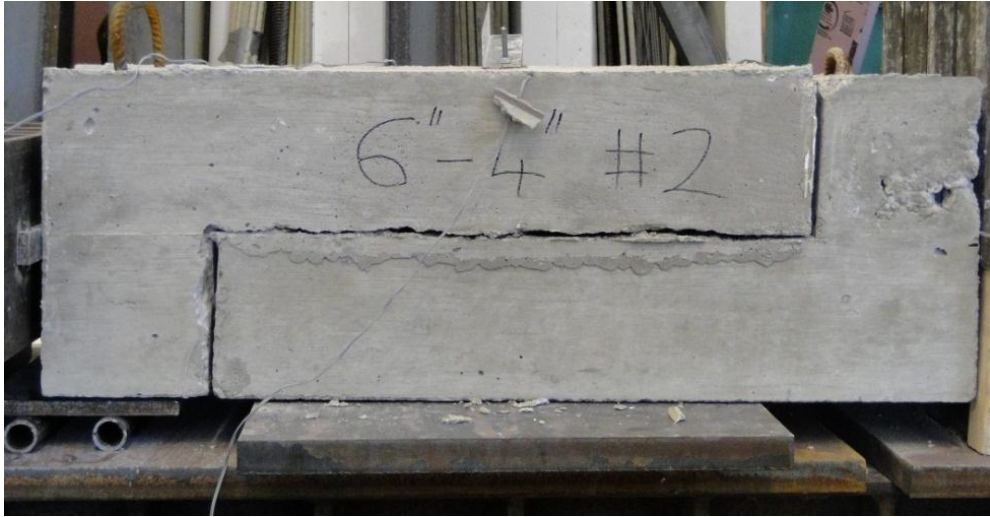
Figure 5-6 Typical failure mode of push-off specimen failure with a 4-in. embedment; no pullout of the bar was observed

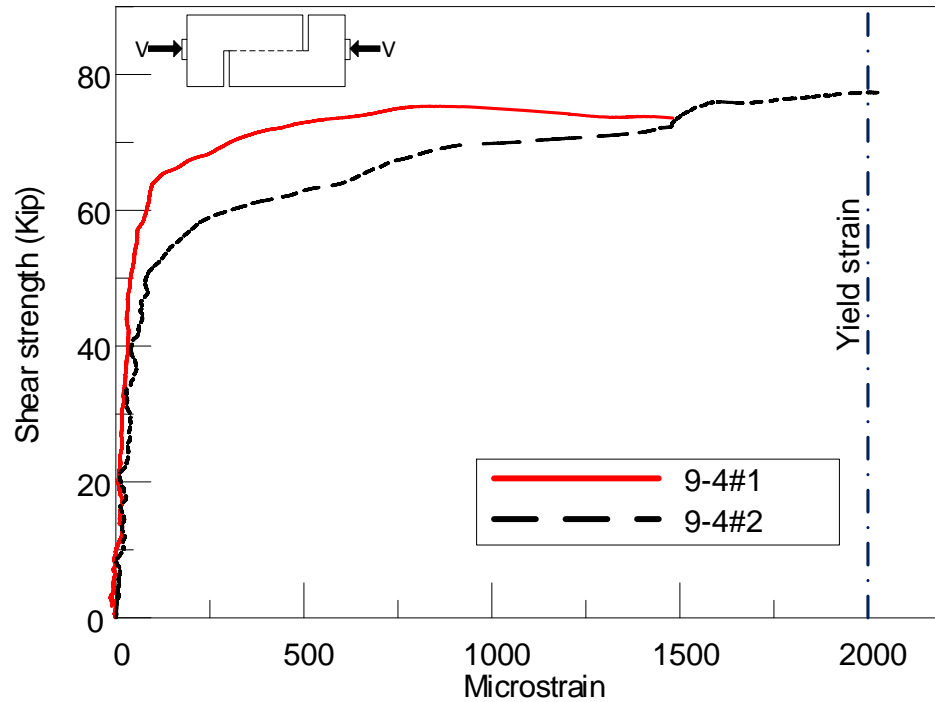
Figure 5-7 Shear strength vs strain plot of 9-in. width horizontal shear reinforcement with 4-in. embedded length push-off specimens

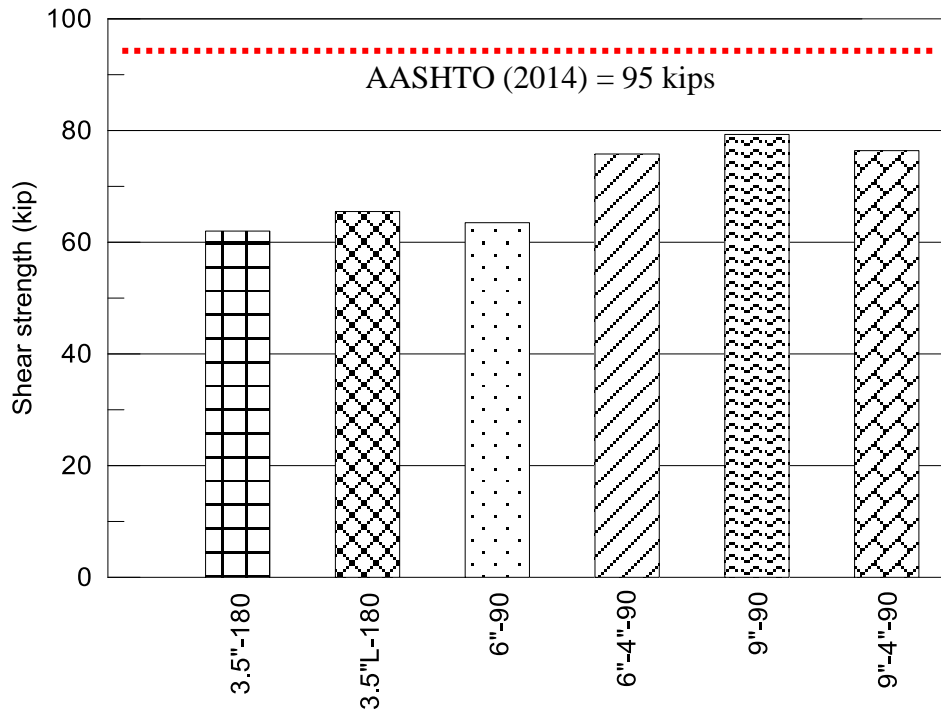
Figure 5-8 Horizontal shear strength comparison

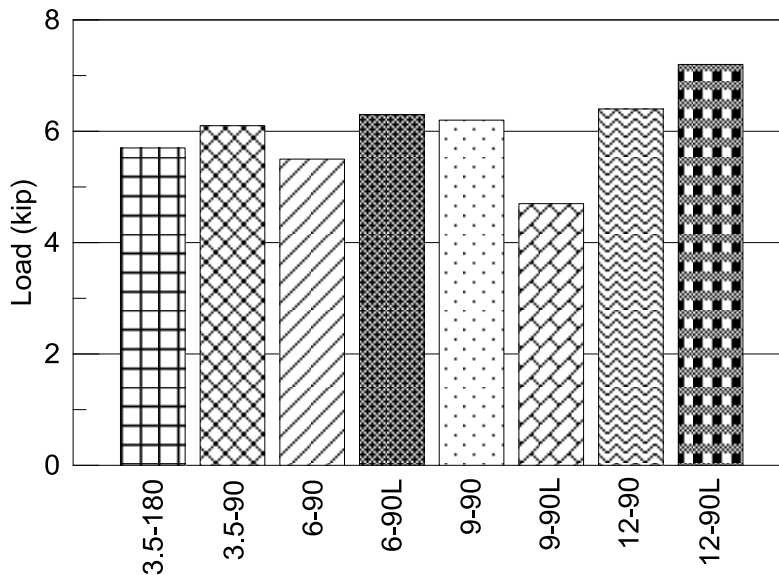
Figure 5-12 Bar pullout strength
