STRENGTH OF HORIZONTAL SHEAR REINFORCEMENT WITH LIMITED
DEVELOPMENT

Presented to the Faculty of the Graduate School of
The University of Texas at Arlington in Partial Fulfillment
of the Requirements
for the Degree of

THE UNIVERSITY OF TEXAS AT ARLINGTON

MAY 2015

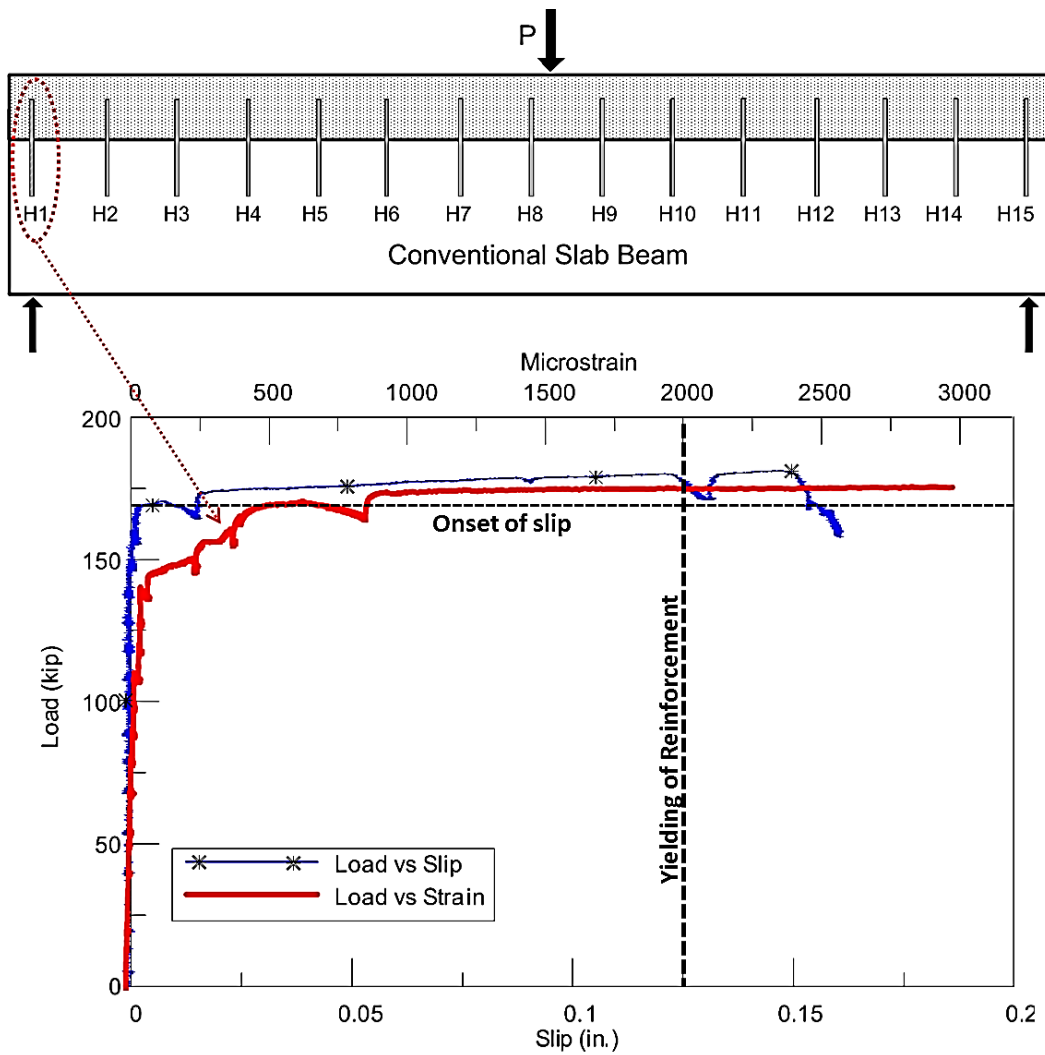
Figure 5-32 Load-slip and load-strain plots for conventional slab beam

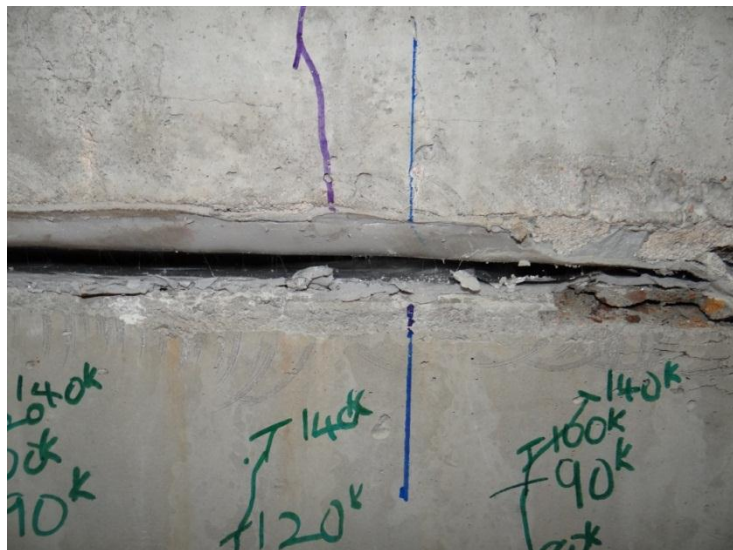
Figure 5-35 Separation of the interface at failure

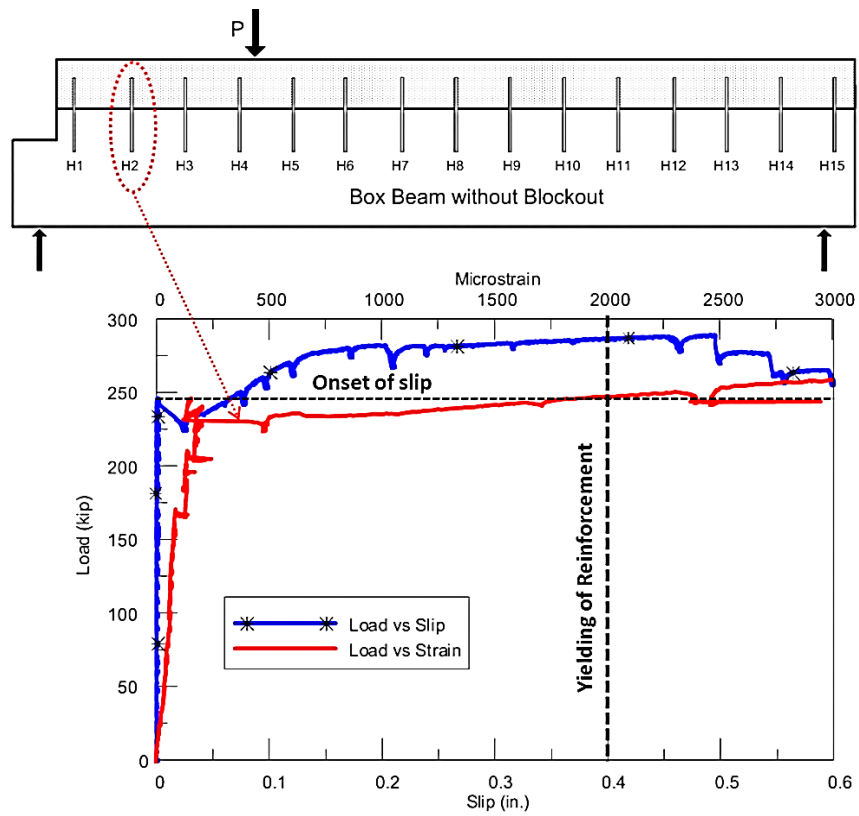
Figure 5-58 Load-slip and load-strain plot for box beam without block-out

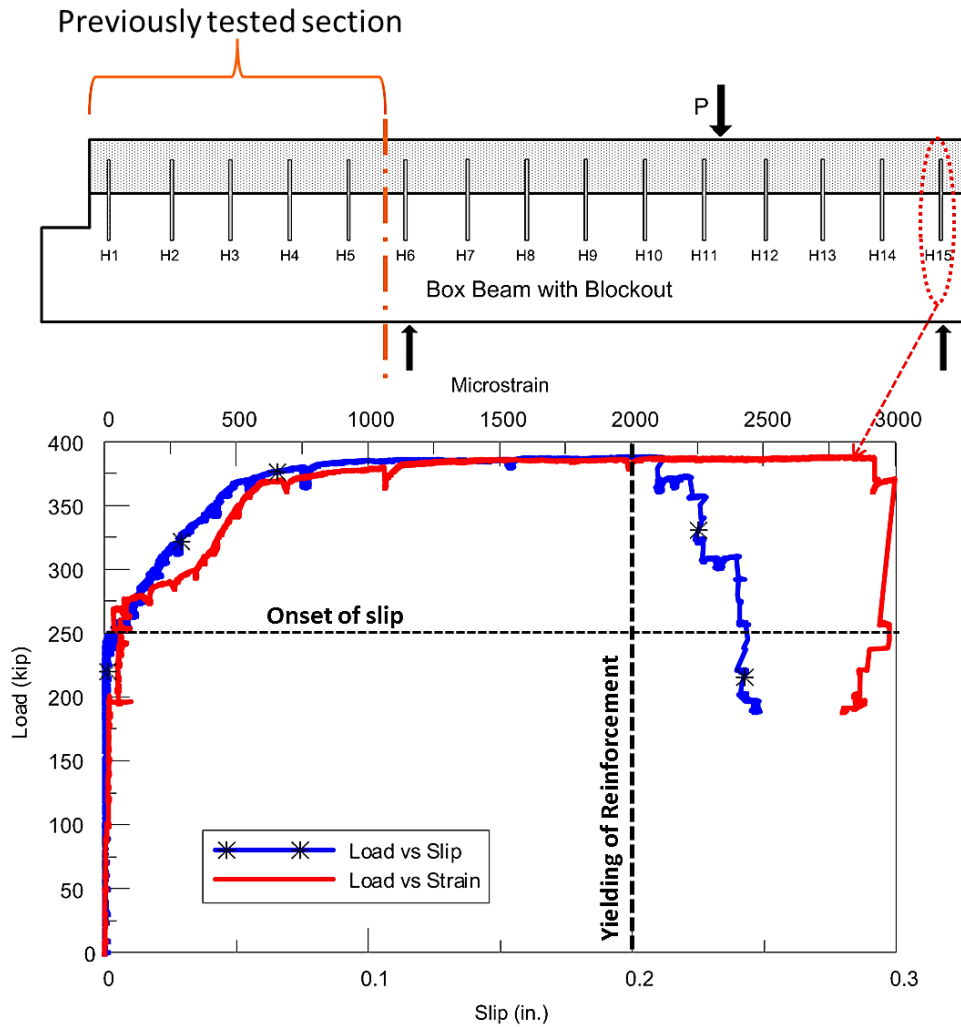
Figure 5-69 Load-slip and load-strain plot for box beam with blockout

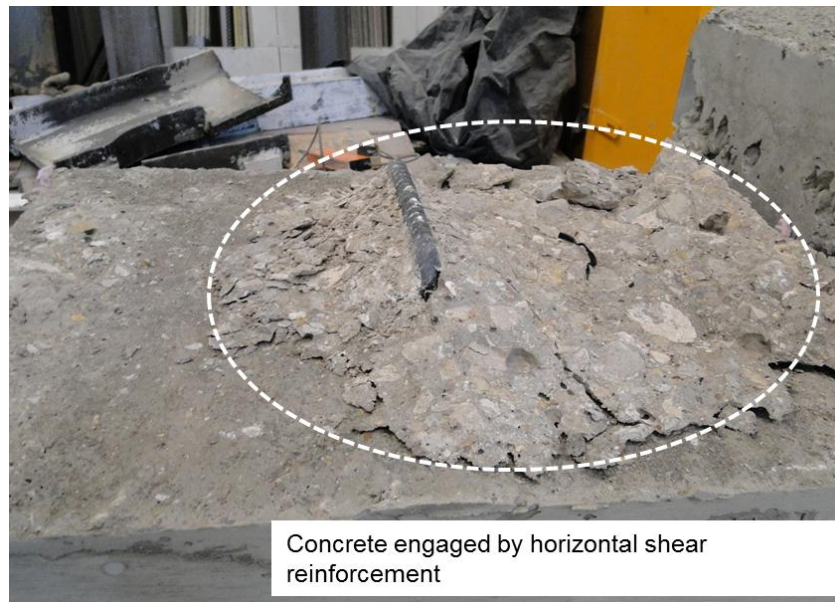
Figure 6-1 Typical failure mode of push-off specimens with 2-in. embedment

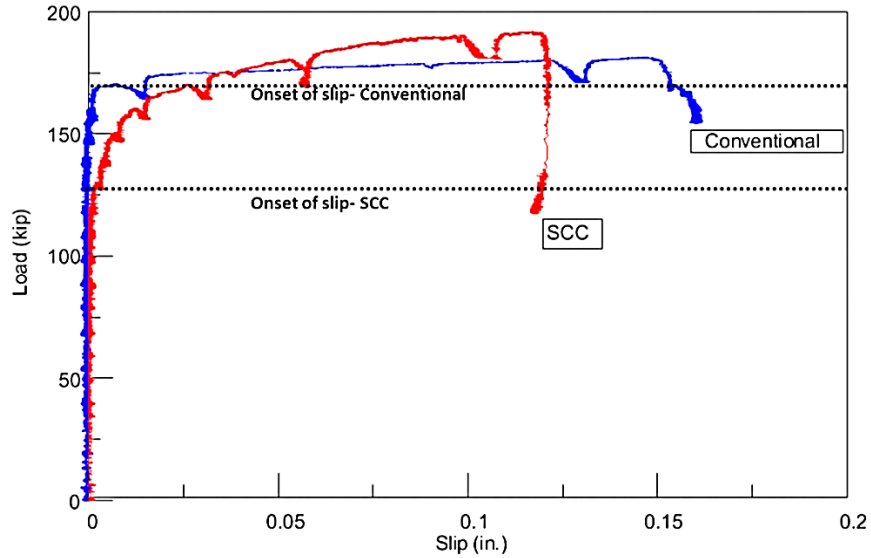
Figure 6-2 Slab beam load-slip comparison

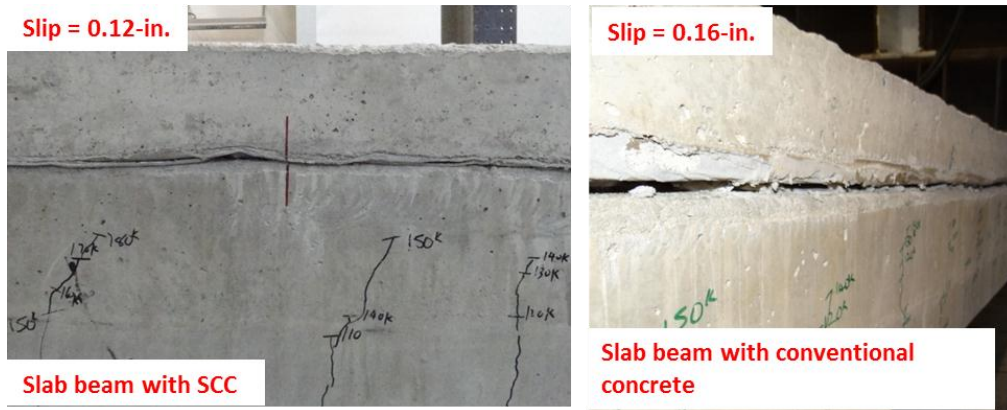
Figure 6-3 Slab beam slip at failure

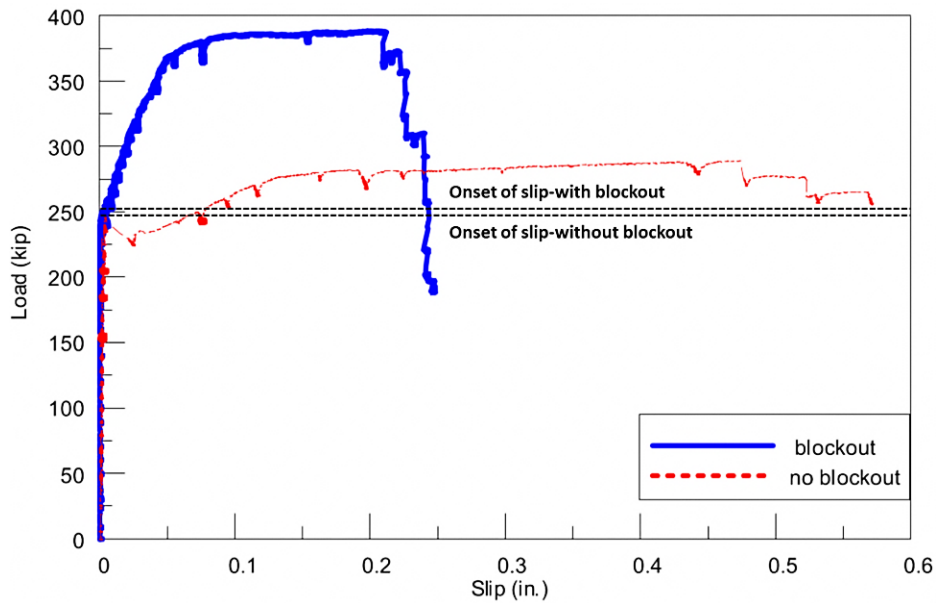
Figure 6-4 Box beam load-slip comparison

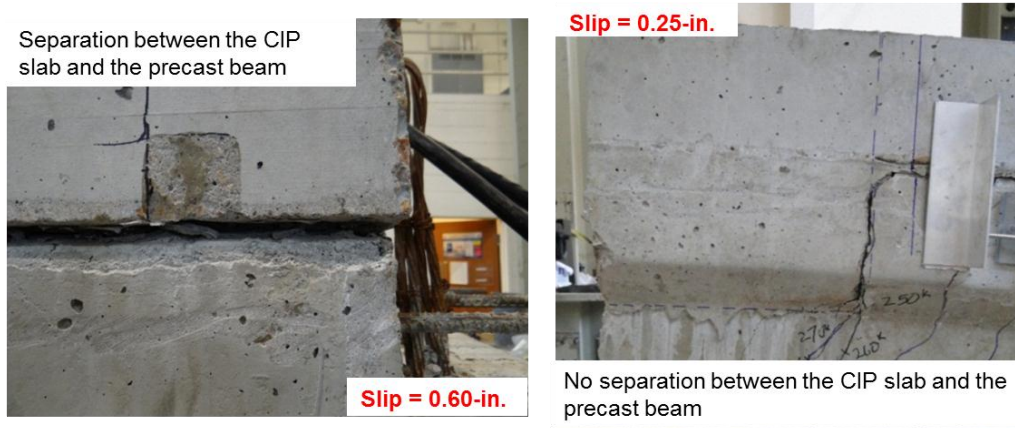
Figure 6-5 Box beam (a) without blockout and (b) with blockout slip at failure
