REPAIR OF IMPACT-DAMAGED PRESTRESSED
CONCRETE BRIDGE GIRDER USING
GLASS FRP REBAR

Presented to the Faculty of the Graduate School of
The University of Texas at Arlington in Partial Fulfillment
of the Requirements
for the Degree of

MASTER OF SCIENCE IN CIVIL ENGINEERING

December 2015

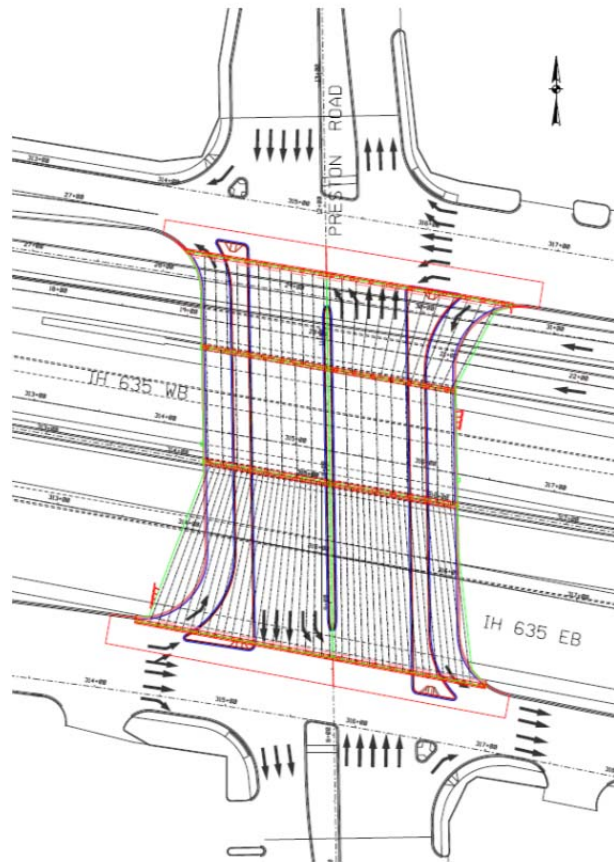
Figure 1-2 Preston Road Bridge, Bridge 54

span number 1 is the southernmost of the structure and the northernmost is the span number 3. The girders used are prestressed with depressed strands. For spans 1 and 2 the girders are type "Tx46" girder and for span 3 are type "Tx28" girder.

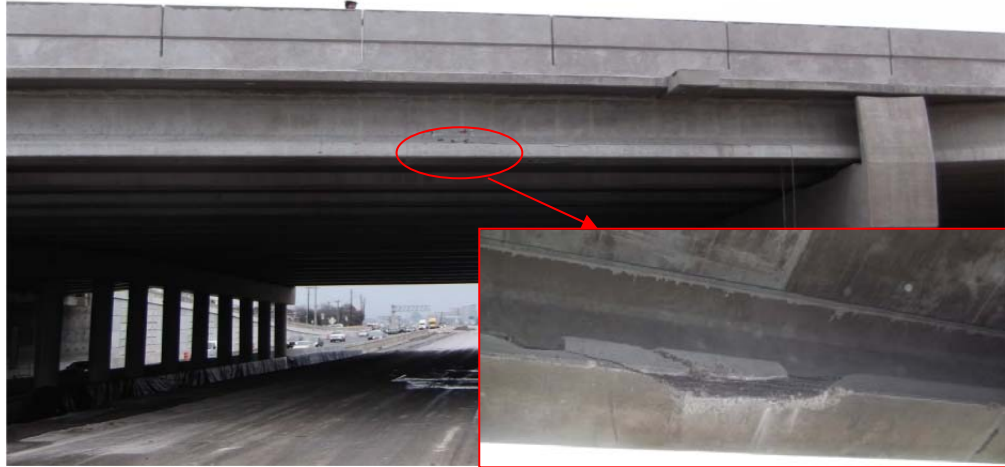
Figure 1-3 Damaged Girder

The girder damaged by the truck was the last girder of the second span in the westbound direction. The impact caused damage along the bottom flange losing concrete and exposing several strands decreasing the strength of the beam.

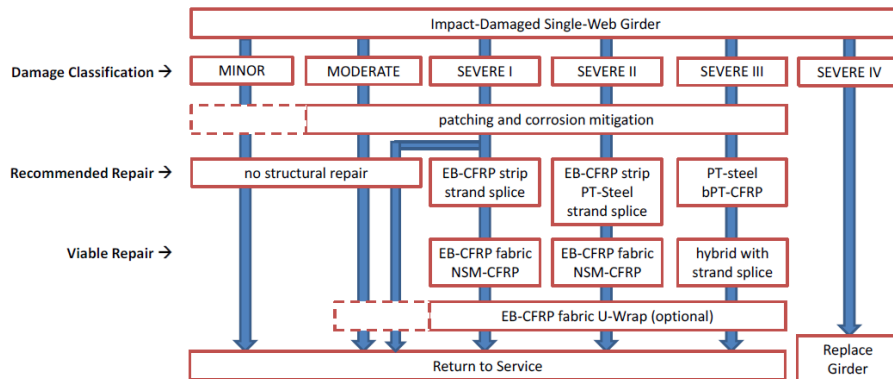
Figure 2-1 Repair Selection Flow Chart For Prestressed Concrete Single-Web Girders (Harries, Kasan, Miller, & Brinkman, 2012)

Once the type of damage has been defined the manual provides several flow charts based on the type of damage and beams with the solution that can be taken.

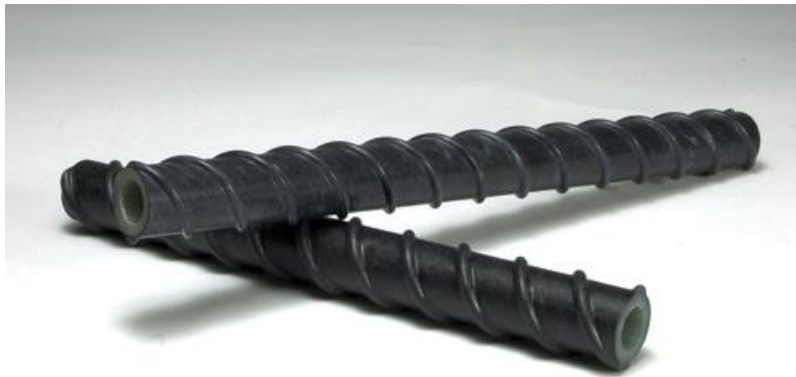
Figure 2-2 Carbon Fiber Rebar

- Carbon. It exhibits modulus and strength three times higher than glass fiber and also it is ten times more expensive. The type of carbon fiber more used in civil engineering is the carbon fiber made from polyacrylonitrile (PAN). PAN-based carbon fiber is characterized by high modulus and high strength. Other kind of carbon fiber that can be found are the carbon fiber made from rayon, used to generate low modulus carbon fiber, and pitch, it has higher modulus than PAN but lower strength.

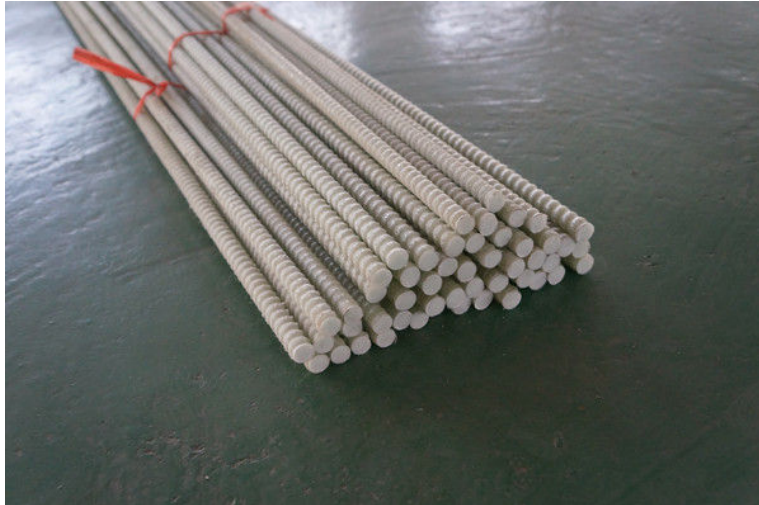
Figure 2-3 Glass Fiber Rebar

- High- Strength (S-glass). It is more expensive than E- glass making it less preferable despite it has a higher modulus and tensile strength.

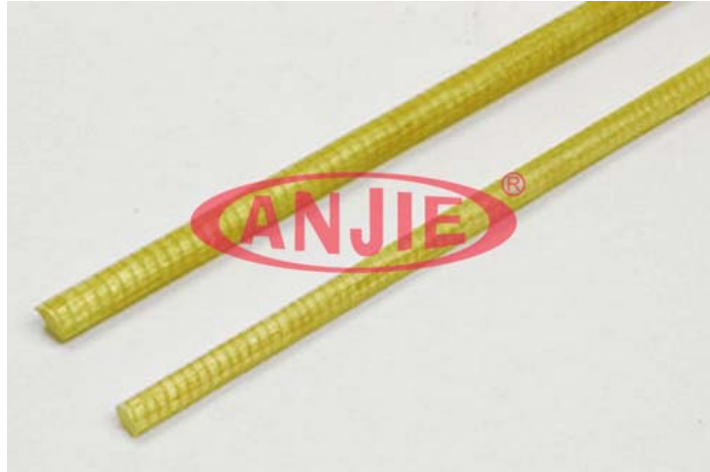
Figure 2-4 Aramid Fiber Composite Rebar

- Aramid. It offers high toughness, high impact resistance and good mechanical properties at low density. The most common type of aramid fiber is Kevlar. It is resistant to lubricants, fuels and organic solvents. Its high price limits its use.

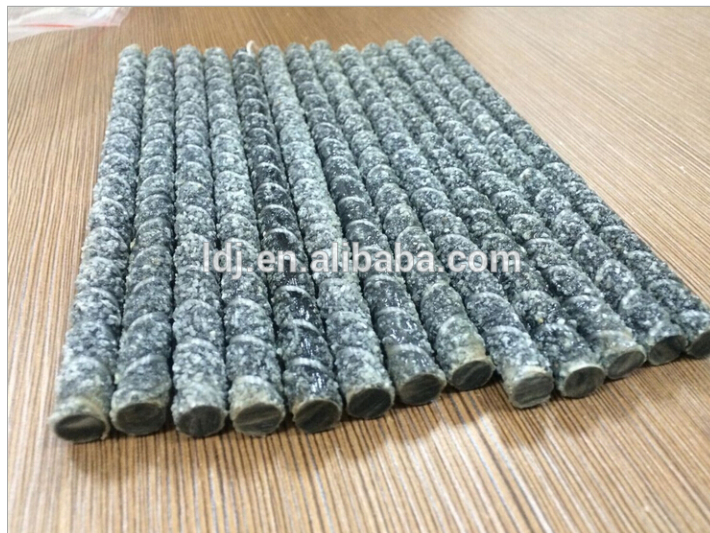
Figure 2-5 Basalt Composite Rebar

- Basalt. It has high elastic modulus and high biosolubility. Basalt fiber is slightly stronger than E-glass, but from an environmental point of view is safer since it is a non-magnetic, non-corrosive and non-toxic material. Also it has very good insulating characteristics and high-heat stability.

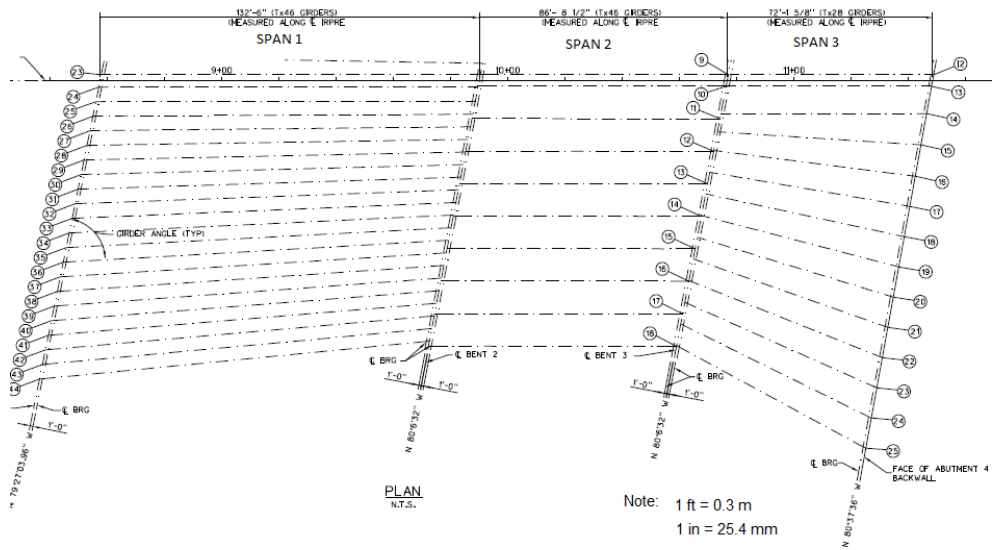
Figure 3-3 Preston Road Northbound Girder Layout

Similarly the northbound structure is formed by 21 prestressed I-girders type Tx46 in the span 1, 9 prestressed I-girders type Tx46 in the span 2 and 13 prestressed I-girders type Tx28 in the span 3, Figure 3-3.

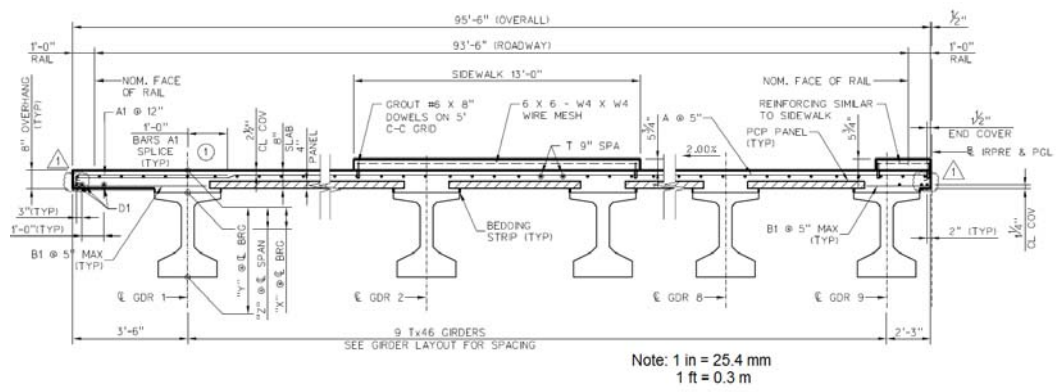
Figure 3-4 Southbound Slab Section

The damaged girder is located in the span 2 of the southbound structure. The span 2 has a total width of 95.5 ft (29.11 m) and its slab is 8 in (203 mm) thick. The spacing between the girders is 11.45 ft (3.5 m). The two overhangs have a width of 3.5 ft (1.07 m) and 2.25 ft (0.69 m), Figure 3-4.

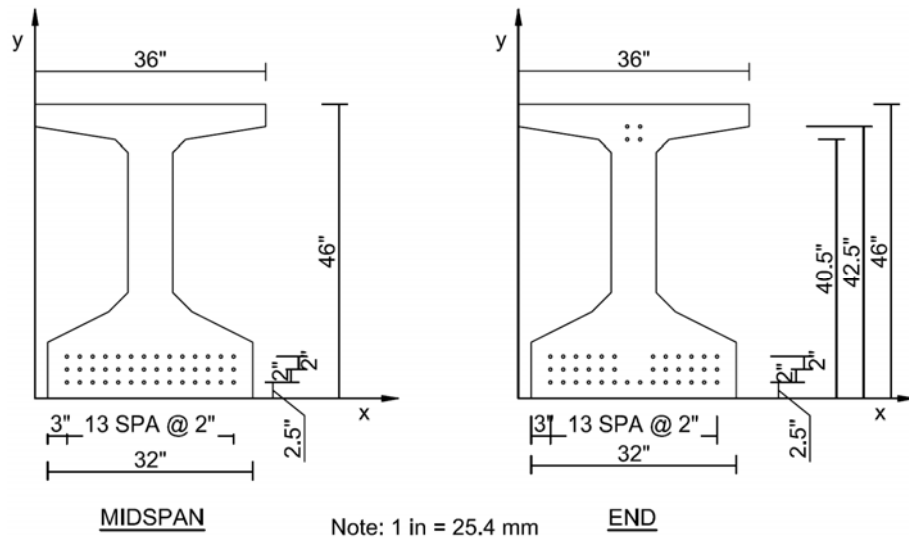
Figure 3-5 Strand Pattern

The girder number 1 of the span 2, damaged girder, is a prestressed concrete I-girder type Tx46 with 42 low relaxation strands placed according to the strand pattern shown in Figure 3-5.

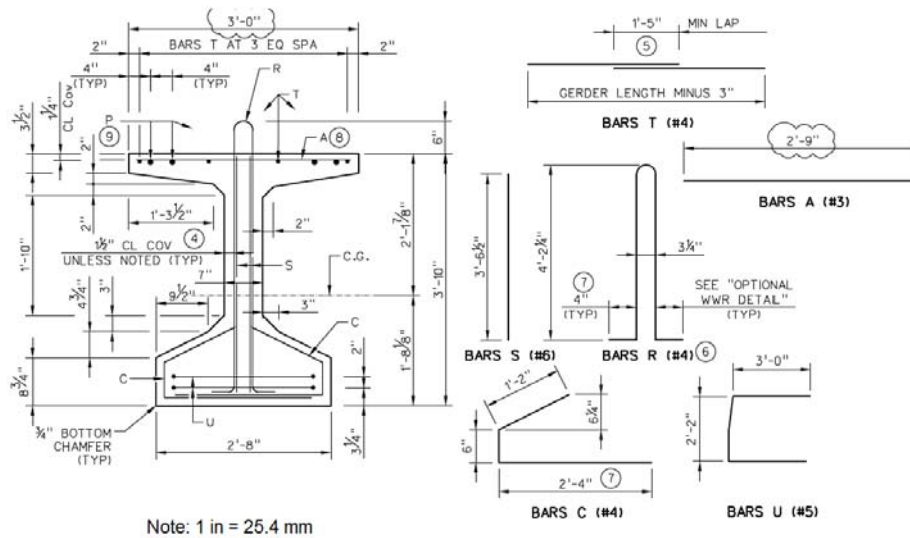
Figure 3-6 Steel Reinforcement

The reinforcement is made with a grade 60 steel, $f_y = 60$ ksi (414 MPa). The bars used were bars number 3, 4, 5 and 6 following the TxDOT standard. The distribution of these bars is shown in Figure 3-6.

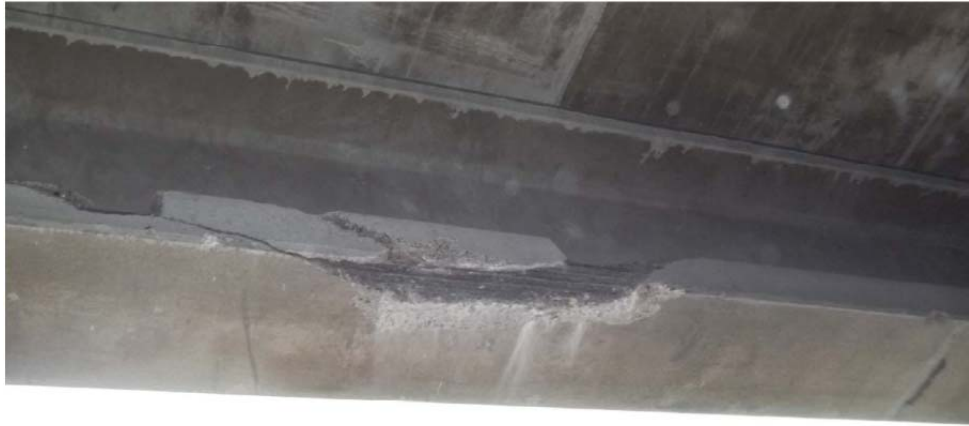
Figure 3-9 Damage

The total length of the damage was about 14 ft (4.3 m), leaving three strands in the bottom row exposed but none of the strands was severed, Figures 3-9 and 3-10.

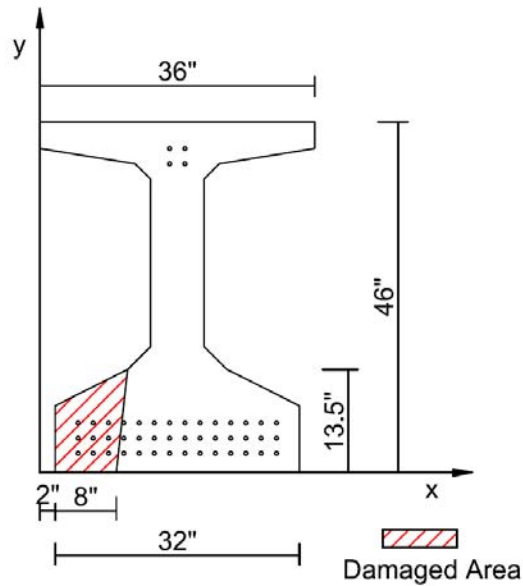
Figure 3-11 Damaged Section

The damaged section is shown in Figure 3-11.

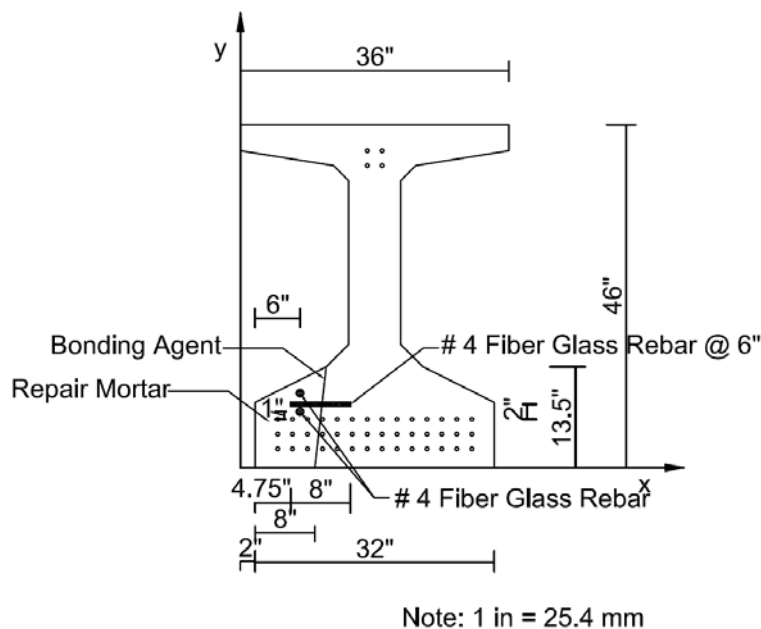
Figure 3-12 Repair Sketch

Once all the delaminated concrete was removed, the third step was carried out. The holes where the transverse rebar had to be placed were drilled following the sketch of Figure 3-12.

- Remove the loss concrete,
- Chip the existing beam to provide a rough surface,
- Drill to place number 4 transverse and longitudinal fiberglass rebar,
- Apply bonding agent, and
- Fill with BASF LA40 repair mortar.

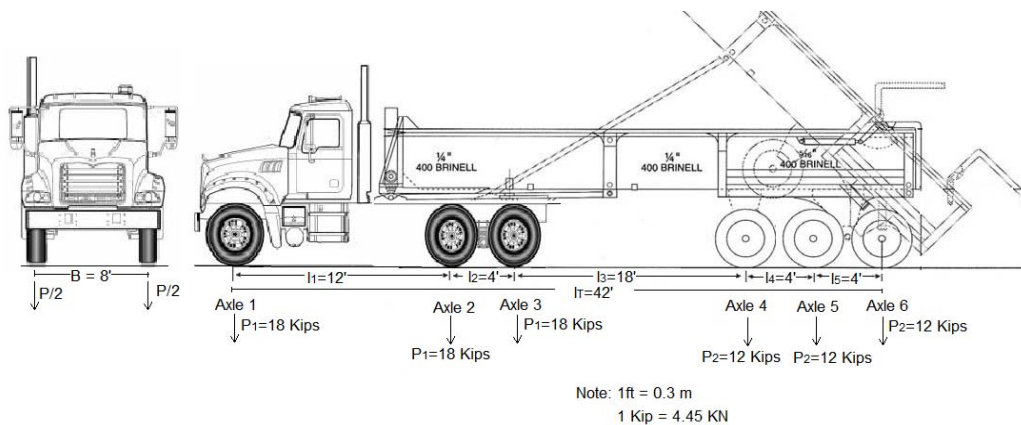
Figure 4-1 Truck Characteristics

The truck used for the test was not the standard truck defined by AASHTO. AASHTO uses a design truck with a total weight of 72,000 lbs (320,272 N). The weight of the truck used for the test was 90,000 lbs (400,340 N). This weight is distributed in six axles. Figure 4-1 shows the characteristics of the truck.

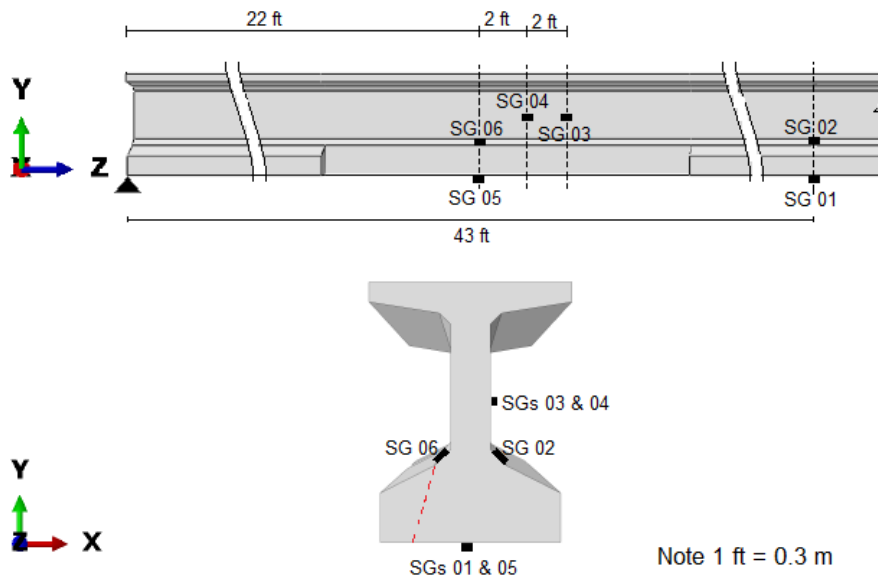
Figure 4-2 Strain Gauges Distribution

The first phase of the test consisted of monitoring the damaged girder strains with the truck placed at two different positions. The strains were measured using six strain gauges, enumerated from 1 to 6, placed according to Figure 4-2.

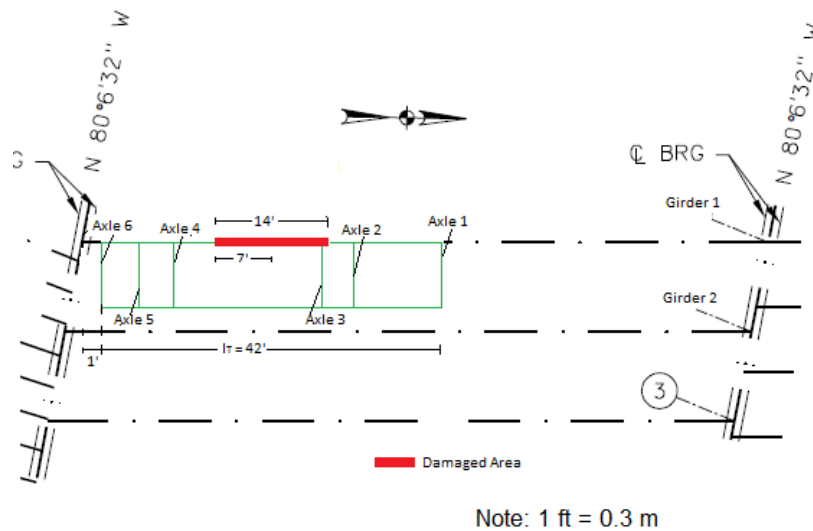
Figure 4-3 Truck Position 1

In the first position, Figure 4-3, the truck was centered on the damage over the damaged girder and stayed in the same position for 650 seconds. The truck was at 3.5 ft (1.07 m) from the barrier.

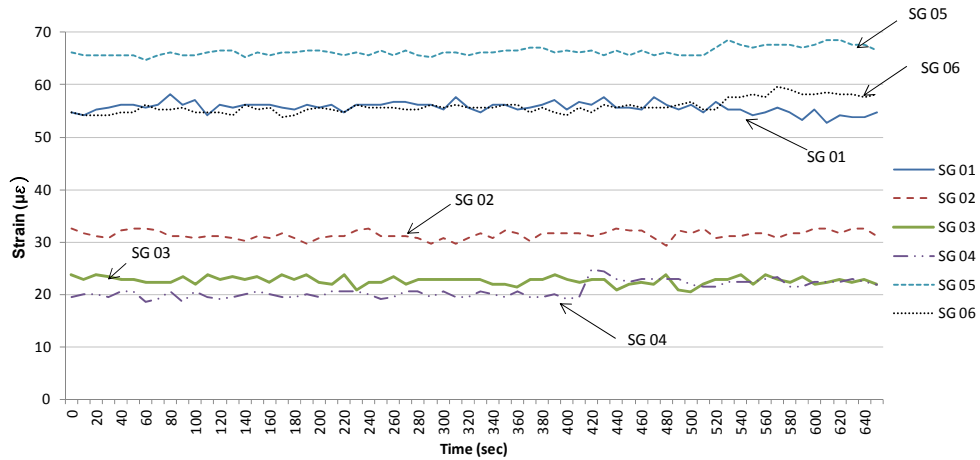
Figure 4-5 Truck Position 1: Strain Measurements

The strains measured by the gauges are represented in Figures 4-5 and 4-6.

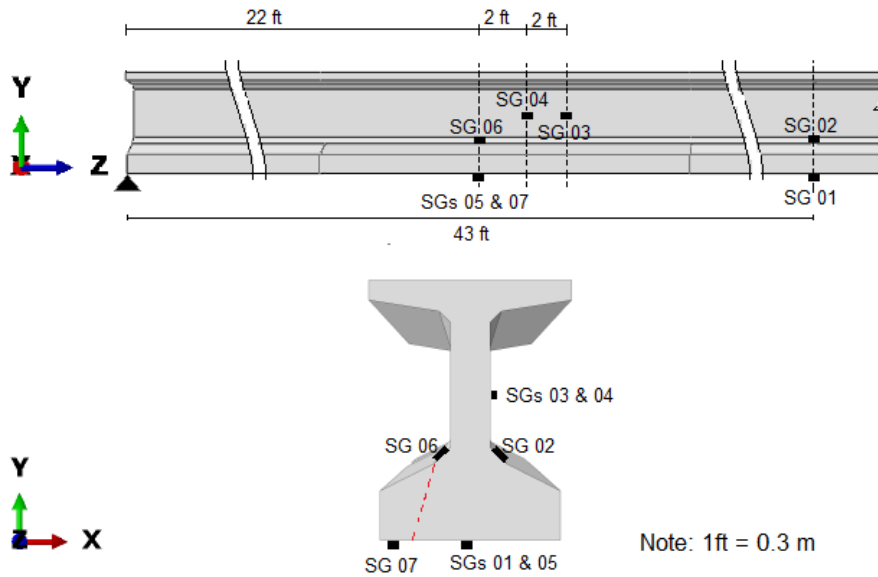
Figure 4-7 Strain Gauges Positions On Repaired Girder.

Once the girder was repaired, the second phase of the field test was performed. On this second phase the strain gauges were placed at the same position that for Phase 1, only one new strain gauge, number 7, was added. This gauge was attached to the bottom of the repaired flange, Figure 4-7

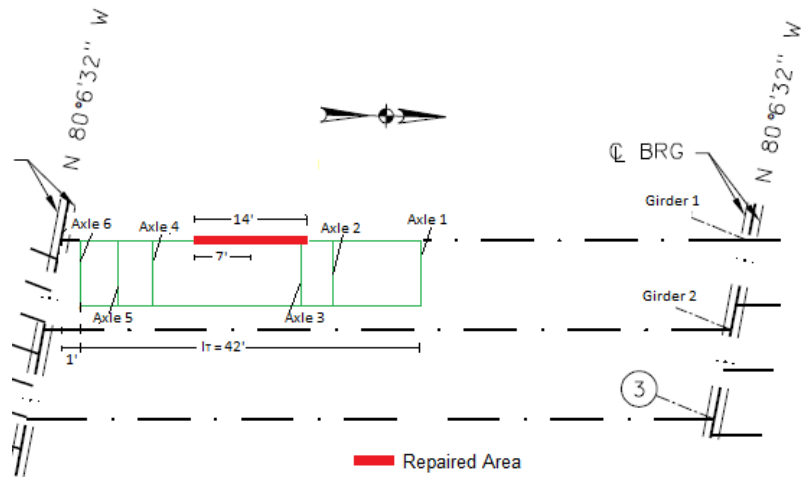
First the truck was placed at 3.5 ft (1.07 m) from the barrier at the girder end, position 3. At this position the truck was centered over the repaired area and stopped for about 100 seconds.

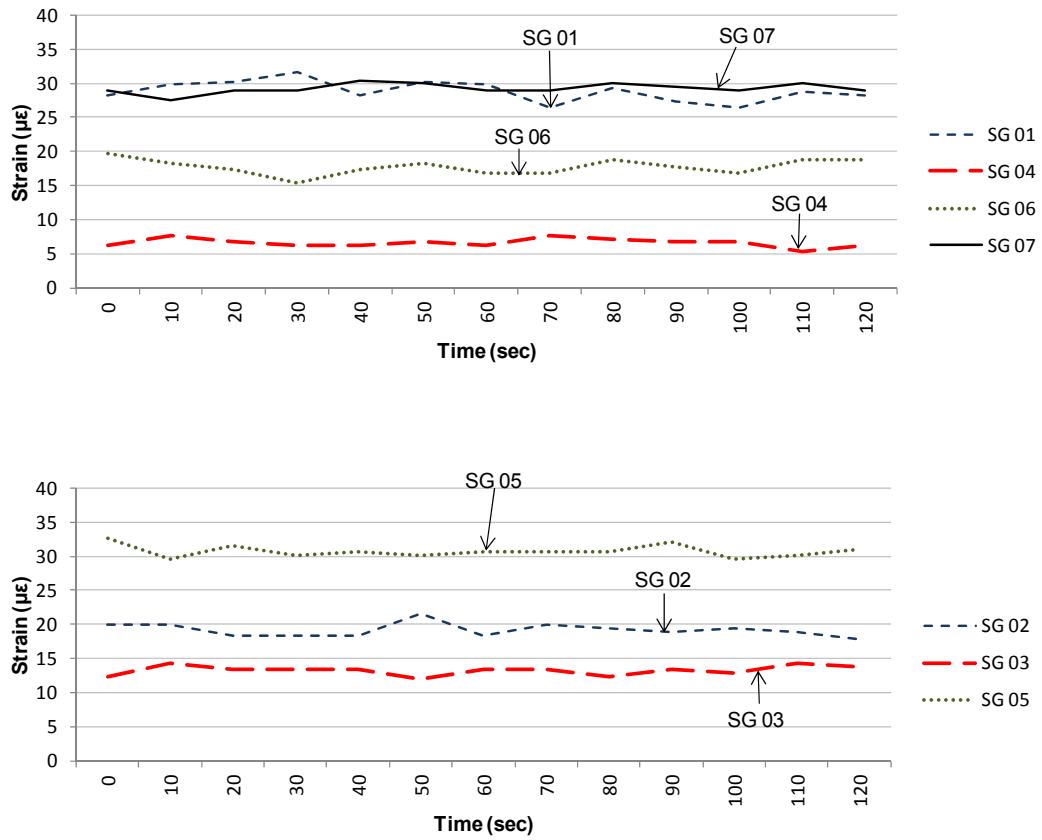
Figure 4-12 Truck Position 3: Strain Measurements

The strains measured by strain gauges 1 to 7 for each truck position are shown in Figure 4-12 through Figure 4-15. For a better understanding the strain measurements for each truck position have been shown in two different graphs.

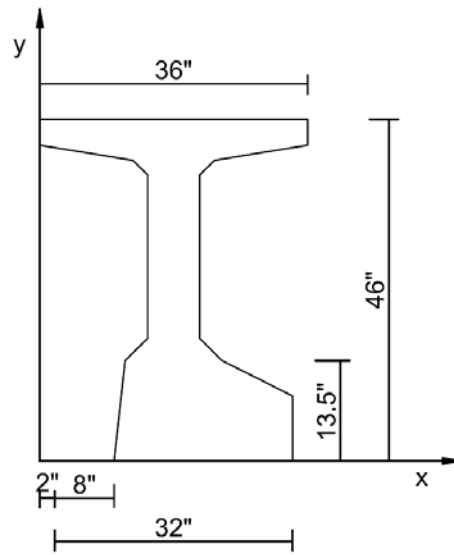
The damaged section, Figure 5-3, has been introduced between the z coordinates 180 in (4,572 mm) to 348 in (8,839 mm), for a total length of 168 in (4,267 mm).

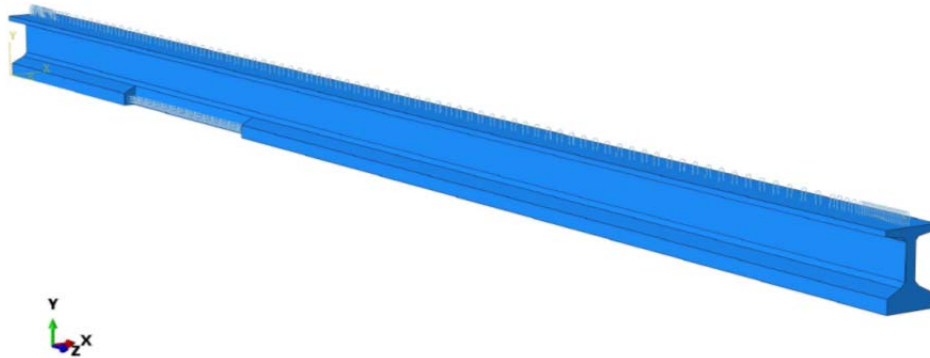
Figure 5-4 ABAQUS. Damaged Girder Model

Figure 5-4 gives a final view of the girder section that has been modeled.

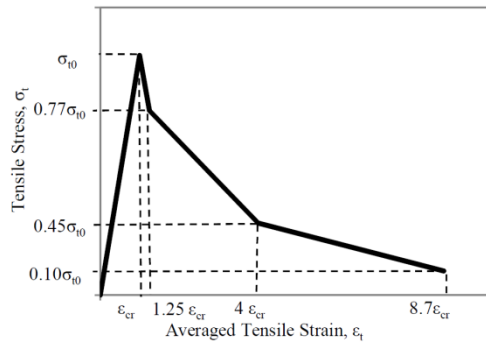
Figure 5-11 Tension Stiffening Model for ABAQUS (Wahalathantri, et al., 2011)

The modified tension stiffening model used by Wahalathantri, et al., (2011), that has been used for this thesis is shown in Figure 5-11.

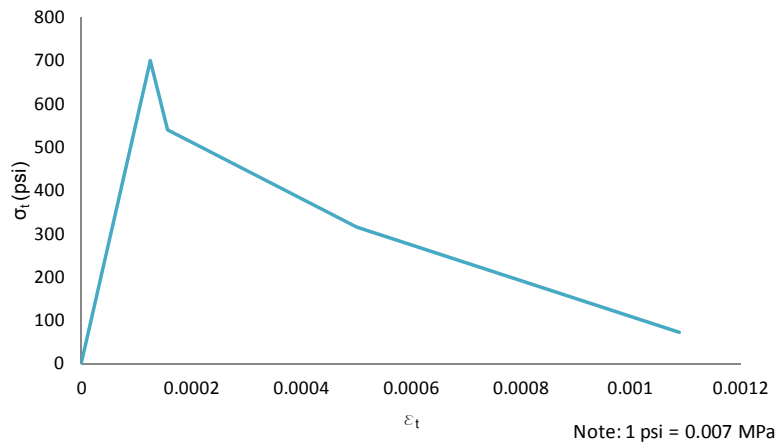
Figure 5-12 Concrete Girder Section. Tensile Stress -Average Tensile Strain Diagram

Applying the modified tension stiffening model for ABAQUS, the tensile behavior of the concrete girder is given by Figure 5-12.

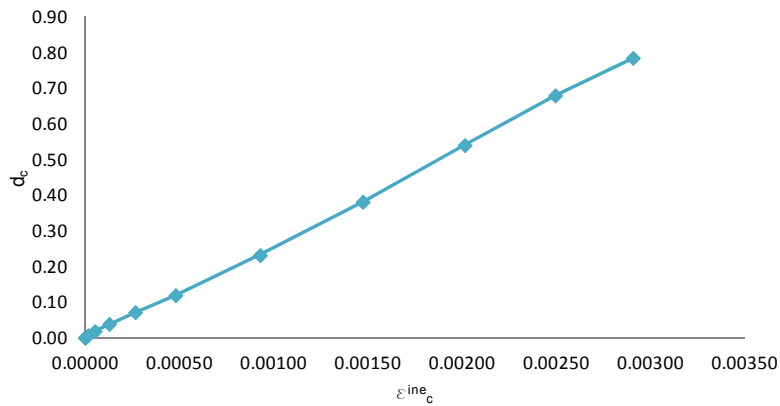
Figure 5-13 Concrete Girder Section. Compressive Inelastic Strain - Compressive Damage Diagram

Evaluating the stresses and strains obtained from the compressive behavior into Equation 8, the values of the compressive damage parameter used in the development of the models with ABAQUS are represented in Figure 5-13.

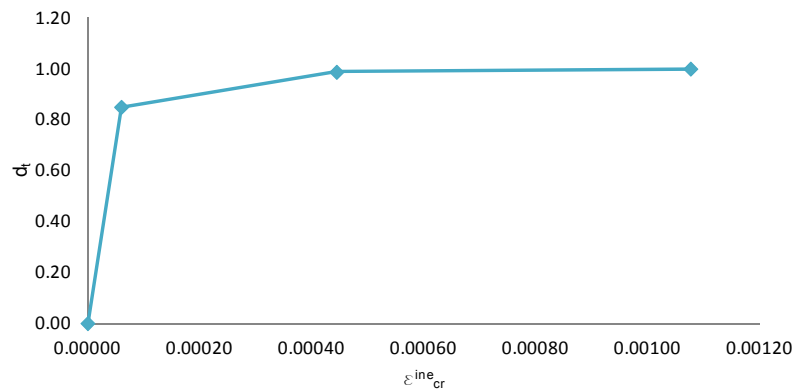
Figure 5-14 Concrete Girder Section. Tensile Inelastic Strain - Tensile Damage Diagram

The data introduced into ABAQUS is represented by Figure 5-14.

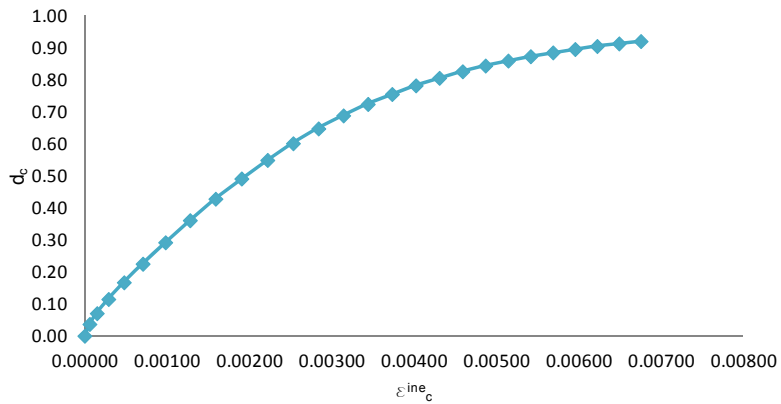
Figure 5-17 Concrete Slab and Haunch Section. Compressive Inelastic Strain - Compressive Damage Diagram

Finally, Figures 5-17 and 5-18 show the damage parameters introduced into ABAQUS obtained from Equation 8 and 10.

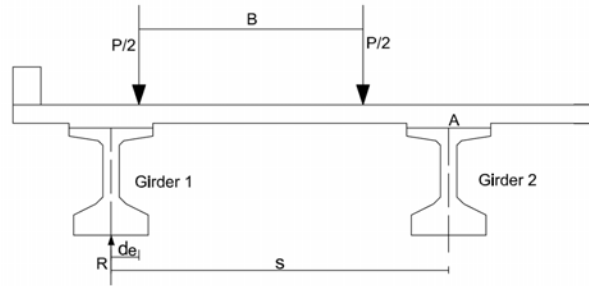
Figure 5-21 Lever Rule. Case 1

Case 1: Truck positioned over damaged girder at 3.5 ft (1.07 m) from barrier:

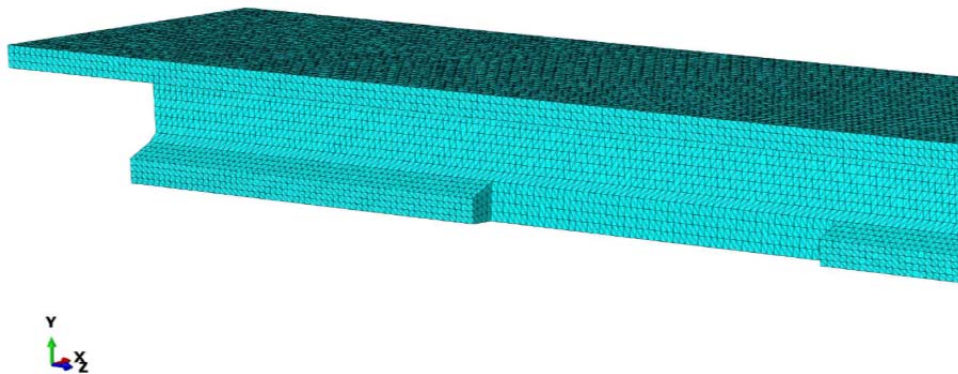
Figure 5-25 Damaged Girder Mesh

The computation was performed first using 15 in (381 mm) elements size. After checking that the model did not have errors, the size of the elements was gradually reduced to 3 in (76.2 mm). Size elements smaller than 3 in (76.2 mm) had a great computational cost that overcame the capacity of the computer used. Therefore, the element used for the mesh had a maximum size of 3 in (76.2 mm), Figure 5-25.

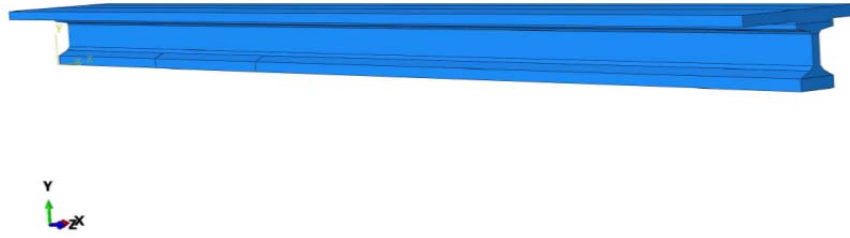
Figure 5-27 ABAQUS Concrete Repaired Section

This part was defined as a 3D deformable extrusion solid. It has the same length than the damage. Its dimensions and position into the ABAQUS model are shown in Figures 5-26 and 5-27.

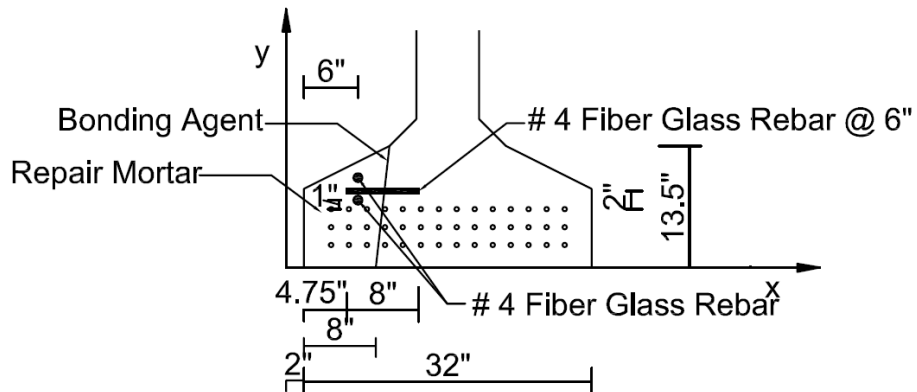
The rebar were placed according to the repair sketch shown in Figure 5-28.

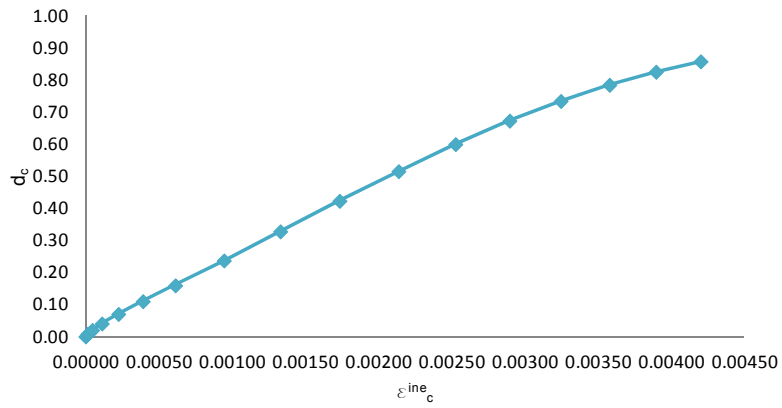
Figure 5-31 Concrete Repaired Section. Compressive Inelastic Strain - Compressive Damage Diagram

From Equations 8 and 10 the damage parameters for the concrete repaired section are shown in Figures 5-31 and 5-32.
