QUALITATIVE EVALUATION OF CFRP-CONCRETE BOND USING NON-
DESTRUCTIVE AND DESTRUCTIVE TESTING METHODS

MASTER OF SCIENCE IN STRUCTURES AND APPLIED MECHANICS

THE UNIVERSITY OF TEXAS AT ARLINGTON

May 2018

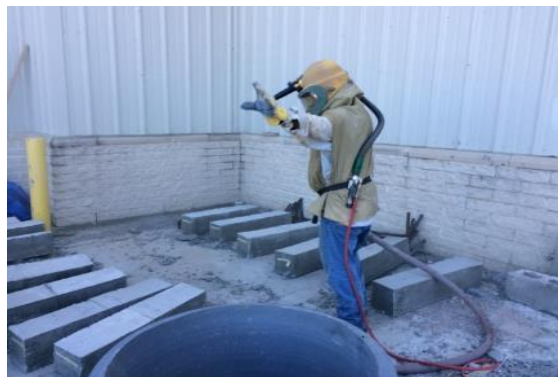
Figure 11 Sand Blasting of Beams

Concrete surface preparation is one of the critical parameters that affect the performance of CFRP strengthened structures. As stated in ACI 440 (2008), the surface needs to be roughened to CSP3 profile to prevent adhesion failures. In addition, the concrete surface must be sound, clean, free from surface defects and dry before the application of CFRP. For the experiment, CSP3 surface profile was achieved by sand blasting and some dirt was planted on the dry surface before the application of CFRP to analyze the effect of dirt and unclean profile on the bond. This was done to consider cases where sand blasting is done days or hours prior to CFRP application or poor workmanship. The unclean concrete surface profile may lead to imperfect bonding.

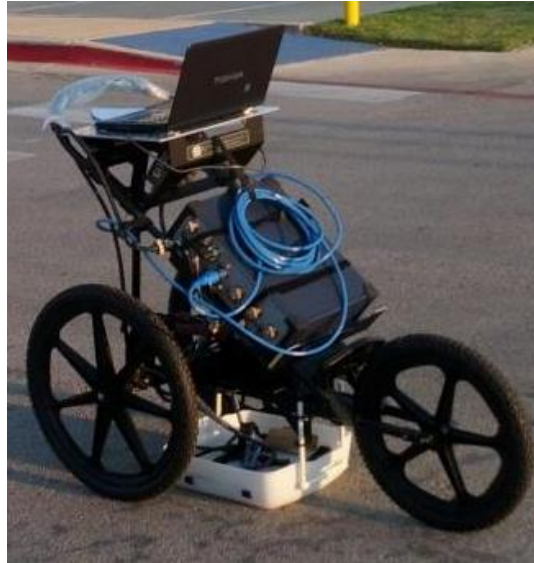
Figure 16 GSSI SIR 30 unit

The GPR antenna transmits electromagnetic pulses into the ground which is then reflected from numerous buried objects (targets) across. The objects (targets) are visible when there is a contrast in the dielectric constant. Dielectric contrast is an indication of the speed of radar energy when it travels through the material. The speed of radar wave depends on the permittivity of the material. Dielectric constant is defined by the ratio of permittivity of the material to the permittivity of free space. For the concrete used in this study, the value of dielectric constant was 5. After the reflected waves are received by the GPR antenna, it displays them in real time on screen. The data is saved for interpretation and processing of the output. The data collection on concrete was done with a ground-coupled antenna from GSSI SIR 30. For the analysis, the orientation of the antenna was both normal and cross polarized. Figure 18 shows normal and cross-polarized antenna. The antenna used in the study was the GSSI (Geophysical Survey System, Inc.) 2.6 GHz antenna.

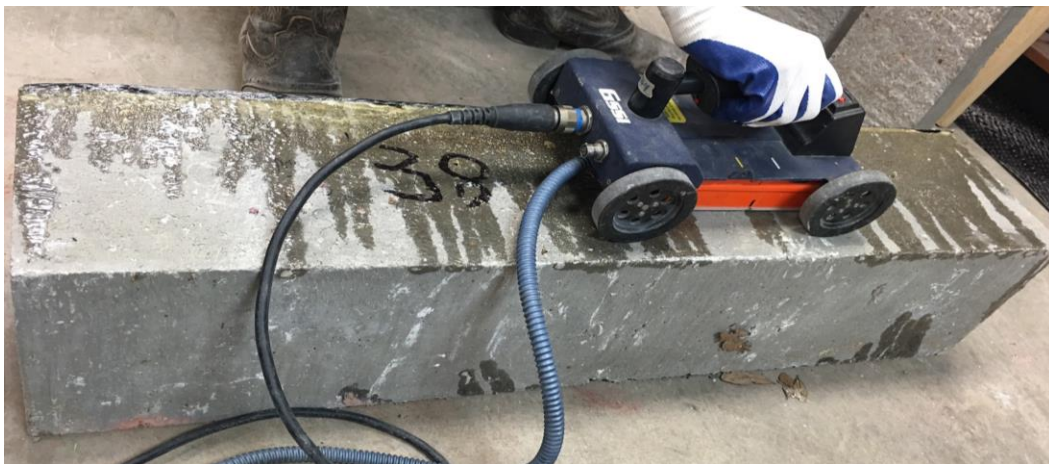
Figure 24 B-Scan of the side of the sample beam

The wave profile, frequency and amplitude of the wave was recorded using the GPR. B-scans along the length of the beam were done and the length and depth unit was inches. During the investigation of the parameters, the scans could detect the presence of voids. Other parameters could not be identified by the GPR. Figure 4-11 a shows a B-Scan of beam 1 that is the control sample. The graph shows a significant change in amplitude and the radargram shows a horizontally oriented black area, this is the interface of concrete additional layer and the beam sample. Presence of voids can be seen as a phase inversion occurs at a concrete-air interface because of the low dielectric of air. A phase inversion is a flip-flopping of the normal polarity sequence. A concrete-air reflection starts with a negative (black) peak followed by a positive (white) peak. The parabolas in the radargram show the presence of air-filled voids, the size of parabola is directly proportional to the size of voids. The Although, it is not possible to determine the size of void based on the radargram. No significant change in the amplitude or radargram is visible for the parameters with surface wetness, upward application of CFRP and improper surface preparation. Thus, in this study, GPR was effective in detecting the sub-surface defects. The radargram for beam 1 was uniform on the grey scale and can be seen in figure 25. Figure 26 shows a small parabola that indicated the presence of voids. The grey scale scan is filtered in the RADAN-7 software and figure 27 shows the filtered scan. The parabola can be seen clearly in the filtered scan and is marked with an arrow. The size of the parabola depends on the size of the voids. For multiple voids, multiple parabolas can be detected.

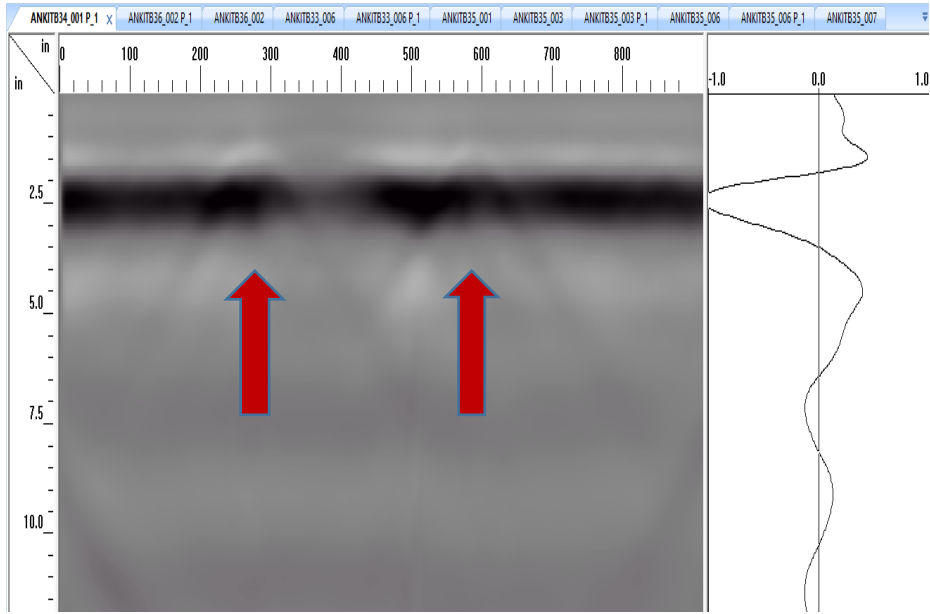
Figure 28 Grey scale scan for beam 4

Figure 28 shows the gray scale scan for beam 4. The black horizontal region in the scan along the length of the beam is the CFRP-concrete interface at the additional layer. Two parabolas can be seen at a depth just after the interface which mark the presence of two voids. The scan was further filtered as shown in figure 29, for better identification of the parabolas. A corresponding change in amplitude can be seen but it is difficult to identify if the change is due to the CFRP-Concrete interface (at the additional layer) or presence of voids.

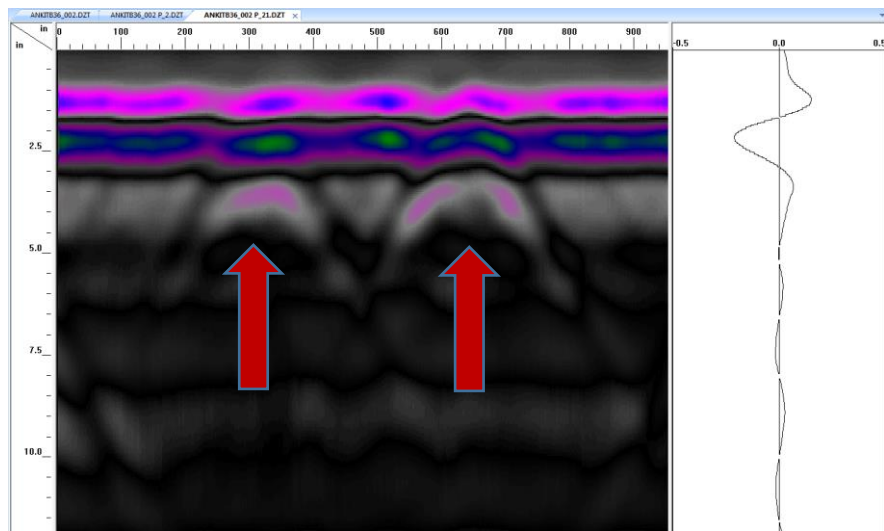
Figure 33 shows the gray scale scan for beam 6. Two parabolas can be seen at the interface which marks the presence of two voids. The scan was further filtered as shown in figure 34, for better identification of the parabolas. The parabolas in this scan were bigger than the other beams, which verifies that the size of the artificially planted voids is bigger for beam 6.

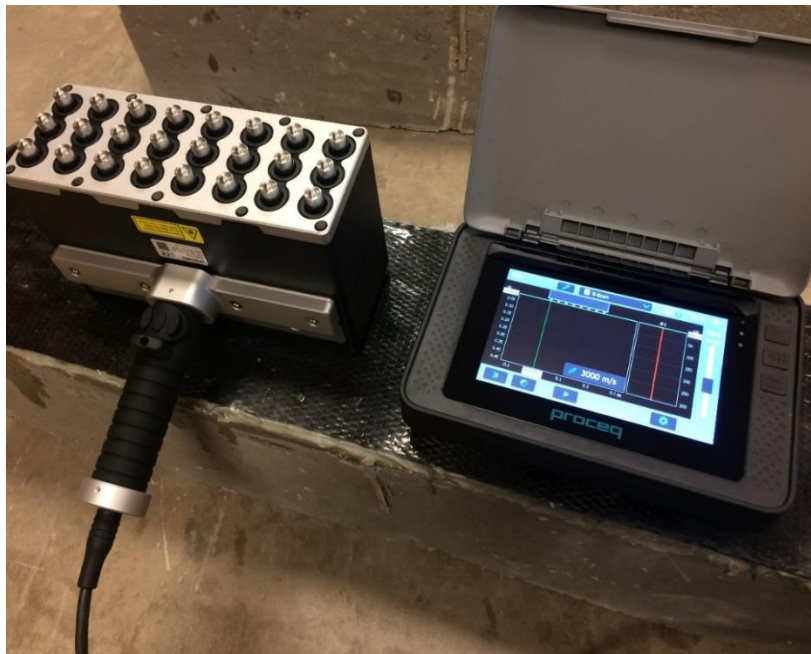
Figure 53 Pundit 250 Array

Ultrasonic multichannel pulse echo technology is a technique that uses ultrasound waves for creating images. The device used for the study is Pundit 250 array from Proceq. The device works on an ultrasonic multi-channel pulse echo technology using 8 channels. One channel transmits, and the other seven channels receive the echoes. Each channel transmits in turn. The components of the device are a touchscreen, transducer, receiver, battery and Pundit 250 Array software. The wave type used by the device is a horizontally polarized shear wave, the nominal transducer frequency is of 50 KHz shear wave and the Pulse Velocity is 200 V. Figure 53 shows the device and figure 54 shows the application of the device in this study where T stands for transmitter and R stands for receiver.

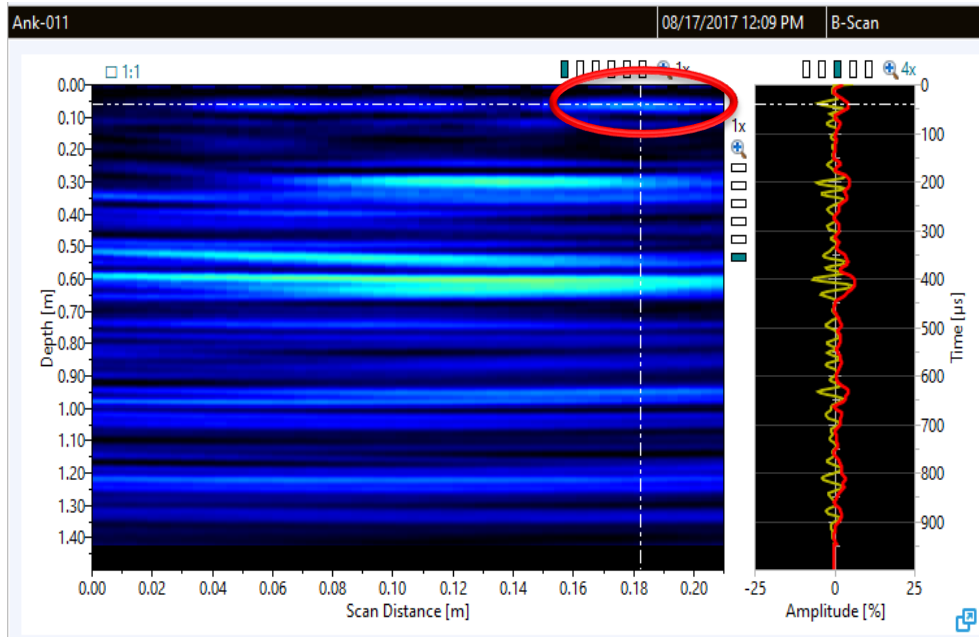
For beams 3,4,5 and 6 the voids can be detected by the bright spots and are circled in the images 59,60,61 and 62 respectively. A corresponding change in the amplitude is recorded.

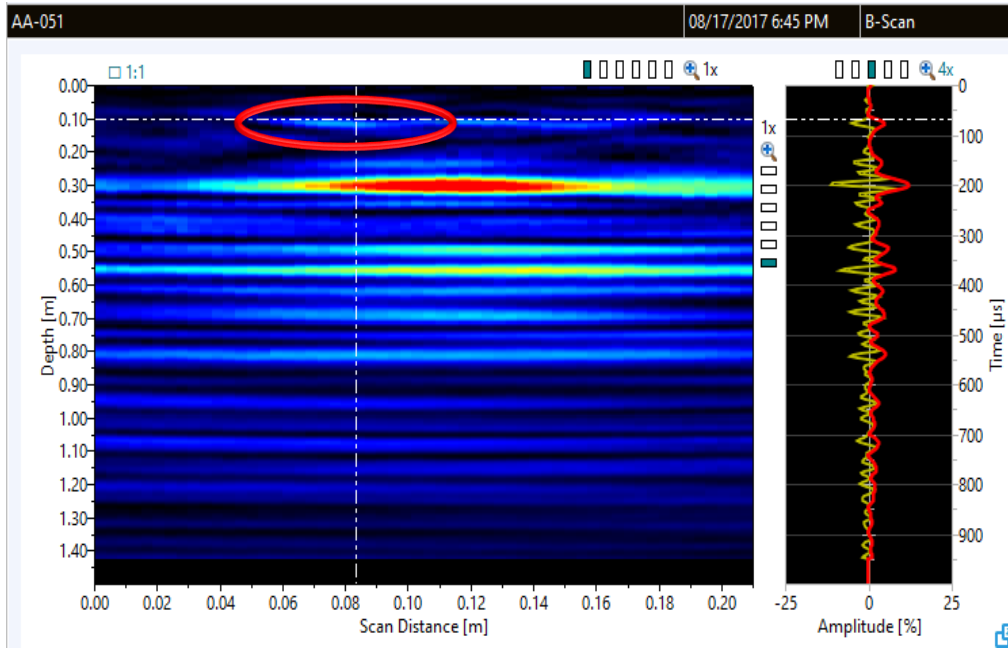
For the beams 9 and 10 with overhead application of the CFRP laminate, a significant change in the percentage of the amplitude can be seen in figure 65 and 66 respectively. The encircled bright spots indicate the presence of epoxy pockets formed due to the gravity effect. Similarly, for beam 11 the ultrasonic tomograph shown in figure 67 indicates the presence of dirt. The corresponding change in amplitude is recorded and compared to the other beam samples.

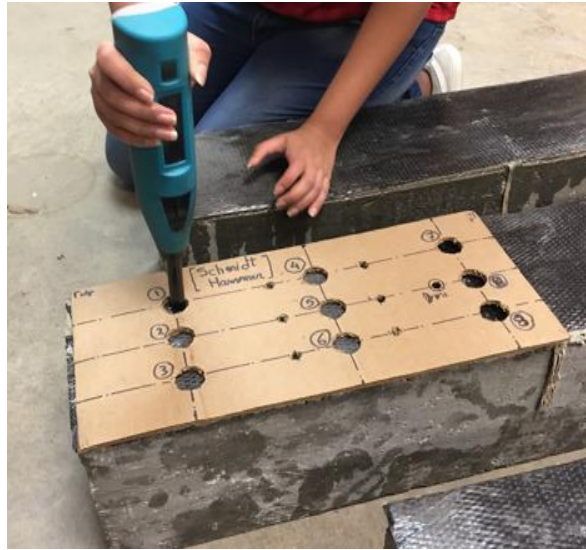
Figure 70 Schmidt Hammer test

equipment. The test was done according to ASTM C805 standards as mentioned in the ACI 440.2R-17 guidelines.
