HPFRC AND RC SLAB-BEAM-COLUMN CONNECTIONS UNDER EXTREME
EARTHQUAKE LOADING AND FURTHER IMPROVEMENT OF
NOVEL DOUBLE-BEAM-COUPLING BEAMS

Presented to the Faculty of the Graduate School of
The University of Texas at Arlington in Partial Fulfillment
of the Requirements
for the Degree of

THE UNIVERSITY OF TEXAS AT ARLINGTON

December 2018

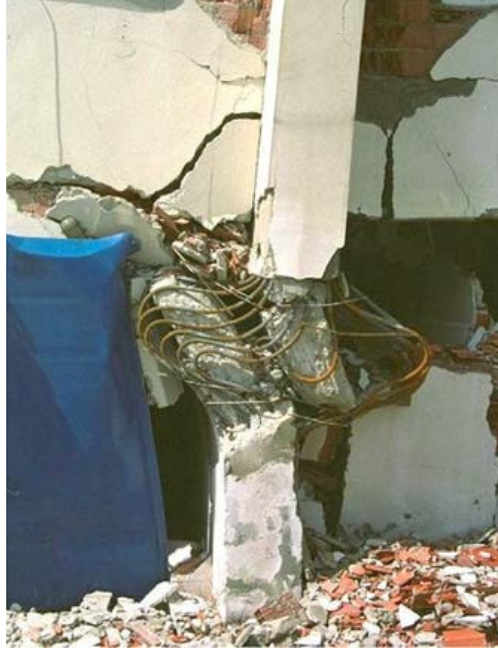
1.3 Column shear failure (Moehle et al., 2008)

The beam mechanism requires beams to yield in flexure. Shear failure in any members, such as beams, columns and beam-column joints, need to be avoided since it is sudden and decreases the strength and stiffness of the members rapidly (Figure 1.3). A capacity design approach is used in design to prevent the shear failure. It is important in the capacity design to find the regions where flexure yielding

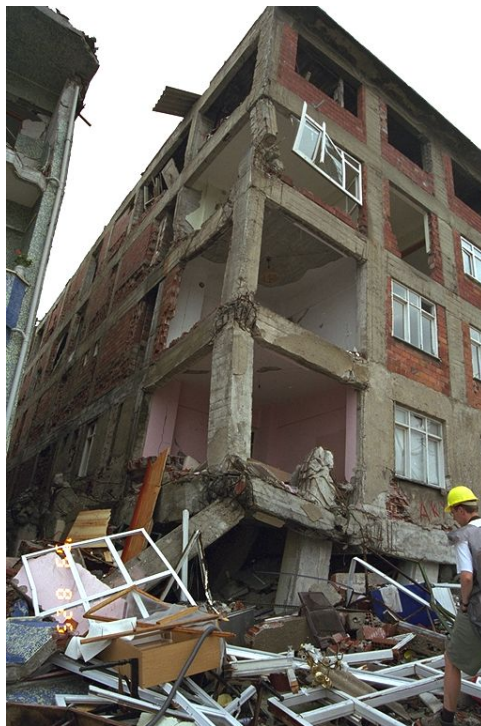
1.4 Joint shear failure

As shown in Figure 1.4, failure in beam-column joints can affect the stability of an entire building. For a moderate earthquake, the joints need to behave in an elastic domain, while some inelastic behavior is allowed for a strong earthquake. The joints are subjected to relatively high shear force during earthquakes, which is approximately five times higher than that in columns. Figure 1.5 illustrates the resultant moment, shear, and axial force that act around the joints. Figure 1.6 and 1.7 show the internal stress resultants on a beam-column joint and shear calculation of the joint. ACI 318-14 considers only concrete contribution to joint shear strength. Therefore, the shear in a beam-column joint is resisted only by a concrete strut as seen in Figure 1.6. The joint shear strength is calculated by Equation 1-1. And, it generally depends on the size of joints, since b_j and h represent beam width and joint depth, respectively.

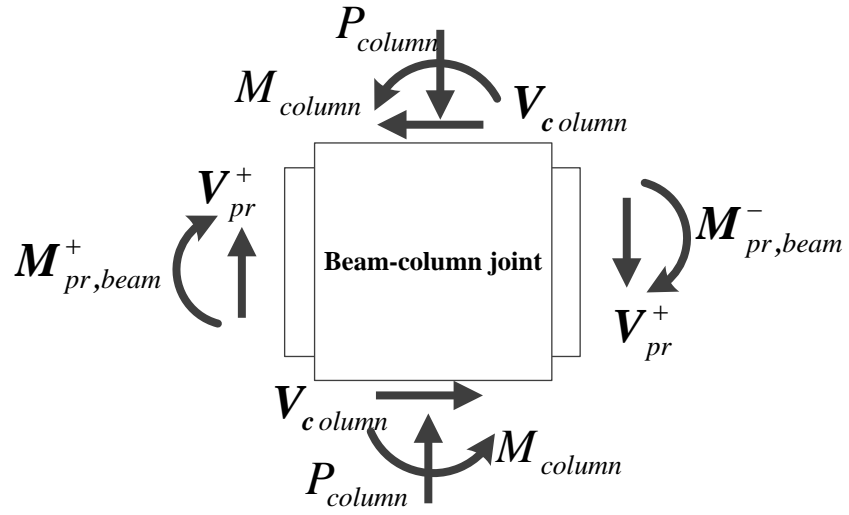
1.5 Moment, shear, and axial force around beam-column joint

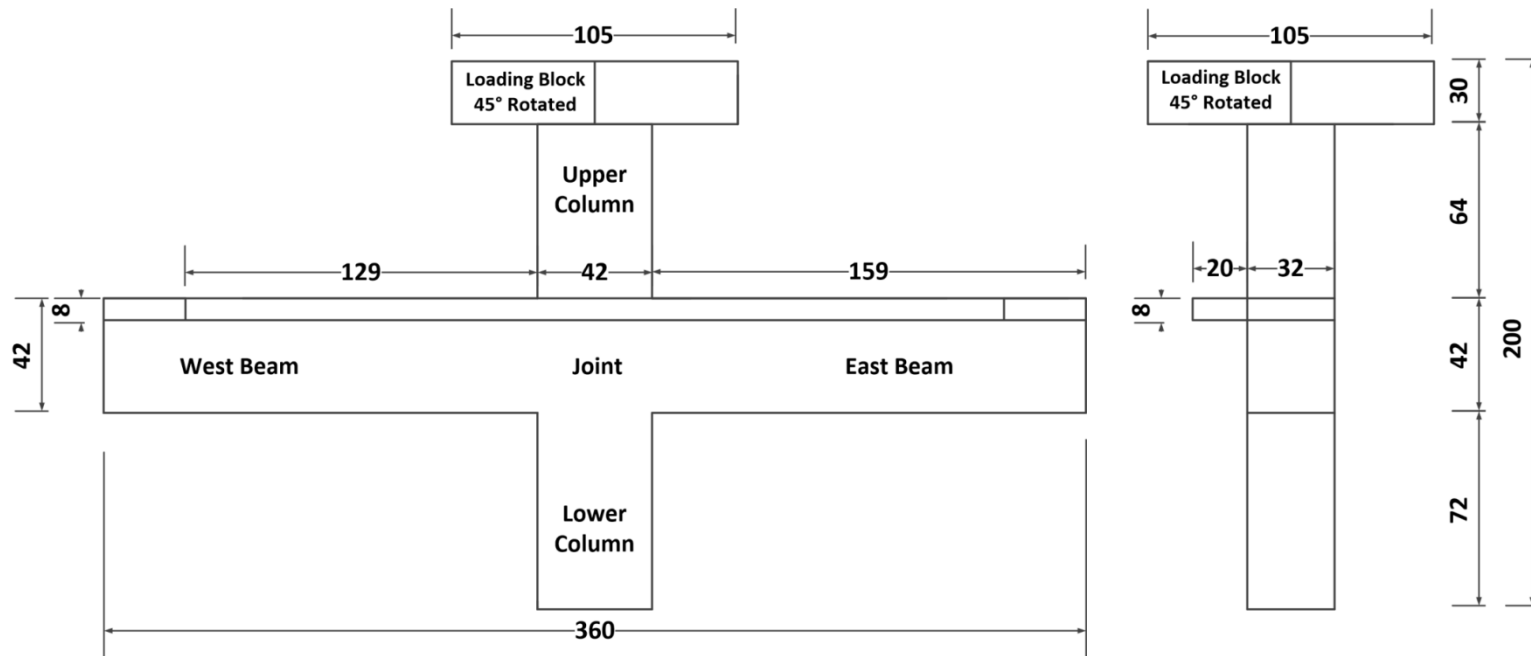
Figure 2.4 Configuration and dimensions of specimens

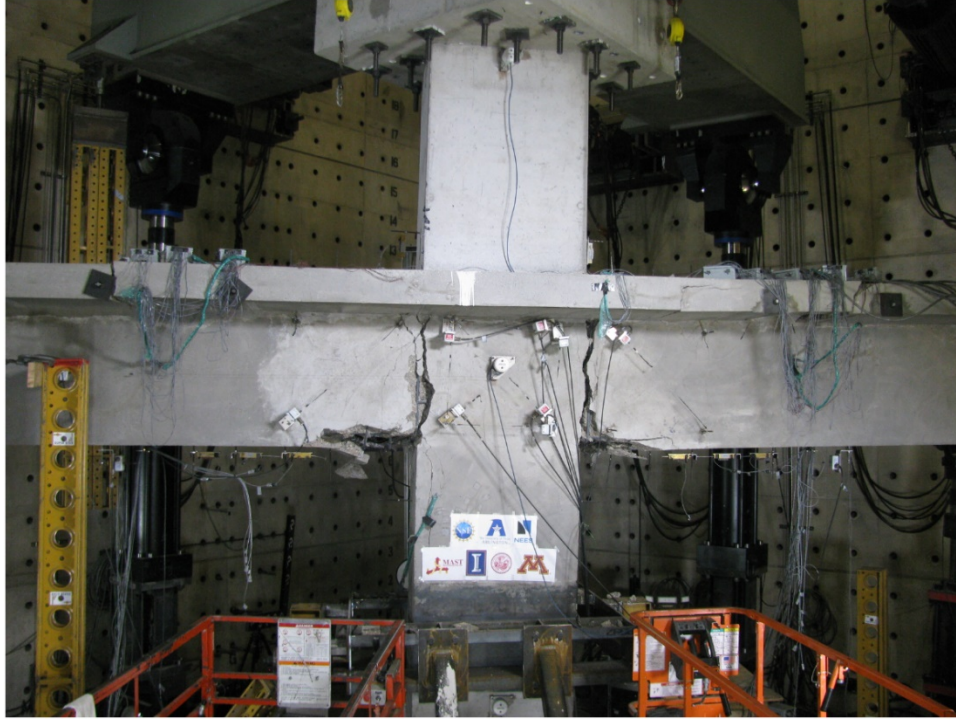
Figure 3.1 RC-SP-NL after test

Figure 3.1 and 3.2 shows the cracks and damage of RC-SP-NL. This specimen was failed due to the buckling of beam longitudinal reinforcing reinforcement. Although some minor cracks were developed, no noticeable damage was found in the column during the test. In the joint, many diagonal cracks and some concrete spalling were observed. However no noticeable damage was observed throughout the test. The first crack appeared at 0.3% column drift ratio. It was a vertical flexure crack developed at a beam-column interface. As load reversed, a similar crack occurred at the opposite side of the column. At this point, no cracks were observed in the columns and joint. At 0.5% column drift level, the first crack in the joint appeared. It was a diagonal crack which developed from a corner to the opposite corner. A few flexure cracks were overserved, which were located away from the beam-column interfaces. No shear cracks were found in the beam plastic hinge regions. As load reversed, another diagonal shear crack was observed in the joint. This diagonal crack intersected previous one building a grid.

continued in a monotonic manner until the crosshead reached its stroke capacity. While this loading all the longitudinal reinforcement in compression zone were buckled out, perpendicular to the beam longitudinal axis. The cracks in the joint, column, and the beams away from the column faces became difficult to observe with bare eyes. Test was finished since the specimen was failed due to the buckling of beams longitudinal reinforcement.

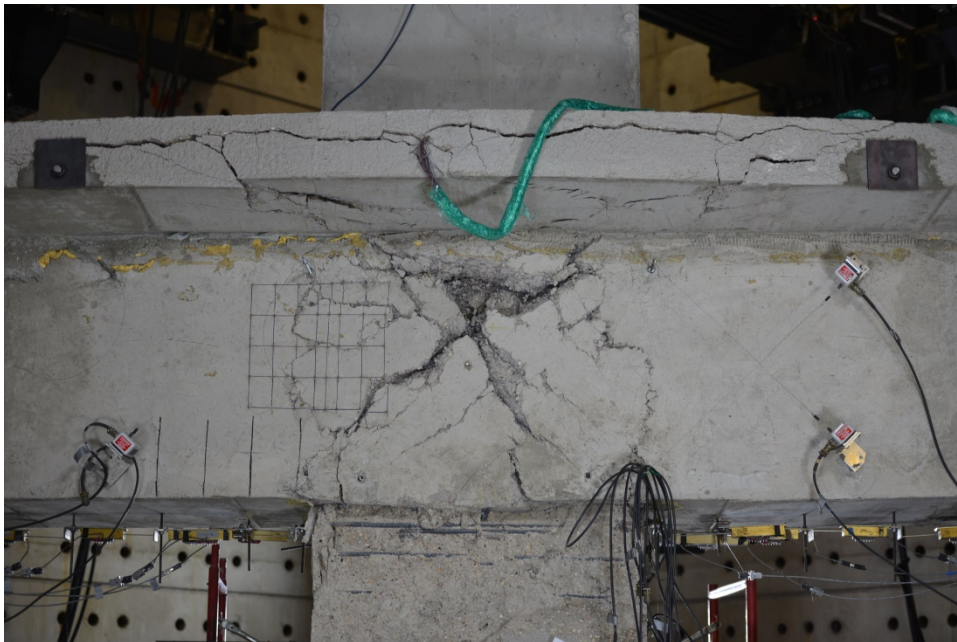
Figure 3.6 Cracks and damage of RC-SP-CL after test

Figure 3.5 and 3.6 show the crack and damage patterns of HPFRC-SP-CL, which can be compared to those of RC-SP-CL since they are subjected to the same cyclic loading. And this can be used to evaluate the performance of HPFRC on controlling the cracks and damage. The testing of HPFRC-SP-CL was able to continue up to 8.0% CDR because the damage in the beams was minimized by the balanced damage in the joint, thereby preventing any significant twisting of the sub-assembly. The joint damage of HPFRC-SP-CL was not noticeable up to 1.75% column drift ratio compared with RC-SP-CL. However, it became much more severe after 2.75% column drift ratio. Some cracks were observed in the column, but no notable damage was found up to the end of the test. The first flexural crack at the bottom of the west beam-column interface developed during the first positive cycle at 0.25% column drift ratio followed by another flexural crack at the east beam-column interface during the first negative cycle at the 0.35% column drift ratio. Unlike RC-SP-CL, these flexural cracks at the bottom of the beam-column interfaces did not interconnect with other cracks from the top of the beam. Therefore, the beam and column did not separate until the end of the test.

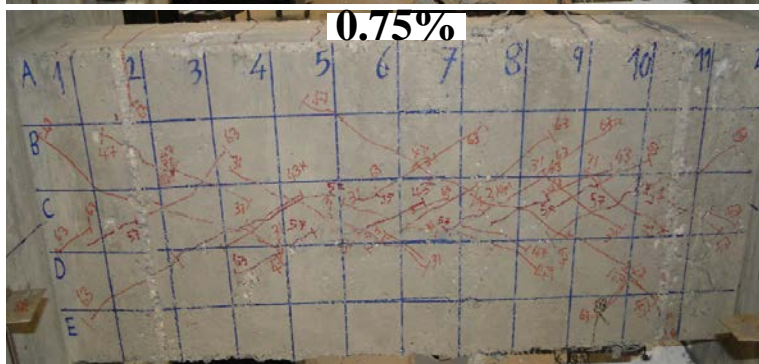
7.7 Cracks and damage patterns of RC-2.4-SC-0.25 (1)

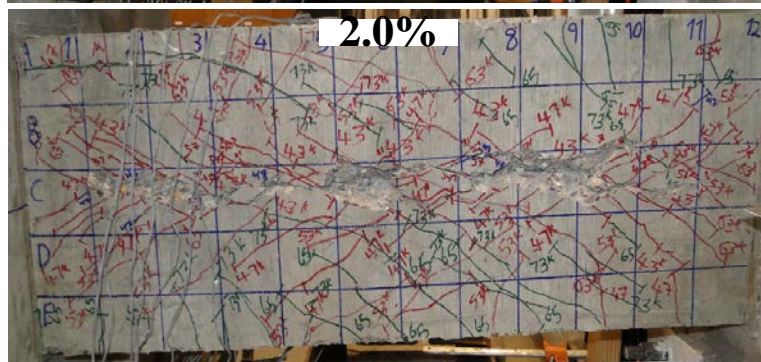
7.8 Cracks and damage patterns of RC-2.4-SC-0.25 (2)

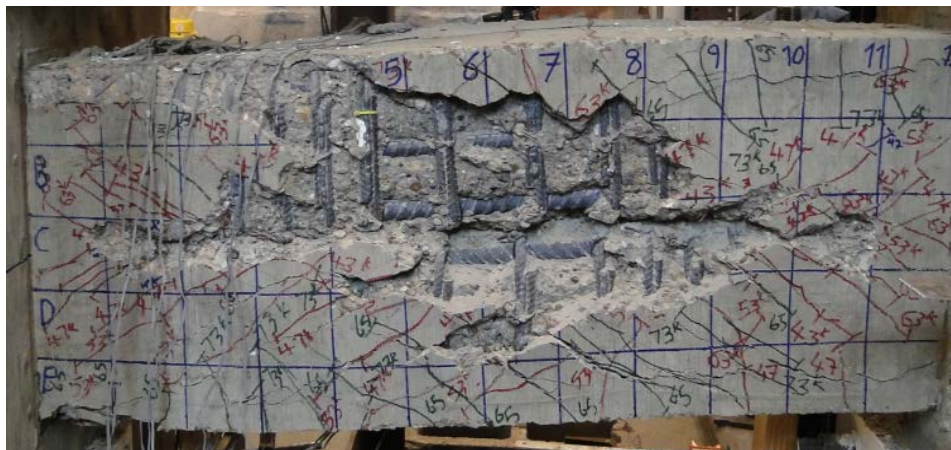
Figure 8.4 (a) Reduced shear span of DBCB and (b) Shear failure of DBCB due to reduced shear span

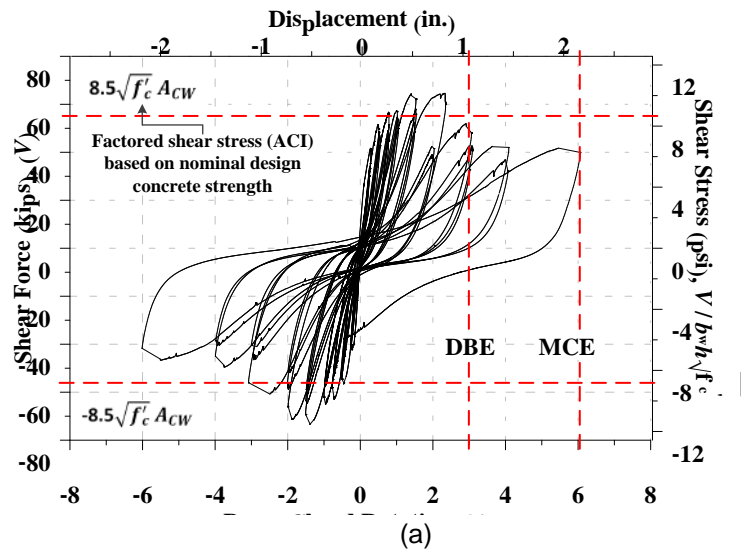
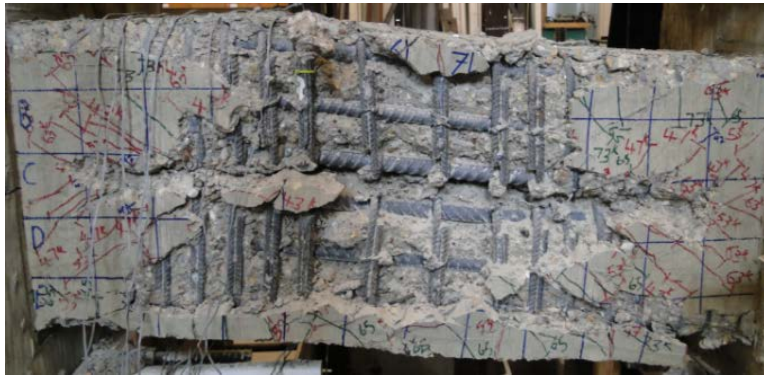
Figure 8.8 (a) Hysteresis response of specimen with 0.25 in.-wide gap and (b) damage pattern at 6% beam chord rotation
