STRUCTURAL SAFETY OF BRIDGE DECKS  
WITH VARIABLE REBAR  
COVER

MASTER OF SCIENCE IN STRUCTURES AND APPLIED MECHANICS

THE UNIVERSITY OF TEXAS AT ARLINGTON

December 2018

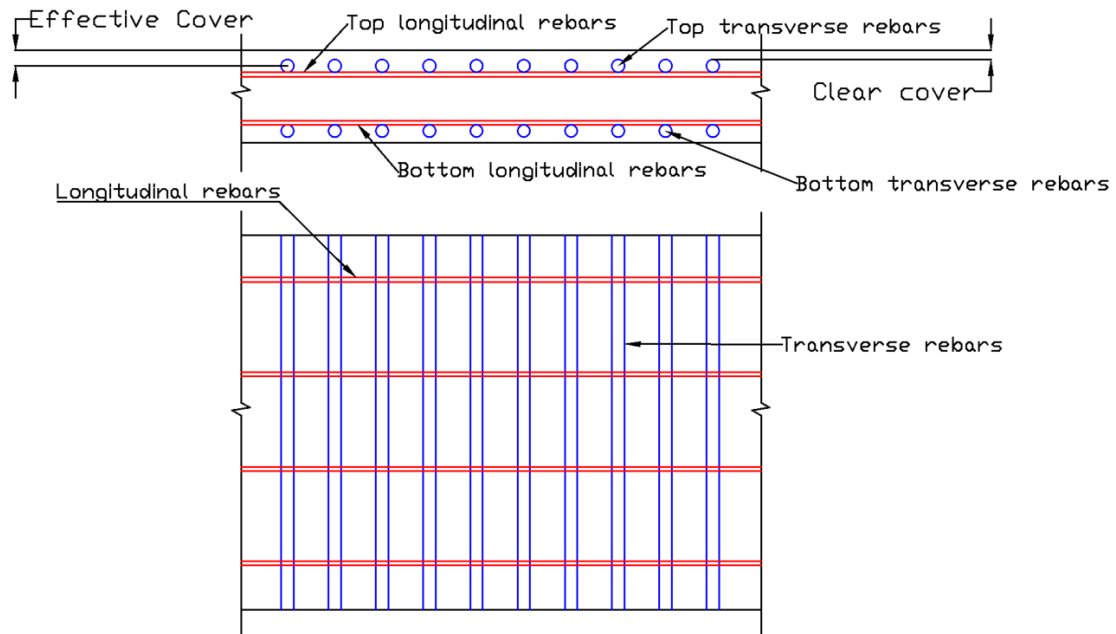
Figure 2-1 Cover on deck for top reinforcement

The distance from the surface of embedded steel in concrete to the outer surface of the concrete is termed as clear cover. It protects rebar against the outside environment responsible for corrosion, distribute stress in concrete, responsible for bond strength and provide thermal insulation. The thickness of the cover is mostly depended on the type of structural element and environmental condition. On bridge deck, top of the concrete slab is subjected to abrasion from vehicle, water and deicing salts hence provided more as compared to bottom cover where no such forces exist. The effective cover is measured from the center of rebar while clear cover from the outer surface. Figure 2-1 shows the cover in deck for top reinforcement and bottom.

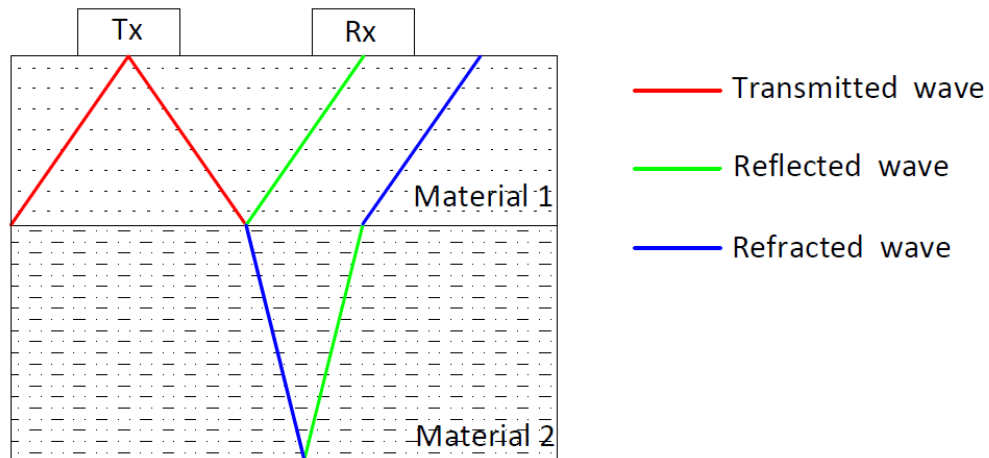
Figure 2-3 Radar waves in different medium

GPR system consists of a control unit, power supply, and antenna. Control unit has electronics which trigger electromagnetic pulse. Antenna housing contains transmitter and receiver, transmitting and receiving reflected energy from objects buried, respectively. When this radar energy encounters a difference in medium three things happen, part of it penetrates, reflects and absorb by the surface. Figure 2-3 shows the Transmitter (Tx) emitting radar energy (red wave) into subsurface material 1. After reaching the interface of two material part of the energy is reflected and captured by Receiver (Rx), part of it is refracted and enter medium 2. This process continues till the radar energy is attenuated. Analyzing the reflected waves gives useful information about subsurface material properties.

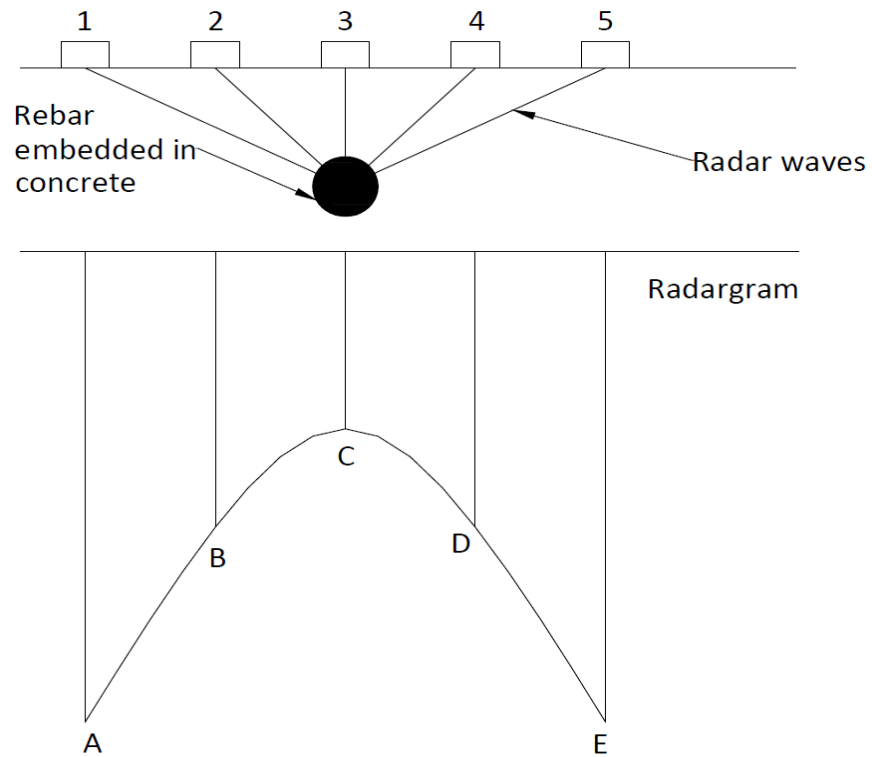
Figure 2-5 Formation of Radargram

Radargram is the term used for output image generated by GPR. The antenna radiates energy in a wide cone. While scanning on a concrete deck with rebar, the reflection looks like the inverted hyperbola because the reflection is received by the receiver before the antenna is at top of rebar. The peak of the hyperbola in radargram represent the exact location of rebar. In Figure 2-5 when the antenna is at 1 the reflected wave is captured, and a point A is obtained in radargram. In a similar way when antenna moves from 1 to 5 it emits waves which get reflected by rebar and hyperbola is produced.

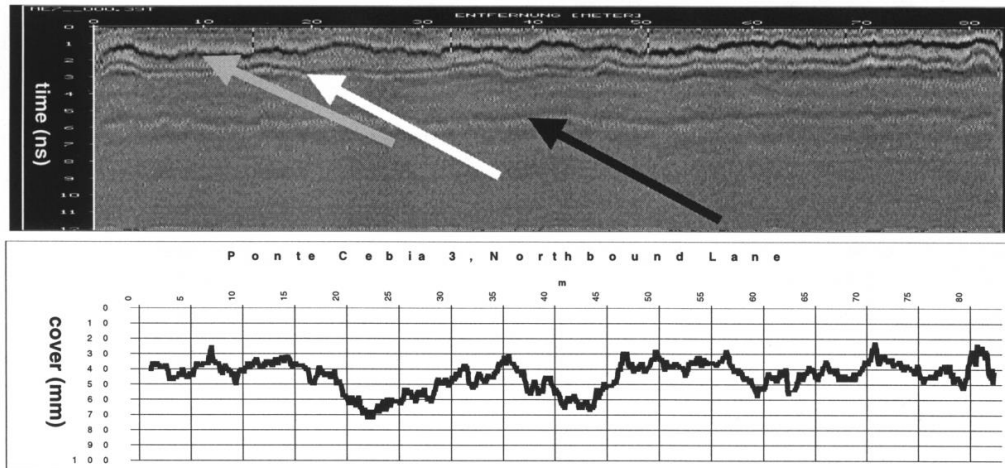
Figure 2-12 Variation in Asphalt Layer (gray arrow), Rebar (white arrow) and Concrete Bottom (black arrow), (Hugenschmidt, 2002)

In the study Hugenschmidt, 2002 horn antenna(ground coupled) with a center frequency 1.2Ghz. A constant signal velocity of  $0.9 \times 10^8$  m/s within the concrete was used to convert the original time axis to depth. A comparison between radar results and 15 cores resulted in a mean difference of 0.24 in. (6 mm) for 4 bridges. Figure 2-12 shows asphalt (gray arrow), white arrow (rebar) and black arrow (concrete bottom). The variation was seen in asphalt pavement thickness and rebar cover. The rapid measurement of thickness from GPR for was demonstrated.

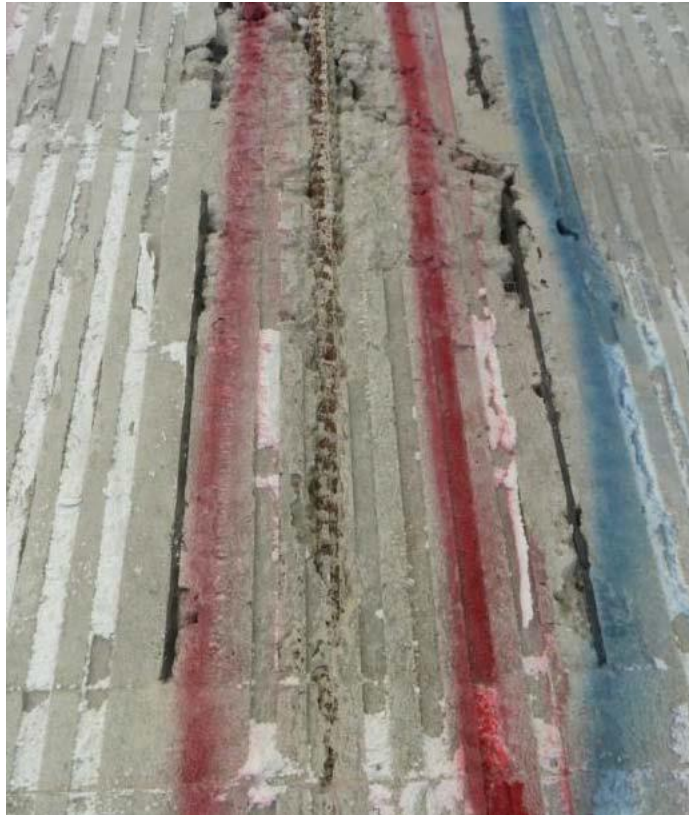
Figure 2-13 Exposed reinforcement in wall outline in red

The case study by Erdem and Peraza (2015) involved assessment of reinforced concrete wall defects. The building was for federal agency, so it was not subjected to local building code regulation and special inspection during construction. This building was constructed using insulated concrete forms which remains and serves a purpose of thermal insulation. The reinforcement location was not in accordance to design was found accidentally and honey combing at several location was observed. Detail inspection at 26 locations was carried using GPR to identify other construction defeats. The vertical reinforcing bars planned centered along the thickness of wall varied as much as  $\pm 2\frac{3}{4}$  in. (69.85mm) beyond the tolerances  $\pm 3/8$  in. (9.525mm) provided by ACI. This was found in 12 of 26 located surveyed causing losses in strength for negative and positive bending. Figure 2-13 is the exposed reinforcement resulted with corresponding reduction of strength tabulated in Table 2-3. This indicated inspection before placement of concrete was not performed properly.

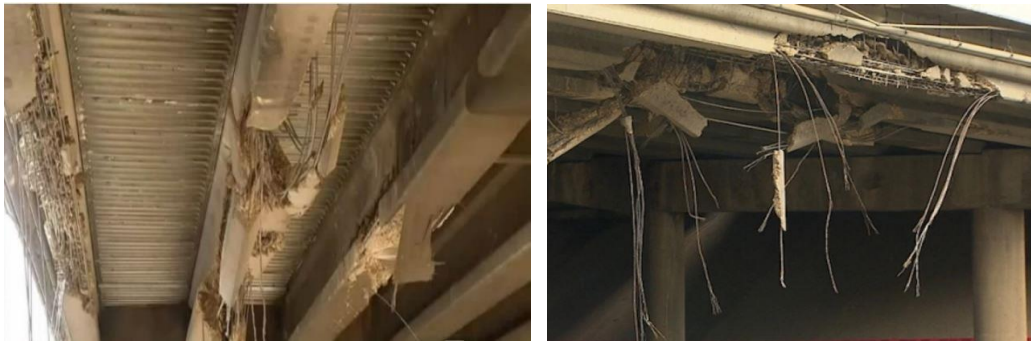
Figure 3-1 Impact Damage on Old SH183 over Loop 12

The Loop 12 bridge carrying State Highway 183 (SH 183) over Loop 12 was constructed in 1959 and later widened in 1969. It was a four span simply supported bridge. Its superstructure comprised pre-stressed concrete I-girder and composite cast-in-place concrete deck. There was impact damaged in 2006 (Figure 3-1) resulting in the replacement of a section of the third span superstructure. Figure 3-2 is the plan of bridge with different construction time and location of repaired deck. The location of bridge is shown in Figure 3-9 in red marker.

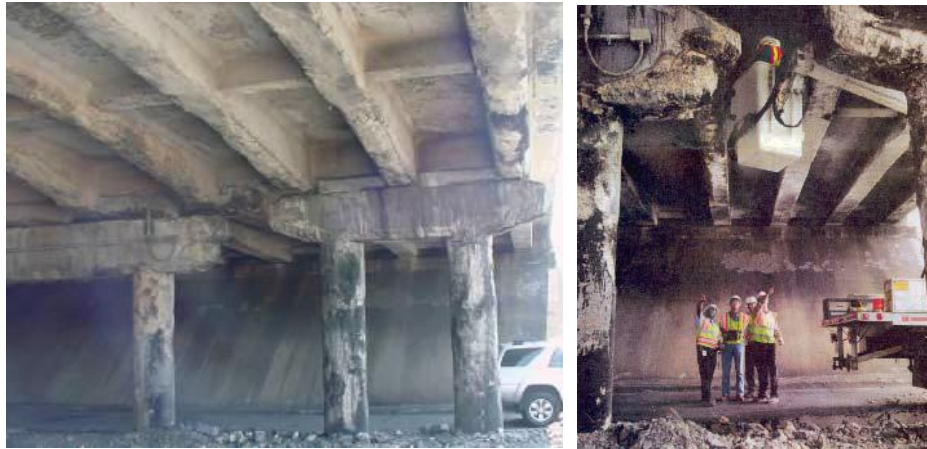
Figure 3-6 Fire Damage on Old SH183 over MacArthur

The old MacArthur Blvd Bridge carrying state highway 183 (SH 183) was constructed in 1958 and later widened in 1970. This bridge is cast-in place reinforced concrete with a continuous span and composite T-beam (Figure 3-7). On the morning of May 28, 2005, a fuel tanker carrying 300 gallons (1136 liter) of fuel heading east on SH 183 fell off the bridge and caught on fire below the bridge (Figure 3-6). The concrete in the bridge beams, columns and the deck suffered spalling and popping damage because of sustained fire. The damaged components were repaired using the mortar and strengthened with CFRP laminates.

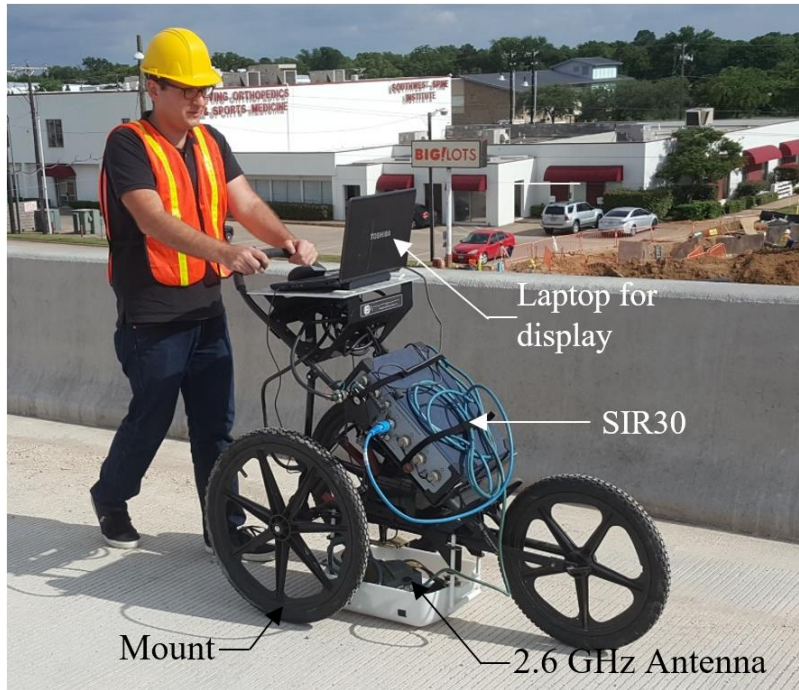
Figure 4-1 Tri-wheel Cart with Ground Coupled Antenna

Before data is collected using GPR the site is prepared. Bridge is closed for traffic by part or whole. The guidelines from start to end of bridge are marked at 3 feet spacing in transverse direction. First line 3 feet from rail to accommodate cart width. The purpose of this lines were to help to ensure the cart moves in straight line.

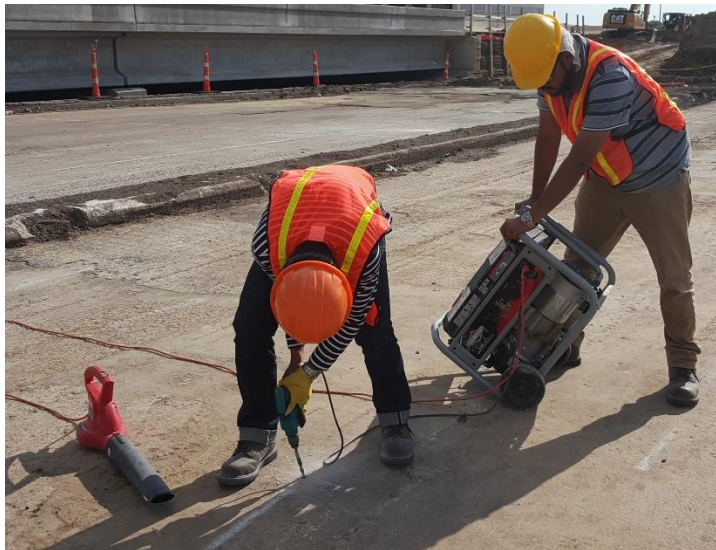
Figure 4-3 Drilling for true concrete cover

After scanning, 1 to 3 individual rebars were located on deck and true depth or clear cover at this location were measured by drilling (Figure 4-3). This will be used later to calculate dielectric constant by ground truth method.

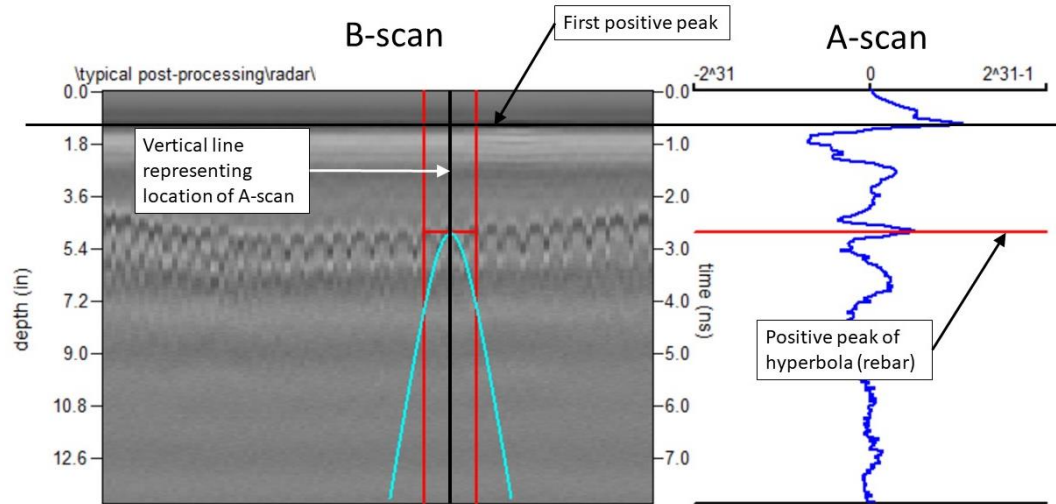
Figure 4-5 Measurement of Rebar Depth

Time-zero correction refer to identification of true concrete surface which is first positive peak in radargram. This is set as a start line for TWTTs measurement. Figure 4-5 shows the B-scan on left and corresponding A-scan to the right. The first positive peak is marked with the black line which is starting axis for the measurement of TWTTs. The clear cover of rebar is equivalent to distance between two positive peaks in A-scan.

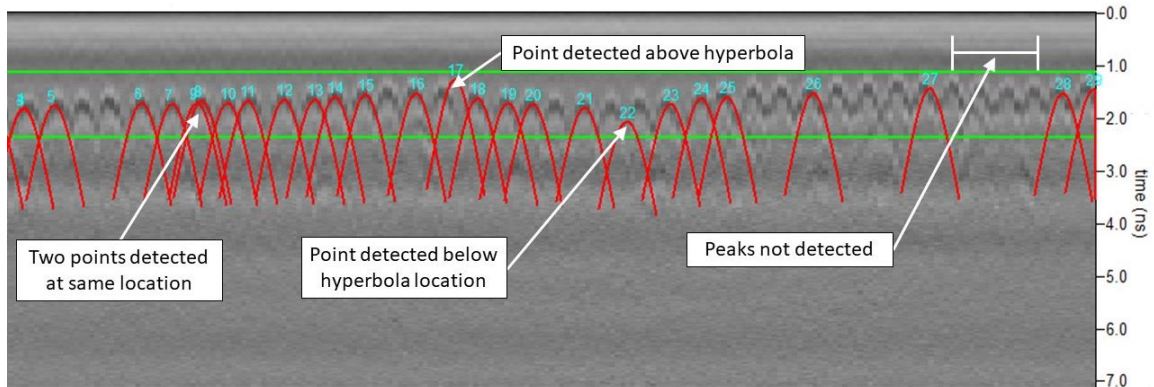
Figure 4-6 Auto-detection of Hyperbola

For a particular radargram, there are 1 to 2 rebars or hyperbolas per foot which equal 150 to 480 hyperbolas per radargram dependent on the spacing of rebar and length of the bridge. For this auto-detection module of GPR-slice is used. The radargrams are filtered by the bandpass filter and background removal which aid in accurate detection. Even with the filters applied detection cannot be perfected (Figure 4-6). The peaks which are off are deleted and manually adjusted. This process is time-consuming so peaks between two linearly varying points are neglected. The information stored in '.dat' file is extracted for next step.

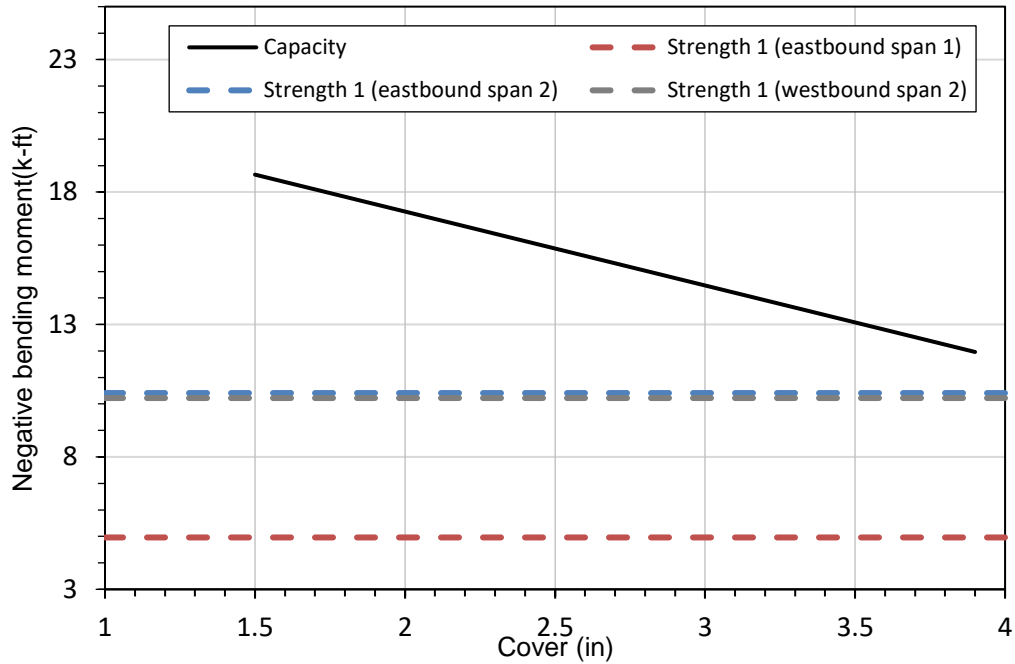
Figure 6-5 Negative bending moment vs clear cover

The Figure 6-5 is the comparison of design negative bending moment and the capacity of the deck. It can be observed that design negative moment is less than the reduced capacity due to variation. This suggest that the deck is safe even with the max cover range. This also implies that deck is over designed.

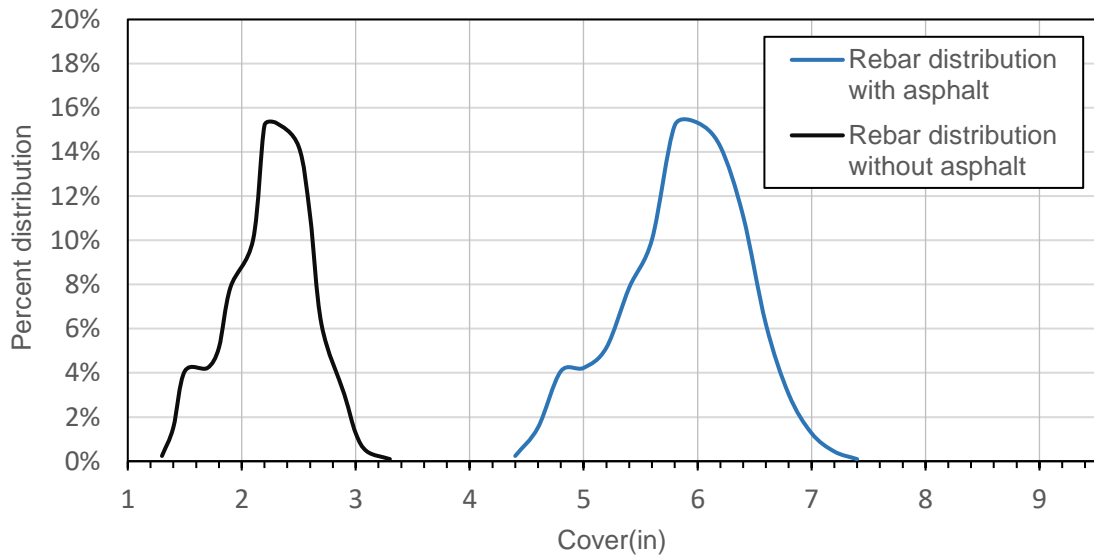
Figure 6-14 Old SH183 Over Loop 12 Westbound Rebar Distribution

6-14). The distribution without asphalt layer was found within 1.3 to 3.3 inch (33 to 84mm). Figure 6-15 is the capacity vs design moment comparison.

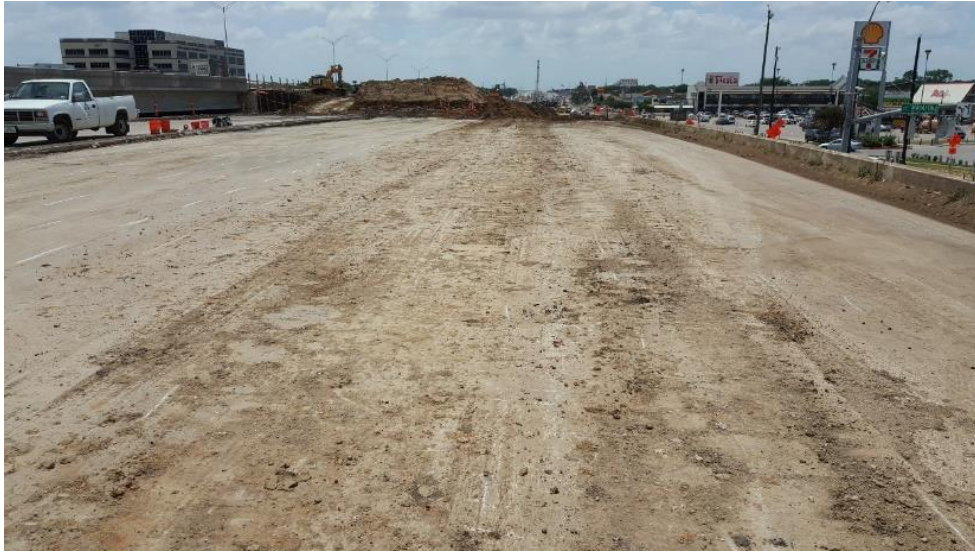
Figure 6-21 Presence of Soil on Deck

Due to stripping on asphalt layer on deck and presence on soil (Figure 6-21) the GPR scan shown huge variation of rebar cover. The Figure 6-22 shows the disturbance in radargram due to stripping of asphalt and presence of soil. Figure 6-23 shows the high cover at start and end of radargram, which is present in all radargram at start. This contributes to the high range of cover variation in old MacArthur bridge. The rebar cover range is from 1.5 to 7 in. (38 to 178mm), about 84.83 % lies with 2 to 4 in. (51 to 102mm) (Figure 6-24).

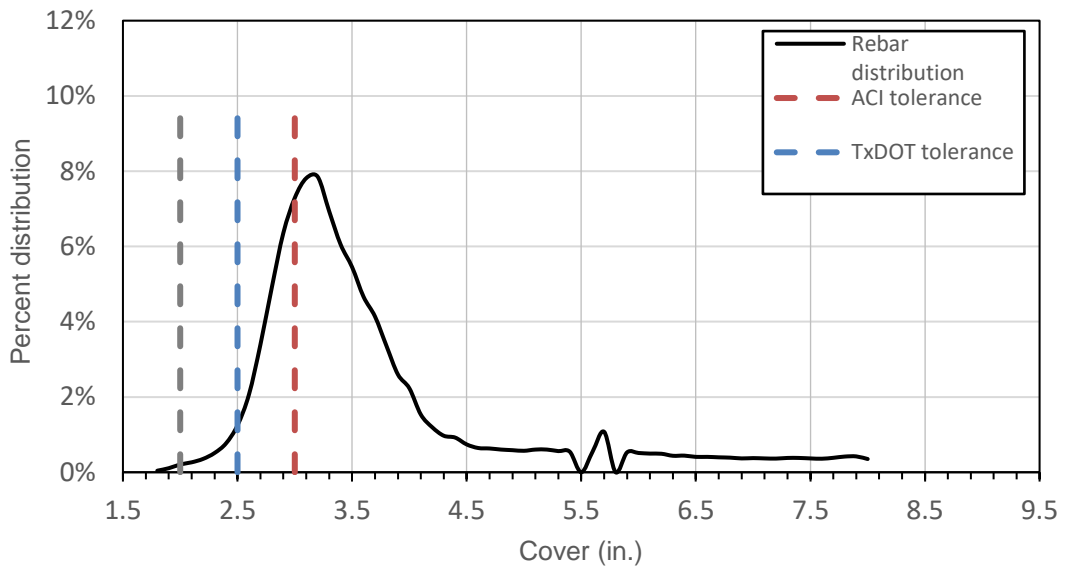
Figure 6-26 Old SH183 over MacArthur Westbound Rebar Distribution

Similarly, for 183 over MacArthur westbound high cover was observed at start and end on westbound of bridge (Figure 6-25). The rebar variation lies between 1.5 to 8 (38 to 203mm) inches, with 78.47% lies within 2 to 4 (51 to 101mm) inches (Figure 6-26). The Figure 6-27 is the design negative moment and capacity comparison.

The Table 6-5 is the standard deviation of the rebar distribution. Old SH183 over MacArthur shows large deviation while new bridges have less. This is due to change in dielectric constant which resulted in improper depth calculation.
