HYDRAULIC PERFORMANCE EVALUATION OF EVAPOTRANSPIRATION COVER  
SYSTEMS

BRETT DEVRIES

Presented to the Faculty of the Graduate School of  
The University of Texas at Arlington in Partial Fulfillment  
of the Requirements  
for the Degree of

THE UNIVERSITY OF TEXAS AT ARLINGTON

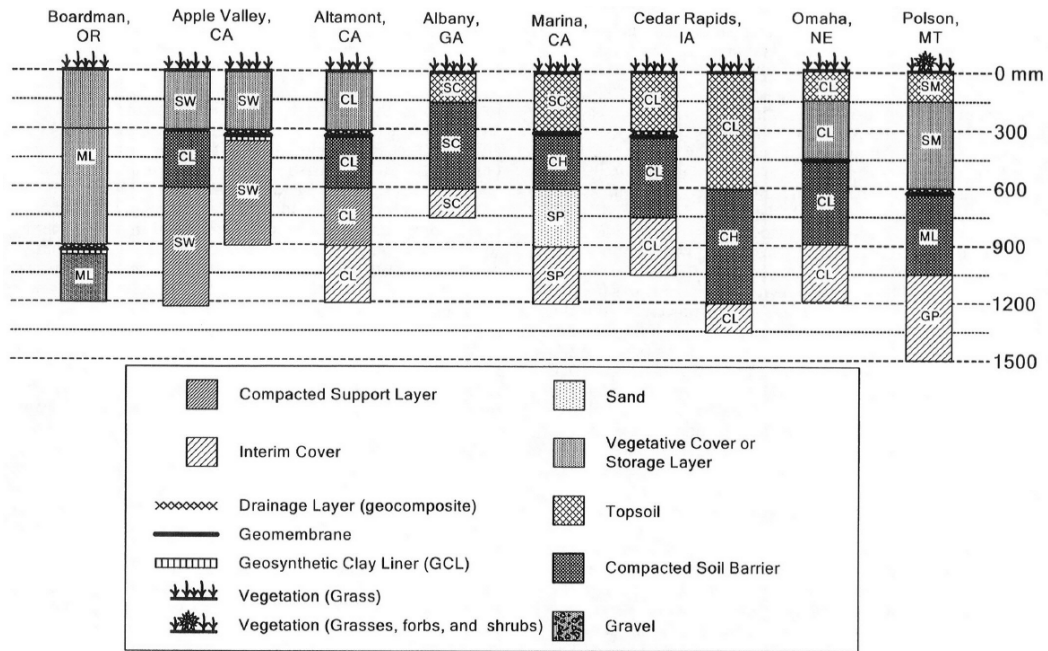
Figure 2.17: Profiles for conventional covers evaluated by the Alternative Cover Assessment Project (ACAP). Two-letter designations are designations in the Unified Soil Classification System per ASTM D-2487: CL, low-plasticity clay; CH, high-plasticity clay; GC, clayey gravel; GP, poorly graded gravel; ML, low-plasticity silt; SC, clayey sand; SM, silty sand; SP, poorly graded sand; and SW, well-graded sand (Albright et al., 2004).

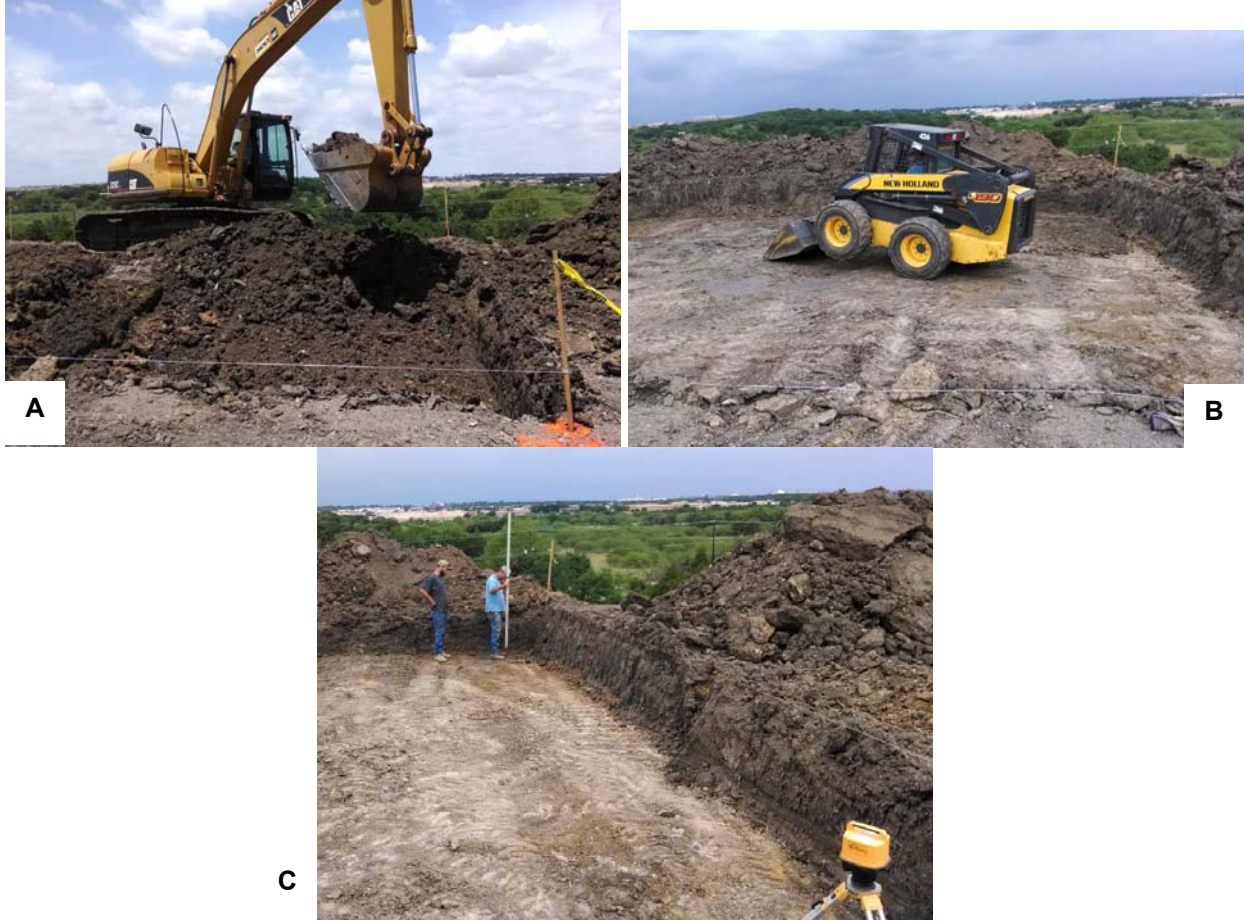
Figure 4.4: Lysimeter excavation a) excavation in preparation for a lysimeter, b) finalizing the lysimeter subgrade and compaction by a skid-steer, and c) subgrade slope and height verification.

Post embankment construction, soil was excavated in the lysimeter locations by the contractor. The excavation areas were approximately 12 x 12-m (40 x 40-ft) wide and approximately 0.9-m (3-ft) deep. Subgrades of the excavated areas were compacted to provide an adequate surface to place geomembrane and ensure minimal hydraulic conductivities below the geomembrane ( $k = 1 \times 10^{-7}$  cm/sec). It was discovered that sloping the sidewalls of the excavation minimized sidewall failure and allowed for easier geomembrane sidewall placement (Step 3). Additionally, the subgrade of the three (3) top sections were slightly sloped for water collection purposes ( $\pm 2\%$ ), and the inclined sections constructed with an approximate slope of 25%. A string line was placed around the perimeter of the lysimeters to help ensure correct dimensions (40-ft by 40-ft). For ease of construction, the top three (3) lysimeters were constructed first (up to Step 7), followed by the inclined sections. Critical steps in the embankment excavation task are presented in Figure 4.4, and UTA provided construction inspection and solved any encountered problems. General details of the embankment excavation (end of Step 2) are provided in Figure 4.5.

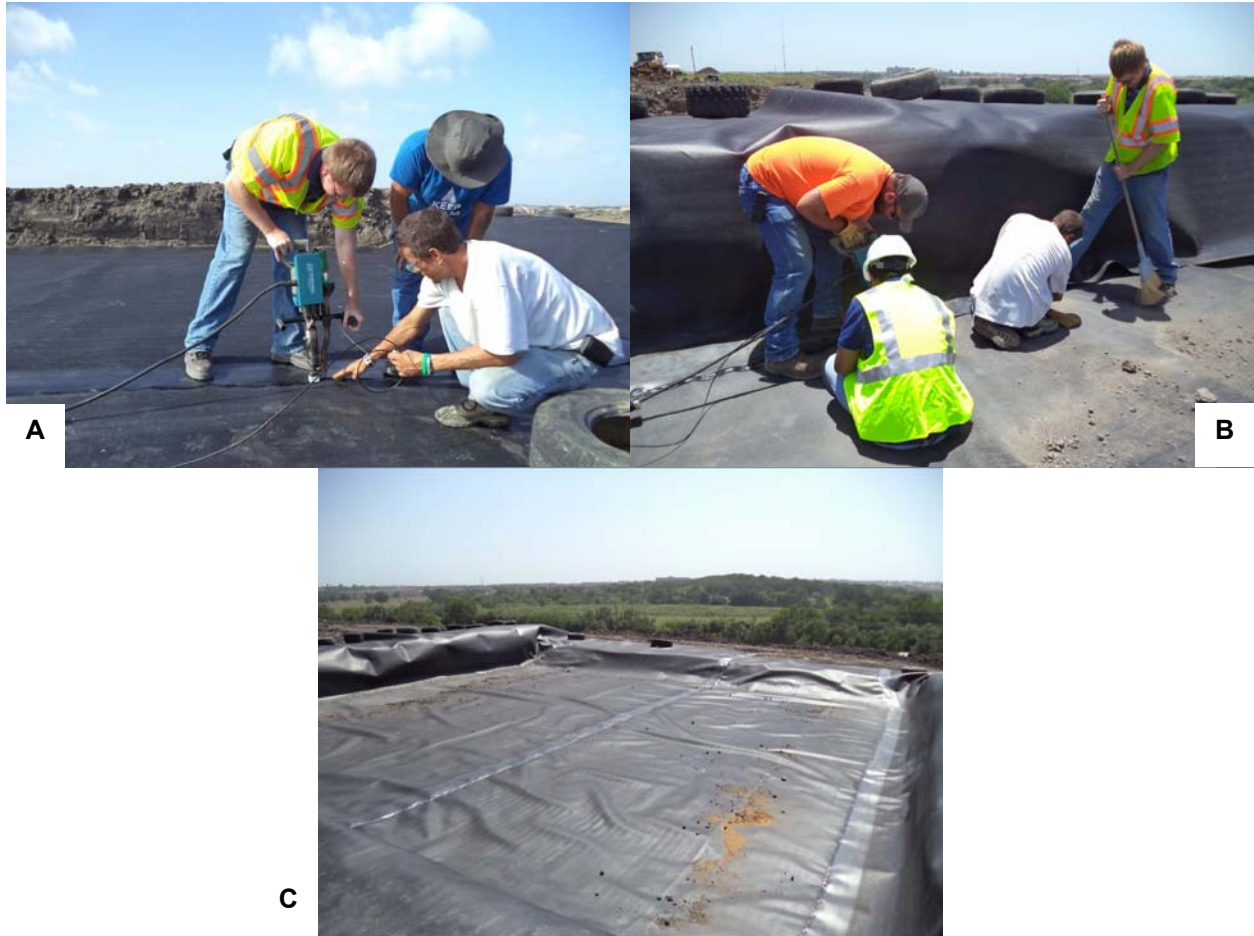
Figure 4.6: Geomembrane placement a) welding the geomembrane, b) sidewall geomembrane welding, and c) finished with the geomembrane in a lysimeter.

Geomembrane (60-mil) was placed on the subgrade and along the sidewalls of the excavations. Three (3) geomembrane sheets were placed downslope [two (2) overlaying the subgrade and one (1) cut into half and placed on the sidewalls]. Prior to geomembrane placement, soil clots and other debris were removed from the subgrade to provide a smooth surface and to prevent holes from developing in the overlaying geomembrane. The geomembrane sheets were welded together along the seams by a hand welder (Figure 4.6a). It was noted that a thinner geomembrane (especially along the sidewalls) may be used to allow greater flexibility and easier construction around corners and sidewalls. Sandbags and tires were placed on the geomembrane on the top of the embankment to avoid wind related issues. It was noted that summer related heat expansion of the geomembrane caused wrinkles, and it may have been beneficial to place the geomembrane during colder times of the year. Substantial amounts of time and effort were expended by UTA and the City of Denton (COD) staff to complete this task, and details are provided in Figure 4.6. General details of the geomembrane placement (end of Step 3) are provided in Figure 4.7.

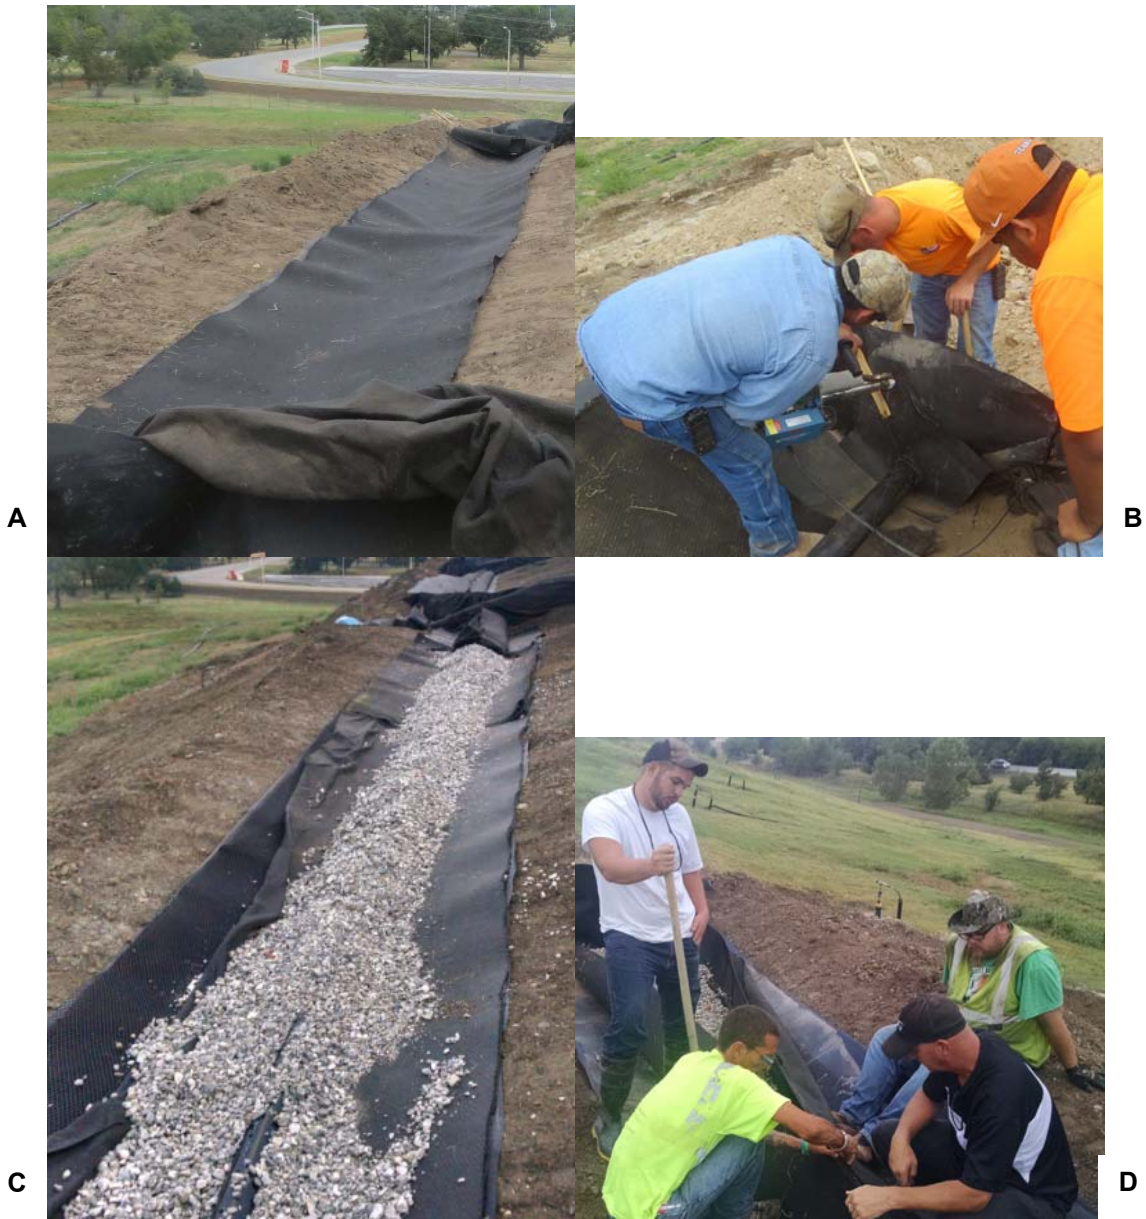
Figure 4.22: Runoff collection system a) geomembrane and geocomposite drain placement, b) welding geomembrane boot, c) runoff collection pipe and pea-gravel placement, and d) placing zip-ties to join the geocomposite drain.

A geomembrane liner was placed below the runoff collection system in an effort to avoid runoff from passing through the “burrito wrap” and infiltrating into the cover system prior to collection. General details of the runoff collection systems (end of Step 10) are provided in Figure 4.23.

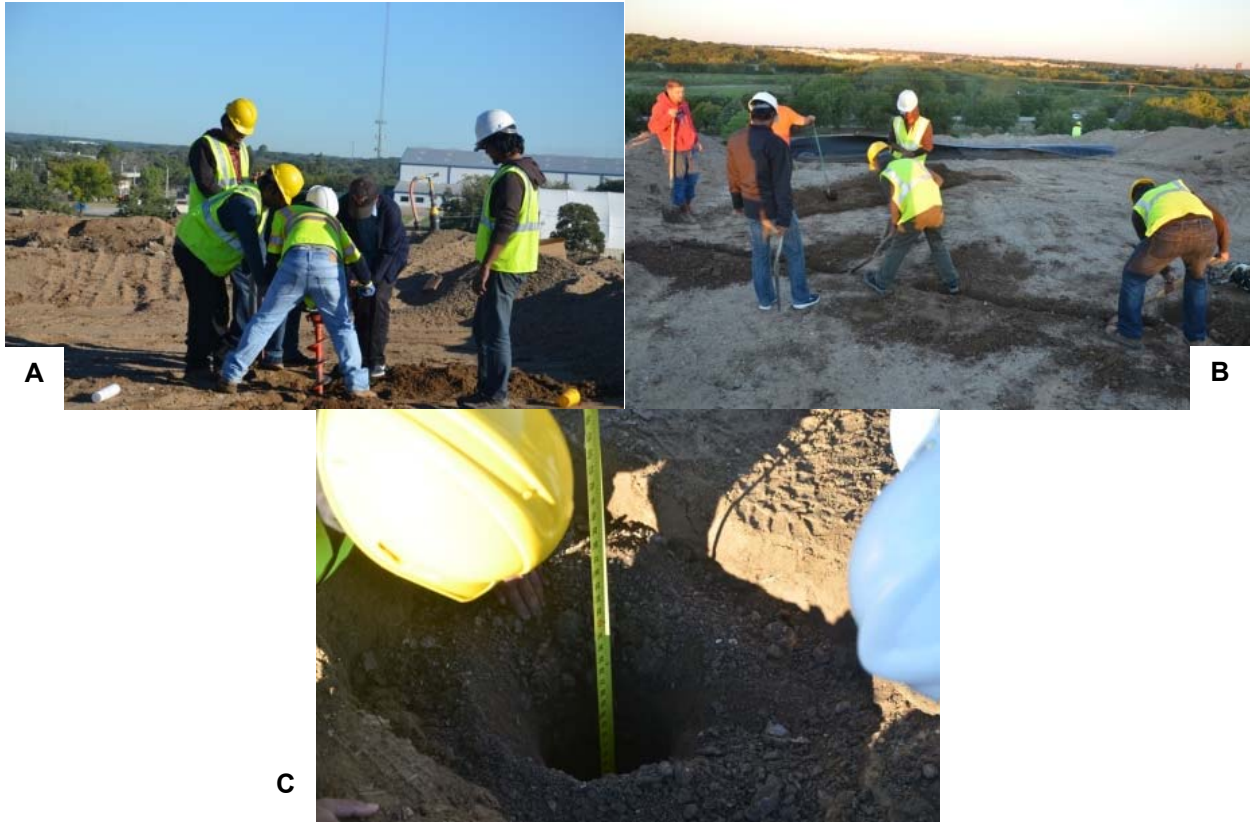
Figure 4.34: Moisture and tensiometers installation a) excavation by hand-held auger, b) digging of trenches for sensor wiring, and c) ensuring correct depth prior to sensor placement.

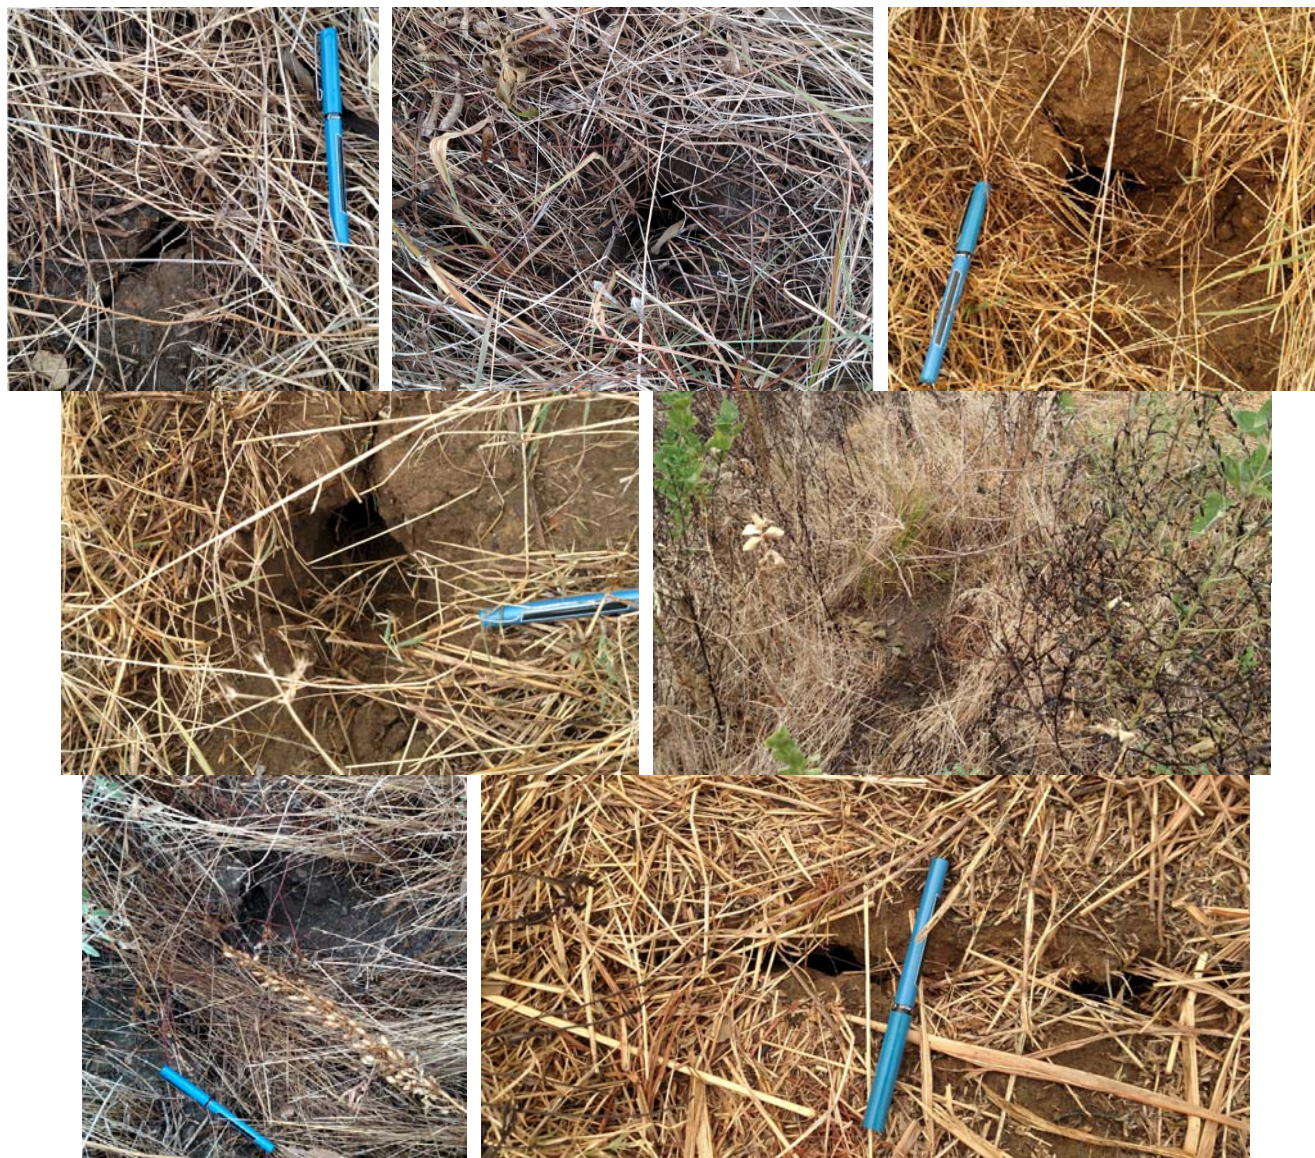
Figure 5.38: Rodent burrows and cracking – August 2016

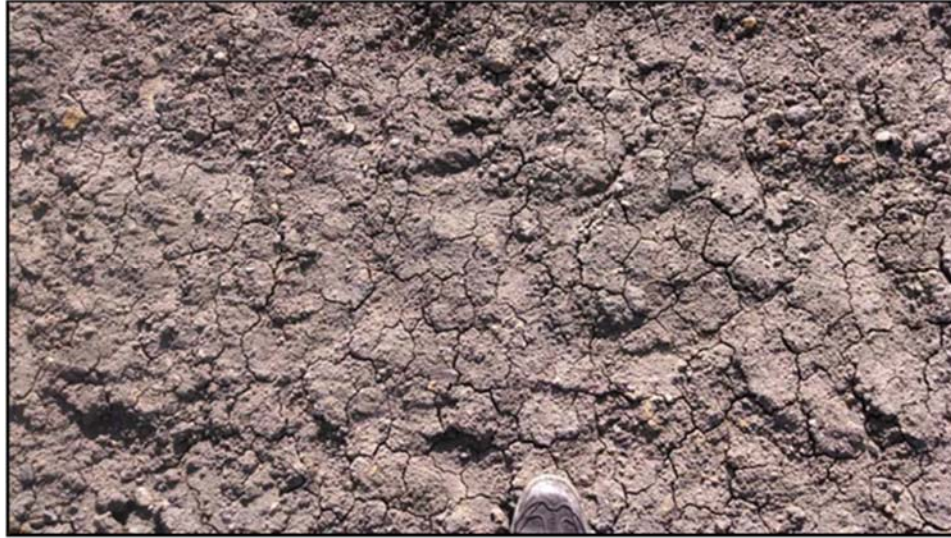
Figure A.51: Evidence of desiccation cracking on the surface of the embankment-one (1).

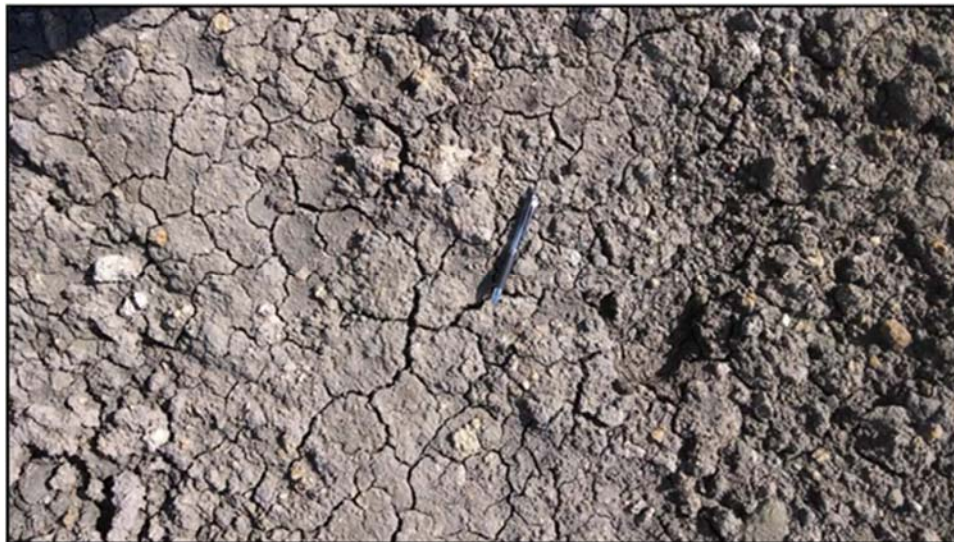
Figure A.52: Evidence of desiccation cracking on the surface of the embankment-two (2).

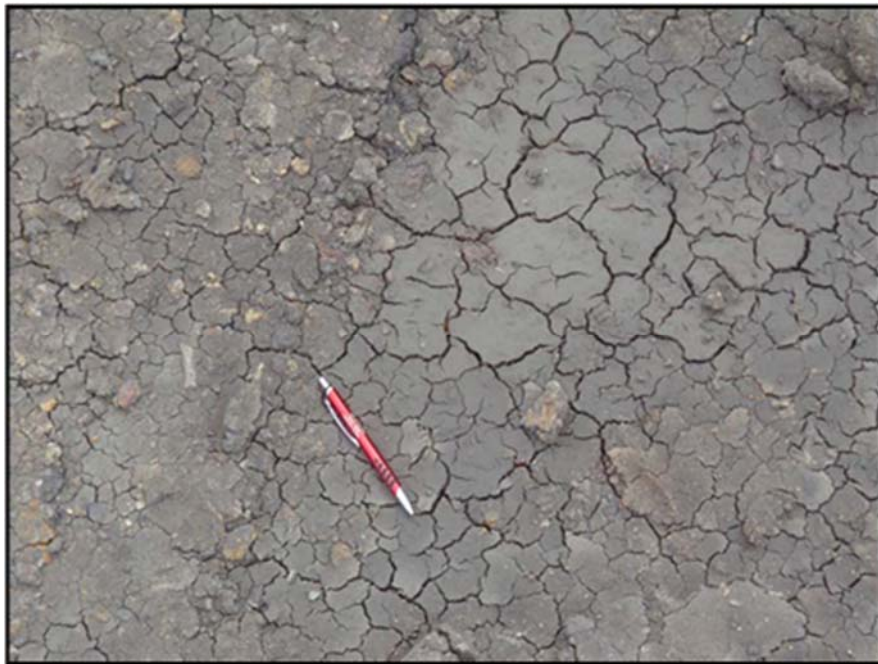
Figure A.75: Desiccation cracking of the subgrade at the beginning of the eleventh day.

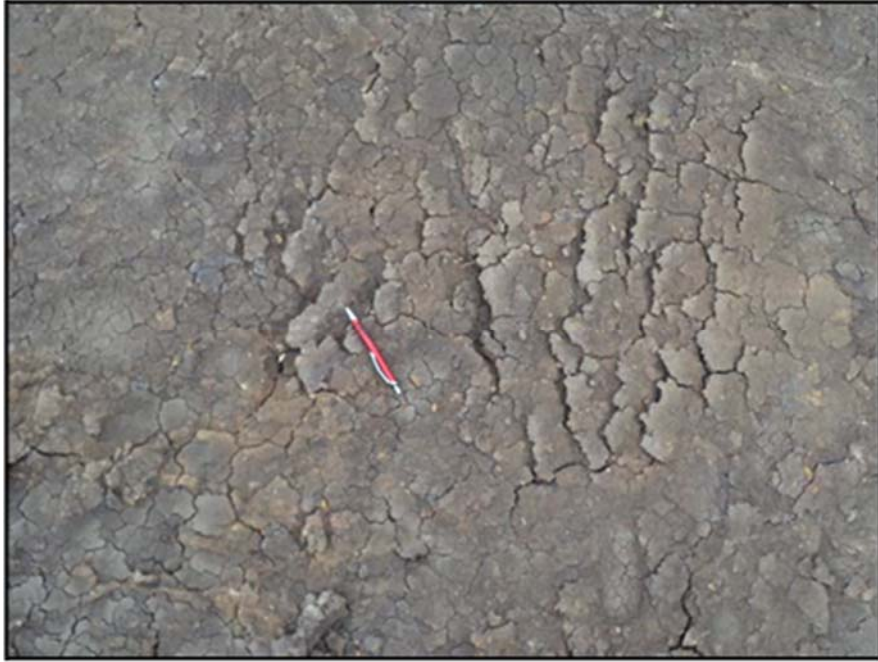
Figure A.76: Subgrade cracking at the beginning of the eleventh day.

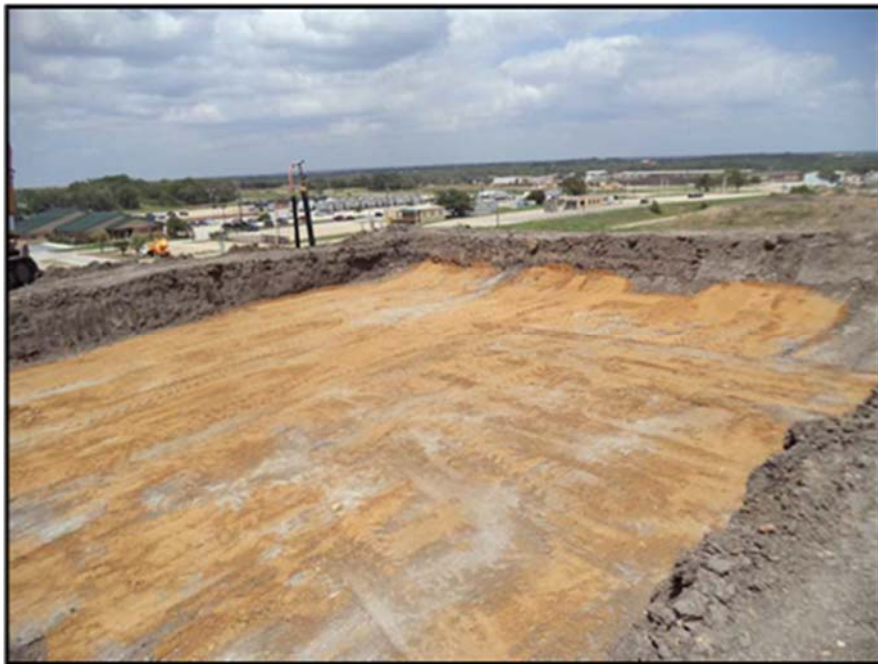
Figure A.77: Subgrade with sandy soil in low-lying areas.

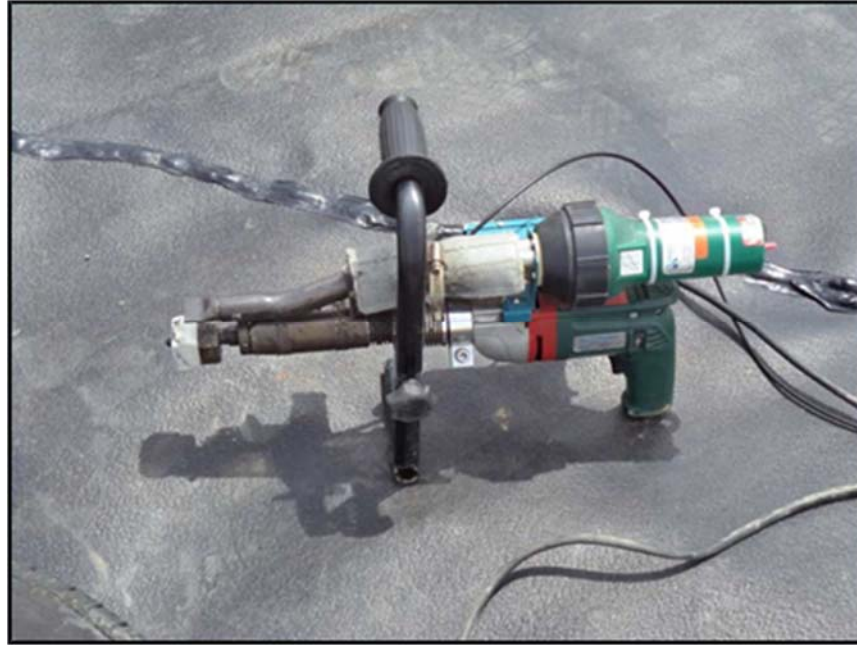
Figure A.101: Replacement extrusion welder (MINI-Z – Extrusion Welder from Polyweld USA).

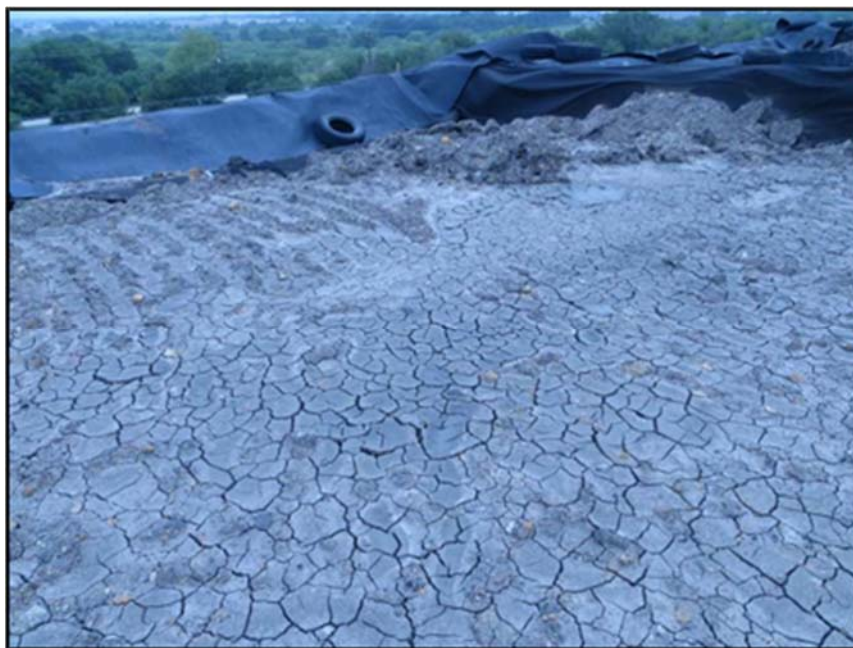
Figure A.212: Desiccation cracks present in the south top test section-one (1).

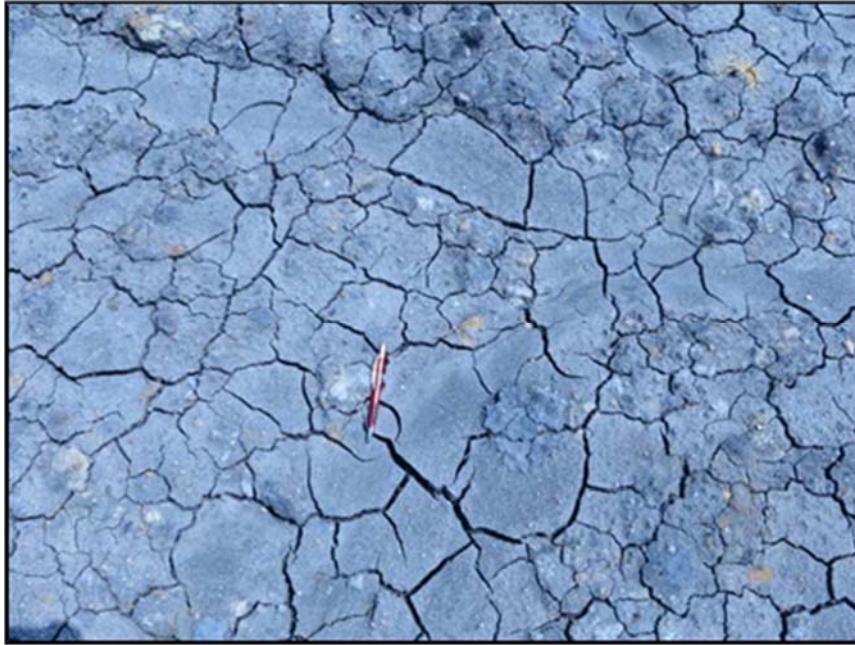
Figure A.213: Desiccation cracks present in the south top test section-two (2).

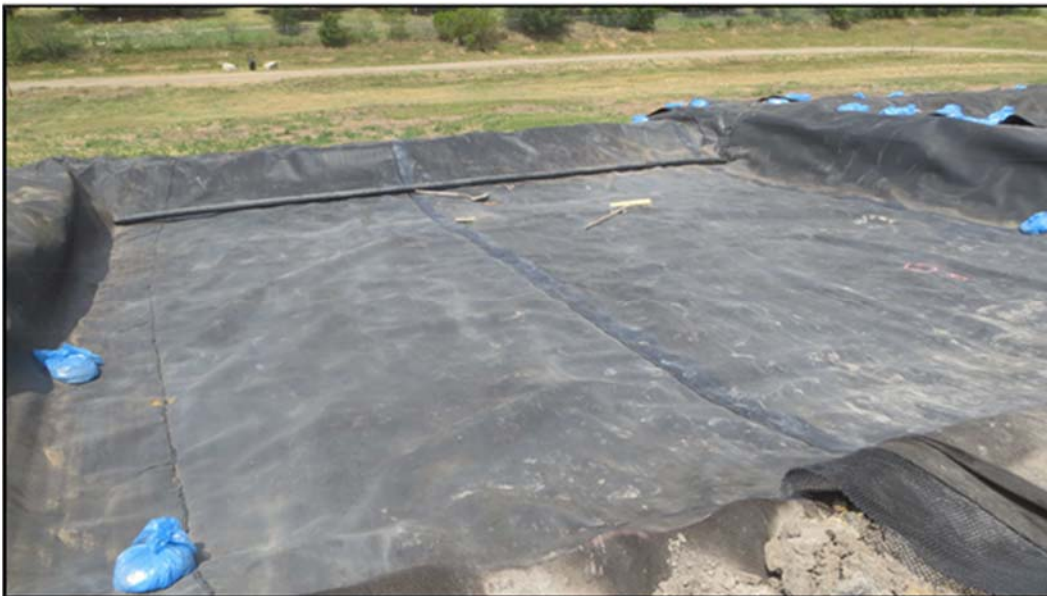
Figure A.283: Middle inclined section with geomembrane and HDPE piping system in place.

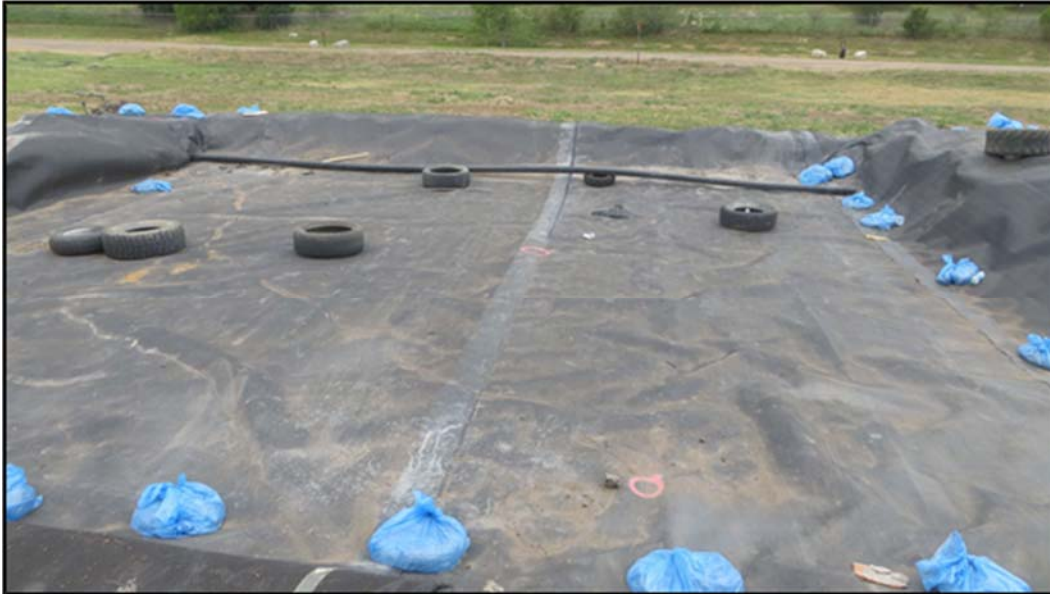
Figure A.284: South inclined section with geomembrane and HDPE piping system in place.

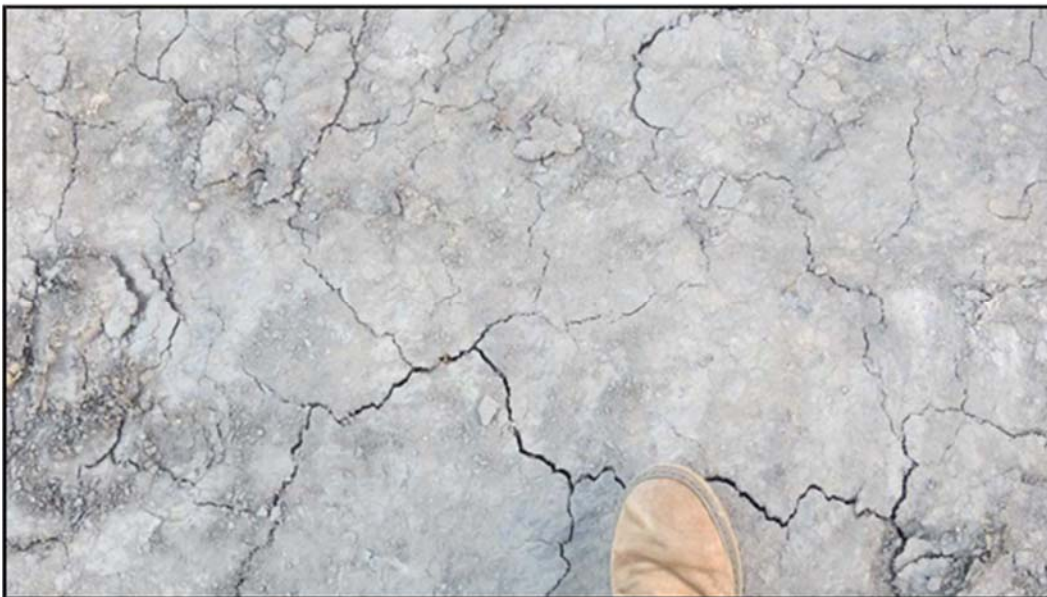
Figure A.315: Desiccation cracks found in the top of the soil layer.

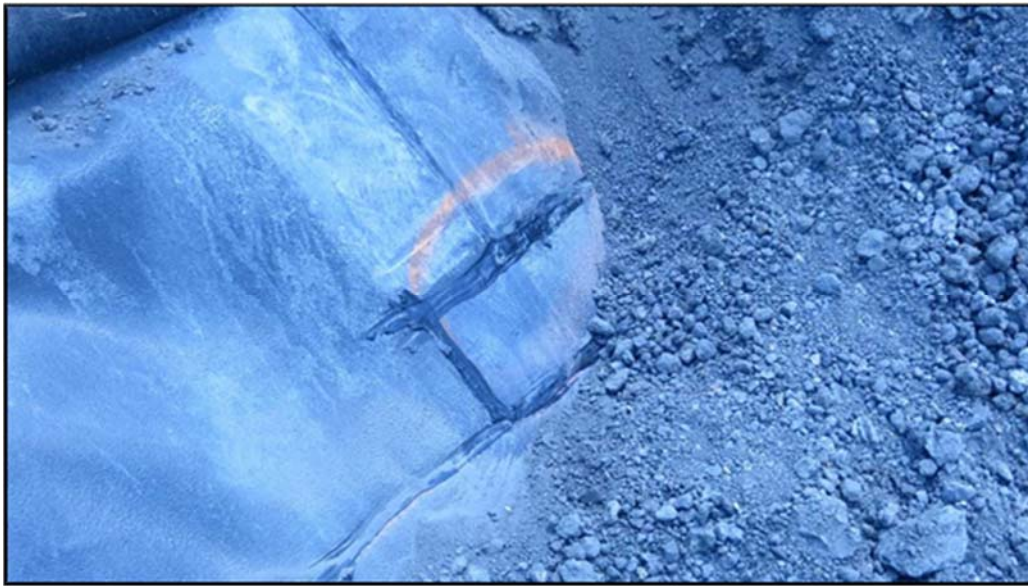
Figure A.316: Results of re-welding the separation in the liner.

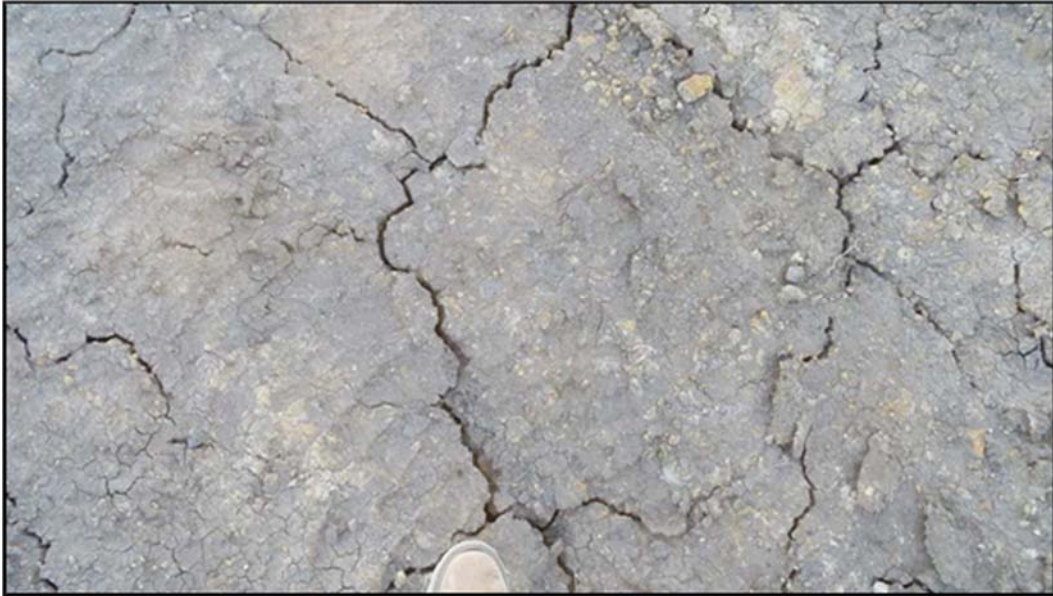
Figure A.349: Desiccation cracks present in an inclined section.

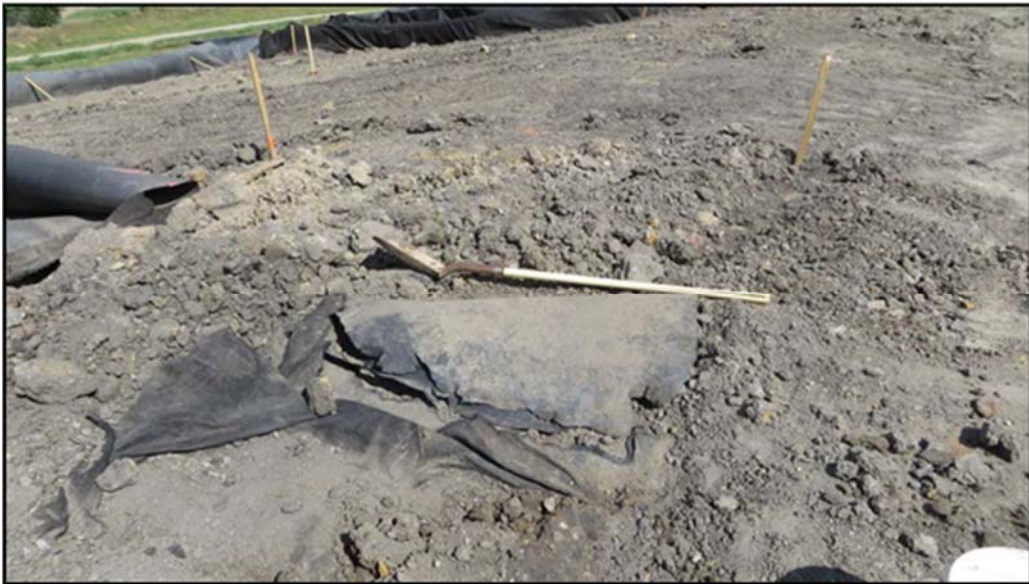
Figure A.350: Cut in the liner between the south and middle top sections.

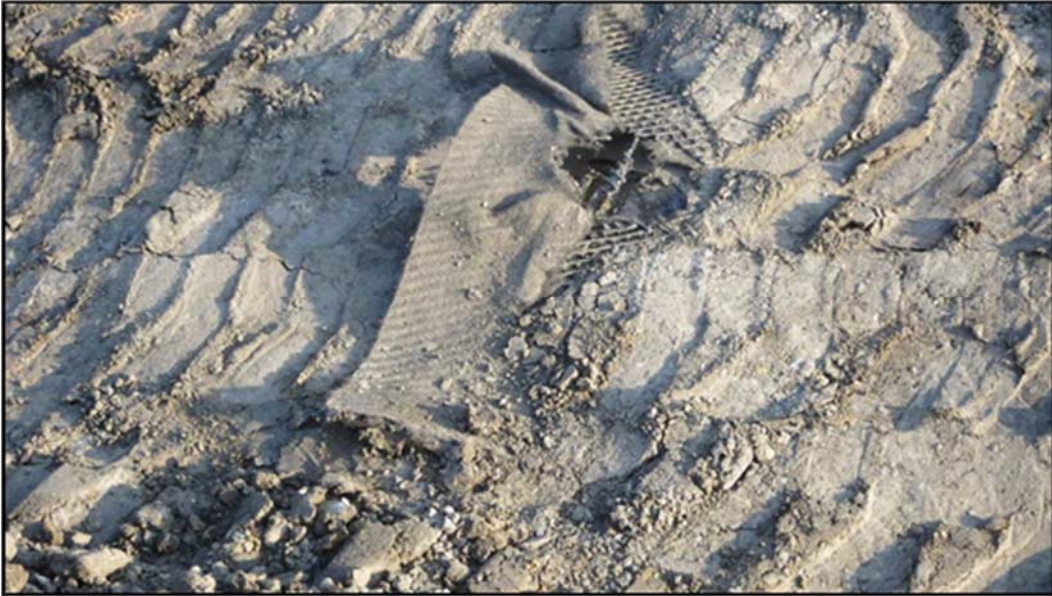
Figure A.365: Cut in the berm between the top and inclined middle sections-one (1).

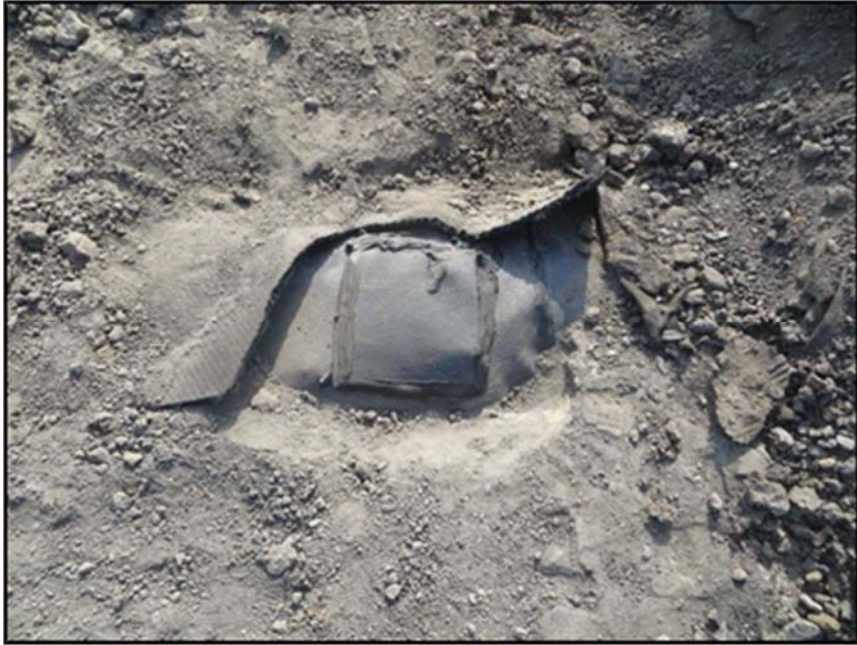
Figure A.367: Repair of the cut in the liner.
