EFFECT OF MODIFIED MOISTURE BARRIERS ON SLOPES STABILIZED WITH
RECYCLED PLASTIC PINS

ANUJA SAPKOTA

DOCTOR OF PHILOSOPHY IN CIVIL ENGINEERING

THE UNIVERSITY OF TEXAS AT ARLINGTON

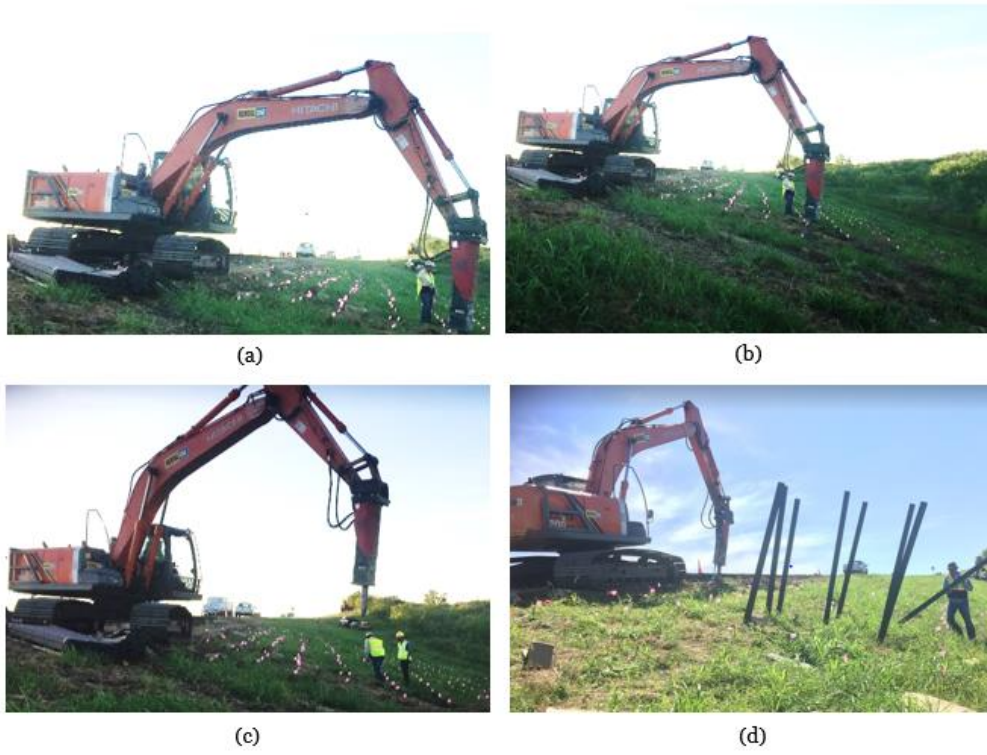
Figure 4-1. RPP installation process: (a) Excavator equipped with a hydraulic hammer, (b) RPP layout using flags, (c) Excavator equipped hydraulic hammer using steel pin to make 1.5 feet deep holes at flag location, (d) RPP placement.
