EVALUATION OF FIBER REINFORCED POLYMER (FRP)  
STRENGTHENING FOR DETERIORATED BRIDGE BENT CAPS

YAZAN ALMOMANI

Presented to the Faculty of the Graduate School of  
The University of Texas at Arlington in Partial Fulfillment  
of the Requirements  
for the Degree of

THE UNIVERSITY OF TEXAS AT ARLINGTON

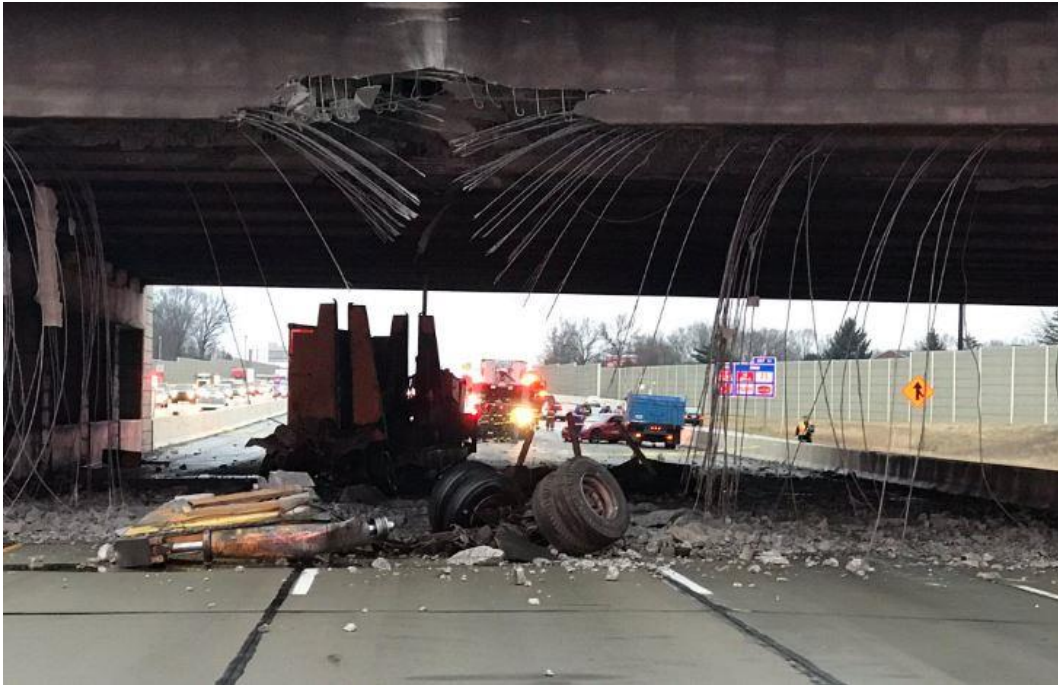
Figure 1-1 Overheight vehicle crash causes significant bridge damage in Indianapolis, Indiana. (FOX59, 2017)

structural deterioration or extreme events such as fire, earthquakes, and accidents as shown in Figure 1-1.

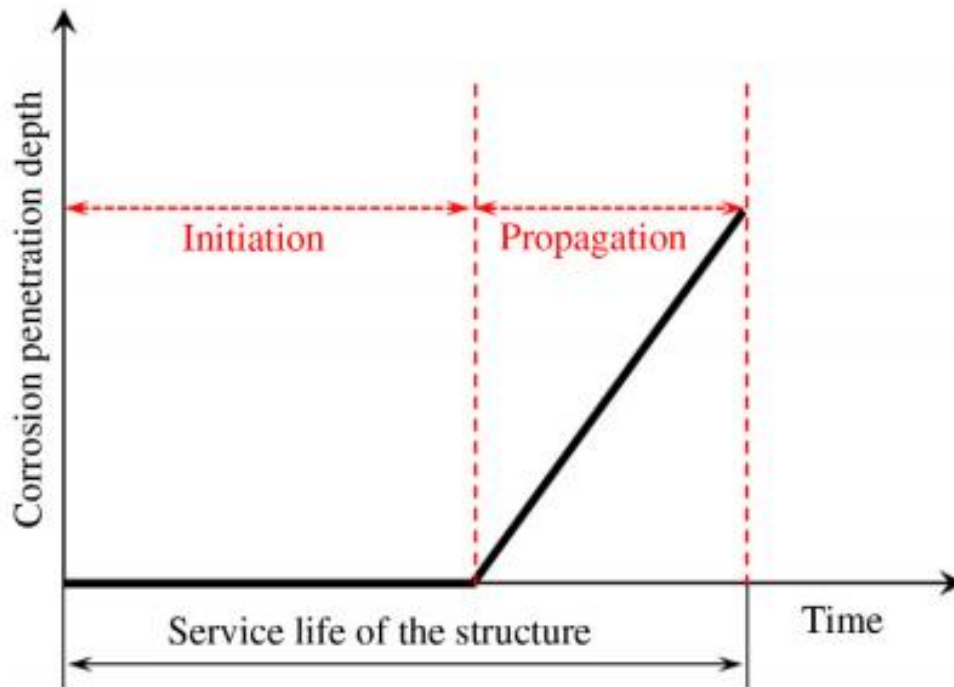
Figure 2-2 Initiation and propagation periods for steel corrosion in concrete (Zhoa and Jin 2016).

Reinforced concrete service life can be divided into two separate phases, as shown in Figure 2.2. The first one is the initiation of corrosion, which is the amount of time needed for chloride ions to reach the steel interface in sufficient amounts to initiate active corrosion (Zhoa and Jin, 2016). The duration of the first (initiation) phase depends on the penetration rate of the aggressive agents through the concrete cover and the corrosion resistance properties of the reinforcement steel in the cementitious environment (Trejo et al. 2009). Design codes normally define minimum cover depths to control the corrosion rate (Zhoa and Jin 2016). The second phase is the propagation of corrosion, which initiates when the steel is depassivated and eventually results in a limit state being reached. This phase is usually identified by the serviceability failure associated with cracking or separation of the concrete cover (Zhoa and Jin 2016). The propagation phase mainly depends on the rate of corrosion of the reinforcement (Trejo et al. 2009).

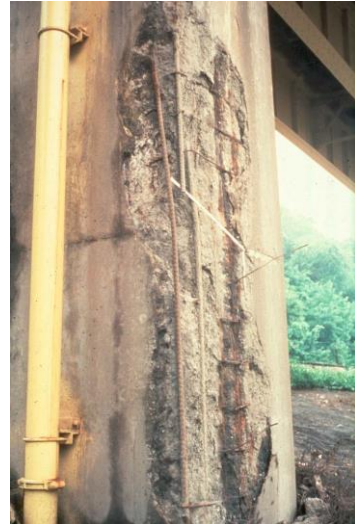
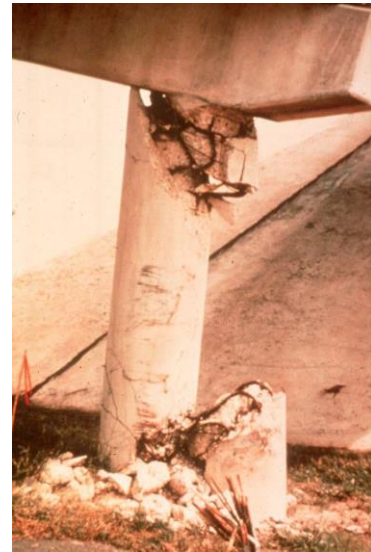
Figure 2-3 Concrete deficiencies: (a) Crack in concrete bent cap, (b) Concrete spalling due to contaminated drainage, (c) Concrete spalling on bent cap (d) Collision damage to concrete pier column (FHWA 2012)

- Cracking (see Figure 2-3 (a))
- Spalling (see Figure 2-3 (b) and (c))

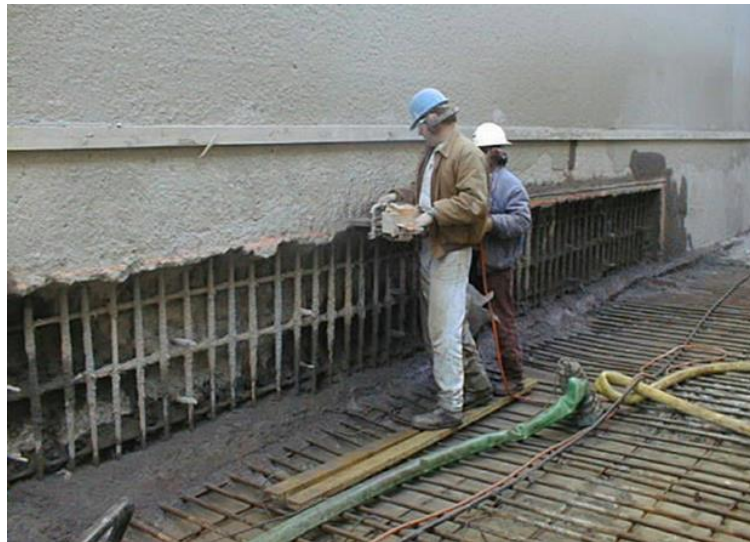
Figure 2-5 Saw cutting the perimeter (Rec

function, and appearance. The most common requirement in repair work is the restoration of durability (Allen et al. 1992). The first stage of repair work is to remove unsound concrete as shown in Figure 2-4. Shoring of the deteriorated members must be provided before starting removals if structural integrity affected by the removals (Nemati 2006). The repair area needs to be saw cut to a depth of about one inch to provide a neat edge as shown in Figure 2-5.

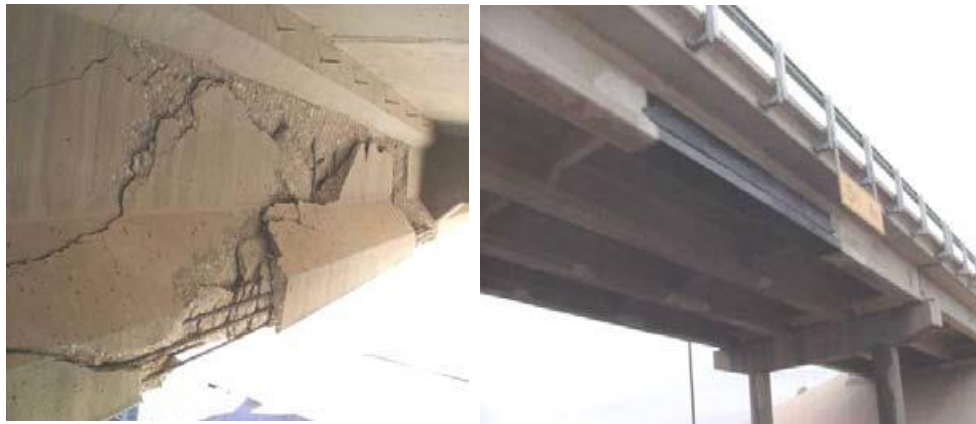
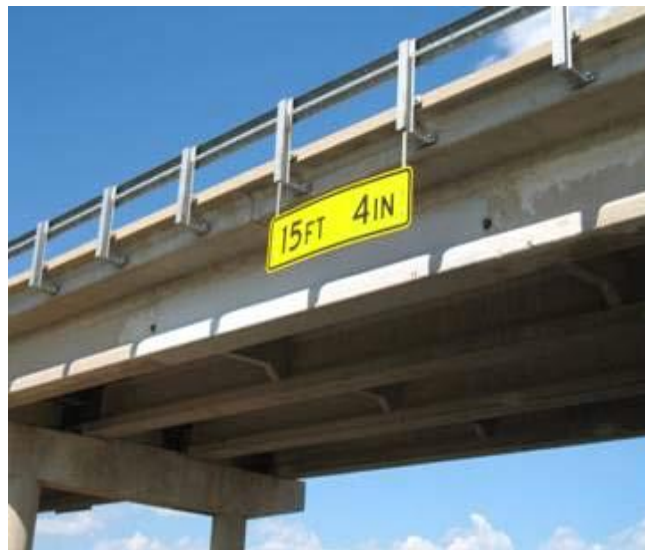
Figure 2-8 Figure 2 8 First impact damaged beam repair with CFRP: (a) The impact damaged beam (b) CFRP u-wrap was applied (c) The repaired beam after five years (Bradberry and Wallace 2003)

The first impact damaged beam in Texas repaired using CFRP is shown in Figure 2-8(a) (Bradberry and Wallace 2003). An exterior prestressed beam was hit by an overheight truck, damaging the bottom flange and severely cracking the entire web. TxDOT engineers decided to wrap the repair area with CFRP, which could add tensile strength, shear strength, and robustness to the repair. The repair option was selected after a comparison between replacement and repair. One ply of a continuous CFRP “U” wrap, covering the entire bottom flange and the web between the two diaphragms, was then installed using wet lay-up techniques as shown in Figure 2-8(b). The bridge was repaired in 5 days with a total direct cost of \$47,000. The installed CFRP was inspected five years later with no sign of delamination

or other deterioration of the CFRP composite (Figure 2c) (Bradberry and Wallace 2003).

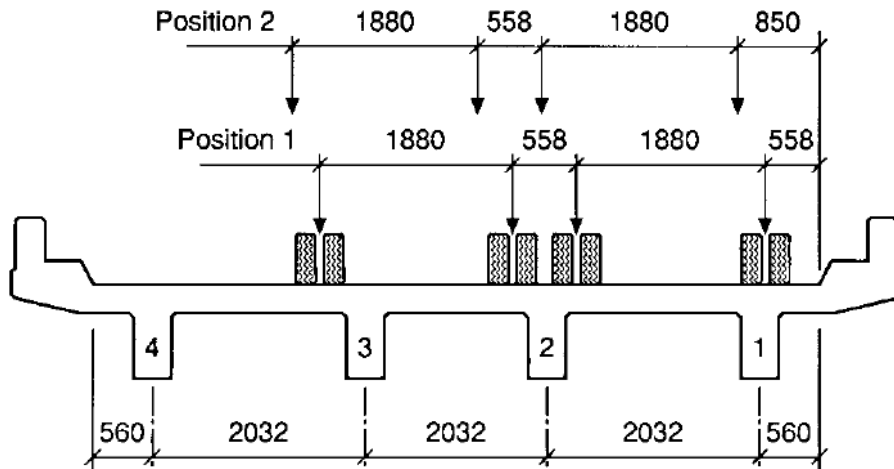
Figure 2-12 Load positions (Stallings 2000)

were performed on the bridge with different load positions as shown in Figure 2-12. Spacings between the trucks were chosen to produce the most extreme load conditions possible.

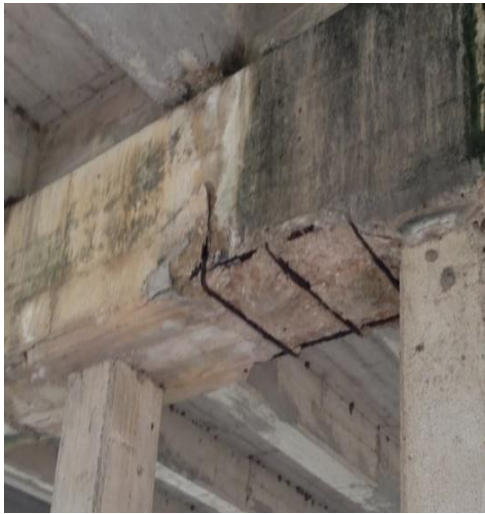
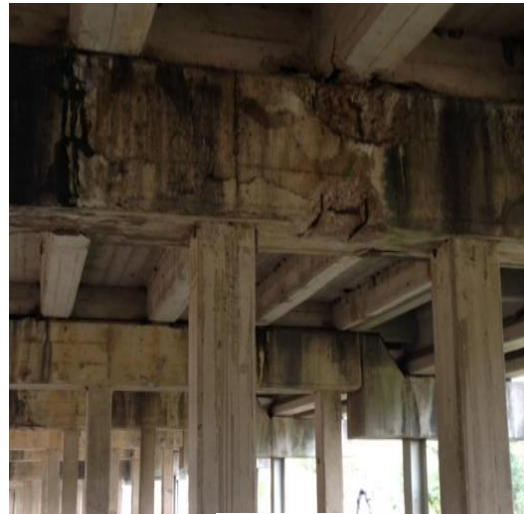
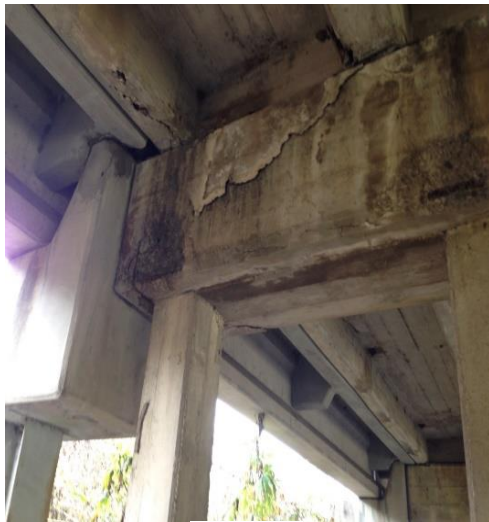
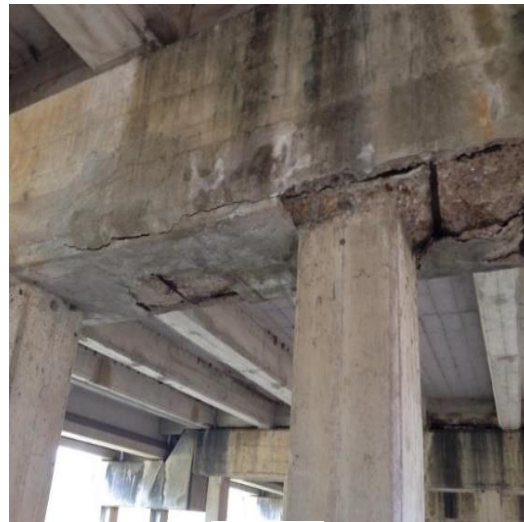
Figure 3-4 Deterioration of the bridge bent caps: (a) Bent Cap 35, (b) Bent Cap 37, (c) Bent Cap 40, (d) Bent Cap 41

Bridge inspection is usually performed every two years to determine the physical and functional condition for most normal bridges (TxDOT 2018). The most recent official inspection report of the WB bridge was performed in March 2016. The deck and superstructure conditions were classified as fair condition, while the substructure as poor condition. A visual inspection of the bridge bent caps was carried out as part of this study in October 2016. The bridge bent caps exhibited a significant amount of concrete spalling as shown in Figure 3-4. Flexural and shear reinforcements exposed in some spalled areas and experienced excessive corrosion. A green residue resulted from water drainage was seen on the concrete spalling areas which caused some steel corrosion. The concrete spalling extended from the bottom up to the side of the bent caps. Eight bent caps were selected for repair and rehabilitation, three of them were selected for load testing.

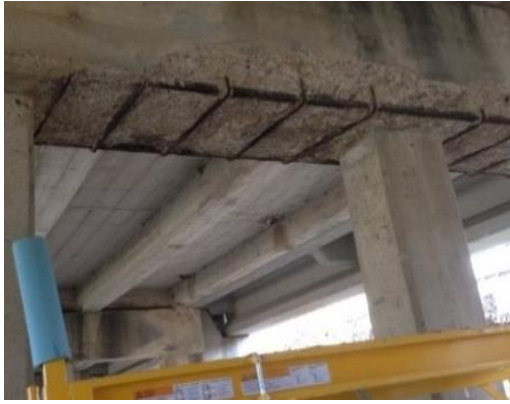
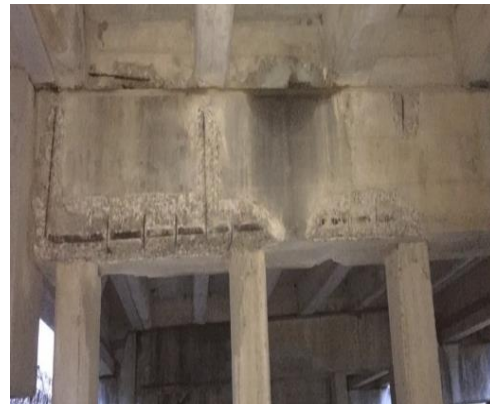
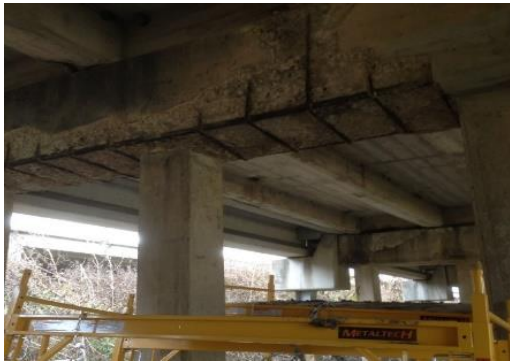
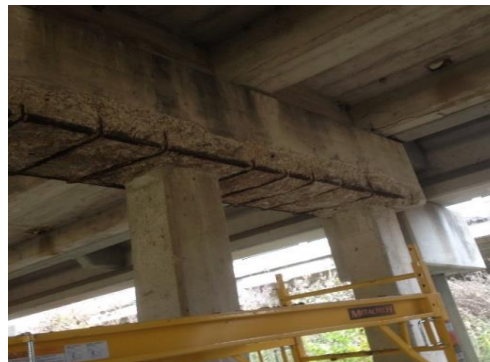
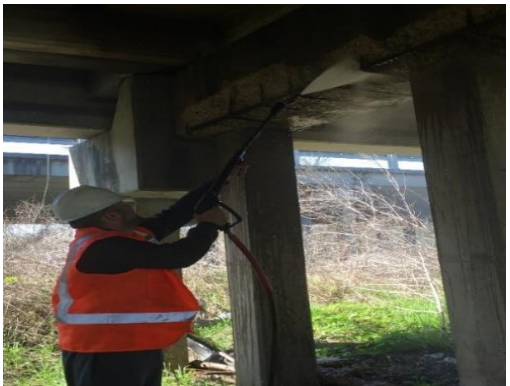
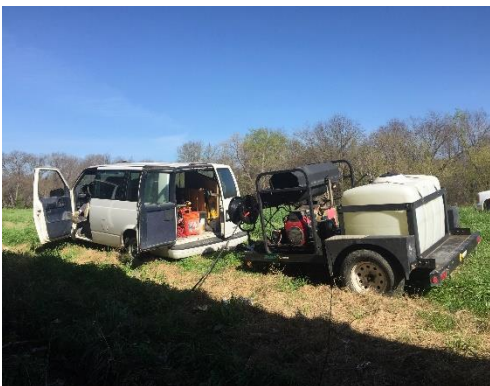
Figure 3-7 Concrete Surface Preparation: (a) Chipping out loose concrete and saw cut the edges, (b) Removing concrete around the rebars, (c) Cleaning the repair area using high-pressure water pump

TxDOT “Concrete Repair Manual” was followed for the repair procedures as shown in Figure 3-6. Damaged or loose concrete was removed using eight-pound power-driven chipping hammers. The concrete around the bars was removed for any mild reinforcement exposed more than half the reinforcement perimeter or exhibited significant corrosion by providing ¾-inch clearance or 1.5 times the largest sized aggregate in the repair material, whichever is greater, between the steel and surrounding concrete to permit adequate flow of the repair material. The patch

perimeters were saw-cut to eliminate feathered edges and to ensure that the repair material will be applied in depths no less than half an inch. A handheld grinder was used to square the patch perimeters. The substrate was roughened to ensure that there would be a mechanical bond between the patch material and the parent concrete. The repair area was cleaned using a towable washer equipped with 3500 psi pressure pump to remove all dust and dirt.

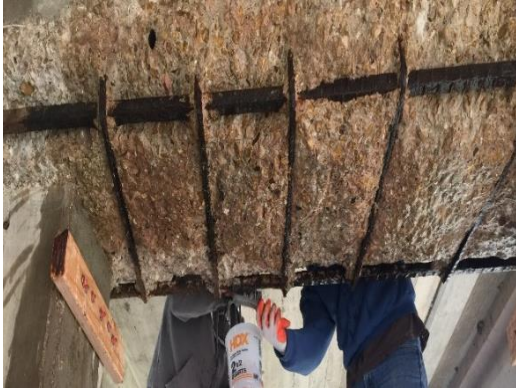
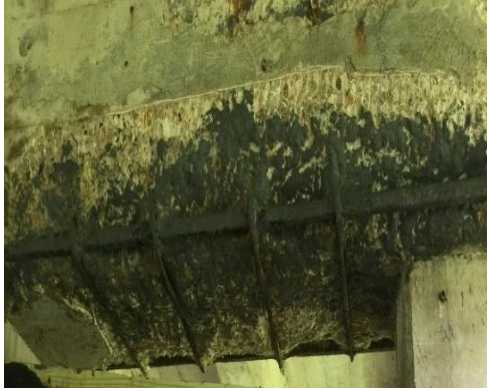
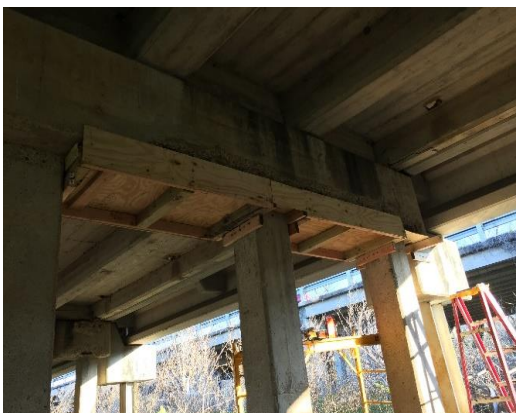
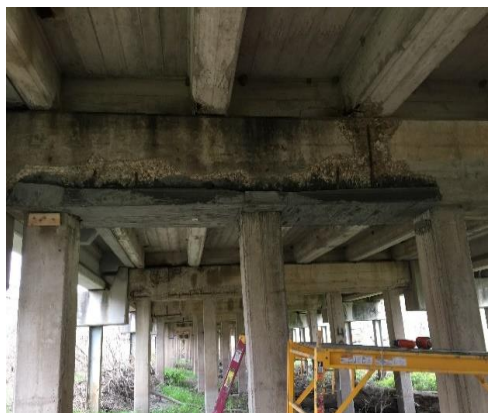
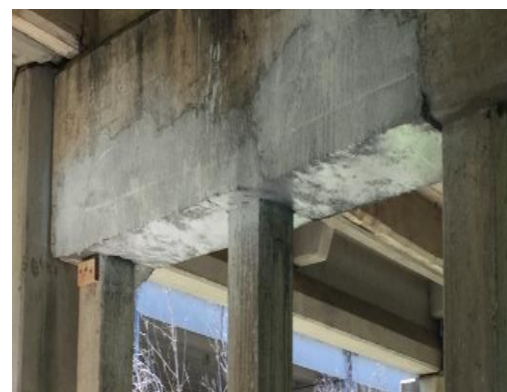
Figure 3-8 Formwork installation and pouring: (a) Steel cleaning and water spraying, (b) Bonding agent application, (c) Formwork installation and pouring, (d) Formwork removal, (e) Curing compound spraying

1. The steel reinforcement was cleaned using a wire brush to remove all the corrosion rust. (Figure 3-7(a)).

2. The repair area was sprayed with water to achieve the Saturated Surface Dry (SSD) condition. (Figure 3-7 (a)).
3. Two studs were placed on the columns face to hold the bottom formwork. (Figure 3-7 (a)).
4. The bonding agent was applied to the steel and concrete. (Figure 3-7 (b)).
5. The bottom formwork was placed, and then the side plywood was attached. (Figure 3-7 (c)).
6. The mortar was mixed and poured inside the formwork. (Figure 3-7 (c)).
7. The formwork was removed after 36 hr. (Figure 3-7 (d)).
8. The mortar was sprayed by a curing compound. (Figure 3-6 (e)).

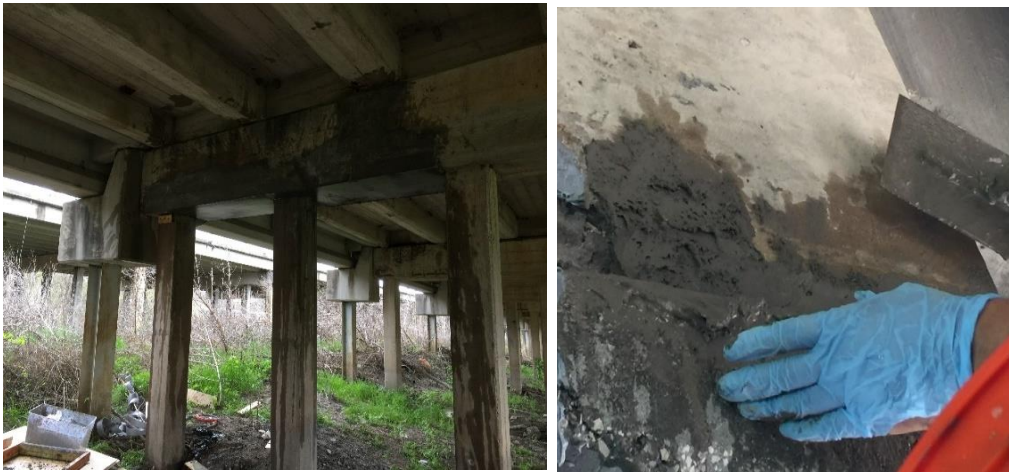
Figure 3-9 Patching mortar application

Patching mortar was placed after formwork installation and pouring was performed. Patching mortar was only applied to vertical repair areas. The specified mortar is SikaQuick VOH with a compressive strength of 5500 psi. The repair area was sprayed with water to achieve the SSD condition, then trowel or other suitable placing tools were used to transport the mortar to the prepared substrate as shown in Figure 3-8. The repair material is pressed into the substrate to develop intimate contact without voids.

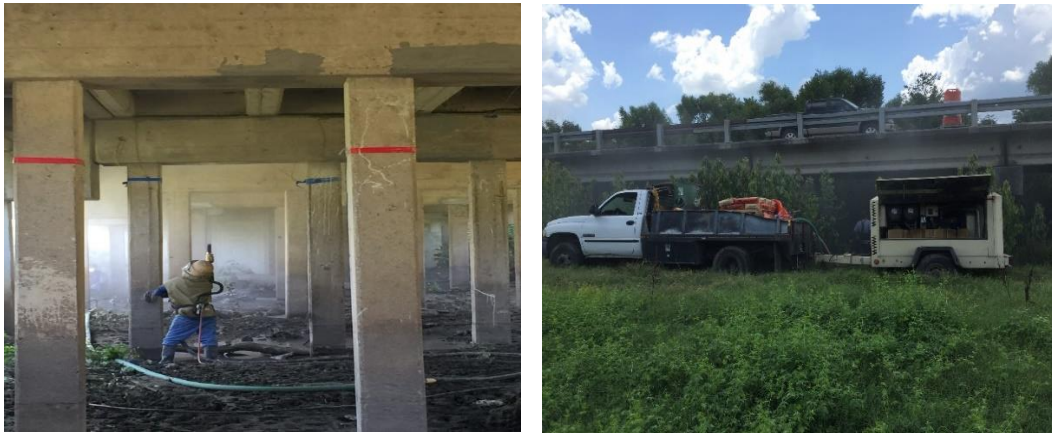
Figure 3-10 Sandblasting the repaired area

Surface preparation for CFRP application was achieved by sandblasting the repaired areas after 28 days of formwork pouring and patching to ensure that the mortar achieved the desired compressive strength as shown in Figure 3-9. The surface profile of the repaired area was prepared to a minimum Concrete Surface Profile (CSP) 3 as defined by the International Concrete Repair Institute (ICRI 2007). The surface profile is critical in providing a good bond between the CFRP and the concrete surface.

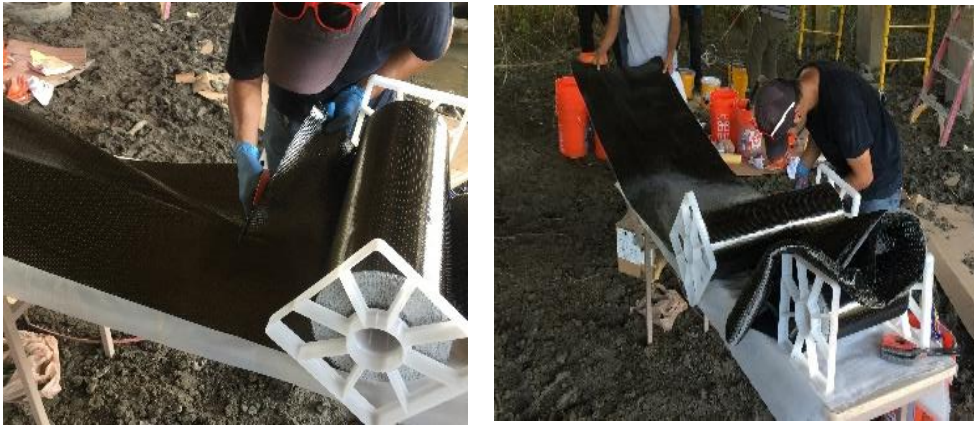
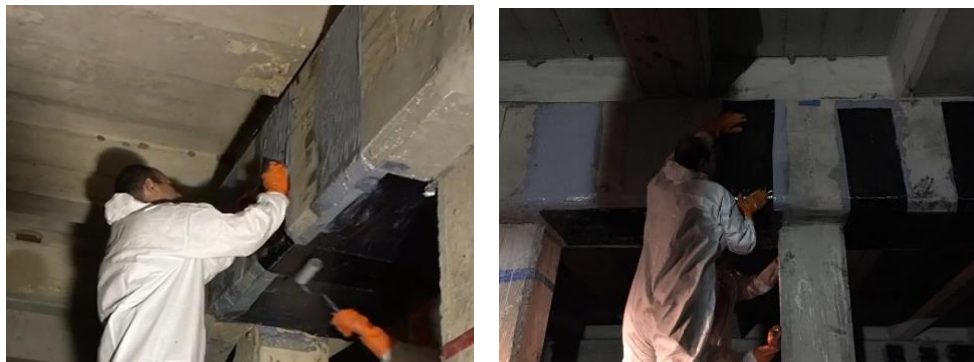
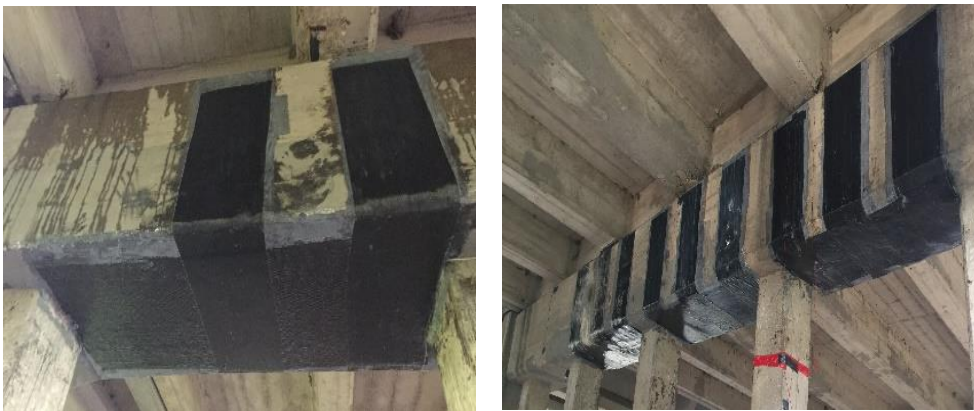
Figure 3-11 CFRP application: (a) Cutting CFRP sheets, (b) Applying CFRP sheets, (c) CFRP sheets after curing

CFRP was applied to the repaired area for the eight selected bent caps. Standard Specifications for Construction and Maintenance of Highways, Streets, and Bridges (TxDOT 2014), was followed for the CFRP application. It requires CFRP should be applied at a temperature between 50°F and 95 °F. Therefore the CFRP was applied at an average ambient temperature of 83°F and in the absence of direct light to prevent any undesirable problems with the epoxy. The CFRP application was started when the temperature was cooling down to prevent the phenomena of outgassing of the concrete which might increase the voids under the CFRP. The CFRP was applied at the bottom face parallel to the bent cap span for strengthening in flexural, while perpendicular to the bent cap span for strengthening in shear. Two types of epoxy were used to attach the CFRP to the bent caps; type I Sikadur 300 and type II Sikadur 330 with tensile strength 55 MPa and 24.8 MPa, respectively. The CFRP was Sika Wrap Hex 117C with 24 in. Width for flexure and 12 in. for shear. Figure 3-8 shows the CFRP application.

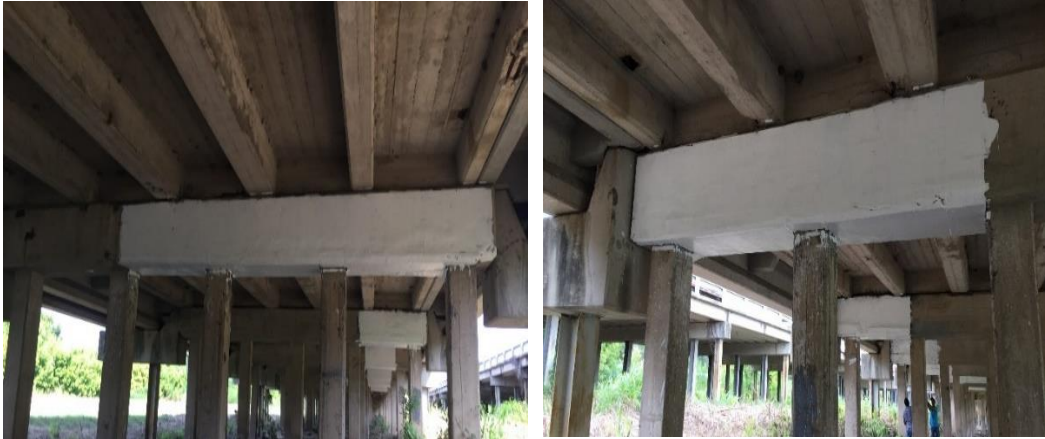
Figure 3-12 Protection top coat application

A protection top coat was applied on the CFRP for weathering resistance. The white colored Sikagard 670w was used as shown in Figure 3-11.

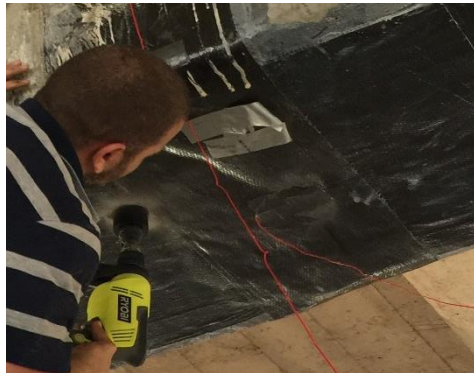
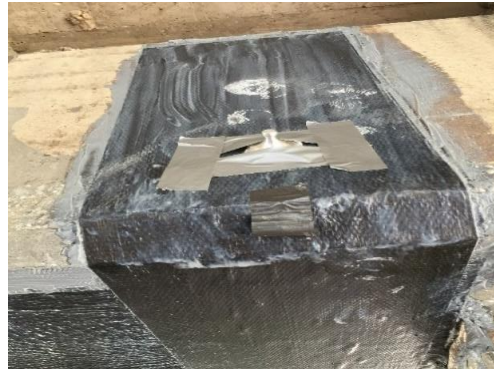
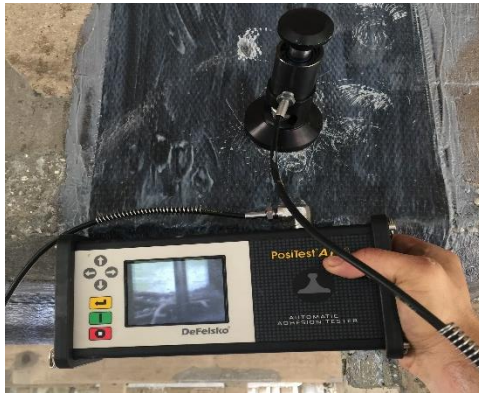
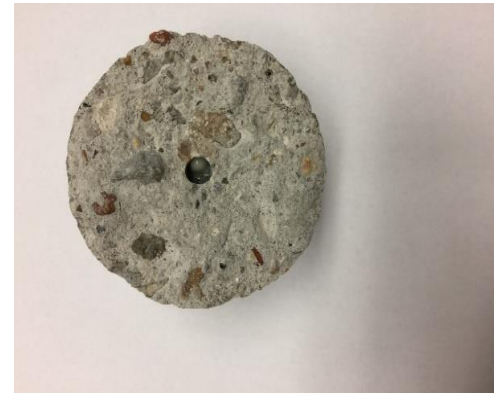
Figure 3-13 Pull off test (a) Preparing the CFRP surface (b) Dolly placing (c) Pulling out the sample (d) Concrete failure sample

The ASTM pull off test was performed on the CFRP as an indication of the strength of the bond in tension. Three direct pull-off tests to verify the bond strength were performed after the FRP had cured and before applying topcoats on the bent caps. The average tensile strength was 400 psi. The failure for one sample was fully in the concrete while the other two were in the bond-line between the CFRP and concrete. (Figure 3-12)

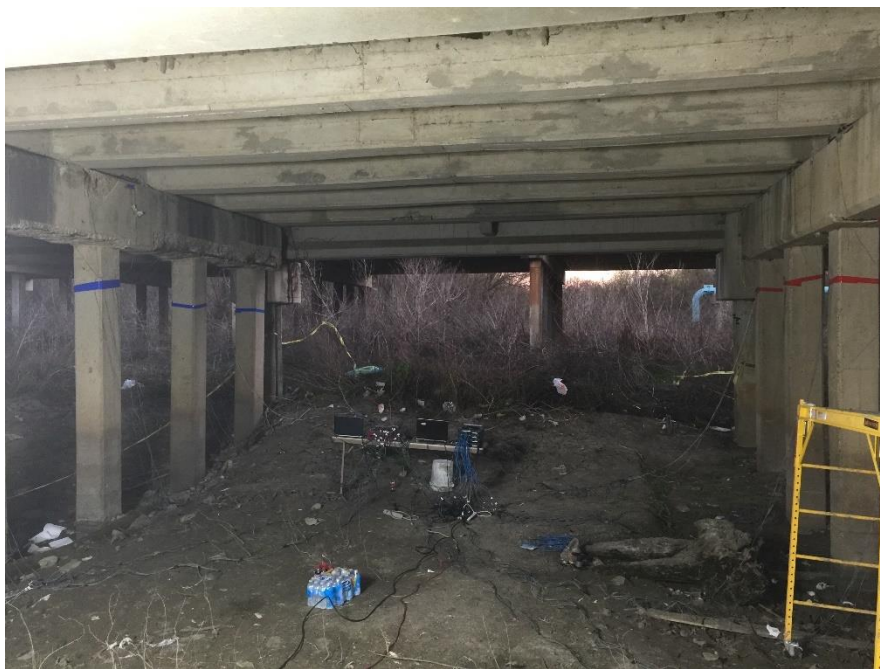
Figure 4-4 Data acquisition system location

in two different locations for two bent caps. The layout of strain gages locations of different sections of the bent caps can be seen in Figure 4-2 and 4-3. The data acquisition systems were placed between bent cap 37 and 36 as shown in Figure 4-4. All strain gauge wires were extended to reach the data acquisition boxes. A Tokyo Sokki DS750 with capacity of 40 channels and a Micro measurement 8000 model DAQs with a capacity of 32 channels were used to collect the data at 100 Hz.

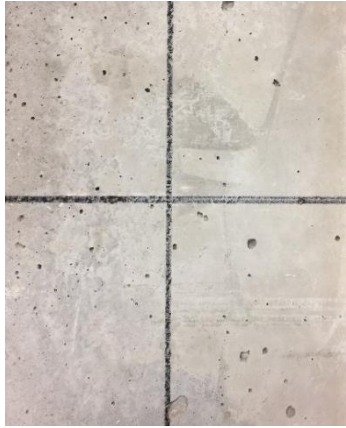
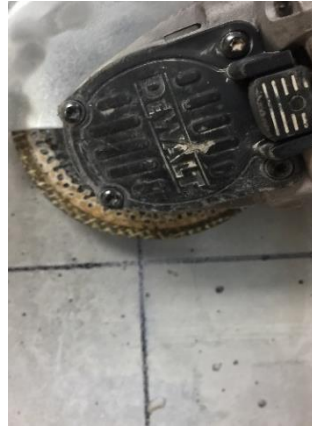
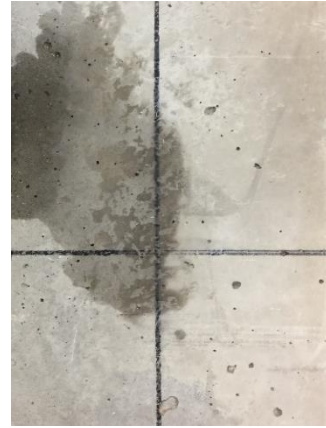
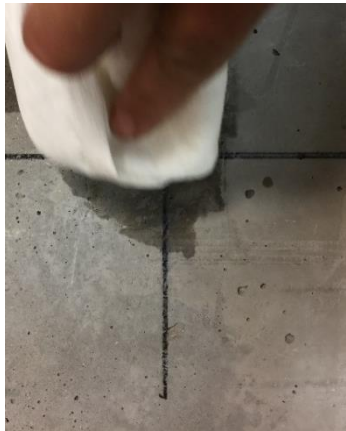
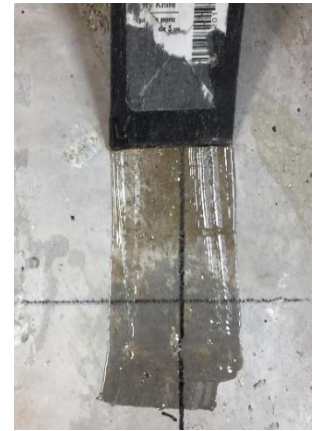
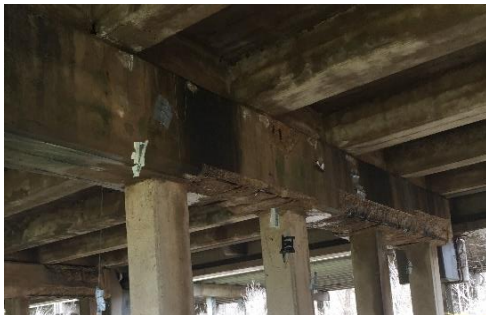
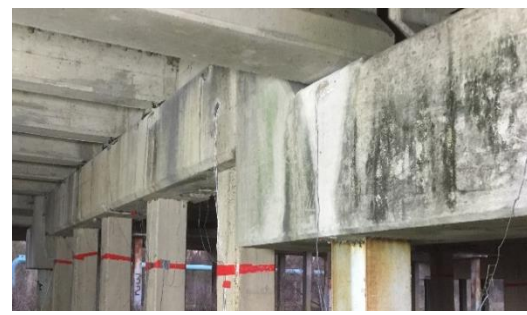
Figure 4-5 Strain gages installation: (a) Marking, (b) Grinding, (c) Applying acetone, (d) Applying water, (e) Applying epoxy, (f) Installing strain gage, (g) Bent cap 37, (h) Bent cap 36

- Strain gages locations were marked on the concrete surface. (Figure 4-5(a))
- Concrete surface was smoothed and grinded by sander or grinder to achieve a uniform and even surface. (Figure 4-5(b))
- Concrete surface was cleaned with acetone to remove dirt, dust, and other particles. (Figure 4-5(c))
- Cleaning the area with water to remove the acetone from the surface. (Figure 4-5(d))
- A fast setting epoxy was applied on the area to fill the voids in the concrete and provide a smooth and even surface. (Figure 4-5(e))
- Strain gage was applied after the epoxy dried using special adhesive designed for bonding strain gages to concrete (Figure 4-5(f))
- Weather proof chemical called 'Epoweld' was applied as a coating on top of the strain gages to protect them from rain, dust, moisture, and other weather effects.

Bent caps 37 and 36 after strain gages installation are shown in Figures 4-5(g) and 4-5(h).

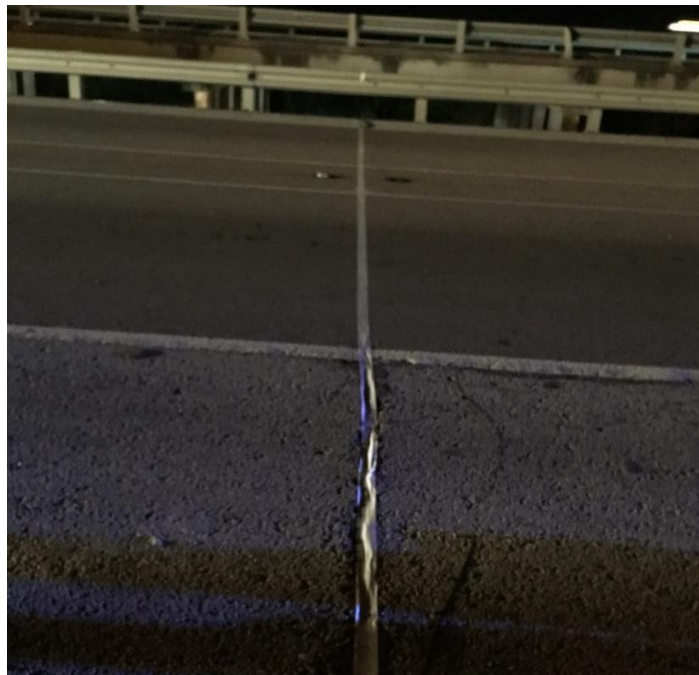
Figure 4-6 Marking the roadway

Marking on top of the bridge was performed one hour before the load testing started. The marking was made perpendicular to the traffic direction along the centerline of bent caps 38, 37, 36, 35, and 34. Bent cap 38 centerline was the starting point of the dump trucks paths while bent cap 34 was the end. Another marking was made parallel to traffic direction, two feet from the lane line to keep the position of the trucks fixed for all the loads configuration. The marking was made using duct tape and chalk as shown in Figure 4-6.

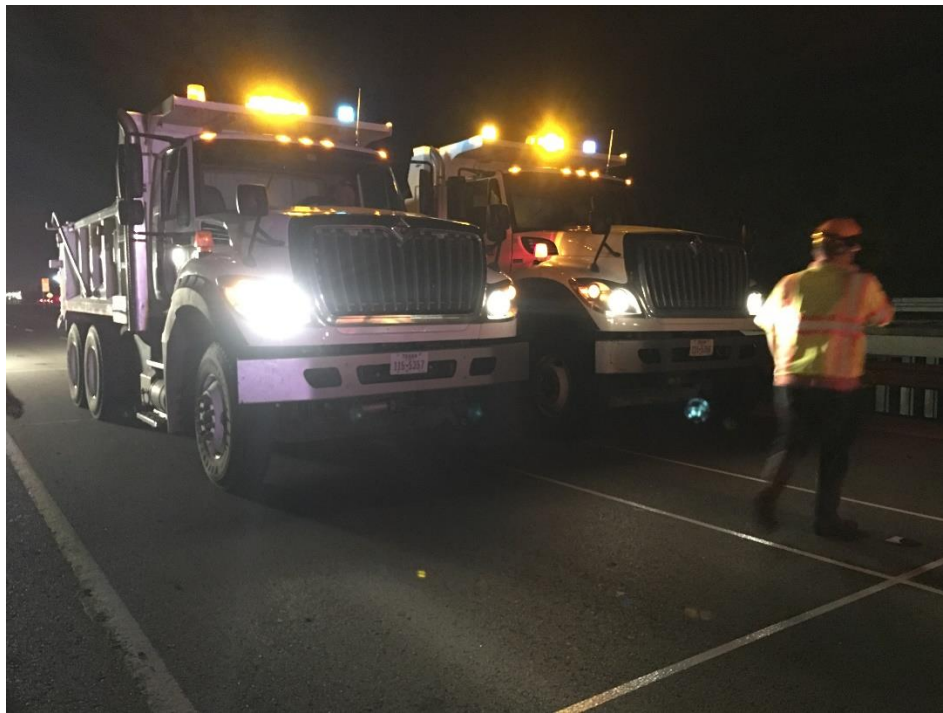
Figure 4-11 Trucks stopped at Bent cap 37

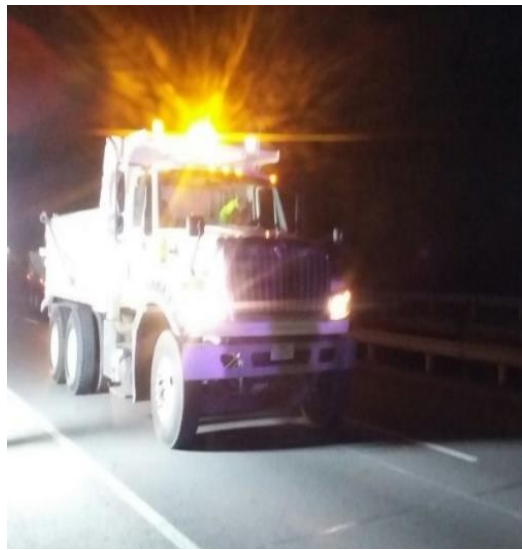
Figure 4-12 Loading Path One

This method is used to consider the effect of moving loads on the overall response of the bridge bent caps. The dump trucks started moving from bent cap 38 at an approximate speed of 5 mph. The strain readings for the crawl speed runs were collected through the data acquisition system. Both lanes of the bridge were loaded separately and simultaneously as shown in Figures 4-12 through 4-14.

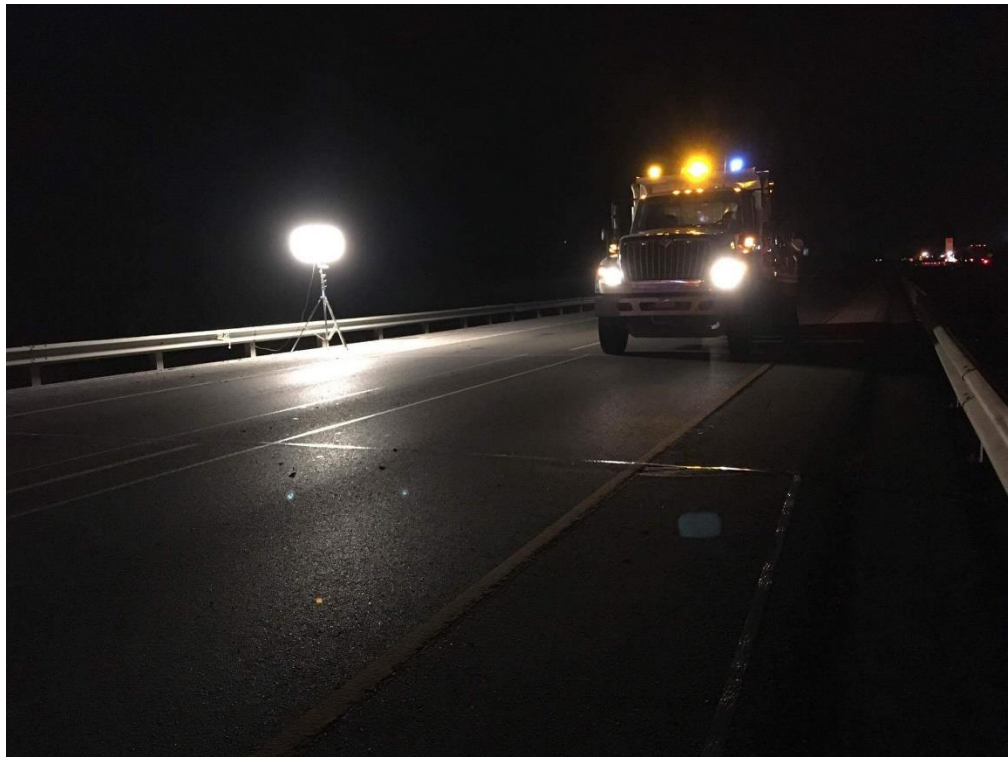
Figure 4-13 Loading Path Two

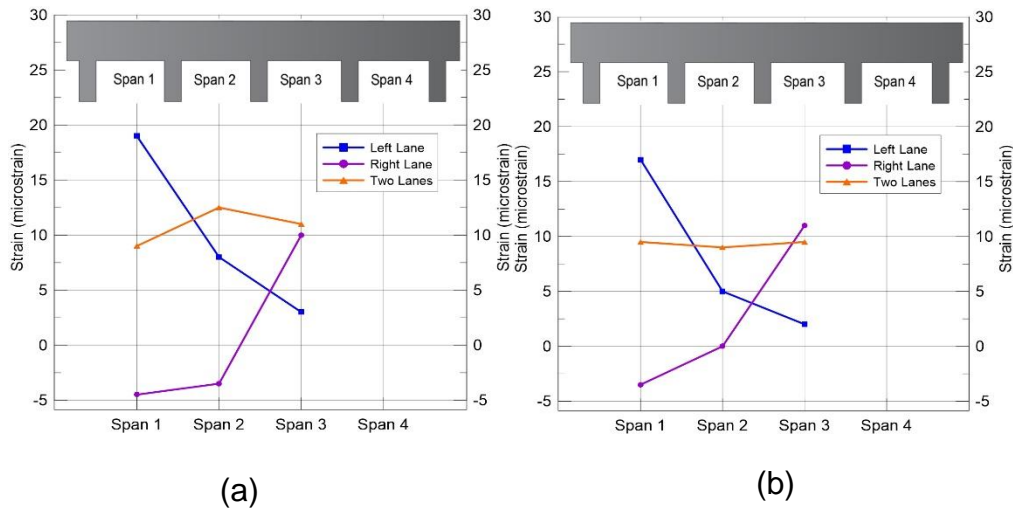
Figure 6-6 strain measurement for the load cases (a) before repair, (b) after repair

For the bridge load tests before and after repair, different load cases were considered to collect the strain data. The load cases were designated to provide a wide variety of data that can be used to calibrate the FE model under different loading scenarios. Also, the load cases data was used to compare the bent cap behavior before and after repair. The load cases were left, right and two-lane loads. Figure 6-7 shows the strain in bent cap 37 before and after repair for different load cases. It can be noted that the left lane load produced the highest strain in span one while right lane load produced the highest strain in span three. This is due to the load distribution factor for the bridge girders. The load distribution factor depends on the truck position. If the distance between the girder and the truck wheels is close, it will take a higher distribution factor. Therefore, it was expected to see the high strain in span one for the left lane load. It can be observed from the figure that span one produced compression strain (-) for the right lane load since the truck is on the other side of the bent cap causing a tensile strain in spans three and four and compression strain in span one.

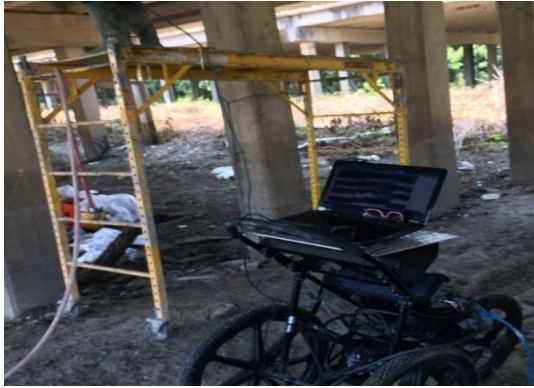
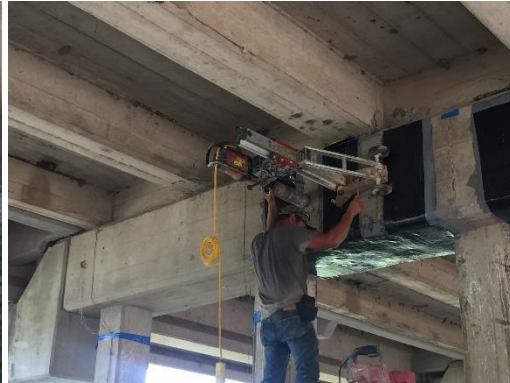
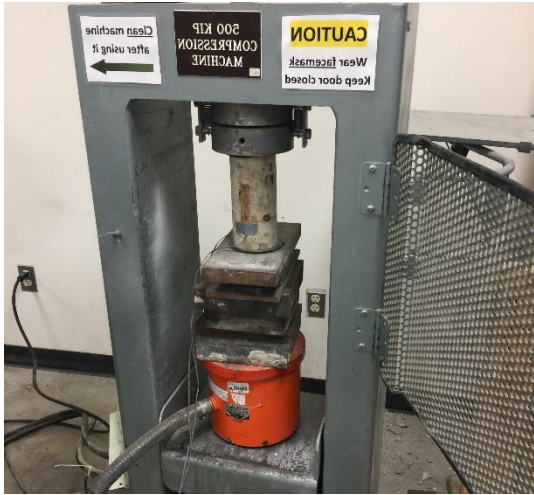
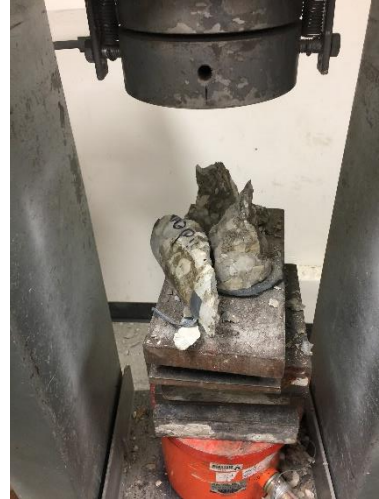
Figure 6-7 Concrete coring procedures: (a) Taking the cores, (b) GPR scanning, (c) Setting up the compression machine, (d) Tested sample

The preliminary model is based on theoretical values and equations from literature which does not take into consideration the actual materials and test conditions. Hence, it is required to calibrate the finite element model to accurately reflect the actual condition of the bridge bent cap. The first step in the model calibration is to determine the actual material properties of the bridge bent caps. Three concrete cores were taken from bent caps 35, 36, and 37. A Ground Penetration Radar (GPR) was used to locate the steel rebars before coring to avoid any rebar damage. The average diameter of the concrete cores was 3.81 in. and the average depth was 8 in. Strain gages were installed on one side of the concrete cores to

get the stress-strain curve of the concrete cores. The strain readings will be used for a better correlation between the calibrated values and experimental measurement. The concrete cores were tested according to the ASTM C39 specifications (ASTM C39 2014) as shown in Figure 6-9. The average compressive strength for bent caps 37, 36, and 35 were 2.69 ksi as shown in Table 6.1.

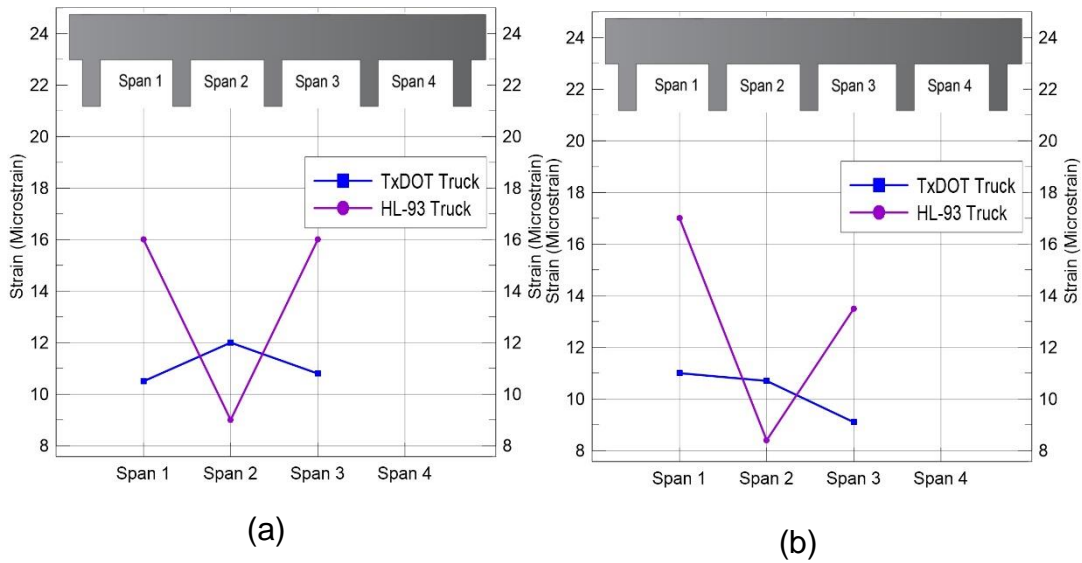
Figure 6-13 HL-93 truck vs. TxDOT truck (a) bent cap before repair, (b) bent cap after repair
