LABORATORY TESTING AND FINITE ELEMENT MODELING OF INVERT
REMOVED CORRUGATED METAL CULVERT BURIED UNDER SHALLOW COVER

Presented to the Faculty of the Graduate School of
The University of Texas at Arlington in Partial Fulfillment
of the Requirements
for the Degree of

August 2019

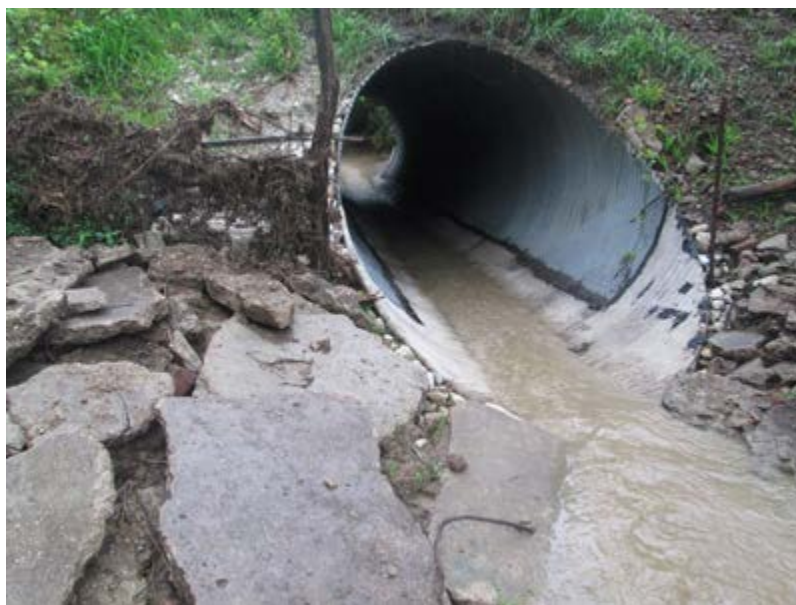
Figure 1-1: 9 ft. diameter CMP with corrugated invert on Elba Township in Knox County, Ill (Miliken Infrastructure Solutions 2016).

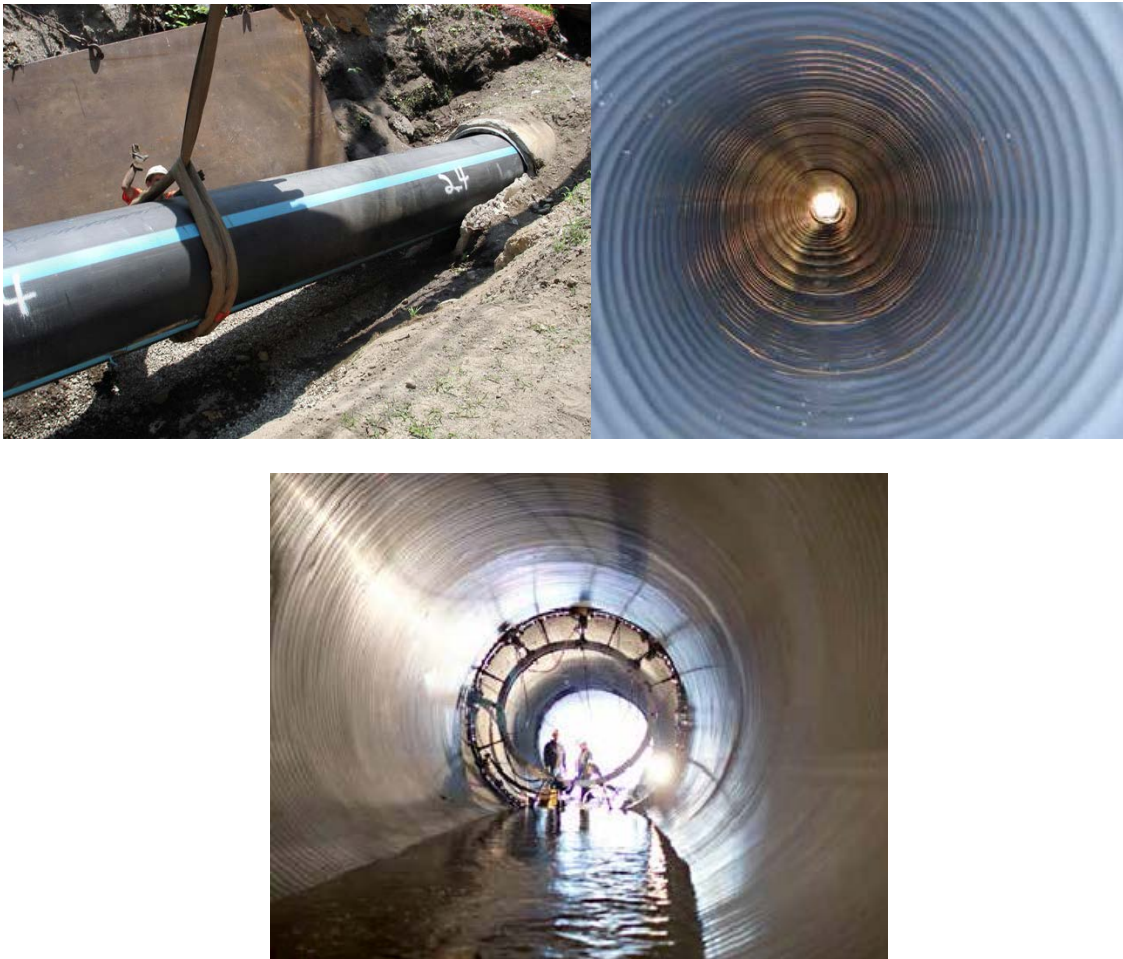
Figure 1-2: Culvert rehabilitation using (left to right): sliplining (DEWCON Infrastructure Rehabilitation 2019), fold-and-form lining and spiral wound lining (Matthews et al. 2012).

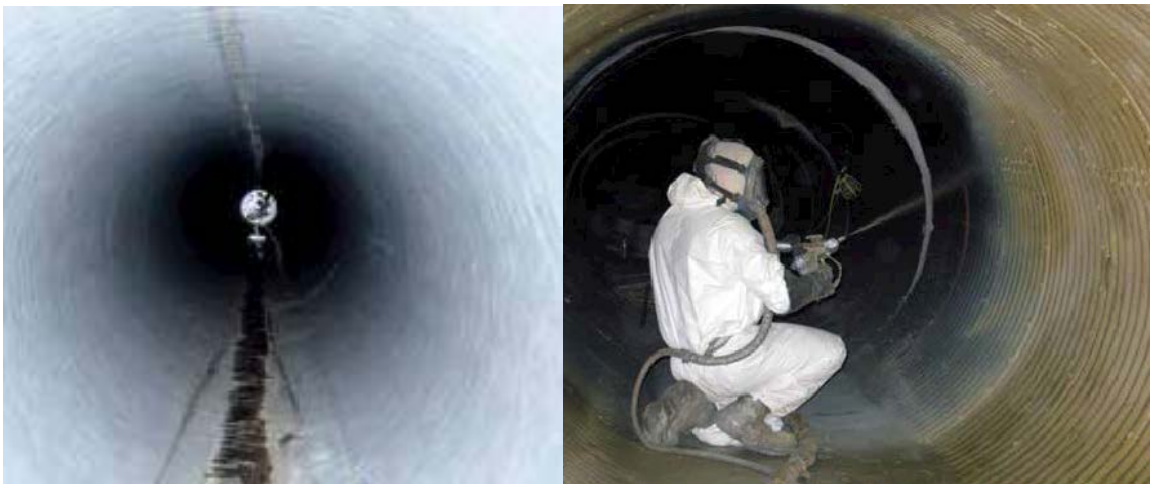
Figure 1-3: Pipe repair using (left to right): CIPP and spray applied liner (Matthews et al. 2012).

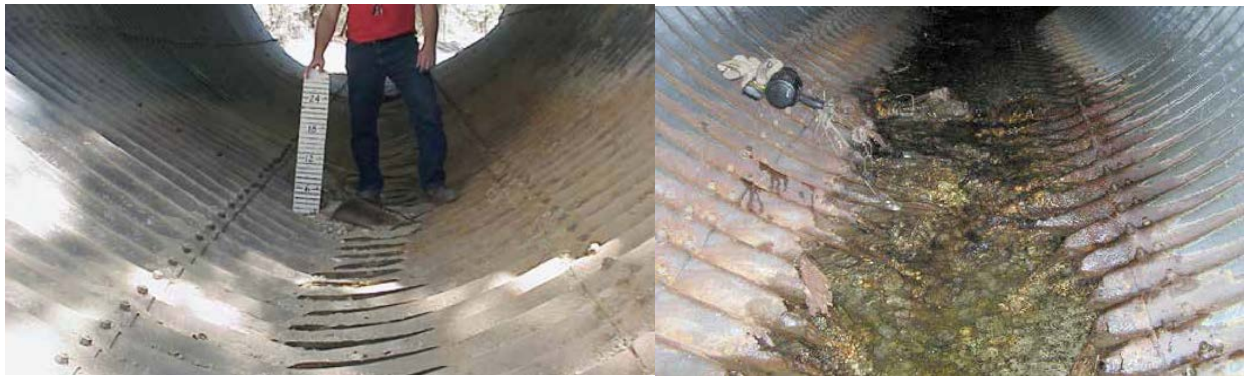
Figure 2-4: Invert damage due to abrasion (left) and corrosion (right) (Matthews et al. 2012)

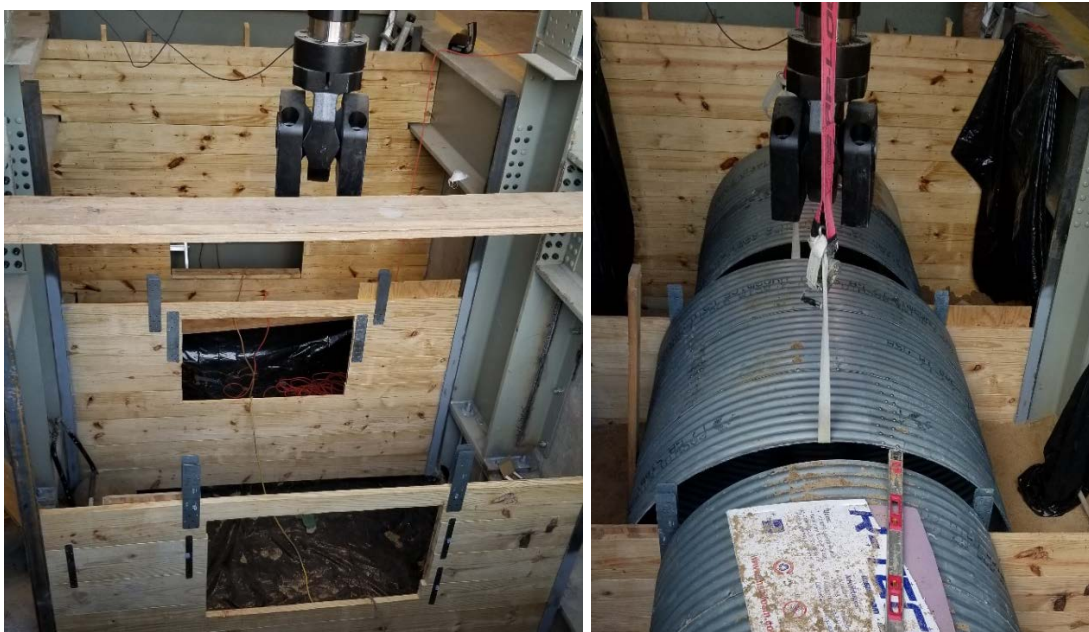
A full-scale laboratory test on buried CMPs was designed for the soil box at CUIRE. The soil box is 25 feet long, 12 feet wide and 10 feet height. This is divided into three cells along the length using wooden partition walls, with each cell being 6 feet long. A hydraulic actuator is installed to apply the load. A reaction frame is installed inside the soil box to support the actuator. The load from the actuator was applied to the soil using a steel load pad of dimension 10 in. by 20 in. This load pad was chosen to represent the standard contact area from the wheels of an AASHTO H20 truck. The two end cells held two circular CMPs (intact and removable invert) while, the middle cell held a corrugated metal arch. The cells were each tested one at a time. Only the tests and results obtained from the circular CMPs are within the scope of this thesis.

Figure 3-1: Soil box before (left) and after (right) installation of the CMPS
(source: CUIRE Laboratory)

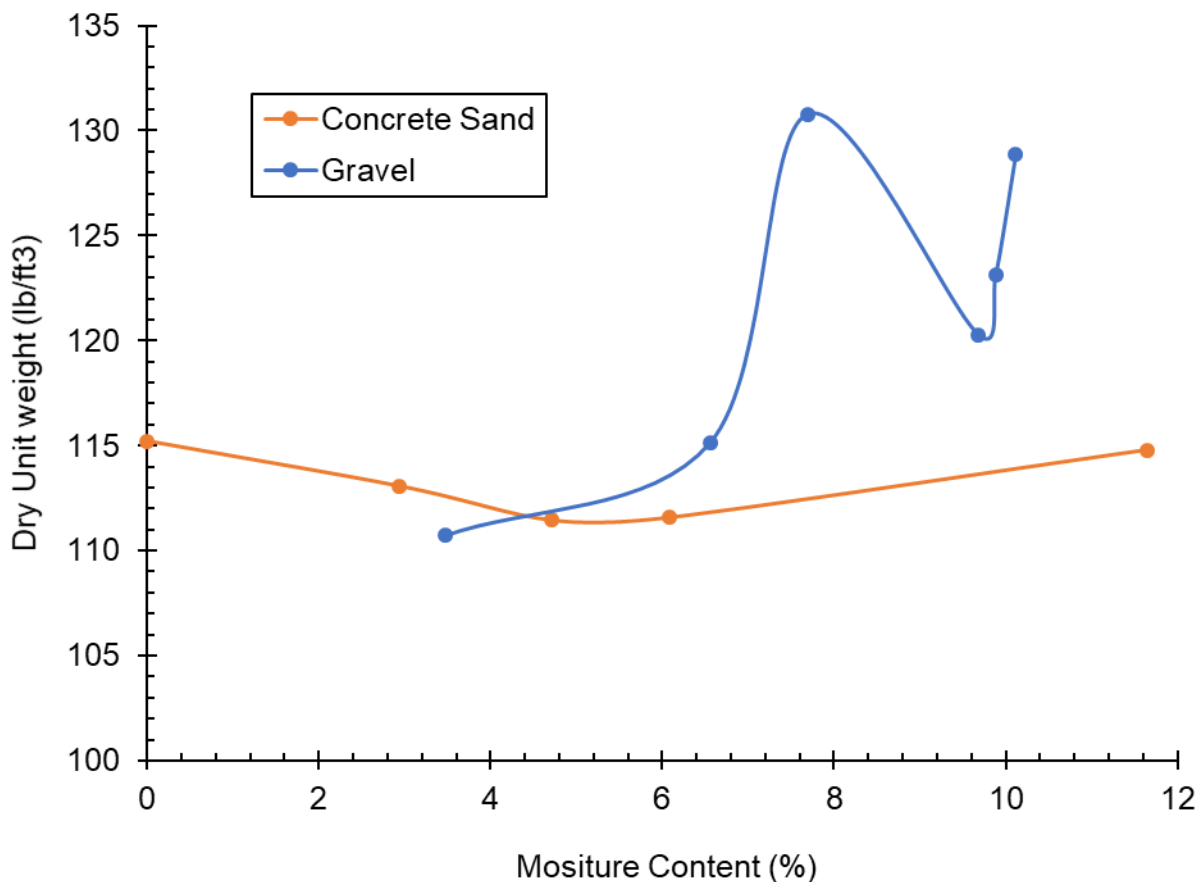
Standard proctor compaction test was performed to check for the maximum dry density and moisture behavior of the soil. The maximum dry density of the sand was found to be 115.2 pcf at zero percent moisture content (oven dried condition). The in-situ moisture content was found to be approximately 6%. For moisture content variation from zero to twelve percent, the dry density variation was within 5 pcf (approx.). For the gravel, the amount of moisture it could keep was not very significant and during compaction, water was seen to be leaking out of the proctor mold even at low water contents. As a result, the moisture-density curve obtained was very uneven and did not provide useful data. This further verifies that moisture content plays a fairly small role when determining the density for granular, free-draining soils.

Figure 3-3: Moisture-density curve for sand and gravel.

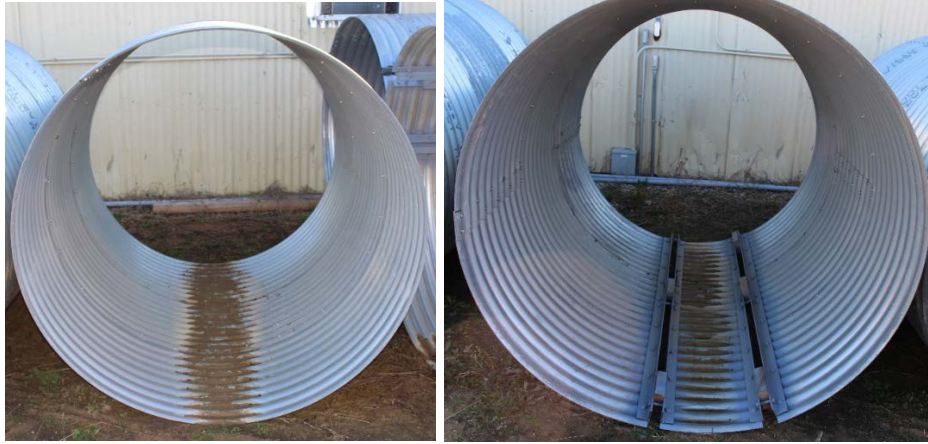
The CMPs used in this study were obtained courtesy of Contech Engineered Solutions. Two types of CMPs were obtained from Contech: one was a regular intact CMP with annular corrugations and other was a custom-made CMP with removable invert. Each of the CMPs were 6 ft. long with 60 in. diameter and had a corrugation profile of 2-2/3 in. by 1-2 in. The CMPs had a wall thickness of 0.109 inches.

Figure 3-4: Regular CMP (left) and CMP with removable invert (right).
(source: CUIRE Laboratory)

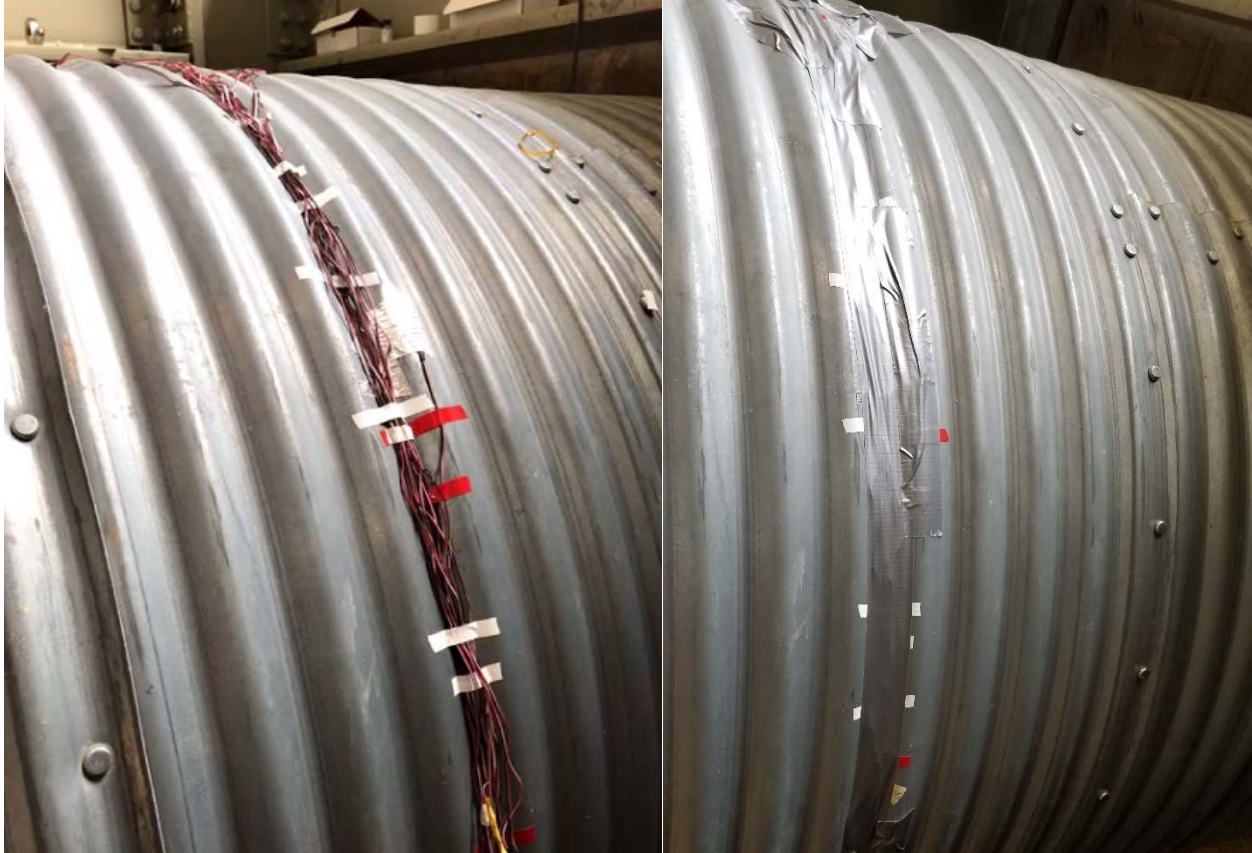
Figure 3-7: Wiring and final duct tape covering over the strain gauges.
(source: CUIRE Laboratory)

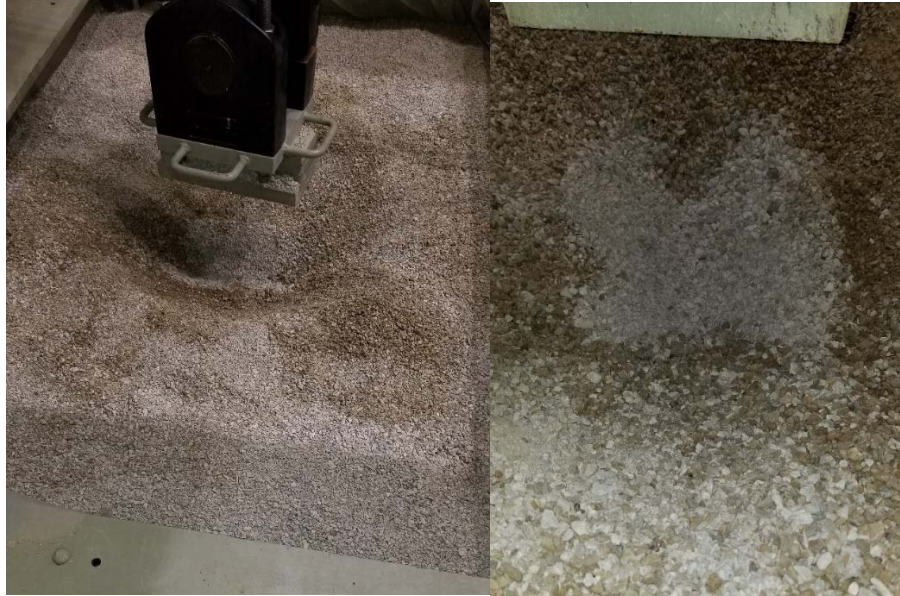
After the test was completed, the soil below the load pad was examined. It was observed that most of the soil in the loaded area was the gravel used as top cover (Figure 3-10). This suggests that the upper rigid gravel layer punched through the weaker underlying sand layer during the test.

Figure 3-10: Bearing failure of soil below the load pad.
(source: CUIRE Laboratory)

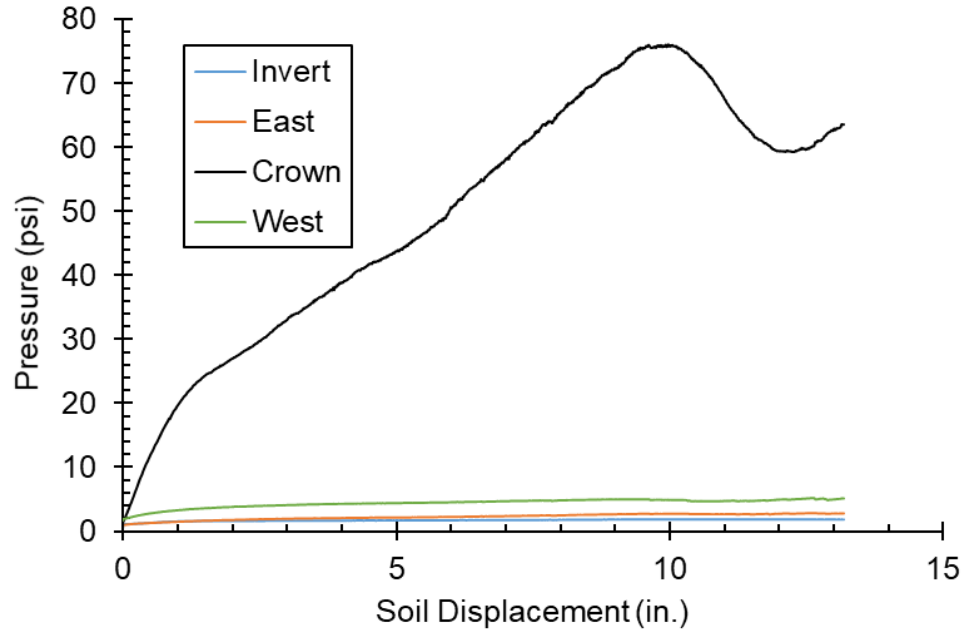
Earth pressure distribution around the CMP was monitored using the installed earth pressure cells. All the installed earth pressure cells had rated capacity of 51 psi. Highest earth pressure reading over the course of loading was seen at the earth pressure cell above the top of the pipe, along the line of the load pad. On the other hand, the earth pressure cells installed at the level of springline and invert showed very small readings of pressure. Since the values of the pressure shown were extremely low as compared to the rated capacity of the earth pressure cells, the accuracy of these numbers is suspect. However, they do hint that there was not significant load transferred to the sides of the CMP.

Figure 3-11: Earth pressure around the CMP.

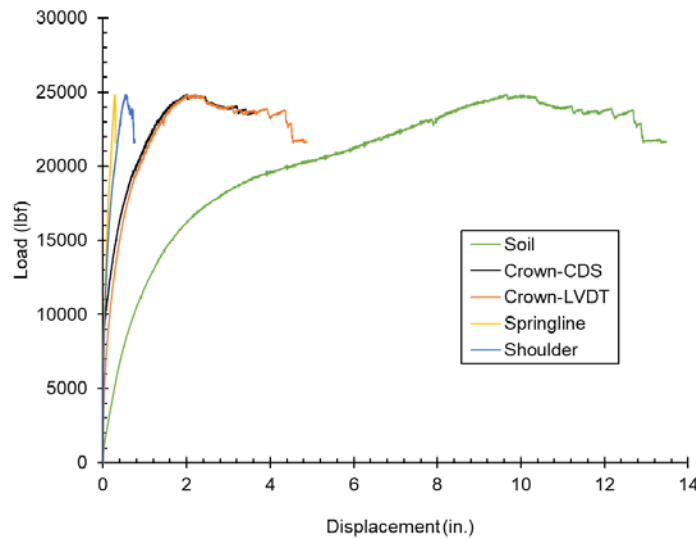
As the applied load was monitored by the actuator, simultaneous observation was made for the displacement of the pipe at crown, springline and east shoulder (Figure 3-12).

Figure 3-12: Load-displacement plots for soil and pipe

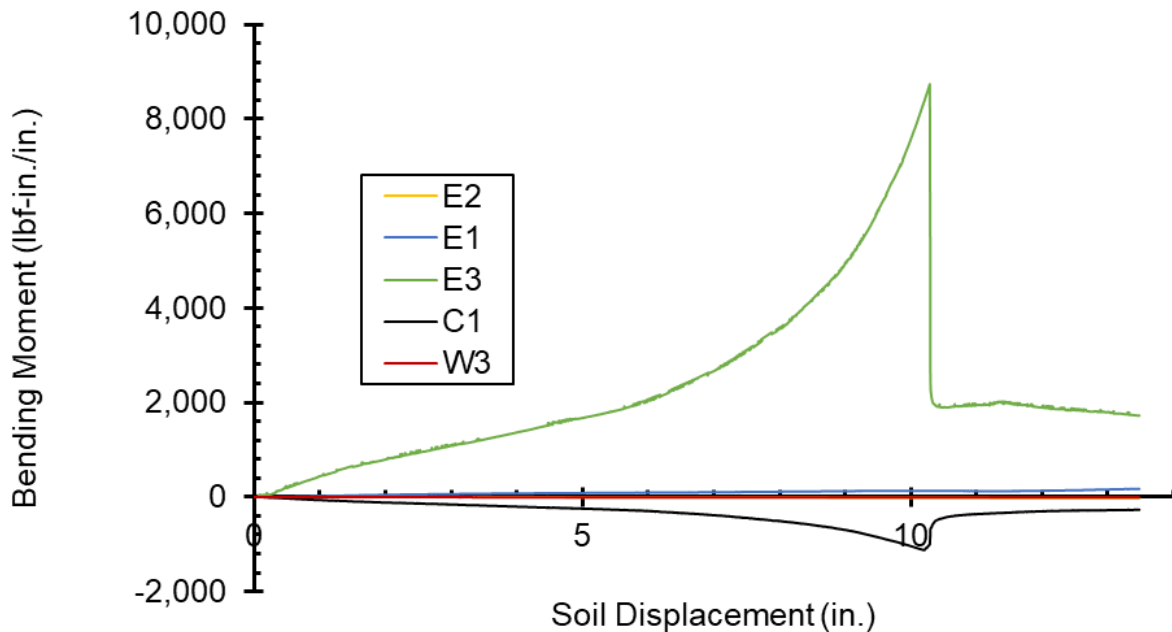
Figure 3-15: Variation of bending moment around the CMP during the test.

Maximum bending moment in the pipe was observed at the top of the pipe. The next high value for strain was located at the shoulder. The strain obtained from the gauges at haunch and springline levels were almost negligible compared to the readings from shoulder and crown. The strains at haunch, springline and shoulder kept rising as the test progressed however, the strain at the top dropped after the pipe started buckling.

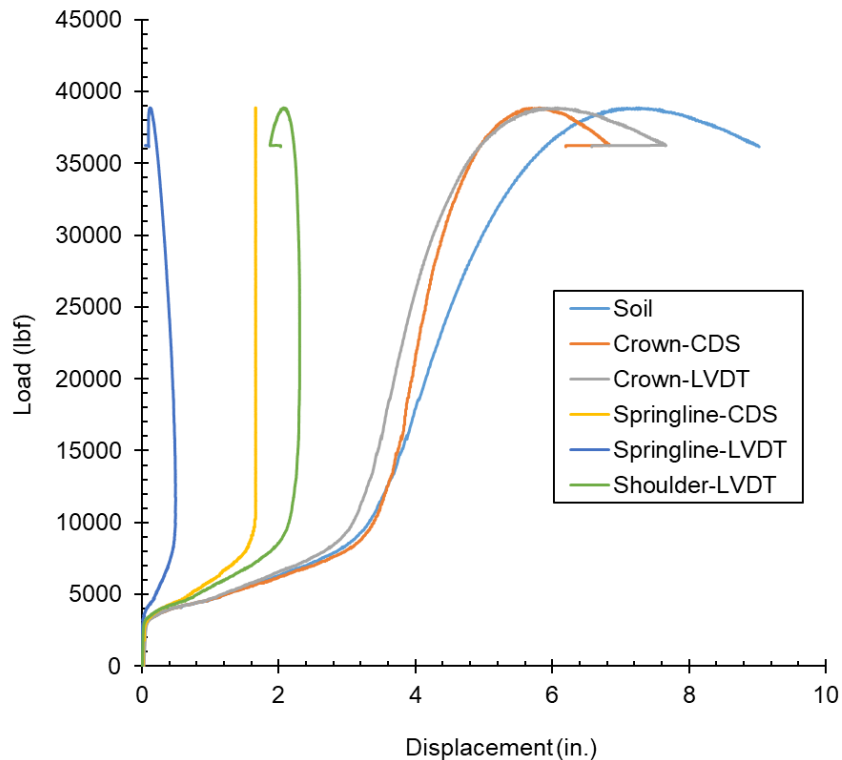
Figure 3-17 shows the combined load displacement plots obtained from the test for soil settlement and pipe deformation at crown, springline and shoulder.

Figure 3-17: Combined load displacement plot for soil and pipe obtained from different sensors.

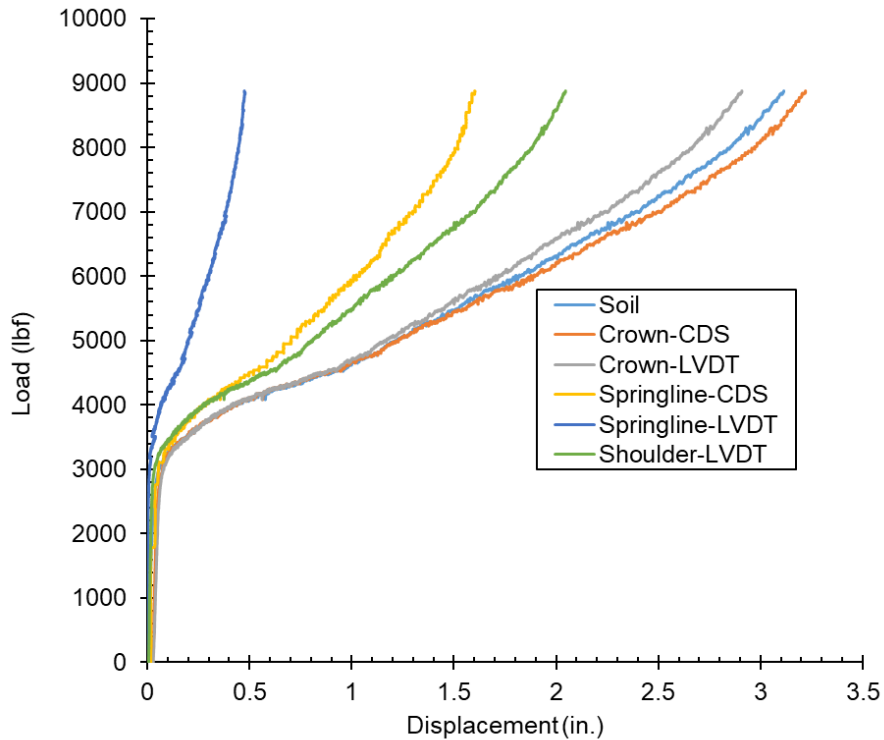
As load was applied to the soil, the load rises at a steep curve as the soil rearranges and presumably, closes the gaps formed due to the sudden movement when the invert of the CMP was removed. Once this is achieved, the slope of the curve begins to drop quite significantly. This drop is accompanied by settlement in the soil and increase in deflection in the pipe. Unlike intact CMP, the deflection at the crown and springline is significantly higher as the CMP has lost its ring stiffness and haunch area around the removed invert starts to move inward. This relatively easy deformation of the CMP is the reason the slope of the load-displacement curve has decreased. However, after a certain point, the system stiffens and the slope of the load-displacement curve increases. This is because the haunch area around the cut invert on either side have come in contact with each other and hence are providing a resisting force. The load taken by the system after this point is quite significant. However, since this is because a significant deflection has already occurred in the CMP before this point and the cut pieces have come in contact, this increase in strength is not useful and the CMP is considered to have failed at the point of slope increase. Hence, the completed curve was reduced to observe the system behavior prior to the cut edges coming in contact (Figure 3-18).

Figure 3-18: Shortened load displacement plots prior to cut edges coming in contact.

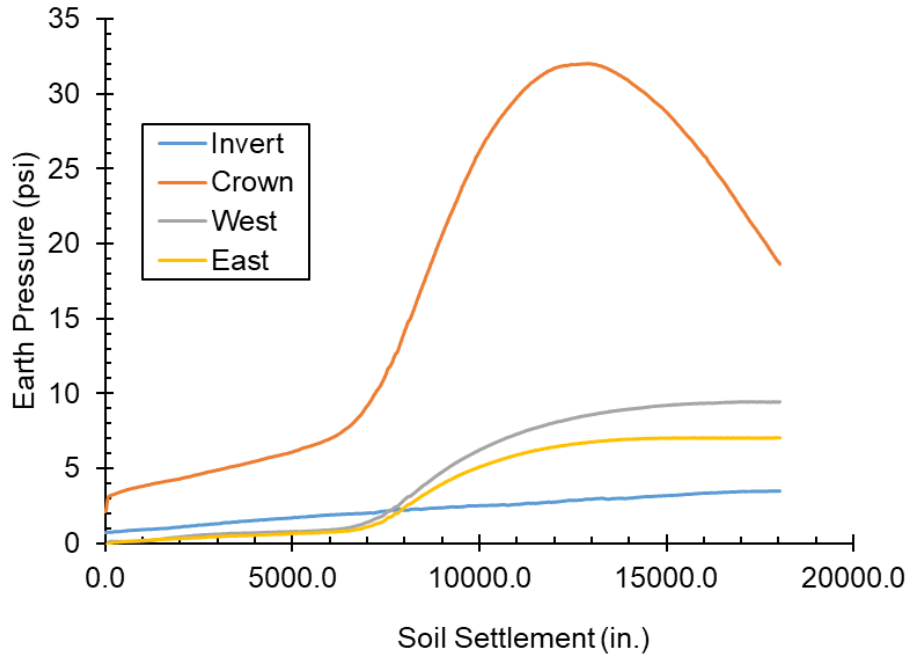
Figure 3-19 shows the earth pressure distribution around the CMP. Similar to intact CMP, the maximum earth pressure is observed at the crown though, the magnitude of the pressure is almost half of that observed during the test of intact CMP. Unlike intact CMP however, significant pressure is observed at the springline levels as well. Similar to the applied load, the pressure around the CMP also shows a significant increase once the cut edges of the invert meet (shown by the dashed line). The least pressure is observed at the invert level, which is as expected as there isn't an invert at all.

Figure 3-19: Earth pressure distribution around the CMP.

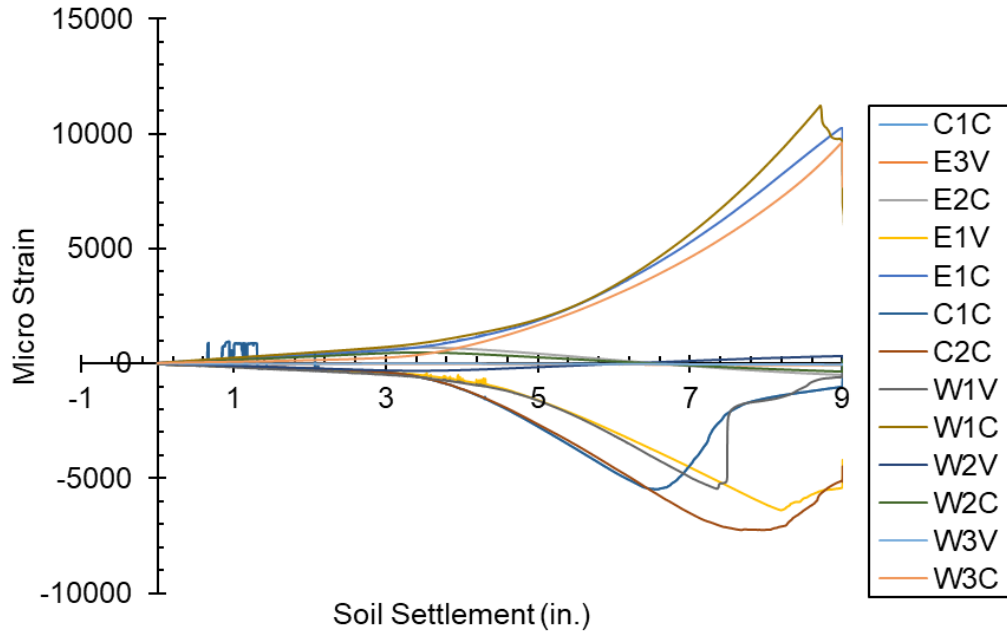
Figure 3-20: Strain distribution around the CMP.

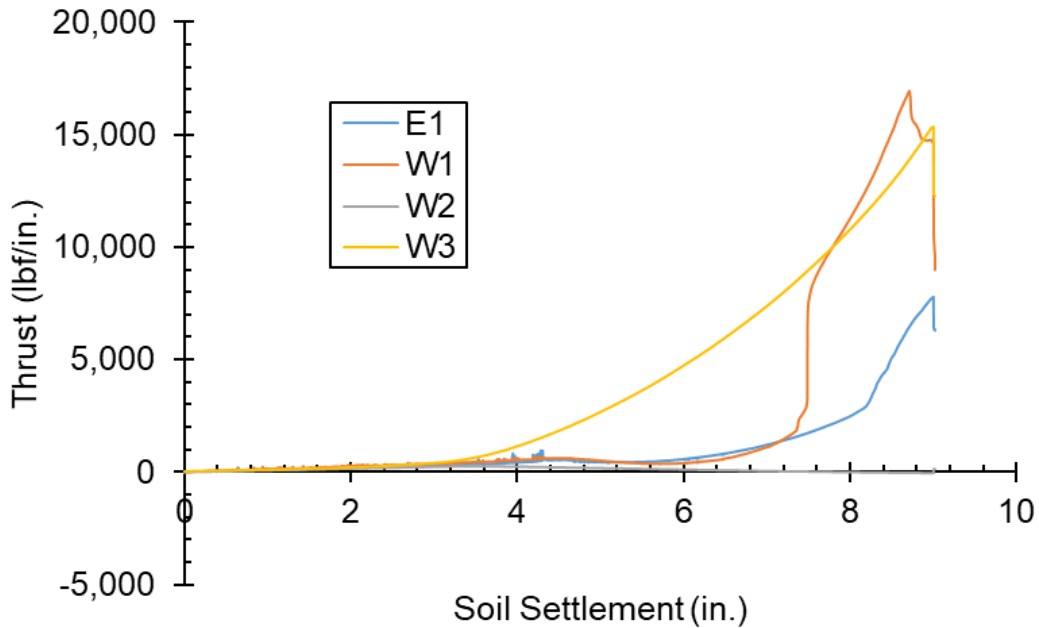
Figure 3-22: Circumferential thrust distribution.

Circumferential bending moments (Figure 3-21) and thrusts (Figure 3-22) distribution were calculated using the same procedure used for intact CMP. It is immediately obvious that the thrust and moments at the locations away from the crown are much more significant than before. Since the moment and thrust information for the crown was not available, the maximum measured bending moment and thrust was observed at the shoulder location.

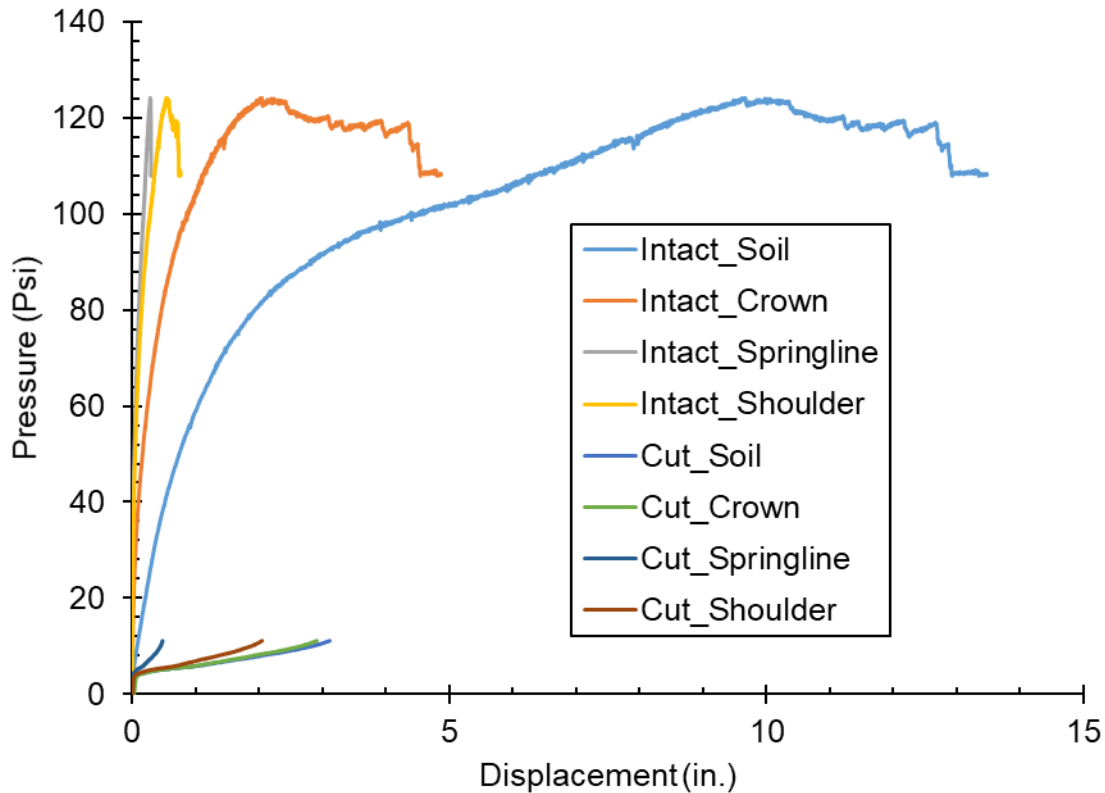
Load deformation behavior for both soil and CMP was compared between the intact and invert cut cases. However, since the two tests had different load pad sizes, direct comparison between the forces could not be made. Instead, applied pressure was used to compare the two cases. There is a drastic difference in pressures that was taken by the system between intact and invert cut CMPs. There is a 91.1% decrease in the maximum pressure that could be taken by the system prior to CMP's failure. Additionally, the mode of failure is also different. In intact CMP, soil failed before the pipe and eventually, the pipe failed in buckling. However, for invert cut CMP, the CMP failed due to excessive deformation as the cut edges of the invert moved towards each other and eventually touched. Hence while the soil was seen as the limiting factor in intact CMP, the limiting factor was the CMP in case of invert cut CMP.

Figure 3-23: Comparison of load deformation capacity for soil.

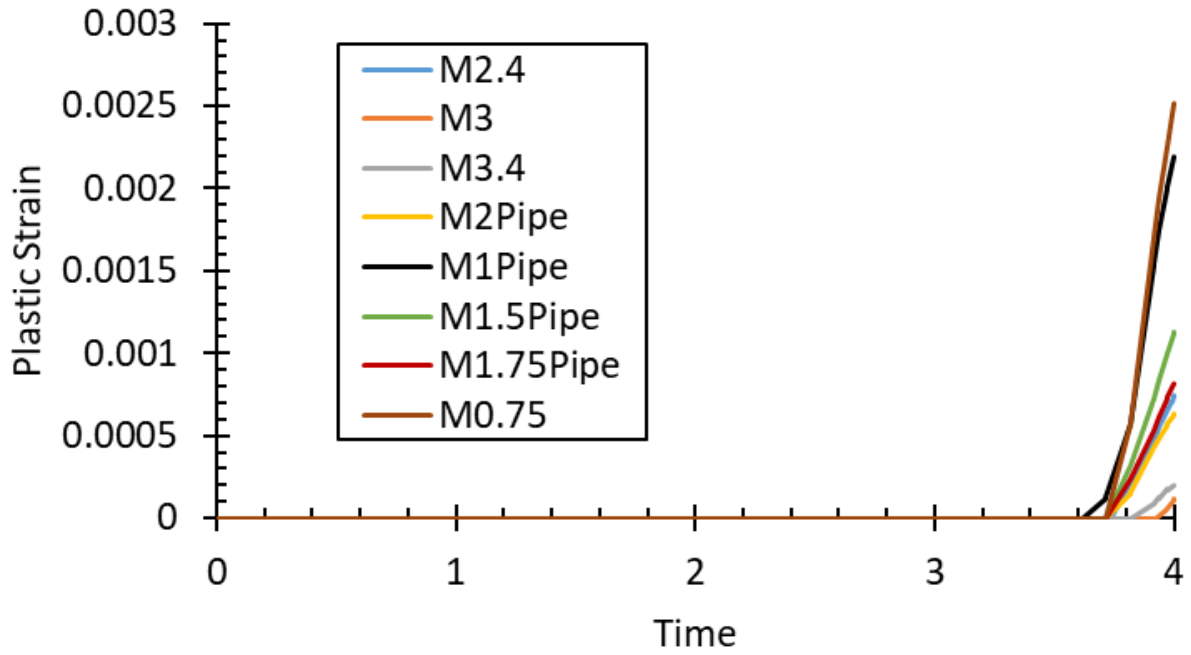
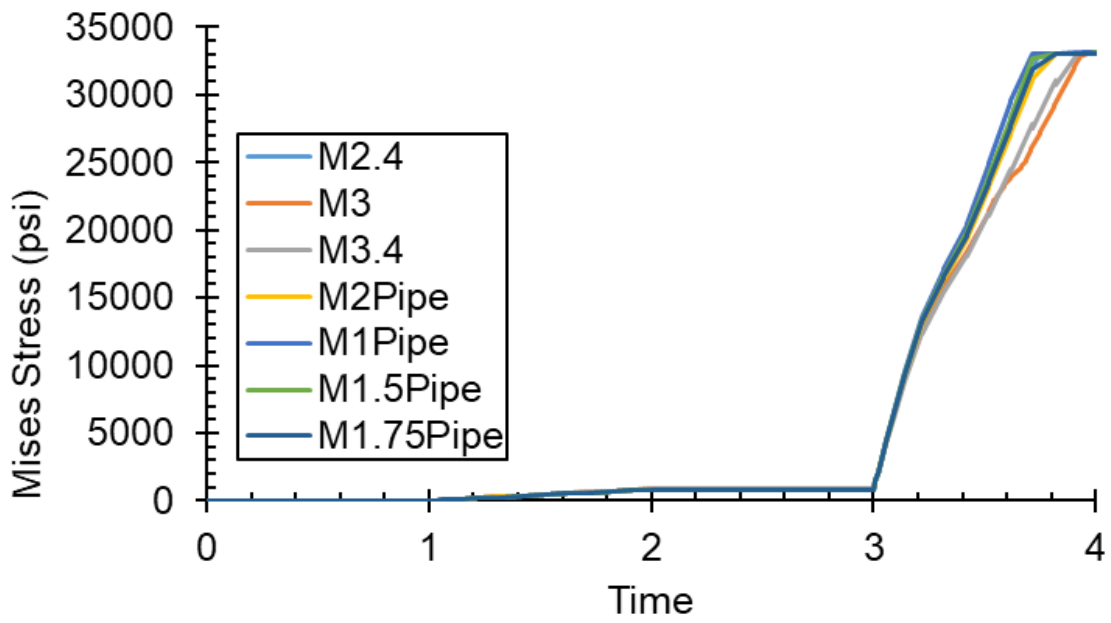
For pipe, the values of Von Mises stress and crown displacement had small differences for mesh sizes 3.4 and 3 however, plastic strains showed a higher value at mesh size 2.4. Hence, the pipe was checked for mesh sizes 2, 1.75, 1.5, 1, 0.75. For all cases, the value of Von Mises stress and crown displacements were virtually identical while the values of plastic strain were very close for sizes 2.4 to 1.5 but increased more for 1 and 0.75.

Figure 4-4: Von Mises stress (top) and plastic strain (bottom) in pipe.

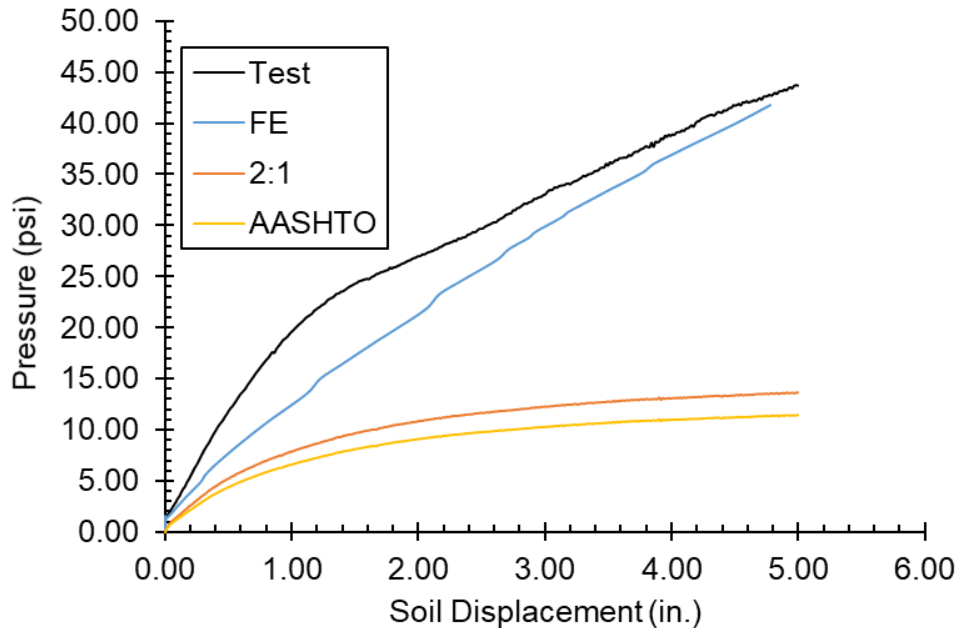
Figure 4-13: Earth pressure distribution at the crown level.

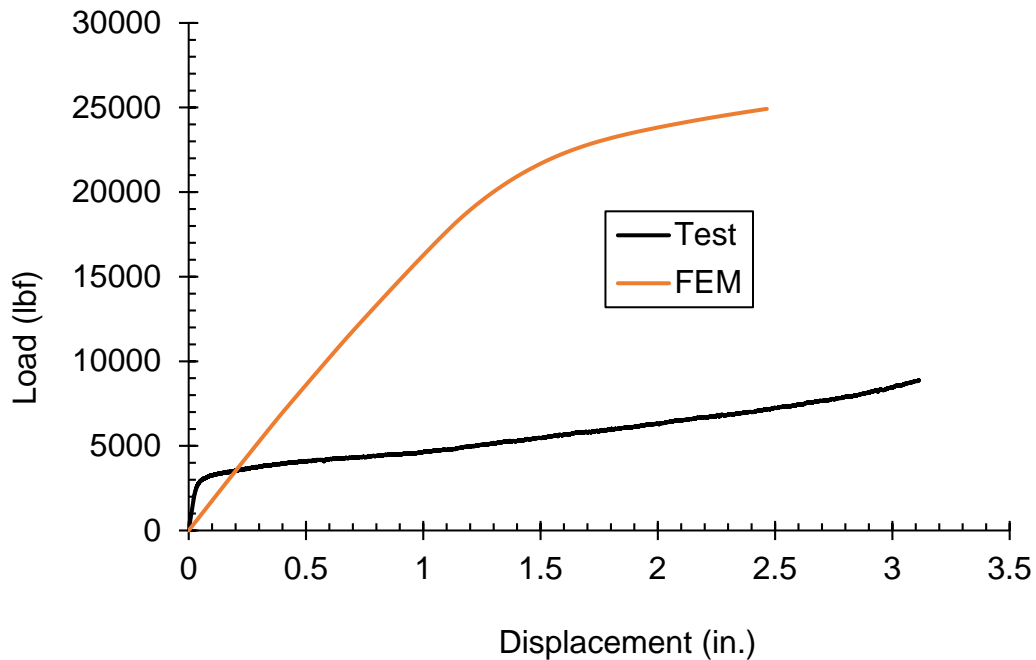
Figure 4-18: Load displacement plot for soil under applied load.

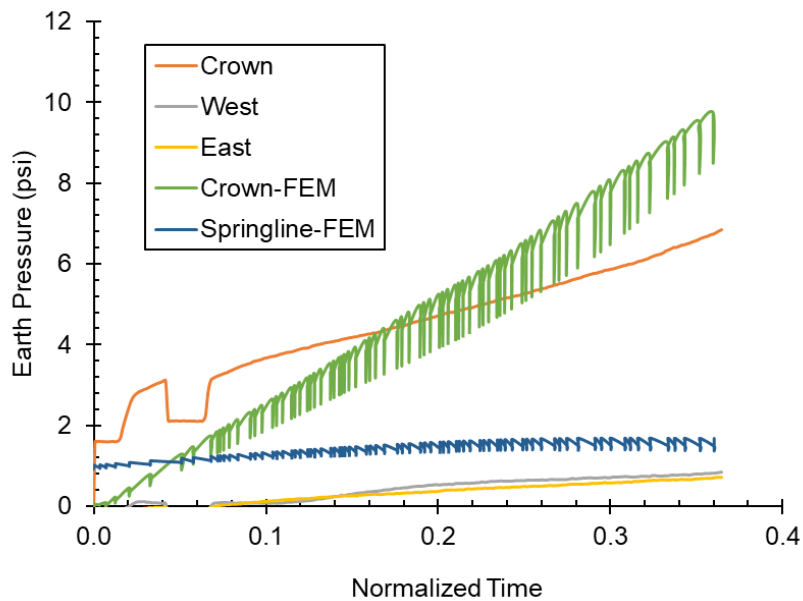
Figure 4-21: Distribution of earth pressure around the CMP.
