DEVELOPMENT OF A STRUCTURAL DESIGN METHODOLOGY FOR  
POLYMERIC SPRAY APPLIED PIPE LININGS

Presented to the Faculty of the Graduate School of  
The University of Texas at Arlington in Partial Fulfillment  
of the Requirements  
for the Degree of

THE UNIVERSITY OF TEXAS AT ARLINGTON

August 2020

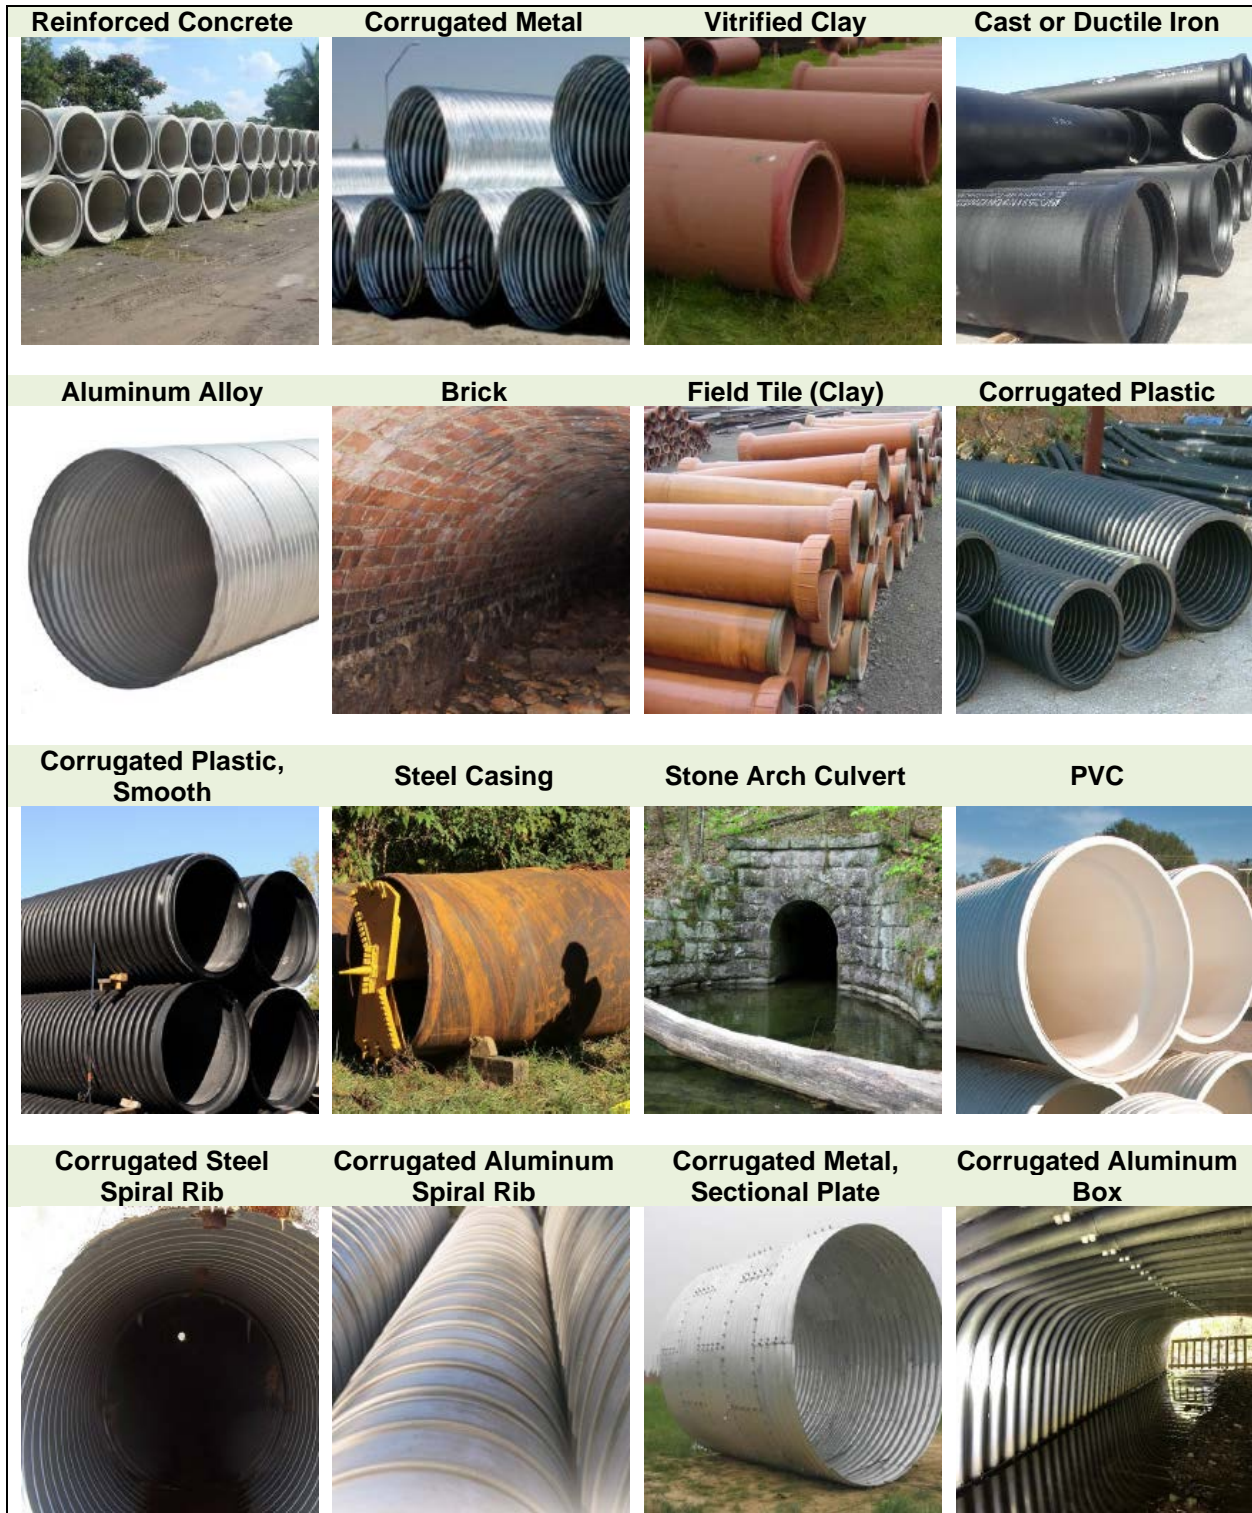
Figure 1-5 Culvert materials (ODOT 2018).

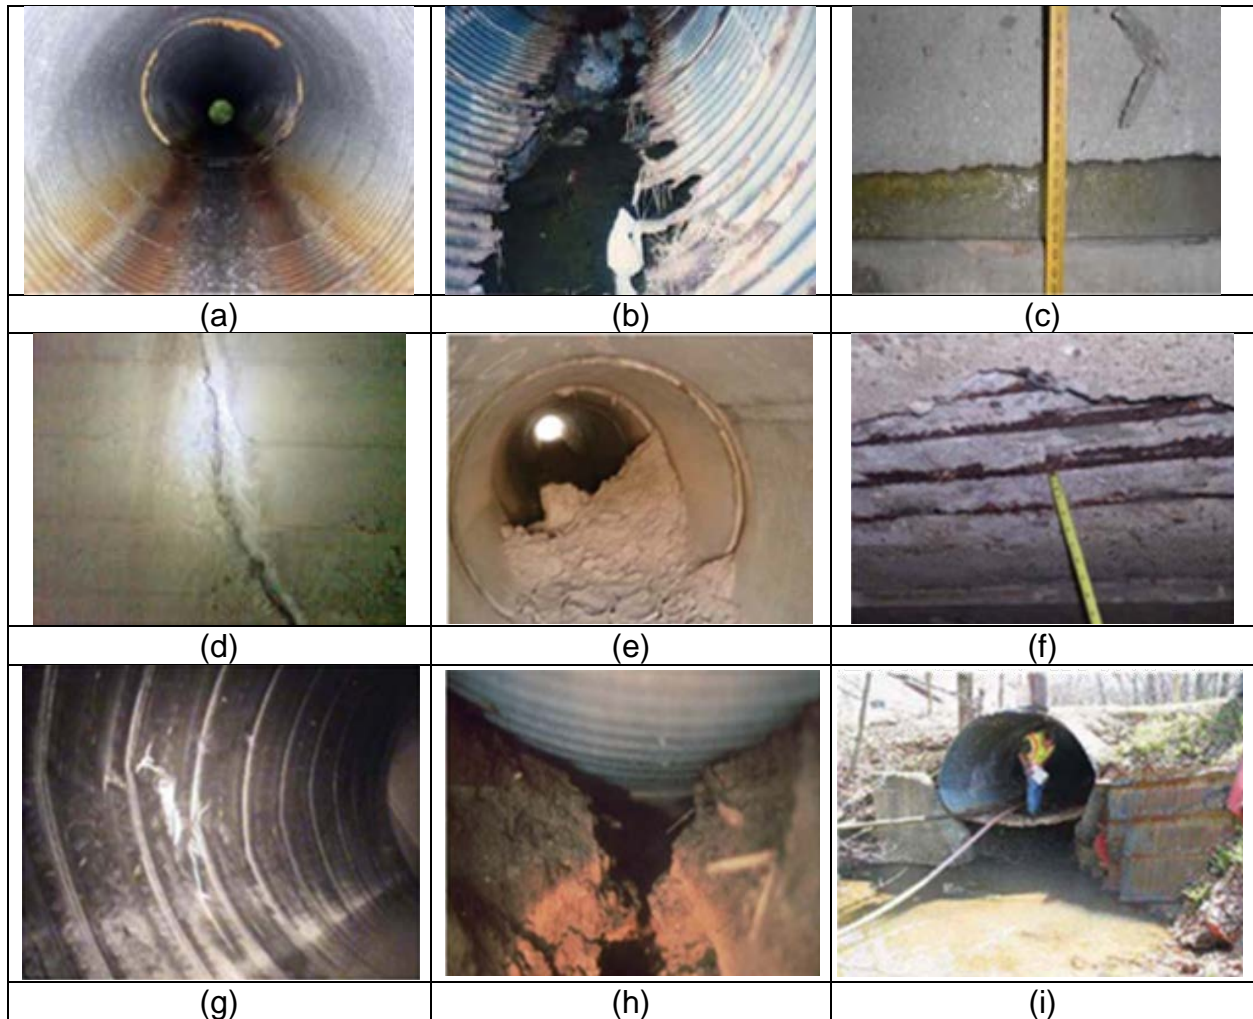
Figure 1-14 Common Defects of Culverts: (a) invert corrosion, (b) invert abrasion, (c) joint separation, (d) crack, (e) joint infiltration, (f) spalling in concrete culverts, (g) wall damages in plastic culverts, (h) piping beneath a culvert and (i) outlet scour (Piratla et al. 2017).

Common defects in culverts can include crack, corrosion, loss of pipe wall thickness, joint infiltration, joint exfiltration, invert deterioration, joint misalignment, shape distortion, debris, loss of wall thickness, and bedding voids, as illustrated in Figure 1-14 (Piratla et al. 2017).

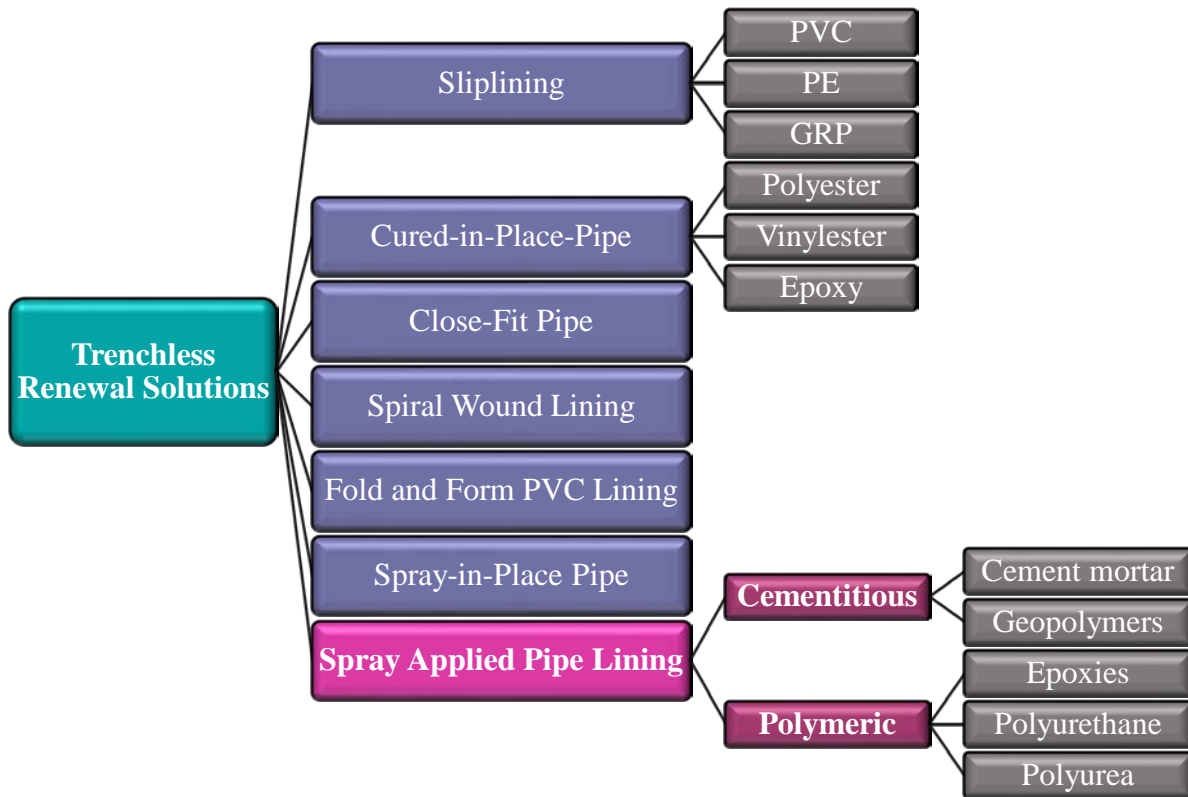
Figure 1-19 Trenchless renewal solutions.

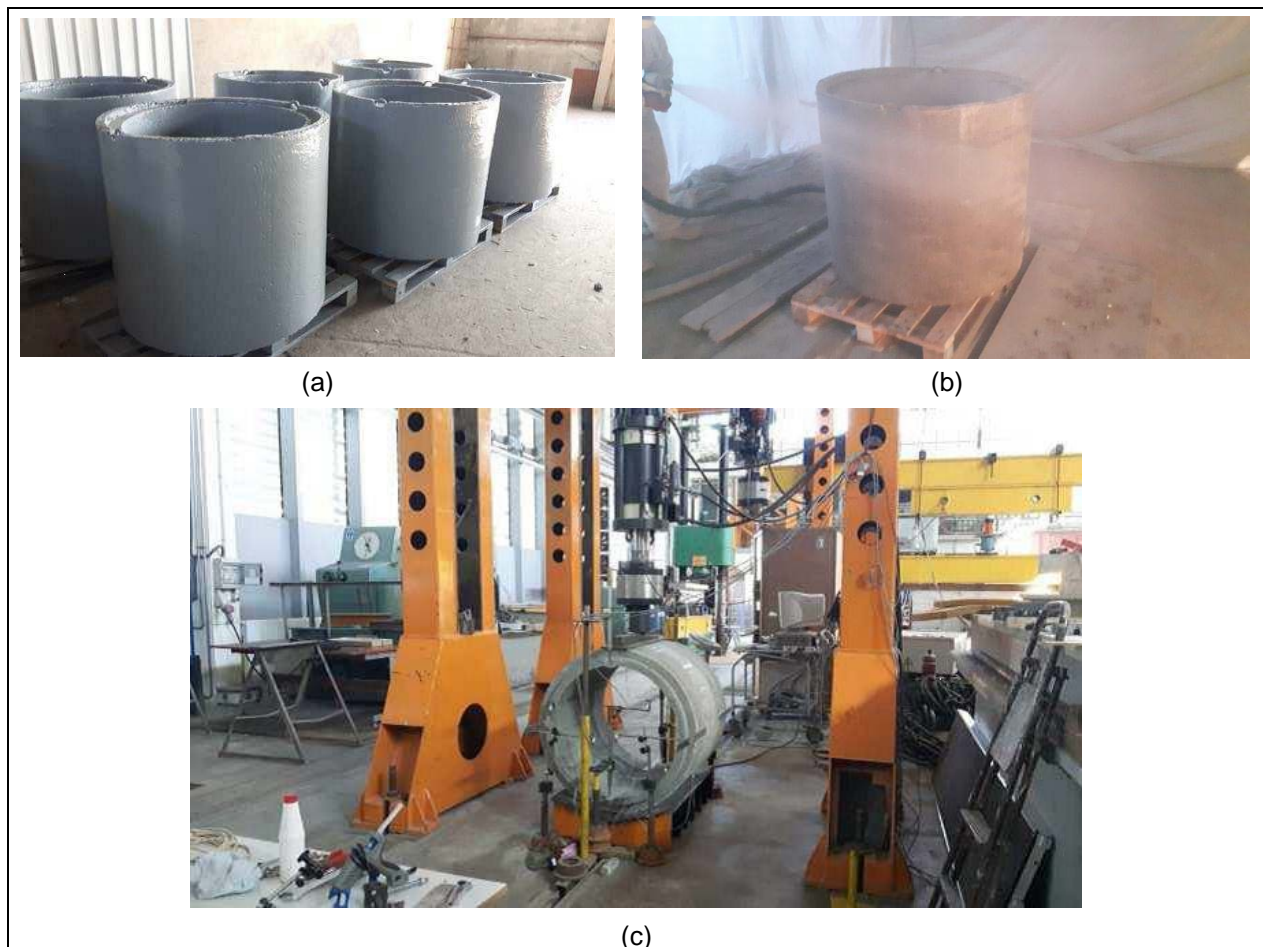
Figure 2-4 Dead-load testing of reinforced concrete pipes (RCPs) renewed with polymeric SAPLs: (a) tested concrete rings covered by polyurea coating, (b) spraying polyurea coating system on concrete ring, and (c) D-load testing frame (Szafran and Matusiak 2017).

impact of soil-pipe-structure interactions. The objective of their study was to evaluate and determine structural behavior and increased compressive strength of RCPs lined with polyurea SAPL. Their methodology was involved static compressive testing on RCP with and without internal and external polyurea SAPL application. Results of these tests indicated that using polyurea SAPL on both internal and external surfaces of RCP increased the peak load of failure by about 21.9%. These results concluded that polyurea SAPL increases the compressive strength of RCP. The authors used external coating and internal spraying, as illustrated in Figure 2-4, which are not usable for the application of renewal of existing culverts (Szafran and Matusiak 2017).

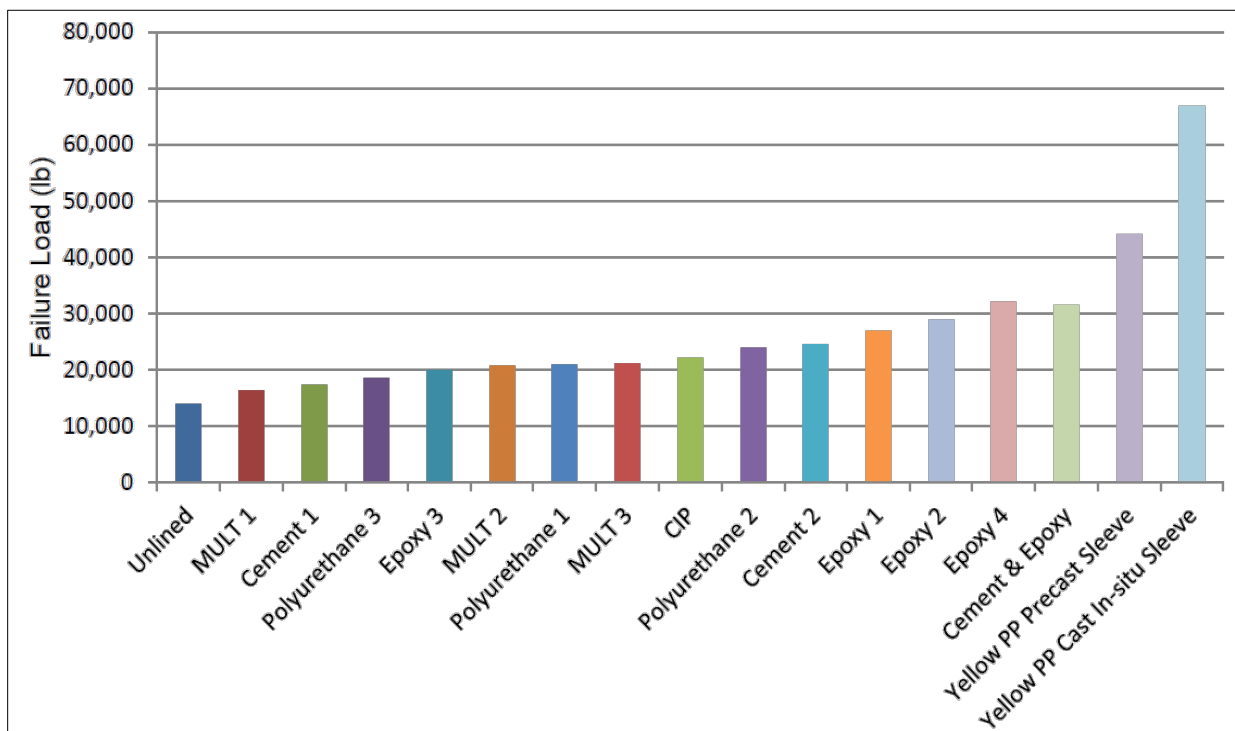
Figure 2-6: Significant increase in renewed CRP structural capacity (Entezarmahdi, 2015).

Entezarmahdi (2015) conducted structural evaluation on 17 reinforced concrete pipes (CRPs), renewed with epoxy lining and tested through three-edge bearing test. The pipe samples had 24 in. inside diameter and were selected from class II category of the ASTM C76 (2015). Different types of liners including epoxy, Polyurethane, Multi structural liners with modified pleurae and foam, cementitious, and resin impregnated cured-in-place lining (CIPP) were applied on different layers and thicknesses. The author summarized the results in one graph as the significant increase in renewed CRP structural capacity by using different liners, showed in Figure 2-6.

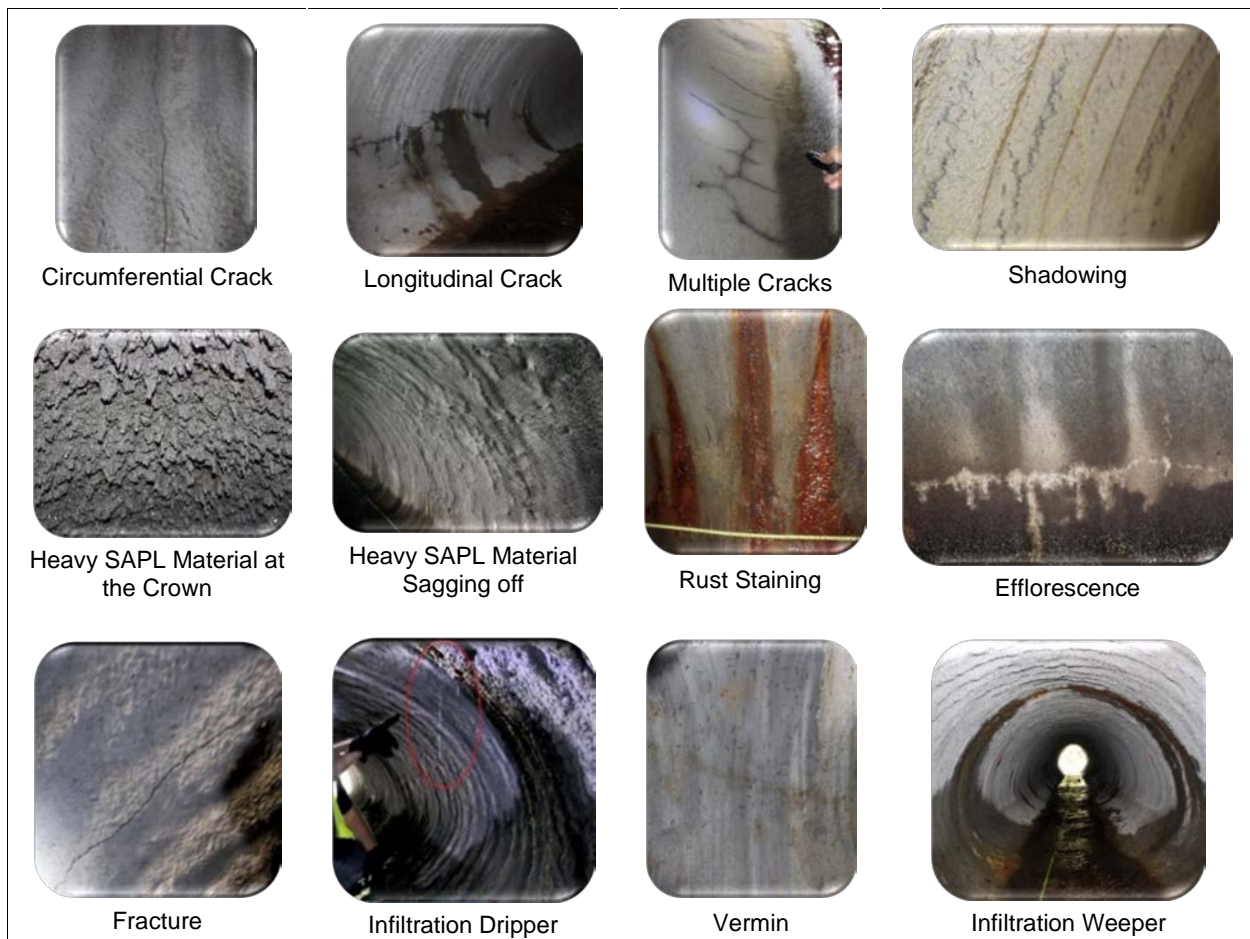
Figure 3-2 Issues found with SAPLs

As stated earlier, currently there are no standard design methodology and construction specifications for proper performance of SAPLs. Lack of standard can be the main cause for SAPL defects, as it is presented in Appendix A. Technical performance construction specifications determine the quality of the product and the required performance. Technical specifications help to install the liner in a feasible and economical manner. Identification and classification of probable SAPL issues help with preparation of performance construction specifications in a manner to avoid and limit those issues. According to the results of field inspection, the photographs of twelve most common SAPL issues are shown in Figure 3-2 Issues found with SAPLs.

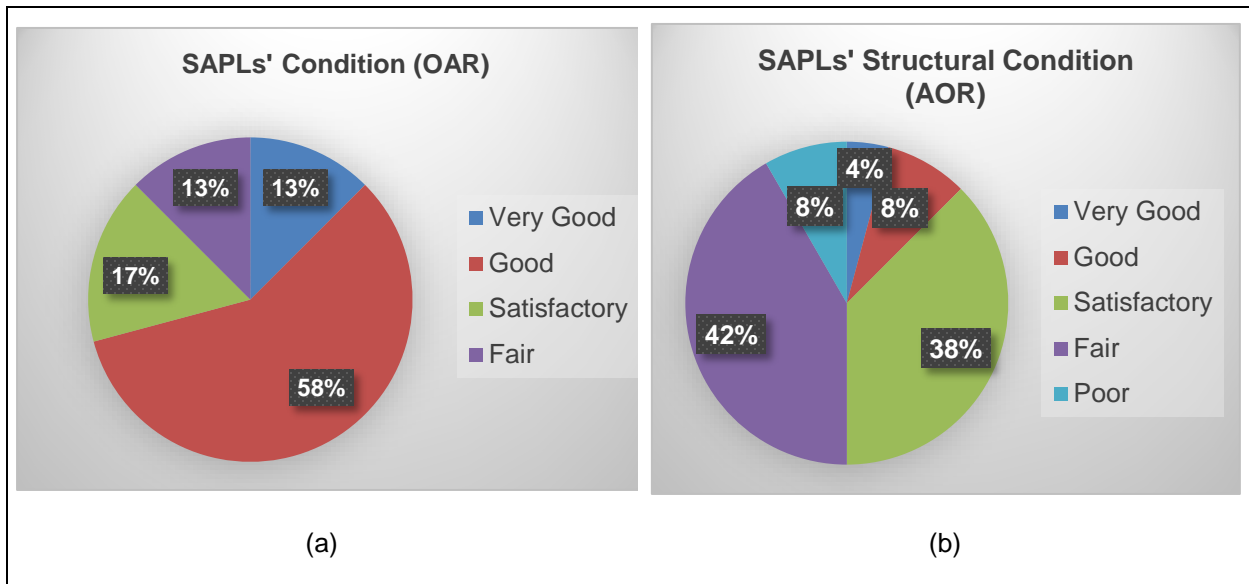
Figure 3-5 Condition assessment of SAPLs. It shows (a) SAPL original condition given as percent of liner condition, (b) SAPLs structural condition given as percent of liner structural condition.

The original average rating score (OAR) and the adjusted overall average score (AOR) were used for condition assessment of SAPLs. The condition of SAPL based on OAR are shown in Table 3-5 (a). According to the rating system definition in this chapter, the results indicate that 13% of 24 SAPLs were in a very good condition, 58% in good condition, 17% in satisfactory condition and 13% in fair condition. The adjusted overall average score was used to quantify the structural SAPLs rates according to available data. Similarly, SAPLs structural conditions were evaluated from the AOR. The structural condition of SAPLs from AOR are shown in Table 3-5 (b). The results indicate 4% of SAPLs were in very good condition, 8% in good condition, 38% in satisfactory condition, 42% in fair condition and 8% in poor condition.

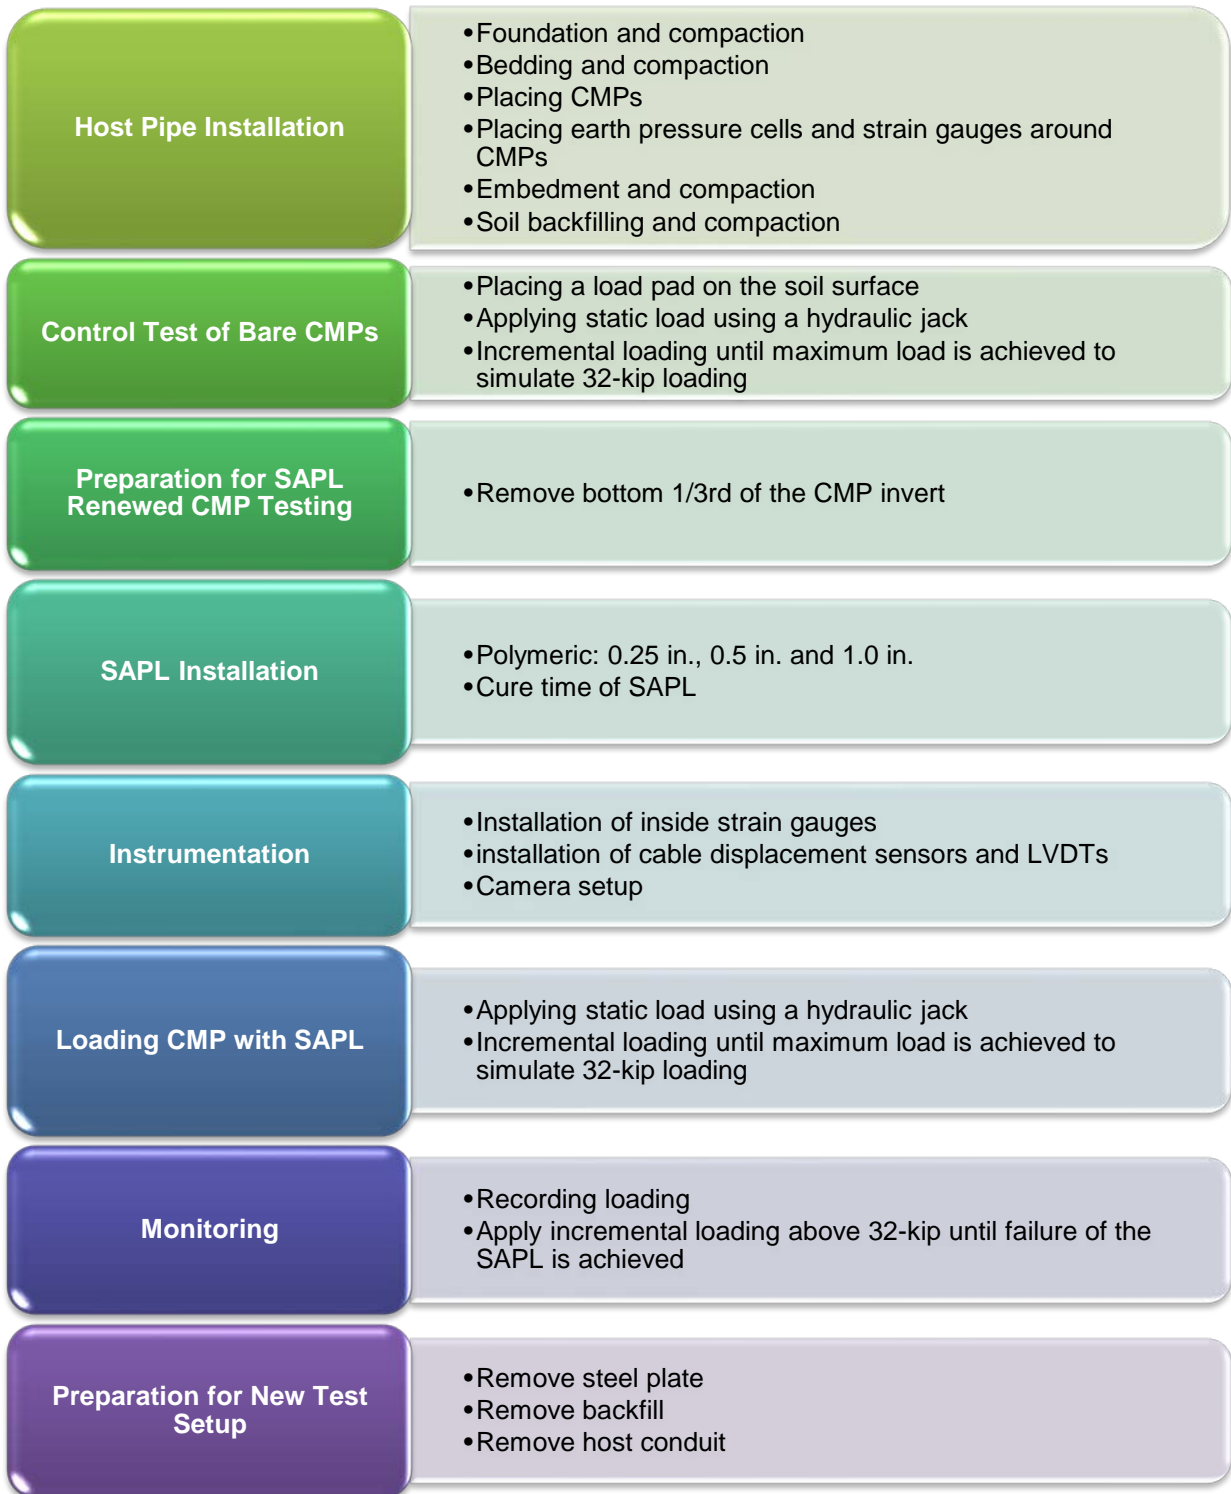
Figure 4-2 Overview of soil box testing steps.

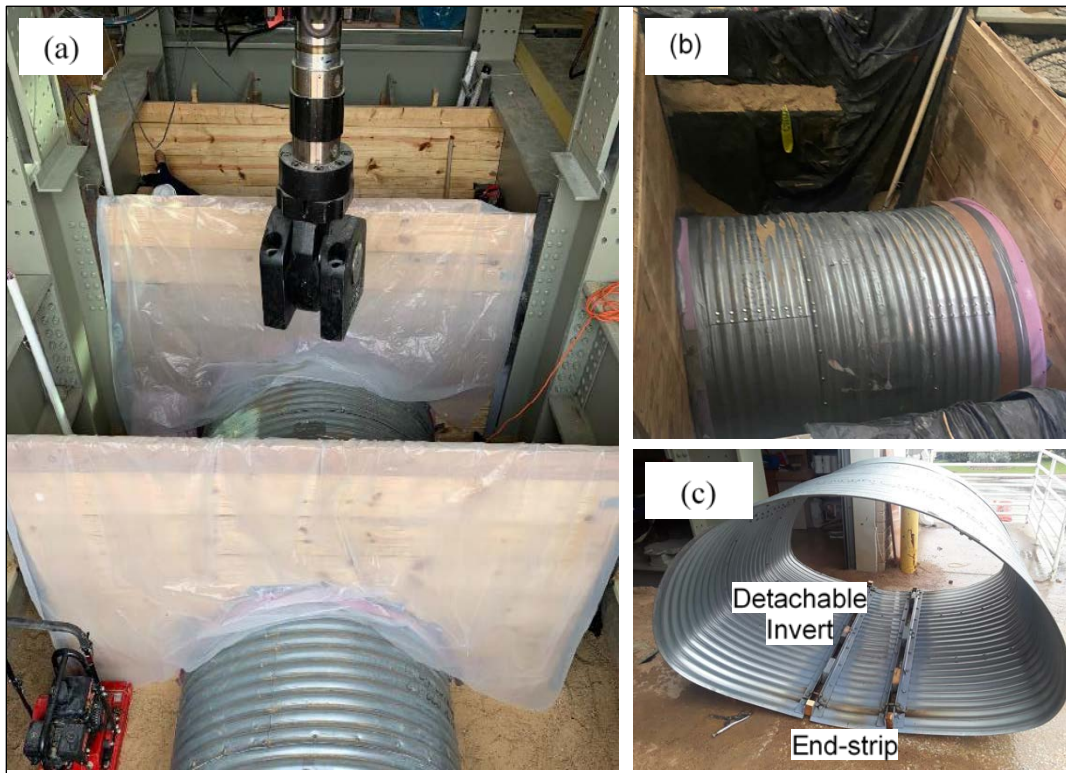
Figure 4-8 Pipe installation: (a) longitudinal configuration of arch CMPs in the soil box of 25 ft × 12 ft × 10 ft at CUIRE, (b) an arch CMP with end sealing, and (c) an arch CMP sample with detachable invert and end-strip section.

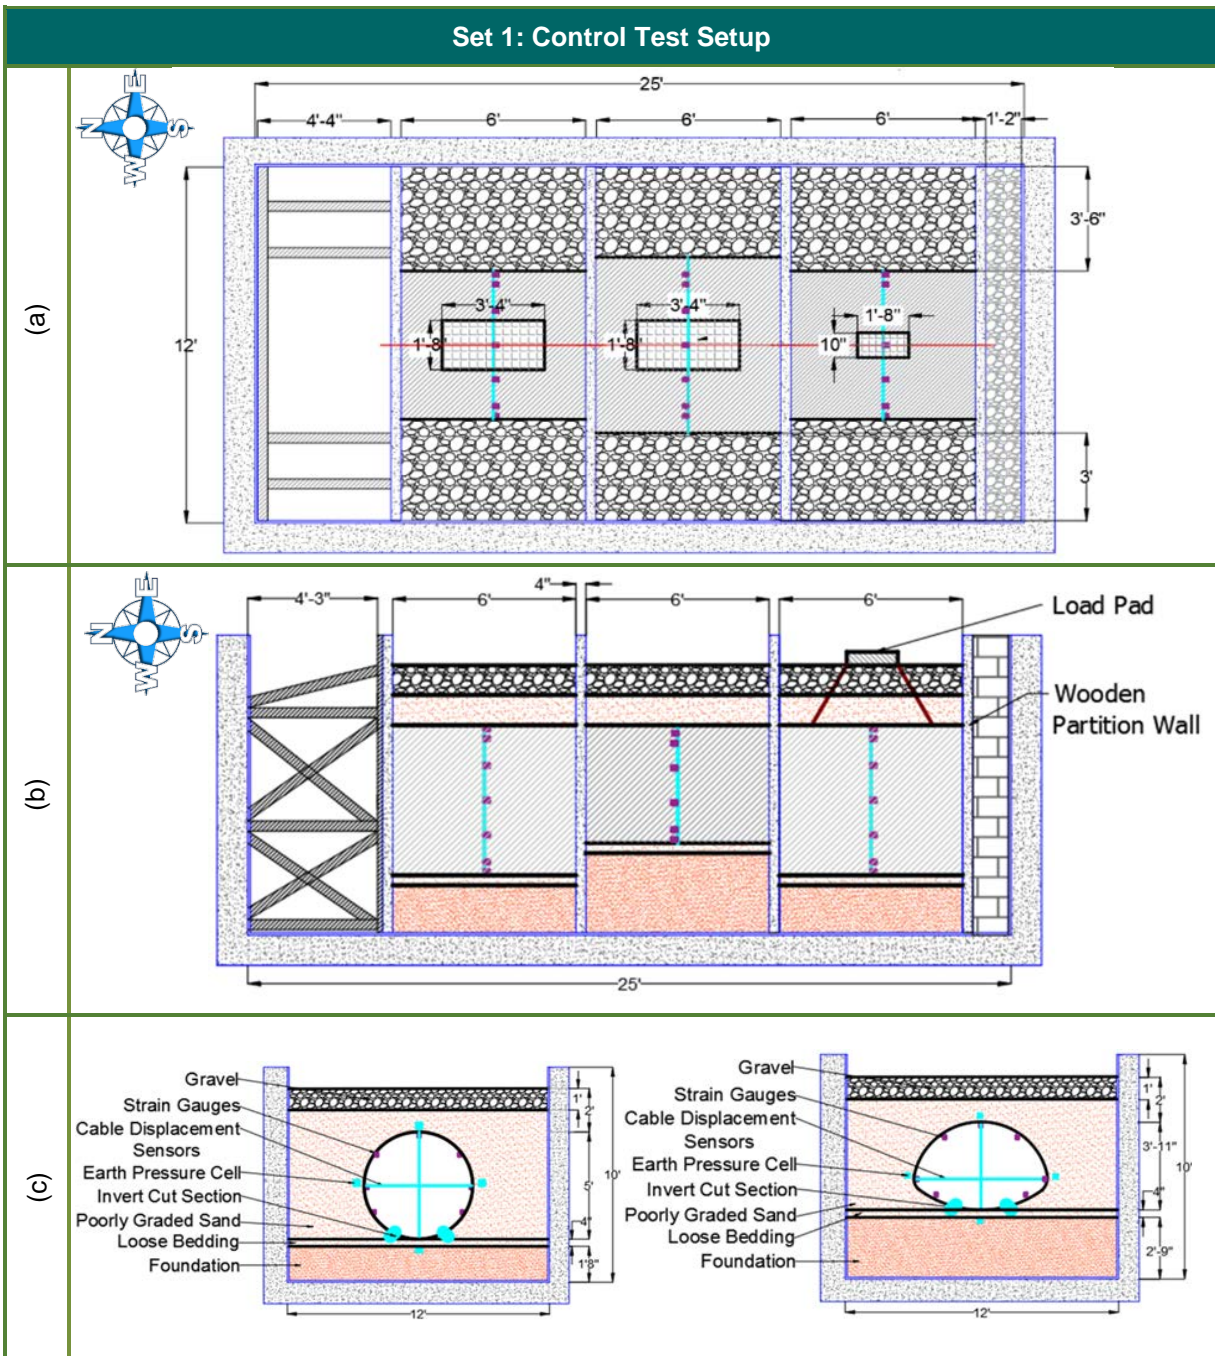
Figure 4-9 The CMPs' burial configuration (1<sup>st</sup> set of soil box testing-control test): (a) plan view, (b) profile view of the aligned CMPs in the soil box, and (c) cross-section view of both circular and arch CMPs.

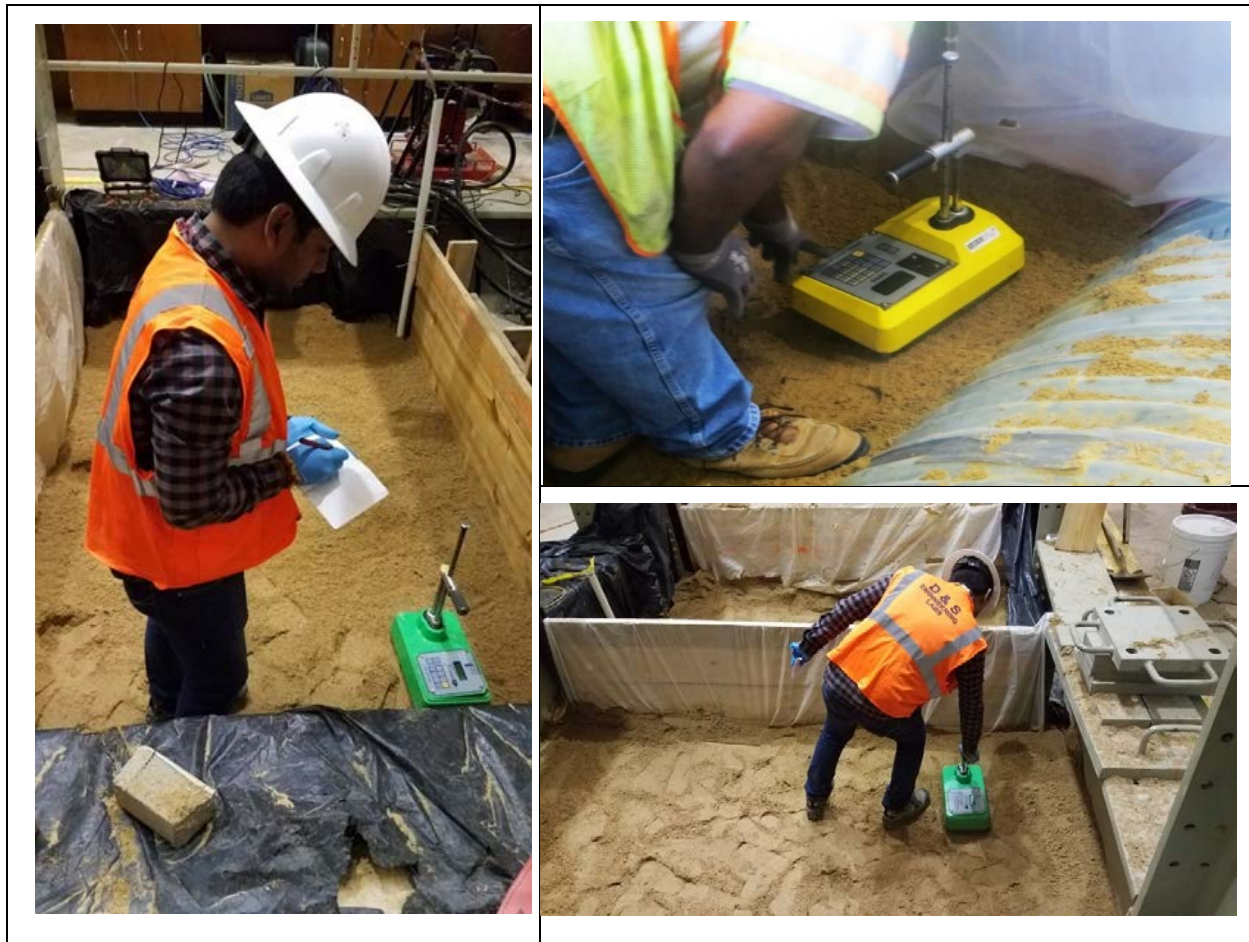
Figure 4-12 Nuclear density measurement (CUIRE).

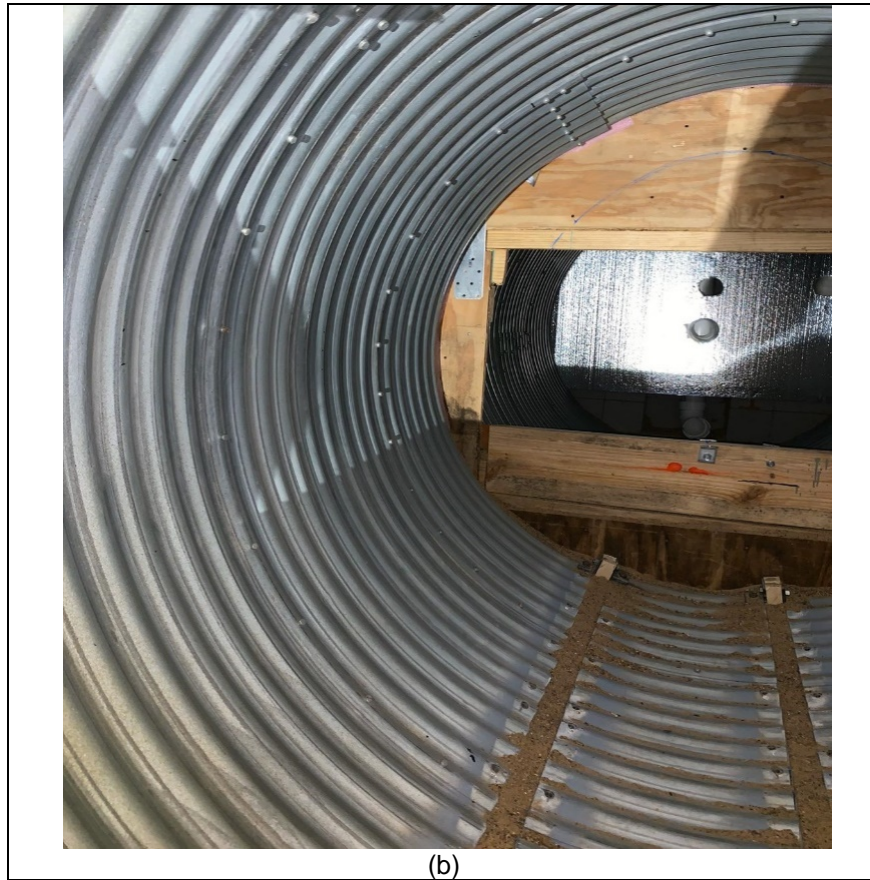
Figure 4-14 CMP surface preparation for SAPL installation: (a) dirt and dust on the CMP, and (b) CMP after power wash without any dirt and dust.

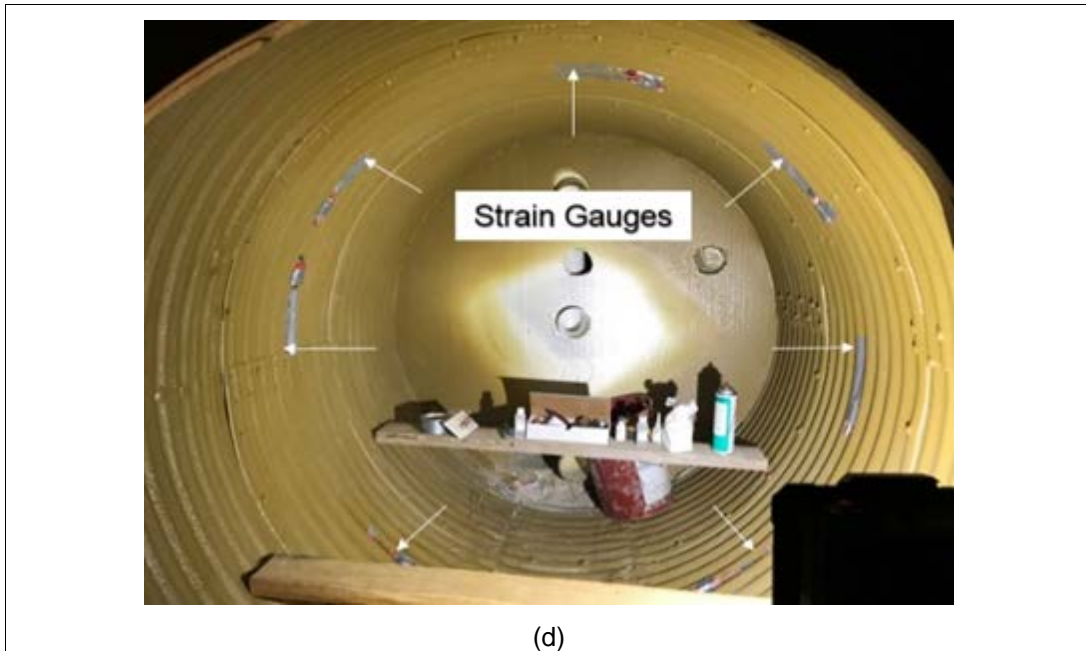
Figure 4-21 Strain gauges configuration and details: (a) schematic profile view at the crown of the bare circular CMP, (b) schematic profile view at the crown of SAPL renewed circular CMP, (c) physical protection of outer surface strain gauges, and (d) installed strain gauges on the inner surface of the SAPL renewed circular CMP.

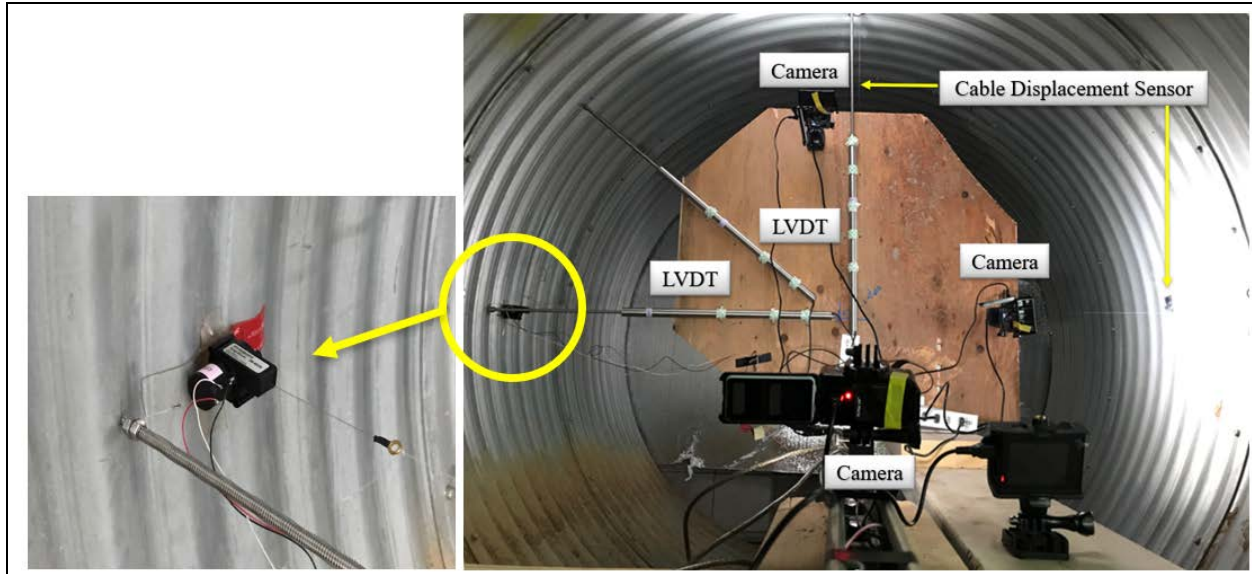
Figure 4-24 LVDTs and cable displacement sensors.

Figure 4-24. LVDTs and CDSs were connected to a data acquisition system that digitalized the transmitted analog signals from the sensors during the tests, as illustrated in Figure 4-25.

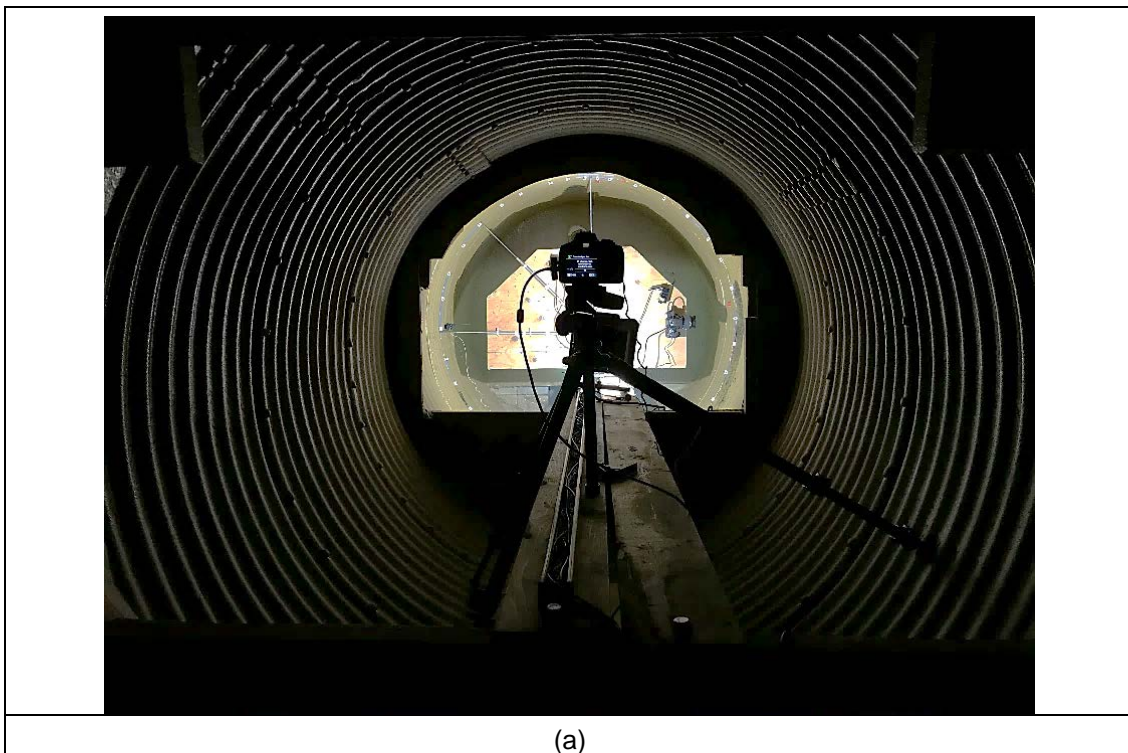
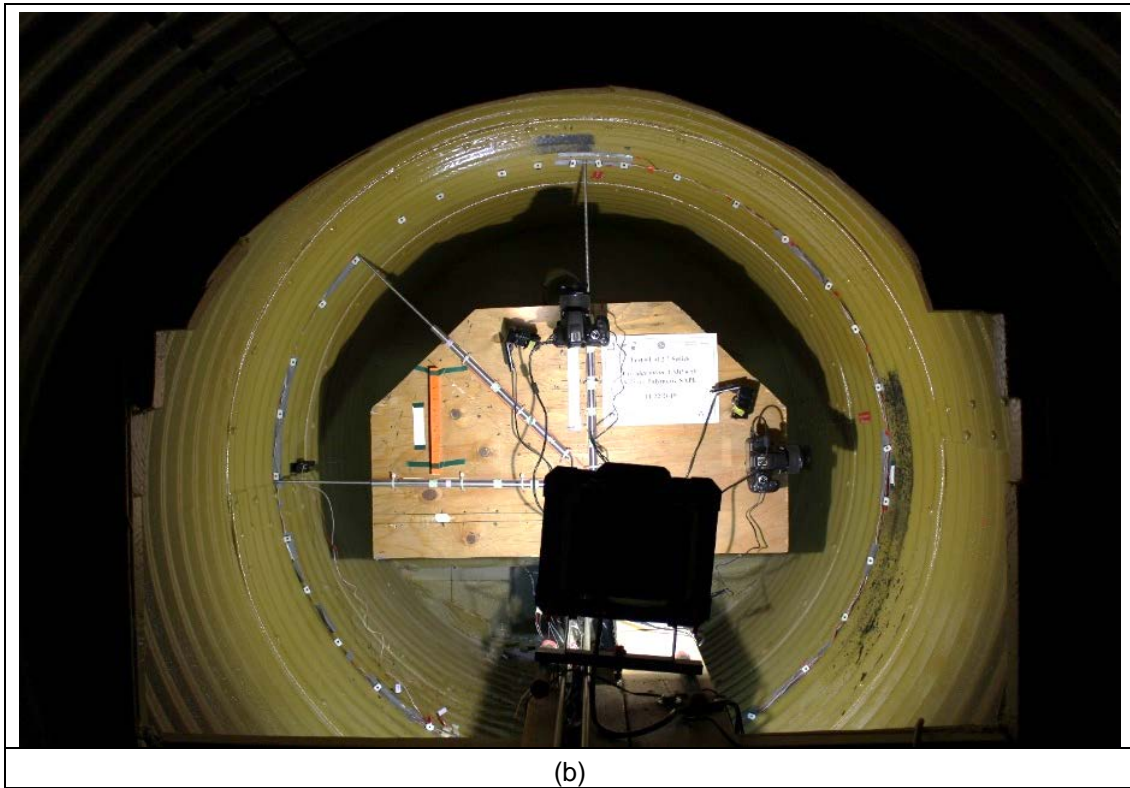
Figure 4-26 Pipe Monitoring: (a) cameras used for capturing changes, and (b) DIC targets for pipe profiling.

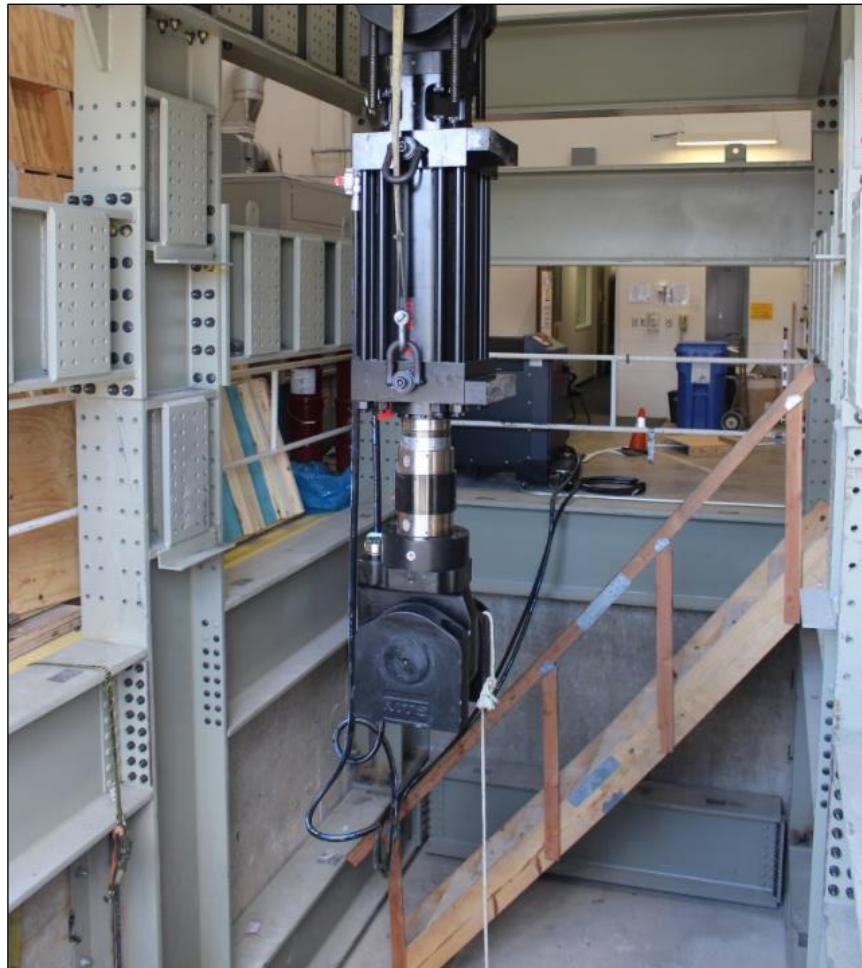
Figure 4-30 The 330-kip MTS actuator hydraulic actuator attached to a reaction steel frame located at the CUIRE Laboratory at the University of Texas at Arlington.

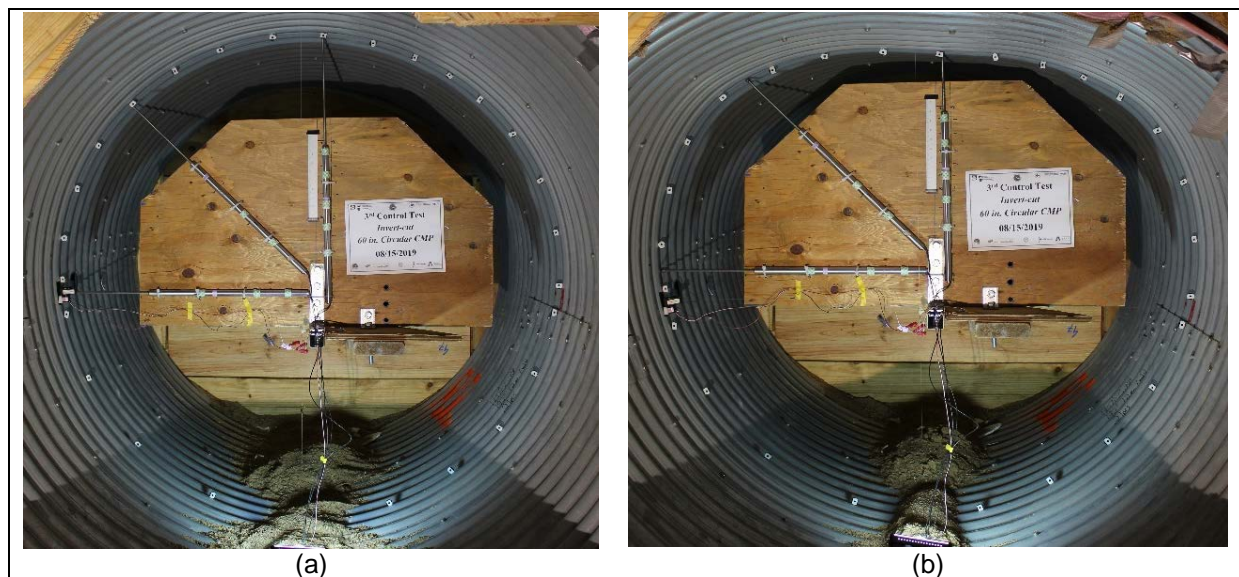
Figure 5-8 60 in. Invert-cut circular CMP soil box testing: (a) before loading, and (b) after loading.

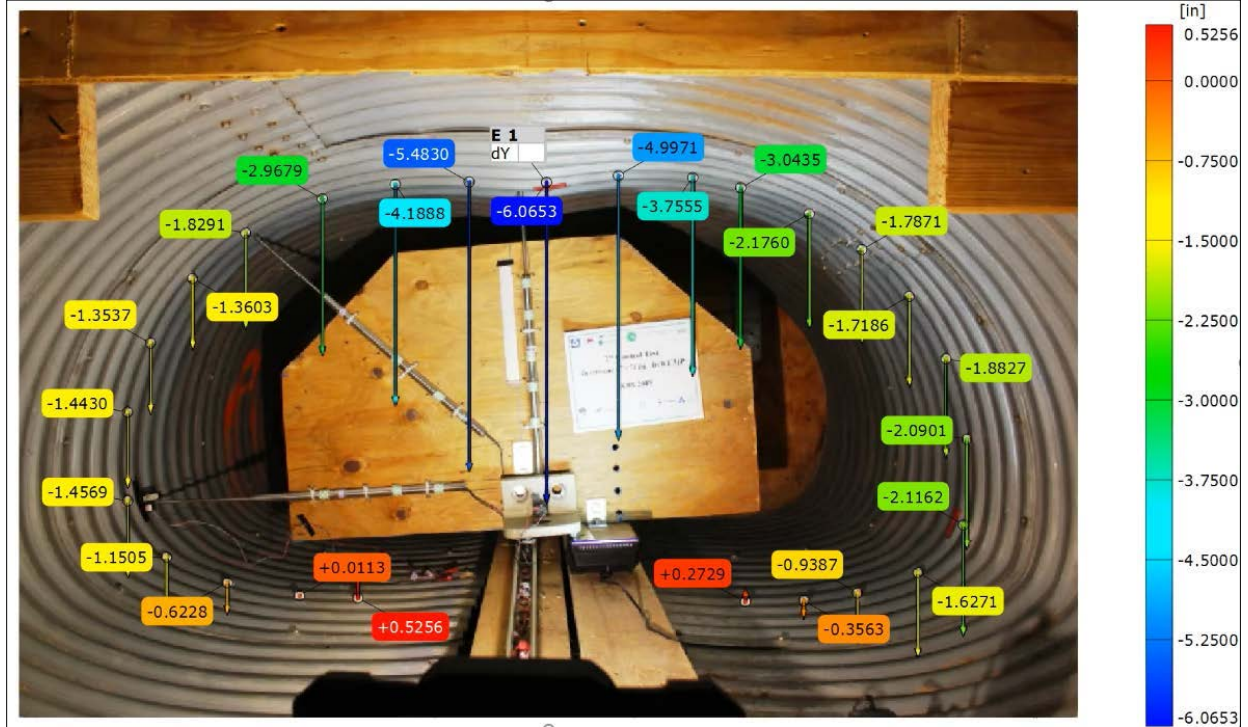
Figure 5-12 Results of DIC measurement at the end of the test – 47×71 in. invert-cut arch CMP.
