DEVELOPMENT OF A STRUCTURAL DESIGN METHODOLOGY FOR  
POLYMERIC SPRAY APPLIED PIPE LININGS

Presented to the Faculty of the Graduate School of  
The University of Texas at Arlington in Partial Fulfillment  
of the Requirements  
for the Degree of

THE UNIVERSITY OF TEXAS AT ARLINGTON

August 2020

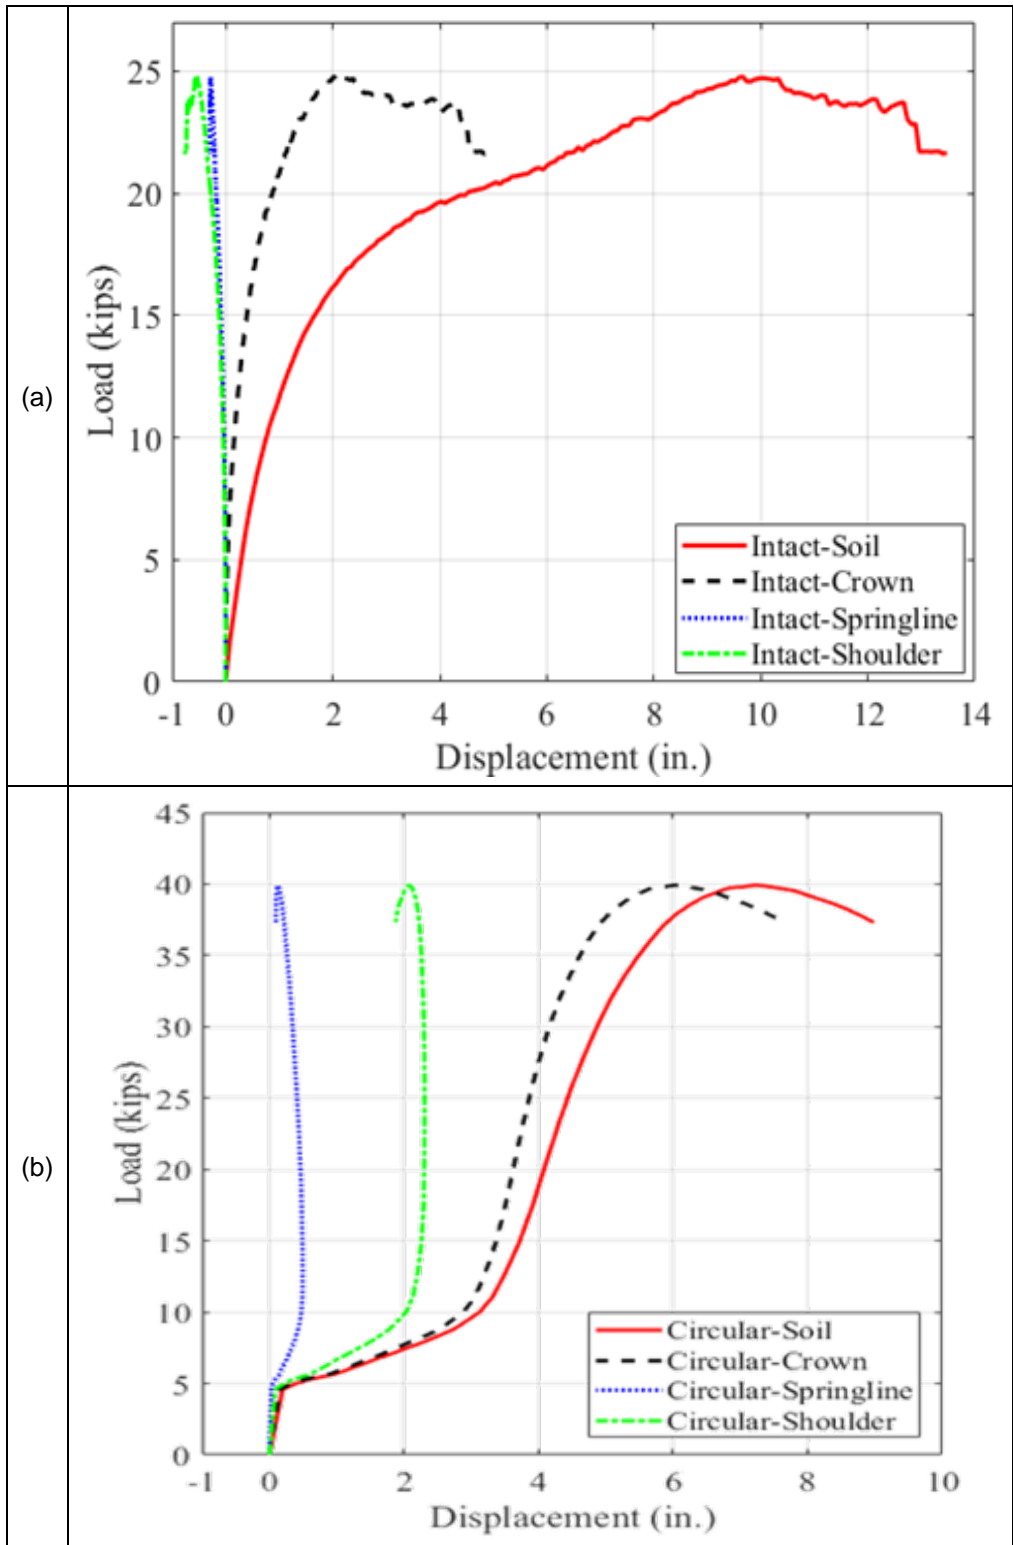
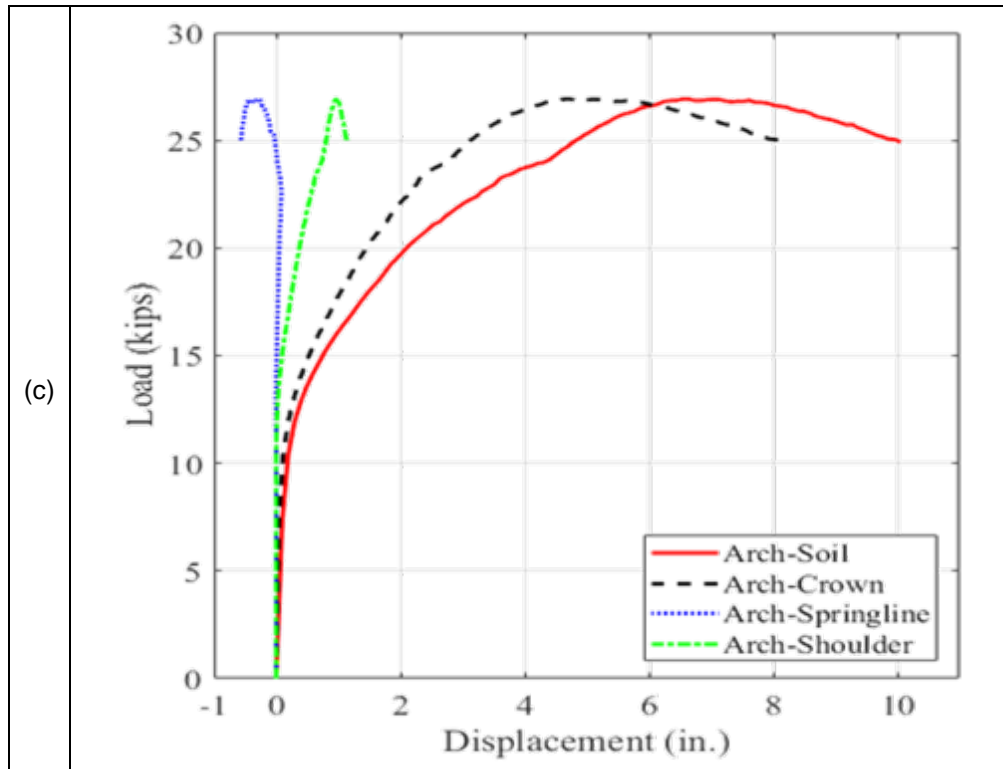
Figure 5-13 Load versus displacement of CMPs at different locations for the control test: (a) intact 60 in. circular CMP under a 10x20 in. steel load pad, (b) invert-cut 60 in. circular CMP under a 20x40 in. steel load pad, and (c) invert-cut 47x71 in. arch CMP under a 20x40 in. steel load pad.

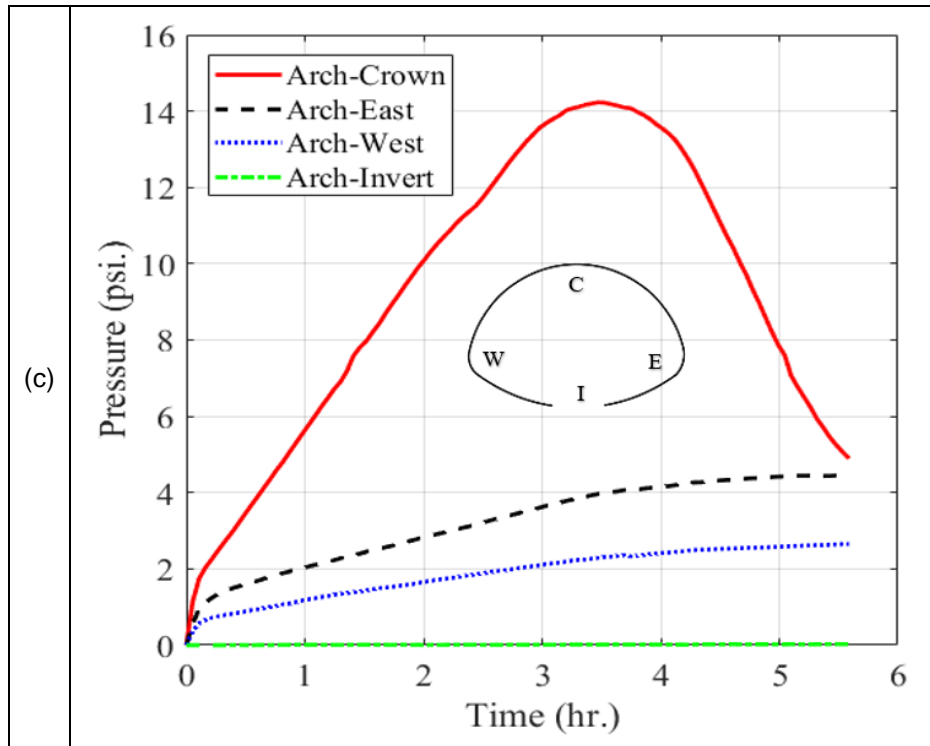
Figure 5-14 Results of earth pressure cells for the CMP control test: (a) intact circular CMP, (b) invert-cut circular CMP, and (c) invert-cut arch CMP.

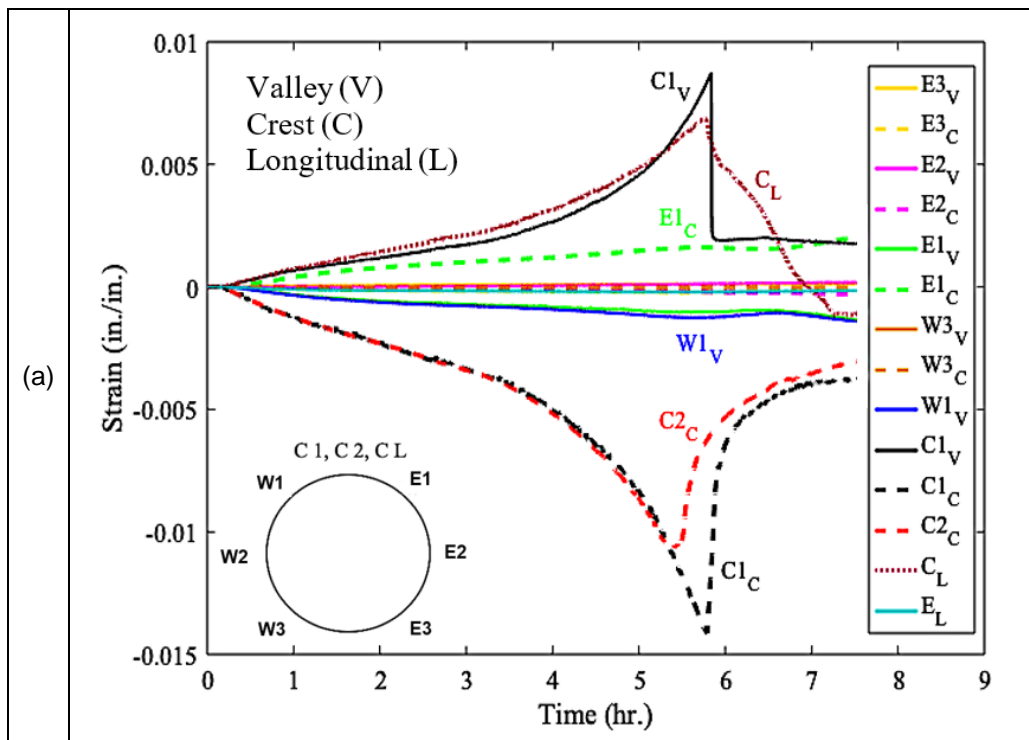
Figure 5-15 Results of strain gauges for the CMP control test: (a) intact circular CMP, (b) invert-cut circular CMP, and (c) invert-cut arch CMP.

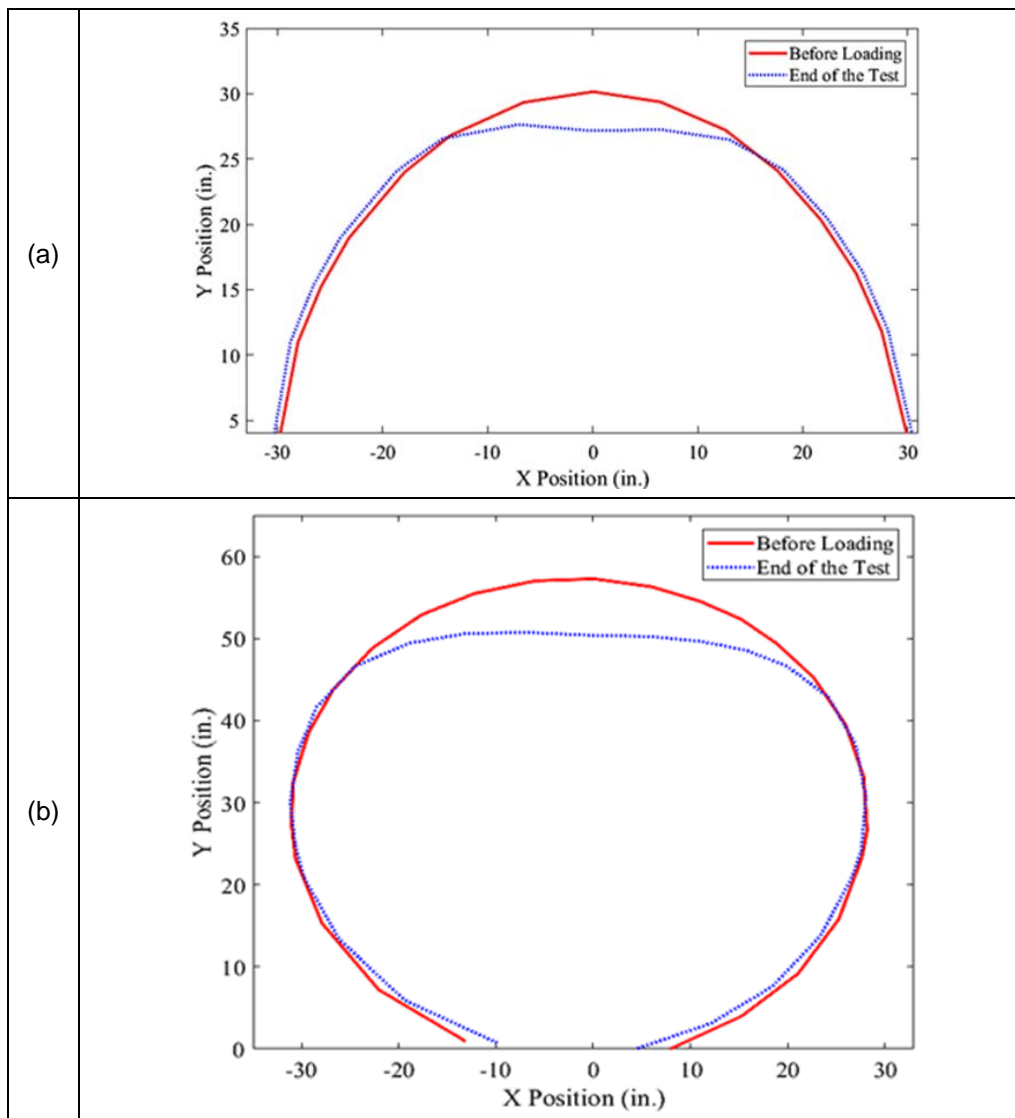
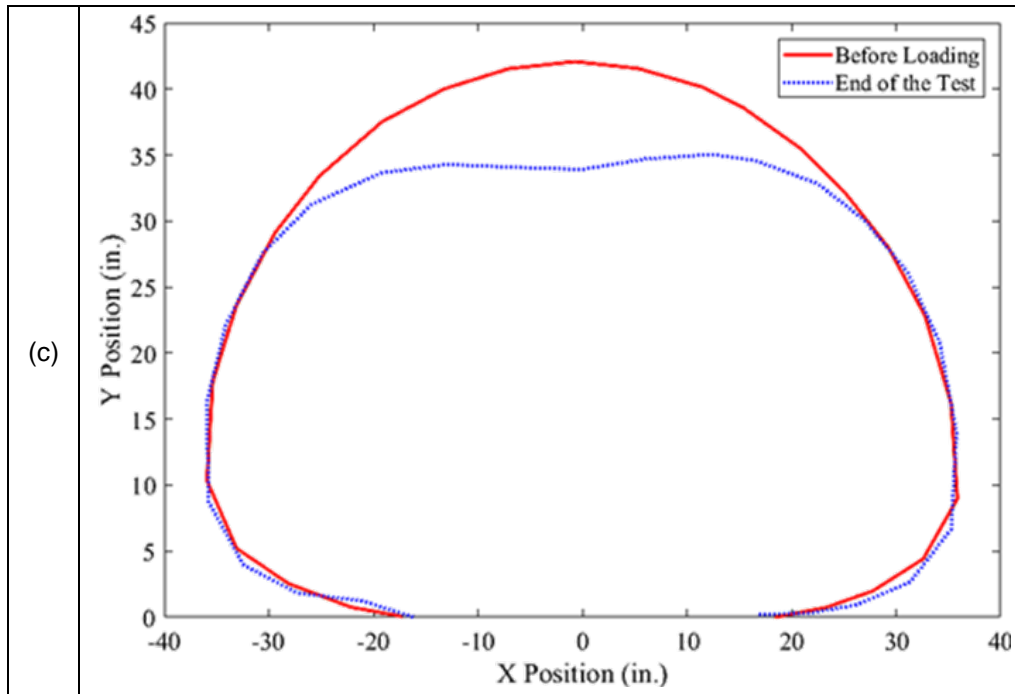
Figure 5-17 Pipe profiling using DIC results before loading and after loading at the ultimate load carrying capacity of the samples: (a) intact CMP, (b) invert-cut circular CMP, and (c) invert-cut arch CMP.

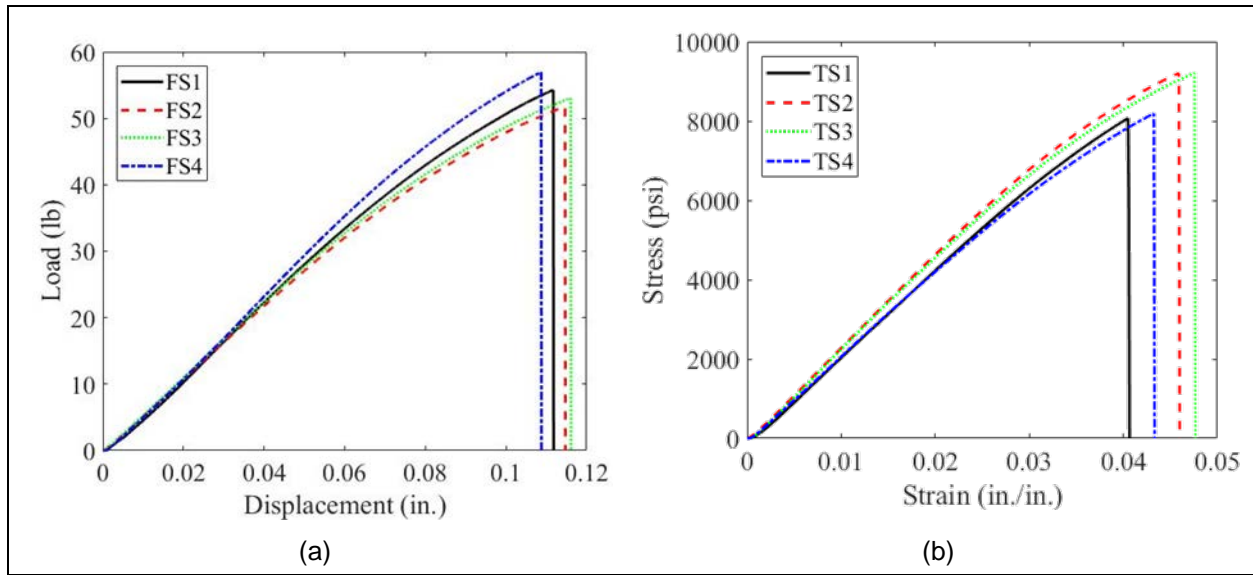
Figure 5-18 Polymer SAPL material property test results: (a) flexural test (ASTM D790), and (b) tensile test (ASTM D638).

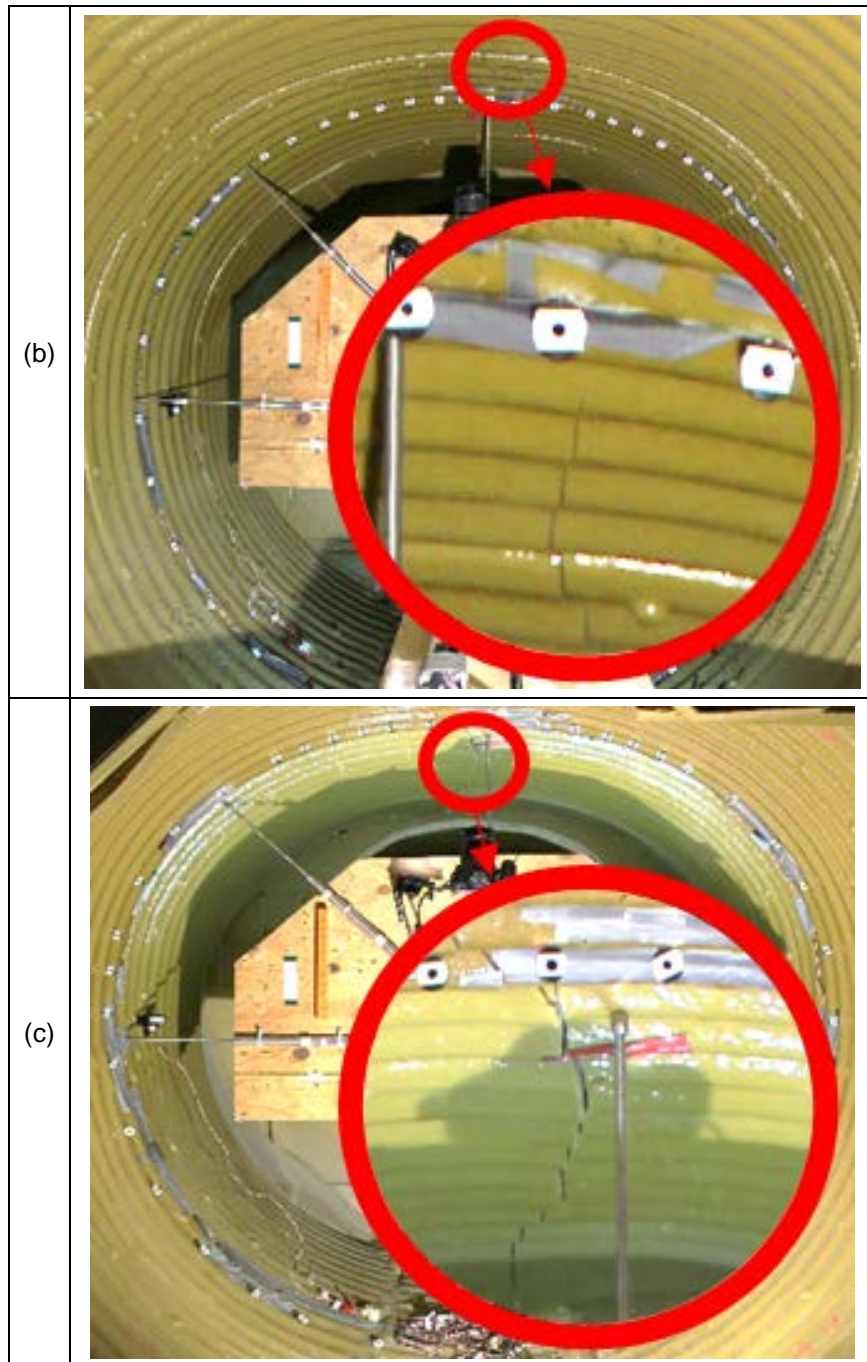
Figure 5-21 Formation of the first structural crack. It shows (a) 0.25 in. SAPL renewed circular CMP at 39 kips, (b) 0.5 in. SAPL renewed circular CMP at 42.78 kips, and (c) 1 in. SAPL renewed circular CMP at 66.26 kips.

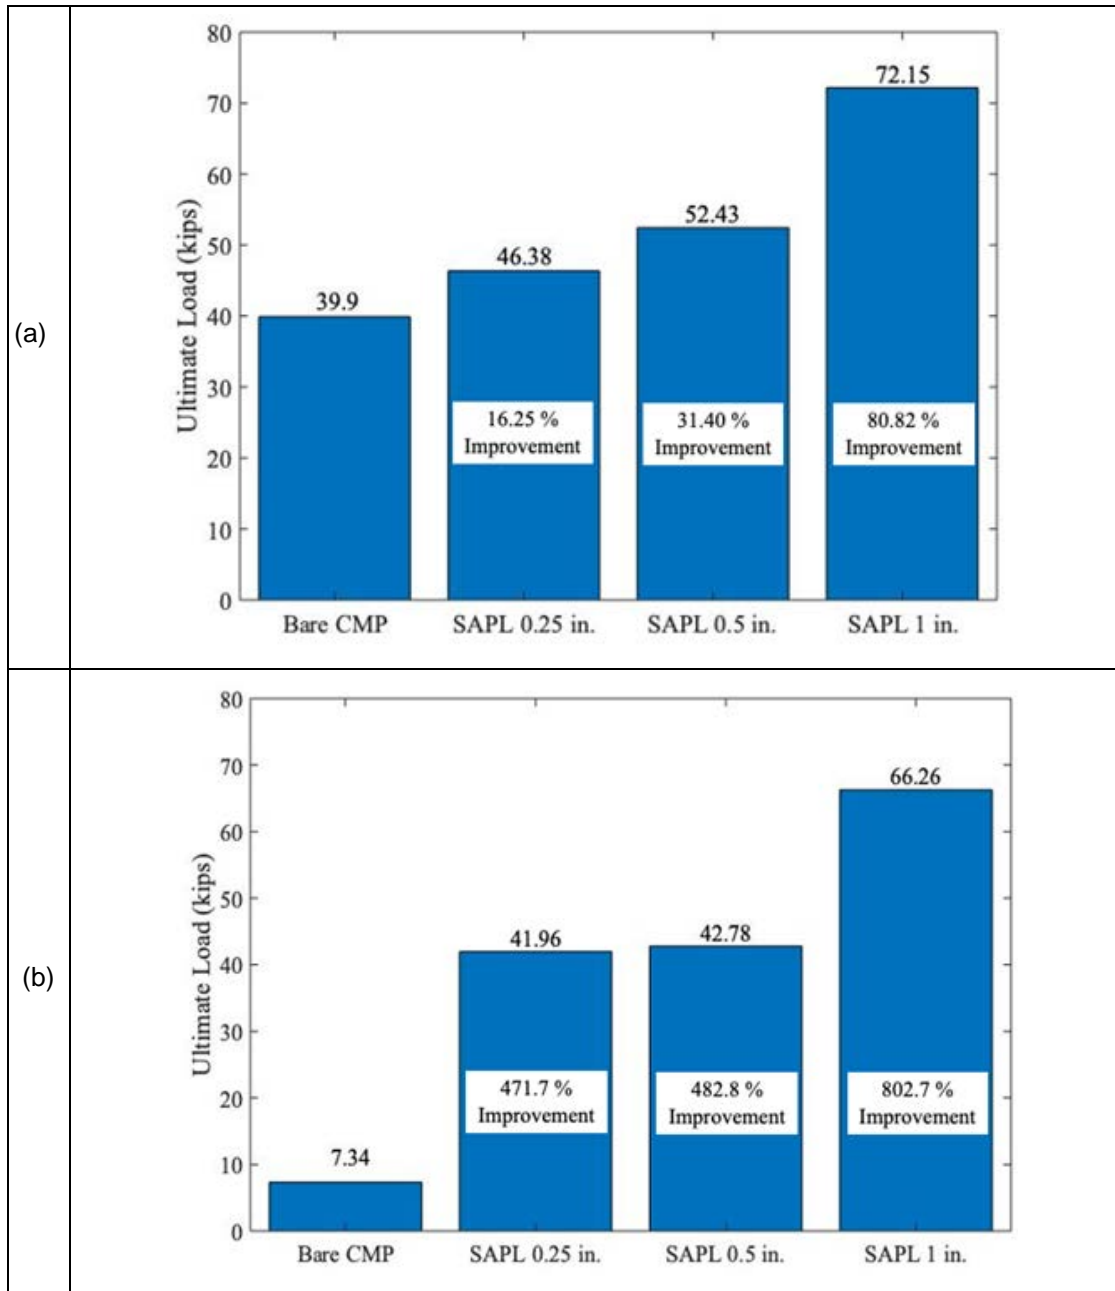
Figure 5-22 Load improvement by SAPL application: (a) ultimate load comparison of renewed SAPL circular CMPs with bare CMP, and (b) load comparison of renewed SAPL CMPs with bare CMP at 2 in. pipe deflection.

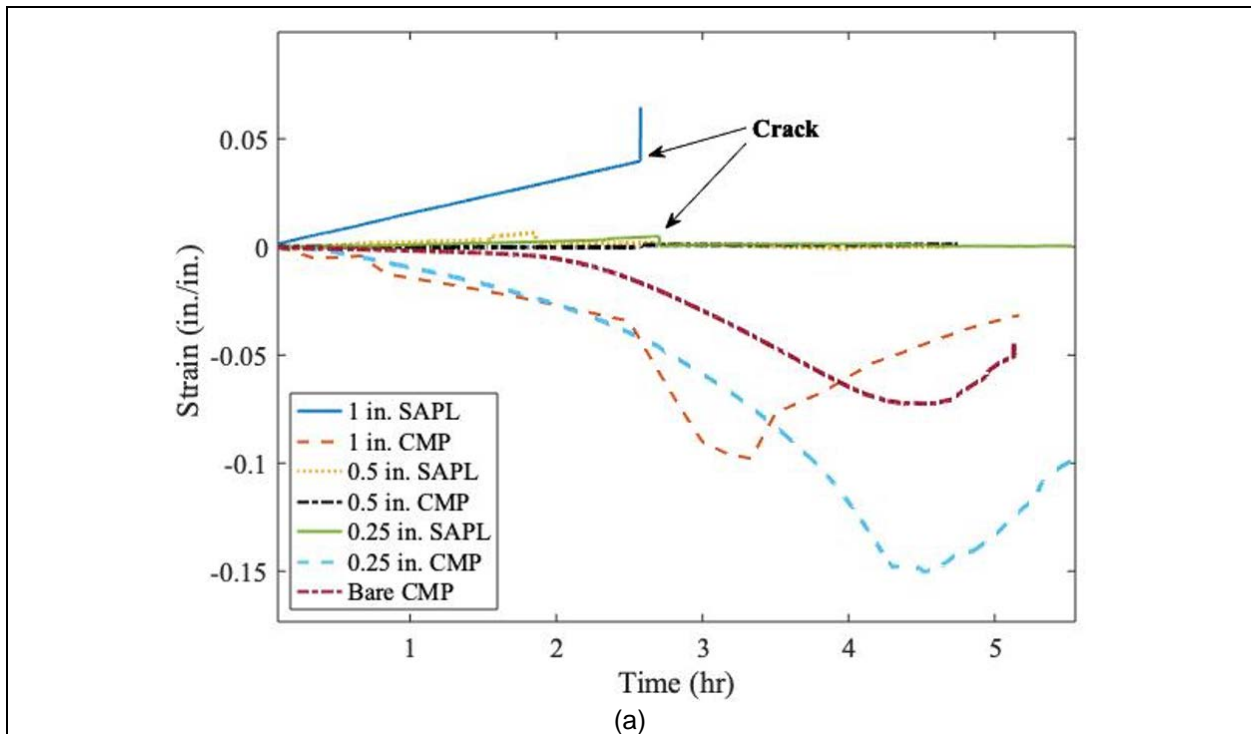
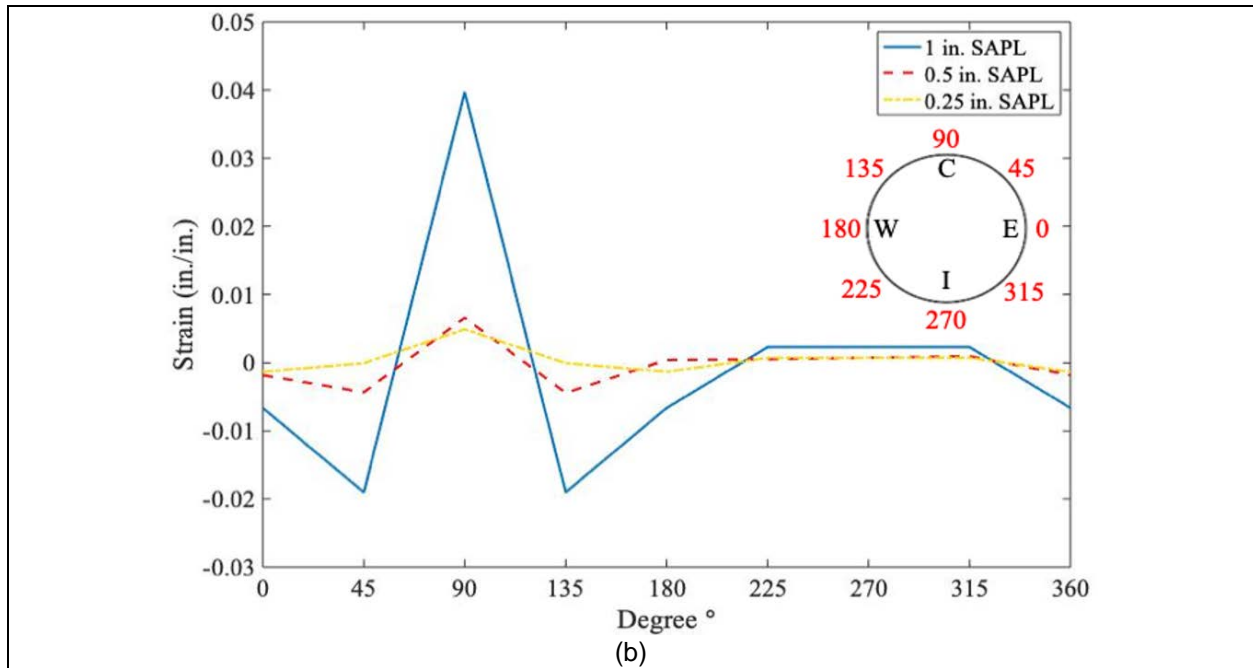
Figure 5-24 Strain gauge results for SAPL renewed circular CMP: (a) at the crown and (b) around the SAPL at the time of first structural crack.

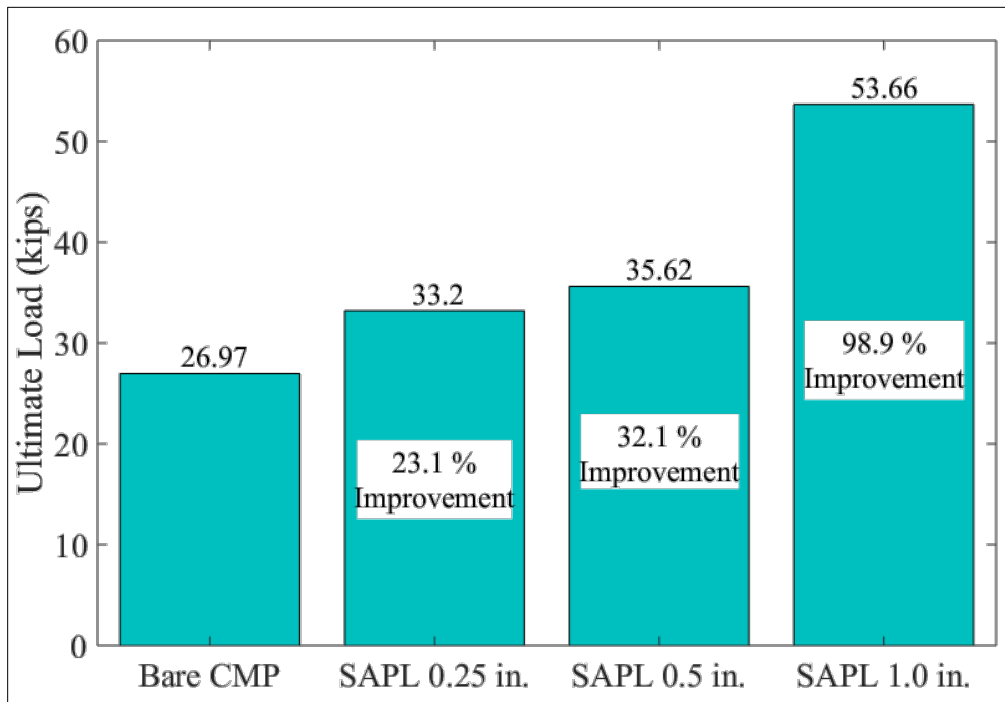
Figure 5-31 Fully Invert deteriorated arch CMPs ultimate load carrying capacity improvement through SAPL application.

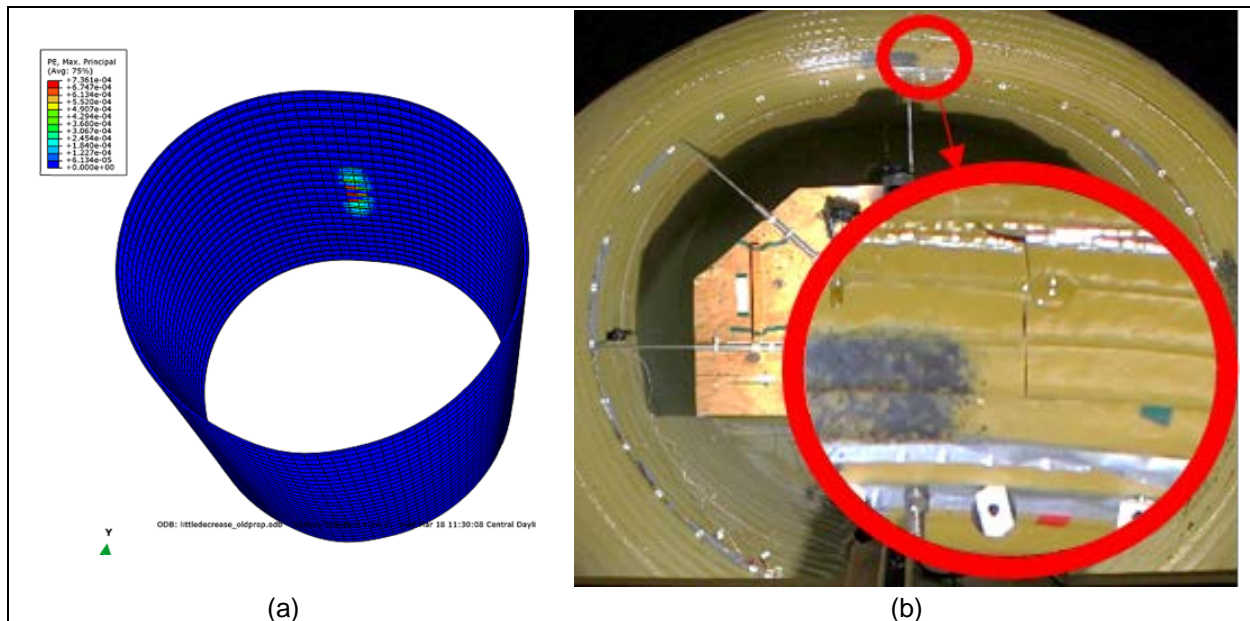
Figure 6-2 Comparison of the soil box testing results and FEM with respect to the occurrence of the first crack: (a) plastic strain predicted by FEM (Source: CUIRE FEM report), and (b) 0.25 in. SAPL first crack at the crown location.

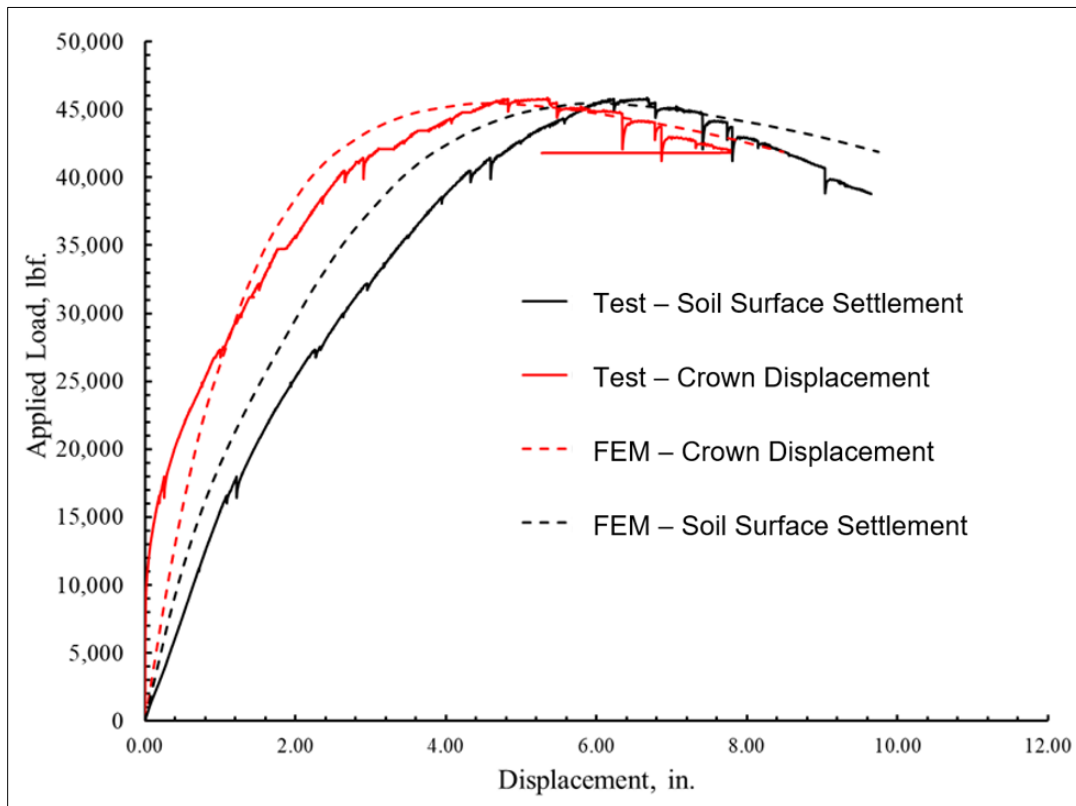
Figure 6-5 Load versus displacement – comparison of soil box testing results and FEM (Source: CUIRE FEM report) results (0.25 in. SAPL).

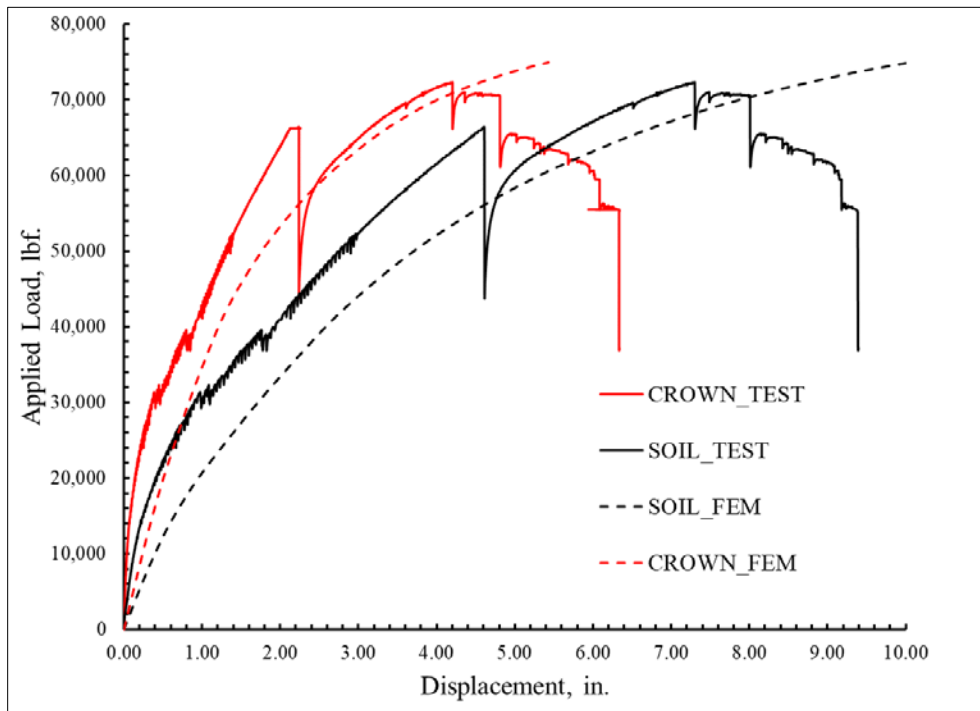
Figure 6-16 Load versus displacement – comparison of soil box testing results and FEM (Source: CUIRE FEM report) results (0.1 in. SAPL).

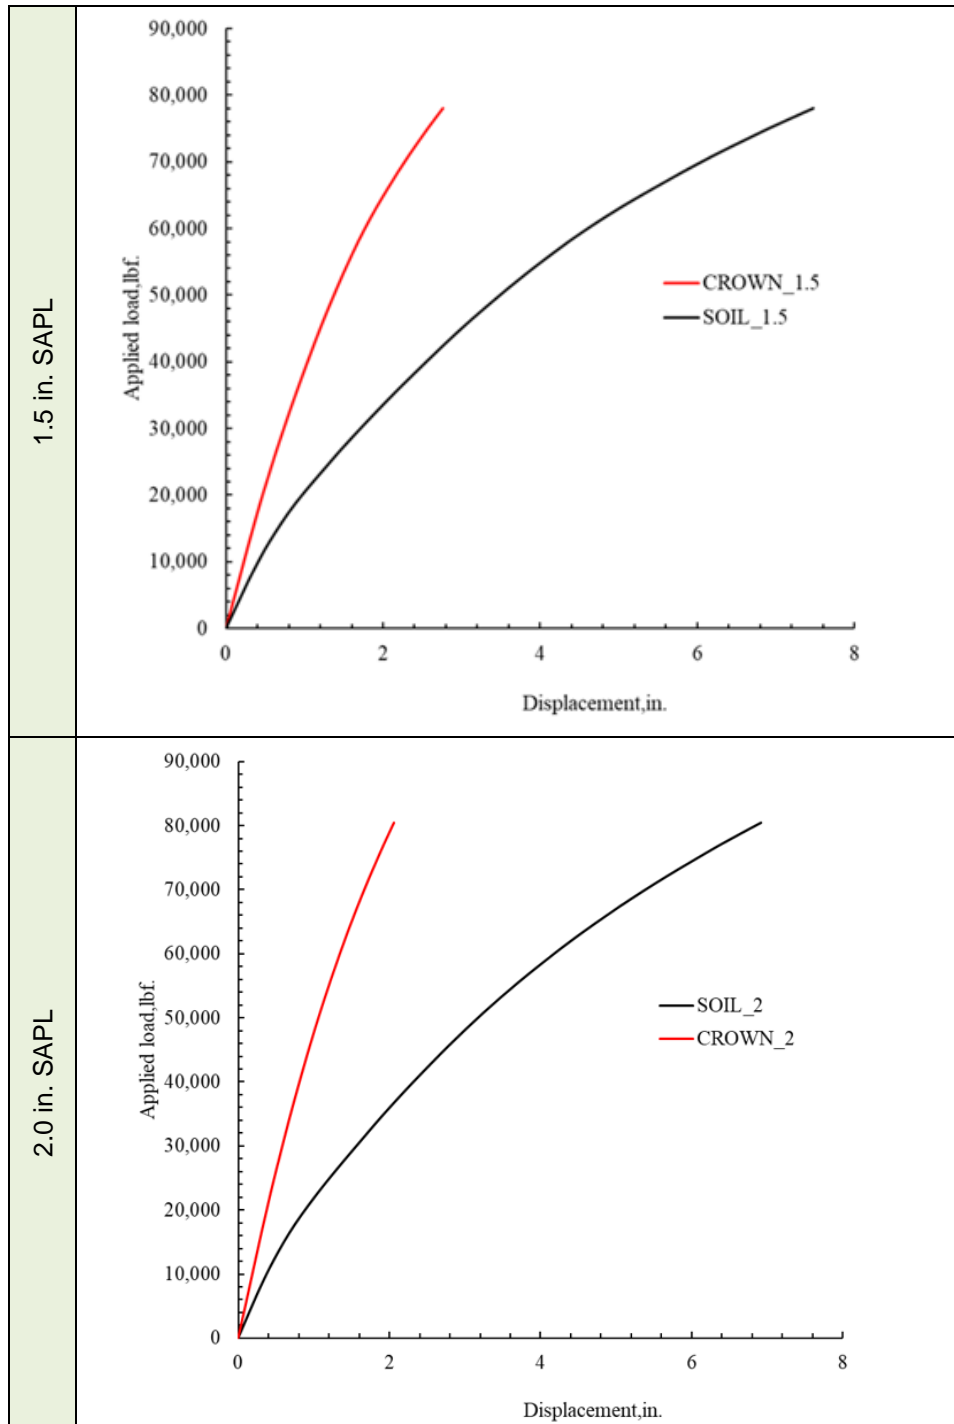
Figure 6-20 Load versus displacement – FEM results for 0.75, 1.5, and 2.0 in. SAPLs

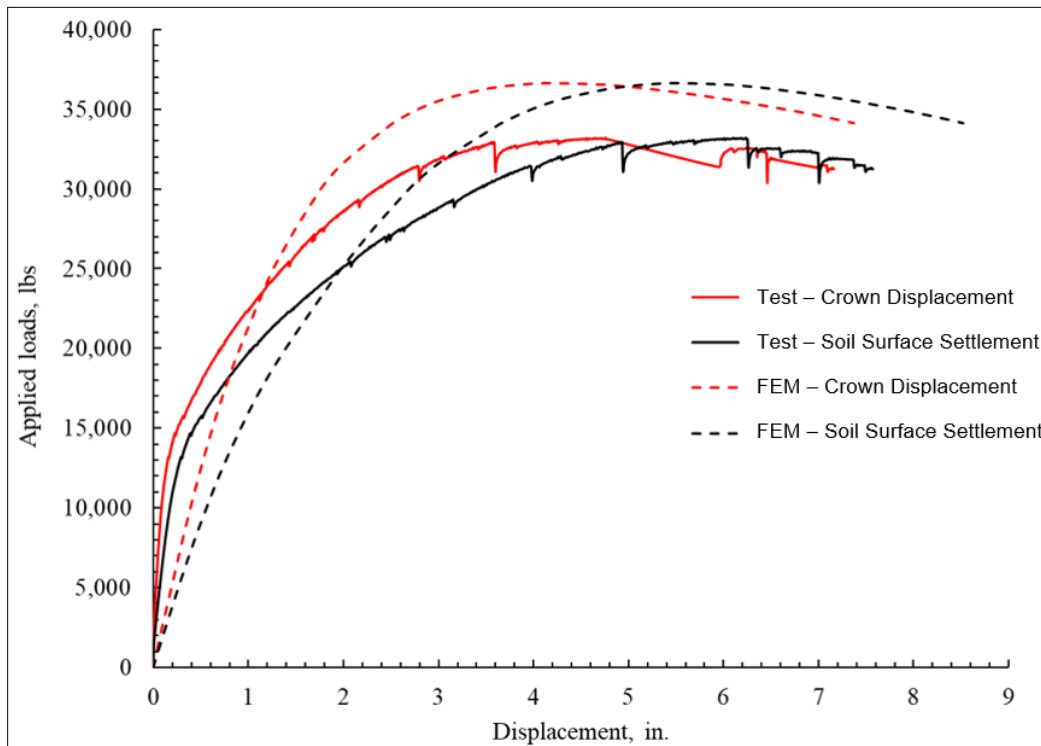
Figure 6-24 Load versus displacement – comparison of SAPL soil box testing and the FEM (Source: CUIRE FEM report) results for 0.25 in. SAPL installed inside the fully invert deteriorated arch CMP sample.

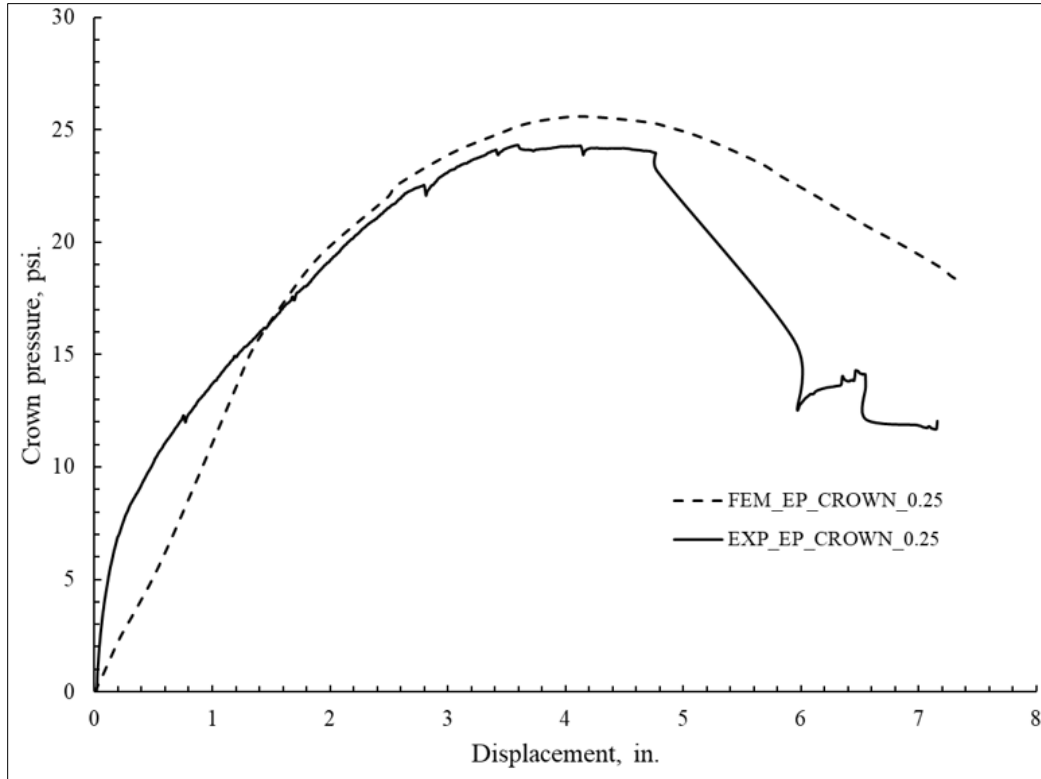
Figure 6-25 The comparison of soil box testing results and FEM (Source: CUIRE FEM report) results for distributed pressure on top of the pipe versus displacement at the crown location (0.25 in. SAPL).

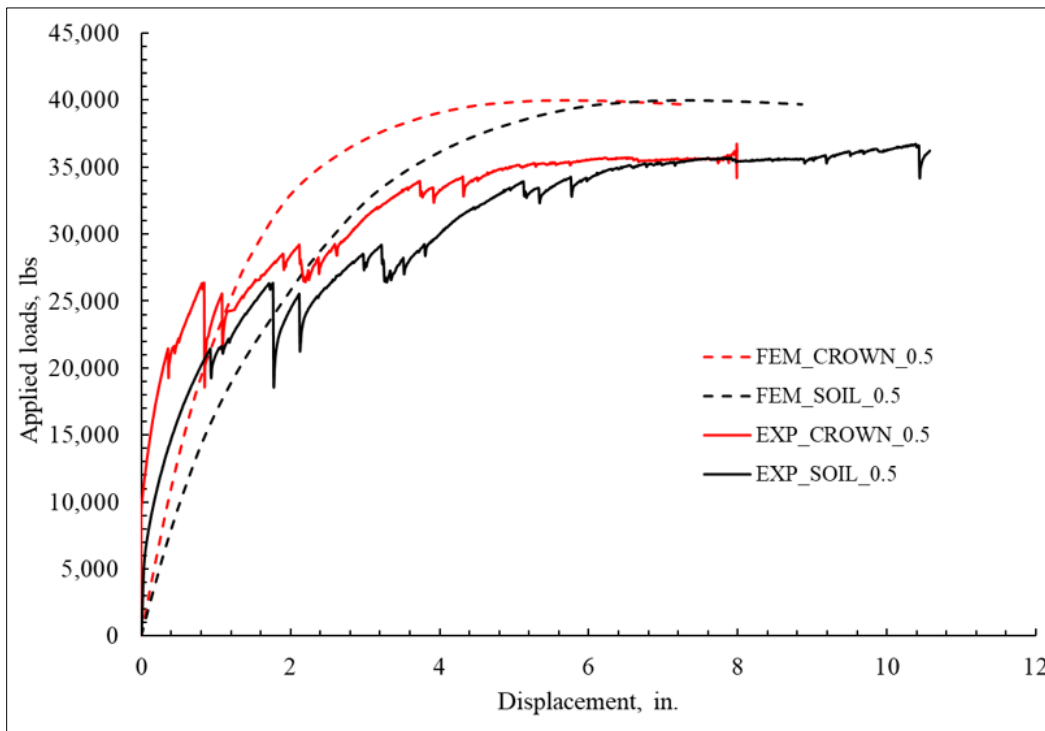
Figure 6-28 Load versus displacement – comparison of SAPL soil box testing and the FEM (Source:

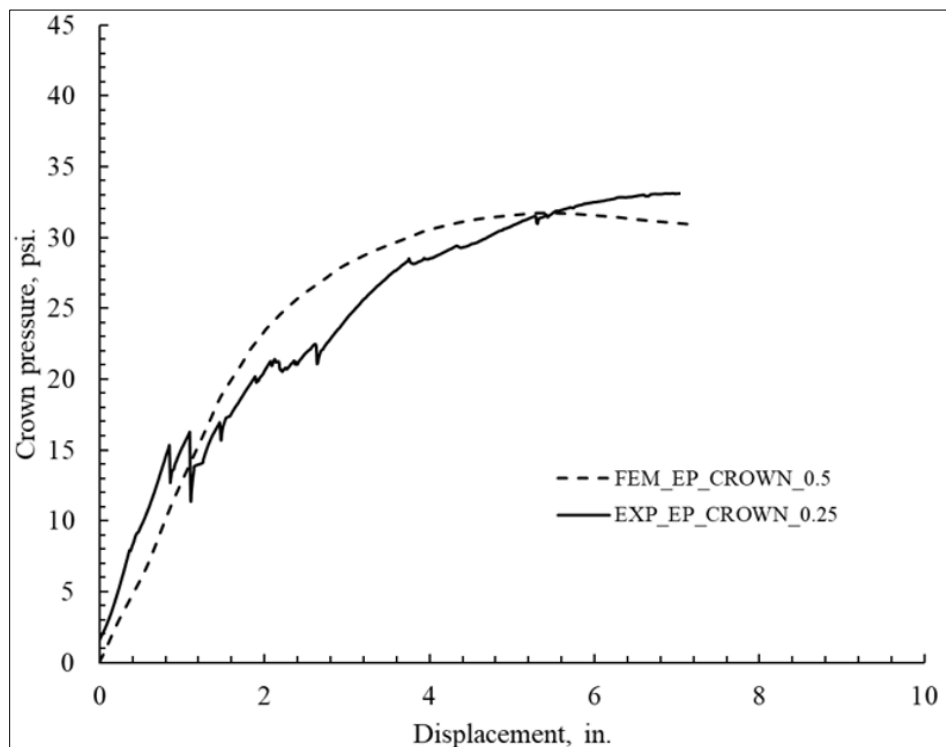
Figure 6-29 The comparison of soil box testing results and FEM (Source: CUIRE FEM report) results for distributed pressure on top of the pipe versus displacement at the crown location (0.5 in. SAPL).

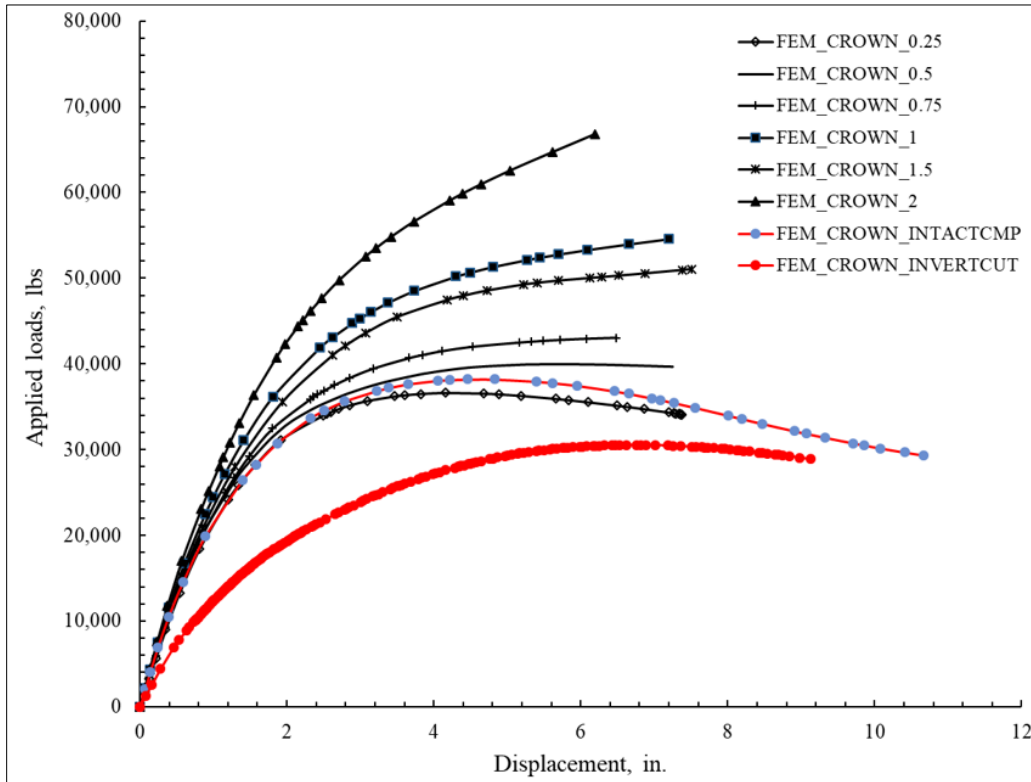
Figure 6-37 Load versus displacement plots – comparison of different SAPL thicknesses installed inside the fully deteriorated invert arch CMP samples (Source: CUIRE FEM report).
