A COMPREHENSIVE FRAMEWORK TO MITIGATE SURFICIAL SLOPE  
FAILURES

Presented to the Faculty of the Graduate School of  
The University of Texas at Arlington  
in Partial Fulfillment of the Requirements  
for the Degree of

THE UNIVERSITY OF TEXAS AT ARLINGTON

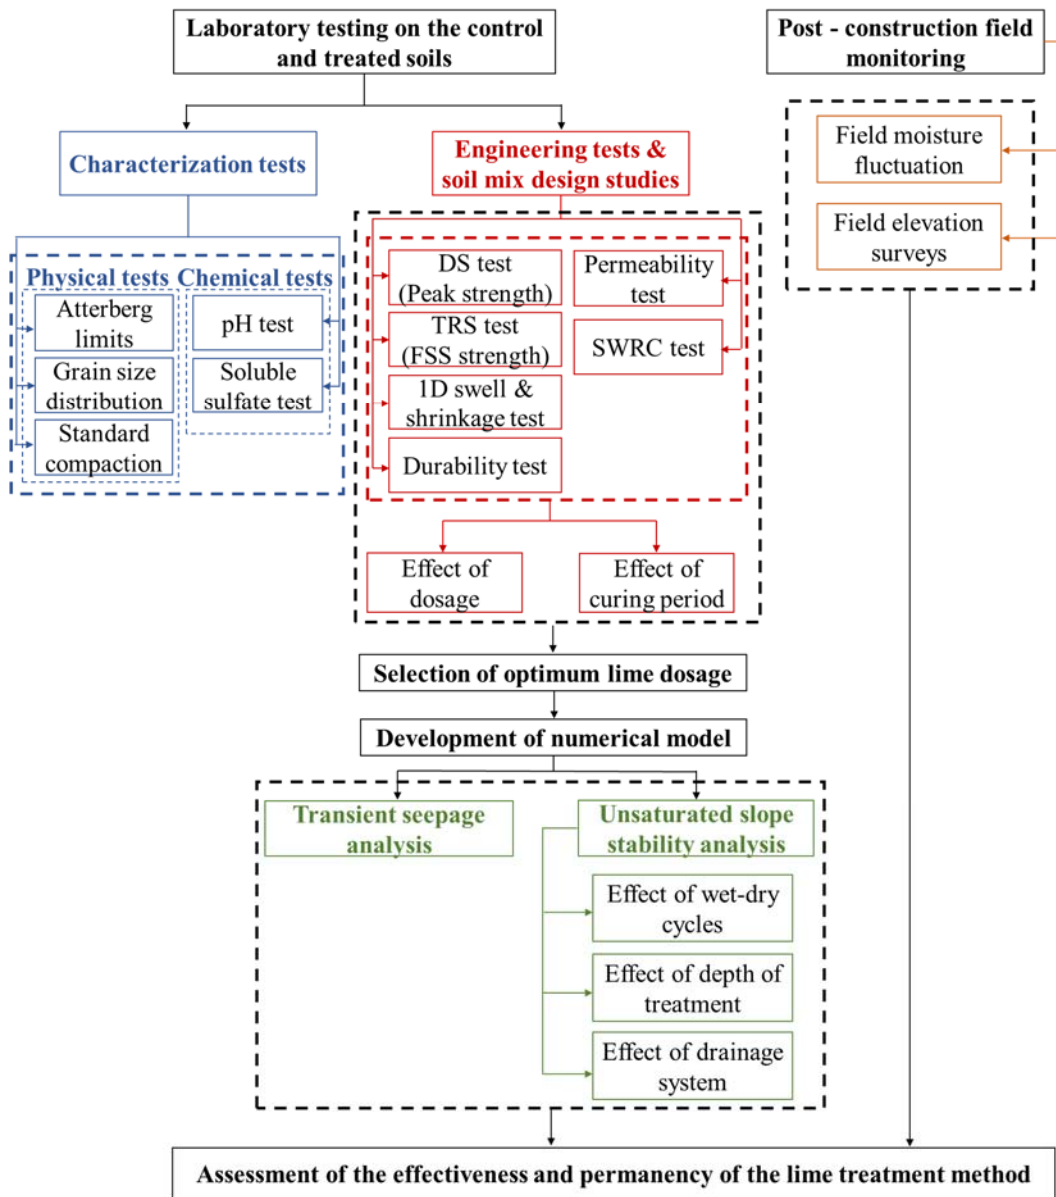
Figure 1.1 A comprehensive flowchart followed to in this research study

These research tasks are conducted as per the developed flowchart as shown in Figure 1.1.

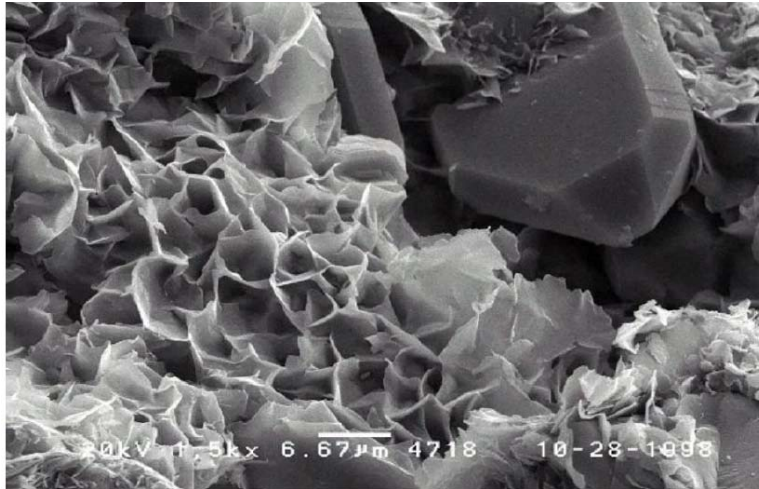
Figure 2.3 (a) SEM pictures of kaolinite, (b) illite, and (c) montmorillonite clay minerals (source: <http://webmineral.com>)

Montmorillonite (Figure 2.3c) has a general chemical formula of  $(1/2\text{Ca}, \text{Na})(\text{Al}, \text{Mg}, \text{Fe})_4(\text{Si}, \text{Al})_8\text{O}_{20}(\text{OH})_4 \cdot n\text{H}_2\text{O}$  with a 2:1 layered structure. Montmorillonite is formed by weathering of igneous rocks which are high in magnesium, iron, and calcium (Rapp 2002). These are platy irregular or hexagonal-shaped particles with an average thickness of 1 nm. Montmorillonite has specific surface area between 600 to 800  $\text{m}^2/\text{g}$  and undergoes significant swelling strains due to weak van der Waals forces between silicate layers. The montmorillonite clay particles can expand up to 12–15 times upon hydration (Al-Ani and Sarapää 2008). Therefore, it is frequently used as mud in drilling operation and fill material to prevent leakage in dam slopes.

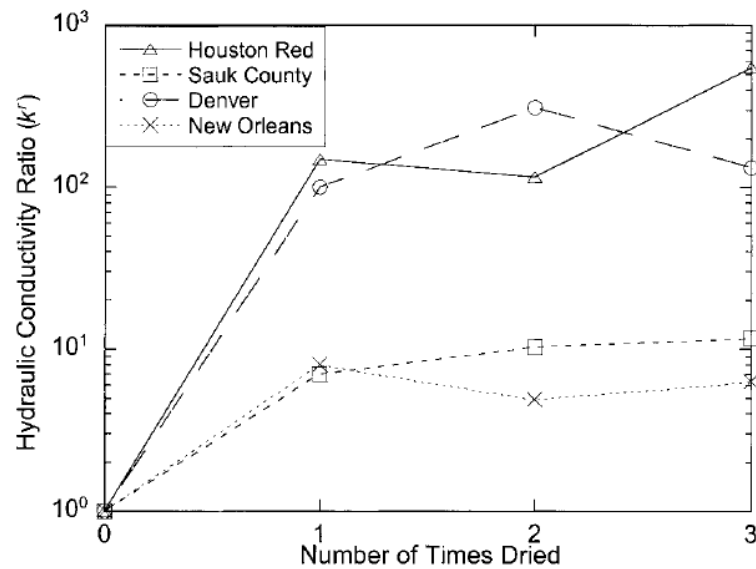
Figure 2.6 Variation in permeability soil under wet-dry cycles (Benson 2001)

increase in permeability water was almost 3 orders in magnitude after three drying and wetting cycles (Figure 2.6).

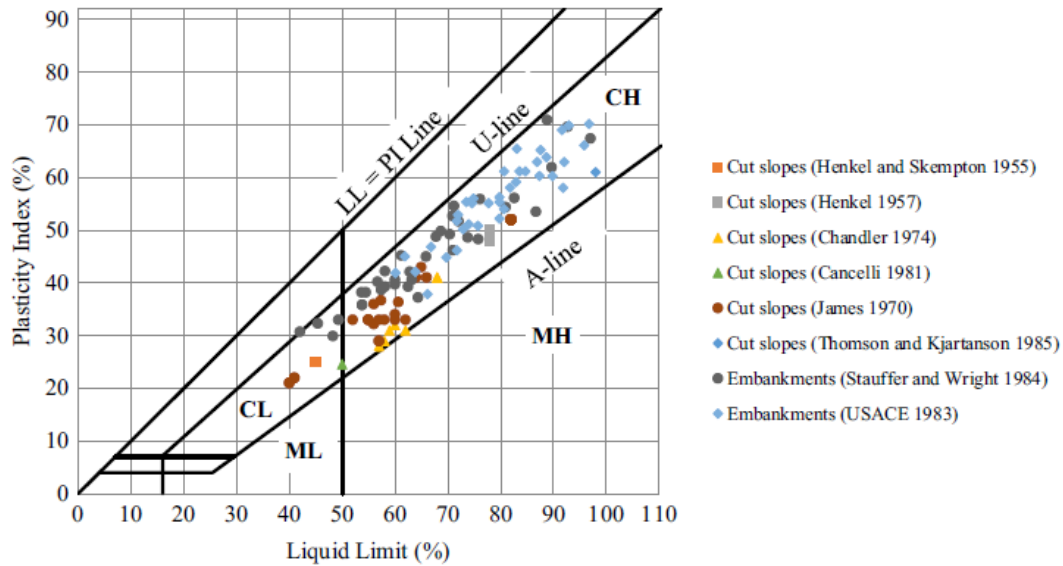
Figure 2.10 Compiled slope failures related to FSS (Castellanos et al. 2016)

Castellanos et al. (2016) compiled a total of 142 slopes that experienced the first-time failure due to strength reduction in the long term. The authors attempted to study the effects of the consistency limits and type of soil on strength reduction. As shown in Figure 2.10, results indicated that the slopes in which failure is related to FSS have a liquid limit (LL) and plasticity index (PI) above 40 and 20 respectively. In a different study, the effect of soil mineralogy, composition, and consistency limits on FSS was evaluated by Tiwari and Ajmera (2011). The FSS value of soils was determined by using direct shear (DS) apparatus under different normal stress values.

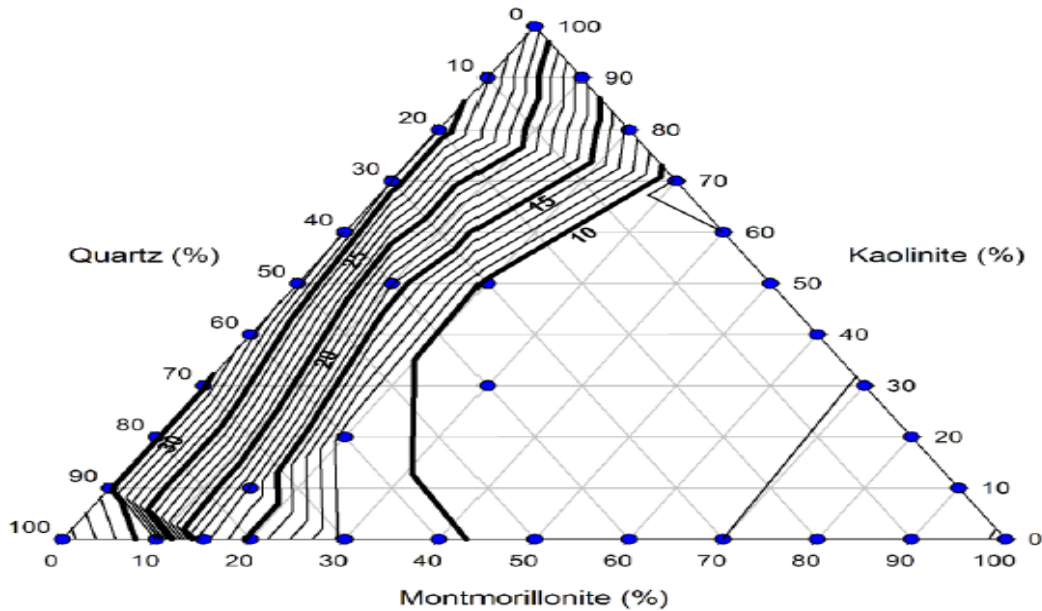
Figure 2.11 (a) Effects of soil composition, (b) clay content, (c) LL, and (d) PI on FSS friction angle value (Tiwari and Ajmera, 2011)

The obtained correlation between FSS friction angle and clay content, LL, PI, and soil composition is presented in Figures 2.11a, b, c, and d, respectively. With an increase in the amount of montmorillonite and kaolinite in the soil, there was a decrease in soil FSS friction angle. Similarly, with an increase in the consistency limits of soil, a decrease in FSS friction angle value was observed. Also, variation in the amount of montmorillonite in soil was found to be a critical factor for FSS friction angle value.

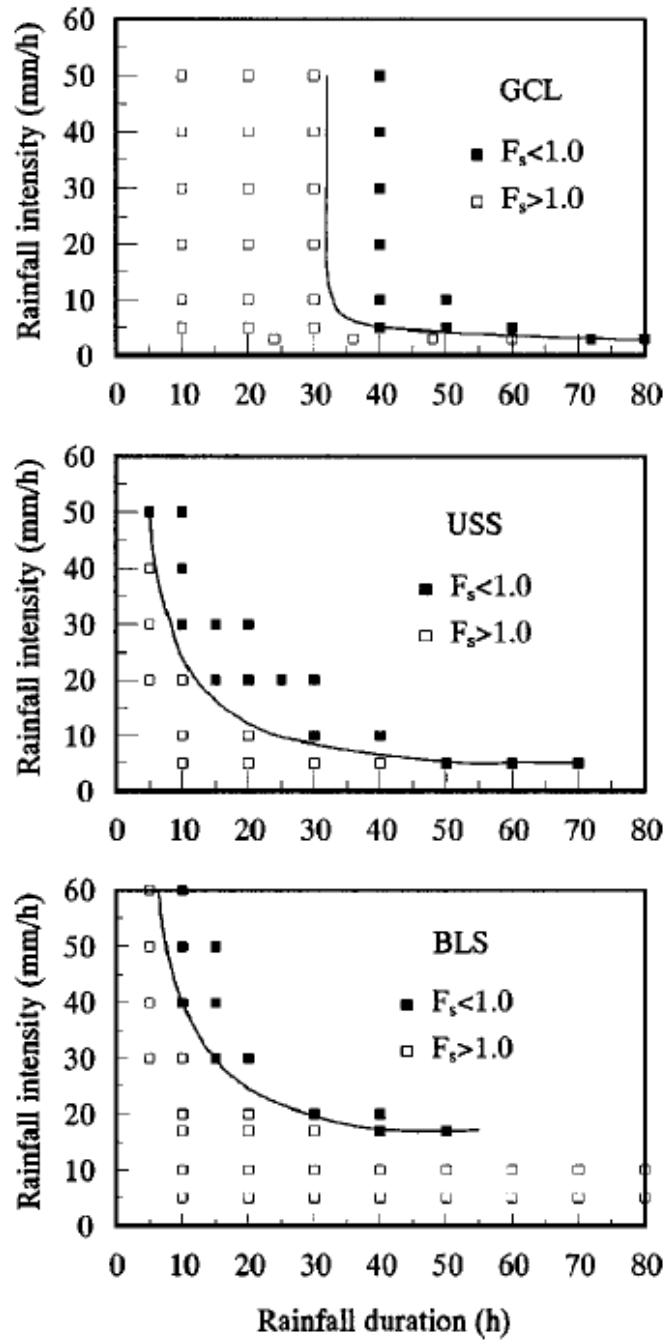
Figure 2.23 Effects of rainfall duration and intensities of slope safety (Cai and Ugai 2004)

The results of the study conducted by Cai and Ugai (2004) showed that for the slopes built with low permeable soil, the rainfall duration is more critical than the rainfall intensity (Figure 2.23). The slopes with low permeable soil might fail only when the rainfall lasts for a long period of time with considerable intensity. However, for the slopes with relatively higher permeable soil, a higher intensity rainfall event for a short duration induces failure. The authors also pointed out that the slope with higher initial volumetric water content or water retention capacity experiences a faster rise in pore water pressure during a rainfall event.

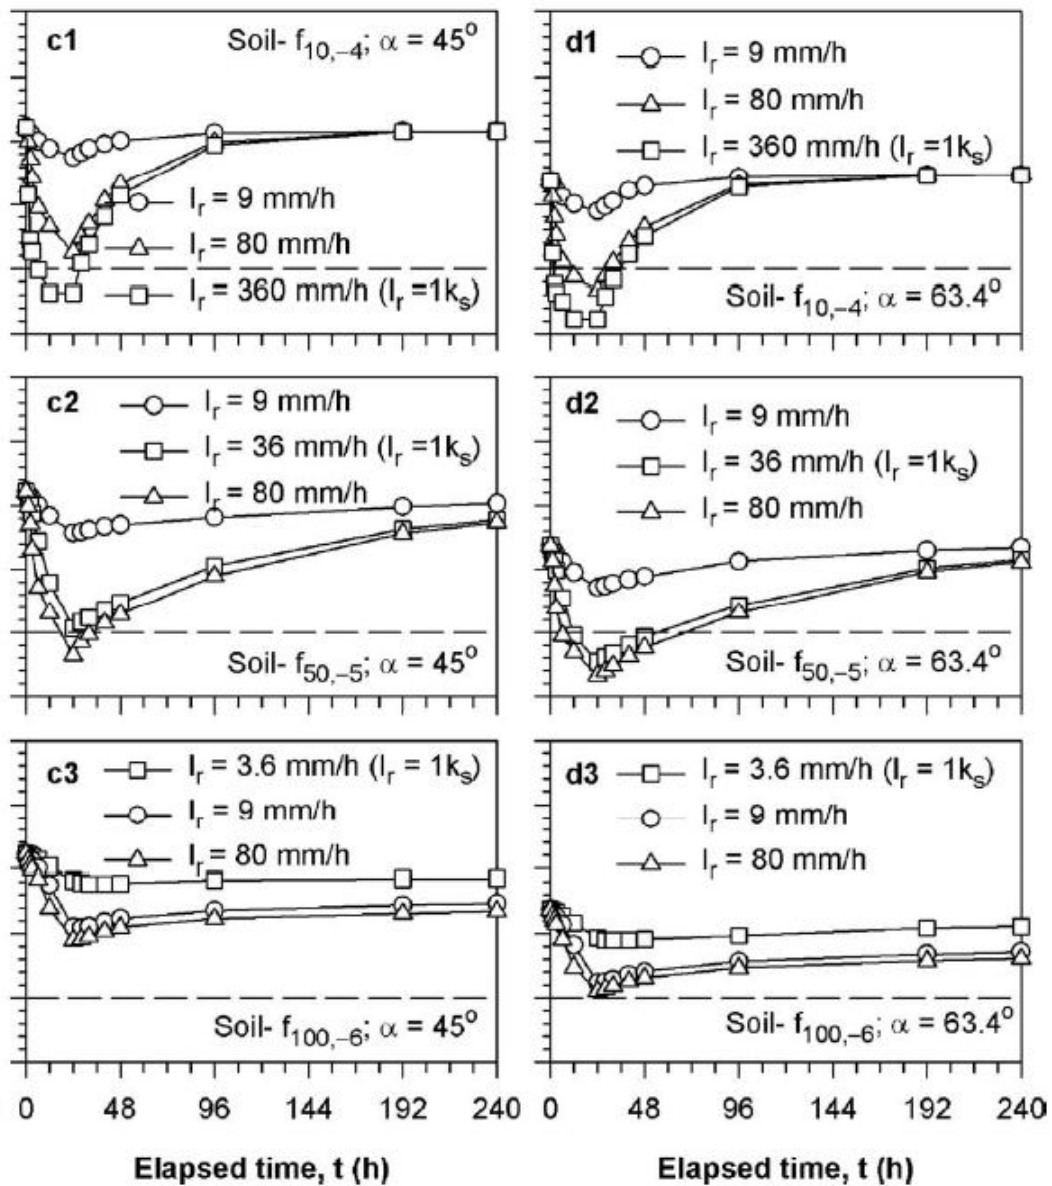
Figure 2.24 Relative effect of slope angle, soil permeability, and rainfall intensity on the variation of FOS under 24h rainfall (Rahardjo et al. 2007)

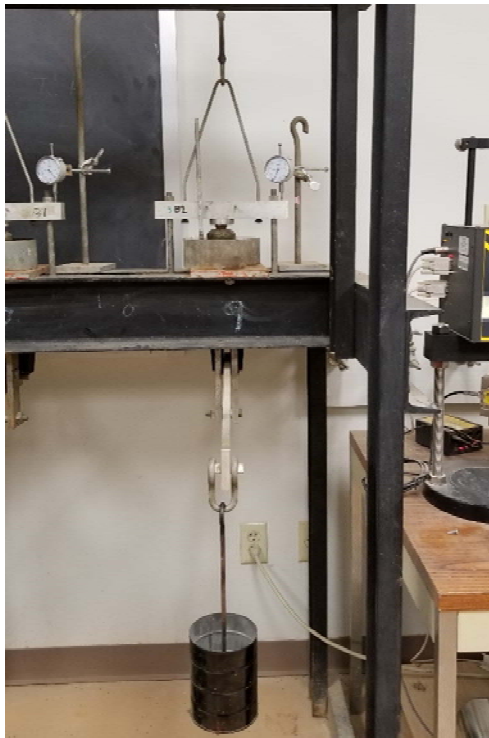
Figure 3.6 1D swell strain test setup

gauges. The test was continued until there was no observed change in the dial gauge reading. 1D swell strain was determined as the percentage increase in height of the specimen with respect to the initial height of the specimen. The test result of the 1D swell test is presented in Figure 3.7.

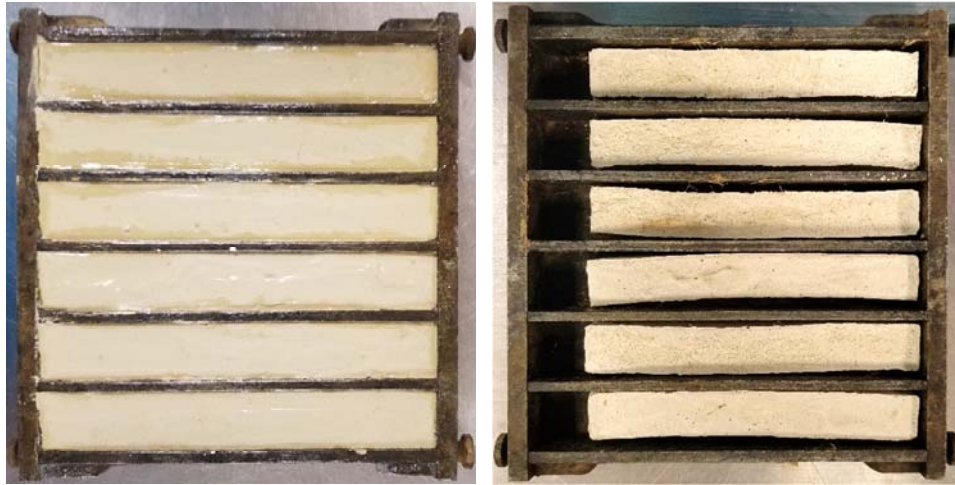
The linear shrinkage potential of soil was determined by measuring the decrease in linear length of soil specimens due to drying. This test was conducted in accordance with the Tex-107-E procedure with soil passing number 40 sieve. The soil was thoroughly mixed with a certain amount of water to obtain the target soil consistency specified in Tex-107-E. The soil specimens were placed in standard linear bar molds that were greased with petroleum jelly (Figure 3.8a). Before placing the molds in oven for drying, they were kept at room temperature until there was a slight change in the color of soil specimens. Once the specimens were dry, the length of dried specimens was measured using Vernier caliper and linear shrinkage strain was calculated with respect to the initial length of soil specimen (Figure 3.8b).

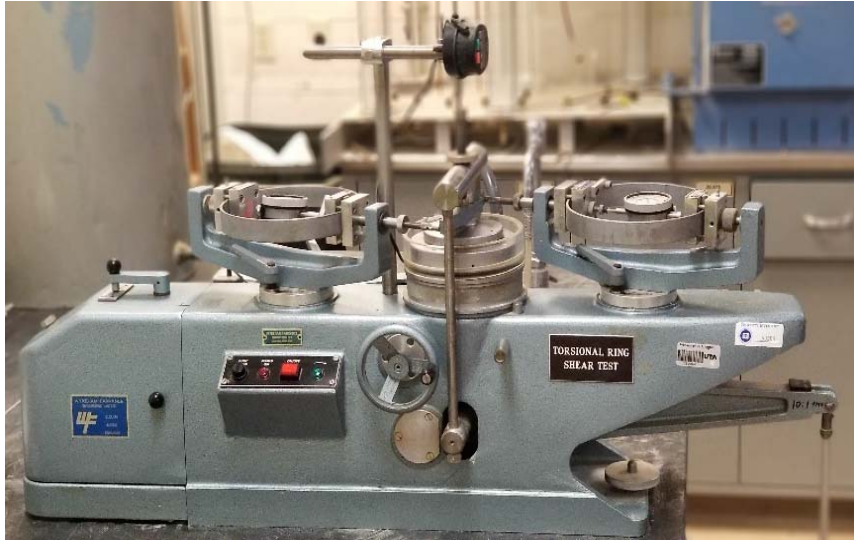
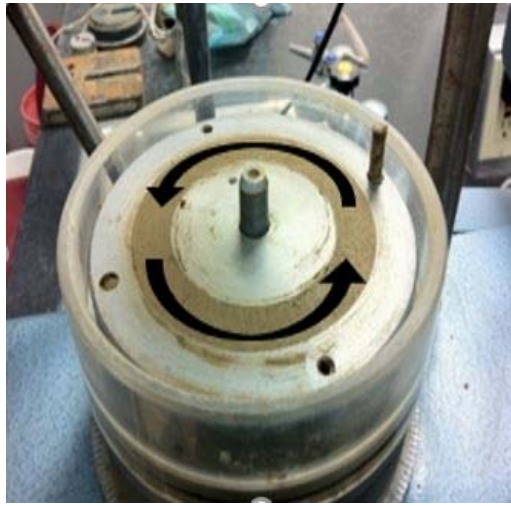
In the present study, TRS tests were conducted as per ASTM D7608-10 standards. A Bromhead ring shear testing equipment, as shown in Figure 3.10a, was used to perform the TRS test. In this test, the soil specimen was prepared in slurry condition by mixing the dry soil with distilled water corresponding to 1.5 times of its LL. The slurry specimen was then placed into an annular mold, as shown in Figure 3.10b, with an inside diameter of 70 mm (2.75 in.) and an outside diameter of 100 mm (4 in.). After placing the specimen in mold, a preconsolidation pressure of 6.25 kPa (130.5 psf) was applied with a load increment ratio of one. Each load increment was kept until the completion of the primary consolidation of soil or achieving the target normal stresses. In this study, TRS tests were conducted at a normal stress of 50 kPa, 100 kPa, and 150 kPa (1044, 2089, and 3133 psf). Once the consolidation was over, the specimens were sheared at a rate of 0.018mm/min ( $7.09 \times 10^{-4}$  in./min) (Figure 3.10c). This small shear rate was chosen to ensure complete dissipation of excess water pressure in specimen.

Figure 3.10 (a) Bromhead torsional ring shear apparatus, (b) annular mold used, and (c) specimen before shearing

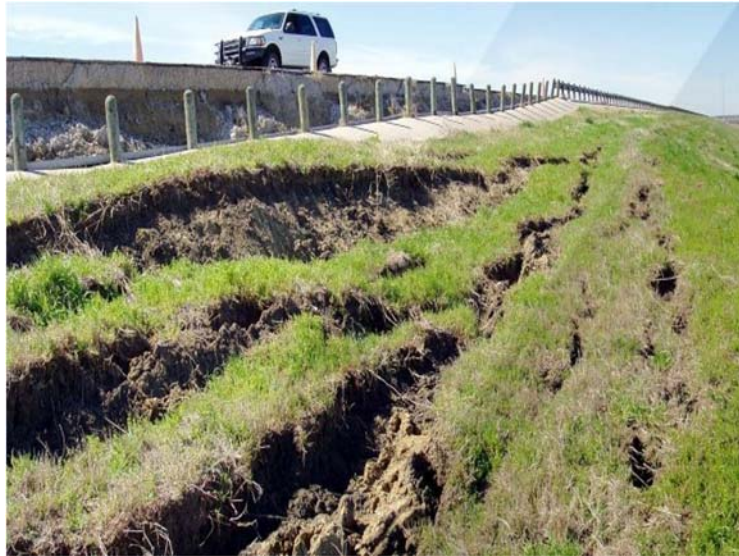
Figure 3.12 Typical slope failures occurred (a) Grapevine and (b) Joe Pool dam  
(Courtesy: USACE, Fort Worth District; Dronamraju 2008)

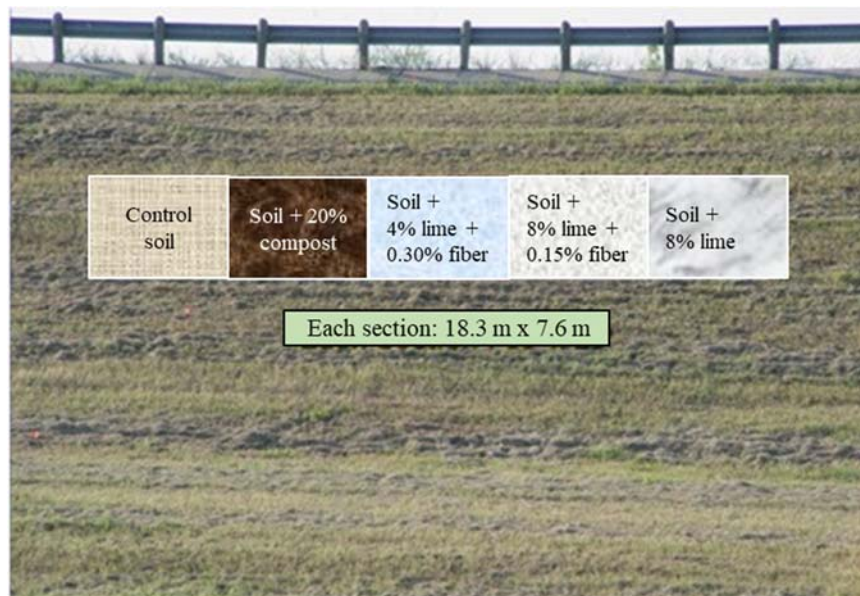
Figure 3.15 Layout of the treated test sections for Grapevine and Joe Pool dams

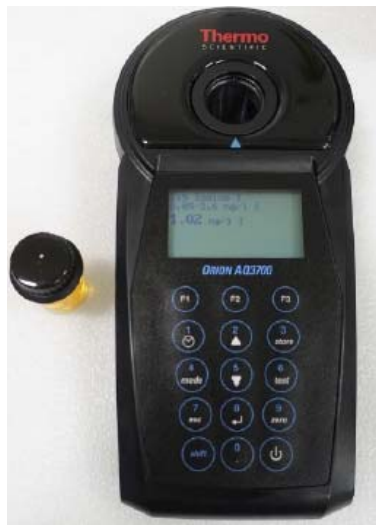
9°F) and pulverized. For this test, 20 g of dry soil passing US sieve number 40 was added to 400 mL of distilled water. The soil-water solution was shaken vigorously for at least a minute to solubilize the sulfate salts. After keeping the solution at room temperature for 12 hours, it was thoroughly mixed and passed through a fine porosity filter paper. In a glass vial, a barium chloride tablet was added and dissolved in 10 ml of the filtrate solution. The amount of sulfate ion in the solution was then measured with a colorimeter (Figure 4.1).

Figure 4.1 Colorimeter used in this study

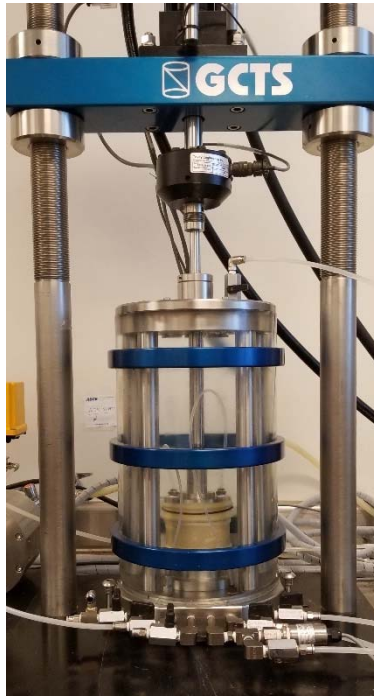
porous stones by fine soil, filter papers were placed between porous stone and soil specimens. After covering the specimens with a latex membrane, the equipment was assembled, and the cell was filled with de-aired water (Figure 4.5). A seating load of 10 kPa (0.15 psi) was applied at the top to ensure proper contact between the soil specimens and top cap.

The specimens were saturated using back-water pressure and the degree of saturation was continuously monitored using Skempton's ' $B$ ' parameter. In this research, the specimens were considered as saturated at  $B$  value of 0.95. Once the specimens were saturated, the permeability tests were commenced by applying a hydraulic gradient across the specimens. A head difference resulting in a hydraulic gradient of 35 was applied and sustained across the specimens throughout the test. Both inflow and outflow rates of water were continuously measured using volume change measurement devices. The tests were performed until the flow became steady and the rate of inflow and outflow became almost the same. After achieving a steady-state flow condition, the coefficients of permeability were calculated using Darcy's law.

Figure 4.5 The modified triaxial apparatus used for permeability test

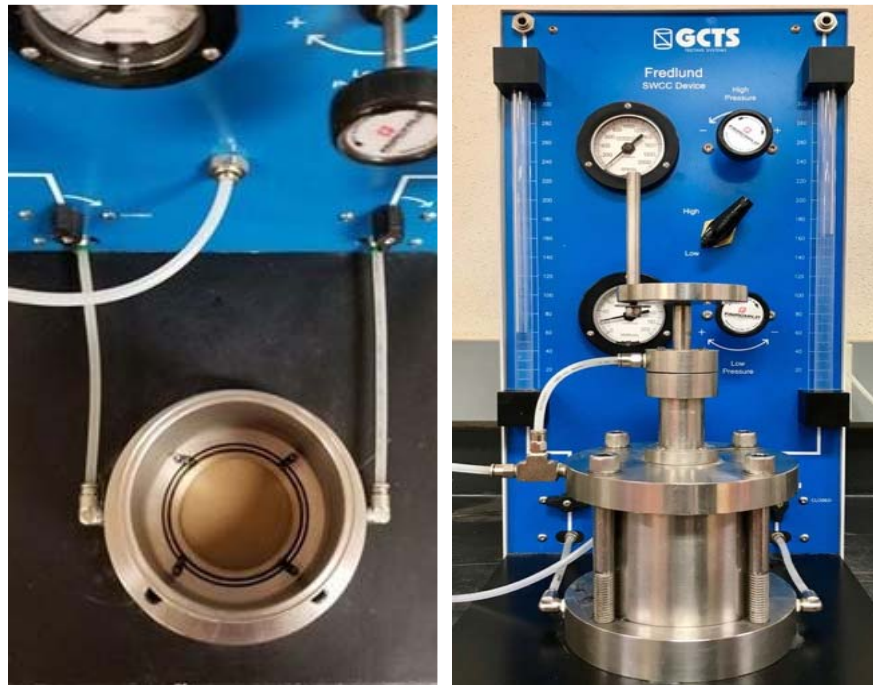
Fredlund's Tempe cell apparatus uses the axis translation technique proposed by Hilf (1956). The soil specimen, 25.4 mm (1.0 in.) in height and 63.5 mm (2.5 in.) in diameter, was statically compacted at its OMC and 95% of the respective MDD. To ensure uniform moisture distributions in the specimen, it was kept in a humidity-controlled room with 100% relative humidity for two days. For saturation, the specimen was confined in a stainless-steel split mold and was submerged in led water. Simultaneously, a 500 kPa high air entry value (HAE) ceramic disk was saturated inside the Tempe cell at a pressure of 150 kPa. After ensuring there is no weight increase in the soil specimen due to saturation, the specimen was placed on the saturated HAE ceramic disk (Figure 4.6a).

The water content and suction relationship of the specimen was determined by applying air pressure on the specimen in the Tempe cell apparatus (Figure 4.6b). For each suction level, the constant air pressure was applied and sustained until no additional water was expelled from the specimen. At the equilibrium condition, the total amount of water drained out from the specimen was measured and the water content of the specimen was calculated. The Tempe cell was flushed every 12 hours to remove accumulated air beneath the ceramic disk during the test.

Figure 4.6 (a) Tempe cell apparatus and (b) specimen placed top of HAE value ceramic disc

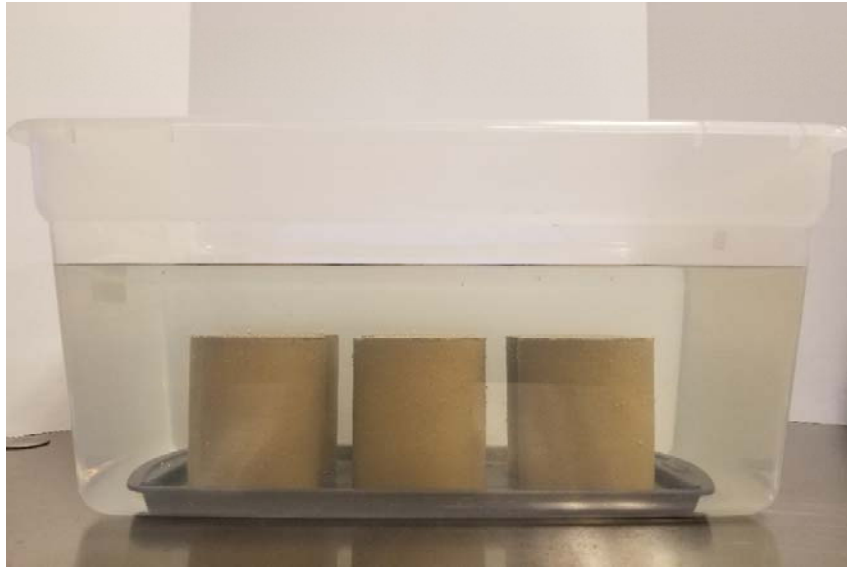
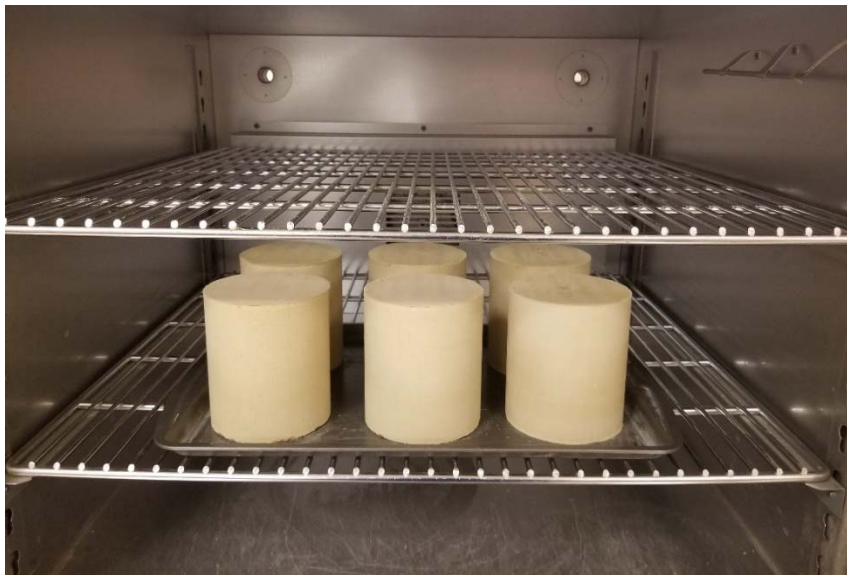
In the laboratory durability test, each weathering cycle consists of 5 hours of wetting followed by 42 hours of drying. Wetting is performed by fully submerging the soil specimen in the water at room temperature (Figure 4.8a) and drying is done by placing specimens in an oven at  $71 \pm 3^{\circ}\text{C}$  (Figure 4.8b). The diameter and height of the specimen were measured, and volumetric strains were calculated after each wet and dry cycle. The test was performed for 14 cycles or until the specimen experienced failure.

Figure 4.8 (a) Wetting and (b) drying process of durability and strength retention studies

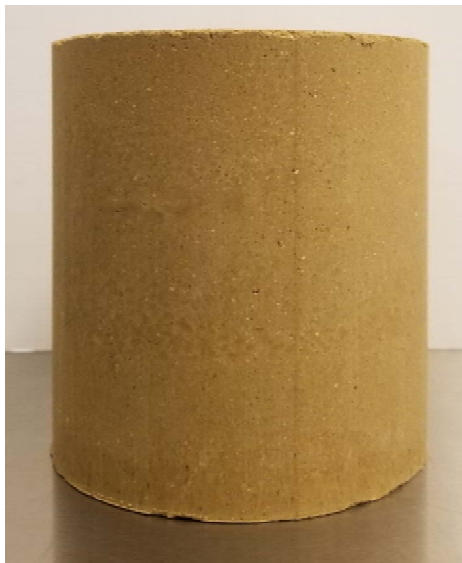
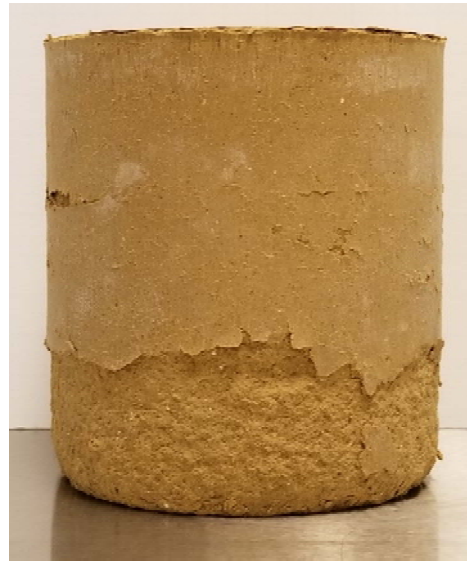
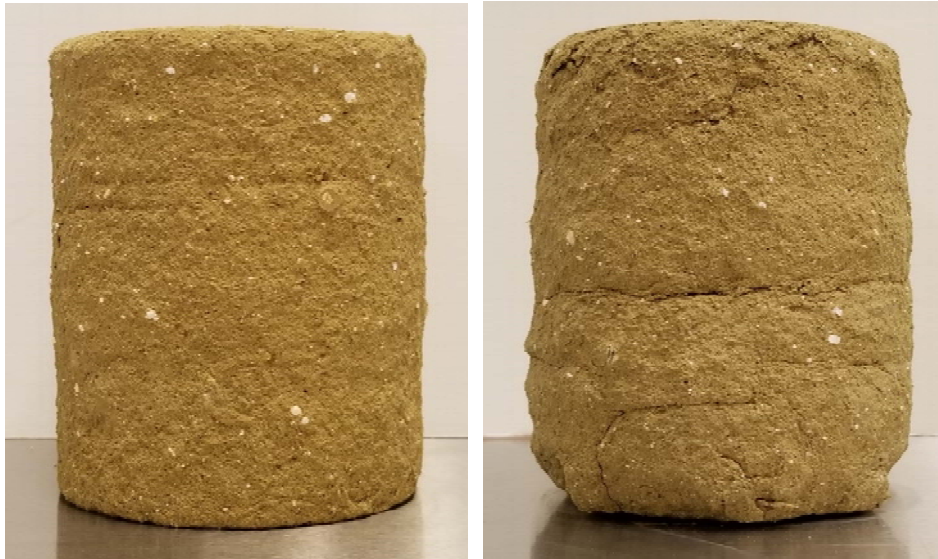
studies. However, 5% lime-treated soil could not withstand the whole 14 cycles and failed during the 8<sup>th</sup> cycle. Only, 8% lime-treated soil was able to withstand the whole 14 durability cycles. Figures 4.15a, b, c, and d present 8% lime-treated soil after 1, 4, 7, and 14 cycles during durability studies, respectively.

Figure 4.15 The condition of 8% lime-treated soil after (a) first, (b) third, (c) seventh, (d) fourteenth cycles

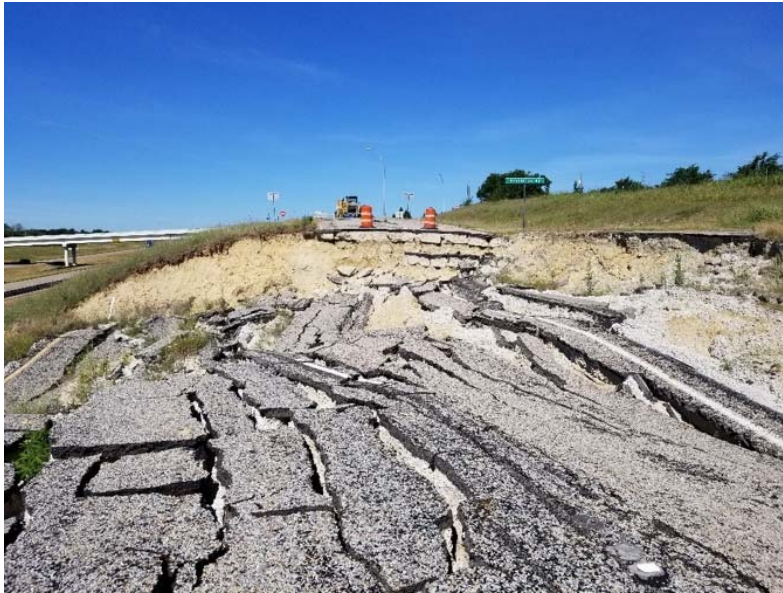
Figure 6.2 Failed portion of slope

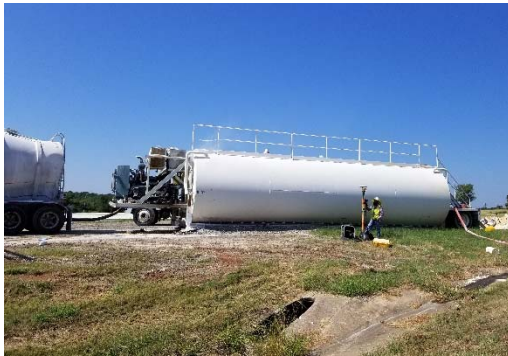
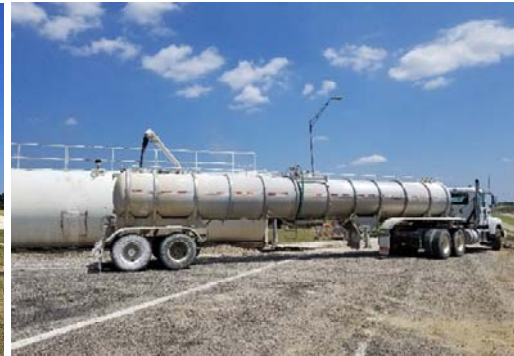
portable lime slakers (Figure 6.5a). During the hydration of lime, an exothermic reaction takes place between water and quicklime, which converts  $\text{CaO}$  to  $\text{Ca(OH)}_2$ . The hydration process was continued for approximately an hour, and once it was over, the hydrated lime was transferred to the construction site using trucks (Figure 6.5b).

Figure 6.5 (a) Portable lime slaker and (b) transportation of hydrated lime

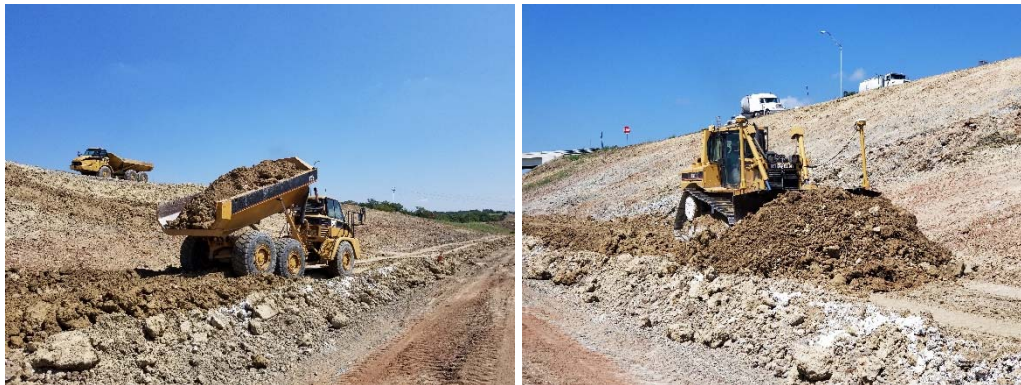
At the field site, lime treatment work was started from the toe area of the slope. In order to provide a better interlocking between the untreated soil and treated layer, the existing untreated soil layer was benched by providing a vertical cut of 0.61 m (2 ft) height with the help of a motor grader machine and crawler dozer (Figure 6.6a). The excavated soil was transferred back to the slope, dumped in lifts of 0.61 m (2 ft) in height and 3.65 m (12 ft) in width (Figure 6.6b), and was graded using a crawler dozer (Figure 6.6c).

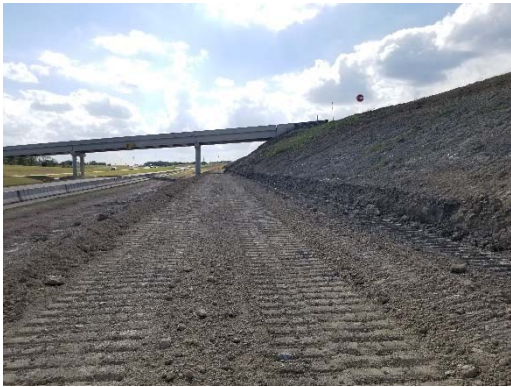
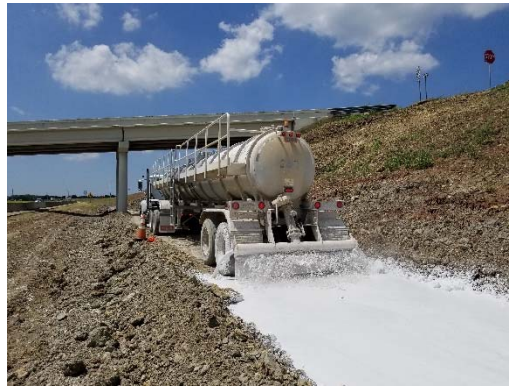
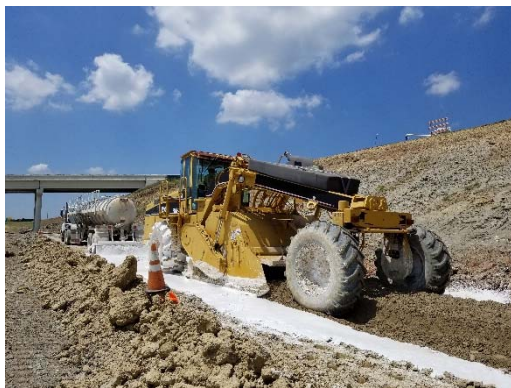
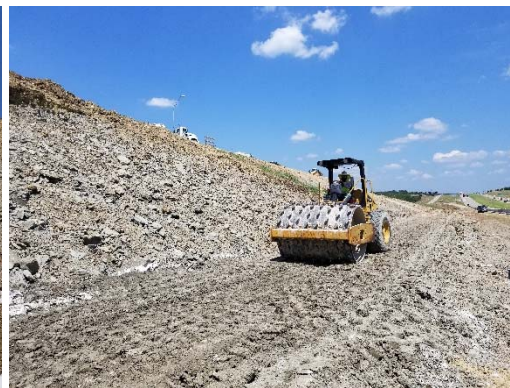
Before mixing the lime slurry with untreated soil, a windrow was built with a crawler dozer to prevent flow of lime slurry from the sides (Figure 6.7a). The lime slurry was then transferred and poured on the untreated soil layer by using a

distributor truck (Figure 6.7b). To maintain the homogeneity and uniform distribution of lime in soil, the slurry was simultaneously blended in soil using a rotary mixer (Figure 6.7c). After a thorough mixing of the lime slurry and soil blend, the lime-treated layer was compacted (0.3 m in height) using a sheepfoot type roller (Figure 6.7d). The entire surface of the slope section was treated by following the aforementioned process.

Figure 6.7 (a) Windrow to prevent lime slurry runoff from sides, (b) application of hydrated lime slurry, (c) mixing of lime slurry in soil with rotary mixer machine,

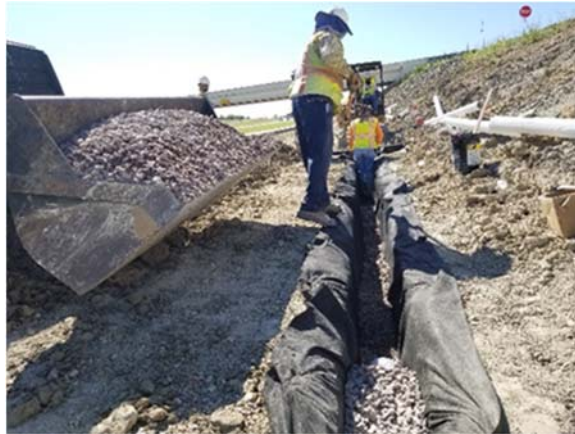
Figure 6.9 shows the installation process of perforated pipes in the longitudinal direction. The underdrains were installed just before the placement of

Figure 6.9 Installation of longitudinal underdrains

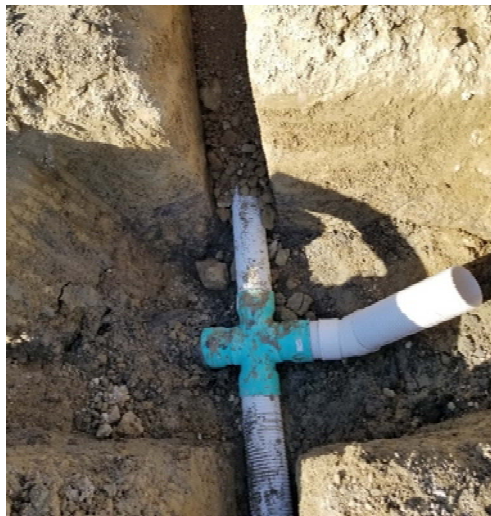
the lime-treated soil layer. Figure 6.10 shows the connection between longitudinal and lateral drainpipes, and another PCV pipe was provided to flush out the drains in case of potential soil clogging. The exit points of these flushing pipes were kept on the surface of slope with moveable lids.

Figure 6.10 Connection of longitudinal and lateral drainpipes

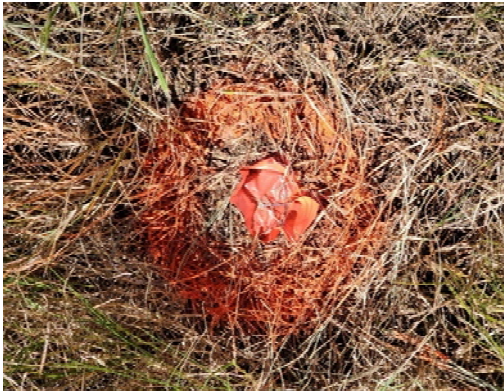
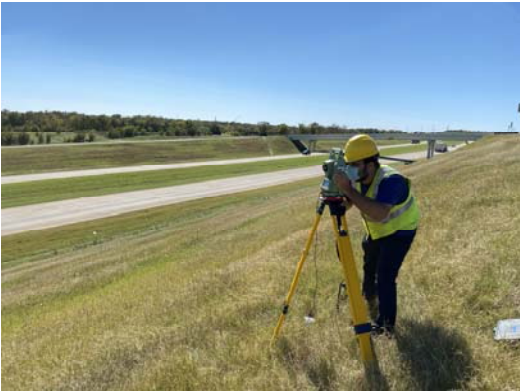
of the survey points were measured with periodic site visits (Figures 6.16b and 6.16c).

Figure 6.16 (a) Schematic showing arrangement of survey points, (b) a survey point on slope, and (c) total station surveying

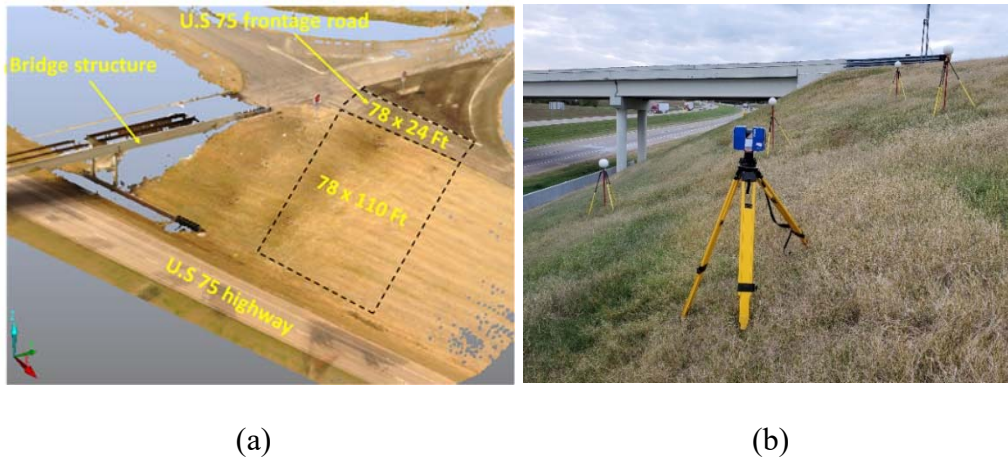
Unlike the total station survey, which is time intensive and requires to stop to traffic, LIDAR surveying can be performed in less time and without traffic interruption (Shafikhani 2018). Therefore, in this research work, an approximately 10,452 ft<sup>2</sup> of area including stabilized slope section and pavement was scanned by LIDAR surveys. Figure 6.17a shows the area of slope where vertical deformations were calculated using LIDAR scans. The optimum LIDAR surveying plan was prepared based on the scanned site area as per Shafikhani (2018). For each survey, a total of 6 LIDAR scans were performed with a ¼ resolution and 4x quality settings.

LIDAR scans were conducted using the 6 spheres of radius 11.4 cm (4.5 in.), and registration of each individual scans in a single point clouds were accomplished using these artificial reference points (Figure 6.17b). Rotation of project clouds are also used achieved using the same size 3 spheres with a fixed elevation placed on the nearby bridge abutment. The registration and rotation of scans was performed by using the Scene software, and determination of relative elevation displacement were computed using the Builder add-ons. The next section provides the results obtained from these surveying works.

Figure 6.17 (a) LIDAR surveying area and (b) LIDAR surveying on the treated slope section
