EXPERIMENTAL AND 3D FINITE ELEMENT ANALYSES OF INVERT-REMOVED
CIRCULAR CORRUGATED METAL PIPE CULVERTS RENEWED
WITH POLYMER SPRAY-APPLIED PIPE LINING

Presented to the Faculty of the Graduate School of
The University of Texas at Arlington in Partial Fulfillment
of the Requirements
for the Degree of

MASTER OF SCIENCE IN CIVIL ENGINEERING
THE UNIVERSITY OF TEXAS AT ARLINGTON

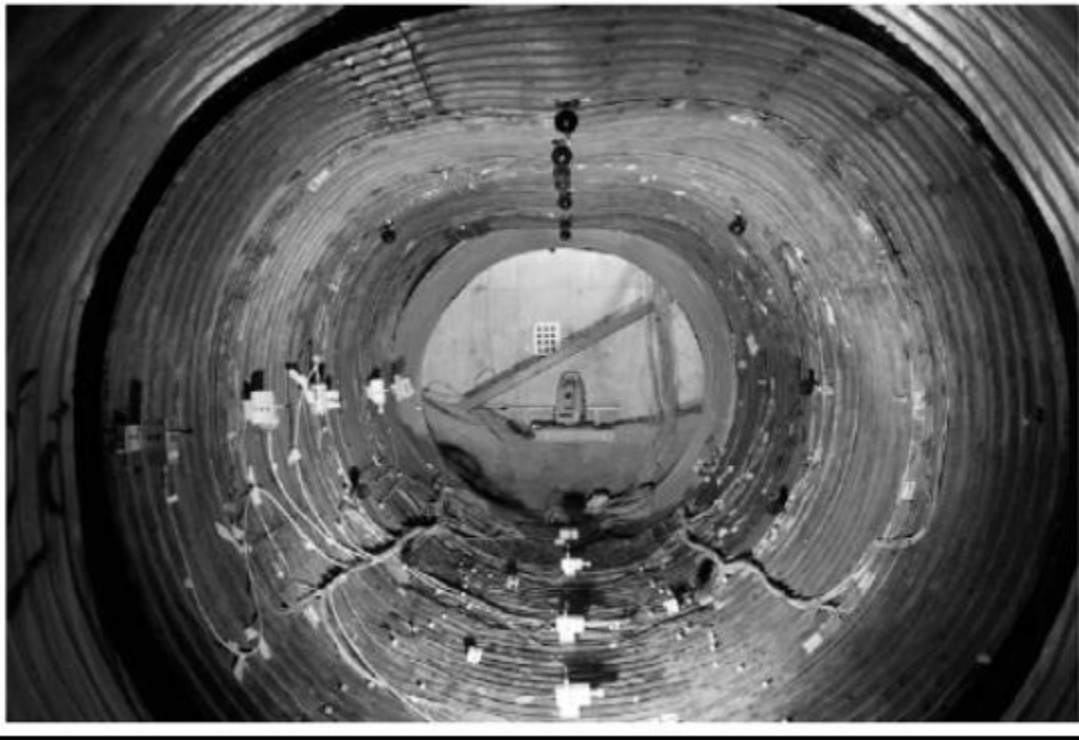
Figure 2-11 Experimental setup (inside the pipe) (Mai, Hoult, & Moore, 2013)

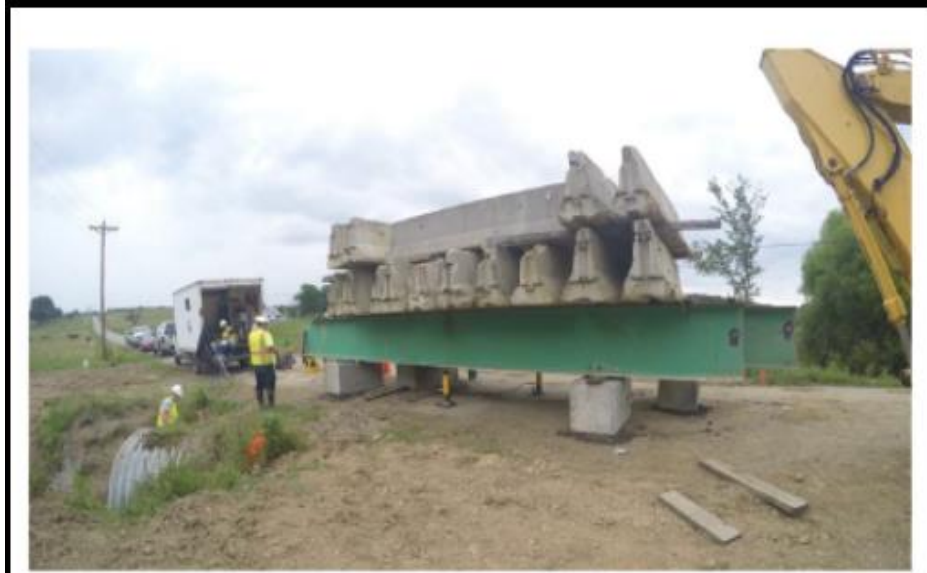
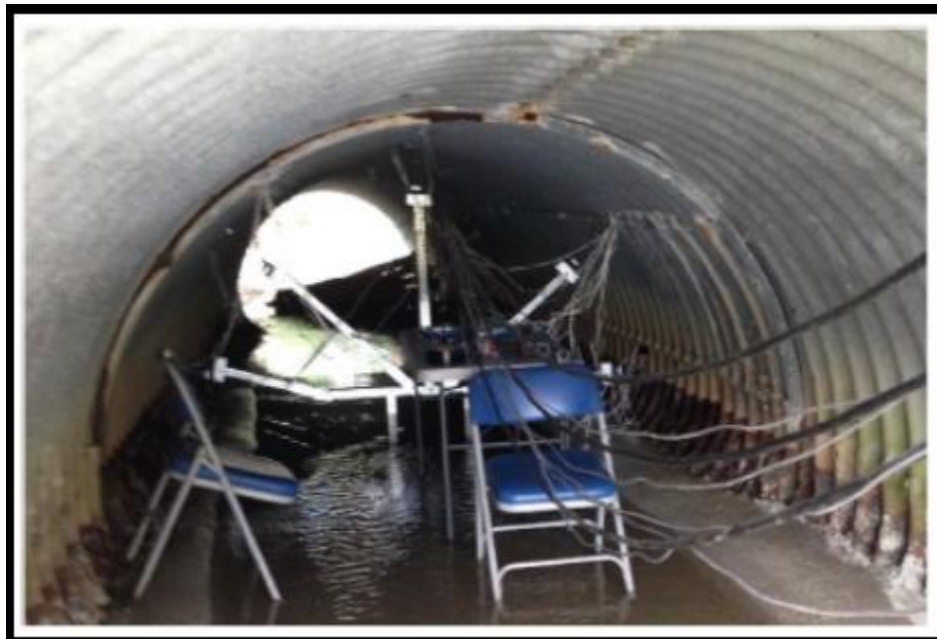
Figure 2-13 (a) Load Configuration for testing (b) Invert Deteriorated Pipe with instrumentation (Sargand, Khoury, & Hussein, 2018)

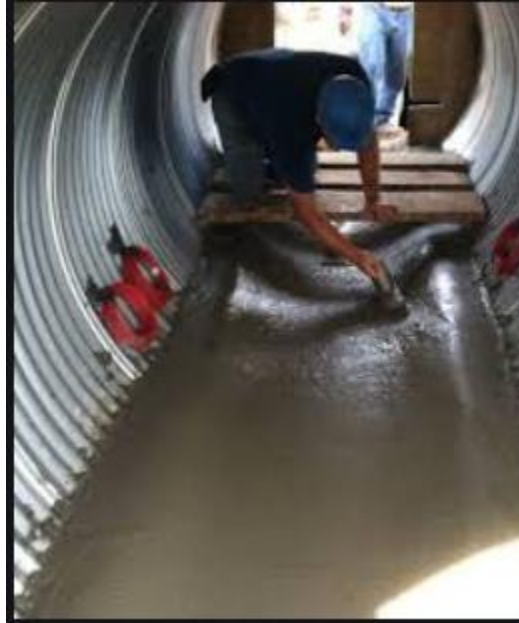
Figure 2-14 Invert Paving (Masada, 2017)

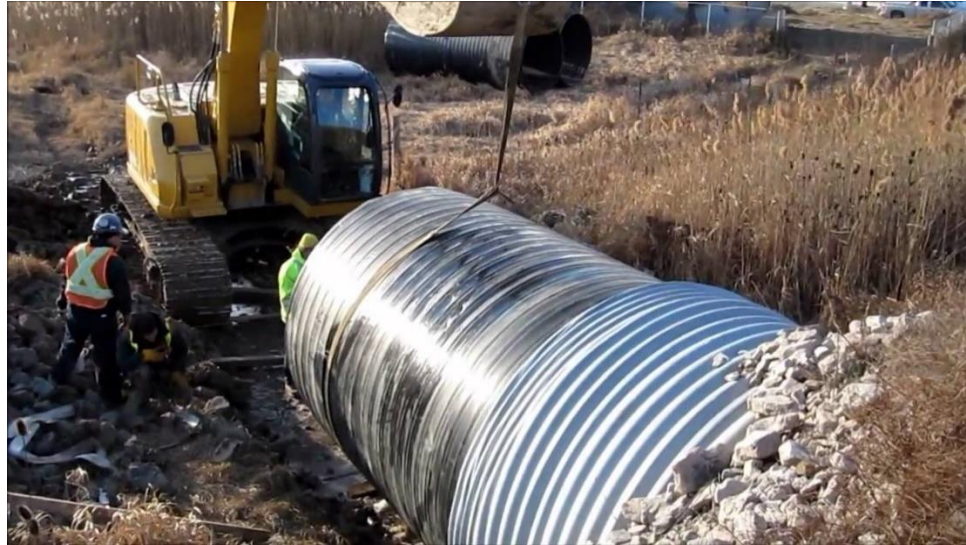
Slip Lining method is the process in which the deteriorated pipe is accesses through the strategic points and whole new pipe is slipped inside the old pipe. When trenching to repair pipes and culverts is not an option, trenchless slip lining technology can be a cost-effective solution. The slip lining could be done using plastic pipes, metal pipes, fiber glass reinforced cement. (Matthews, Simicevic, & Kestler, 2012).

Figure 2-15 Slip Lining Method of pipe rehabilitation (TerraFix Geosynthetics, 2011)

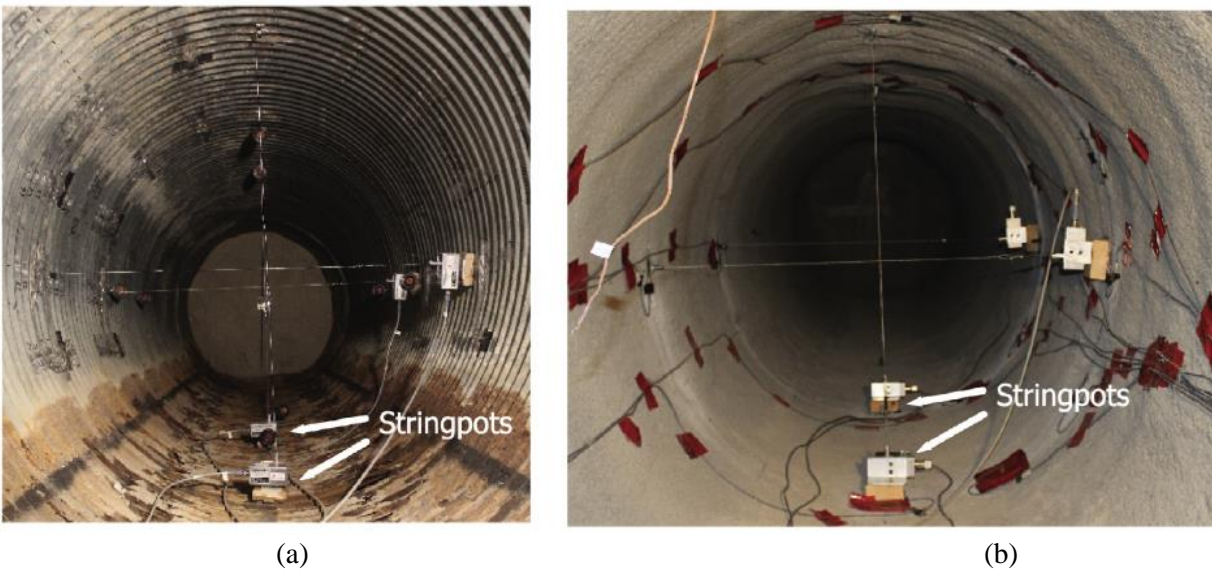
- The study found that the deteriorated pipes were able to carry the service load as they could not see the signs of the failure of pipe up to 203 kN.
- With the application of the liners it was observed that the change in the vertical and horizontal diameter was minimal thus providing the semi rigid response of the pipe. Also, the change of curvature of the pipe was small for similar load conditions which indicated the increase in the circumferential bending stiffness. Thus, strengthening the fact of semi-rigid behavior of the pipe after the application of the liner.
- The study also concluded that the increase in the liner thickness increased the stiffness of the rehabilitated pipe.

Figure 2-17 (a) Pipe before the application of the liner (b) Pipe after the application of the liner (Garcia & Moore, 2015)

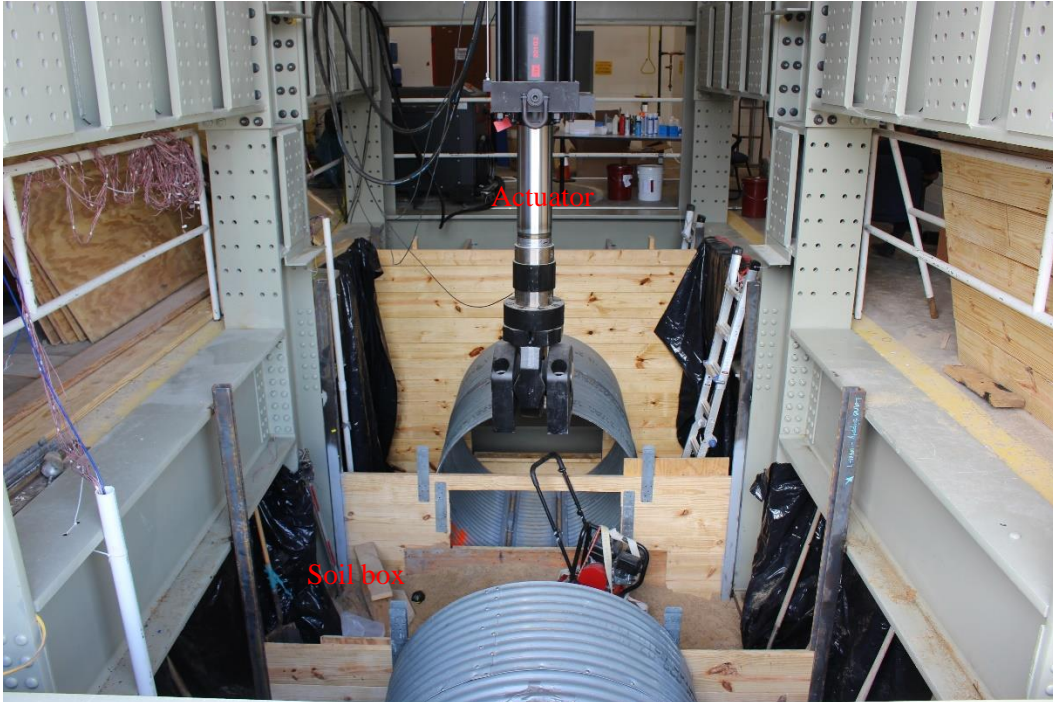
A 25'x12' soil box, 10' depth was divided into three segments (Figure 3-22). Each of the segments were 6 ft. in length and were separated by 2 in. thick wooden partition walls. The wooden partition wall was braced at each end and its stability under the application of the load was checked through theoretical calculations and FEM method. The depth of foundation, embedment and soil cover was 2 ft., 5ft. and 2 ft. respectively.

Figure 3-22 Lab setup (Source: CUIRE Laboratory)

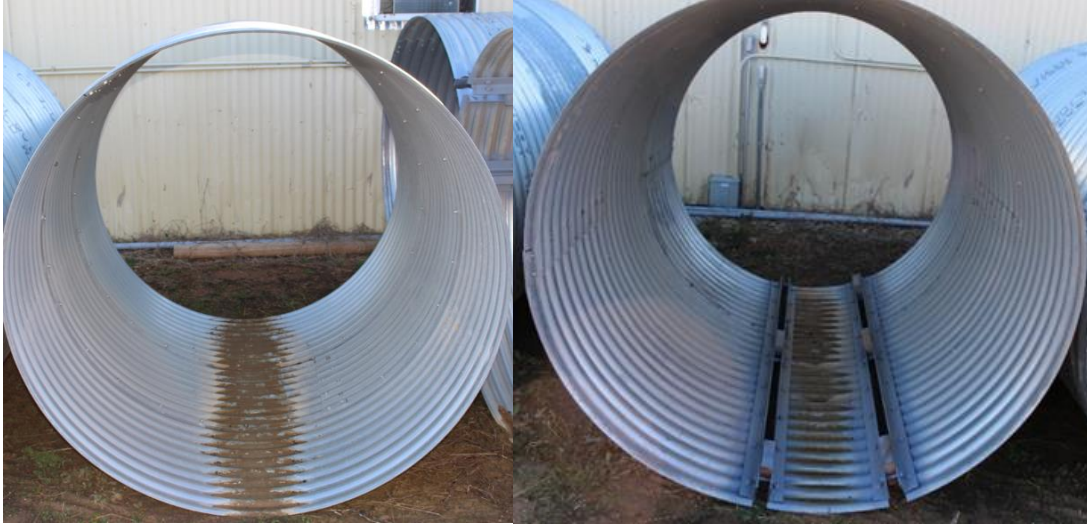
To represent the deterioration in CMP, the CMPs were fabricated in such a way, 18 in. of the invert from the CMPs could be removed once it was buried in the soil (Figure 3-25).

Figure 3-25 (a) Intact CMP (b) CMP with invert removal arrangement

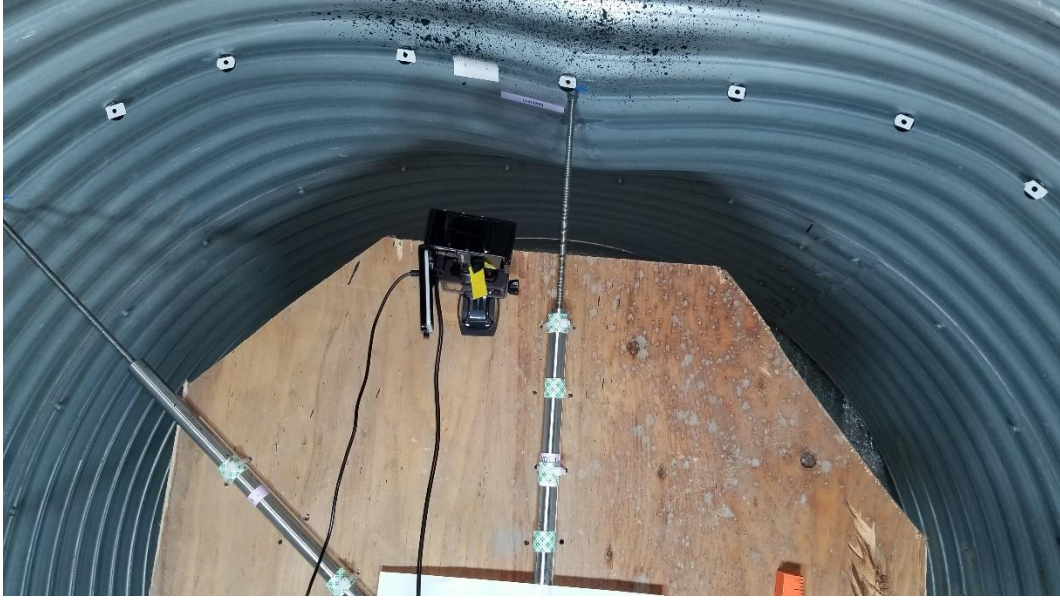
Displacement was recorded at the spring line of the CMP using LVDT. It was observed that the displacement at the springline was only 0.294 in. at 21 kips of load and it remained constant at the ultimate load condition of 25 kips. The movement of the shoulder was found to be 0.76 in. at 21 kips of load while at 25 kips the shoulder displacement was observed to be 0.757 in. Figure 3-43, Figure 3-44 shows the plot of the load displacement for the soil and CMP.

Figure 3-42 Deformation of the CMP after loading (Source: CUIRE LAB)

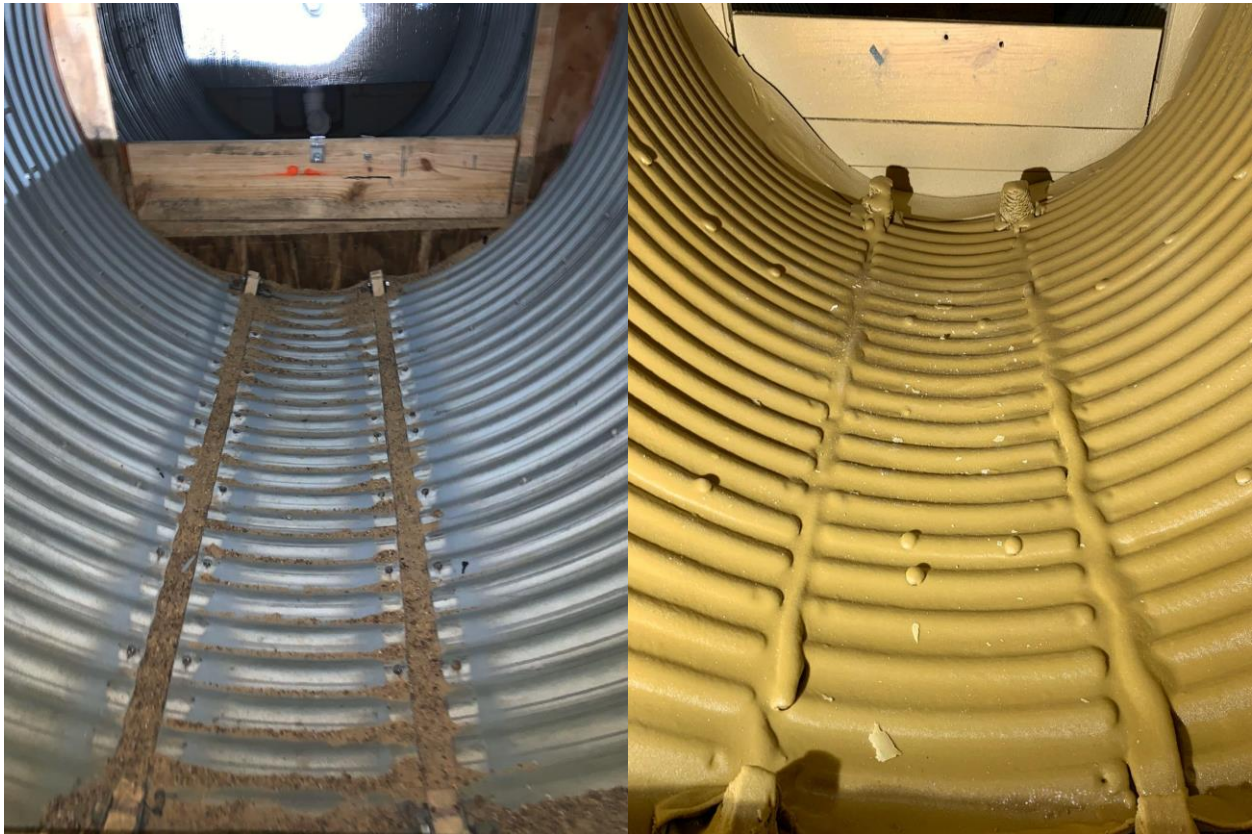
After the control test, next set of tests were performed in invert removed circular CMPs rehabilitated by the spray applied polymeric liner. The tests were performed on the three different thickness of the polymeric liner i.e. 0.25 in., 0.5 in. and 1 in. to find the suitable thickness required to increase the structural performance of the invert loss CMP greater than the intact CMPs. Since the material properties suggests the brittle nature, the failure mode of the CMP was excessive cracking rather than the deflection of the CMP.

Figure 3-54 Invert detached CMP before and after the application of the liner (Source: CUIRE LAB)

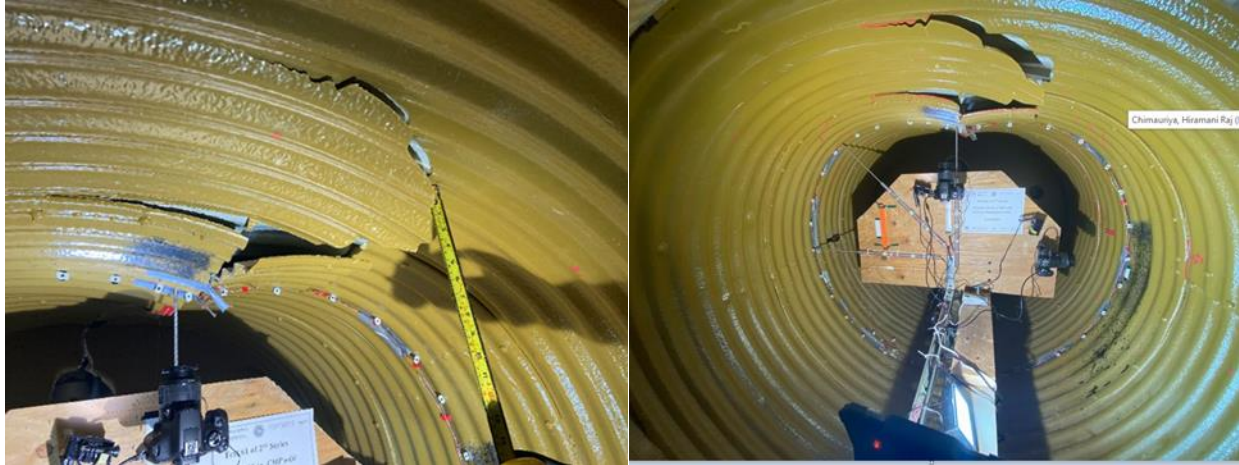
Figure 3-57 Cracks in lined CMP after the completion of test for 0.25 in. thick liner (Source: CUIRE Laboratory)

No cracks were observed in the invert region of the liner where the invert of the CMP was separated.

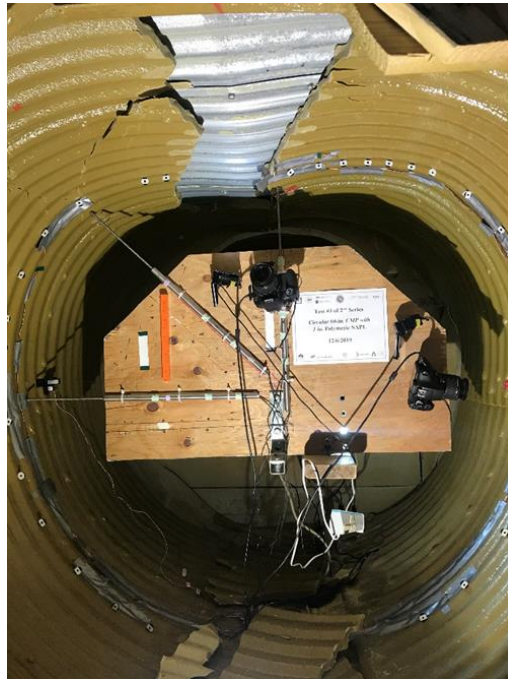
Figure 3-68 Crack in 1 in. thick liner after the completion of test for 1 in. thick liner (Source: CUIRE Laboratory)

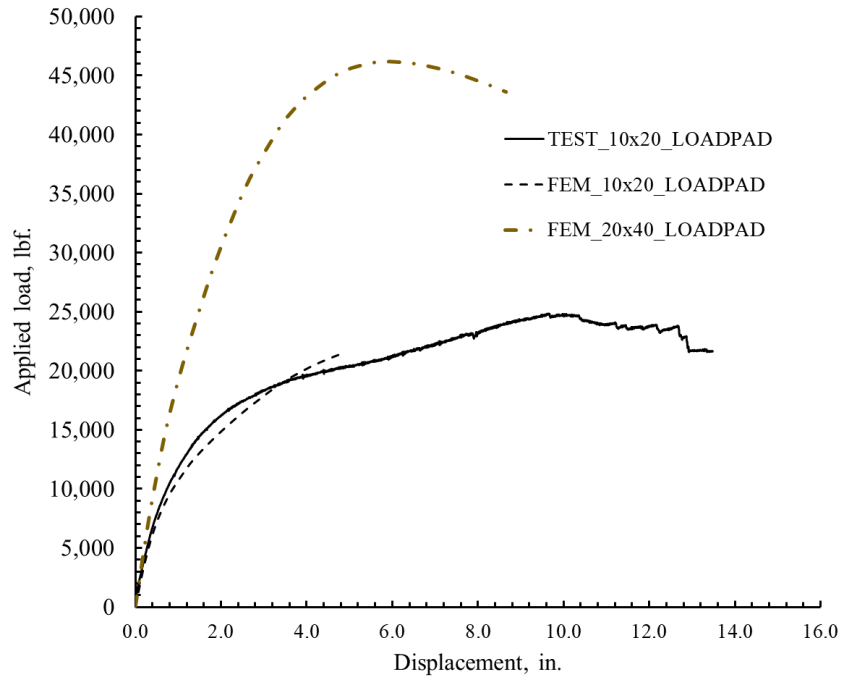
Figure 4-23 Load displacement from soil for the bigger load pad compared with the test result with smaller load pad (10x20 in²)

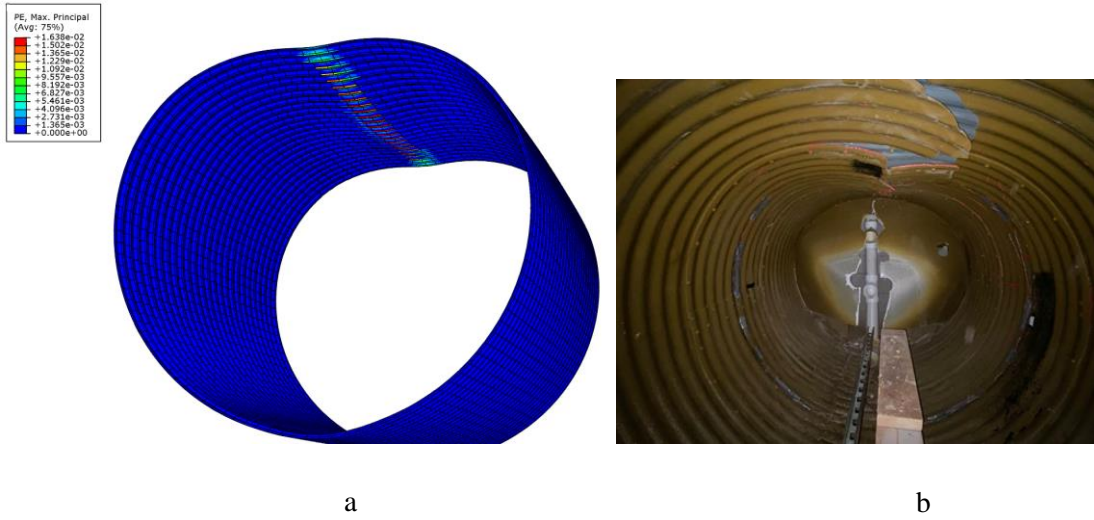
Figure 4-36 (a) Plastic strain at the ultimate load in the FE model (b) Crack in the model at the end of the test for 0.25 in. thick liner (Source: CUIRE Laboratory)
