EVALUATION OF FIRE-AFFECTED CONCRETE STRUCTURES BY  
NON-DESTRUCTIVE TESTING METHODS

Presented to the Faculty of the Graduate School of  
The University of Texas at Arlington in Partial Fulfillment  
of the Requirements  
for the Degree of

DECEMBER 2019

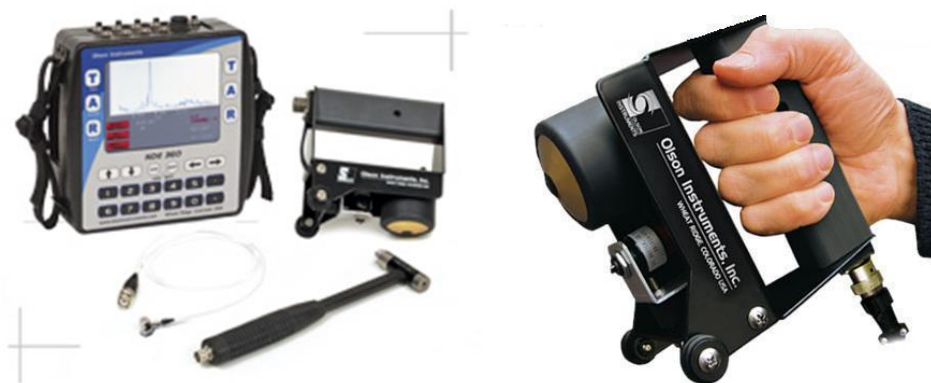
Figure 2- 7: Olson Instruments impact echo (IE) device.

honeycombs, and/or cracks are suspected. The device creates an impact at a spot on the surface and then records and analyzes the echo. Unlike the GPR, it is a spot scanning device, which is used to scan discrete data points in a pre-determined grid on the concrete deck surface. Figure 2- 7 shows the impact echo device that was used for the research.

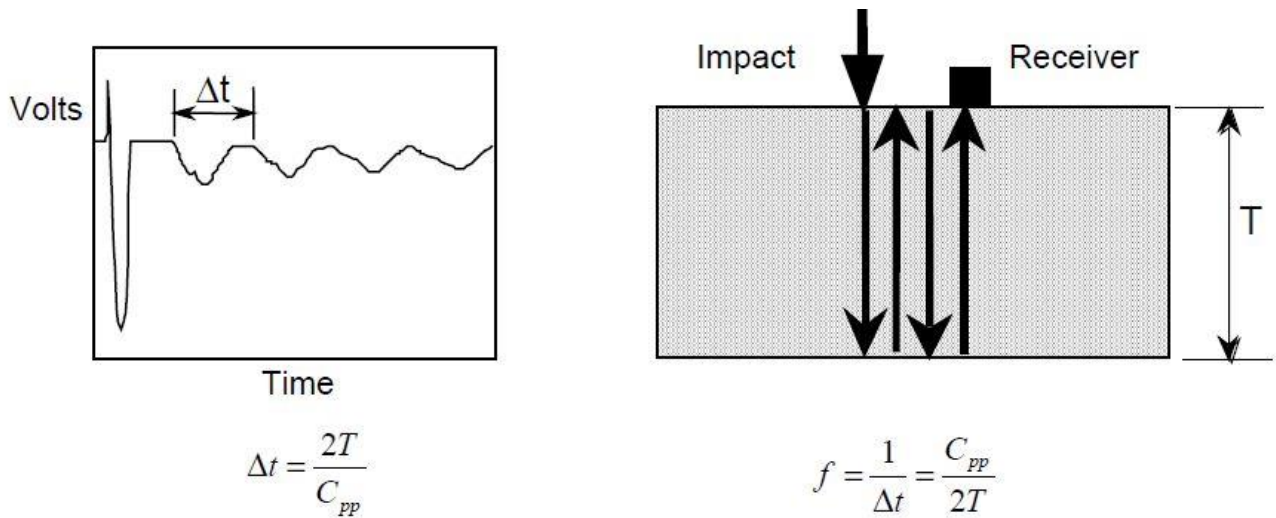
Figure 2- 8 Principle of frequency analysis in impact echo.

A key development leading to the success of the impact-echo method was the use of frequency analysis instead of time-domain analysis of the recorded waveforms (Carino et al., 1986). The principle of frequency analysis is illustrated in Figure 2- 8. The P-wave produced by the impact undergoes multiple reflections between the test surface and the reflecting interface. Each time the P-wave arrives at the test surface, it causes a characteristic displacement. Thus, the waveform has a periodic pattern that

If the test object is a solid plate, the frequency calculated according to equation [2-1] is called the plate thickness frequency (Carino, 2001).

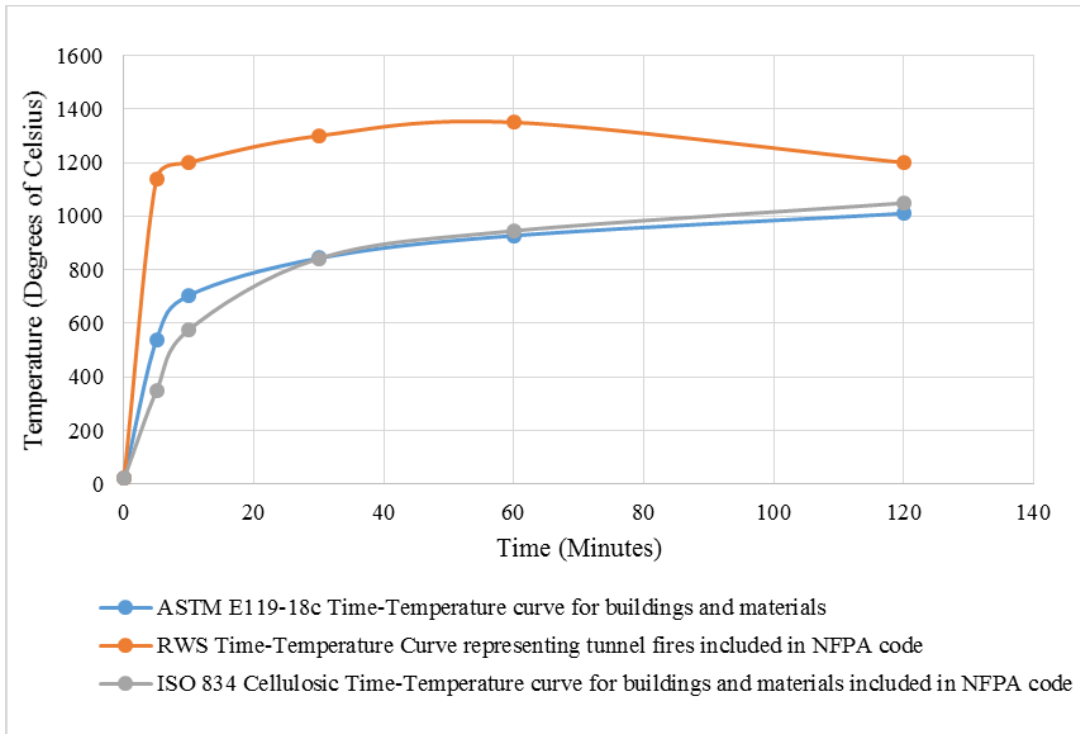
Figure 2- 13: Comparison between ASTM E119-18c and two curves included in the NFPA code (in °C).

Time (min)	ASTM E119-18c Time-Temperature curve for buildings and materials		RWS Time- Temperature curve representing tunnel fires included in NFPA code (°C)		ISO 834 Cellulosic Time-Temperature curve for buildings and materials included in NFPA code (°C)	
	°C	°F	°C	°F	°C	°F
0	20	68	20	68	20	68
5	538	1000	1140	2084	349	660
10	704	1300	1200	2192	576	1069
30	843	1550	1300	2372	842	1548
60	927	1700	1350	2462	945	1733
120	1010	1850	1200	2192	1049	1920

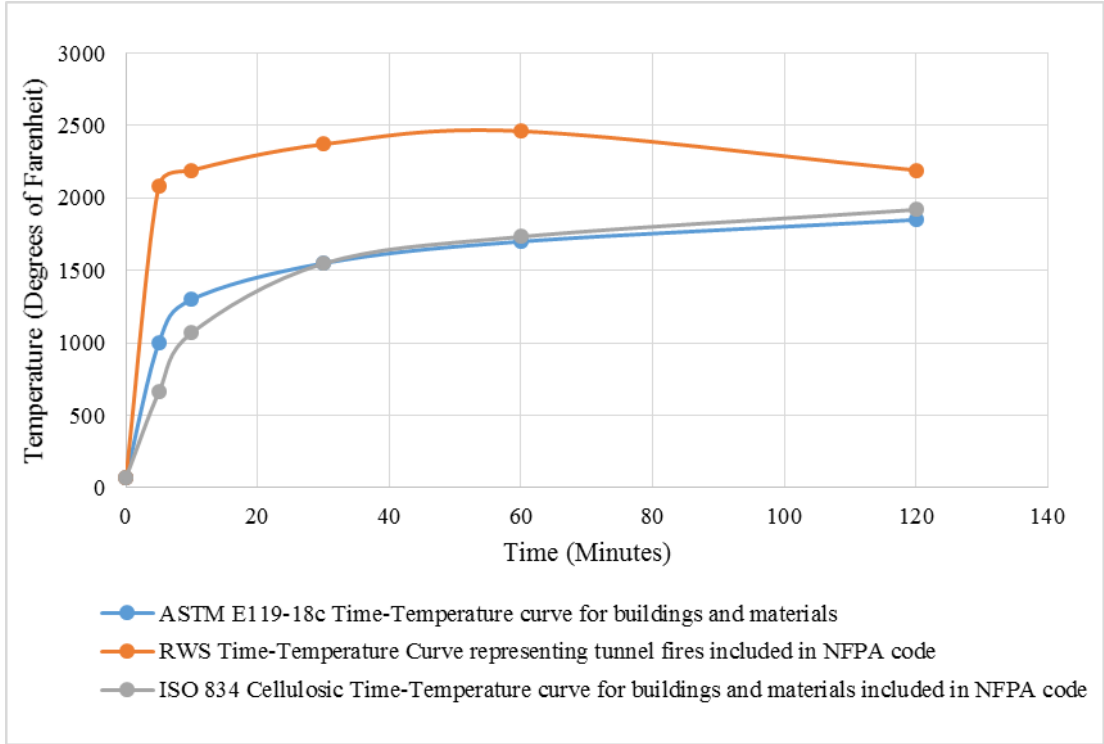
Figure 2- 14: Comparison between ASTM E119-18c and two curves included in NFPA code (in °F).

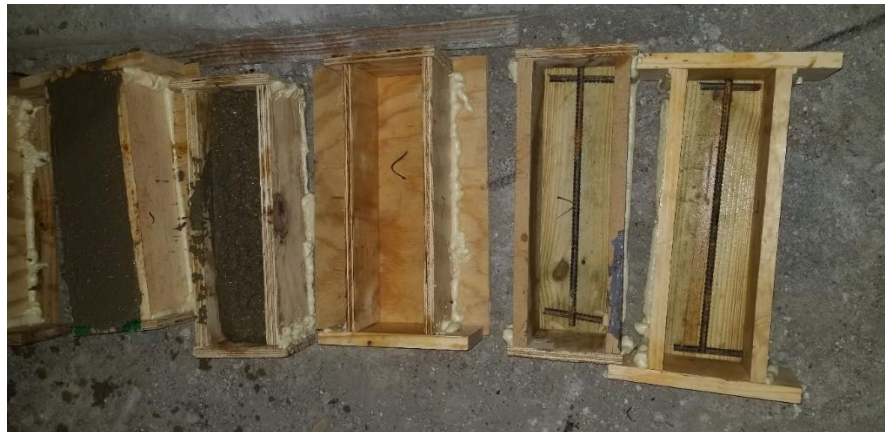
Figure 3- 1: Preparing preliminary study samples formwork and rebar placing.

For this study, a simple rectangular short beam of 4" X 4" X 15" (100 mm X 100 mm X 375 mm), and American Standard for Testing Materials (ASTM) approved size is chosen. Eight of these beams were prepared considering fireproofing, variable concrete strength and rebar. First, the formworks were prepared at the lab and the rebars were placed (Figure 3-1). Curing compound was used on the beams after casting to seal the top layer so that there is an ample amount of moisture trapped inside the concrete for hydration (Figure 3- 2).

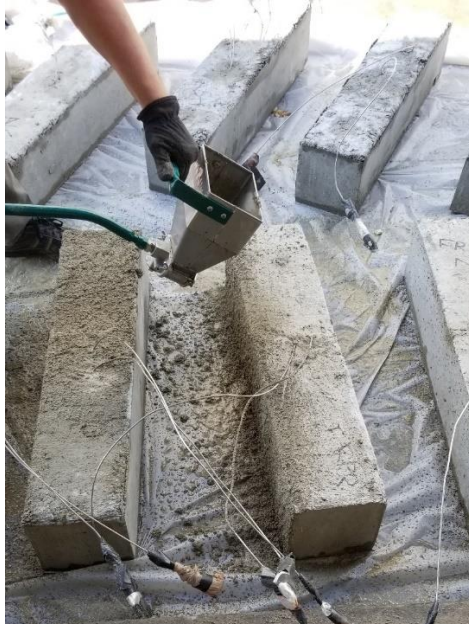
Figure 3- 8: Applying fireproofing mortar by spray or shotcrete.

Afterward, Sikacrete 213F fireproofing mortar was applied on all the surfaces of the selected beams from the experimental design matrix. The mortar was applied by spraying (Figure 3- 8) as a 1 inch (25.4 mm) coating. The considered thickness did not require any wire mesh or reinforcement as per the product manual. Afterward, curing was done to ensure the bonding of the coating and to prevent cracks.

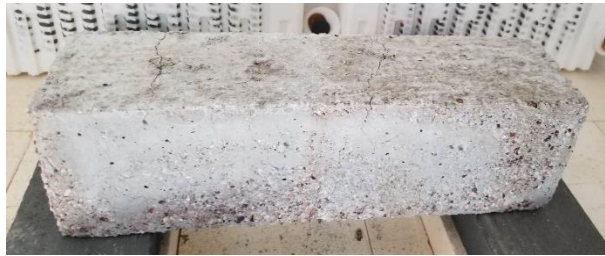
(a)  $\frac{1}{2}$  hour heat-treated sample

It appeared that 1 hour heat-treated samples endured significantly high damage than  $\frac{1}{2}$  hour heat-treated samples. The samples having fireproofing appeared to be damaged in the fireproofing layer only (Figure 3- 11). It was decided that, further study was needed to check if the damage due to heat exposure is only limited to the fireproofing layer or it propagates beyond that.

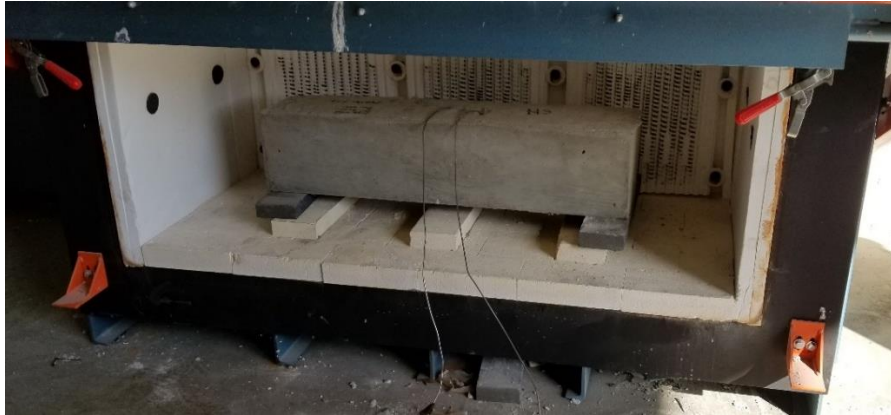
(a) Placing the main study beam samples in the furnace for heat treatment.

32 short scale concrete beams of 8" X 8" X 36" (200 mm X 200 mm X 900 mm) size were prepared according to the experimental design mentioned earlier. 24 beams including the fireproofed beams were treated with high temperature for 1 hour and ½ hour according to the ASTM E119-18c graph in the laboratory furnace. This range was chosen because at a temperature higher than this, the concrete properties may deteriorate beyond the capacity of inspection. For the heat treatment, in addition to the two embedded thermocouples inside the samples at rebar level and at mid-level, at least two additional thermocouples were used on the top and bottom surfaces of the beam in the furnace (Figure 3- 12). All the thermocouples data were recorded through a data logger box during the heat treatment procedure. Afterward, NDT was performed on all the specimens.

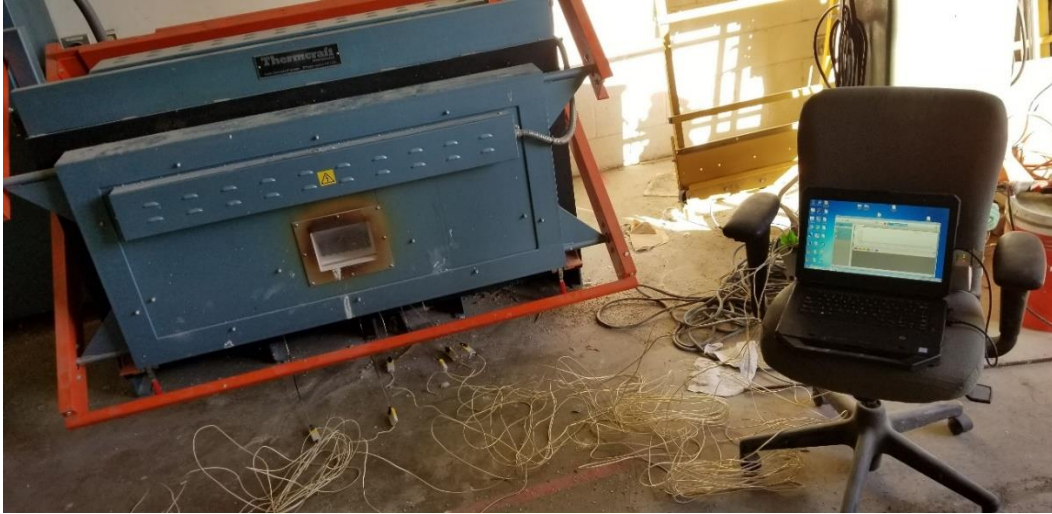
(c) Heat treatment setup with data logger and computer.

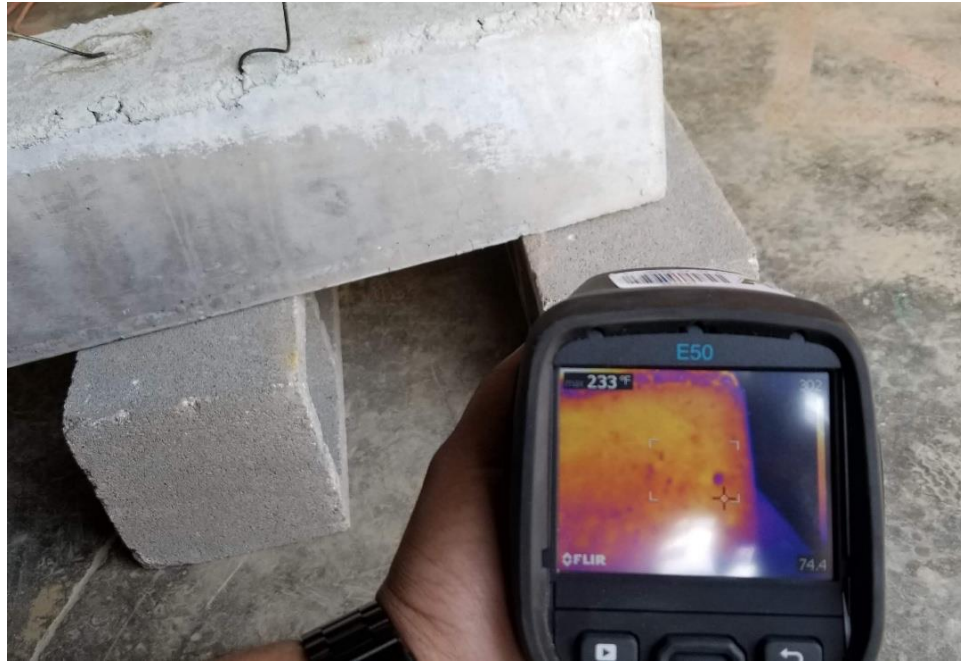
Figure 4- 4: Infrared camera view vs bare eye view.

environment. Figure 4- 4 shows a near-surface void visible only by the infrared camera in a heat-treated concrete sample.

Now the infrared camera could successfully identify the locations of the most damaged area in a heat-affected sample after 15 minutes of heat exposure, whereas, the damage was not visible to bare eyes at that time. However, after 2 weeks of storage from the heat exposure, when the samples top surface crumbled apart, the same damaged areas seen in the thermal images became visible (Figure 4- 5). These examples indicate that the infrared camera can successfully perform a qualitative analysis to find

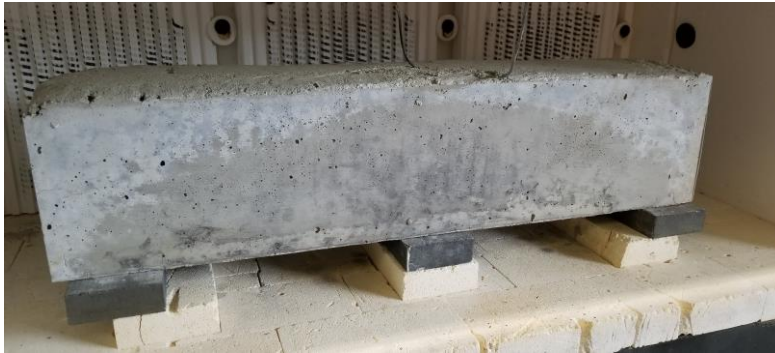
Normal strength concrete beam at 15 minutes after one hour heat exposure

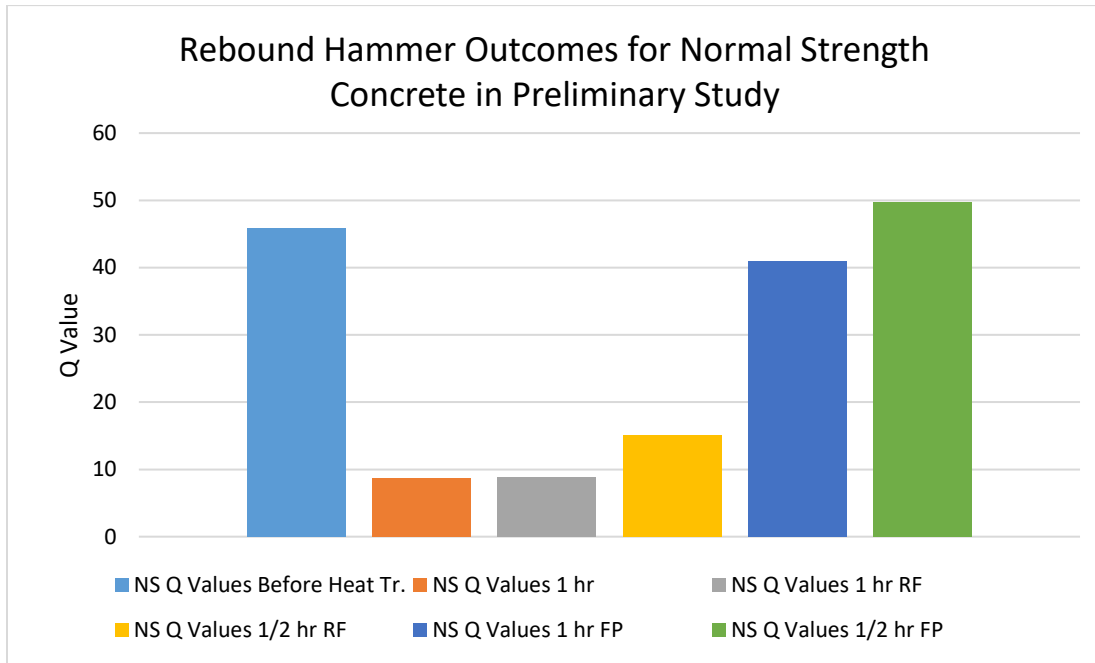
Figure 4- 7: Q values for normal strength concrete samples.

duration heat-treated and the fireproofed samples show higher values compared to other samples (Figure 4- 7). The Q values for the high strength concrete samples are presented in Figure 4- 8.

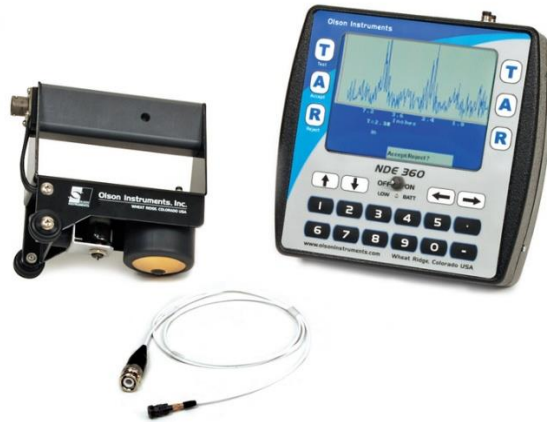
Figure 4- 24: Impact Echo (IE) device.

The Olson Instruments impact echo (IE) system (Figure 4- 24) is designed to determine the condition and thickness of concrete structural members when voids, honeycombs, and/or cracks are suspected. IE device creates an impact on the surface and records the echo through its sensor. The recorded data is then analyzed and post processed for any possible cracks, honeycombs or delamination inside the concrete.

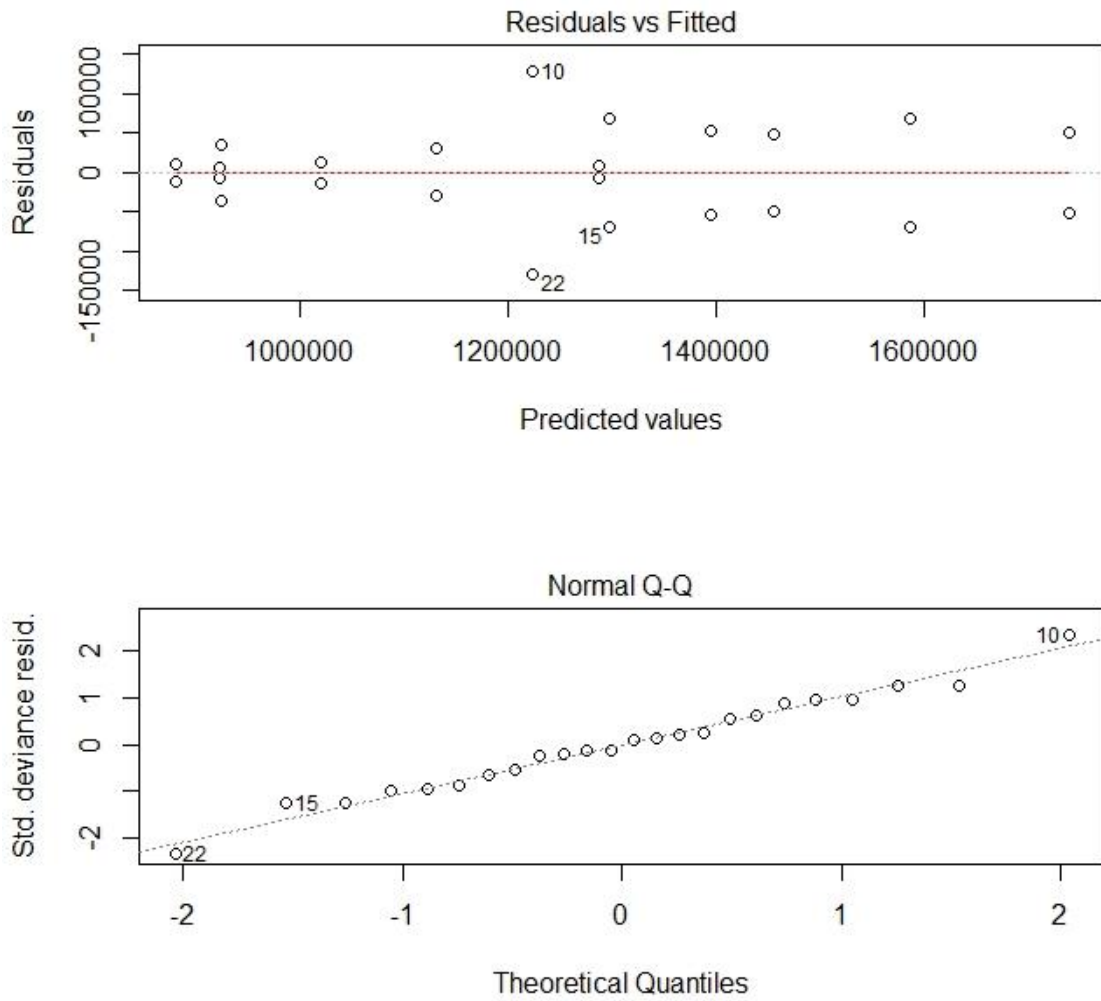
Figure 4- 39: Residuals vs fitted values and Normality Probability Plot for GPR test data.

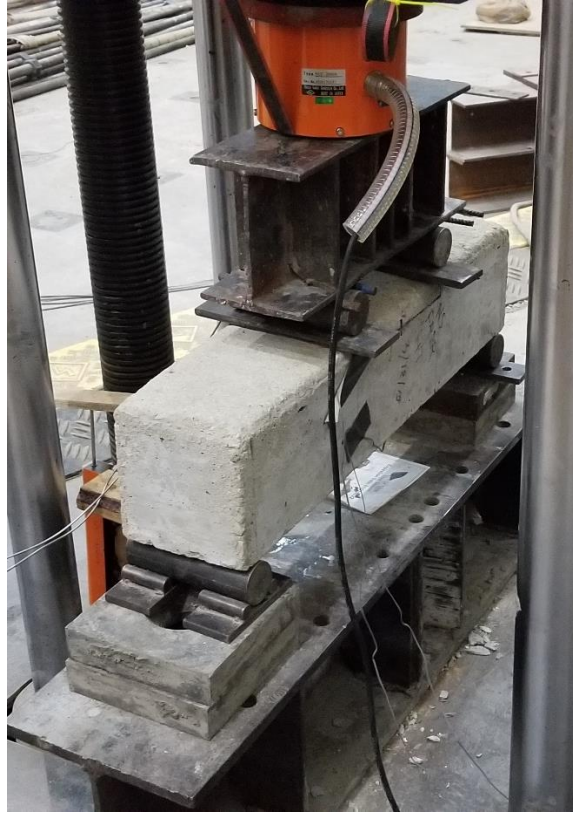
Figure 5- 3: Four point bending in laboratory.

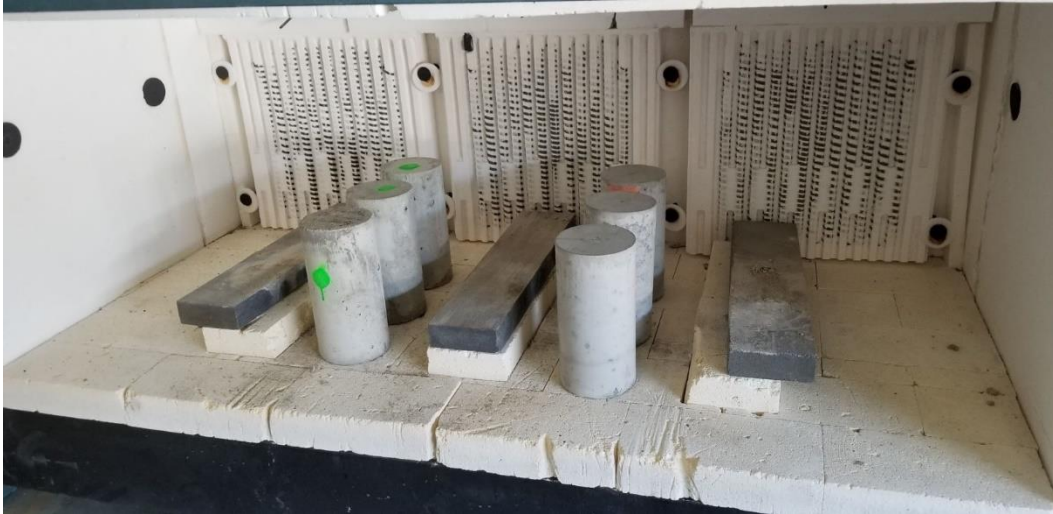
(a) Placing the cylinders in the furnace for heat treatment.

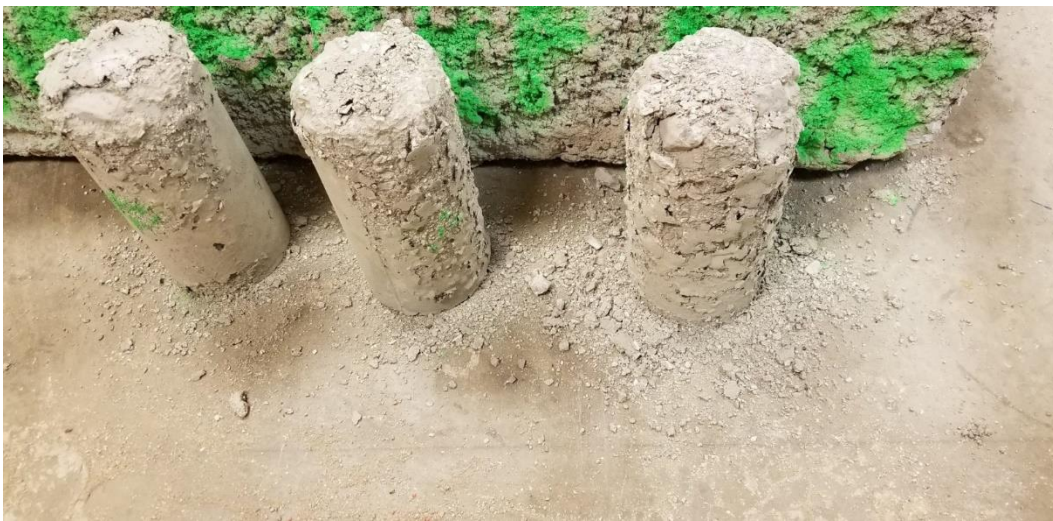
(b) Heat exposed damaged concrete cylindrical samples.

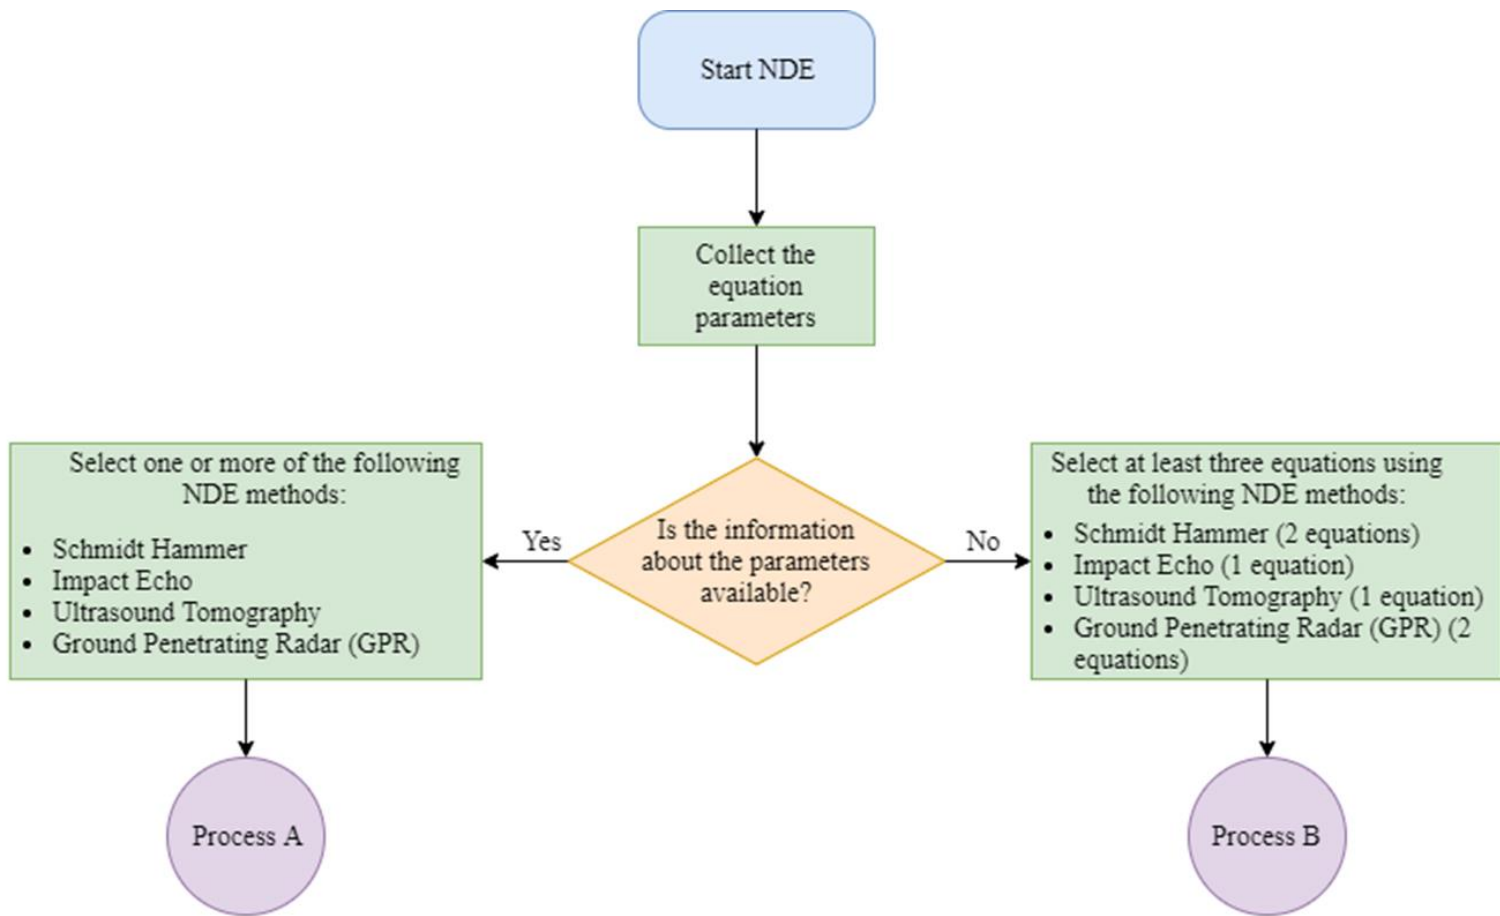
Figure 7- 1: Proposed procedure (part 1).
