**PAVEMENT TEMPERATURE RESPONSE TO COLD FRONTS:  
A MODEL COLUMN STUDY IN A FREEZER BOX**

Presented to the Faculty of the Graduate School of  
The University Texas at Arlington  
In Fulfillment of the Requirements for the Degree of

MASTER OF SCIENCE IN ENGINEERING

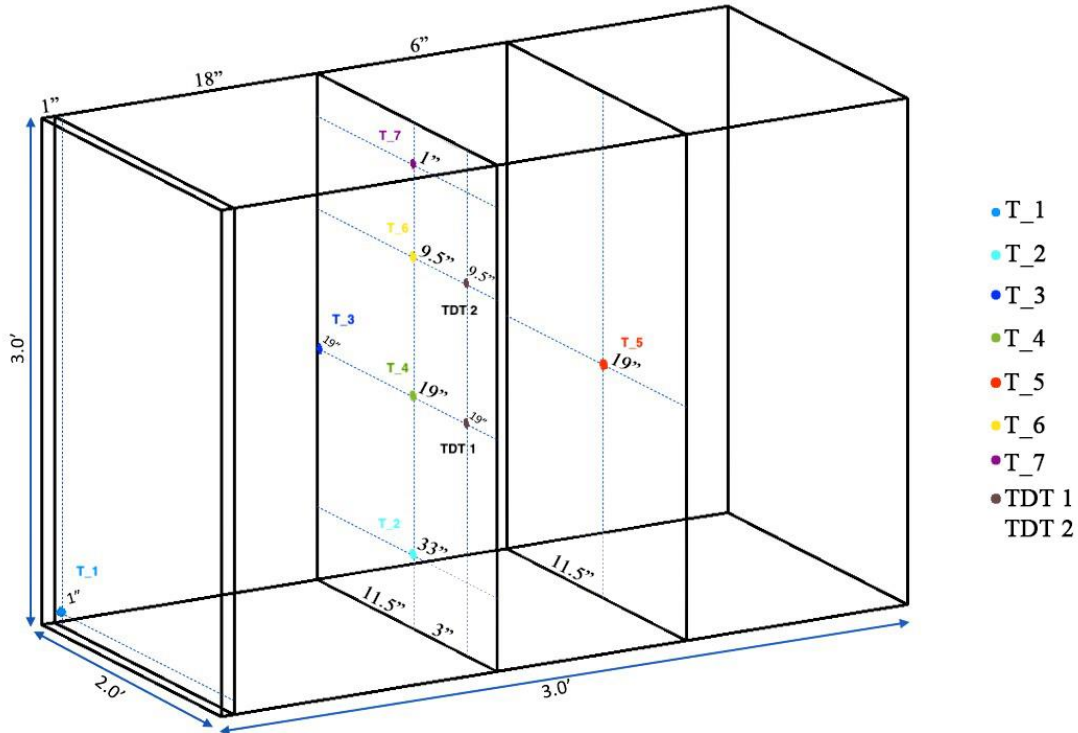
Instrumentation Schematic – (sandy lean clay)

Various sensors were used to monitor the temperature of the slab and the soil, as well as the ambient conditions in the freezer box (Table 1). Figures 4 and 5 illustrate the location of the sensors within the soil and the slab.

Two TDT SDI-12 temperature and moisture sensors manufactured by Acclima, Inc. are also installed in the soil column. TDT 1 is located at mid-depth in lift 4, in line with T\_3 and T\_4. TDT 2 is located in line with T\_6, 10.5-in from the surface. The sensors are intended to confirm that the thermistors are reading temperature correctly. Through the monitoring the volumetric moisture content of the soil, it can be confirmed that the wrapping of the system in plastic has sufficiently kept moisture from infiltration during the various misting operations performed.

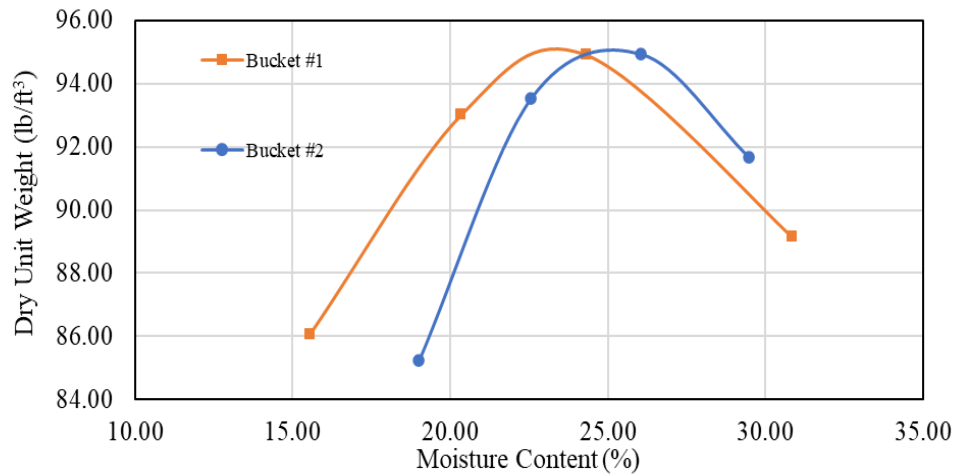
Figure 9. Proctor compaction curve

To determine the maximum dry density and optimum moisture content of the soil, the Standard Proctor Test for compaction was performed according to ASTM standard designation D698. The results of the compaction test are a maximum dry density of 94.92 pcf and an optimum moisture content of 25% (Fig 9). Tabulated calculations for the Standard Proctor Test results can be found in Appendix 2, Table 25.

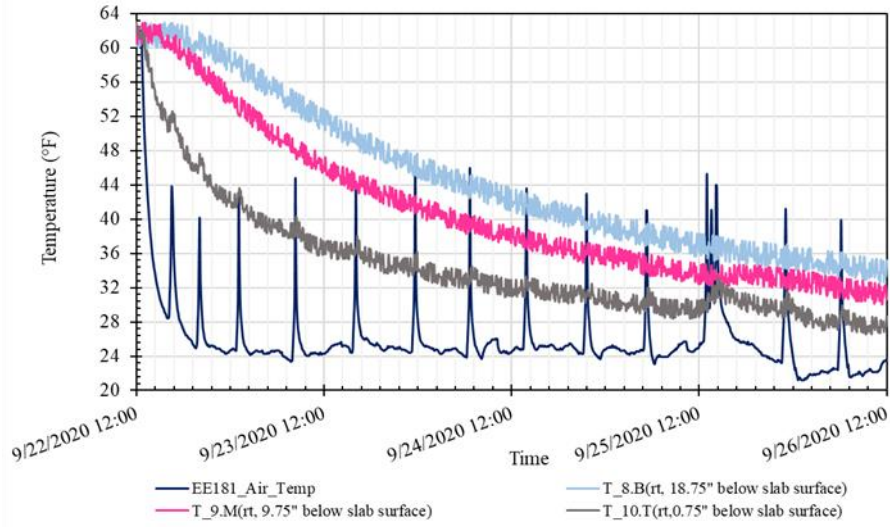
Figure 15. Variation of ambient freezer temperature and slab surface

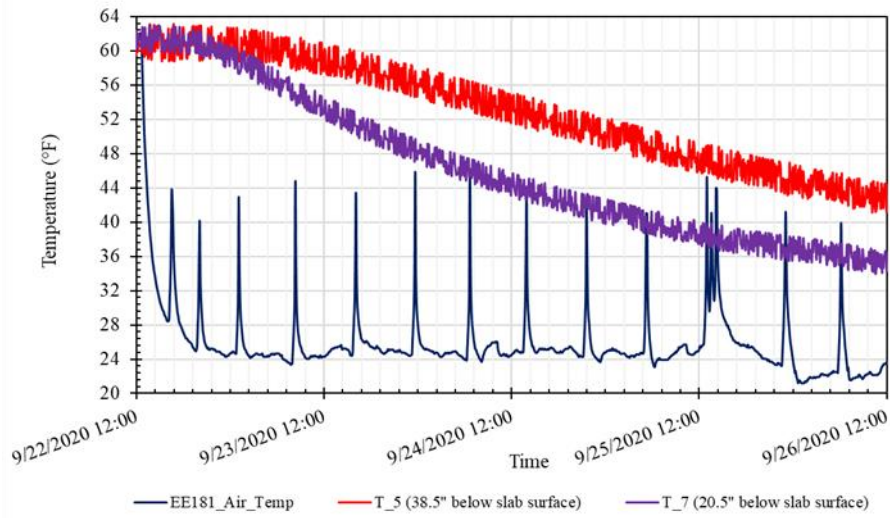
Figure 18. Variation of ambient freezer temperature, soil at 38.5" below slab surface, and soil at the slab-soil interface

Figure 18 illustrates the greater influence the ambient temperature has on the upper-most layer of soil as opposed to the mid-depth layer. The vertical temperature profile shown in Fig 19 illustrates the temperature change of the system at 24-hour increments throughout the test. The highlighted legend entries indicate the start and end of the test. It can be observed that at the beginning of the test the system has reached a steady state. By the end of the test, the slab decreased by 30°F while the soil at 38.5-in below the slab surface decreased by 20°F.

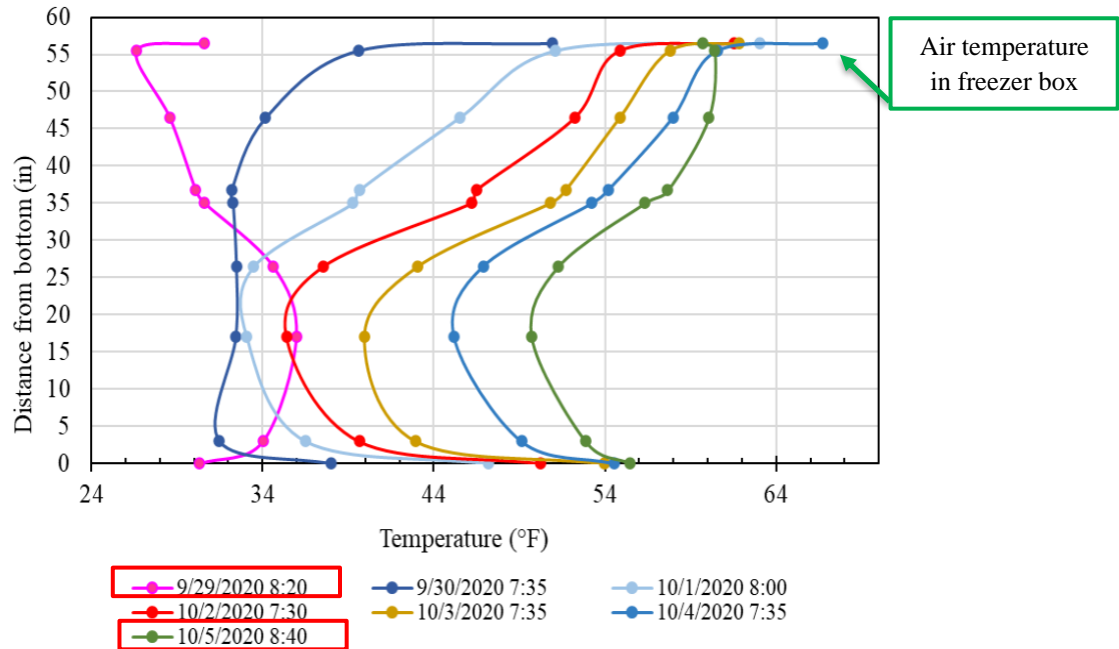
Figure 24. Vertical profile of temperature variation in the system (24-hour increments)

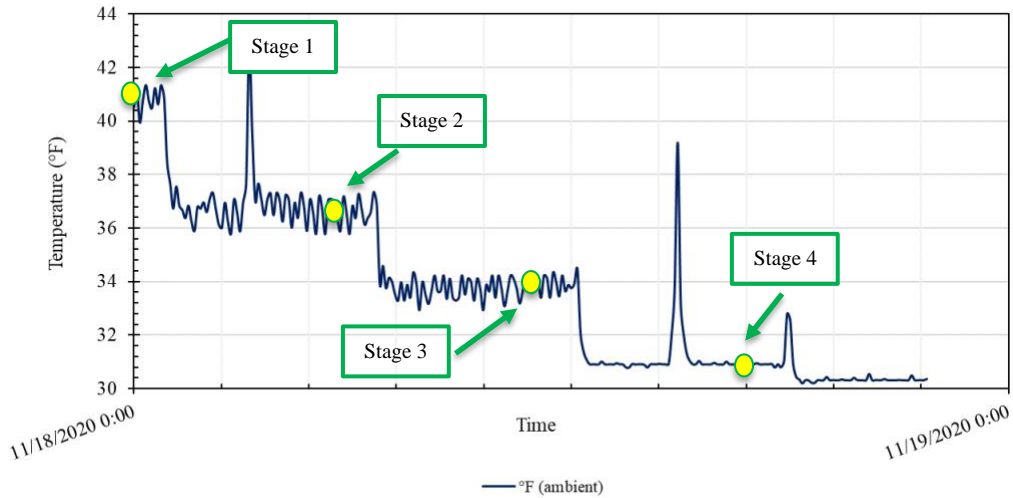
Figure 26. Ambient freezer temperature during case 1 testing

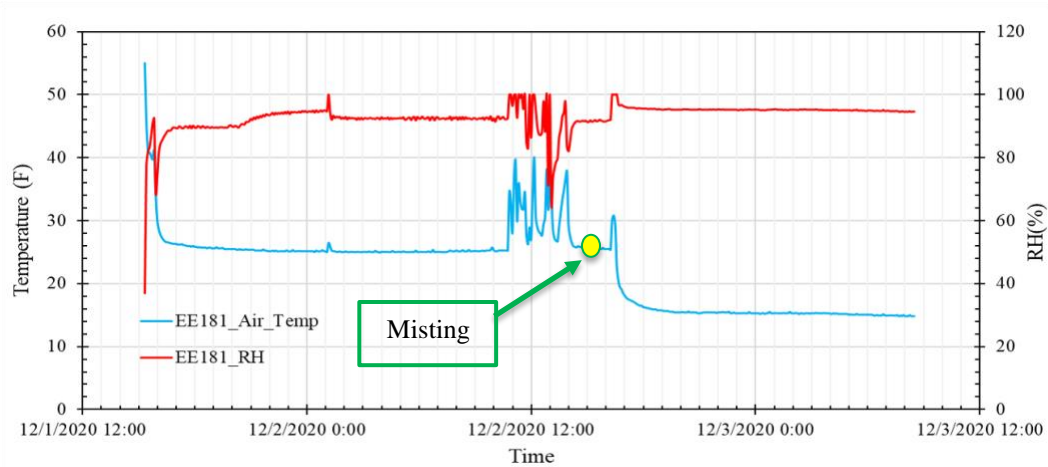
Figure 30. Ambient temperature and relative humidity of freezer during case 2 testing

determine the conditions for icing on the slab surface. The case 2 test was performed on December-03-2020 on the campus of UTA. The duration of the test was 41 hours. The misting operation utilized 18-20 gallons of a water/ice mixture with the duration of the misting operation being 8 minutes (Fig 30). Please refer to Table 9 for the time log of the test procedure. The temperature of the water/ice mixture was monitored using a thermistor located on the outside of the freezer box, connected to the data logger. Once the misting operation was completed, the freezer box was set to 15°F where it remained for 16.37 hours before concluding the test.

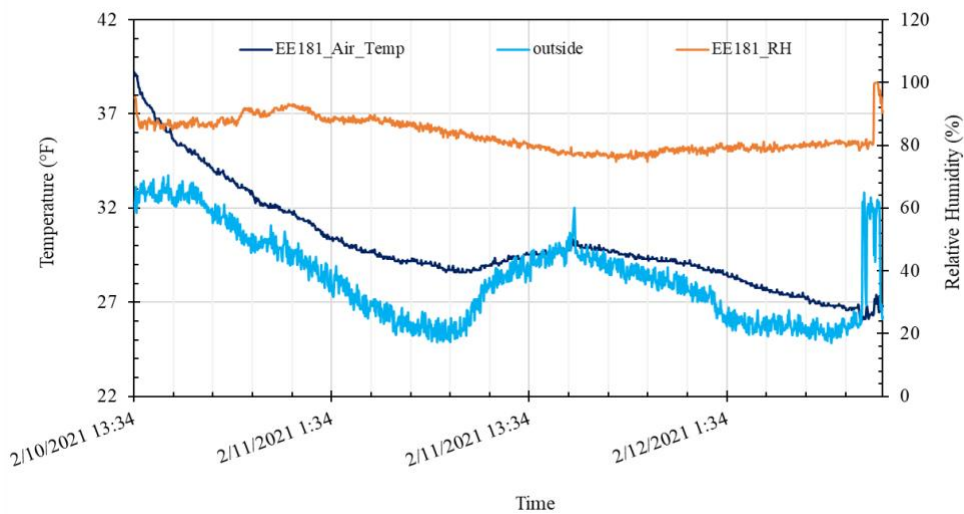
Figure 39. Ambient temperature in freezer, relative humidity in freezer, and outside air temperature during case 4 testing

The weather scenario being tested for case 4 was to open the freezer box door to allow the outside air to influence the freezer box environment. This test was performed during a cold snap experienced in Texas. The objective of the test was to observe how the system reacts to conditions that are similar to field conditions and to observe how long it takes for the formation of ice to occur when a misting operation is performed at freezing conditions. The outside air temperature was 31°F at the start and 26°F at the end of the test. The test was performed on February-12-2021 and the duration of the test was 46 hours (Fig 39). The misting operation used 36-40 gallons of water. The water was kept outside for the complete duration of the test and was 32°F when the misting began. The duration of the misting operation was 21 minutes. Please refer to Table 15 for the time log of the test procedure. Once concluded, the freezer was closed and returned to a setting of 40°F.

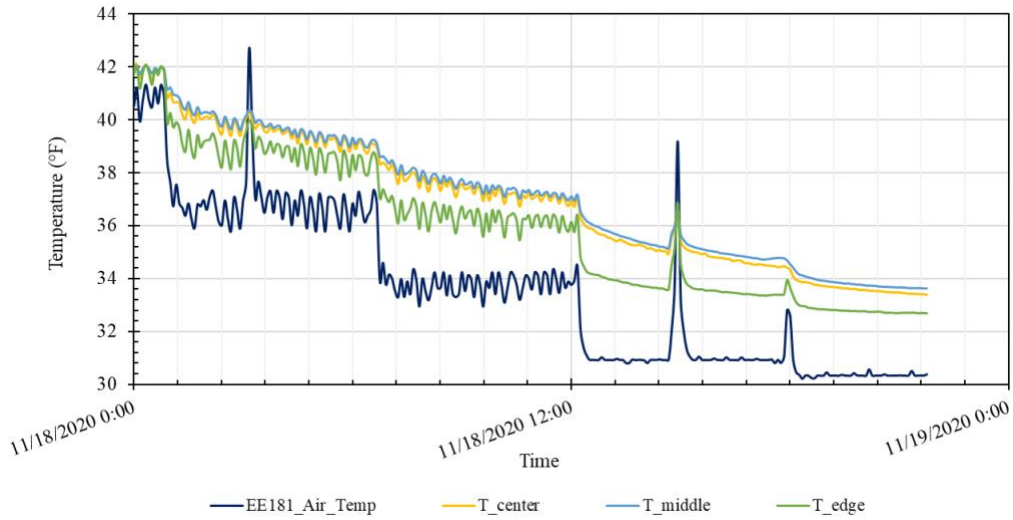
Figure 40. Variation of ambient freezer temperature and slab surface

During case 1 test, the freezer box temperature was gradually decreased to a final temperature of 30°F. The freezer box remained at this setting for 5.70 hours, at which time the misting operation began. The ambient temperature of the freezer box was 30.9°F at the start of the misting operation. However, the slab surface did not reach freezing conditions at any point during the testing of case 1. Please refer to Fig 40 and Fig 41.

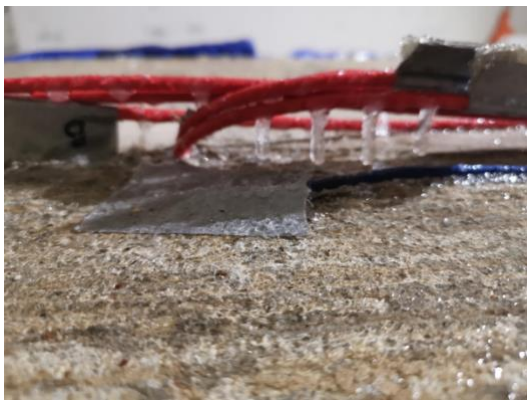
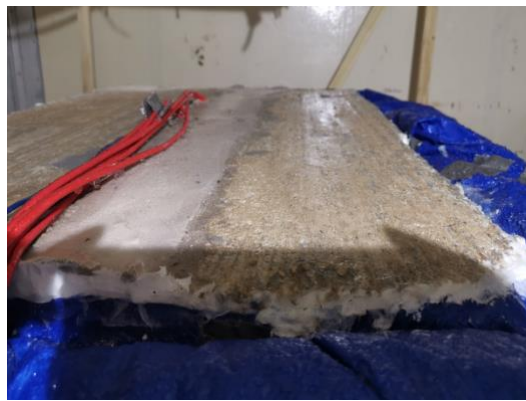
Figure 49. Final slab condition with the formation of glaze after case 1.1 testing

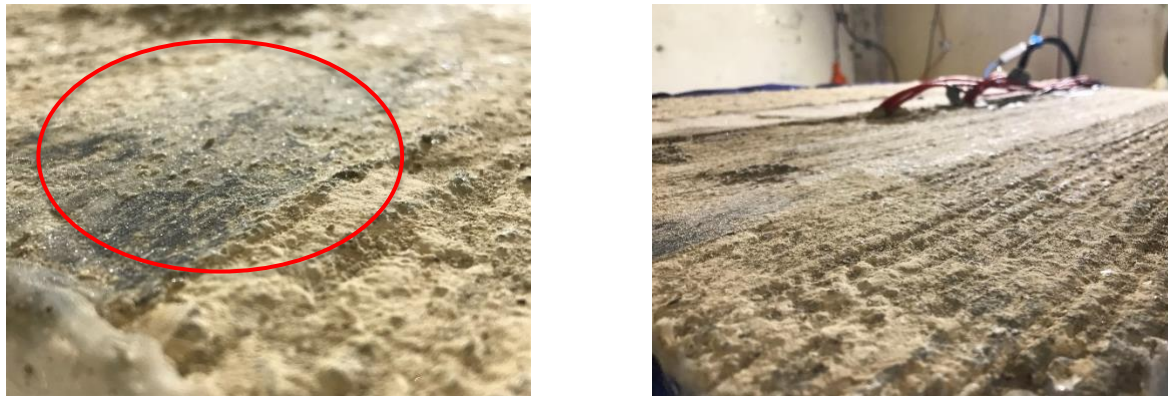
Figure 57. Light coating of frost on the surface of the slab

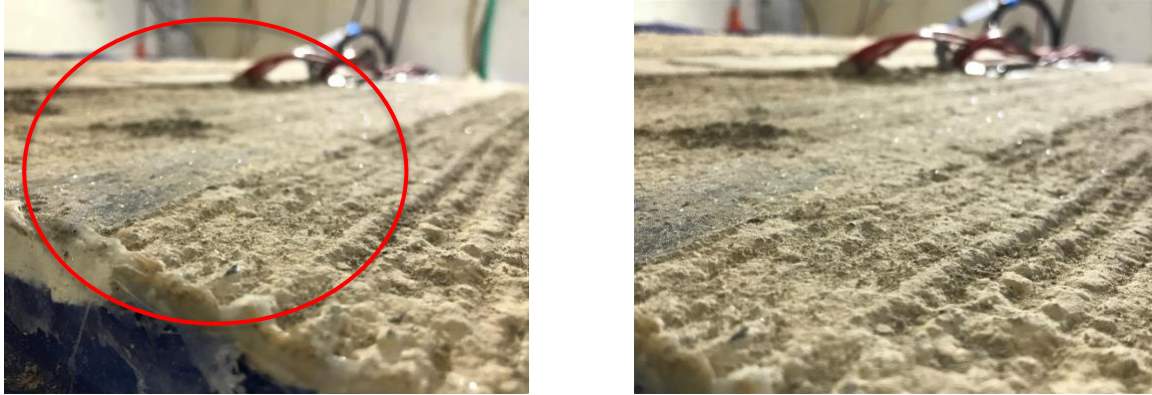
Figure 59. Fine layer of frost on the slab surface

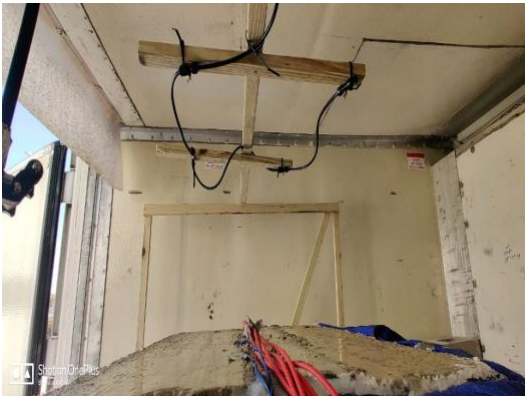
Figure 77. New misting system for case 1.1
