PERFORMANCE EVALUATION OF RECYCLED PLASTIC PINS IN TWO LAYERS
TO STABILIZE DEEP SLOPE FAILURES

DOCTOR OF PHILOSOPHY IN CIVIL ENGINEERING

THE UNIVERSITY OF TEXAS AT ARLINGTON

December 2022

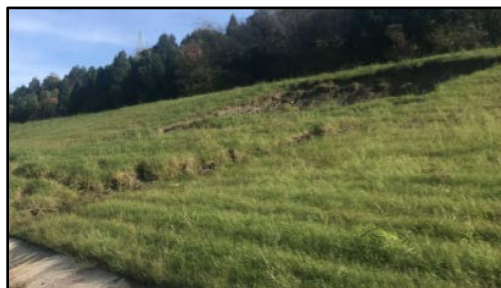
Figure 2.2 Shallow Slope Failure (Rauss, 2019).

Shallow slope failures are typically seen on highway embankments. Shallow slope failures occur as a result of rainwater infiltration into the slope surface and the cyclic weather conditions in the Texas region. Depth of shallow slope failures are usually between 3-6 ft. (Kim et al., 2004; Khan et al., 2017). Shallow failures are more frequent since the top few feet of the slope are more susceptible to moisture variations than deeper soil layers (Khan et al. 2017).

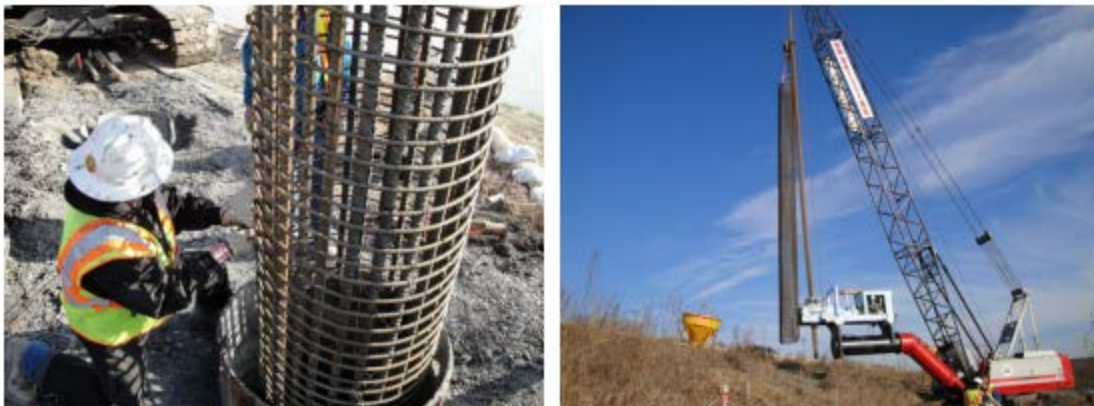
Figure 2.13 Construction of Drilled Shafts.

A case study in Lake Ridge Parkway Station 248, Grand Prairie, TX was shown by Gregory (2011) to show the effect of drilled shafts to stabilize an embankment against deep slope failure. The embankment was constructed of residual fat clays of eagle ford geological formation. Many shallow slope failures occurred and was repaired using fiber-reinforced soil. During repair a much deeper failure was discovered and found to be a creep type failure: a soil mass sliding along a soft bentonite seam within the underlying shale (Gregory, 2011).

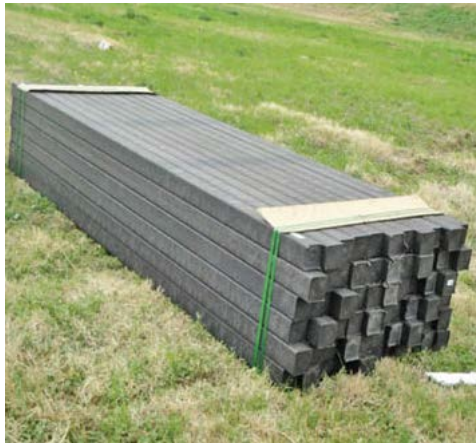
Figure 2.16 Stack of Recycled Plastic Pins (RPP)

The manufacturing of Recycled Plastic pins includes pulverizing, blending, heating, partially melting and compressing into molds of plastic materials forming plastic lumber (Loehr et al., 2000). Two methods of production were mentioned by Bowders et al. (2002) as compression molding and extrusion forming. In the process of compression molding, the plastics are pulverized, melted, and is compressed into desired shapes in molds. In comparison, extrusion forming involves forcing the material through a die of desired

cross-section. Extrusion process is more advantageous since any length of the pins can be easily produced without a mold.

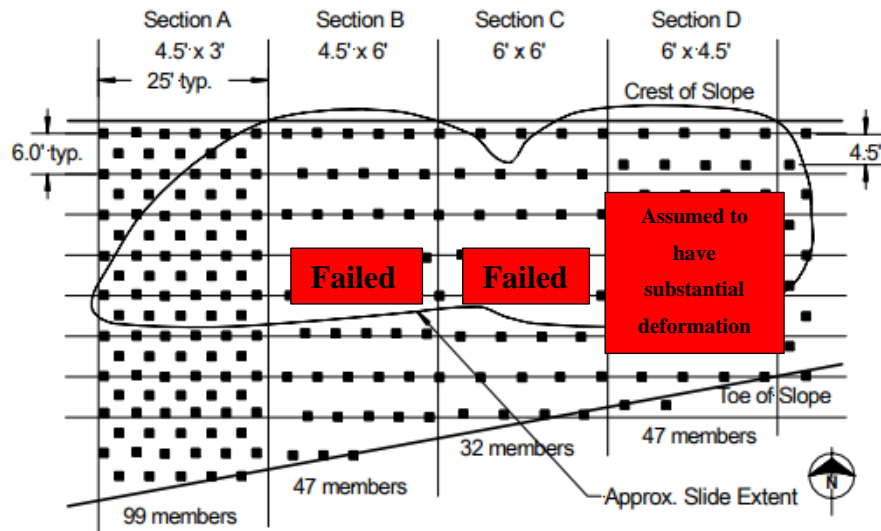
Figure 2.30 Stabilization Scheme for I-70 Emma- Section 3 (Loehr & Bowders, 2007).

Site 3 was stabilized using different orientation of reinforcing members and was presented by Loehr and Bowders (2007) (Figure 2.30). Closer and wider spacing was used to stabilize the failed section. The authors observed failures in sections B and C after 2 years of monitoring. Section D was also assumed to have experienced large deformations although it was not observed at site due to lower slope height.

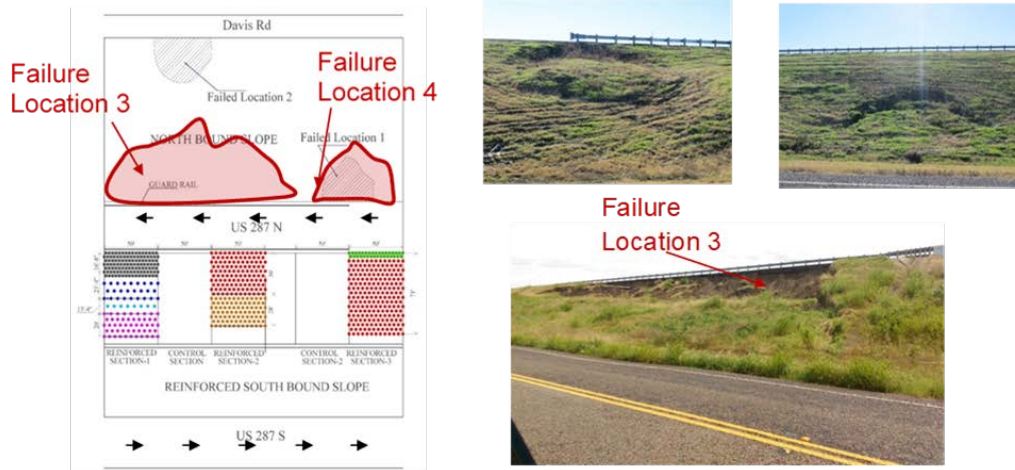
Figure 2.36 Slope failures observed in Northbound Control Slope (Khan, 2017)

Failure Location	Time
Failure Location-1	October 2013
Failure Location -2	October 2013
Failure Location-3	June 2015
Failure Location-4	June 2015

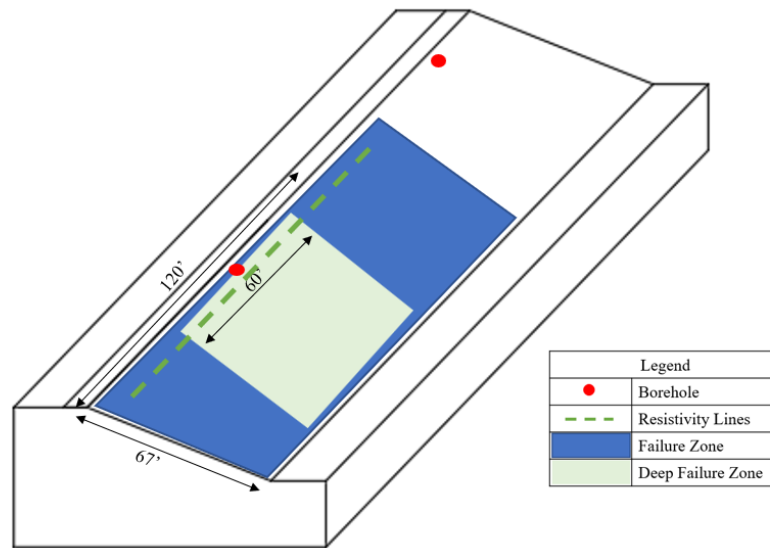
Figure 3.4 Schematic of 2D Electrical Resistivity Imaging Location

Two borings were advanced up to a depth of 30 feet as shown in Figure 3.4 to investigate the subsurface conditions of the project site. Subsurface exploration and geophysical testing using 2D electrical resistivity imaging (ERI) were conducted in July 2019 (Figure 3.4).

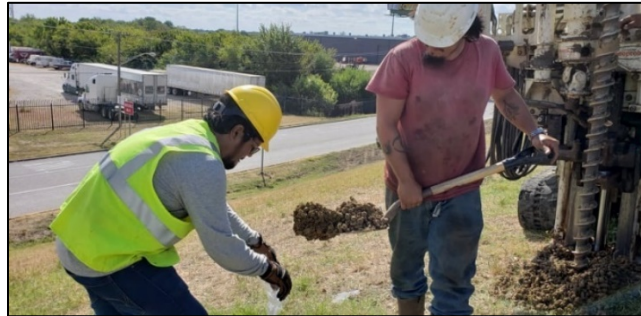
Figure 3.5 Collection of Samples

Two soil test borings were conducted in the reinforced section and control section for the sub-surface sample collection. Both soil test boreholes were located at the crest of the slope. Truck mounted drilling rig was used for the drilling. Hollow-stem augers with 5-inch diameter was used. Disturbed and undisturbed samples were collected throughout the two boreholes. Undisturbed samples were collected at intervals of 5 ft, using 3-inch diameter thin-walled Shelby tube sampler. Similarly, Disturbed Samples were collected

at 5 ft intervals. The Shelby tube samples obtained from the first 15 ft were not continuous due to the presence of small stones and sand.

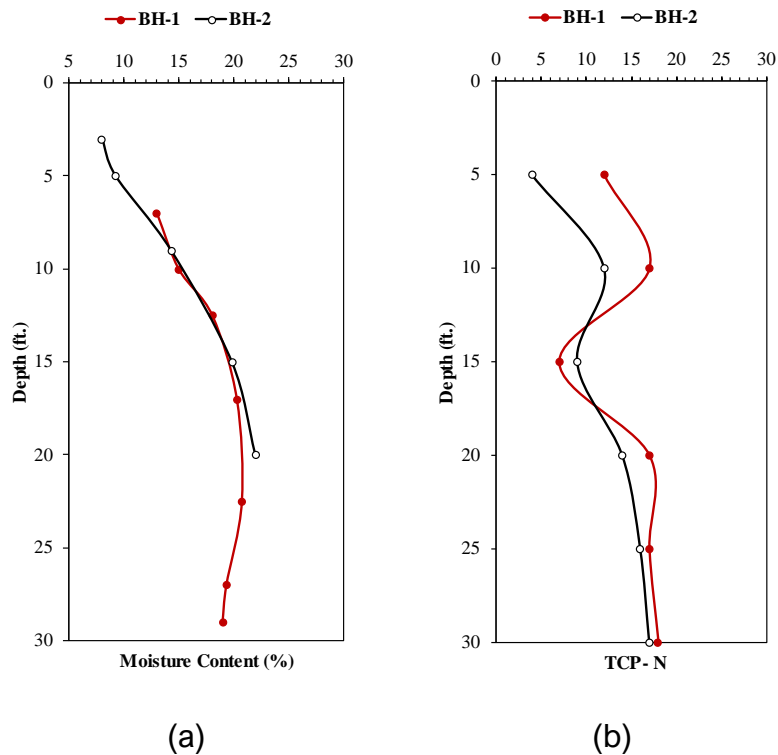
Figure 3.10 (a) Variation of Moisture Content (b) Variation of TCP-N Blow Count with Depth

Depth (ft.)	TCP Results	
	Blow Count (N Value) BH-1	Blow Count (N Value) BH-2
5	12	4
10	17	12
15	7	9
20	17	14
25	17	16
30	18	17

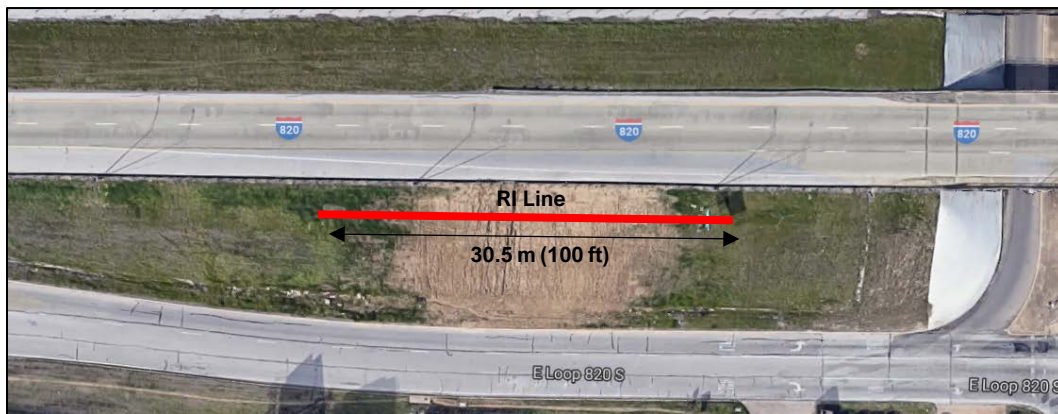
Figure 3.11 Location of Resistivity Imaging.

Geophysical testing was performed using 2D electrical resistivity imaging (ERI). ERI uses a multi-electrode array system and inversion modeling to provide a continuous image of the subsurface. Resistivity Imaging (RI) was conducted at the crest of the slope along the failed section to determine the moisture variation in the slope (Figure 3.12).

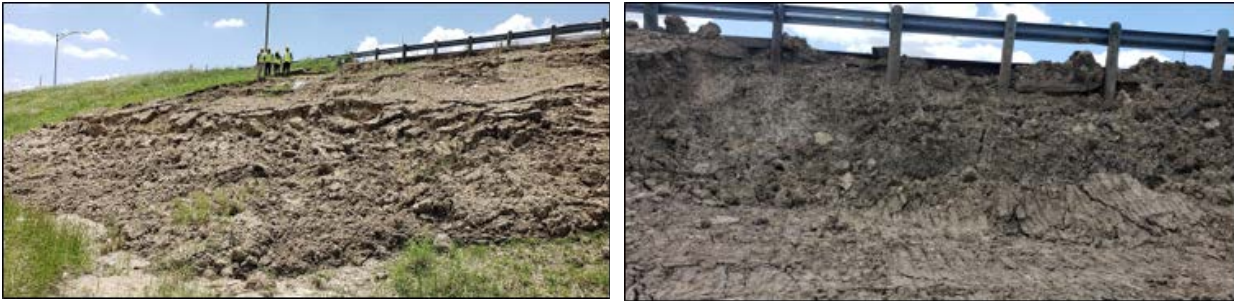
Figure 3.13 IH-820 & Rosedale St. (a) Slope Failure; (b) Head Scarp.

According to Duncan (2014) the head scarp indicates the extent of the movement of the slope. The head scarp during failure in IH-820 & Rosedale Street extended up to 5.5 ft which indicated the occurrence of large slope movements (Figure 3.13 (b)).

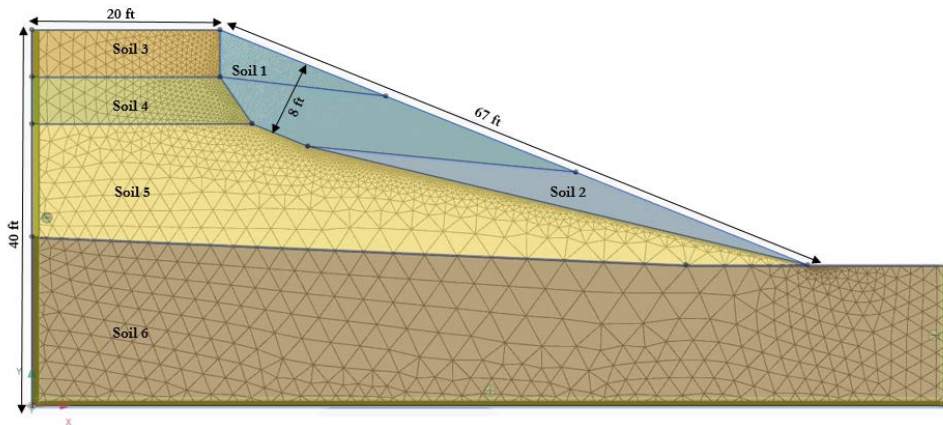
Figure 3.14: Soil Profile

failure zone with residual strength (Figure 3.14). Residual strength parameters were considered since this slope experienced several failures before the failure discussed in this study (Al-Homoud et al., 1997). The soil parameters for the remaining layers were obtained using the soil test results done during site investigation. The soil profile is shown below (Figure 3.14). Several iterations were carried out during the analysis to calibrate the soil model to represent failure as observed at site. The residual parameters for the top 8 feet were back calculated to stimulate the failure at a factor of safety of 1. Head scrap of 5 ft and bulging initiating from the middle of the slope was observed in the model as well as the field after failure (Figure 3.15 (a)). The soil parameters that yielded a factor of safety of 1.00 is shown in Table 3.4.

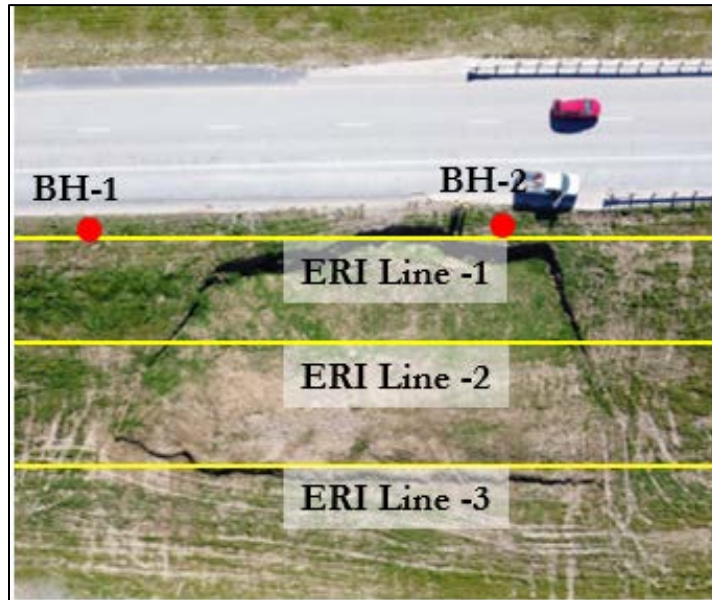
Figure 3.18 Location of Boreholes and ERI Lines.

Two borings were advanced up to a depth of 30 feet at the crest of the slope as shown in Figure 3.18 to investigate the subsurface conditions of the project site. Subsurface exploration and geophysical testing using 2D electrical resistivity imaging (ERI) were conducted in March 2021.

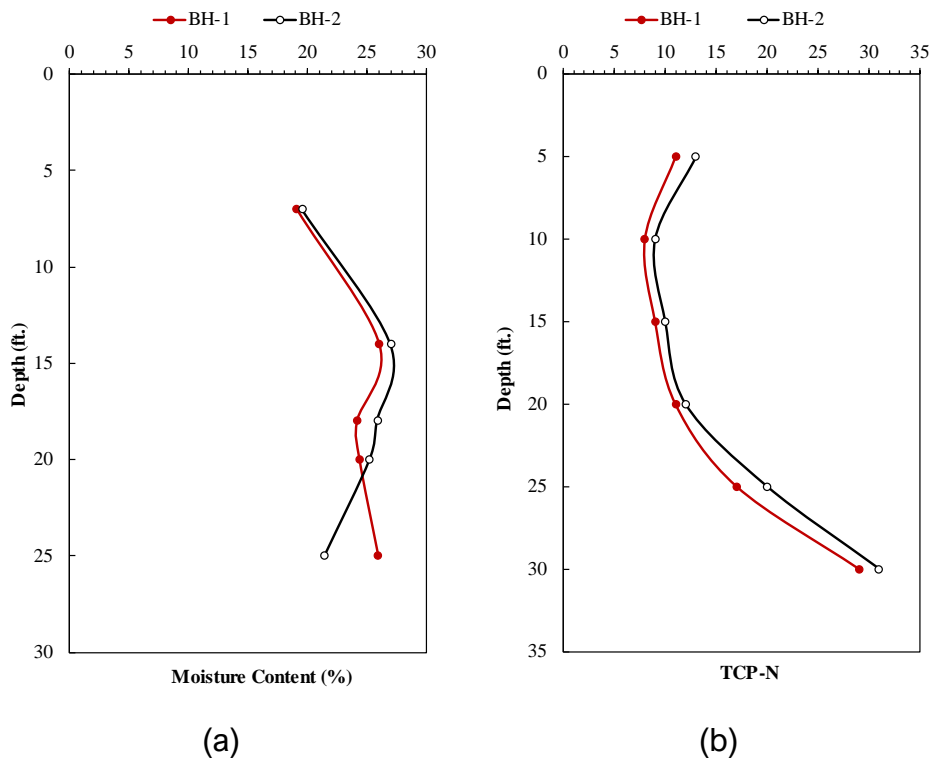
Figure 3.20 (a)Variation of Moisture Content (b) Variation of TCP Blow Count with Depth

Depth	TCP Blow Count (N- Value)	
	BH-1	BH-2
5	11	13
10	8	9
15	9	10
20	11	12
25	17	20
30	29	31

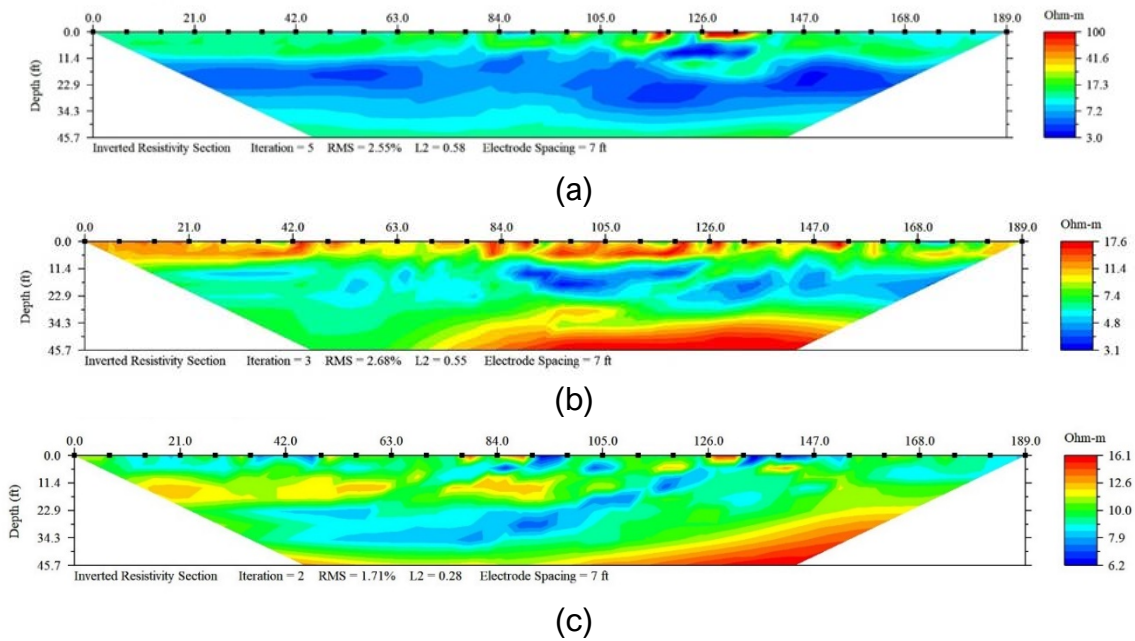
Figure 3.22 Result of Resistivity Imaging; (a) Crest (b) Middle (c) Toe.

clayey soil which was verified during soil investigation. Higher resistivity pockets at the surface shows the presence of voids and cracks.

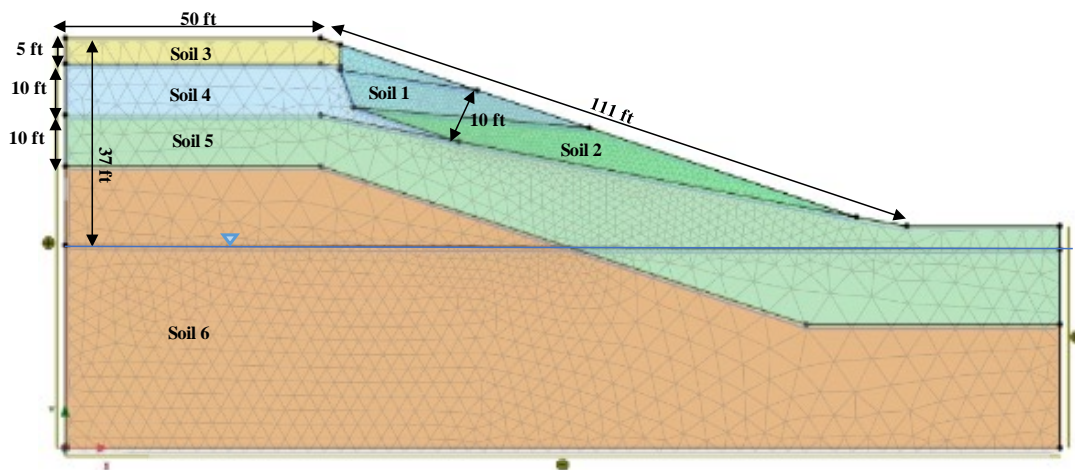
Figure 3.24 Soil Profile.

(Soil 2) was considered as the failure zone with residual strength (Figure 3.14). Fully softened soil parameters were used for the soil over the assumed failure plane. The soil parameters for the remaining layers were obtained using the soil test results determined during site investigation. The soil profile is shown below (Figure 3.24). Several iterations were carried out during the analysis to calibrate the soil model to represent failure as observed at site. The fully softened parameters for the top 10 feet were back calculated to stimulate the failure at a factor of safety of 1. Head scrap of 5 ft originating approximately 10 ft into the slope face and bulging initiating from the middle of the slope was observed in the model as well as the field after failure (Figure 3.25 (a)). The slip circle in the model was observed as expected originating at failure initiation point and ending 3/4th into the slope. The soil parameters that yielded a factor of safety of 1.00 is shown in Table 3.7.

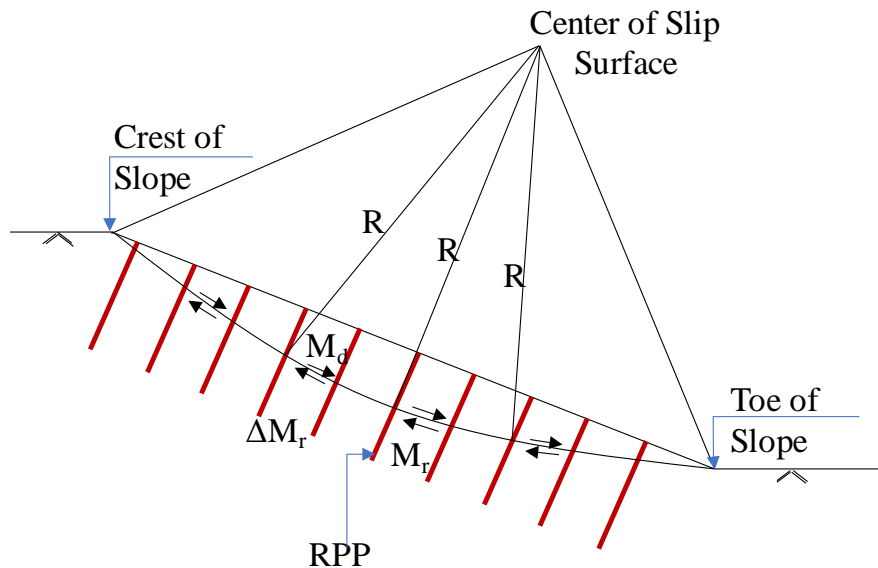
Figure 4.1 Schematic of Mechanism of Slope Failure

Recycled Plastic Pins (RPP) are used as piles driven into stable soil below the assumed sliding surface to provide reinforcement against the sliding mass. The reinforcing members intersect the failure plane perpendicularly and add an additional resisting force against the driving force of the weight of the soil. The general factor of safety equation is the ratio of the resisting moment (M_r) to the driving moment (M_d). The shear strength of the soil provides the resisting moment in an unreinforced slope where the weight of the soil provides the driving moment. The reinforcement adds the extra resisting moment of (ΔM_r), thereby increasing the factor of safety.

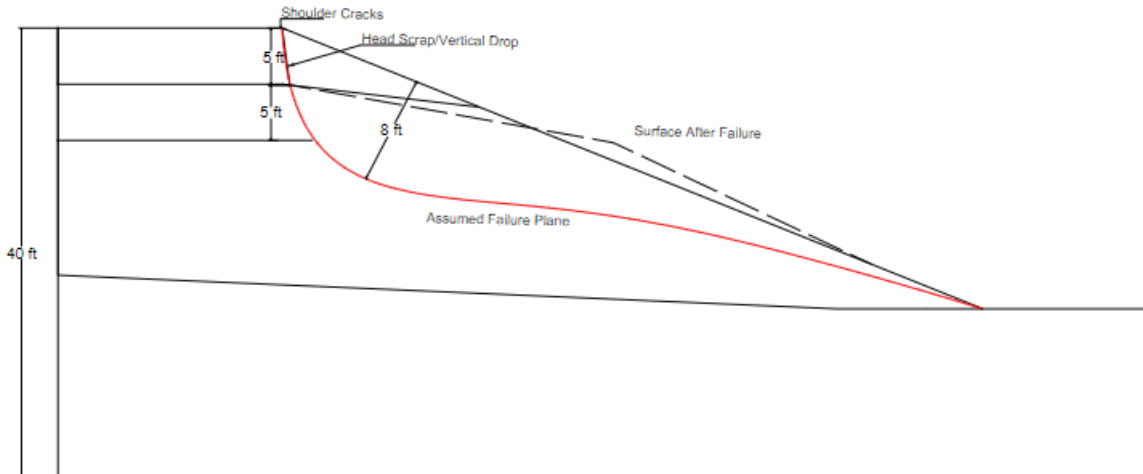
Figure 4.4 Cross-sectional view of the Slope and Possible Failure Plane.

The site investigation results, and the nature of the slope failure observed at site was considered for the design of the slope. A 120 ft failed section was selected to be reinforced with RPP and a section adjacent to the failed section was designated as a control section. The middle of the failed section (60 ft) where the failure was observed to be the deepest was selected to be reinforced with two layers.

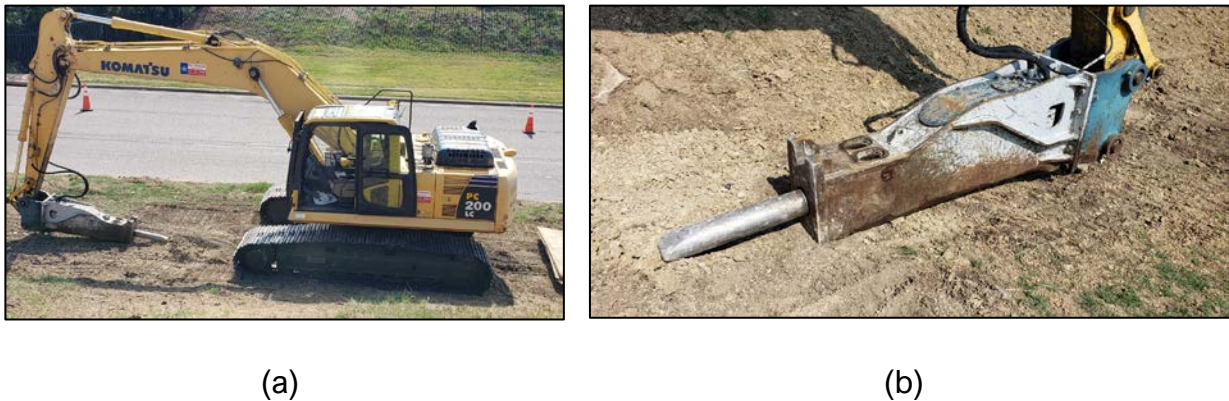
Figure 4.9 RPP Installation Equipment; Excavator Equipped with Hydraulic Hammer, (b) Hydraulic Hammer

Following the results obtained from research done by Sommers et al., (2000) and the site observations during other installation done in sites in Texas an excavator (Komatsu PC200 LC) equipped with a hydraulic hammer (NPK GH-15) was used in the RPP installation for this study.

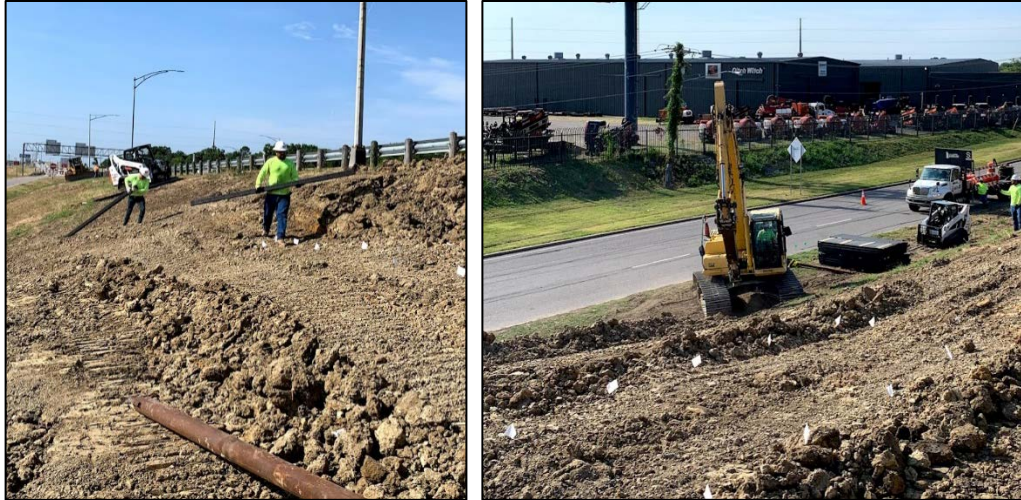
Figure 4.10 Benching and Compaction of the Crest of the Slope.

During a slope failure that extends deeper than a shallow failure, a deeper vertical drop/head scrap is observed at the crest of the slope after failure (Duncan et al., 2014). This vertical drop will be used to drive in reinforcement that will advance deeper into the slope and intersect deeper failure planes. The vertical drop/crest fall observed at IH-820 & Rosedale St. site during failure was approximately 5.5 ft. The section was initially benched and compacted so that the equipment could easily install the first layer of reinforcement (Figure 4.10). The three lines of deep pins (layer 1) was installed as shown in Figure 4.11. The deeper pins were installed vertically flush to the ground. This layer of pins will be at depths of 15-16 ft from the top of the slope (at grade) after backfilling of the slope.

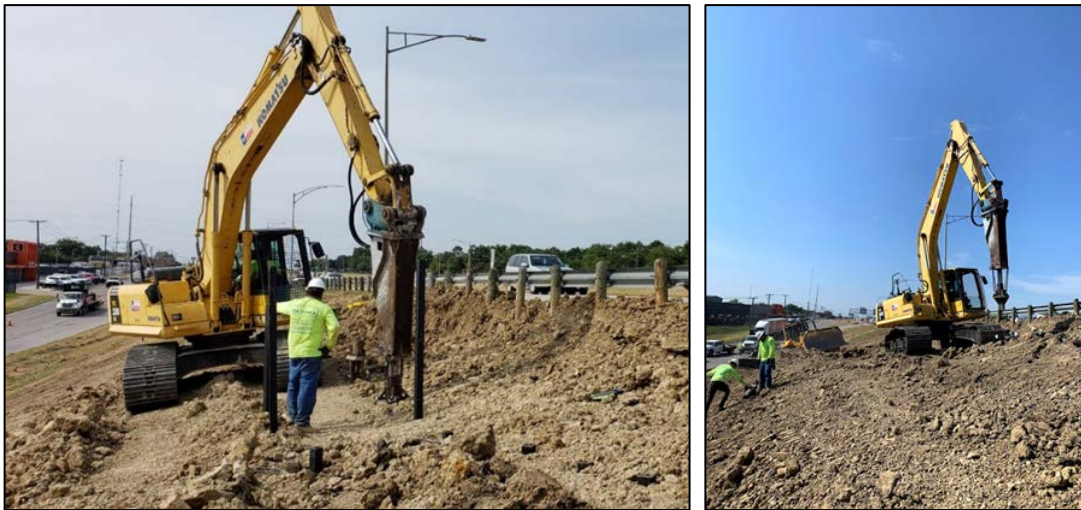
Figure 4.11 Installation of Deeper Pins.

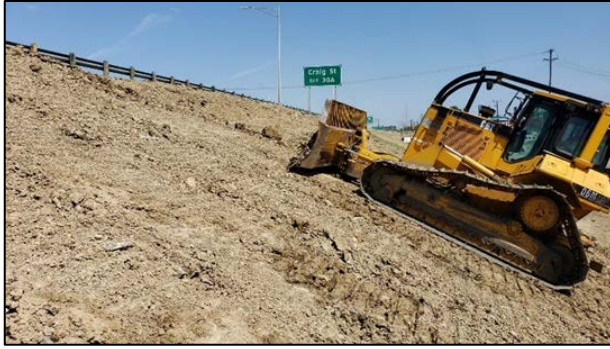
Figure 4.12 (a) Backfilling of the Slope; (b) Installation of Shallow Pins (at grade).

In the next phase of construction, the slope was backfilled over the first layer of RPP and compacted (Figure 4.12 (b)). This process was followed by the installation of shallow pins (layer 2), flush to the ground (Figure 4.12 (b)).

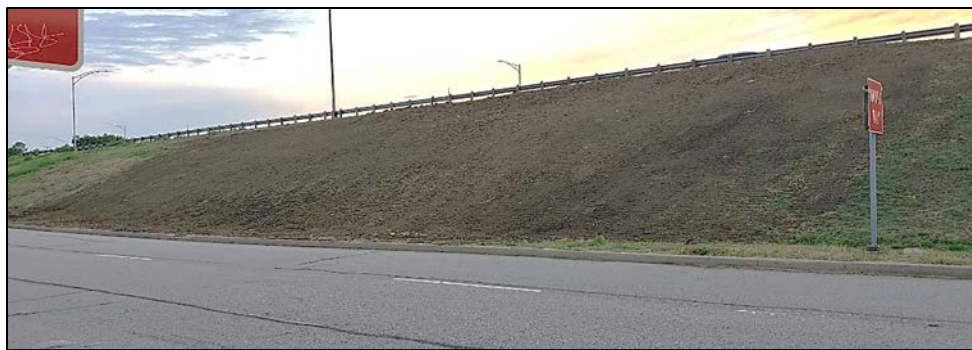
Figure 4.13 Fully Reinforced Section.

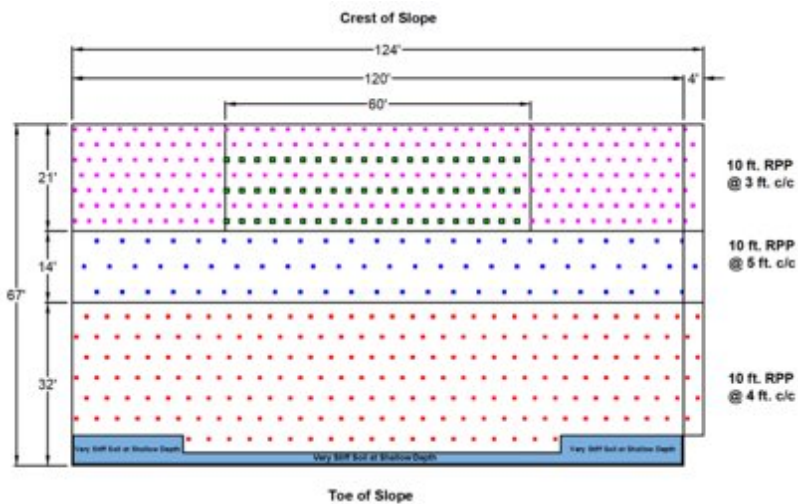
Figure 4.14 As-built Design

The design was altered during installation according to site conditions. Closer spacing section was extended for better reinforcement. The slope was completely reinforced with a total of 548 RPP as shown in Figure 4.14.

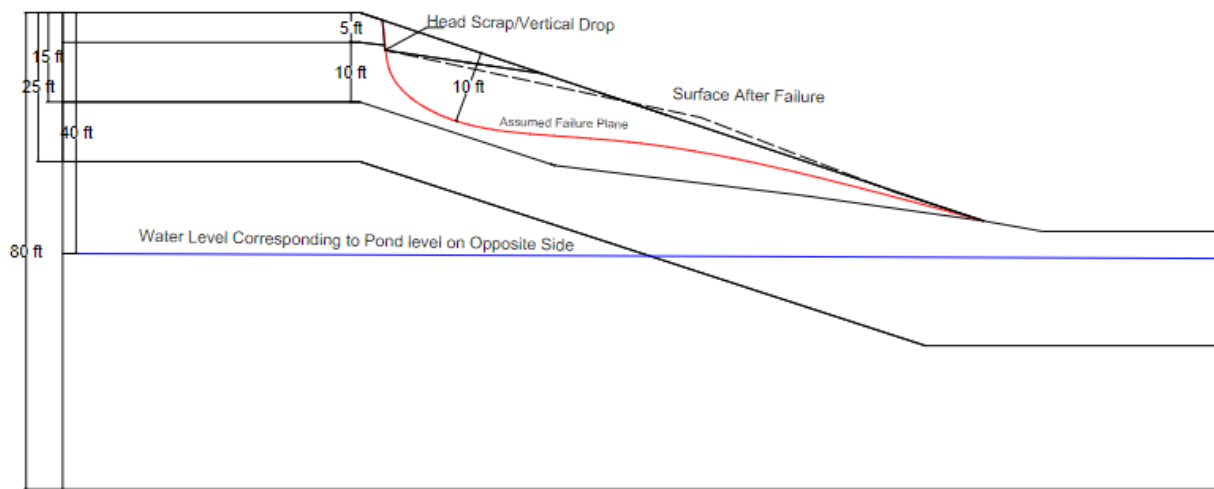
Figure 4.15 Cross-sectional Slope Profile.

The site investigation results, and the nature of the slope failure observed at site was considered for the design of the slope. A 180 ft failed section was selected to be reinforced with RPP and a section adjacent to the failed section was designated as a control section. The middle of the failed section (140 ft) where the failure was observed to be the deepest was selected to be reinforced with two layers.

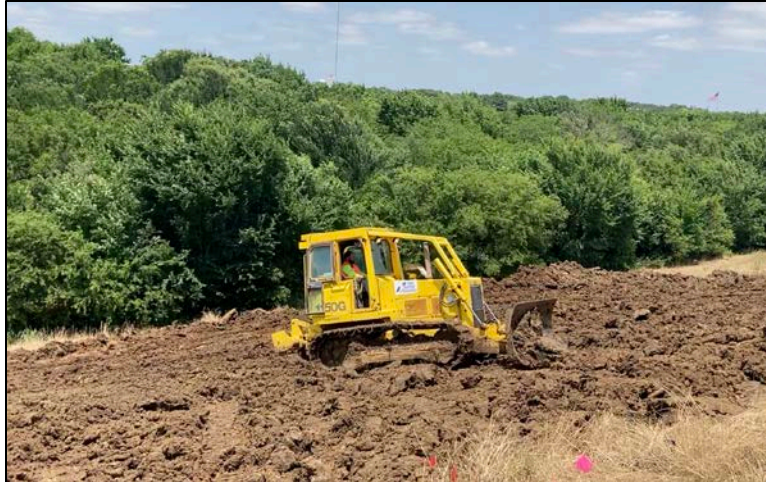
Figure 4.20 (a) Backfilling of Slope and (b) Installation of Second Layer of RPP

The crest drop was benched and compacted to install the first layer of RPP followed by the backfilling and compaction to match the existing grade (Figure 4.19). The second layer of RPP was installed flush to the ground over the backfilled slope (Figure 4.20 (b)).

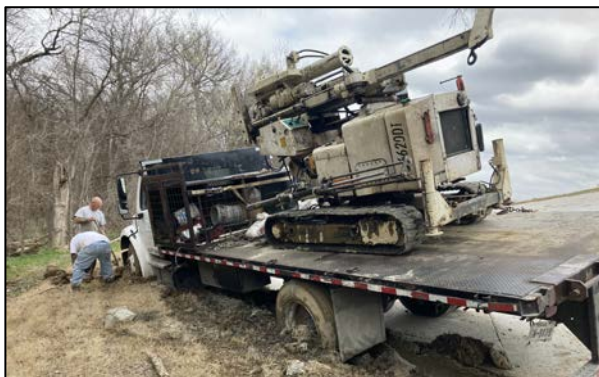
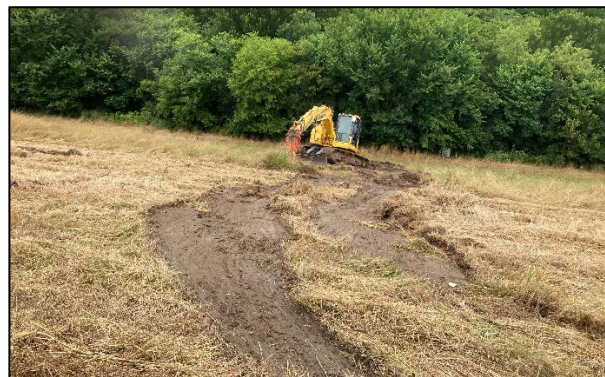
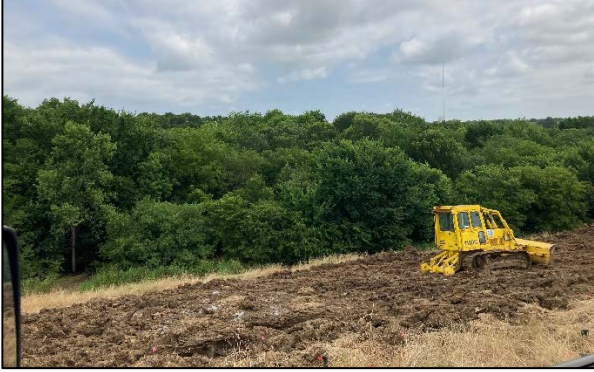
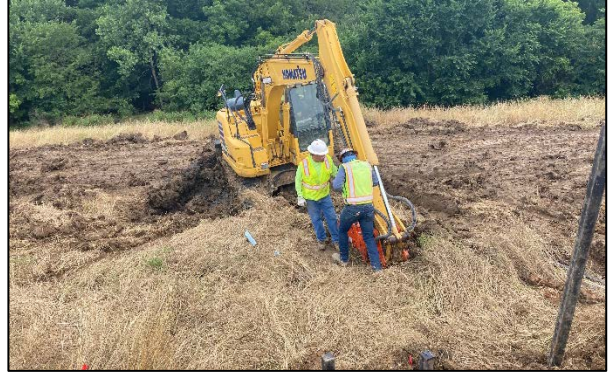
Figure 4.22 (a) Geotechnical Drill Rig delivery truck stuck, (b) Excavator stuck at the toe of the slope, (c) Visible perched water in the middle of the slope and (d) Installation equipment stuck due to the extremely soft soil.

The soft soil present at site created issues for the installation process. The soil was observed to be extremely soft after rainfall events. The installation equipment had difficulties maneuvering and installing pins due to soft and clayed soil present at site (Figure 4.22).

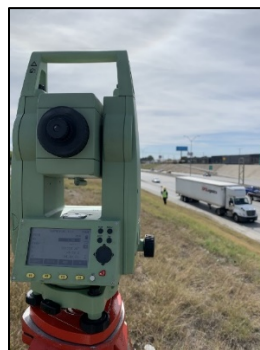
Figure 5.2 Total Station

Topographic survey was conducted by the use of a Total station (Leica Geosystems) (Figure 5.2). Three permanent objects around the test site are selected as fixed/anchor points. The survey is conducted using a reflector held at each pre-determined location. The data collected on a monthly basis is compared to the baseline reading to determine the vertical displacement of the slope.

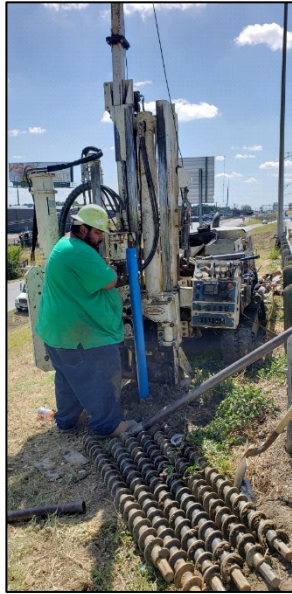
(a)

Figure 5.4 Inclinometer Casings Installation: a) Drilling and Placing Inclinometer Casing, b) Inclinometer Casing After Installation.

Vertical inclinometer casings to monitor the lateral movement of the slope were installed on 1st October 2019. Two inclinometer casings with depths of 30 ft. were installed vertically in the middle of the reinforced section and the control section (Figure 5.3). Two 30 ft. boreholes were drilled using an 8-inch hollow stem auger to insert the inclinometer pipes into the slope (Figure 5.4). Three 10 ft. commercially available inclinometer casings were connected to get a total length of 30 ft. The bottom of the casing was sealed with a bottom cap and inserted into the pre-drilled borehole. The top of the pipe was fixed with bentonite. The top of the inclinometer casing was cut to be about 1 foot from the ground surface as shown in Figure 5.4 (b).

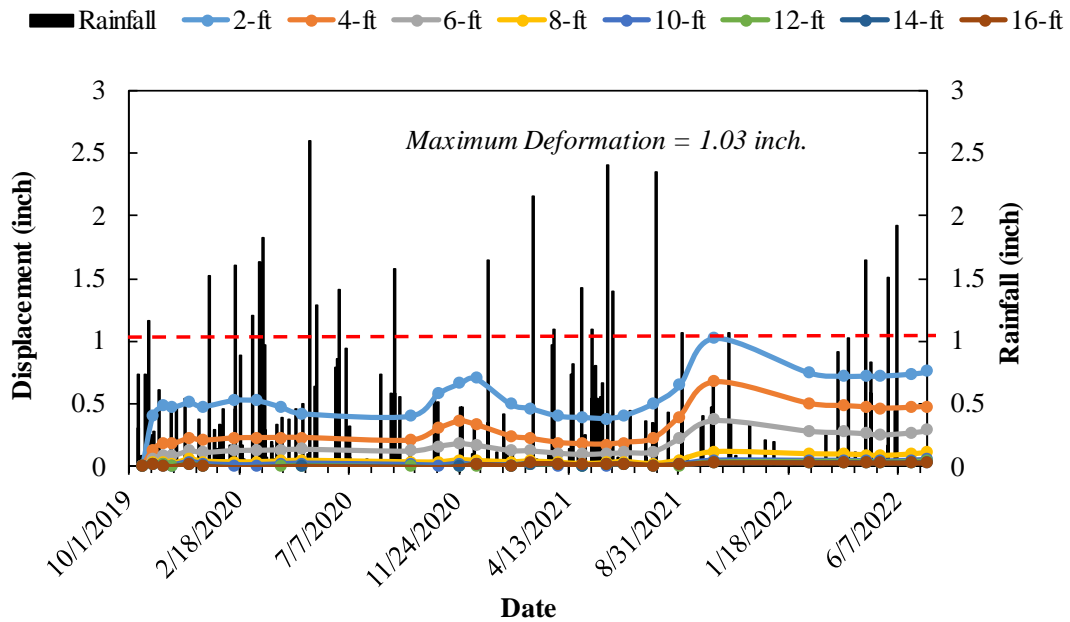
Figure 5.6 Lateral Movement in the Control Section.

The variation of lateral movement of the slope was monitored monthly. The variation of lateral displacement of the slope with depth and rainfall is shown in Figure 5.8 and Figure 5.6 for the reinforced and control sections, respectively. The baseline reading was taken on 18th October 2019 after two weeks adjustment period for casing stabilization and monitoring was continued monthly. The maximum displacement for both sections were observed at the crest. The lateral movement variation in the control section is shown in Figure 5.6. Maximum displacement of 1.03 inches was observed in October 2021 with movement up to a depth of 10 feet. The cyclic behavior of the slope was observed in the results where the dips and peaks in movement was observed with the rainfall patterns.

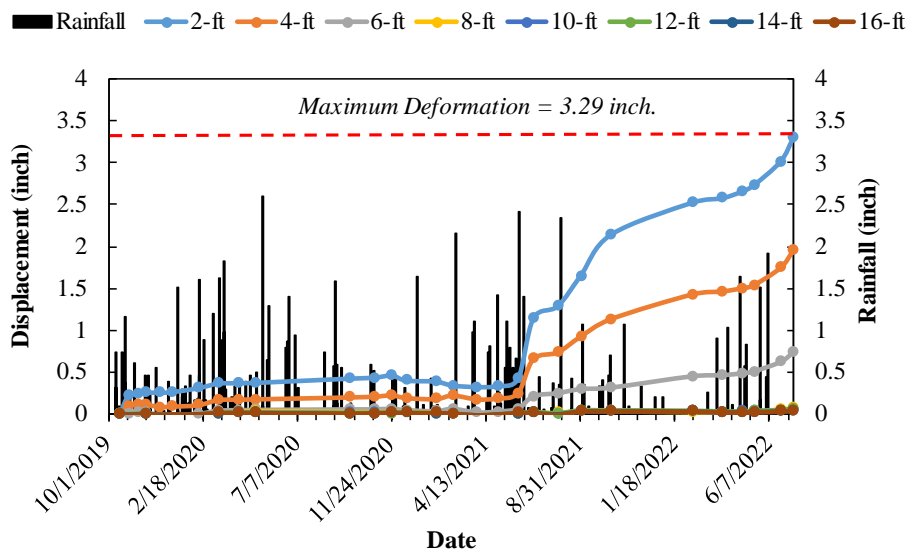
Figure 5.8 Lateral Movement in the Reinforced Section.

The effect of the formation of the drainage channel and increased infiltration of rainwater into the slope was observed in the inclinometer readings after 20 months. The lag in the effect observed in the results is because the soil strength takes cycles of wet and dry patterns to lose strength and initiate movement. It must be noted that even with the effect of erosion the movement in the reinforced section was limited to the top 6 feet while the control section showed movement depths greater than 10 feet. Therefore, the two layered design is aiding in minimizing movement at deeper depths.

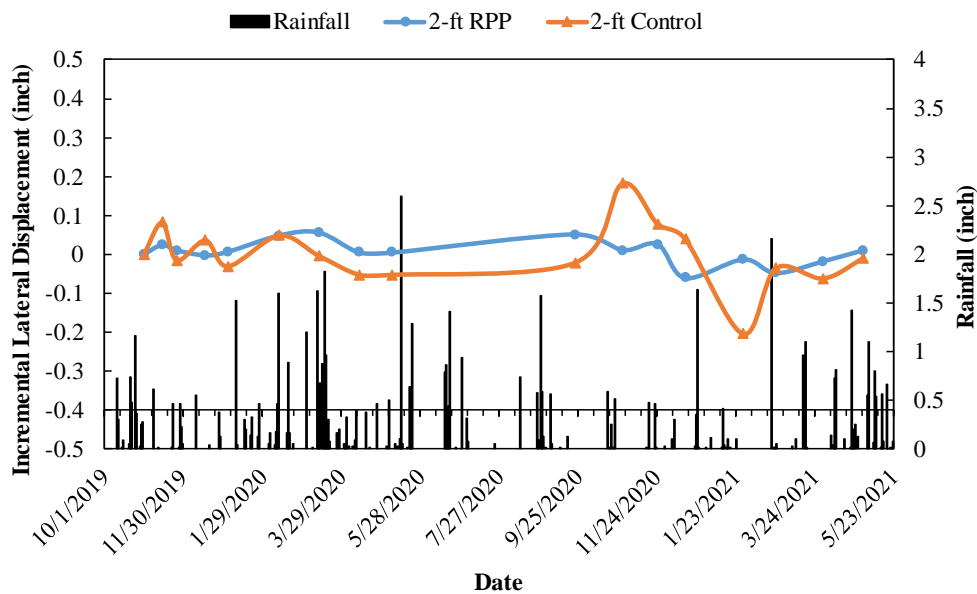
Figure 5.10 Comparison of Incremental Lateral Displacement of the Crest in the Reinforced and Control Section.

control section is significant compared to the reinforced section. The movement of the slope due to the swell and shrink behavior is observed in these results. The soil is observed to swell after periods of rainfall and shrink after periods of reduced rainfall. The low peak observed in January 2021 after a period of low rainfall can be accounted for the movement due to the shrinkage effect of the soil. In comparison, the reinforced section shows minimum variation since the reinforcing members are providing resisting loads against the movements.

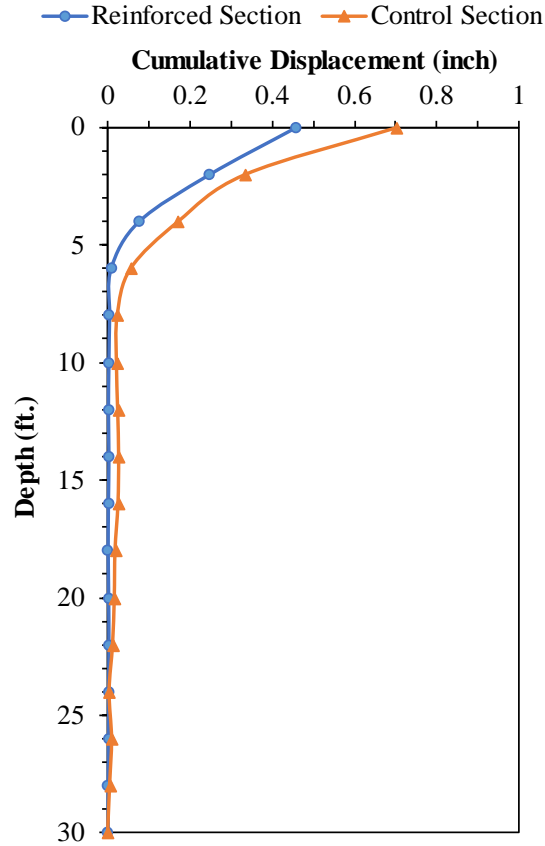
Figure 5.11 Cumulative Lateral Displacement with Depth for Reinforced and Control Sections.

The maximum cumulative lateral displacement with depth for a monitoring period of 20 months is shown in Figure 5.11. The movement in the reinforced section is observed to be limited to the top 6 feet while the movement in the control section at deeper depths. The two layered RPP is providing resistance against movement at deeper depths.

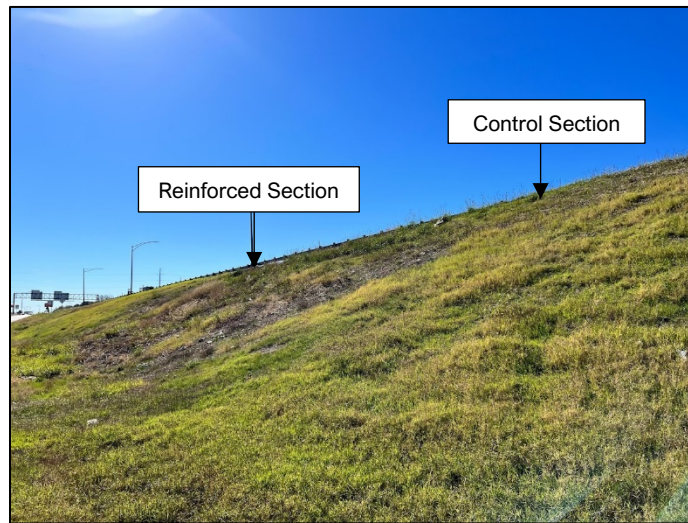
Figure 5.16 Grass Cover in the Reinforced Section and Control Section in November 2021.

period which reduces the surface erosion resulting in decreased vertical ground settlement. In comparison the reinforced section has negligible grass cover for over a year after the installation (Figure 5.16).

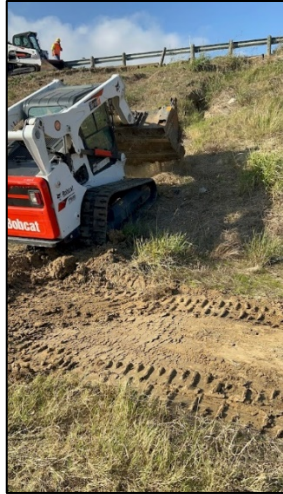
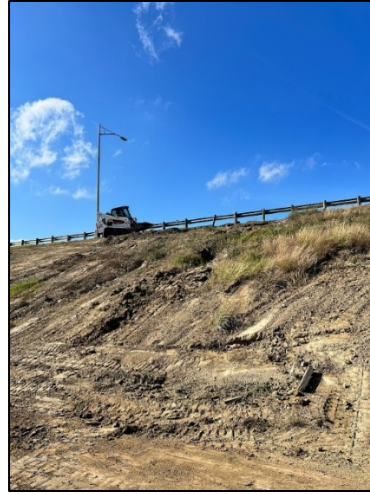
Figure 5.17 Backfill of Slope.

In December 2021, the trenches were backfilled and the compacted to prevent further soil erosion. Figure 5.17 shows the backfilling process by TxDOT. Biodegradable erosion was placed as an erosion control method as shown in Figure 5.18.

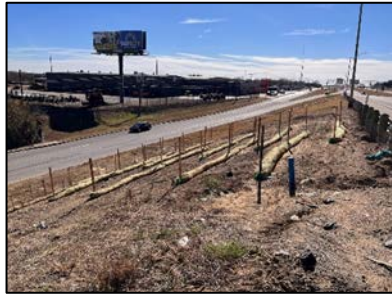
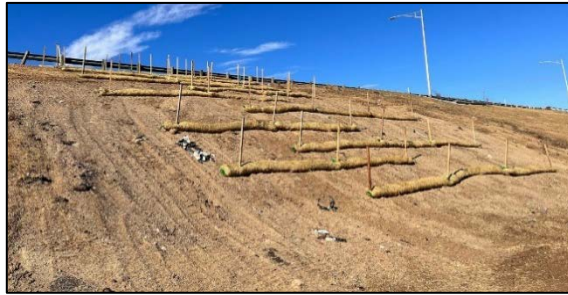
Figure 5.18 Biodegradable erosion control

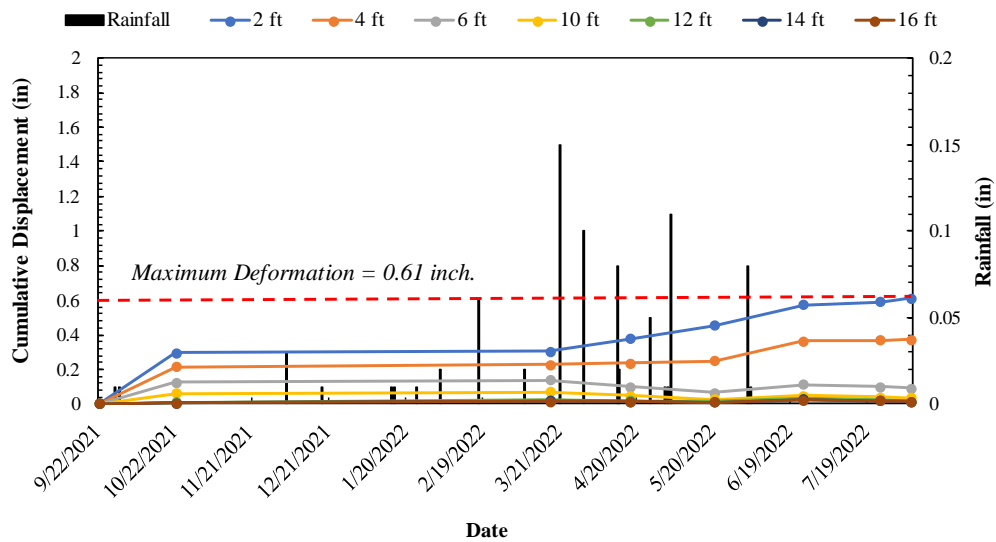
initiates movement. The reinforcing members are mobilized against this movement and provide resisting loads until equilibrium of the slope is reached. Additional movement is resisted by the reinforcing members after this point. Further movement would be observed if the pore pressure increases beyond the previously experienced allowing the members to mobilize increased resistance. The initial higher movement observed after installation in the reinforced section is accounted for the mobilization of the RPP against failure.

Figure 5.24 Variation of Lateral Displacement with Rainfall in the Reinforced Section. The lateral movement variation in the control section is show in Figure 5.25. Maximum displacement of 1.00 inches was observed in August 2022 with movement up to a depth of 10 feet. The period between October 2021 and March 2022 was not monitored due the inclinometer being repaired.

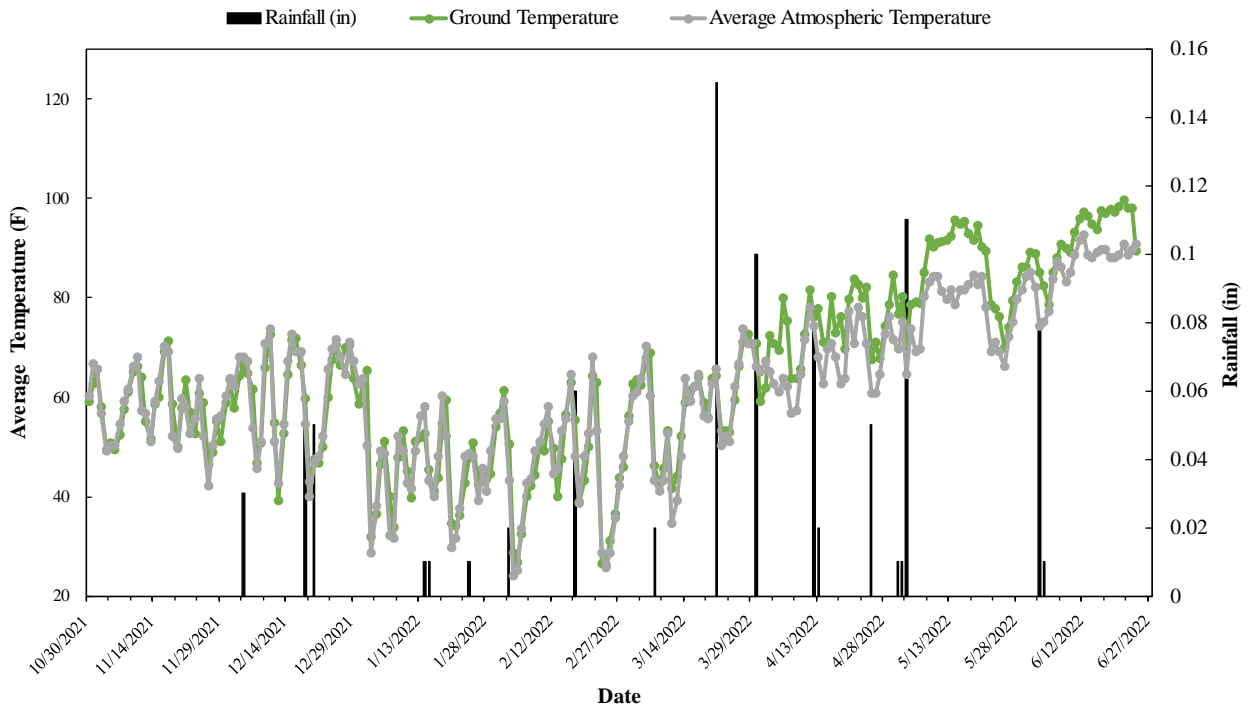
Figure 5.29 Variation of Average Ground and Atmospheric Temperature.

Administration) with rainfall is shown in Figure 5.29. The ground temperature and the atmospheric temperature is showing close correlation.
