**PERFORMANCE EVALUATION AND RETROFITTING OPTIONS FOR  
AN IMPACT DAMAGED NON-COMPOSITE STEEL GIRDER BRIDGE**

Presented to the Faculty of the Graduate School of The University of Texas at Arlington in  
Partial Fulfillment of the requirements for the Degree of

### Performance Evaluation and Retrofitting Options for an Impact Damaged Non-Composite Steel Girder Bridge

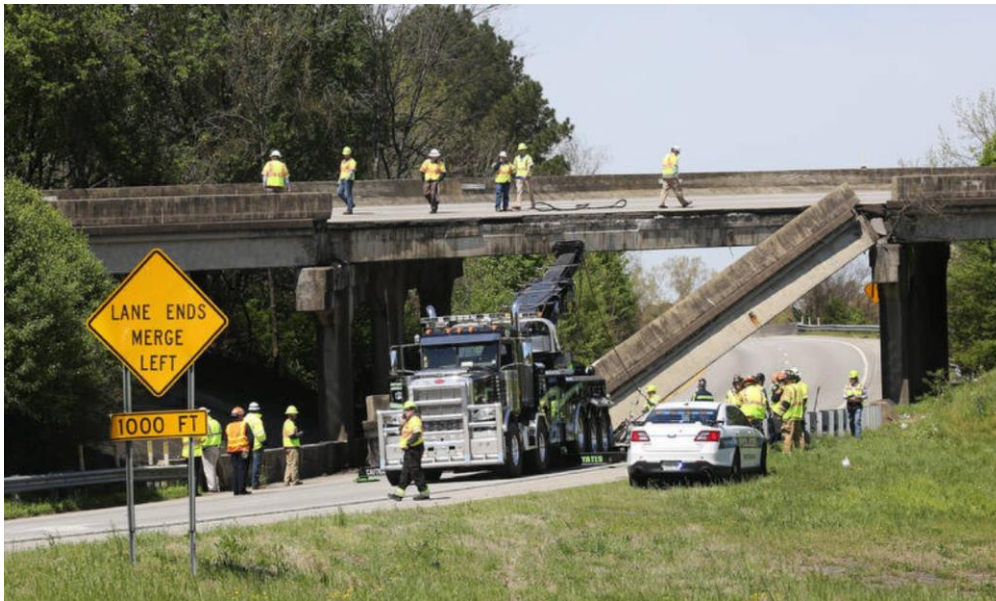
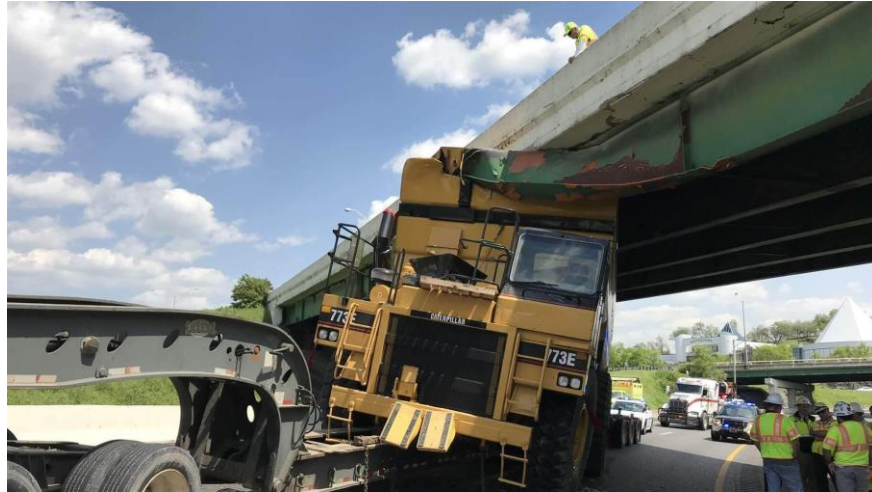
Figure 1- 1 Impact damaged: (a) Concrete bridge on IH 75 South ramp to IH-75 South in Tennessee after being struck by an oversized rig (Benton 2020); (b) Steel bridge at the interchange of IH40 and 65 in Nashville after a tractor-trailer hauling a Caterpillar tanker truck struck the bridge (Alison and Buitrago 2018)

Structural deficiencies of the bridges could be due to fire, poor design or construction, time-dependent deterioration, corrosion, or impact of vehicles. One of the common problems is the impact caused by over-height vehicles that exceed the posted clearance for a bridge. In the case of concrete bridges, impact damage includes concrete spalling or cracking, exposed or broken reinforcement/prestressing strands (Figure 1-1a) whereas in steel bridges, this damage includes global and local buckling of the structural member or piercing through the steel girder (Figure 1-1b).

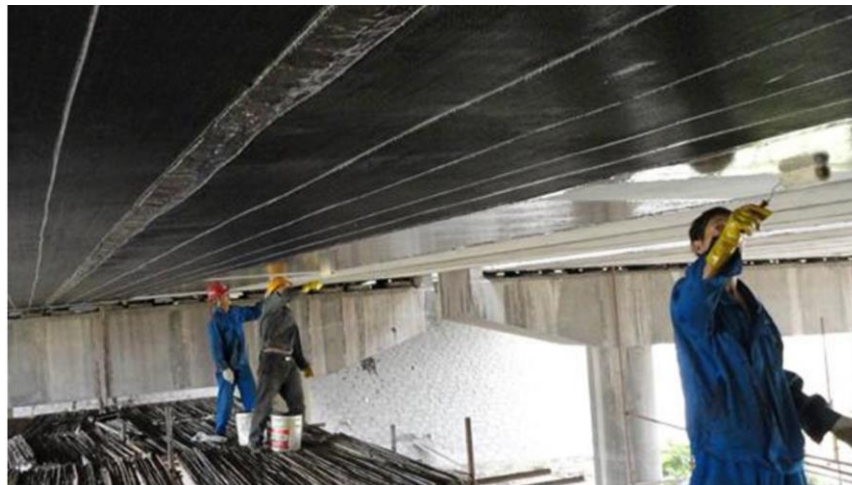
Figure 2- 10 Application of CFRP sheet (Horse Construction)

Carbon Fiber Reinforced Polymer (CFRP) is rapidly gaining popularity as a cost-effective method for strengthening and retrofitting concrete structures. CFRP provides a number of benefits over conventional retrofit techniques, including a high strength-to-weight ratio, greater corrosion resistance, simplicity of installation, and suitability for use in regions with restricted access. Figure 2-10 presents the application of CFRP underneath the deck.

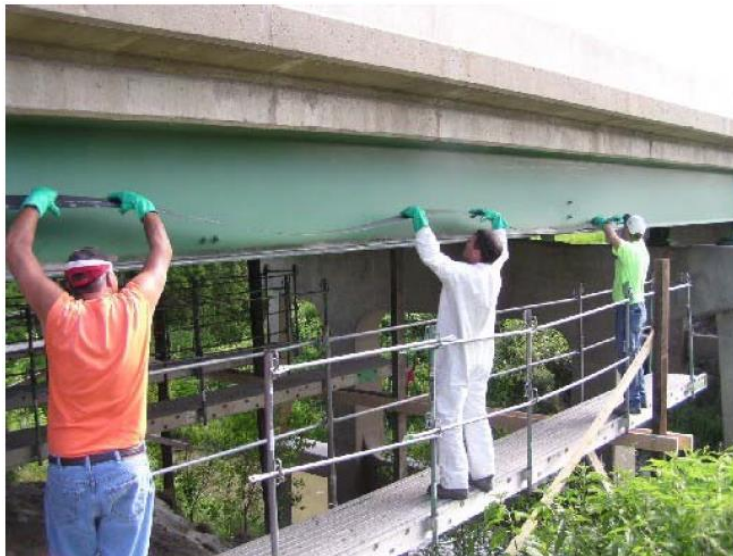
Figure 2- 16 Application of CFRP strips on girder (Iowa DOT)

FRPs, specifically CFRP, are being increasingly used in steel structures due to its superior properties like light weight, high strength. Previously, additional steel plates were used to strengthen the steel structures. The retrofitting method that utilizes steel plates, however, requires heavy lifting equipment for the plates and additional dead load to the steel structure while CFRP is a more practical approach with less cumbersome equipment and load requirements (Tawfiq 2010). In Iowa, a bridge was strengthened by installing CFRP plates on the bottom flange of girders in the positive moment regions. Figure 2-16 shows the application of CFRP strips.

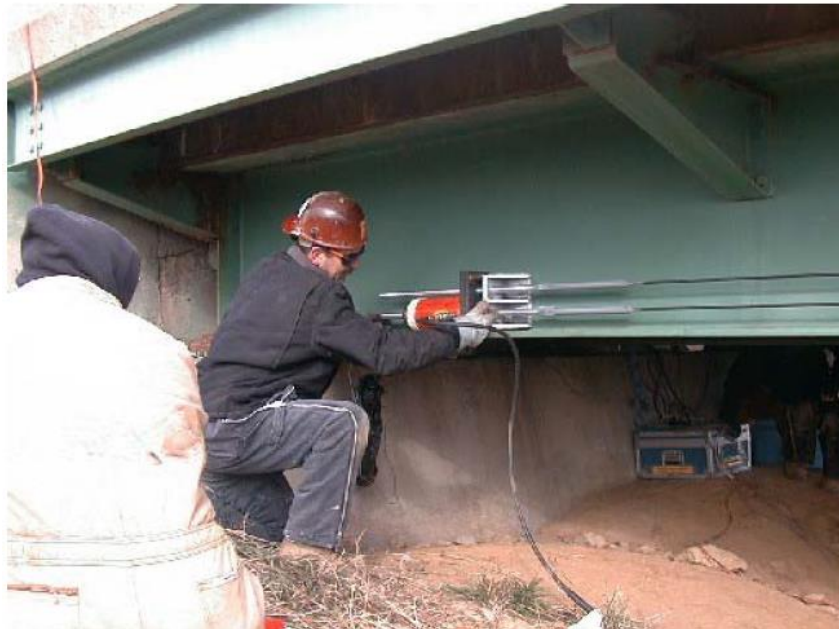
Figure 2- 17 Installation of PT system (Terry et al. 2003)

External PT increases the stiffness and the load-carrying capacity of the steel beam by adding reinforcing steel/CFRP bars to a segment of the beam. In Iowa, a bridge (Number 3903.0S141) was strengthened with the post-tensioning of CFRP rod. It is located in southwest-central Iowa in Guthrie County approximately 1.6 miles west of Bayard, Iowa, carrying state highway IA 141 over Willow creek. The PT system was installed in the positive moment region of the exterior girders (Terry et al. 2003). Although PT does not significantly reduce live load deflections, it does increase the live load carrying capacity of the bridge by generating strain opposite to the strain produced by dead load and thus allows the bridge to carry additional traffic live loads (Figure 2-17).

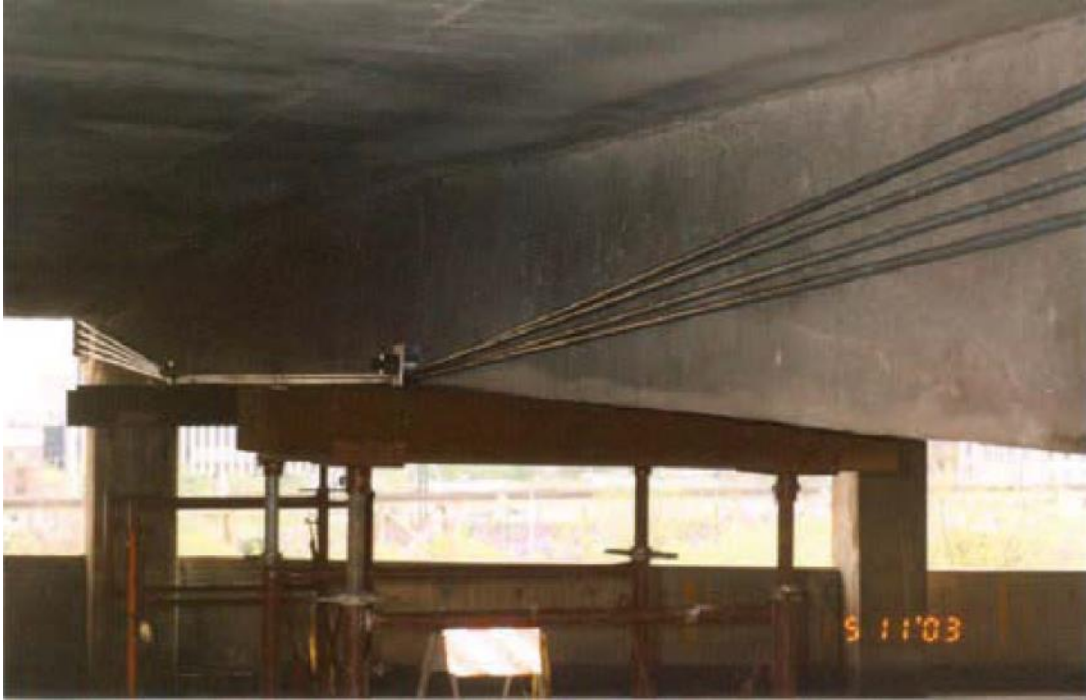
Figure 2- 18 Deviated beam strengthening tendons (Krauser, 2006)

Post-tensioning tendons offer a reasonable way of strengthening the existing deteriorated structures (Krauser 2006). PT can be easily used in the structures to apply vertical forces at the needed points, as shown in Figure 2-18.

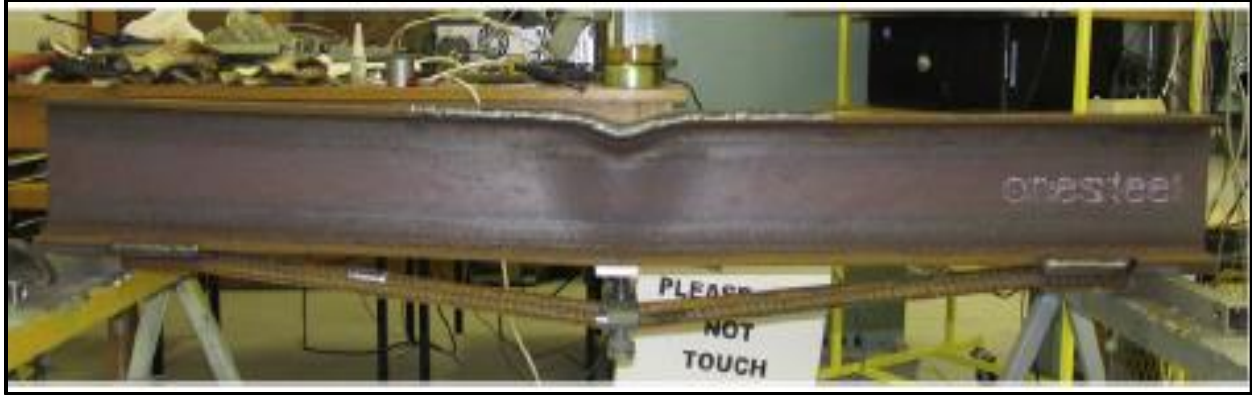
Figure 2- 19 External post-tensioning of steel beam (Taoum and Holloway, 2015)

Taoum and Holloway (2015) upgraded the steel beam using locally prestressed reinforce bars. The reinforcing steels were welded to beams flange and web at both ends. A manual jack screw was used for prestressing the reinforcing bars. The researchers tested seven different steel beams with different variables until failure under three points bending. Taoum and Holloway concluded that the level of pre-stress, the type of local prestress (internal or external), and the diameter of rebars used affects the beam load carrying capacity and stiffness. The results of their study also indicated that the application of local pre-stressed reinforcing bars in conjunction with a stiffener to prevent buckling could add up to 60% of the load-carrying capacity of the steel I-beams. Moreover, the larger the diameter, the higher beam's stiffness. Figure 2-19 shows the external post-tensioning of the steel beam while Figure 2-20 presents the experimental setup.

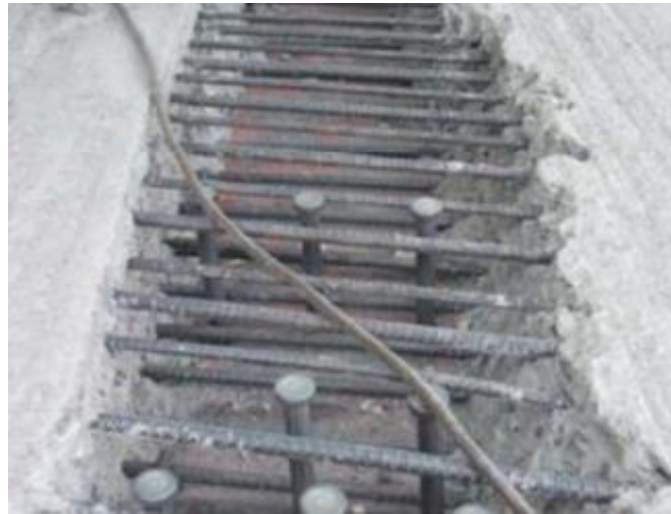
Figure 2- 21 Welded headed studs welded to the steel girder (Collin et al. 2015)

girder before pouring new concrete. Figure 2-21 shows the welded headed studs on the top of the girder line.

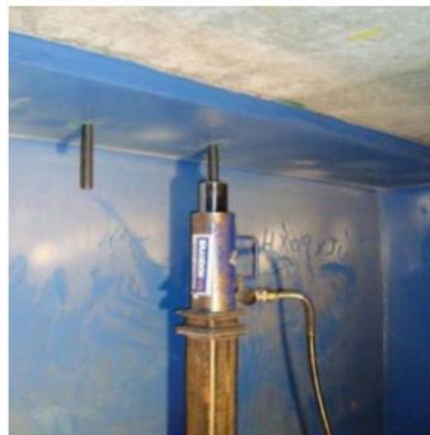
Figure 2- 26 Hydraulic jack used for inserting spiral pins into the bridge (Collin et al. 2015)

In Pitsund Bridge coiled spring pins were used to create the composite action between the deck and steel girder. The installation involved drilling through the steel flange and into the concrete deck from underneath, applying lubricant, and pressing the spring pins into place by using a hydraulic jack. Figure 2-26 shows the installation of a spiral pin into a bridge.

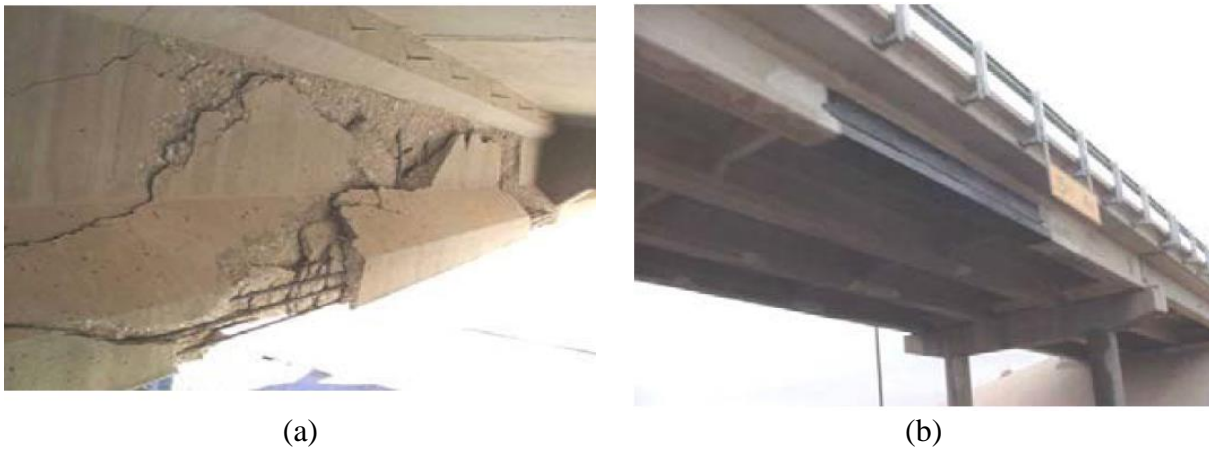
Figure 2- 27 Bridge Condition: (a) impact damaged; (b) impact damaged repaired with CFRP (Yang et al. 2011)

A CFRP-repaired impact-damaged beam in Texas is shown in Figure 2–27. After being struck by an over-height car, the outside beam was extensively fractured in two places between two inside diaphragms. The collision severed the prestressing strands. Concrete repair and epoxy injection were used to fix the damaged girder, and then wet lay-up procedures were used to build one ply of continuous CFRP to cover the whole bottom flange and web (Yang et al. 2011).

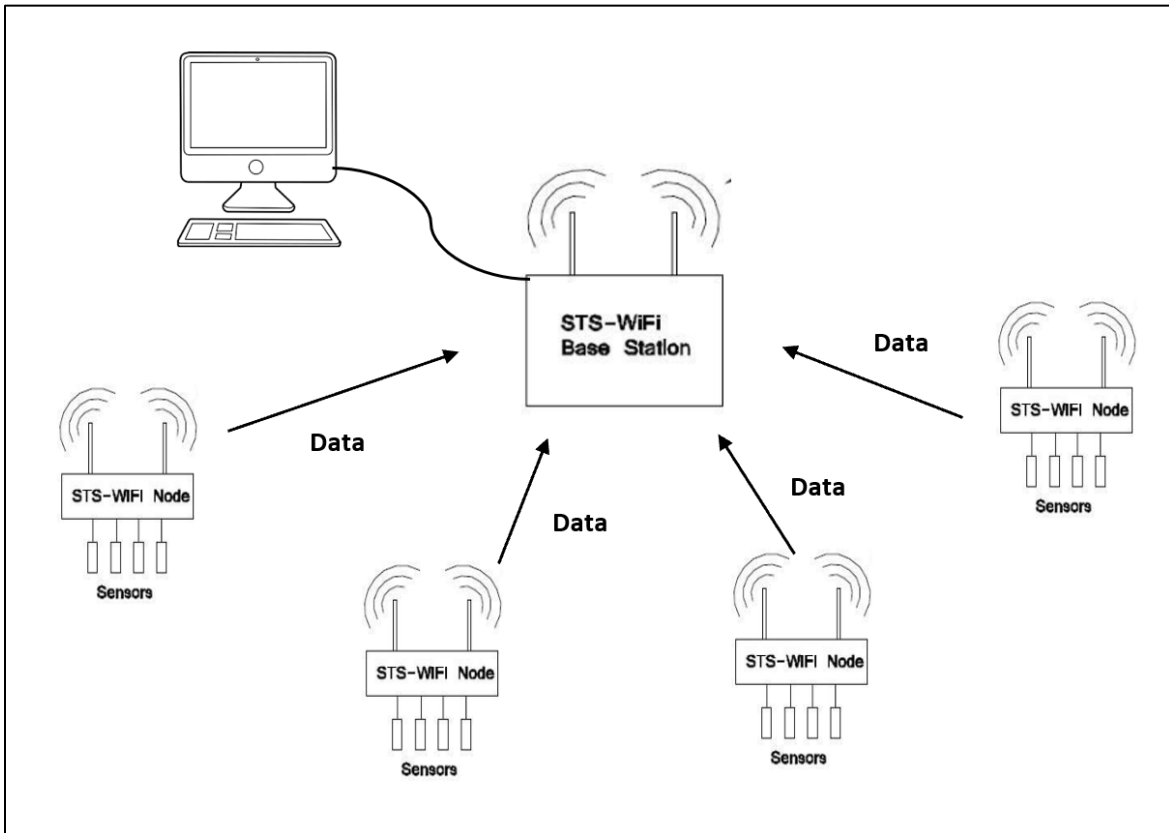
Figure 4- 5 STS Wi-Fi network setup (BDI 2010)

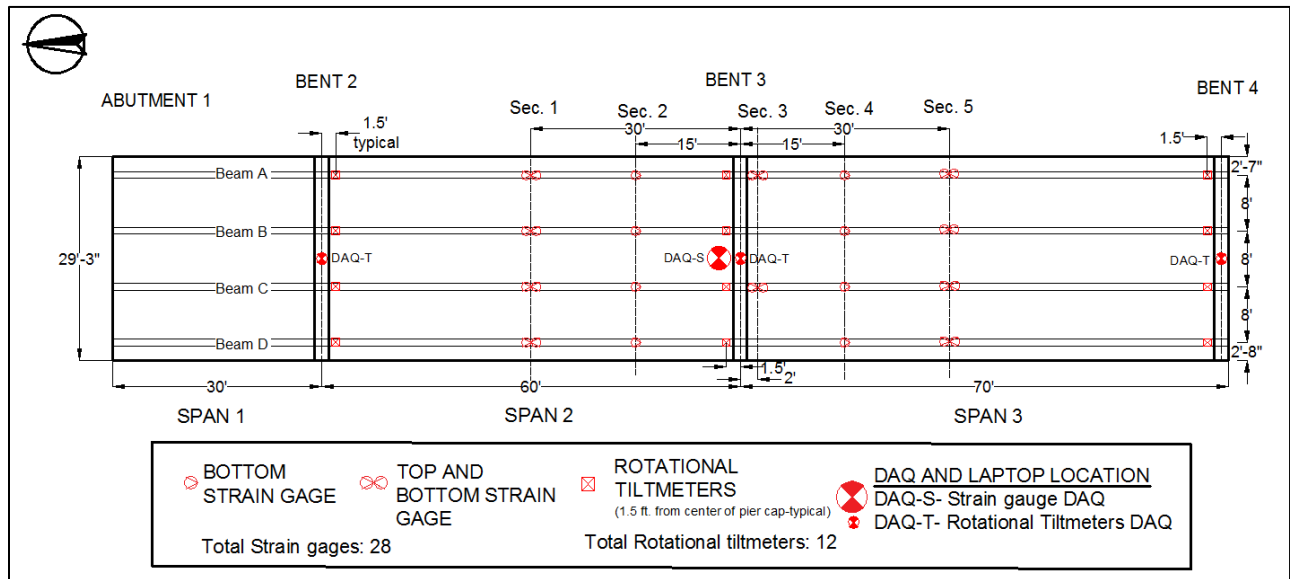
Figure 4- 6 Instrumentation plan for load testing

Instrumentation of the bridge was carried out from 22<sup>nd</sup> October 2018 to 29<sup>th</sup> October 2018. A total of 28 strain gages were installed in different critical locations along the steel girders to evaluate the overall behavior of the bridge. Most of the gauges were installed in a pair to record the compression and tension response and evaluate the neutral axis of the beam. Both the spans (Spans 2 and 3) of the bridge were instrumented with strain gages. Gages were attached on the mid-span at the maximum moment region as well as near supports at the negative moment region of the continuous beam. The strain gage, tiltmeter, and the automated data acquisition system (DAQ) locations are shown in Figure 4-6.

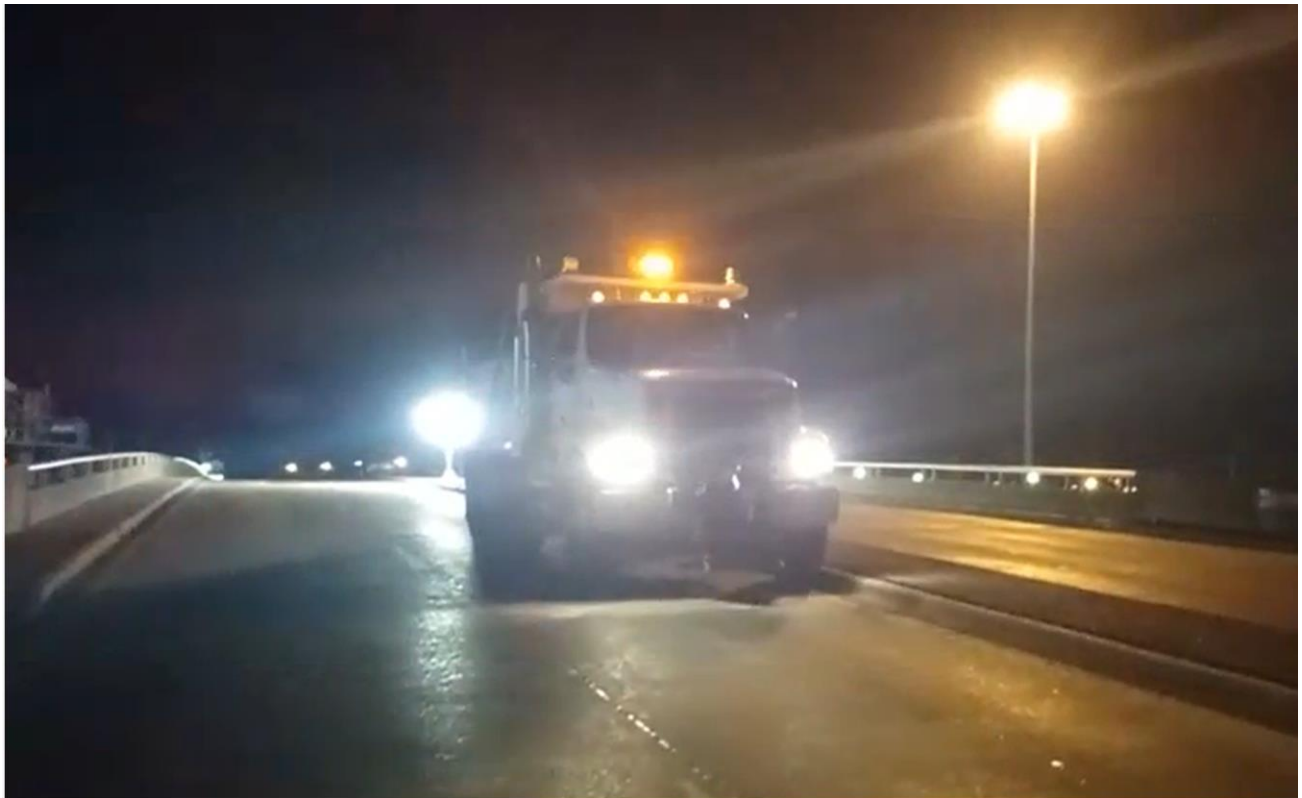
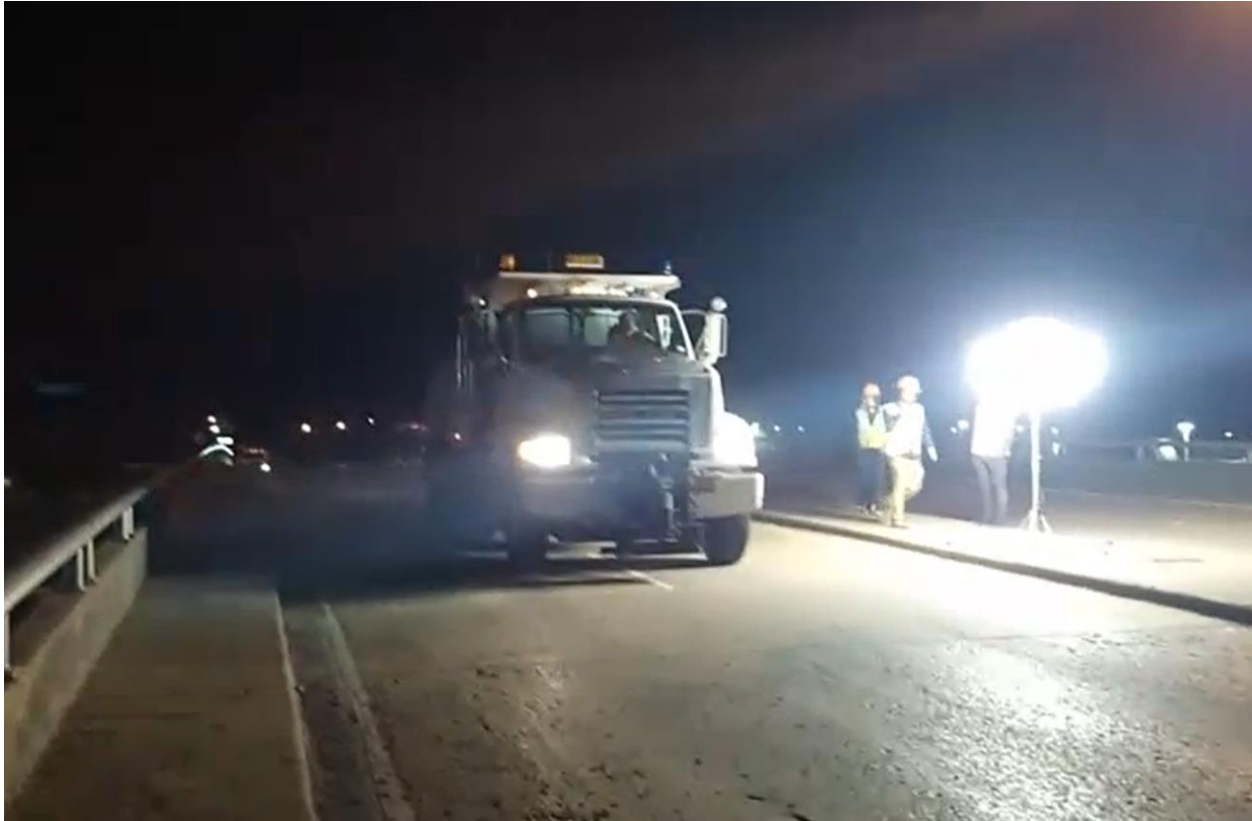
Crawl speed tests were carried out where the trucks moved at a constant speed of 5 mph in three predetermined paths. The truck's speed was kept low to prevent the effects of vibration-induced during the load test. The lower speed also helps to prevent dynamic effects on the bridge. The tests were repeated for each path (Run 1 and Run 2) to verify the accuracy of the data. The truck started from the mid-span of span 4 and went up to mid-span of span 1. Figure 4-12a shows the load test path P2 during the experimental load test, and Figure 4-12b presents the Path P3.

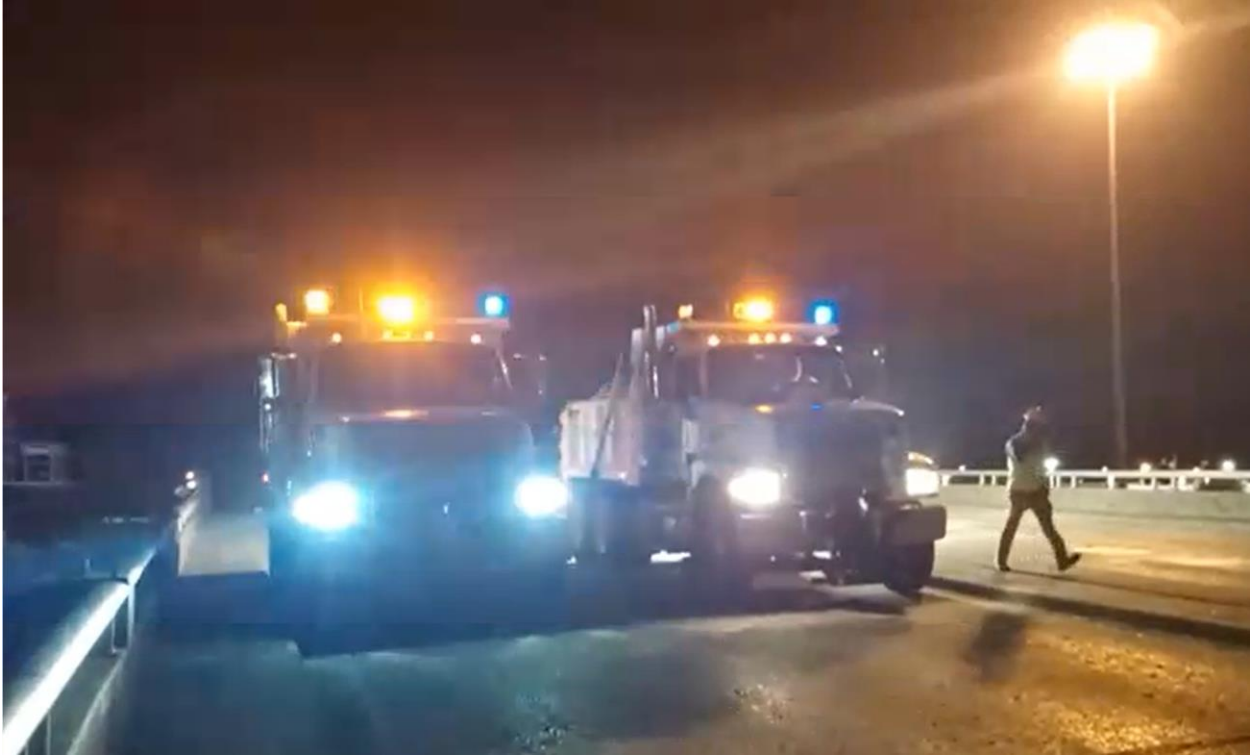
Figure 4- 13 Dump truck on Path P4 (stop location test)

For the stop location test, the trucks were stopped at a predetermined location (mid-span) on the bridge for observation of the responses of the bridge. The stop locations were specifically chosen so the vehicles could produce the maximum moment on the bridge girders. The trucks were moved along the paths and made stops at the specified stop location for 20 seconds so that the reading could be taken, and no dynamic effects were induced (AASHTO MBE 2018). Figure 4-13 shows dump trucks during the stop location test.

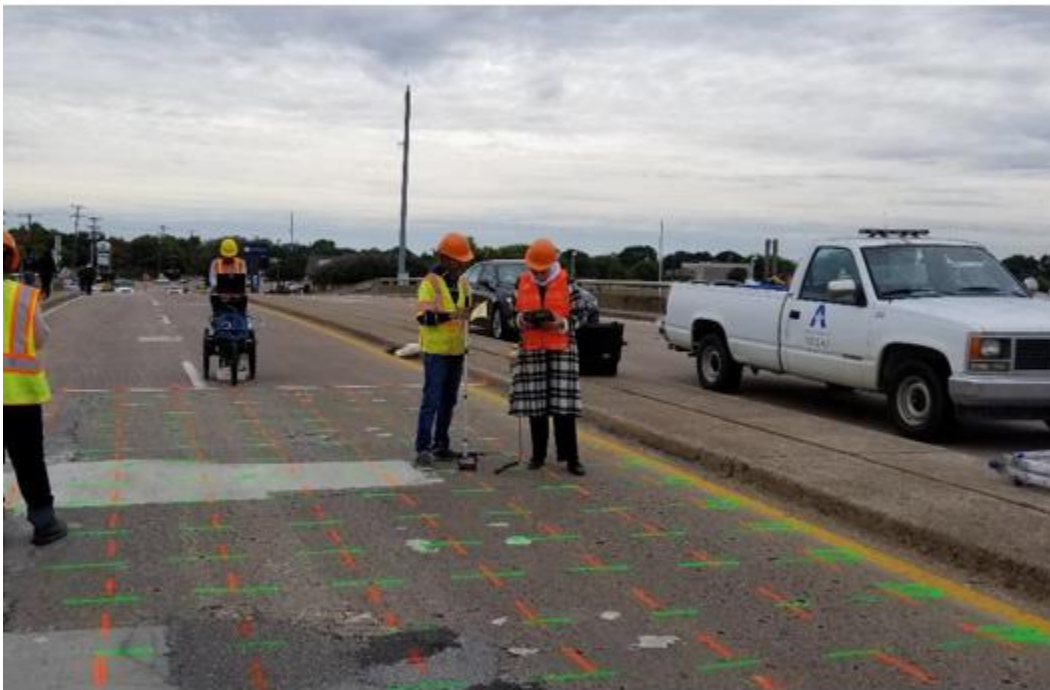
Figure 5- 4 Scanning with Cart-Mounted GPR and IE.

- First, traffic on top of the bridge was closed to facilitate the NDE work on Spans 2 and 3.
- Square grids measuring 2 ft. spacing were marked on the deck surface for both the IE and GPR scans. For GPR scanning, parallel grid lines spaced at 2 ft. were used. For IE scanning, square grids with 2 ft. spacing were used.
- IE and GPR were used to scan the top of the bridge deck along the grid lines. IE scan was taken at each grid point individually, while the GPR scan was performed by line scanning using the cart mount (with one 2.6 GHz antenna, as shown in Figure 5-4).
- Scanning was performed over one full day, 22<sup>nd</sup> October, 2018. Lanes 1s and 2s (Figure 3-3) on Spans 2 and 3 were accordingly scanned.
- The data were analyzed according to the grid locations to test for any cover variations and possible delamination.

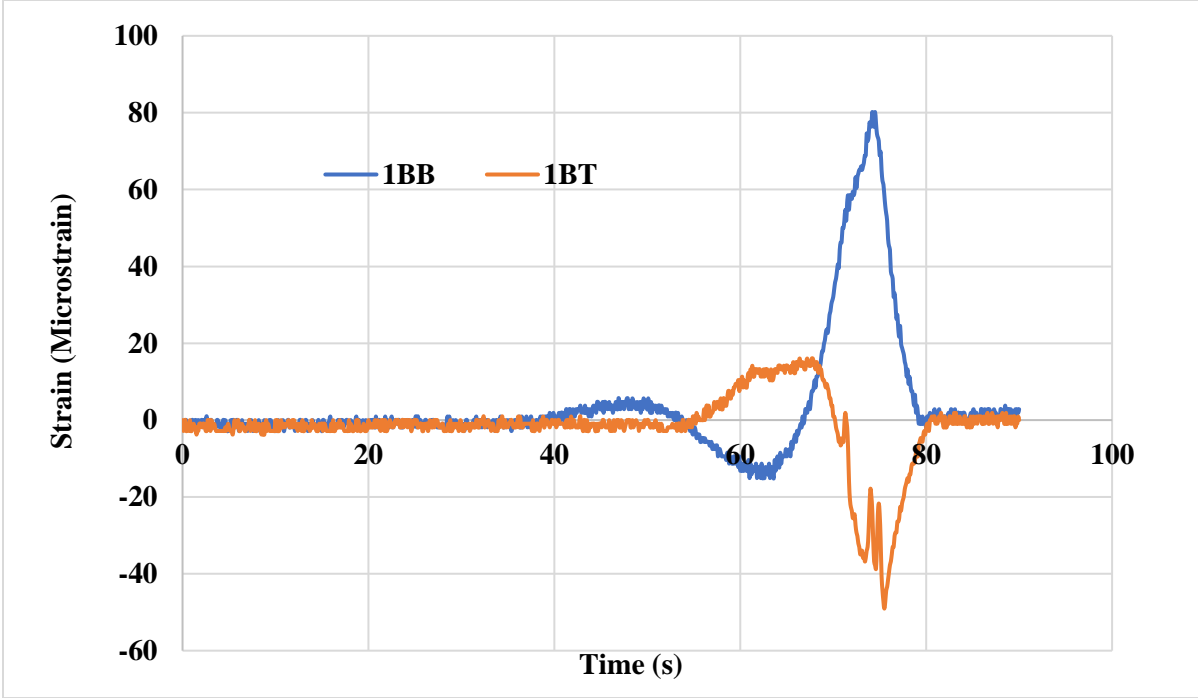
Figure 7- 1 Raw strain data for Path P1 Run 1 (Section 1, Span 2 of Girder B).

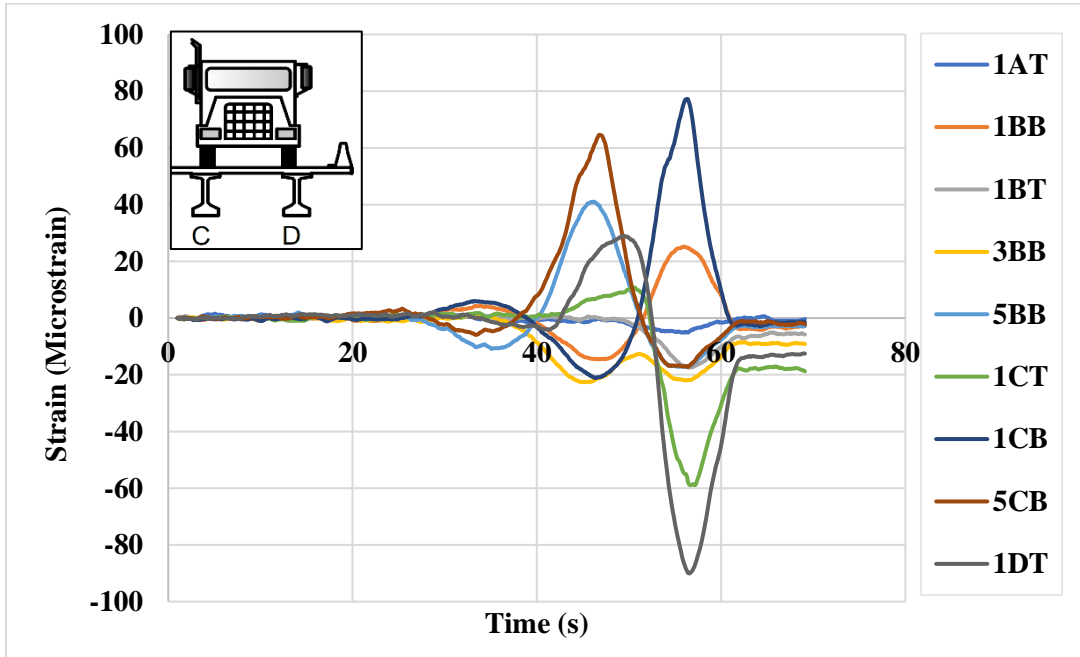
Figure 7- 6 Strain vs time diagram for Path 2 Run 1
