PERFORMANCE EVALUATION OF THE MODIFIED MOISTURE BARRIER IN
STABILIZING SHALLOW SLOPE FAILURES

DOCTOR OF PHILOSOPHY IN CIVIL ENGINEERING

THE UNIVERSITY OF TEXAS AT ARLINGTON

DECEMBER 2022

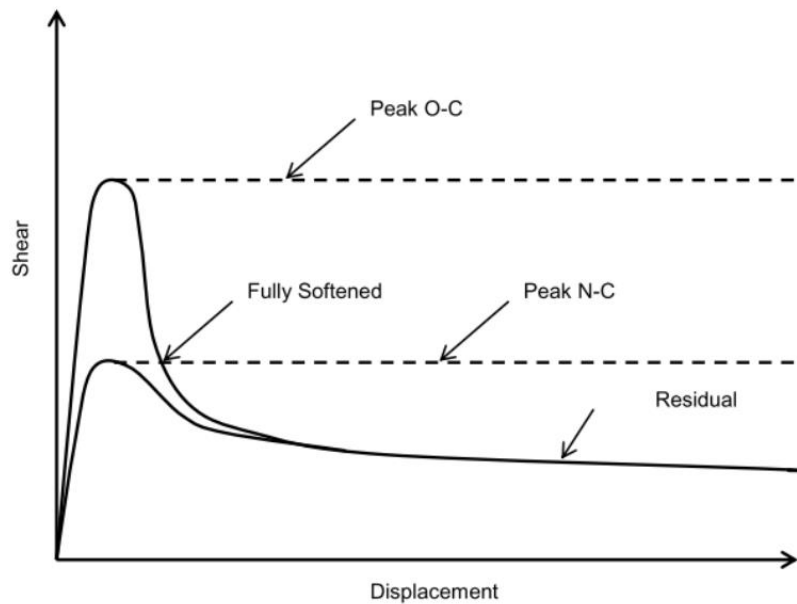
Cyclic wetting and drying causes expansive soil to undergo softening and experience a reduction in shear strength ultimately reaching a fully softened state (Wright, 2005). Fully softened shear strength refers to the shear strength of clay with high plasticity which develops over time, due to recurrent wetting and drying (Wright, 2005). Skempton (1977) indicated that fully softened shear strength is comparable to the shear strength of the soil in a normally consolidated state and lies between peak and residual strength as shown in Figure 2-3.

Figure 2-3 Comparisons of peak, fully softened, and residual shear strength (Skempton, 1970).

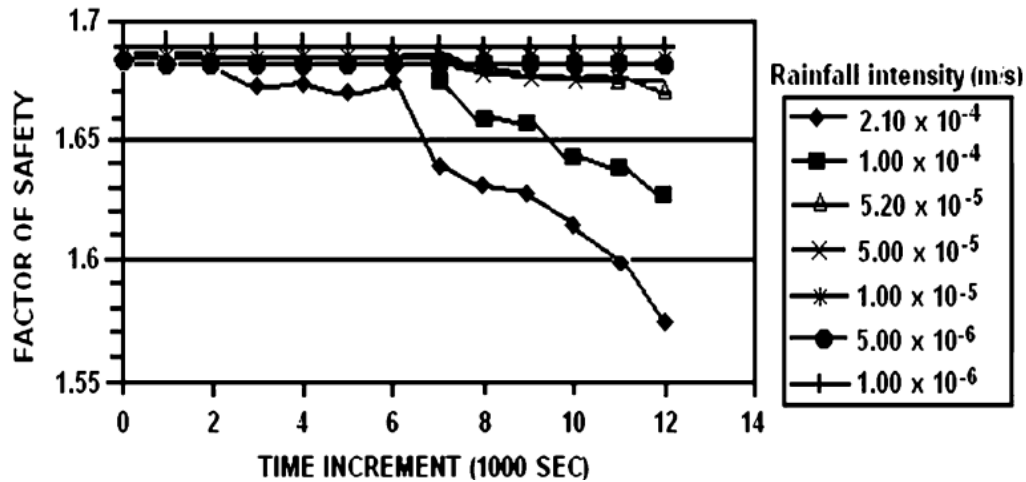
Rainfall intensity affects the infiltration rate of the slope soil in turn governing the factor of safety of the slope. Huat et al. (2006) showed that during rainfall events of low intensities, the factor of safety of a slope remains almost constant while that experiences a marked drop during higher rainfall intensities. Foley and Silburn (2002) also observed higher infiltration rates with higher rainfall intensities. According to Dunne et al. (1991), infiltration increases with rainfall intensity for two reasons: (i) high rainfall intensities exceed the saturated hydraulic conductivity of larger proportions of soil surface hence raising the spatially average hydraulic conductivity and (ii) increasing rainfall intensity increases run off rate and flow depth.

Figure 2-9 Effect of rainfall intensity on factory of safety of a slope (Huat et al., 2006).

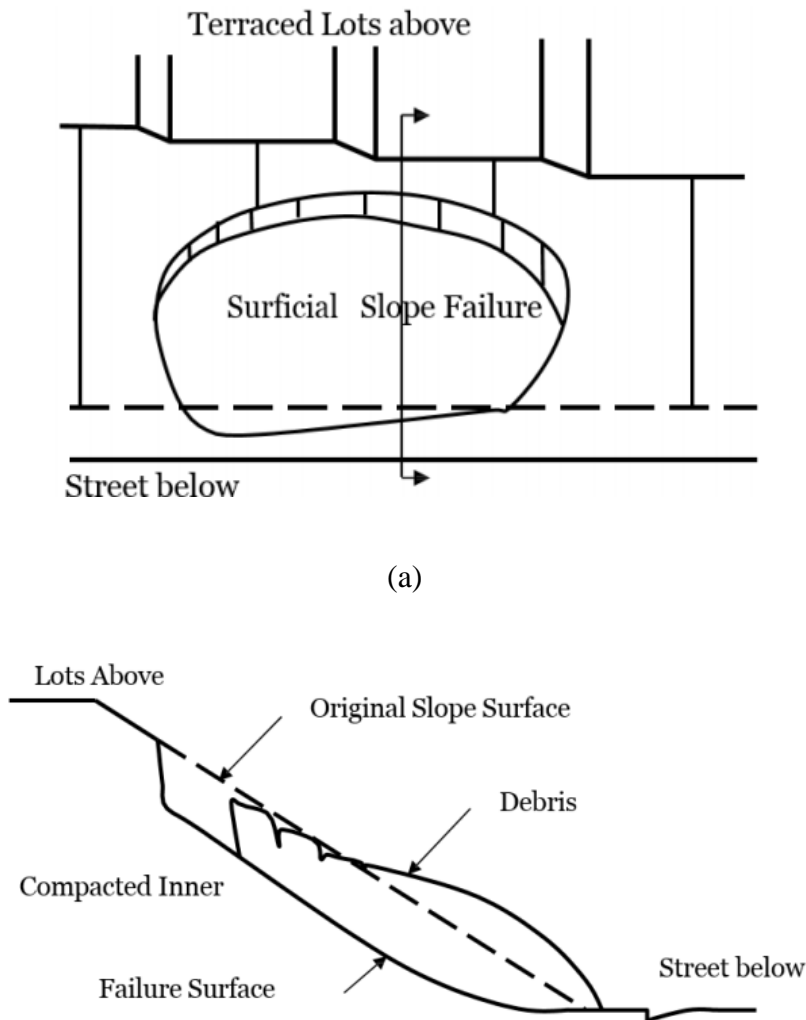
and when the intensity of rainfall exceeds the infiltration rate of the soil, failure takes place (Abramson et al., 2001). Depths and plan dimensions for such slides differ with predominant soil type, soil stratification, groundwater, slope geometry, and seepage, but are characterized by sliding depths of less than 10 feet, with depths of 3 to 6 feet being commonplace (Loehr et al, 2007; Titi and Helwany, 2007). According to Day and Axten (1989), shallow slope failures can be considered as infinite slope failure meaning the failure plane is approximately parallel to the slope face (Das, 2010). An illustration of a typical surficial slope failure is shown in Figure 2-10.

Figure 2-10 Typical surficial slope failure (redrawn after Day and Axten, 1989).

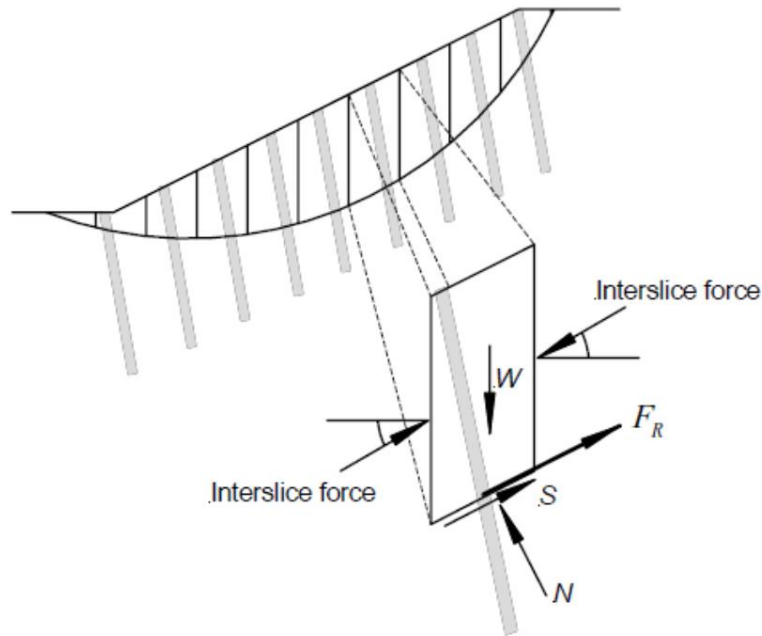
Where F is the factor of safety against sliding along the considered sliding surface, s is the maximum shear strength of the soil and reinforcement along the considered sliding surface, and τ is mobilized shear stress. Method of slice can be utilized to carry out the integration. The method of slices concept involves dividing the slope continuum into several vertical slices, as shown in Figure 2-18. Each slice is then analyzed by applying the equations of equilibrium. Strength parameters of the soil and reinforcement are calculated using Mohr Coulomb failure criterion and limiting strength of reinforcement, respectively and the mobilized shear stress is calculated by applying the principle of equilibrium to each slice. Similar calculations are carried out for all the slices to obtain the factor of safety of the slope against sliding. The process is then repeated for many potential and unique failure surfaces to identify the failure surface which generates the minimum factor of safety. Finally, the minimum factor of safety is considered to be the factor of safety of the slope against sliding.

Figure 2-18 Equilibrium of an individual slice in the method of slices (Khan, 2014).

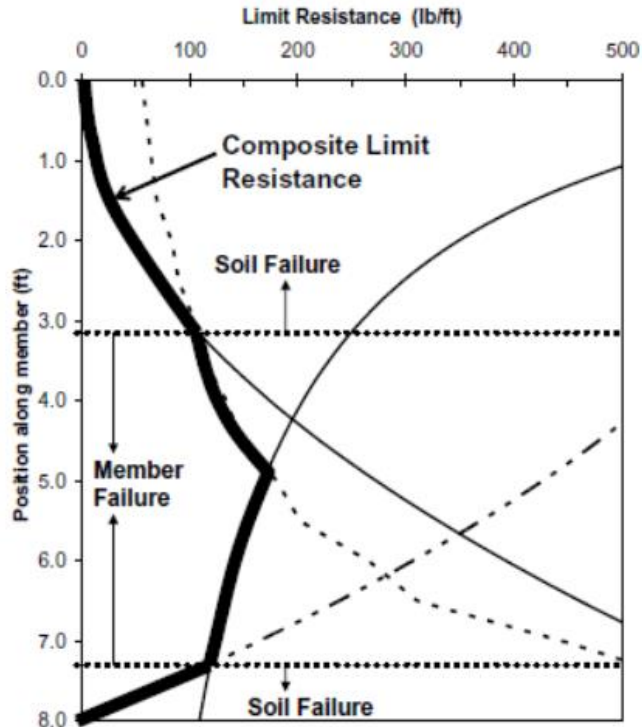
Failure Mode	Description
Mode 1	Failure of soil mass above the sliding surface
Mode 2	Failure of soil mass below the sliding surface due to insufficient anchorage
Mode 3	Bending failure of member
Mode 4	Shear failure of member

Figure 2-19 Combined limit resistance curve (Loehr and Bowders, 2007).

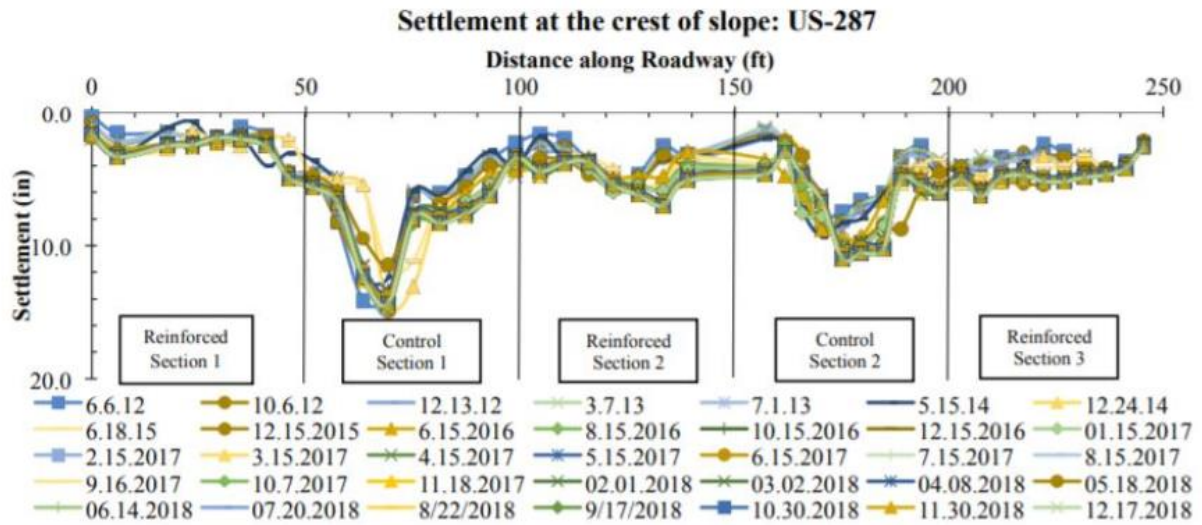
Figure 2-27 Vertical settlement of the slope at the crest (Rauss, 2019).

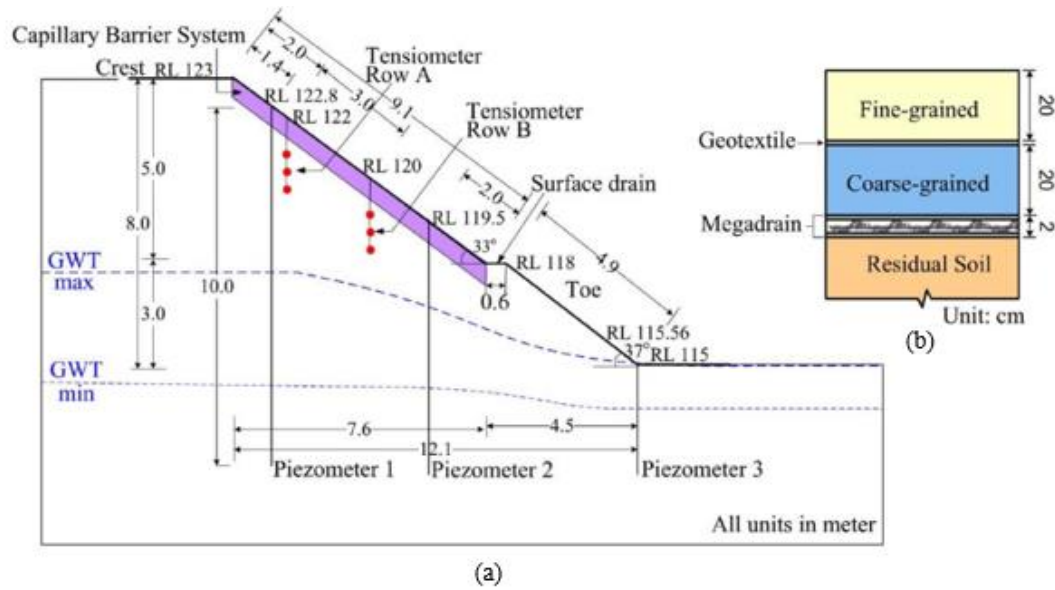
Figure 2-28 (a) Schematic of stabilized slope (b) Cross section of CBS (Rahardjo et al., 2012).

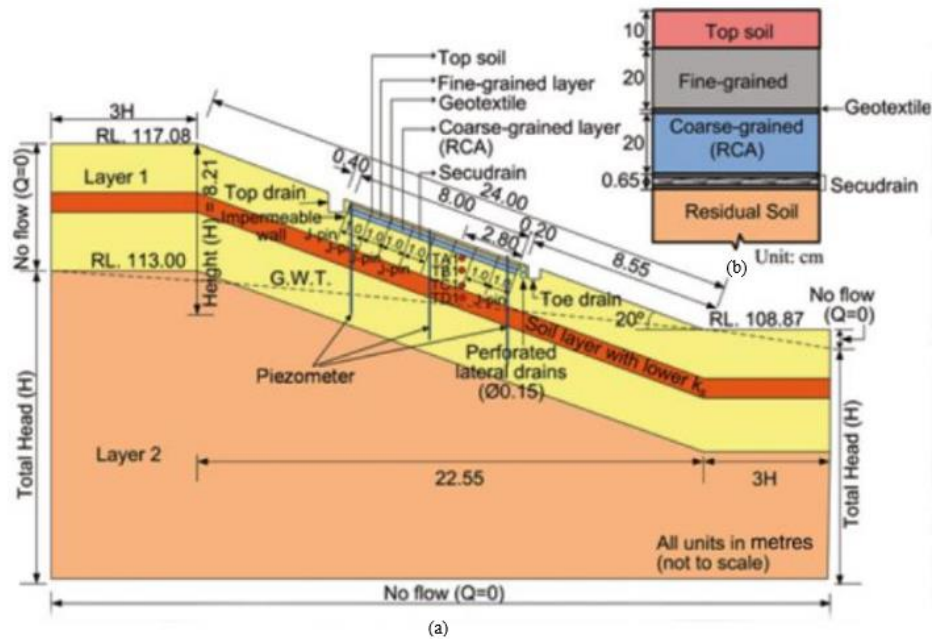
Figure 2-30 (a) Schematic of stabilized slope (b) Cross section of CBS (Rahardjo et al., 2013).

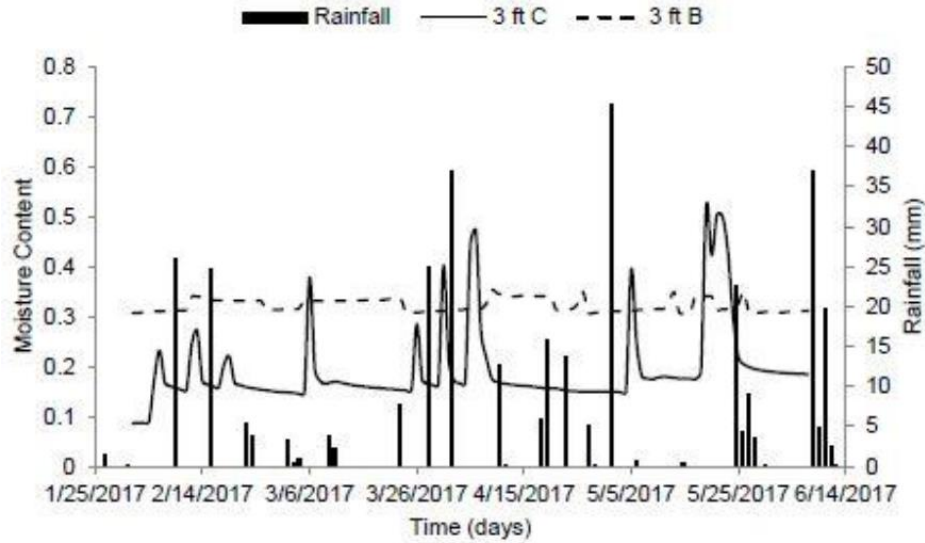
Moisture variation at a depth of 3 feet obtained from field installed moisture sensors in both test section and control section is presented in Figure 2-37. From the results, it was observed that the barrier section was able to maintain almost constant moisture content in the subgrade soil while significant fluctuation due to climatic loading was observed in the control section. The results indicated the effectiveness of modified moisture barrier in preventing rainwater from reaching the subgrade soil hence preventing its detrimental effect on pavement structure.

Figure 2-37 Comparison of moisture content for barrier section and control section at 3 feet depth (Ahmed et al.,2017).

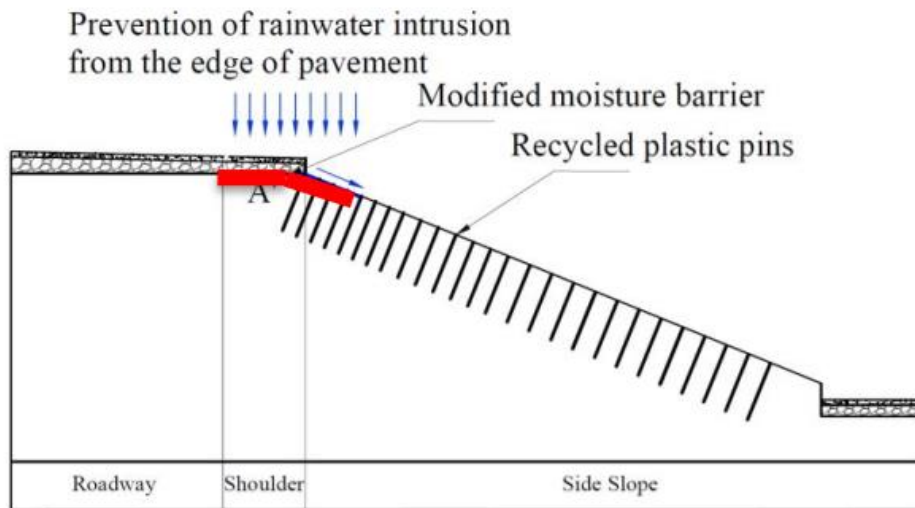
section. It can be seen that with successive rainfall events the barrier section experienced insignificant variation in volumetric moisture content compared to that of the control section. Furthermore, the maximum lateral deformation of the barrier section was approximately three times lower than that of the control section. The combined use of recycled plastic pins and modified moisture barrier can effectively stabilize shallow slope failures.

Figure 2-38 Schematic diagram of slope stabilized with recycled plastic pins and modified moisture barrier (Sapkota et al., 2019).

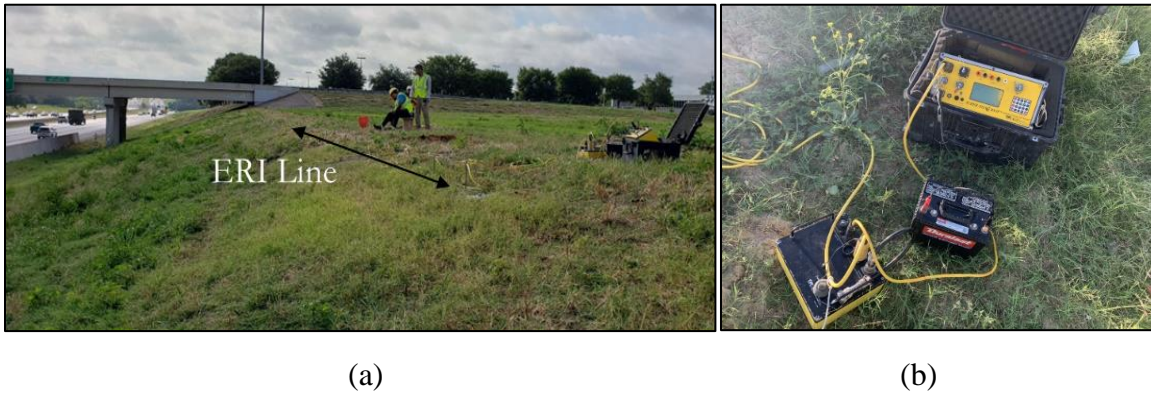
Figure 3-9 (a) Location of ERI line (b) 8 Channel SuperSting Equipment.

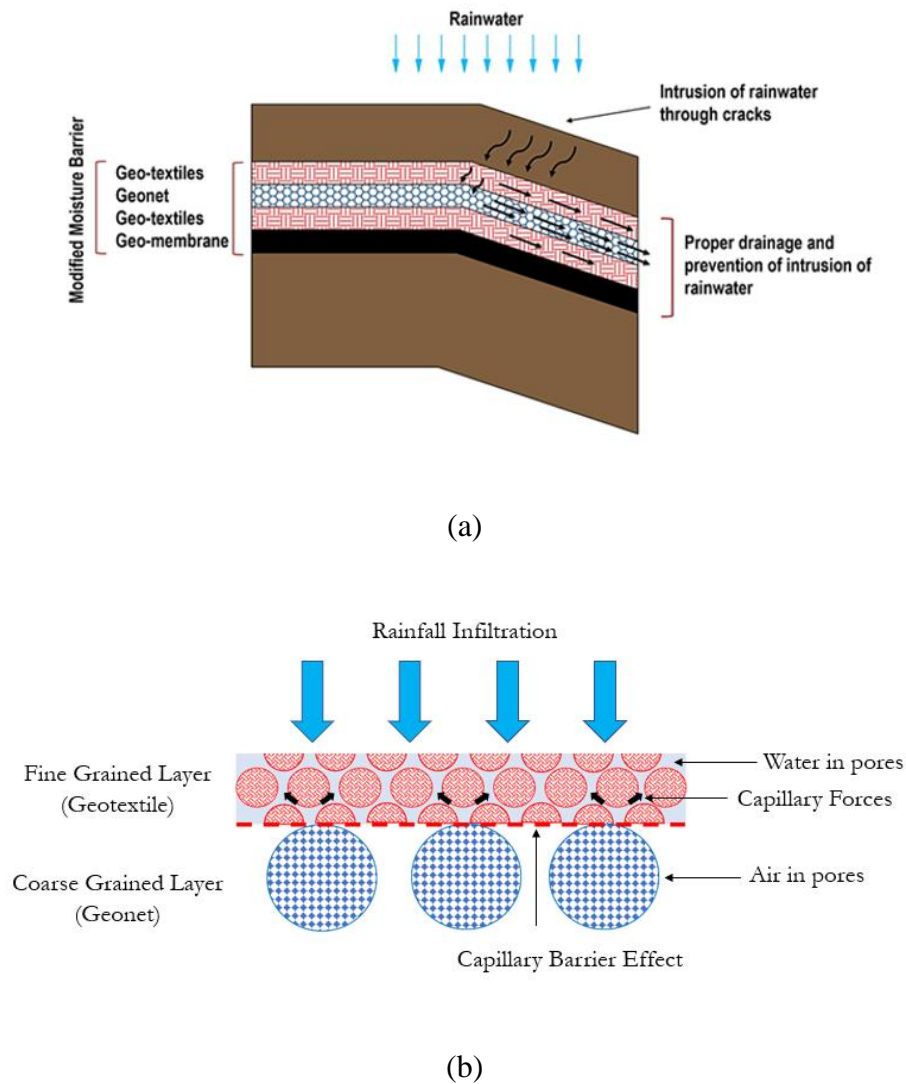
Considering the effectiveness of the modified moisture barrier in controlling moisture intrusion in previous studies (Ahmed, 2017 and Sapkota et al., 2019), the current study utilized the modified moisture barrier alone at the crest of a highway slope to prevent shallow slope failure.

Figure 3-11 (a) Detailed mechanism of the modified moisture barrier (b) Capillary barrier effect in the MMB.

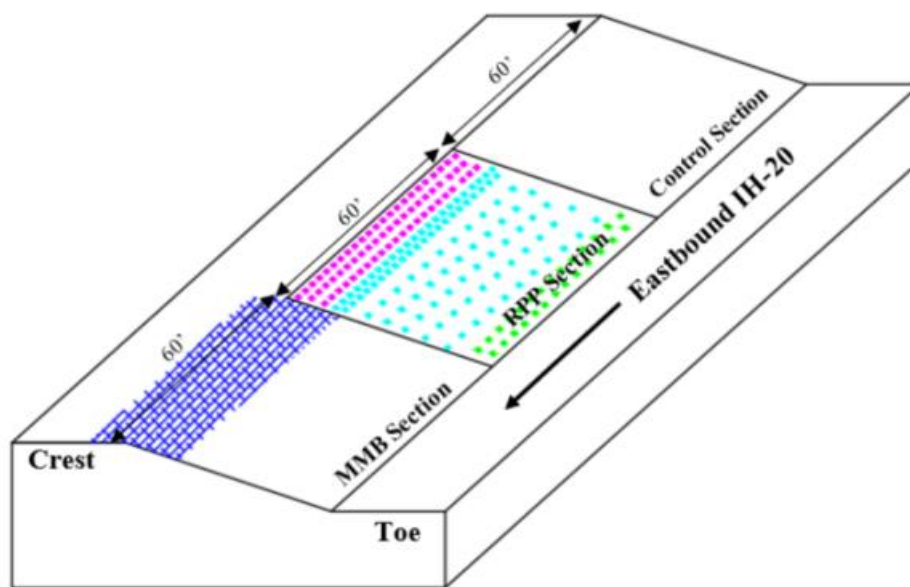
The slope stabilization plan was designed to evaluate the effectiveness of the modified moisture barrier to combat rainfall induced shallow slope failure and further compare its performance to that of recycled plastic pins (a mechanical stabilization method). To this end, a failed portion of the highway slope was stabilized using two sections: modified moisture barrier section (MMB Section) and recycled plastic pins section (RPP Section). A portion of the original slope adjacent to the test sections was selected to serve as the control section for this study. Each test section (MMB Section, RPP Section and Control Section) was 60 ft. in length and width along the slope as shown in Figure 3-12. The design of the test section and selection of materials is discussed in the following sections.

Figure 3-12 Schematic of test sections.

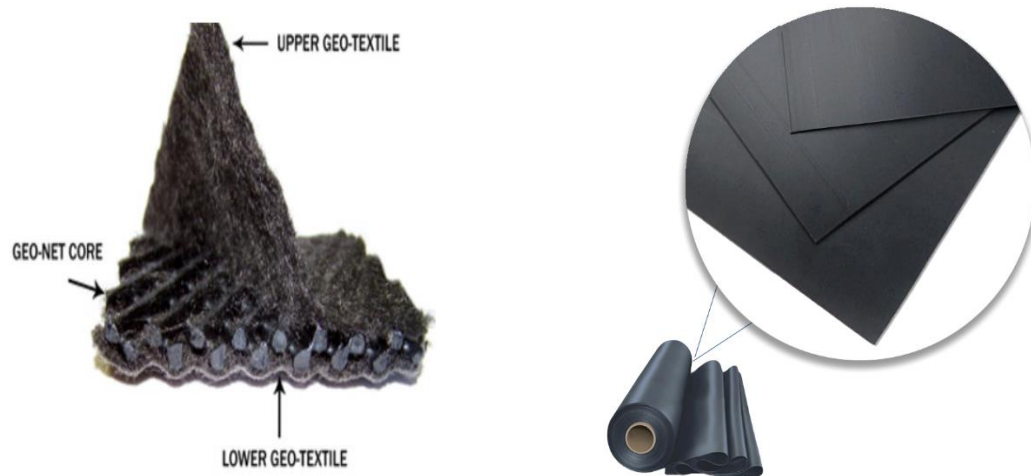
2022). A 60 ft. section of the failed portion of the slope was stabilized using the modified moisture barrier. The modified moisture barrier used in this study was 60 ft. in length and 14 ft. in width. Of the 14ft. width of the MMB, 4ft. was designed to be towards the crest of the slope while the remaining 10 ft. was designed to be along the slope as shown in Figure 3-14. It consisted of a 40 mil Linear Low-Density Polyethylene (LLDPE) impermeable geomembrane and an 8 oz. High Density Polyethylene (HDPE) geocomposite as shown in Figure 3-13. The selection criteria of the materials are discussed below.

Figure 3-13 Materials used in the MMB (a) HDPE Geocomposite (<https://skaps.com/>) (b) LLDPE Geomembrane (<https://www.americover.com/>)

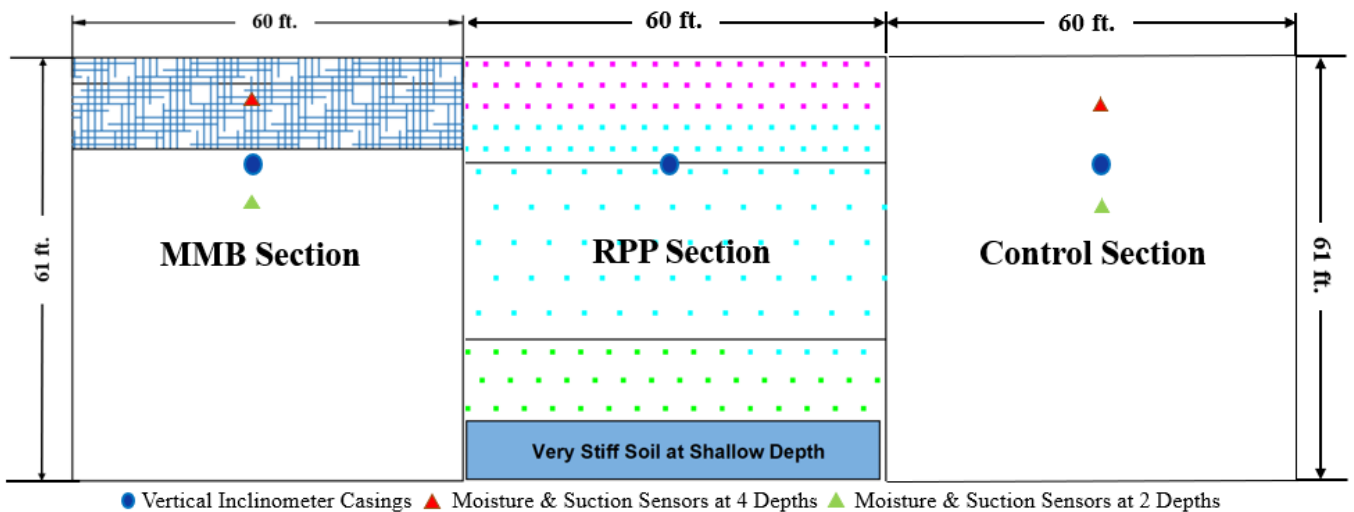
The test slope sections were instrumented with integrated moisture temperature sensors, suction sensors, and inclinometer casings as shown in Figure 4-4.

Figure 4-4 Instrumentation Layout.

Sixteen integrated moisture-temperature sensors and soil water potential sensors were installed at the crest of the slope. Two 10 ft. deep boreholes were drilled at the MMB section and the control section to install the sensors at varying depths (at depths of 3 ft., 5 ft., 7 ft., and 9 ft.). The locations of the sensors at the MMB Section are shown in Figure 4-8. It should be noted that at the MMB section, the borehole was drilled, and sensors were installed after a trench was excavation and prior to the installation of the MMB. A total of 8 integrated moisture-temperature sensors and 8 soil water potential sensors were installed at the crest of the slope. After the installation of each sensor, the soil was carefully compacted to avoid damage to the sensor. The process of sensor installation is depicted in Figure 4-9. The sensors were then connected to a data logger to the ZL6 which was set to record hourly readings. Furthermore, two boreholes each of 2 feet depth were drilled using a hand auger after a period of 23 months at the middle section of the slope at the MMB section and control section. A total of four sensors, two integrated moisture and temperature sensors and two soil water potential sensors, were installed at depths of 2 feet and 1 feet below the ground surface. The sensors were then collected to a datalogger to collect hourly readings. The layout of sensor installation is shown in Figure 4-4.

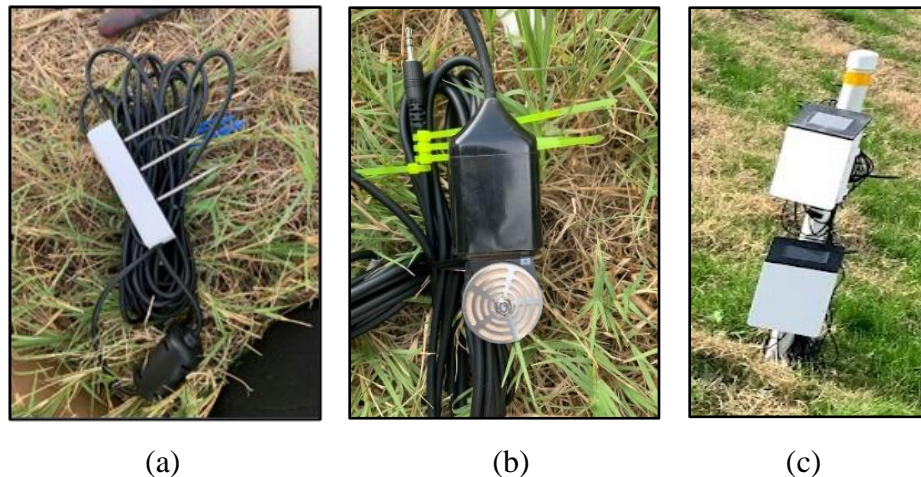
Commercially available integrated moisture -temperature sensors, Teros 12 from Meter Group and soil water potential sensors, Teros 21 from Meter Group were installed to measure the volumetric water content, temperature, and matric suction of the soil respectively. The sensors were then connected to a data logger, ZL6 from Meter Group to record, collect and store data. The selected datalogger collects data continuously and can store up to 80000 scans. The sensors and datalogger are shown in Figure 4-5.

Figure 4-5 (a) Integrated Moisture-Temperature Sensor (b) Soil Water Potential Sensor (c) Datalogger.

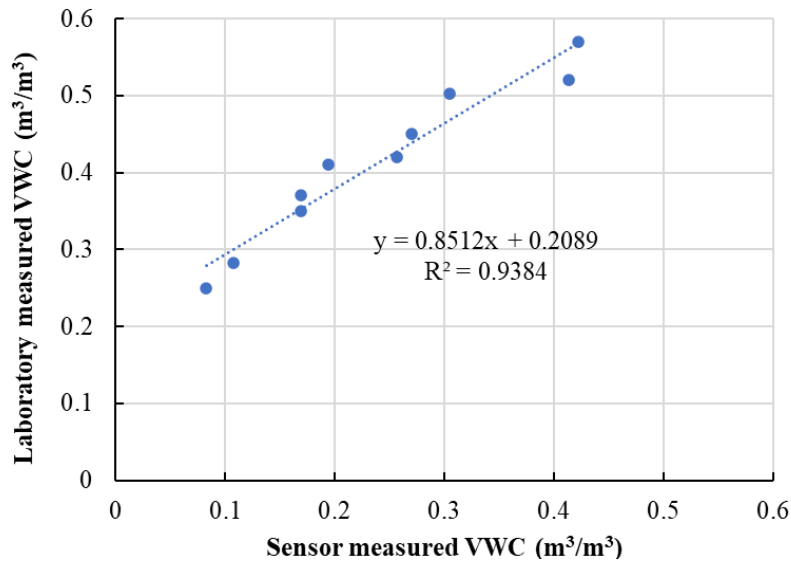
Integrated moisture and temperature sensors were calibrated prior to field instrumentation to ensure proper performance. In order to perform calibration of the integrated moisture temperature sensors, moisture content of several samples was manually determined and compared with sensor measurements (Cobos and Chambers, 2010). Recorded values showed good agreement with manually measured moisture content as shown in Figure 4-7.

Figure 4-7 Calibration of Sensors.

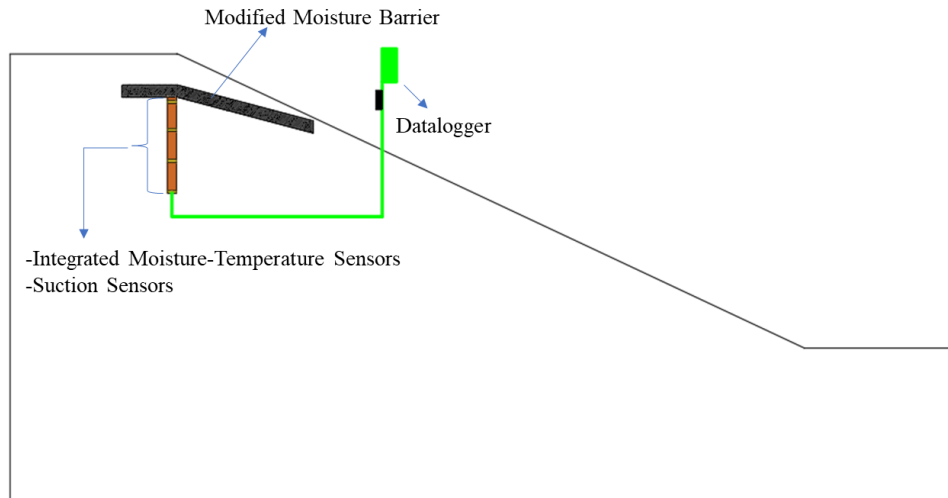
Figure 4-8 Location of sensors and data logger for MMB Section.

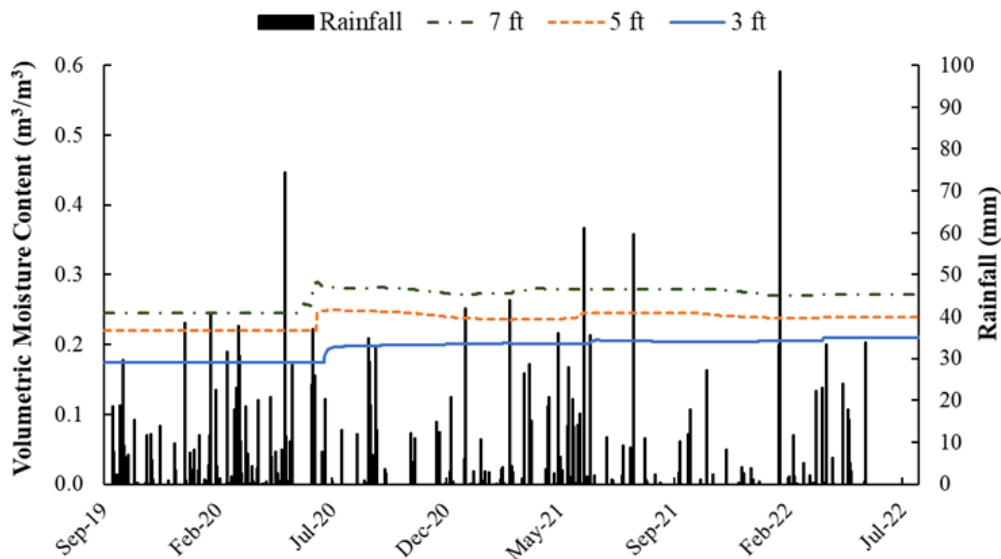
in Figure 5-1. During this monitoring period a cumulative rainfall of 99.4 in was recorded by the nearest weather station. The frequency of rainfall was higher during the wet period and lower during the summer. However, insignificant variation in volumetric water content was observed in the MMB sections despite rainfall events. At all depths, moisture content showed no dependency with precipitation events. Although a rise in water content was recorded at all depths April 2020, the increase in moisture content was first recorded by the deepest sensor at 7 ft. followed by that at 5 ft. and lastly an increase was observed at depth of 3 ft. This trend implied an upward movement of water as opposed to an increase in moisture content due to rainfall infiltration. Furthermore, following this rise, volumetric moisture content in the MMB section has remained almost constant at 19 %, 24 %, and 28 % at depths of 3 ft., 5 ft., and 7 ft. respectively throughout the monitoring period. The insignificant fluctuation of moisture content in the MMB section can be attributed to the effectiveness of the modified moisture barrier in preventing rainfall infiltration into the underlying soil.

Figure 5-1 Variation of volumetric moisture content with time and rainfall events at the MMB Section.

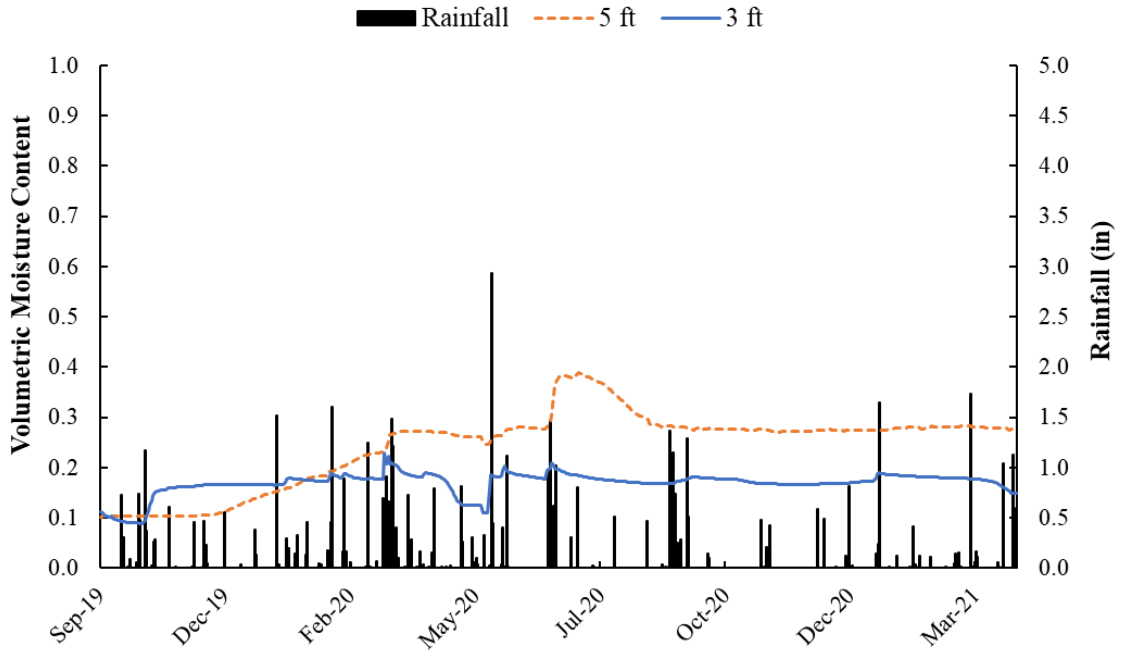
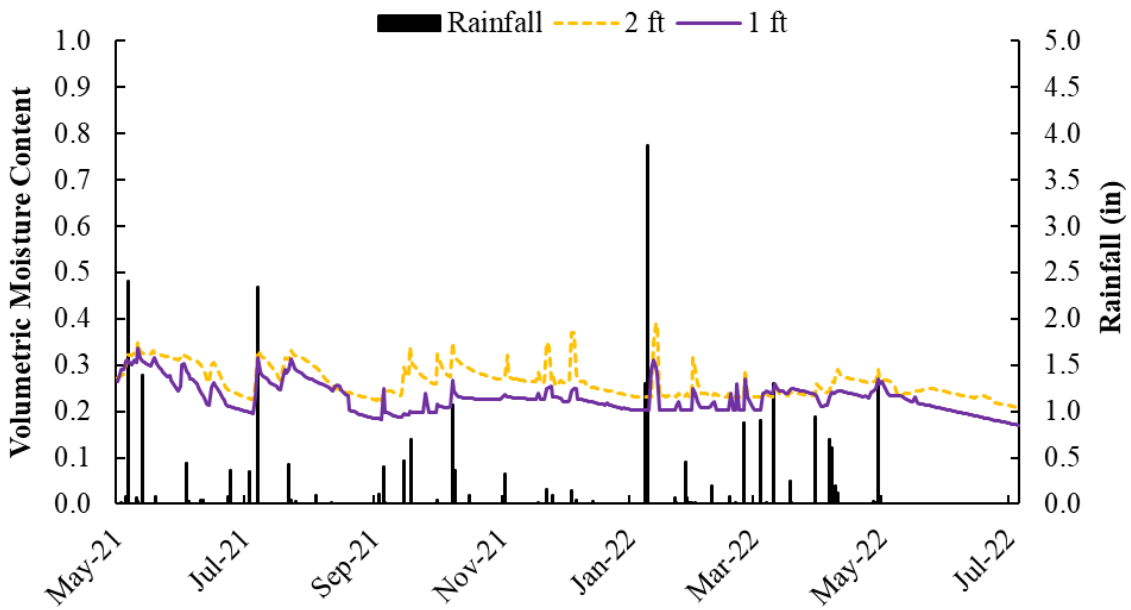
Variation of volumetric water content with time and rainfall events at the control section at the crest of the slope and middle section of the slope is presented in Figure 5-2 (a) and (b), respectively. The average moisture content at the crest of the slope was 16 % and 24 % at depths of 3 ft and 5 ft respectively. Sensors installed showed a direct relationship between soil moisture content and rainfall. Several peaks and drops in the value of volumetric moisture content were observed to occur due to precipitation events. For instance, on 18th May 2020, rainfall of 2.93 in was recorded and consequently water content increased from 10% to 19% and 25% to 28% at depths of 3 ft and 5 ft respectively. Contrastingly, during the period of June to August 2020 with relatively less rainfall moisture content was observed to decrease from 20 % to 16 % at depth of 3 ft. The fluctuation was more pronounced at shallower sensors where the peaks were observed right after rainfall events, as shown in Figure 5-2 (b). On the other hand, at deeper depths, the change in moisture content was more gradual and influenced by long term events with no prominent peaks and drops in the graph with respect to rainfall events. The increase in moisture content recorded by the sensors installed in the control section can be attributed to the infiltration of rainwater into the slope.

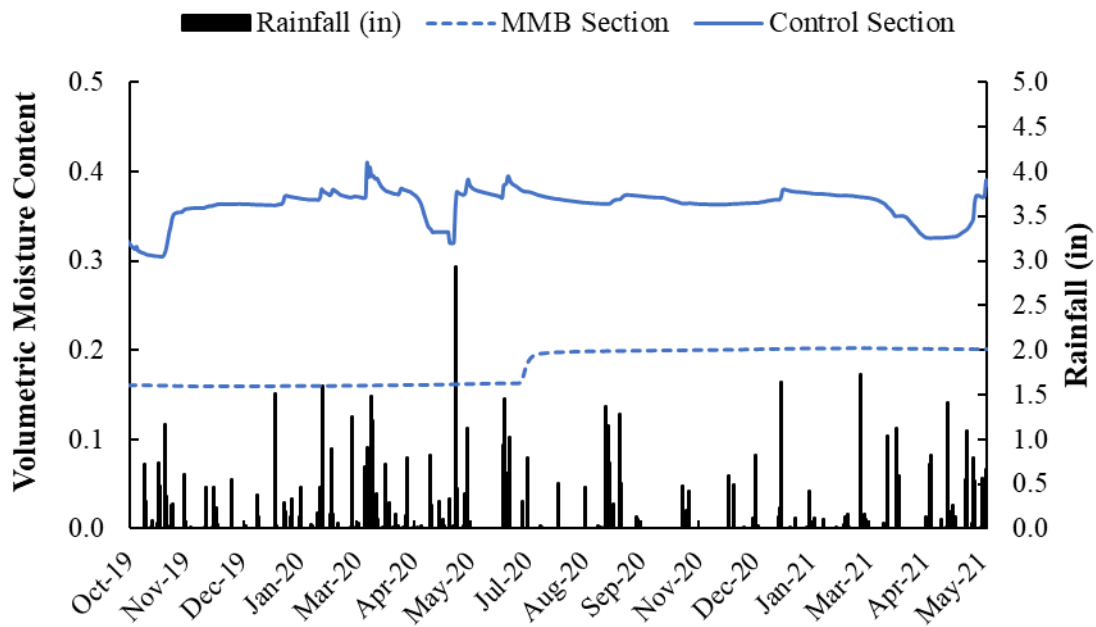
The variation of volumetric moisture content, at a depth of 3 feet below the ground surface at the crest of the slope, with time and rainfall events was compared for the control and MMB sections and the result is presented in Figure 5-3. Several peaks and drops depicting sudden increase and decrease of moisture content were observed in the control section while the volumetric moisture content of the MMB section remained almost constant, with respect to precipitation events. The observed peaks and drops of the control section moisture content can be attributed to infiltration of rainwater into the slope soil. Additionally, the moisture content of the barrier section was lower than that of the control section. These observations indicate that the proposed approach can effectively control fluctuation of soil moisture content caused by climatic variation.

Figure 5-3 Comparison of moisture content variation at 3 ft depth at the crest of the slope.

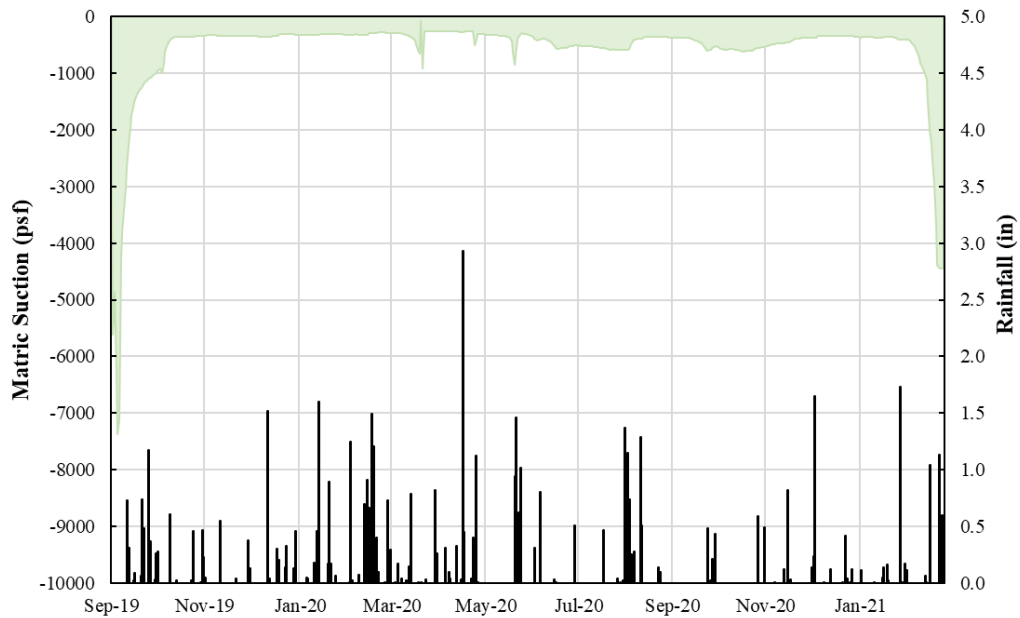
(a)

On the contrary, as can be seen in Figure 5-4 (b), the MMB section maintains a minimum suction value of -600 psf throughout the monitoring period indicating that the soil underneath the barrier was not subjected to rainfall infiltration or evaporation. Higher suction value observed initially can be attributed to the adjustment period immediately after installation as the soil surrounding the sensor was relatively disturbed. Therefore, the modified moisture barrier can effectively maintain constant soil matric suction in the underneath soil hence preserving the soil shear strength by reducing infiltration of rainwater.

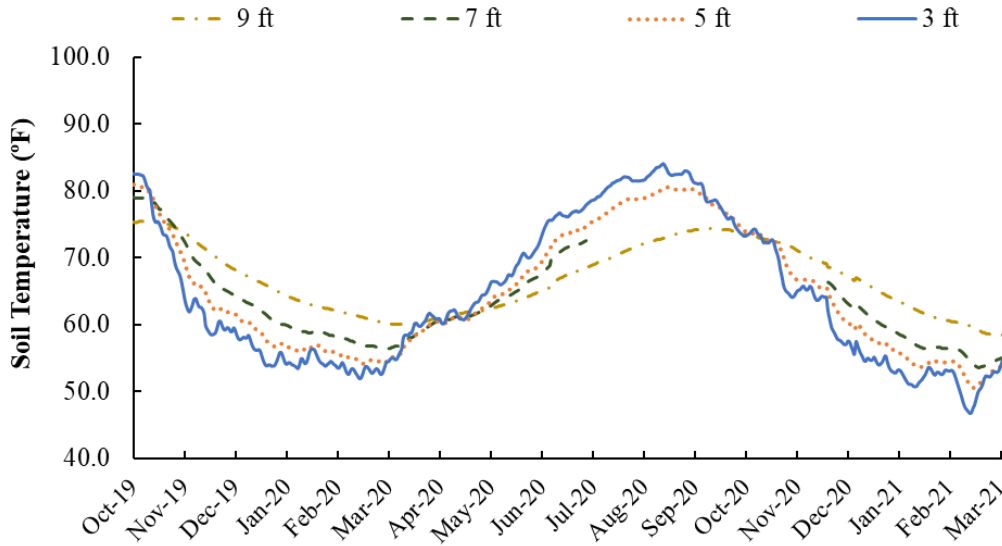
Variation of soil temperature is a function of incident solar radiation, rainfall, local vegetation cover, air temperature, humidity, type of soil and depth in the earth (Olness et al., 2001). Soil temperature of the test sections was monitored at depths of 3 ft., 5 ft., 7 ft., and 9 ft., as presented in Figure 5-5. The highest temperature recorded was about 84 °F in August 2020 while the lowest was about 46 °F in February 2021. Up to a depth of 7 ft., changes in temperature were more pronounced. With increase in depth, the amplitude of the annual cycle of temperature decreased and the phase of the annual cycle also shifted. These observations were found to be consistent with previous studies where temperature variation was monitored (Al-Hinti et al., 2017).

Figure 5-5 Variation of soil temperature with time.

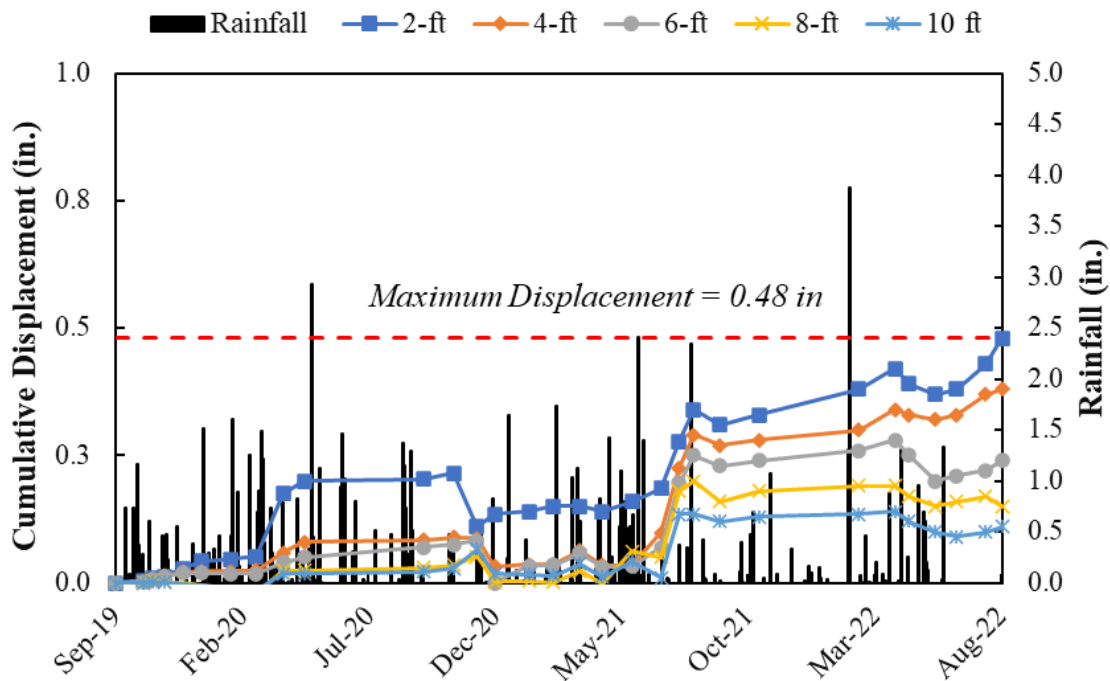
Figure 5-6 Lateral deformation with time and rainfall for control section.

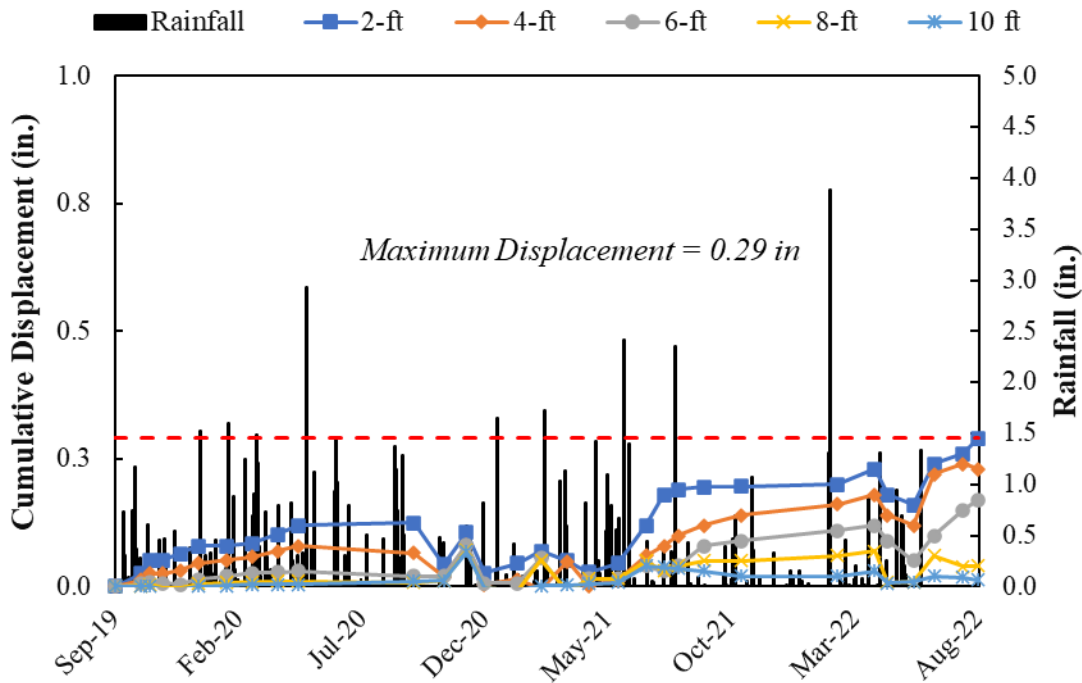
Figure 5-7 Lateral deformation with time and rainfall for MMB section.

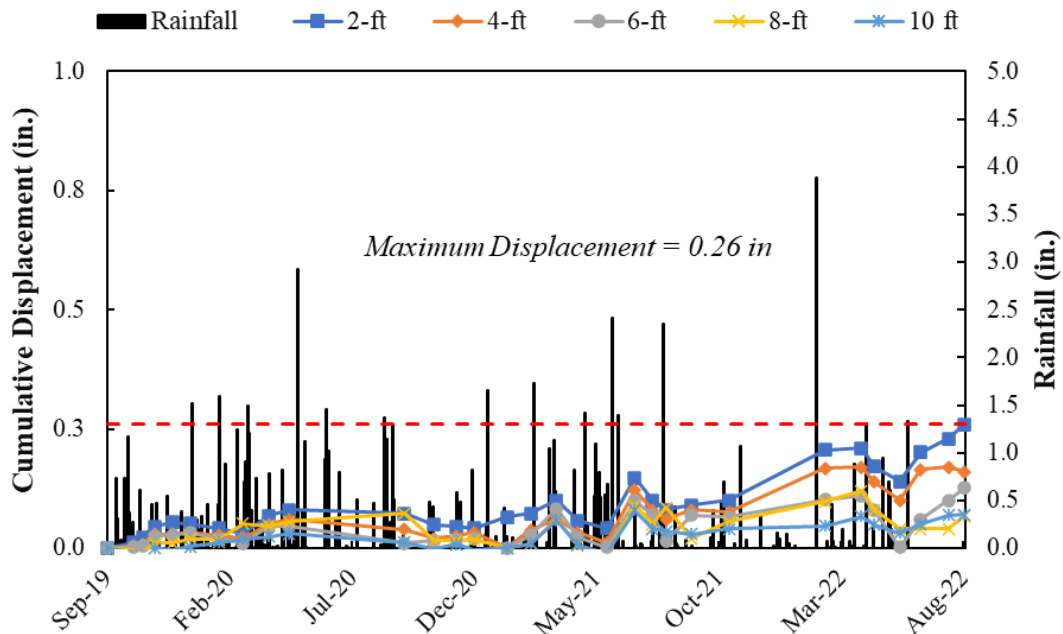
Figure 5-8 Lateral deformation with time and rainfall for RPP section.

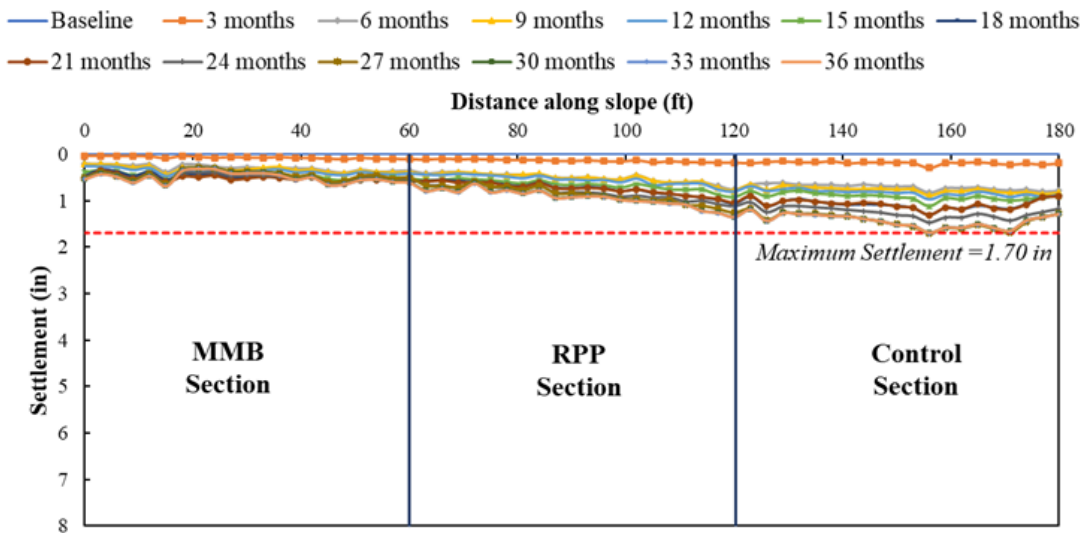
Figure 5-11 Vertical settlement at the crest of the slope.

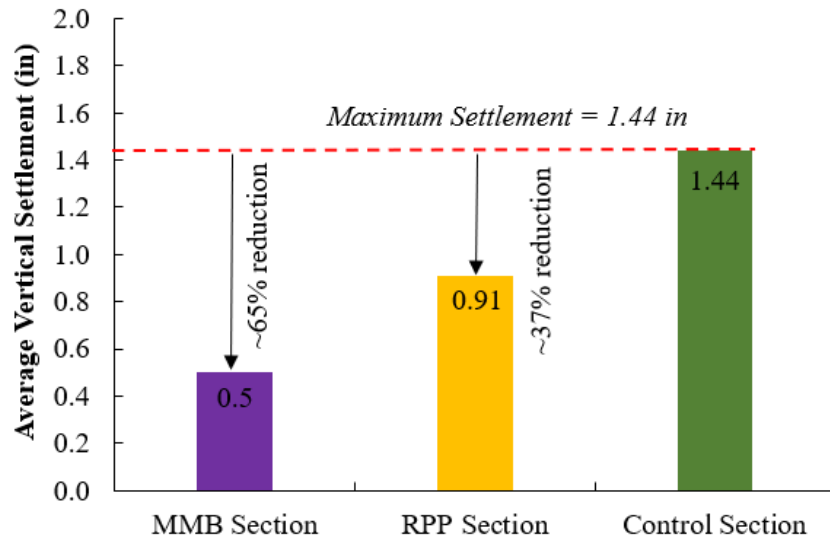
Figure 5-12 Comparison of average settlement of test sections at crest of the slope.

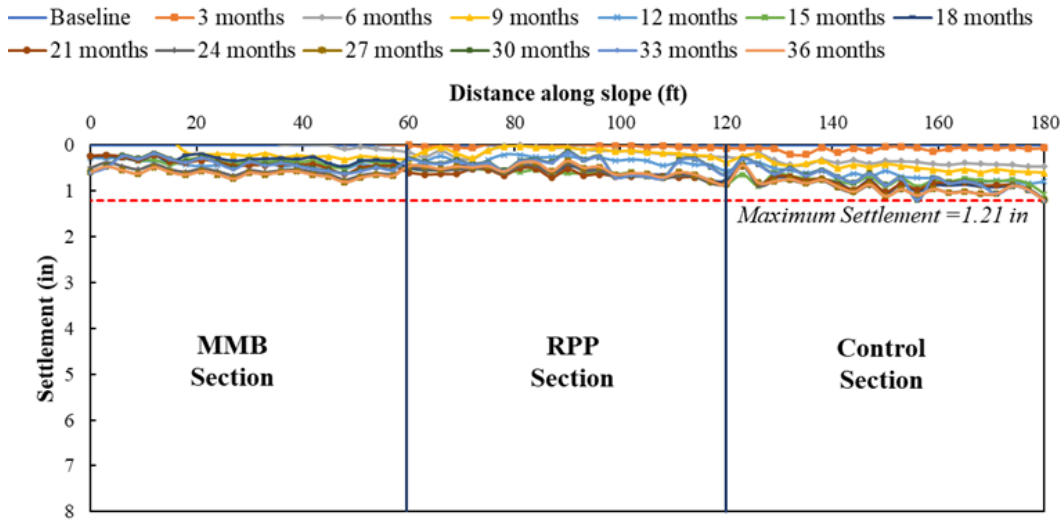
Figure 5-13 Vertical settlement at the middle of the slope.

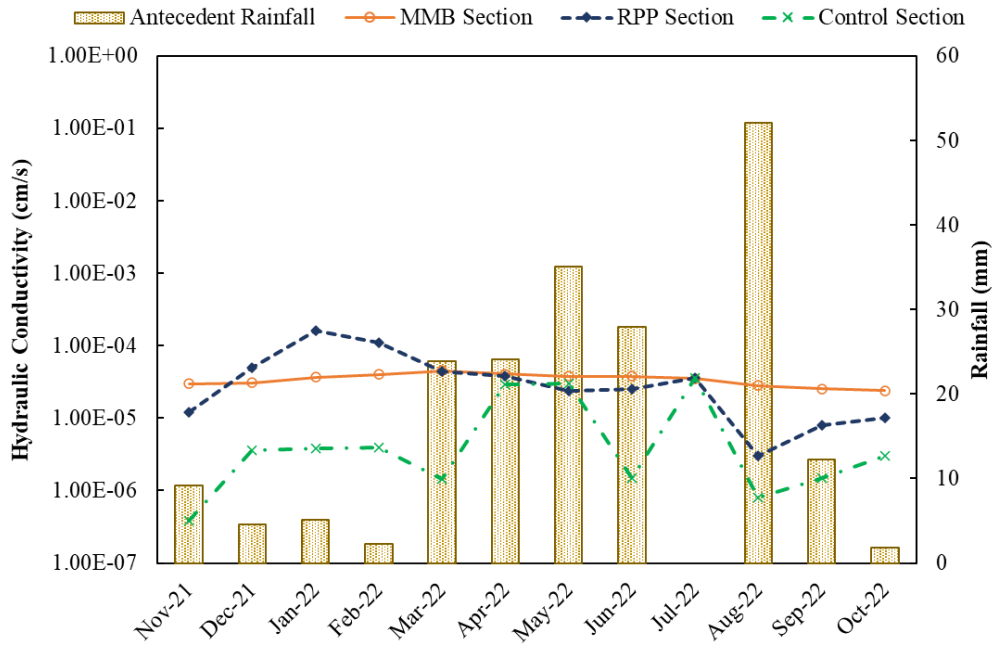
Figure 5-16 Variation of field hydraulic conductivity at the crest of the slope.
