PERFORMANCE EVALUATION OF THE MODIFIED MOISTURE BARRIER IN
STABILIZING SHALLOW SLOPE FAILURES

DOCTOR OF PHILOSOPHY IN CIVIL ENGINEERING

THE UNIVERSITY OF TEXAS AT ARLINGTON

DECEMBER 2022

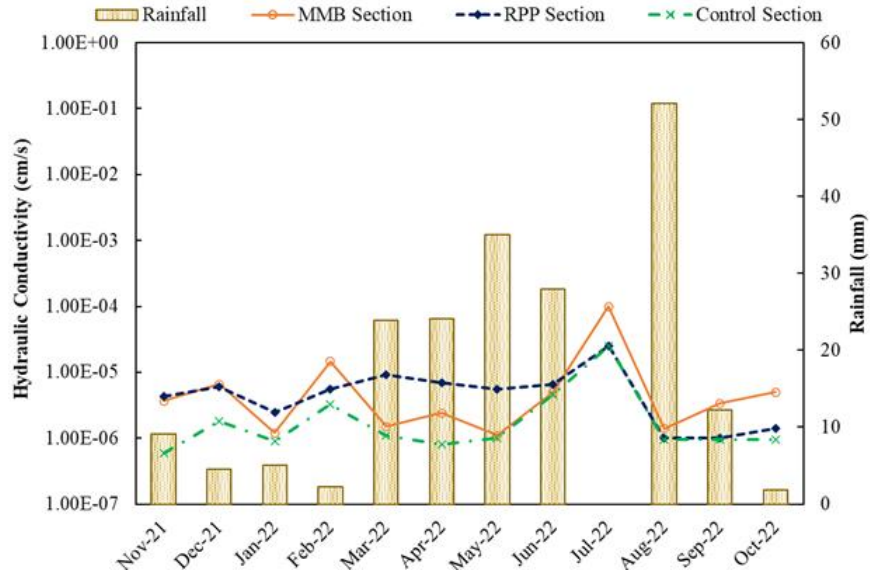
Figure 5-17 Variation of field hydraulic conductivity at the middle of the slope.

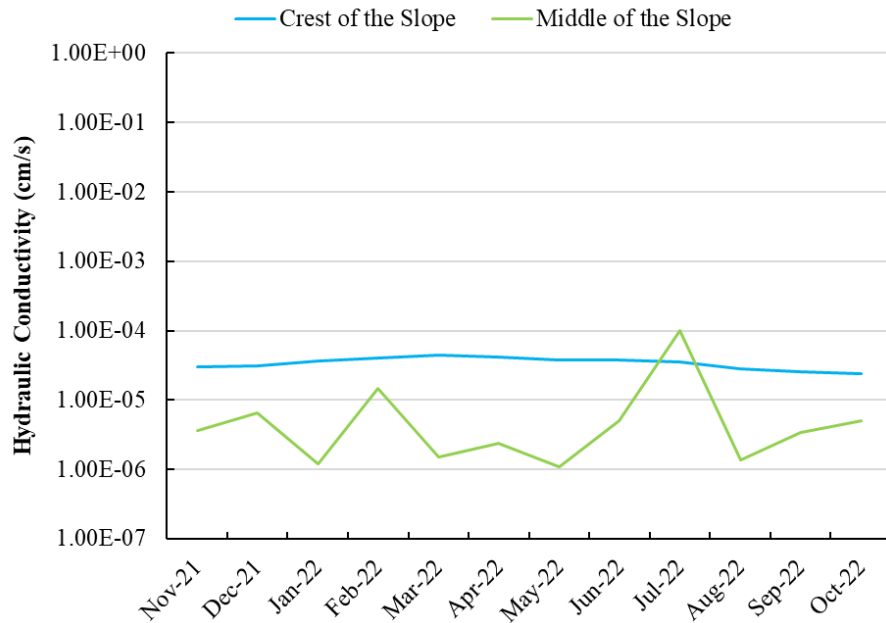
Figure 5-18 Comparison of hydraulic conductivity of the MMB section (s) crest of the slope (b) middle of the slope.

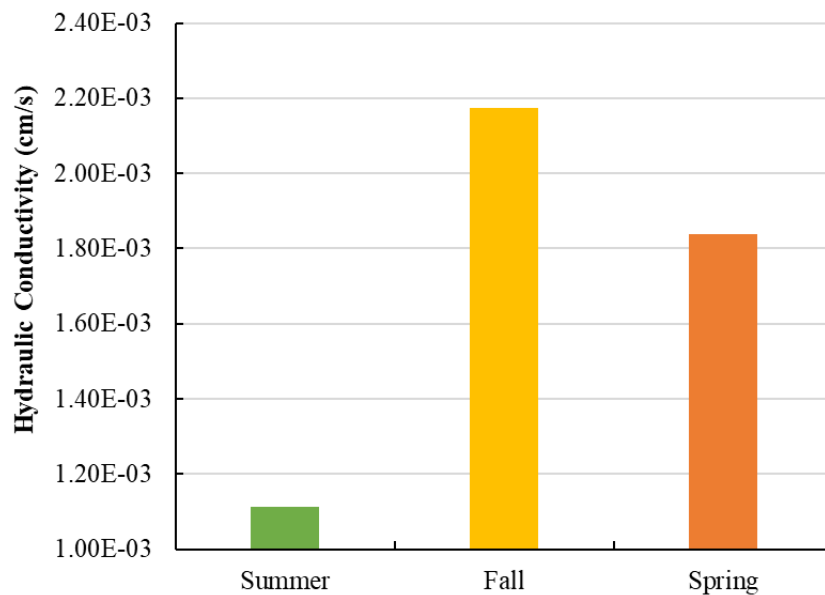
Figure 5-19 Average hydraulic conductivity in each season (Gupta et al., 1994).

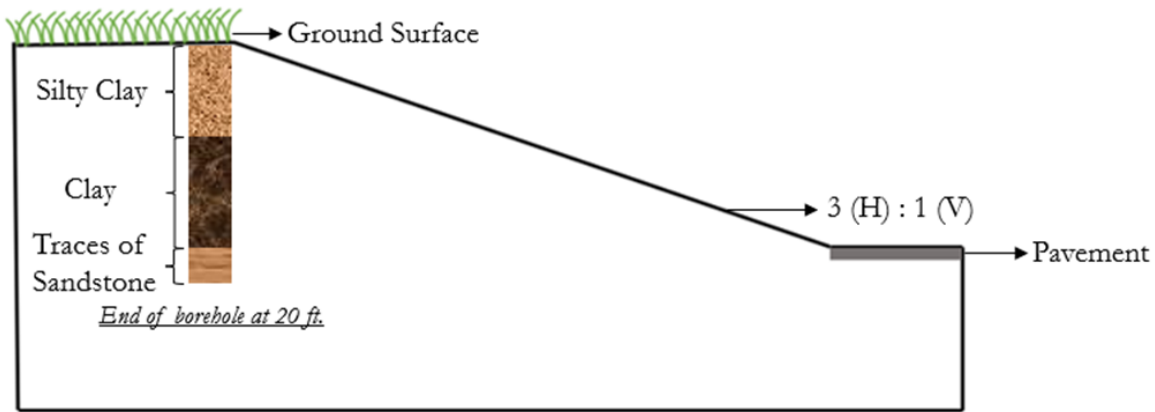
Figure 6-1 Schematic of Slope Section.

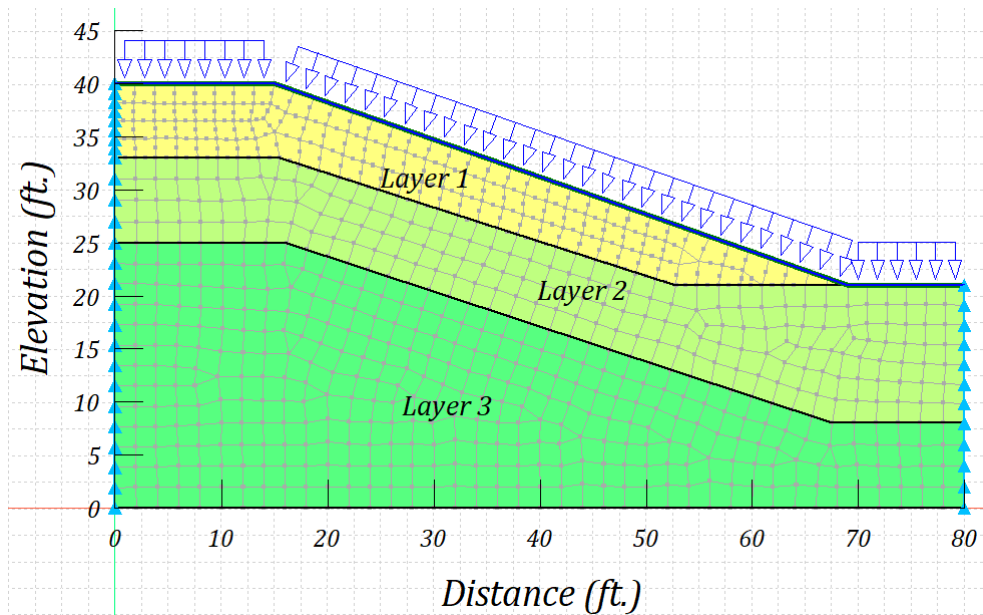
Figure 6-2 Slope geometry and boundary conditions used for analyses.

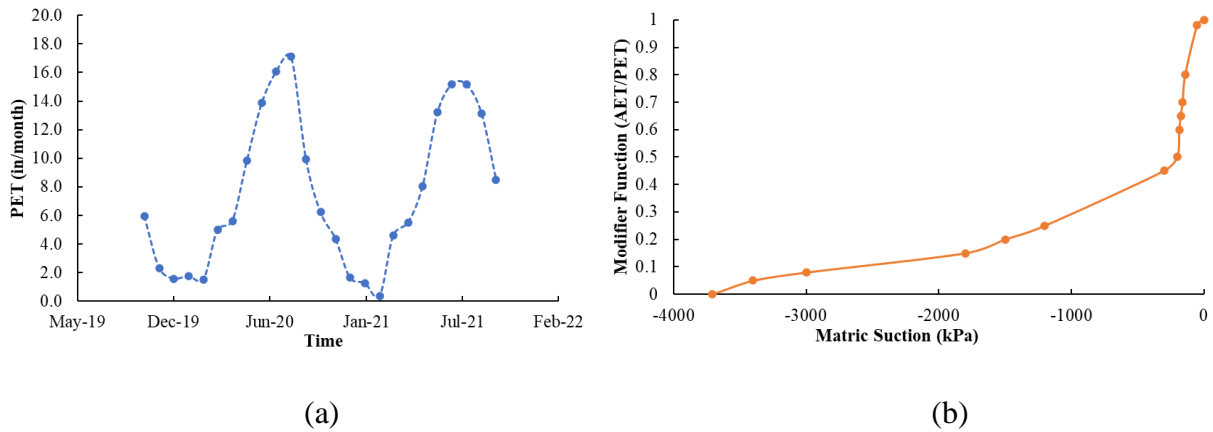
Figure 6-5 (a) Estimated PET (b) AET/PET as a function of suction.

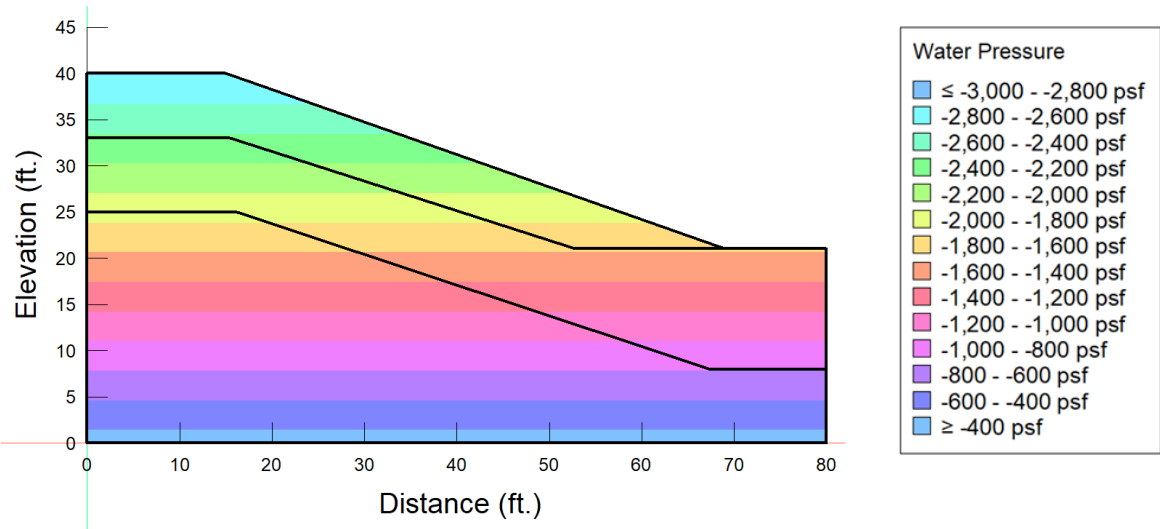
Figure 6-6 Initial porewater pressure distribution profile.

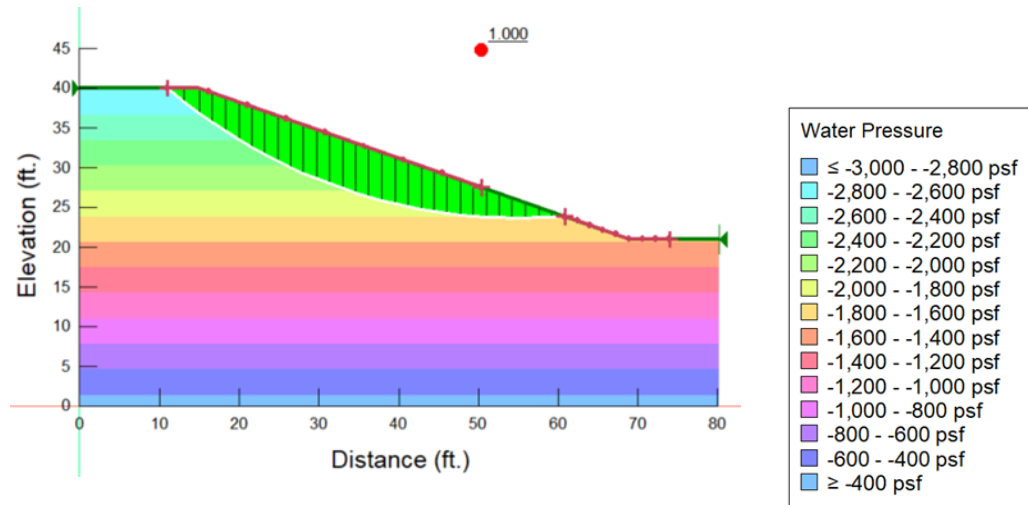
Figure 6-9 Result of slope stability analysis (initial).

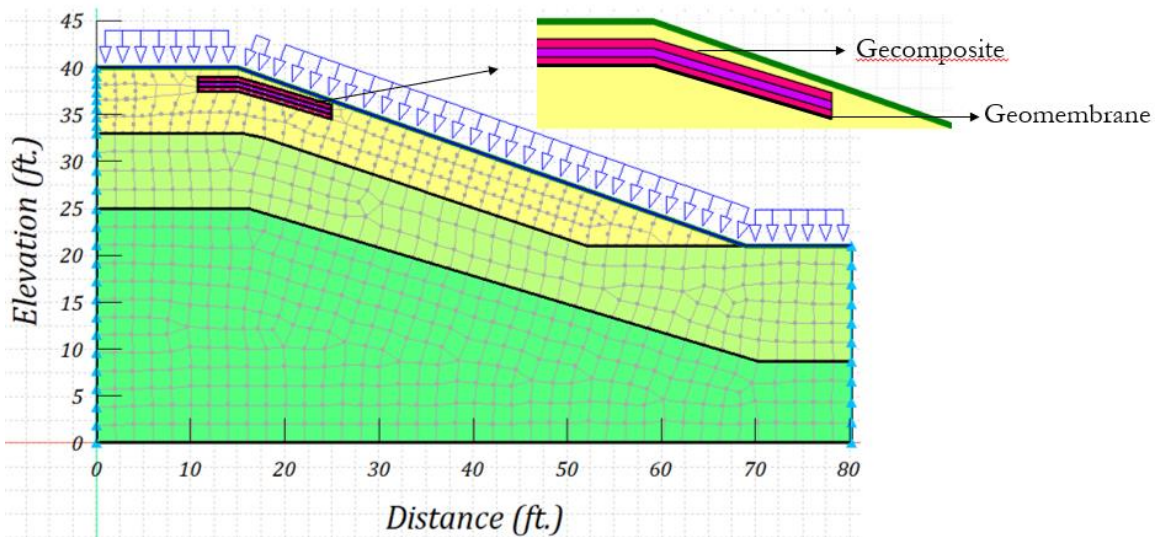
Figure 6-10 Model geometry with MMB.

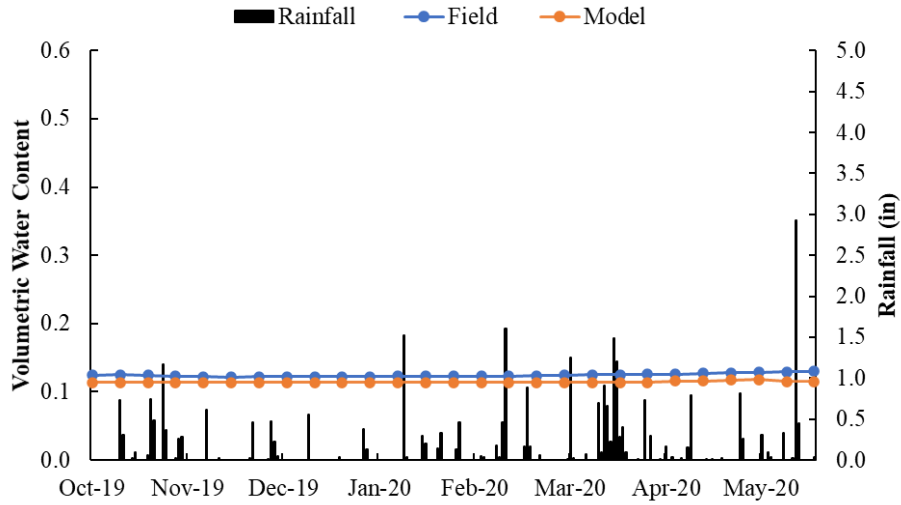
Figure 6-11 Measured and Modeled Volumetric Moisture Content for Slope with MMB.

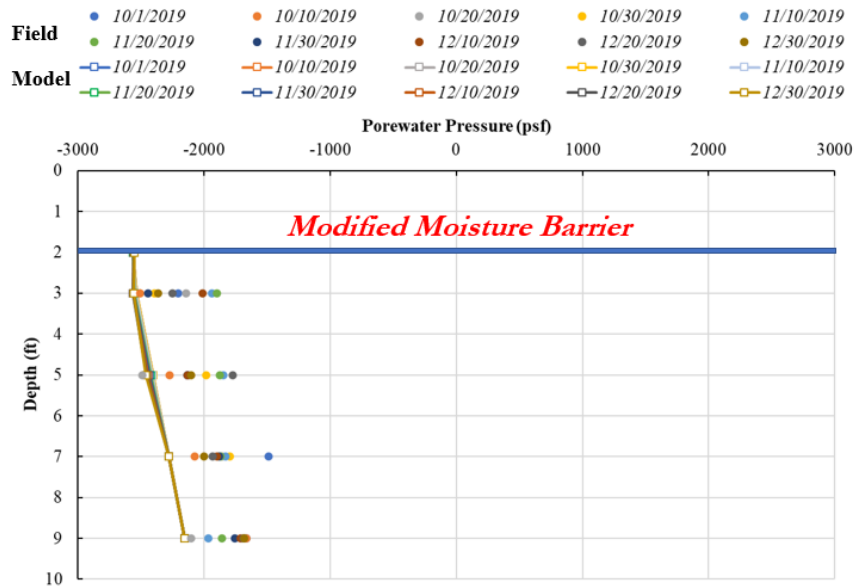
Figure 6-12 Measured and Modeled Porewater Pressure for Slope with MMB.

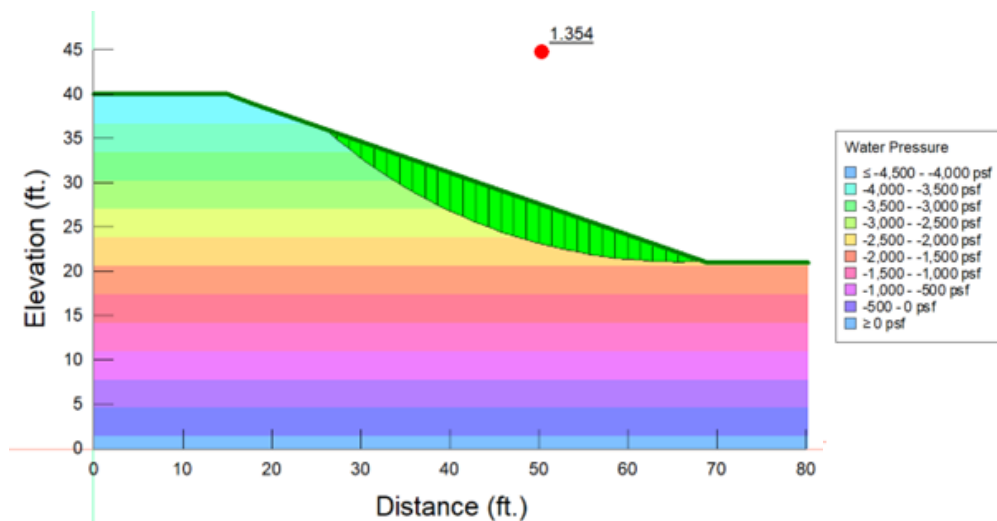
Figure 6-13 Results of Slope Stability Analysis after 90 days of Natural Rainfall for the slope with MMB.

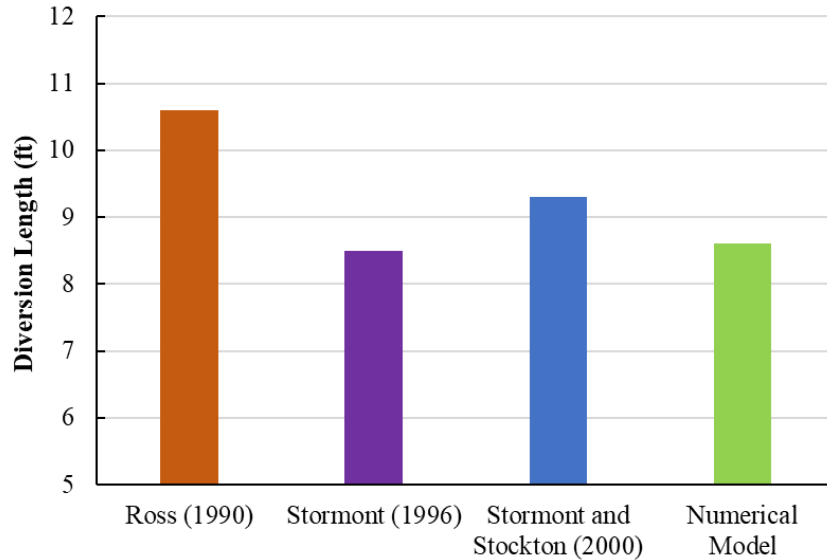
Figure 6-22 Comparison of flow diversion length obtained from numerical study and analytical solutions.

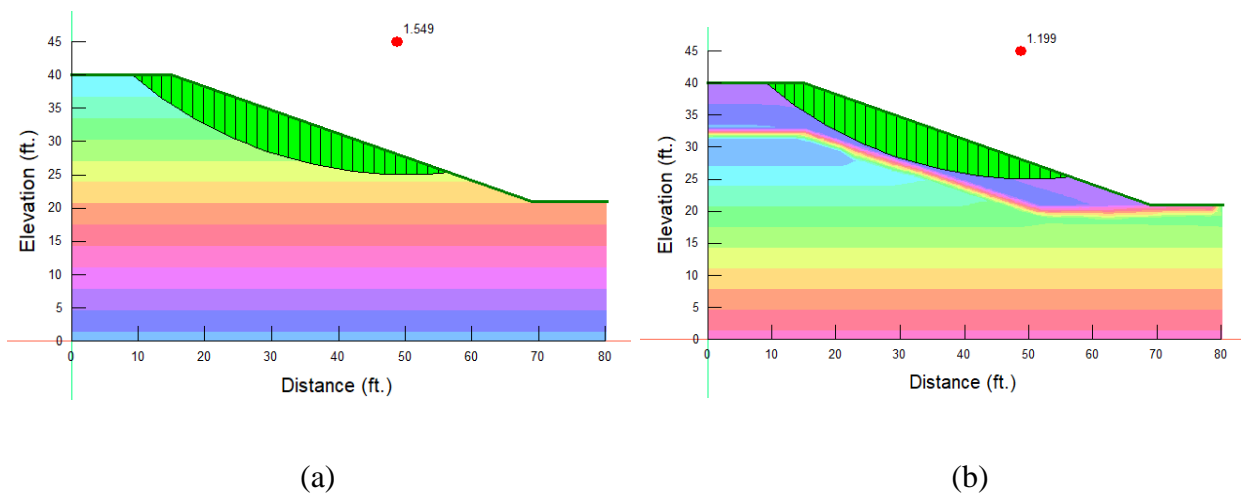
Figure 6-26 Factor of safety of recompacted slope (a) Initial (b) After Rainfall.

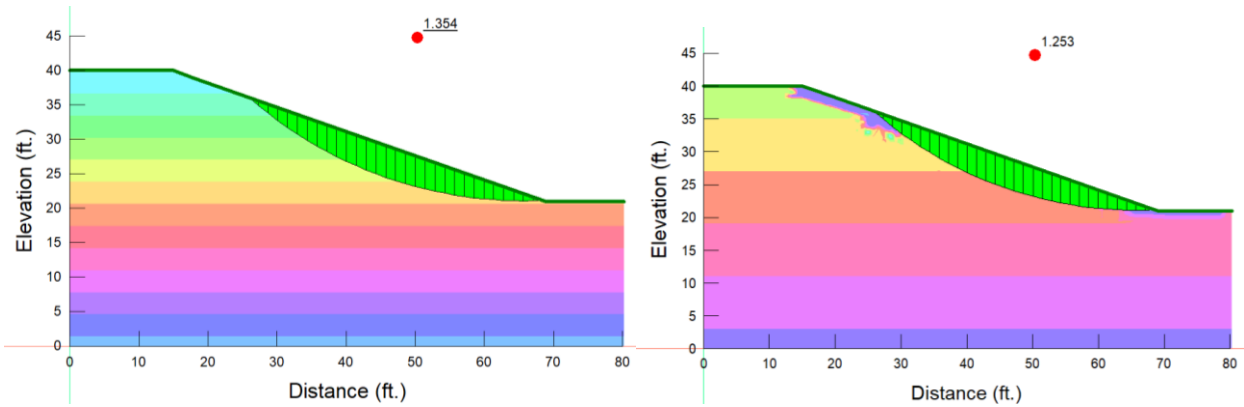
Figure 6-28 Factor of safety of slope stabilized with MMB (a) Initial (b) After Rainfall.

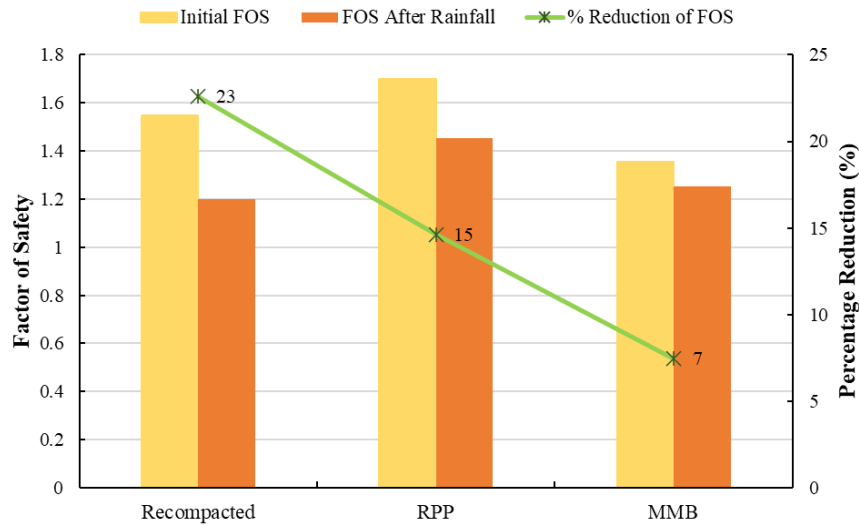
Figure 6-29 FS reduction due to rainfall for different stabilization methods.

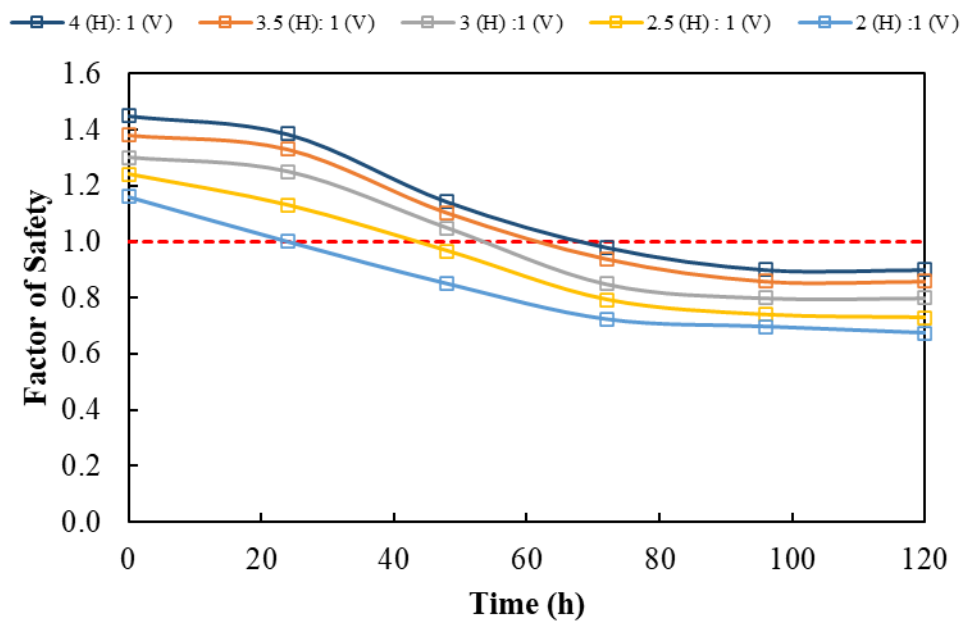
Figure 6-31 Effect of slope angle on factor of safety.

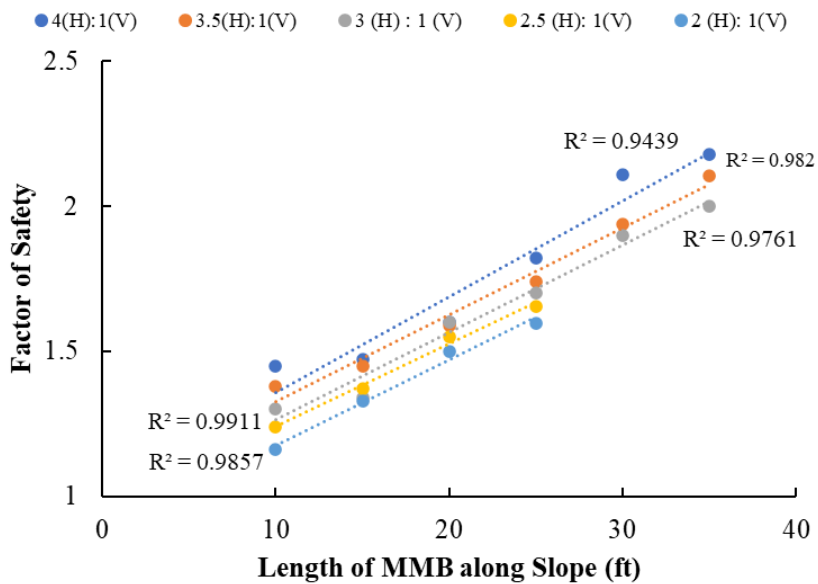
Figure 6-32 Variation of FS with respect to increase in MMB length for different slope inclination.

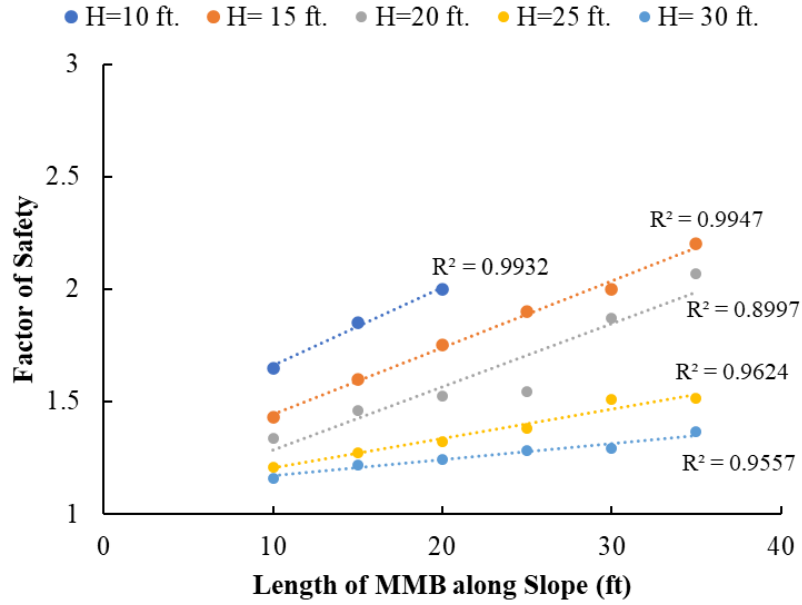
Figure 6-36 Effect of MMB on FOS for different slope heights.

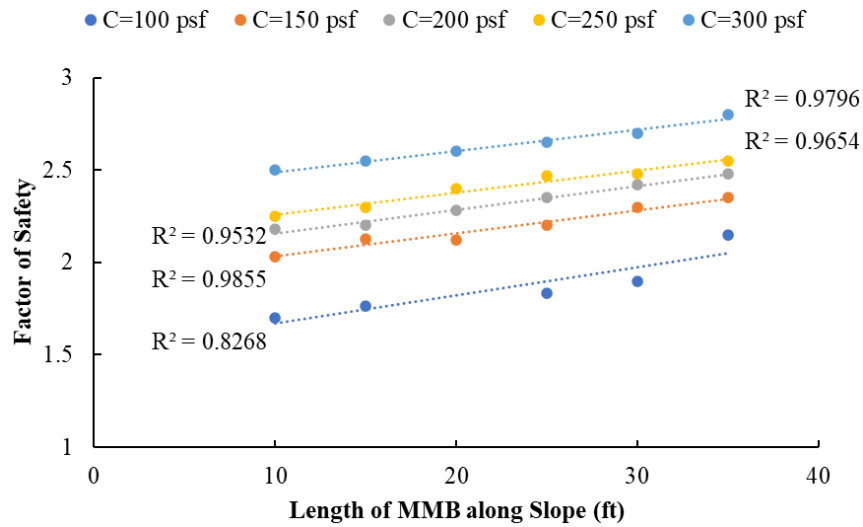
Figure 6-39 Effect of MMB on FOS for various cohesion.

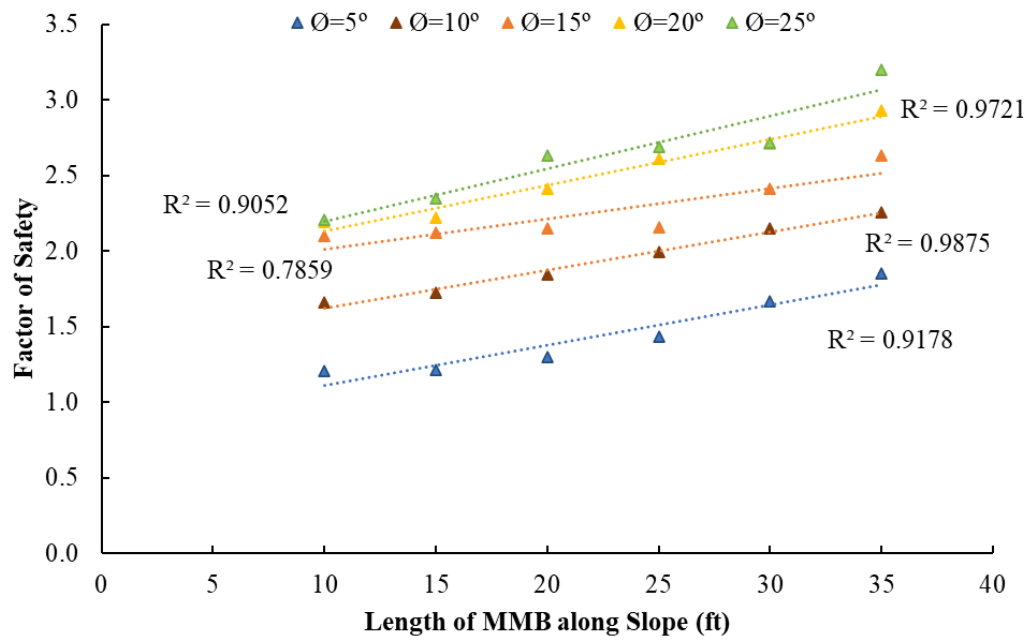
Figure 6-42 Effect of MMB on FOS for various angle of friction.

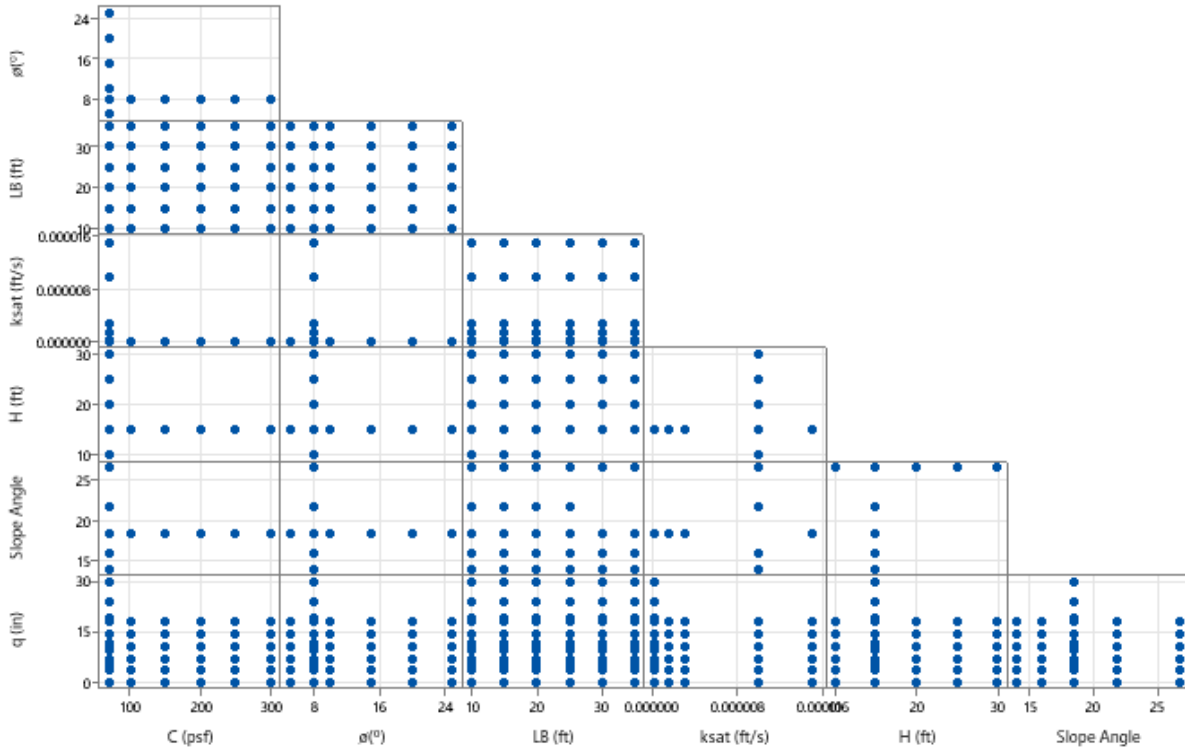
Figure 7-2 Correlation among predictor variables.

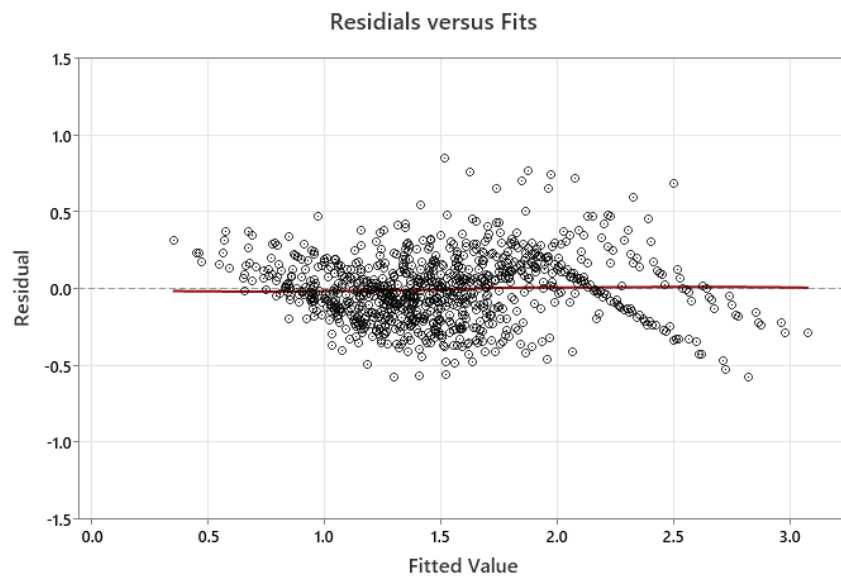
Figure 7-5 Plot of residual vs. fitted value for the preliminary model.

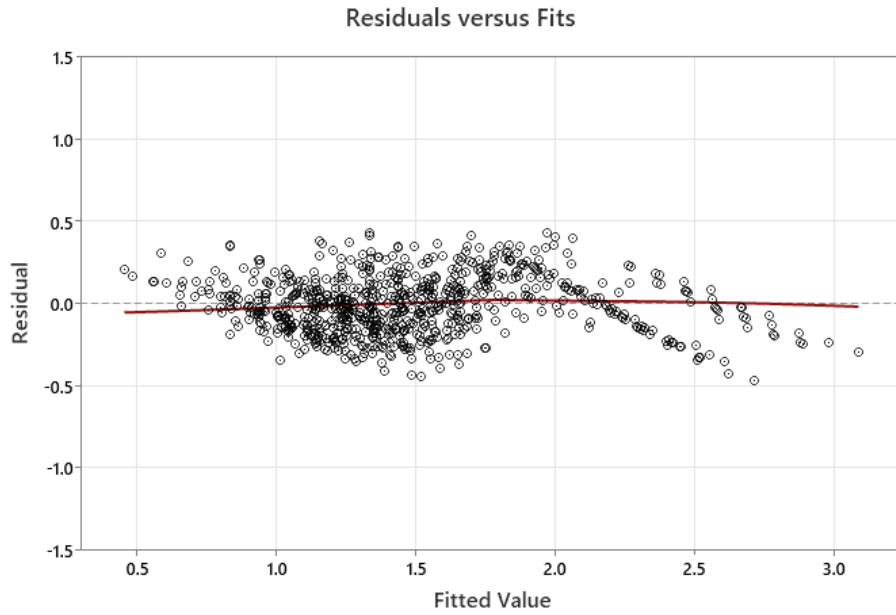
Figure 7-9 Plot of residual vs. fitted value for the final model.

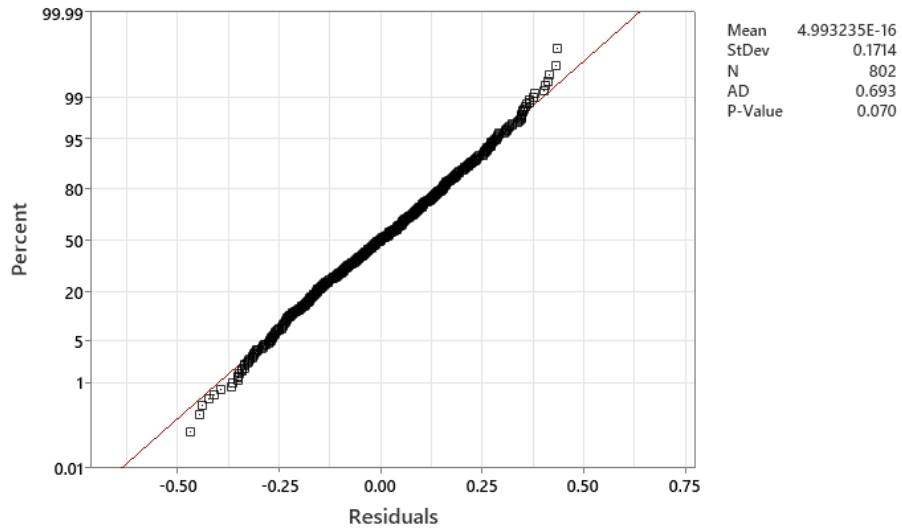
Figure 7-11 Normal probability plot for the final model.
