THE EFFECT OF FIBER CORROSION ON SHEAR CAPACITY OF STEEL FIBER
REINFORCED CONCRETE BEAMS AND AN INITIAL INVESTIGATION ON
ALKALI-SILICA REACTION IN STEEL FIBER REINFORCED CONCRETE

MASTER OF SCIENCE IN CIVIL ENGINEERING

THE UNIVERSITY OF TEXAS AT ARLINGTON

August 2011

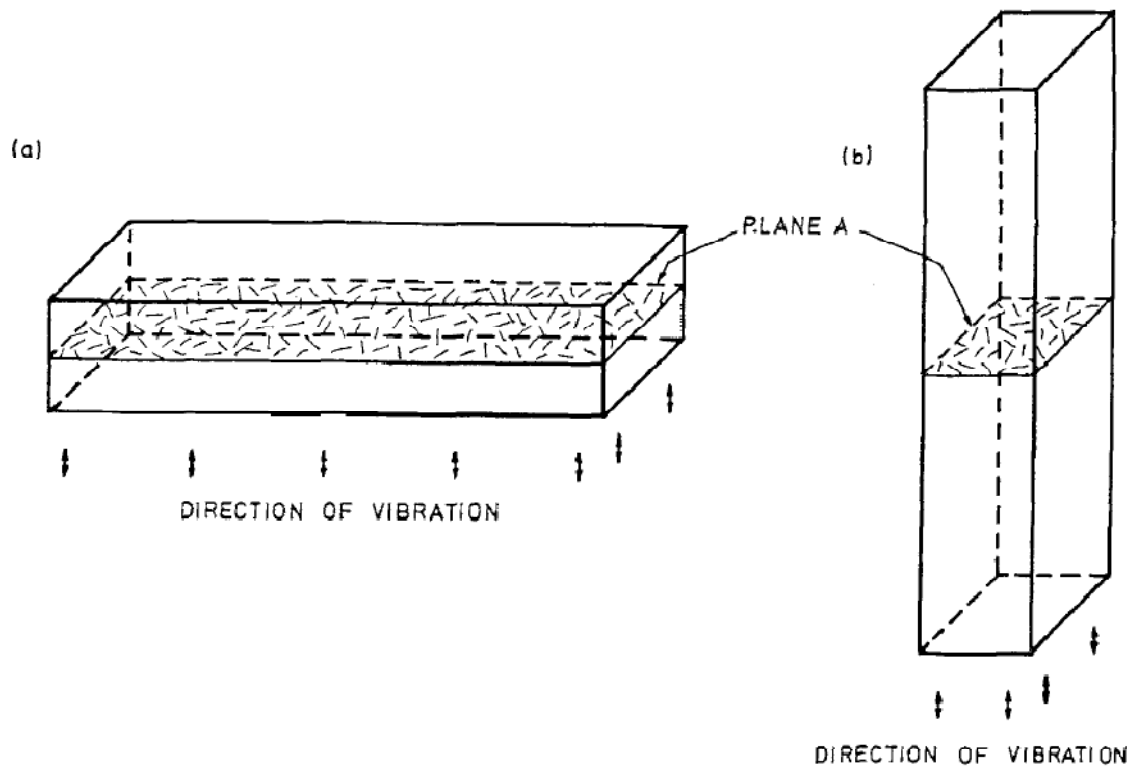
Edgington and Hannant (1972), observed that fibers tend to be aligned in horizontal planes when compacted using table vibration (Figure 2.2).

Figure 2.2 Effect of casting flexural specimens horizontally and vertically on fiber orientation (adapted from Edgington and Hannant, 1972)

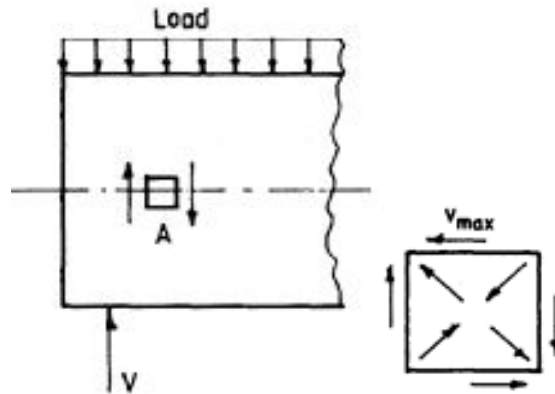
In a homogeneous elastic beam a vertical shear force will cause complimentary shear stresses and diagonal tensile and compressive stresses of the same magnitude. Figure 2.4 below shows the stresses on a small element near the neutral axis.

Figure 2.4 Shear stresses on a small element (adapted from Park and Paulay, 1975)

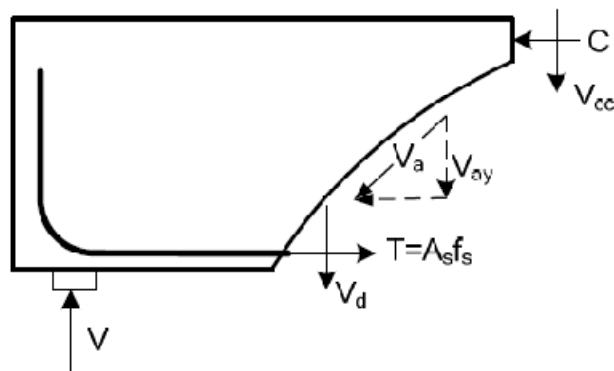
A simply supported beam over which the shear force is constant is shown in Figure 2.5 below.

Figure 2.5 Shear resisting components after formation of diagonal crack (adapted from Dinh, 2009)

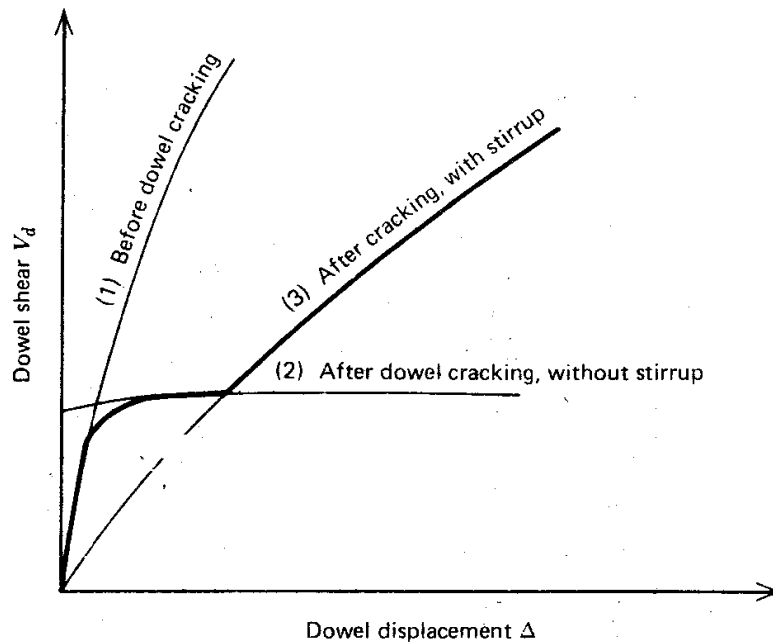
In beams without shear reinforcement, the contribution of dowel action is not more than 25 percent of the total cantilever resistance. Dowel action is more significant in the presence of stirrup reinforcement as these will aid in confining the longitudinal bars. Cracks will develop parallel to the longitudinal bar before the stirrups can come in and contribute to carrying dowel forces. The Figure 2.6 below shows the qualitative load-displacement relationships for dowel action.

Figure 2.6 Shear-dowel displacement relationships (adapted from Park and Paulay, 1975)

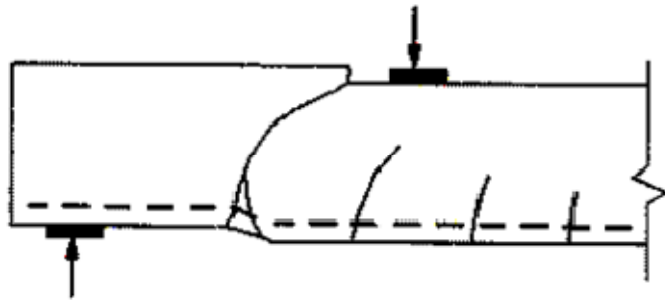
1. **Diagonal tension failure:** An inclined crack propagates rapidly due to inadequate shear reinforcement.

Figure 2.7 Diagonal tension failure

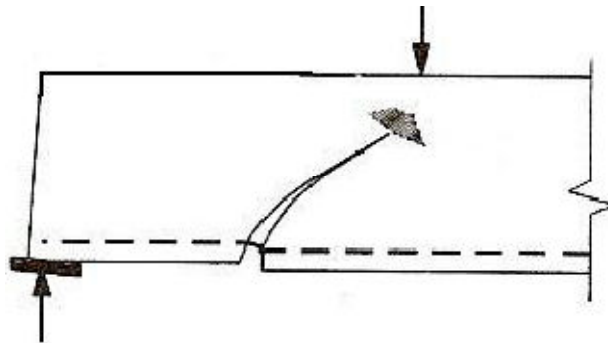
2. **Shear compression failure:** Crushing of the concrete occurs near the compression flange above the tip of the inclined crack.

Figure 2.8 Shear compression failure

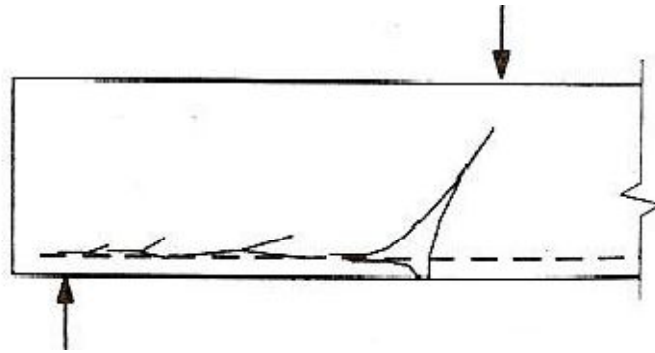
3. **Shear tension failure:** The diagonal cracks propagate horizontally along the longitudinal bars due to lack of enough anchorage.

Figure 2.9 Shear tension failure

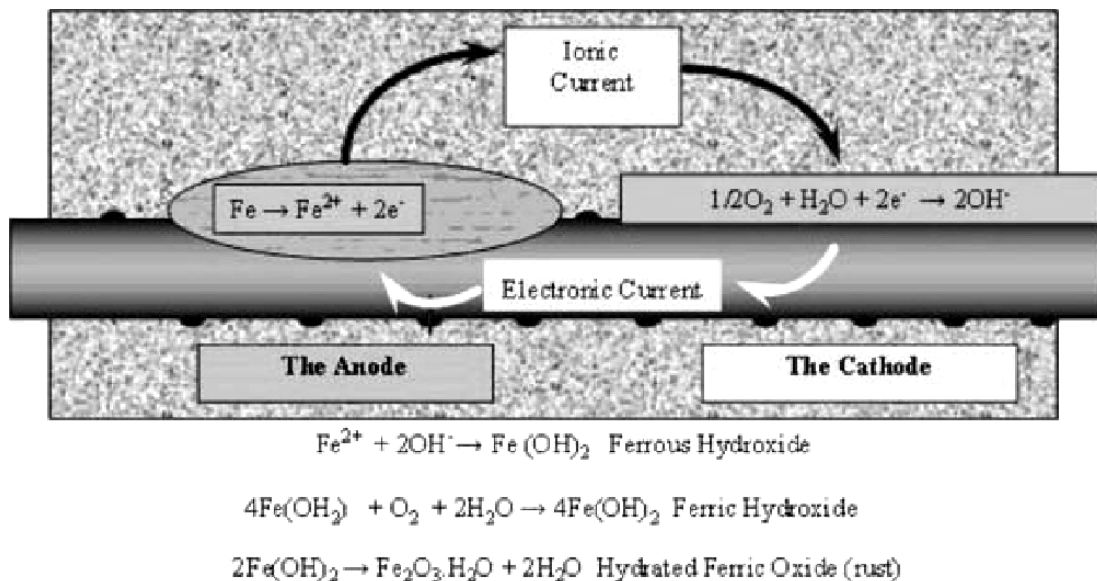
Figure 2.10 Corrosion process (adapted from BS EN 1504)

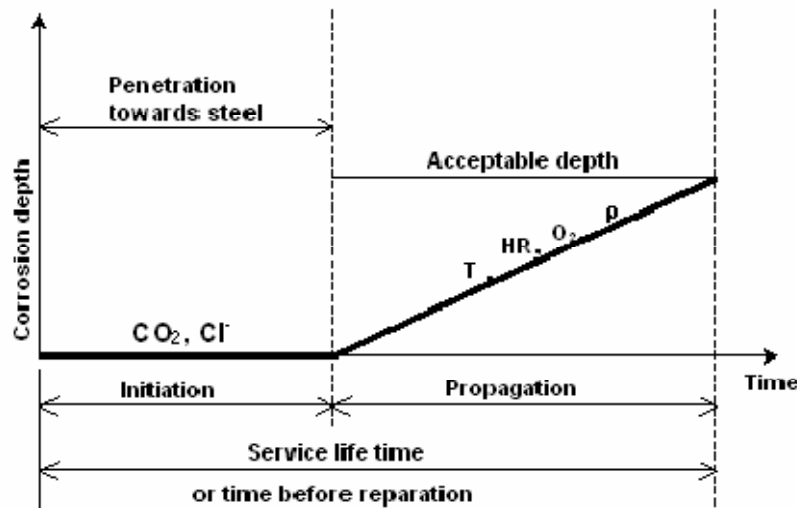
Figure 2.11 Stages of Corrosion (adapted from Tuutti, 1982)

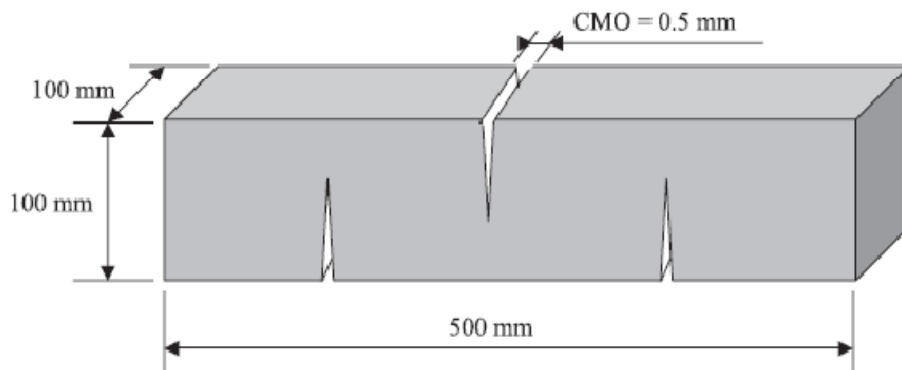
Granju and Balouch (2004) investigated the effect of corrosion of fibers on the spalling of concrete as well as its influence on the durability of the structure. The tests were performed on cracked SFRC specimens with 0.5mm crack widths exposed to marine-like environment for one year. Concrete prisms of 10 x 10 x 50cm in dimension were cast and cured for one week before being cracked in three positions as shown in the Figure 2.14 below.

Figure 2.14 Crack positions (Granju and Balouch, 2004)

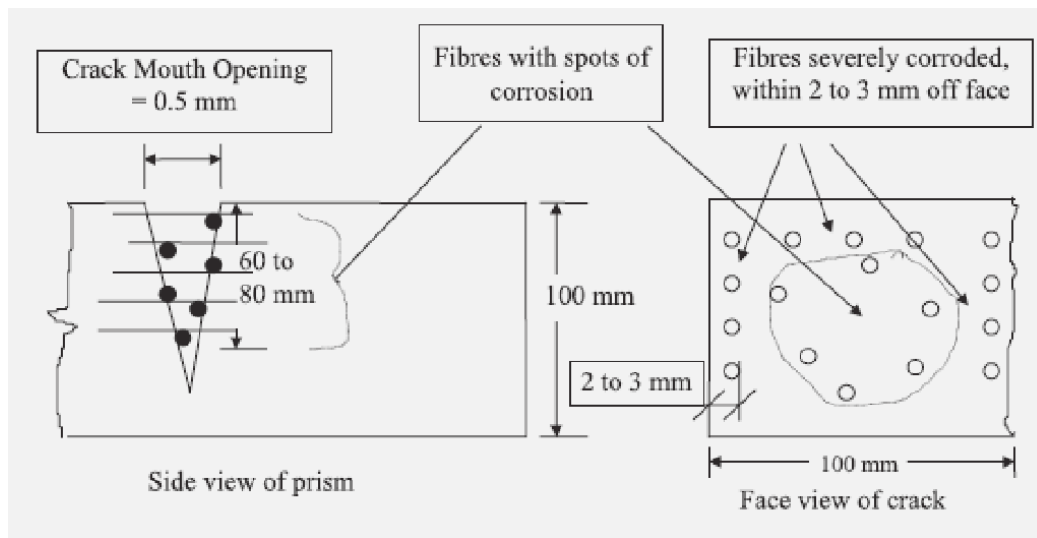
the researchers came to the conclusion that the light corrosion that had developed at the surface of the fibers enhanced their bond through increased friction with the cement matrix. The visual examination carried out on the specimens after the flexural test showed that no concrete bursting or spalling had occurred due to corrosion of fibers. They also observed that fibers within a rim of 2 to 3mm wide from the surface of the specimen were severely corroded (Figure 2.15).

Figure 2.15 Visual examination of corrosion in the crack

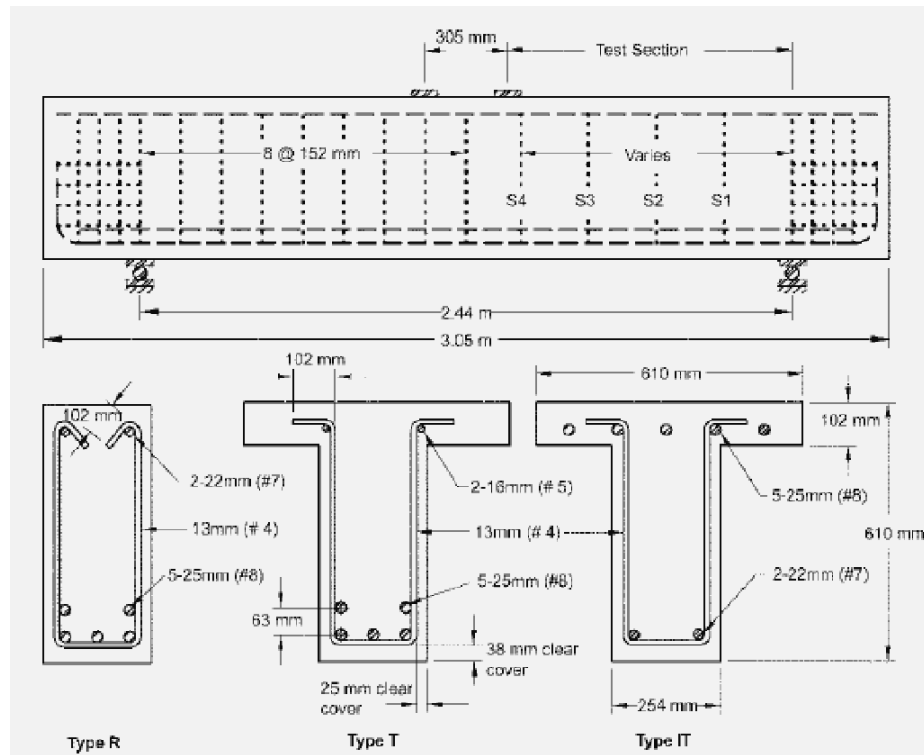
Higgins and Farrow (2006) investigated the corrosion of stirrups and its effect on the shear capacity of conventionally reinforced concrete beams. Large size beam specimens were cast and the embedded stirrups subjected to accelerated corrosion. Three different cross sectional shapes were investigated as shown on Figure 2.16 below. The flexural reinforcement was epoxy coated to isolate corrosion to the stirrups.

Figure 2.16 Specimen cross sections (Higgins and Farrow 2006)

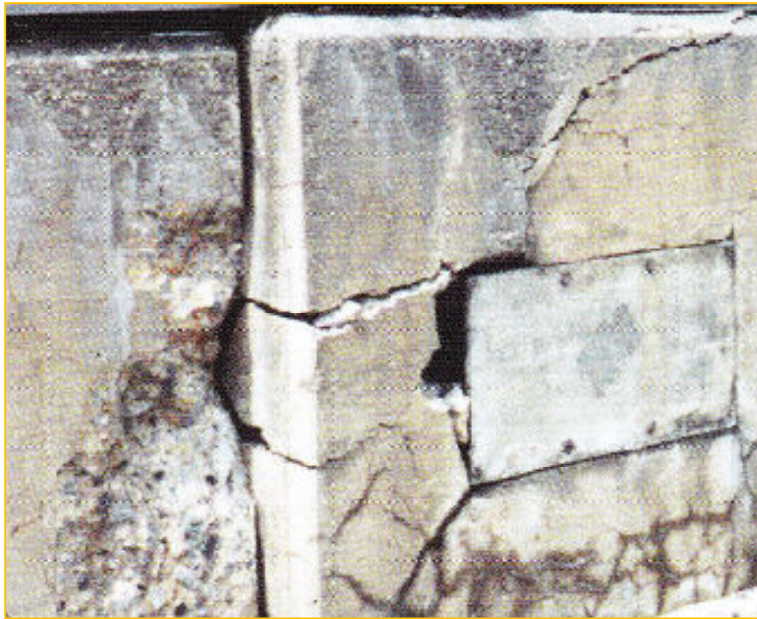
Figure 2.18 Noticeable cracking, joint closing and spalling of concrete surface on parapet wall due to ASR (adapted from ACPA, 2007).

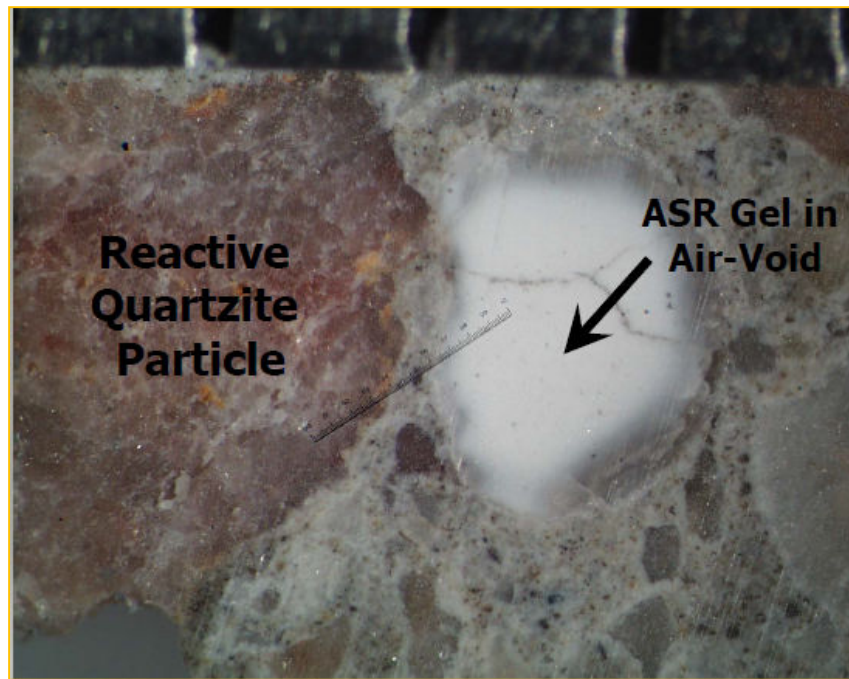
When a sample of affected concrete is cut open, the gel appears to be transparent, having a resinous appearance with a viscosity between that of thick motor oil and resin (Figure 2.19). Typically gels will carbonate with time and with exposure to air to become white and hard with cracks similar to the ones seen in dried mud. Researchers are advised to look for gel immediately after breaking the suspected concrete because drying of the gel on the surface of the concrete make it less visible. Cores taken from structures suspected to be affected by alkali-silica reaction are usually wrapped in layers of cling film and sealed in polythene while still moist from coring process. This is done to allow the gel to be identified on the surface on concrete when unwrapped the gel appears as shiny or sweaty patches on the surface. This occurs due to the hygroscopic nature of the gel (Swamy, 1992).

Figure 2.19 The ASR gel (Rangaraju, 2008)

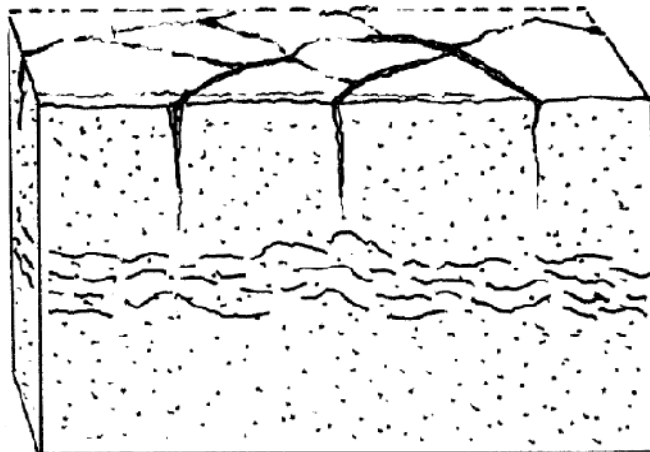
Figure 2.20 shows the different types of cracks that can help to identify a structure affected by ASR.

Figure 2.20 The sketch shows some typical features of map cracking and sub-parallel cracks due to ASR (adapted from ACI, 2008).

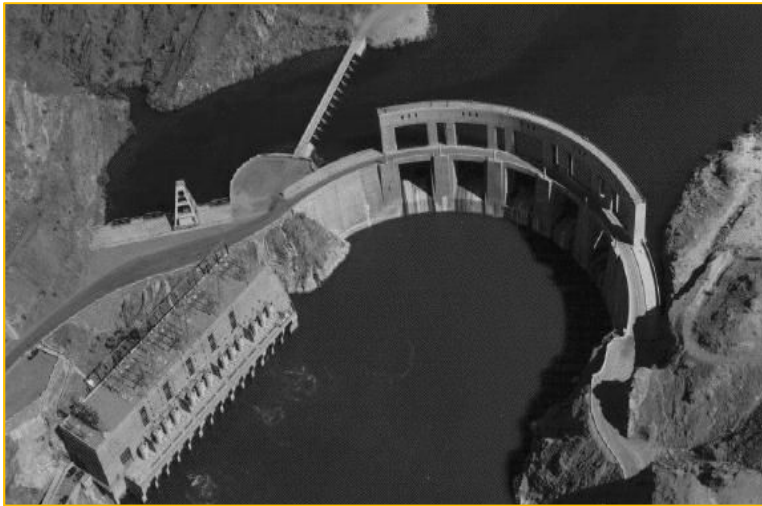
The hydroelectric dam (Figure 2.21) built in 1938 that experienced 180 mm of arch deflection due to alkali silica gel expansion. Also noted was cracking and gel flow in the concrete (www.people.ce.gatech.edu).

Figure 2.21 Alkali-Aggregate Reactions in Hydroelectric Plants and Dams (adapted from <http://www.acres.com/aar/>)

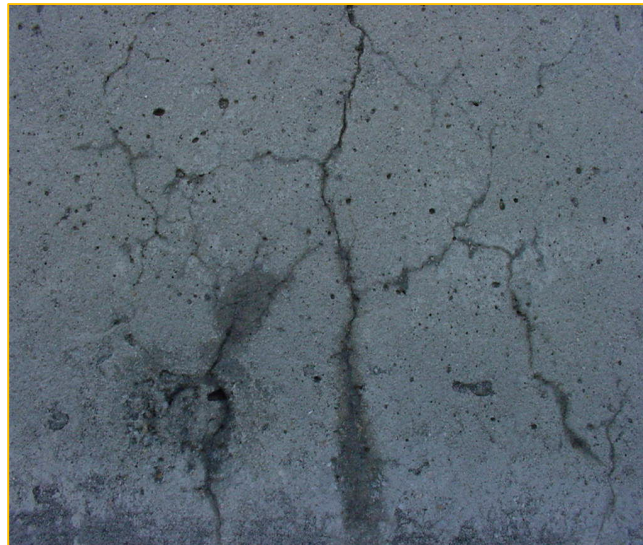
Figure 2.22 Possible ASR damage on concrete retaining wall (adapted from www.people.ce.gatech.edu)

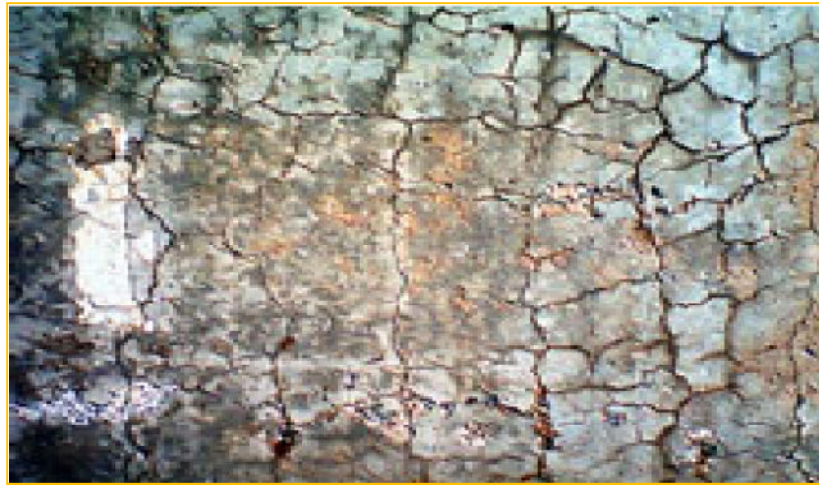
ASR was reported on the pile head of bridge in Sg. Pontian. Random map cracking was observed (Figure 2.23) and a full analysis was conducted by Dr. Hashim of the University of Malaysia who confirmed the presence of ASR.

Figure 2.23 Map cracking on bridge in Sg. Pontian

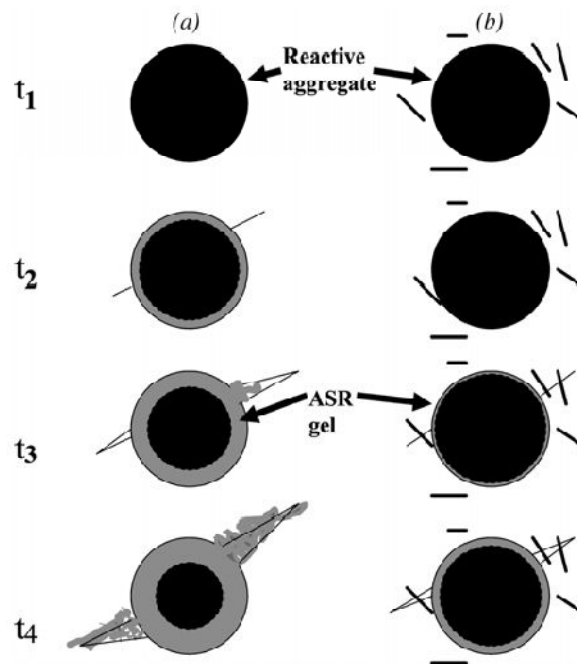
Figure 2.24 ASR gel formation in (a) control specimen and (b) in SMF mortar specimen

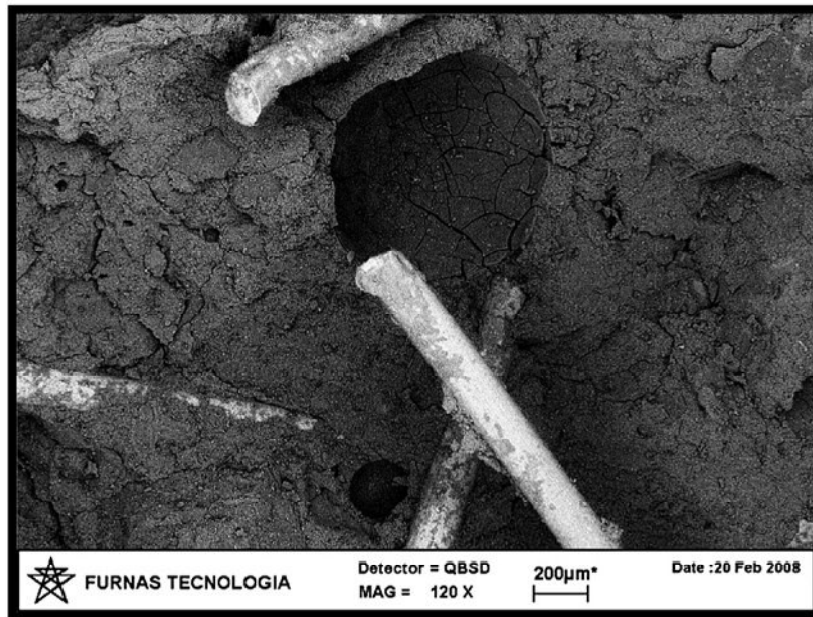
They observed that the fibers bridged the cracks reducing the macroscopic mechanical expansion (Figure 2.25). The flexural test showed that that the higher the contents of fibers, the higher the capacity of the specimens to absorb energy.

Figure 2.25 Pore filled with cracked gel, and fibers around the pore (Carvalho et al., 2009)

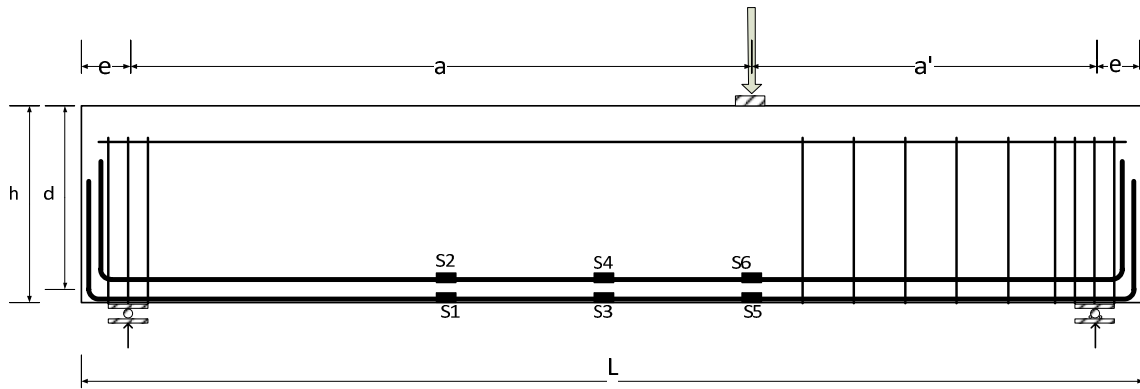
The length of the bottom reinforcement was designed such that no anchorage failures would occur (Figure 3.2) and the shorter shear span was reinforced with stirrups to ensure a shear failure in the longer shear span. For anchorage, 90° hooks were used for the bottom bars as shown in Table 3.4. A detailed reinforcement specification is shown in Appendix I.

Figure 3.2 Basic beam layout

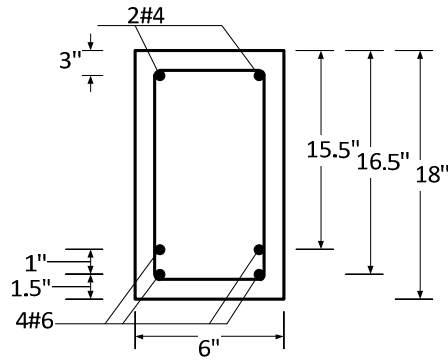
Figure 3.4 Typical beam cross section

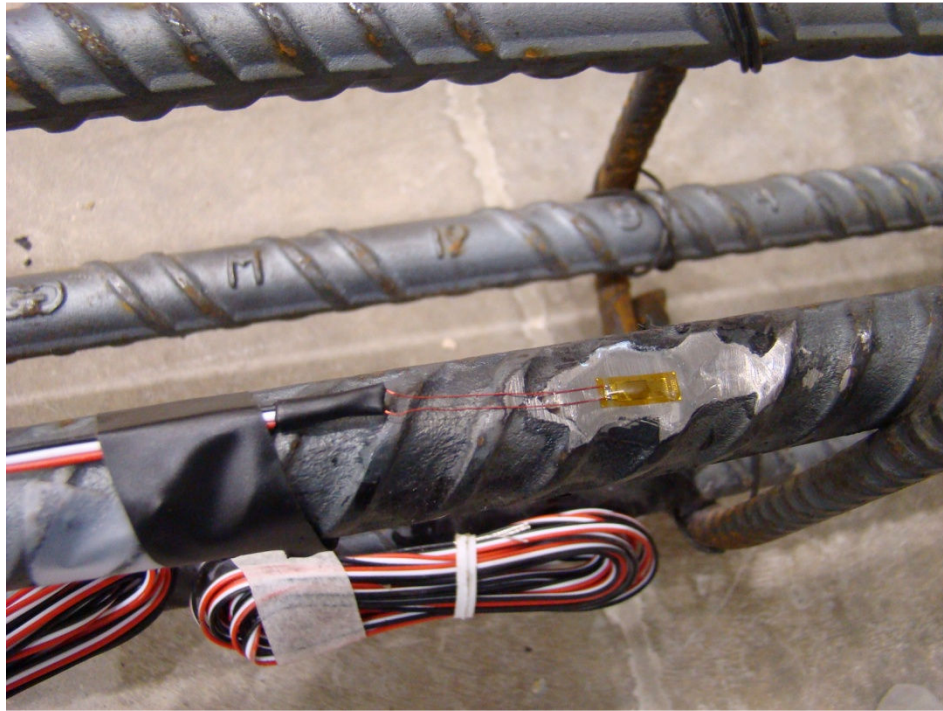
Foil-type strain gauges were installed on the top side of the tensile reinforcing bars. Six strain gauges labeled S1 to S6 were placed at a spacing of 15 inches starting from the loading point. Each strain gauge was glued to a degreased flat area through cyanoacrylate glue and protected by three coating layers, namely polyurethane, nitrile coating, and a rubber pad sealed by electric liquid tape. The Figure 3.5 below shows the mounting of the strain gauge. A voltmeter was then used to check that the strain gauges are working correctly.

Figure 3.5 Attachment of the strain gauge onto the bar

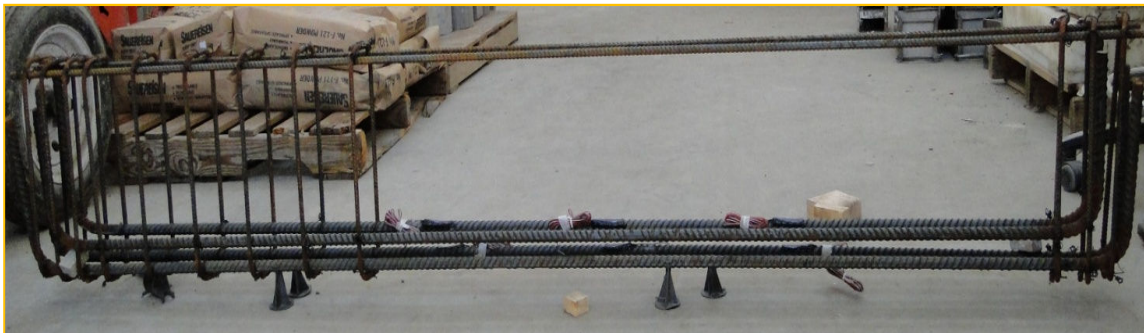
avoid damage to the mounted strain gauges. Wooden formwork was fabricated and oiled prior to placement of the reinforcement cage. Stiffeners were attached to the sides of the formwork to avoid bulging in the formwork after concrete is poured. A one inch concrete cover was obtained by placing one inch concrete blocks between the reinforcement cage and the formwork while the cage was fixed into position using wire tied to the formwork. The stirrup locations were then marked by a permanent marker on the top sides of the formwork so that their exact location in the beam could be known. The strain gauge wires were loosened and then taped to the formwork to prevent them from falling in while casting and to give enough sag to prevent them from pulling off. The end of the strain gauge wires was then covered with plastic bags to prevent them from coming into contact with moisture. Clamps were also used during the pouring of concrete to prevent the top part of the formwork bulging due the pressure of the concrete hence maintain the required width. Hooks were installed into the beams at the time of casting to facilitate the lifting and moving of the beam. Figure 3.6 below shows a completed reinforcement cage while the formwork is shown on Figure 3.7

Figure 3.6 Reinforcement cage

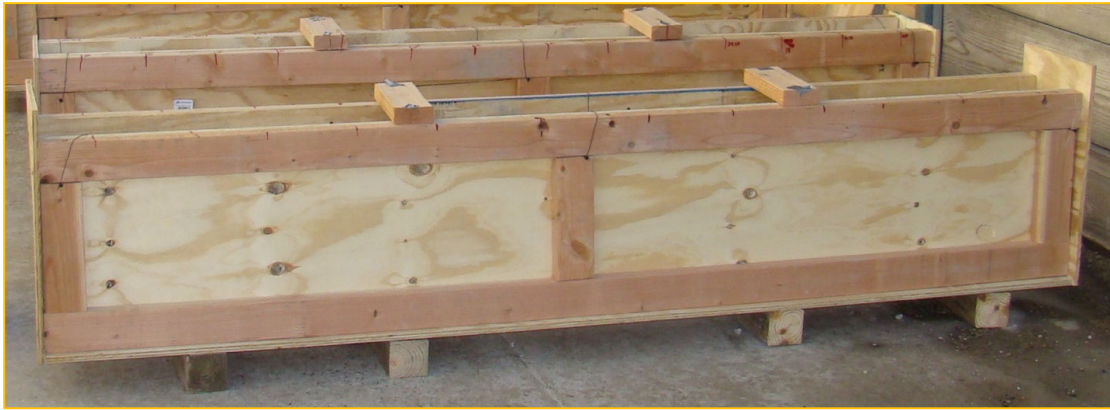
Figure 3.7 Fabricated formwork

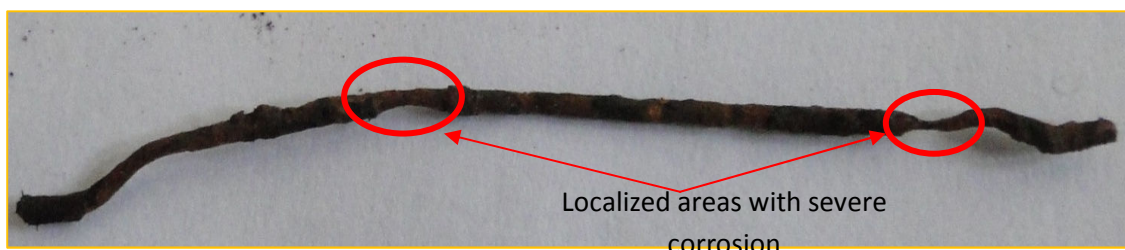
To make it possible to measure the loss in fiber diameter, the fibers were cleaned to remove all corrosion products by brushing off. The diameter was measured by a digital caliper. It should be noted that the corrosion of the fibers is not even at most times as was explained earlier in chapter two due to pitting (Figure 3.9). Thus the fibers were measured along their length and the least diameter recorded. The least diameter was used realizing the fact that this will be the area of least resistance in the fiber and hence will be the controlling one. The loss in minimum diameter is presented as percent of the original diameter.

Figure 3.9 Fiber pitting

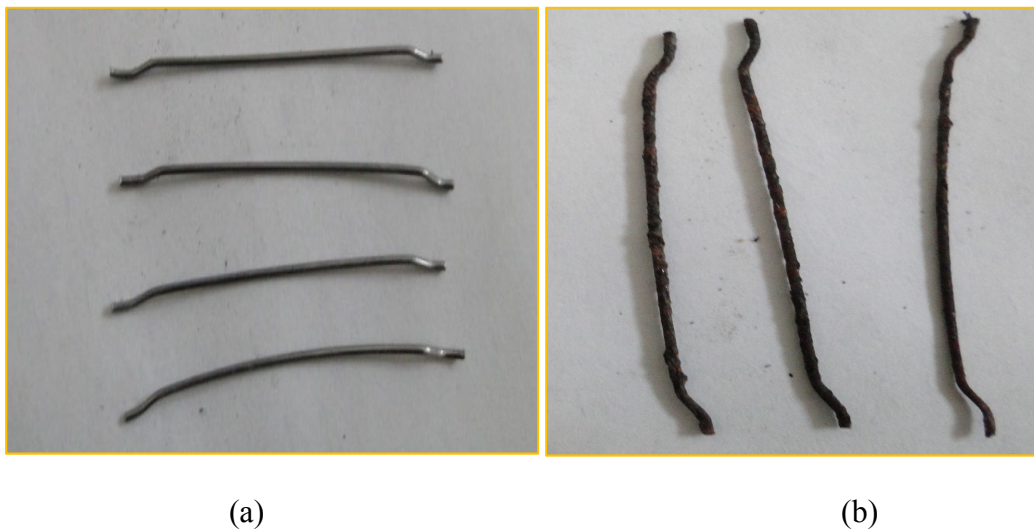
Initially, weighing of fibers to estimate the corrosion extent was an alternative. This idea was however discarded as it is not a realistic approach since there will be at least a 1% variance in original weight. If the fiber diameter reduces by 10% on a 3mm length fiber, it would not be detectable. By measuring say 60 fibers it gives a variance of 0.8% in original diameter which is acceptable. Figure 3.10 below shows the original fibers and fibers with 50% reduction in diameter.

Figure 3.10 Fibers with (a) no corrosion and (b) with 50% corrosion

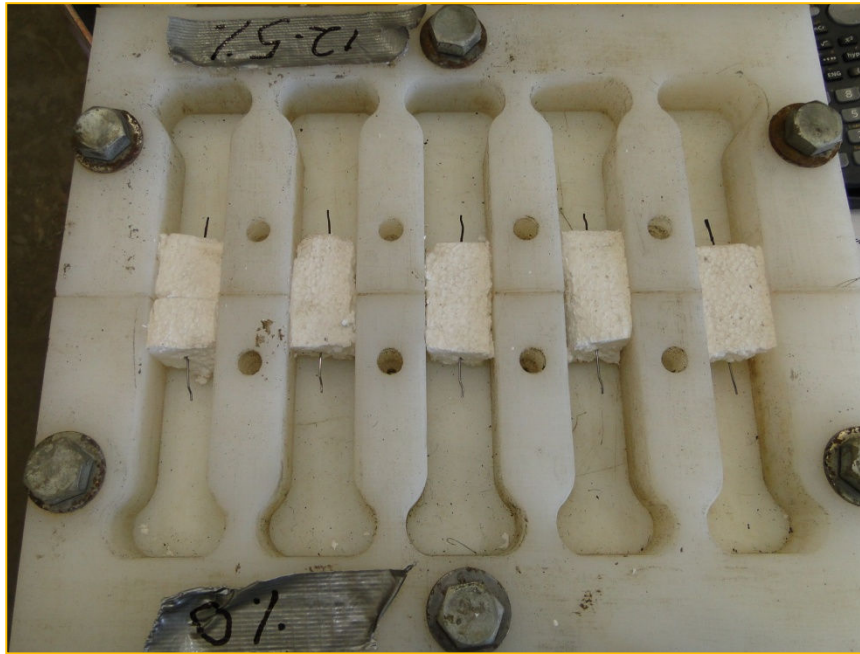
Fiber pullout tests are generally used as an indirect method to evaluate bond. The test specimens were prepared using Plexiglas molds having 0.98 x 0.90 in. cross section and 2.76 in. length. Fibers were selected from each of the corrosion extents and embedded within the desired embedded length ($l_d/4$). The fibers were kept in place by embedding them in styrofoam blocks measuring 1x 2 in. The Figure 3.11 below shows the specimen preparation. The concrete mix was poured into the moulds and lightly vibrated. The specimens were then finished and covered by plastic sheet for 24 hours; after which they were demoulded, labeled and stored for testing. Figure 3.12 shows the demoulded pullout specimen.

Figure 3.11 Fiber pullout specimen preparation

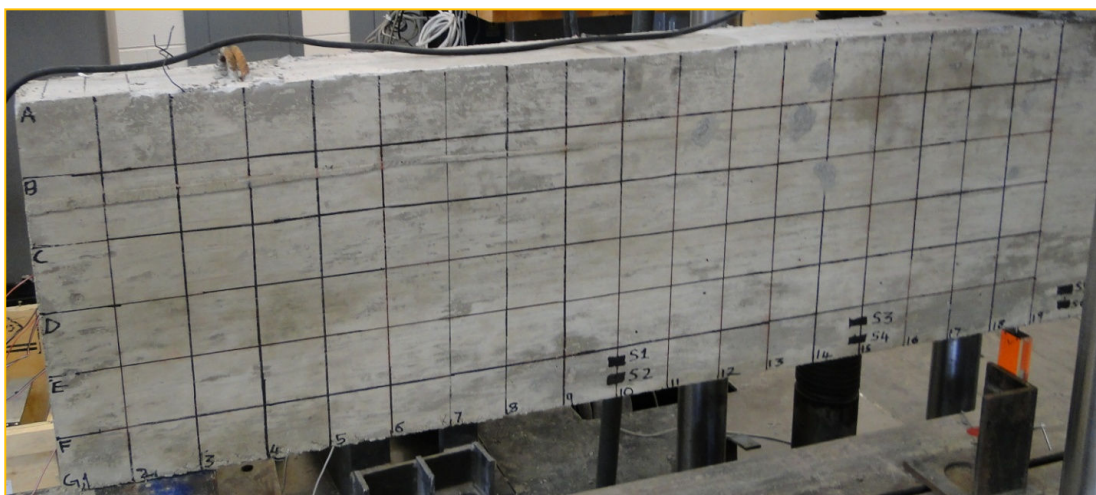
Grids measuring 3x3 in. were drawn on the beam throughout the entire shear span and labeled. These were useful to ensure that the cracks drawn on paper were at the exact position as those on the beam. Figure 3.14 below shows the grids as well as position of the strain gauges drawn on the beam.

Figure 3.14 Grid lines and strain gauges positions

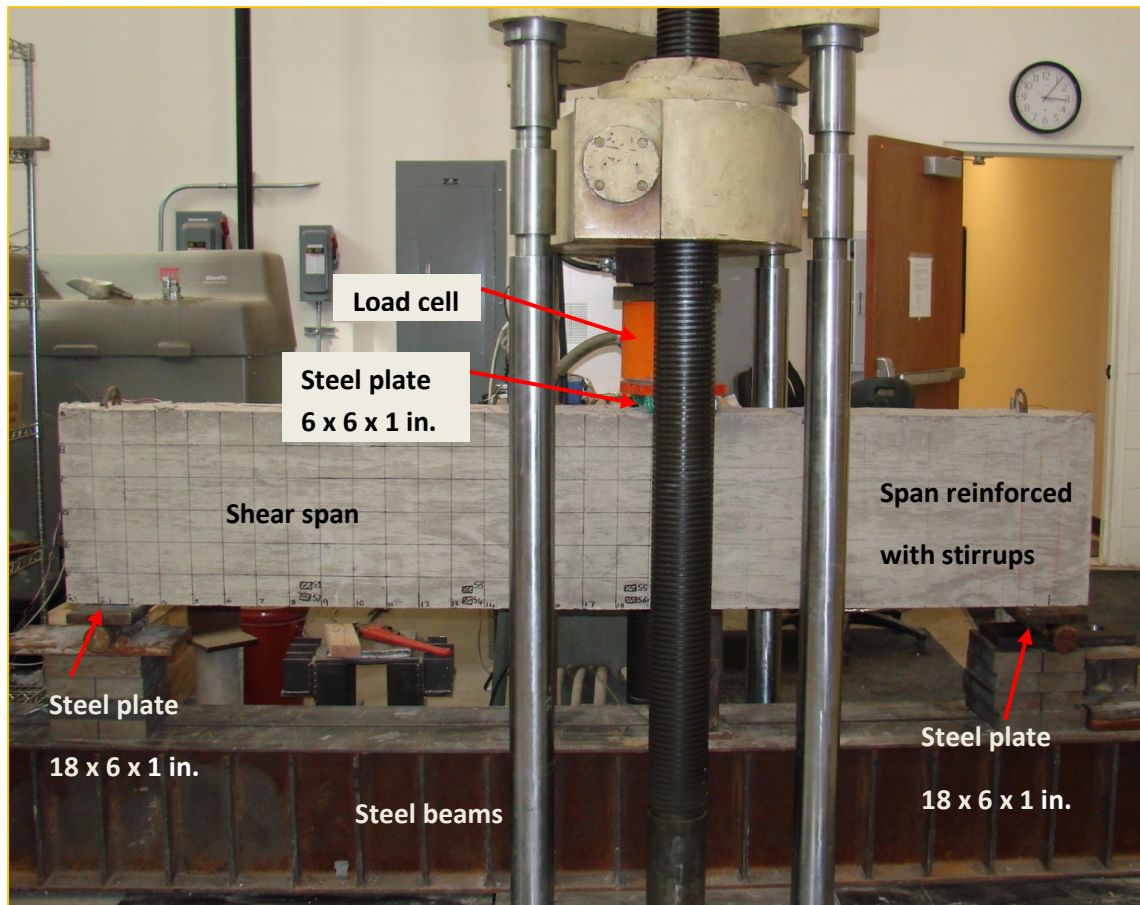
The beams were tested using a 400 kips universal testing machine under monotonic loading. The force from the machine was measured by an external 500-kip load cell placed between the beam and the actuator which was also attached to the data acquisition system. As mentioned earlier a non-shrink grout was applied between the beam and the plate and then the load cell was placed after the grout had hardened. The beam was supported on both sides at 4 inches from the end of the beam. Plates measuring 18 x 6 x 1 in. were used at the support whereas at the load point, a plate measuring 6 x 6 x 1 in. was used (Figure 3.15). These plates were used at the supports and the loading point to distribute the loads such that bearing stresses remained below acceptable limits. The test specimens were placed on top of steel spreader beams.

Figure 3.15 Beam test setup

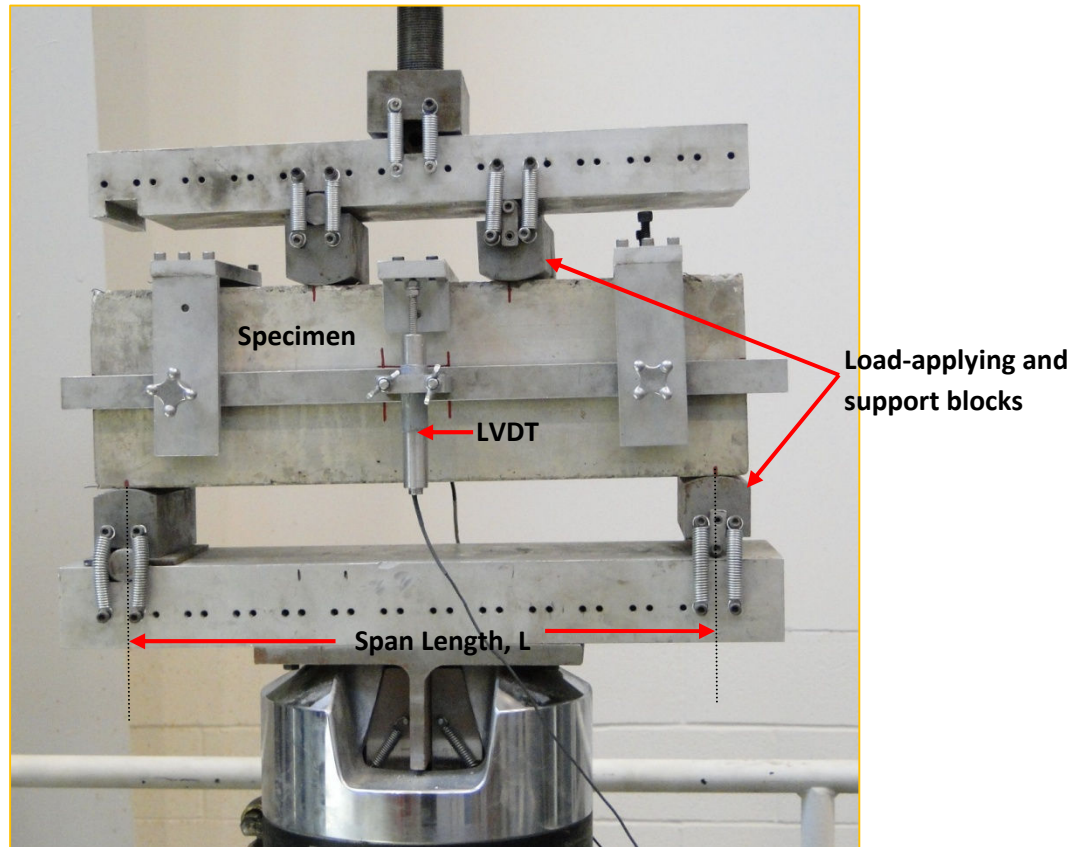
were loaded at a rate of 0.005 inches per second. Two linear variable differential transducers (LVDT) were attached on each side of the beam to measure the net deflection of the beam. The test was terminated at a net deflection of 0.12 in. which is equivalent to 1/150 of the span length.

Figure 3.17 ASTM Beam Setup

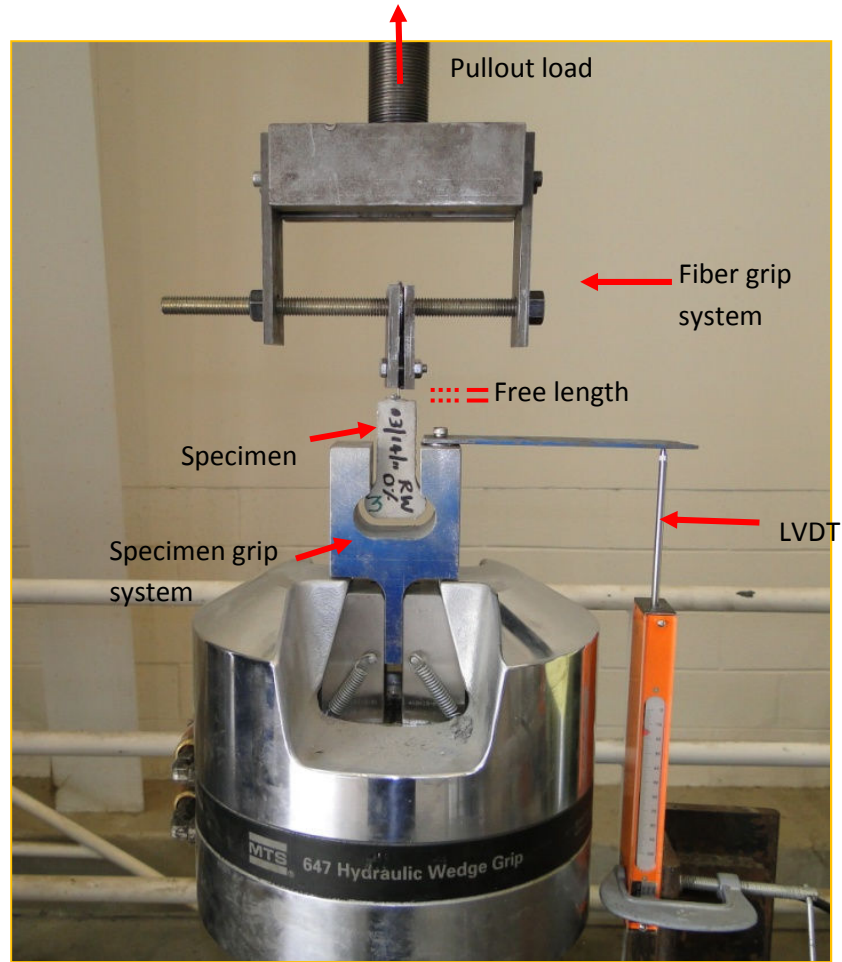
The top of the specimen was gripped by a specially designed clamp which was attached to the load cell of the testing machine. The body of the specimen was restrained by a grip used to test ASTM tensile mortar specimens. The free length of the specimen should be minimized in order to simulate a fiber pulled in a typical cracked tensile specimen and minimize the effects of free elongation of the fiber. One LVDT was placed to the side of the specimen to measure the differential movement between the fiber end and the fixed matrix specimen (slip). Figure 3.18 below show the test setup as described above.

Figure 3.18 Fiber pullout test setup

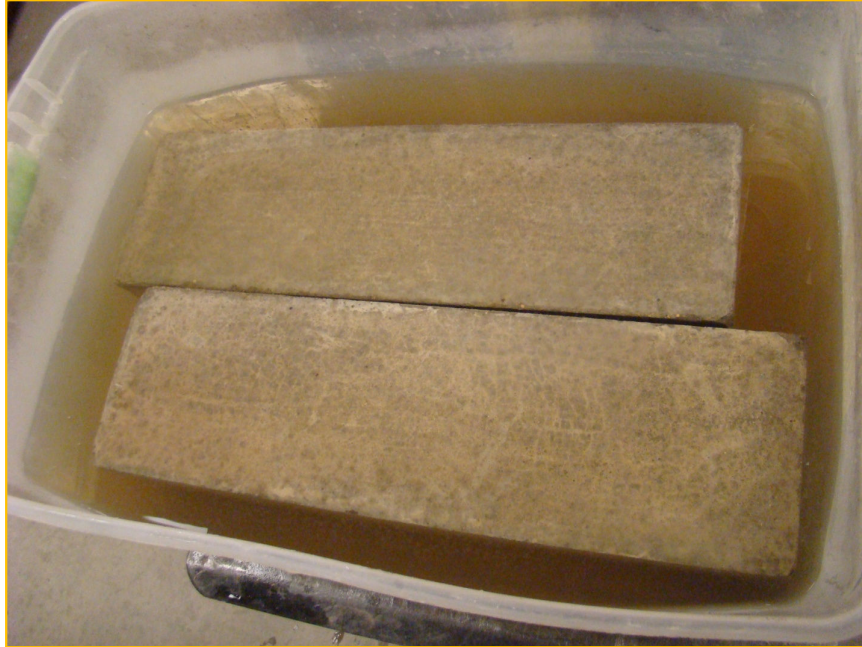
Figure 3.21 Specimens immersed in 1N NaOH solution.

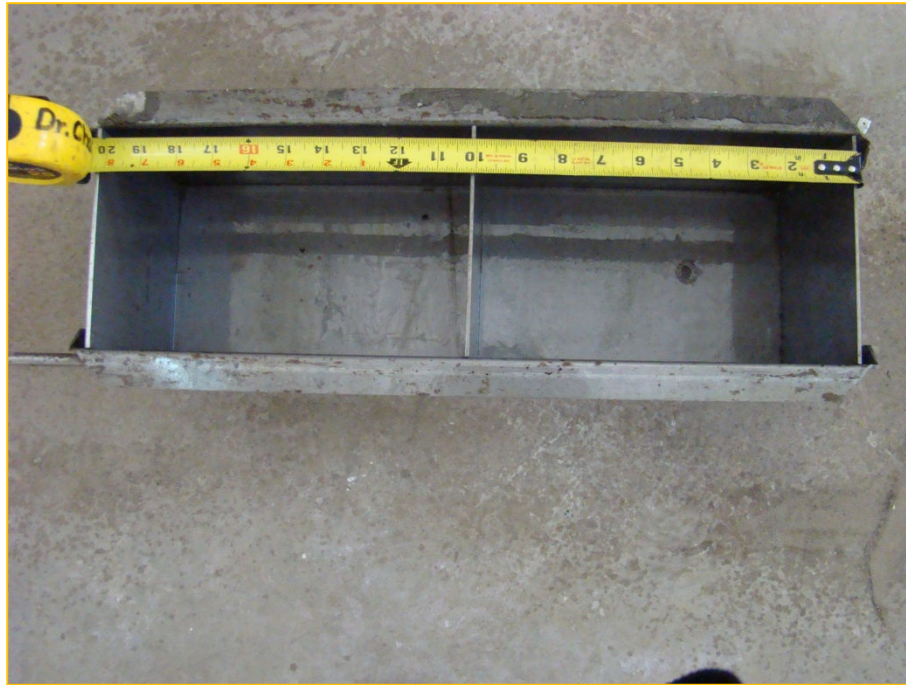
Figure 3.22 Partitioning of the ASTM beam into two equal sections.

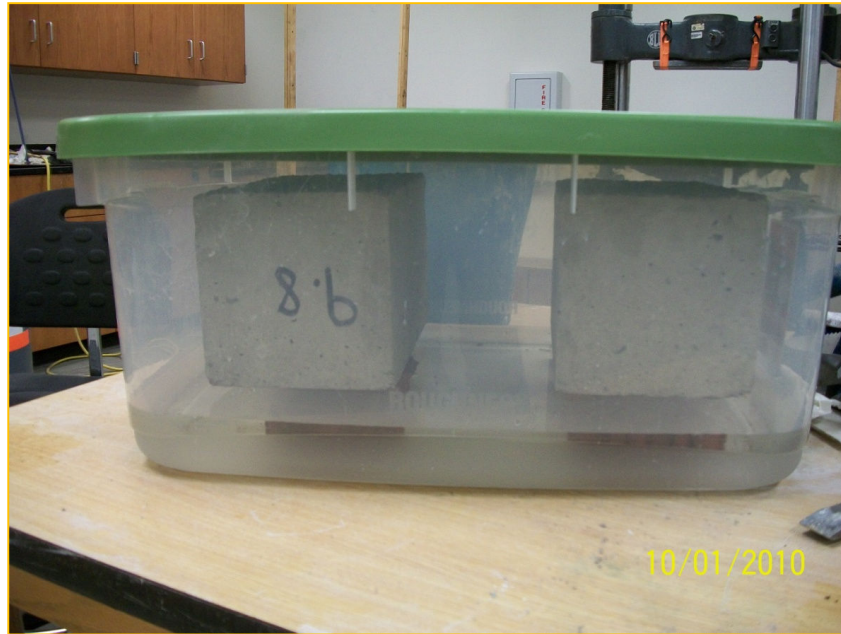
Figure 3.24 Specimen conditioning setup

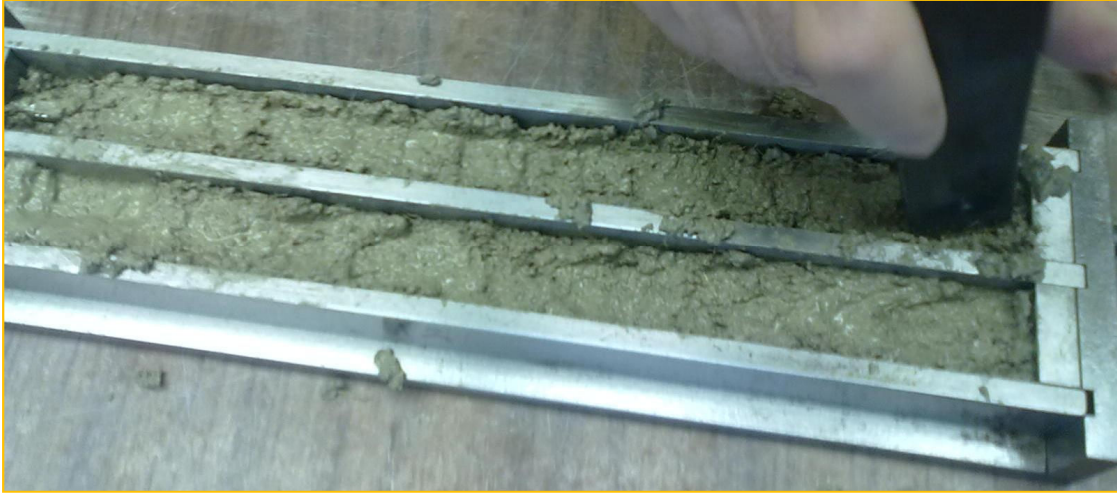
Figure 3.25 Compaction of the mortar in the mold

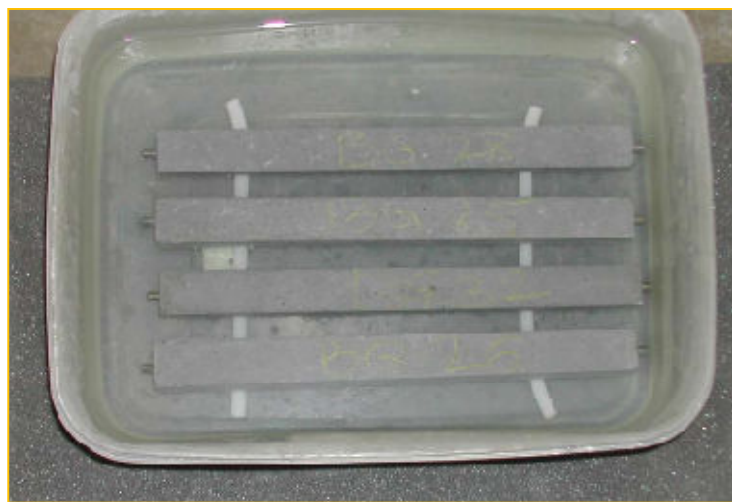
Figure 3.26 Specimen conditioning in NaOH solution

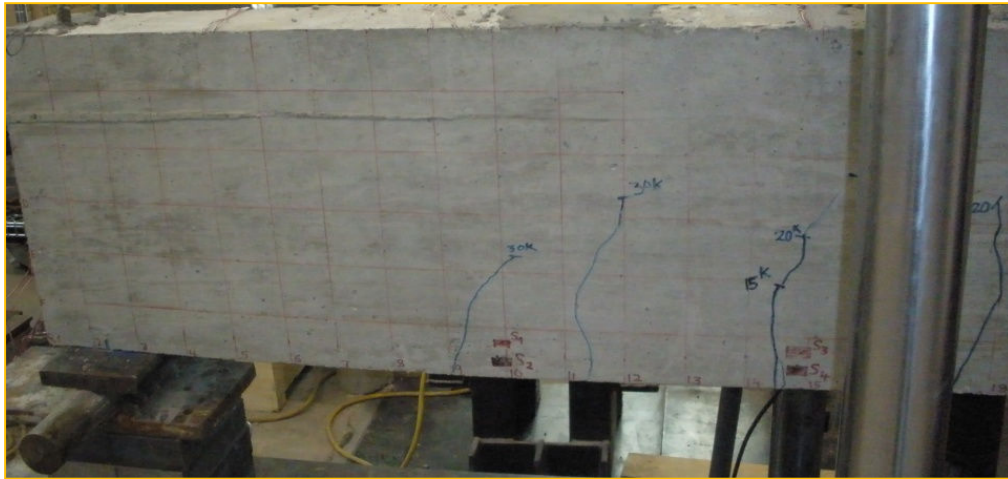
Figure 4.1 Formation of flexural cracks

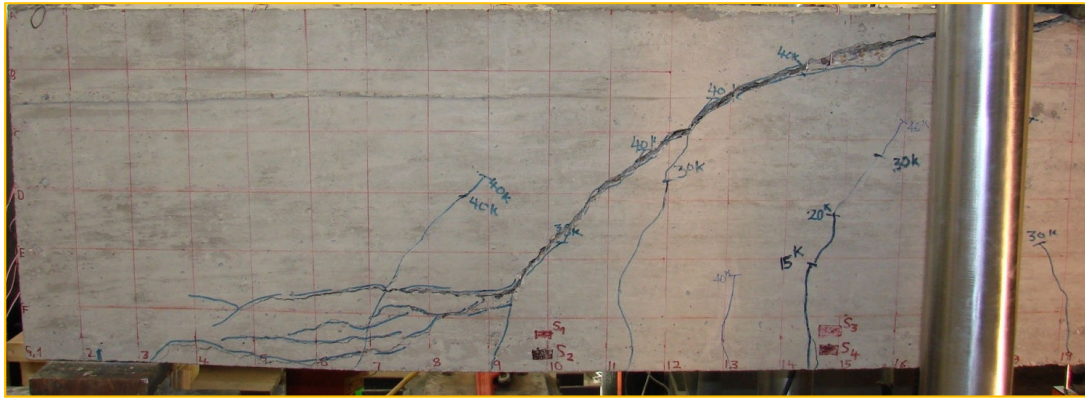
Figure 4.2 Shear failure at 42 kips
