THE EFFECT OF FIBER CORROSION ON SHEAR CAPACITY OF STEEL FIBER
REINFORCED CONCRETE BEAMS AND AN INITIAL INVESTIGATION ON
ALKALI-SILICA REACTION IN STEEL FIBER REINFORCED CONCRETE

MASTER OF SCIENCE IN CIVIL ENGINEERING

THE UNIVERSITY OF TEXAS AT ARLINGTON

August 2011

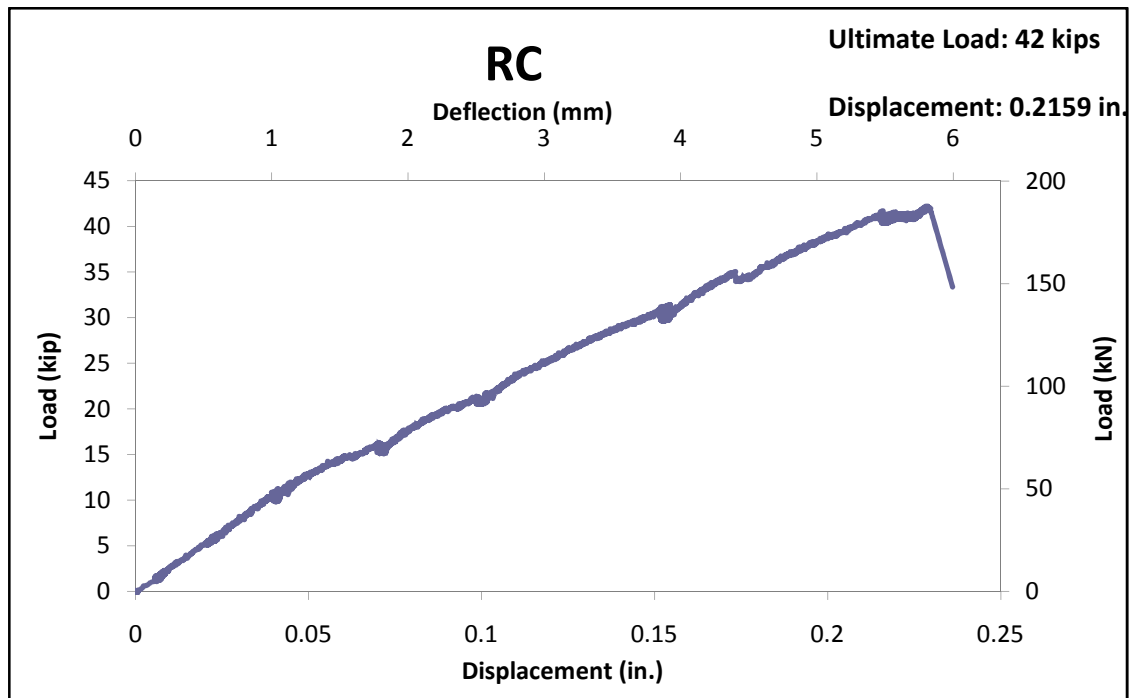
Figure 4.3 Load deflection curve

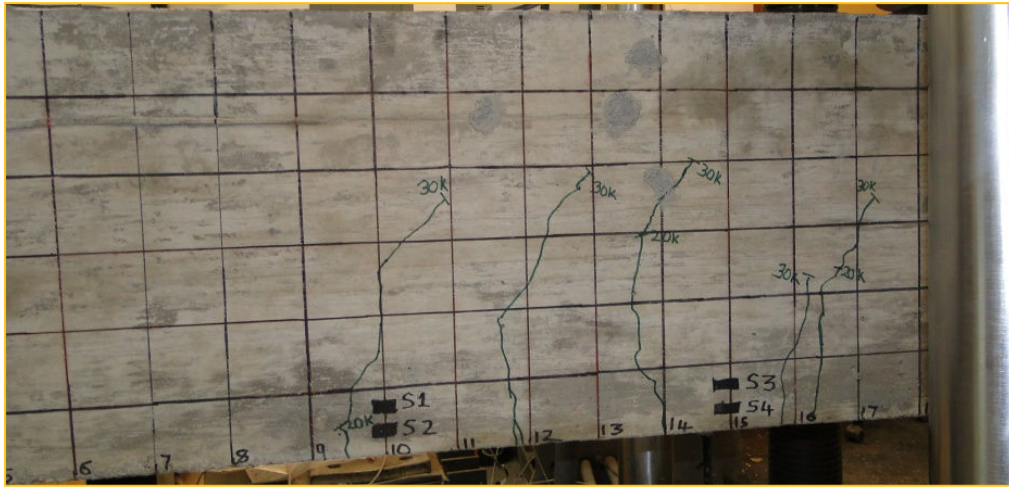
Figure 4.4 Formation of flexural cracks

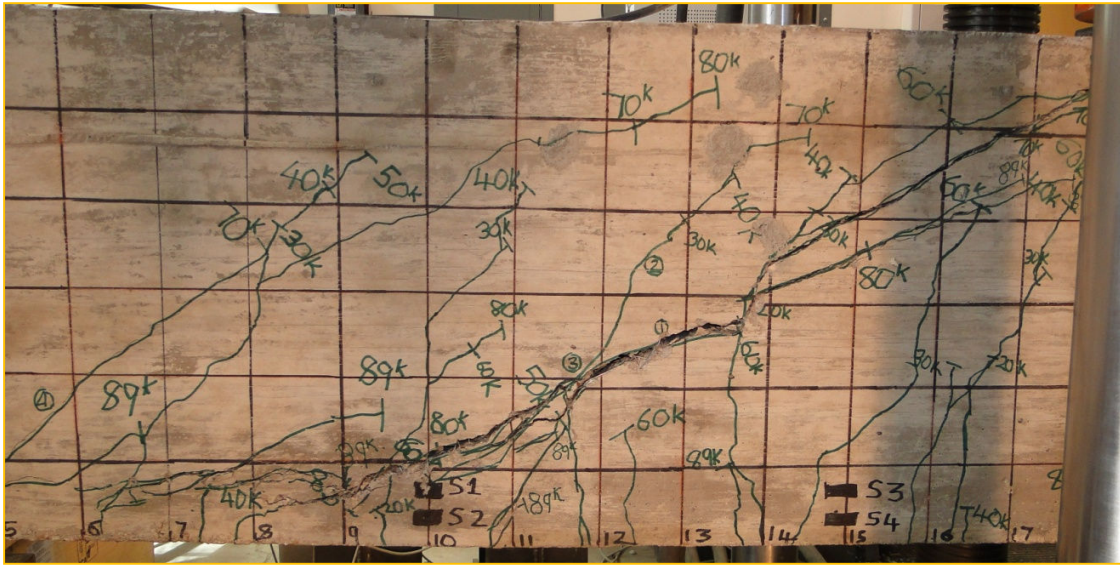
Figure 4.5 Shear failure at 90 kips

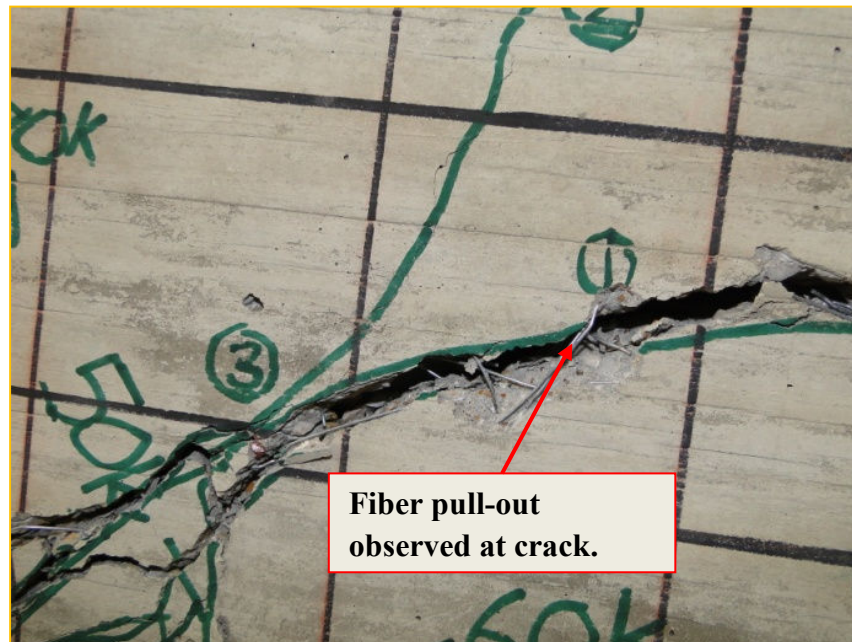
Figure 4.6 Fiber pullout in SFRC1 beam specimen

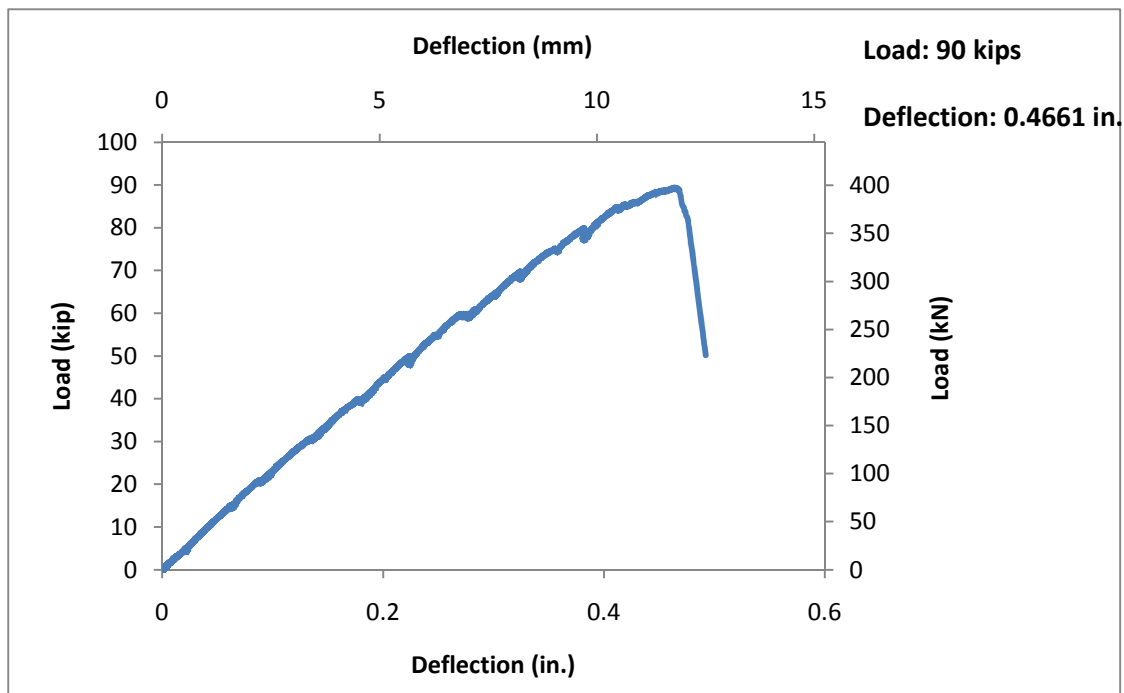
Figure 4.7 SFRC1 Load-deflection curve

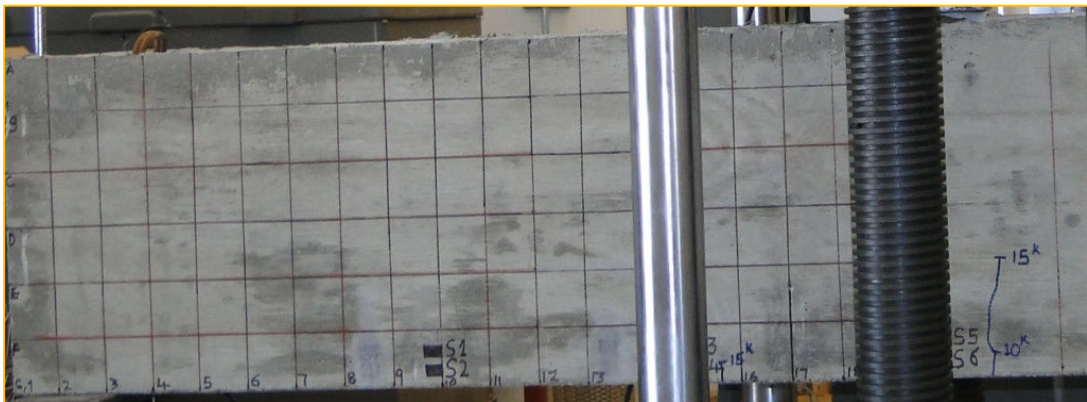
Figure 4.8 Formation of flexural cracks on SFRC2

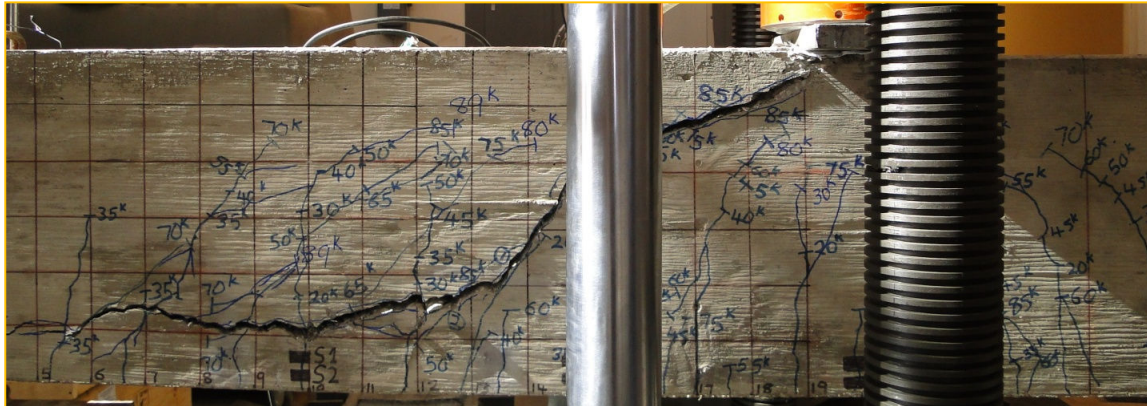
Figure 4.9 SFRC2 shear failure at 89 kips

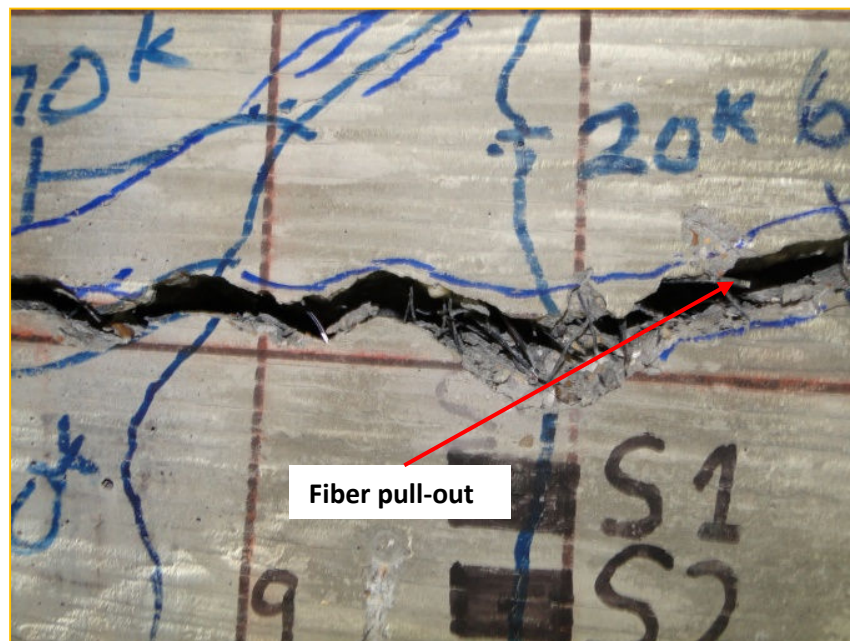
Figure 4.10 Fiber pullout in SFRC2 beam specimen

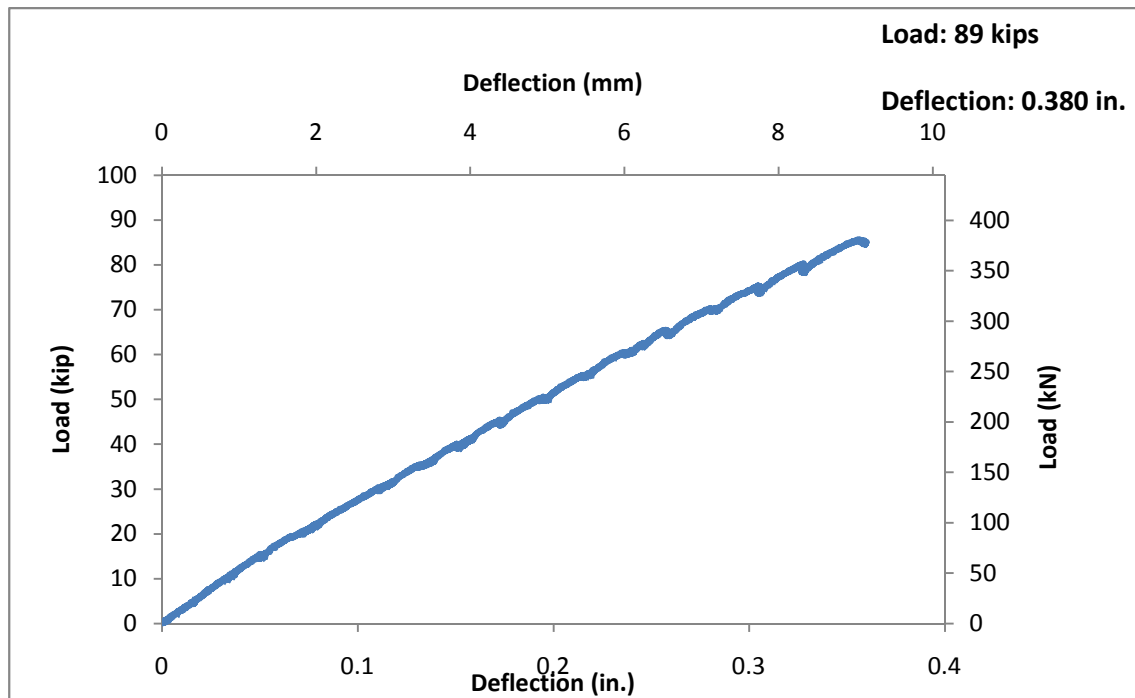
Figure 4.11 SFRC2 load-deflection curve

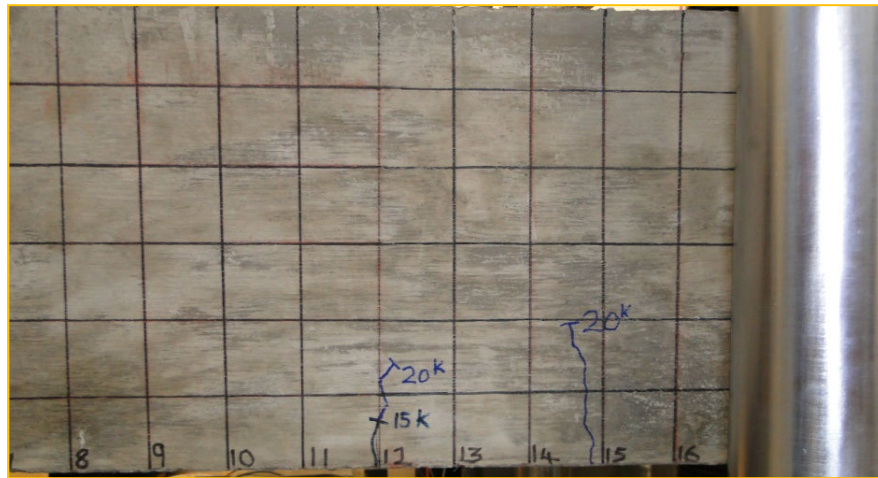
Figure 4.12 Formation of flexural cracks in SFRC3

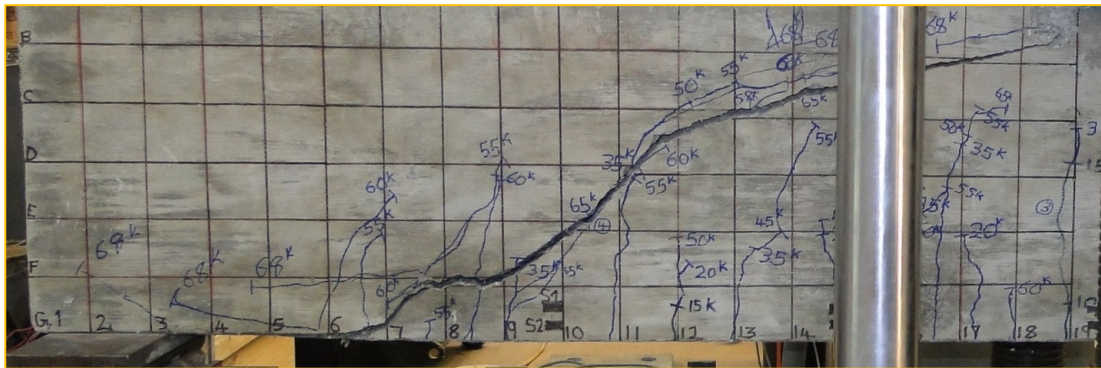
Figure 4.13 SFRC3 shear failure at 68 kips

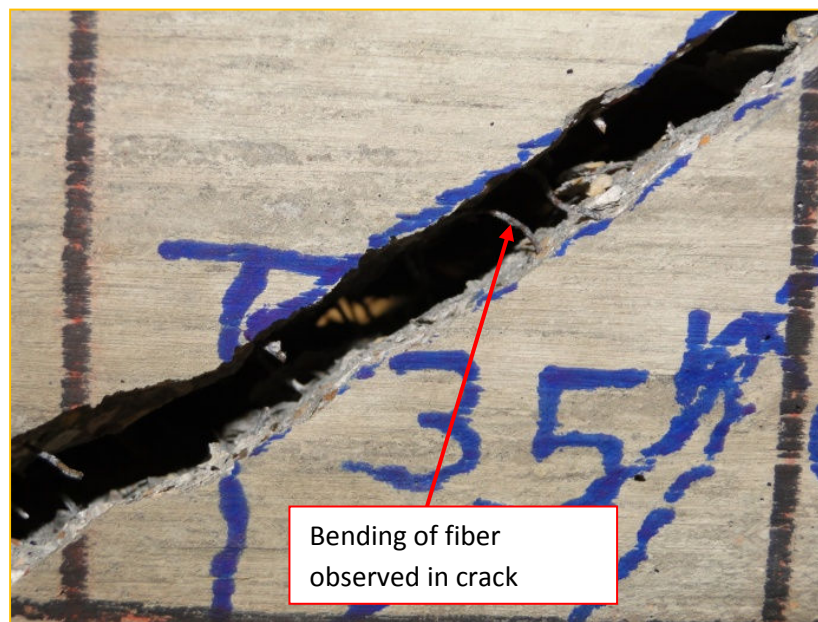
Figure 4.14 Fiber pullout and bending in SFRC3

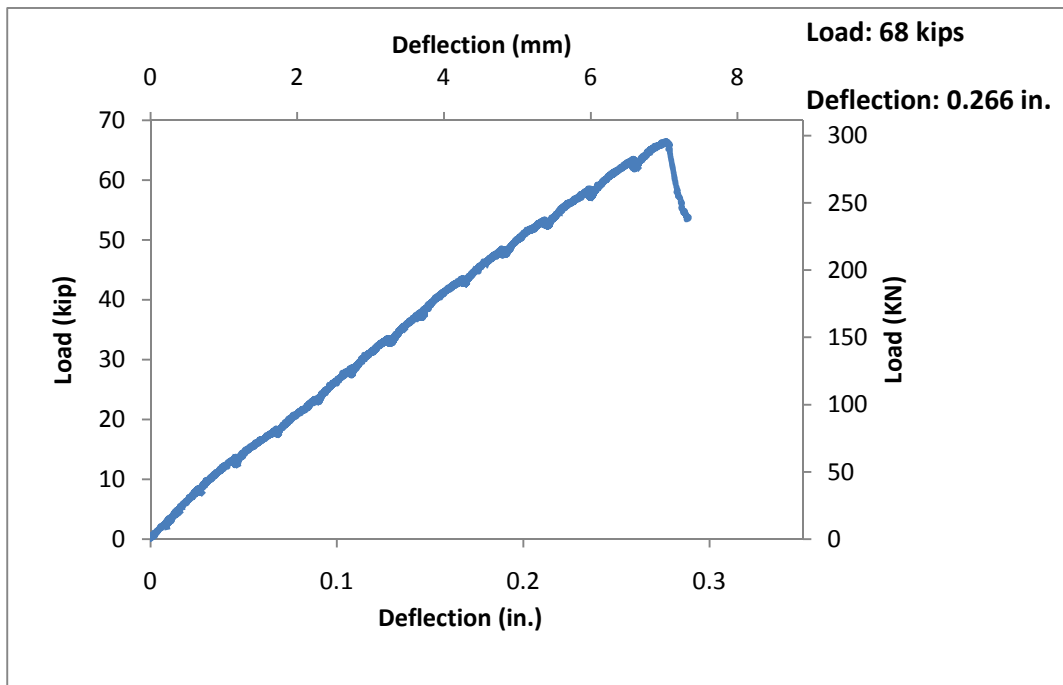
Figure 4.15 SFRC3 load-deflection curve

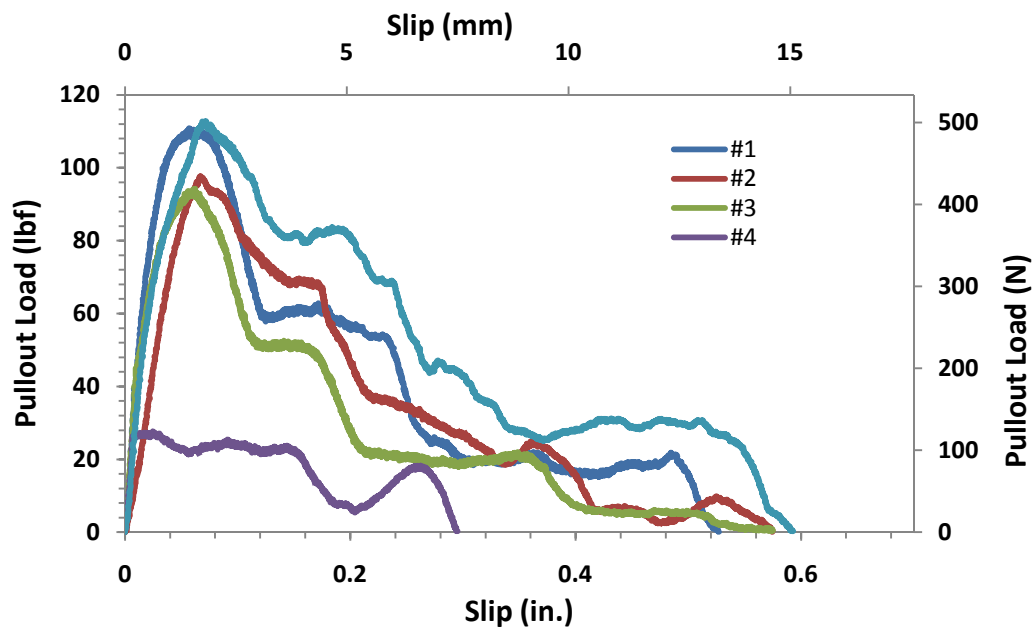
Figure 4.16 SFRC1 load versus slip

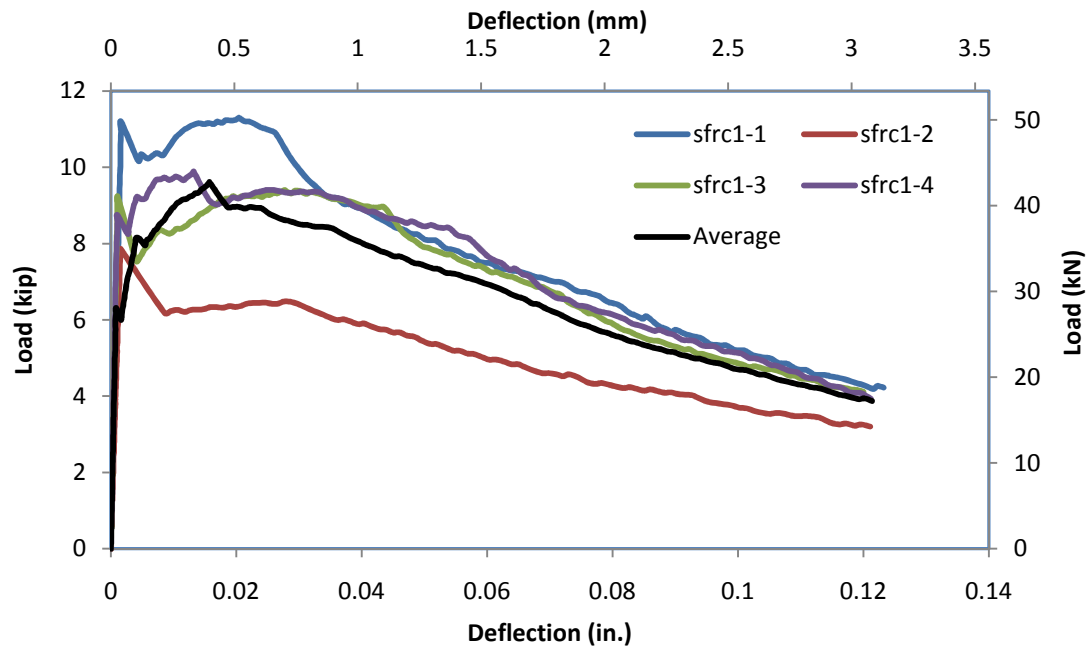
Figure 4.22 SFRC1 Load-Deflection Curves

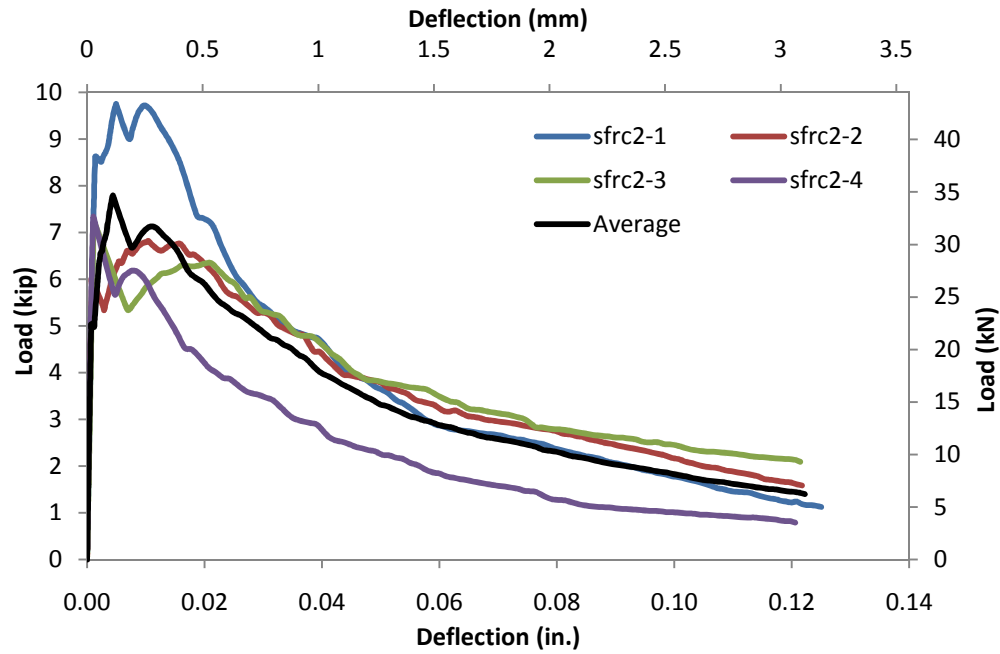
Figure 4.23 SFRC2 Load-Deflection Curves

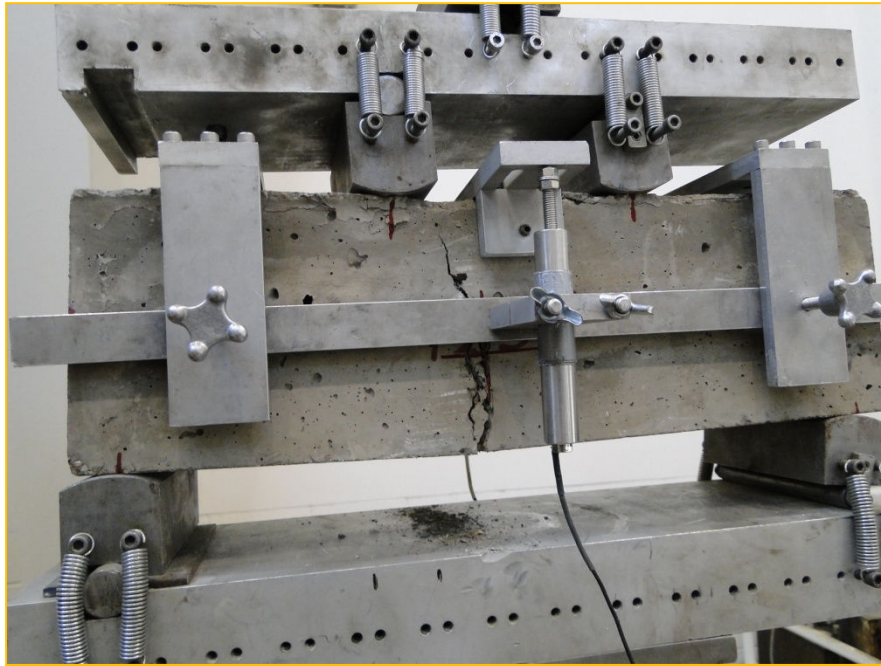
Figure 4.24 SFRC2 Specimen at Failure

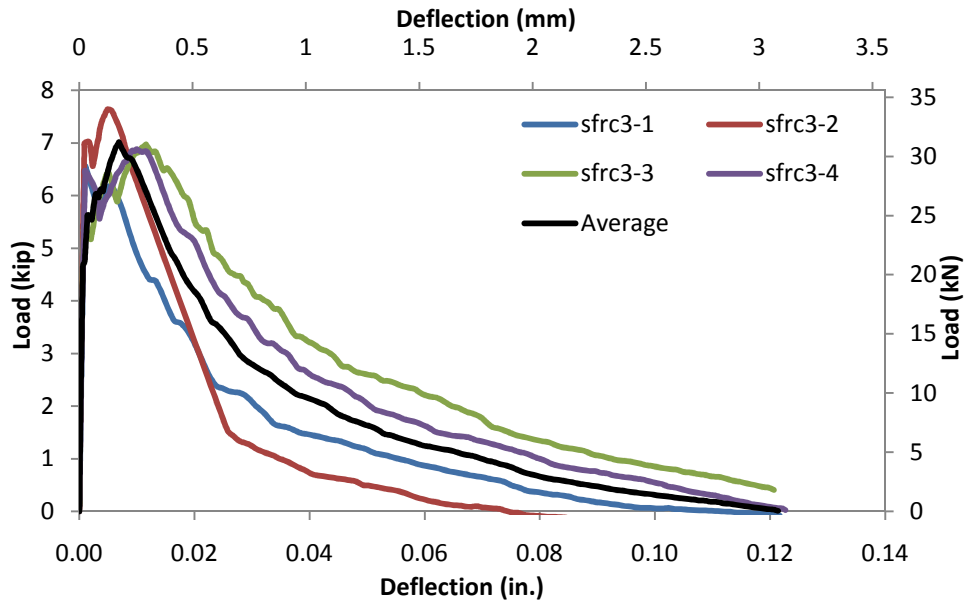
Figure 4.25 SFRC3 Load-Deflection Curves

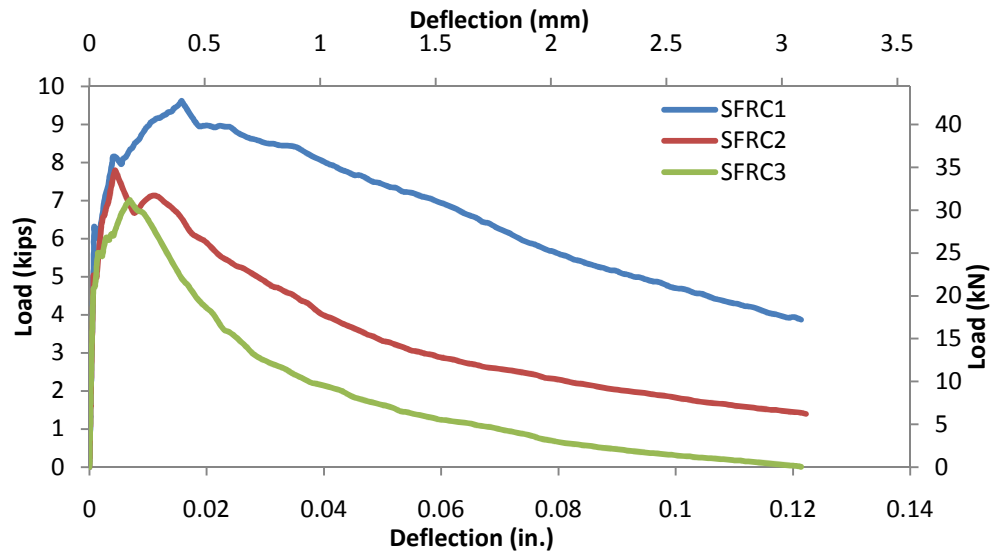
Figure 4.26 Comparator Load-Deflection Curves

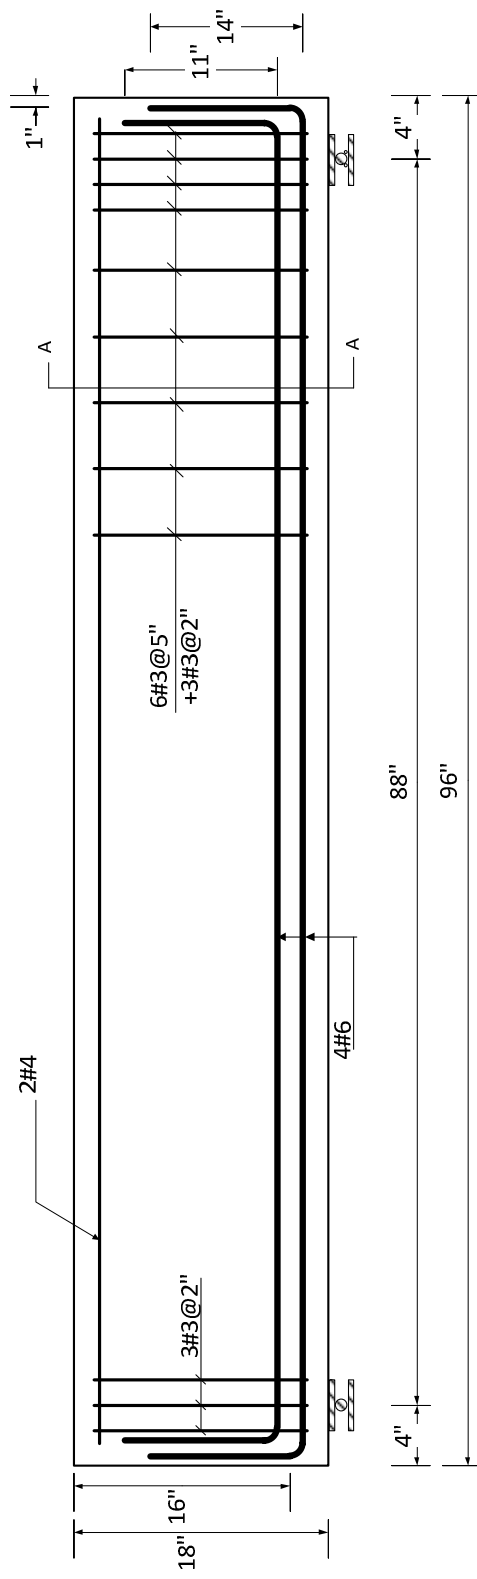
Longitudinal Reinforcement Detail
