EXPERIMENTAL AND FINITE ELEMENT BASED INVESTIGATIONS OF
SHEAR BEHAVIOR IN REINFORCED CONCRETE
BOX CULVERTS

Presented to the Faculty of the Graduate School of
The University of Texas at Arlington in Partial Fulfillment
of the Requirements
for the Degree of

THE UNIVERSITY OF TEXAS AT ARLINGTON

May 2007

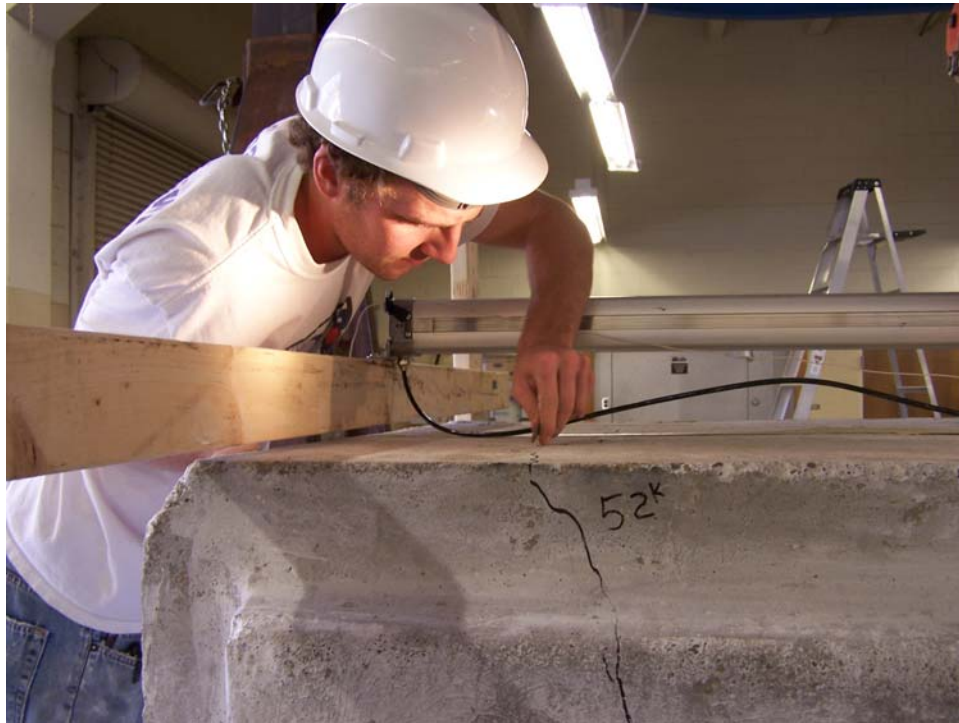
Figure 2.19 Crack Monitoring Process

While testing, to ensure consistency between the tests, a method was used for identifying crack initiations. After a crack initiated, a black marker was used to draw a line parallel to the crack. When the crack was no longer visible in the culvert, a bar was drawn across the previously drawn line indicating the end of the crack for that load. The load was written in kips next to the line for the ease of the referencing during the testing and future evaluations (Figure 2.19).

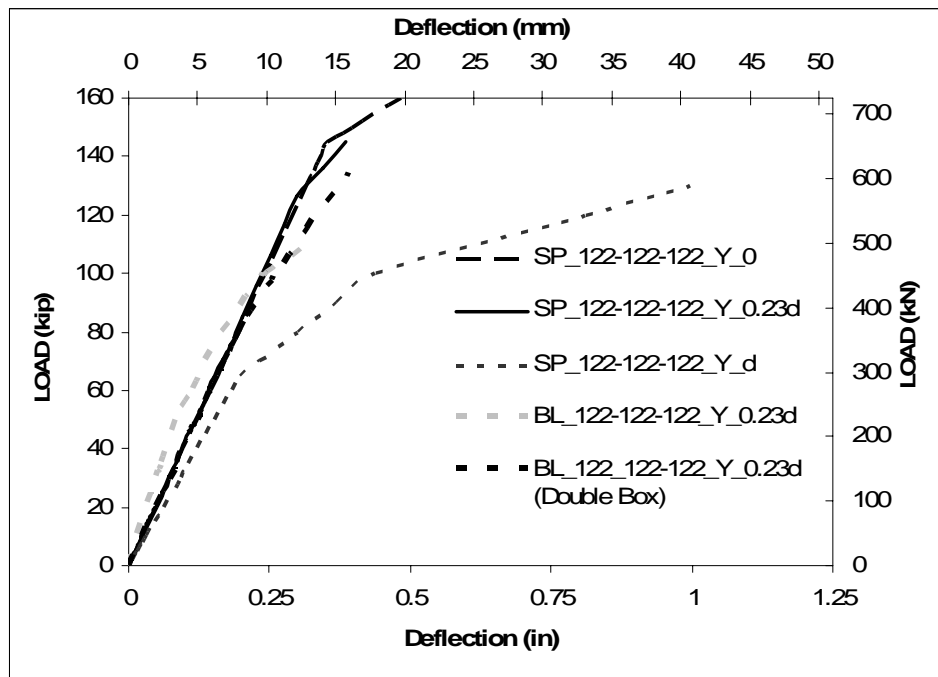
Figure 2.20 Load versus Deflection Plots for 122 cm (4 ft) Span and 122 cm (4 ft) Joint Length Boxes

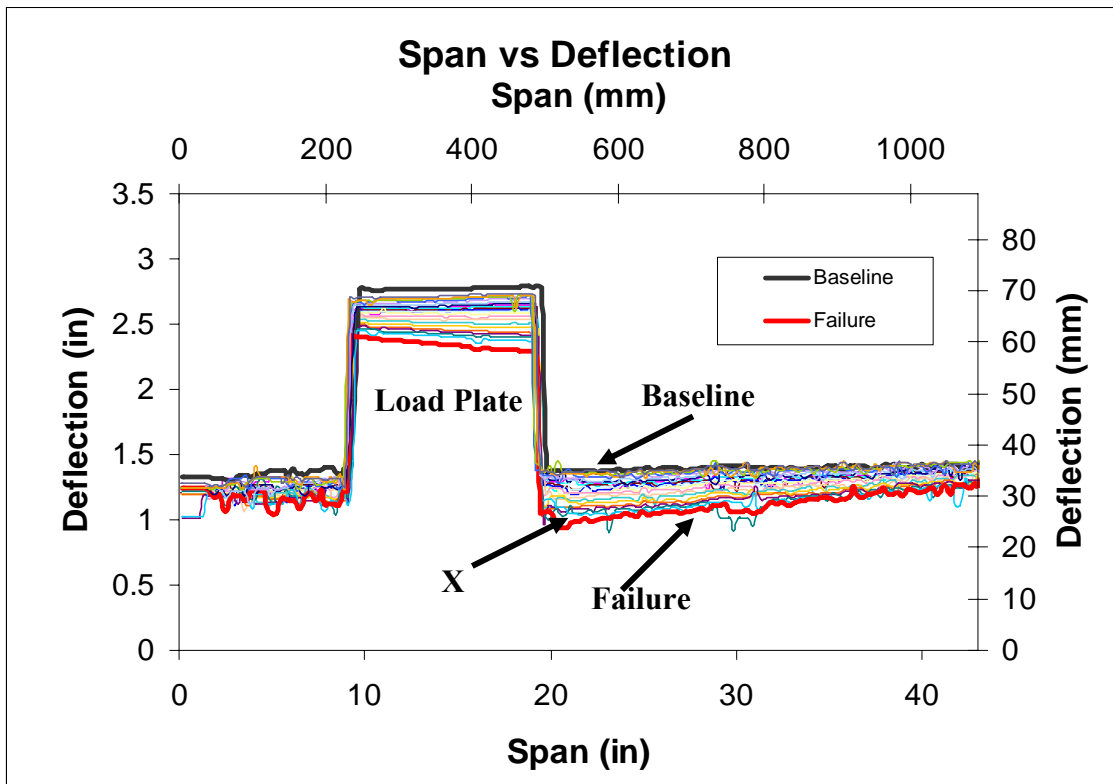
Figure 2.22 Test: SP_122-122-122_Y_0 (SP_4-4-4_Y_0) Laser Sensor Deflections

The load plate was placed with its edge at the tip of the haunch, on the spigot end. In this test, no shear crack detected until 267 kN (60 kip) of load and the box failed at 712 kN (160 kip). The detailed events of this test are presented in Table A2 of Appendix A. The Photographs of the cracks and the associated failure are shown in Figure B2 of Appendix B. Also, the deflection of the top slab, obtained from optoelectronic displacement sensor, is shown in Figure 2.22.

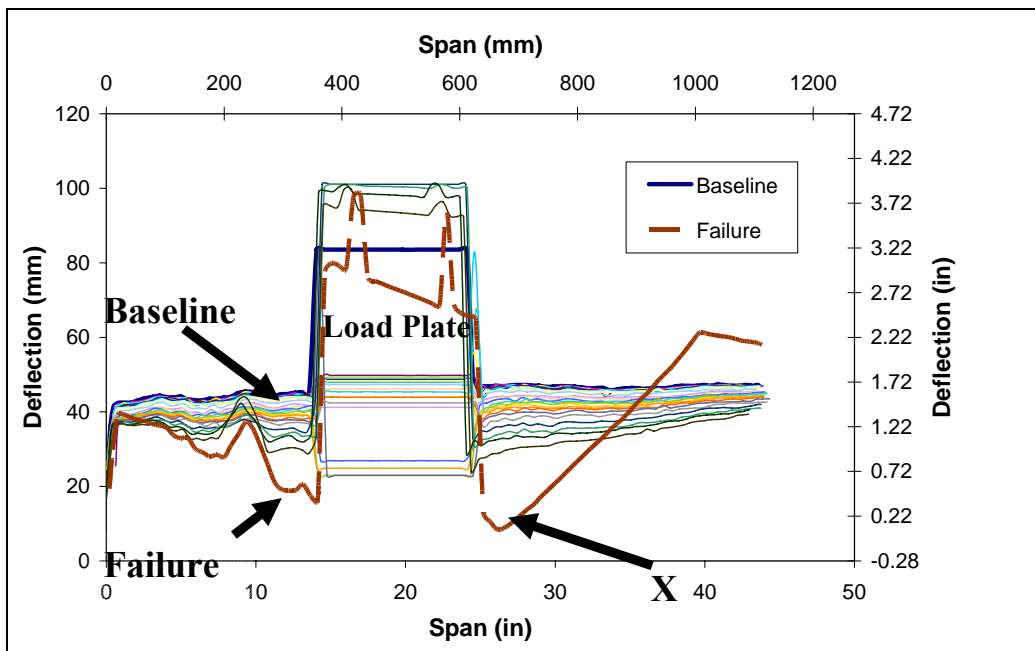
Figure 2.23 Test: SP_122-122-122_Y_d (SP_4-4-4_Y_d) Laser Sensor Deflections

The load plate was placed on the spigot end at a distance of $d = 16.5$ cm (6.5 in) from the tip of the haunch. In this test, the first shear crack detected at 534 kN (120 kip) of load and the box failed at 578 kN (130 kip). The detailed events of this test are presented in Table A6 of Appendix A. The Photographs of the set up and the failure are shown in Figure B6 of Appendix B. Also, the deflection of the top slab, obtained from optoelectronic displacement sensor, is shown in Figure 2.23.

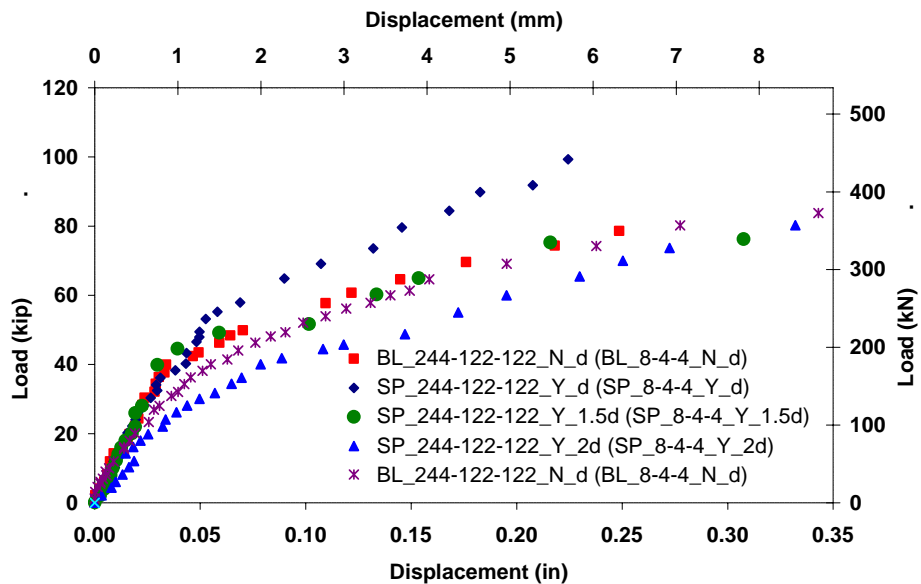
Figure 2.25 Load versus Center-Load Plate-Deflection Plots for 244 cm (8 ft) Span 122 cm (4 ft) Joint Length Boxes

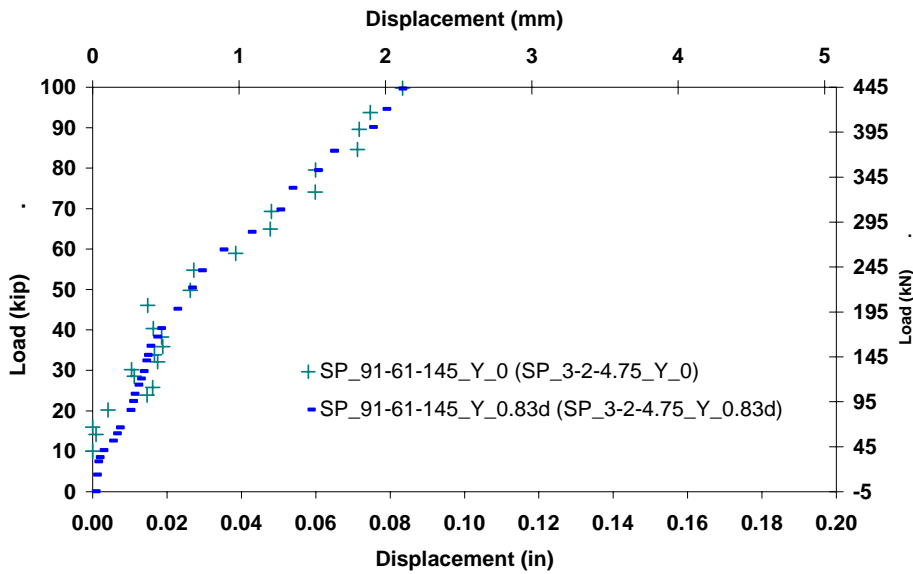
Figure 2.29 Load versus Deflection Plots for 91 cm (3 ft) Span, 61 cm (2 ft) Rise and 145 cm (4.75 ft) Joint Length Boxes

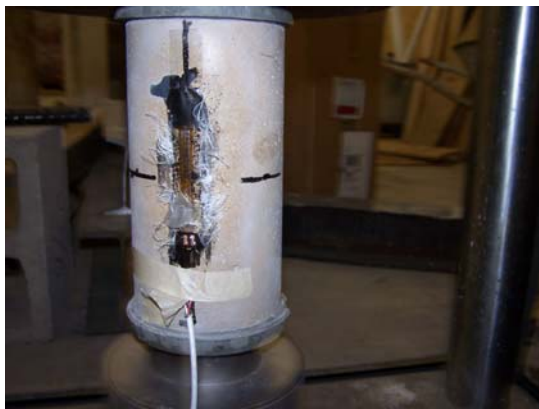
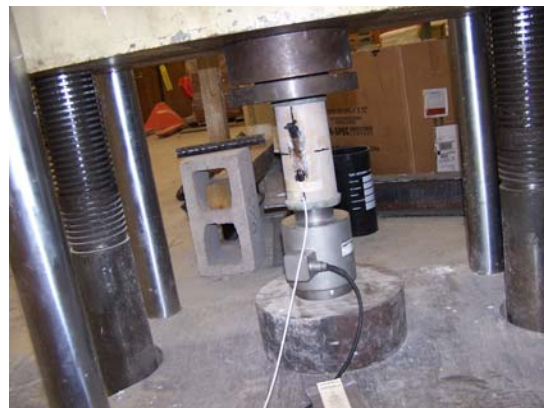
Figure 2.30 Concrete Cylinder Compression Test with Strain Gauge (a) Concrete Cylinder with Strain Gauge; (b) Strain Gauge in Close up; (c) Concrete Cylinder after Failure; and (d) Test Set up for concrete Cylinder Testing

the gauge with adhesive under pressure for curing. After curing for 24 hours the gauges were connected to the data acquisition unit and the cylinders were tested for compression until failure (Figure 2.30). The load displacement plots are shown in Figure 2.31, which indicates that the concrete modulus of elasticity varies from 17.2 kN.mm² to 29.4 kN/mm² (2500 ksi to 4260 ksi). The standard value per ACI 318-05 is 27.6 kN/mm² (4000 ksi) for a compressive strength of 34.5 N/mm² (5000 psi) concrete.

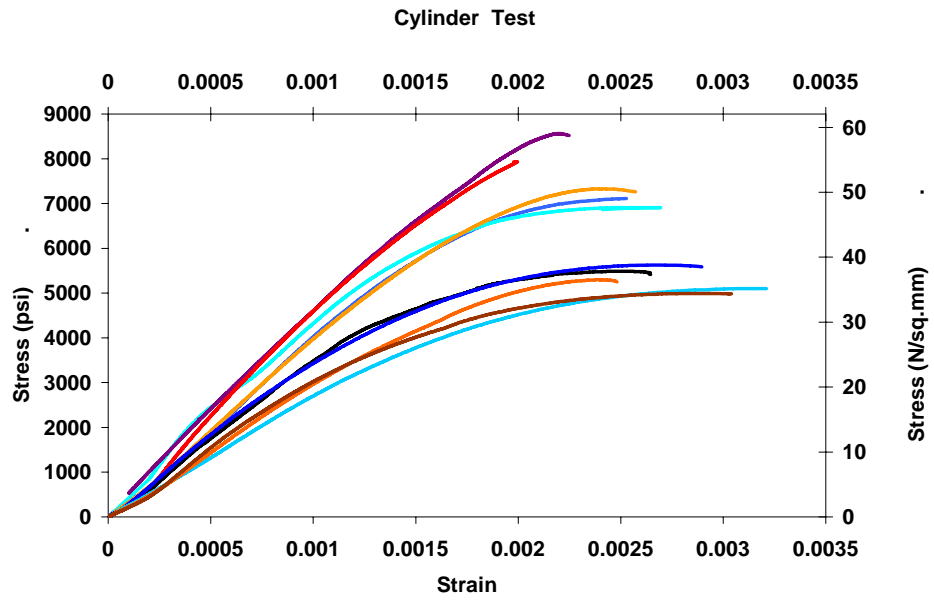
Figure 2.31 Stress Strain Plot for Concrete Cylinders using Strain Gauges

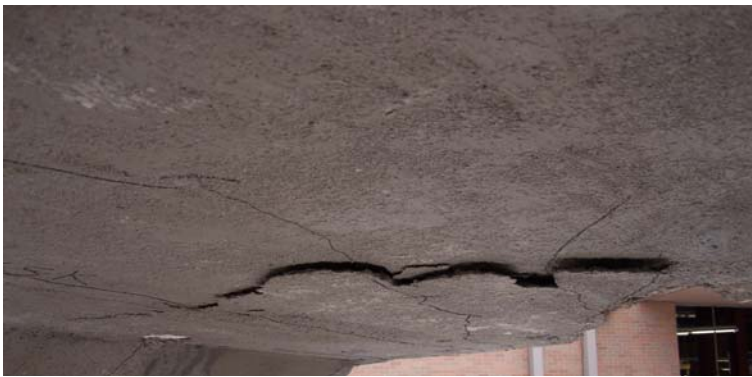
Figure B4 Experimental Photograph for Test: BL_122-122-122_Y_0.23d (BL_4-4-4_Y_0.23d) (a) Test Set-up; (b) Ultimate Failure; and (c) Inside Face of Top Slab

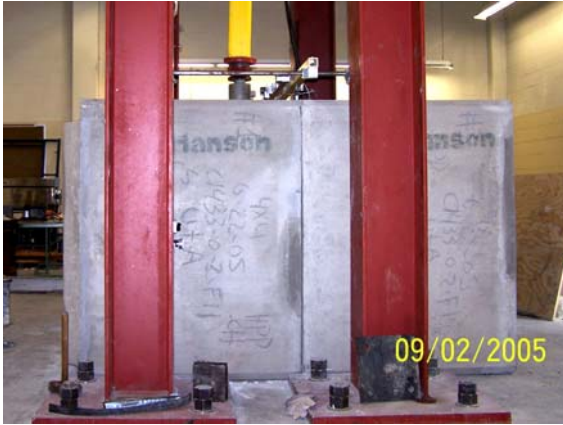
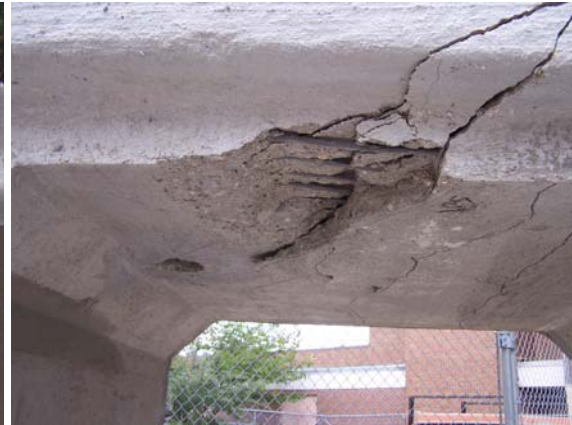
Figure B5 Experimental Photograph for Test: BL_122-122-122_Y_0.23d (BL_4-4-4_Y_0.23d) (Double Box) (a) Test Set up; (b) Failure (Double Box); (c) Failure (Spigot Box); and (d) Failure Bell Box

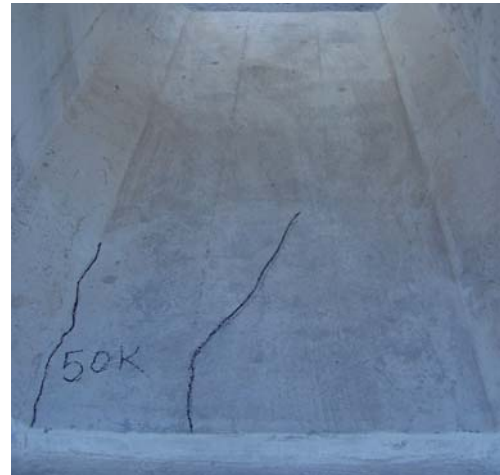
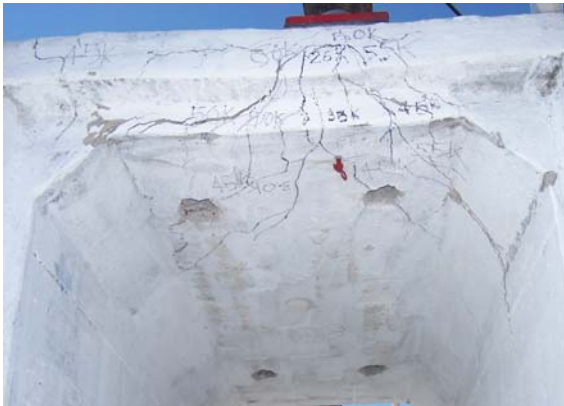
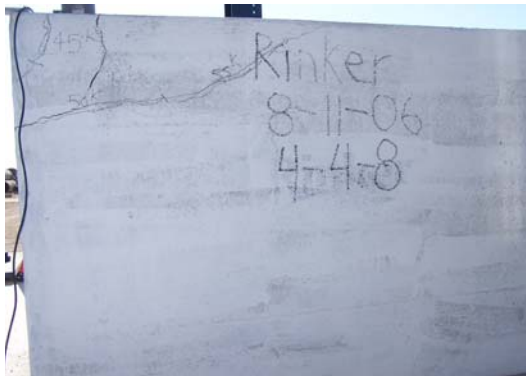
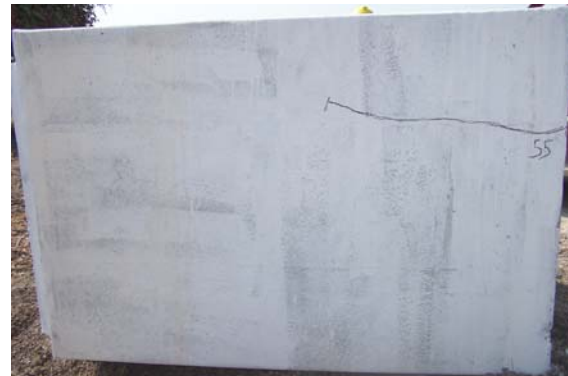
**Figure B8 Experimental Photograph for Test: BL_122-122-244_Y_d.
(BL-4-4-8_Y_d) (a) Bell End; (b) Inside Face of Bottom Slab; (c) Inside Face of
Top Slab; (d) Outside Face of Top Slab; (e) Outside Face of Right Wall; and
(f) Outside Face of Left Wall**

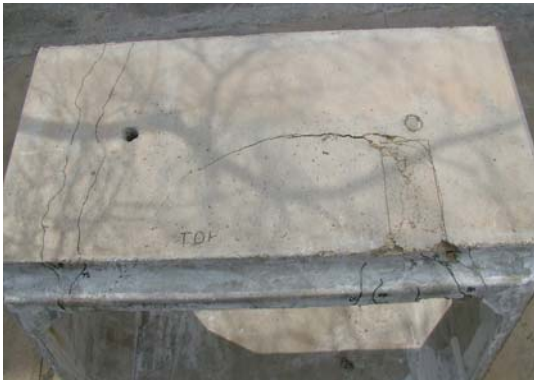
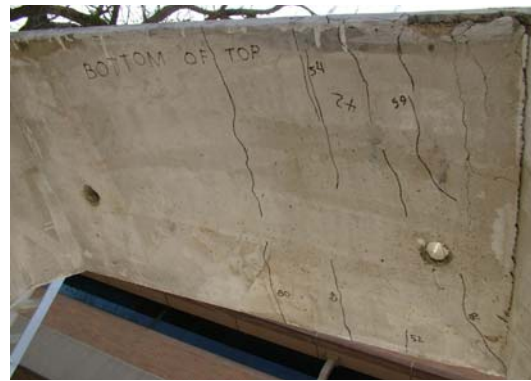
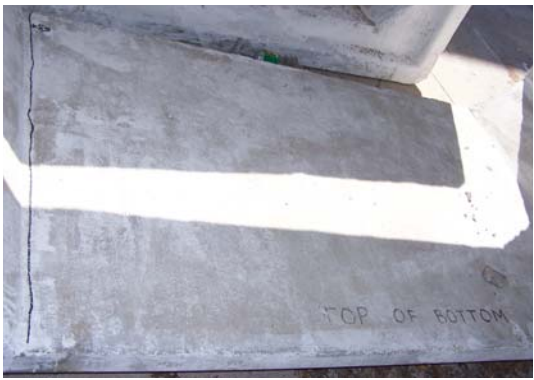
Figure B9 Experimental Photograph for Test: SP_244-122-122_N_d (SP-8-4-4_N_d) (a) Outside Face of Top Slab; (b) Inside Face of Top Slab; (c) Inside Face of Bottom Slab; (d) Spigot End; (e) Outside Face of Left Wall; and (f) Outside Face of Right Wall

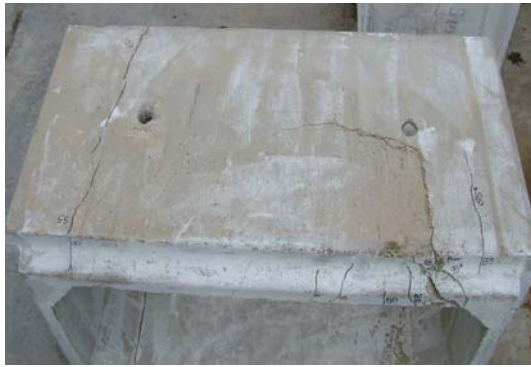
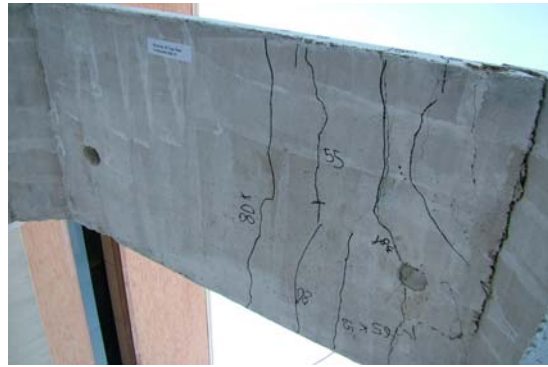
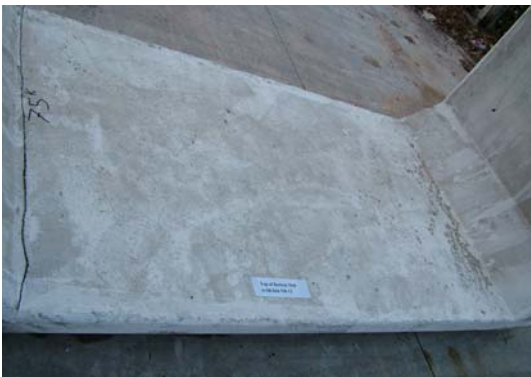
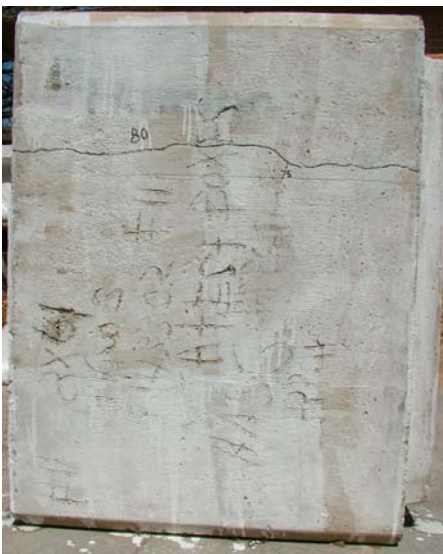
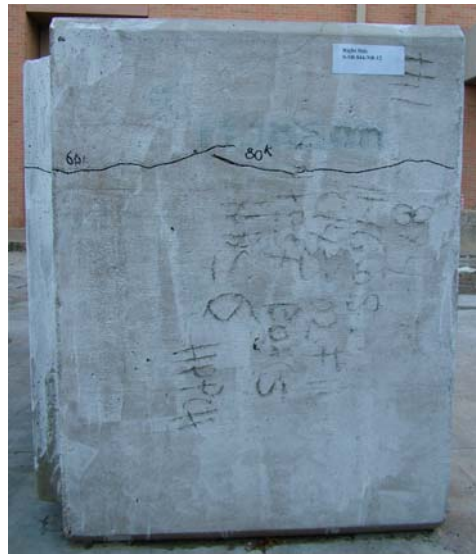
Figure B10 Experimental Photograph for: Test: SP_244-122-122_Y_d (SP-8-4-4_Y_d) (a) Outside Face of Top Slab; (b) Inside Face of Top Slab; (c) Inside Face of Bottom Slab; (d) Spigot End; (e) Outside Face of Left Wall; and (f) Outside Face of Right Wall

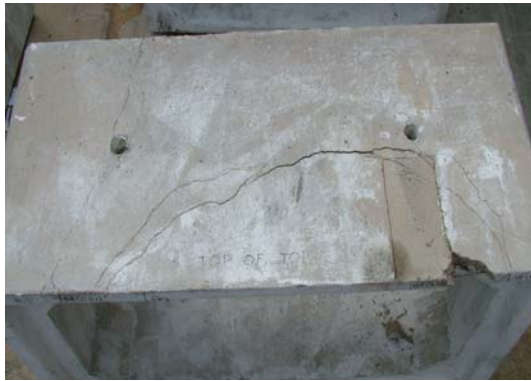
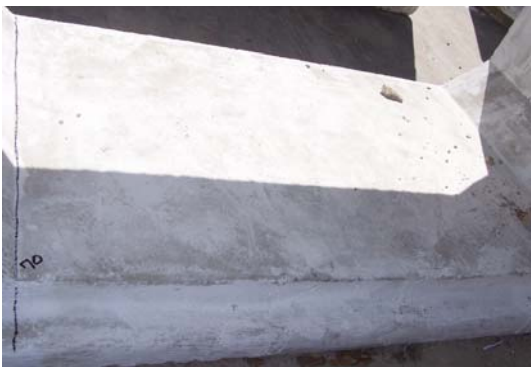
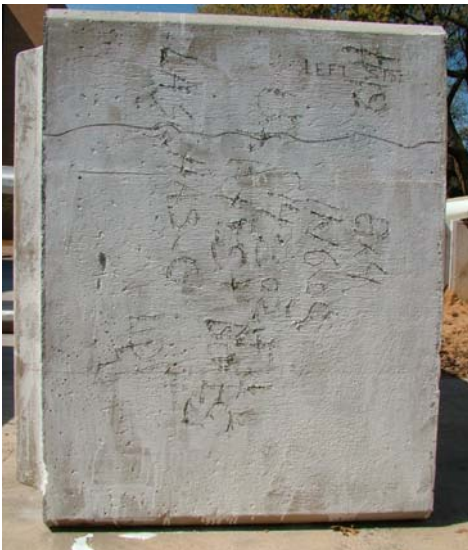
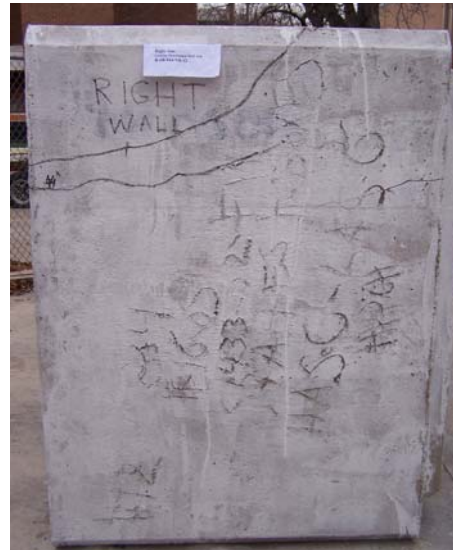
Figure B11 Experimental Photograph for Test: BL_244-122-122_N_d (BL-8-4-4_N_d) (a) Outside Face of Top Slab; (b) Inside Face of Top Slab; (c) Inside Face of Bottom Slab; (d) Bell End; (e) Outside Face of Left Wall; and (f) Outside Face of Right Wall

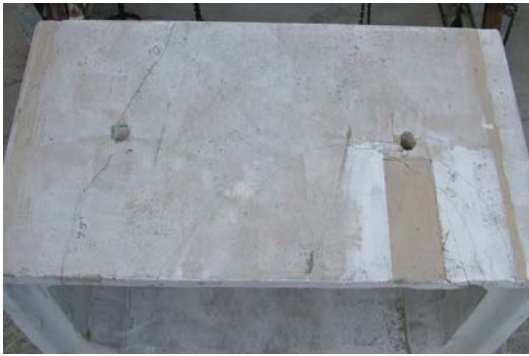
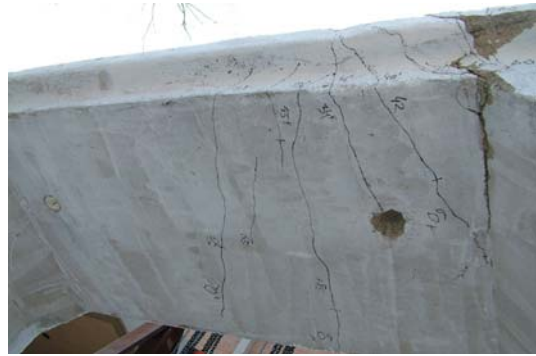
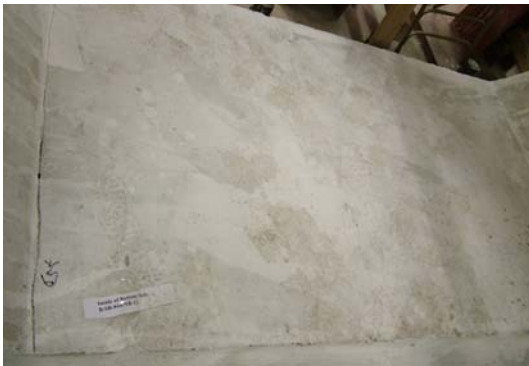
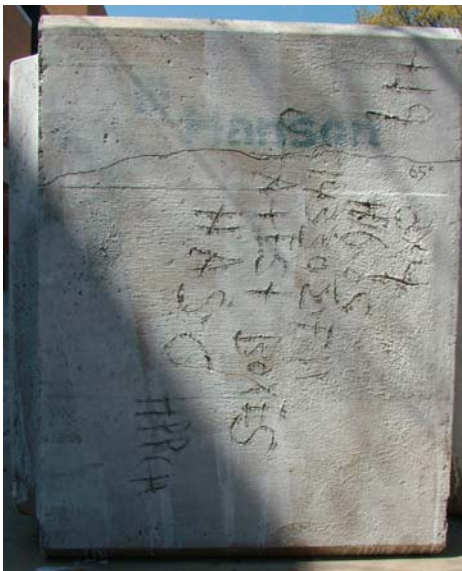
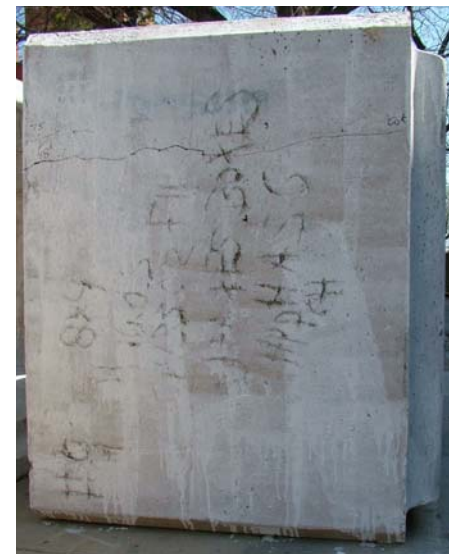
Figure B12 Experimental Photograph for Test: BL_244-122-122_Y_d (BL-8-4-4_Y_d) (a) Outside Face of Top Slab; (b) Inside Face of Top Slab; (c) Inside Face of Bottom Slab; (d) Bell End; (e) Outside Face of Left Wall; and (f) Outside Face of Right Wall

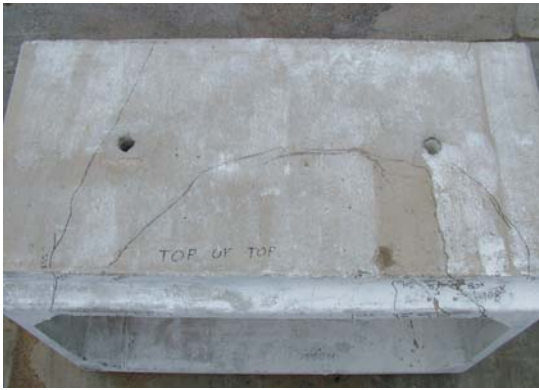
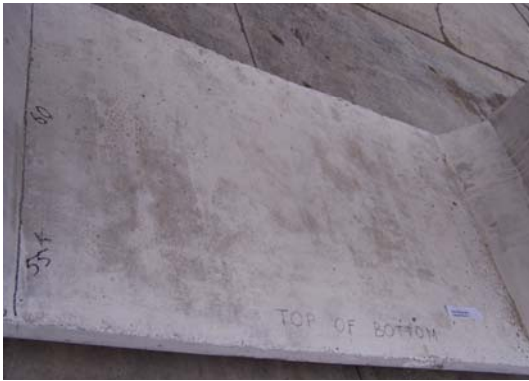
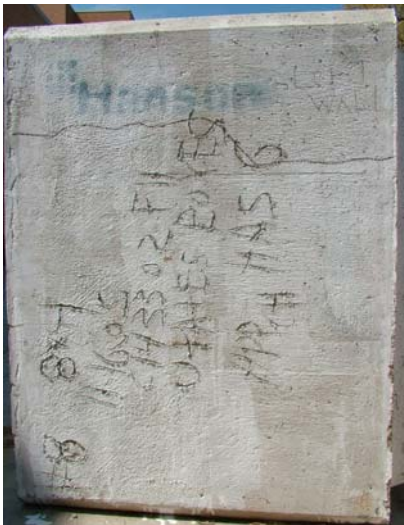
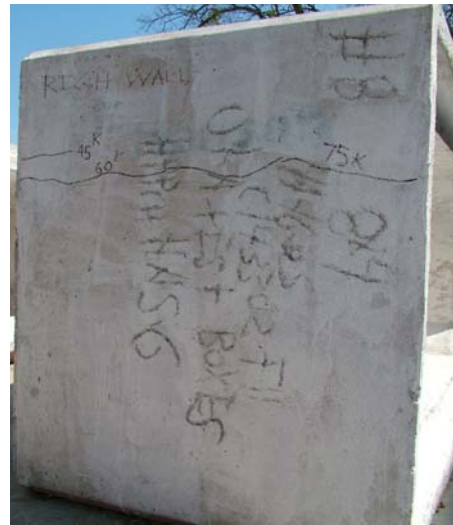
Figure B13 Experimental Photograph for Test: SP_244-122-122_Y_1.5d(SP-8-4-4_Y_1.5d) (a) Outside Face of Top Slab; (b) Inside Face of Top Slab; (c) Inside Face of Bottom Slab; (d) Spigot End; (e) Outside Face of Left Wall; and (f) Outside Face of Right Wall

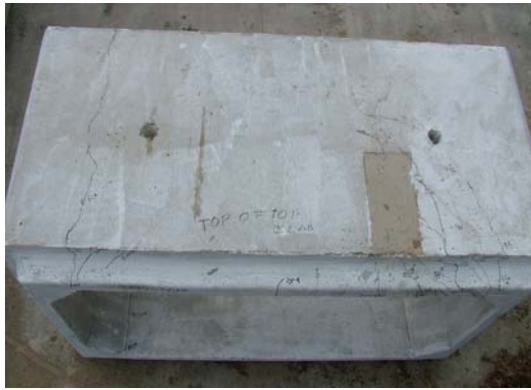
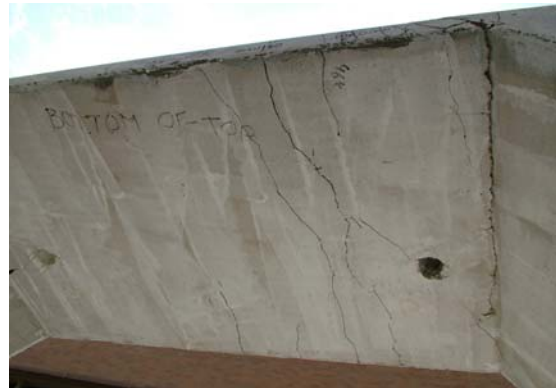
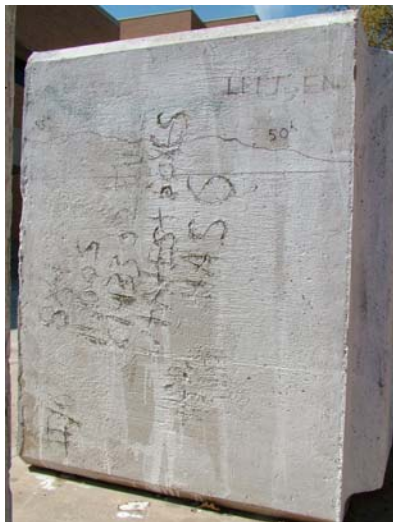
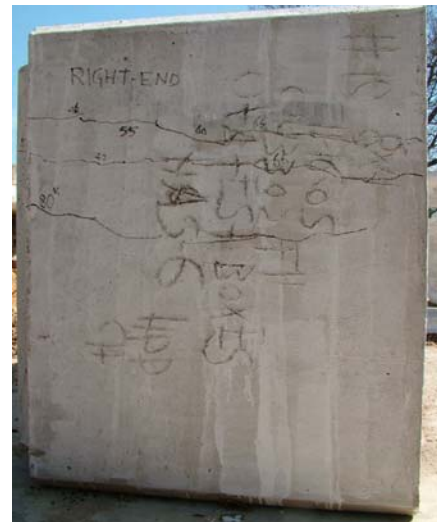
Figure B14 Experimental Photograph for Test: SP_244-122-122_Y_2d (SP-8-4-4_Y_2d) (a) Outside Face of Top Slab; (b) Inside Face of Top Slab; (c) Inside Face of Bottom Slab; (d) Spigot End; (e) Outside Face of Left Wall; and (f) Outside Face of Right Wall

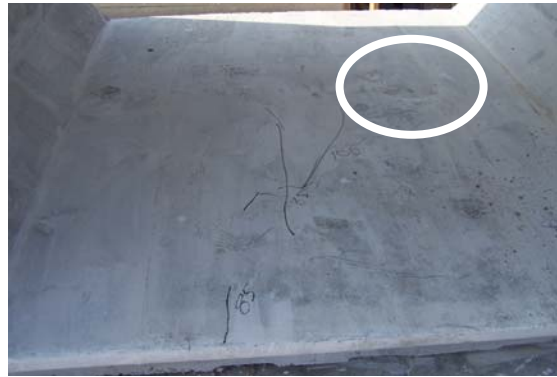
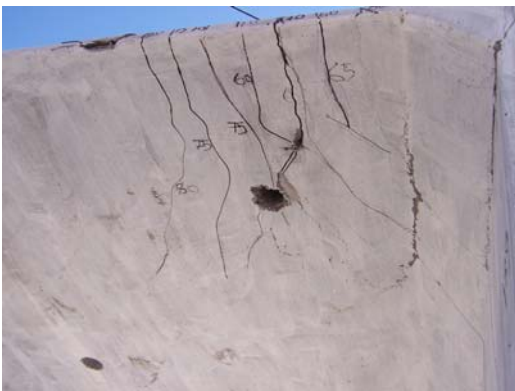
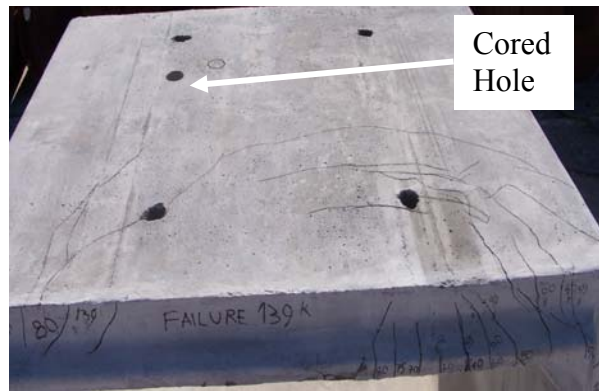
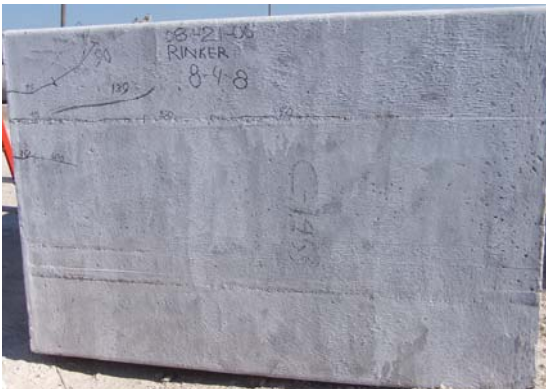
Figure B15 Experimental Photograph for Test: SP_244-122-244_Y_d (SP_8-4-8_Y_d) (a) Spigot End; (b) Inside Face of Bottom Slab; (c) Inside Face of Top Slab; (d) Outside Face of Top Slab; (e) Outside Face of Right Wall; and (f) Outside Face of Left Wall

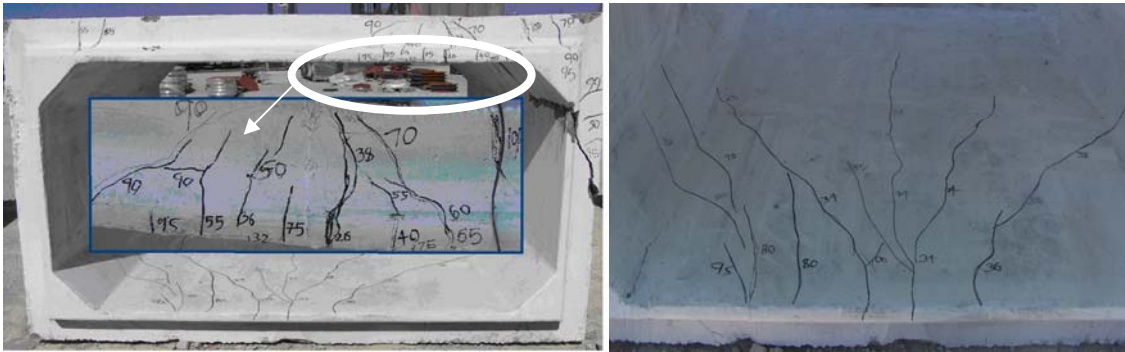
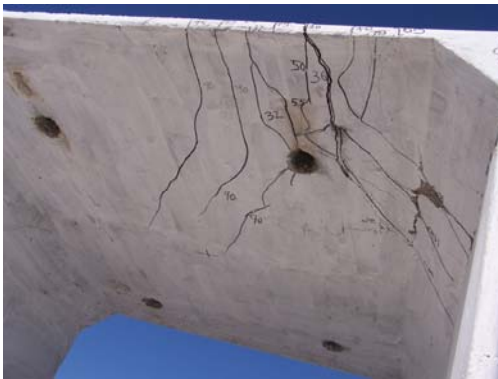
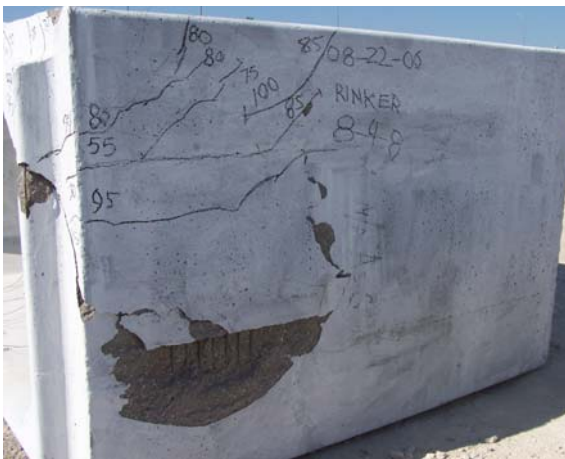
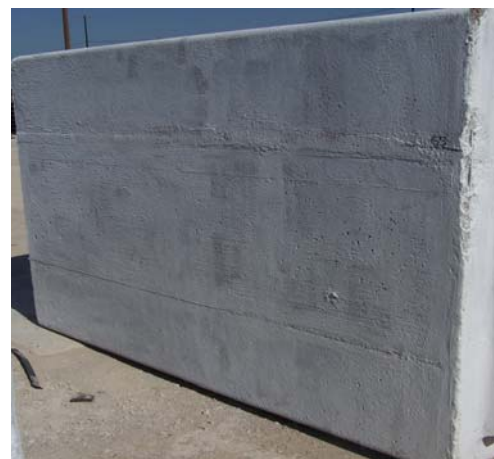
Figure B16 Experimental Photograph for Test: SP_244-122-244_N_d (SP_8-4-8_N_d) (a) Spigot End; (b) Inside Face of Bottom Slab; (c) Inside Face of Top Slab; (d) Outside Face of Top Slab; (e) Outside Face of Right Wall; and (f) Outside Face of Left Wall

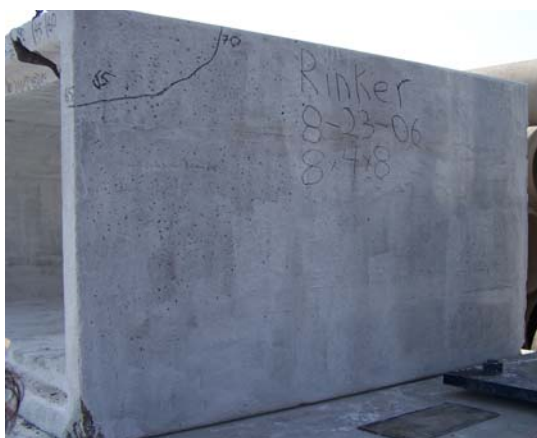
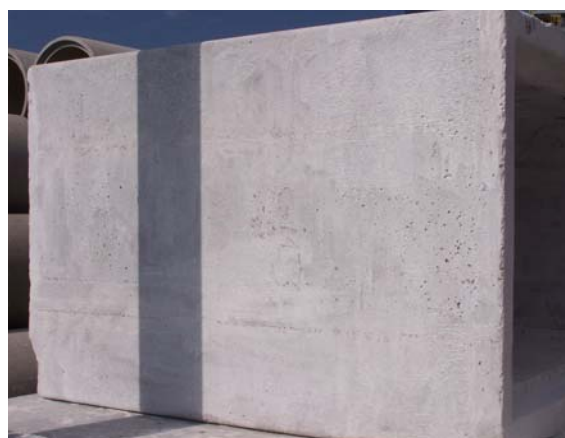
Figure B17 Experimental Photograph for Test: BL_244-122-244_N_d (BL_8-4-8_N_d) (a) Bell End; (b) Inside Face of Top Slab; (c) Outside Face of Top Slab; (d) Inside Face of Bottom Slab; (e) Outside Face of Right Wall; and (f) Outside Face of Left Wall

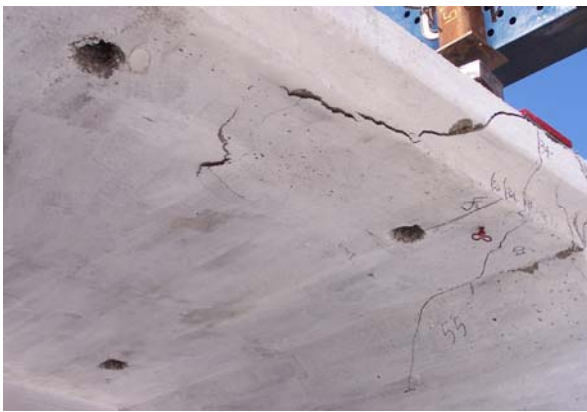
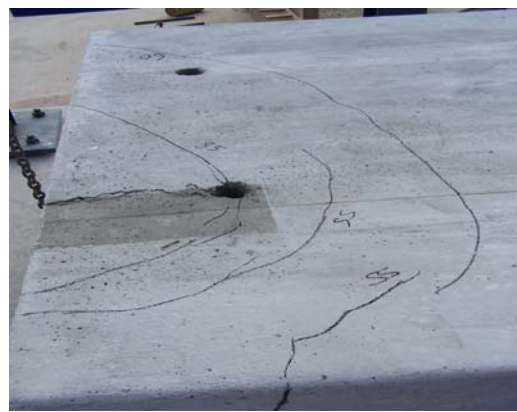
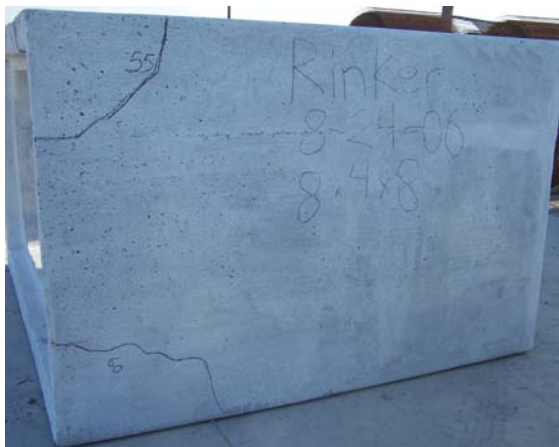
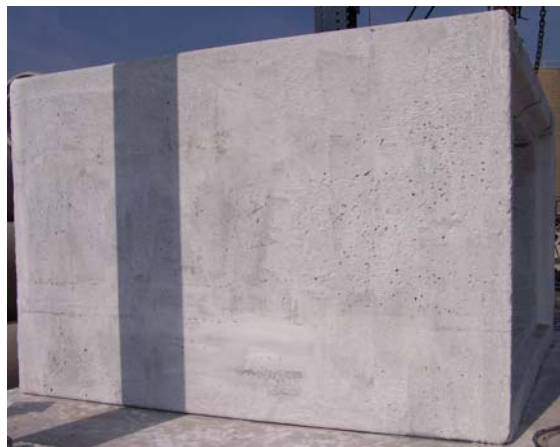
Figure B18 Experimental Photograph for Test: BL_244-122-244_Y_d (BL_8-4-8_Y_d) (a) Bell End; (b) Inside Face of Bottom Slab; (c) Inside Face of Top Slab; (d) Outside Face of Top Slab; (e) Outside Face of Right Wall; and (f) Outside Face of Left Wall

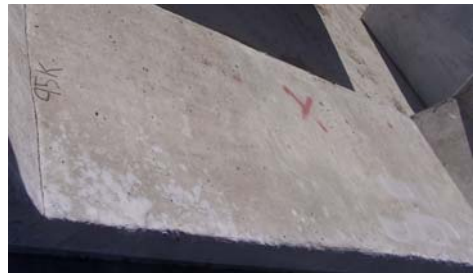
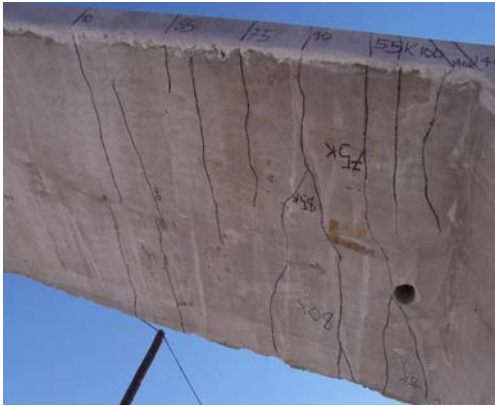
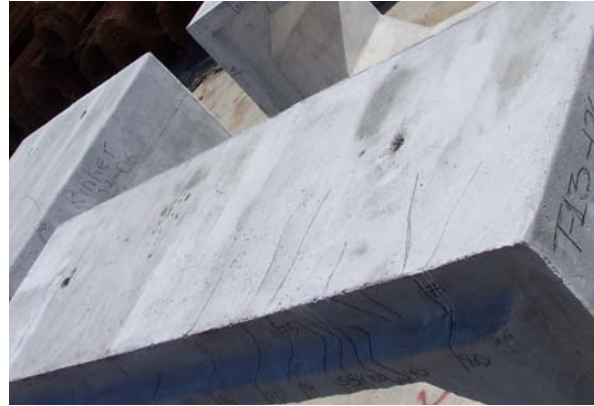
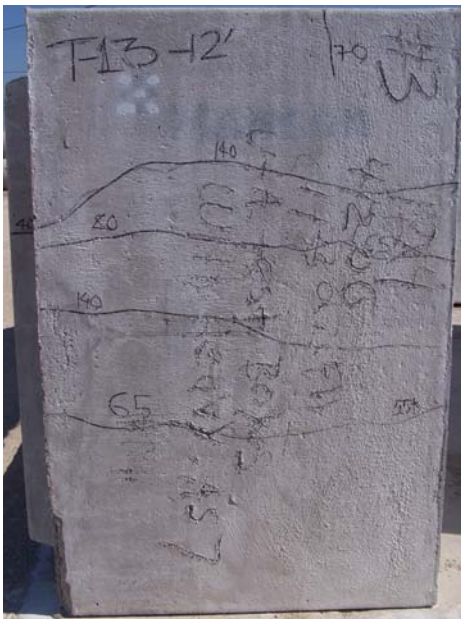
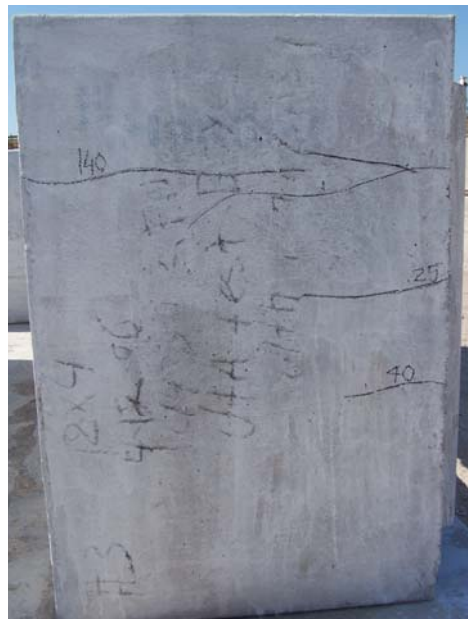
Figure B19 Experimental Photograph for Test: SP_366-122-122_Y_d (SP_12-4-4_Y_d) (a) Spigot End; (b) Inside Face of Bottom Slab; (c) Inside Face of Top Slab; (d) Outside Face of Top Slab ; (e) Outside Face of Right Wall; and (f) Outside Face of Left Wall

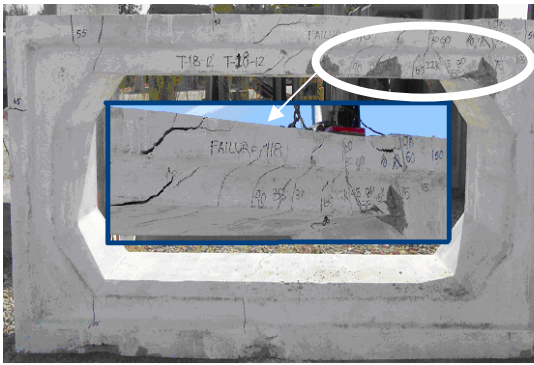
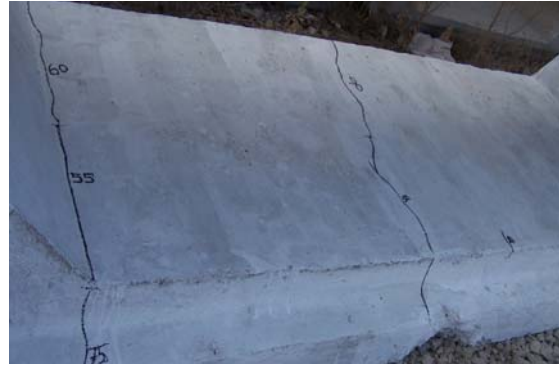
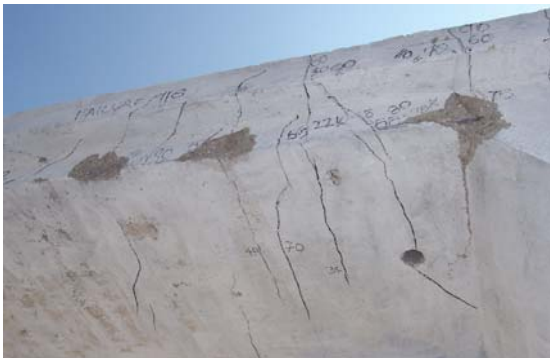
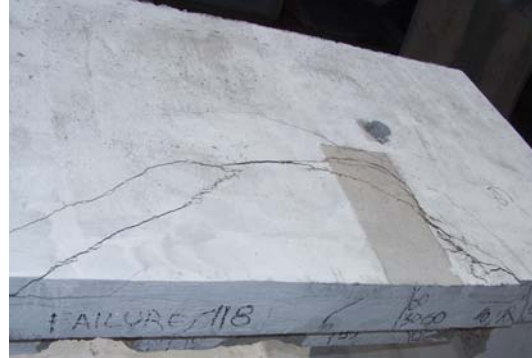
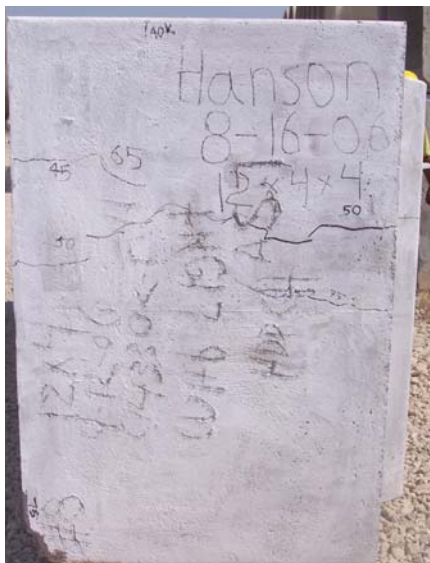
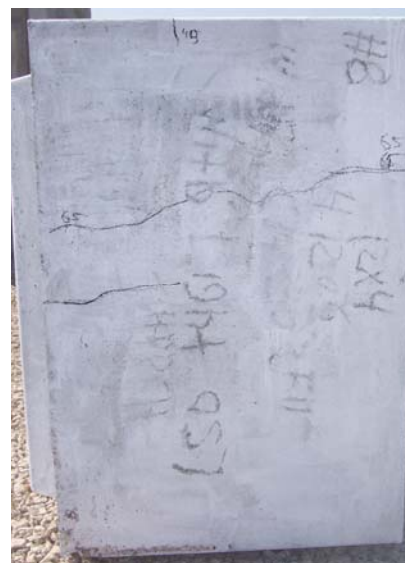
Figure B22 Experimental Photograph for Test: BL_366-122-122_N_d (BL_12-4-4_N_d) (a) Bell End; (b) Inside face of Bottom Slab; (c) Inside Face of Top Slab; (d) Outside Face of Top Slab(e) Outside Face of Right Wall; and (f) Outside Face of Left Wall

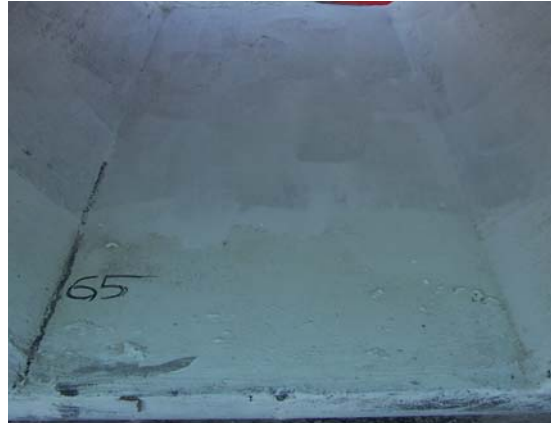
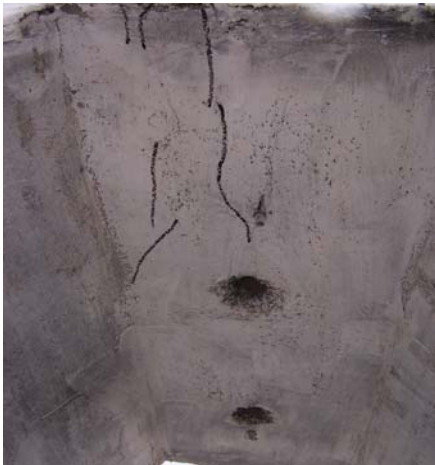
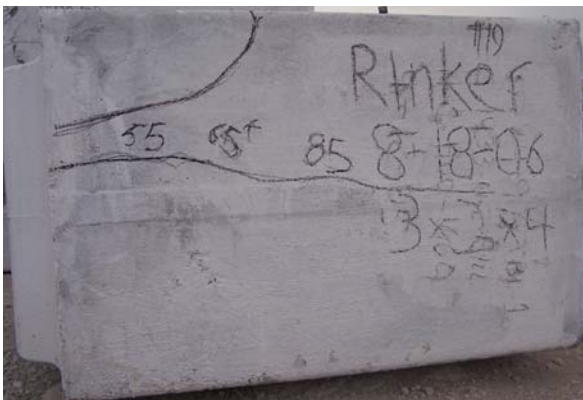
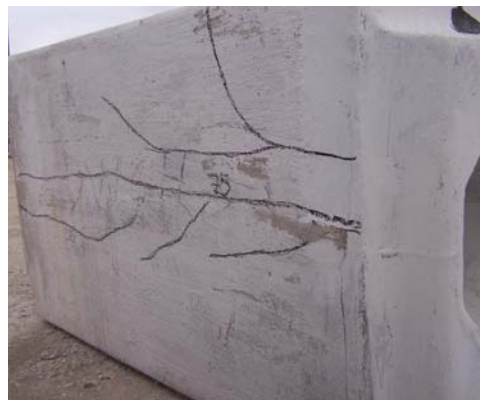
Figure B23 Experimental Photograph for SP_91-61-145_Y_0 (SP_3-2-4.75_Y_0)
(a) Spigot End; (b) Inside Face of Bottom Slab; (c) Inside Face of Top Slab; (d)
Outside Face of Top Slab; (e) Outside Face of Right Wall; and (f) Outside Face of
Left Wall

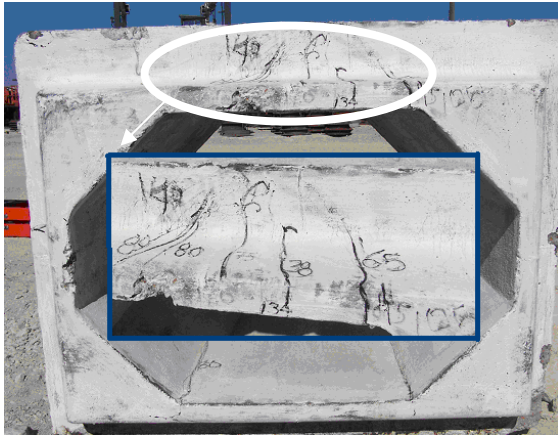
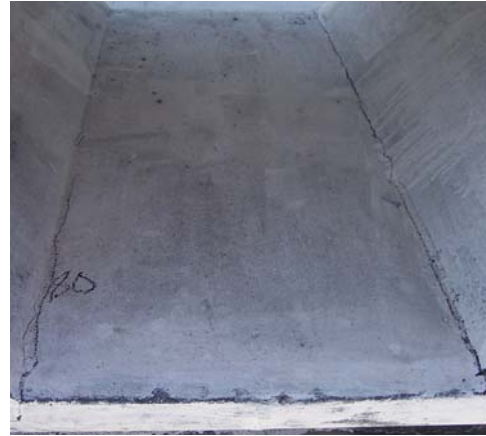
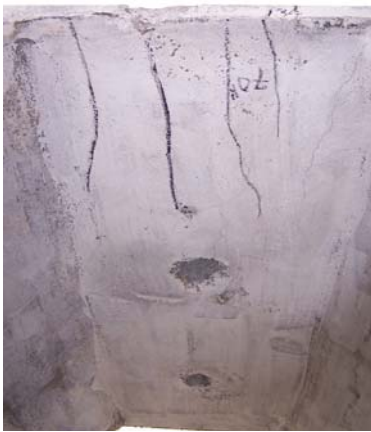
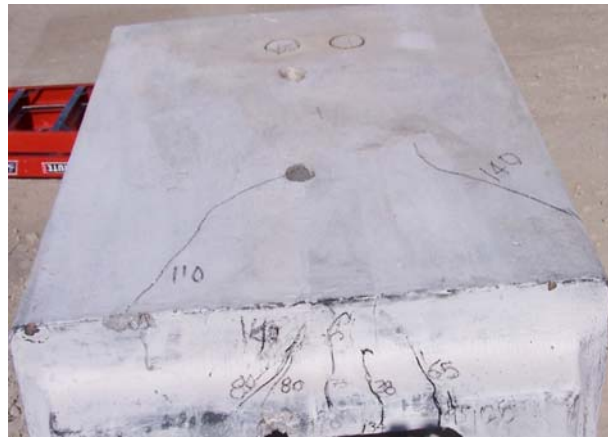
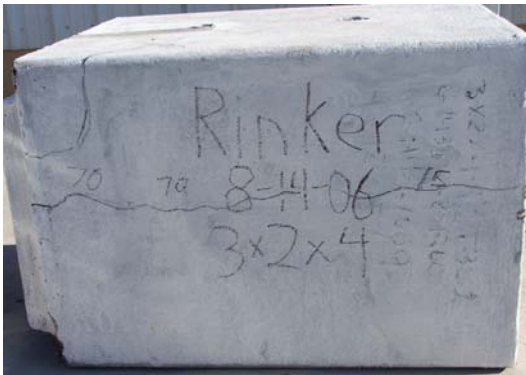
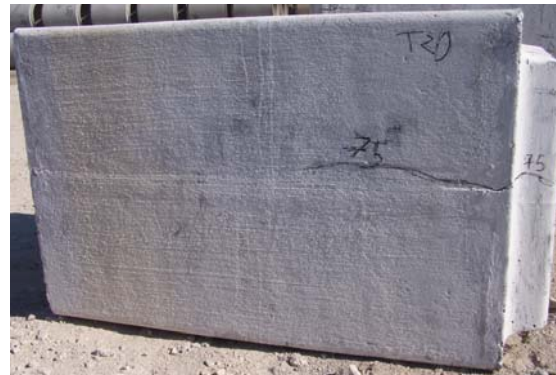
Figure B24 Experimental Photograph for Test: SP_91-61-145_Y_0.83d (SP_3-2-4.75_Y_0.83d) (a) Spigot end; (b) Inside Face of Bottom Slab; (c) Inside Face of Top Slab; (d) Outside Face of Top Slab; (e) Outside Face of Right Wall; and (f) Outside Face of Left Wall

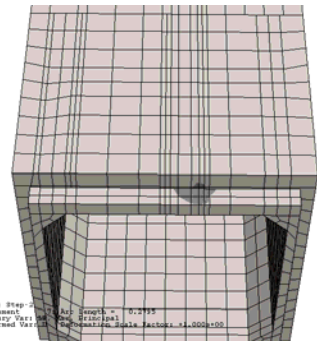
At 138 kN (31 kip) Load

Figure C2 FEM Crack Prediction of Model SP_122-122-122_N_d (SP_4-4-4_N_d)

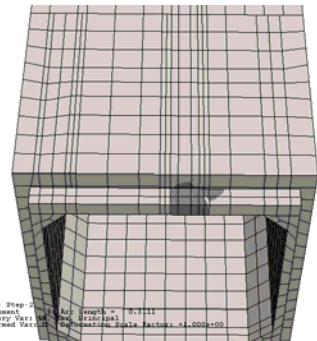
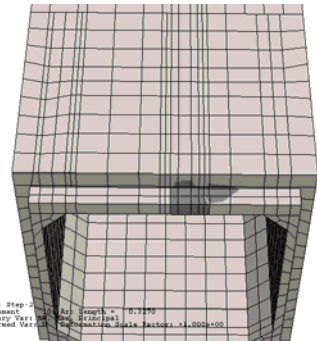
Figure C3 FEM Crack Prediction of Model SP_122-122-122_N_d (SP_4-4-4_N_d)

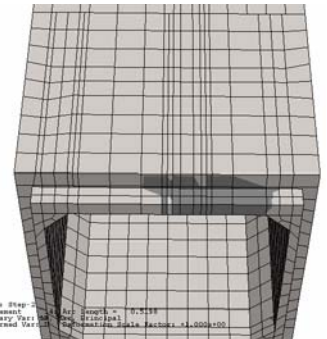
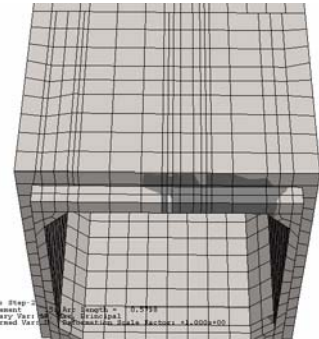
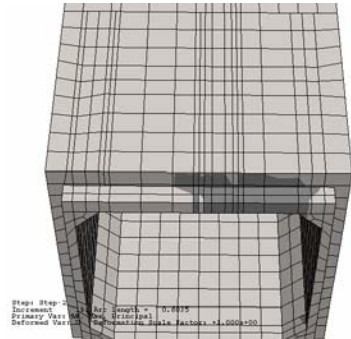
Figure C5 FEM Crack Prediction of Model SP_122-122-122_N_d (SP_4-4-4_N_d)

Figure C6 FEM Crack Prediction of Model SP_122-122-122_N_d (SP_4-4-4_N_d)

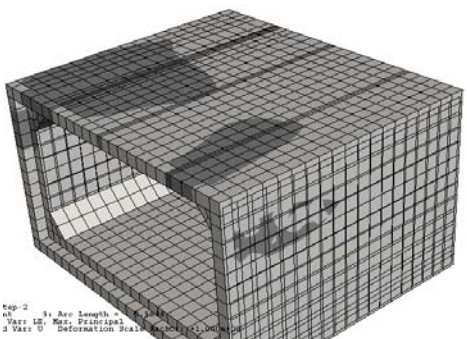
At 258 kN (58 kip) Load

Figure C29 FEM Crack Prediction of Model BL_244-122_244_N_d (BL_8-4-8_N_d)

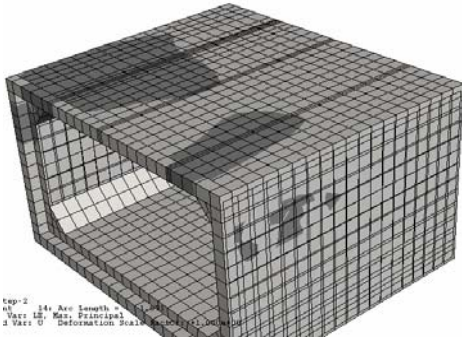
At 262 kN (59 kip) Load

Figure C30 FEM Crack Prediction of Model BL_244-122_244_N_d
(BL_8-4-8_N_d)
