EFFECTS OF A DEBONDING FLAW SIZE AND LOCATION  
ON THE FLEXURAL PERFORMANCE OF CFRP  
RETROFITTED STEEL SECTIONS

Presented to the Faculty of the Graduate School of  
The University of Texas at Arlington in Partial Fulfillment  
of the Requirements  
for the Degree of

MASTER OF SCIENCE IN CIVIL ENGINEERING

THE UNIVERSITY OF TEXAS AT ARLINGTON

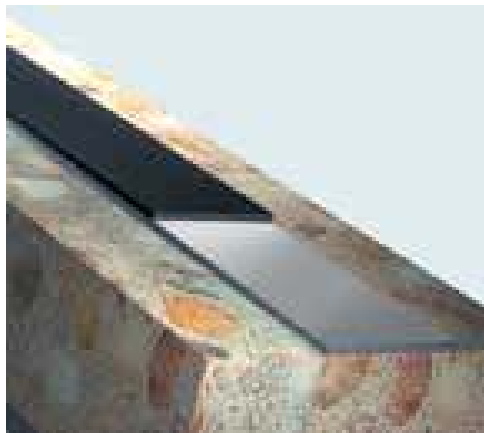
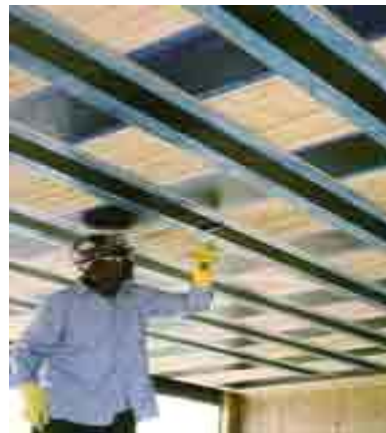
Figure 1.1: Some Commercial CFRP laminates by Degussa Buildings [15]

Commercially available Fiber Reinforced Polymer (FRP) laminates are shown in figure 1.1. They are typically made of glass (GFRP), Aramid (AFRP) and/or carbon (CFRP) which are bonded with an epoxy. Some of the engineering properties of these Fiber are summarized in table 1.1.

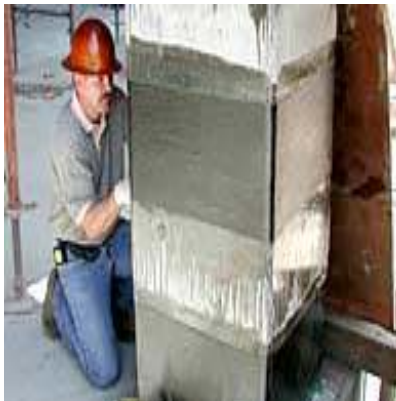
Figure 1.3: Removal of air voids during hand lay-up sheet CFRP [18]

- Flaw due to presence of air voids, moisture or even excessive amount of solvent used in making pre-peg, Figure 1.3.
- Co Resin starved areas, due to bleeding of resin during resin transfer molding, Figure 1.4..

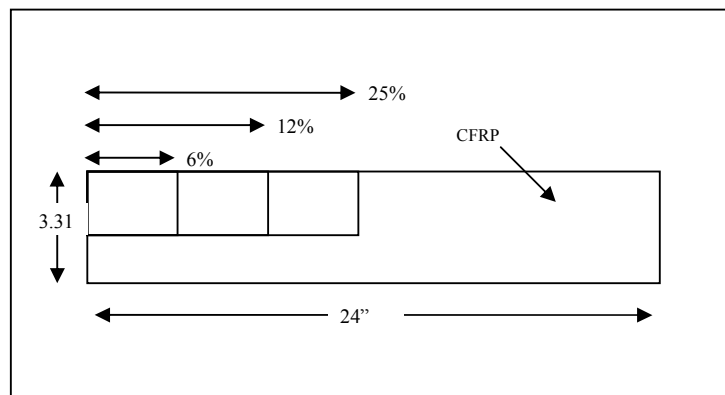
Figure 1.10: Different flaw size created in the FRP

Fifteen systematic experimental tests were conducted to study the variation of strength of CFRP bonded to steel due to the presence of surface flaws in CFRP. These experiments were conducted under static loading. To allow the transfer of stresses from steel section to CFRP, a four inch-long notch was created in tension flange at the center. A flaw was introduced by pasting wax paper to CFRP and not allowing it to bond with the steel I-section directly. Different percentages of flaw (6%, 12% and 25%) were achieved by varying the percentage of bonded area to study the variation of strength as shown in Figure 1.10.

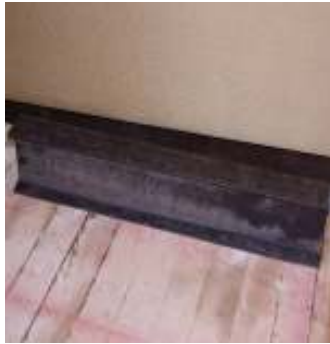
Figure 2.3: Steel beams of A-36 grade

Thirty six inch (914mm) long steel beams (S6x12.5) shown in Figure 2.3 were used in this investigation. The material properties of steel were provided by the supplier and were according to ASTM structural steel specifications for GR36. The yield strength values of the steel beam were 36ksi (2530kg/sqcm), which were determined by test.

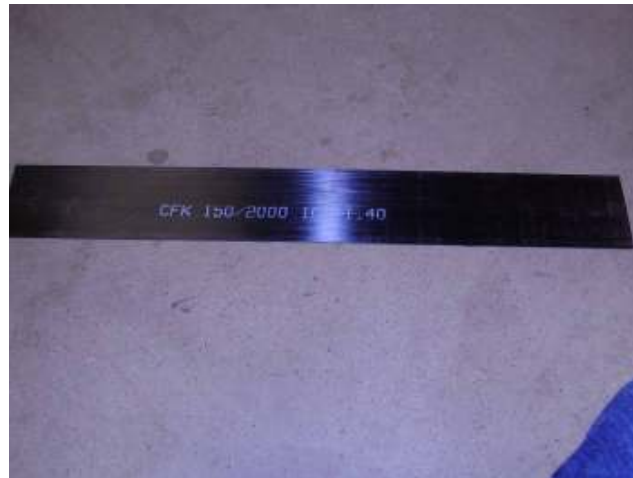
Figure 2.4: CFRP laminate used in research

The Laminate used in the current research was provided by Degussa. It was shiny black color as can be seen in figure 2.4. These were made of high strength carbon fiber. Some of the engineering properties of the laminate is tabulated in Table 2.1.

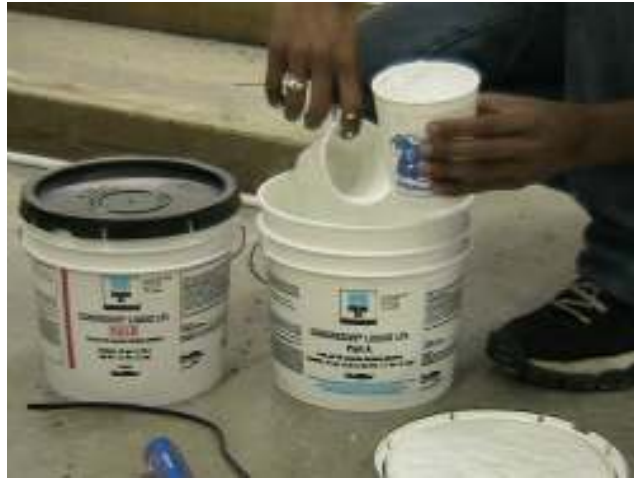
Figure 2.5: Epoxy used in research

The epoxy used in this research was provided by the same supplier. This epoxy is used for a CFRP laminate called Conc. Liquid LPL. The epoxy was a combination of two components A (white semi-liquid) and B (black semi-liquid) as shown in Figure 2.5, in the ratio of 2:1 by volume. The engineering properties of the epoxy are tabulated in Table 2.2.

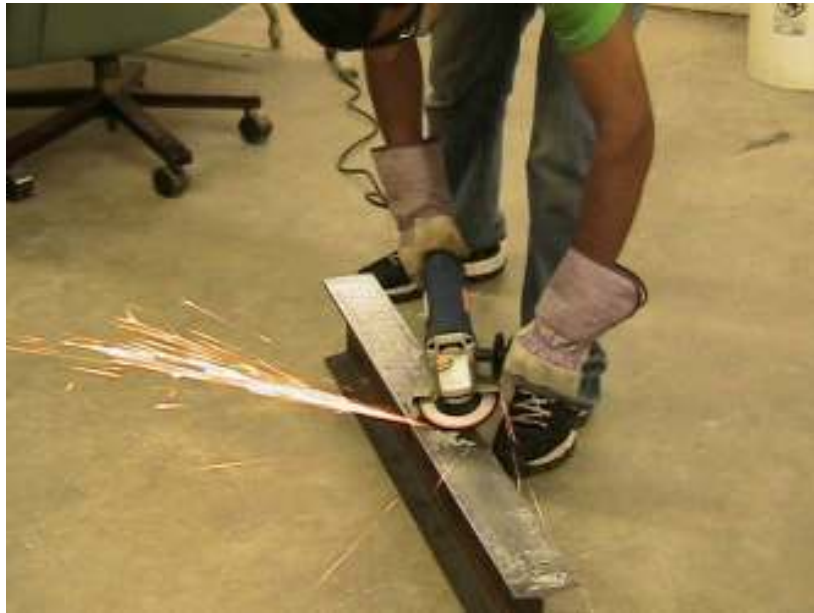
Figure 2.6: Specimen preparation

The first step was to have the surface preparation process completed before applying the laminate. According to the supplier (Degussa buildings), the steel should be free from any grease, oil, paint, or rust that might affect the bond between the steel and the laminate. It was decided to remove paint, rust and grease off the top by using a hand grinder as shown in Figure 2.6. Then, the steel was cleaned with sand paper to make it totally free from any paint.

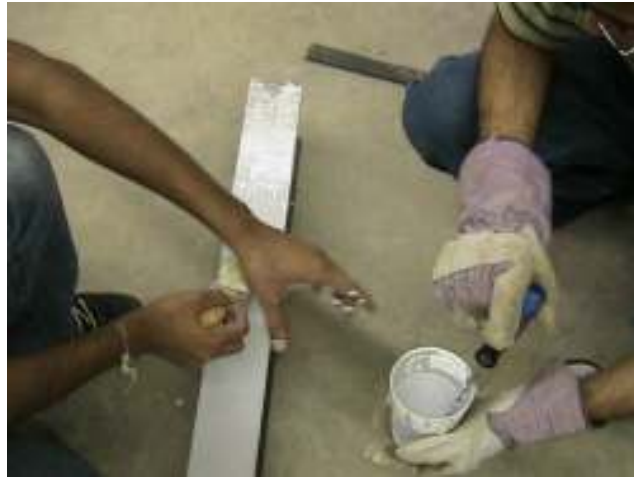
Figure 2.7: Applying epoxy to CFRP laminate

The epoxy was applied onto the surface of the CFRP laminate using a brush as shown in Figure 2.7. It was then spread using a paint brush. After applying the epoxy, the laminate was placed on a prepared area of steel and was pressed by hand. Later, some loads were placed over it to provide extra pressure. Then, it was left alone and allowed to cure for seven days at room temperature.

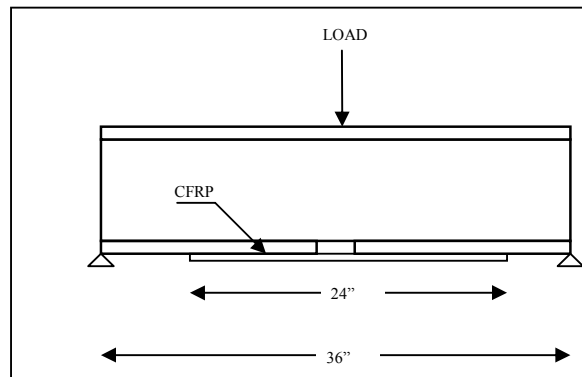
Figure 2.8: Test set up for the experiment

All fifteen I-beams were tested for three point static loading. The loading was applied using a 400kip (150mt) Tinius Olsen testing machine. The load was applied at the mid span of the beam, by a manually operated hydraulic pump. All the beams were loaded to 6000lb (2721kg) to counter the weight of the hydraulic slab that was used for our testing. Then, the entire additional load (in excess of 6000lbs) was used to test the I-beam. A typical load set up is shown in Figure 2.8.

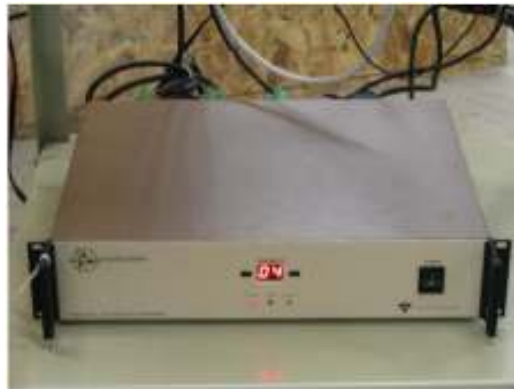
Figure 2.10: System 5000 model 5100 Vishay strain sensor

described in section 2.2.3 of this thesis) to the tension flange of the steel sections. The steel beams were supported at one inch from each end. Two strain gauges were placed, one on top of the flaw area, a second on top of the non flaw area at the same position but on the opposite side as shown in Figure 2.9b. The point load was placed at the center, 17inch (432mm) from the supports. The load was applied hydraulically by rotating the knob of the Tinius Olsen machine .Deflection were recorded by two methods – digitally by software called MTESTW, and analog by using a dial gauge. Strain gauges were measured using the System 5000 Model 5100 Vishay Strain Sensor, which is shown in Figure 2.10.

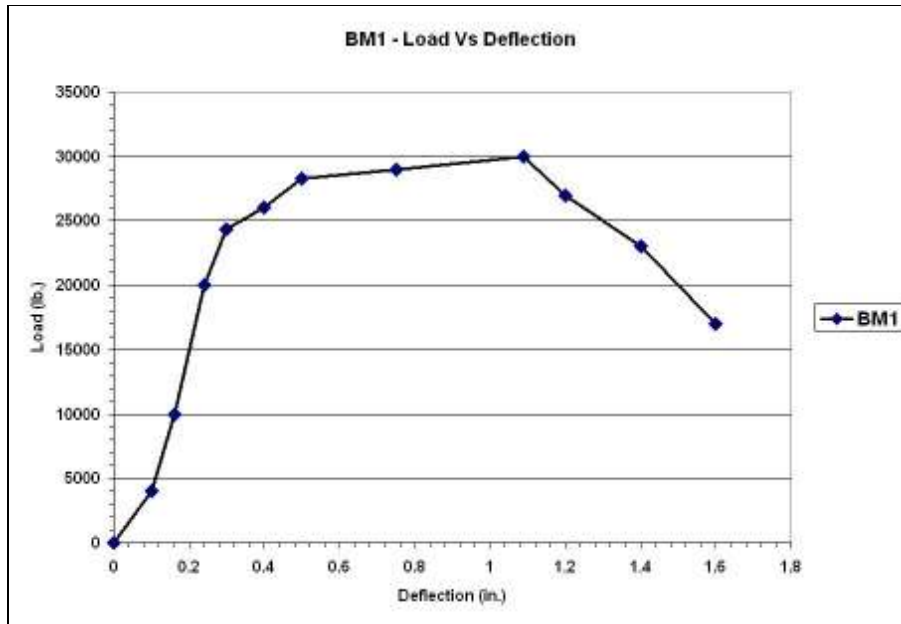
Figure 3.1: Load vs. deflection for un-notched 0 percentage flaw without CFRP

It was observed from the load vs. deflection graph shown in Figure 3.1 that the steel section failed at 30kips (13.60mt). This observation was used as a reference point to conclude that all the beam samples utilized for the purpose of this research are of A36 grade.

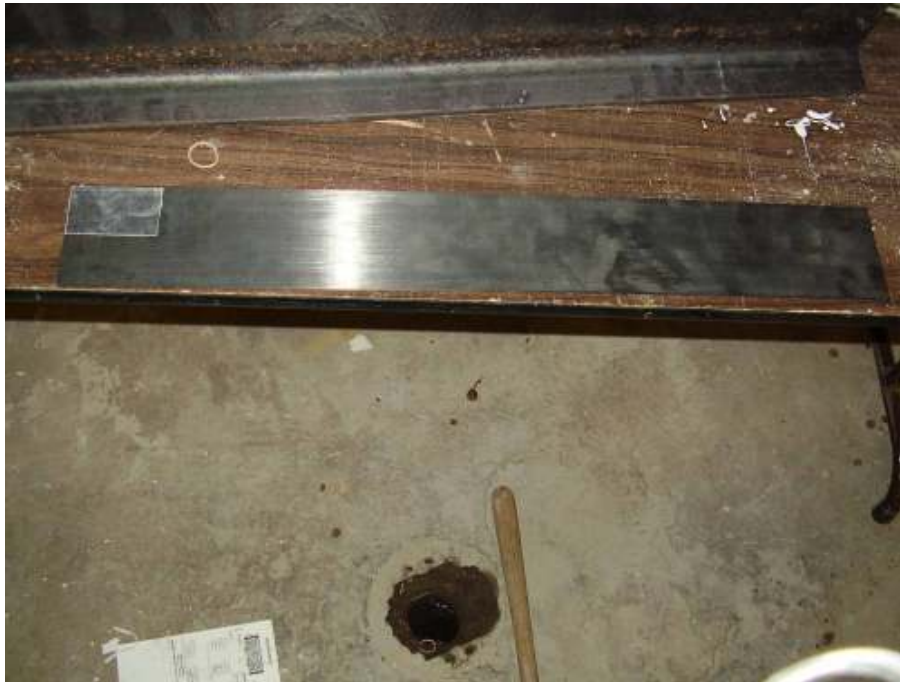
Figure 3.2: Showing 6 percentage flaw

The three point bending test was performed on an un-notched steel section with a flaw of 6%. The reason for choosing 6 % flaw was, in practice 5% flaw of total area bonded is considered as acceptable flaw. This flaw was created by attaching a wax paper separator of dimension 2.7 x 1.66inch (69 x 42mm) to the corner of the laminate as shown in Figure 3.2. This laminate was then bonded to the steel section using the specified epoxy described in section 2.2.3 of this thesis. The load-deflection plot for this test is shown in Figure 3.3 of this thesis.

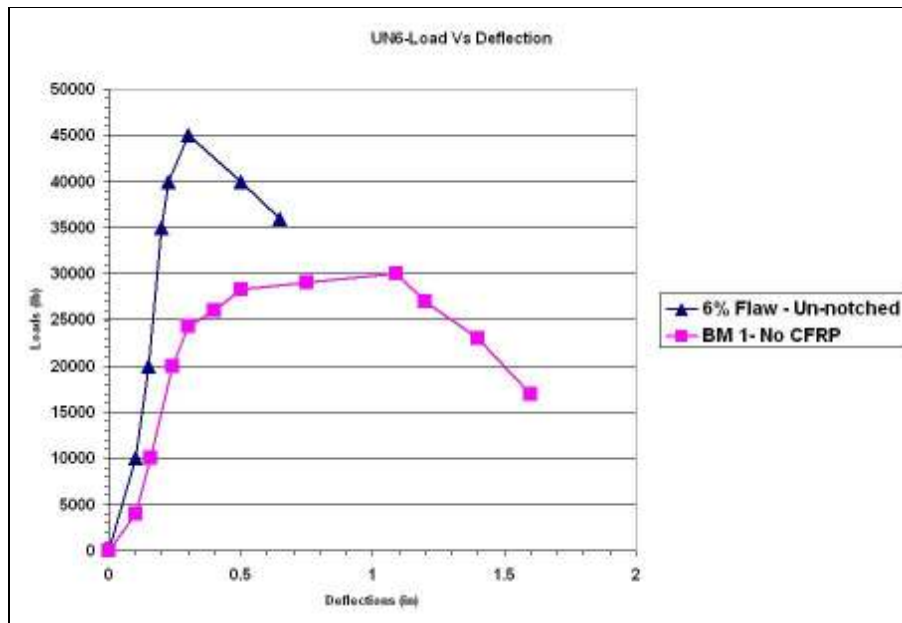
Figure 3.3: Load vs. deflection for 6 percentage flaw

De-lamination of the CFRP laminate from the steel section occurred, which resulted in a sudden failure in the form of lateral torsion buckling. This de-lamination and the resulting failure are suspected to be due to the presence of a small strip of laminate protruding out from the steel beam. Therefore it is not considered as valid test for data.

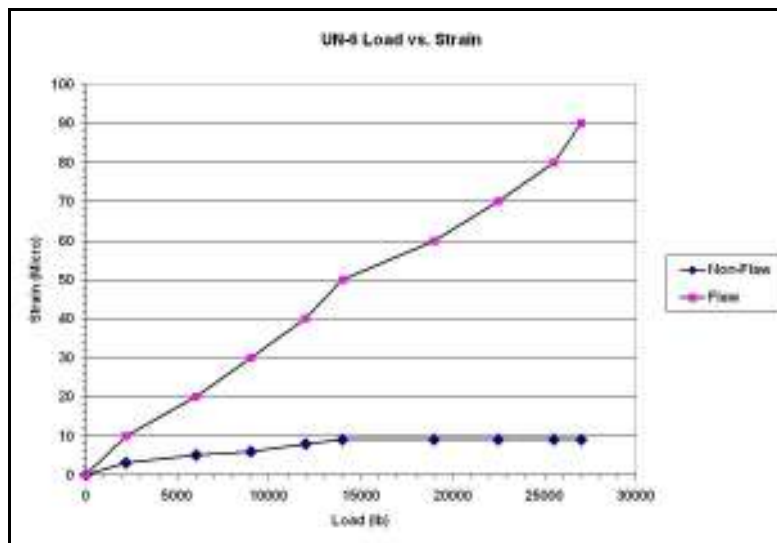
Figure 3.5: Load vs. strain graph for un-notched 6% flaw

The values of strain were recorded for increment of load. The strain values measured for both flaw and non flaw areas are shown in fig 3.5.

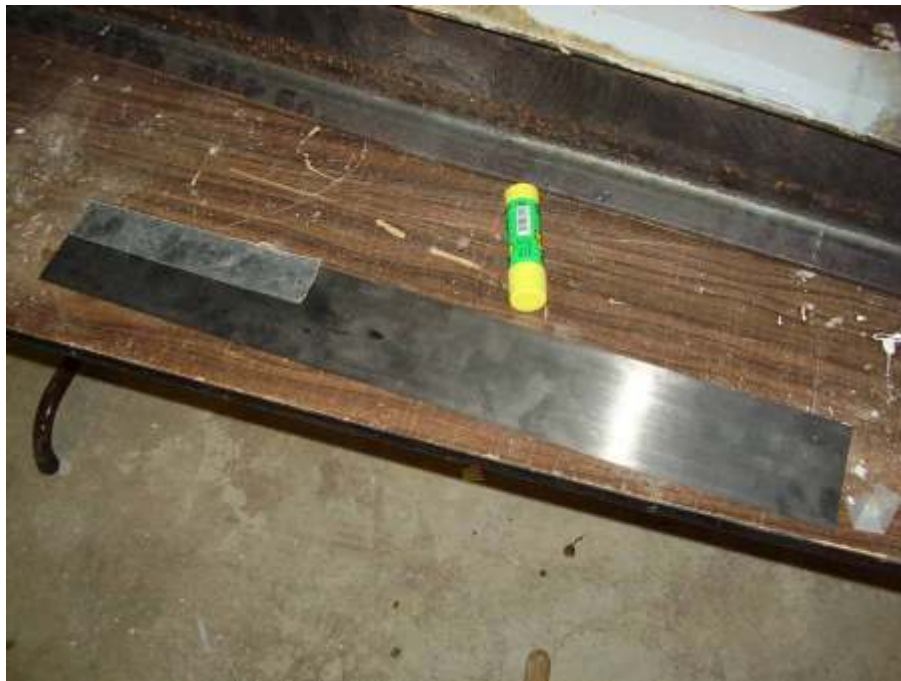
Figure 3.6: Showing 12 percentage flaws

The three point bending test was performed on an un-notched steel section with a flaw of 12%. This flaw was created by attaching a wax paper separator of dimension 5.4 x 1.66inch (137 x 42mm) to the corner of the laminate as shown in Figure 3.6. This laminate was then bonded to the steel section using the specified epoxy.

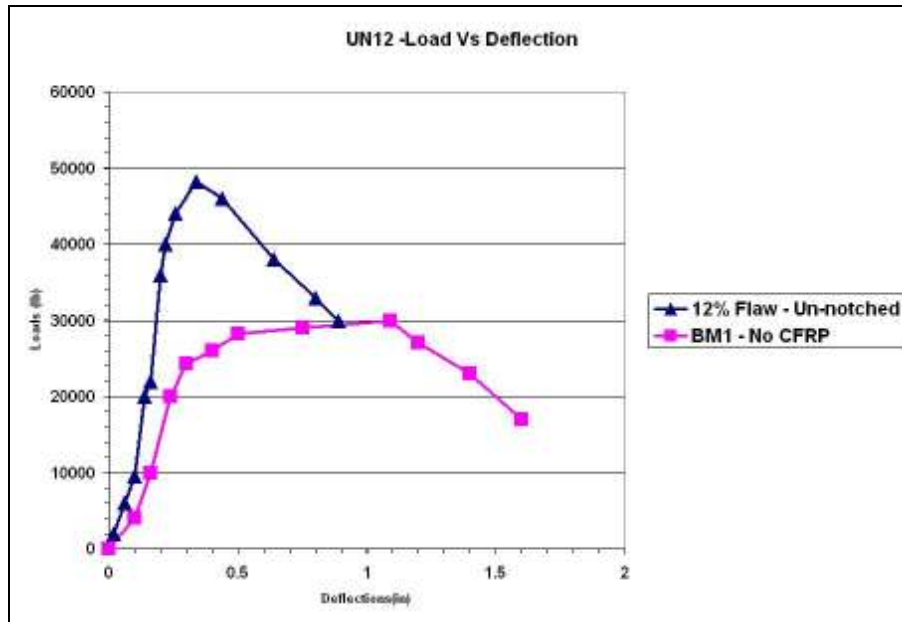
Figure 3.7: Load vs. deflection for un-notched 12 % flaw

From Figure 3.7 we observe that there was no influence of flaw over the ultimate capacity of the steel section as when compared to the values in the 6% flaw experiments of section 3.2.1.1 of this thesis.

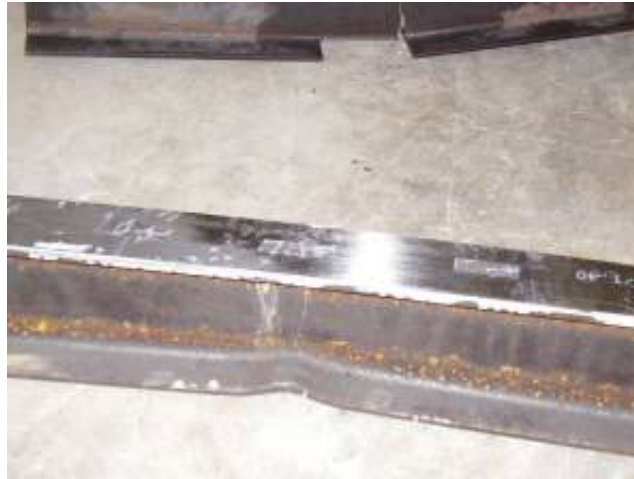
Figure 3.8: Failures in lateral torsion buckling

There were a total of three strain gauges applied to CFRP one on top of the flaw area, a second on top of the non flaw area at the same position but on the opposite side, and third at the center of the beam as shown in Figure 3.8.

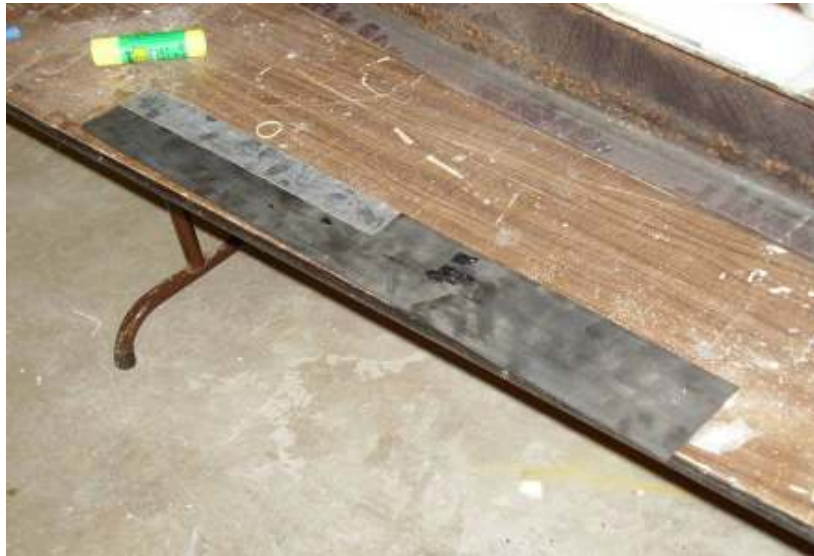
Figure 3.10: Showing 25 percentage flaws

The three point bending test was performed on an un-notched beam with a flaw of 25%. This flaw was created by attaching a wax paper separator of dimension 12 x 1.66inch (305 x 42mm) to the corner of the laminate as shown in Figure 3.10. This laminate was then bonded to the steel section using the specified epoxy.

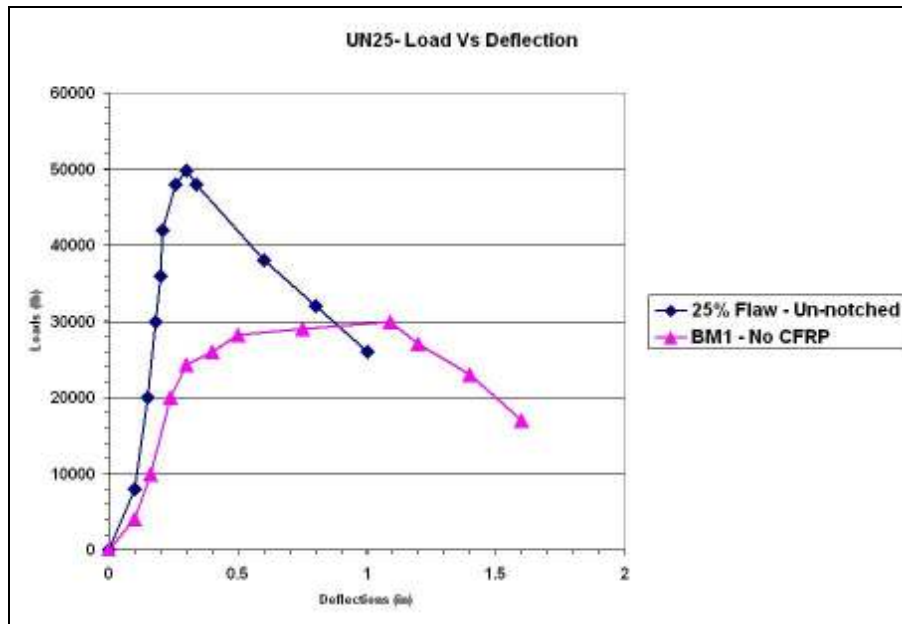
Figure 3.11: Load vs. deflection for un-notched 25 percentage flaw

As seen in Figure 3.11, due to the presence of the flaw in the laminate, there was no variation in the ultimate capacity of steel sections as when compared to the previous experiments.

It can be concluded from Figure 3.11 that the percentage of flaw created is not changing the ultimate capacity.

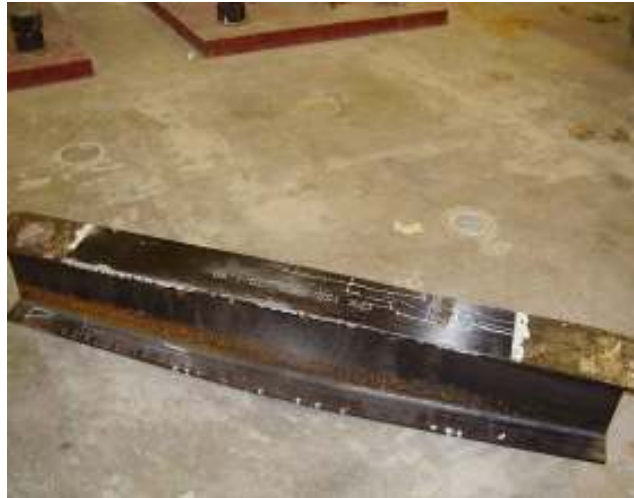
Figure 3.12: Failures in lateral torsion buckling

Strain gauges were placed this time at the CFRP and on the steel section as shown in Figure 3.12 to study the reason for no de-lamination.

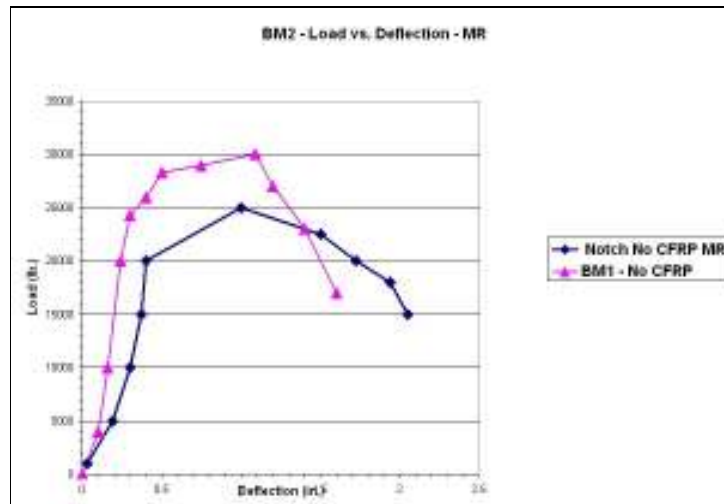
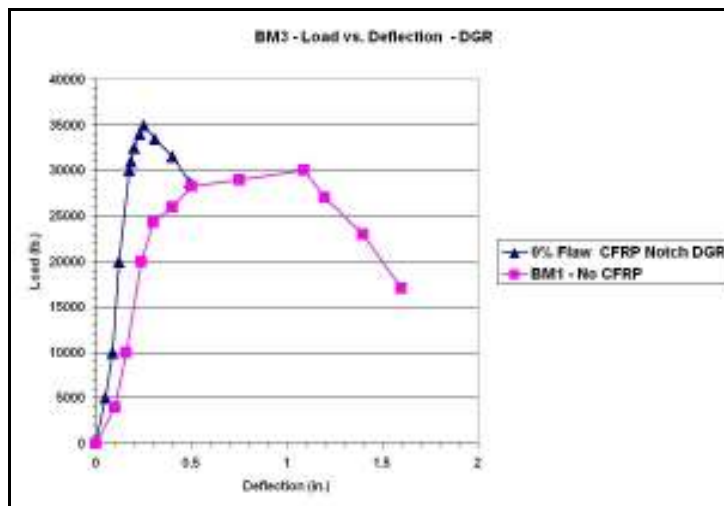
Figure 3.14: Load vs. deflection for N-steel section without CFRP: a) machine reading b) dial gage reading

It was found the steel section failed at 25kip (11.34mt) in the experiment, there was reduction of strength due to presence of notch as expected. The load vs. deflection graph can be seen in Figure 3.14b.

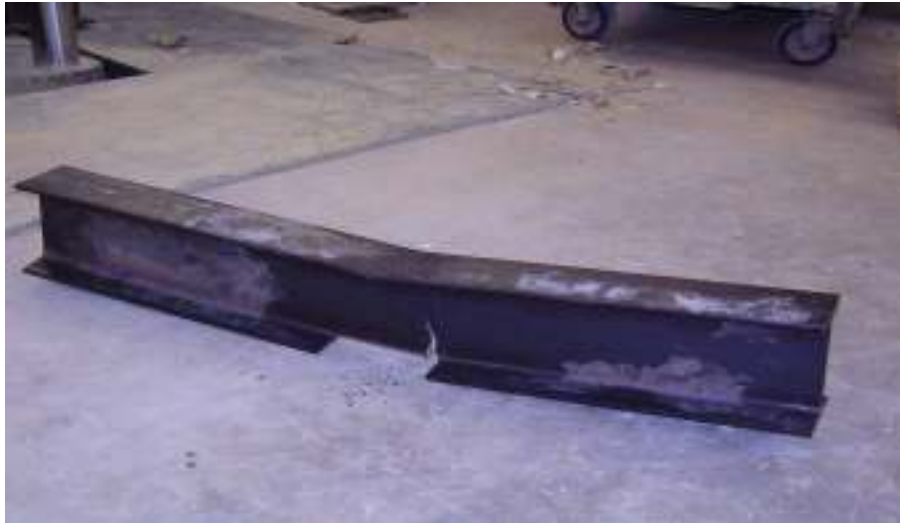
Figure 3.15: Failures in tearing of beam

The aim of the experiment was to determine the ultimate capacity of steel section with notch. The failures in the form of tearing of the steel section can be see in Figure 3.15.

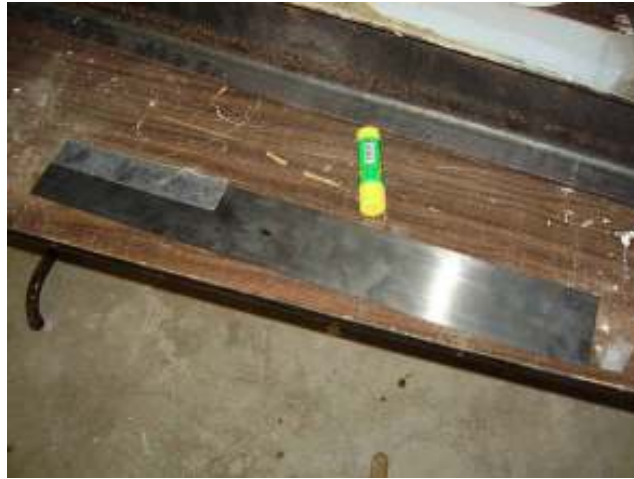
Figure 3.16: Showing 25 % flaw with notch

The three point bending tests were performed on a 4inch (102mm) notch with a 25 % flaw. The flaw was created in same way as it was created in earlier test and was glued at a quarter of the laminate as shown in Figure 3.16.

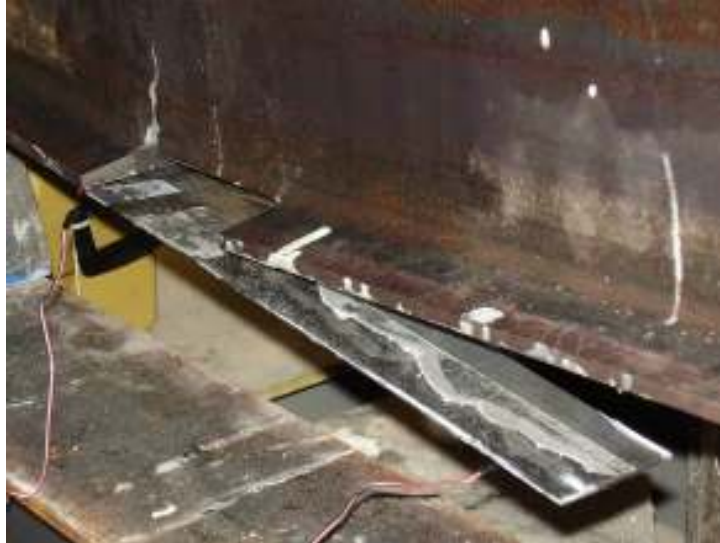
Figure 3.19: Failures with de-lamination and tearing of beam

The section failed in de lamination of laminate and tearing of steel section where notched was created . This can be clearly seen in Figure 3.19.

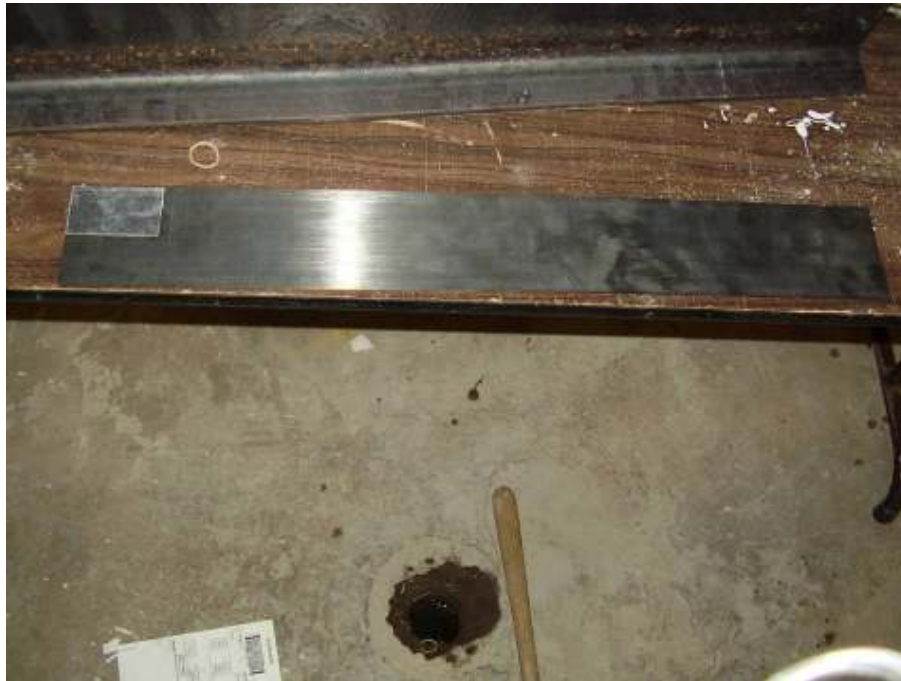
Figure 3.24: Showing 6% flaw in notched section

The three point bending test experiment was performed on a notch of length 4inch (102mm), with a 6 % flaw in the laminate. The flaw was created in the same way as it was created in previous tests, at a location shown in Figure 3.24. The hydraulic load was applied at the center of the beam.

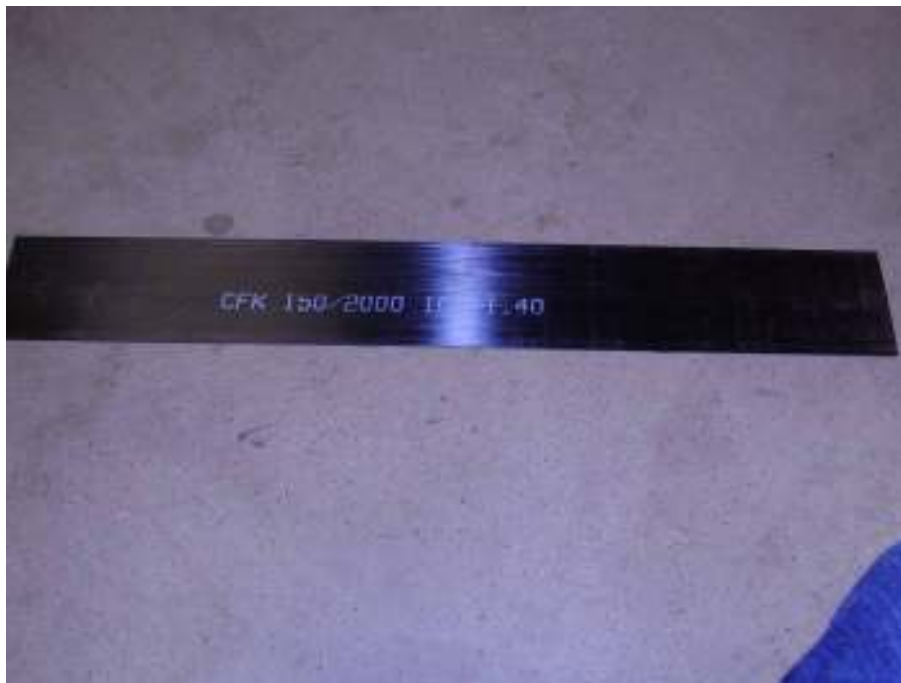
Figure 3.28: Notched steel section with 0% flaw.

The last three point bending test experiment was performed on a 4 inch notch with a 0 % flaw. This was achieved by bonding the pure CFRP laminate to the steel section, with the specified epoxy resin, and without the addition of any flaws, as shown in Figure 3.28.

The failure of this beam manifests itself in the form of de-lamination of CFRP and tearing of the notch in the beam. The beam failed at 35kip (15.90mt), indicating that the critical flaw occur between at 6 % flaw

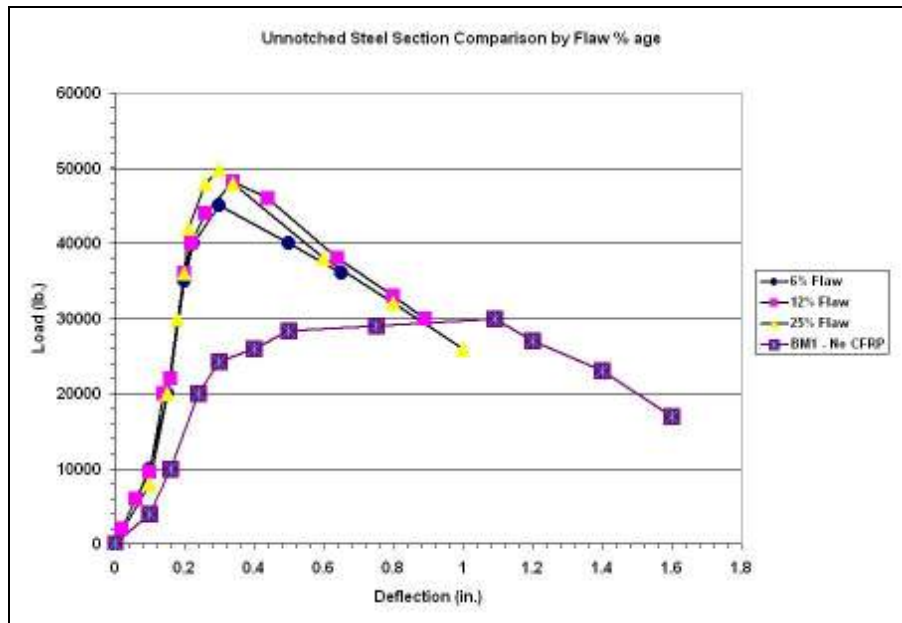
Figure 4.2: Un-notched steel section comparison

Three point bending tests were conducted to study the relationship between the percentage flaw (Surface flaw created artificially described in earlier sections) and the variation in strength of the steel beams. The Load vs. Deflection comparison is shown in Figure 4.2. It consists of results for all the un-notched steel section test data in one graph.

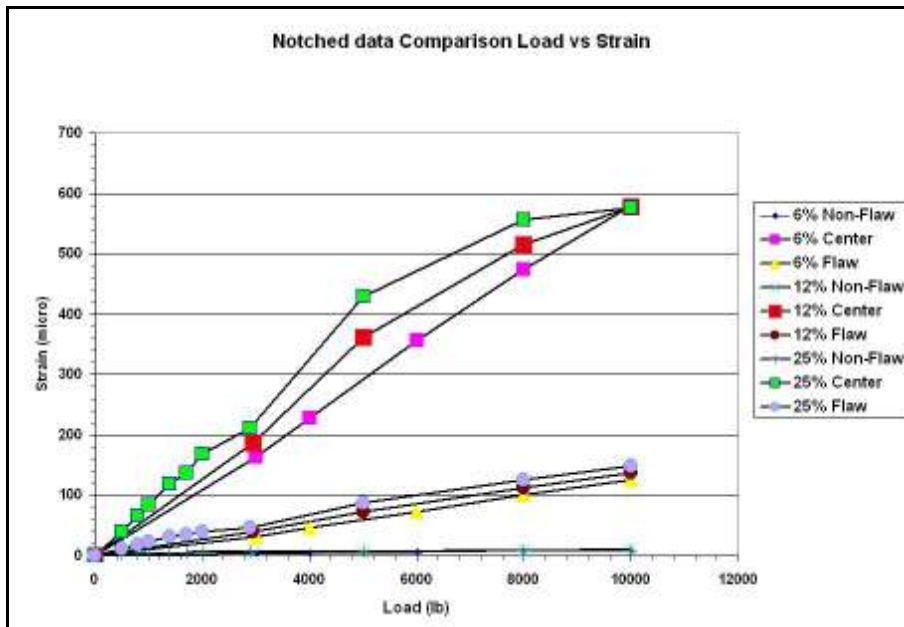
Figure 4.4: Load vs. strain plot for notched steel section for 6%, 12% and 25% flaw

In this phase of experiments, a strain gauge called ‘flaw’ was placed at the top of the CFRP laminate area where the flaw was created. Simultaneously, at the other end of the CFRP laminates, a strain gauge was placed at a location congruent to the flaw location, and was called ‘non-flaw’. A third strain gauge was placed at the center of the CFRP laminate, and was called ‘center’. This setup was implemented on the steel sections with 6%, 12% and 25% flaws, in order to analyze the behavior of the strain in the notched beams with changing flaw.
