SHEAR BEHAVIOR OF STEEL FIBER REINFORCED PRESTRESSED  
CONCRETE BEAMS WITHOUT SHEAR REINFORCEMENT

Presented to the Faculty of the Graduate School of  
The University of Texas at Arlington in Partial Fulfillment  
of the Requirements  
for the Degree of

THE UNIVERSITY OF TEXAS AT ARLINGTON

December 2011

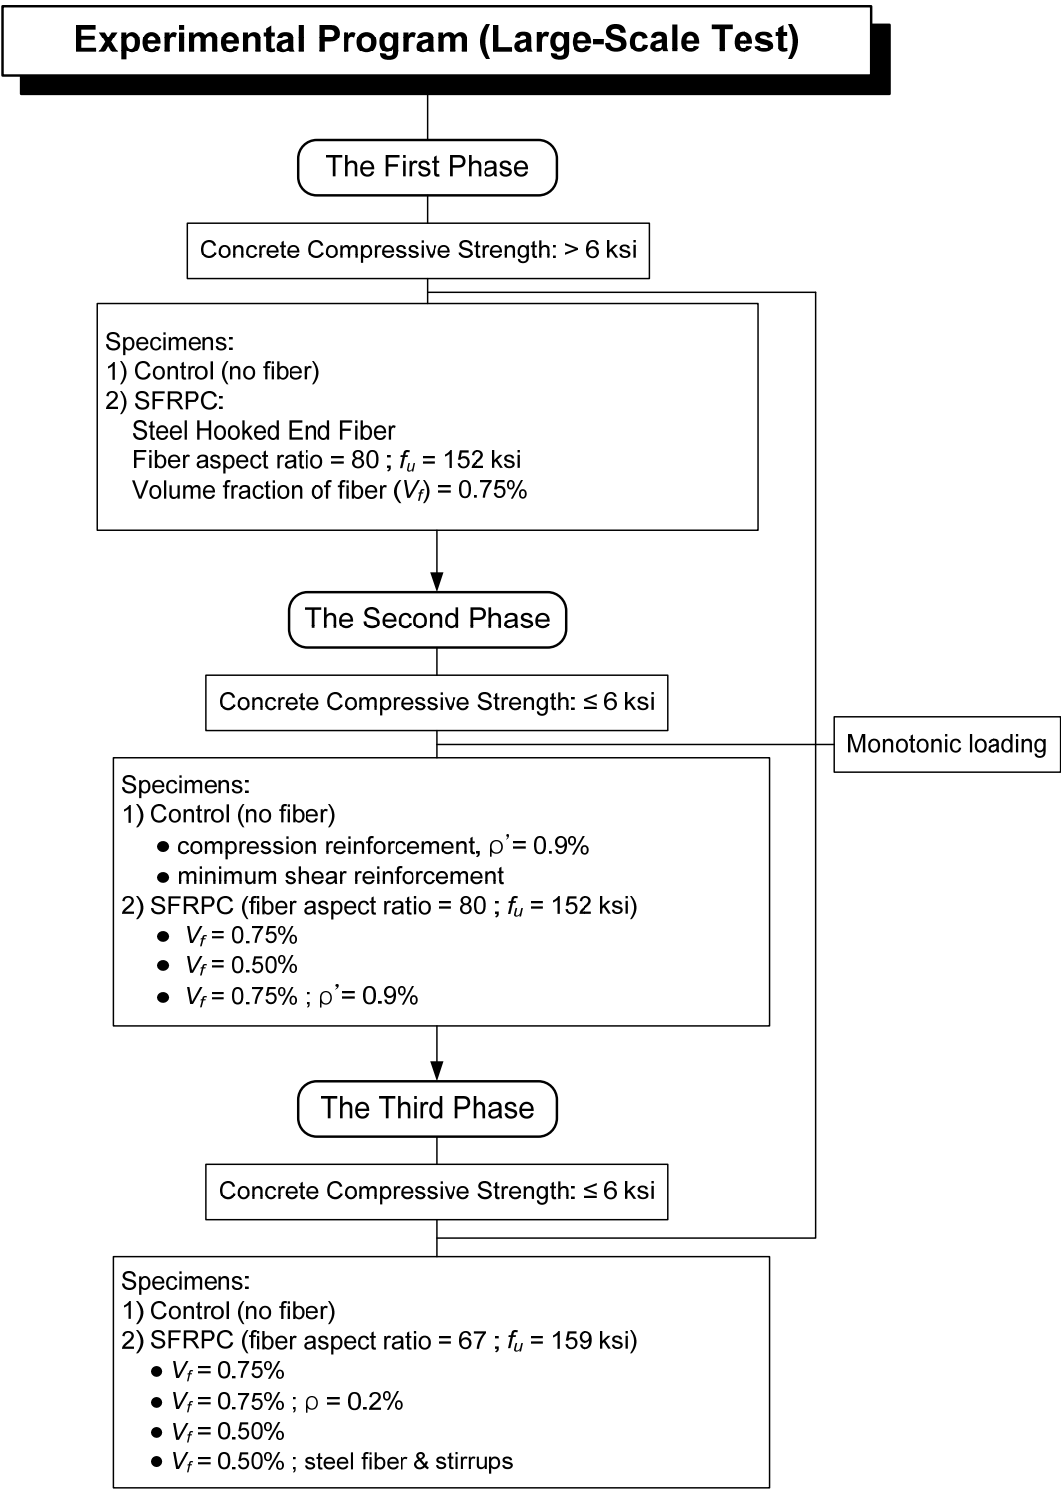
Figure 1.2 Flowchart of the experimental program for large-scale tests

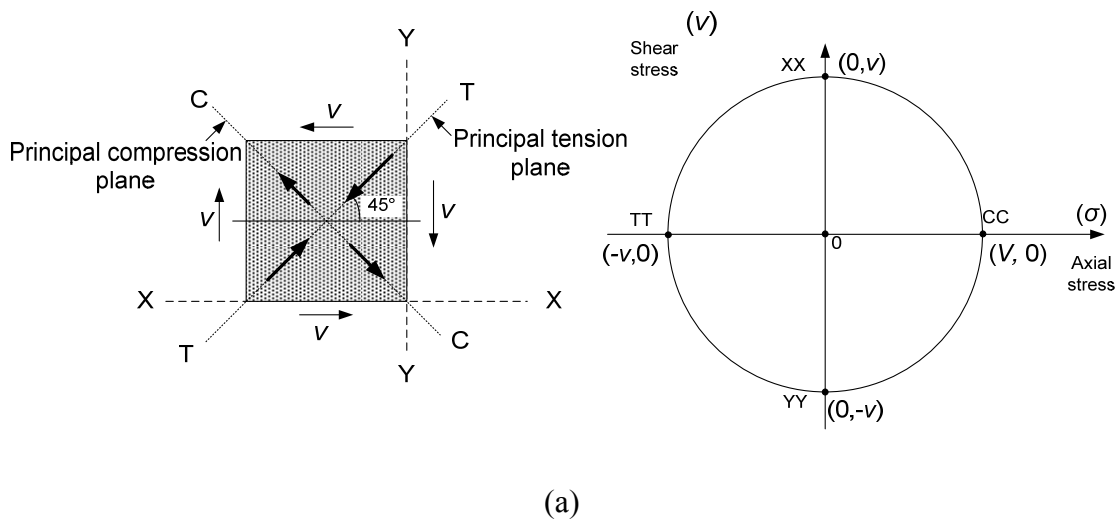
Figure 2.9 Mohr's circle for an element taken along the neutral axis; (a) Nonprestressed concrete; (b) prestressed concrete (Naaman, 2004)

Prestressed concrete beams have two major advantages in terms of shear resistance over nonprestressed concrete beams (Naaman, 2004). Shear stress in prestressed concrete beams can be smaller due to slope of the prestressing force when the tendons are draped or harped. In this case the vertical component of the pre-compression counteract part of the shear stresses induced by the external loads, thus reducing the shear force and the diagonal tension.. In addition, as mentioned previously the diagonal crack will occur when the principal tensile stress exceeds tensile strength of concrete, however, the principal tensile stress ( $TT$ ) becomes smaller in prestressed concrete than in reinforced concrete due to the compressive stress induced by the prestressing force as can be seen in Figure 2.9. Therefore, prestressed concrete beams generally have better shear resistance over nonprestressed concrete beams.

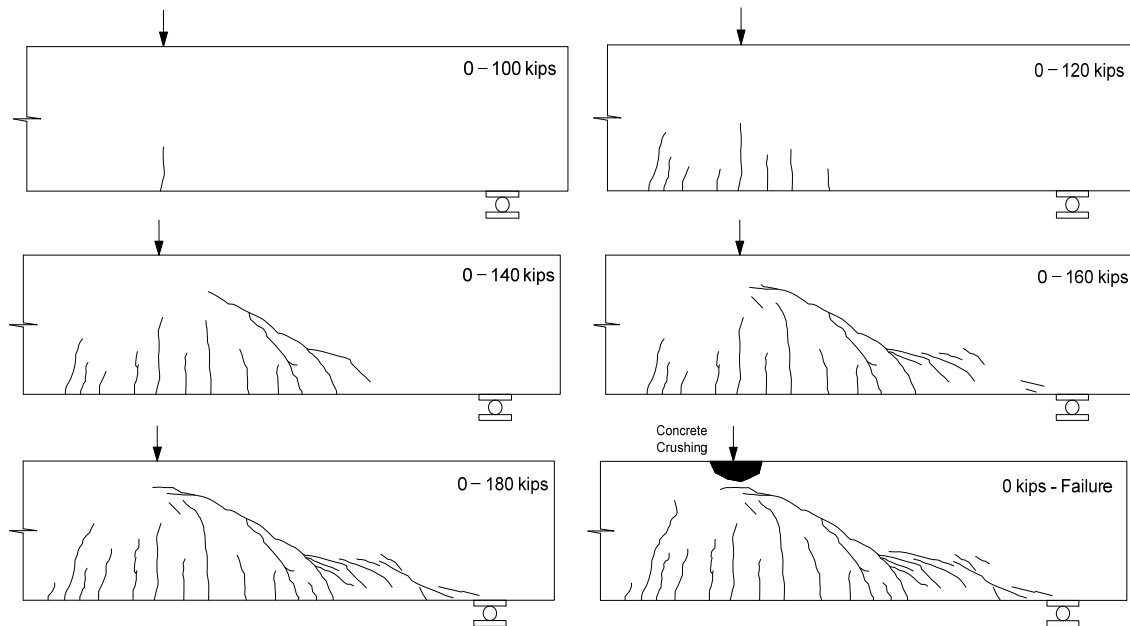
Figure 5.28 Crack pattern for 2 – SFRPC#1
