AN OVERVIEW OF MITIGATION STRATEGIES FOR SETTLEMENTS
UNDER BRIDGE APPROACH SLABS

MASTER OF SCIENCE IN CIVIL ENGINEERING

THE UNIVERSITY OF TEXAS AT ARLINGTON

December 2011

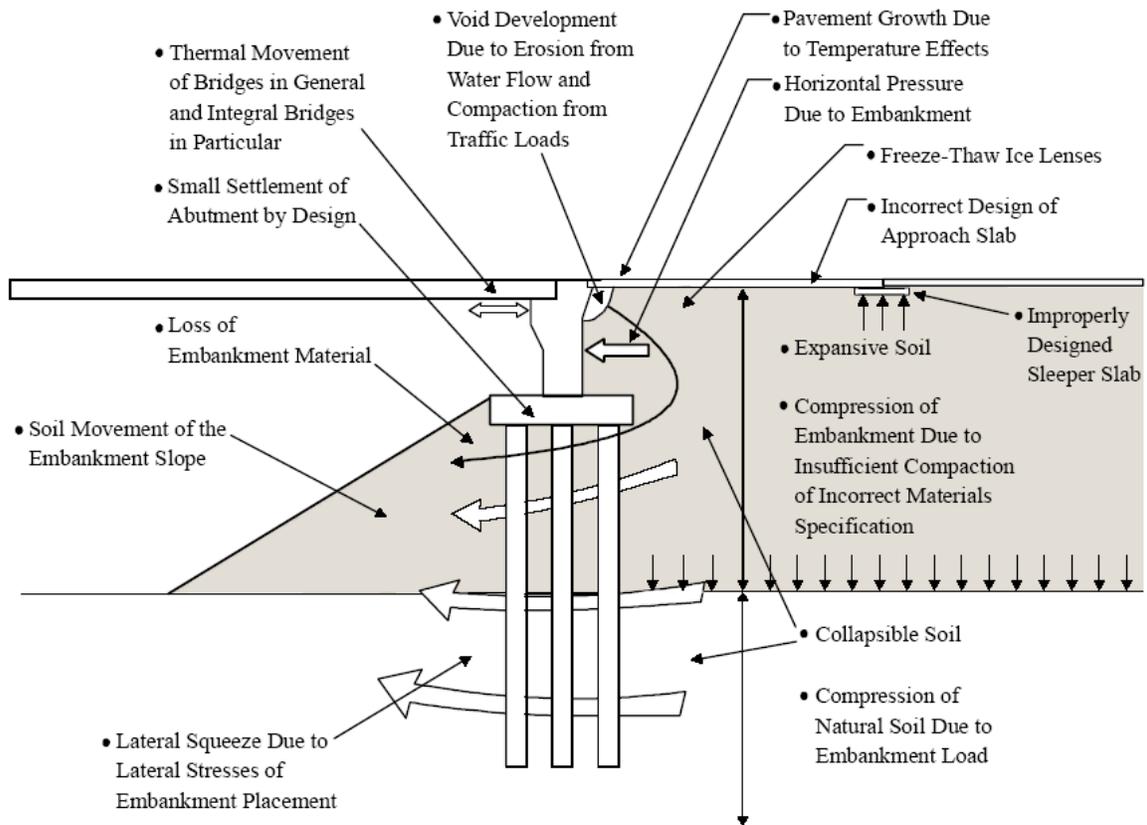
Figure 2.1 Schematic of different origins leading to formation of bump at the end of the bridge (Briaud et al., 1997)

In the following, three studies by Briaud et al. (1997), Seo (2003) and White et al. (2007) listed factors that contribute to bumps. Briaud et al. (1997) summarized various factors that contributed to the formation of bumps/settlements at the approach slabs in Figure 2.1. These factors were grouped and ranked in the following order in which they contribute to the soil movements: fill on compressible foundation; approach slab too short; poor fill material; compressible fill; high deep embankment; poor drainage; soil erosion; and poor joint design and maintenance.

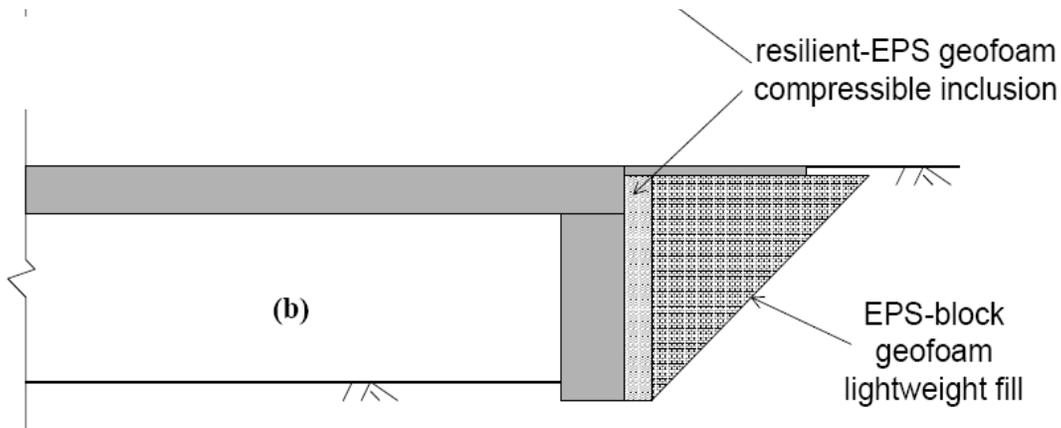
Figure 2.2 A design alternative by using geof foam as a backfill (Horvath, 2000)

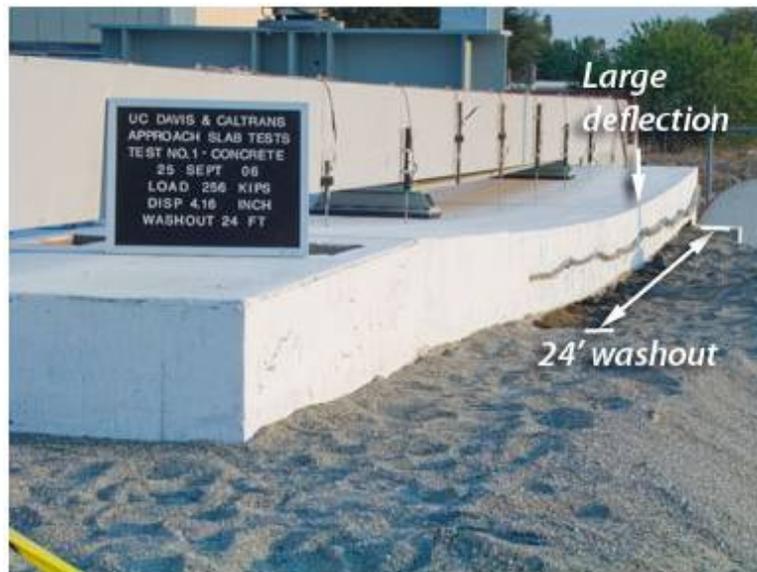
Figure 2.3 Simulated approach slab deflection due to washout by UC Davis research team (<http://cee.engr.ucdavis.edu/faculty/chai/Research/ApproachSlab/ApproachSlab.html>)

the construction process results in frequent closure of lanes, traffic congestion, etc. A new internal research project has been initiated by the California Department of Transportation to examine different replacement alternatives for deteriorated approach slabs. In this project, prefabricated Fiber Reinforced Polymer (FRP) decks as well as FRP gridforms and rebars were investigated as replacement options. Full scale approach slabs were tested under simulated wheel loads. Performance of the approach slabs were also examined under simulated washout conditions. Figure 2.3 shows the test schematic.

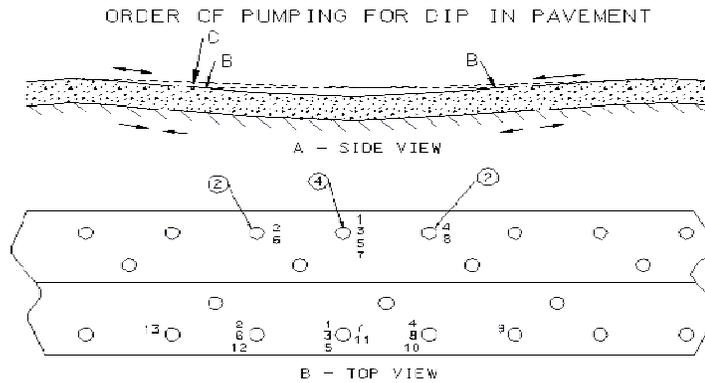
Figure 2.4 Mud-jacking injection sequences (MoDOT, EPC)

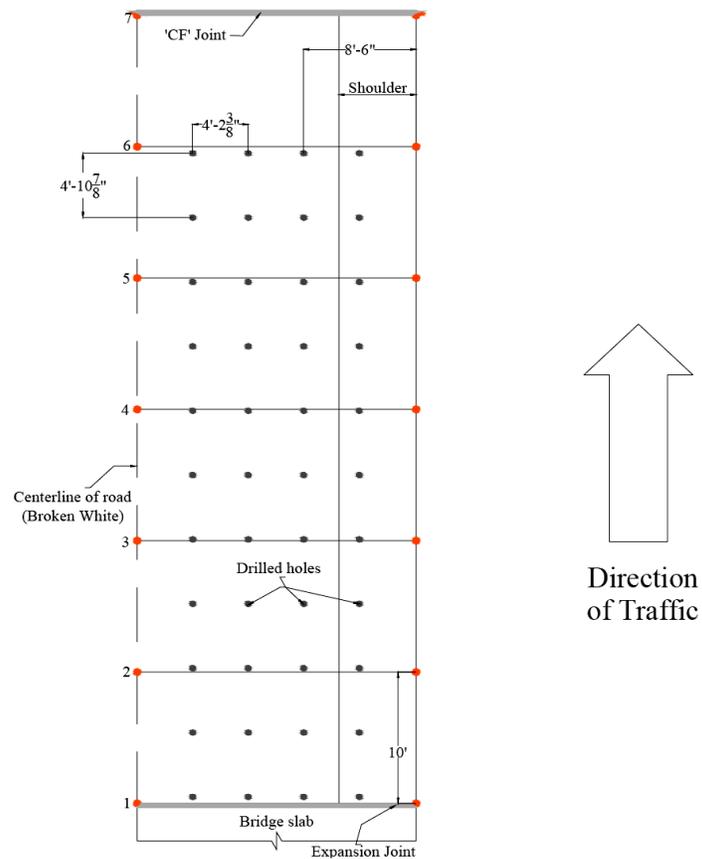
Figure 2.5 Location of holes drilled on an approach slab (White et al., 2005)

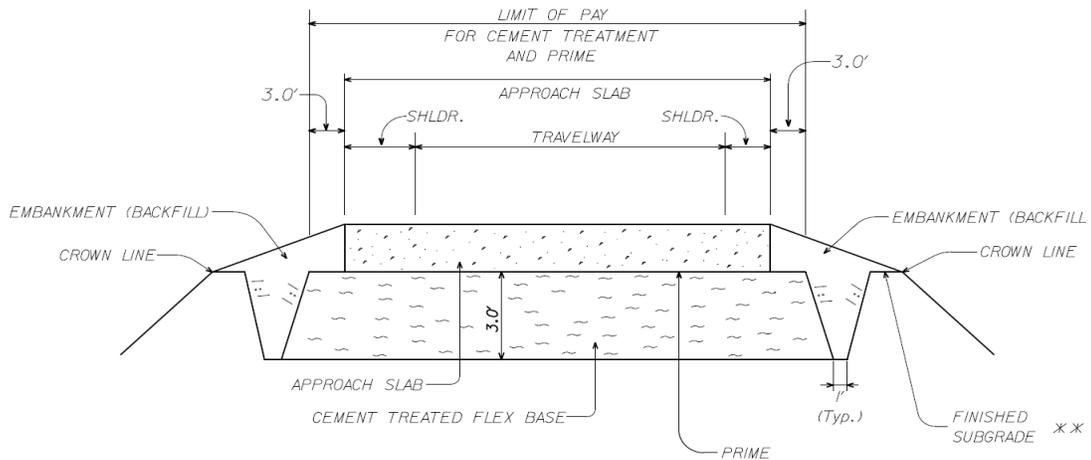
Figure 2.7 The flowable fill used as a base material (Du, 2008)

using flowable fill, which consisted of sand, flyash and water; no cement (Williammee, 2008). The compressive strength of cored samples indicated that the long-term strength and rigidity of the flowable fill were strong enough to serve this purpose (NCHRP, 597). After the mixture proportions were adjusted to have adequate flowability for the application, the flowable fill has shown a great success for repairing the approaches (Du et al., 2006 and Williammee, 2008). Recently, the flowable fill was used in the Fort Worth District in place of a flexible base beneath the approach slab. The 3 ft. deep flex base is prepared with Type 1 cement (2.4% by weight) as a base material as shown in Figure 2.7.

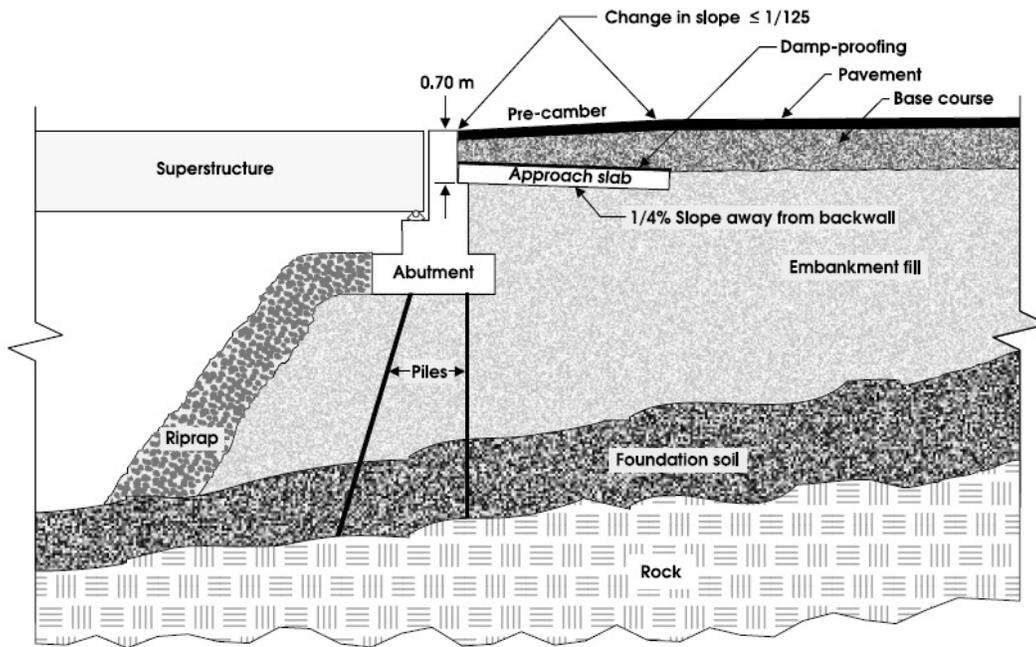
Figure 2.8 Pre-cambered Approach Design (Hoppe, 1999)

Wong and Small (1994) conducted laboratory tests to investigate the effects of constructing approach slabs with an angle from the horizontal on reducing the bump at the end of the bridge. It was found that horizontal slabs suffered a rapid change in surface deformation with the formation of obvious bumps, while pre-cambering the slabs with angles of 5° to 10° provided a smoother transition.

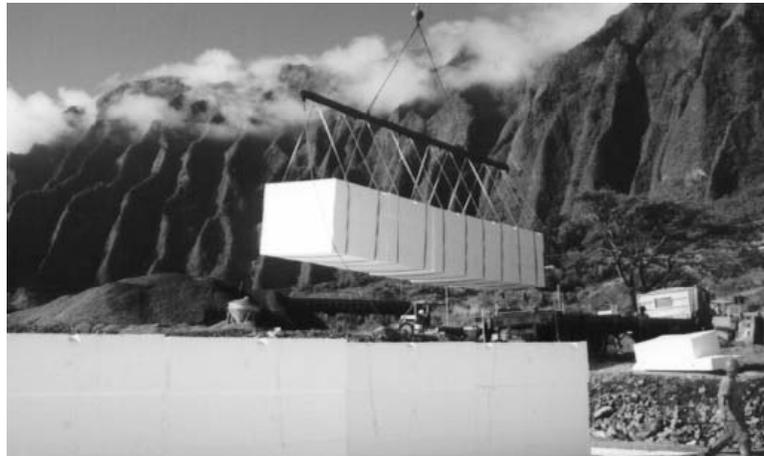
Figure 2.9 Emergency Ramp and High Embankment constructed using EPS Geofoam at Kaneohe interchange in Oahu, Hawaii

Lightweight EPS Geofoam was used as an alternate fill material at Kaneohe Interchange in Oahu, Hawaii while encountering a 6m thick layer of very soft organic soil during construction. 17,000 m³ of EPS Geofoam was used to support a 21 m high embankment construction (Mimura and Kimura, 1995). They reported the efficiency of the material in reducing the pre- and post-construction settlements. Figure 2.9 shows the construction of the embankment with the EPS Geofoam.

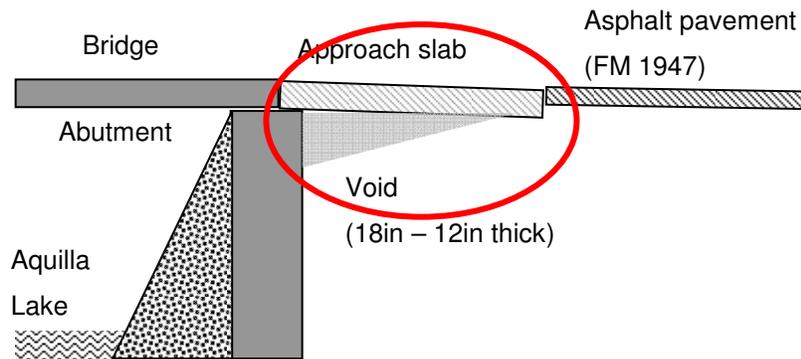
Figure 3.2 Problem definition sketch of FM 1947 Bridge site, Hillsboro, Texas

Figure 3.2 presents a sketch of the pavement and bridge sections observed in this study.

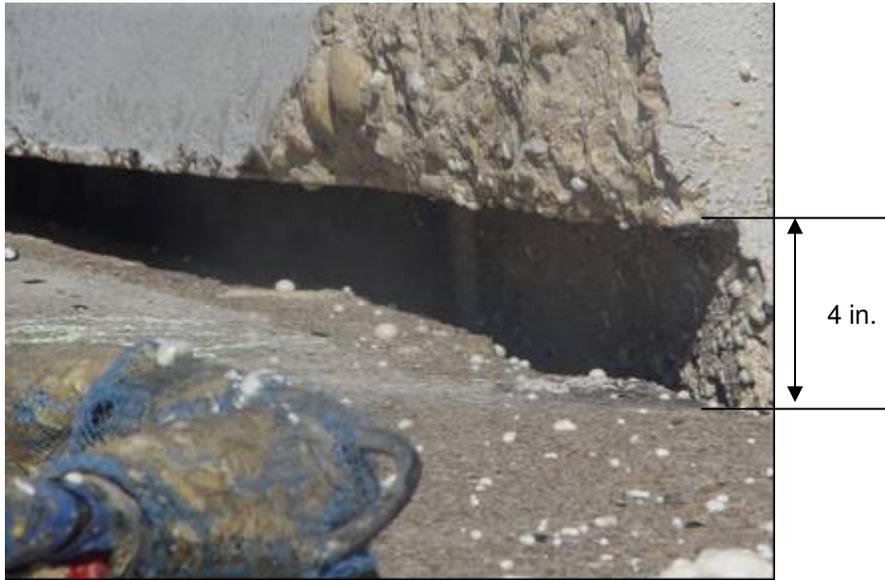
Figure 3.3 Settlement of the approach slab.

The urethane injection work at this site has been carried out by URETEK Company, USA. Before the actual injection process has begun, elevation levels were taken on firm bridge portion and settled approach slab. A leveling thread was run through the settled approach slab and firm adjacent pavement to estimate the required amount of uplift of the approach slab. The total settlement of the approach slab is around 4 in. before the repair. The depth of void adjacent to the bridge abutment varied from 2 in. to 18 in., gradually increasing towards the abutment. Figure 3.3 and Figure 3.4 show the settlement and void formation respectively. Figure 3.5 gives a closer view of the void under the slab.

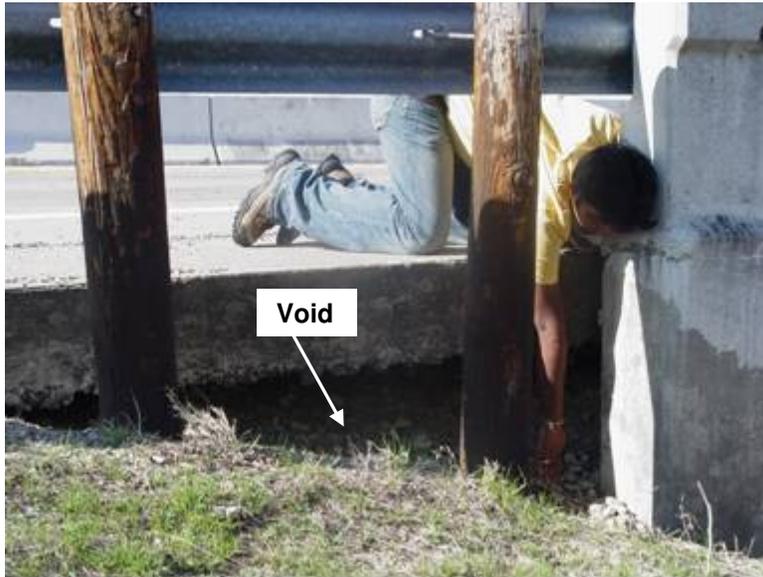
Figure 3.4 Void developed adjacent to abutment

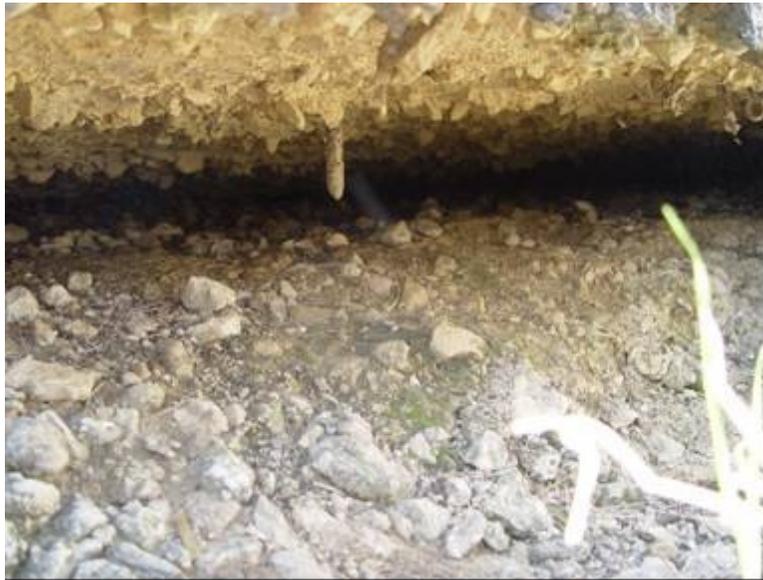
Figure 3.5 Closer view of the void gap

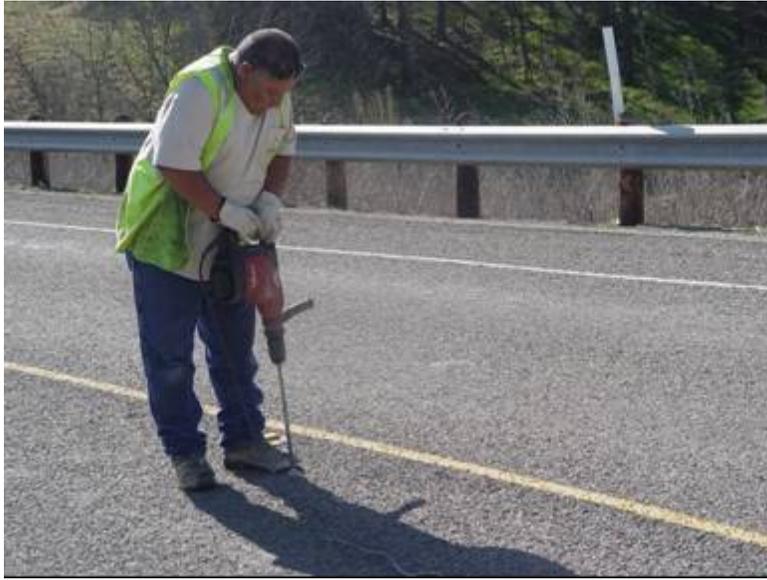
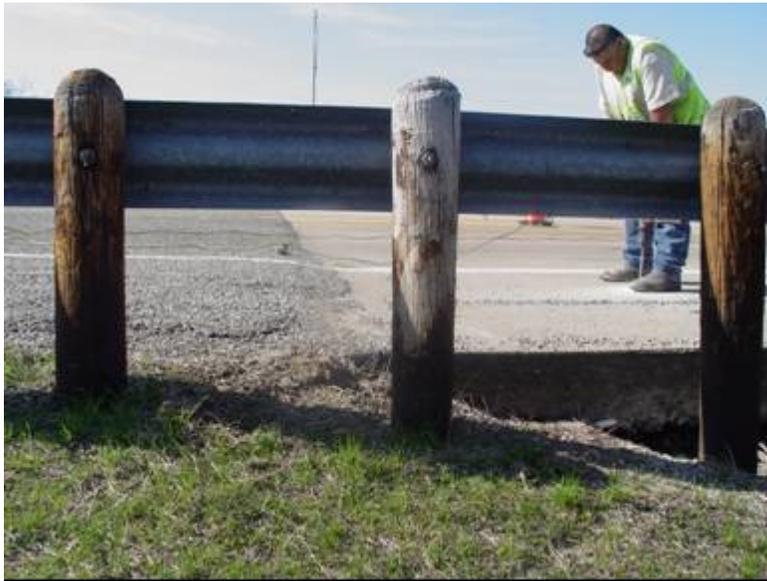
Figure 3.6 Drilling holes into the approach slab

Figure 3.7 Another view of drilling holes

The actual injection process began with drilling tiny holes of size 5/8" diameter into the approach slab in a rectangular pattern to inject the polymer/Urethane. Urethane polymer expanded forming foam and hardened in place in less than 15 min. and lifted the settled approach slabs to the required elevation. Since this complex material is very light weight, the pressure coming to the subsoil due to the expanded foam is expected to be very low. Besides, the time required for this treatment process was very short (total process time is in hours) when compared to the other conventional treatment techniques for this kind of situation such as cement grouting, asphalt overlay or complete excavation and replacement of existing approach slabs. Figures 3.6 to 3.12 show the process of Urethane injection beginning from the drilling of holes to the level up of sections after the uplift of the settled approach slab.

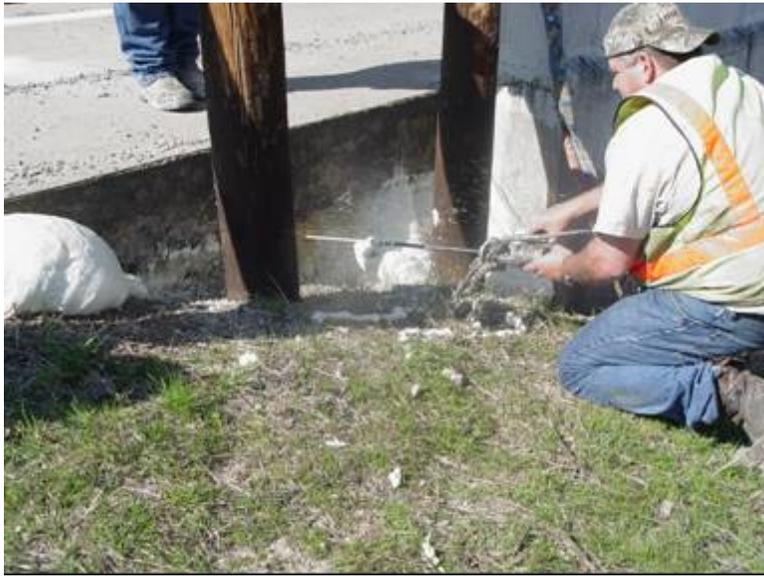
Figure 3.8 Sealing the void from exterior face to protect loss of injected Urethane

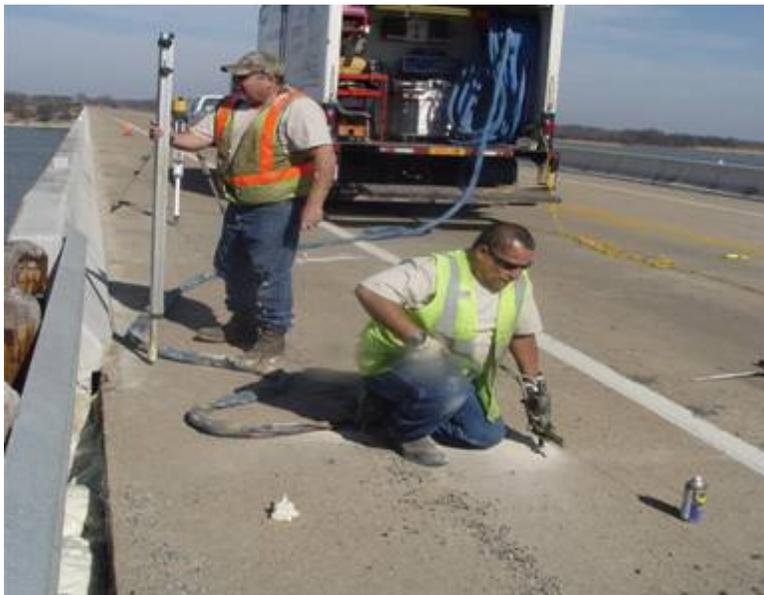
Figure 3.9 Taking levels during the injection process to check for extra injection

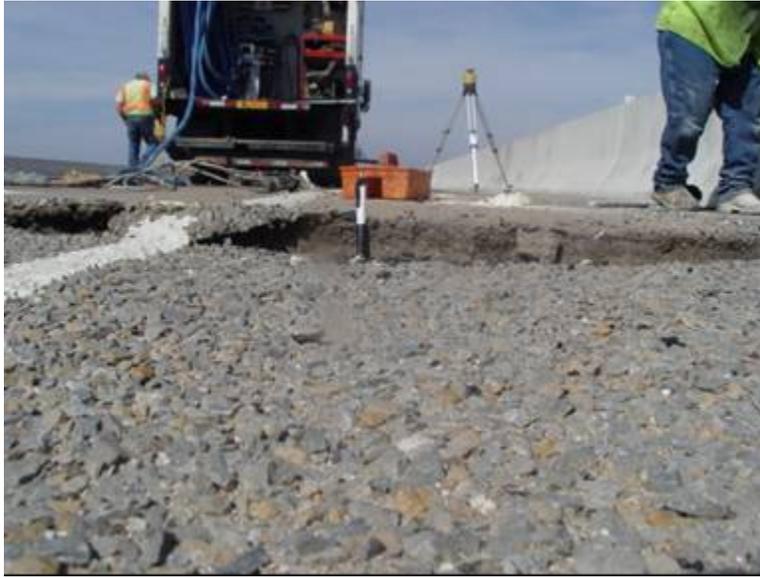
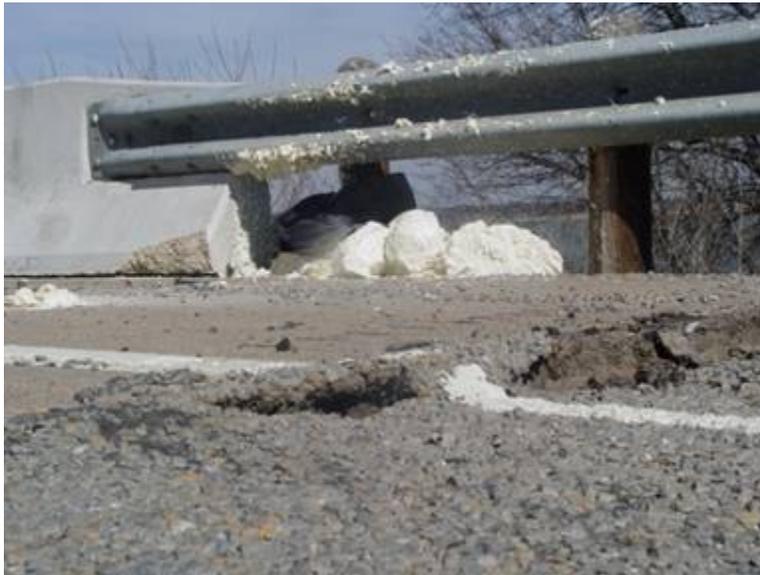
Figure 3.10 Uplift of approach slab during the injection process

Figure 3.11 Another view of uplift of approach slab

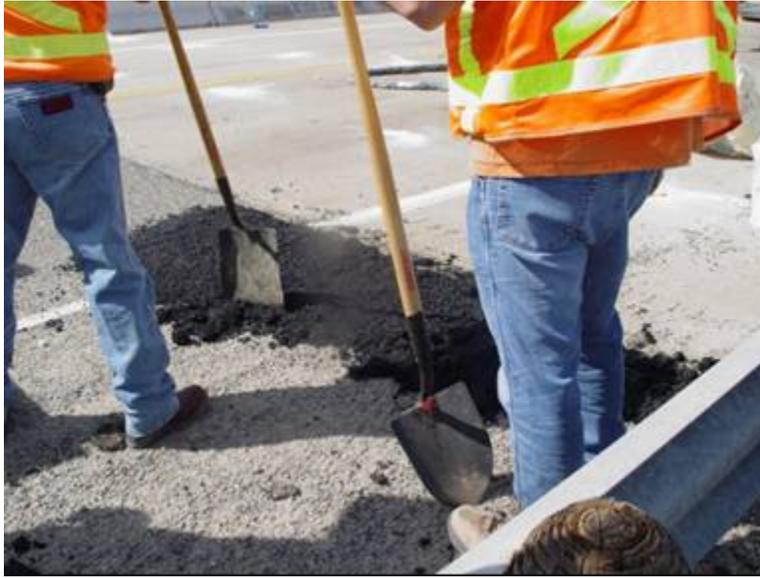
Figure 3.12 Level-up of uneven sections with cold asphalt mix

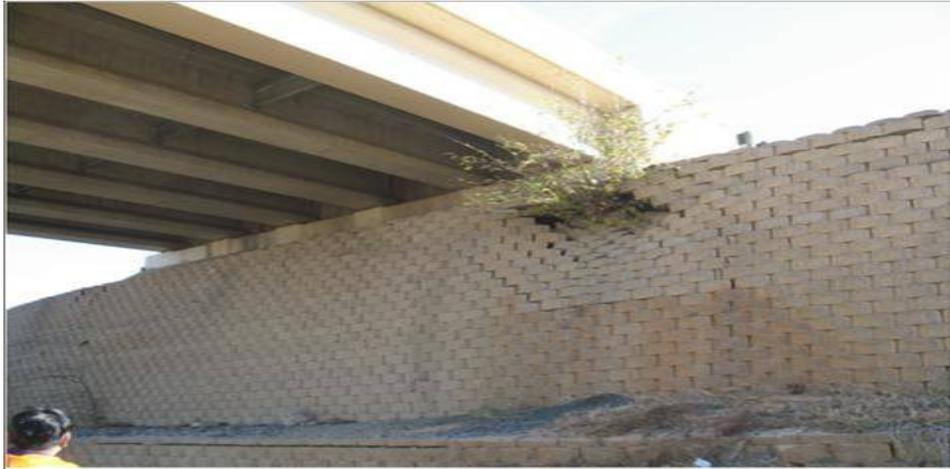
Figure 3.15 Failure of the MSE wall

As a part of the research, laboratory tests were performed on the fill material under the approach slab. This material is classified as non plastic, poorly graded sand. The problems for the distress in the approach slab are probably due to the erosion of fill under the slab and the settlement of the underlying foundation. The failure of the MSE wall and the erosion of soil under the slab are shown in Figures 3.15 and 3.16.

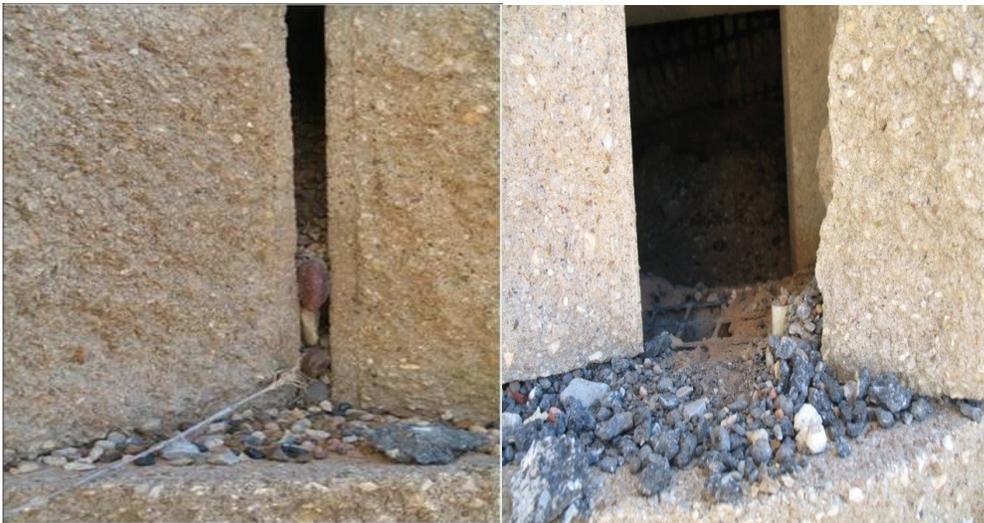
Figure 3.16 Erosion of soil under the slab

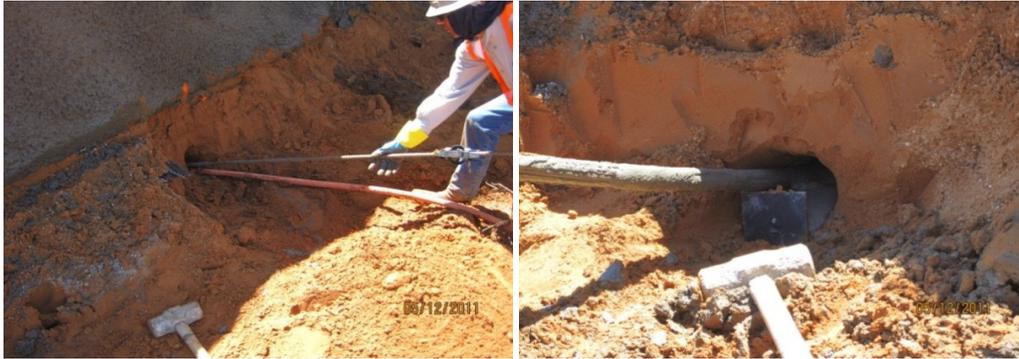
Figure 3.18 Placing of nails and grouting the holes

The soil nails were placed at a horizontal spacing of 6 ft. and a vertical spacing of 4 ft. interval. The length of each nail is 16 ft. After the placement of the nails, the hole was completely grouted. Samples of the grout were collected to test the compressive strength of the grout. The placing of the soil nails and the grouting the drilled hole is shown in Figure 3.18.

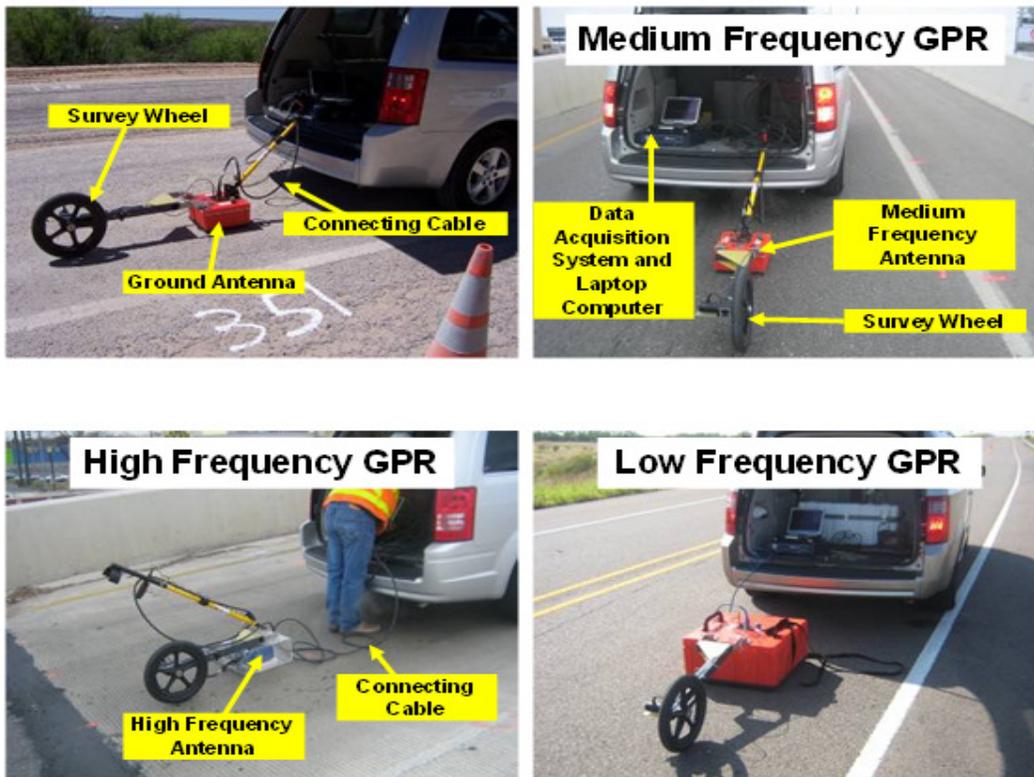
Figure 3.21 GSSI GPR System and Antennas used in this study

The test setup used in this study is shown in Figure 3.21. The equipment used for the GPR survey consists of a GSSI SIR-20 (SIRveyor) two-channel data acquisition unit controlled by a laptop computer, a ground-coupled antenna and a survey wheel attached to the antenna. For this study, three different antennas were used: a 1.6 GHz (GSSI Model 5100), a 400 MHz (GSSI Model 5103) and a 200 MHz (GSSI Model 5106). The three antennas were used to cover different penetration depths, identify precisely pavement interfaces and also detect presence of utilities or anomalies at different depths. The maximum depth of penetration of each antenna reaches to about 18 inches, 4 ft and 8 ft respectively, depending on the conductivity of the materials underneath.

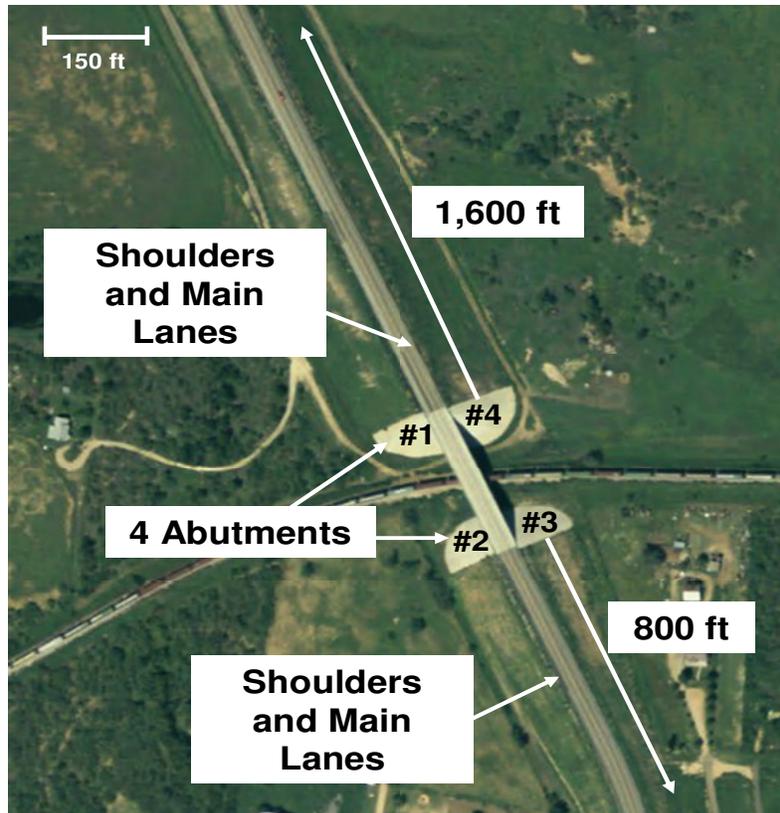
Figure 3.22 Test section along SH 6 in Quanah

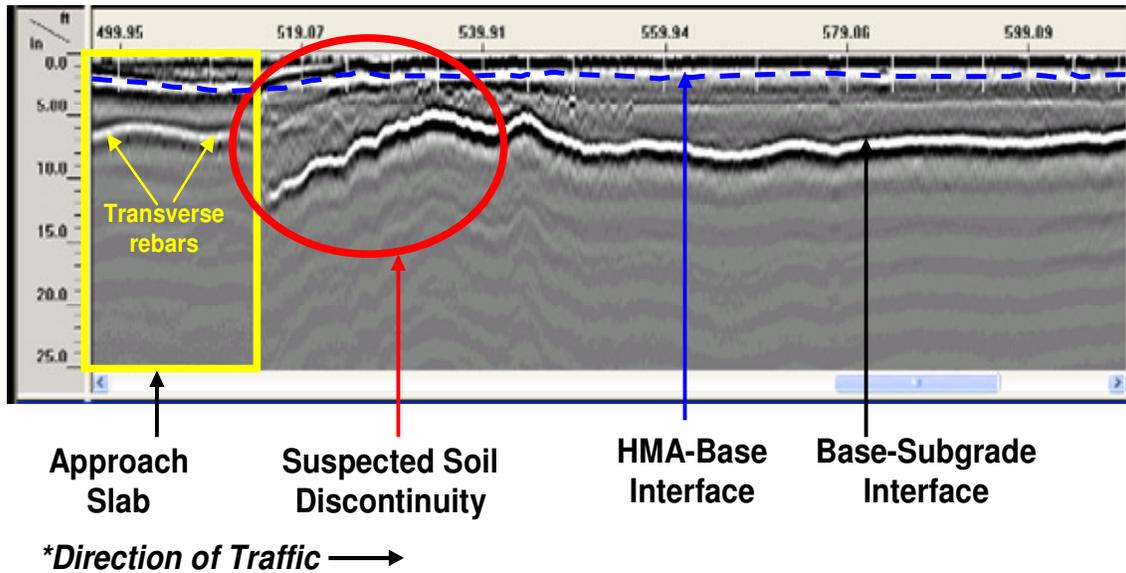
Figure 3.24 Typical Linescans from Quannah Bridge with High Frequency Antenna

approach slab, HMA-base interface, and subgrade-base interface are identified in the figure. For the approach slab, the bottom of the HMA and the transverse reinforcement within the slab are marked. Based on the linescan, the thickness of the HMA was approximately 2.5 in and the reinforcement appeared about 5 in. below that.

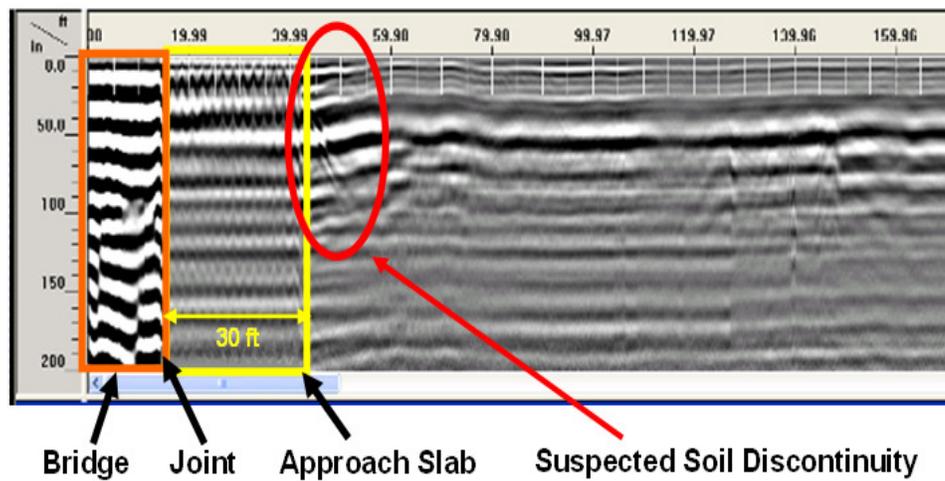
Figure 3.25 Typical Linescans from Quannah Bridge with Low Frequency Antenna

Strong reflections are observed at the beginning of the linescan that correspond to the bridge slab. Due to the lower frequency of the antenna, details of the approach slab are not as clearly identified as with the other antenna. The suspected soil discontinuity is also present that is extended deeper than the previous linescan. Like the high frequency antenna, several other horizontal interfaces are observed, but with stronger reflections. Similarly, these layers can be assumed as different strata within the subgrade.

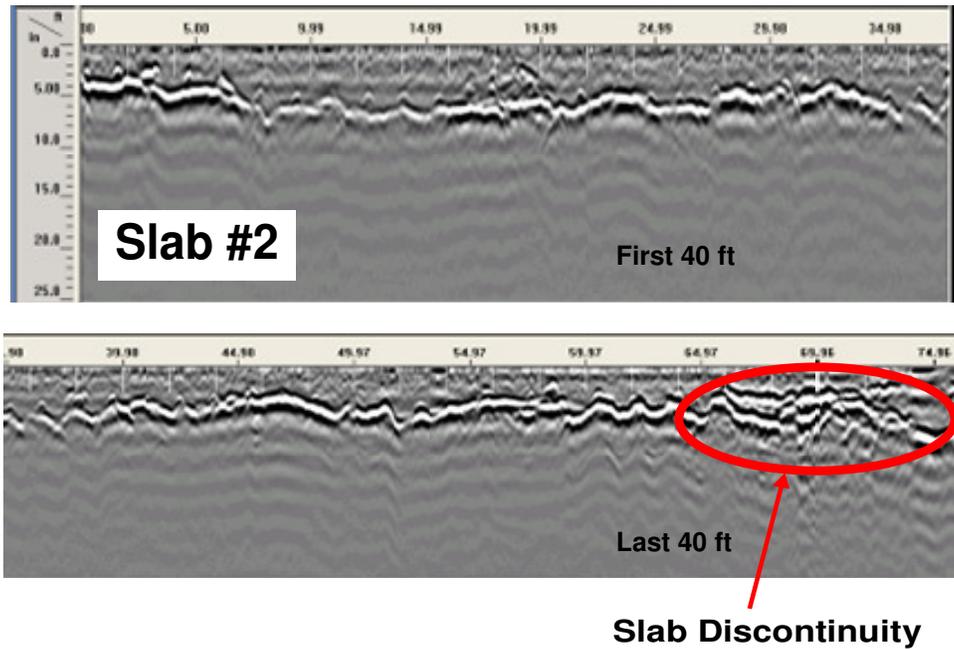
Figure 3.26 Typical Linescans from Quanah Abutment

A sample linescan along the second slab of Abutment #3 is shown in Figure 3.26. Some anomalies along the last 10 ft (closer to the top of the abutment) were observed. These may reveal the presence of voids or areas of concerns.

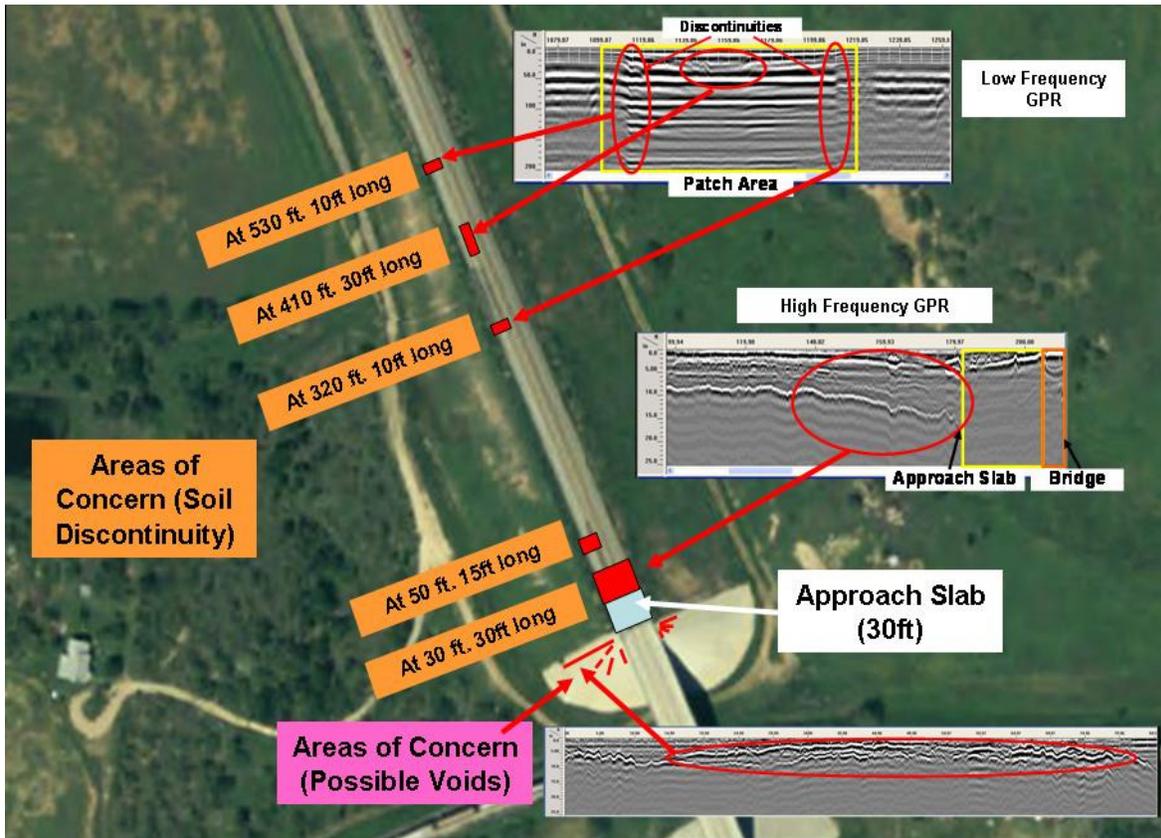
Figure 3.27 Overall results from Quanah Bridge (North Side)

The overall results from this survey are summarized in Figures 3.27 and 3.28 for the North and South sides of the bridge, respectively. GPR scans on most critical areas are also shown. The locations of possible voided areas on concrete abutments are also depicted. Based on the GPR data, areas of concern along the north side are located mainly on the southbound shoulder and lane and also about 30 ft from the approach slab. Only one area on the south side contiguous to the approach slab seems to show some anomalies. For the case of the concrete abutments, the outer lines of Abutments #1 and #2 appear to have the longest voided areas.

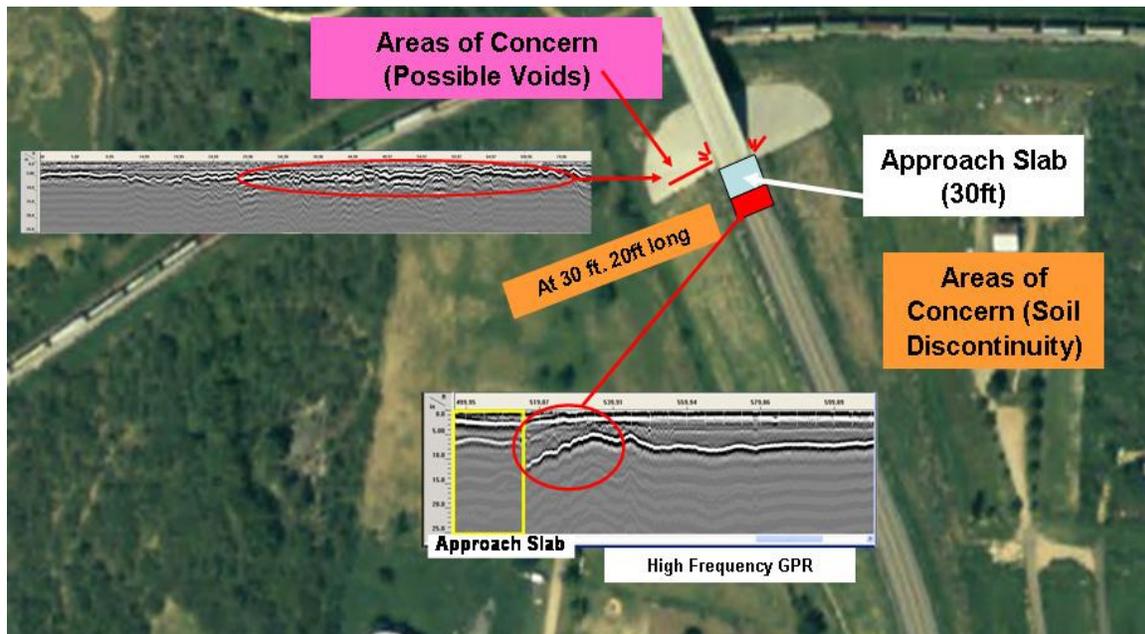
Figure 3.28 Overall results from Quanaah Bridge (South Side)

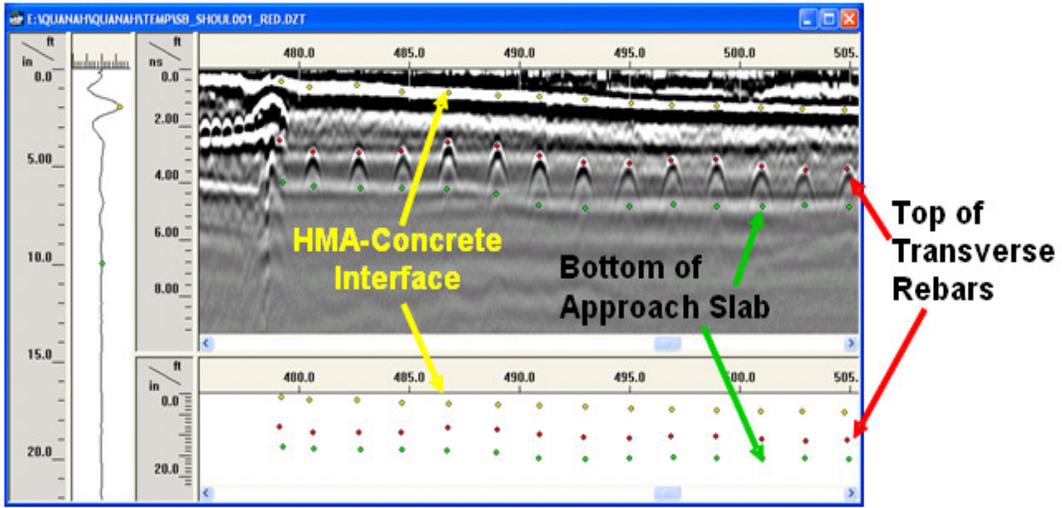
Figure 3.29 Selection of points from GPR Linescan

An estimation of the suspected voids under the approach slabs, immediately before the bridge deck was carried out. For this estimation, detailed GPR scans on the approach slabs were evaluated. As an example, Figure 3.29 shows a linescan of the southbound shoulder. The HMA-concrete interface, transverse rebar, and the bottom of the approach slab are identified at several selected points. With the assumed dielectric constant of the pavement structure, estimated depths were obtained and are presented on Figure 3.30. The suspected void under the approach slab adjacent to the bridge joint is also depicted. This suspected voided area was measured by calculating the compound average difference of the bottom of the approach slab away from the bridge joint, and the measured from the linescan adjacent to the bridge joint.

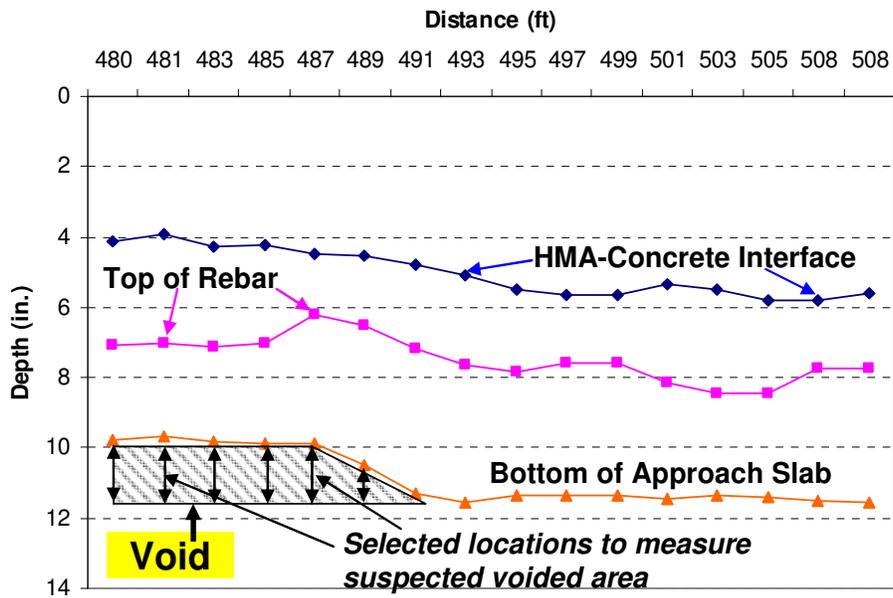
Figure 3.30 Estimated Depth Profile

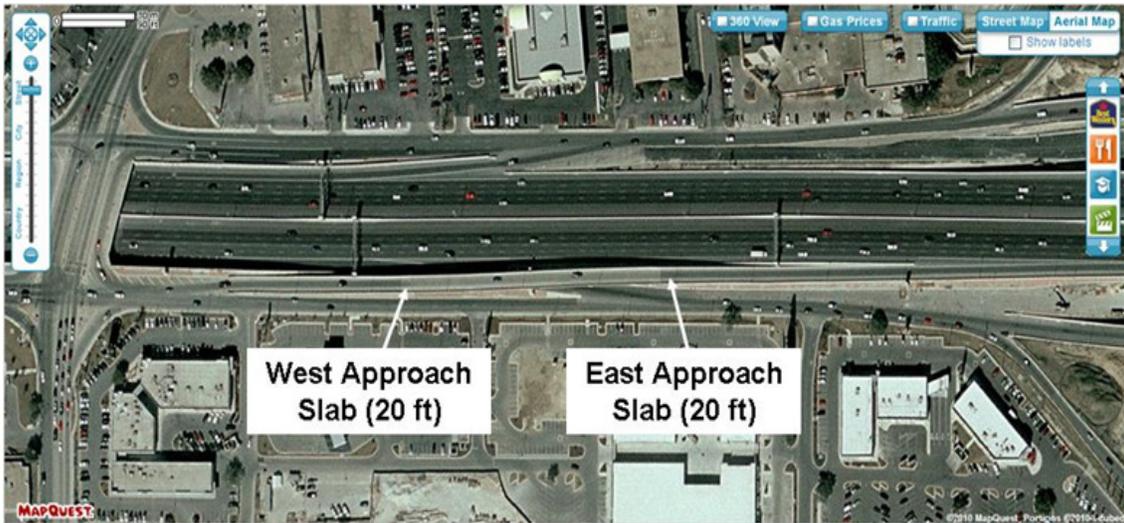
Figure 3.32 Overall section view of San Antonio site

The overall view of the section is shown in Figure 3.32 and the views of the investigated west and east approach slabs are illustrated in Figure 3.33. Both slabs were 20 ft in length. Five longitudinal and five transverse linescans were obtained per each approach slab. The location of each line is detailed in Figure 3.34. GPR surveys were performed with a medium (400 MHz) and high (1.6 GHz) frequency antennas. The longitudinal surveys were carried out on the approach slab and also on 50 ft of the bridge ramp.

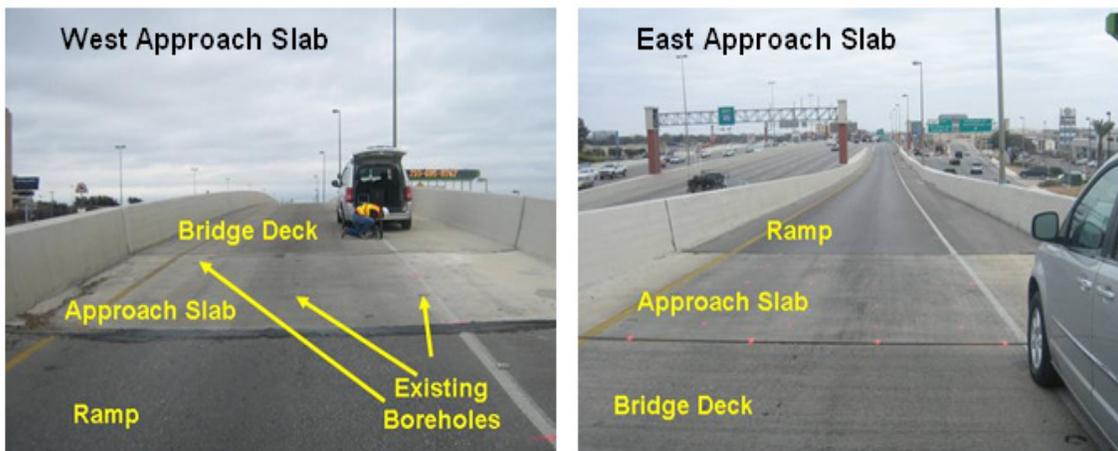
Figure 3.33 Sectional views of west and east approach slabs

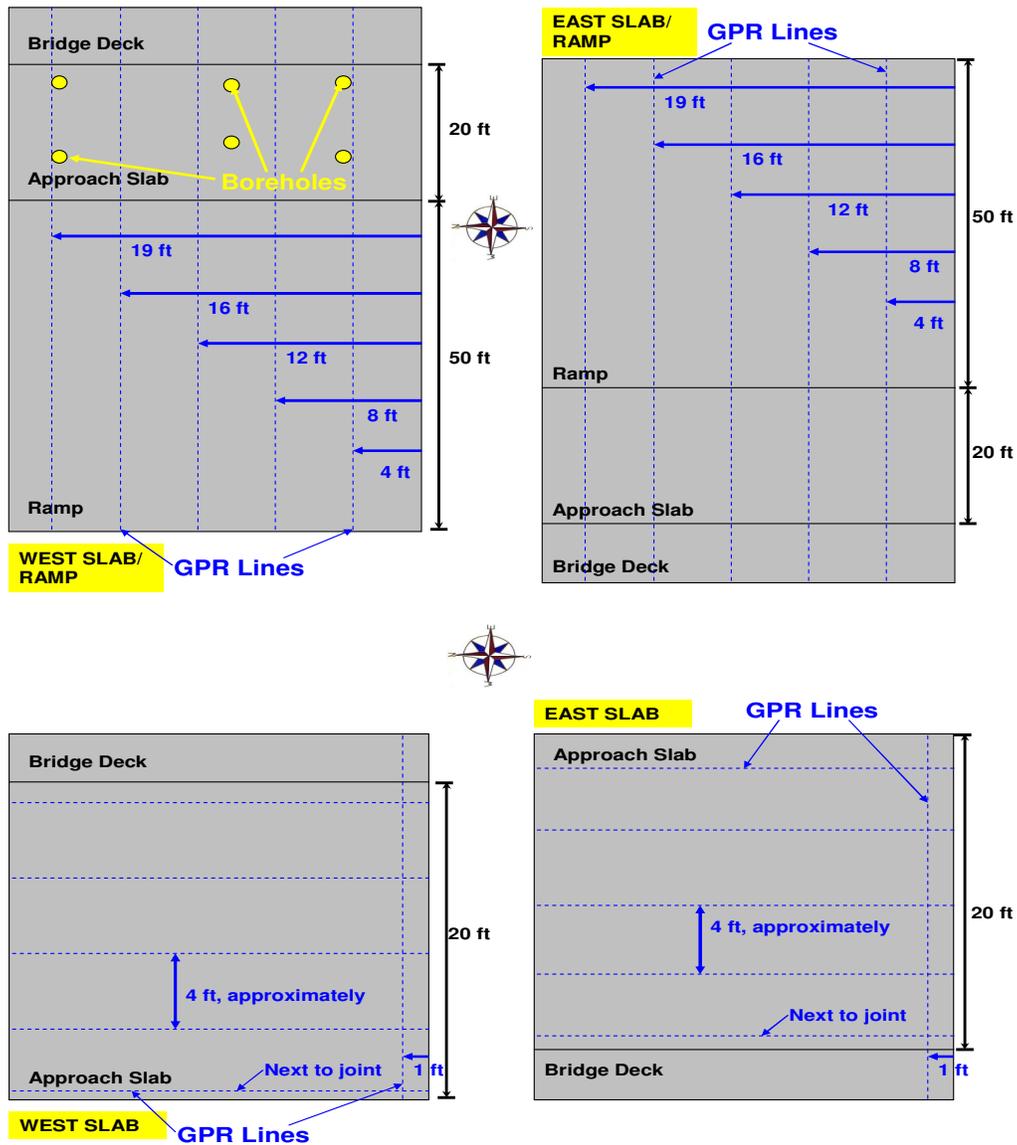
Figure 3.34 Detailed location of each line

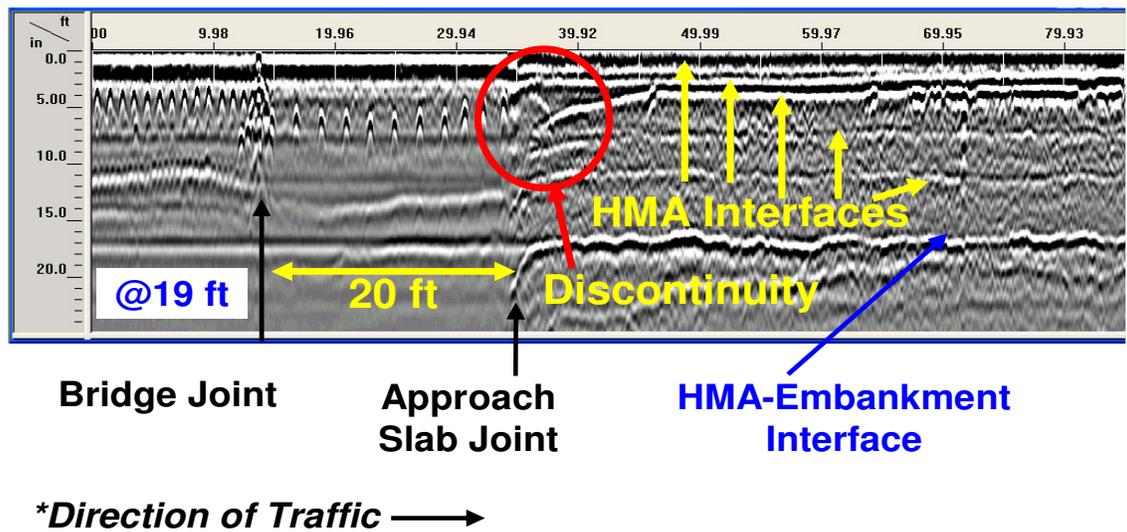
Figure 3.35 Typical linescan of west approach slab with High Frequency Antenna

The first four reflections were attributed to different HMA interfaces that might represent several asphalt layers. What appears to be the HMA-embankment interface turns up at a depth of about 18 in. Some anomalies adjacent to the approach slab were also observed. For the approach slab, the transverse reinforcement is clearly detected at two different depths: between 4 and 6 in. and at 14 in. approximately. The bottom of the pavement structure was detected at about 18 in.

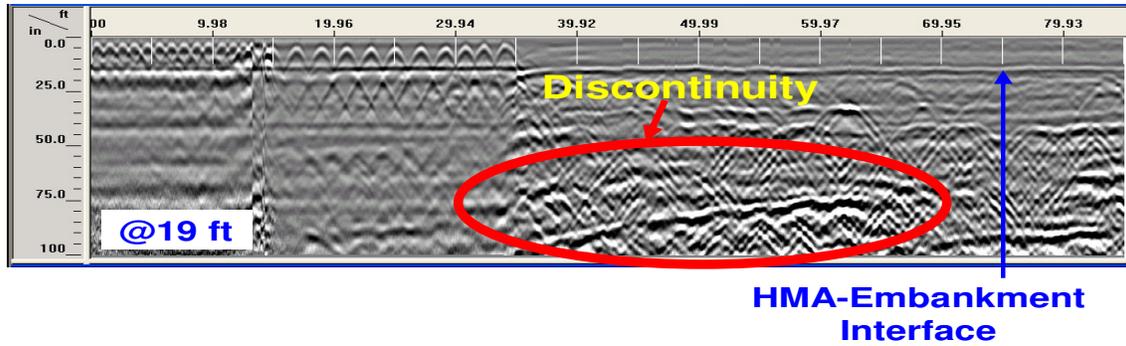
Figure 3.36 Typical linescan of west approach slab with Medium Frequency Antenna

the approach slab is highlighted. This area was approximately 30 ft long and showed erratic interfaces at depths of 75 in. approximately.
