AN OVERVIEW OF MITIGATION STRATEGIES FOR SETTLEMENTS
UNDER BRIDGE APPROACH SLABS

MASTER OF SCIENCE IN CIVIL ENGINEERING

THE UNIVERSITY OF TEXAS AT ARLINGTON

December 2011

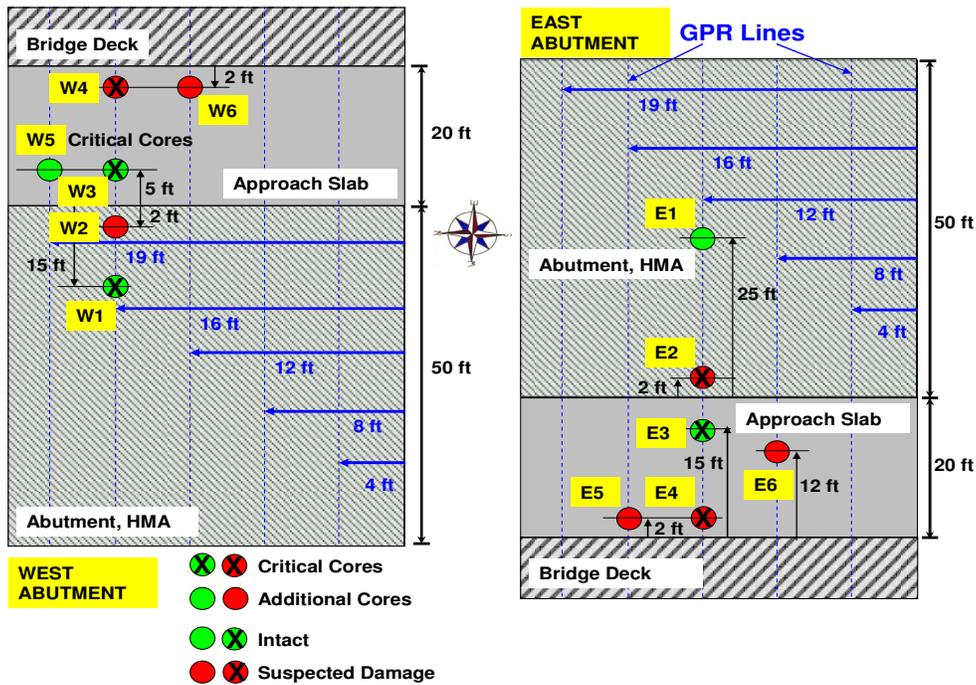
Figure 3.37 Proposed Core layout for San Antonio Bridge

From the GPR information, a core plan was established for the two approach slabs, presented in Figure 3.37. Six cores per slab were identified on intact and anomalous areas, as detailed in Figure 3.37. On the west slab, cores were designated from W1 to W2 and on the east slab from E1 to E6. From these six cores, four were marked on the approach slab and two on the asphalt pavement.

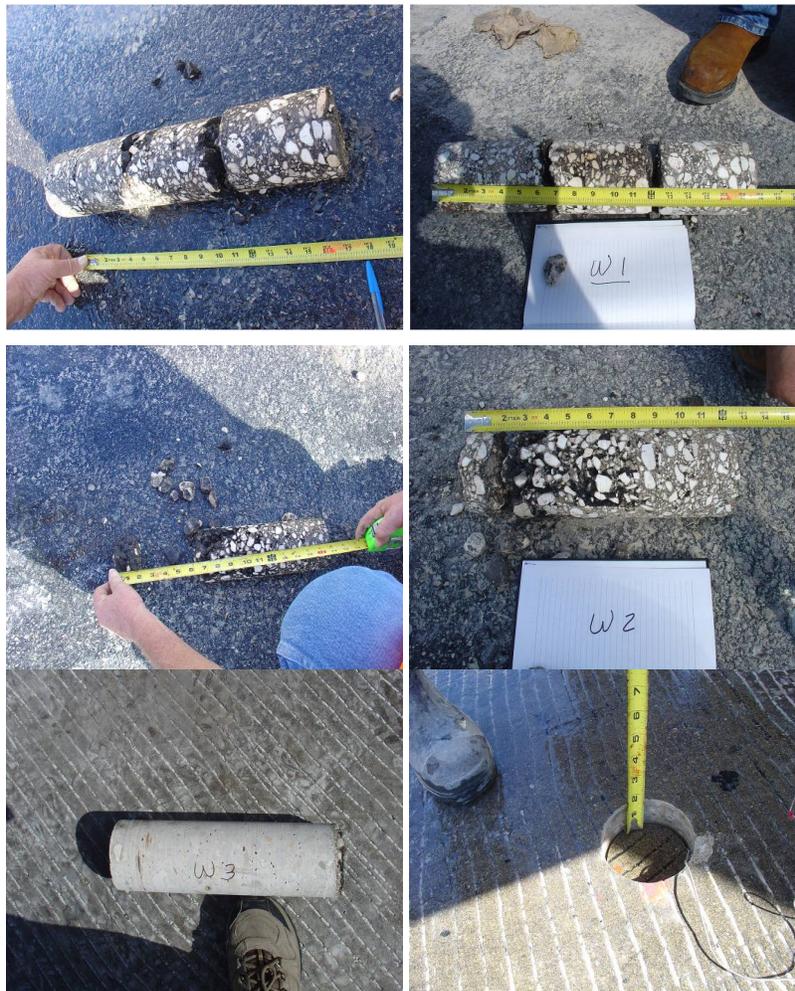
Figure 3.38 Retrieved cores from west slab

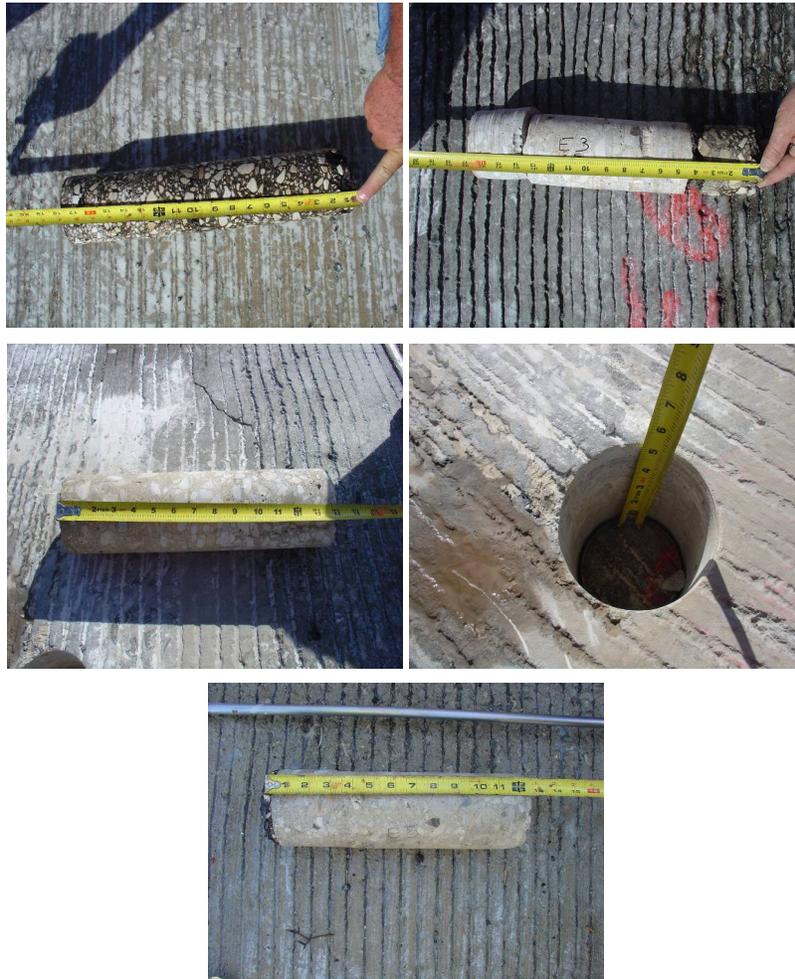
Figure 3.39 Retrieved cores from east slab of San Antonio Bridge

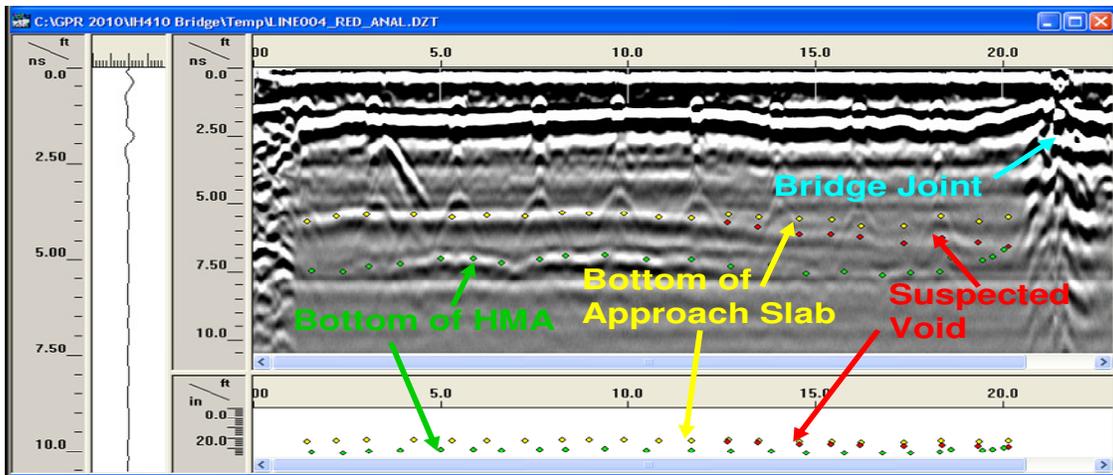
Figure 3.41 Selection of points from GPR linescan

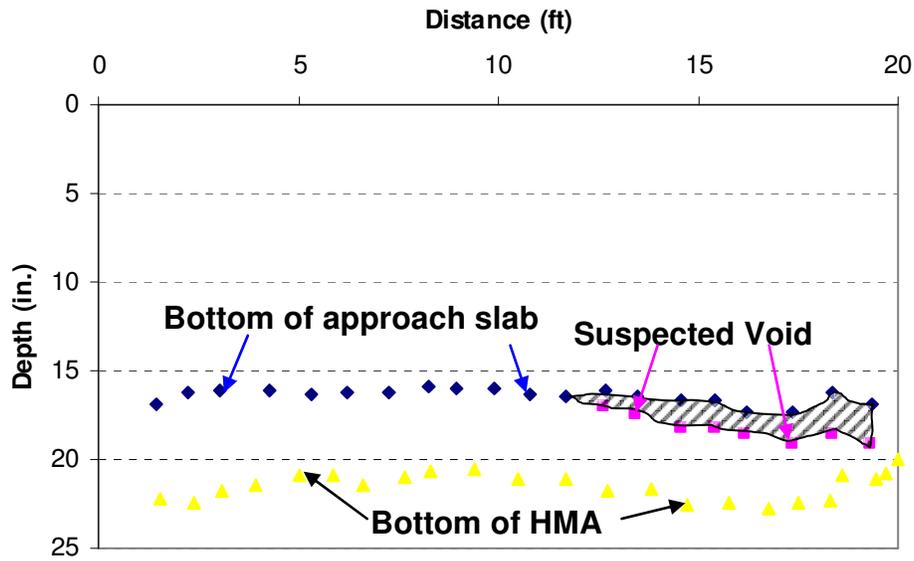
Figure 3.42 Estimated depth profile

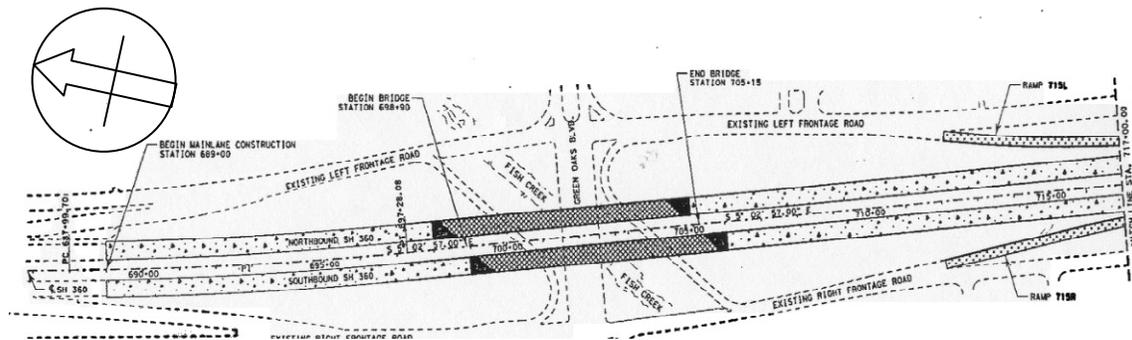
Figure 4.1 Details of ECS Bridge Site, SH 360, Arlington, TX

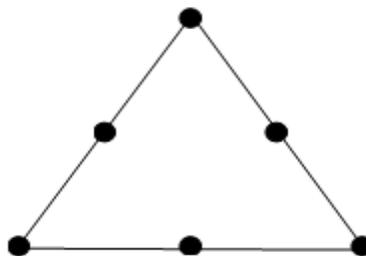
Figure 4.2 Six noded triangular element (Plaxis manual)

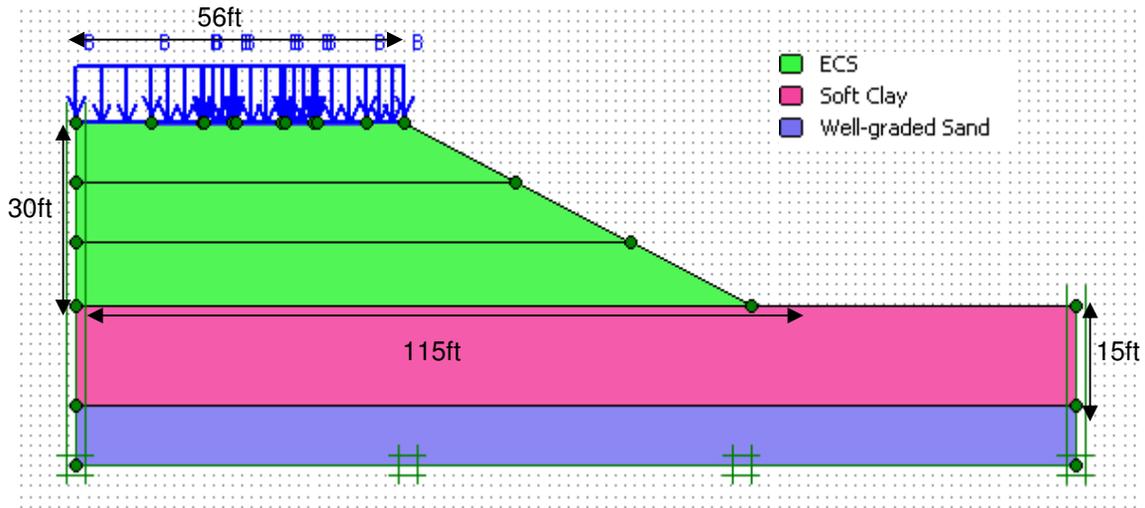
Figure 4.4 Geometry and boundary conditions of the ECS test section

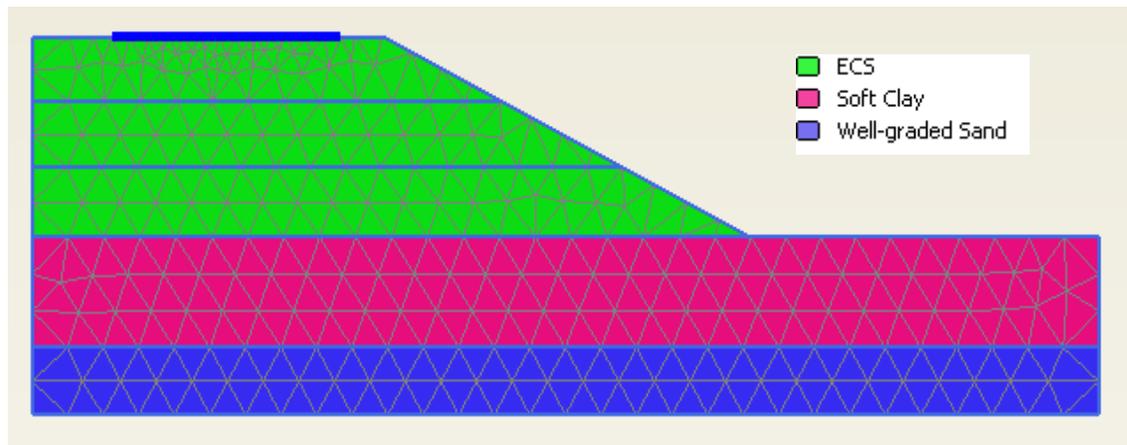
Figure 4.5 Nodes and elements in the test section

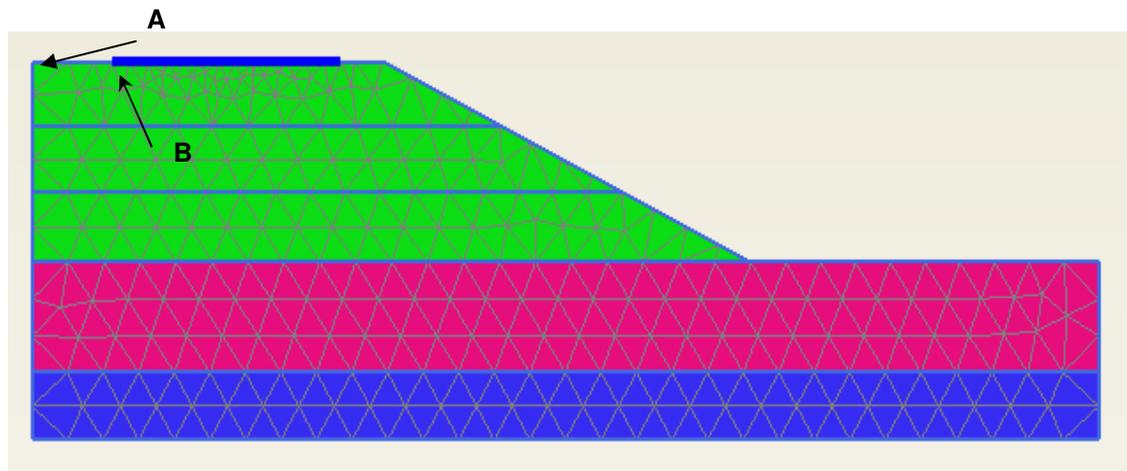
Figure 4.7 Observation points in the settlement calculation

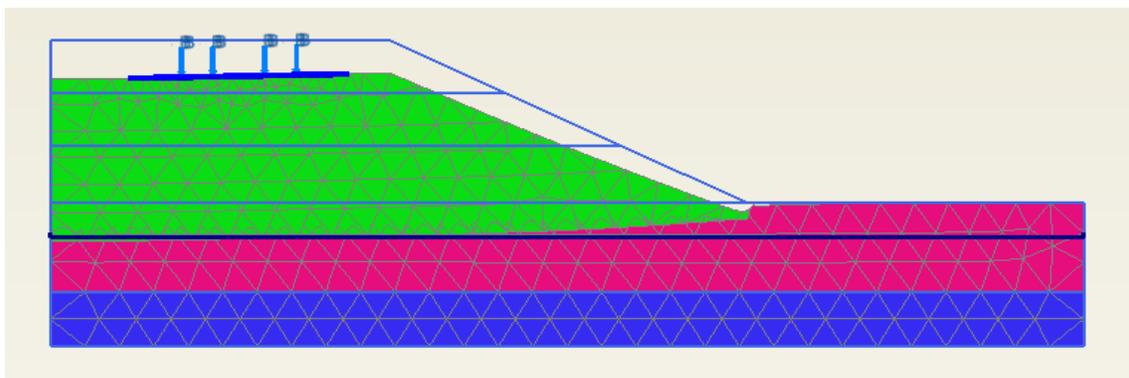
Figure 4.8 Deformed mesh of the test section (displacement scaled up 50 times)

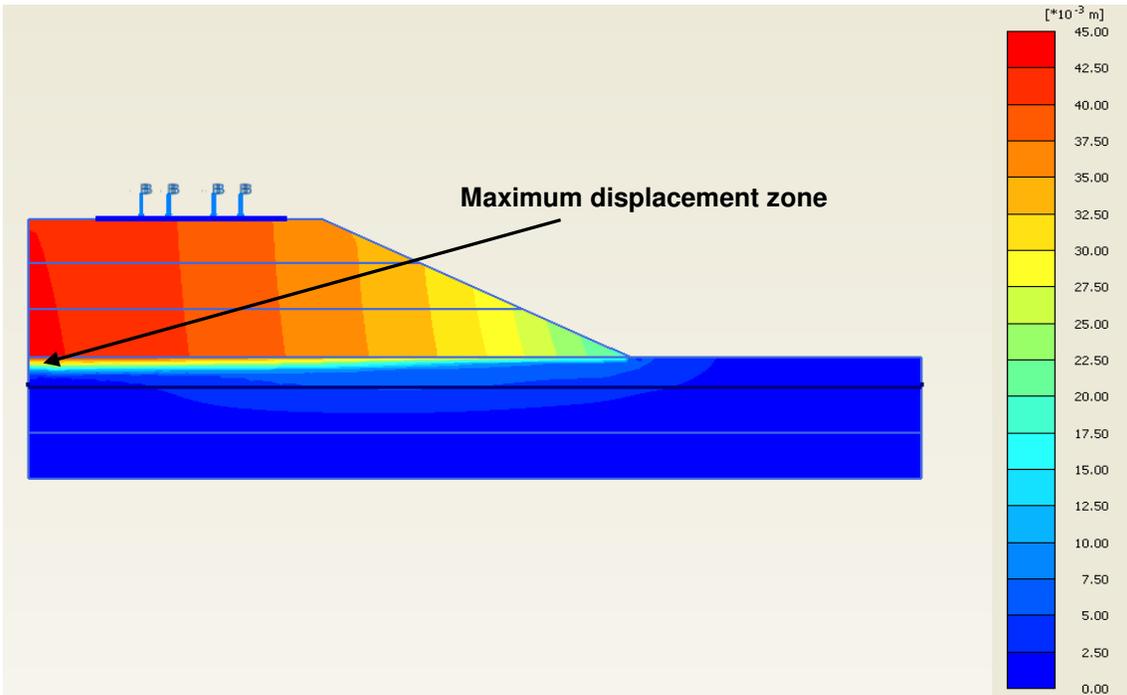
Figure 4.9 Total displacements in the test section

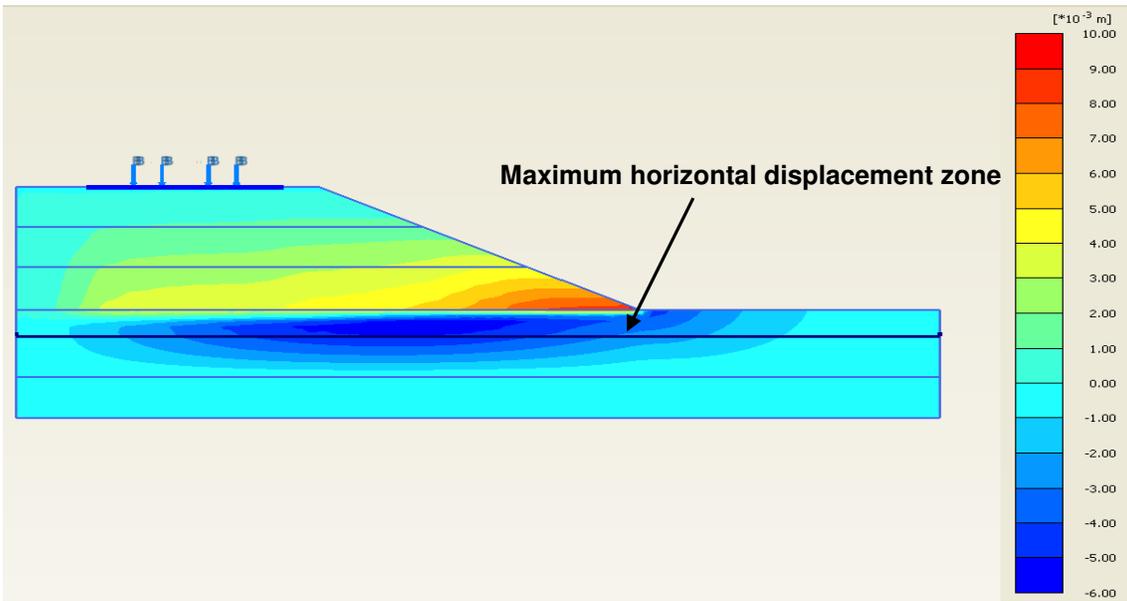
Figure 4.10 Horizontal displacements in the test section

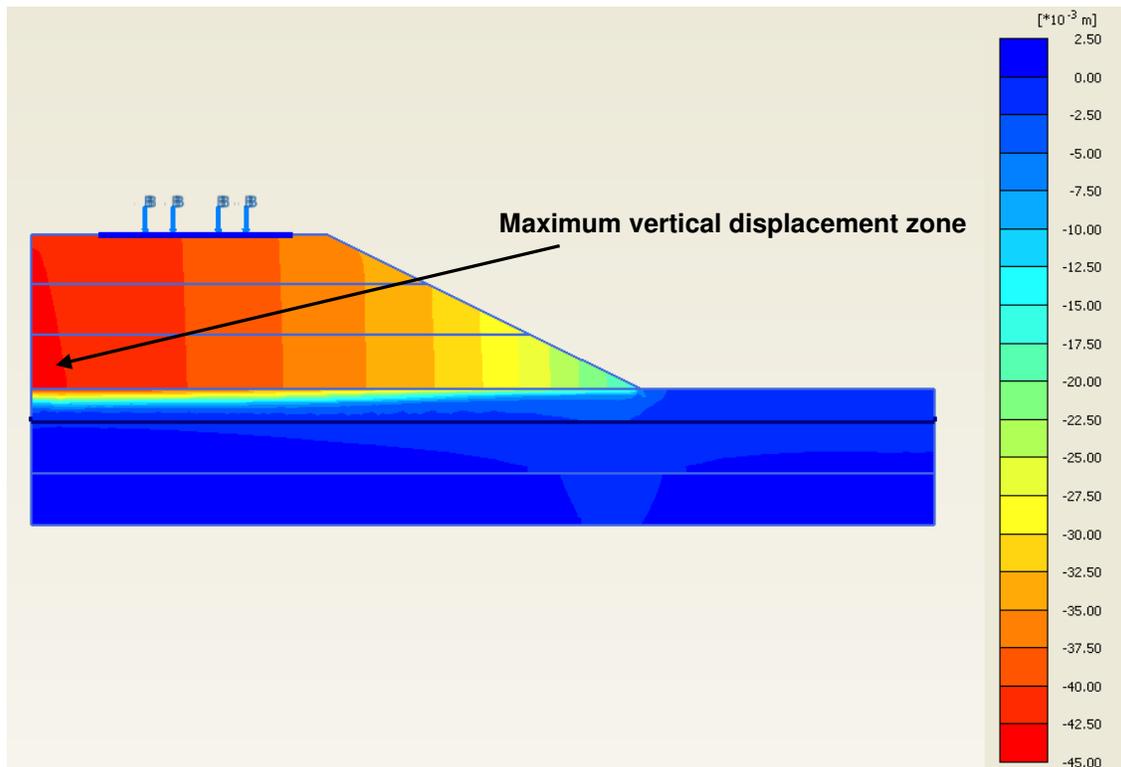
Figure 4.11 Vertical displacements in the test section

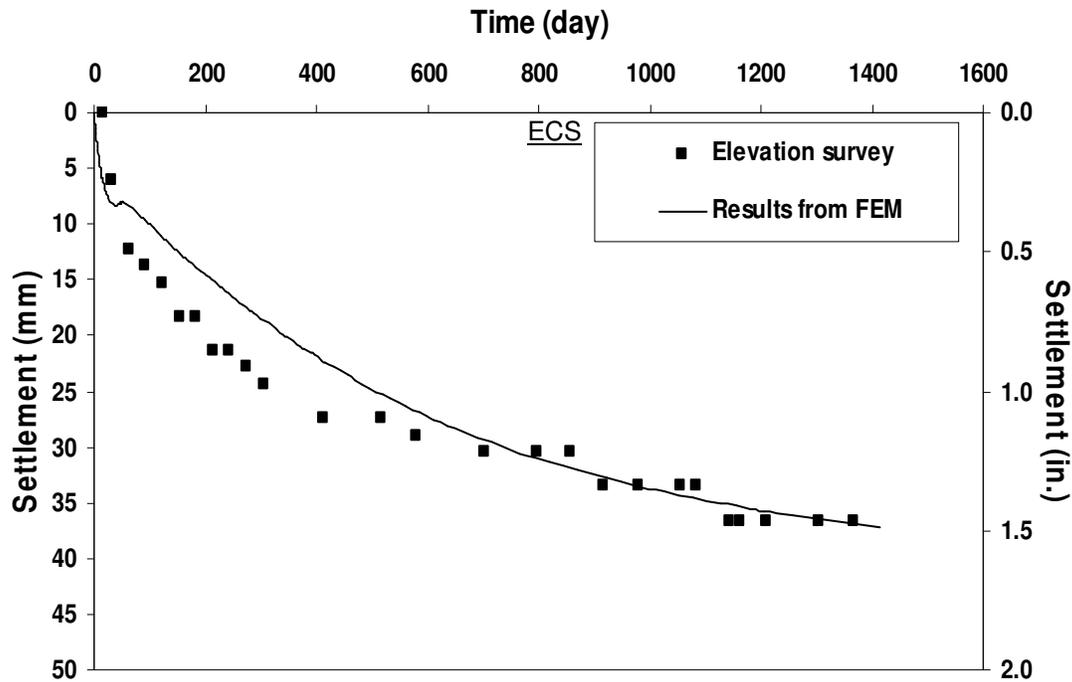
Figure 4.12 Comparison of vertical displacements in a test section between data obtained from elevation surveys and results from numerical analysis

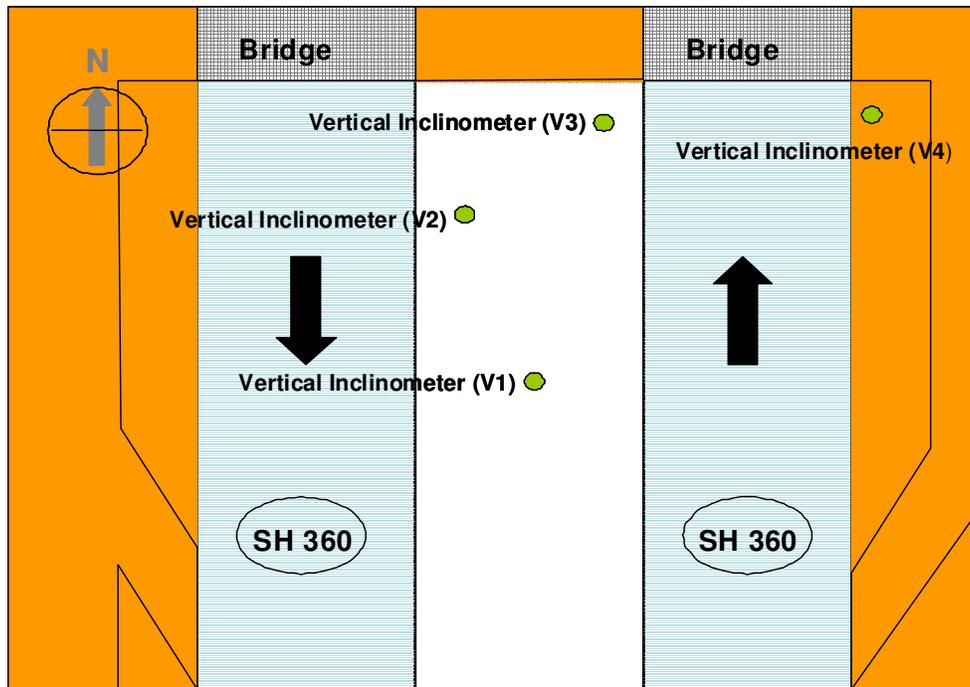
Figure 4.13 Location of vertical inclinometers installed on ECS embankment, SH 360.

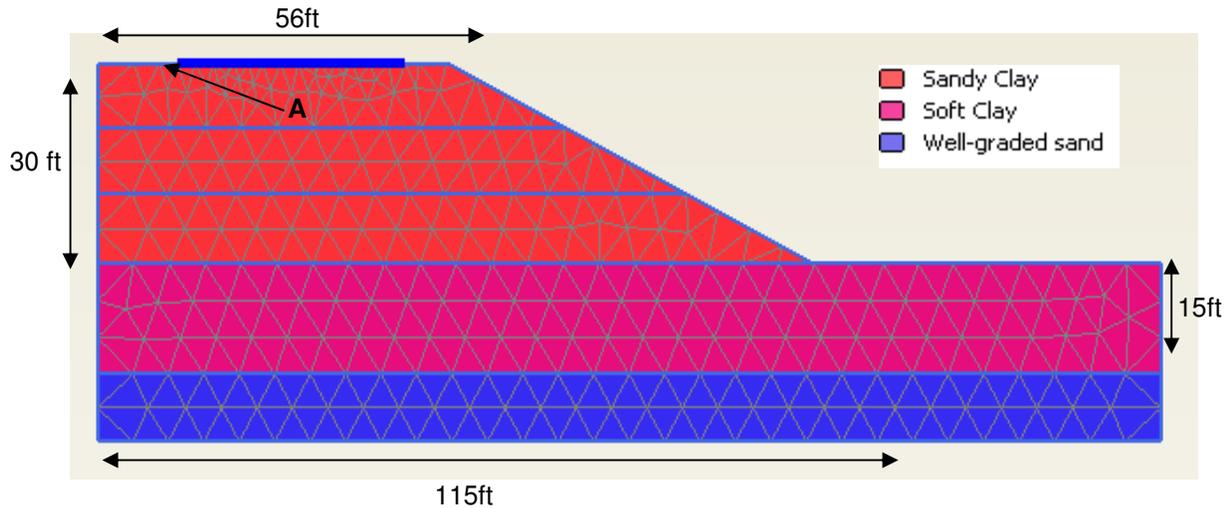
Figure 4.15 Nodes and elements in the control section

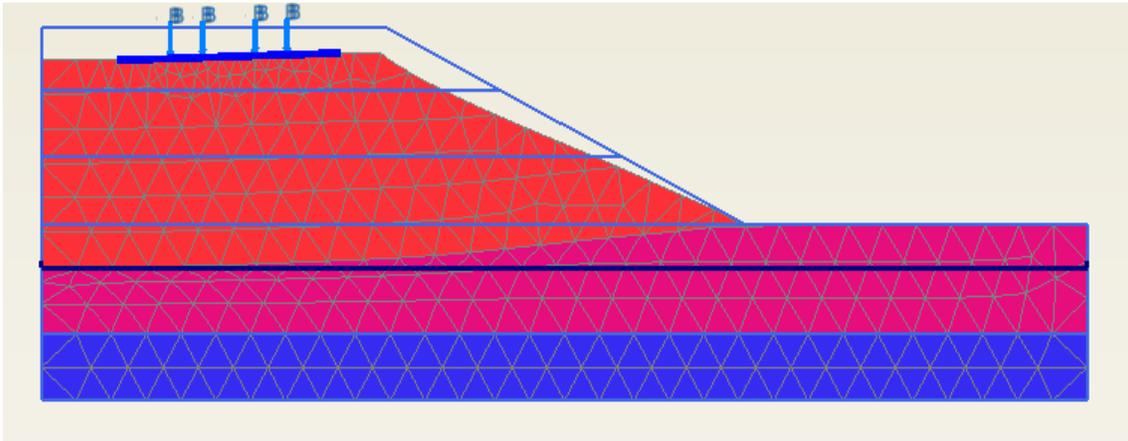
Figure 4.16 Deformed mesh of the control section (displacement scaled up 20 times)

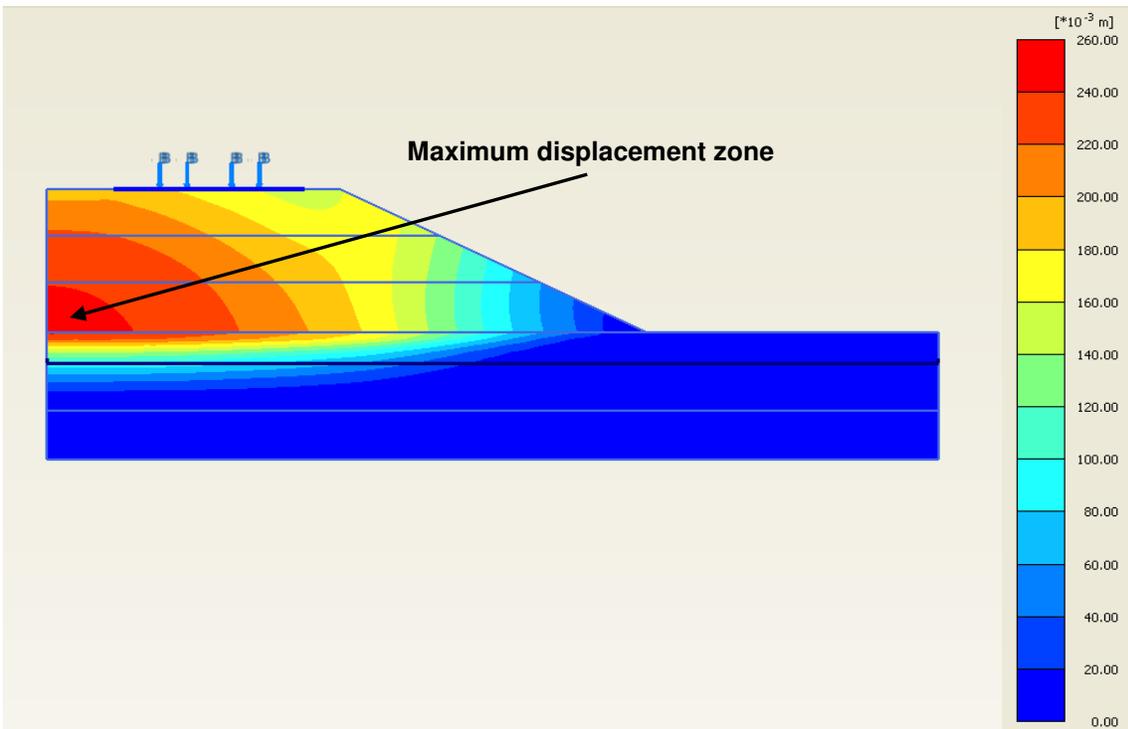
Figure 4.17 Total displacements in the control section

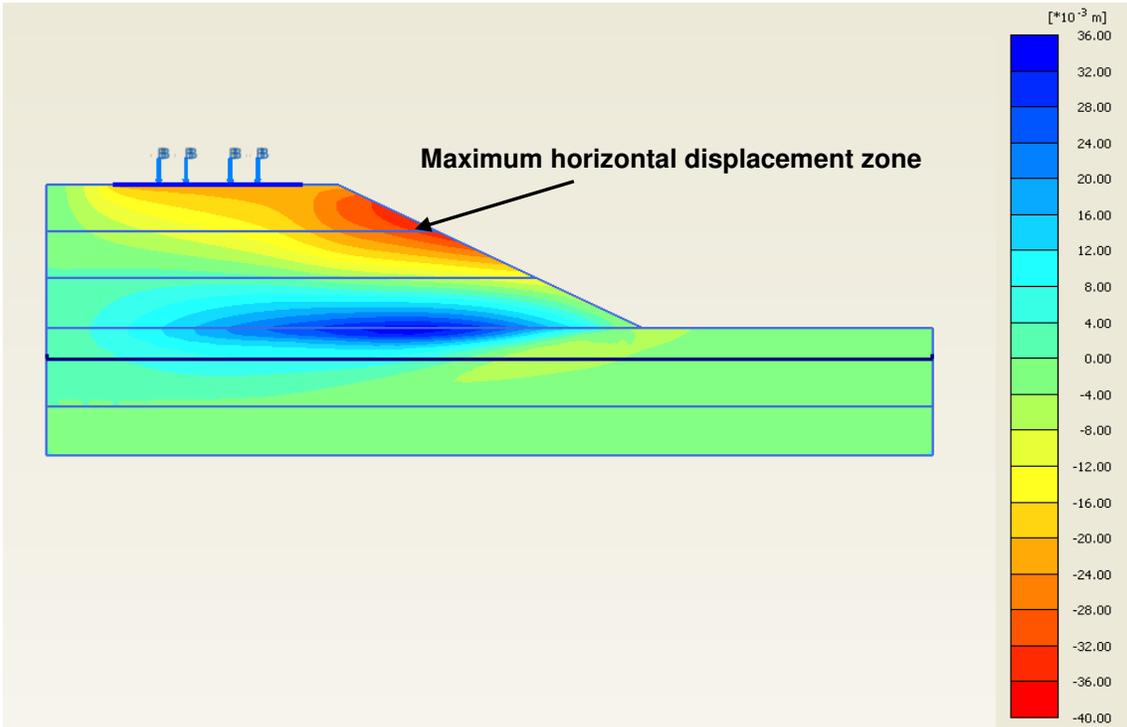
Figure 4.18 Horizontal displacements in the control section

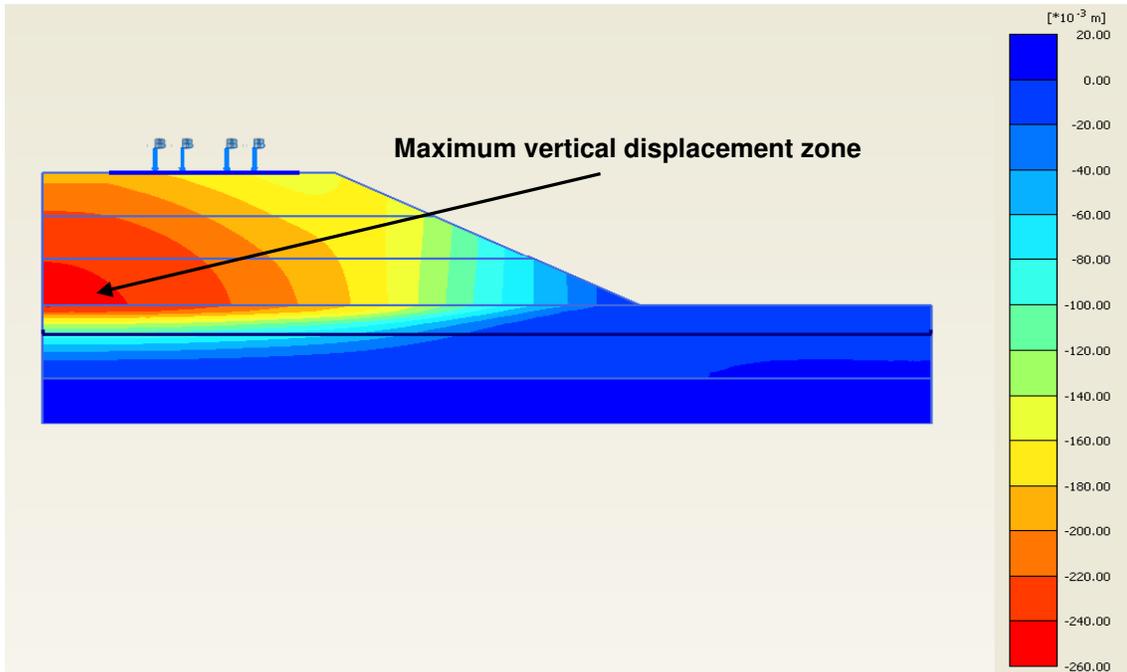
Figure 4.19 Vertical displacements in the control section

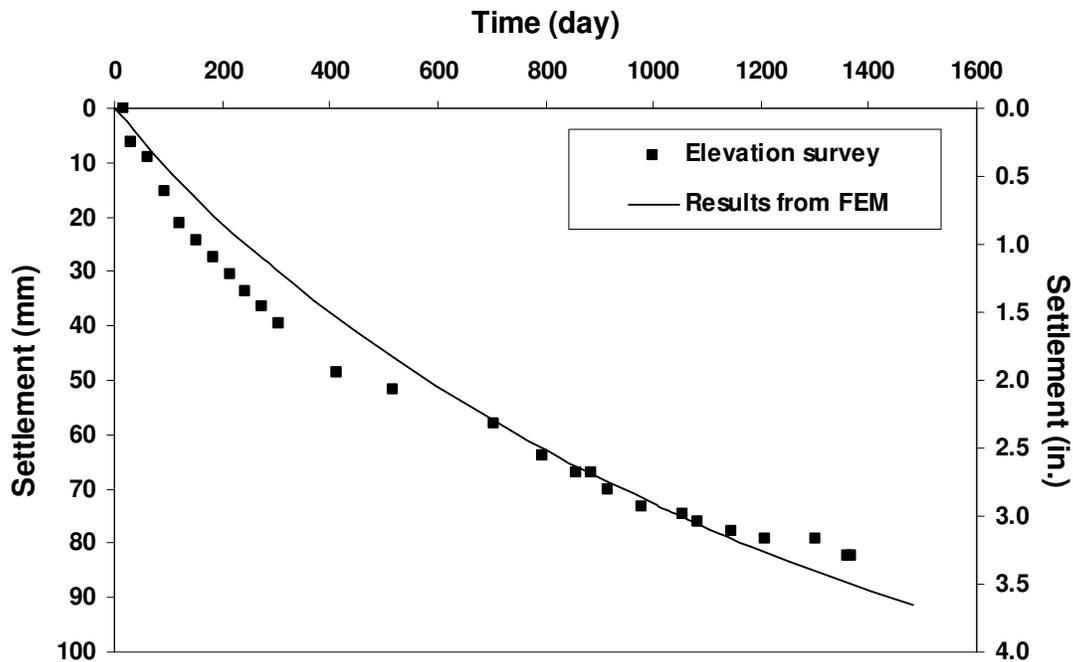
Figure 4.20 Comparison of vertical displacements in a test section between data obtained from elevation surveys and results from numerical analysis

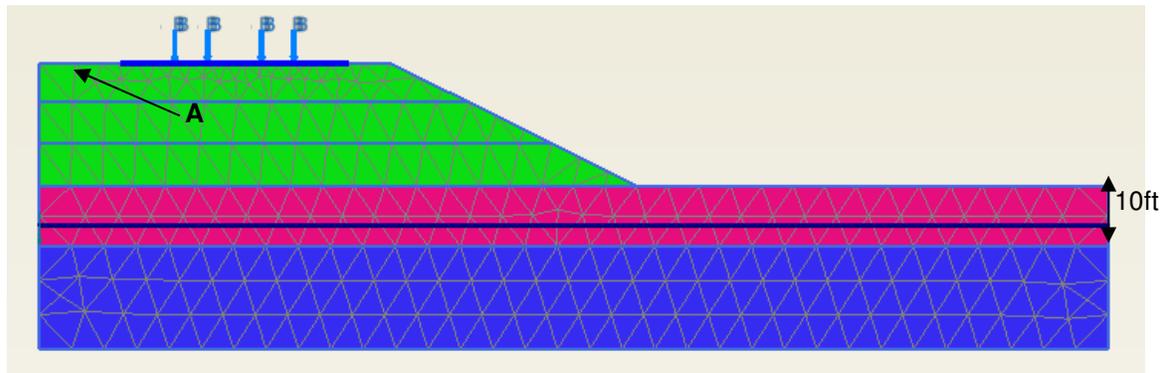
Figure 4.21 Geometry of the test section with a height of 20 ft (6.0 m) and subgrade thickness of 10 ft (5.0 m)

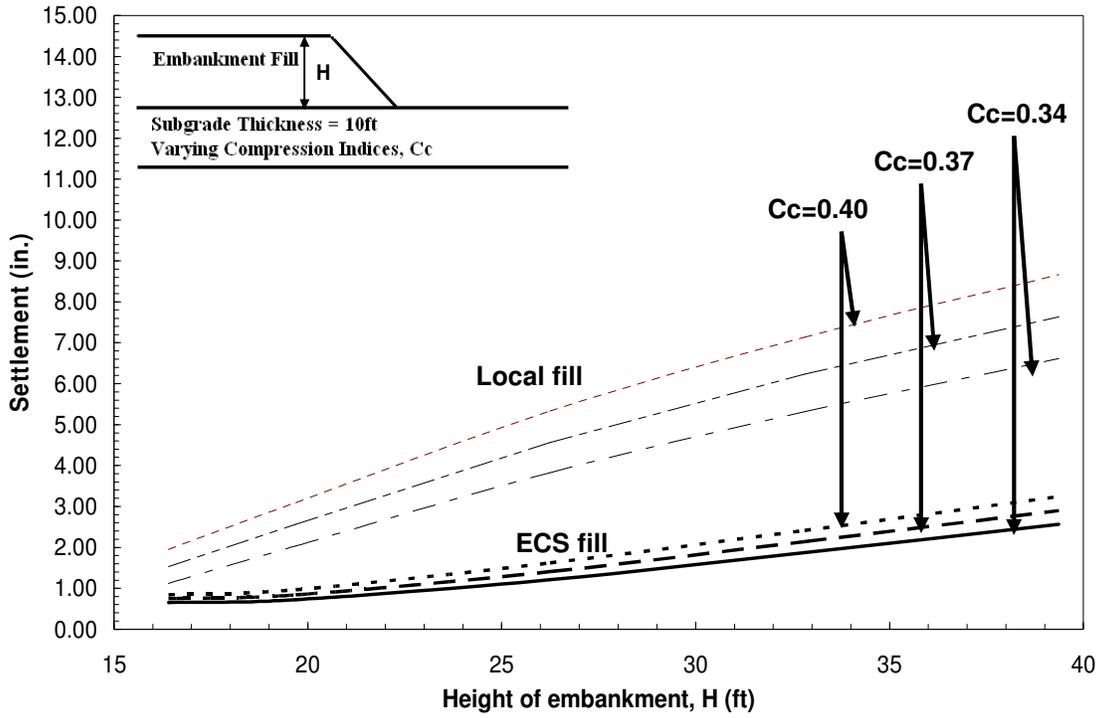
Figure 4.23 Design chart for ECS embankment with subgrade thickness 10 ft

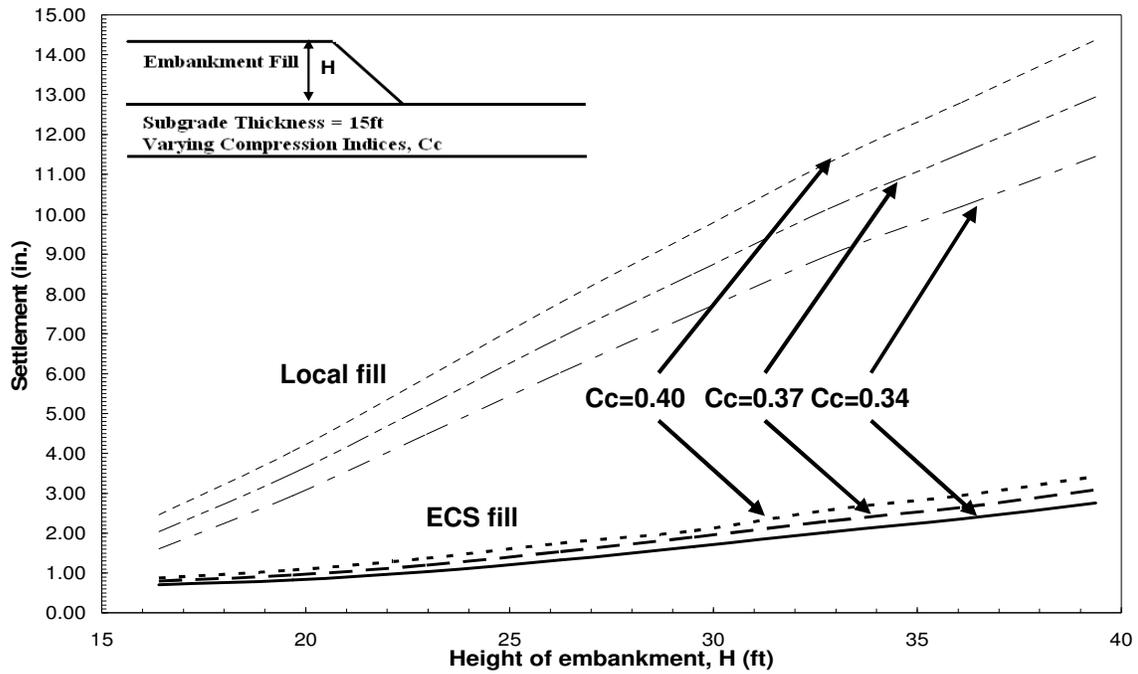
Figure 4.24 Design chart for ECS embankment with subgrade thickness 15 ft

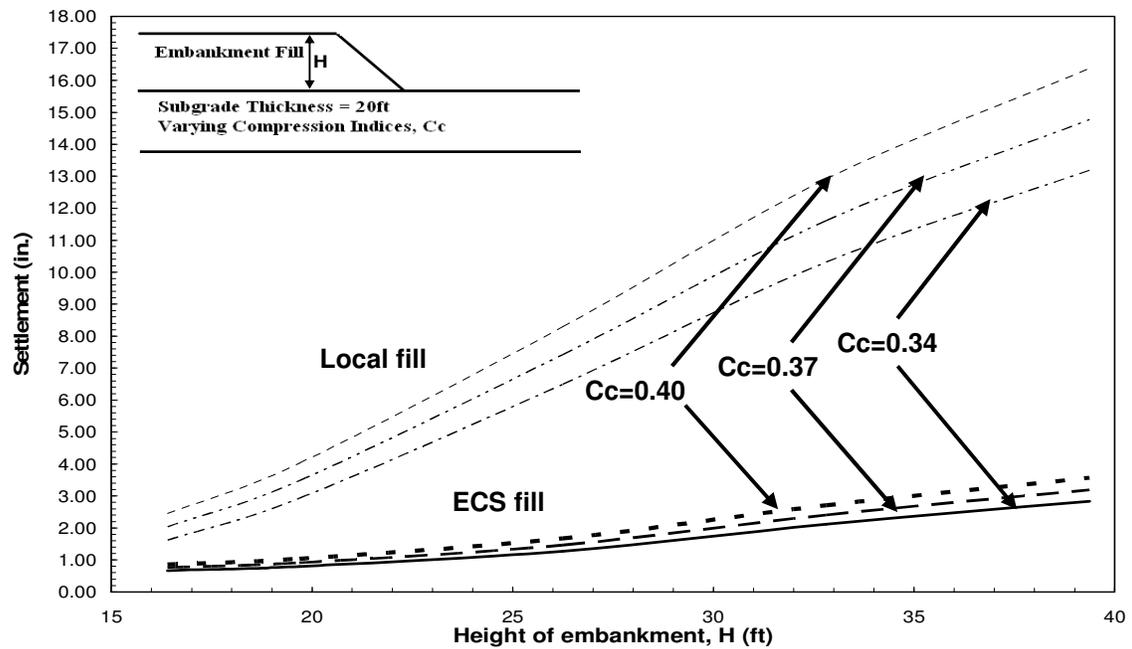
Figure 4.25 Design chart for ECS embankment with subgrade thickness 20 ft
