CONDITION ASSESSMENT OF (FRP)
FIBER REINFORCED POLYMER
STRENGTHENING OF BRIDGE
COMPONENTS

MASTER OF SCIENCE IN CIVIL ENGINEERING

THE UNIVERSITY OF TEXAS AT ARLINGTON

December 2014

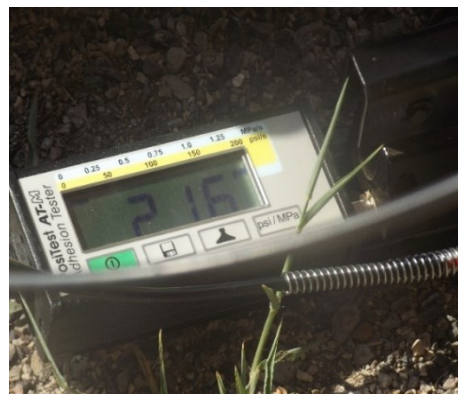
Figure 4-11 Failure stress observed after pull off test

After allowing the Loctite epoxy to cure for 22 hours and the Pull-Off tests were performed on the following day. The central grip of the Positest adhesion tester was connected to the loading fixture, and the force indicator was set to zero. Mechanized loading was applied until a failure occurred, or the maximum capacity of the Positest adhesion tester was reached (Figure 4-11). Figure 4-9 shows the Positest Pull-Off adhesion tester used for pulling the test dollies. If a failure had occurred, the test dolly was removed, put into a bag and labeled. The reading from the tester and a brief description of the failure were recorded for each test (Figure 4-11). The pull off test was performed by Steel Inspectors of Texas, Inc.

After the completion of pull off tests, Sika Dur 31 epoxy was used to fill the residual dents. Figure 4-12 shows the epoxy used for repairing the dents. The epoxy used for the repair was a two part Sika Dur 31, Hi-Mod Gel. One part of component B is mixed with 1 part of component A for 3 minutes with a paddle on low speed (400-600 rpm) drill until uniform in color. Once the two-part epoxy was well mixed, the primer was distributed to the repair areas using 9" rollers. The CFRP fabric was saturated by applying the epoxy to both sides of the fabric and then placed on the dents using hand pressure and rollers. Figure 4-13 shows the repaired sections after re-application of FRP.

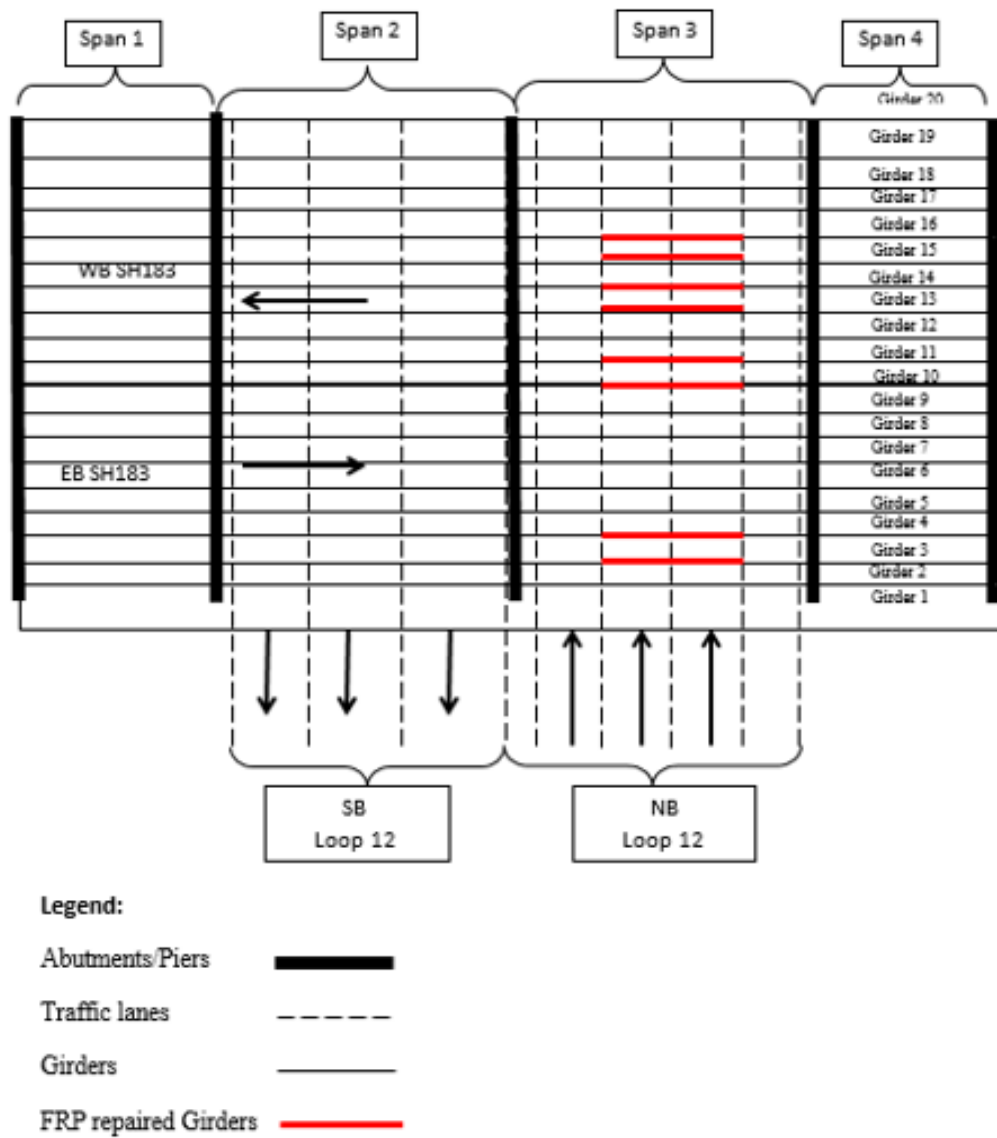
Figure 5-1 FRP strengthened girders in Bridge 1

This bridge on SH 183 across Loop 12 is located in Dallas County (Figure 5-2). As shown in Figure 5-1, seven girders (3, 4, 10, 11, 13, 14, 15 and 16) were previously repaired and strengthened with FRP on 11/06/2006. Sample locations of the Pull-Off testing are presented in Table 5-1. The test sections selected were cored on 09/14/2013. Failure of core occurred in sample 4 while core drilling (Figure 5-3). Dollies were glued in place on top of the cored areas. Temperature was around 90° F and humidity was approximately 40% when the dollies were attached. The dollies were pulled on 09/15/2013. The different types of failure modes observed after Pull-Off test are shown in Figure 5-4. The results of the Pull-Off test are presented in Table 5-1.

Sample Number	Location of Sample	Failure Stress (psi)	Failure mode per ASTM D7522
1	Girder 3, north face of bottom flange	159	F (98% E, 2% G)
2	Girder 4, north face of 45 degree chamfered portion	26	A*
3	Girder 10, north face of bottom flange	261	70% G, 30% C
4	Girder 11, south face of web	-	Core broke off in concrete while drilling
5	Girder 14, south face of bottom flange	254	10% B, 40% top coat cohesion and 50% FRP top layer to top coat adhesion

*Glue mixed incorrectly, not cured

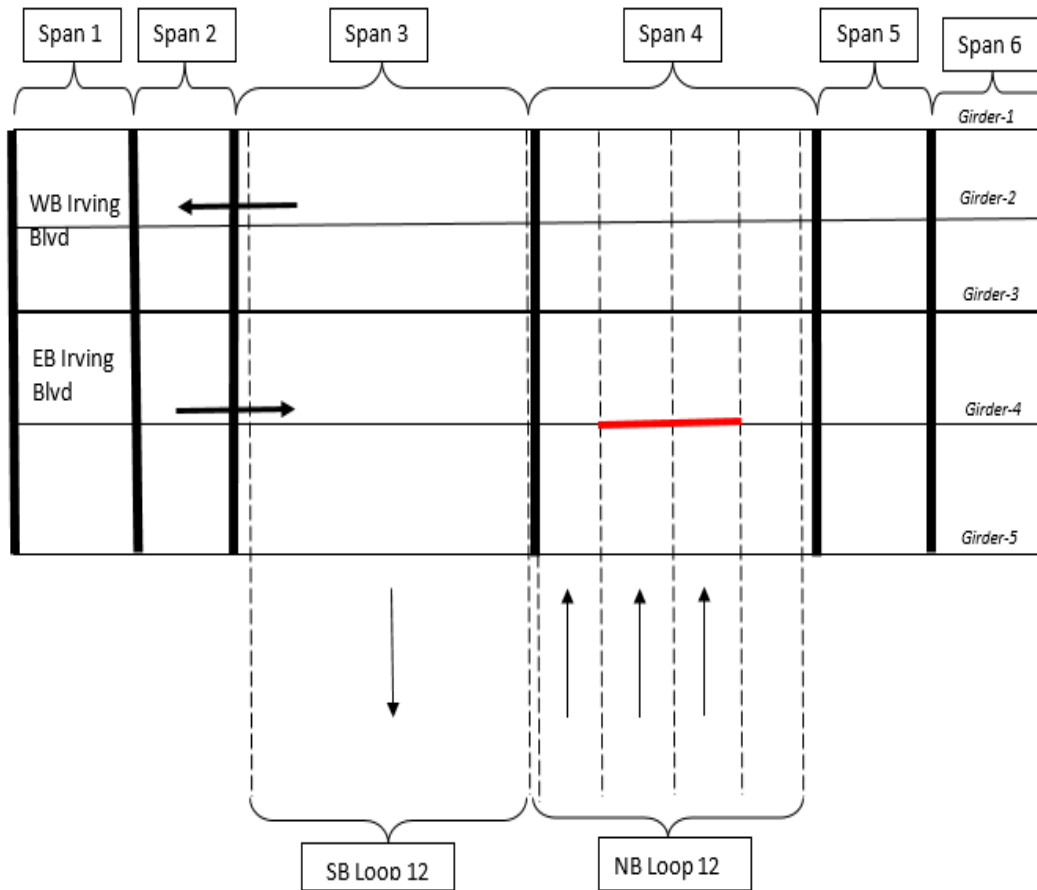
Figure 5-5 FRP repaired girders in Bridge 2

This bridge on Loop 12 across Irving Blvd. is located in Dallas County (Figure 5-6). As shown in Figure 5-5, girder 4 was previously repaired and strengthened with FRP on 07/14/2011. Locations of the Pull-Off testing are presented in Table 5-2. The test sections selected for Pull-Off strength test were cored on 09/14/2013 (Figure 5-7). Dollies were glued in place on top of the cored areas. Temperature was around 90° F and humidity was approximately 40% when the dollies were attached. The dollies were pulled on 09/15/2013 (Figure 5-8). The different types of failure modes observed after Pull-Off test are shown in Figure 5-9. The results of the Pull-Off test are presented in Table 5-2.

Sample Number	Location of Sample	Failure Stress (psi)	Failure mode per ASTM D7522
1	Girder 4, South face of web	352	100 % G
2	Girder 4, North face of bottom flange	281	A*

* Test dolly came off glue at 281 psi. When area was cleaned for repair, it was found that the glue/FRP piece was loose and the entire 2 in. circle came off in one piece at concrete level.

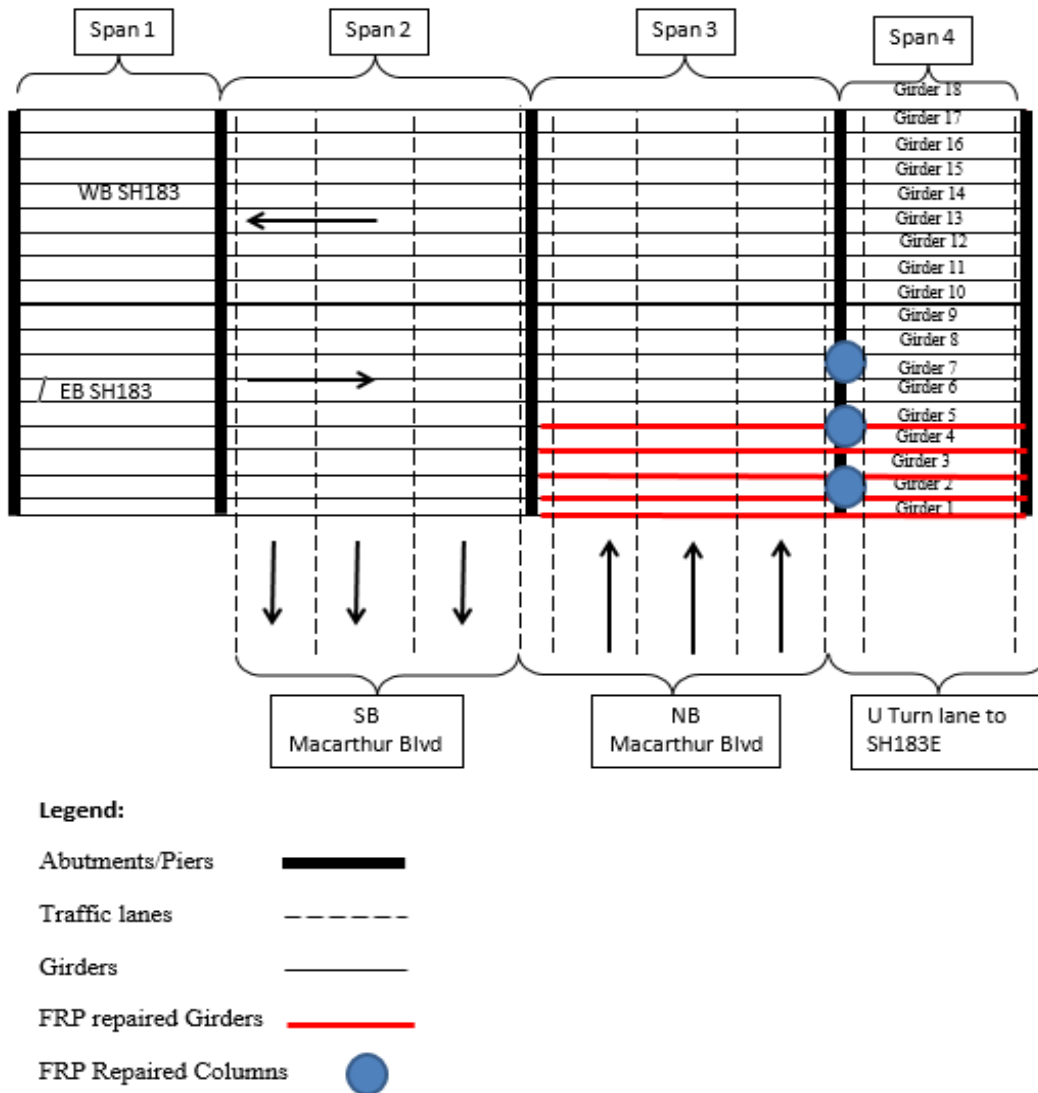
Figure 5-10 Repaired components in Bridge 3

This bridge on SH 183 across MacArthur Blvd. is located in Dallas County (Figure 5-11). As shown in Figure 5-10, four girders (1, 2, 3 and 4) and three columns were previously repaired and strengthened with FRP on 12/21/2005. Locations of the Pull-Off testing are presented in Table 5-3. The test sections selected for Pull-Off strength test were cored on 09/14/2013(Figure 5-12). Dollies were glued in place on top of the cored areas. The temperature was around 90° F and humidity was approximately 40% when the dollies were attached. The dollies were pulled on 09/15/2013 (Figure 5-13). Different types of failure modes observed after Pull-Off test are shown in Figure 5-14. The results of the Pull-Off test are presented in Table 5-3.

Sample Number	Location of Sample	Failure Stress (psi)	Failure mode per ASTM D7522
8	Girder 4, North face of web	364	100% G
9	Girder 5, Bottom face	323	100% G

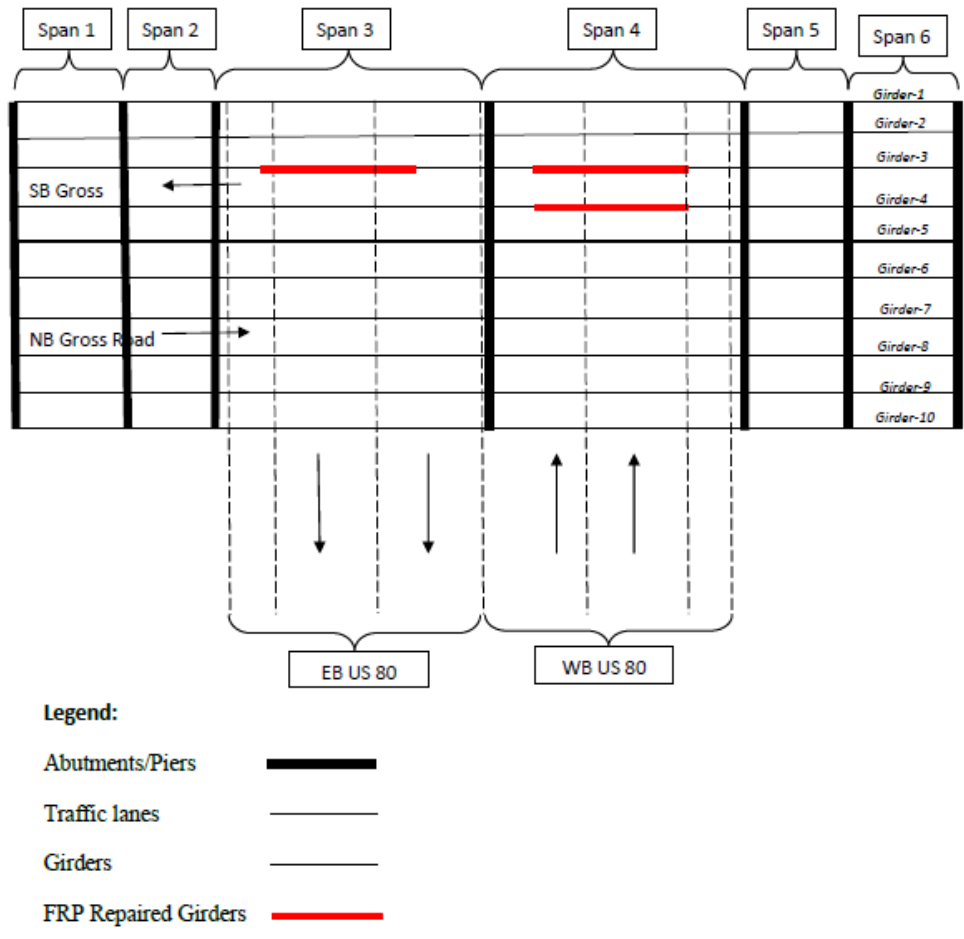
This bridge over highway U.S. 80 is located in Dallas County (Figure 5-16). As shown in Figure 5-15, girder 3 on span 3 and girders 3/4 on span 4 were previously strengthened with FRP on 03/04/2011. Locations of the Pull-Off testing are presented in Table 5-4. The test sections selected for Pull-Off strength test were cored on 10/26/2013. Dollies were glued in place on top of the cored areas. Temperature was around 60° F and humidity was approximately 70% when the dollies were attached. The dollies were pulled on 10/27/2013 (Figure 5-17). Different types of failure modes observed after Pull-Off test are shown in Figure 5-18. The results of the Pull-Off test are presented in Table 5-4.

Figure 5-15 Repaired girders in Bridge 4

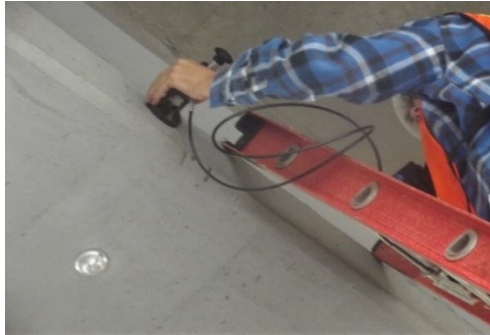
Sample Number	Location of Sample	Failure Stress (psi)	Failure mode per ASTM D7522
1	Girder 3, West face of bottom flange	352	100 % G
2	Girder 3, Bottom face	478	C (1%), G (99%)

Figure 5-17 Pull-Off test on (sample 1), girder 3, Bridge 4

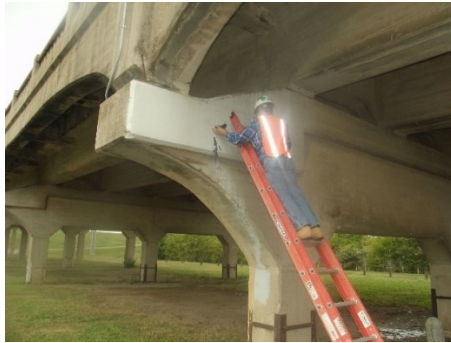
Sample Number	Location of Sample	Failure Stress (psi)	Failure mode per ASTM D7522
1	North face of pier cap	336	C (12%), G (88%)
2	South face of pier cap	372	F (5% E , 95%G)

Figure 5-21 Pull-Off test on pier cap (sample 1), Bridge 5

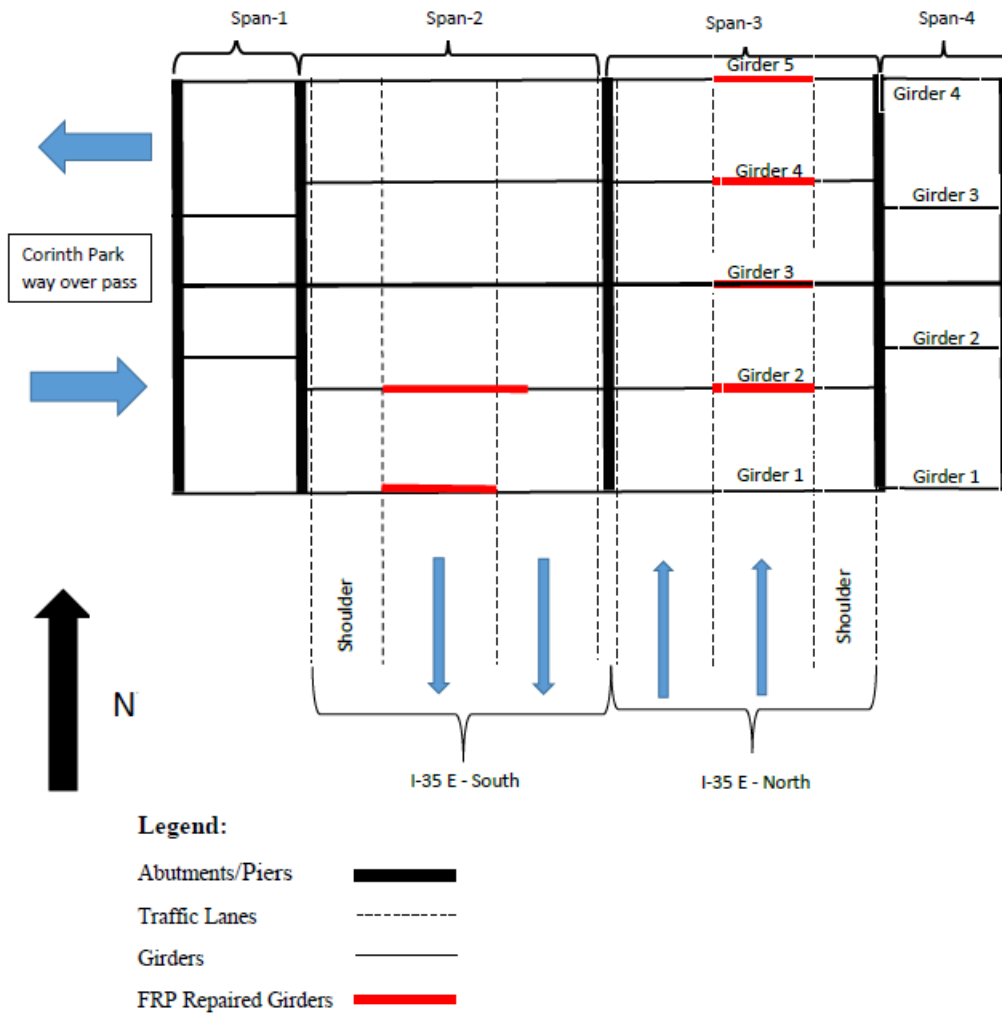
This bridge is located on IH-35E in Denton County (Figure 5-24). As shown in Figure 5-23, on IH 35E North span 3, Girders 2, 3, 4, and 5 were repaired, and on IH 35E south span 2, Girders 1 and 2 were repaired previously and strengthened with FRP on 03/08/2007. Locations of the Pull-Off testing are presented in Table 5-6. The test sections selected for Pull-Off strength test were cored on 10/26/2013 (Figure 5-25). Dollies were glued in place on top of the cored areas. Temperature was around 60° F and humidity was approximately 70% when the dollies were attached. The dollies were pulled on 10/27/2013. Different types of failure modes observed after Pull-Off test are shown in Figure 5-26. The results of the Pull-Off test are presented in Table 5-6.

Figure 5-23 Repaired girders in Bridge 6

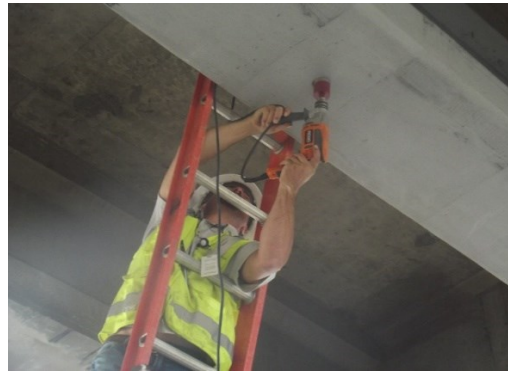
Sample Number	Location of Sample	Failure Stress (psi)	Failure modes per ASTM D7522
1	Girder 2, South face of web	416	A (40% Glue to dolly, 5% FRP finish coat adhesion, 55% glue to finish coat adhesion)
2	Girder 4, South face of bottom flange	239	F (20% G, 80% E at grout to concrete adhesion)
3	Girder 4, Bottom face	-	Core broke off in concrete while drilling
4	Girder 4, Bottom face	278	100 % G

Figure 5-25 Core drilling (sample 3) in girder 4, Bridge 6

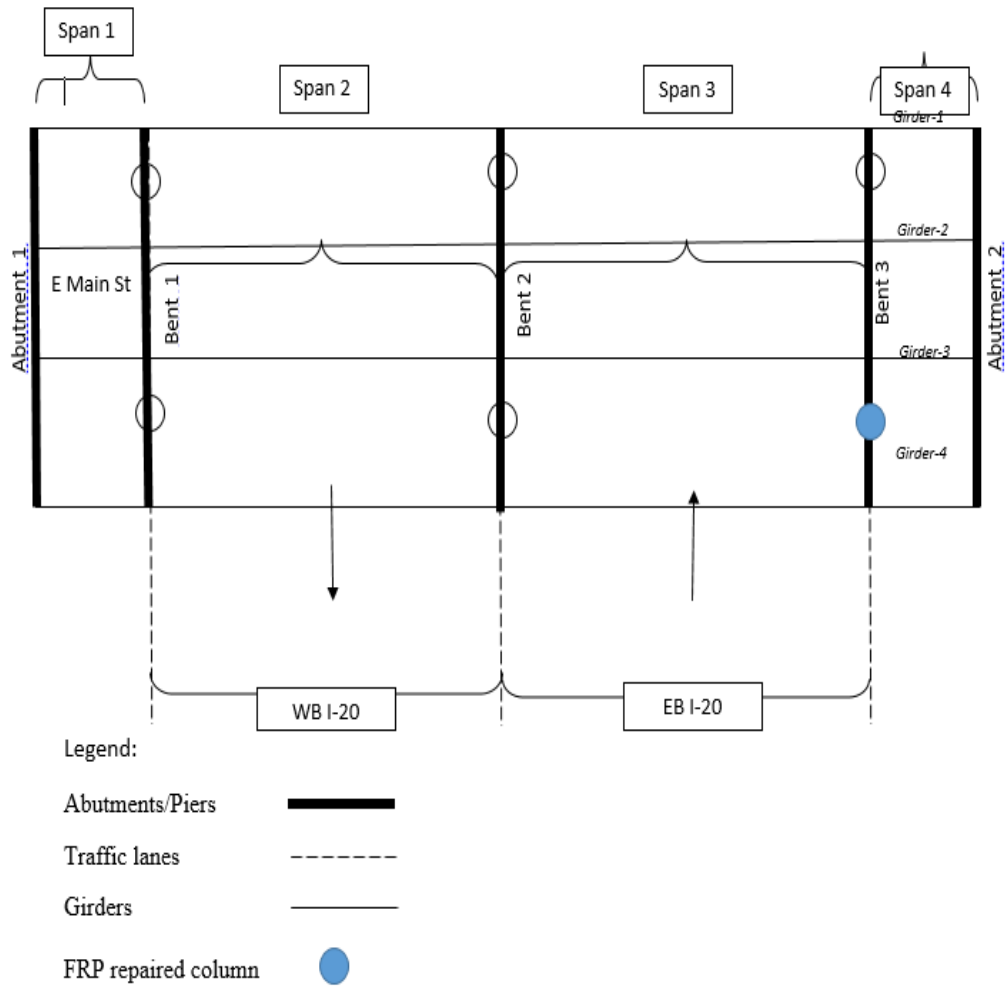
This bridge is located in Parker County (Figure 5-28). As shown in Figure 5-27, only one column was repaired previously and strengthened with FRP on 09/01/2007. Locations of the Pull-Off testing are presented in Table 5-7. The test sections selected for Pull-Off strength test were cored on 12/17/2013 (Figure 5-29). Dollies were glued in place on top of the cored areas. Temperature was around 60° F and humidity was approximately 40% when the dollies were attached. The dollies were pulled on 12/18/2013 (Figures 5-30). Different types of failure modes observed after Pull-Off test are shown in Figure 5-31. The results of the Pull-Off test are presented in Table 5-7.

Figure 5-27 Repaired components in Bridge 7

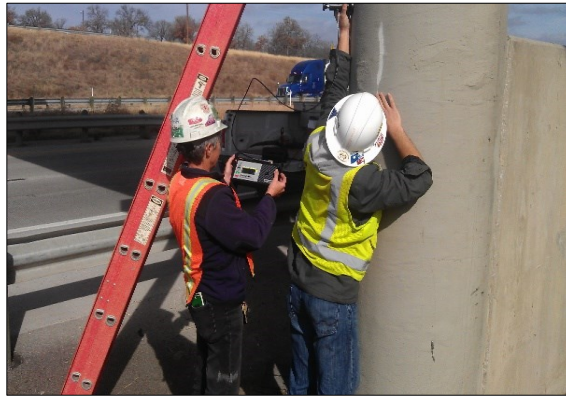
Sample Number	Location of Sample	Failure Stress (psi)	Failure mode per ASTM D7522
1	Top of 1 st column	156	100% G
2	Middle of 1 st column	290	100% G
3	Bottom of 1 st column	294	100% G

Figure 5-30 Pull-Off test on sample 1 in column 1, Bridge 7

Large variation in the bond strength was witnessed. For example, for Bridge 7, failure stress of sample 1 was 156 psi, whereas the failure stresses of other two samples are 290 psi and 294 psi. It is worth noting that all three pull-off tests showed the desirable Mode G failure. Likewise in Bridge 3, sample 1 failed in mixed mode (A and B) with a failure stress of 261 psi, whereas sample 3 failed in Mode G type with failure stress of 177 psi. The reasons for this inconsistent failure stress pattern might be the improper application of FRP at the time of repair and variations in the depth of core cut before attaching dollies, which in turn might have affected the Pull-Off test failure stress.

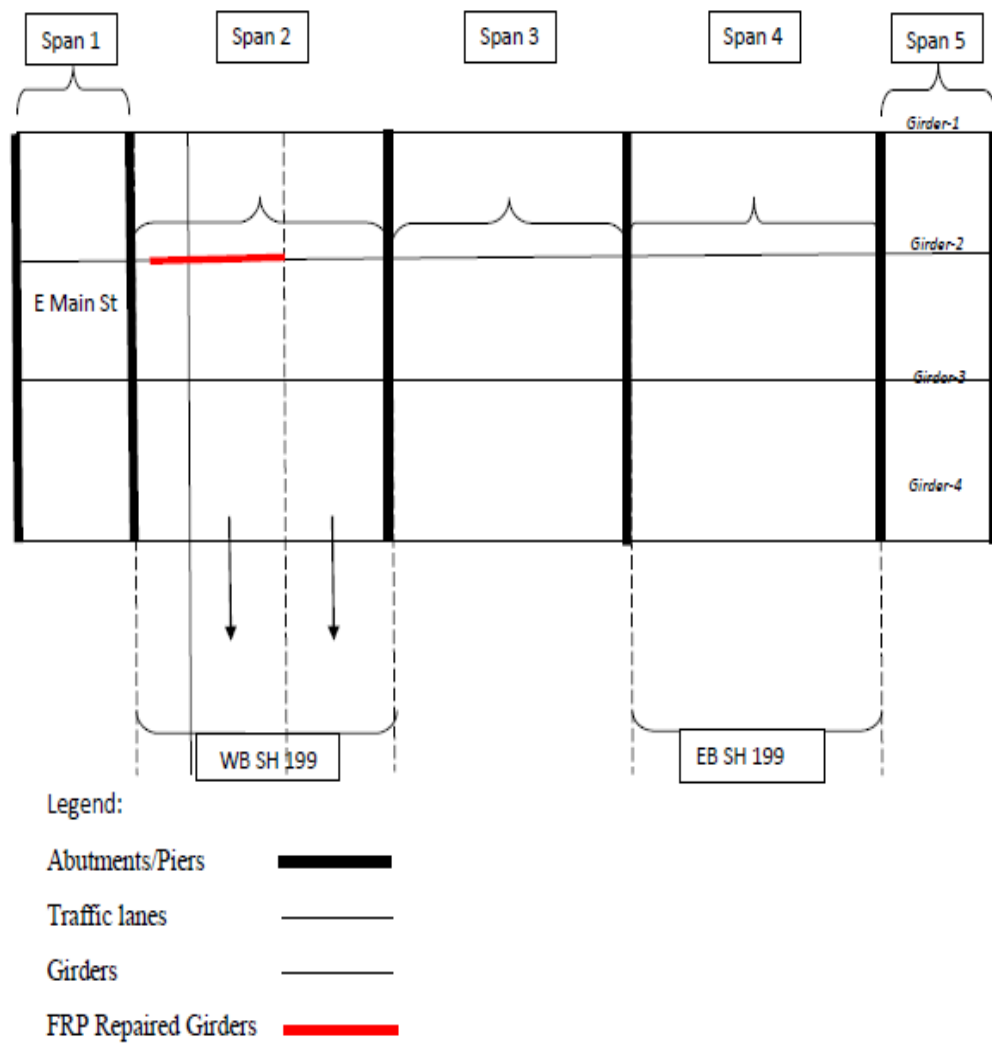
This bridge is located in Tarrant County (Figure 5-33). As shown in Figure 5-32, only one girder (#2) was repaired previously and strengthened with FRP on 10/01/2008. Locations of the Pull-Off testing are presented in Table 5-8. The test sections selected for Pull-Off strength test were cored on 12/17/2013. Dollies were glued in place on top of the cored areas. Temperature was around 60° F and humidity was approximately 40% when the dollies were attached. The dollies were pulled on 12/18/2013 (Figure 5-34). At the time of Pull-Off test on the dollies, the gauge stopped at maximum Pull-Off pressure (480 psi) of the adhesion tester without any rupture (Figure 5-35). The dollies were detached manually by gentle hammering. Different types of failure modes observed after Pull-Off test are shown in Figure 5-36. The results of the Pull-Off test are presented in Table 5-8.

Figure 5-32 Repaired girder in Bridge 8

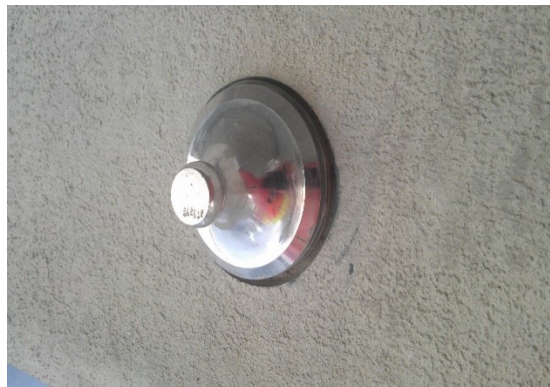
* Gauge stopped at maximum Pull-Off pressure of the adhesion tester for 50 mm dolly.

Figure 5-35 Unfailed sample 2 after reaching maximum pressure of the tester, Bridge 8

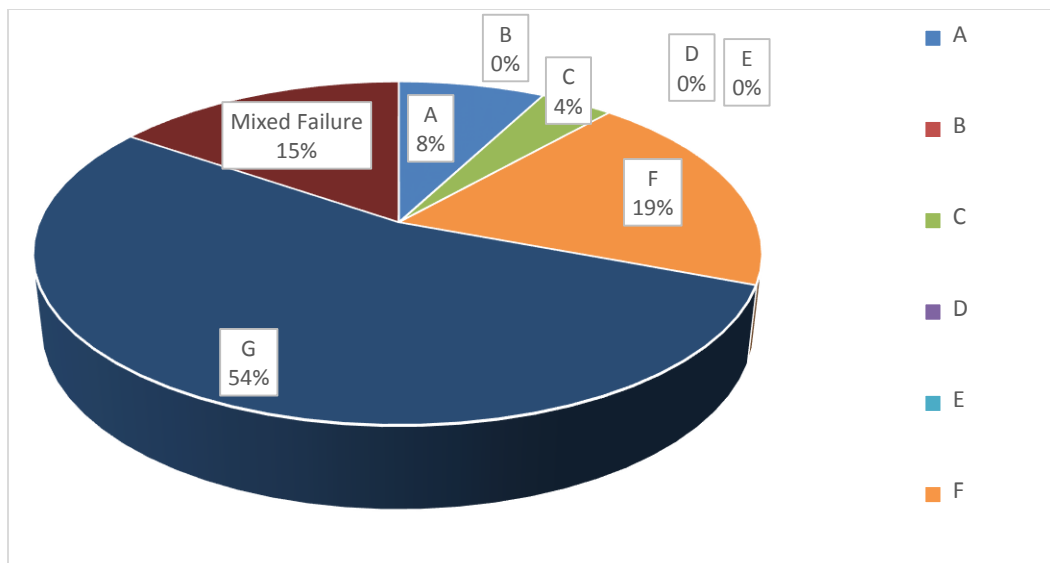
A total of 29 test sample sections were selected for the Pull-Off test from various FRP strengthened sections on the eight selected bridges. Three of the samples failed in the core while scouring the FRP laminate before attaching the dollies. The summary of Pull-Off test results is presented in Figure 5-37 and Table 5-9.

The predominant failure mode observed was a cohesive concrete failure, also known as Mode G per ASTM D7522, in 14 samples (53.84%) out of 26 total samples. The mean and standard deviation of the Pull-Off test results are 290.23 psi and 120.51 psi respectively. A considerable amount of concrete remained bonded to the test dolly after failure in these samples. The amount of concrete that remained bonded to the test dollies varied. Strengths ranged from as low as 26 psi to as high as 480 psi. Large variations in the bond strength results were witnessed. In two of the samples, failure Mode A (bonding epoxy failure at loading fixture) was observed. Five test samples failed in Mode F (mixed cohesive failure in the substrate and epoxy failure at the epoxy/substrate interface). Four samples failed in mixed failure modes (i.e. combination of two or more failure modes). The concrete bonded to the test dollies was spotty, very thin, and contained no coarse aggregate.

Possible reasons that may have caused non-G type or mixed type of failures are as follows:

- a. Improper application of FRP strengthening at the time of repair.
- b. Experimental errors (Misalignment between the circular loading fixture and the adhesion tester, improper surface preparation and improper curing of bonding epoxy).

- c. Application of FRP strengthening at a non-standard temperature or relative humidity.
- d. Degradation of bond strength between CFRP laminate and concrete substrate over time due to environmental conditions.
- e. Reduction in the FRP quality due to aging.
- f. Improper preparation of the testing surface, such as the presence of moisture as well as torsional and thermal stresses applied during the core drilling process, and variations in the depth of the core cut.

Figure 5-37 ASTM Failure modes from Pull-Off tests

None of the five test samples in Bridge 1 failed in Mode G and the failure modes varied from A through F, which suggest that the bond between FRP and concrete substrate either weakened with time due to various factors, or improper application of FRP. Apart from Bridge 1, majority of samples in all other bridges failed in the desirable Mode G.

However, the Pull-Off strengths were low in some of the samples, indicating the presence of damage to the FRP-concrete bond. The minimum failure stress specified for a Pull-Off test is 200 psi (Master Builders, 1993), and 23% (6 of 26) of the test results fell below this level. In Bridge 8, the gauge of the adhesion tester reached the maximum capacity (480 psi) before any failure. The samples were detached manually by gentle hammering. The bridge was not very old, and the bond between FRP and concrete was possibly strong.

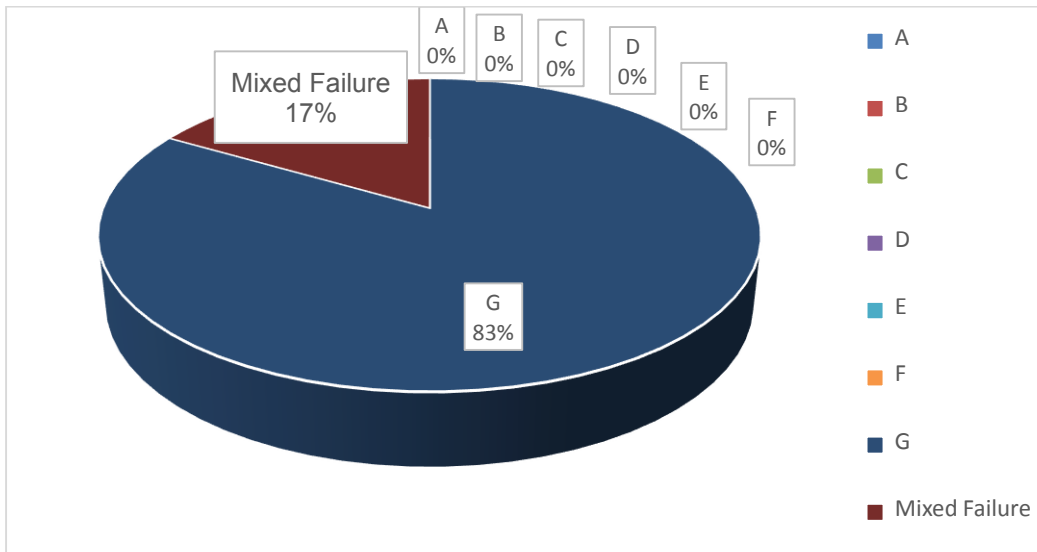
A total of seven samples from various locations of FRP strengthened columns were tested (Table 5-9). One of the samples from Bridge 3 failed in core during the scoring process and could not be evaluated. Strengths after Pull-Off test ranged between 156 psi and 294 psi. The mean and standard deviation of the Pull-Off test results are 240.5 psi and 59.71 psi respectively. The dominant failure mode observed in the majority of samples (5) was type G (83.3%). The other sample failed in mixed mode. The results of Pull-Off tests on columns are presented in Figure 5-38.

Figure 5-38 Failure modes in FRP strengthened columns

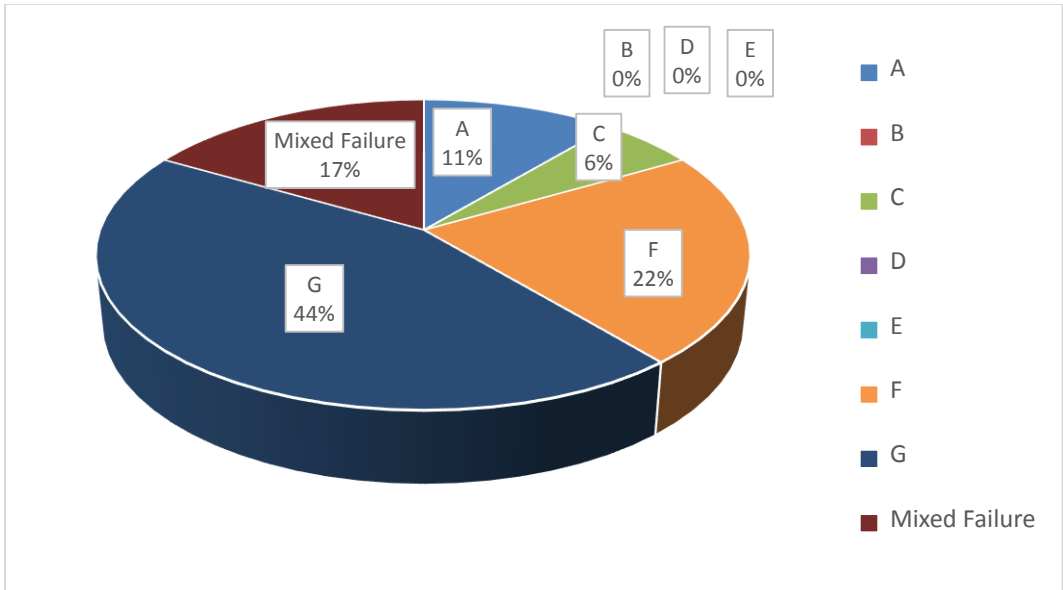
A total of 22 samples were tested from various locations on FRP strengthened girders. Two samples failed in the core during the scoring operation. The pre-dominant failure mode observed was type G (44%). The results were scattered, with failure modes varying from Mode A through Mode G. Pull-Off strengths ranged between 26 psi to 480 psi. The mean and standard deviation of the Pull-Off test results are 299 psi and 140 psi, respectively. The results are presented in Figure 5-39. The high standard deviation shows the large scatter in the obtained results. Unlike the slight variations in failure stress patterns observed in columns, large variations in the failure stresses for samples failing in the similar mode was witnessed.

The percentage of samples failing in Mode G (44%) was less, compared to columns (83%). The probable reasons for this are:

- a. Improper application of FRP. Application of FRP on girder surfaces is more difficult (due to various sides and accessibility issues) than application on columns.
- b. The depth of core cut prior to attachment of dollies was not uniform in all the samples which might have affected the failure stress.

Figure 5-39 Failure modes in FRP strengthened girders

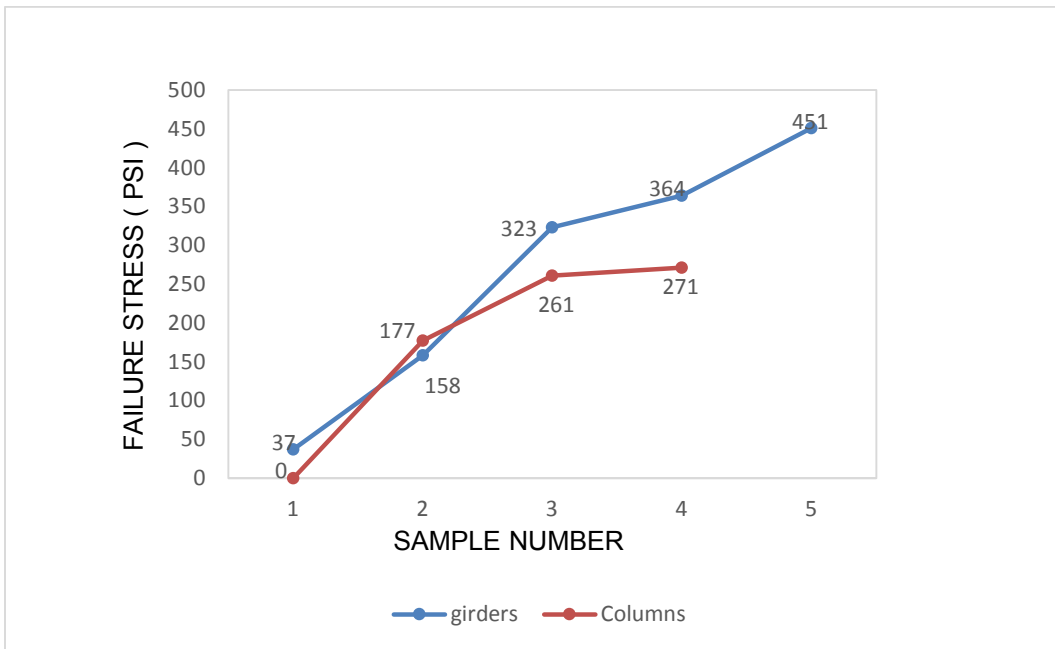
Sample Number	Location of sample	Failure Stress (psi)	Average Failure Stress (psi)	Failure Mode
1	Column	261	236	25% B, 75% top coat cohesion
2	Column	177		100% G
3	Column	0		Core broke off
4	Column	271		100% G
5	Girder	37	266	100% C
6	Girder	158		F (10% E, 90% G)
7	Girder	451		F (80% E, 10% G and 10% top coat to FRP adhesion)
8	Girder	364		100% G
9	Girder	323		100% G

The failure stresses for CFRP strengthened Girders and Columns in Bridge 3 are plotted in Figure 5-40.

Figure 5-40 Variation of failure stresses in girders and columns, Bridge 3

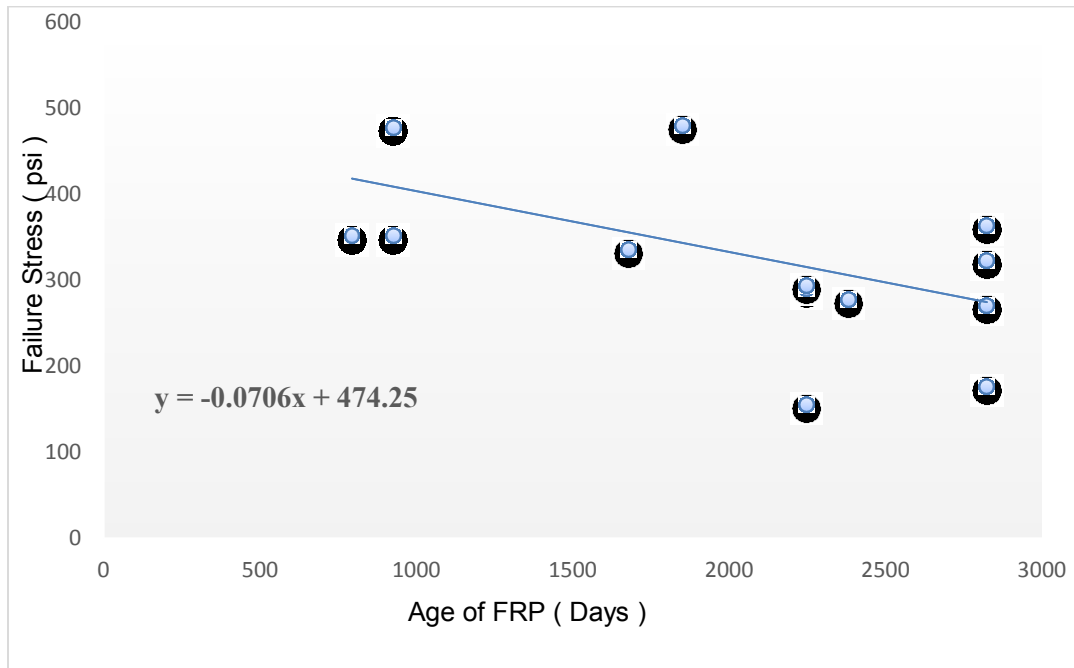
- a. It is evident that, with the increase of FRP age, the bond strength decreased, and the mode of failure changed from G to other types. The strength values for all Mode G failures are plotted as a function of FRP age in Figure 5-41. The best fit trend line is also plotted, and the trend line equation is shown ($x = \text{age}$, $y = \text{strength}$). The equation can be conveniently used to predict the Pull-Off strength of FRP strengthening on concrete.

Figure 5-41 Relationship between FRP age and strength in Mode G type of failure

- b. Failure stress of sample with FRP age of 926 days was observed to be 478 psi whereas the sample with FRP age of 2825 days was only 177 psi. A decrease of 62.9% in the failure strength of FRP is observed. A possible explanation for this reduction is the degradation of bond strength between CFRP laminate and concrete substrate over time due to the effect of environmental conditions.
